RE: Complaint Follow-up Site Visit at 7th Avenue Service on August 3, 2010

ERTS – Internal Site Visit Report

ERTS # 620637	Facility or Site name 7th Avenue Service, LLC	Date of site visit August 3, 2010
RCRA Site ID # None	Site address 701 S. Jackson Street Seattle WA 98104-3011	Site website
Site phone # 206 622-6511	Site contact Patrick Abe	Site contact e-mail

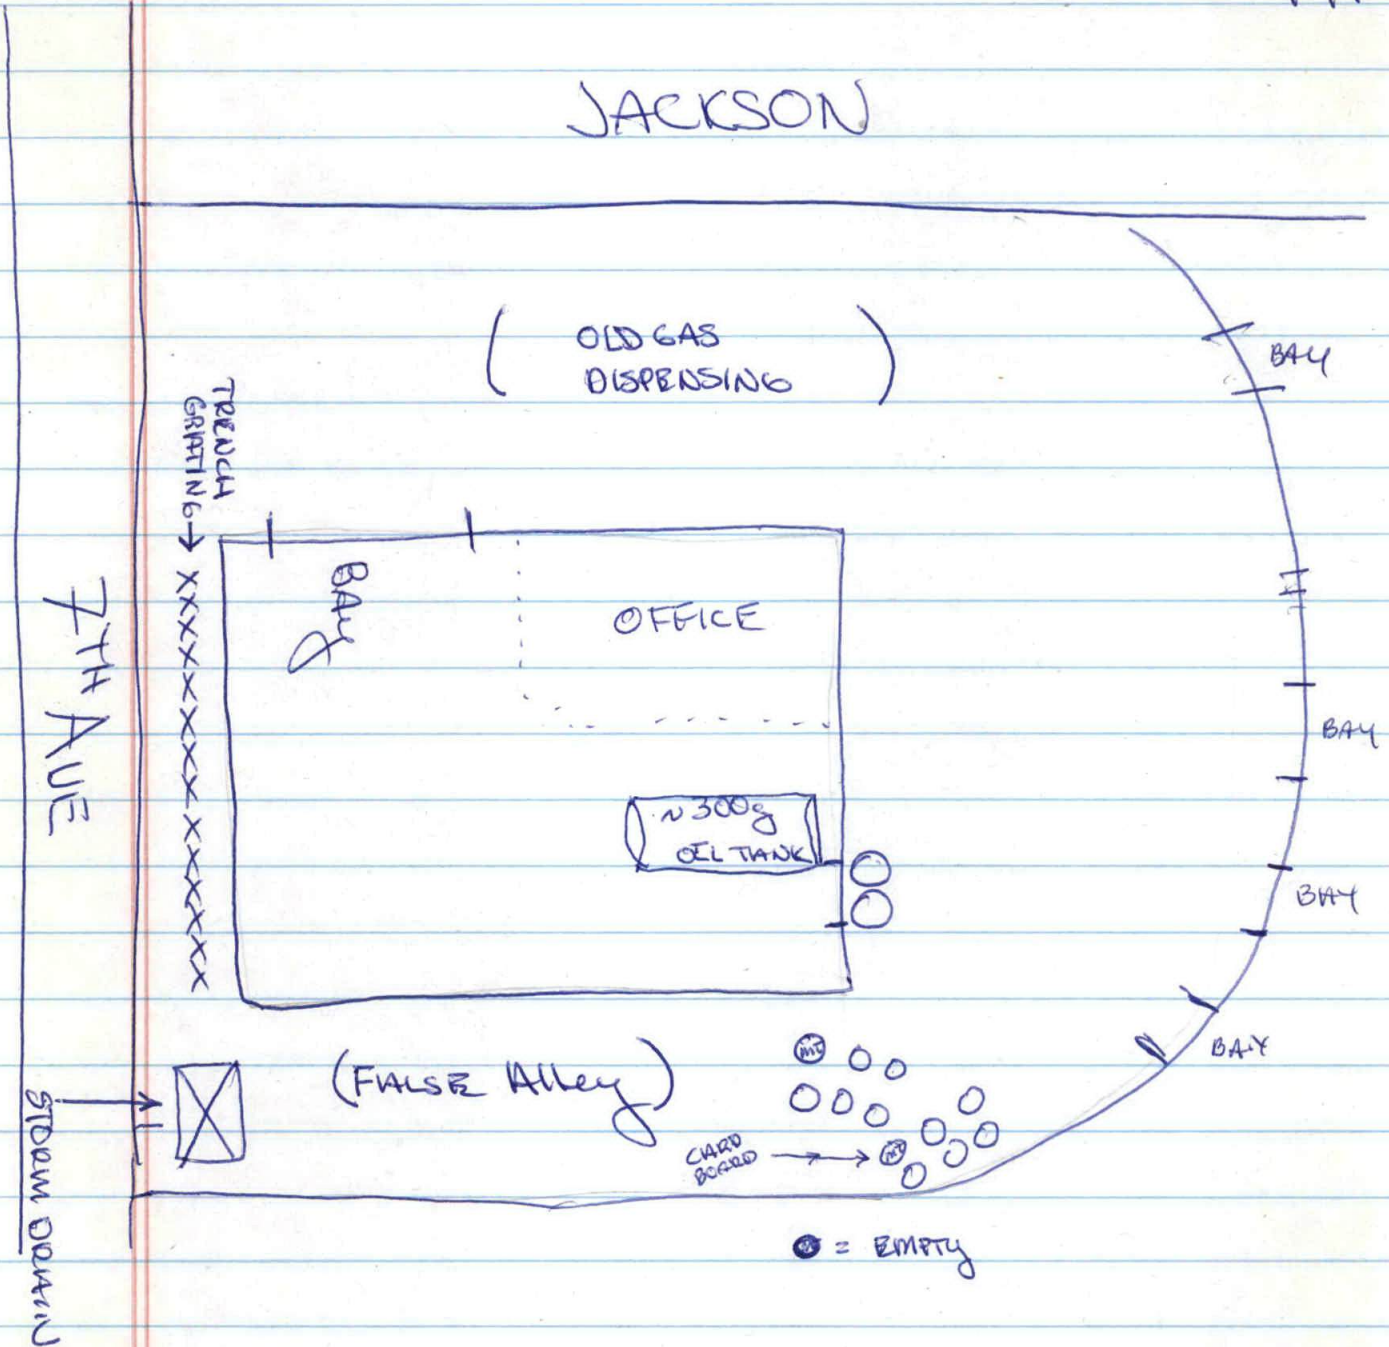
JACKSON

On August 3, 2010, Warren Walton and I (Trudy Harding) went to the property on S. Jackson St. to look at the drums Mr. Autry spoke about in his initial ERTS call. We found twelve unlabeled, full drums and two empties located in a false alley parallel to Jackson St and Mr. Warren numbered those drums. We noted this site is an old gas station but no longer dispenses gas but does do vehicle servicing (LOFs) and some minor repairs. There was also a For Sale sign on the top of the building.

1. Label drums appropriately as "hazardous waste", "regulated solid waste" or as "waste pending analysis". Label with an accumulation start date.
2. Designate and dispose of dangerous waste accumulated in containers. Designate all residues and cleanup waste as required in WAC 173-303-070, and properly dispose of them. Provide

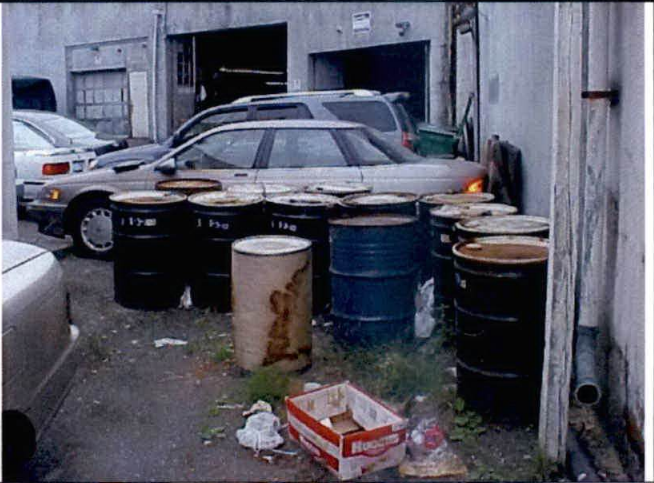
Area & Description	Photographs
<p>#1</p> <p>Partial Alley leading to 7th Ave</p> <p>Overview of 10 of 12 full – unlabeled drums.</p> <p>Two empty metal drums and one empty cardboard drum.</p>

A photograph showing a narrow alleyway between a building and a parked car. In the foreground, there are several large metal drums (barrels) of various colors (black, blue, brown). Some are full, and some are empty. A cardboard box is on the ground. The alleyway leads towards a building with a large open bay door.
<p>#2</p> <p>Partial Alley leading to 7th Ave</p> <p>Drums numbered 1 and 2 plus marked empty drums.</p>

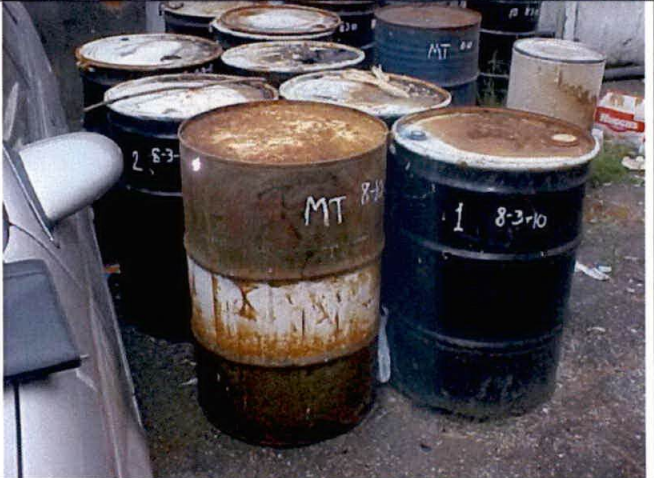
A close-up photograph of several metal drums in the alleyway. Two drums in the foreground are clearly marked with white paint. One drum has 'MT 8-3' written on it, and another has '1 8-3-10'. There are other drums in the background, some with 'MT' markings.

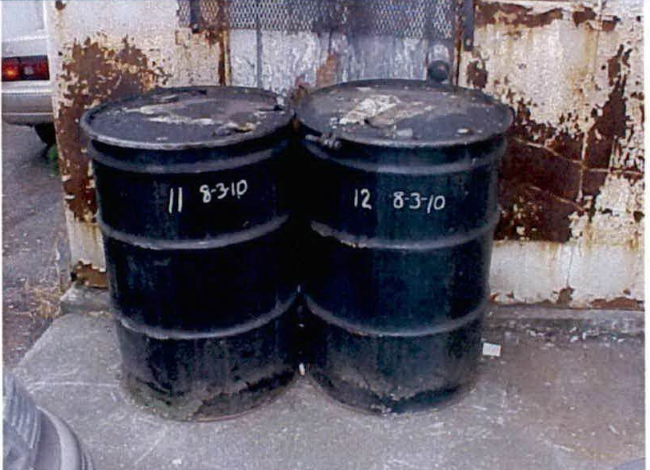
Area & Description	Photographs
<p>#6</p> <p>Side of Main Building, looking toward 7th Ave</p> <p>Drums numbered 11 and 12 sit in front of door on east side of office building.</p>

A photograph showing two black metal drums sitting on a concrete step in front of a building. The drum on the left is marked with the number '11' and the date '8-3-10'. The drum on the right is marked with the number '12' and the date '8-3-10'. The building behind them has a rusted metal mesh fence.
<p>#7</p> <p>Partial Alley leading to 7th Ave</p> <p>Staining around the building was somewhat common. Owner at this location since 1972.</p>

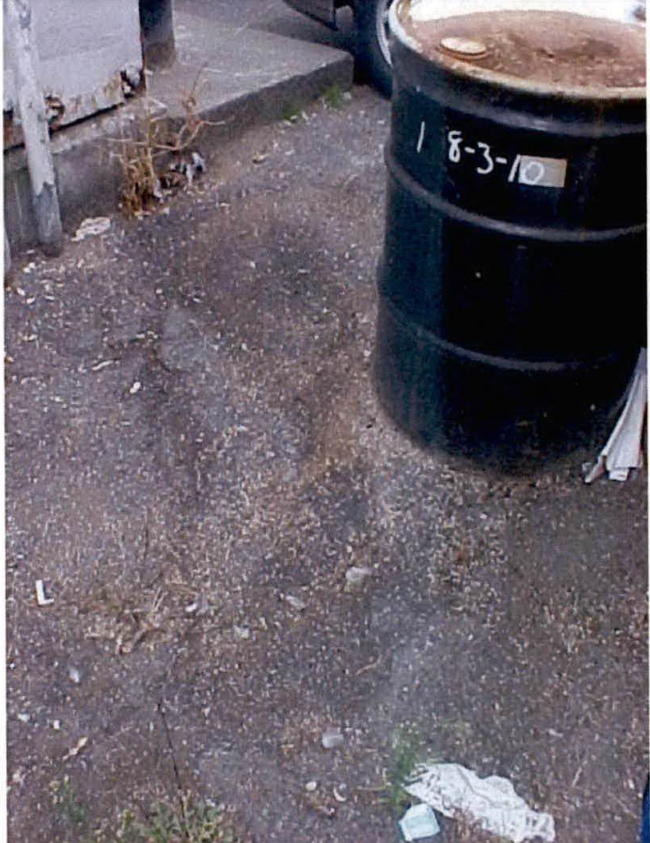
A photograph of a black metal drum in an alleyway. The drum is marked with the number '1' and the date '8-3-10'. The ground is gravel and dirt, and there is some debris and staining visible. A concrete step is visible in the background.

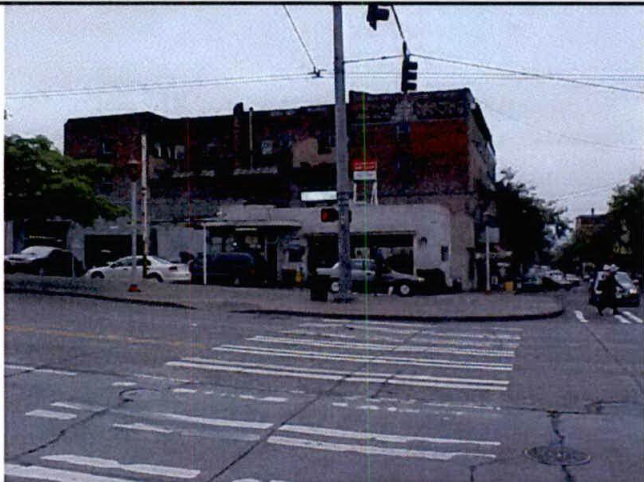
Area & Description	Photographs
<p>#8</p> <p>Overview</p> <p>Garage photo from across Jackson Way. Drums are behind the building and to the left of this picture</p>

A photograph showing a street intersection. In the background, there is a multi-story building with a red facade. A traffic light pole is visible in the foreground. The street has a crosswalk with white stripes.
<p>#9</p> <p>Along 7th Avenue</p> <p>Looking along west side of building. Alley begins where the car is (in center).</p> <p>Drain leads to catchment basin (next photo).</p>

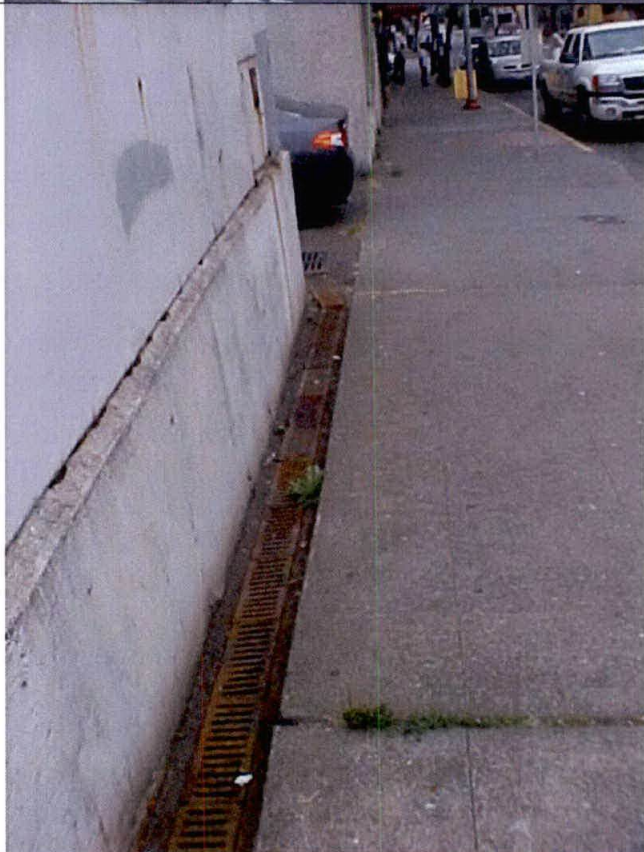
A photograph of a narrow alleyway. On the left is a white concrete wall. A dark car is parked in the center of the alley. A metal drain grate is visible in the foreground, running along the wall. The alleyway leads to a street with parked cars and a yellow traffic cone.

- It is the responsibility of site operators (or business owners) to ensure that no solid or liquid wastes are migrating offsite into stormwater conveyances such as the trench and storm drain paralleling 7th Avenue. Activities such as routine sweeping and immediate clean up of minor spills should be established at your site.

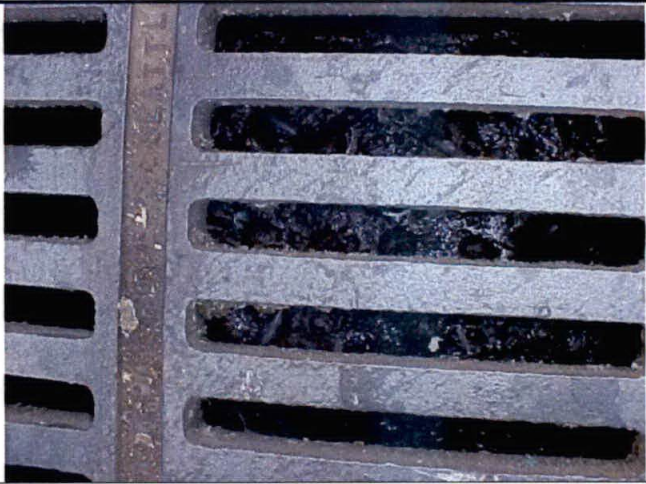
Area & Description	Photographs
<p>#10</p> <p>Along 7th Avenue</p> <p>Catchment basin on south side of building between alley and street. Depth of basin unknown, but clearly there is mud and debris in the bottom.</p>
