**UST Closure Services  
Issaquah Plant  
611 Front St N.  
Issaquah, WA 98027**

January 24, 2012

**G-Logics Project 01-0779-A  
Copyright 2012 G-Logics, Inc.  
All Rights Reserved**

**Subject: UST Closure Services  
Issaquah Plant  
611 Front St N.  
Issaquah, WA 98027**

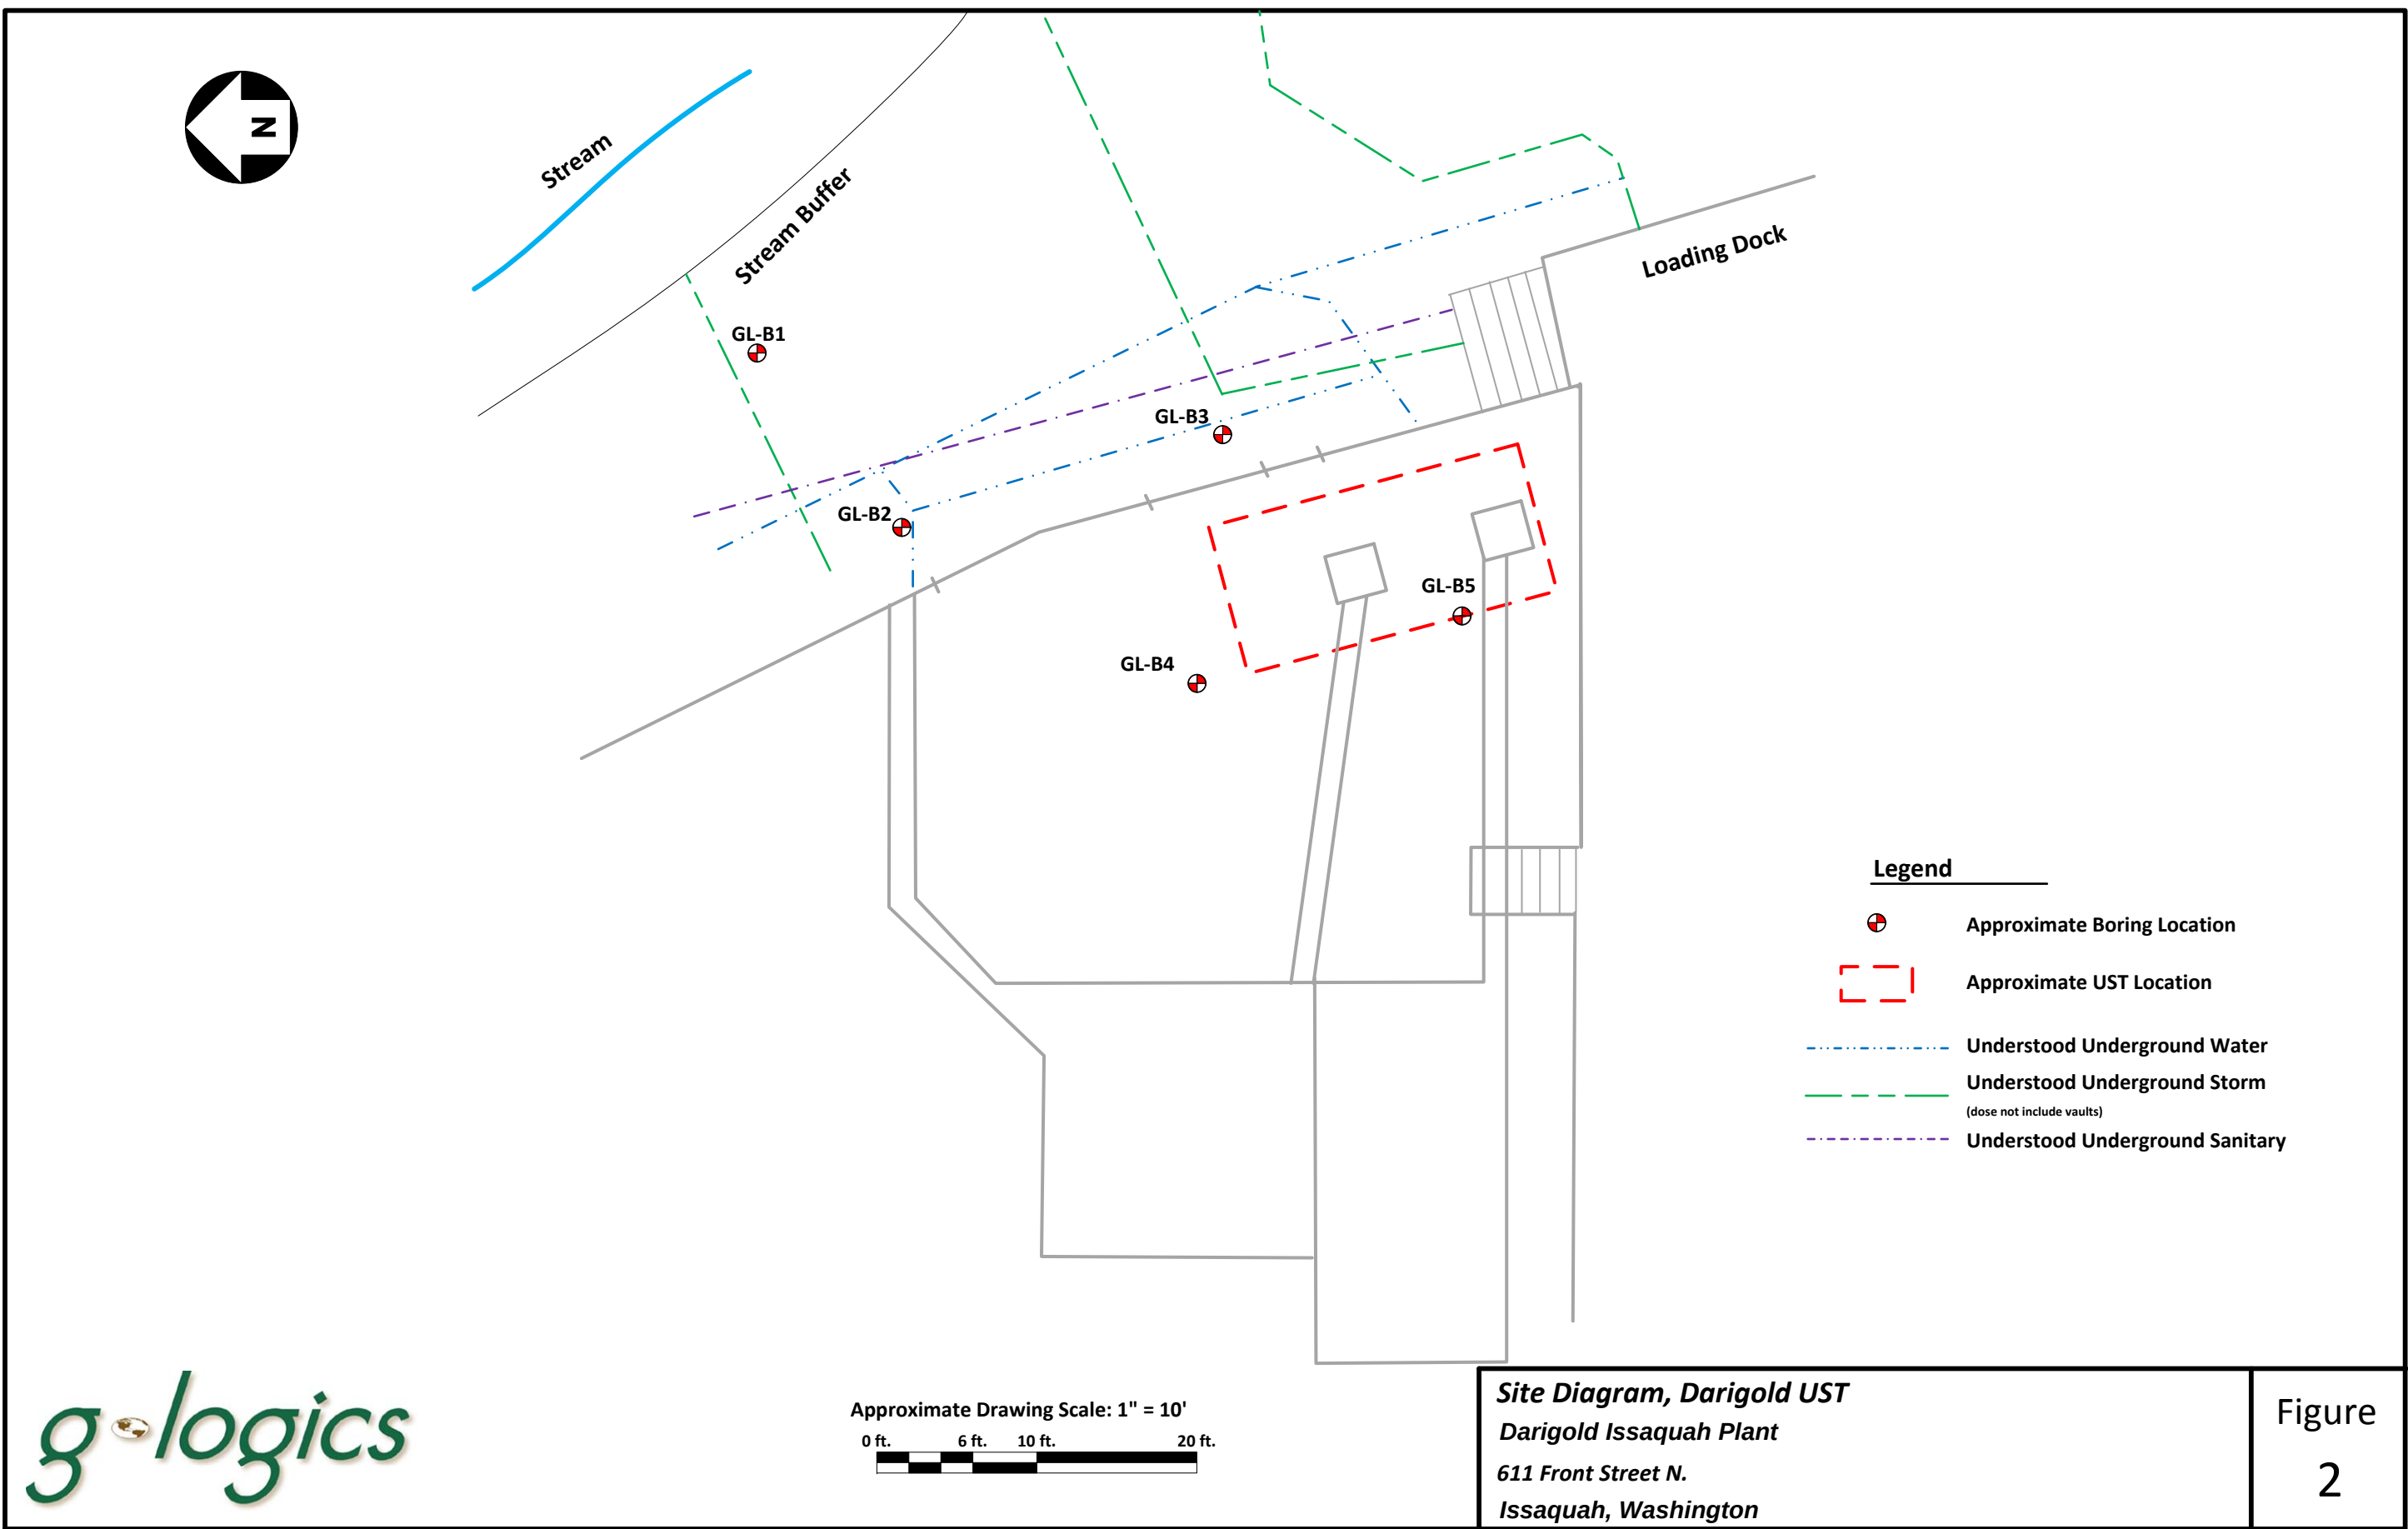
Figure 2 – Site Diagram, Tank Removal Soil Samples

A G-Logics UST Site Assessor conducted the subsurface investigation and sample collection. Ten soil samples were collected from five borings located near the UST (see Figure 2 for boring locations). Shallow groundwater was not discovered in the completed borings. Borings were advanced using an air knife and vactor truck due to the presence of many underground utilities. Diesel odors were not detected in any of the subsurface borings. Soil samples were retrieved using a hand-operated auger. Descriptions of the soils encountered are presented on the boring logs in Appendix B.

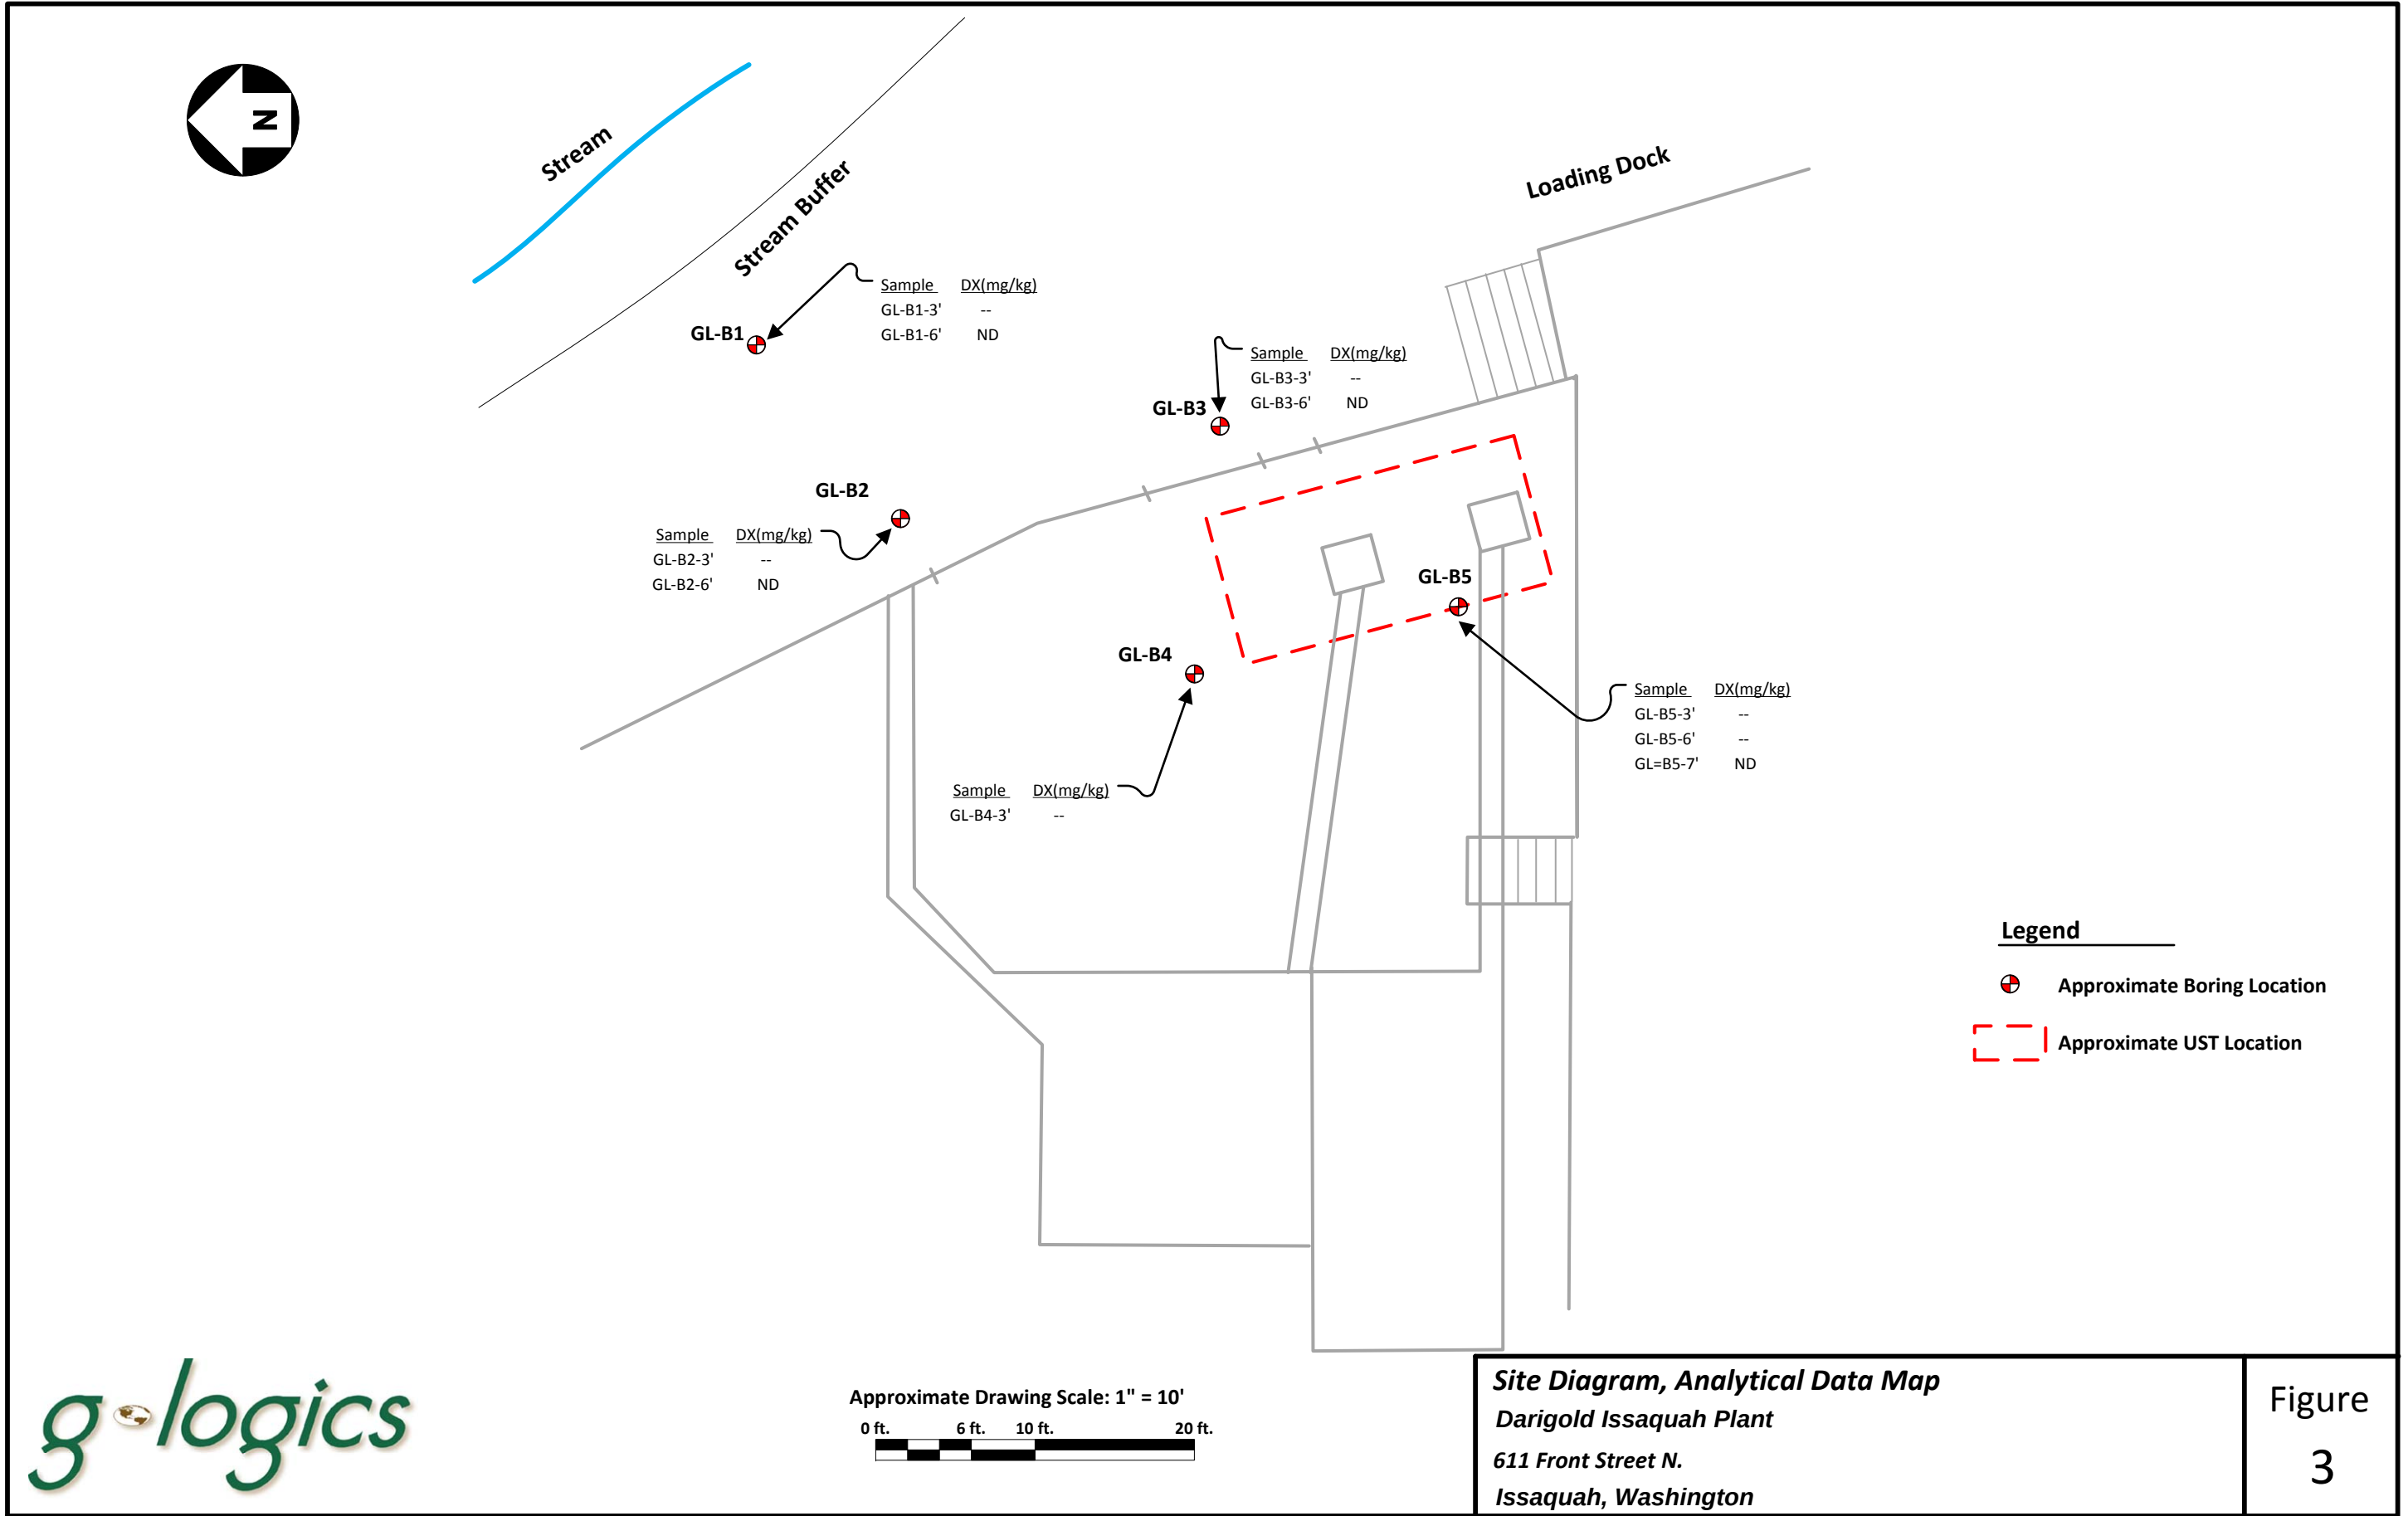
Figure 3 – Site Diagram, Analytical Data Map

A G-Logics site assessor was present during the UST decommissioning and performed the subsurface exploration. Particular attention was given to noting visible evidence of staining, discoloration, odors, or other relevant factors indicative of a release of diesel fuel. Soils were classified in accordance with the Unified Soil Classification System. Boring logs are attached as Appendix B with locations shown on Figure 3.

Four representative samples collected were analyzed for diesel with no detections reported. Libby Environmental, an Ecology-accredited laboratory located in Olympia, Washington, performed the analytical testing. The results of laboratory analysis are summarized in Table 1. The laboratory report and chain-of-custody documentation are presented in Appendix F.

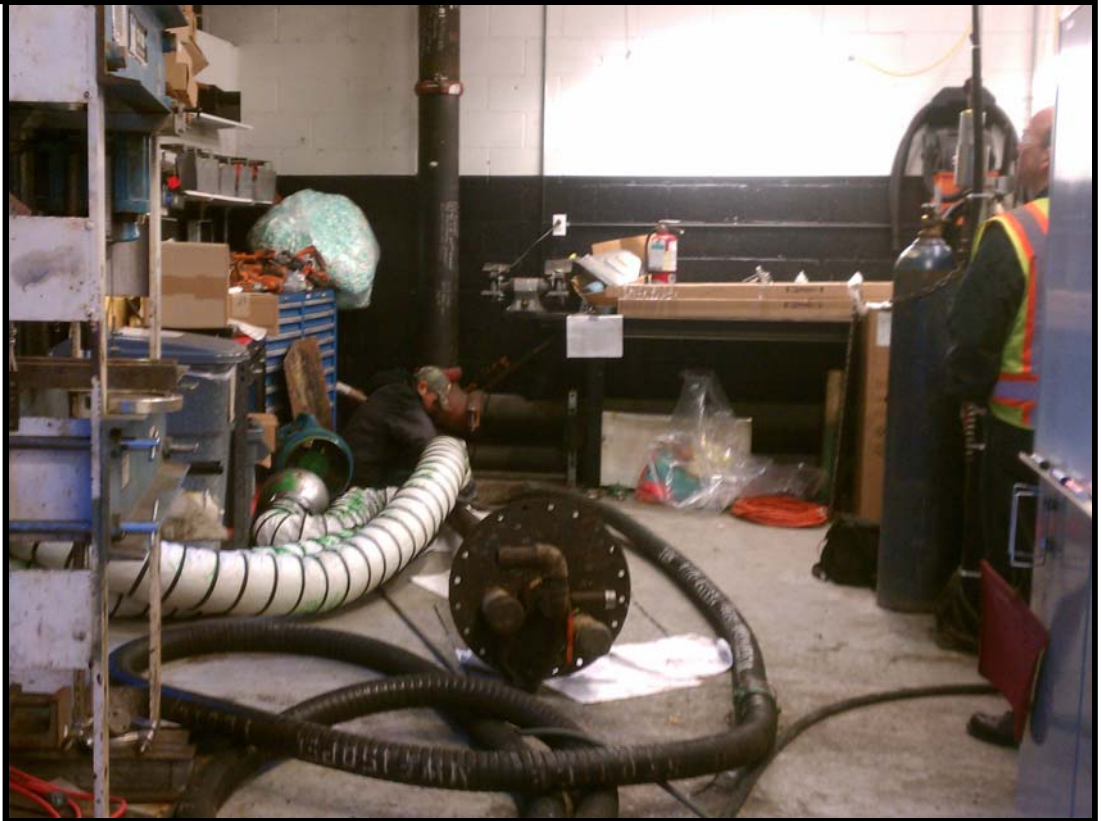
On December 27, 2011, the UST was triple rinsed by Washington Marine Services and Kleen Environmental (Photos 1 & 2). Approximately 1,000 gallons of rinse water and sludge material was removed from the tank and transported offsite to Emerald Services in Seattle, Washington. The USTs were observed to be in good condition with no evidence of leakage. Copies of the cleaning and disposal certificates are presented in Appendix C & D.

**Description:** UST triple rinsing and confined space entry work space.

**Comments:** UST was ventilated to exterior and rinse water was extracted by Vactor hose.

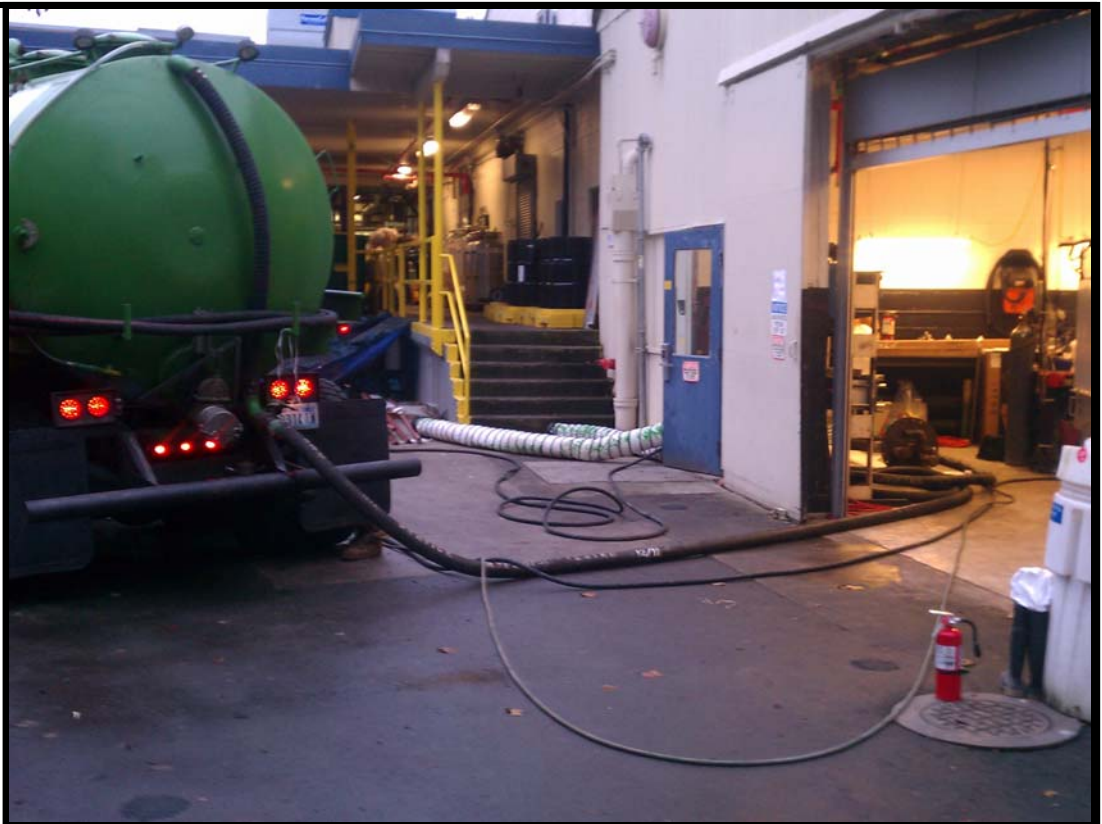
2

**Description:** Vactor truck with hose to work space.

**Comments:** All rinse water was extracted directly to vactor truck and transported offsite.

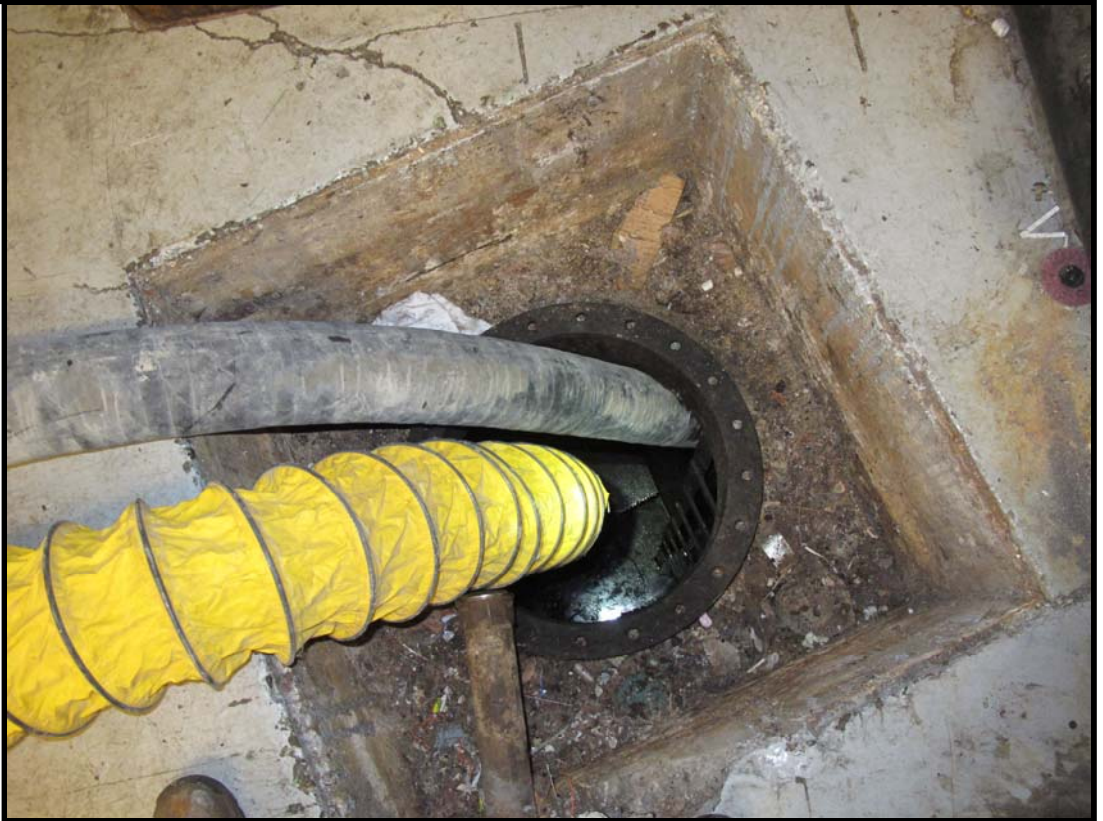
On January 5, 2012, the UST was completely filled with CDF by Cadman, Inc. and Kleen Environmental (Photos 3 & 4). Prior to filling, the tank was ventilated to the building exterior to ensure vapors did not become displaced into building interior areas during the filling procedure. Approximately seventy-eight cubic yards of CDF was required to fill the UST. Copies of the truck-weight tickets are included in Appendix E.

**Description:** UST manhole, ventilation line, and CDF fill hose.

**Comments:** UST was ventilated prior to filling to prevent displacement of vapors to the interior.

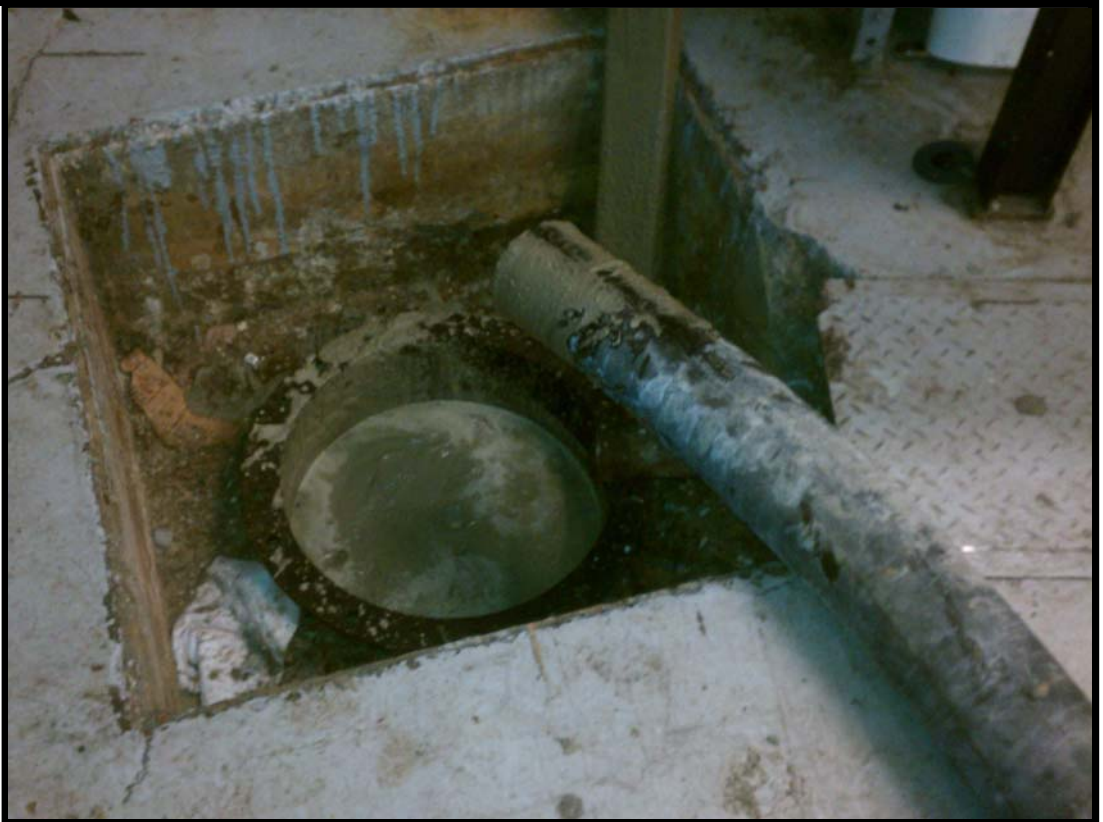
4

**Description:** UST manhole after CDF filling.

**Comments:** CDF was brought to the top of the UST. Approximately 78 cubic yards of CDF was used.

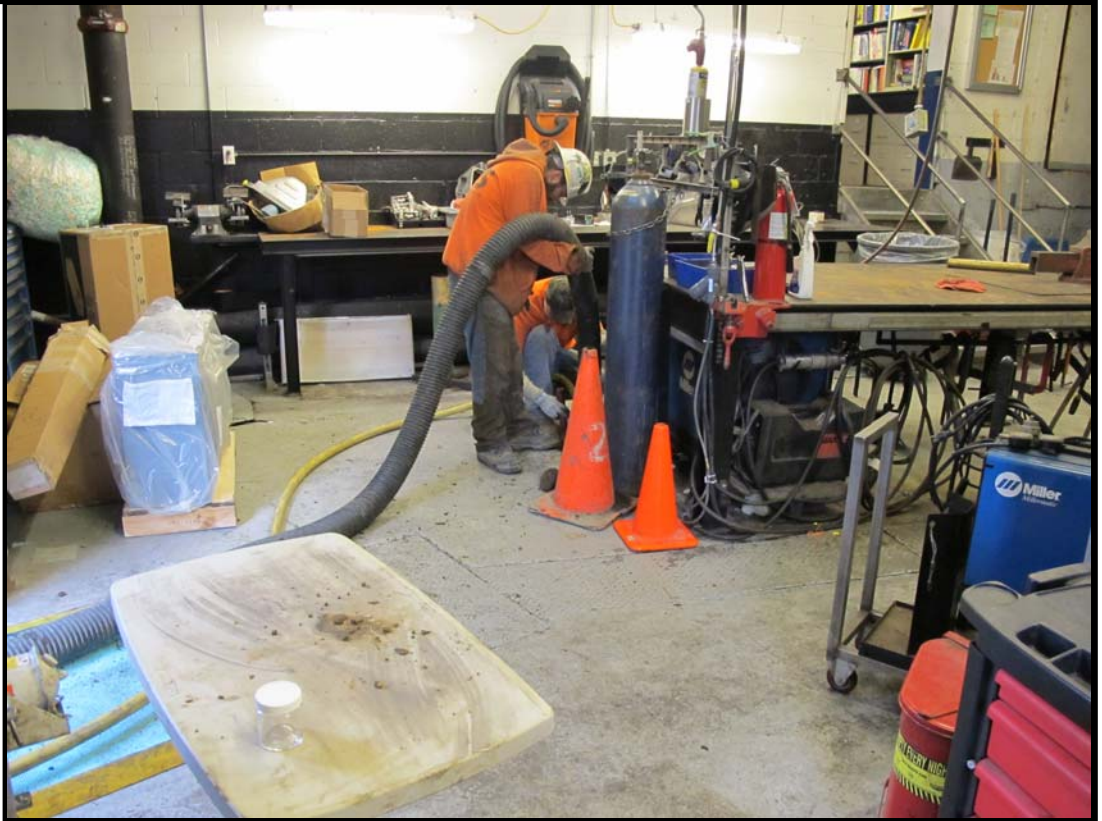
5

In borings GL-B2 and GL-B3, numerous subsurface utilities were observed, confirming the appropriate use of air knife and vactor truck to conduct the subsurface exploration. In boring GL-B5, the UST sidewall was exposed and a soil sample was collected (GL-B5-7) at the maximum depth just beneath the UST wall (Photos 5-6).

**Description:** Boring location, GL-B5.

**Comments:** Subsurface exploration using vector truck and air knife.

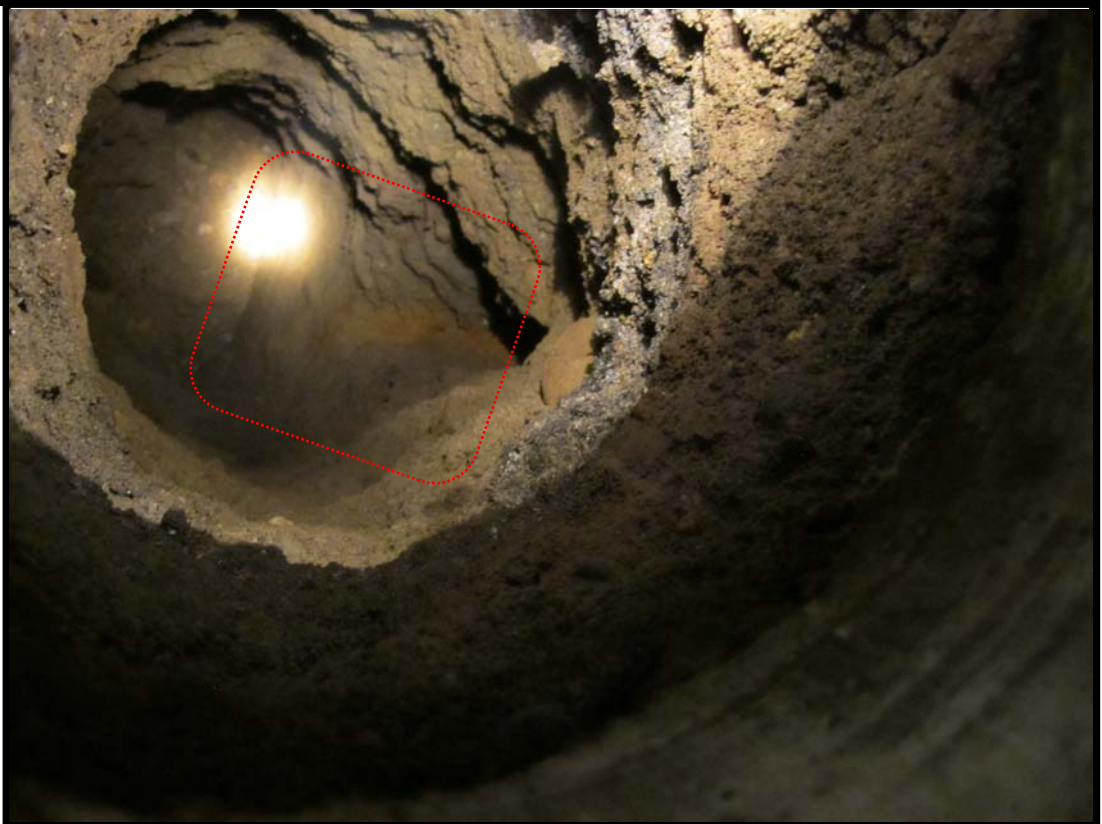
6

**Description:** Boring location, GL-B5.

**Comments:** Sidewall of UST was observed in GL-B5 from 44" to 78" (highlighted in red).
