**PROPOSED GROUNDWATER AND SOIL VAPOR MONITORING PLAN  
AMERICAN LINEN SUPPLY CO-DEXTER AVENUE SITE  
AGREED ORDER NO. DE 14302**

On behalf of BMR-Dexter LLC (“BMRD”), PES Environmental, Inc. (“PES”), is submitting this proposed plan for monitoring groundwater and soil vapor at the American Linen Supply Co–Dexter Avenue Site (Figure 1). The purpose of the plan is to detail the monitoring to be conducted at the 700 Dexter Avenue North property (the “Property”) and outside of the Property (together, the “Site”) after emulsified vegetable oil (“EVO”) has been injected in the perimeter wells located adjacent to the Property along 8<sup>th</sup> Avenue North and Roy Street. The monitoring plan covers the period from November 2020 through the issuance by the Washington State Department of Ecology (“Ecology”) of the Final Cleanup Action Plan (“CAP”) (which is currently anticipated occur in the second half of 2022) and applies to the monitoring points previously monitored pursuant to the Final Interim Action Work Plan (“IAWP”),<sup>1</sup> Final Contingent Action Addendum (“CAA”) to the IAWP<sup>2</sup>, Final Remedial Investigation/Feasibility Study (“RI/FS”) Work Plan,<sup>3</sup> and F

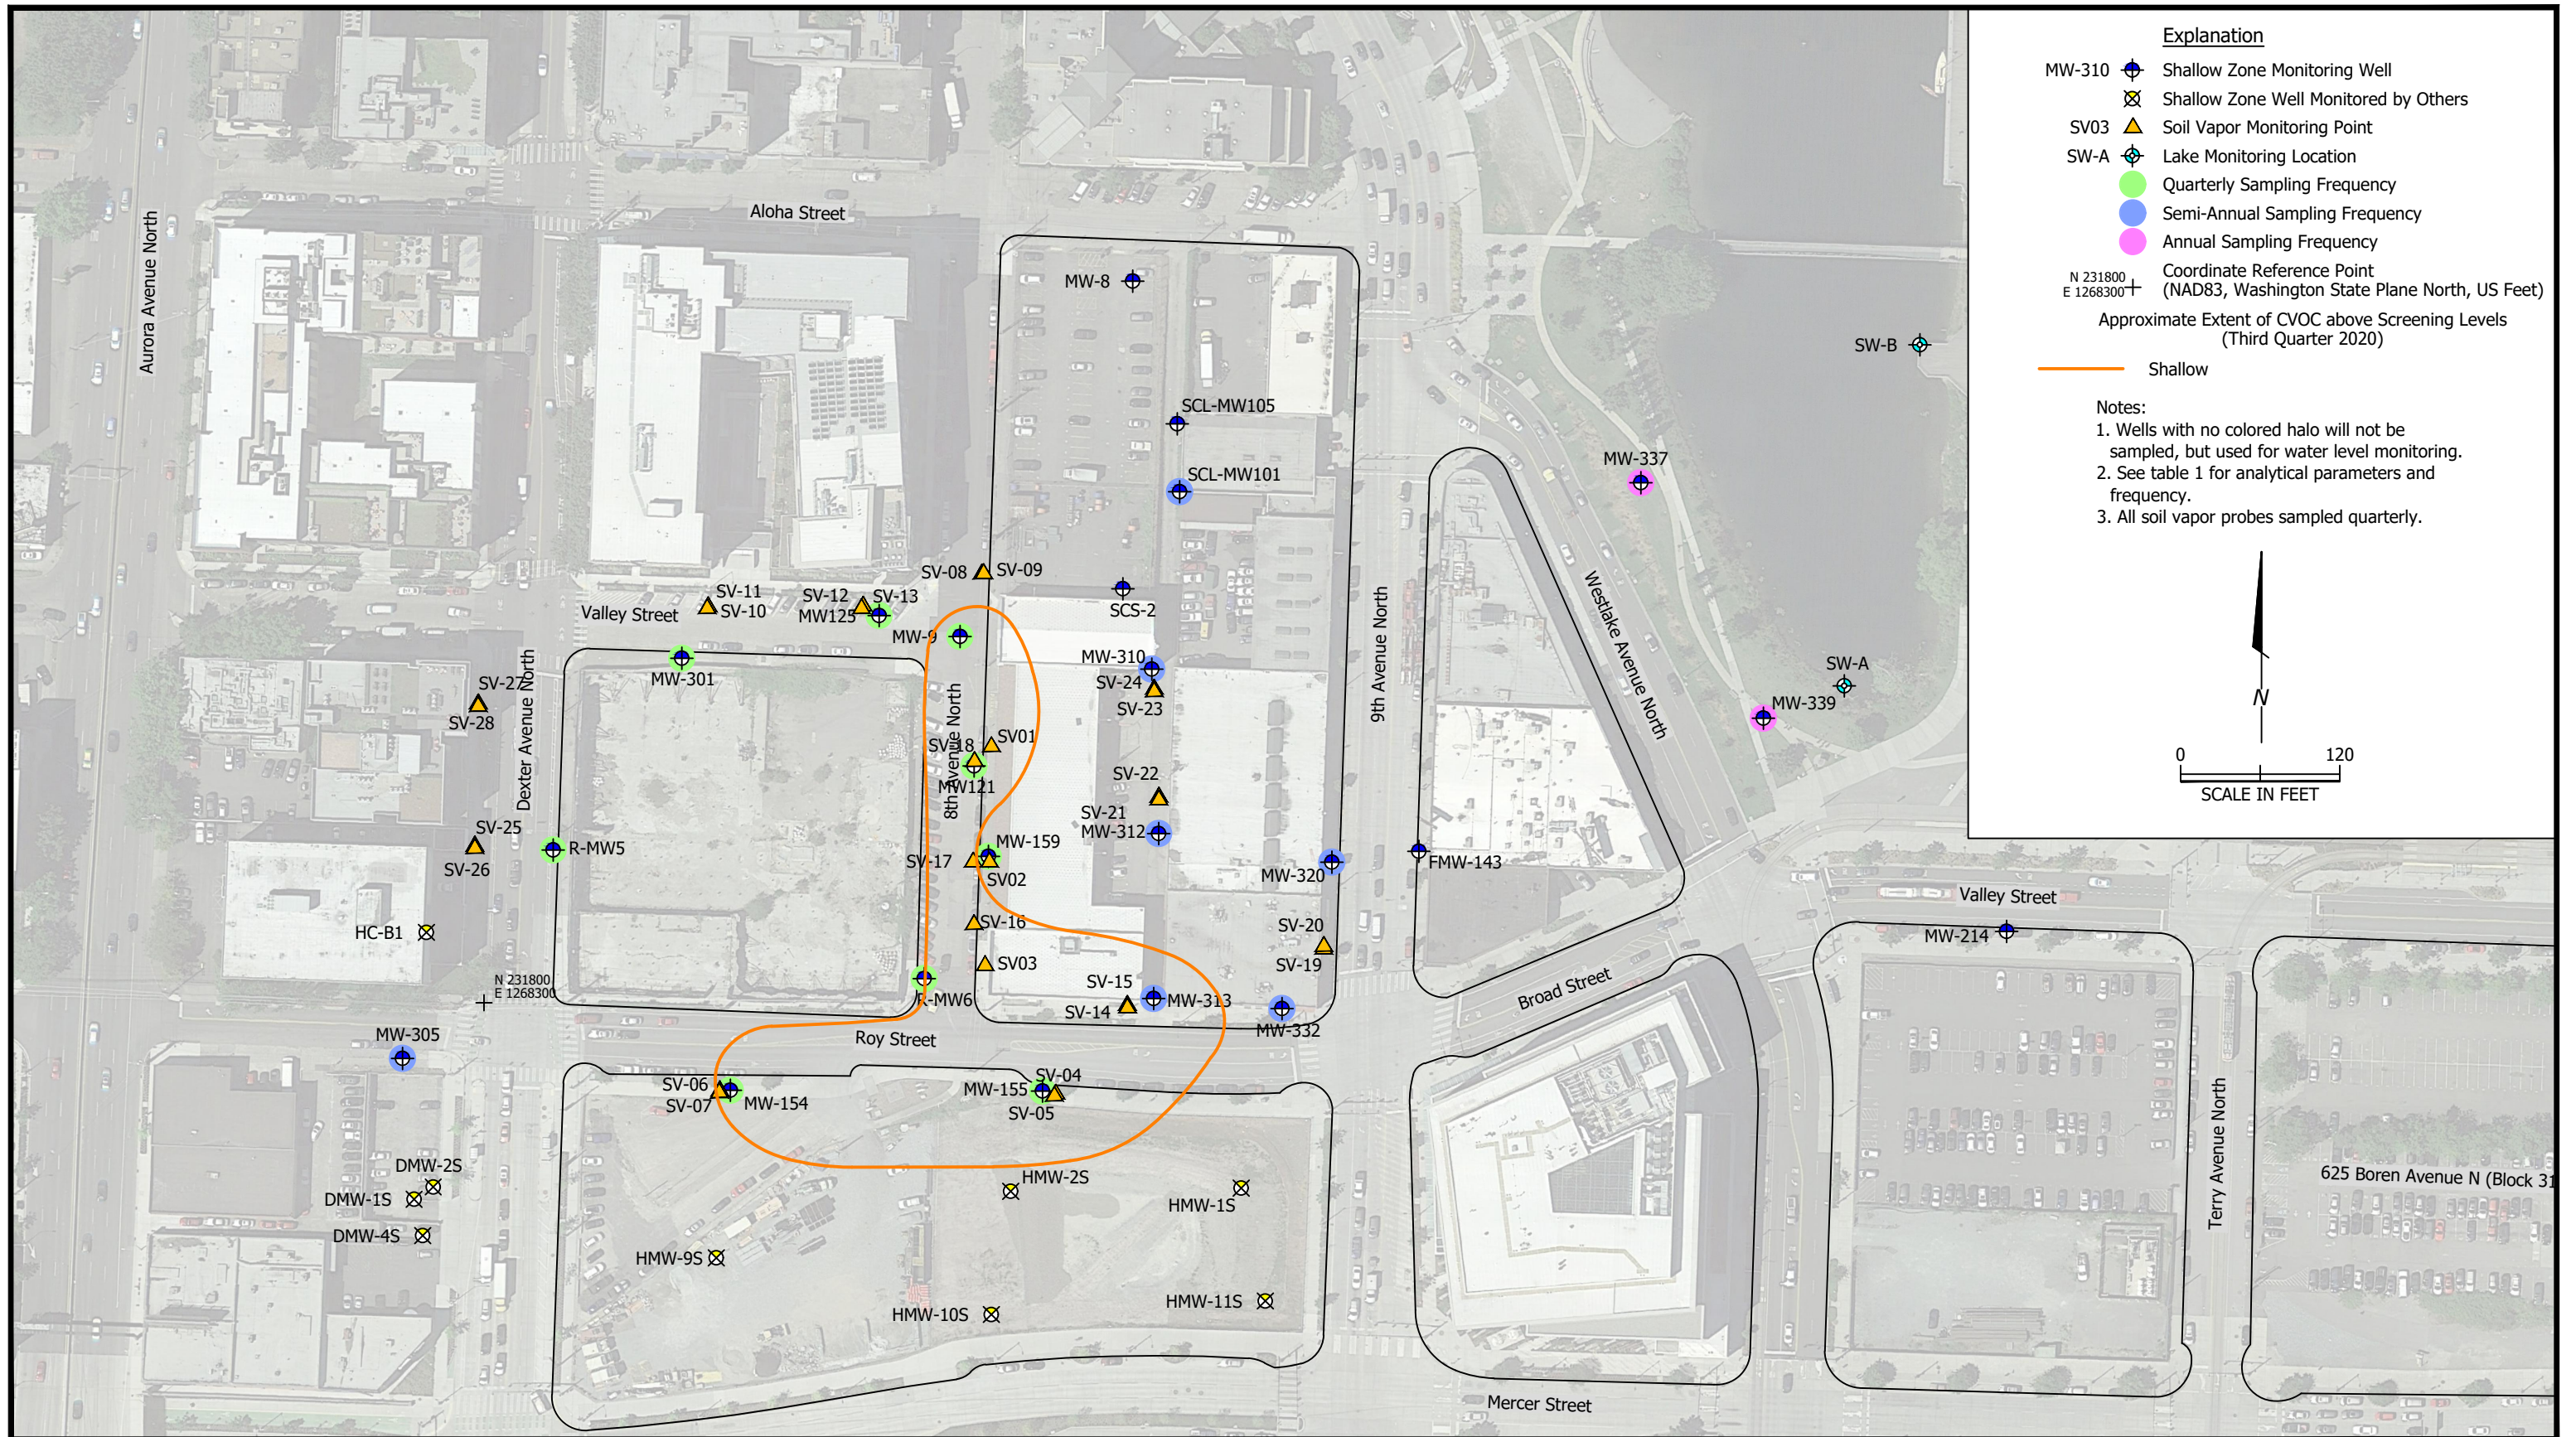
and CAA programs (shown as IA/CAA performance monitoring wells in Table 1) would continue to be monitored. PES proposes eliminating 7 of the 62 former RI monitoring wells (shown as plume monitoring wells in Table 1), including 6 shallow wells (FMW-143, MW-8, MW-214, SCL-MW105, SCS-2, and SMW-3) and Intermediate A well GEI-1. All of these wells are well beyond the edges of the plumes that they are monitoring, with closer wells that define the edge of the plume or a nearby well with easier access. Figures 3 through 6 show the wells to be monitored in the Shallow, Intermediate A, Intermediate B, and Deep Zones, respectively. The CAA wells, which were screened according to IA treatment zones, are shown on Figures 3 through 6 in the stratigraphic zone most applicable to their screen depths, with Treatment Zone A wells in the Intermediate A Zone, Treatment Zones B and C wells in the Intermediate B Zone, and Treatment Zone D wells in the Deep Zone. PES will continue to incorporate into the Site database data collected by others on properties in and around the Site, including data collected at Seattle DOT Mercer Parcels, Seattle DOT Dexter Parcel, and 701 Dexter Parcel (Figures 3 through 6).
