# CLEANUP ACTION PLAN

## Remdial Action Unit 1

### Camp Bonneville, Washington

**July 2004**

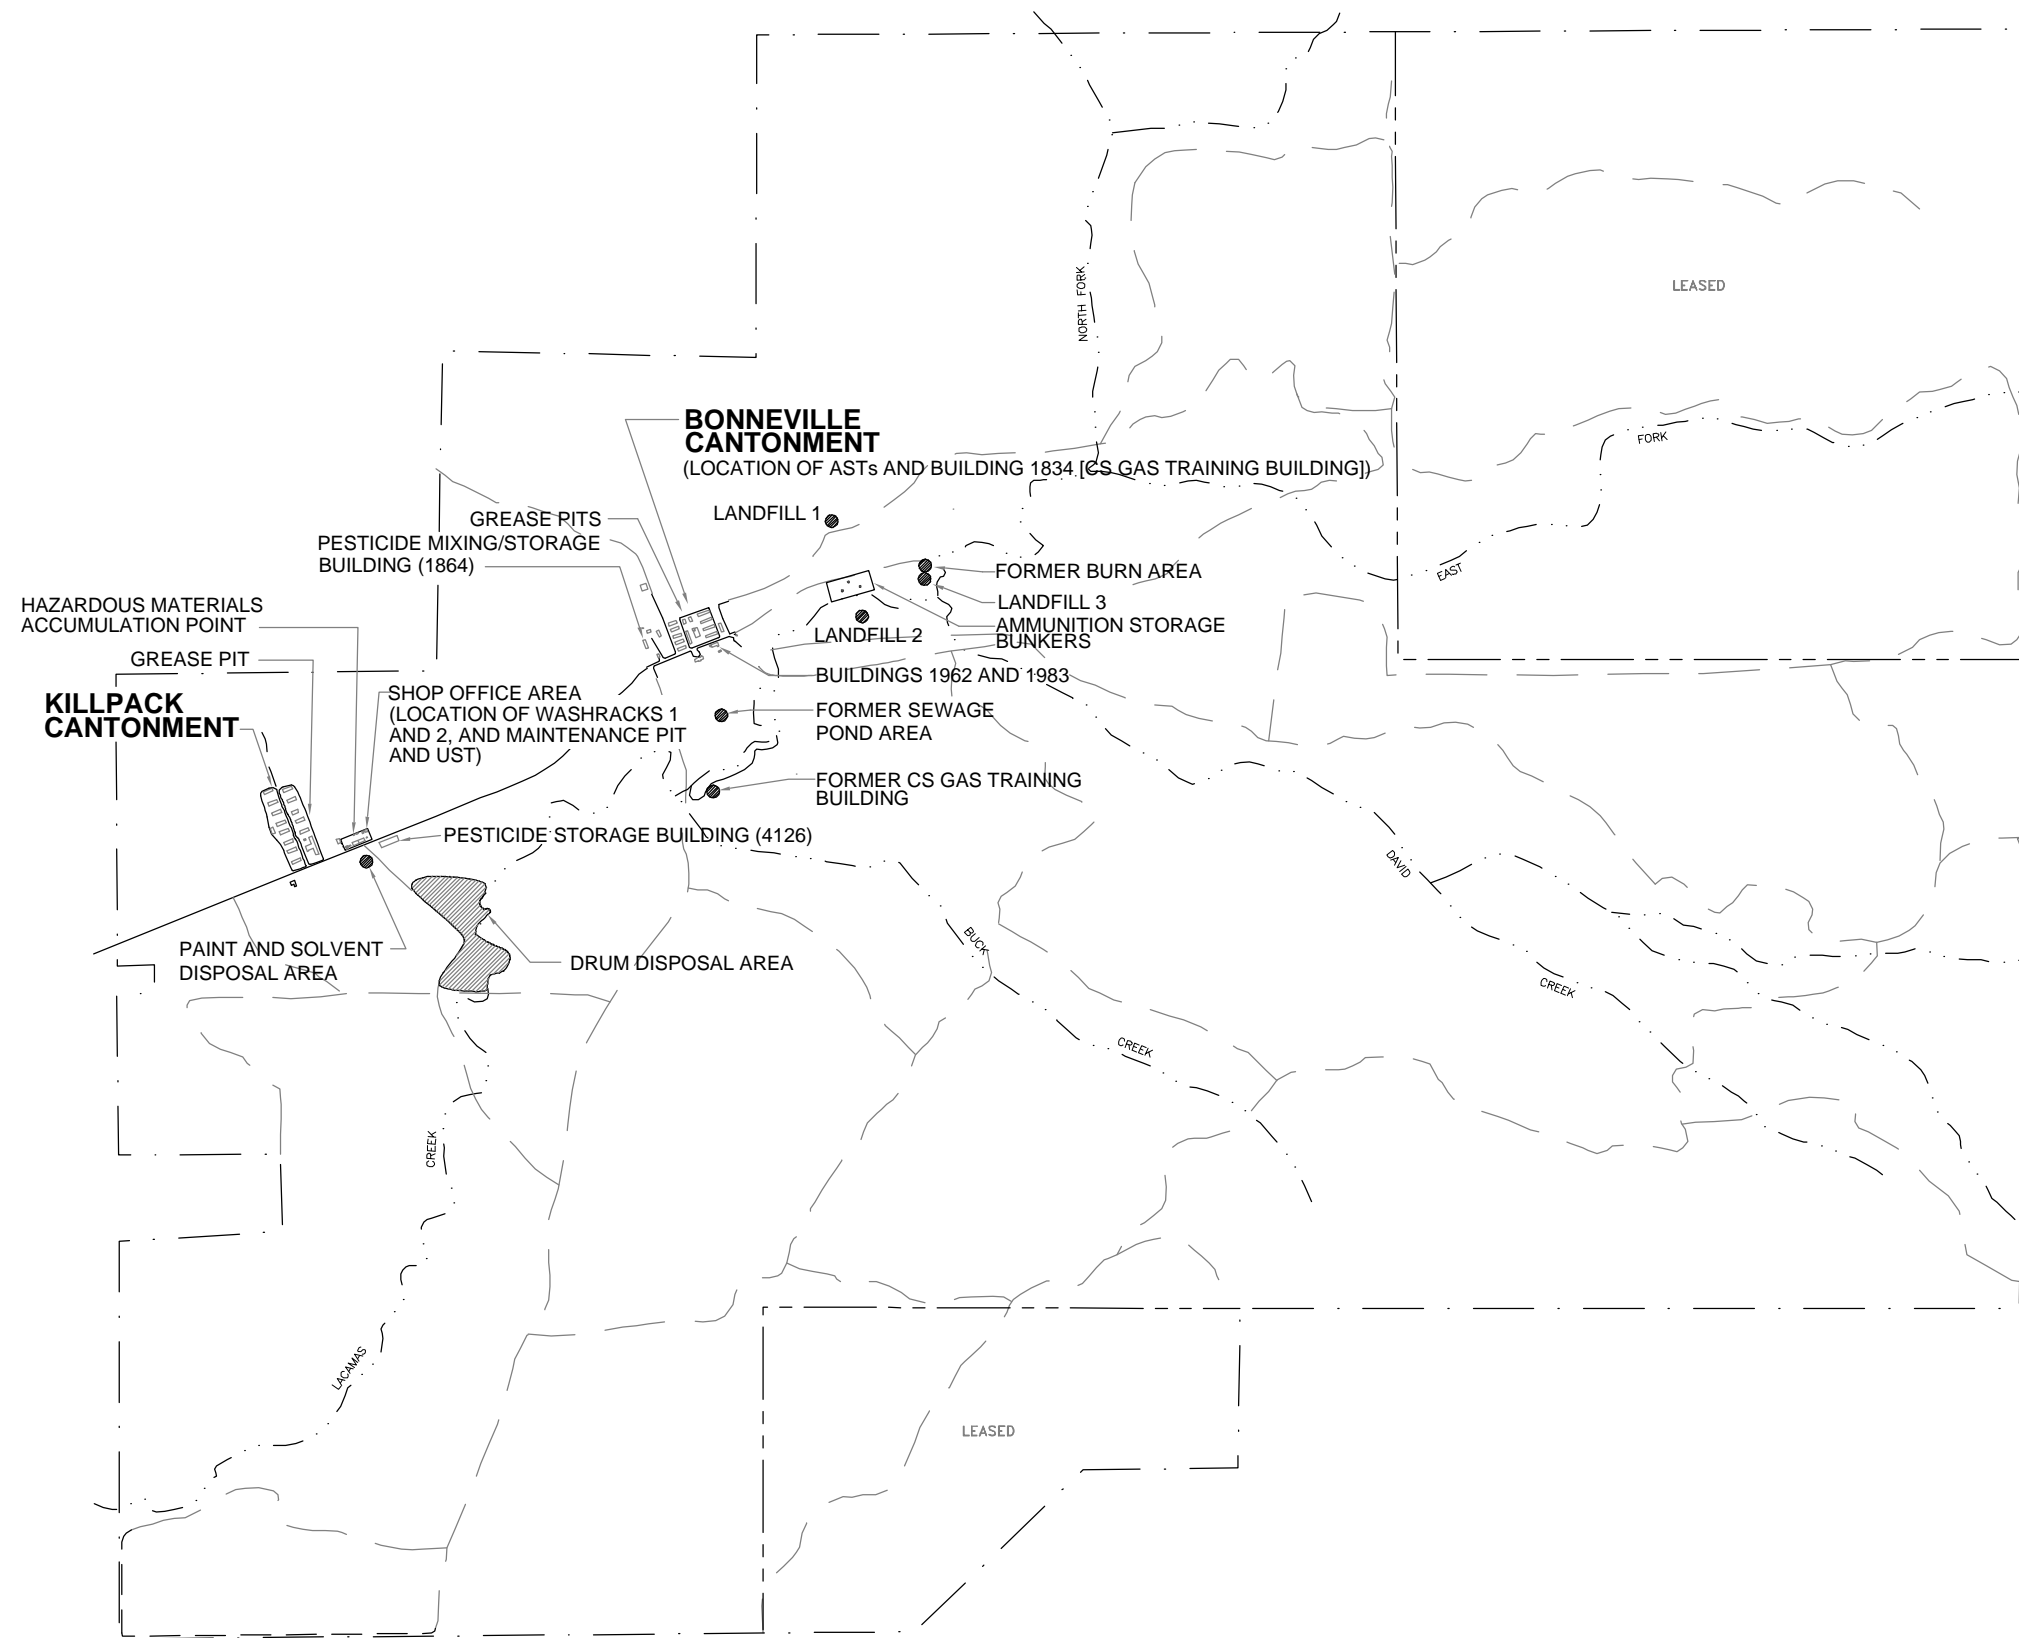
<b>URS</b>		U.S. ARMY CORPS OF ENGINEERS SEATTLE DISTRICT SEATTLE, WASHINGTON
<b>LOCATION OF SITES COVERED BY CAP</b>		
<b>CAMP BONNEVILLE</b>	<b>53-03100477.04</b>	<b>WASHINGTON</b>
<b>FIGURE 1-2</b>

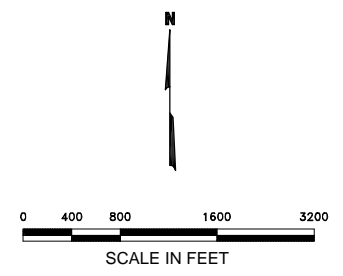
The individual sites within Camp Bonneville that are covered by this Cleanup Action Plan (CAP) are collectively referred to as Remedial Action Unit 1 (RAU 1) and include (Figure 1-2):

As indicated in Section 2 and shown in Figure 1-2, the sites included in RAU 1 are Landfills 1, 2, and 3; the Former Burn Area; Buildings 1962 and 1983; the Grease Pits; the Former Sewage Pond; the Hazardous Materials Accumulation Point; the Drum Disposal Area; the Paint and Solvent Disposal Area; Washracks 1 and 2; the Maintenance Pit; the Pesticide Storage/Mixing Building (Building 1864); the ASTs; the CS Gas Training Building Site; the Pesticide Storage Building (Building 4126); the Ammunition Storage Bunkers, the CS Gas Chamber Building (Building 1834), and the underground storage tank formerly associated with Building 4475.

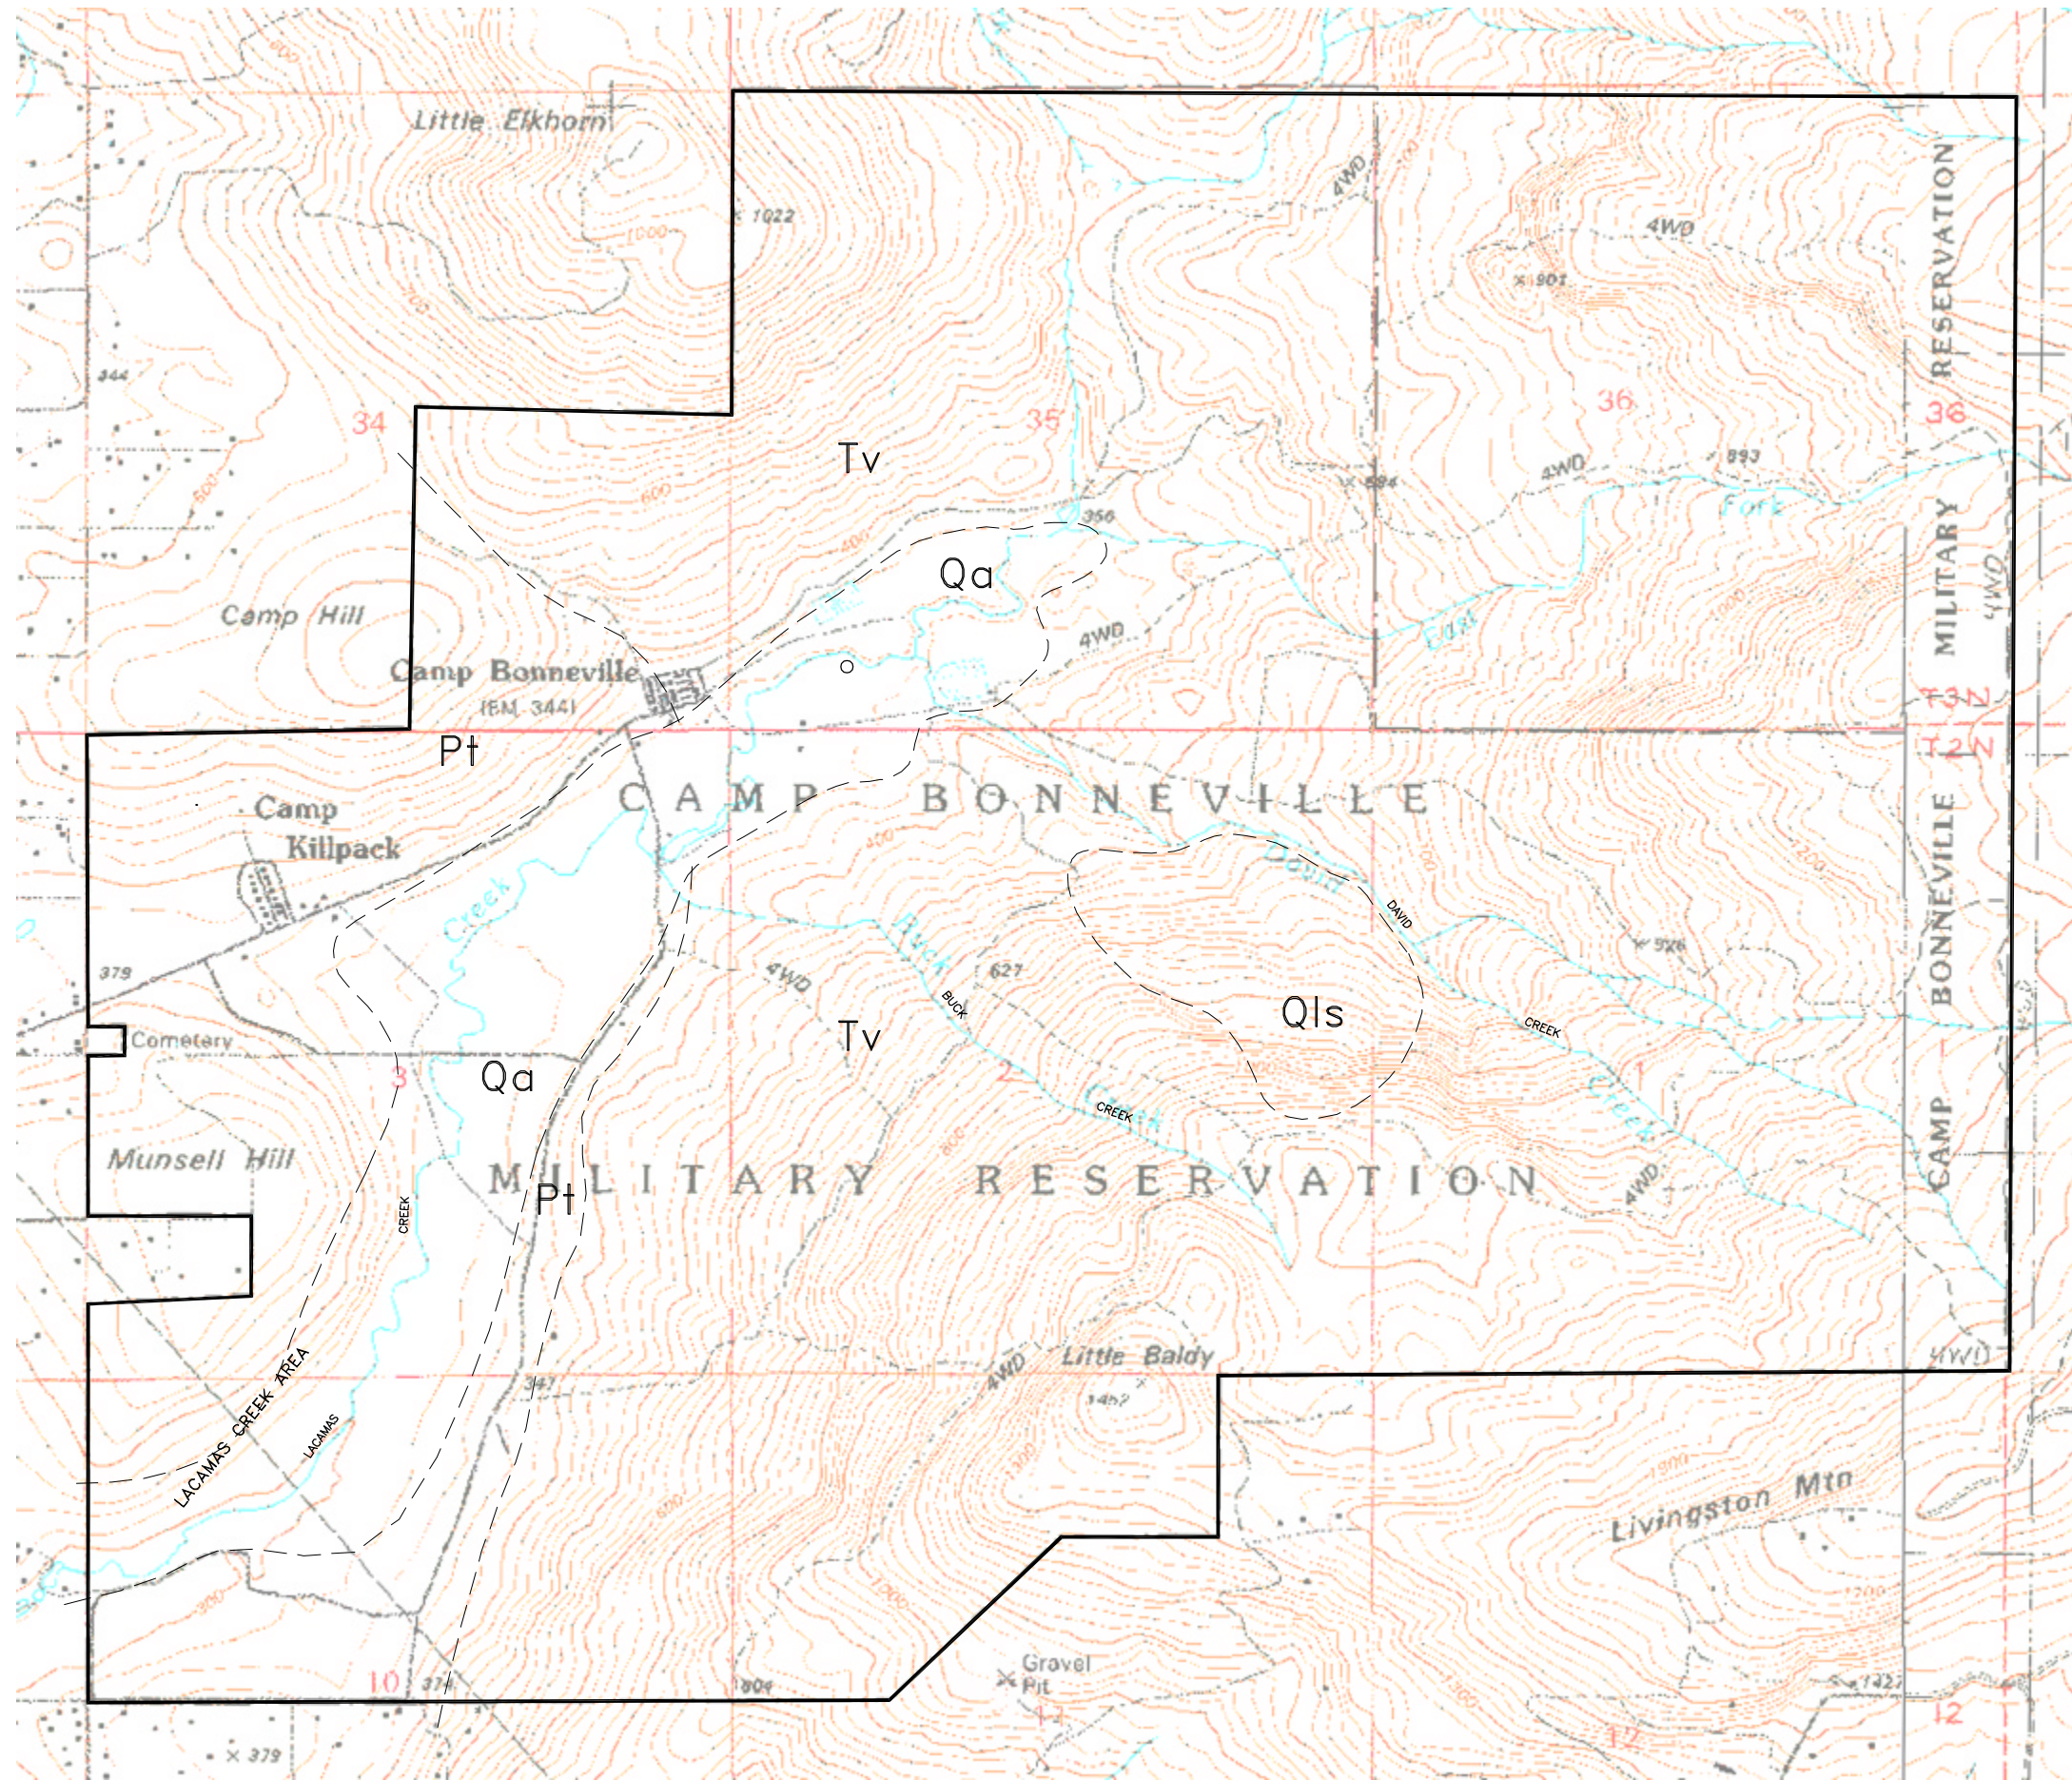
**LEGEND**

----- GEOLOGIC FORMATIONS

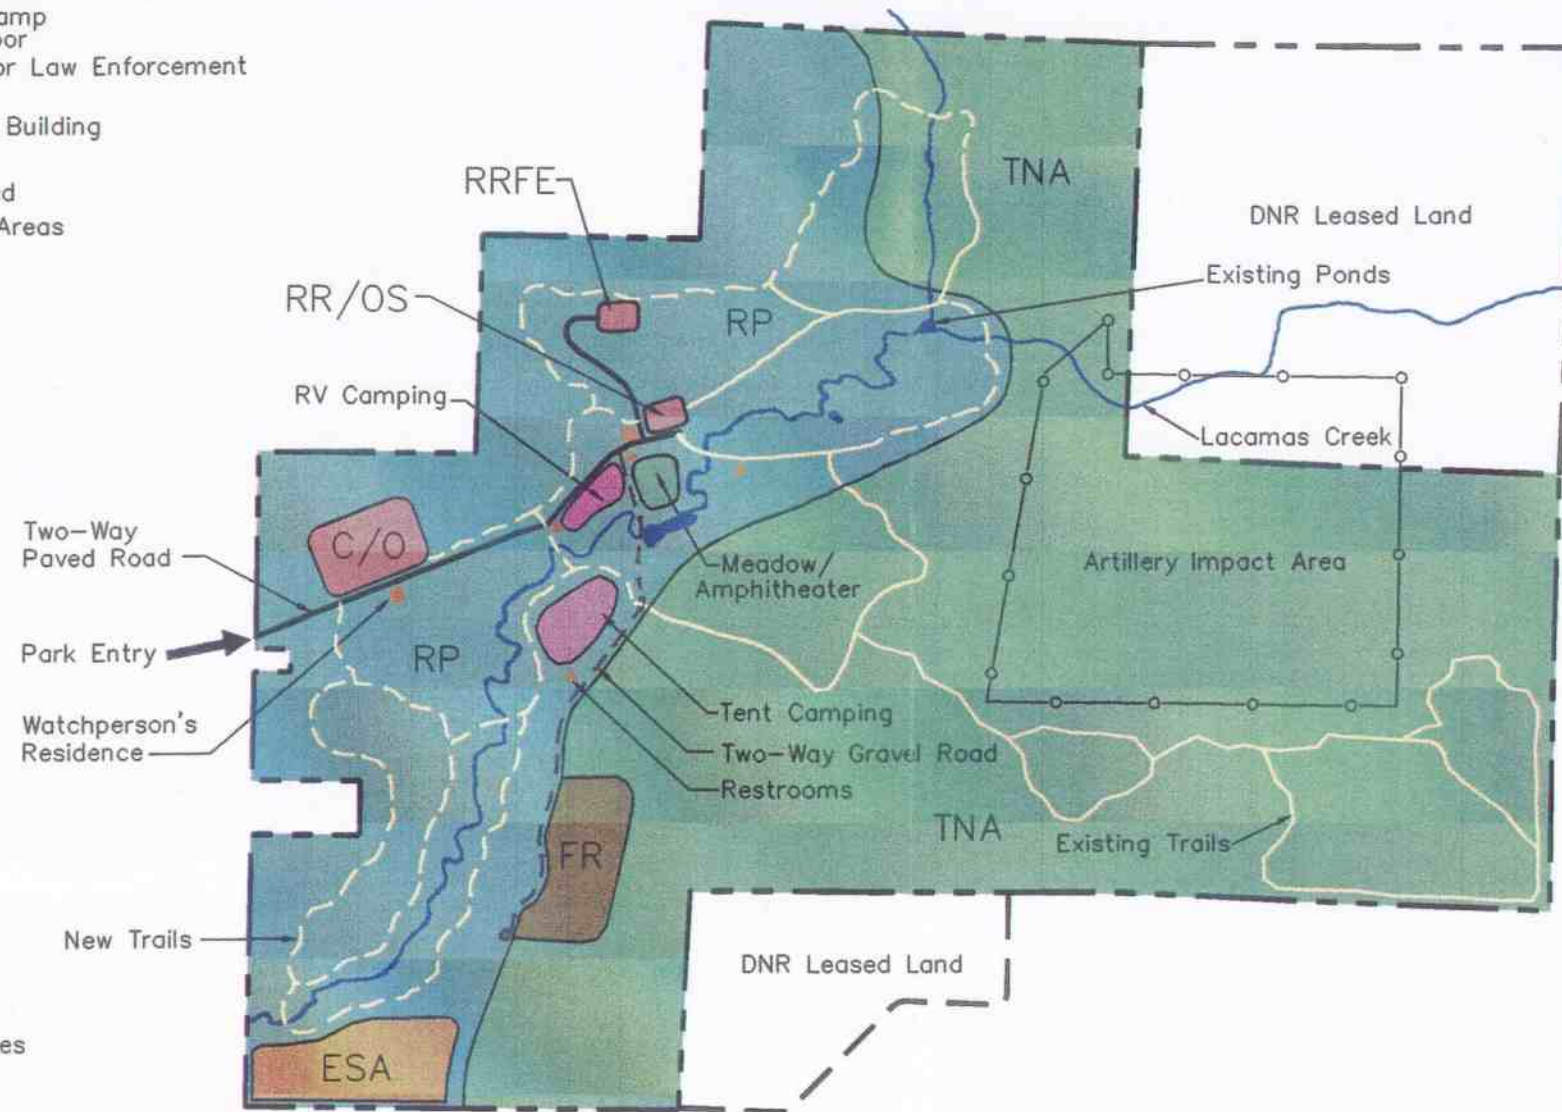
Figure 5-1  
**Camp Bonneville Reuse Plan**

**Environmental Study Area (ESA)**

- Outdoor Studies

**Rustic Retreat/Outdoor School  
(RR/OS)**

- Reuse/Renovate Existing Camp Bonneville Buildings
- Classrooms
- Lodging
- Native American Cultural Center
- New Multi-Purpose Building and Other Building Expansion As Needed

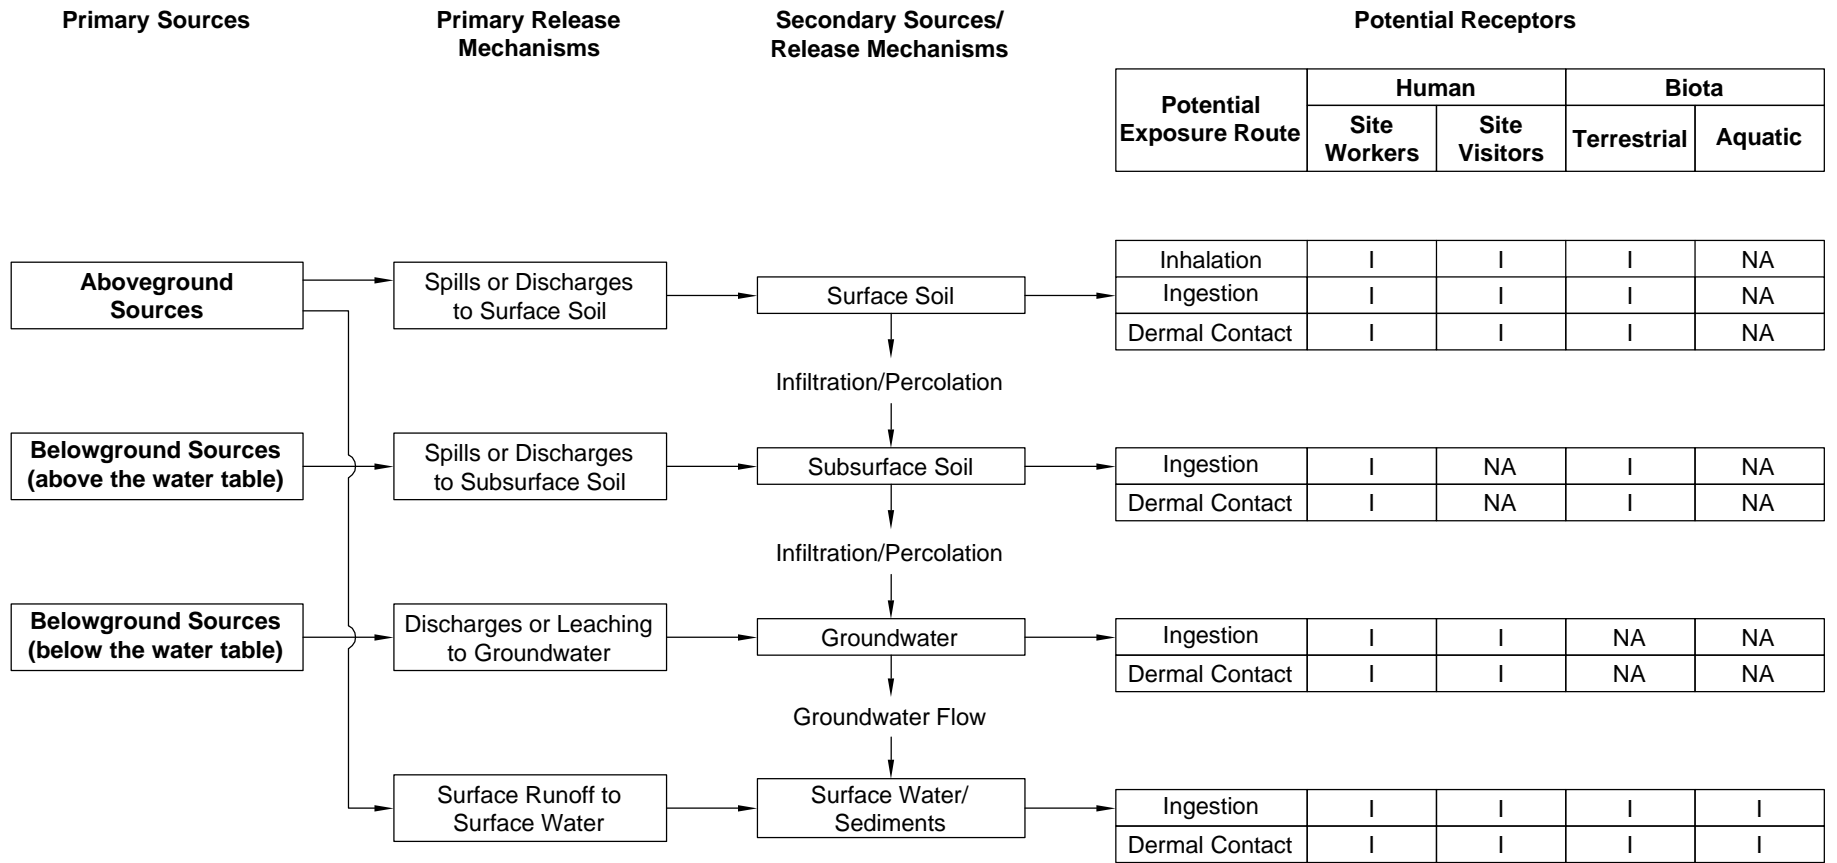
**Aboveground Sources**

- Hazardous Materials Accumulation Point
- Former Burn Area
- Former Buildings 1962 and 1983
- Washracks 1 and 2
- Pesticide Storage/Mixing Building (Bldg. 1864)
- CS Gas Training Area
- ASTs
- Pesticide Storage Building (Bldg. 4126)
- Ammunition Storage Bunkers

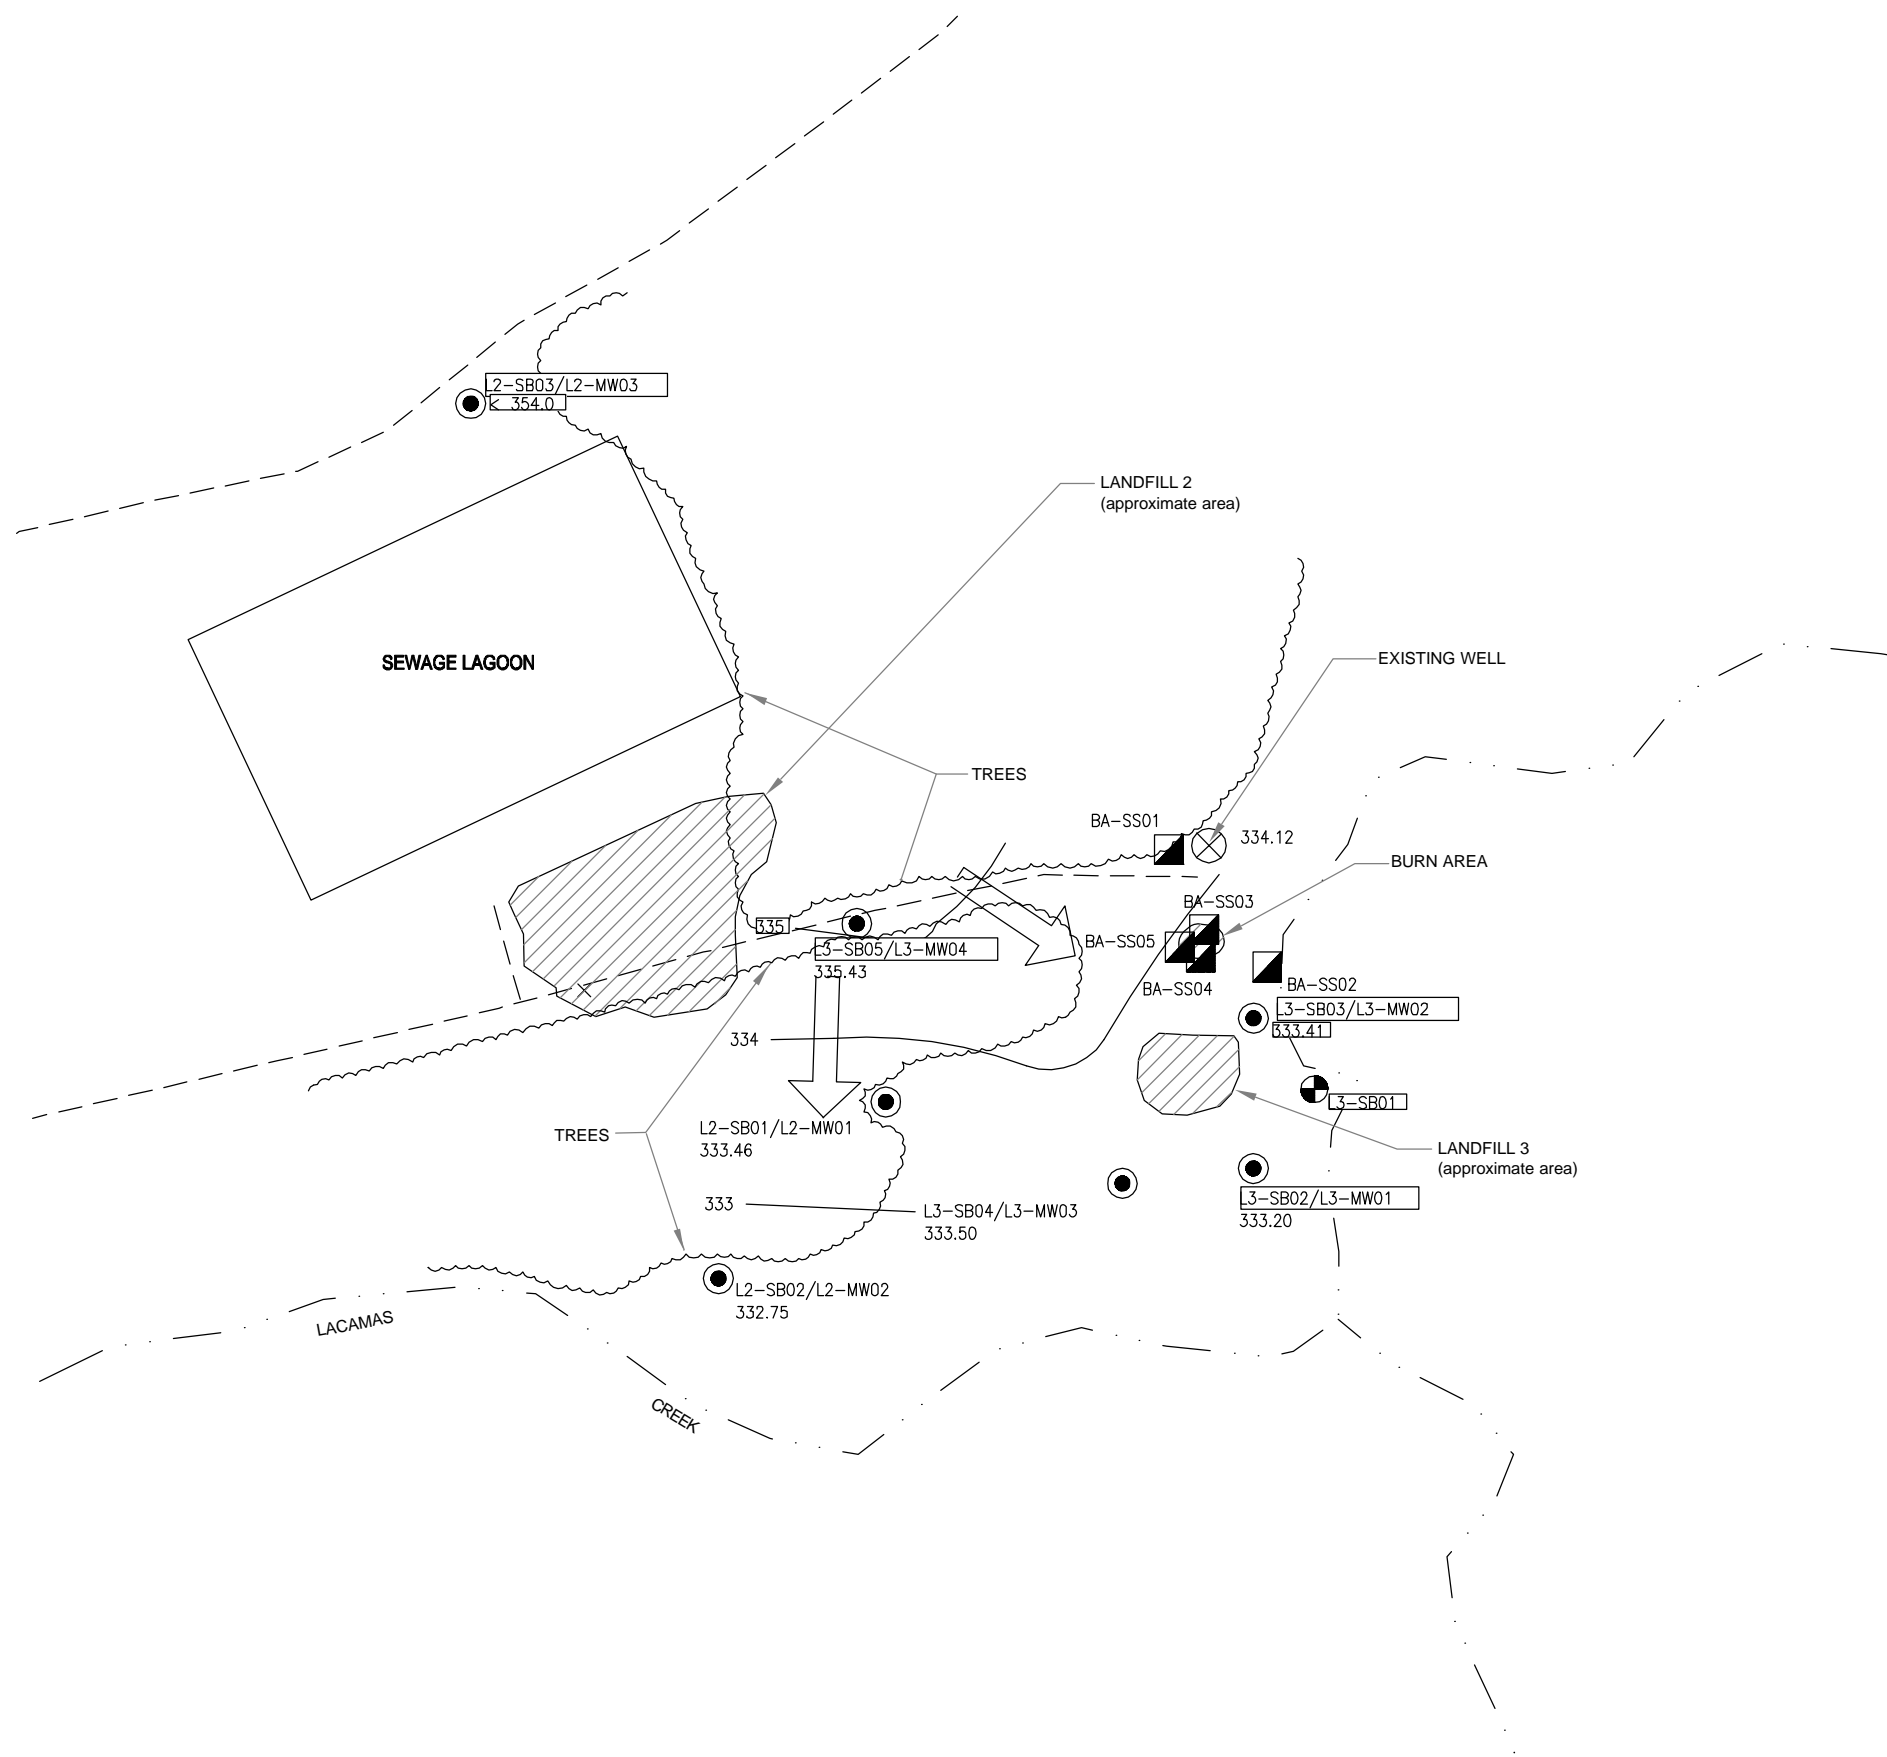
Camp Bonneville Location, WA	Project No. 53F0072250.00	<b>FORMER SEWAGE POND EXPLORATION PLAN</b>	<b>Figure A-2</b>
<b>URS</b>

- GRAVEL ROAD
- CREEK
- L3-SB01 ● SOIL BORING LOCATION AND DESIGNATION
- L3-SB02/L3-MW01 333.20 ● BORING AND MONITORING WELL LOCATION, DESIGNATION AND GROUNDWATER ELEVATION (MEASURED 8-3-98)
- BA-SS1 ■ SURFACE SOIL SAMPLE LOCATION AND DESIGNATION
- 333' ↘ GROUNDWATER ELEVATION CONTOUR AND APPROXIMATE DIRECTION OF GROUNDWATER FLOW

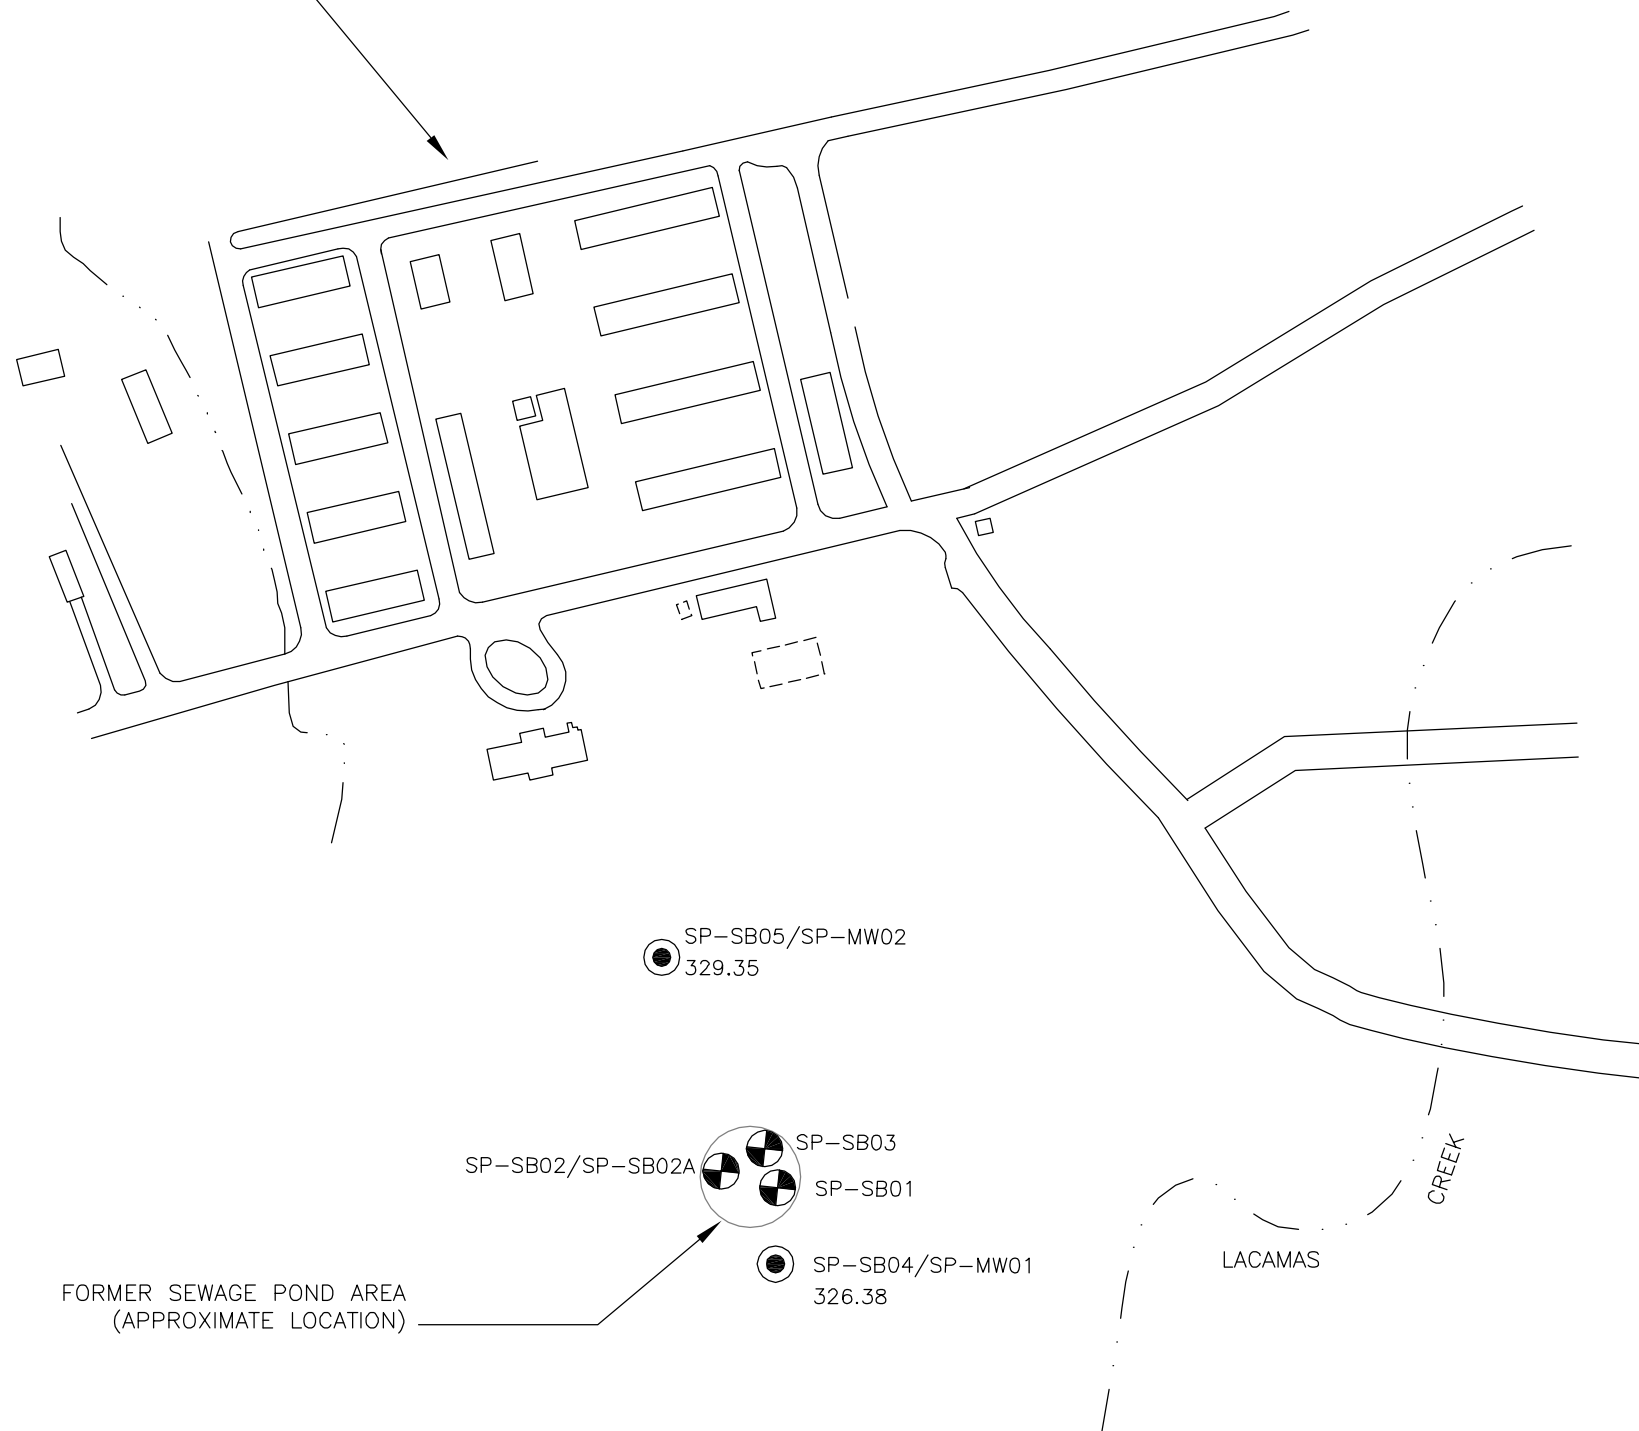
- ROAD
- - - CREEK
- SP-SB01 SOIL BORING LOCATION AND DESIGNATION
- SP-SB05/SP-MW02 BORING AND MONITORING WELL LOCATION, DESIGNATION, AND GROUNDWATER ELEVATION (8-3-98)

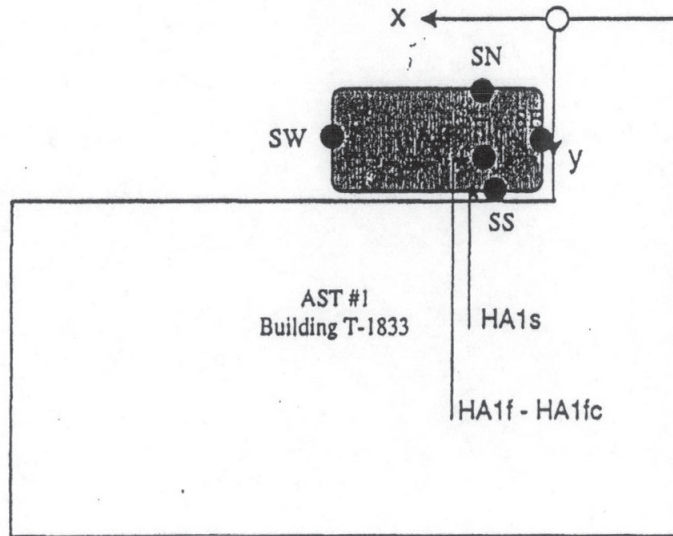
AST #1/Bldg T-1833 Samples

#	X	Y	depth
FL	5.6	6.4	2
	5.6	6.4	4
SN	5.6	3.4	1
	5.6	-2.0	1
SE	3.2	5.8	1
SS	5.2	8.0	1
SW	15.0	5.8	1

All dimensions in feet and tenths of feet.  
 Depths are feet below ground surface (bgs).

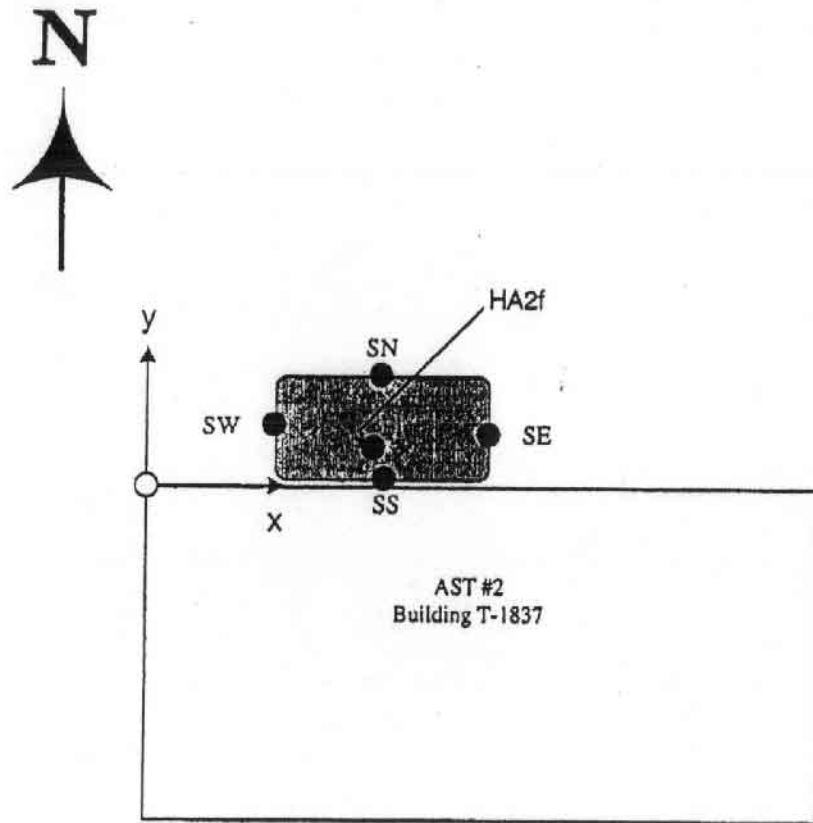
AST #2/Bldg T-1837 Samples

#	X	Y	depth
FL	14.0	1.4	5
SN	14.3	5.8	3
SE	18.8	2.3	3
SS	14.6	0.5	4
SW	11.0	2.6	3

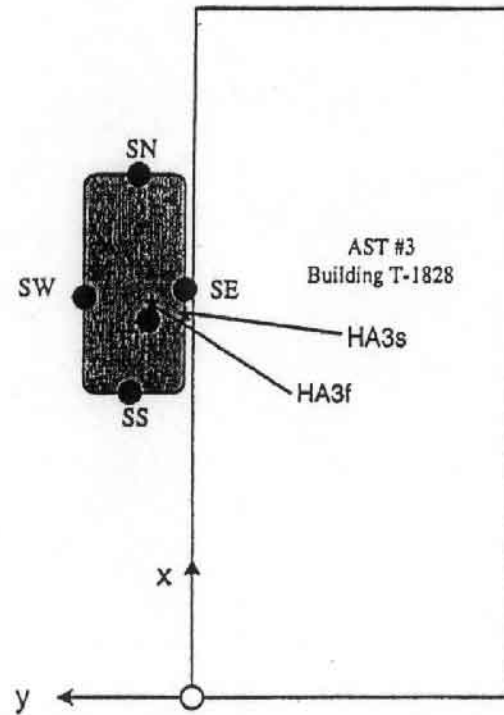
Figure A-9  
**AST#3 - Bldg T-1828 Sample Locations**

AST #3/Bldg T-1828 Samples

#	X	Y	depth
FL	18.2	2.7	5.0
SN	23.8	3.0	2.4
SE	20.8	1.0	2.8
SS	16.4	3.3	3.2
SW	19.8	6.0	3.0

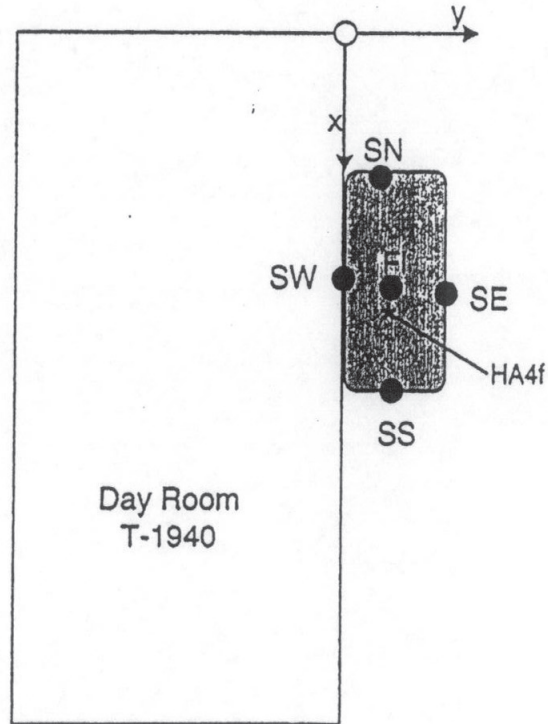
AST #4/Bldg T-1940 Samples

#	X	Y	depth
FL	18.2	2.6	2.5
SN	14.2	2.2	1.3
SE	18.7	7.8	2.2
SS	23.0	2.6	1.3
SW	18.0	0.5	1.5

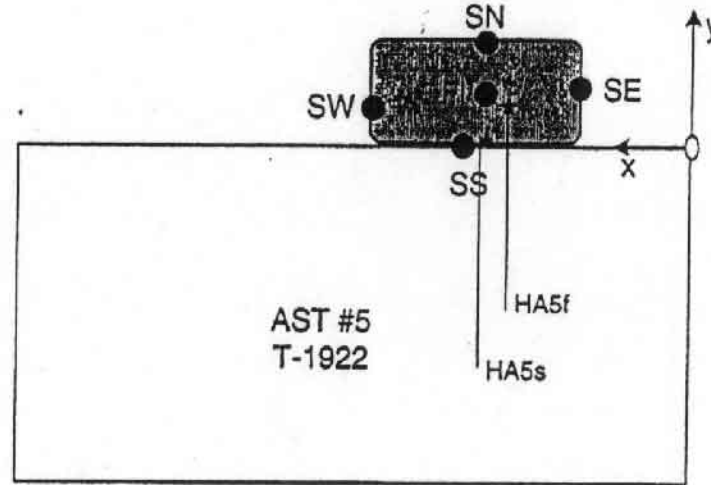
Figure A-11  
**AST#5 - Bldg T-1922 Sample Locations**

AST #5/Bldg T-1922 Samples

#	X	Y	<u>depth</u>
FL	18.6	2.1	2.3
SN	18.6	5.7	1.4
SE	13.0	2.5	1.4
SS	19.2	0.8	1.8
SW	23.0	1.9	1.8

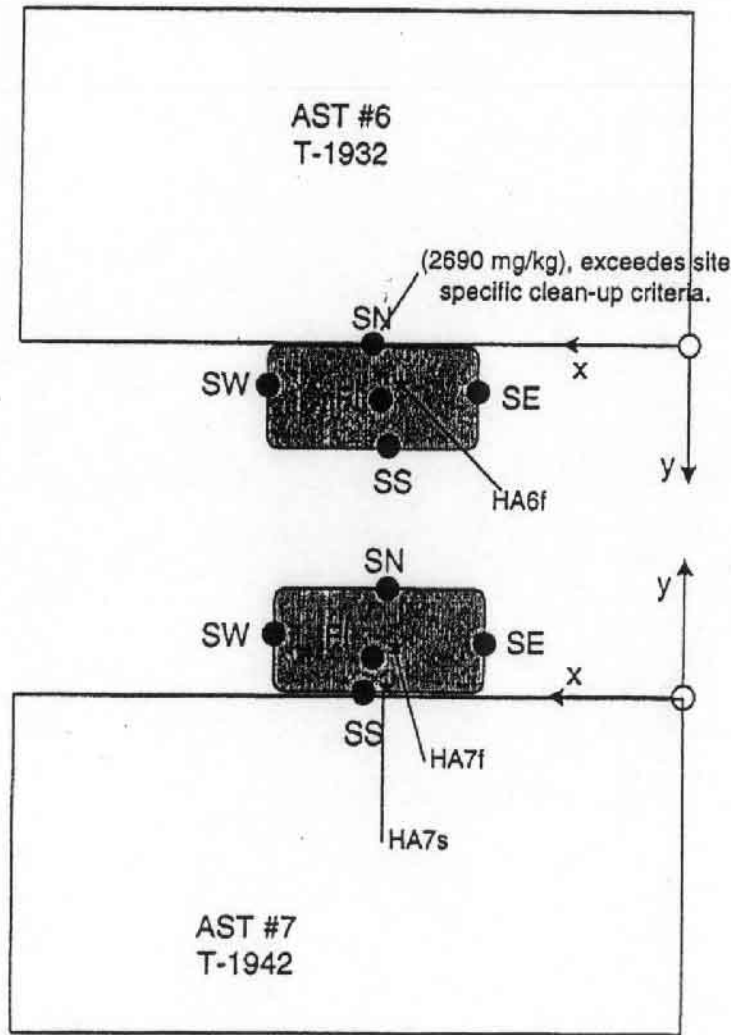
Figure A-12  
**AST#6 - Bldg T-1932, AST#7 - Bldg T-1942, Sample Locations**

AST #6/Bldg T-1932 Samples

#	X	Y	depth
FL	45.7	3.2	4.5
SN	46.0	0.8	3.9
SE	41.1	3.1	3.5
SS	44.7	7.6	2.6
SW	49.5	2.7	3.0

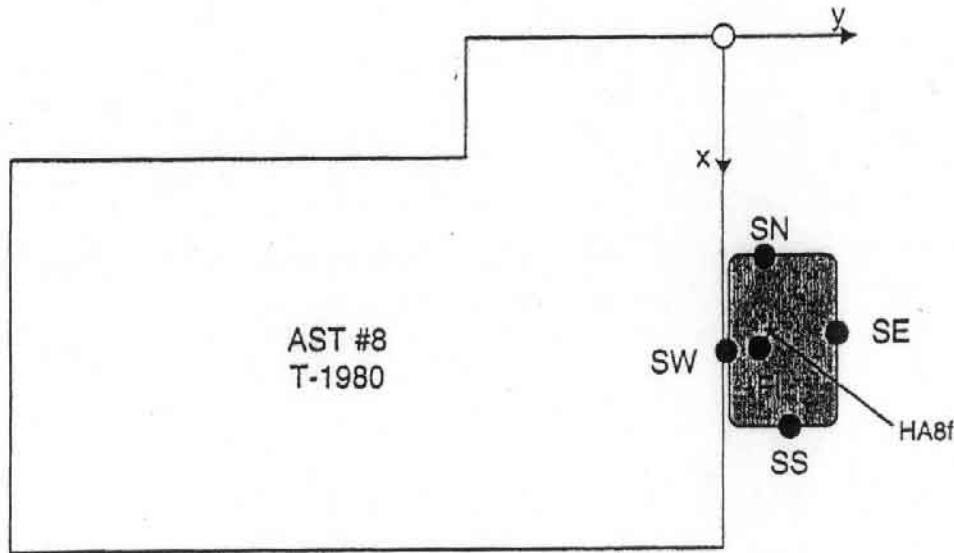
AST #8/Bldg T-1980 Samples

#	X	Y	depth
FL	19.5	2.4	1.9
SN	17.1	2.9	1.8
	14.2	6.0	3.0
SE	19.2	5.6	1.5
	20.2	10.4	2.8
SS	22.9	3.6	0.9
SW	19.6	0.9	1.2

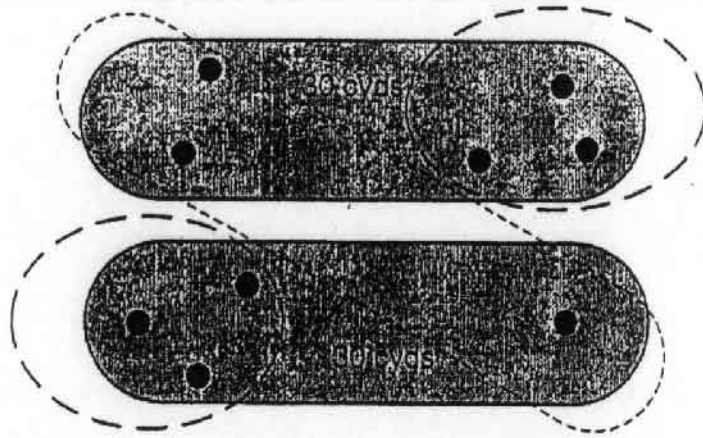
Figure A-14  
**AST Stockpiles Sample Locations**

One composite sample made up of 3 sample locations per 25 cubic yards of stockpiled material.

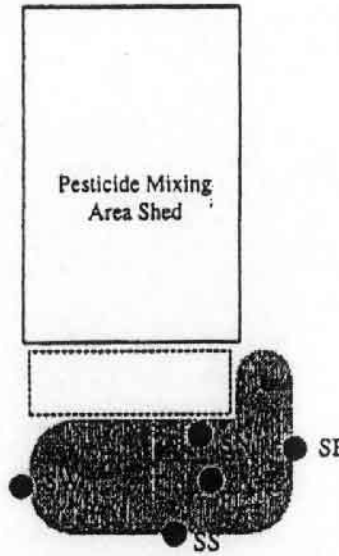
Figure A-15  
**Pesticide Mixing Area Sample Locations**

Pesticide Mixing Area Samples

#	X	Y	depth
FL	10.3	20.1	2.5
SN	10.7	20.8	1.5
SE	7.0	20.3	1.5
SS	12.5	15.1	1.5
	10.0	12.4	2.3
SW	15.9	19.2	1.5

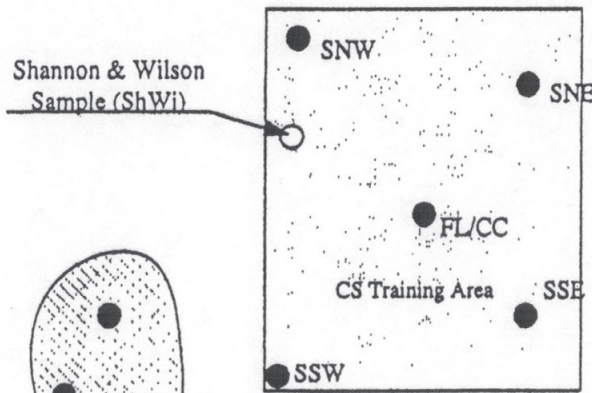
Figure A-21

CS Training Area Samples			
#	X	Y	depth
FL	19.8	14.1	1.0
	19.8	14.1	2.0
	19.3	16.3	3.0
SSW	27.0	24.6	1.0
	27.0	24.6	2.0
SSE	25.2	4.2	1.0
SNE	16.4	4.0	1.0
SNW	12.7	22.3	1.0
ShWi	17.0	23.1	???

### CS Training Area Sample Locations

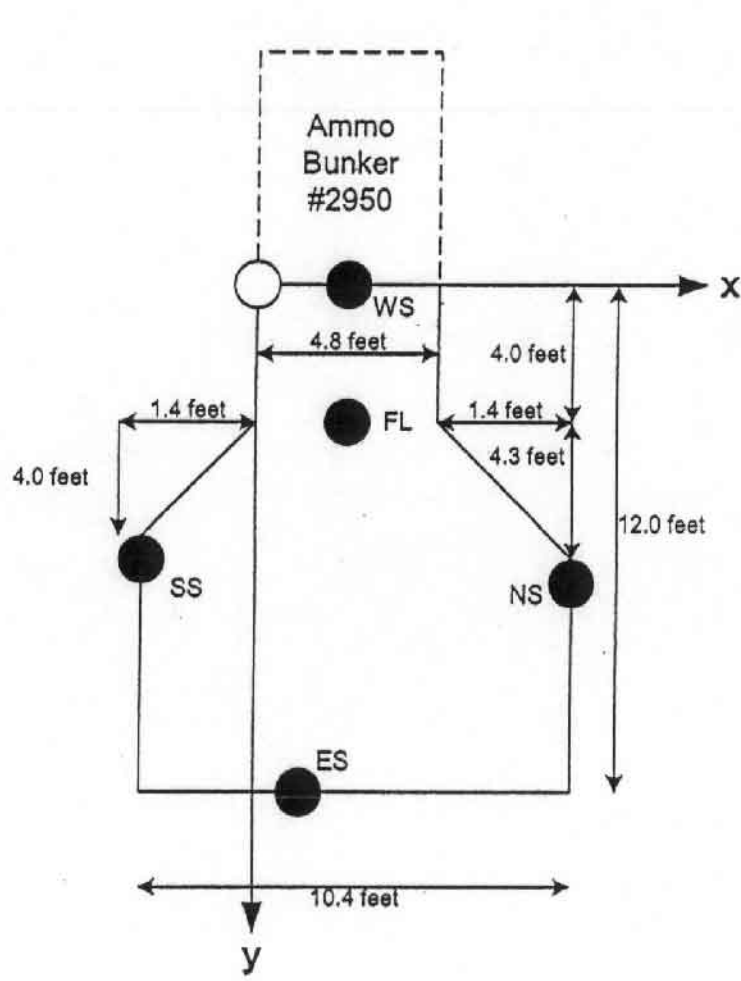
Figure A-26

Ammo Bunker #2150 Samples

#	X	Y	depth
FL	2.0	4.0	1
NS	6.2	8.3	1
ES	1.5	12.0	1
SS	-1.4	8.0	1
WS	2.0	0.0	1

**Ammunition Bunker #2950 Sample Locations**

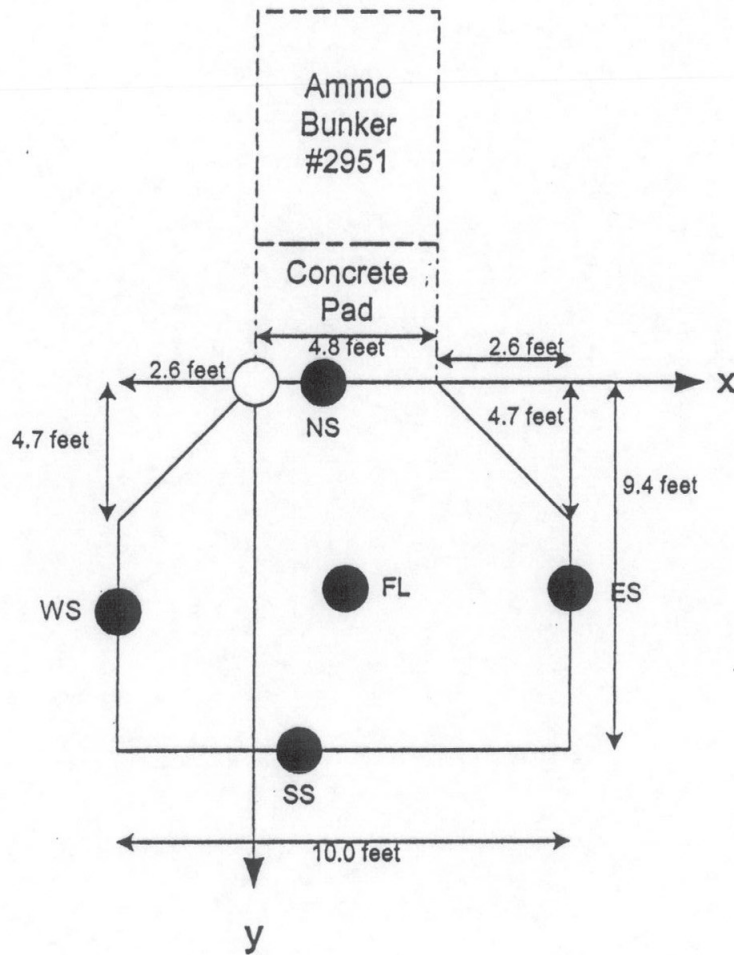
Figure A-27  
**Ammunition Bunker #2951 Sample Locations**

Ammo Bunker #2151 Samples

#	X	Y	depth
FL	3.4	4.9	1
NS	2.6	0.0	1
ES	7.4	7.0	1
SS	2.2	9.4	1
WS	-2.6	7.7	1
