# CLEANUP ACTION PLAN

## Remdial Action Unit 1

### Camp Bonneville, Washington

**July 2004**

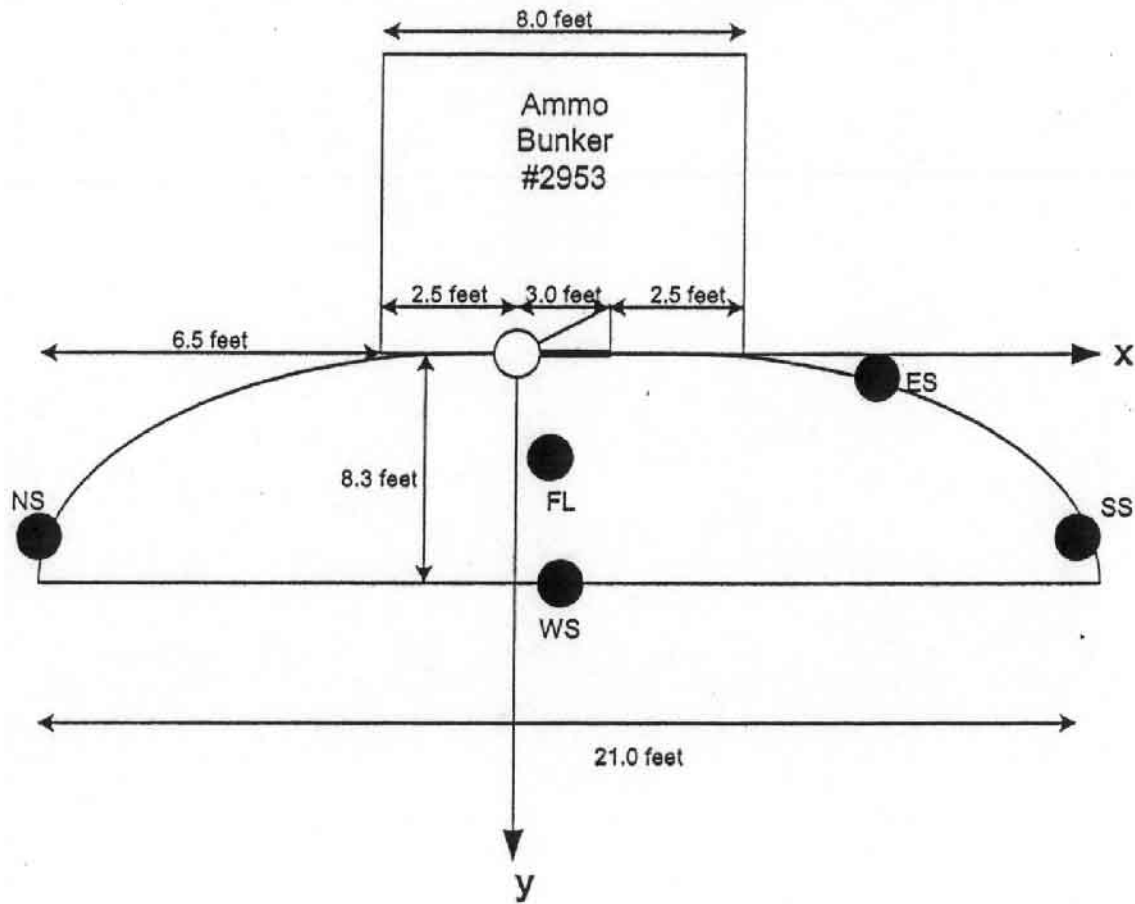
Figure A-28  
**Ammunition Bunker #2953 Sample Locations**

Ammo Bunker #2153 Samples

#	X	Y	depth
FL	1.2	4.0	1
NS	-9.0	7.2	1
ES	4.3	0.5	1
SS	10.5	7.0	1
WS	4.0	8.3	1

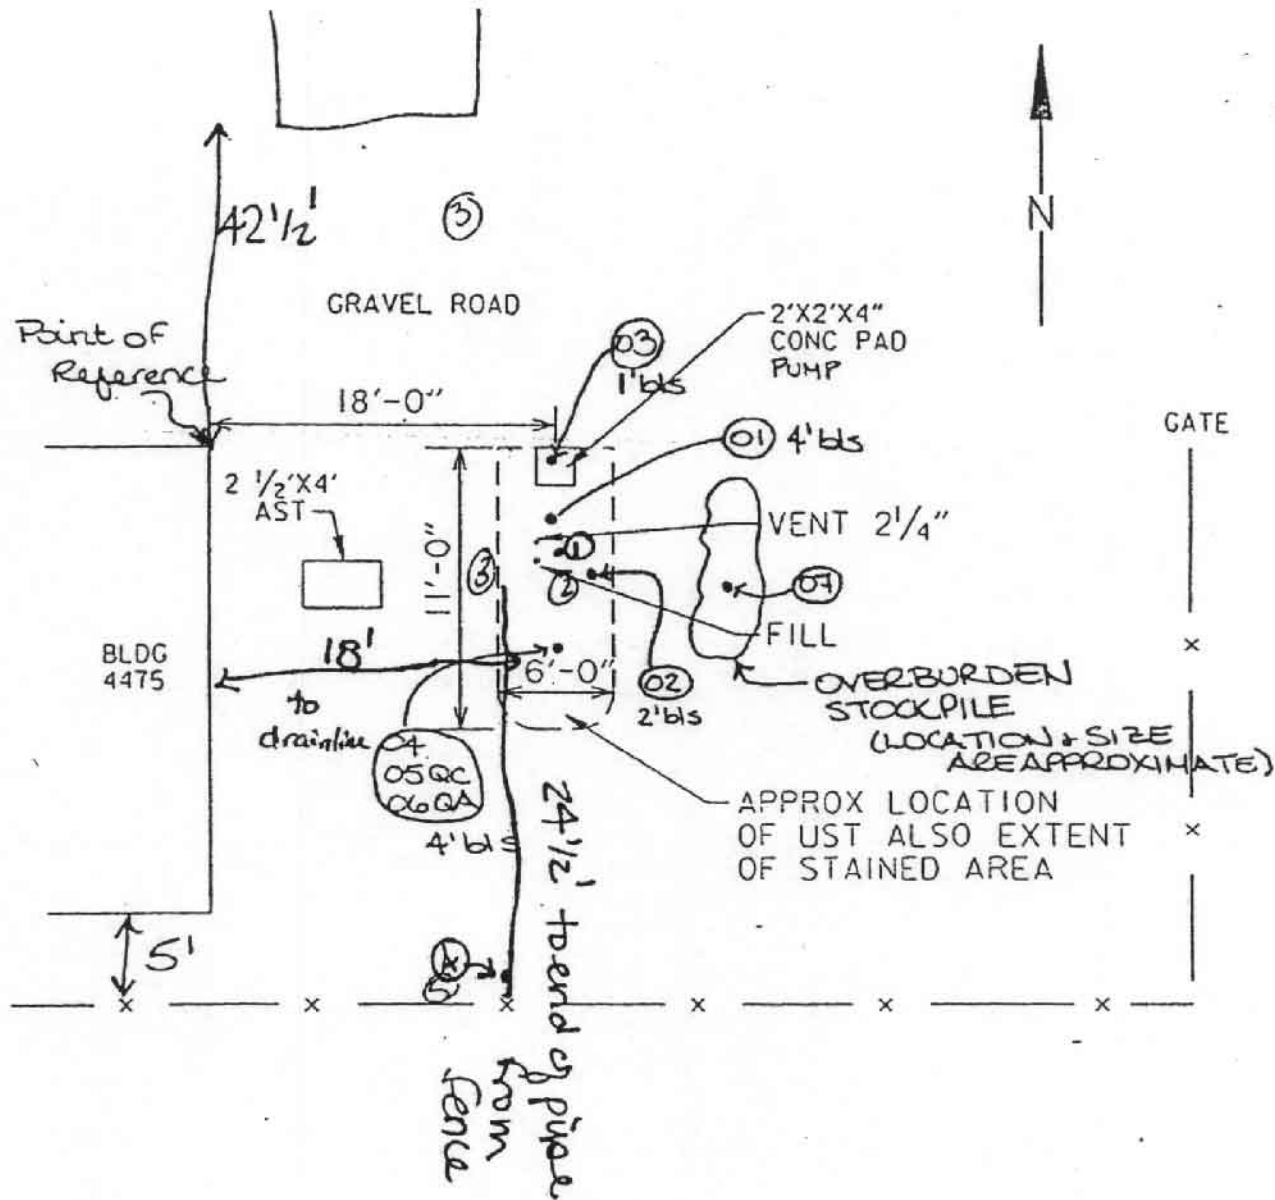
Figure A-29

UST Tank #7, Tank ID #CMPBN

Buried Drainage Pipe

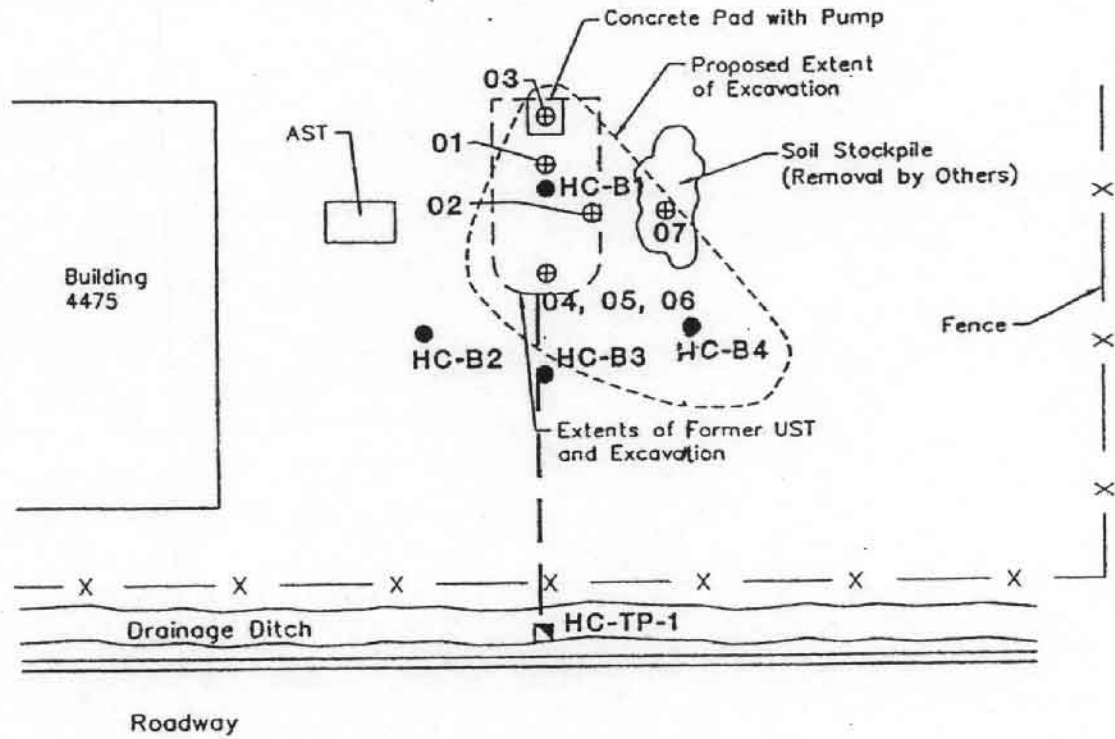
Former UST Excavation Samples (February 1993)

Soil Sample ID	Depth in Feet	TPH Concentration in mg/kg	Description
01	4	600	Excavation Bottom
02	2	110	East Side Wall
03	1	57	North Side Wall
04	4	2,600	South Side Wall
05	4	-	South Side Wall
06	4	2,300	South Side Wall
07	-	4,900	Soil Stockpile

The underground storage tank was formerly located approximately 10 feet east of Building 4475. This UST was part of a refueling system connecting one 275-gallon diesel AST with the 300-gallon diesel UST. The UST was thought to be leaking because the fuel consumption and tank filling records did not coincide. Additionally, petroleum stains were prevalent on the ground surface around the fueling site. As a result, the 300-gallon diesel UST was removed in 1995. Contaminated soil was discovered during the UST removal. This is discussed in more detail in Section 5.20.

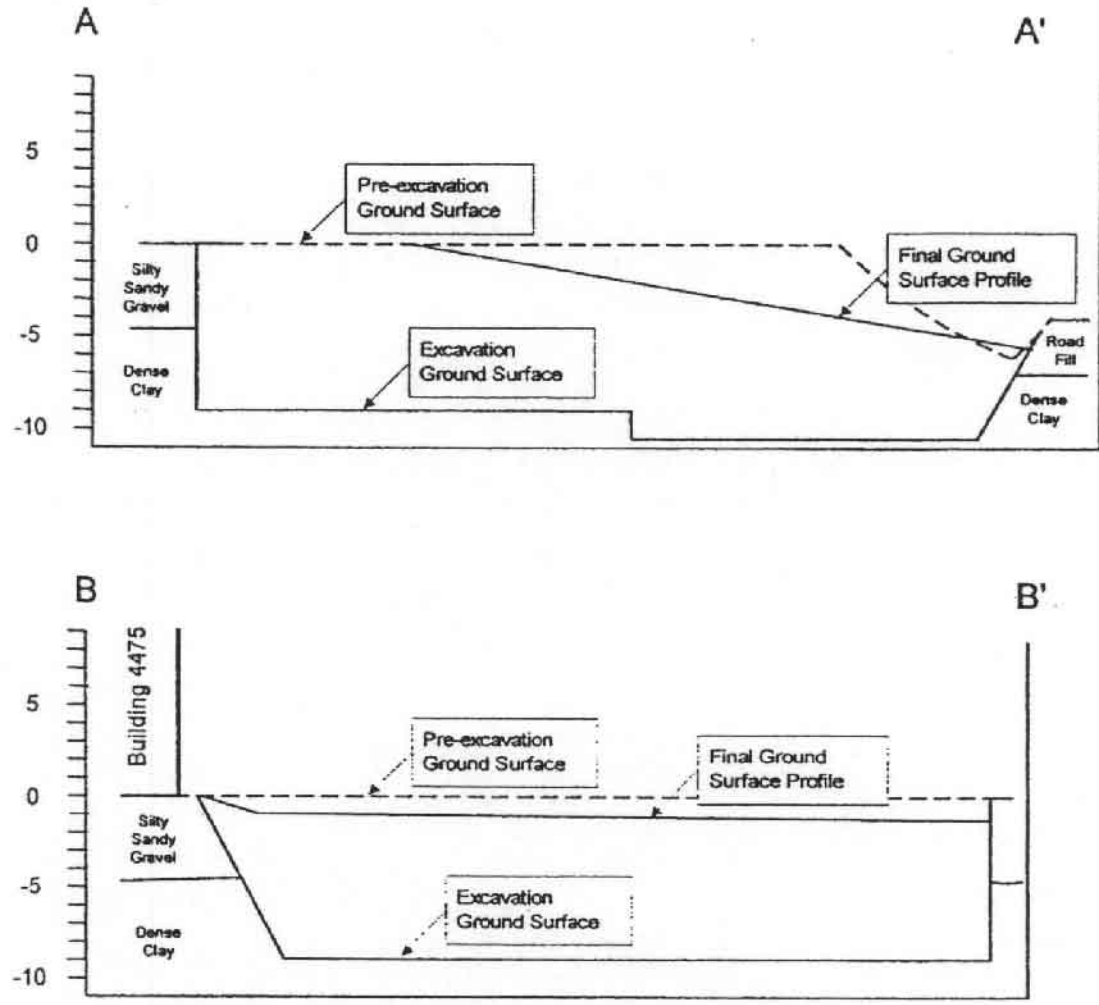
Figure A-33  
SBldg. #4475, Tank 7-CMPBN, Site Cross-Sections

VERTICAL EXAGGERATION = 2x

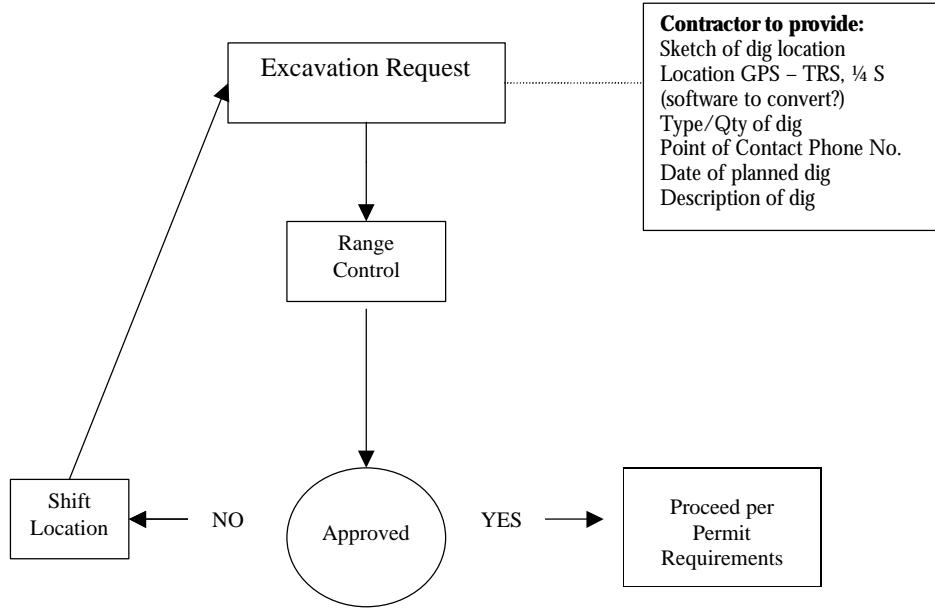
<b>URS</b>	U.S. ARMY CORPS OF ENGINEERS SEATTLE DISTRICT SEATTLE, WASHINGTON
<b>Excavation Permit Process</b>	
CAMP BONNEVILLE	WASHINGTON

# EXCAVATION PERMIT PROCESS
