# Washington State Department of Ecology

## Stream Discharge Technical Notes

**Station ID:** 01C070

**Station Name:** Hutchinson Creek near Acme

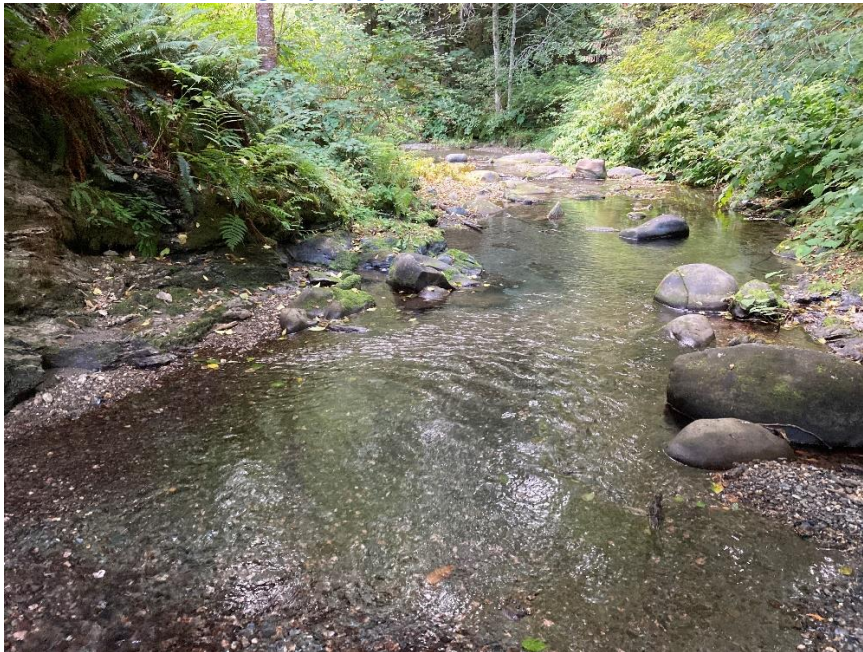
*Figure 1: Gage pool control of Hutchinson Creek.*
