# Lower Duwamish Waterway RM 1.0 to 1.3 West (Kellogg Island to Lafarge)

## Summary of Existing Information and Identification of Data Gaps

April 2011

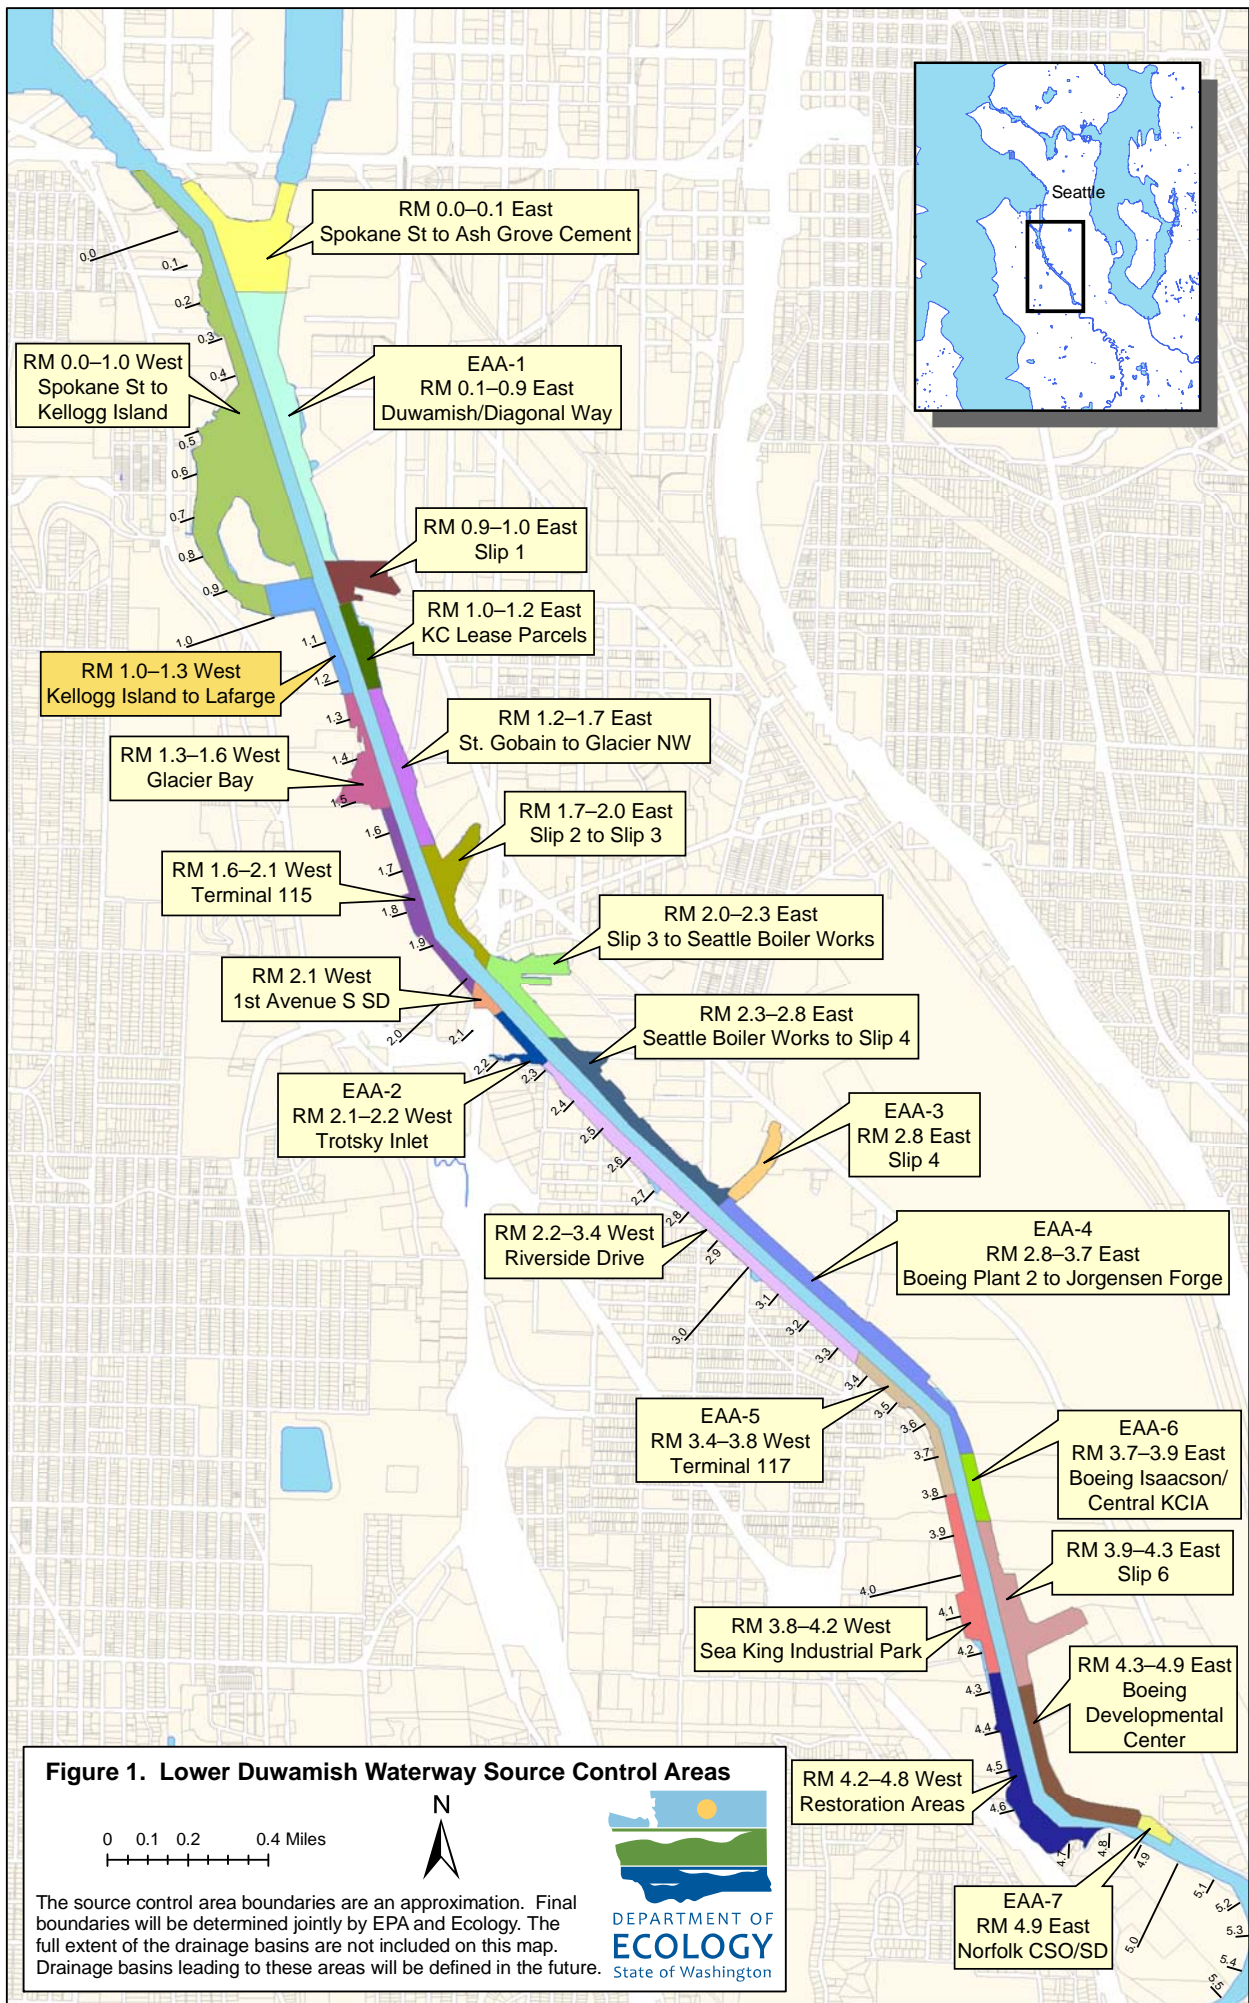
**Figure 2. Lower Duwamish Waterway Storm Drain Basins — West Side**

the source control areas, generally defined by stormwater drainage basins. The seven candidate EAAs and 17 additional source control areas are shown on Figure 1. Stormwater drainage basins located in the vicinity of the RM 1.0-1.3 West source control area are shown on Figure 2.

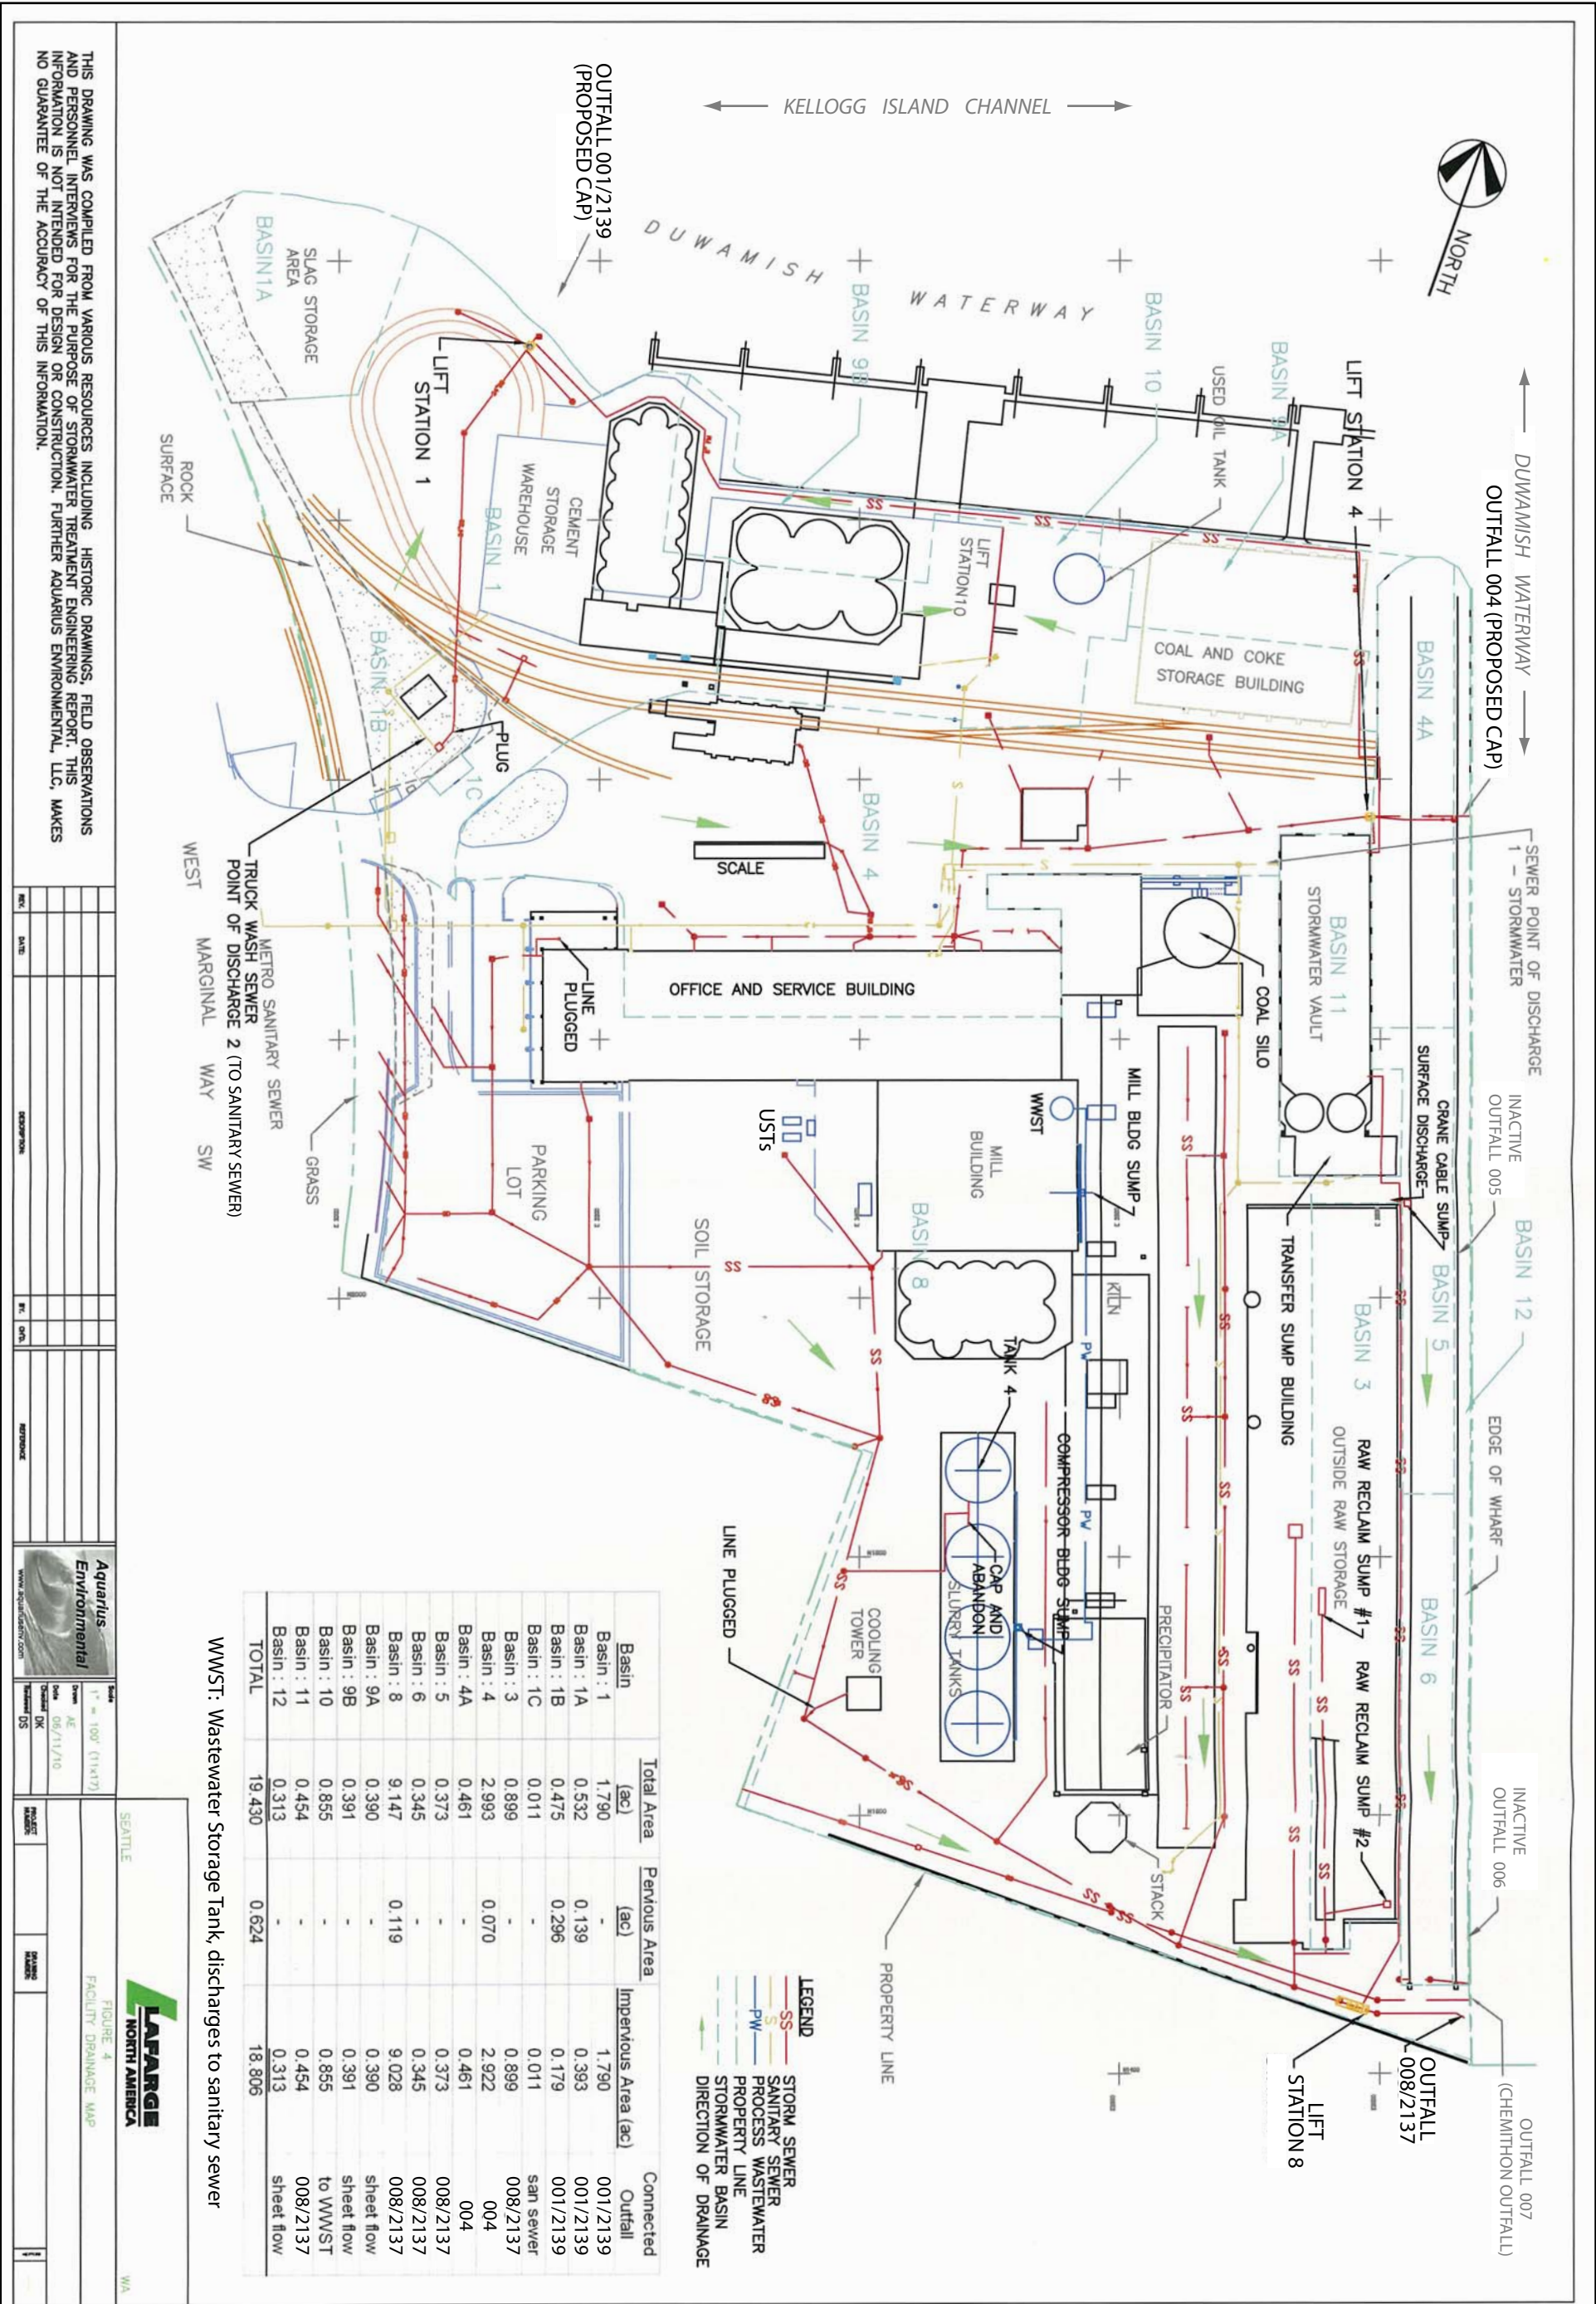
THIS DRAWING WAS COMPILED FROM VARIOUS RESOURCES INCLUDING HISTORIC DRAWINGS, FIELD OBSERVATIONS AND PERSONNEL INTERVIEWS FOR THE PURPOSE OF STORMWATER TREATMENT ENGINEERING REPORT. THIS INFORMATION IS NOT INTENDED FOR DESIGN OR CONSTRUCTION. FURTHER AQUARIUS ENVIRONMENTAL, LLC, MAKES NO GUARANTEE OF THE ACCURACY OF THIS INFORMATION.

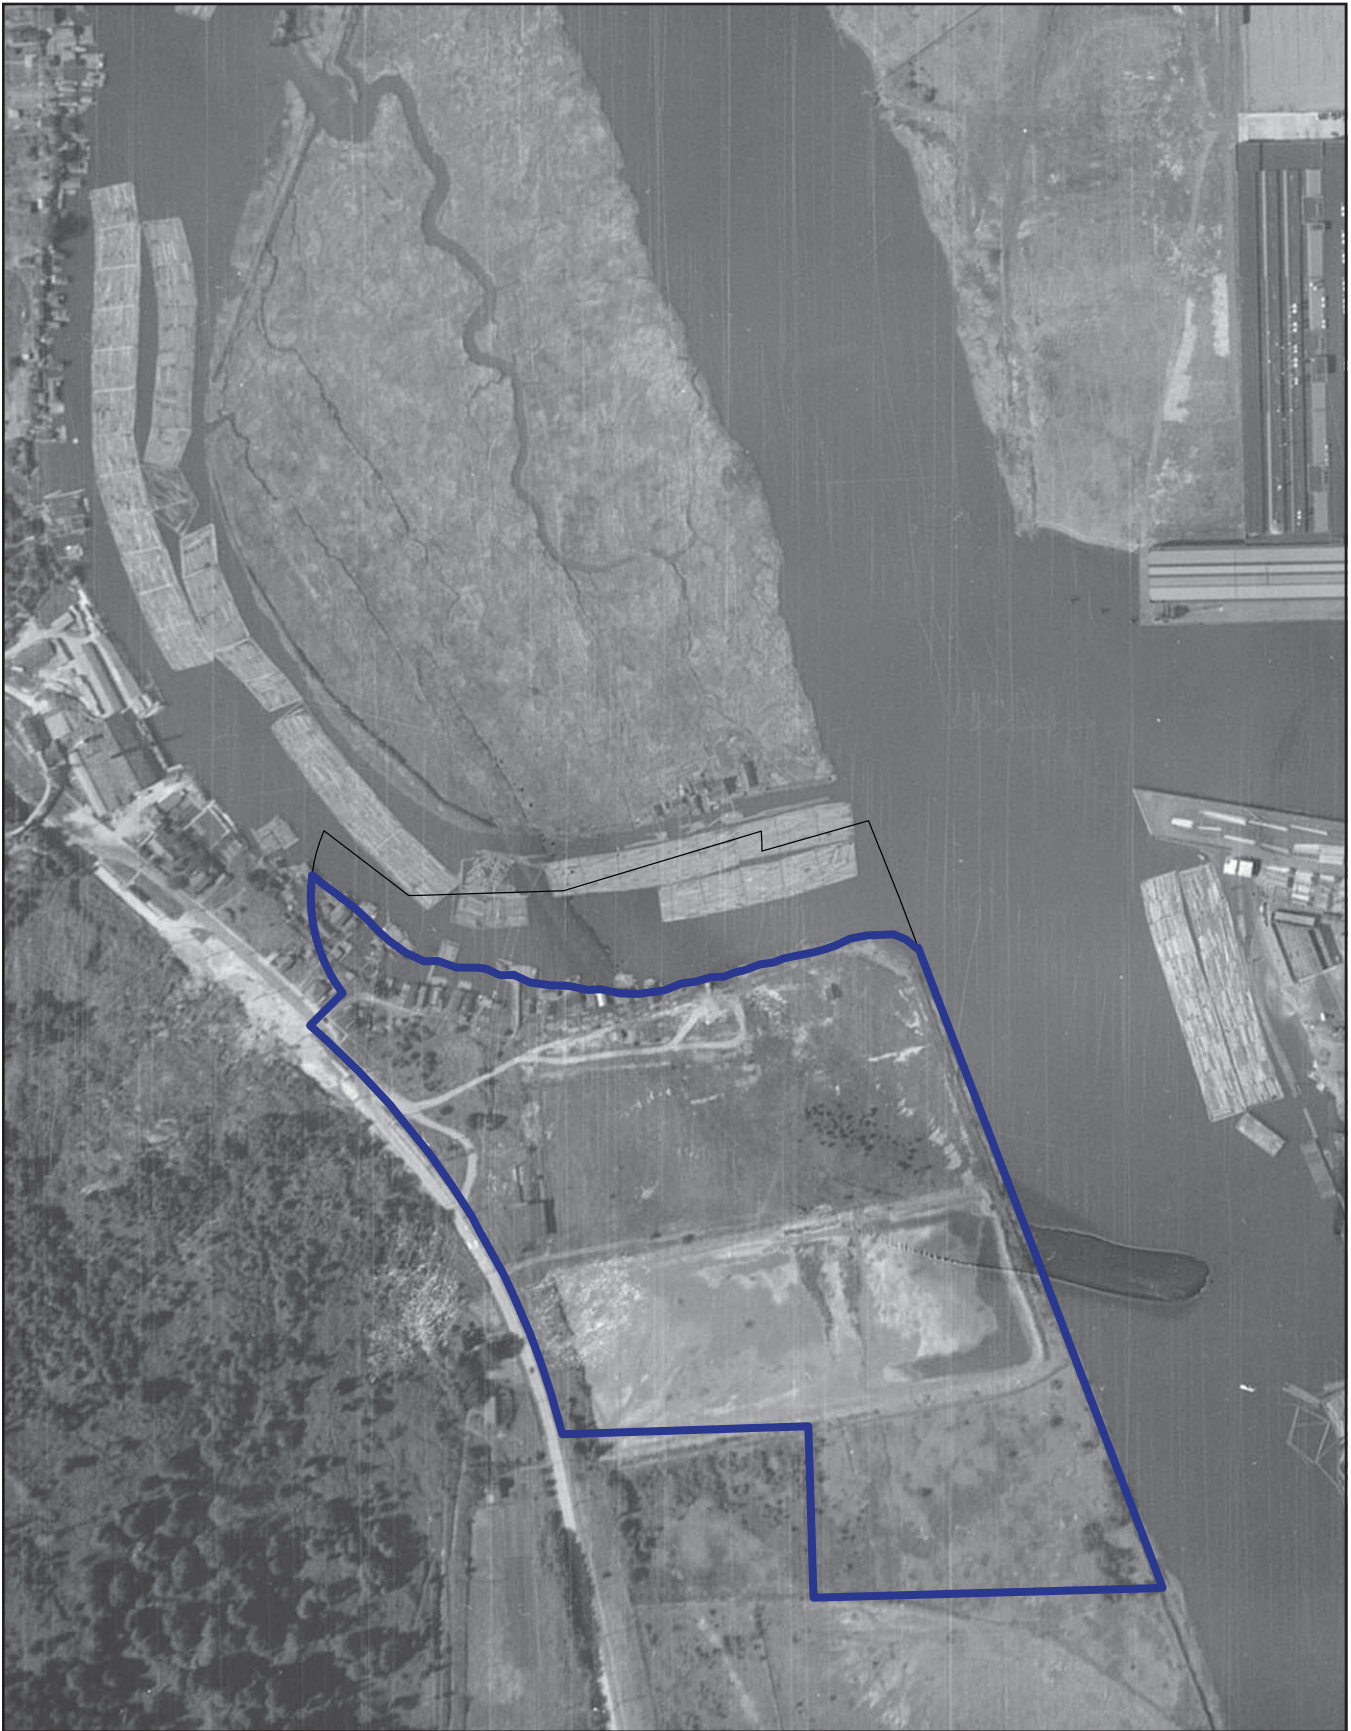
**Figure B-1. RM 1.0 to 1.3 West  
(Kellogg Island to Lafarge): 1936**

In an effort to more thoroughly understand and evaluate historical facility operations and development in the RM 1.0–1.3 West source control area, SAIC reviewed historical aerial photographs from 1936 to 2004. At a minimum, these photographs represent conditions of roughly each decade. Additional photographs are available; however, if during a cursory assessment there were no apparent changes, photographs less than a decade apart were not included in this summary. Aerial photographs for the years 1936, 1946, 1956, 1960, 1969, 1974, 1980, 1990, and 2004 are described below.

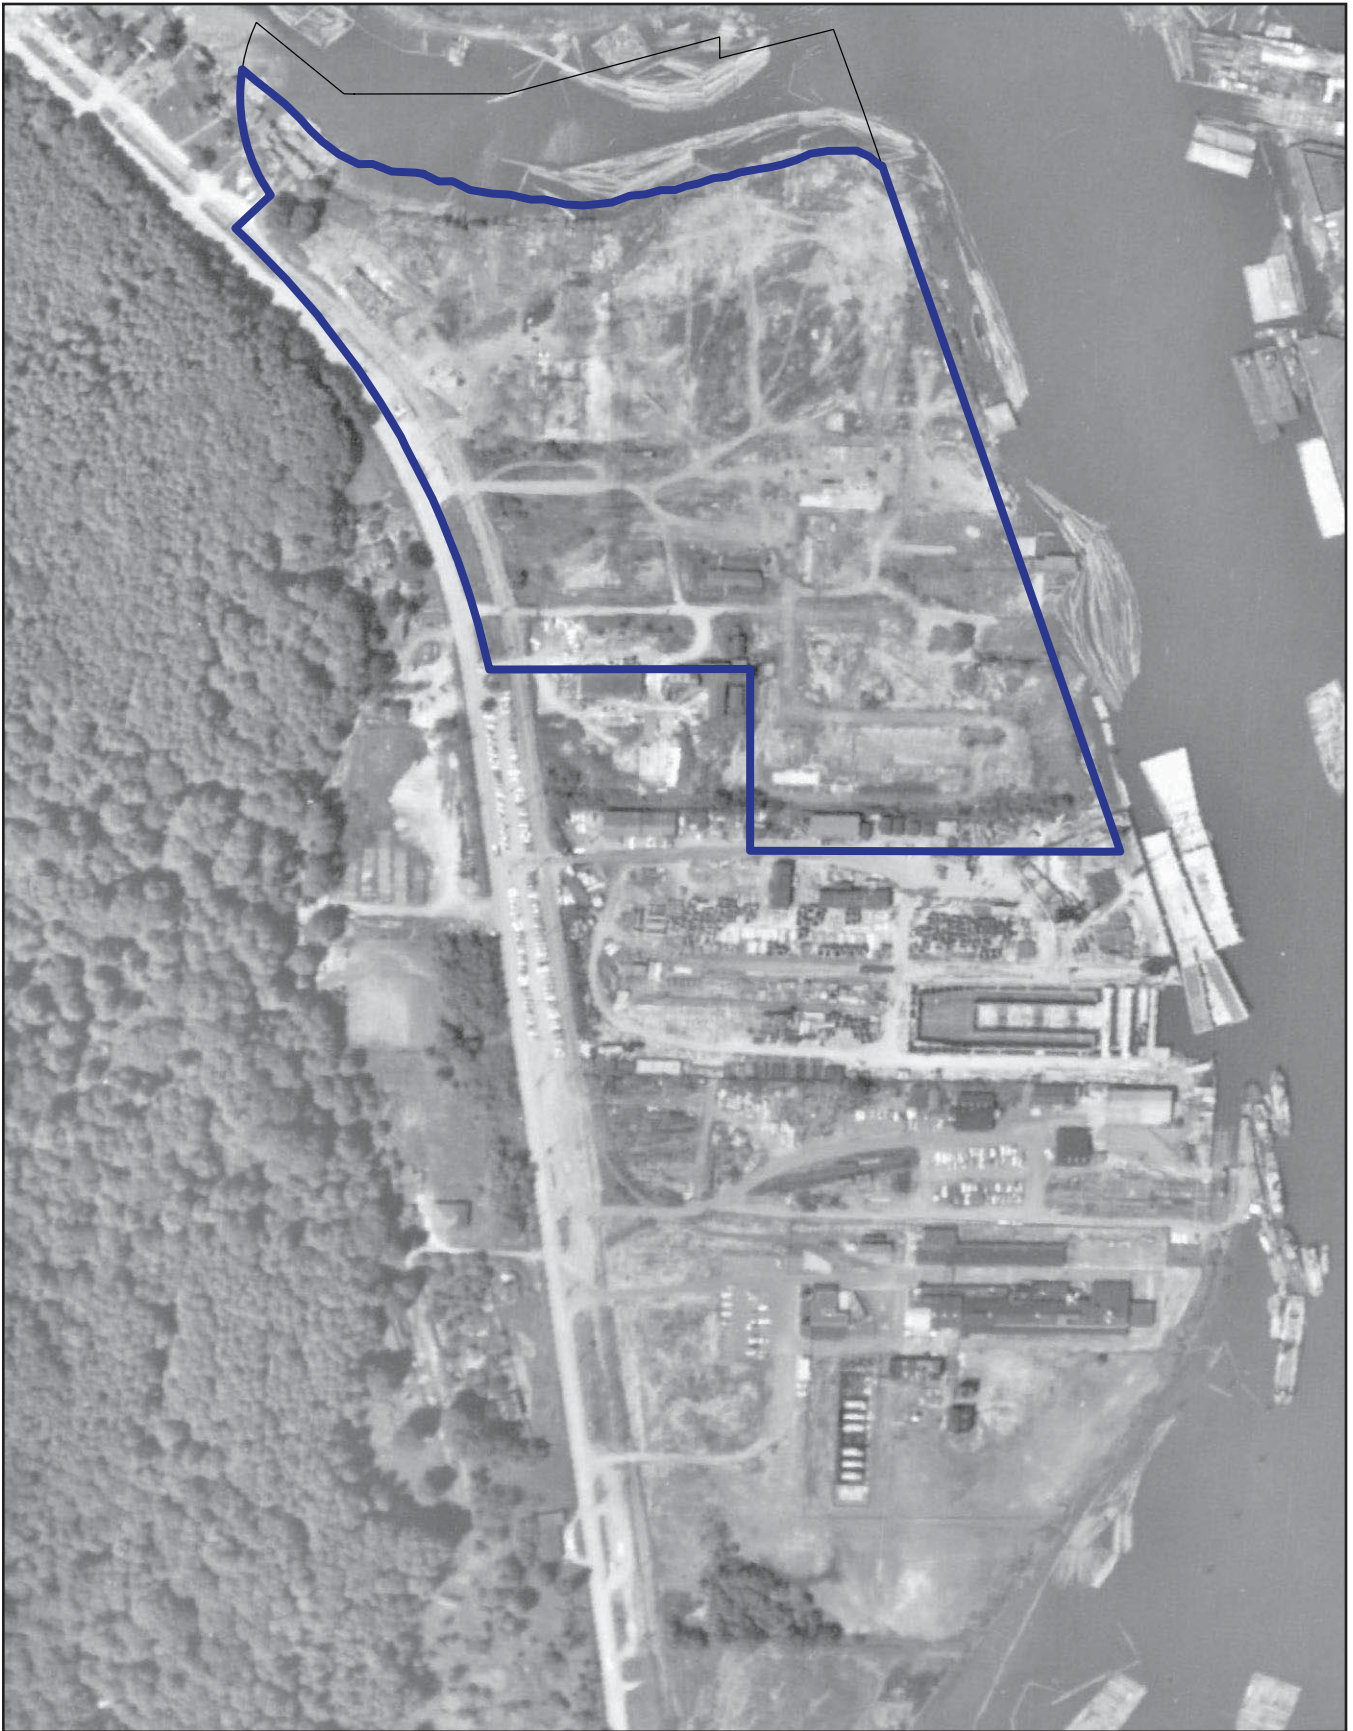
Figure B-4. RM 1.0 to 1.3 West  
(Kellogg Island to Lafarge): 1960

The buildings on all areas of the property have been deconstructed but not replaced. Dirt roads running through the property remain similar to previous years. Logs continue to be rafted along the eastern edge of the property. A railway has been constructed along the western property boundary, parallel to West Marginal Way SW.

**1960:** The buildings on all areas of the property have been deconstructed but not replaced. Dirt roads running through the property remain similar to previous years. Logs are rafted along the eastern edge of the property. A railway has been constructed along the western property boundary, parallel to West Marginal Way SW.

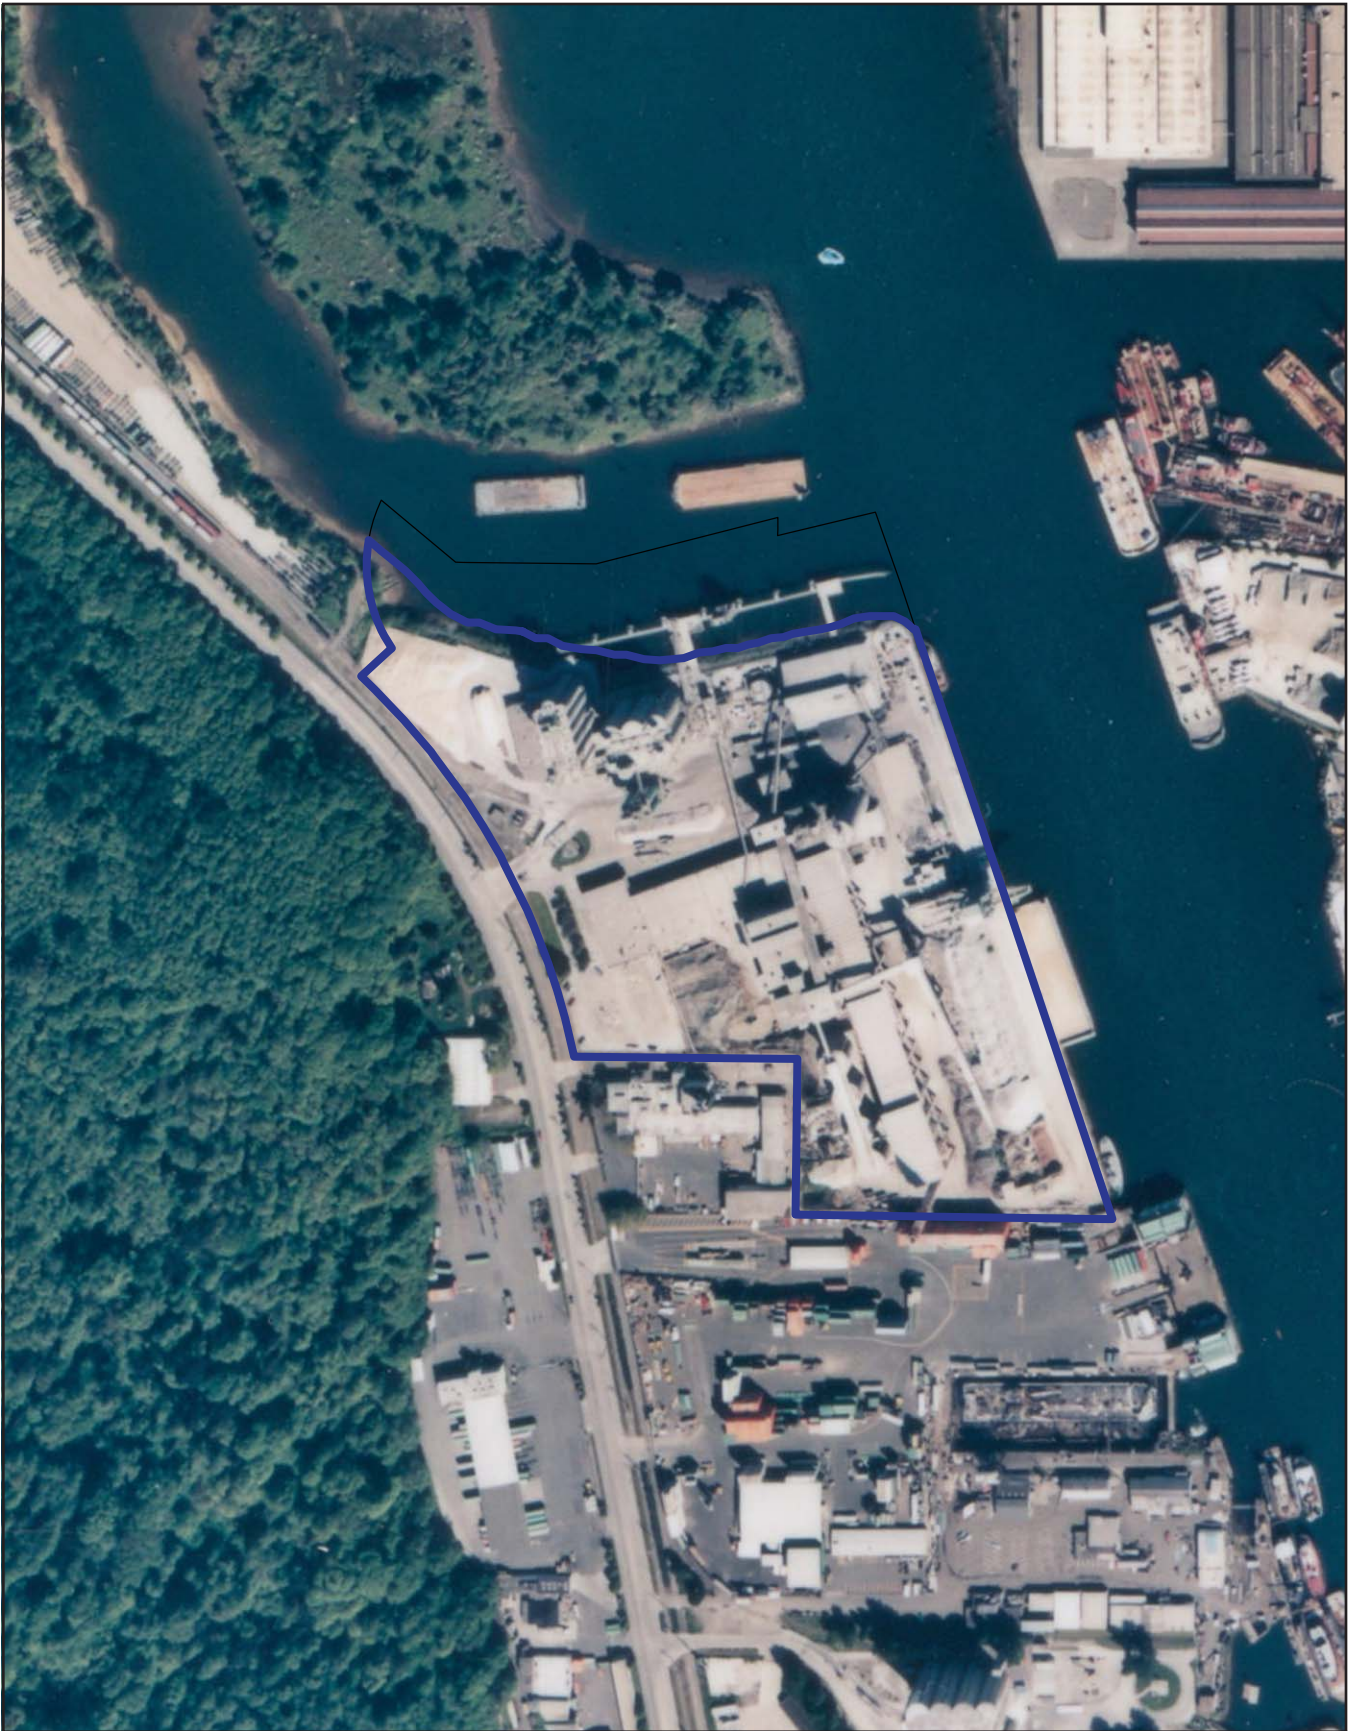
**Figure B-9. RM 1.0 to 1.3 West  
(Kellogg Island to Lafarge): 2004**

The source control area is relatively unchanged.

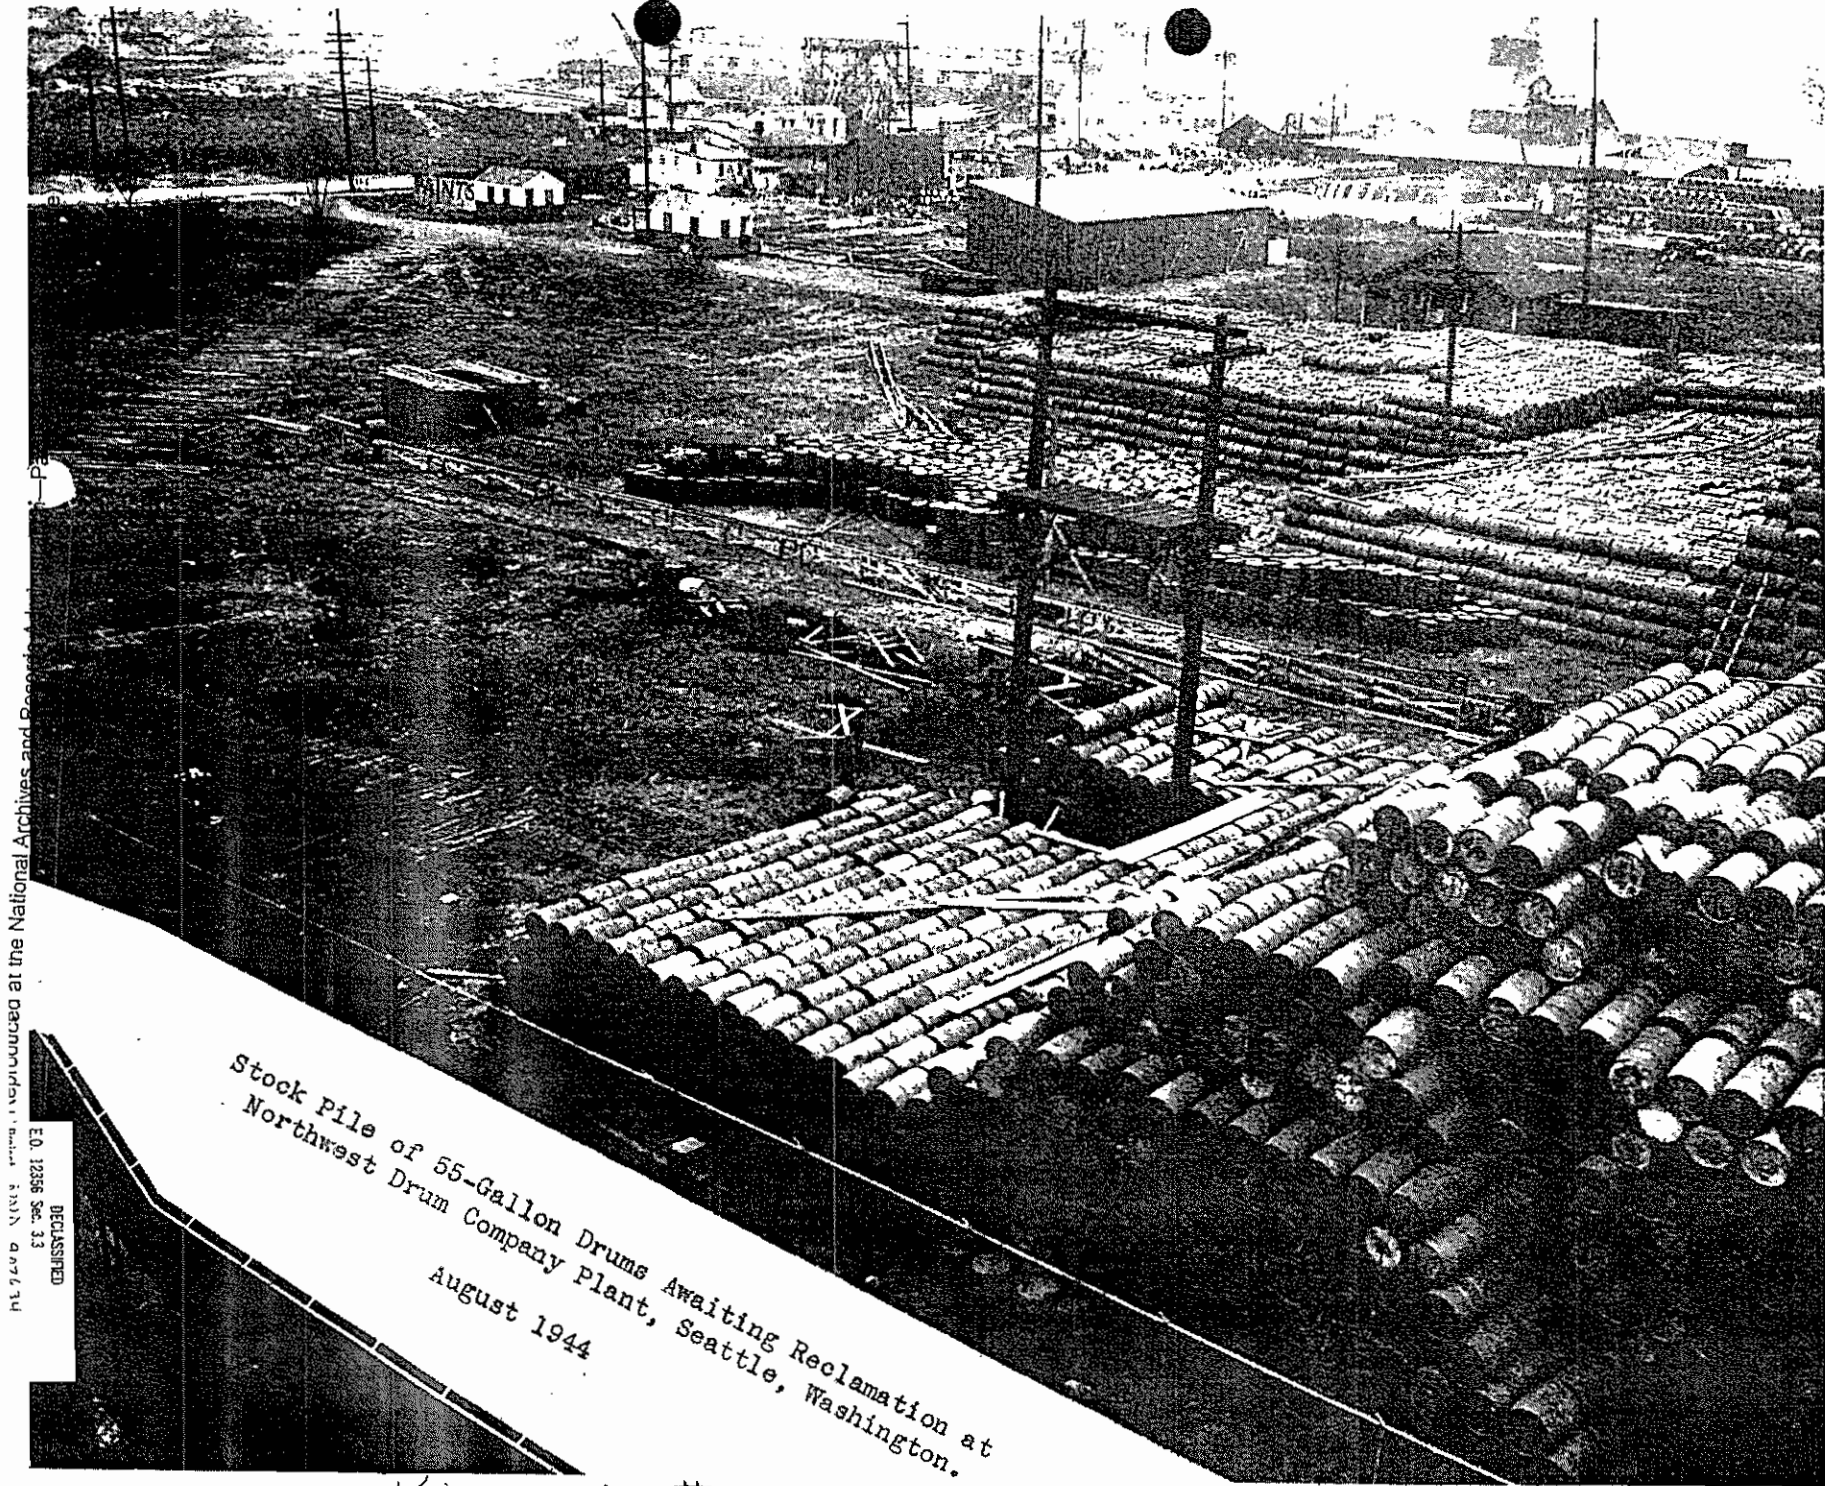
Stock pile of 55-Gallon Drums Awaiting Reclamation at  
Northwest Drum Company Plant, Seattle, Washington.  
August 1944

The United States Army implemented a 55-gallon drum reclamation program from June 1944 to March 1946 at five sites along the LDW. The Northwest Drum Company performed drum reclamation for the Army at the location that is now occupied by Lafarge. Small-scale operations began in July 1944, with full production capacity by August 1944. Drums arrived at the location by ship and were stockpiled. The drums had been used to store petroleum products. Dents were removed and the drums were sandblasted to remove residual material and heavy rust. Drums were then painted before being sent off site to be refilled. Galvanized drums were stockpiled for disposal and were not recycled. The plant had the capacity to reclaim 4,500 drums every 24 hours. Drum reclamation was terminated in September 1945 and all surplus drums were shipped off site by March 1946 (McKnight 1946). Drums appear to be stored at the facility in the aerial photo B-4 in Appendix B. Based on photographs of the Northwest Drum Company (Appendix D), the facility was not paved.

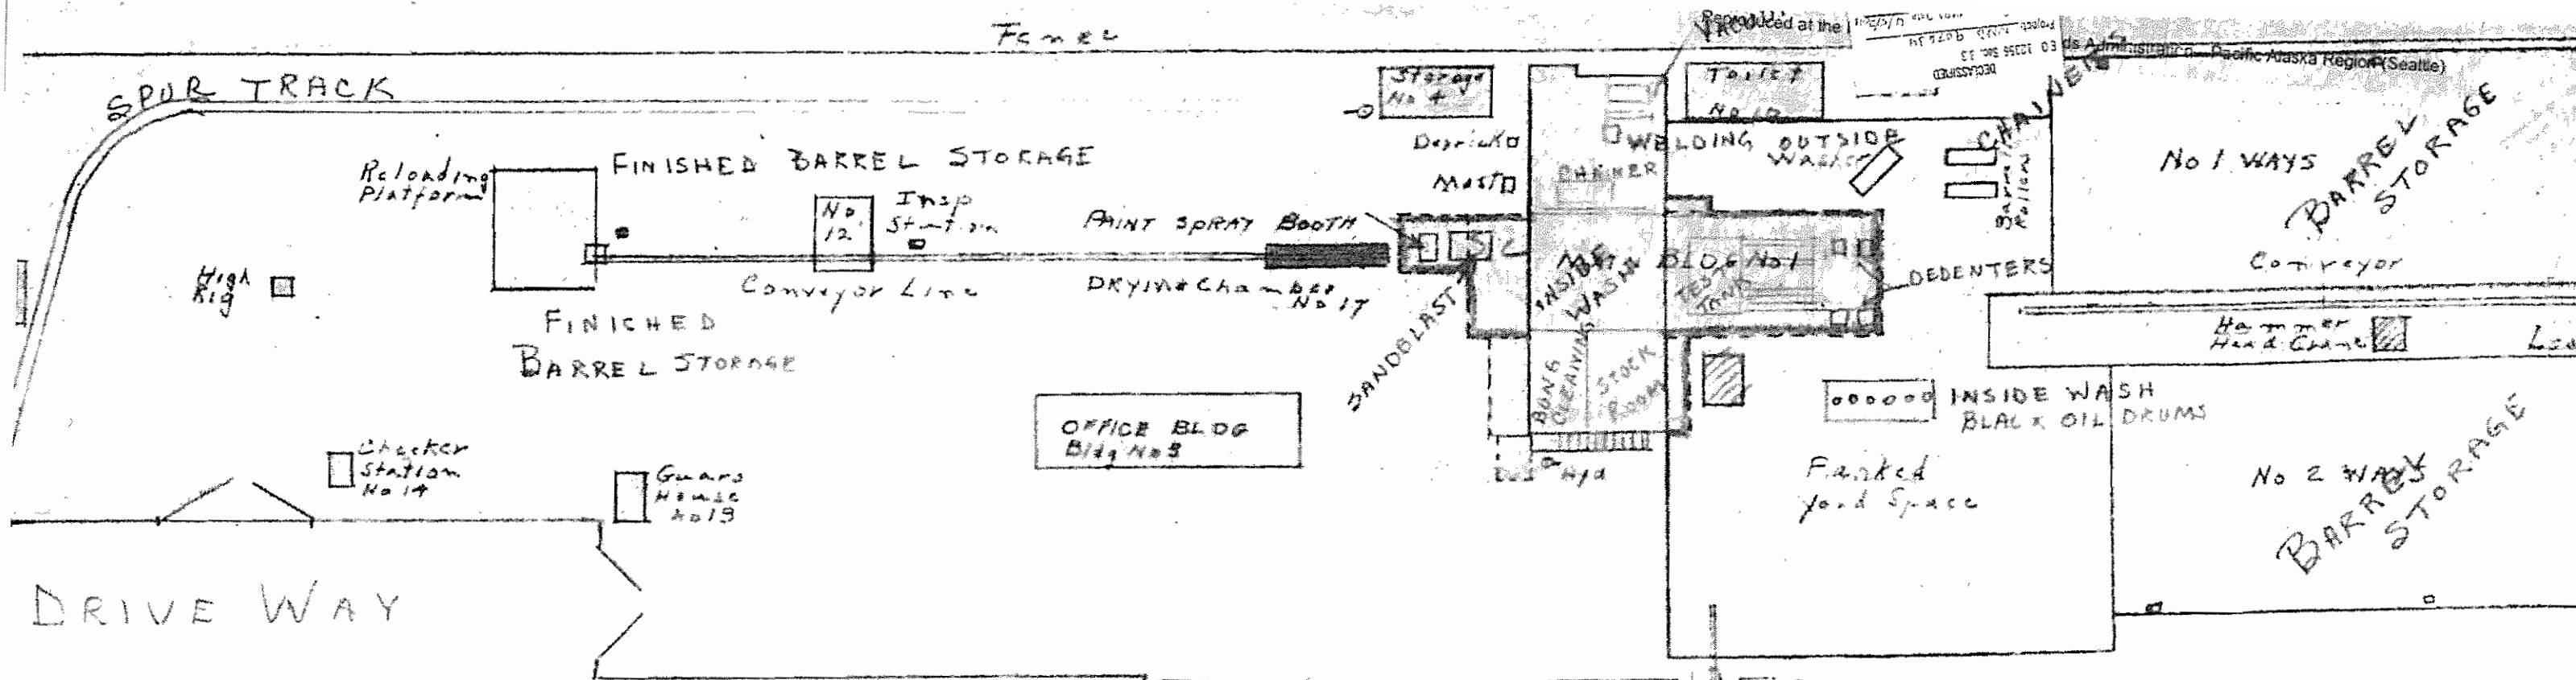
NORTHWEST DRUM CO  
 5400 WEST MARGINAL NA:  
 SEATTLE, WASH  
 SCALE 1" = 50'

BARREL STORAGE
