INITIAL INVESTIGATION FIELD REPORT

<u>Site Name (Name over door):</u> Talita Ballard	<u>Site Address (including City, State and Zip):</u> 7500 - 7530 15th Ave NW Seattle, WA 98117	<u>Phone</u> <u>Email</u>
<u>Site Contact, Title, Business:</u> Daniel Whitman Whitman Environmental Sciences	<u>Site Contact Address (including City, State and Zip):</u> 6812 16th Ave NE Seattle, WA 98115	<u>Phone</u> (206) 523-3505 <u>Email</u> whtenviro@yahoo.com
<u>Site Owner, Title, Business:</u> The Isola Group LLC	<u>Site Owner Address (including City, State and Zip):</u> 1518 1st Ave S, Ste 301 Seattle WA 98134	<u>Phone</u> <u>Email</u>
<u>Site Owner Contact, Title, Business:</u> Mr. Alex Mason The Isola Group LLC	<u>Site Owner Contact Address (including City, State and Zip):</u> 1518 1st Ave S, Ste 301 Seattle WA 98134	<u>Phone</u> (206) 512-3606 <u>Email</u> alex.mason@isolacm.com
<u>Previous Site Owner(s):</u>	<u>Additional Info (for any Site Information Item):</u> ** Parcels: 3491300011, 3491300012, 3491300023, 7748000005, 7748000010 & 7748000015

Figure 3 - Underground Storage Tank Excavation and Sampling Plan

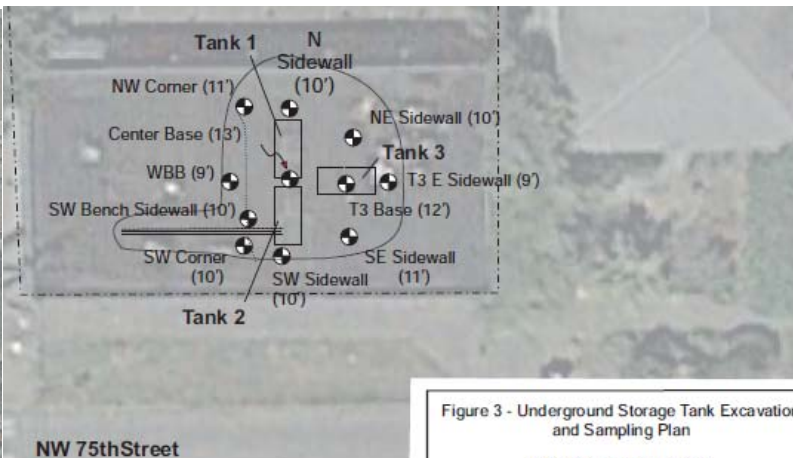
Contamination sources were identified during property redevelopment, including standing water with petroleum sheen in a concrete stairwell, one residential heating oil UST, hydraulic lifts at a former muffler shop, three USTs at a gasoline station, and improper waste disposal.

A total of 341 tons of petroleum-contaminated soil was removed from the property during cleanup and disposed at a permitted off-site facility. Standing water and wastes were also disposed. Confirmation samples documented removal of soil to concentrations below MTCA cleanup levels. Five borings drilled to 21.5 feet below ground surface (bgs) and one boring drilled to 23 feet bgs did not encounter groundwater. This cleanup meets the criteria for Model Remedy No. 1.
