STATE OF WASHINGTON DEPARTMENT OF ECOLOGY

Re: No Further Action at the following Site:

• Site Name: Cleaning Center of Redmond

$\label{eq:continuous} \textbf{Enclosure A}$ Description and Diagrams of the Site

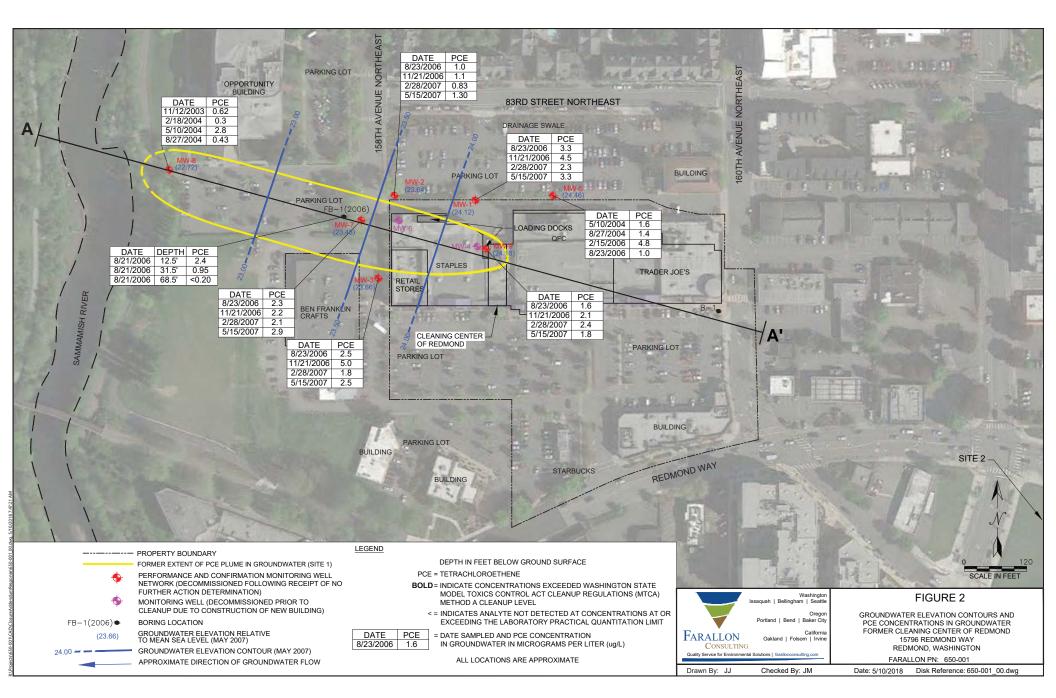
Enclosure A, Figure 2

<u>Surface/Storm Water System</u>: The Site begins at the Former Cleaning Center of Redmond and continues west to the Sammamish River. The river is approximately 600 feet west of the Property (**Figure 2**).

- Human health protection from drinking groundwater pathway exposure.
- Human health protection from vapor intrusion from groundwater to indoor air pathway.
- Human health and ecological protection from discharge of ground water to surface water (the Sammamish River); see **Enclosure A**, **Figures 2 and 3**.

Area and Property Description: The Property consists of one King County tax parcel (number 719890-0080) and is approximately 6.93 acres in size. A strip mall currently occupies the Property and is bordered on the west by 158th Avenue South, on the east by 160th Avenue Northeast, on the south by Redmond Way Northeast, and on the north by a parking lot and NE 83rd Street. Land use surrounding the Site includes commercial businesses, residential apartments and condominiums. (**Figure 2**).

An SVE remediation system was installed in 2003 to address concentrations of PCE in soil and groundwater. Soil and groundwater monitoring data was collected on a scheduled basis from 2003 to 2007 and demonstrated that the SVE remediation system was effective in removing PCE in soil and groundwater to concentrations below MTCA Method A cleanup levels (**Figures 4 and 2, respectively**).

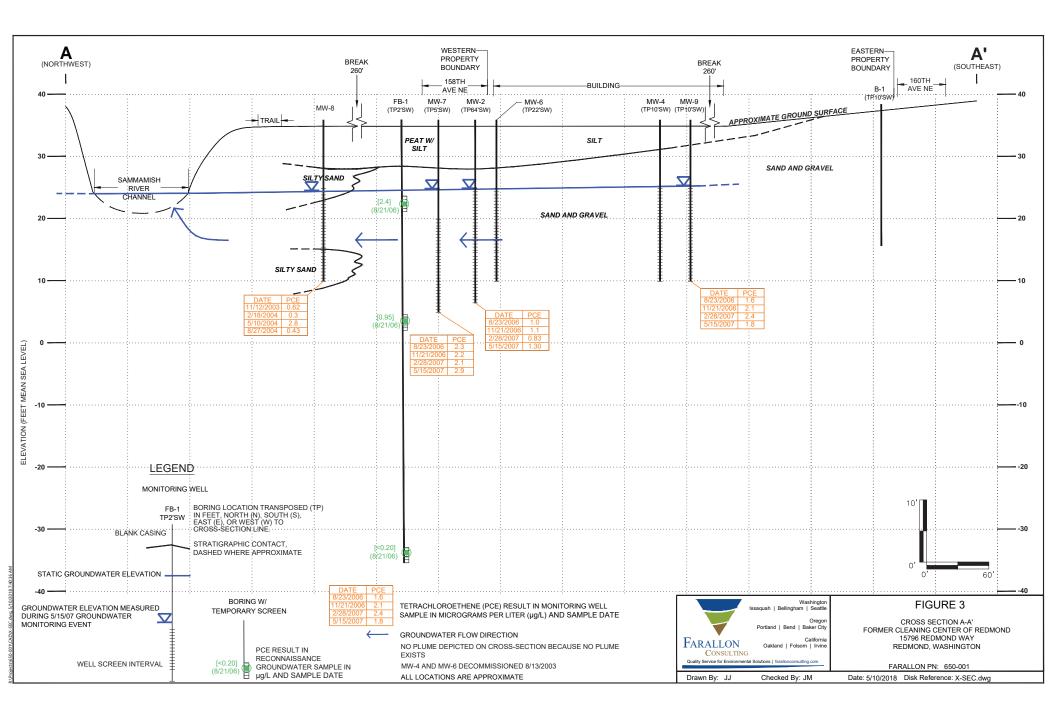
Enclosure A, Figure 3

Shallow soil encountered during subsurface investigation activities in the vicinity of the Site consisted primarily of sand and gravel, with the exception of soil encountered northwest of the northern commercial building (**Figure 3**). The shallow soil in this location included a layer of silt and peat from approximately 2.5 to 8 feet below the ground surface (bgs). Underlying the silt and peat was sand and gravel consistent with the other boring locations.

Ground Water: The shallow aquifer is unconfined and extends to a minimum of 70 feet bgs at the Site, based on the deep boring assessment conducted in 2006 (**Figure 3**). Groundwater levels measured at the Site in 2007 ranged from 9.62 to 11.99 feet below the top of the well casings. The estimated groundwater flow direction consistently been to the northwest toward the Sammamish River (**Figure 2**). Groundwater elevations calculated from the monitoring well gauge data indicate that the potentiometric surface of the unconfined aquifer is at a similar elevation as the surface of the Sammamish River, suggesting that they are hydrologically connected (**Figure 3**).

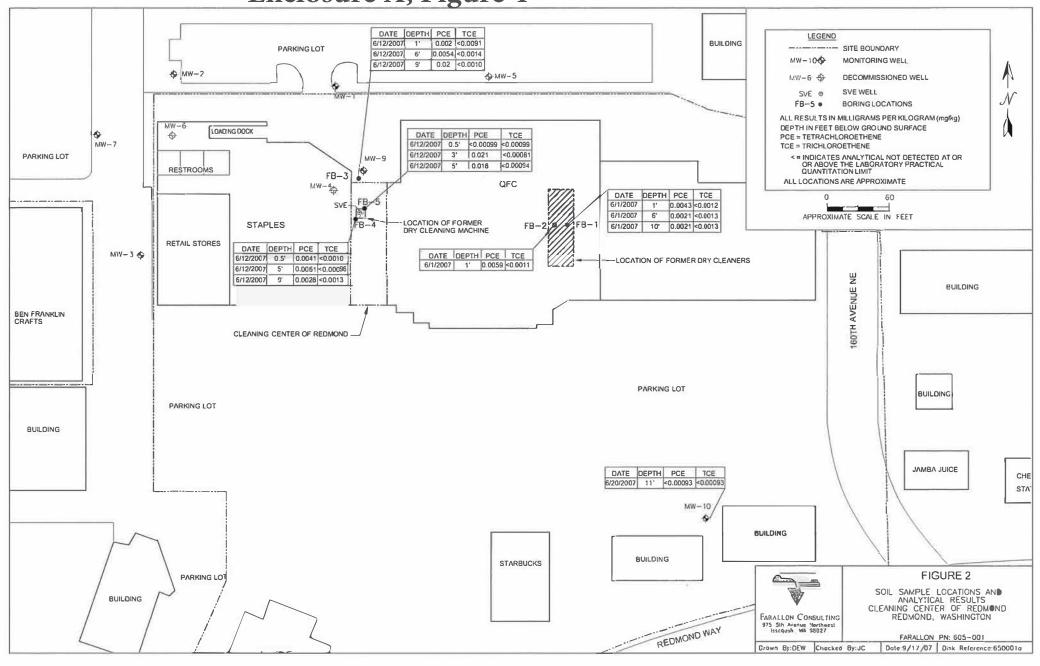
Enclosure A, Figure 4

<u>Contaminant Source</u>: The source of contamination on the Property was the former dry cleaning machine which used the dry cleaning solvent PCE (**Figure 4**). A release occurred in the vicinity of the dry cleaning machine and was documented in 1999.

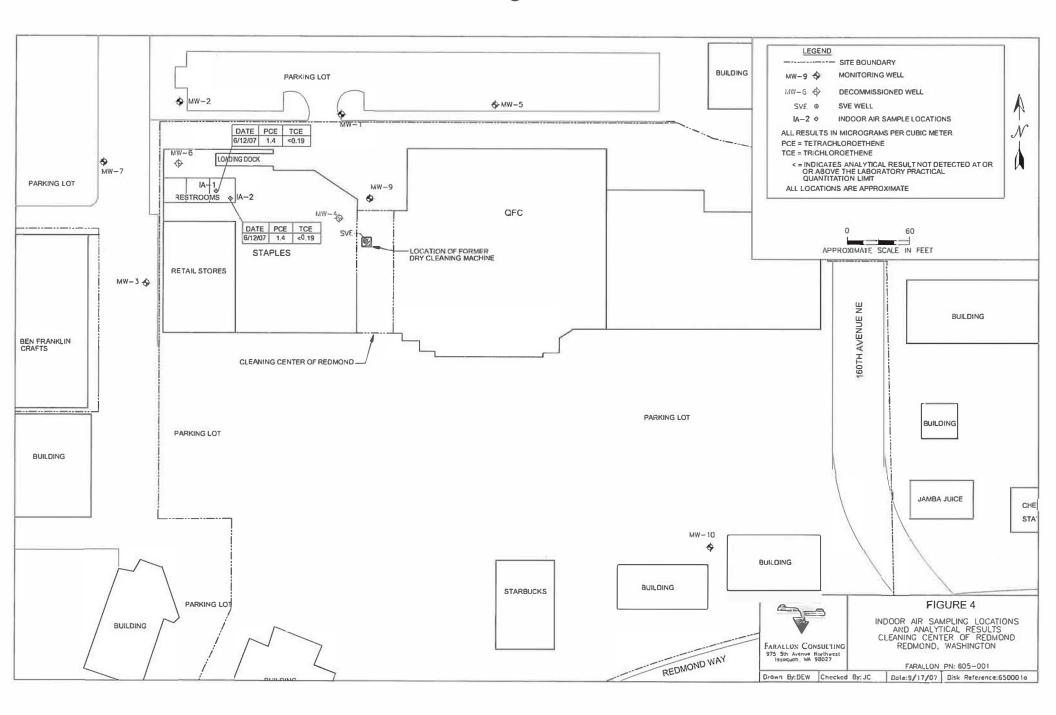
Enclosure A, Figure 5

Indoor air sampling was conducted in 2007 in building spaces overlying the contaminant plume, to assess potential vapor intrusion impacts. The results showed concentrations below MTCA air cleanup levels (**Figure 5**).

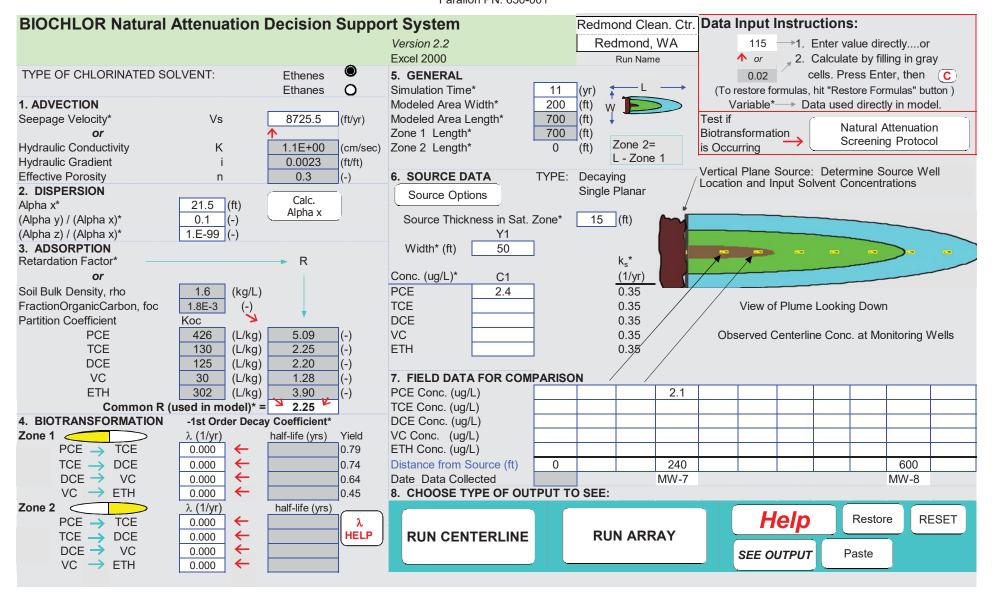
Enclosure A, Figure 6

Figure 6A

BIOCHLOR Model Inputs - Decaying Source at MW-9 Using 2007 Data Former Cleaning Center of Redmond Redmond, Washington Farallon PN: 650-001

As the Site was also defined by the release of PCE to ground water migrating off-Property to the northwest, additional sampling and analysis has been conducted. An empirical evaluation was conducted, and confirmed that the PCE-contaminated ground water is no longer moving off-Property, and will not result in future exceedances of the ground water cleanup levels for the Site under MTCA (**Figures 6 and 7**).

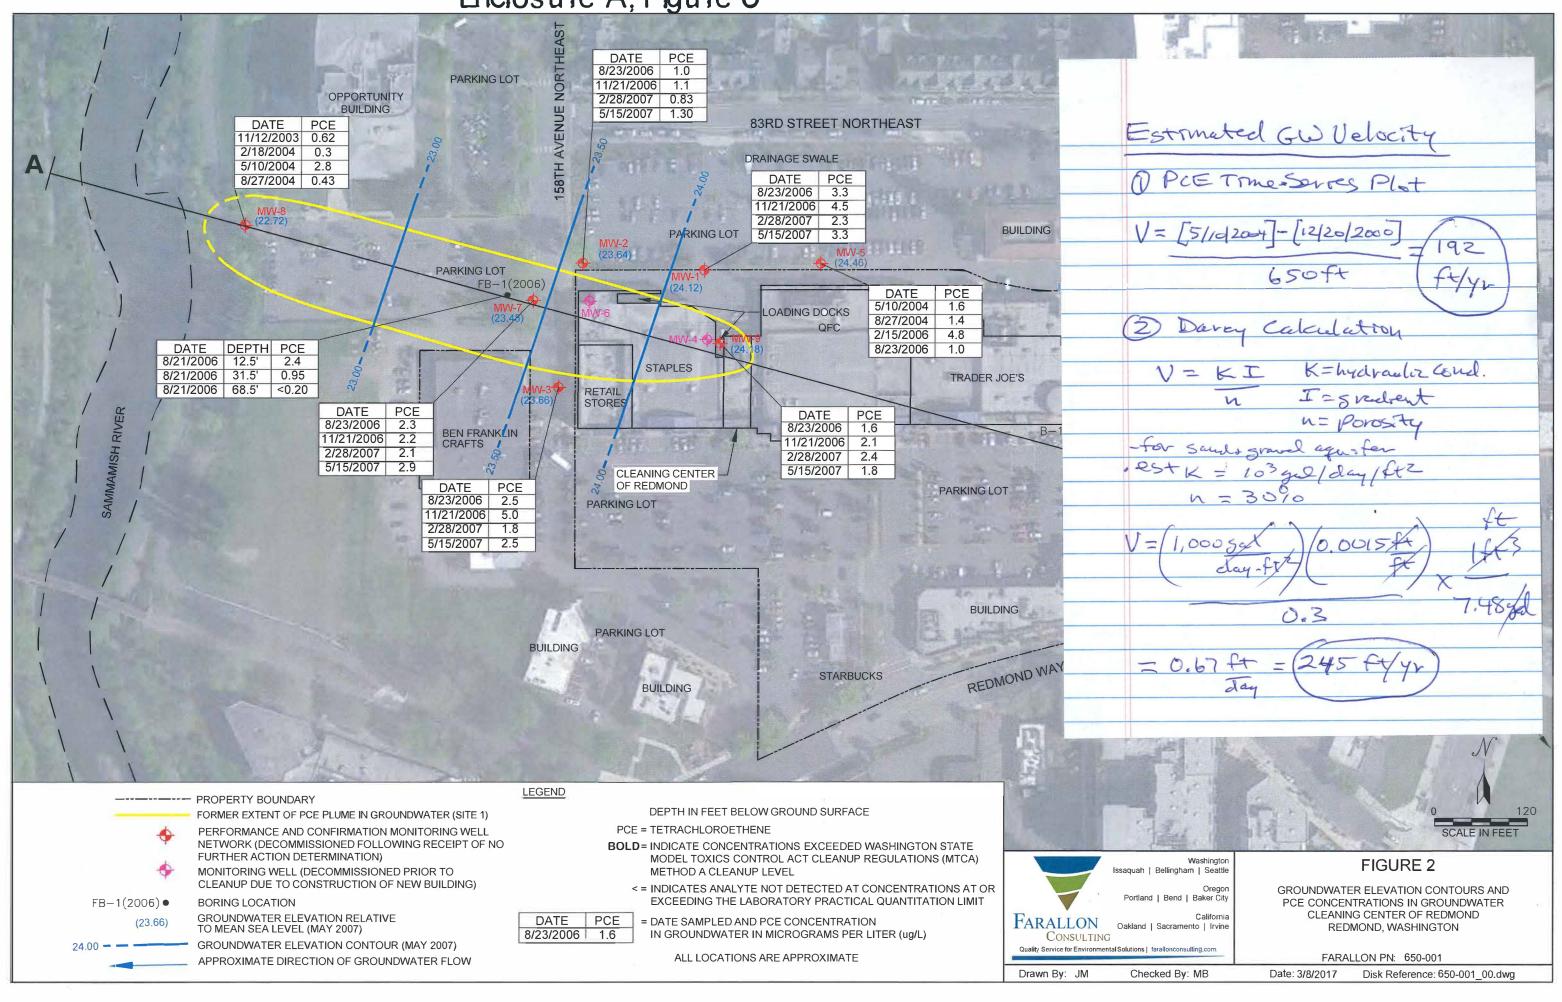
Enclosure A, Figure 8

Ecology also evaluated the behavior of PCE in ground water at the Site over time, with respect to ground water flow velocity (**Figure 8**). This evaluation is consistent with the empirical demonstration and modeling results.
