Subject: Outfall Evaluation for NPDES Permit No. WA0040967
Vancouver, Washington

Annual Outfall Inspection - 2014**TOC Holdings Co. - HANDY ANDY #8****HANDY ANDY #8 - TOC Holdings No. 01-115**
Vancouver, Washington**AMEC Field Personnel:** Bill McFarland**Project #:** 461M076114.01.1**AMEC Project Mgr:** Jack Spadaro**Date:** 11/5/2014**Time:** 12:00**NPDES Permit No. WA0040967****Treated Water Outfall #001:** Located at Burnt Bridge Creek below 2818 NE Cherry Road, Vancouver, WA

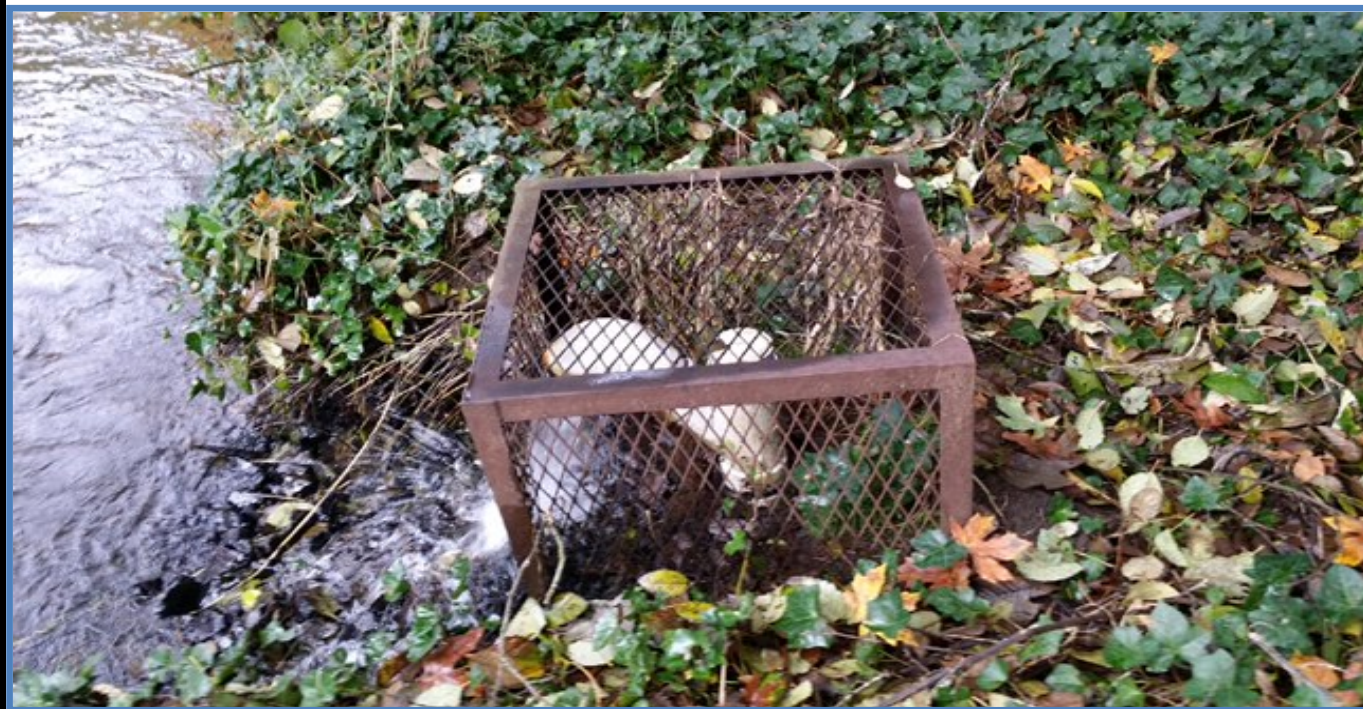
Site Inspection Photograph

At least once per quarter, AMEC staff inspected the outfall pipe to confirm its integrity and continued function in accordance with the NPDES waste discharge permit. An inspection form and photograph from the November 5th inspection of the outfall structure are attached. The physical condition of the outfall structure components, including the P-trap (U-turn) at the top of the discharge pipe, the surrounding protective cage, concrete foundation, and diffusing rock arranged below the outfall pipe all appear to be in good condition and functioning as designed. There is no evidence of sediment accumulation inside the discharge pipe, in the P-trap and on the surrounding splash block/rock. The discharge pipe, P-trap and diffusing rock appear to be free of obstructions and are allowing uniform flow.

Photograph Note: Photo of the outfall during the inspection. The outfall structure is clean and draining normally (drainage is toward the left into Burnt Bridge Creek).

No recommendations or actions appear to be warranted at this time.
