STORMWATER COMPLIANCE INSPECTION REPORT

Name and Location of Site inspected A E Downs Enterprises 22227 76 th Ave S Kent, WA 98032-1924	GPS Entrance: Lat: N 47° Long: 122° 15.290' 25.937' Discharge: Lat: 47° Long: 122° 15.214' 25.917'	Entry Time 10:18	Permit Effective Date 1/14/2005
		Exit Time 10:55	Permit Expiration Date 9/20/2007
On-Site Representative(s): Name(s)/Title(s)/Contact number(s) or E-mail Jean Crocker- Secretary		Additional Participants: Jaron Smith- Ecology	
Responsible Official(s): Barbara Downs A E Downs Enterprises 22227 76 th Ave S Kent, WA 98032-1924 Phone: (253) 872-8147		Yes No Samples Taken? <input type="checkbox"/> <input checked="" type="checkbox"/> Photos Taken? <input checked="" type="checkbox"/> <input type="checkbox"/>

PHOTO ADDENDUM – A E DOWNS ENTERPRISES 5/16/2006

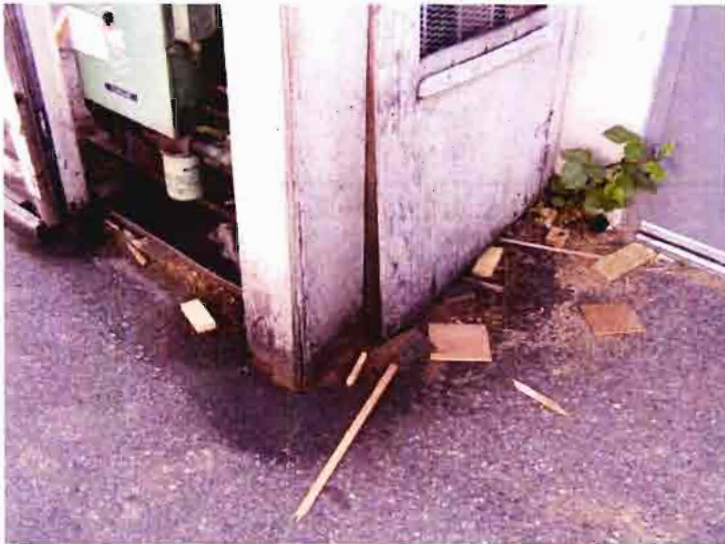
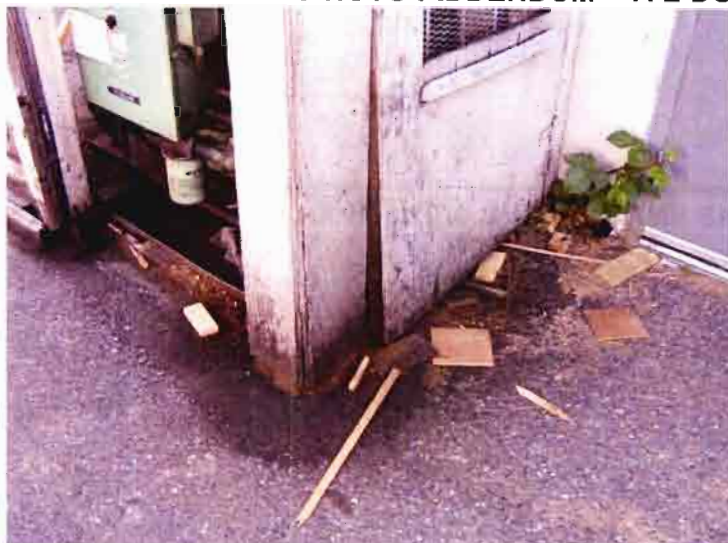
Against the building on the west side of the facility is a shed that houses a compressor. The compressor appears to be leaking oil, which is seeping out from under the wall of the shed (P5160034). Oil leaks from the compressor need to be contained so that they do not come into contact with stormwater. We also observed several open bags of sawdust and a few drums that contained finely ground sawdust powder (P5160036). All sawdust needs to be kept in sealed containment. Sawdust is a pollutant and must not be allowed to mix with stormwater that will flow off-site to Mill Creek.

P5160035 DESCRIPTION: OIL LEAKING OUT AROUND COMPRESSOR SHED

- Implement the necessary BMPs around the compressor to prevent oil leaks from flowing out to exposed areas.
- Discharge monitoring may not have been conducted in the optimal location. Changing the location of your sampling point so that it is representative of the industrial activities of your facility is recommended. Discharge sampling from a new location may return results that are drastically different from the results at your current sampling location. Consider sampling from the catch basin located behind your facility, west of the dumpster near the railroad tracks. Contact Elaine Worthen with the Department of Ecology, at (360) 407-7229, when changing your sampling location.

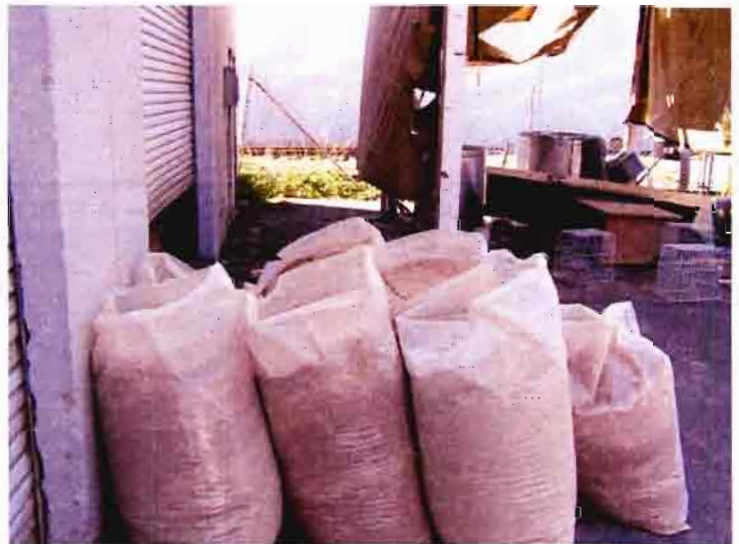
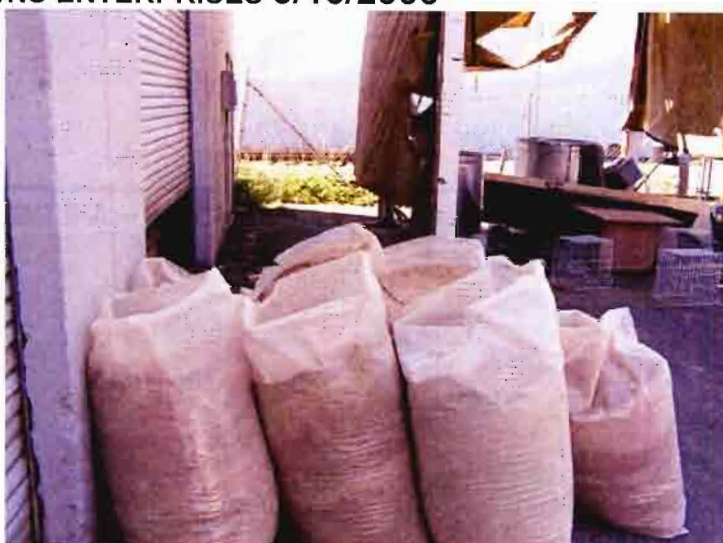
P5160036 DESCRIPTION: EXPOSED AND OPEN BAGS OF SAWDUST POWDER

- Implement the necessary Best Management Practices (BMP) to prevent sawdust from polluting stormwater. Sawdust containers should be covered or sealed if stored outside or disposed of in uncovered dumpsters. Also, ensure that saw dust around the lot is swept up frequently and disposed of properly to reduce the potential to pollute stormwater.

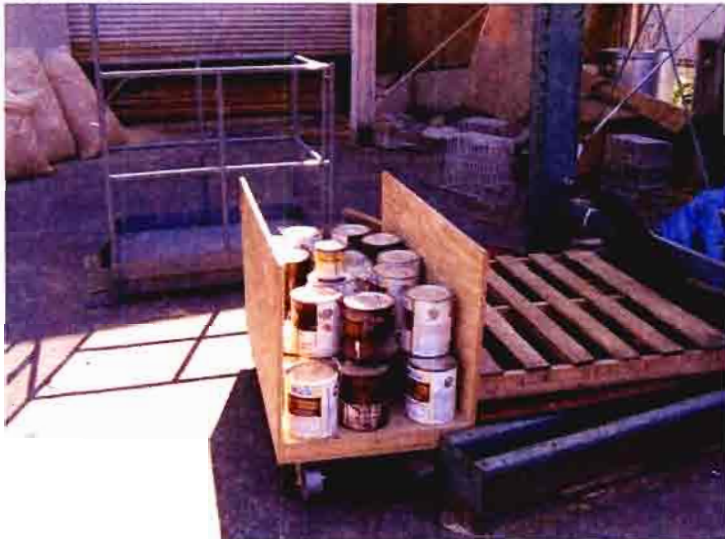
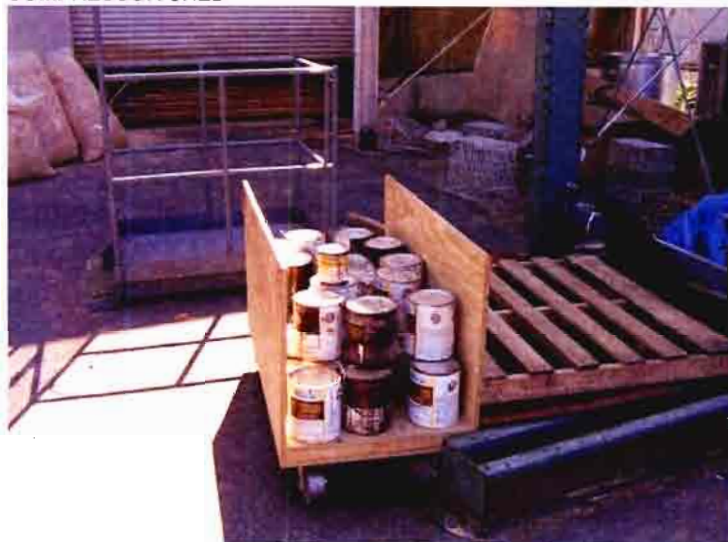
The exposed area on the west side of the building had two large dumpsters and numerous barrels full of wood debris, used paint cans, and other garbage (P5160038, P5160039 and P5160044). There was also a cart stacked with paint cans and two drums stacked on secondary containment crates in this area. The secondary containment crates are nearly full of stormwater and will not be effective at containing any chemical spills (P5160040 and P5160037). Secondary containment is

P5160037 DESCRIPTION: PAINT CANS STORED IMPROPERLY

- Implement the proper chemical handling BMPs (such as cover and containment) for all chemicals at the site. Paint cans need to be stored properly and disposed of properly. Secondary containment that is allowed to collect stormwater freely is not effective in preventing potential spills of hazardous materials. (this is mentioned at the bottom of this section)

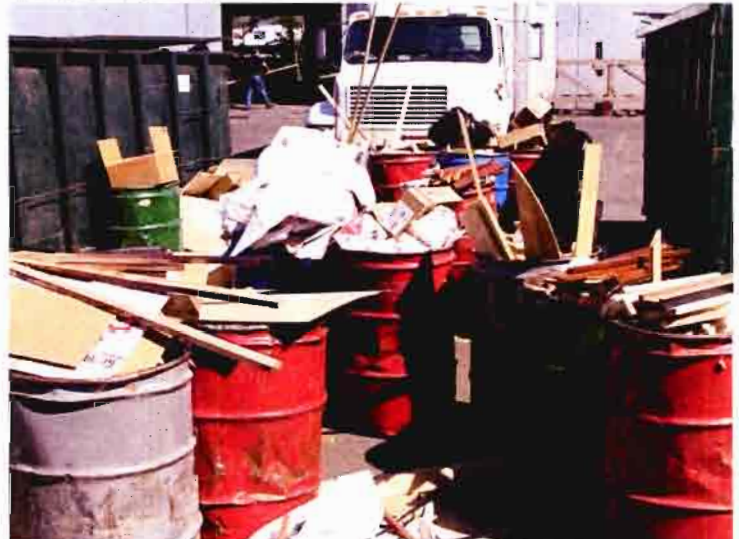
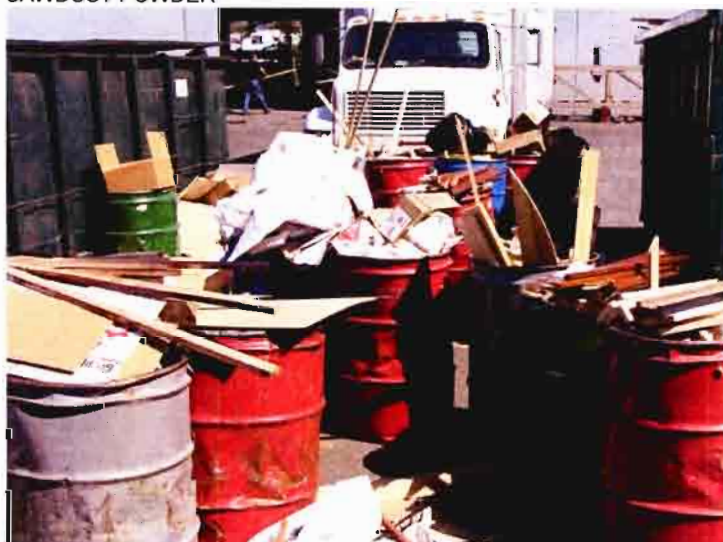
P5160038 DESCRIPTION: BARRELS OF ASSORTED WASTE MATERIALS

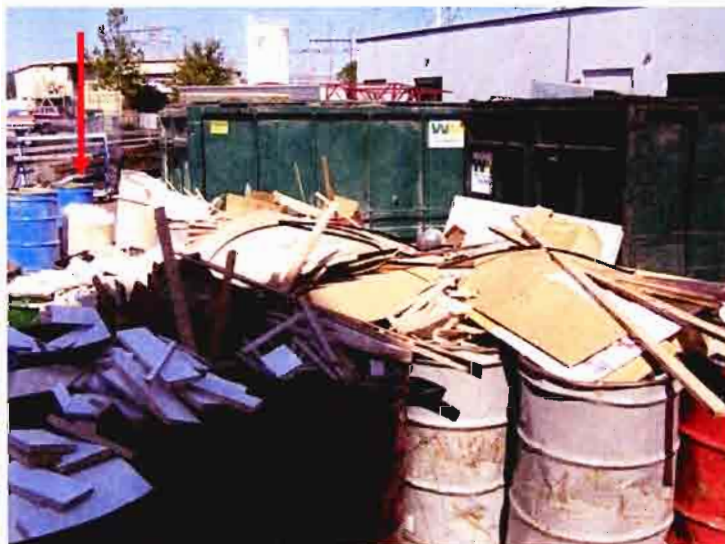
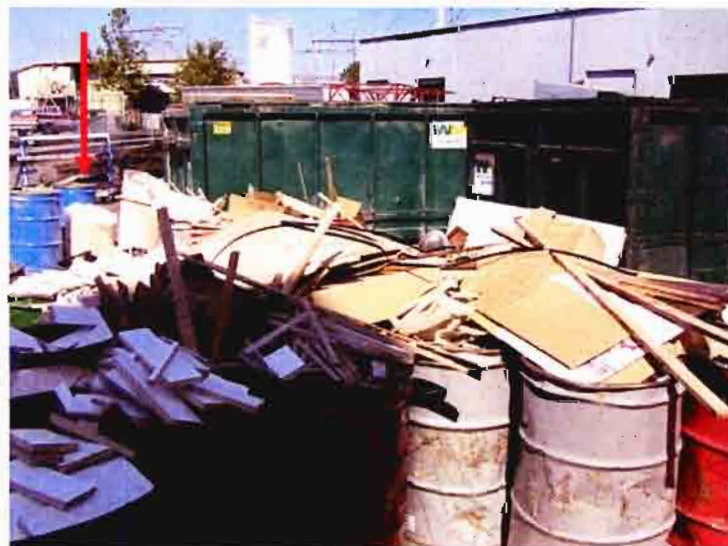
P5160039 DESCRIPTION: MORE WASTE BARRELS AND OPEN SAWDUST CONTAINERS

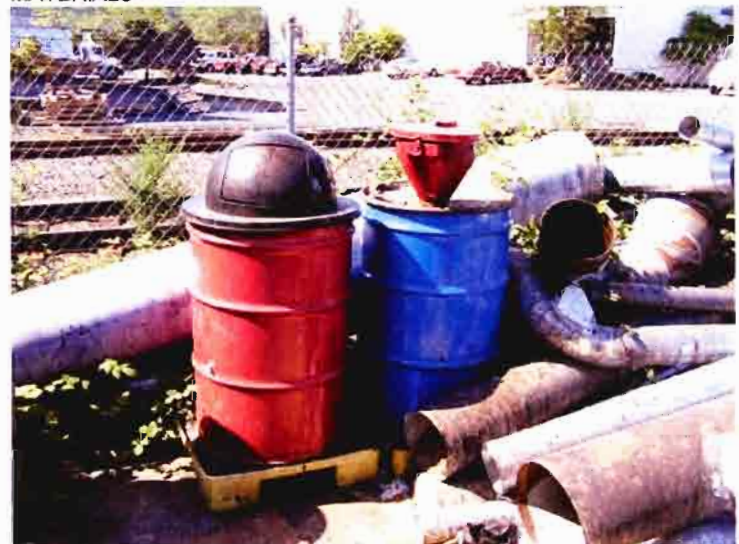
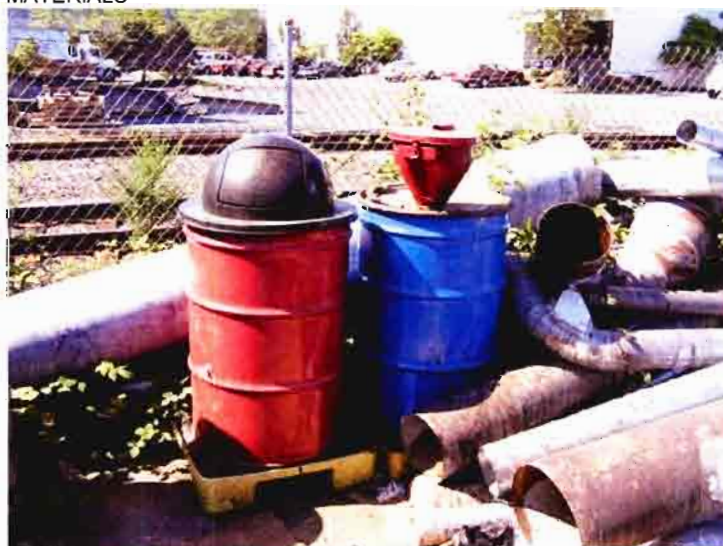
most effective if it is paired with cover to prevent rainwater from filling the space intended to collect spills.

P5160040 DESCRIPTION: BARRELS OF HAZARDOUS MATERIALS KEPT ON SECONDARY CONTAINMENT FULL OF RAIN WATER

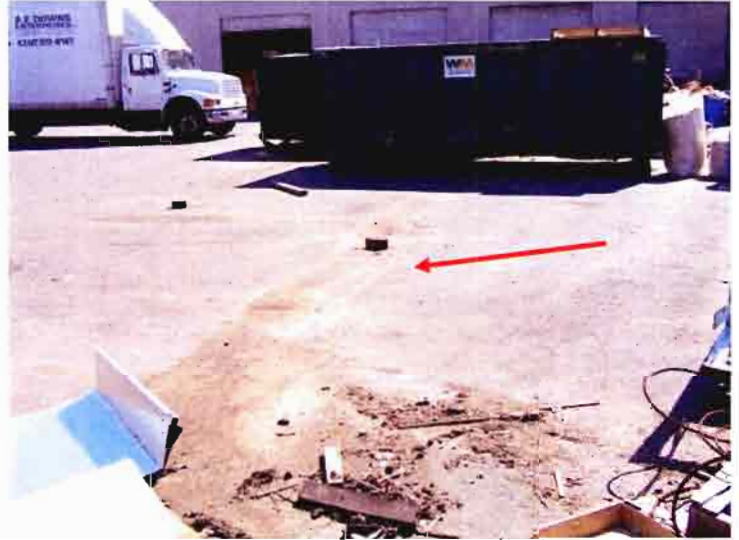
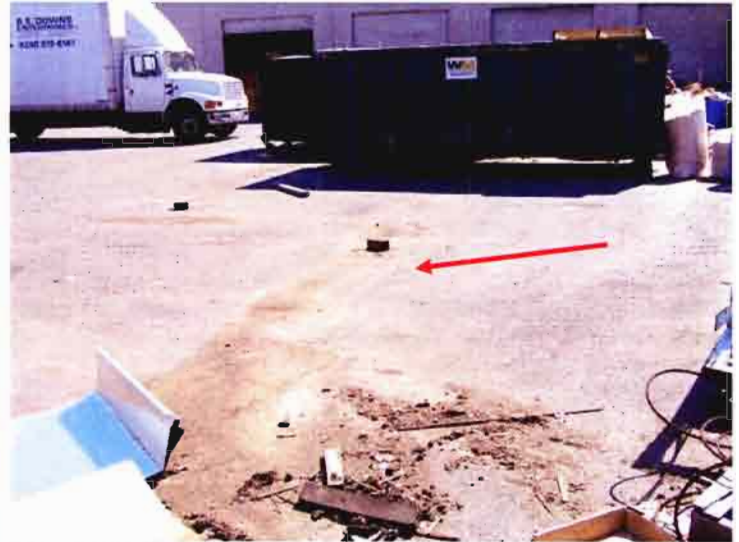
Ms. Crocker pointed out a catch basin on the north side of the building that she thought was the sample point. This catch basin is located in the facility parking lot near the building. This sampling point is not the ideal location, as it does not represent the industrial practices at this facility. There is a catch basin on the west side of the facility where it appears stormwater from the back of the facility flows to in a rain event. (P5160042). The stormwater from this area of the facility would be a better representation of the industrial activities at the site (P5160041). When I spoke with Barbara Downs on the phone (May 18, 2006) she said that she was unsure where they have been sampling in the past, but would make sure all future stormwater sampling was in the area described above.

**P5160042 DESCRIPTION: SEDIMENT TRAIL TO PROPOSED SAMPLE POINT**

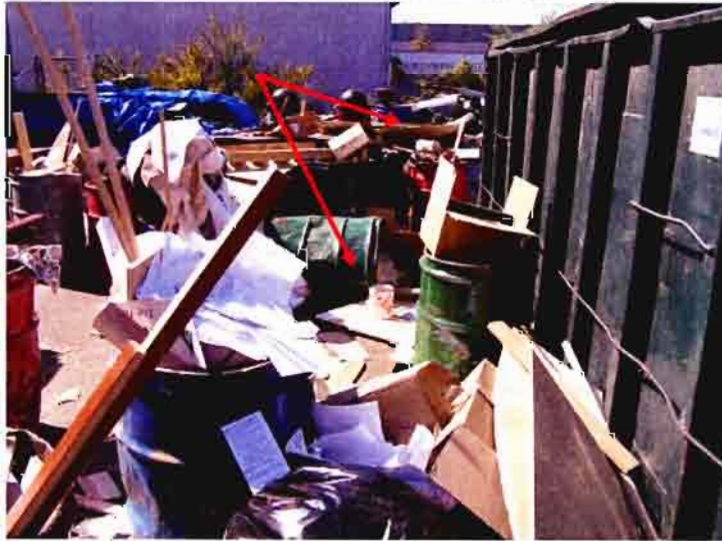
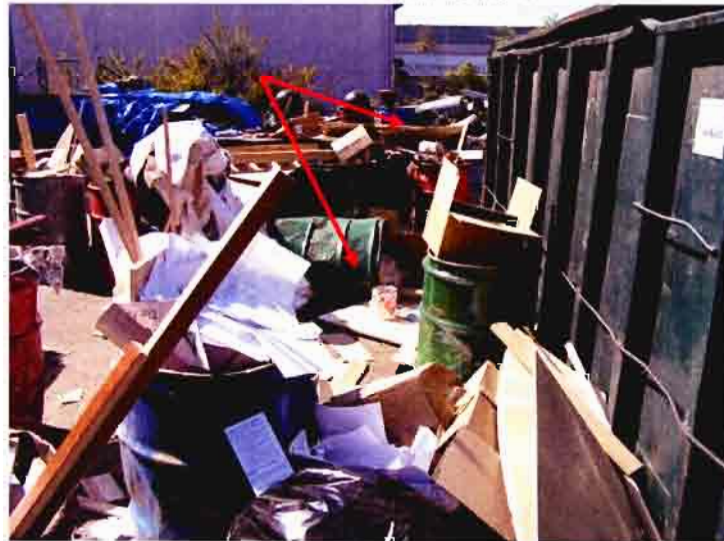
**P5160044 DESCRIPTION: MORE TRASH, NOTE PAINT CANS**
