# STORMWATER COMPLIANCE INSPECTION REPORT

State of Washington Department of Ecology  
1250 W Alder St, Union Gap, WA 98903

<b>Name and Location of Site Inspected</b> TreeTop Selah 111 S Railroad Ave Selah, WA 98942			Entry Time 1:30pm Exit Time 2:30pm	
			GPS Lat: Long:	
			Entrance: <b>46.651577, -120.527688</b>	
			Discharge: 46.653925, -120.523842	
<b>On-Site Representative(s): Name(s)/Title(s)/Contact number(s) or E-mail</b> Jared Murrey / Environmental Specialist / 509.698.1613 / <a href="mailto:jared.murrey@treetop.com">jared.murrey@treetop.com</a>			<b>Additional Participants:</b> None	
<b>Responsible Official(s):</b> Jared Murrey				
			Samples Taken? <input type="checkbox"/> Yes <input checked="" type="checkbox"/> No Photos Taken? <input checked="" type="checkbox"/> <input type="checkbox"/>

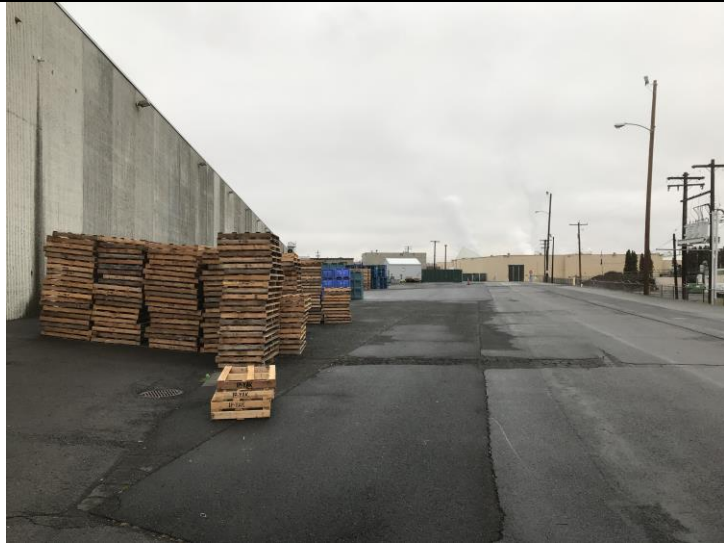
FIGURE 1: STORM DRAIN PIPING WAS EXCAVATED AND RE-ROUTED TO THE WASTEWATER LAGOON PUMP STATION

Treetop operates in Selah under the NAICS 311421 - Fruit and Vegetable Canning. The site has an industrial NPDES individual permit (WA0002437). The site cancelled its industrial stormwater general permit in 2014, when all stormwater was re-routed and pumped to the site's wastewater lagoon for land application.

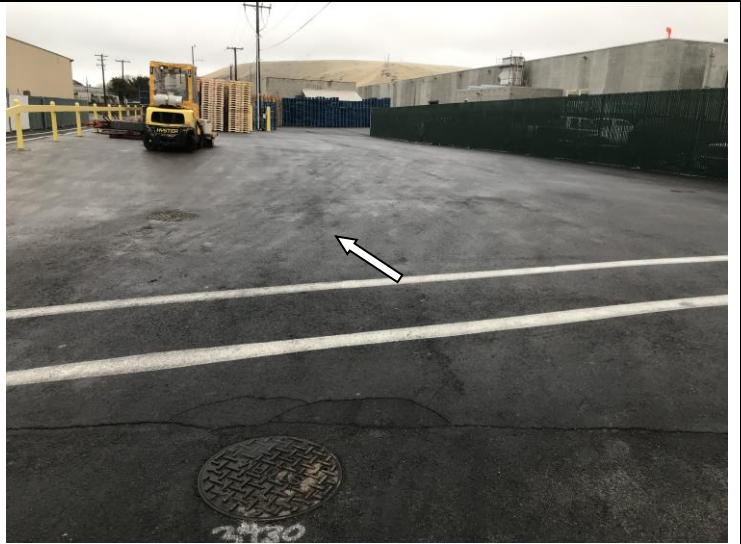
FIGURE 2: UNDERGROUND STORMWATER STORAGE VAULT AND ADJACENT PUMP STATION.

There is a large underground vault and pump station that was built in 2014 to store stormwater from large storm events and then transfer stormwater to the wastewater lagoon pump station. During my visit there were many vehicles and forklifts operating on site.

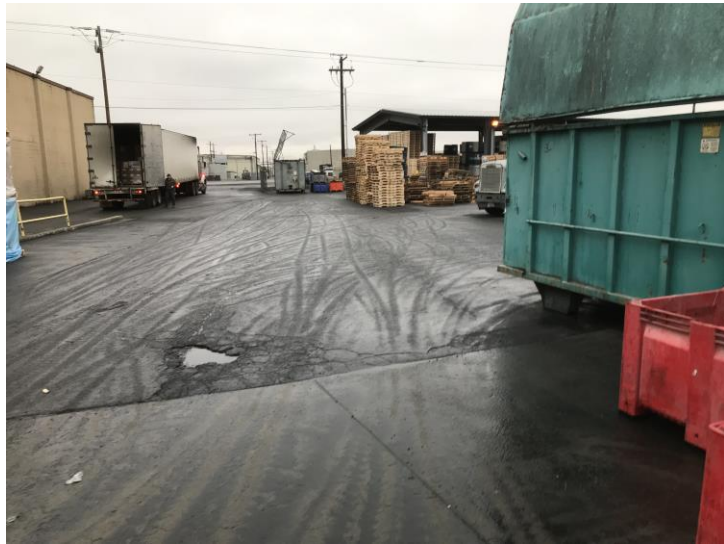
FIGURE 3: SIGNS OF TRUCK AND FORKLIFT VEHICLE TRAFFIC
