STATE OF WASHINGTON
DEPARTMENT OF ECOLOGY

**Re: Miles Resources, LLC - Lakeview Plant – Sand & Gravel General Permit No. –
WAG501290 Compliance Inspection**

Water Compliance Inspection Report

Photograph Log

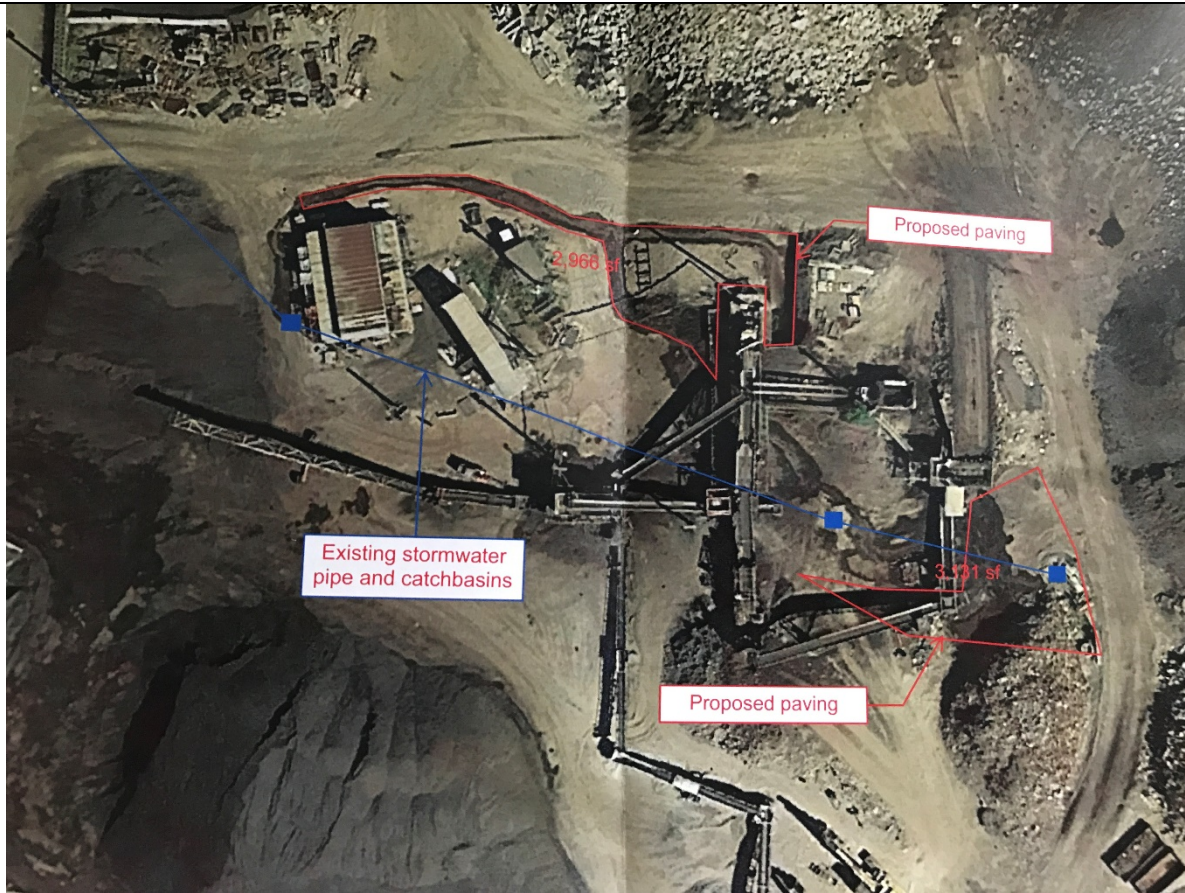
Housekeeping has occurred within portions of the concrete recycling area. Portions of the recycling operation sit on a concrete slab that was buried below the by-product and sediment build up. Miles has plans to implement additional impervious surfaces near the catch basins and in conveyance channels (Photo 1).

Photograph 1: Miles plans to pave additional areas for conveyance improvements.

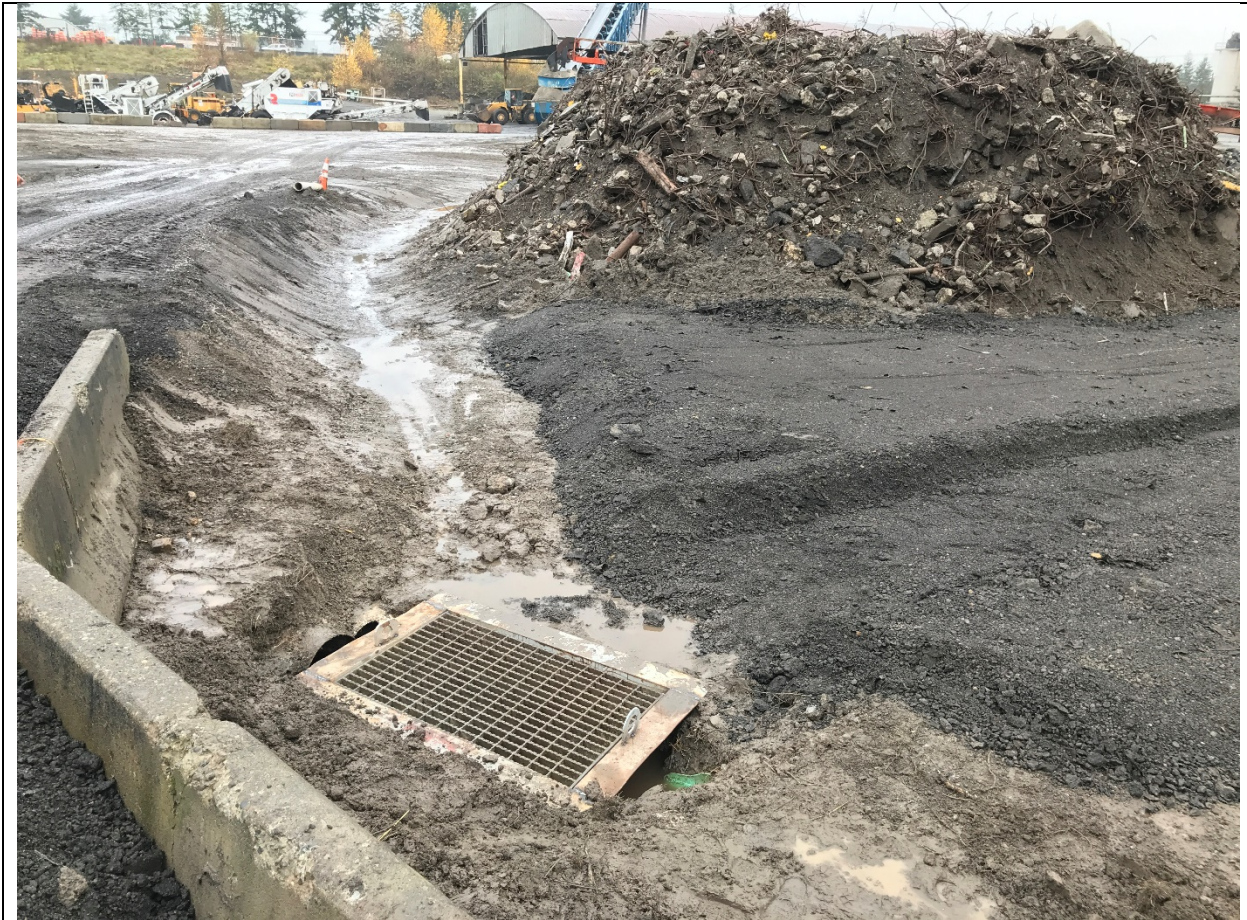
Photograph 2: The catch basin previously buried by concrete recycling by-product and sludge has been uncovered. Additional impervious surface and lined channel conveyance needed.

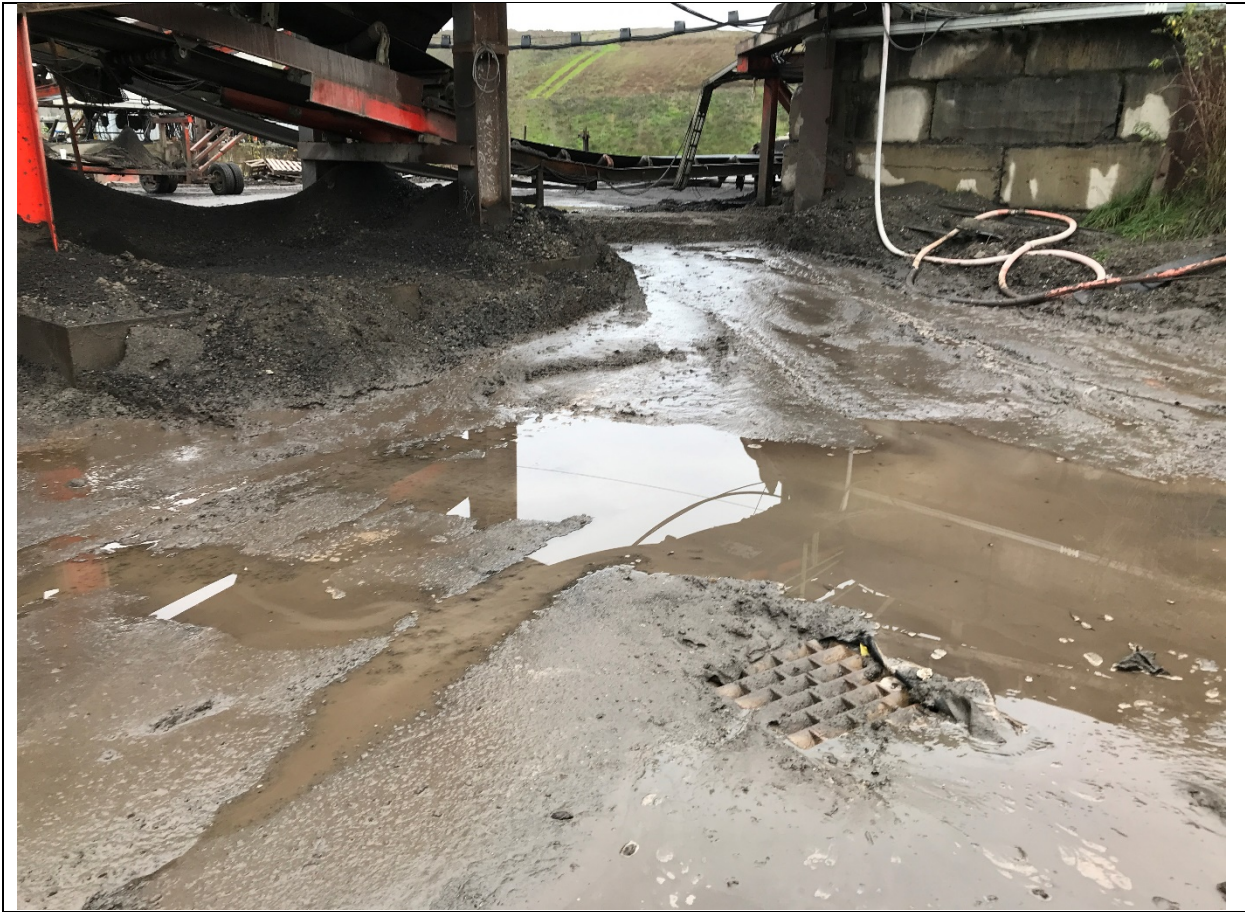
Photograph 3: Concrete recycling by-product sludge near a catch basin.

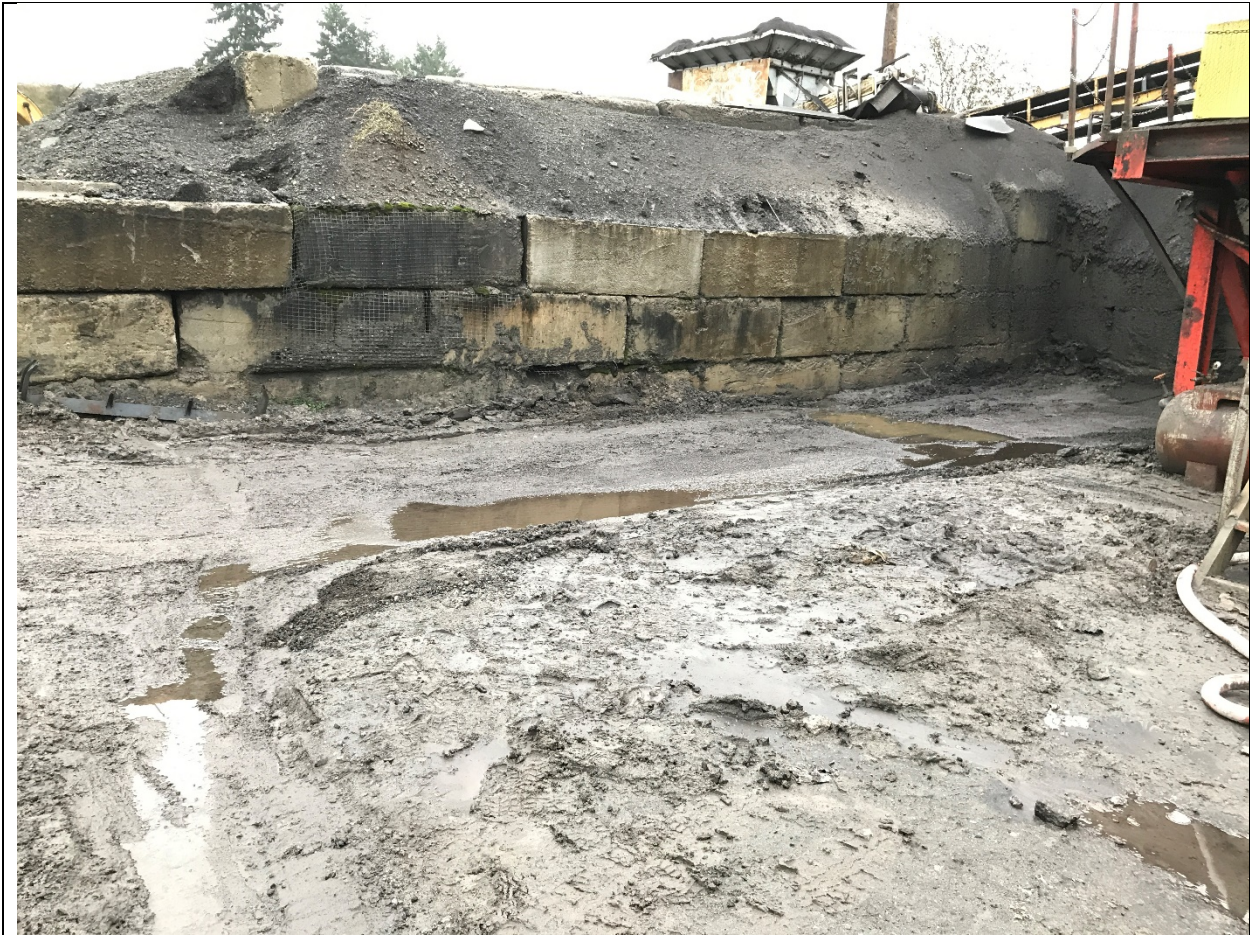
Photograph 4: The cement slab below the sludge has been exposed after by-product/sludge removal. Runoff from the remaining sludge is measured at a pH of 10.80 S.U. on the lined conveyance.

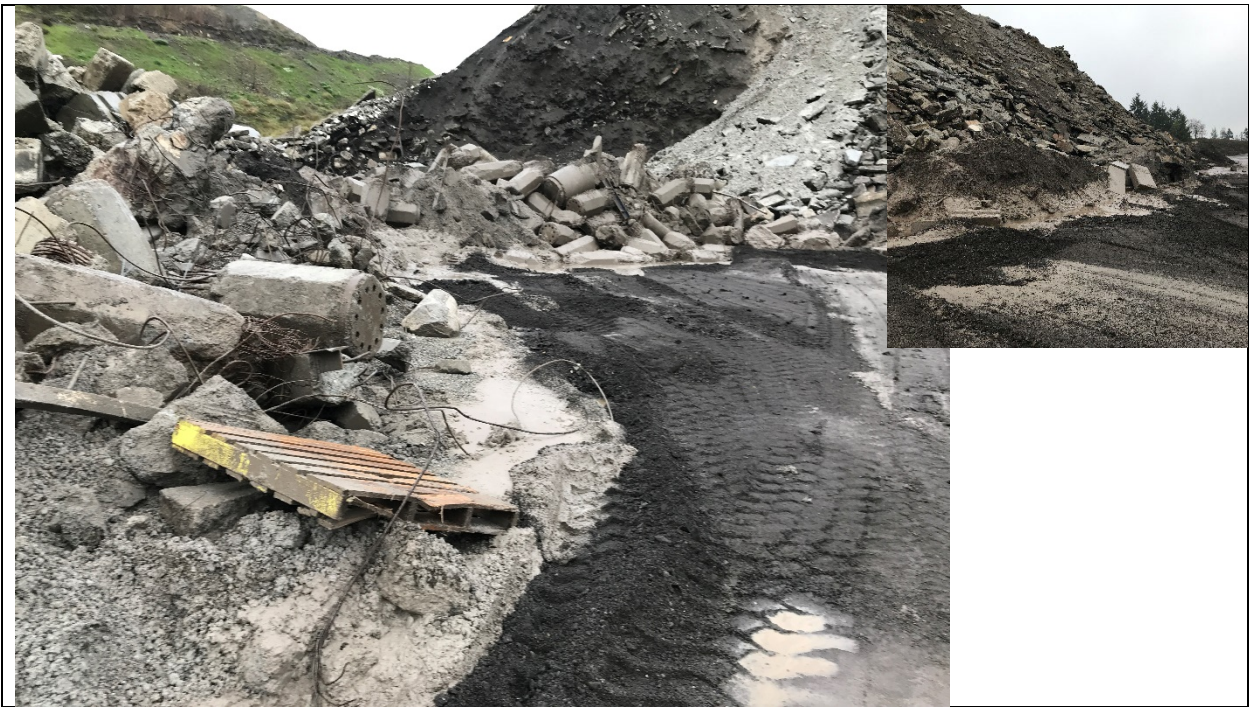
Concrete by-product and sludge stripped from the recycling area have been moved to the concrete stockpile located on bare ground. The depression at the base of the concrete pile is filled with leachate and concrete sludge, and has been partial covered by recycled asphalt product (RAP). A pH measurement of 11.83 S.U. was sampled from water at the base of the concrete stockpile where discharge to groundwater is occurring; **this is a violation of Water Quality Standards and Permit Special Condition S.3.**

Photograph 5: The base of the concrete stockpile has been partially covered with recycled asphalt product (RAP). Concrete sludge and unhardened concrete are observed on the bare ground. The discharge to groundwater is measured at pH 11.83 S.U for monitoring point G003.

Additional implementation of source control Best Management Practices (BMPs) is needed to comply with **Administrative Order 20863 (due December 31, 2021)**. Sludge waste disposal and storage of unhardened concrete must not cause violations of water quality standards. Please continue to monitor the concrete stockpile area discharge to groundwater (monitoring point G003) as agreed.

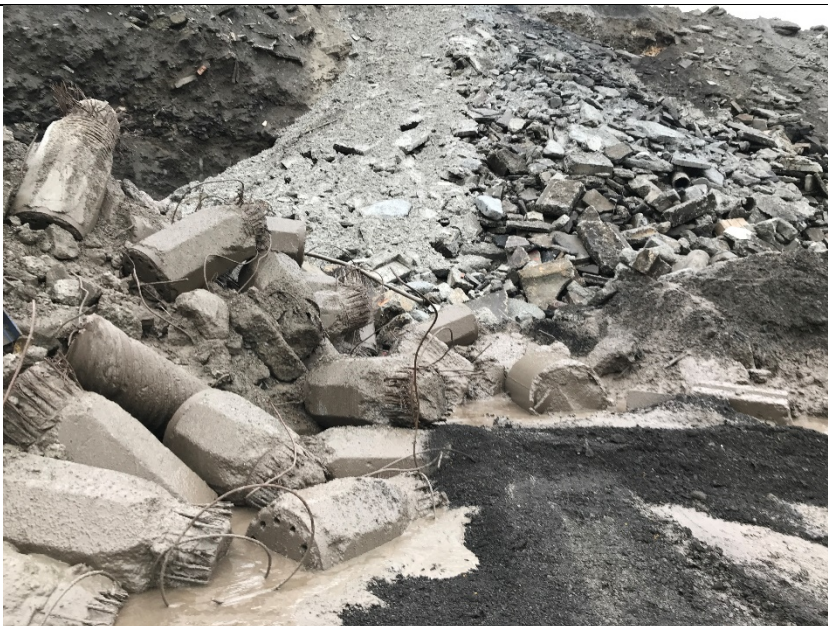
Photograph 6: RAP covering concrete sludge and discharge to groundwater.

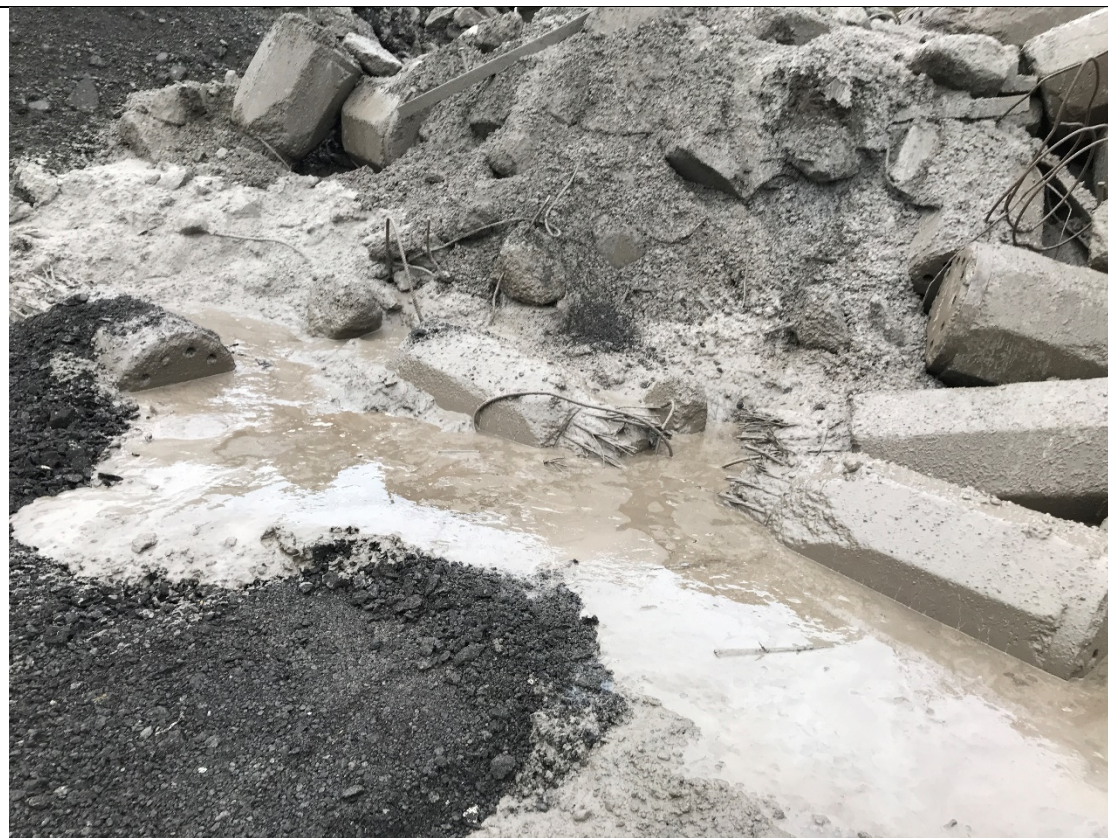
Photograph 7: Concrete sludge and unhardened concrete on bare ground.

Store unhardened concrete, any type of concrete solids (does not include fully cured or recycled concrete), returned asphalt, and cold mix asphalt on a bermed impervious surface. This includes comeback concrete, ecology blocks, septic tanks, jersey barriers, and other cast concrete products. Treat all stormwater that contacts these materials in a lined impoundment. Discharge of this water is subject to the effluent limitations in [S2](#) and must not cause a violation of water quality standards.

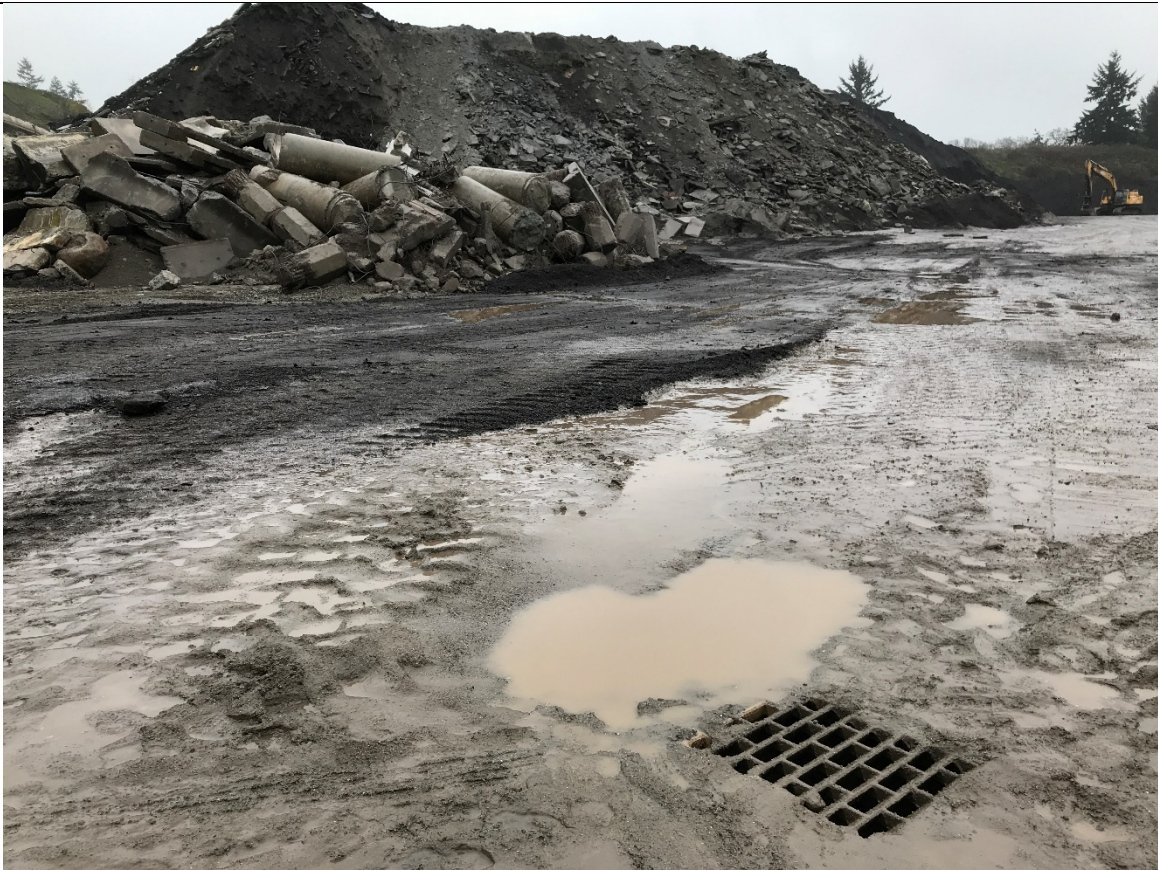
Photograph 8: Runoff from the concrete stockpile depression area is not contained by an impervious surface or lined channel conveyance to the catch basin.
