STATE OF WASHINGTON
DEPARTMENT OF ECOLOGY

**Re: Miles Resources, LLC – Lakeview Plant - Sand & Gravel General Permit No. –
WAG501290 Compliance Inspection**

Water Compliance Inspection Report

Photograph Log

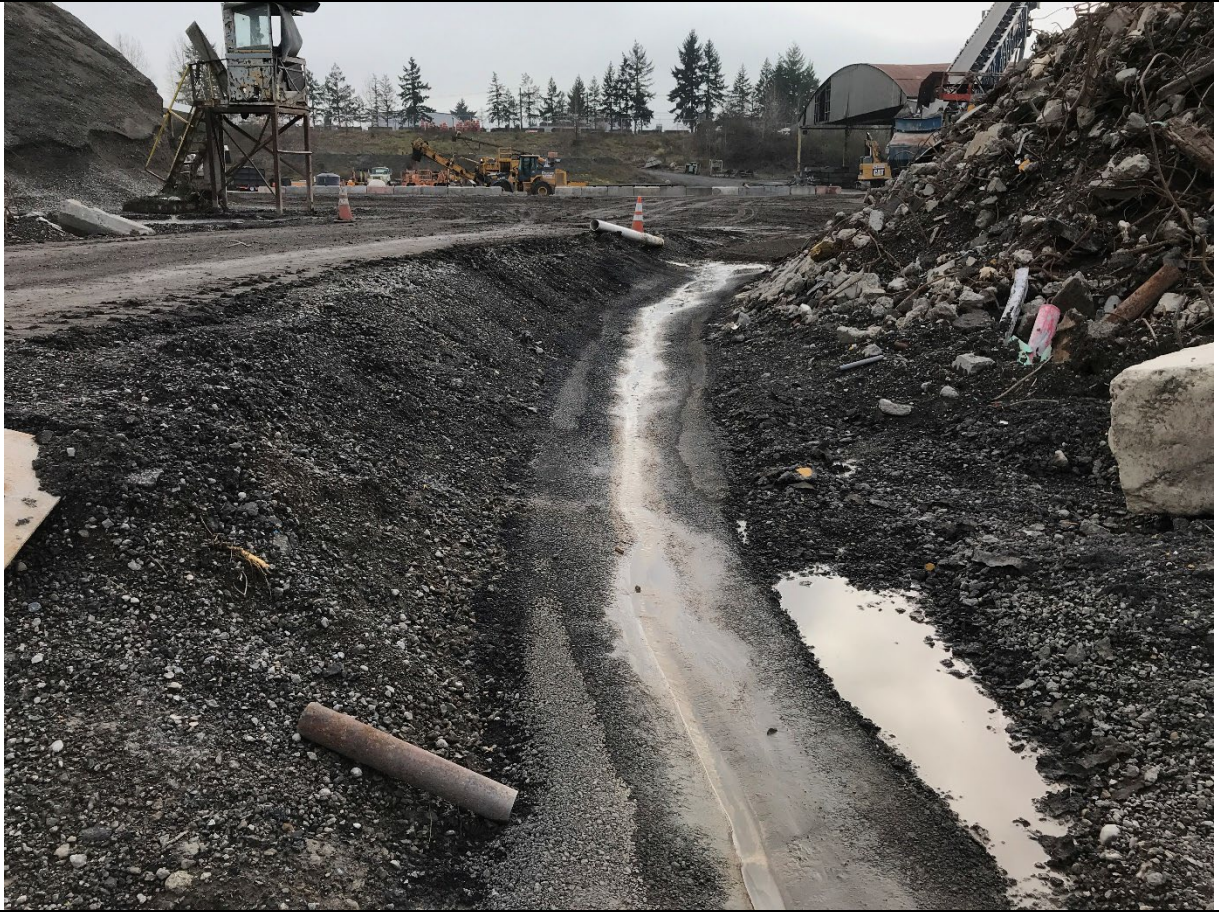
Photograph 1: Asphalt lined conveyance.

Conveyance for concrete runoff and areas below the crushing operation have been lined with asphalt since the December 7, 2021 inspection for Best Management Practices (BMP) improvement. Unhardened concrete, concrete sludge and leachate striped for the asphalt improvements, has been moved to the top of the concrete stockpile.

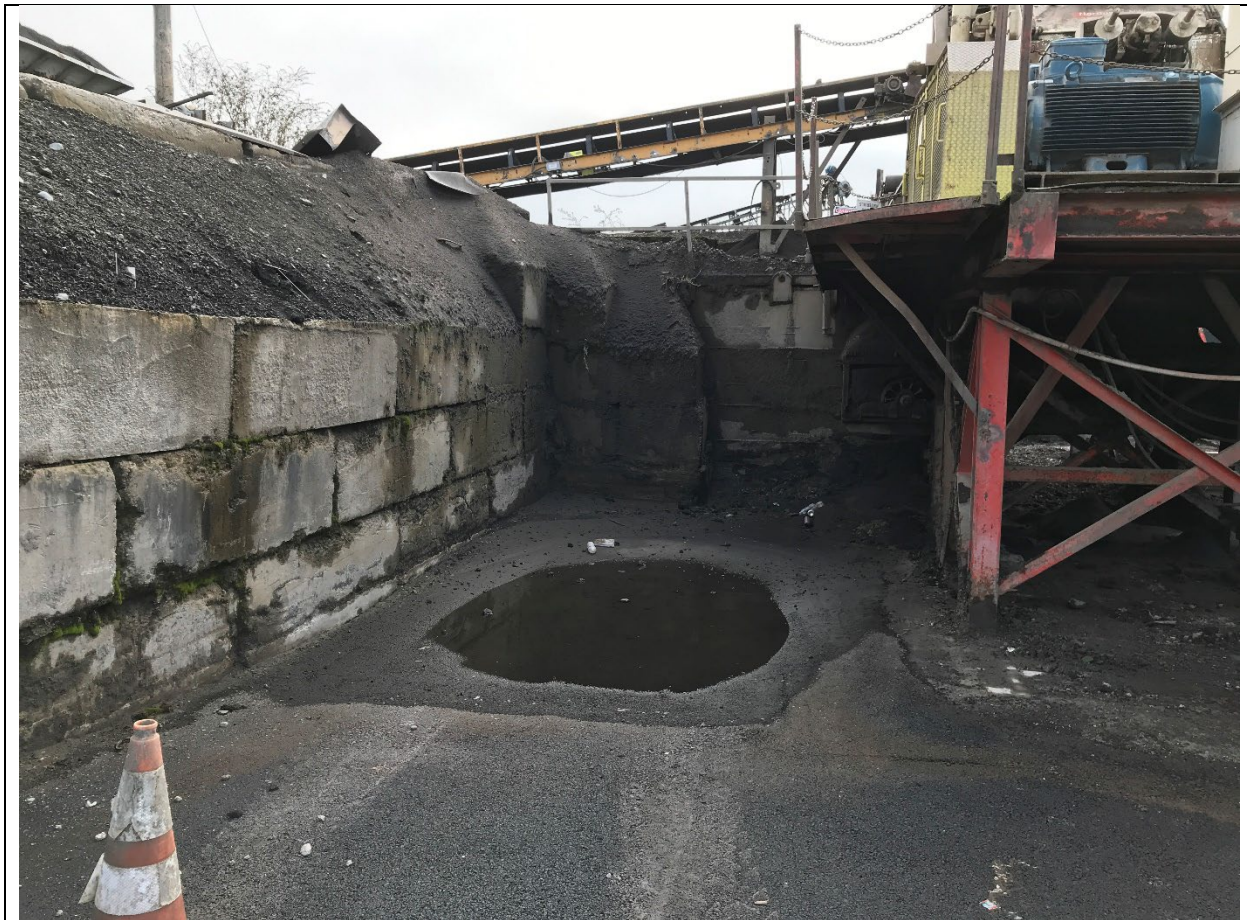
Photogrpah 2: Asphalt paving below the concrete crusher.

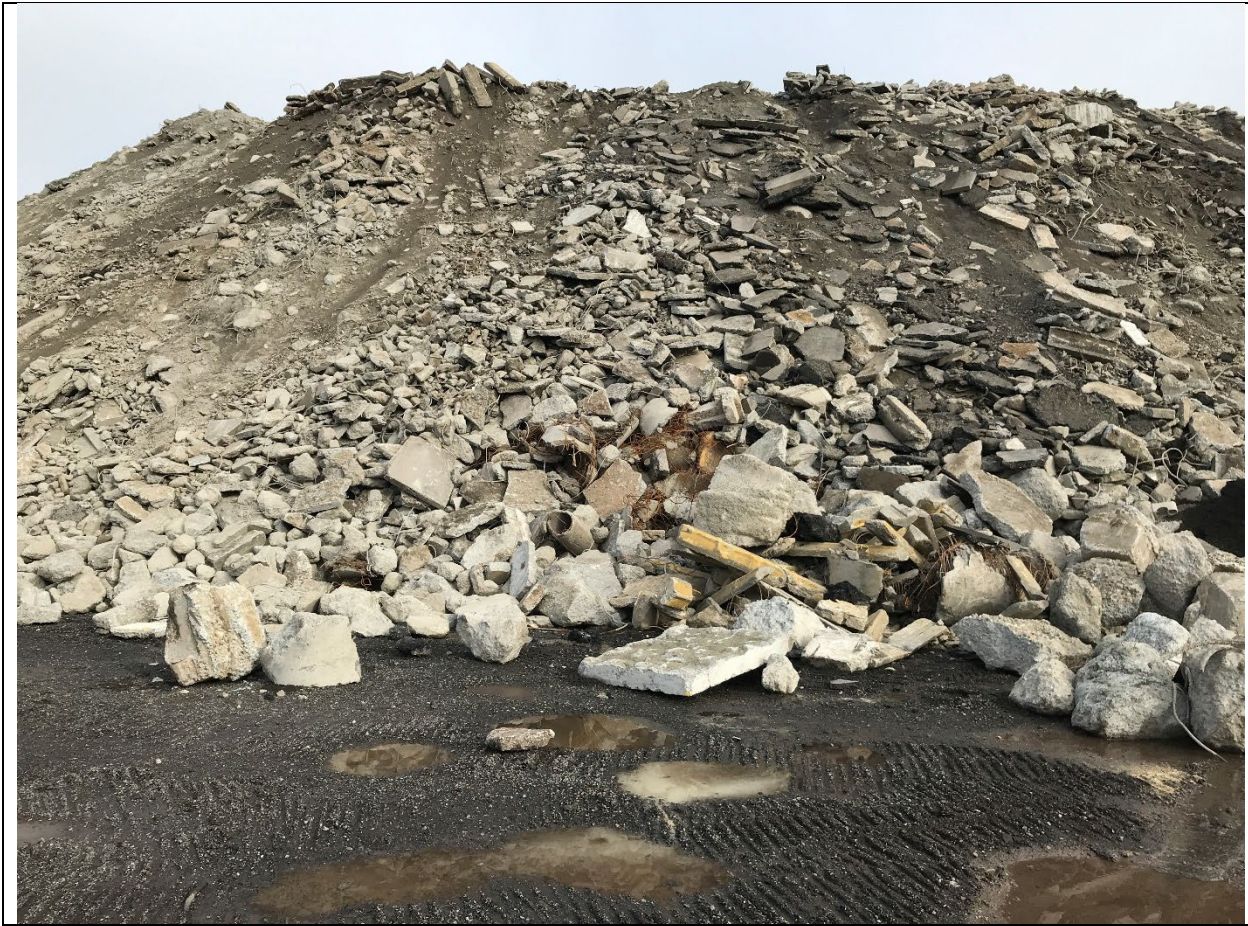
- The weather condition during the inspection was sunny with ponding water, and roughly 37 degrees Fahrenheit.
- A pH effluent violation was measured in runoff discharging to groundwater near the concrete stockpile (pH 10.61 measured with a digital meter calibrated on January 25, 2022).
- Concrete crushing by-product and sludge removed for new asphalt paving, has been moved to the concrete stockpile located on bare ground.
- Additional housekeeping and source control Best Management Practices are needed to comply with Administrative Order 20863 (due March 30, 2022).
- Disposal of concrete recycling by-product, sludge, and solid waste material must comply with all solid waste regulations.

Photograph 3: Discharge to groundwater with concrete leachate below the concrete stockpile (monitoring point G003). The pH measured to 10.61 S.U. with a digital meter calibrated on January 25, 2022.

Discharge Monitoring Reports (DMRs) have been submitted with “no discharge” for monitoring point G003. Water pooling on the bare ground with pH effluent exceedance continues to discharge around the concrete stockpile area (monitoring point G003). **Please implement additional source control BMPs to eliminate all pH effluent exceedance violations in discharges to groundwater and avoid the need for continued G003 monitoring.**

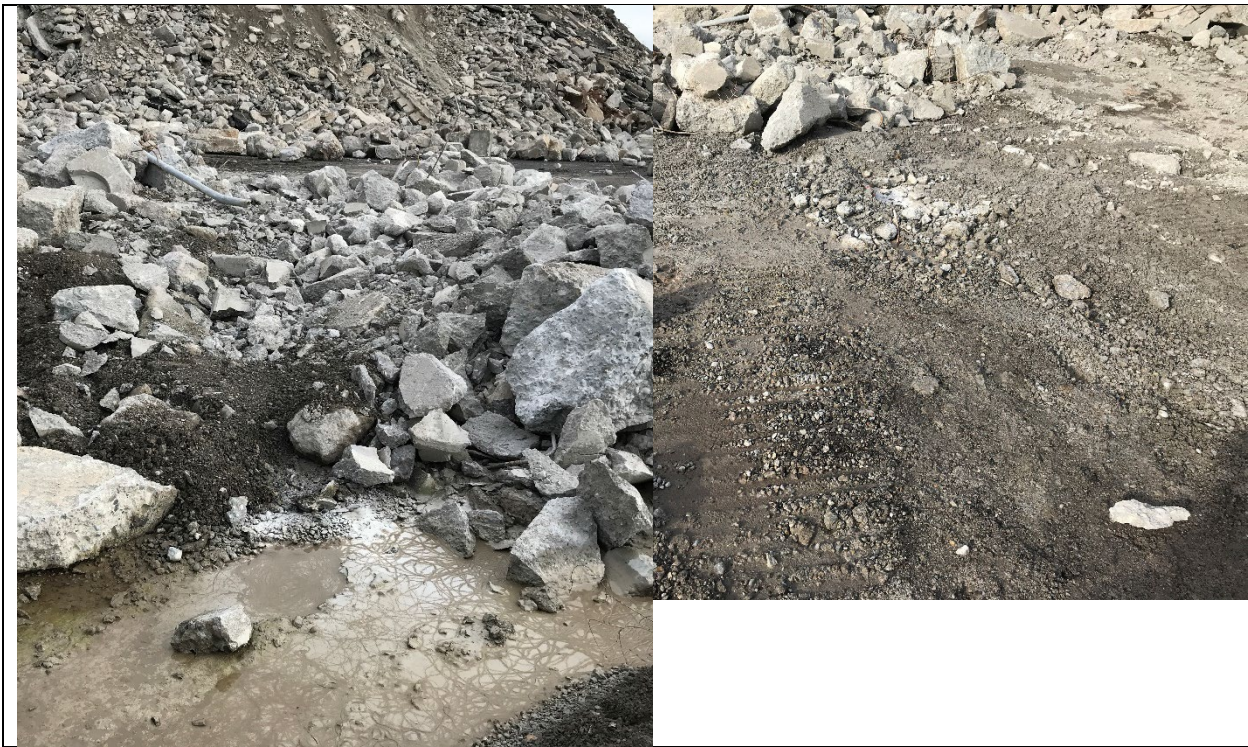
Photograph 4: Unhardened concrete, leachate, and discharges to groundwater remaining near the base of the concrete stockpile (monitoring point G003).

During the inspection we discussed removing the remaining unhardened concrete/sludge/leachate where pH effluent exceedances continue in pooling water on bare ground, and expanding the asphalt surface under the concrete stockpile to comply with the Administrative Order #20915 actions due by March 30, 2022.

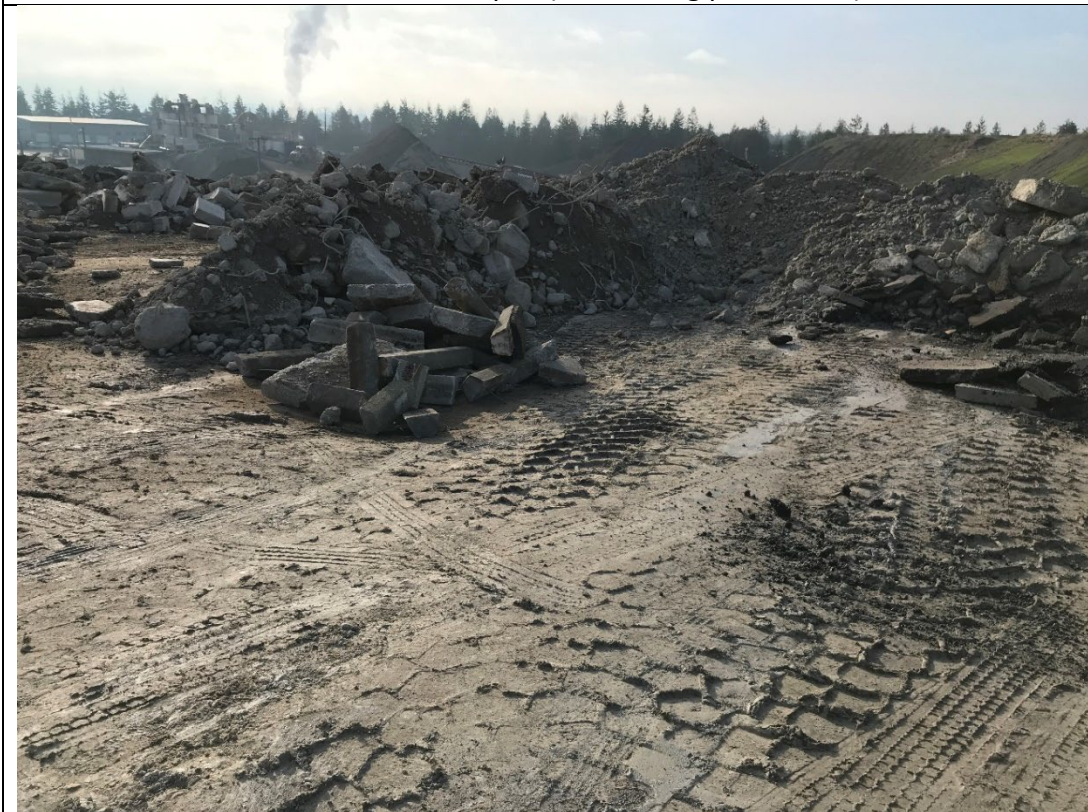
Photograph 5: Concrete sludge and unhardened concrete moved to the top of the stockpile.
