Technical Memorandum

Project No.: M0120.01.006

Re: Western Wood Preserving Co. Stormwater Biofiltration Pond Maintenance and Compliance with National Pollutant Discharge Elimination System Waste Discharge Permit No. WA0040738 10-30-2023

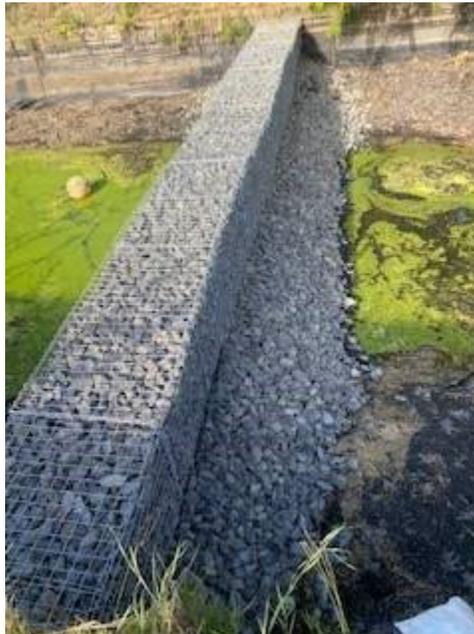
The cell was drained to confirm that the total depth matches the pond design depth of 4 feet. The height of the reconstructed gabion-rock wall extends above the design height to prevent stormwater from flowing over the wall and ensure all runoff is filtered through the rock. The gabion baskets were filled with 2- to 3-inch drain rock to provide sufficient void space for runoff to flow through, while also providing filtration and slowing the flow velocity to enhance settling and biofiltration. The below photo shows the reconstructed gabion-rock wall.

WWPC conducted significant maintenance of the biofiltration pond in August 2023 to enhance the treatment efficiency. Maintenance activities consisted of the removal of vegetation from the two upstream pond cells and rebuilding of the downstream gabion basket wall.
