**Actions Taken in Response to
Level II Source Control Report- Zinc
Seattle Yachts- North Yard- BYGP#: WAG994608**

For 3 Benchmark Exceedances in 2023

Prepared by: Dave Habenicht, Seattle Yachts Facilities Manager
September 17, 2024

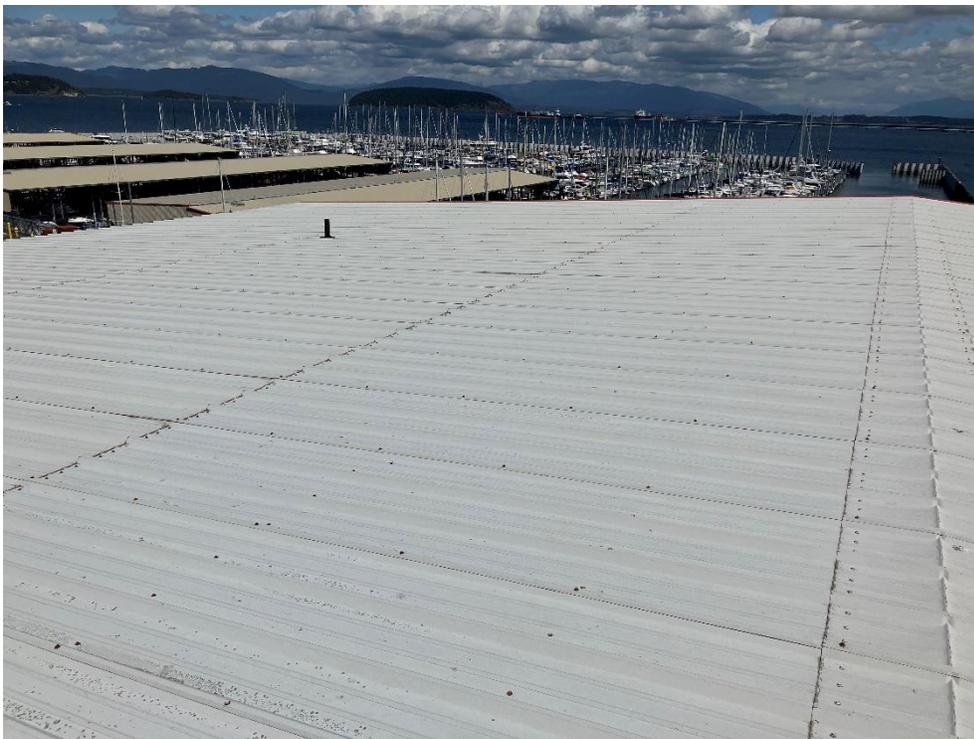
Before Paint

The Level II Source Control Report- Zinc of March 28, 2024 detailed repainting of the workshop roof as an actions to be taken to reduce the high levels of Zinc in water running off the roof, down the downspouts and into the stormwater drains. Water samples drawn from the roof downspouts previously had shown measured Zinc levels exceeding benchmark limits.

On August 29, 2024 the North Yard workshop roof was repainted with one coat of Sherwin Williams Pro-Cryl Universal Acrylic Primer and one coat of Sherwin Williams Multi-Surface Acrylic Coating after having been pressure washed a few weeks previously. Please see following before and after photos.
