Livestock and Water Quality Site Visit

Site Visit Information	<input type="checkbox"/> First Visit	<input checked="" type="checkbox"/> Follow-up Visit
Prepared by: Mak Kaufman	Arrival Time: 9:00 am	Departure Time: 10:45 am
Date: 11/09/2012	Current Weather Conditions: Sunny and about 45 degrees F

Site Information	
County: Whatcom	Watershed: Headwaters of Samish River
<p>General site description (include information about nearby waterbodies and description of farm conditions): Mr. Knaus has been issued a Warning Notice and Opportunity to Correct letter for a contaminated discharge into the southside Saxon Road ditch (state waters) on January 4, 2012. Mr. Knaus has been working cooperatively with both Skagit and Whatcom Conservation District's and NRCS to develop a farm plan that is protective of surface and groundwater quality. Mr. Knaus has not gotten final approval to install several structural BMPs that will provide permanent solutions that are protective of water quality. This inspection was conducted to provide Mr. Knaus with some temporary solutions that he could implement to get his property through the upcoming rainy season without causing contaminated discharges into state

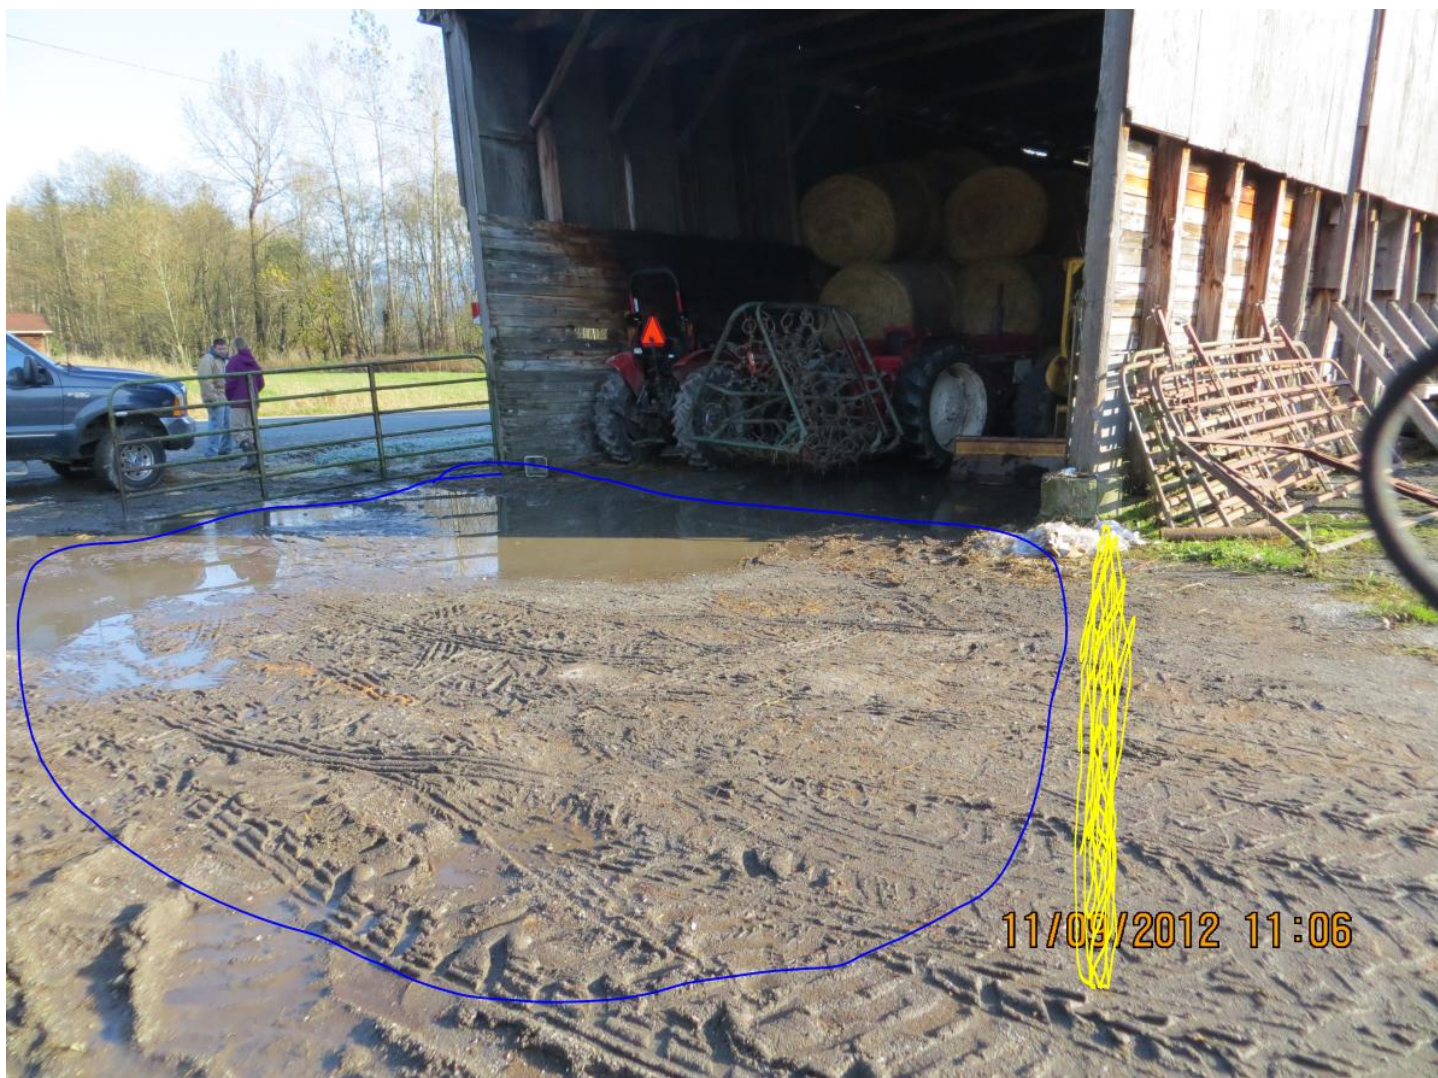
Photo 1: Photo shows manure contaminated muddy area adjacent to Mr. Knaus' hay bunker that was part of the source of contamination that was detected in a sample that was collected on January 4, 2012. As a short-term temporary solution to get Mr. Knaus through the upcoming winter rainy months without contaminated discharges flowing into state waters, I have strongly recommended and Mr. Knaus has agreed to scoop up all of the mud and gravel from the area which is underlain by concrete and then pressure wash this area to remove any remaining contaminants. Additionally, I have advised Mr. Knaus to install a "speed-bump" type curb (shown as yellow lines) that would direct all contaminated run-on flows into a vegetated swale and a sump that he can then pump out to his grass fields. It is the combination of these two practices that should allow storm water to contact the clean concrete surfaces and then flow into the south Saxon Road ditch as uncontaminated storm water.

- ☐ Construct stream-crossings and emergency water locations in ways that protect the stream
- ☒ Other Actions: Clean concrete slab and pressure wash and install concrete "speedbump" type curb to direct contaminated water away from "clean" area in front of hay bunker.
