Lake Tapps (Pierce County) Monitoring

Final Data Report

January 2006

Publication No. 06-03-006

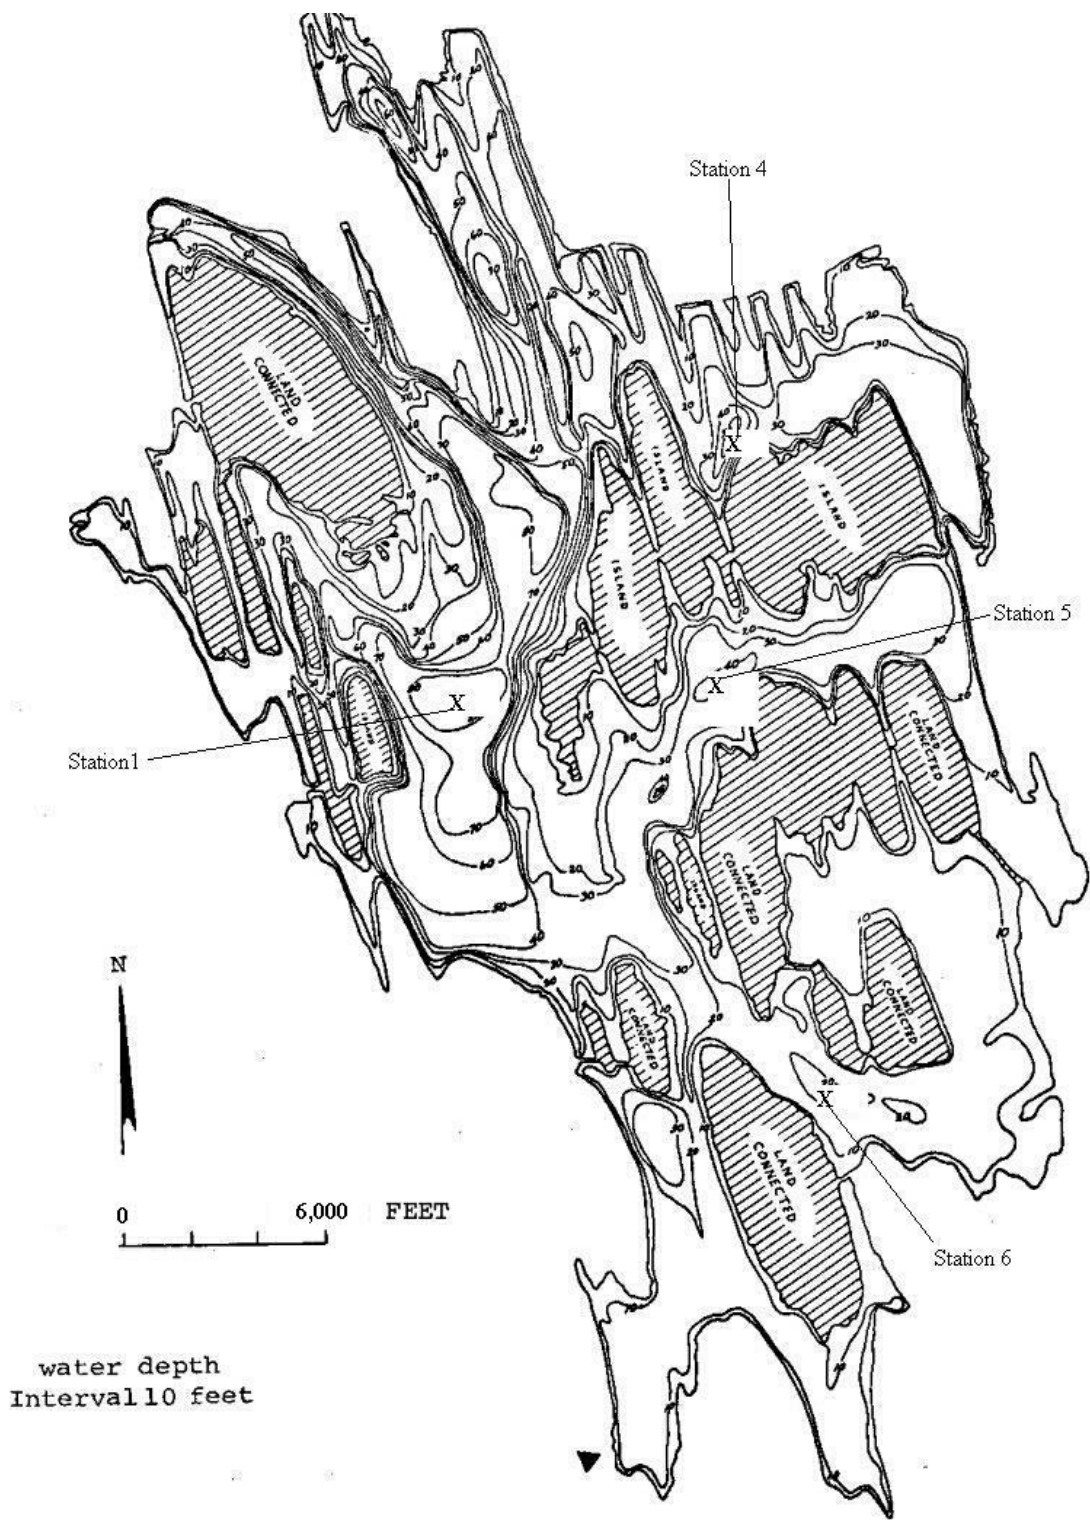
Figure 2. Morphometric map of Lake Tapps showing lake sampling locations.

Tapps Lake, Pierce County. From
 U.S. Geological Survey, May 31, 1974.

Samples were collected from four open-water stations: the central lake, and each of the three eastern basins (Table 1 and Figure 2). Stations were chosen based on a review of lake bathymetry, shoreline maps, and aerial photos. The lake consists of a main basin to the west, through which most of the water may flow directly from the inlet to the outlet, and three side-basins that are northeast, east, and southeast of the main basin.

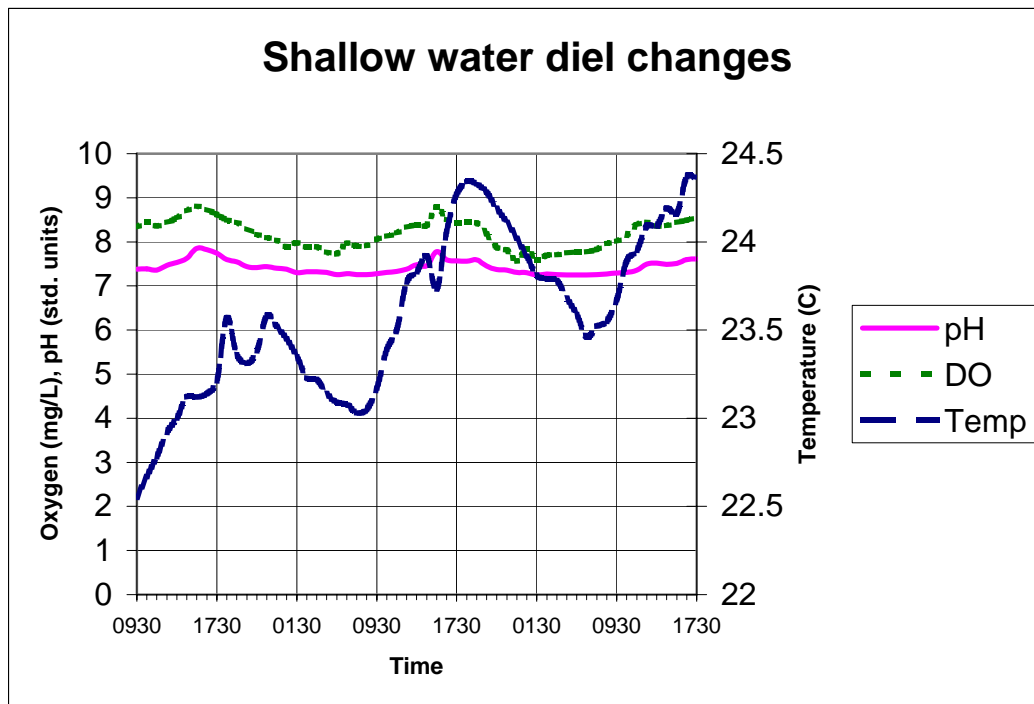
Figure 3. Near-surface diel oxygen (estimates), pH, and temperature collected on August 8-10, 2004.

The diel fluctuations in temperature, pH, and oxygen were low (Figure 3), as might be expected in conditions with low algal and aquatic macrophyte productivity. These data were collected on only one occasion and at only one site, and will not be representative of the entire lake. However, open water fluctuations were likely less than the fluctuations from the shallow embayment reported here because the ratio of overlying water volume to sediment area is so much greater in deep water locations.

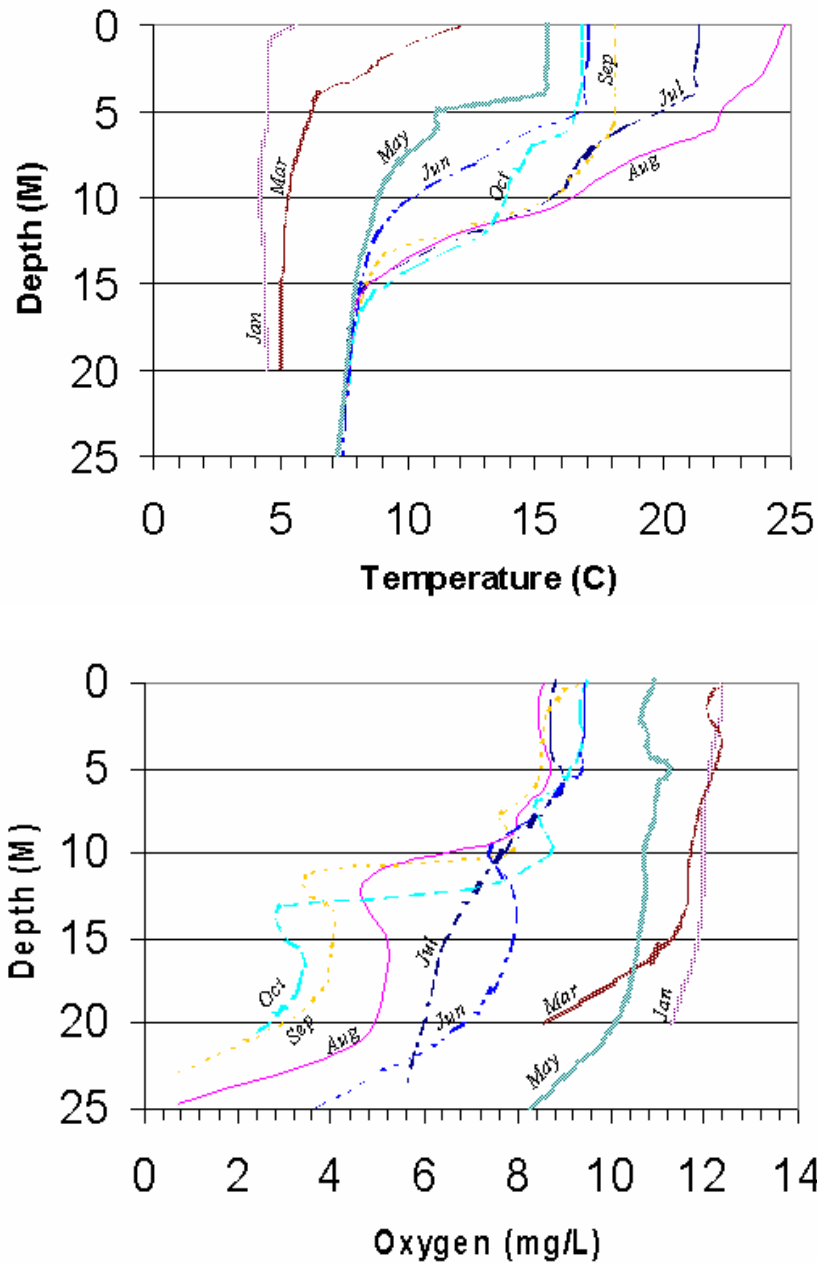
Figure 4. Temperature (top) and oxygen (bottom) profiles from Lake Tapps station 1 (the deep basin).

Water temperature measurements were warmest in August and coldest in January; the lake was stratified with a clearly defined epilimnion during all monitored months except January and March (Figure 4, top). Oxygen profiles indicate hypolimnetic concentrations below 8 mg/L during all sampled months except January, March, and May, with near-bottom concentrations approaching 0 mg/L in August and September (Figure 4, bottom).

The small mid-water column dip in oxygen concentration during those two months and in October may be a result of the decomposition of organic matter accumulated at the density gradient caused by the thermocline (metalimnion). In this case, however, the inlet from the White River contributes an interflow at about this depth that complicates the explanation.

Other indications of mesotrophy include hypolimnetic oxygen depletion (Figure 4) and extensive filamentous algae growth observed near Lake Tapps North Park. These blooms occurred during mid-winter drawdown (Field Notes, Appendix A). Workers at the park also reported that extensive filamentous algae growth occurred periodically on the boat launch. Future limnological researchers of Lake Tapps should consider including a periphyton component.

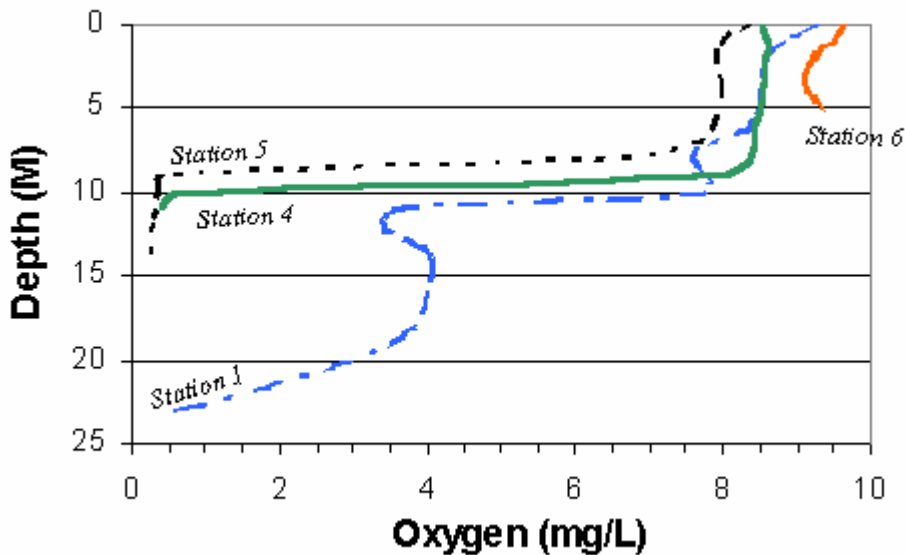
Figure 5. September 16, 2006 oxygen profiles from Lake Tapps monitoring stations.

September oxygen profiles from all four lake stations are shown in Figure 5. The hypolimnion at stations 4 and 5 was anoxic. This anoxia is attributable in part to the narrowness of the hypolimnetic zone (1 to 5 m): the amount of oxygen available at these stations to be consumed by decomposition was small relative to the open lake station with its far deeper hypolimnion. Although the substrate at all stations was fine, gray, glacial silt, there was apparently enough organic matter present for decomposer activity to cause anoxia, at least near the bottom.

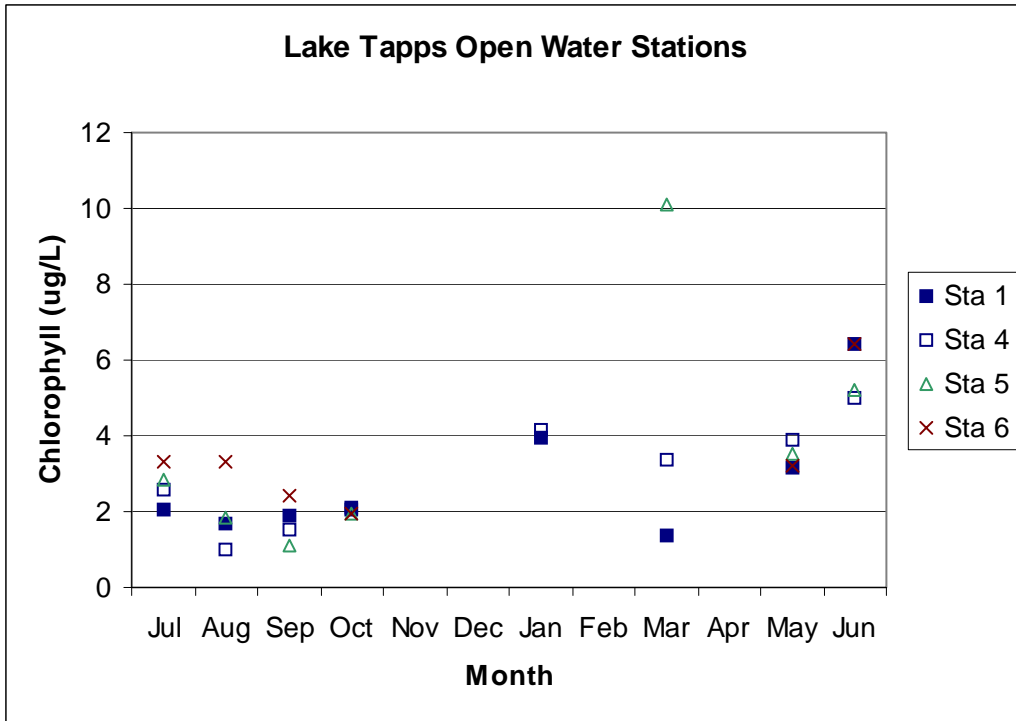
Figure 6. Chlorophyll *a* concentrations at lake stations from July 2004 to June 2005.

The average chlorophyll *a* concentration for Lake Tapps was 3.0 µg/L (Table 4). This concentration is in the mesotrophic range (2.6 – 6.4 µg/L; Carlson, 1977). Concentrations in July through October 2004 were mostly in the oligotrophic range, while later results were mostly in the mesotrophic range (Figure 6).

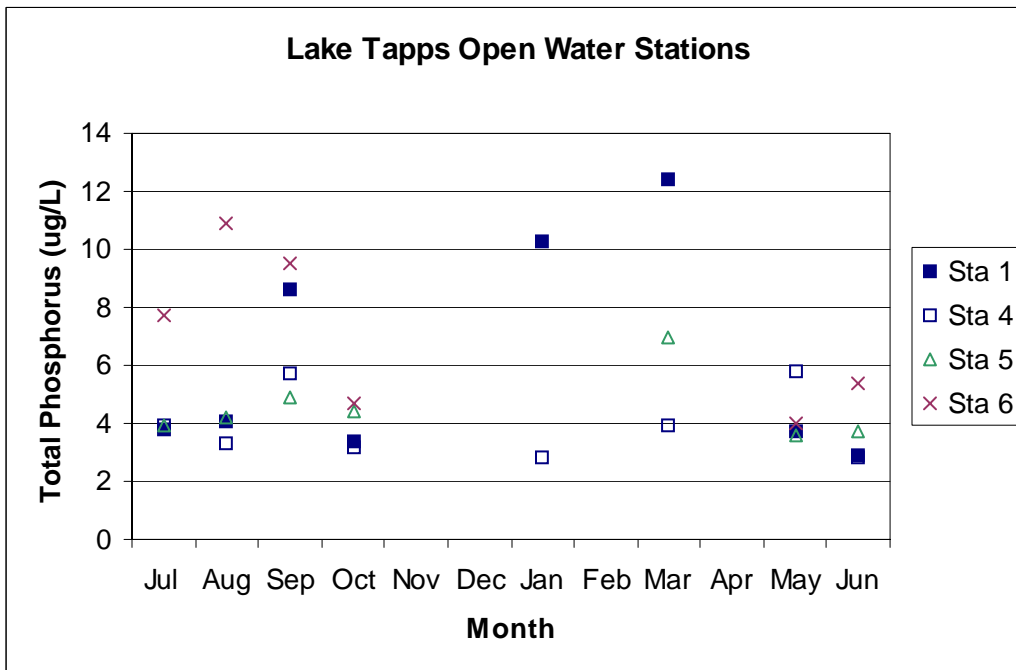
Figure 7. Total phosphorus concentrations at lake stations from July 2004 to June 2005.

Total phosphorus (TP) concentrations in the epilimnion averaged 5 µg/L, well within the typical oligotrophic range (<10 µg/L). Individual results rarely exceeded that criterion (Figure 7) except at station 1 during winter draw-down. High nutrient concentrations entering the lake had greater influence on water quality during the winter months when lake levels were low and the lake was not stratified.

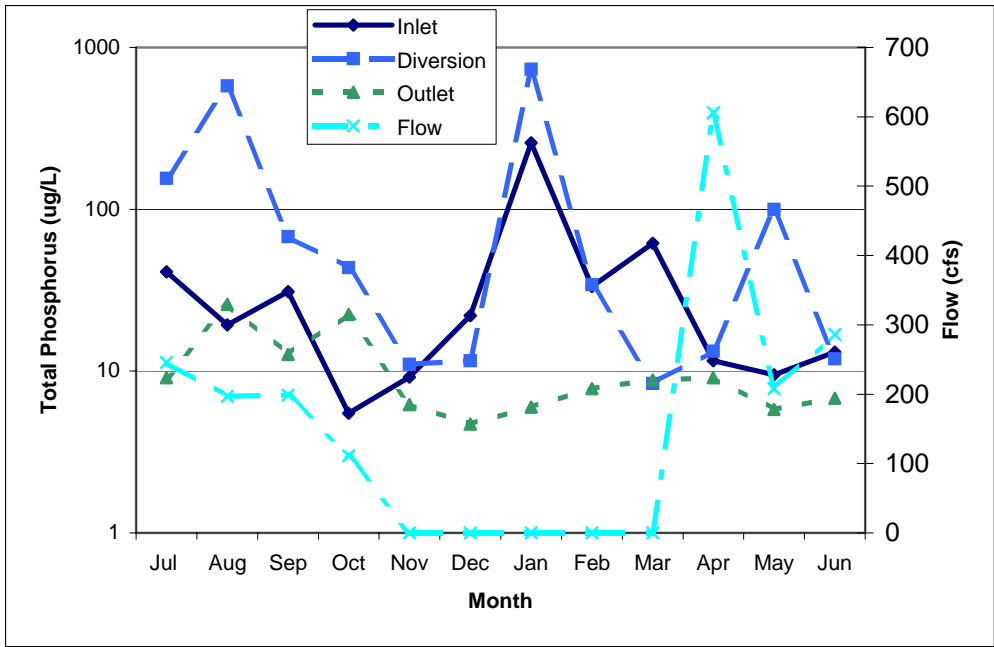
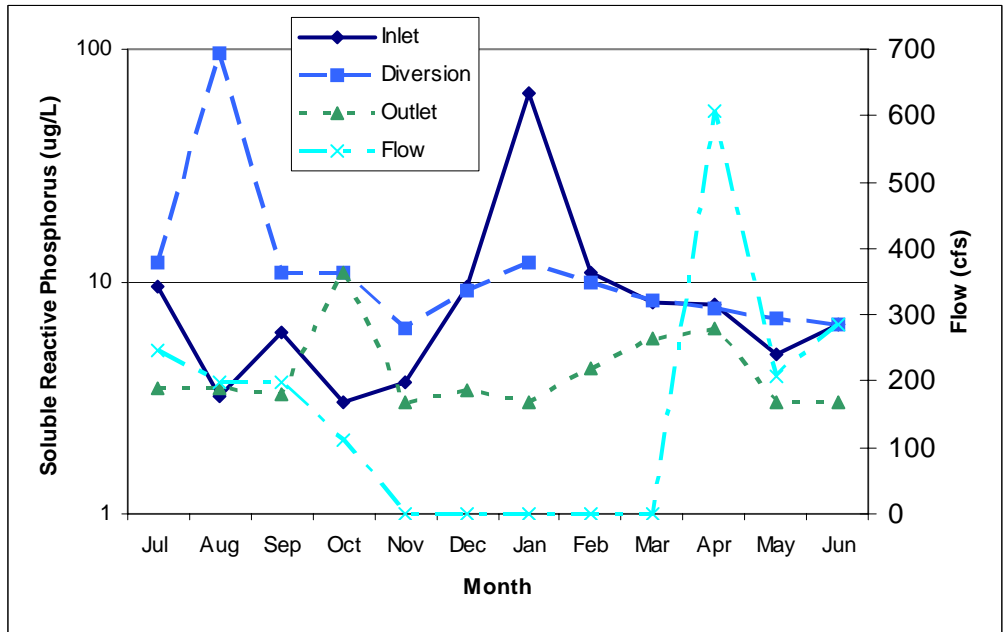
Figure 8. Total phosphorus (top) and soluble reactive phosphorus (bottom) at Lake Tapps inlet and outlet stations. Flow at the diversion is also shown.

- At the White River diversion (station 8), TP concentrations were periodically extremely high (>500 µg/L; Figure 8 and Table 6).
- TP concentrations were usually lower at the lake inlet (station 7) than at the diversion (mean concentrations were 43 and 147 µg/L, respectively). The only times this was not true was when flow was low (Figure 8, top). This reduction between the diversion and the inlet is probably due largely to settling of sediment and associated TP in the diversion channel settling ponds.
