Lower Duwamish Waterway Source Control Action Plan for Glacier Bay Source Control Area

November 2007

Publication No. 07-09-005

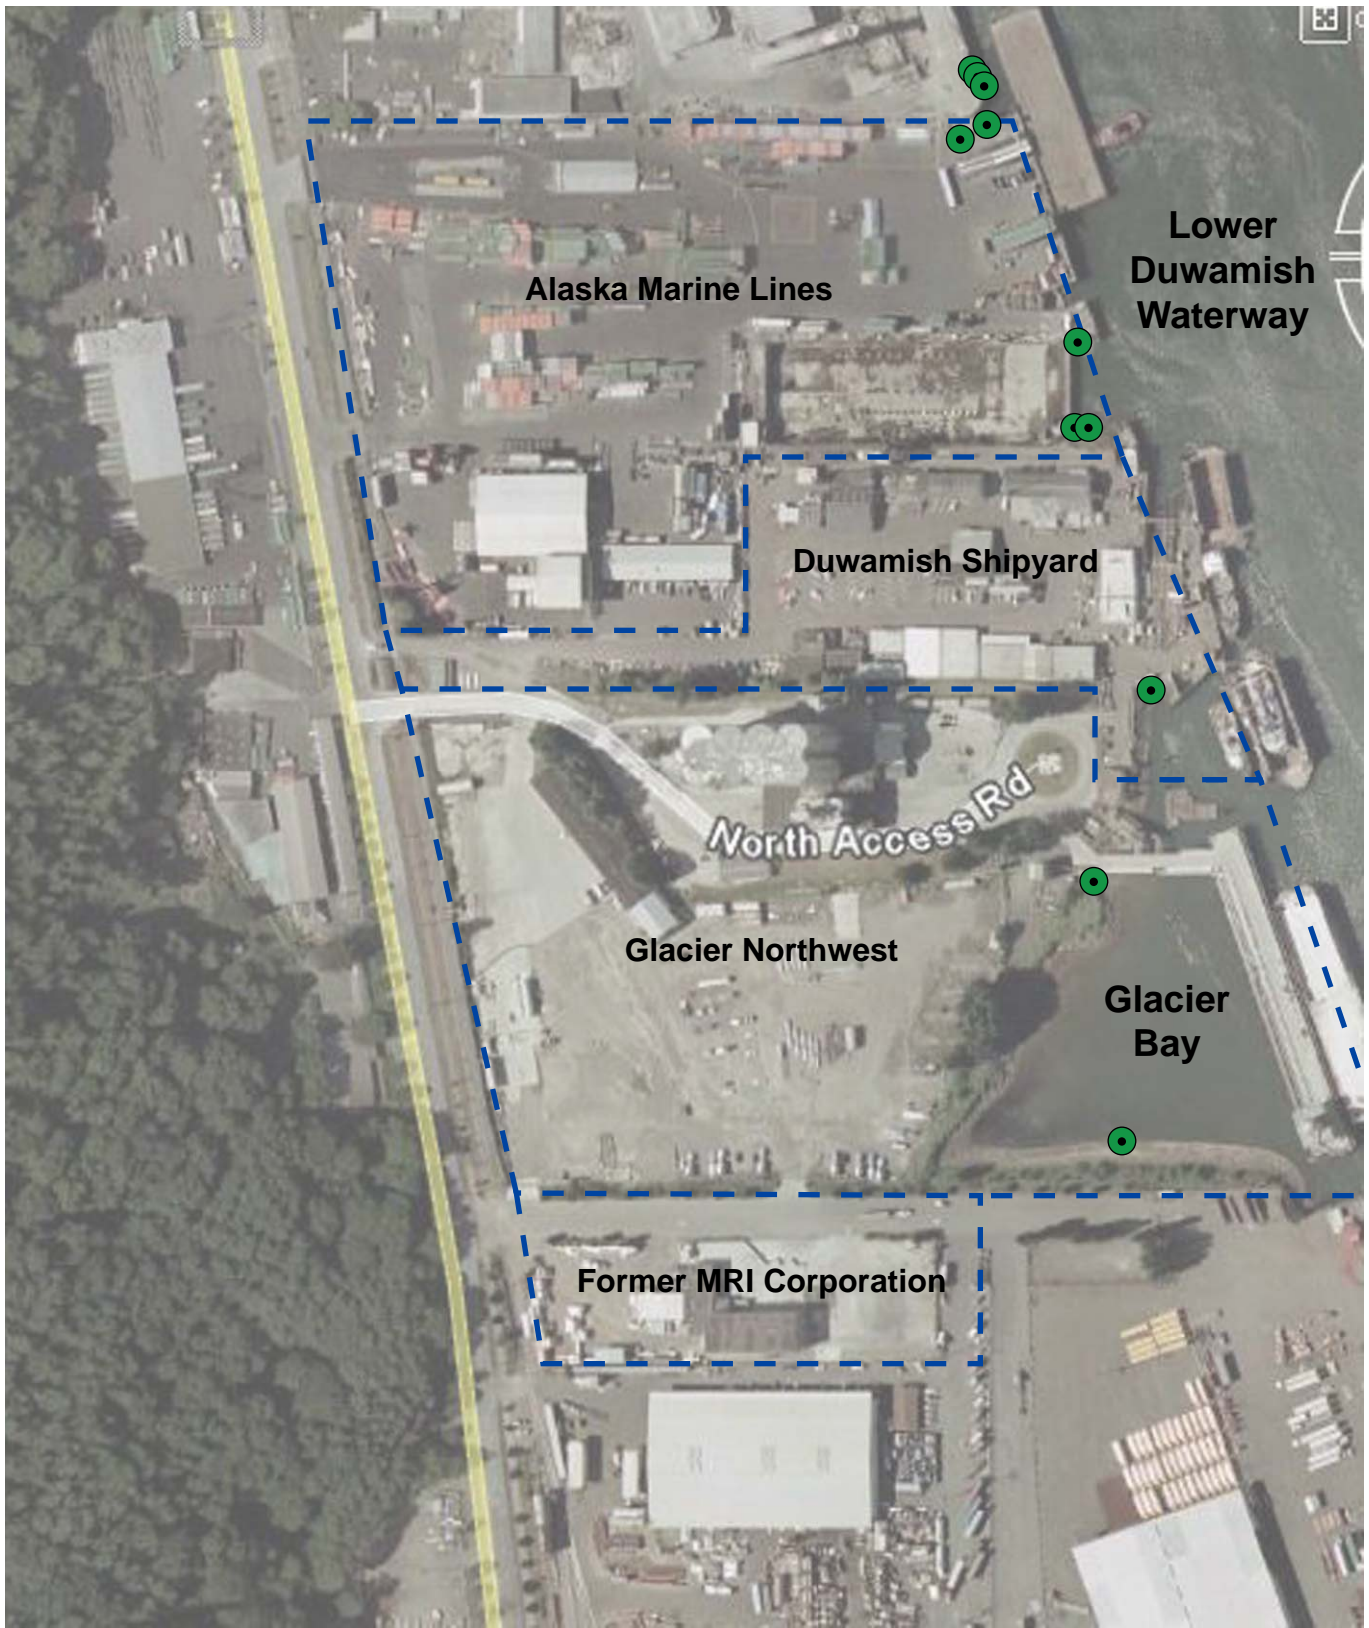
Figure 3. Glacier Bay Source Control Area

- Stormwater Outfall
- - Property Boundary

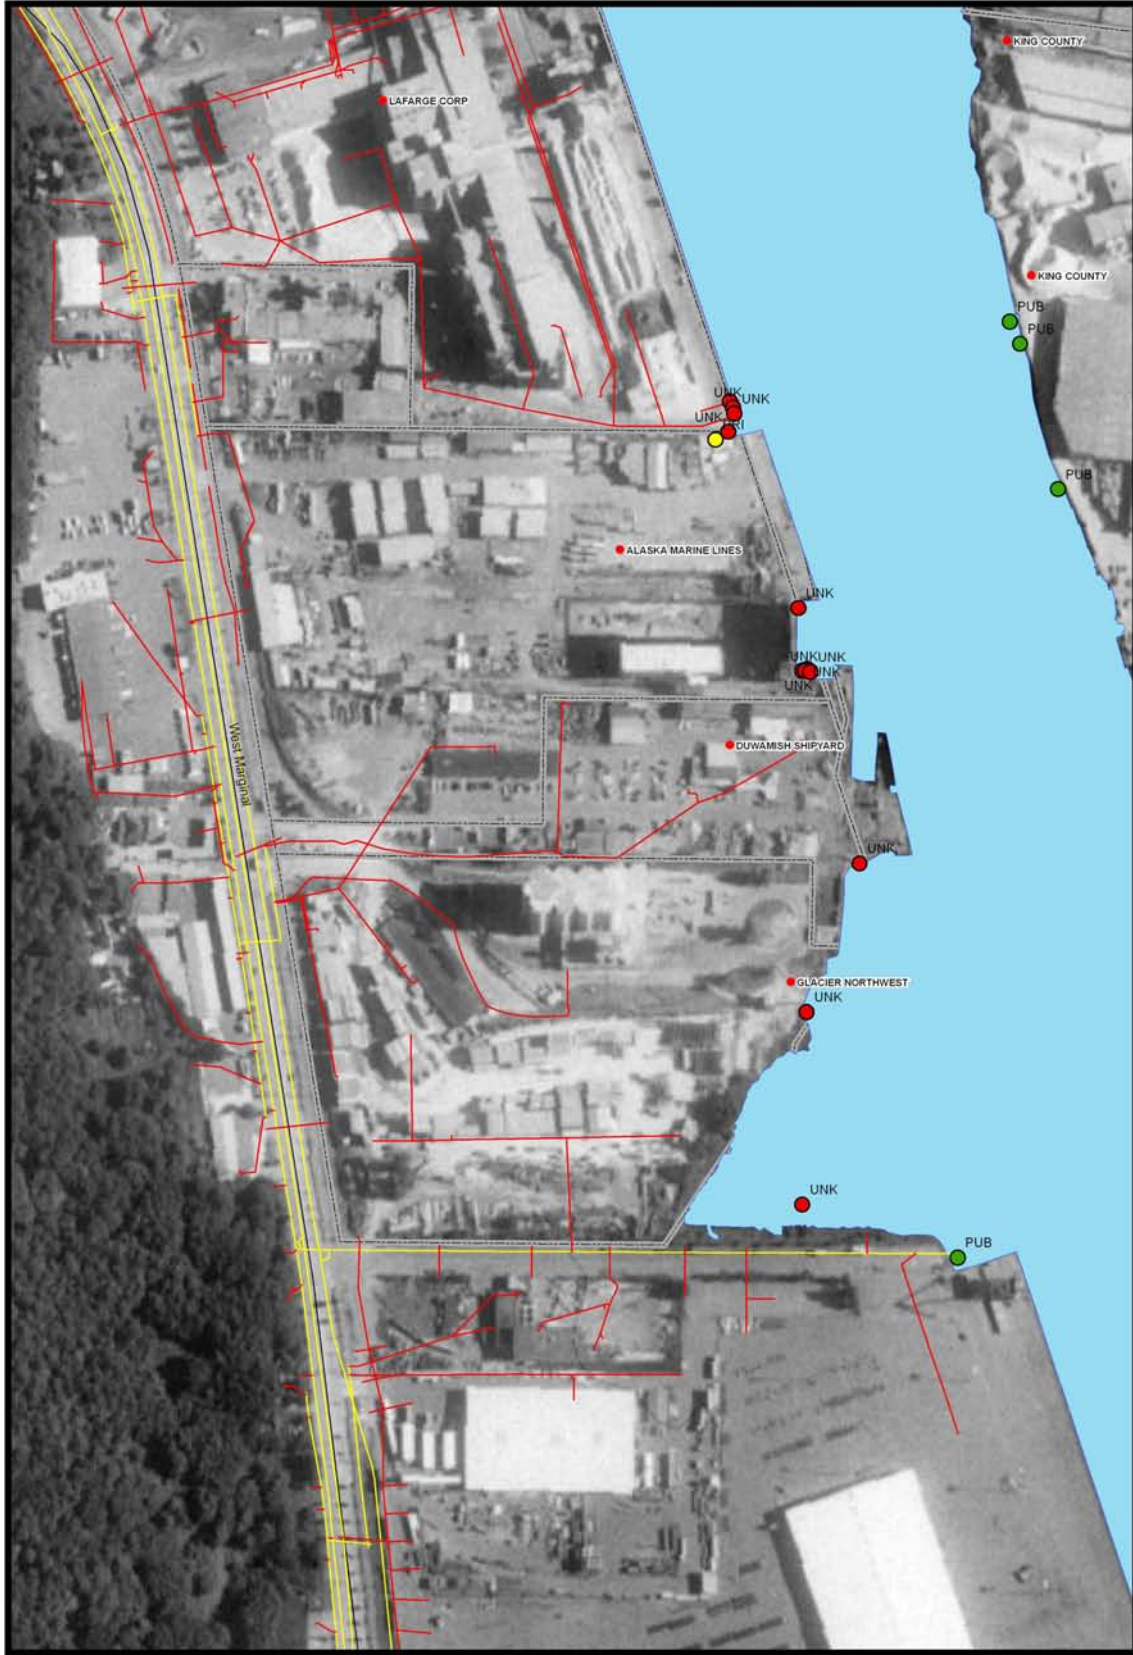
Figure 5. Storm Drain Lines at Glacier Bay Source Control Area

- Public Outfall
- Private Outfall
- Unknown

Source: Seattle Public Utilities
