# Growing Pains in Pullman

## Improving Construction Stormwater Discharges

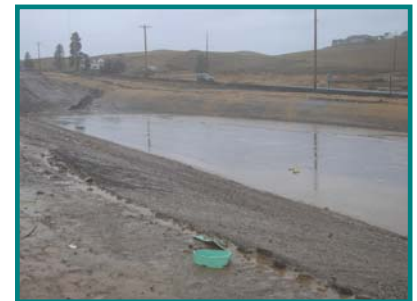
Managing stormwater runoff from construction sites in Pullman and the surrounding areas can be very difficult because of:

- Highly erodible soils,
- Unpredictable weather
- The fact that most construction sites are near one of the many streams that run through or around Pullman.

On December 23, 2005, Dave Duncan and Jeremy Ryf traveled to Pullman in response to complaints that construction stormwater runoff was discharging into local streams and rivers after snow melt and heavy rains. While in Pullman, they conducted a construction stormwater compliance inspection at a housing subdivision. The construction activities at this development were not being conducted in phases. The site was cleared of all vegetation and graded before erosion and sediment control BMPs were installed. During the inspection, they observed that the development's detention ponds were filling with a large amount of sediment-laden stormwater, eroded material from their construction site, and sediment from a heavily tilled agricultural field above the project. Their detention ponds were nearly full of highly turbid stormwater which discharged into a small stream northwest of Pullman. Turbidity is a measurement of the cloudiness of the water. Highly turbid water can cause significant harm or kill aquatic life. The development had inadequate BMPs that failed to prevent erosion and keep sediments from entering their stormwater.

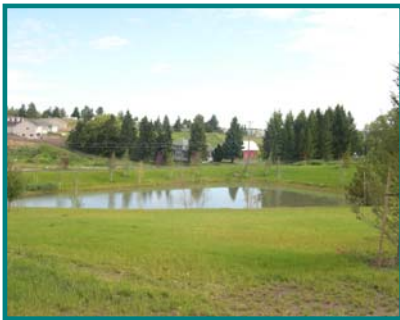
Whispering Hills subdivision is a 30-acre housing development being developed by Copper Basin Construction on the Pullman-Wawawai Road in Pullman. The stormwater runoff from this subdivision discharges into Hatley Creek, which is a small tributary to the South Fork Palouse River. At the first compliance inspection, Ecology staff met with an on-site representative and informed him that they needed to implement additional BMPs and repair existing ones. After the inspection, staff contacted the owner of Whispering Hills subdivision and informed him about the stormwater related problems on this site. They arranged a second inspection with him for the following week. During the second compliance inspection, Ecology Staff met with the owner and the engineer of the subdivision to discuss actions that need to be taken to reduce or eliminate the turbid discharge from the site. By the end of the inspection, the owner of Whispering Hills realized the severity of the problems on their site and was going to have their contractor install and repair the erosion and sediment control BMPs as soon as possible. Over the next year and half Ecology staff continued to conduct additional construction stormwater compliance inspections at Whispering Hills subdivision. The staff provided technical assistance and guidance to help the owner and developer comply with the Construction Stormwater General Permit and reduce the turbidity of the discharge from the site.

After experiencing the stormwater-related problems during Phase 1 of the development, they are planning to first construct and start to revegetate the detention ponds and install other stormwater BMPs before they start clearing and grading the home sites. They also are planning to phase the construction of the new subdivision so that only those areas actively under construction have exposed soils. Because of the vegetation's ability to minimize erosion, limiting and phasing its removal can significantly reduce soil erosion.
