Lead and Copper Concentrations In North Creek, Gig Harbor

Publication No. 08-03-038

Lead and Copper Concentrations in North Creek, Gig Harbor

By Steven Golding

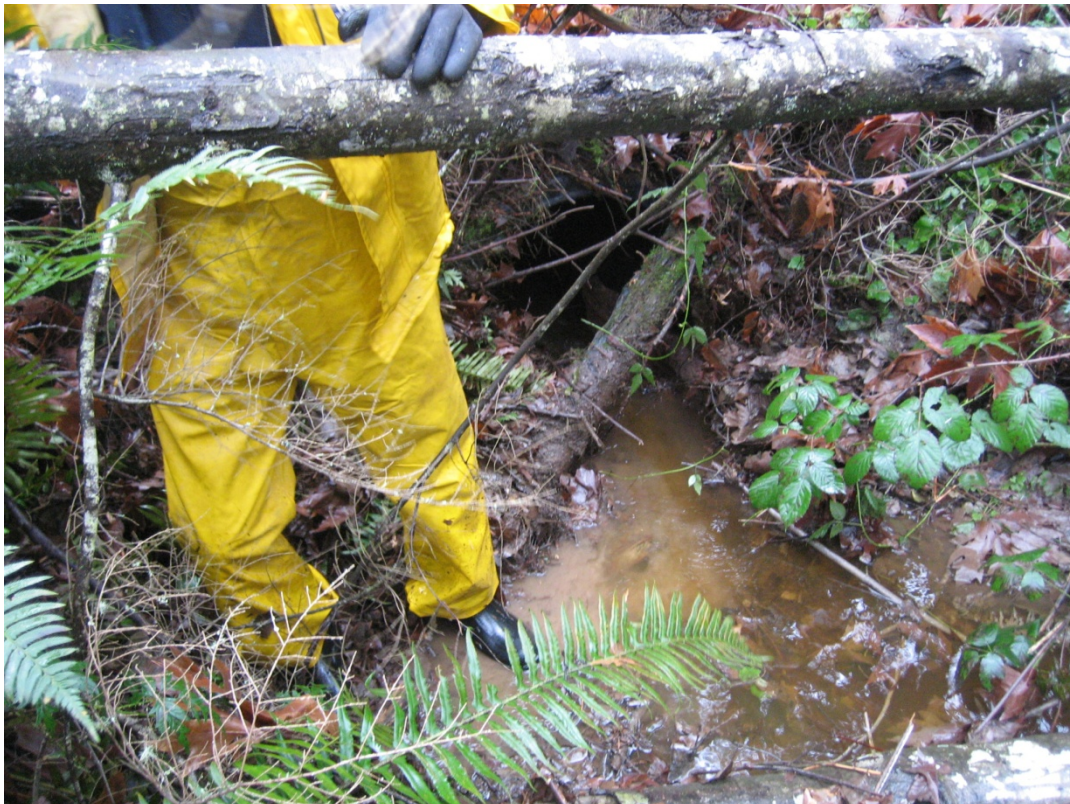
Cover photo: North Creek sampling site #1. The creek is about 3 feet wide at that point, typical of its width throughout the project area. The black area that appears behind the Ecology employee is a culvert where the creek enters the Gig Harbor Sportsman Club property.

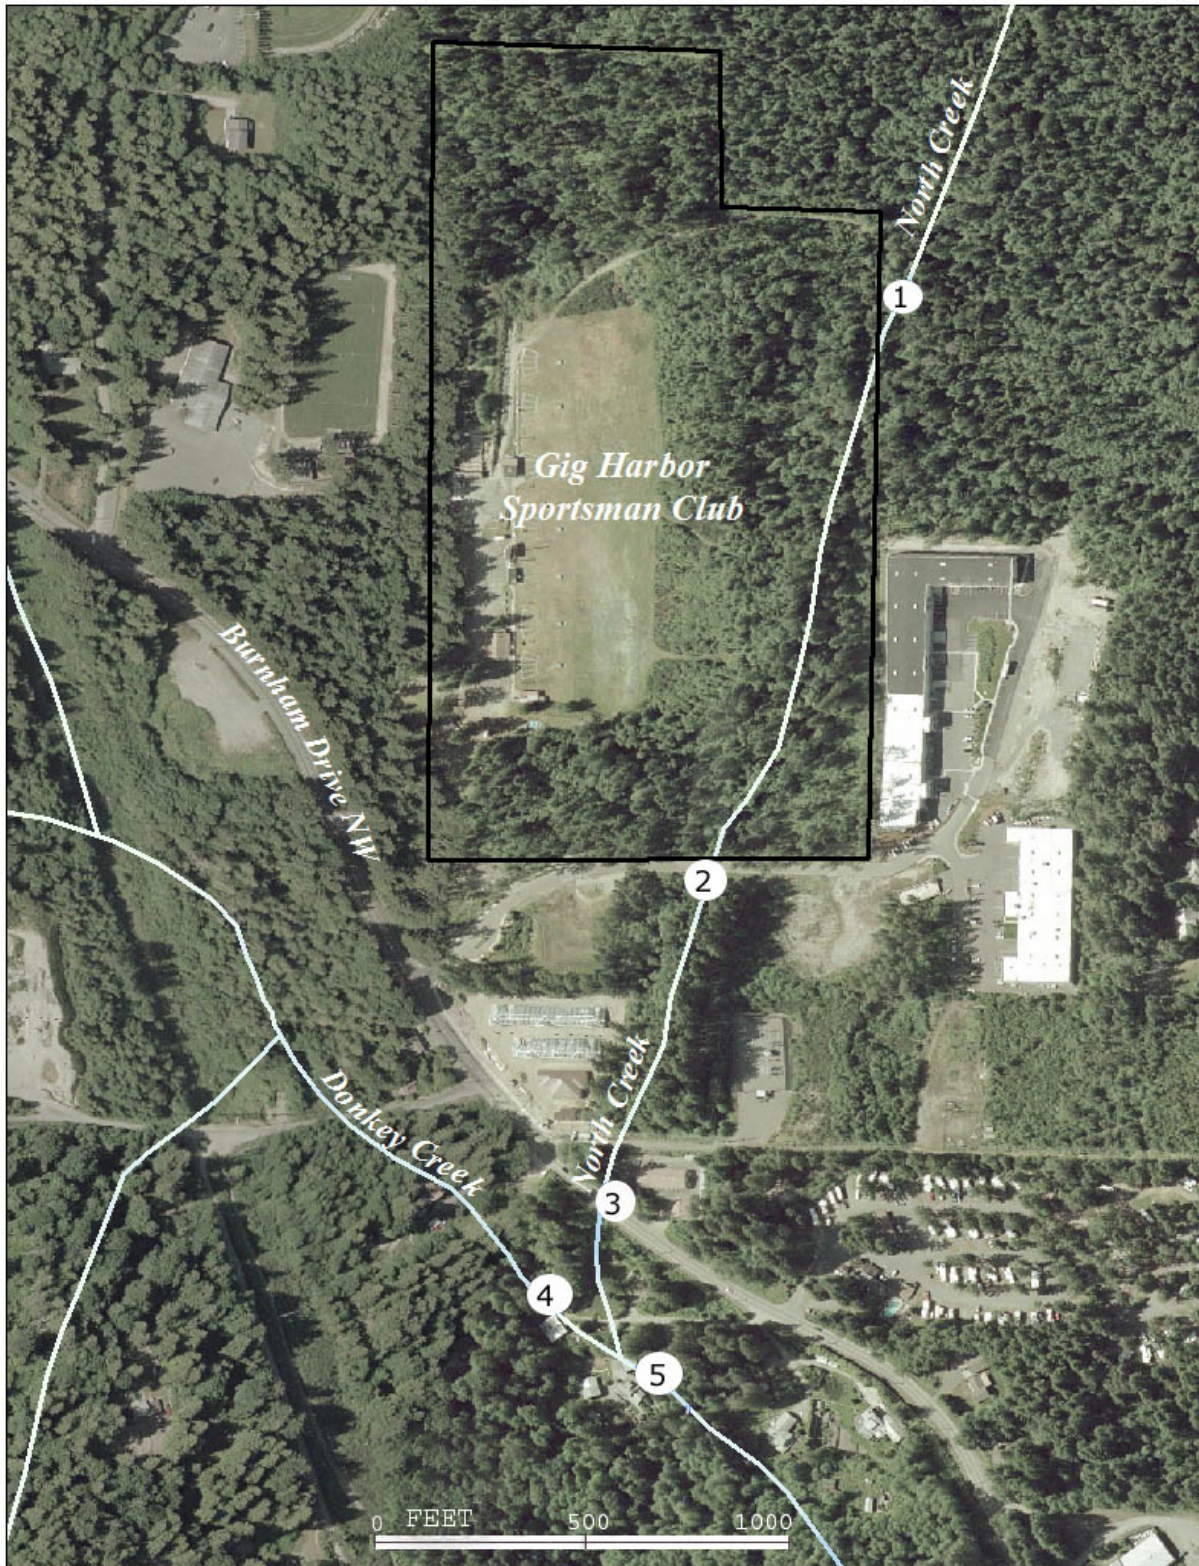
Figure 1. Site map showing Sportsman Club boundaries, creeks, and sampling sites .

Figure 1 shows sampling stations on North Creek adjacent to the Club boundary and upstream and downstream of the site (#1; #2, Figure 1). North Creek was also sampled just upstream of North Creek's confluence with Donkey Creek (#3). Donkey Creek was sampled above and below the confluence (#4; #5) to determine background levels of lead and copper in Donkey Creek and any measurable impact of North Creek metals on Donkey Creek.
