Town of Rockford

Thinking Outside of the Box

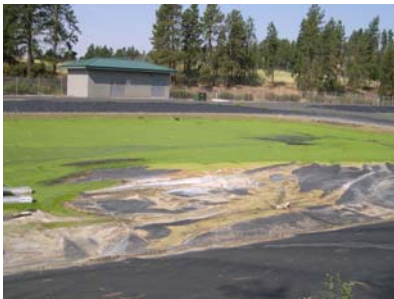
Liner under the lagoon

In the fall of 2006, the town approached Ecology and asked permission to install an underdrain with town funding and labor. TD&H provided an engineering design and the town hired S & L Underground to excavate the ground to prepare it for an underdrain. Due to the time of year the project began, everyone knew there was a limited timeframe for completing the project. S & L Underground came in on a Monday and worked steadily – even working Saturday into the evening to finish the project. Paul did much of the work himself. He laid gravel in the excavated area, constructed all the piping for the underdrain system, excavated an area, and installed a concrete vault to house the pump. He also bought and delivered all the materials to the jobsite for the contractor. He spent approximately two weeks of time getting the project completed while staying in close contact with Ecology and the town's consultant. When the underdrain was installed, Ecology staff and TD&H staff inspected the work and gave permission for the town to have the liner repaired. The underdrain system went online in October 2006. After initially discharging to the storage lagoon while testing was conducted to ensure there were no leaks, the town was given permission to discharge to Rock Creek. In the first 395 days of operation, the underdrain pumped 1,258,000 gallons of water from under the liner.

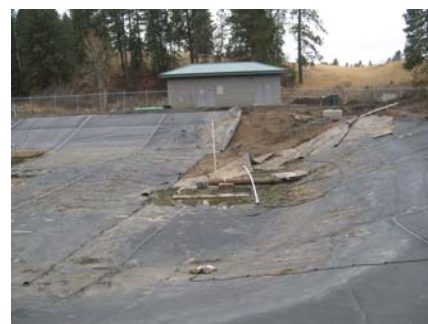
Underdrain piping
