Tucannon River and Pataha Creek Temperature Total Maximum Daily Load

Water Quality Improvement Report and Implementation Plan

July 2010 Publication no. 10-10-019

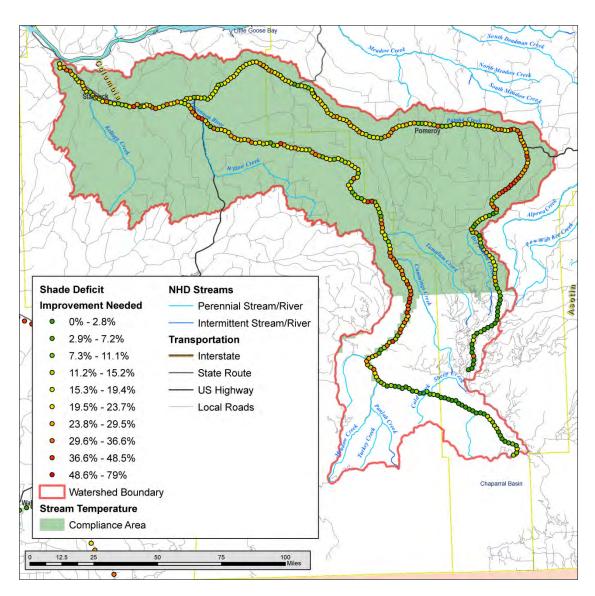
Figure ES-2. Tucannon temperature TMDL compliance area and modeled shade deficit values for Tucannon River and Pataha Creek.

This temperature TMDL develops load allocations for effective shade on the Tucannon River and its tributaries that would occur from system potential mature riparian vegetation (Figure ES-2).

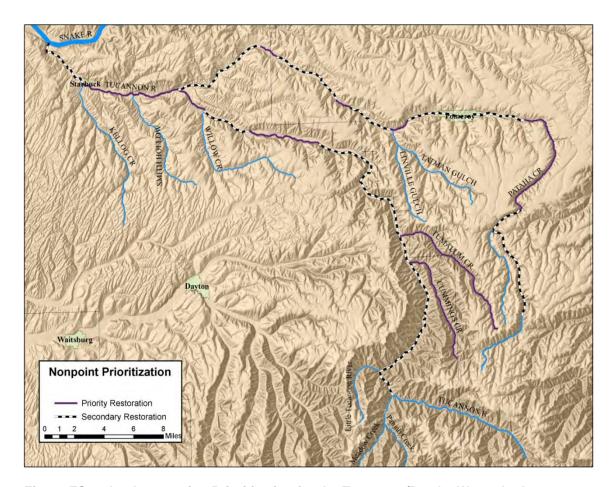
Figure ES-3. Implementation Prioritization for the Tucannon/Pataha Watershed.

Figure ES-3 prioritizes reaches for the implementation of nonpoint source pollution control and restoration activities. This map was developed by combining the results of the TMDL shade deficit analysis with existing hydrologic data.

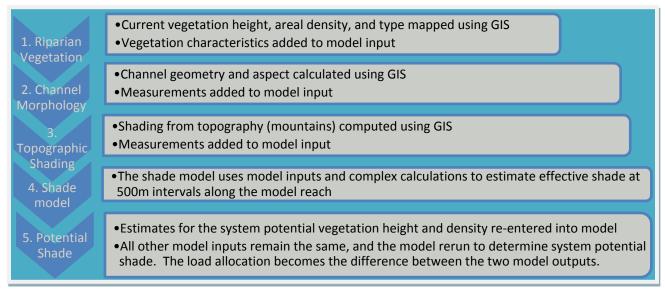
Figure 2. Shade modeling process steps.

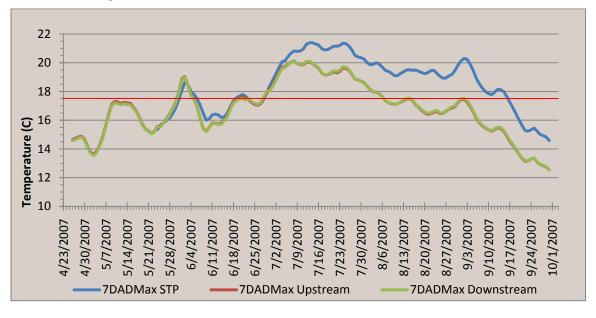
Figure 3. 7-day average daily maximum stream temperature for Pataha Creek and Pomeroy STP effluent.

Pataha Creek violates the stream temperature standards mostly during July and August. However, there may be short-term weather variations that raise background temperatures above the criteria at other times of the year (Theurer et al, 1985).

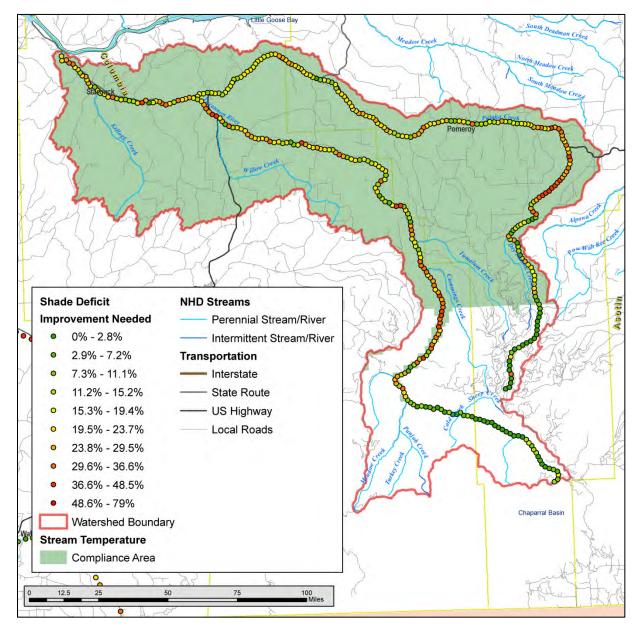
Figure 4. Percent shade deficit load allocations for Tucannon River and Pataha Creek

Non-point source pollutant load targets have been set in this TMDL and described in Figure 4. Because non-point pollution comes from diffuse sources, all upstream watershed areas have the potential to affect downstream water quality. Therefore, all potential nonpoint sources in the watershed must use the appropriate best management practices to reduce impacts to water quality. Similarly, all point source dischargers (the city of Pomeroy's wastewater treatment plant and the Tucannon Fish Hatchery) in the watershed must also comply with the TMDL.

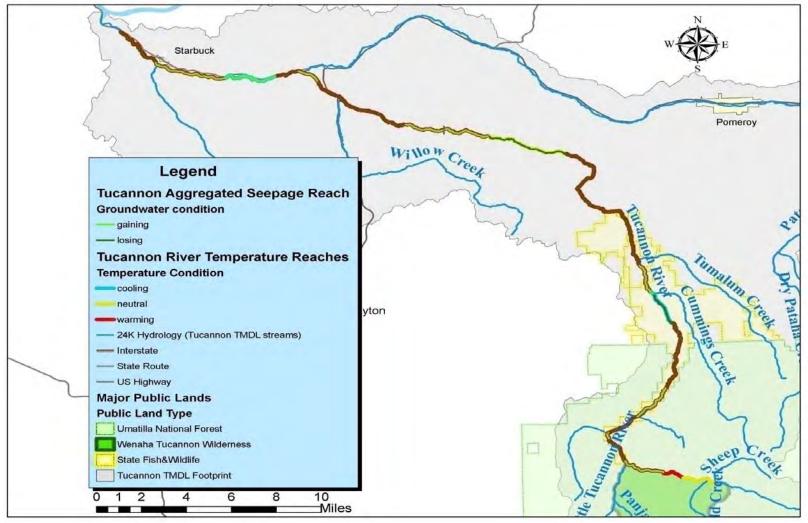
Figure 5. Areas of groundwater/surface water interactions and daily maximum stream temperatures during July 13, 2005.

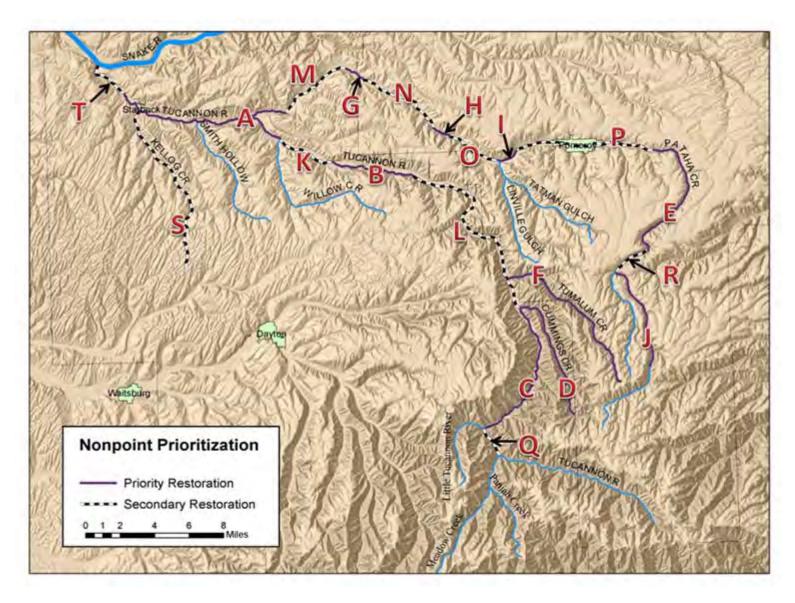
Figure 6. Priority restoration and protection zones for the Tucannon/Pataha watershed.

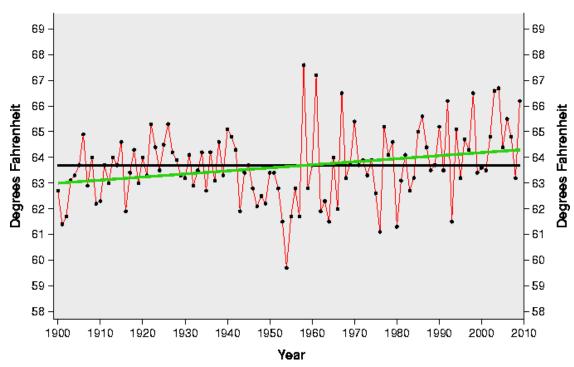
Figure 7: A statewide graph of mean temperature trends during the summer period (Jun-Aug) from the year 1900 to present. Graph taken from the website for the Office of the Washington State Climatologist (http://www.climate.washington.edu/).

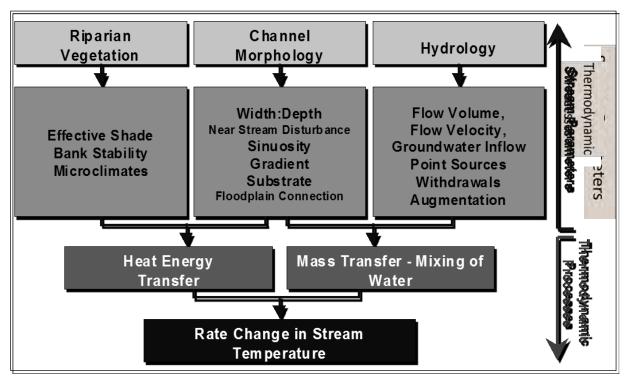
Figure C-1: Conceptual model of factors that affect stream temperature.

The temperature of a stream reflects the amount of heat energy in the water. Changes in water temperature within a particular segment of a stream are induced by the balance of the heat exchange between the water and the surrounding environment during transport through the segment. If there is more heat energy entering the water in a stream segment than there is leaving, the temperature will increase. If there is less heat energy entering the water in a stream segment than there is leaving, then the temperature will decrease. The general relationships between stream parameters, thermodynamic processes (heat and mass transfer), and stream temperature change is outlined in Figure C-1.

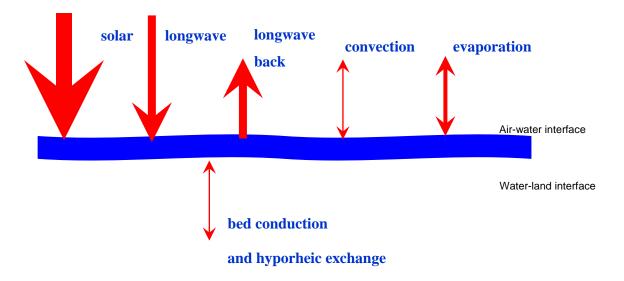
Figure C-2: Surface heat exchange processes that affect water temperature (net heat flux = solar + longwave atmosphere + longwave back + convection + evaporation + bed). Heat flux between the water and streambed occurs through conduction and hyporheic exchange.

Heat exchange processes occur between the water body and the surrounding environment; these processes control stream temperature. Edinger et al., (1974) and Chapra (1997) provide thorough descriptions of the physical processes involved. Figure C-2 shows the major heat energy processes or fluxes across the water surface or streambed.

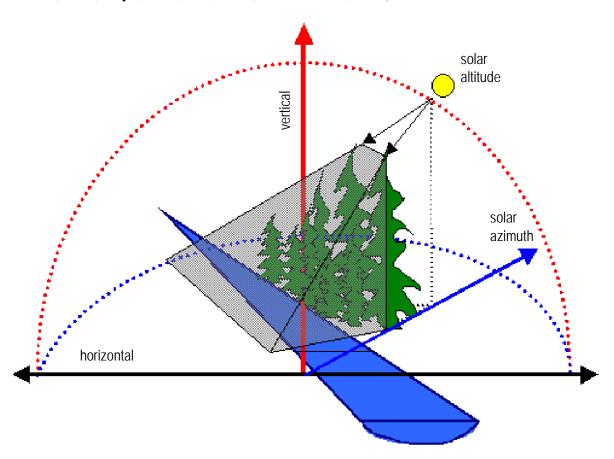
Figure C-3: Parameters that affect shade and geometric relationships. Solar altitude is a measure of the vertical angle of the sun's position relative to the horizon. Solar azimuth is a measure of the horizontal angle of the sun's position relative to north. (Boyd and Kasper, 2003.)

While the interaction of these shade variables may seem complex, the mathematics that describes them is straightforward geometry. Using solar tables or mathematical simulations, the potential daily solar load can be quantified. The shade from riparian vegetation can be measured with a variety of methods, including hemispherical photography and solar pathfinder. (Ice, 2001; OWEB, 1999; Boyd, 1996; Teti, 2001; Teti and Pike, 2005):

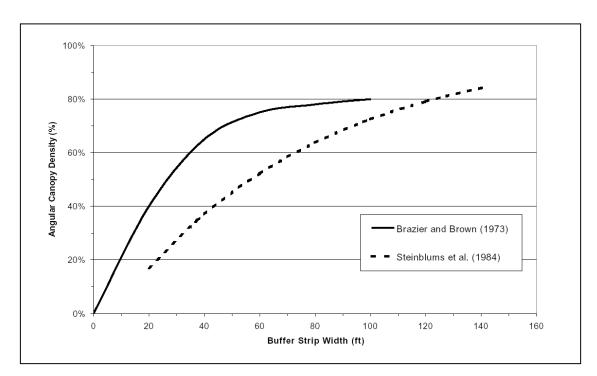
Figure C-4: Relationship between angular canopy density (ACD) and riparian buffer width for small streams in old-growth riparian stands (after Beschta et al., 1987 and CH2M Hill, 2000).

The shade, as represented by angular canopy density (ACD) for a given riparian buffer width, varies over space and time. This is because of differences among site potential vegetation, forest development stages (e.g., height and density), and stream width. For example, a 50-foot-wide riparian area with fully developed trees could provide from 45 to 72% of the potential shade in the two studies shown in Figure C-4.

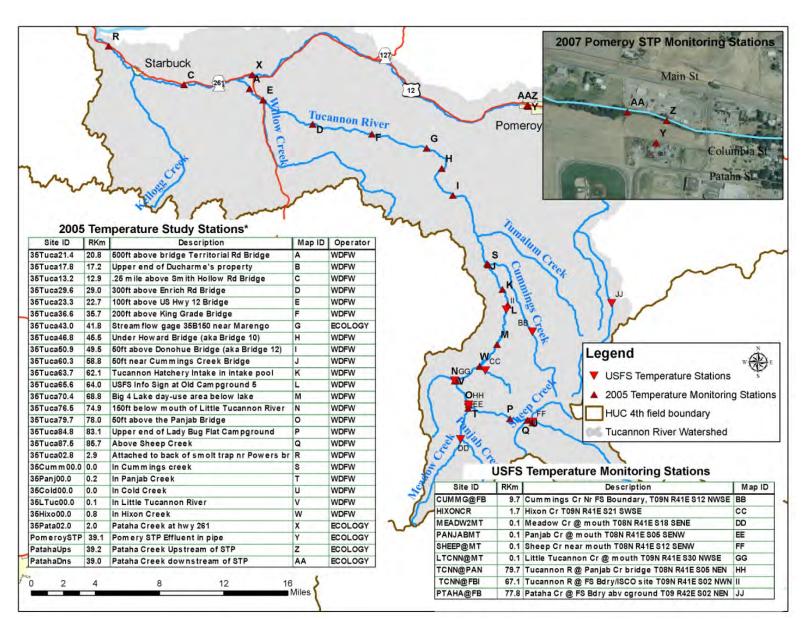
Figure D-1: Stream temperature monitoring stations.

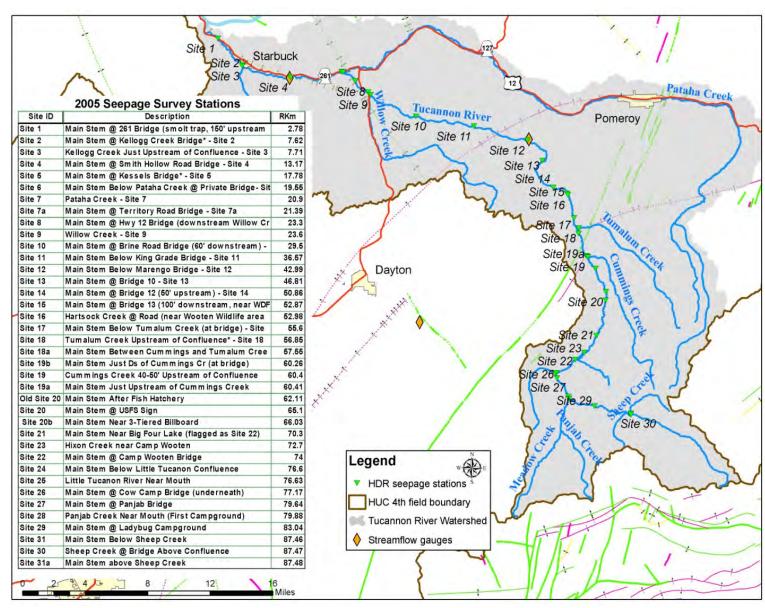
Figure D-2: Streamflow measurement stations.

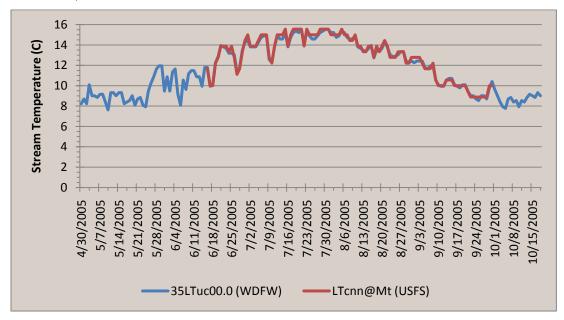
Figure E-1: Comparison of daily maximum temperatures measured by WDFW and USFS on Little Tucannon River near mouth.

average difference between the Little Tucannon River locations (near the confluence with the Tucannon River) was 0.54°C that occurred on 9/16/2005.

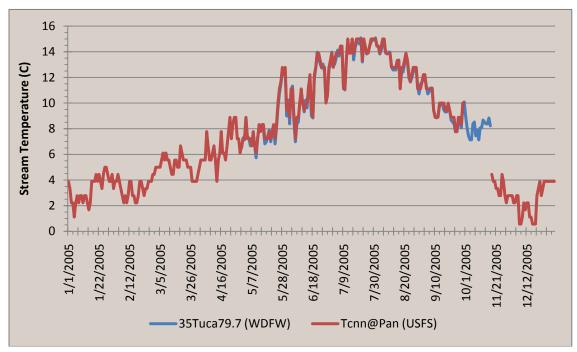
Figure E-2: Comparison of daily maximum temperatures measured by WDFW and USFS on Tucannon River downstream of Panjab Creek.

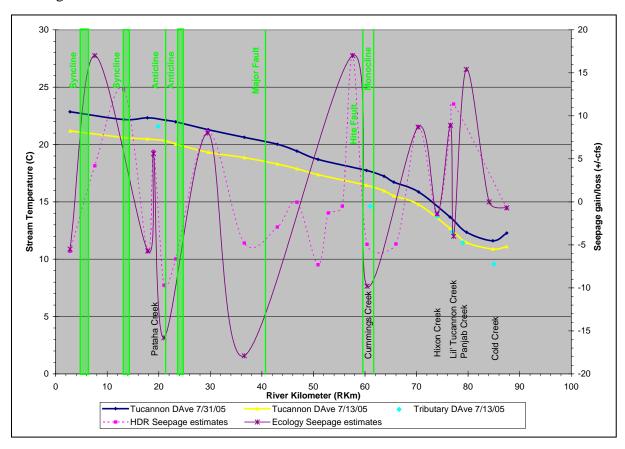
Figure E-3: Comparison of daily average (DAve) stream temperature for the Tucannon River and tributaries as well as groundwater gain and loss volumes using HDR and Ecology seepage analysis values.

Figure E-3 shows the comparison between the HDR seepage results and Ecology's analysis of the same data. Daily average (DAve) stream temperatures are graphed for the day of the seepage run (7/13/05) and the warmest day of this time period (7/31/05). When comparing the big gains and losses in surface water with the location of known geologic features, such as the Hite Fault and numerous geologic folds and faults in the lower watershed, it appears that geology is controlling streamflow in the Tucannon River.

Figure 14 also shows that when the river loses significant amounts of water, through surface water withdrawals or groundwater recharge, the slope of the daily average stream temperature

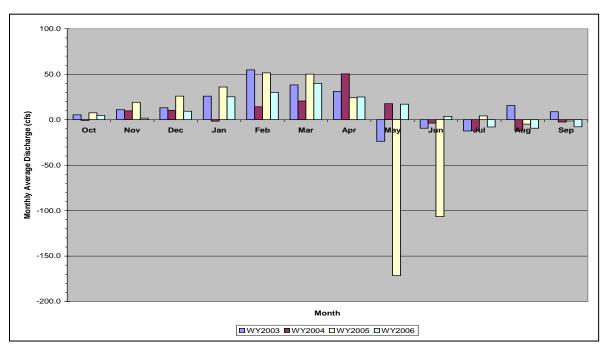
Figure E-4: Difference in Monthly Average streamflow between the gage near Marengo and the gage near Starbuck for WY2003-2006.

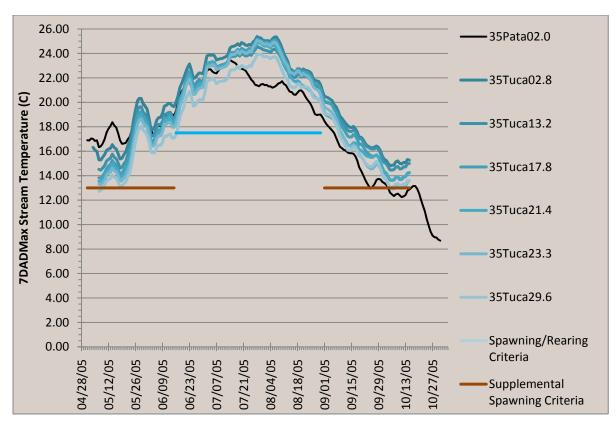
Figure E-5: 7DADMax stream temperatures from the Tucannon River where salmon spawning/rearing and supplemental spawning temperature criteria applies.

The general trend for the Tucannon River shows stream temperature continually increasing as surface water moves downstream (Figure E-5). The river begins exceeding the 7DADMax 17.5°C standard during the 2005 summer period (July – August) and also warmer than the supplemental salmon spawning and incubation criteria of 13°C during May, September, and October where data is available. Pataha Creek was warmer than Tucannon during the spring freshet and then several degrees cooler beginning in July and continuing thru October.

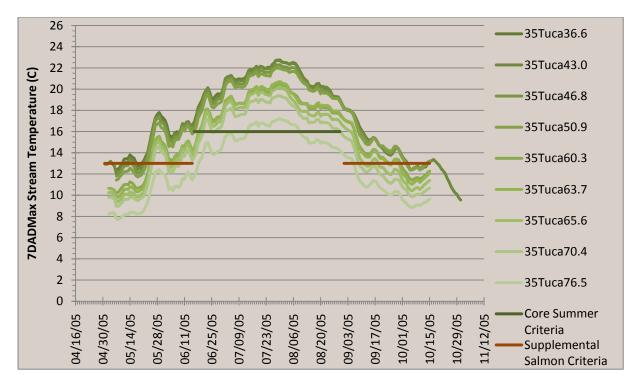
Figure E-6: 7DADMax temperatures where core summer rearing criteria apply.

The monitoring stations where core summer habitat aquatic criteria applies, show a similar pattern of temperature exceedences. Figure E-6 shows stations where stream temperatures increase rapidly between Rkm 60.3 and 50.9 (RM 37.5 – 31.6) as well as Rkm 76.5 and 70.4 (RM 47.5 – 43.7) where there is a nearly 2°C increase in the 7DADMAx along a 6.1 kilometer long reach despite cooler water entering from the Little Tucannon River. It is important to note that this reach shows alternating groundwater discharge (gaining) and groundwater recharge (losing) conditions between Cold Creek and Hixon Creek. The influence of groundwater and surface water interactions and the deficit of riparian shade are probably causing the rapid increase in stream temperature in this reach.

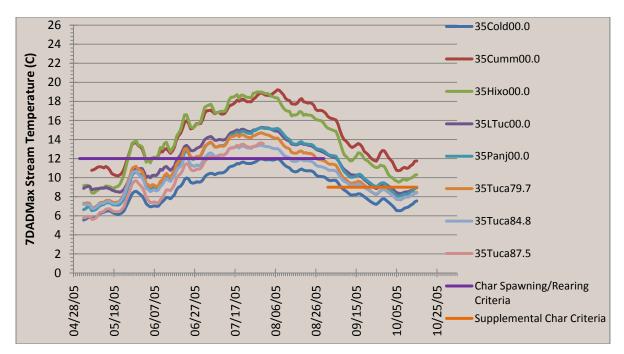
Figure E-7: 7DADMax stream temperatures where the Char spawning/rearing criteria apply.

The Tucannon River and tributaries designated with char spawning/rearing temperature criteria of 12°C 7DADMax exceeds the standard (Figure E-7), even though daily maximum summer temperatures didn't exceed 16°C. Of particular interest in this reach is how much warmer Cummings Creek and Hixon Creek are compared to the Tucannon River (2-4°C during the summer. Both of these tributaries contribute significant heat loading to the river.

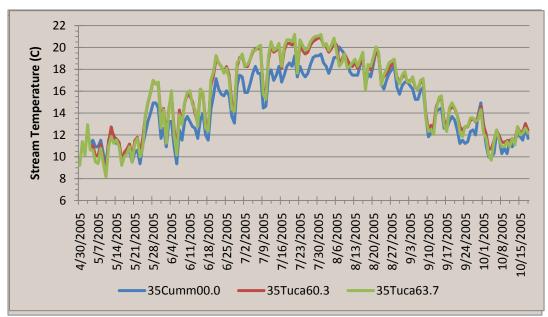
Figure E-8: Tucannon River and Cummings Creek stream temperatures.

Cummings Creek has very poor riparian cover. However, Cummings Creek appears to help moderate the daily maximum temperature of the Tucannon between the fish hatchery intake and the Cummings Creek bridge during the summer critical period (Figure E-8). Therefore, a reduction of temperature in Cummings Creek would help further reduce the temperature of the Tucannon River.

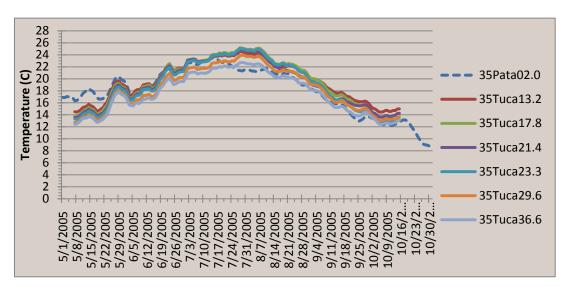
Figure E-9: Comparison of 7DADMax temperatures for Tucannon River monitoring stations from the lower part of the watershed (HDR, 2006).

Figure E-9 shows 2005 stream temperatures for the lower part of the Tucannon River. The rate of heating is less here than in the upper watershed reaches. There are interesting thermal patterns, including a cooling reach between station 35Tuca17.8 (downstream of the Pataha Creek confluence) and 35Tuca13.2 (above Smith Hollow Bridge). Stream temperature increases by several degrees celsius between Einrich Road bridge (35Tuca29.6) and 35Tuca17.8. This is a long losing reach. The cooler stream temperatures measured near Smith Hollow Bridge are likely influenced by cooler groundwater inflow in this gaining reach as well as riparian and stream channel improvements already in place. Figure E-(9) 23: Comparison of 7DADMax temperatures for Tucannon River monitoring.

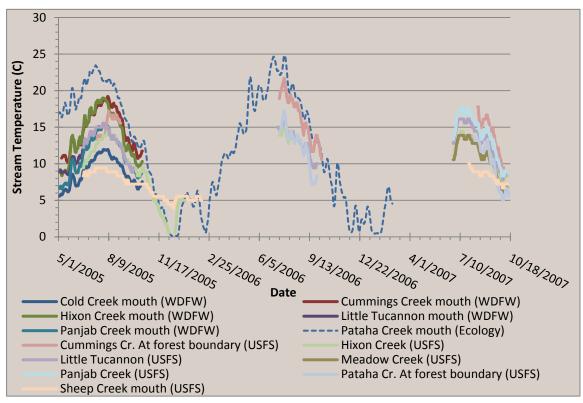
Figure E-10: Tributary 7DADMax stream temperatures for the time period beginning May 2005 through mid-October 2007.

Tributary 7DADMax temperatures, shown in Figure E-10, which include data for 2005 through 2007. Cummings Creek, Hixon Creek, and Pataha Creek were the warmest tributaries measured. The coldest tributaries measured were in the upper watershed and include: Cold Creek, Little Tucannon River, Panjab Creek, Meadow Creek, and Sheep Creek. These creeks are all at higher elevations in the Umatilla Forest and have significantly higher densities of riparian vegetation than the nearer, warmer neighboring catchments of Hixon, Cummings, and Tumalum Creeks.

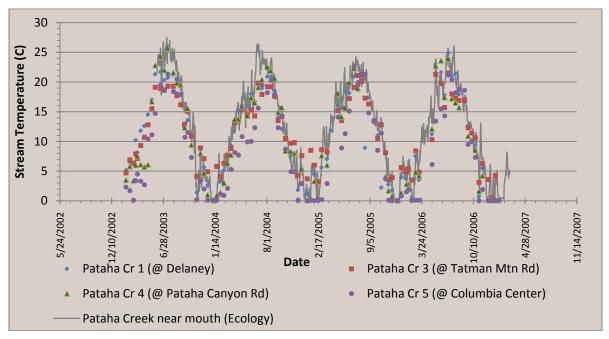
Figure E-11: Pataha Creek stream temperature data from Garfield County Riparian Restoration Study.

maximum temperatures are expected to occur. Temperature measurements taken at downstream stations were taken earlier in the day and may not represent the daily maximum for the station.

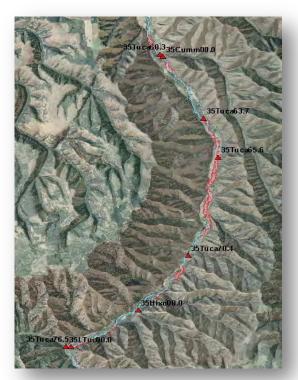
Figure E-12: Burned Tucannon River riparian areas from the 2005 School Fire

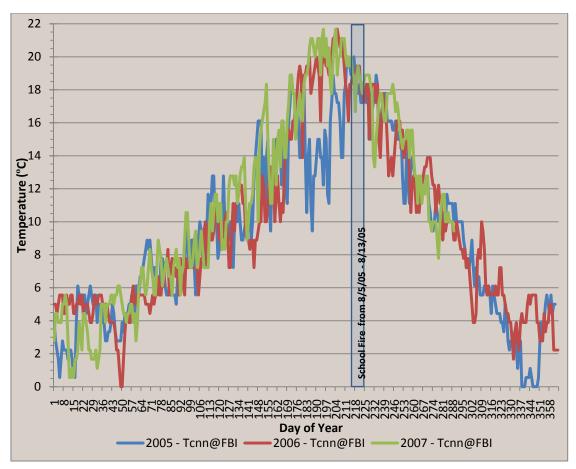
Figure E-13: Tucannon River temperature at the Umatilla National Forest Boundary for 2005-2007.

unclear from the available stream temperature data (Figure E-13) how the 2005 School Fire affected the critical period temperatures of the Tucannon River. July stream temperatures collected in 2005 before the fire were cooler than July temperatures measured in 2006 and 2007. July stream temperatures in 2007 were much warmer than in 2006 but may be within the range of annual variability. Increased stream heating along the burned reaches are most apparent in July and early August.

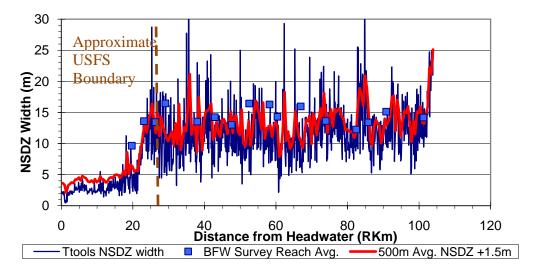
Figure F-2: Calibration of Tucannon River channel geometry for NSDZ model input.

Figure F-2 compares the average bankfull width measured during the HDR channel surveys to the measurements derived with Ttools. The digitized data fits the field data best using the digitized width plus 1.5 meters if averaged over 500-meters (red line on Figure F-2). Large jumps in the NSDZ width and in the wetted widths graphed on Figure G-3 are due to braided channels where the widths of both channels are combined.

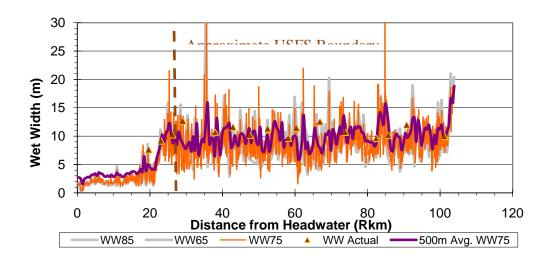
Figure F-3: Calibration of Tucannon River channel geometry for wetted width model input.

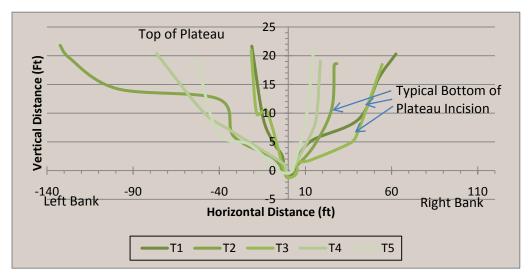
Figure F-4: Channel survey results for one reach on Pataha Creek. The graph is normalized so that all lines below y=0 is the wetted stream portion and x=0 is the location of the thalweg.

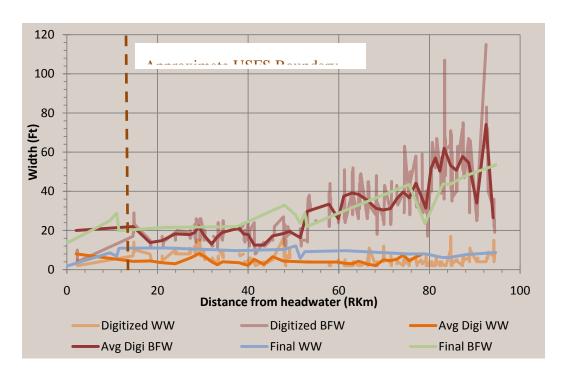
Figure F-5: Calibration of Pataha Creek channel geometry for model input. The final WW and BFW were derived from field survey data.

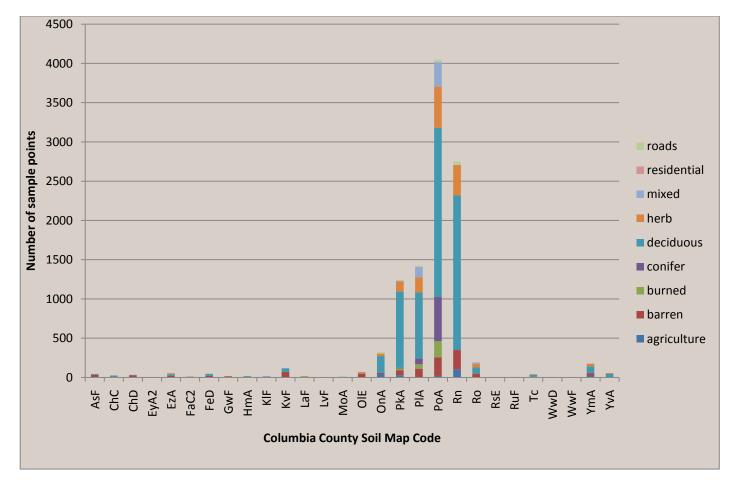
Figure G-1: Columbia County soil types represented at riparian vegetation Ttools sample points.

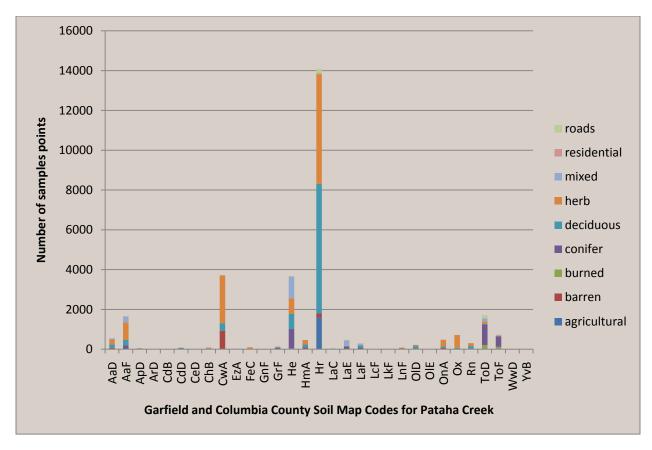
Figure G-2: Soil types represented at riparian vegetation Ttools sample points.

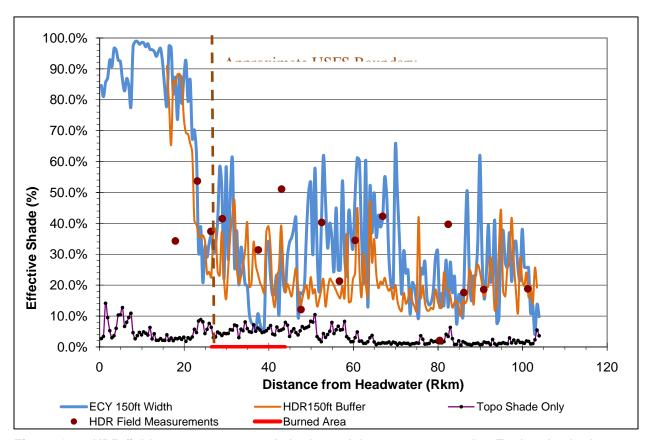
Figure G-3: HDR field measurements and shade model output compared to Ecology's shade model output.

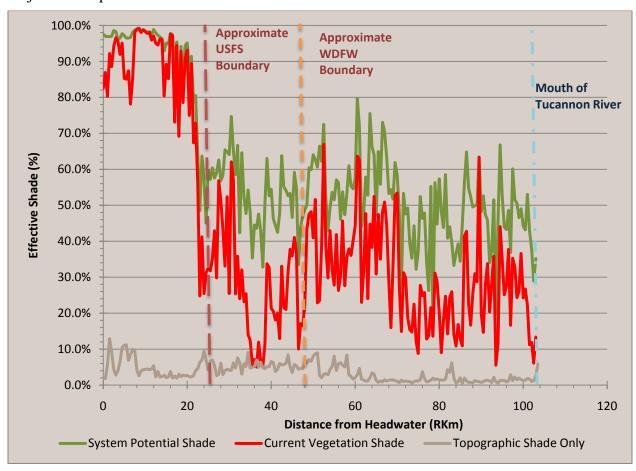
Figure G-4: Comparison of current riparian shade and system potential shade for Tucannon River.

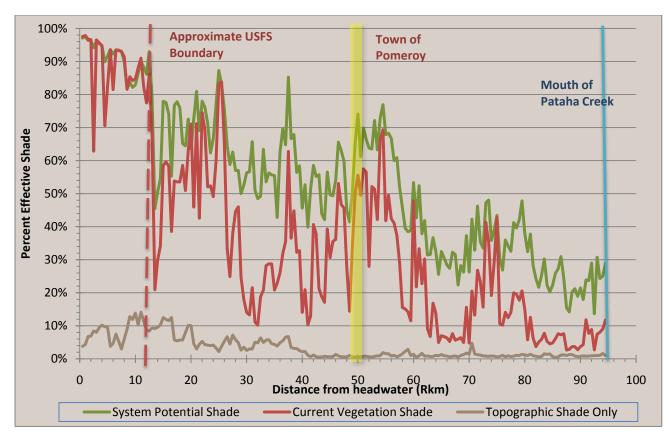
Figure G-5: Comparison of current riparian shade and system potential shade for Pataha Creek. Large increases in shade can be achieved in many reaches along the creek, especially in the lower reaches downstream of Pomeroy. Riparian restoration in these areas will be difficult due to the severe entrenchment of Pataha Creek (Figure G-6), which effectively lowers the water table out of reach to replantings on top of the incised banks. This problem could increase management costs and resources for irrigating restoration projects that are not planted down in the incisions along the new floodplain. Riparian restoration efforts should focus replanting within the incised channel in reaches where that is a problem.

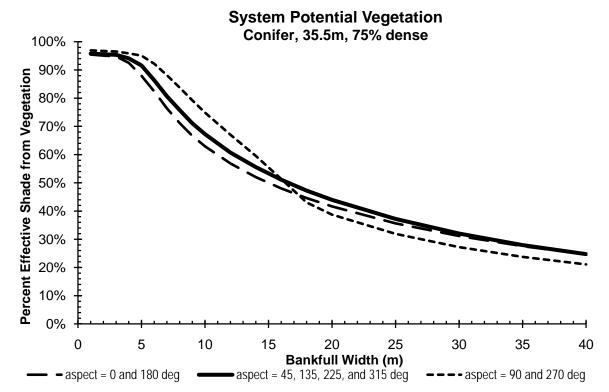
Figure G-7: Shade Curve for riparian conifer vegetation on tributaries to the Tucannon River and Pataha Creek

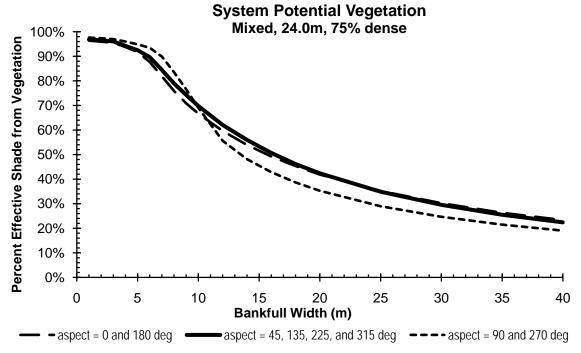
Figure G-8: Shade Curve for riparian mixed vegetation on tributaries to the Tucannon River and Pataha Creek.

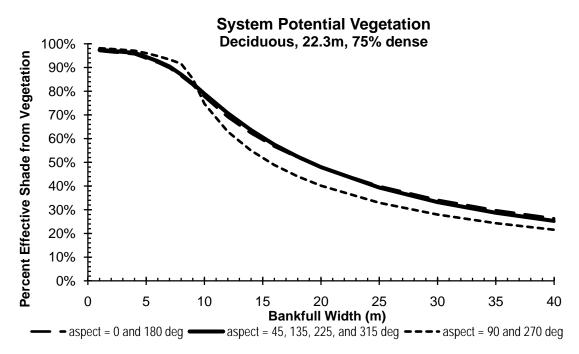
Figure G-9: Shade Curve for riparian deciduous vegetation on tributaries to the Tucannon River and Pataha Creek.
