WEBB HILL BIOSOLIDS FACILITY HYDROGEOLOGIC INVESTIGATION - PHASE 1 Mason County, Washington

**Prepared for: Mason County Department of Community Development,
on behalf of WRIA 16 Planning Unit**

Project No. 070041-001-01 • September 6, 2007

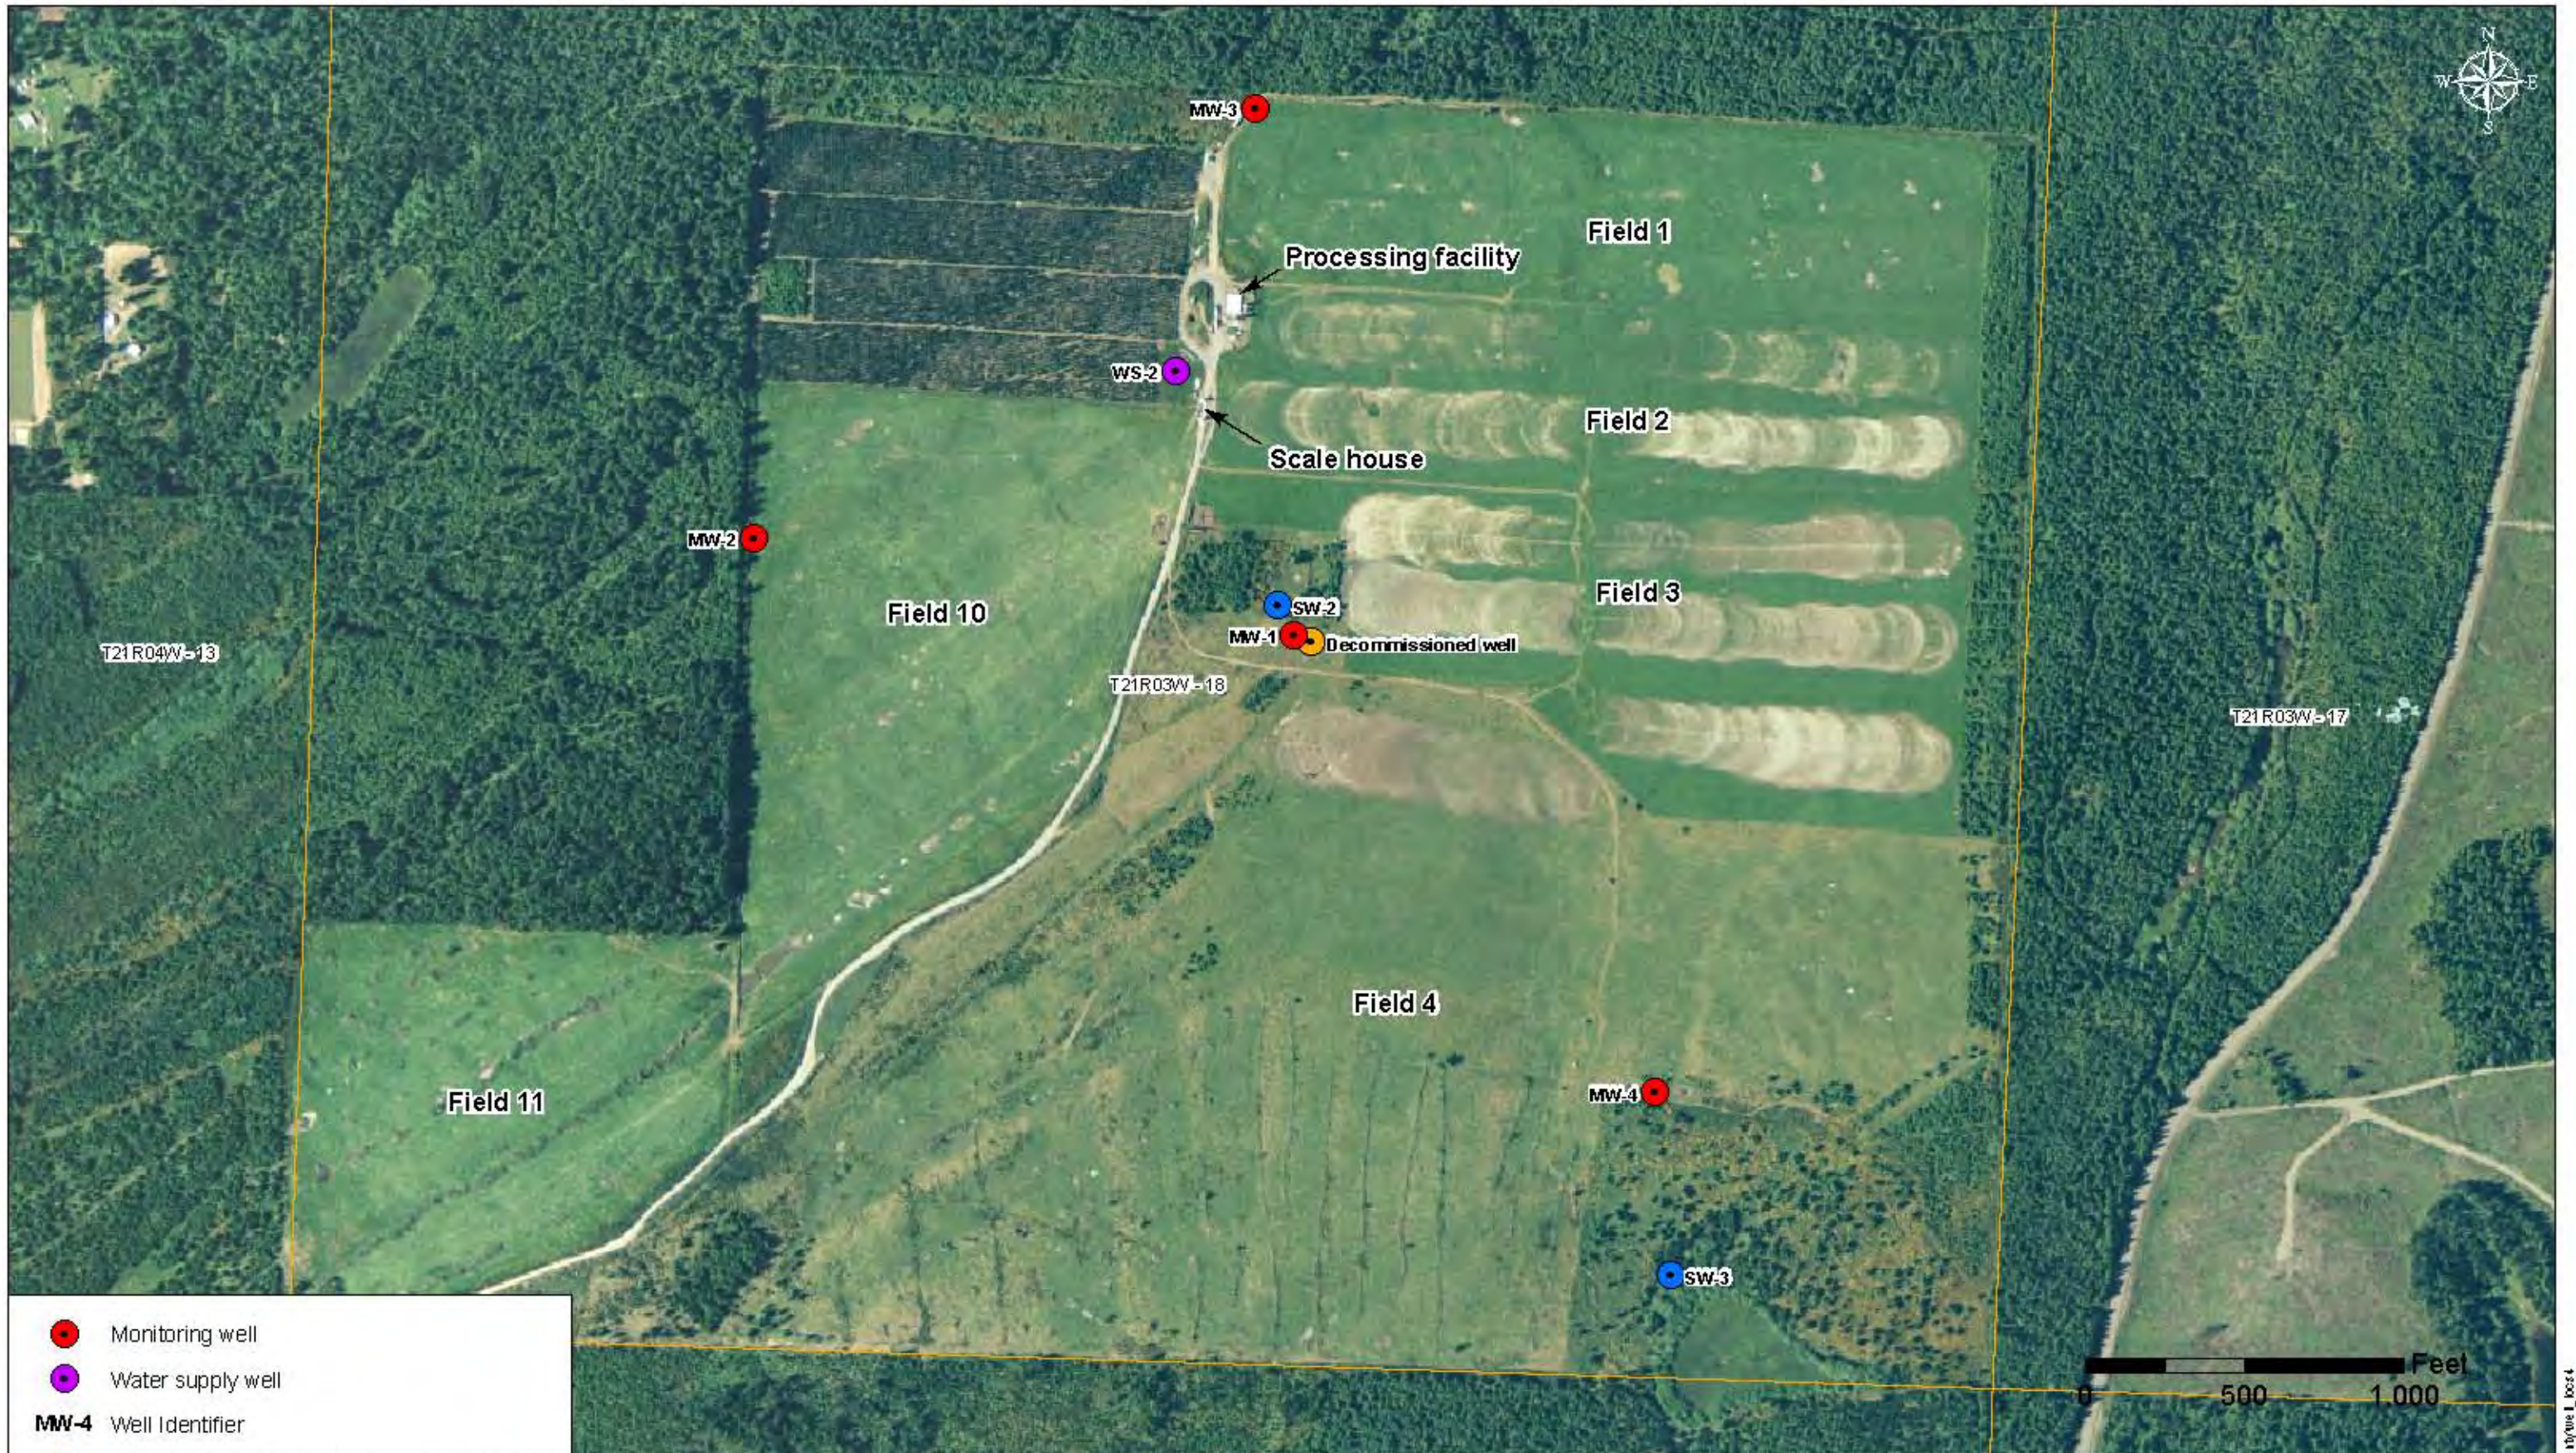
DATE:	June 2007	PROJECT NO.:	070041
DESIGNED BY:	EWM	FIGURE NO.:	1.2
DRAWN BY:	ACM		
CHECKED BY:	ACM

- Monitoring well
- Water supply well
- MW-4** Well Identifier
- Decommissioned well (location approximate)
- Surface water sample location
- Sections

An on-site well is used predominantly for wash-down purposes. This well was installed in April 2000 and replaced an earlier water supply well that was decommissioned in May 2000. The location of the existing well and the approximate location of the decommissioned well are presented on Figure 1.2 and well logs/decommissioning log for these wells are included in Appendix B. As described below, these wells have been routinely sampled as part of the facility monitoring program.

Monitoring well MW-1 lies down gradient of application fields 1, 2 and 3 (Figures 1.2 and 4.2) and shows degraded water quality in comparison to background well MW-3. This well exhibited the greatest nitrate concentration (13.3 mg/L) of the monitored wells. Relative to background conditions at MW-3, the pH (6.7) and dissolved oxygen (8.85 mg/L) were depressed and specific conductance (374 umhos/cm) elevated.

lies downgradient of the east portion of field 4 (Figures 1.2 and 4.2). Similar to well MW-1, dissolved oxygen and pH were depressed relative to background conditions and specific conductance was elevated. Changes in dissolved oxygen, pH, and specific conductance between MW-3 and MW-4 were similar to the changes between MW-3 and MW-1.

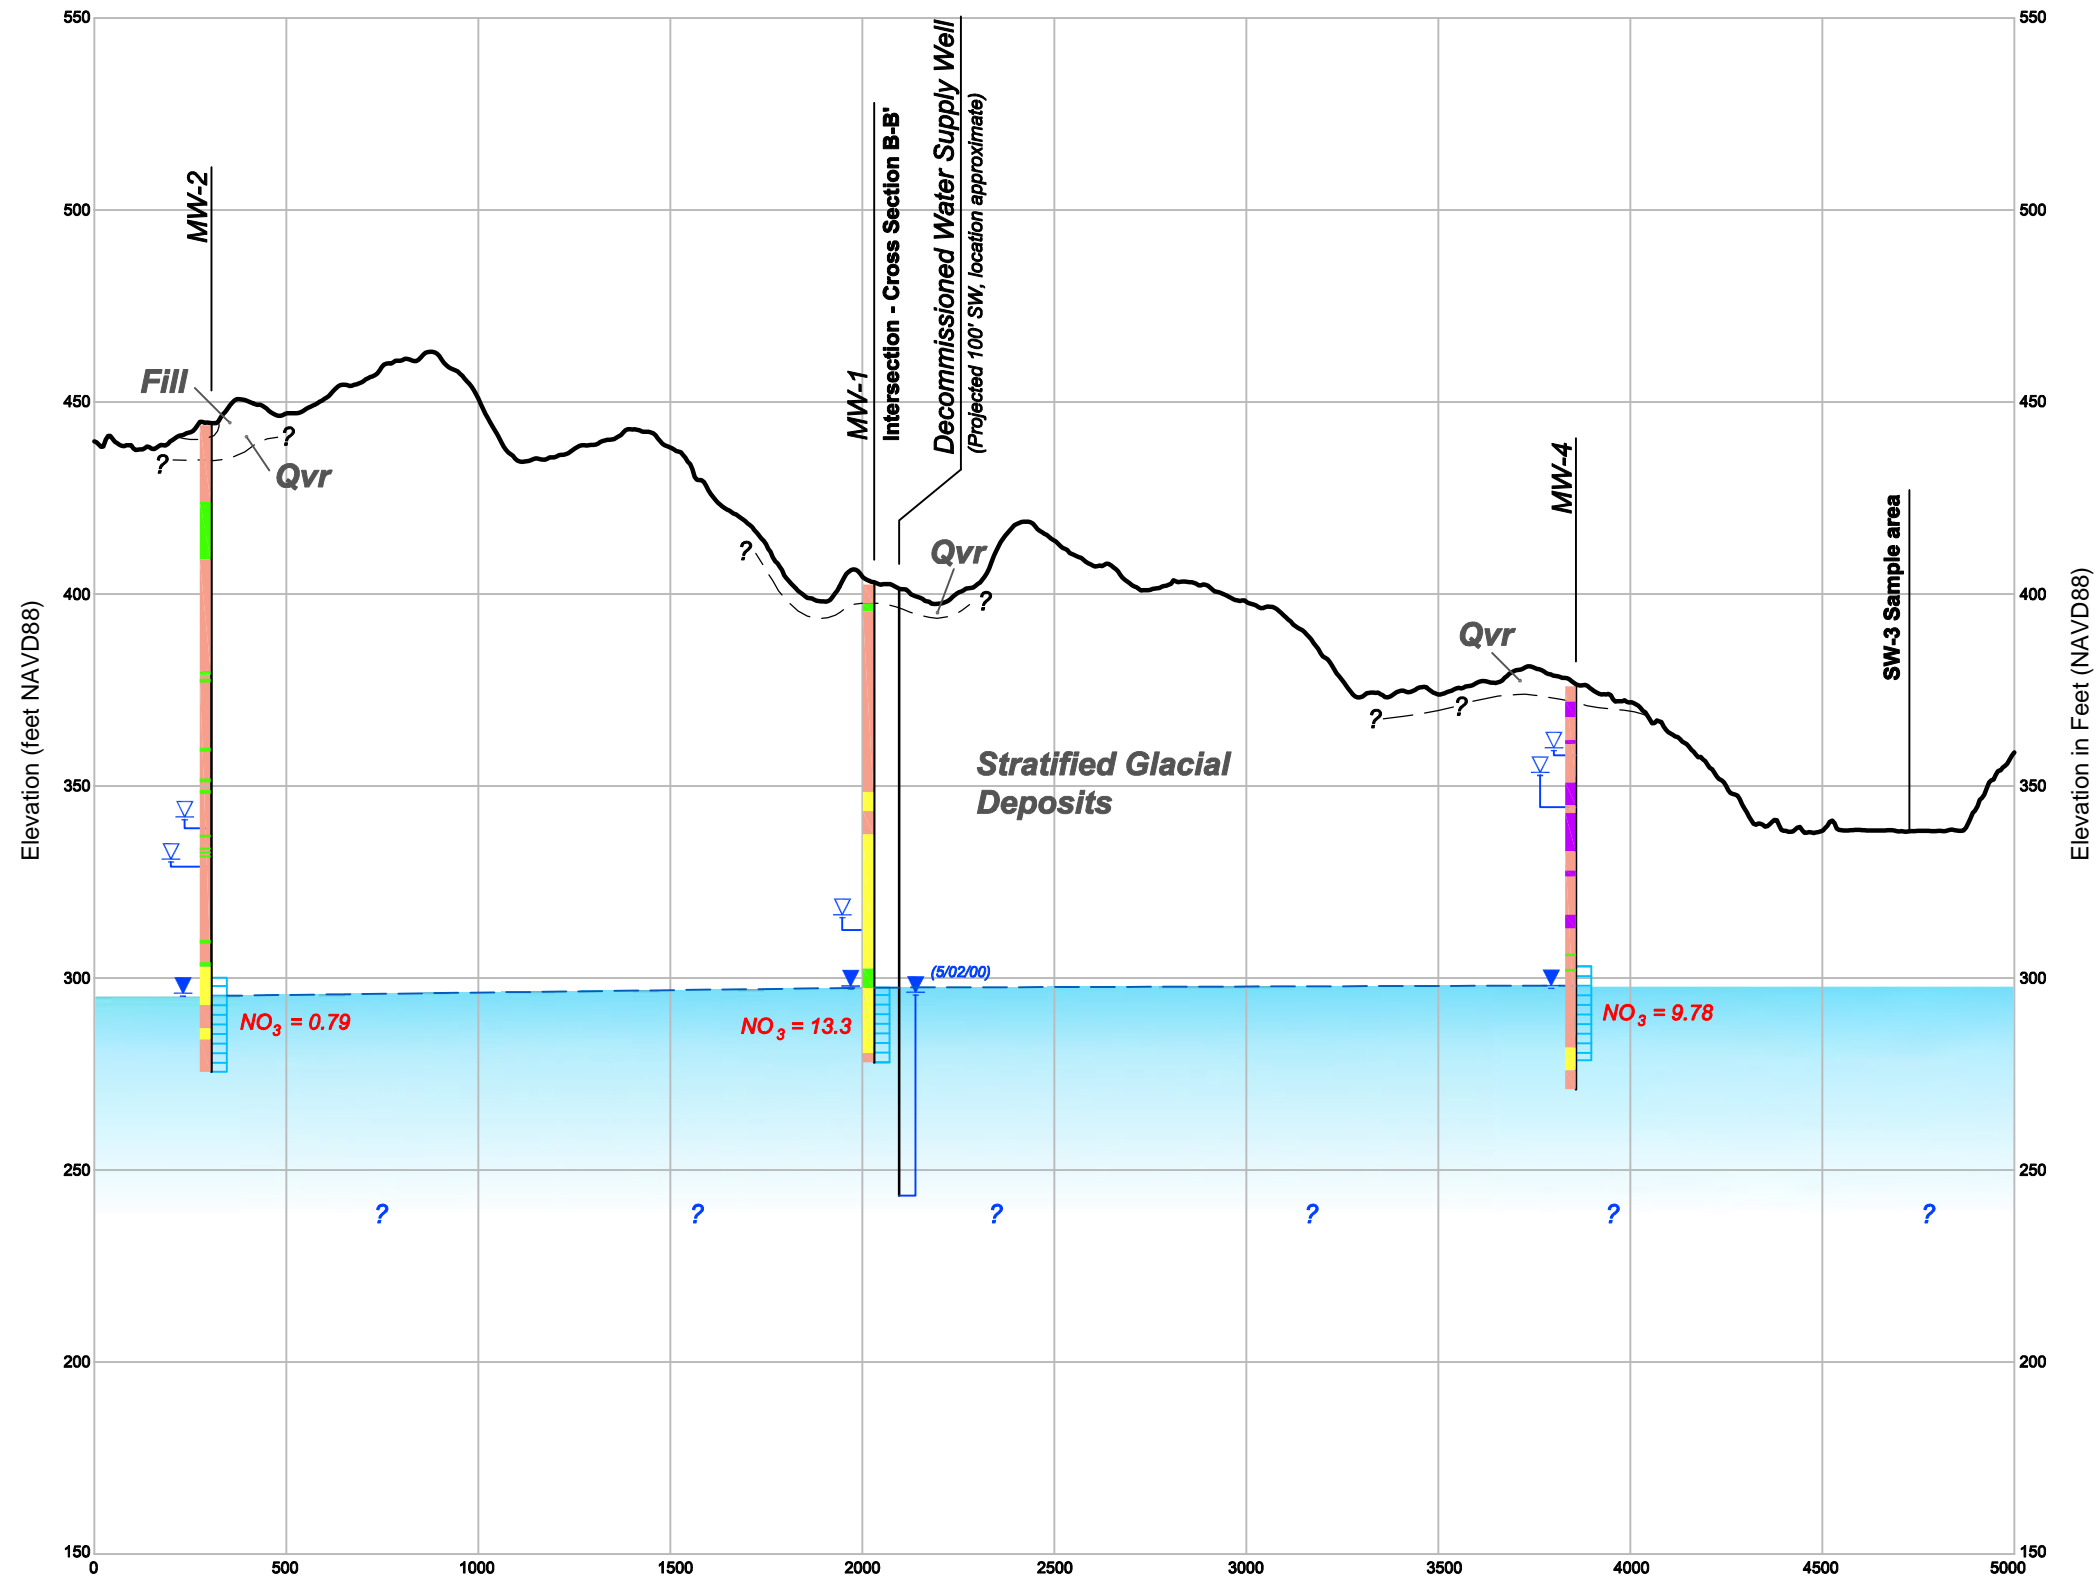
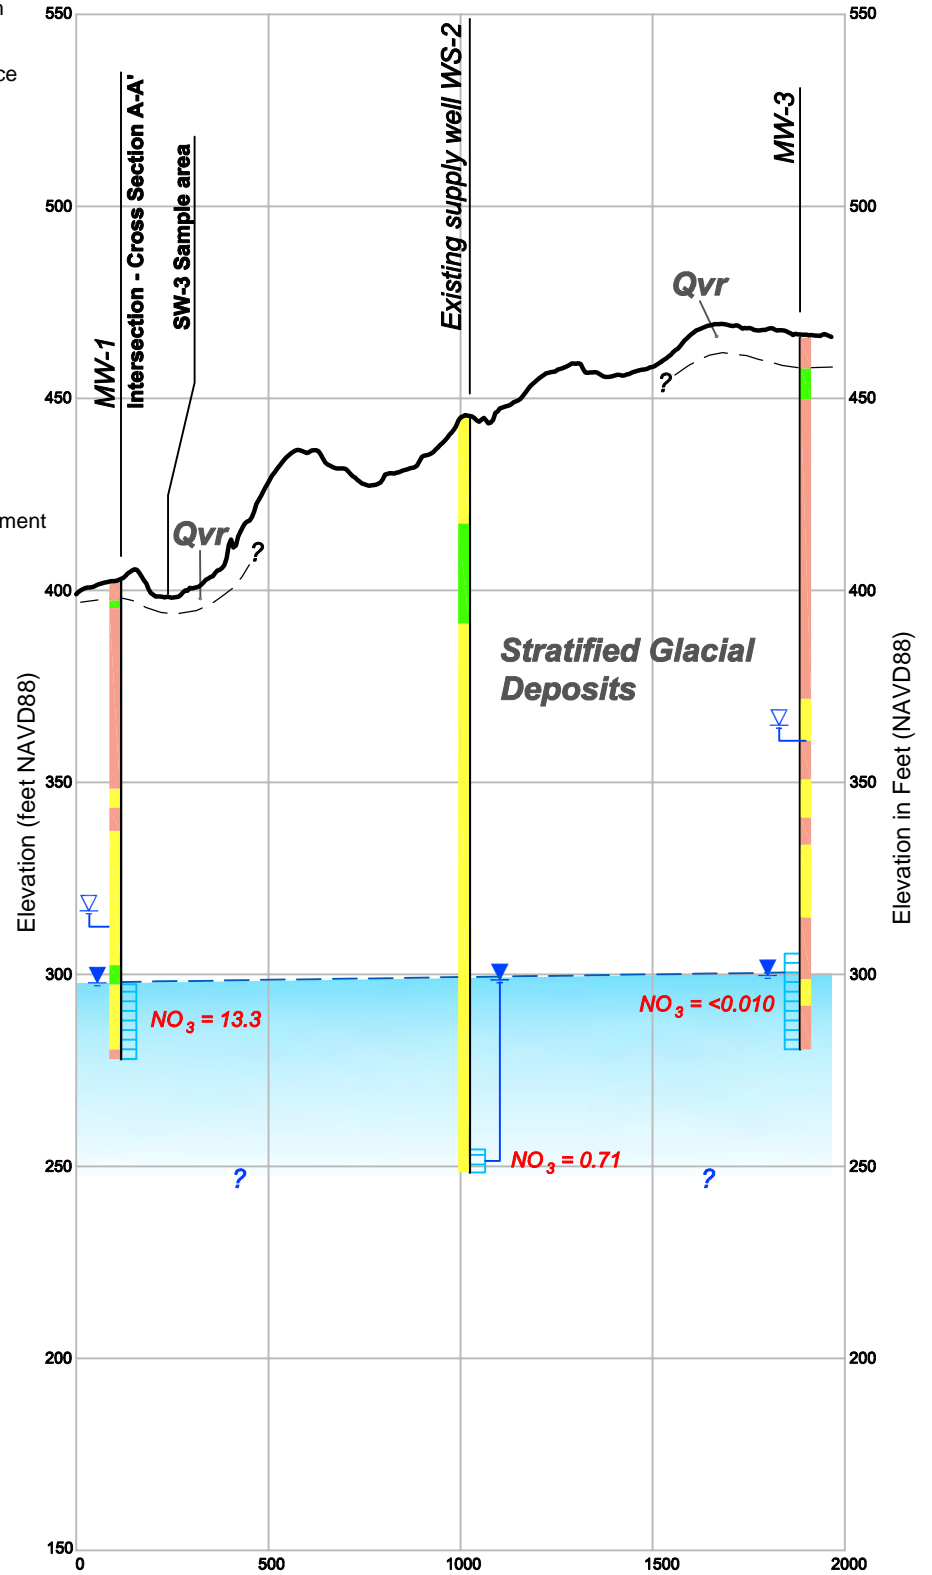
A Northwest **Southeast A'**

B South **North B'**

Vertical Exaggeration = 10X
 Scale: 1" = 500' Horiz.
 1" = 50' Vert.

Although the deposits were found to be heterogeneous, some generalities on the distribution of these deposits may be made. In general, the occurrence of cleaner sands and gravels increases with depth. A sequence of clean sand and/or gravel was present beneath elevation 300 feet in each of the boreholes. Thick clean sand and/or gravel sequences up to 30-foot-thick were identified in monitoring wells MW-1 and MW-3. Fewer and thinner clean sand interbeds were identified in monitoring wells MW-2 and MW-4 (Figure 3.2). The increase in well-sorted, fluvial deposits with depth suggests that the deeper portion of the deposits may be part of or grading into a proglacial advance outwash sequence. A thick sequence of coarse sand and gravel logged by the driller of the on-site water supply well WS-2 was identified down to elevation 250 feet (about 30 feet below the monitoring wells) and suggests that the clean sand and gravel identified in the monitoring wells are at the top of a thicker sequence of advance outwash deposits.
