New Tidegate for Batt Slough

Collaboration builds trust in the valley

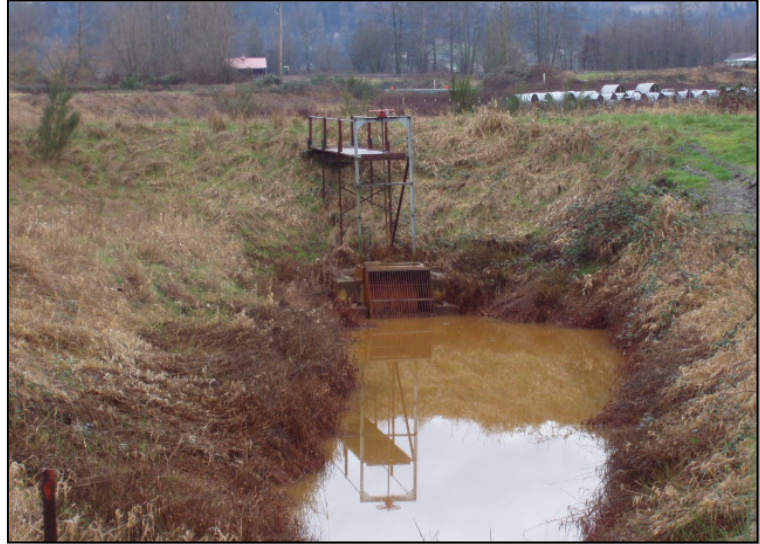
Batt Slough prior to new tidegate installation

With help from the Snohomish Conservation District and a grant from the U.S. Fish and Wildlife Service, a marginally functioning 50-year-old failing structure was replaced with a modern high-tech, low-maintenance flood gate. This provides for more efficient flood water return, allows access for juvenile salmon and other fish, and improves water quality.

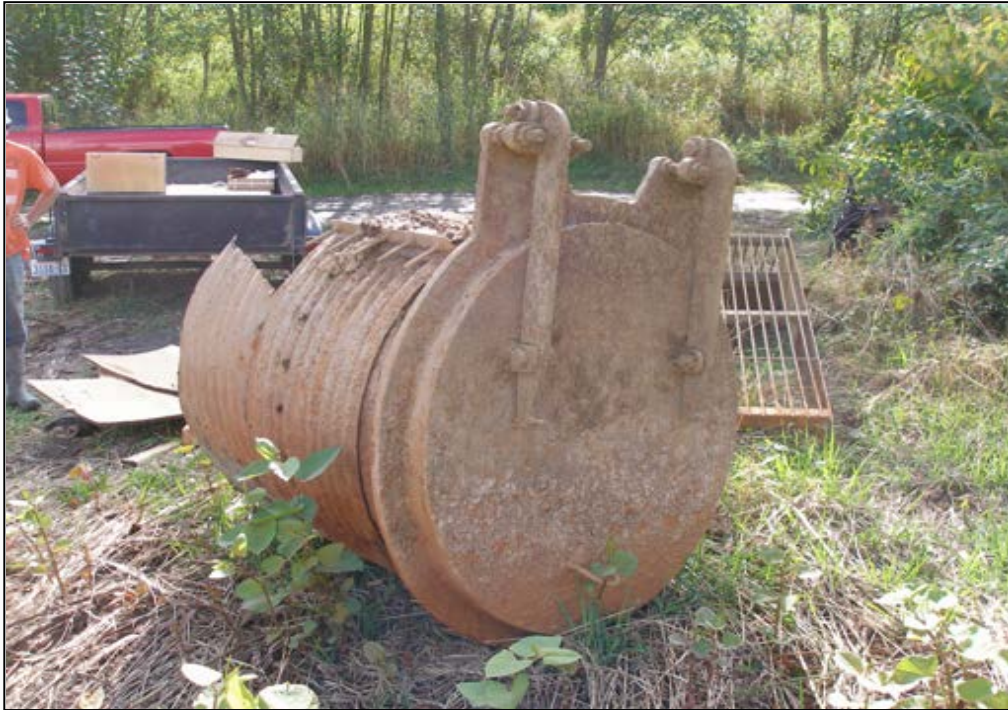
It was an old flapper-type gate, a four-foot diameter rusty steel gate which was so difficult to open it was causing water to back up and affect the land inside the levee. The water in the slough became stagnant, discoloring with high temperatures and low oxygen in the summer.

Old 48-inch flapper valve tide gate

New self-regulating tide gates utilize the pressure difference inherent in the rise and fall of tidally influenced water to open and close the gate. They have a record of being low maintenance and to operate in severe conditions when access to manually-operated gates is limited or unsafe due to floodwater.

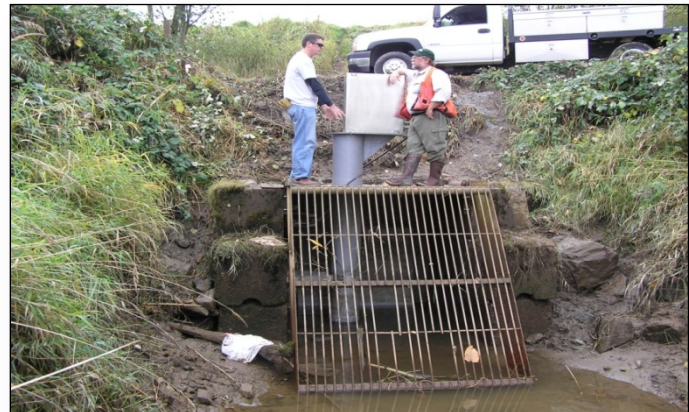
Bob Penhale inspects the final tidegate

MCFD hired Glacier Peak Construction through a competitive bid process. They removed the old tide gate and replaced it with the new high-tech version. The timing of the tides required some early morning odd hours and working under artificial light, as well as the typical fine tuning required in any project. A final inspection by the tide gate's manufacturer gave the installation a thumbs-up. We were ready for winter. Observations thus far show water quality has visibly improved, the fish are utilizing the Slough and flood control mandate has been met.
