## **Second Periodic Review Palouse Producers Site**

**335 E. Main St., Palouse, Whitman County  
Facility Site ID: 787, Cleanup Site ID: 4973**

**Toxics Cleanup Program, Eastern Region**

July 2026, Publication 26-09-028

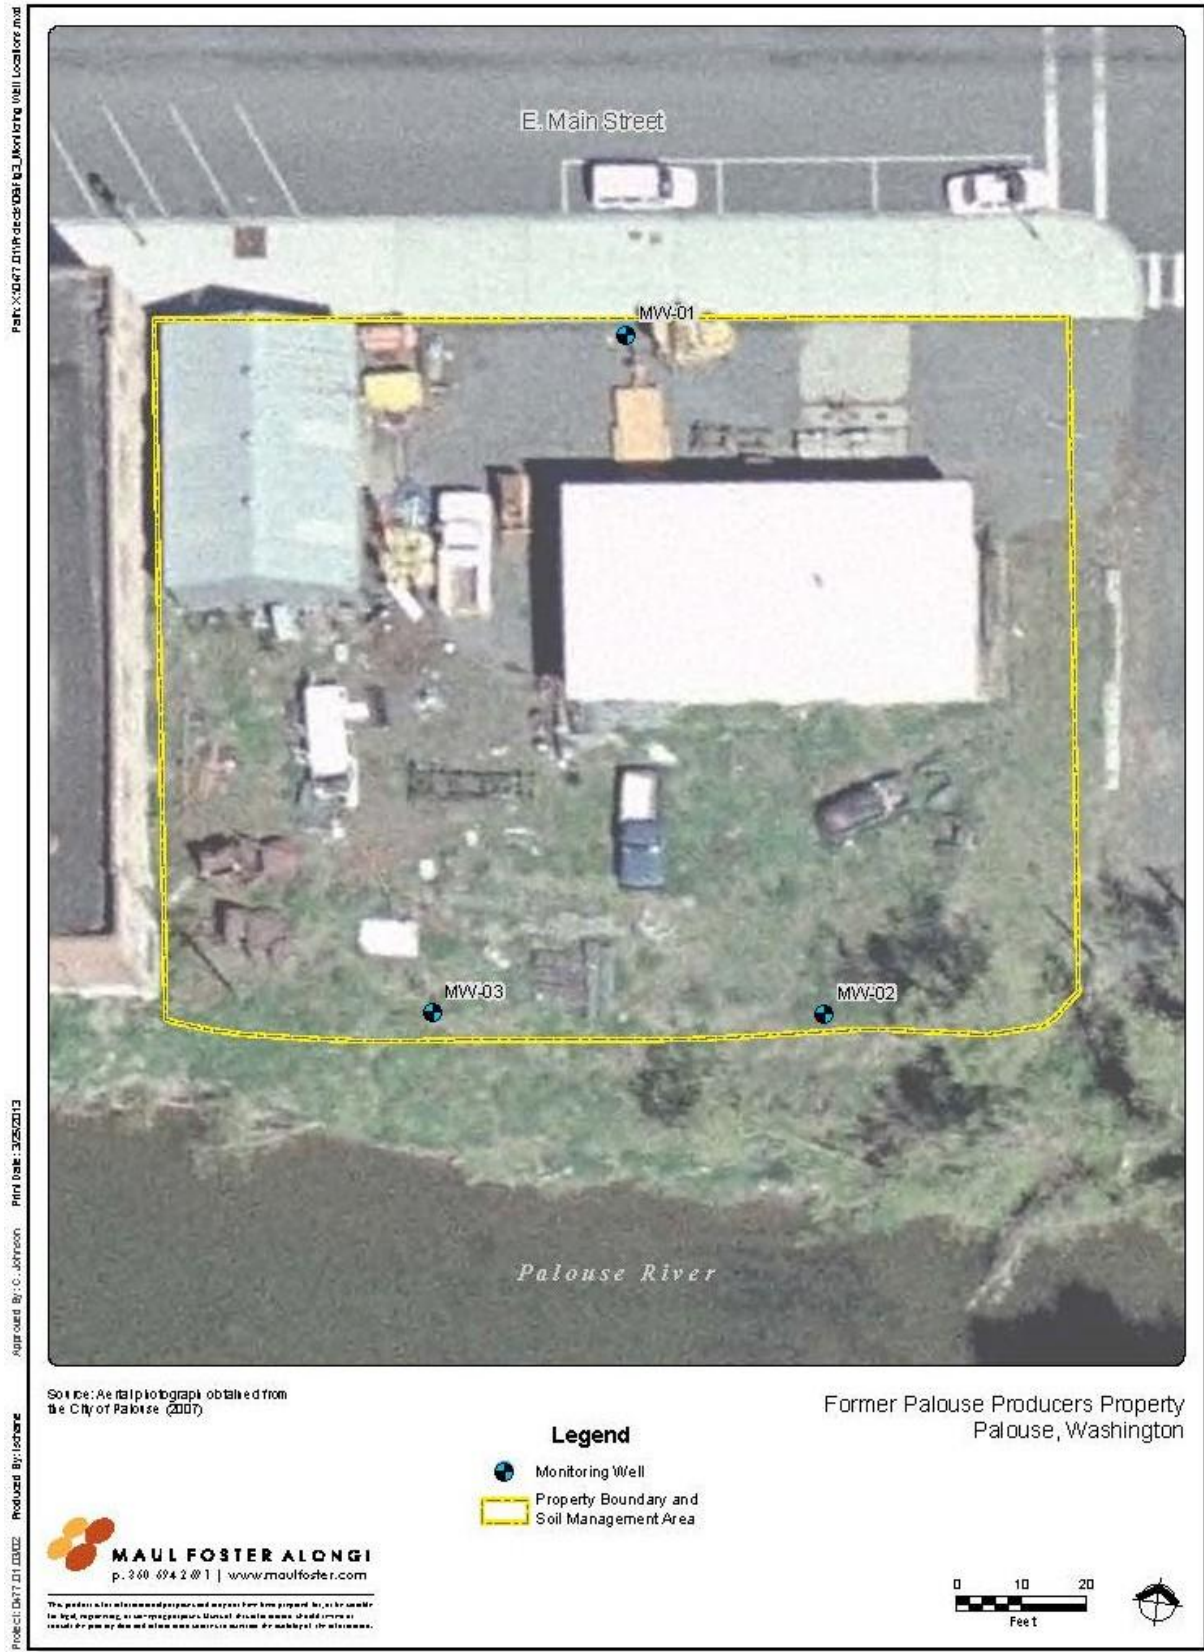
Figure 3. Well locations

Ecology required all three monitoring wells at the Site to be sampled twice a year (Figure 3). Samples are analyzed for petroleum hydrocarbons, benzene, arsenic, lead, and manganese. In 2017, monitoring was reduced to once a year; in 2020, monitoring was changed to once every five years to coincide with periodic reviews.

Three wells are present at the Site. MW1 is the upgradient well and shows the levels of contaminants in groundwater entering the Site and is unaffected by Site contamination. MW2 and MW3 are downgradient wells, with MW2 slightly near the edge of the main contamination plume and MW3 directly in the plume. Because saturated soils were left behind, Ecology expects groundwater contamination will continue until natural attenuation has time to lower concentrations.

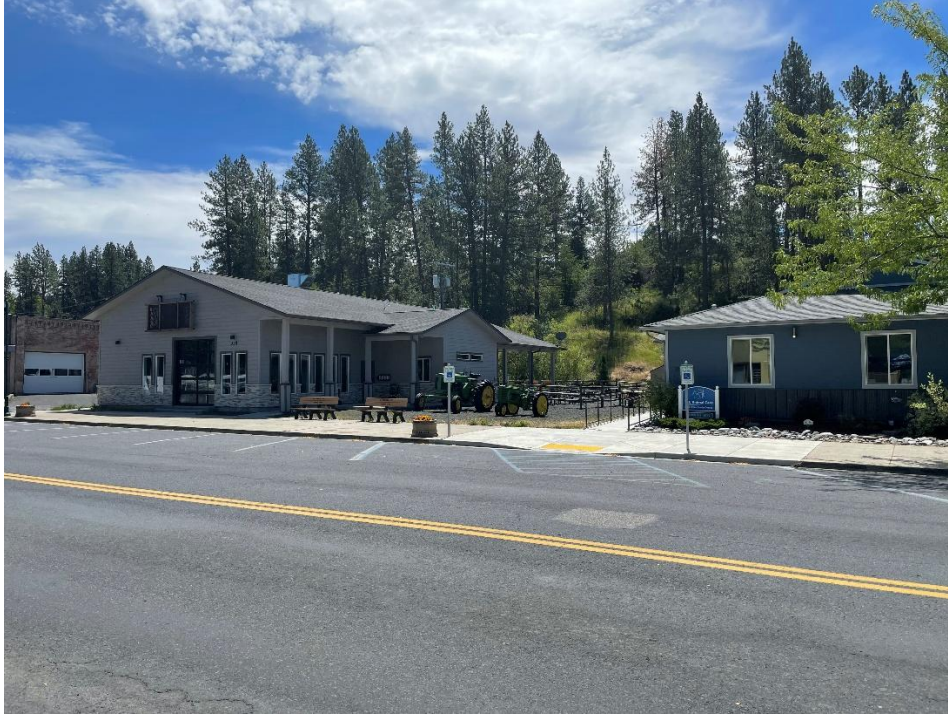
**Photo 1: View of the Site looking south**

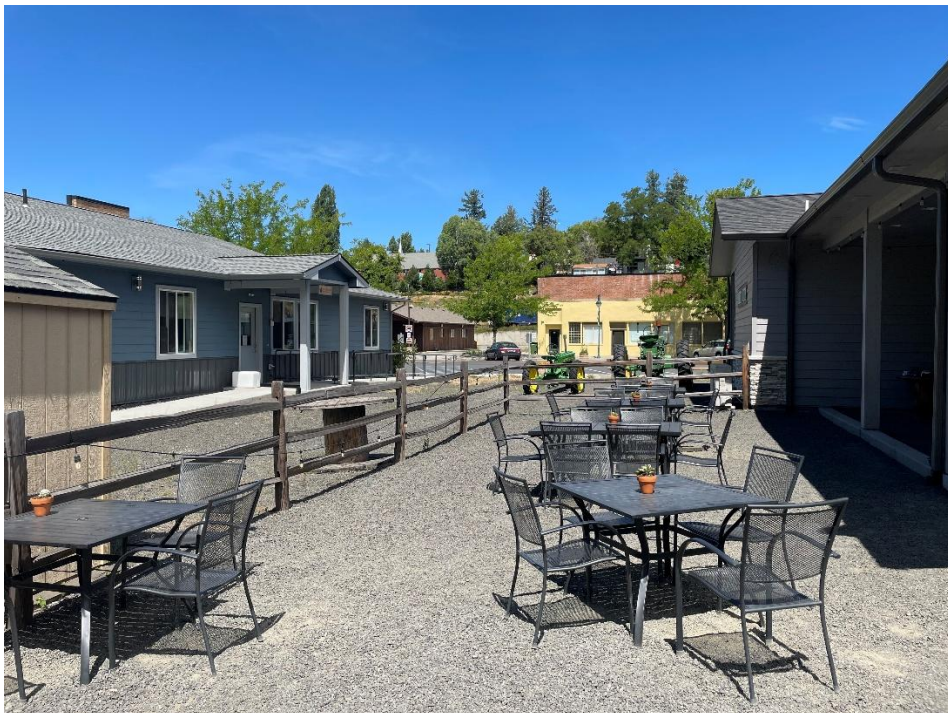
During the Site visit Ecology conducted on April 20, 2026, the remedy appeared to be functioning as intended. Wells remain accessible and in good condition. The site has been developed with two businesses, after Ecology was consulted and involved per the environmental covenant. Building construction was slab on grade, and ground disturbance was shallower than 7 feet. Access to wells has been properly maintained. Areas not covered by buildings are covered with gravel and maintained for thickness and weed prevention. Shoreline areas are maintained with vegetation.

**Photo 2: View of capped area looking north**

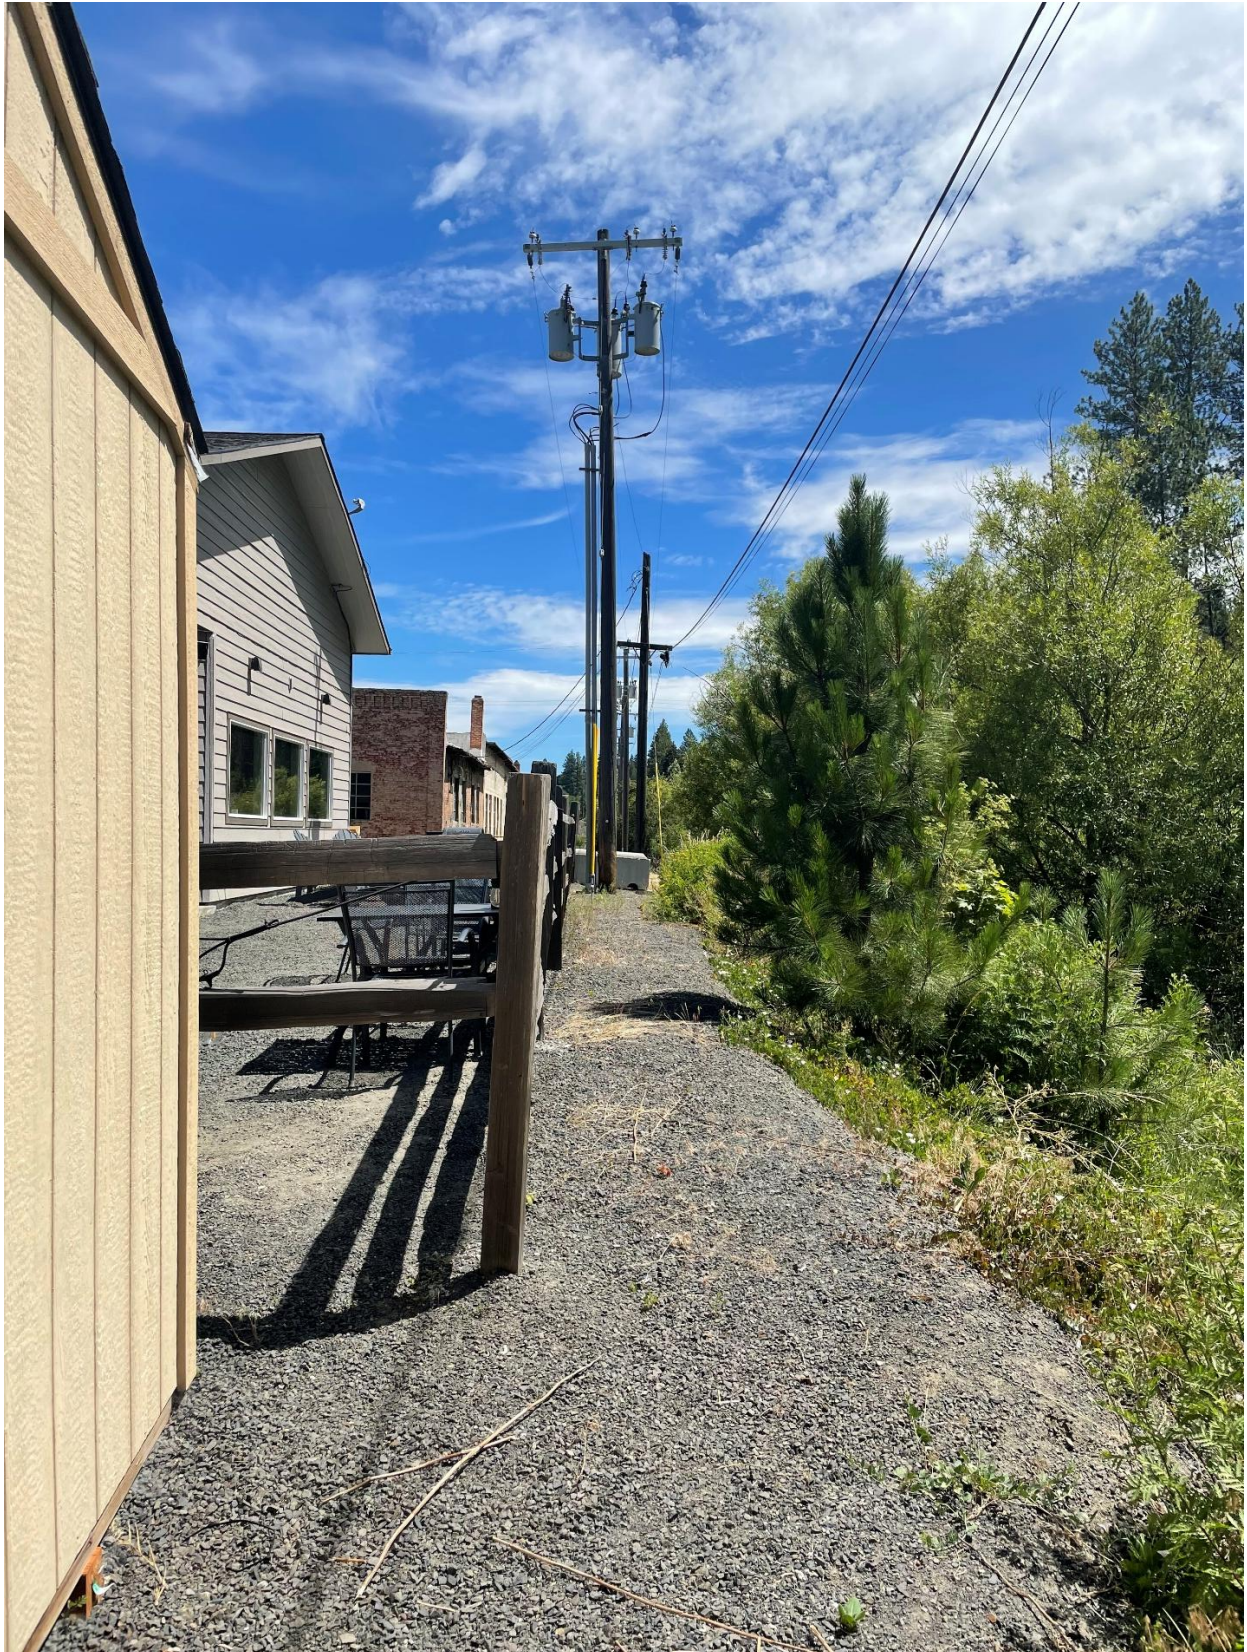
**Photo 3: View of shoreline looking east**

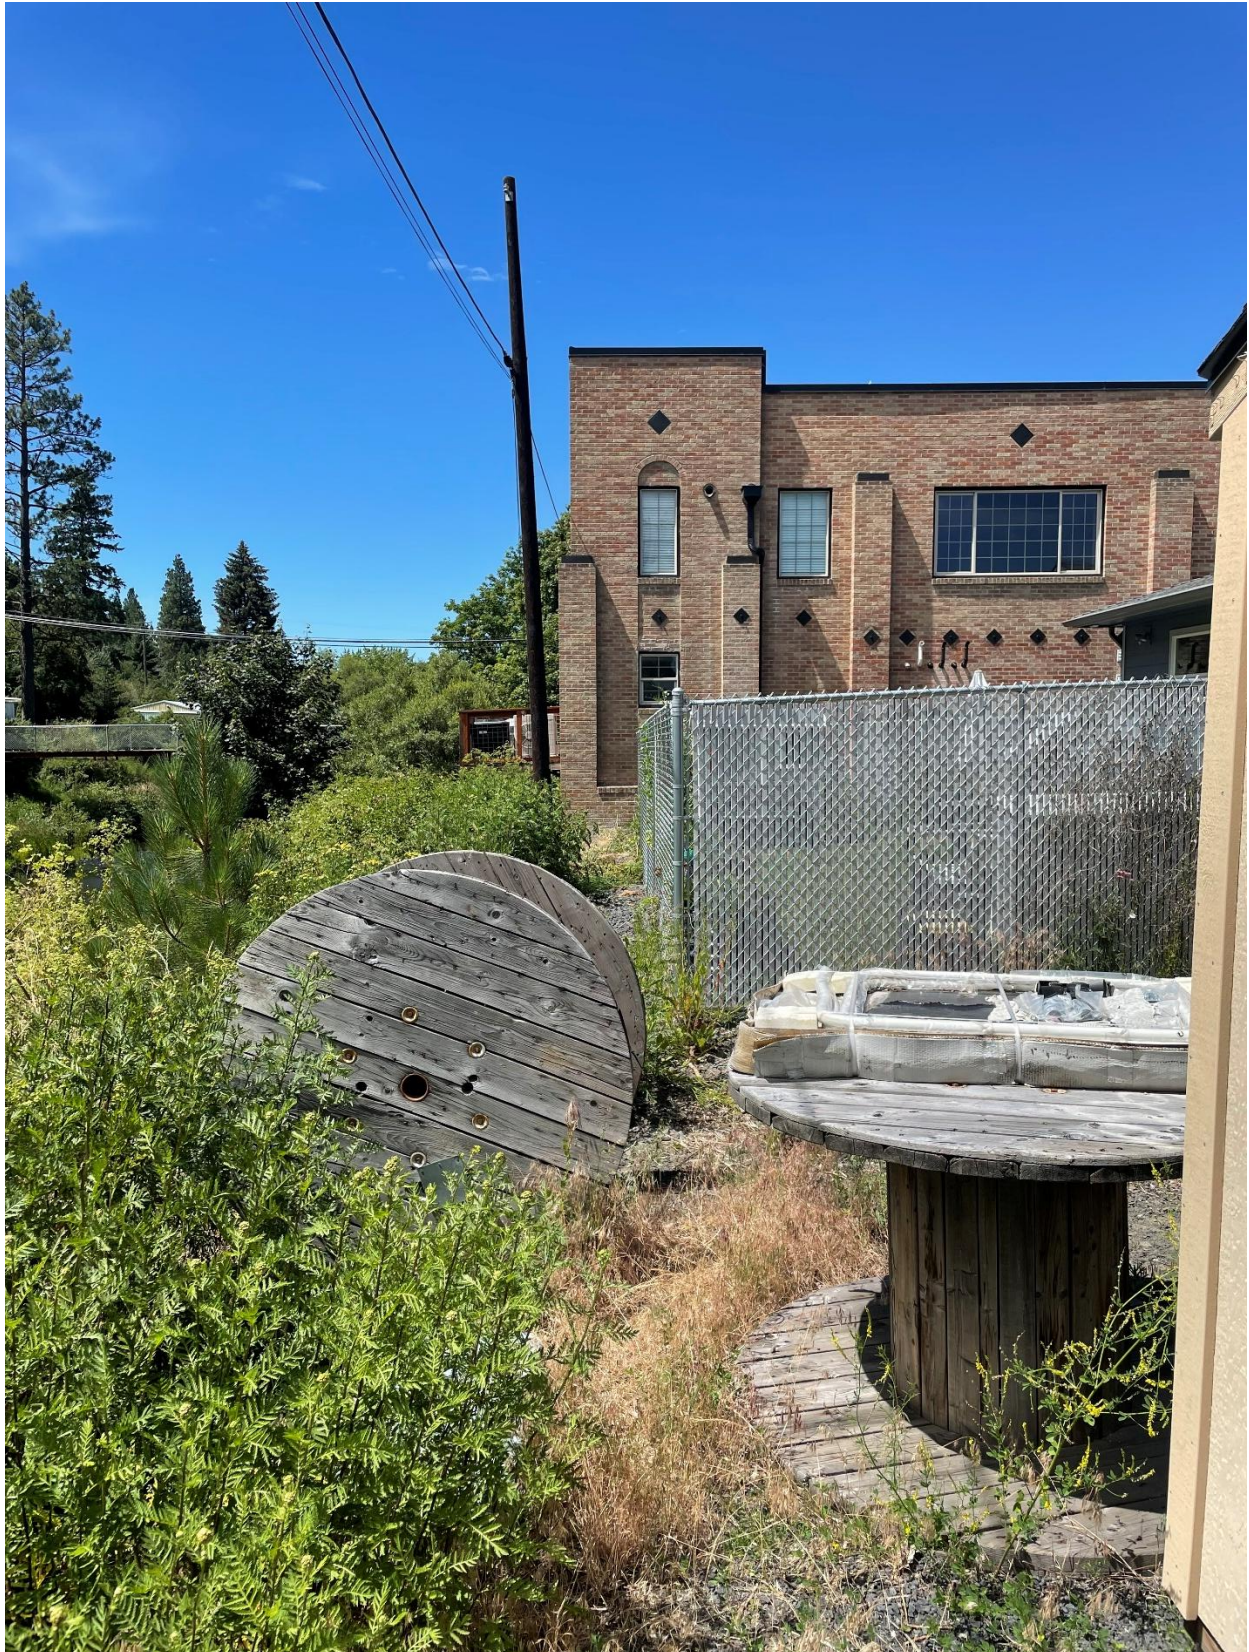
Photo 4: View of shoreline looking west

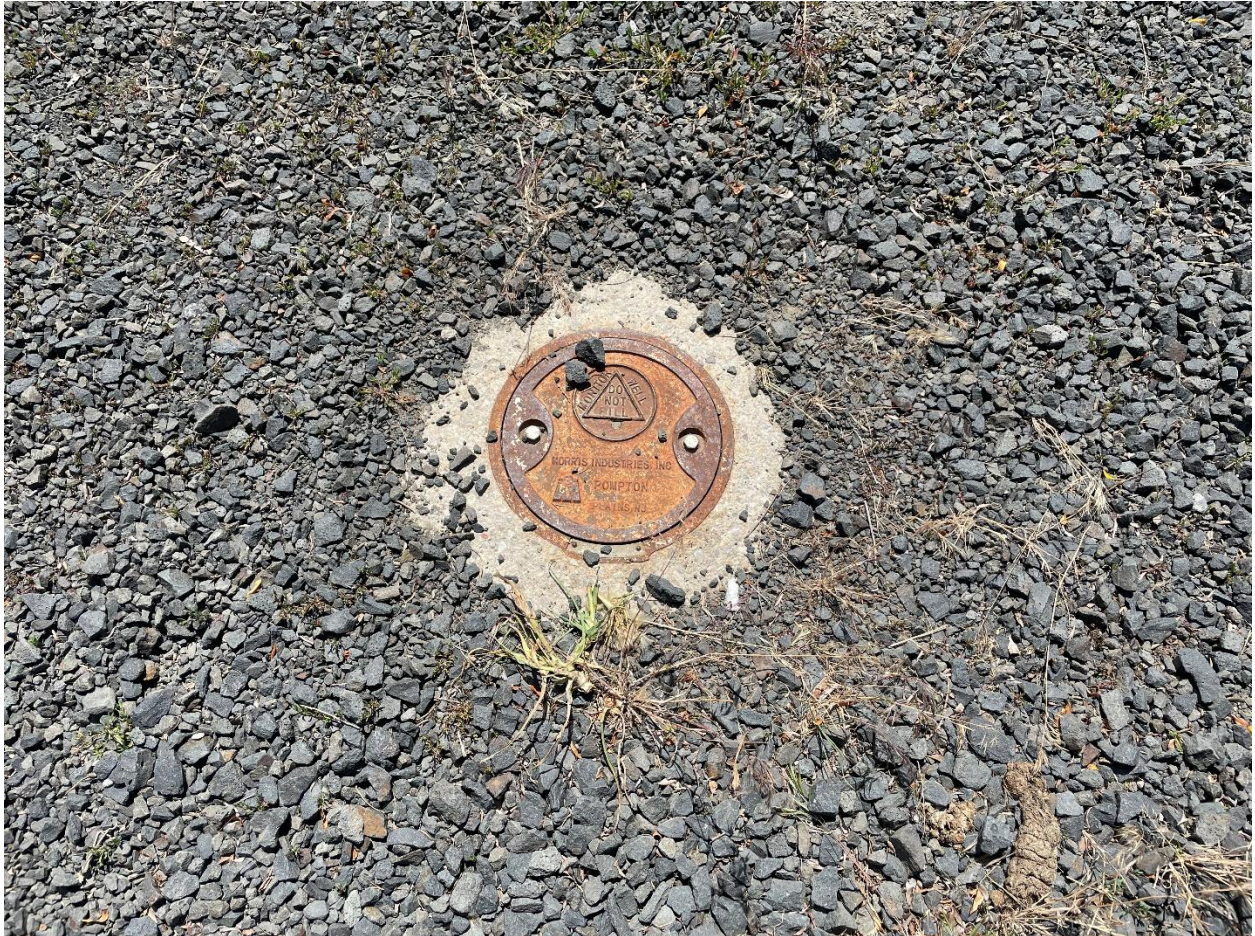
**Photo 5: View of MW1 wellhead**
