Ground Water Quality Survey
near Edaleen Dairy,
Whatcom County, Washington

January 1990 to April 1993

April 1994
Publication No. 94-37

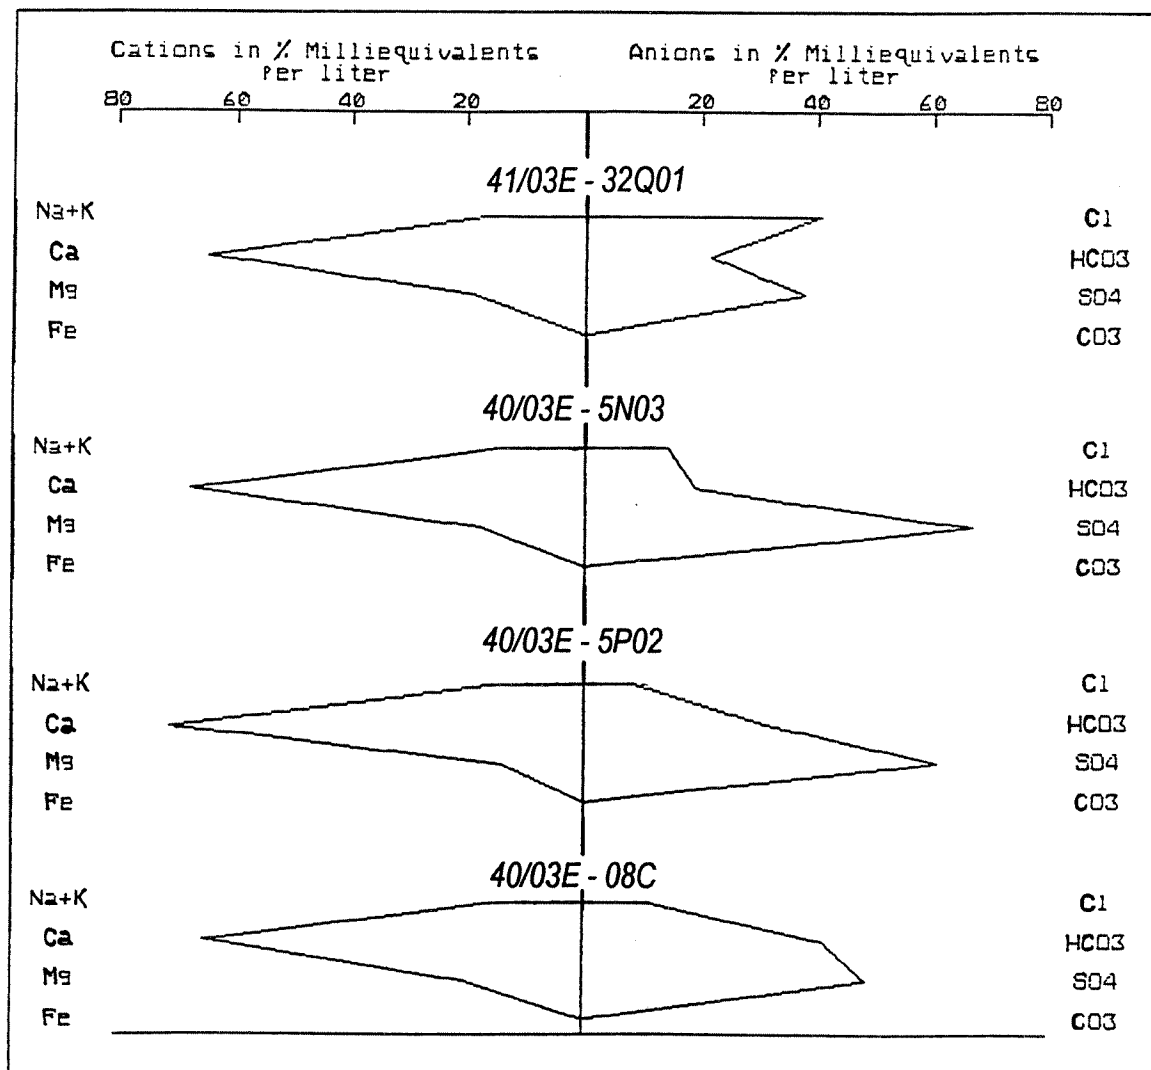
The composition of ground water quality samples from four domestic wells in the Edaleen study area are graphically depicted by Stiff diagrams in Figure 9. Bicarbonate concentrations were converted from total alkalinity results. Hydroxide and carbonate alkalinity are not expected to be significant because pH in the shallow aquifer is typically below pH 7 (Erickson, 1991).

Figure 9. Comparison of water quality in four domestic wells.

There was little variation in cationic concentrations while anionic concentrations varied substantially between wells. Chloride concentrations were higher in wells with elevated nitrate concentrations. The unusually high chloride concentration in the sample from well 32Q01 is classified as "mixed" CaCl-CaSO₄ type water. Well 32Q01 also had elevated nitrate concentrations. Sample results for the study area indicate that calcium sulfate (CaSO₄) type water is prevalent in the shallow aquifer, with minor differences between individual wells.

The composition of representative water samples was illustrated using Stiff diagrams. Stiff diagrams depict water quality and water type based on the concentrations of major cations and anions. The milligram per liter (mg/L) concentrations were converted to

percent milliequivalents per liter (% meq/L) and plotted along scaled horizontal axes separated by a vertical zero axis. Cations and anions are shown on opposite sides of the diagram and the points are joined producing an irregular polygonal pattern that is characteristic of the particular water type. Stiff patterns can be a distinctive method of showing water-composition differences and similarities (Hem, 1989). Stiff diagrams were computer plotted using the HC-GRAM program, developed by the Office of Surface Mining (McIntosh and Miller, 1991).
