## Outfall Verification Report

**Location:** East, West, and Upper Duwamish Waterway  
**Report Date:** 9/12/2007  
**Inspection Date:** 6/13/2007 & 6/14/2007  
**Present:** Matt Eyer, Phoinix Corporation  
Edwin Wong, Phoinix Corporation  
Tim Fitzgerald, Port of Seattle Contractor

**Purpose:** To locate and verify outfall locations from the Port of Seattle properties into the Duwamish, focusing on the East, West, and Upper Duwamish waterway. Also to confirm and obtain outfall pipe sizes, material, photos, and location.

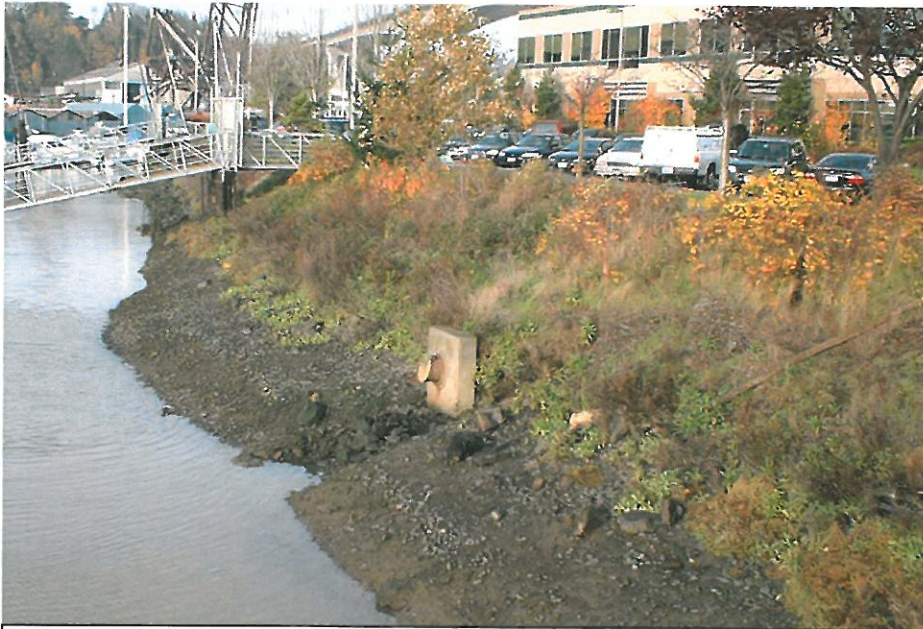
November 10, 2006 - Photo 100-0004  
Looking northwest at outfall # T102\_Outfall\_03.
