2019 Land Use Control Inspection Technical Memorandum

Fleet Logistics Center Puget Sound Manchester Fuel Depot

Manchester, Washington

Department of the Navy

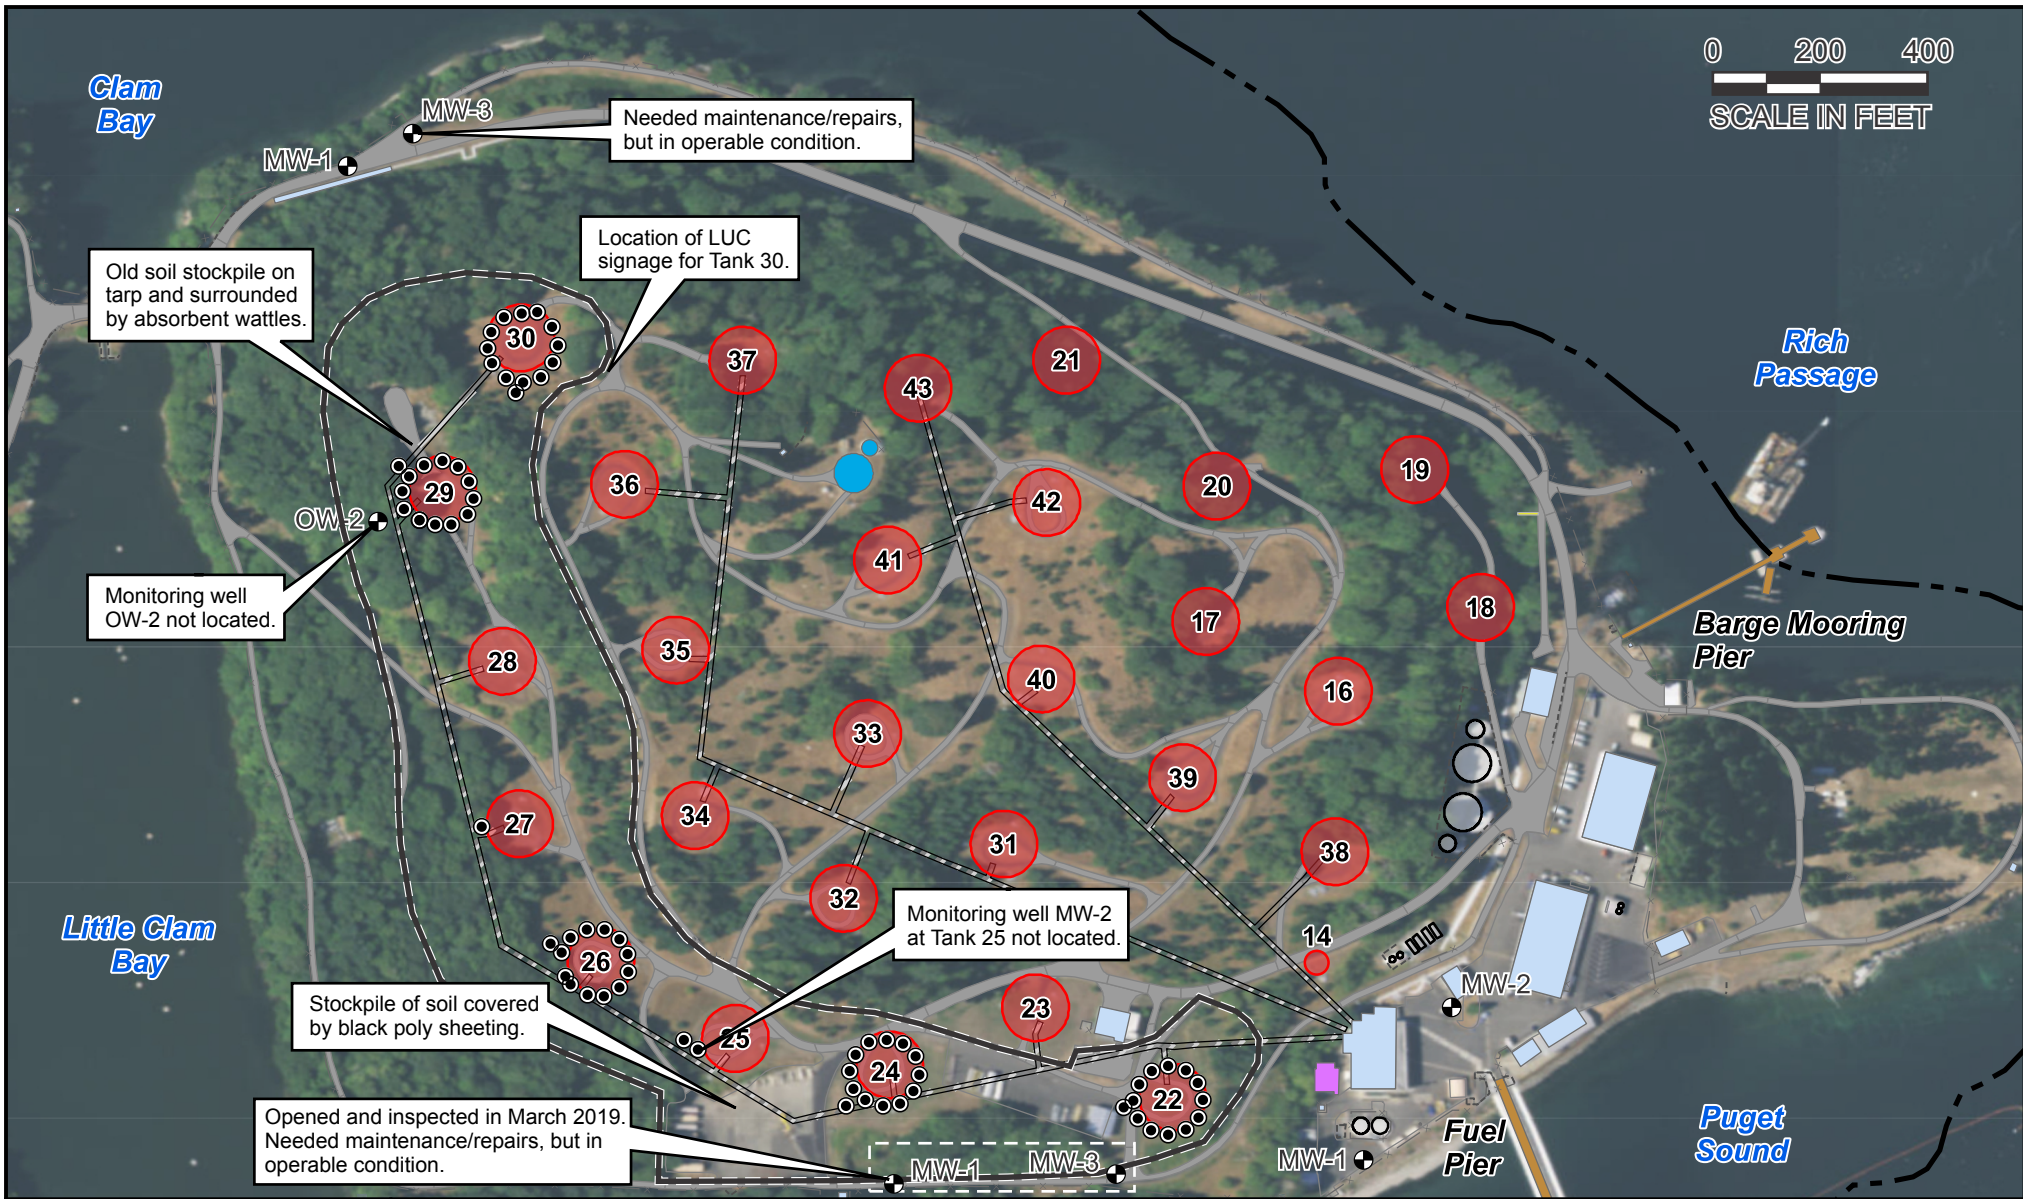
DESIGNED BY			
JH			
DRAWN BY	Figure 4. Site 303 – D-Tunnel Tanks LUC Inspection Findings		
JEH/VS			
CHECKED BY	MFD, MANCHESTER, WA		
AP	100126487-X064NW41	SITE303_LUC03.CDR	DATE 04/19

1. An unmarked stockpile of soil covered by black poly sheeting in the northwest corner of the construction laydown area southwest of Tank 24. However, this soil stockpile appears to be part of the general stockpiled materials for activities at MFD.
2. An old stockpile of soil on a tarp and surrounded by absorbent wattles in the laydown area north of Tank 29.

It was also noted that the LUC signage for Tank 30 is located at the fork in the access road, not at the tank as with other LUC signage and their respective tank. The locations of these and other findings/observations are depicted in Figure 4. The LUC inspection checklist for Site 303 was completed based on these findings/observations and is provided in Appendix A. The field notes and photographs from Site 303 are provided in Appendices C and D, respectively.

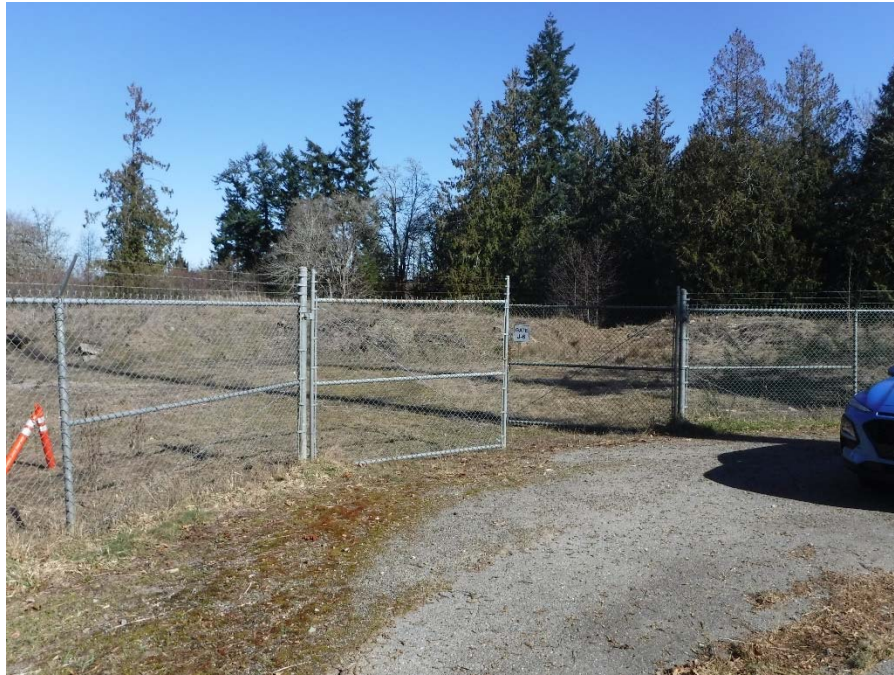
File Name: DSCF3954
Date Taken: 03/04/2019

Photo 1 - Description: Site 302, PCB Site, Main entrance/gate (Gate J-6) along southern boundary of site

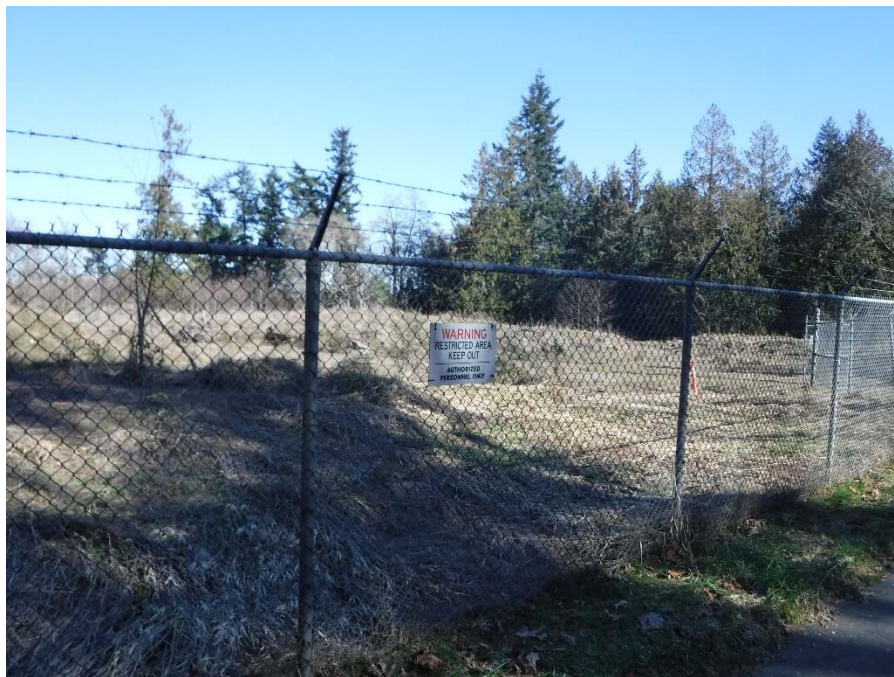
File Name: DSCF3955
Date Taken: 03/04/2019

Photo 2 - Description: Site 302, PCB Site, One of six Restricted Area/Keep Out signs along the southern boundary of the site

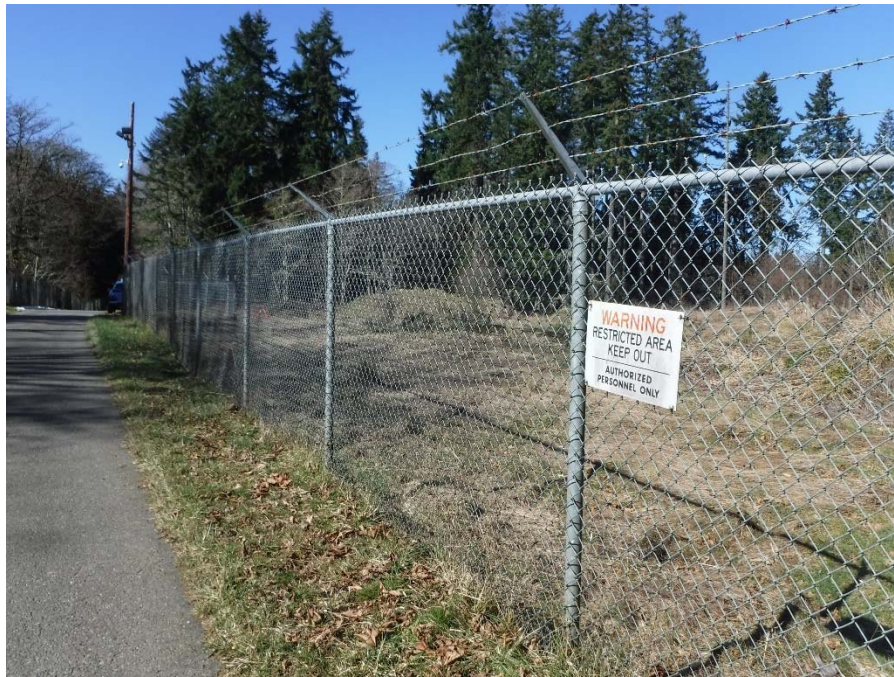
File Name: DSCF3952
Date Taken: 03/04/2019

Photo 3 - Description: Site 302, PCB Site, Fencing intact along southern boundary of site

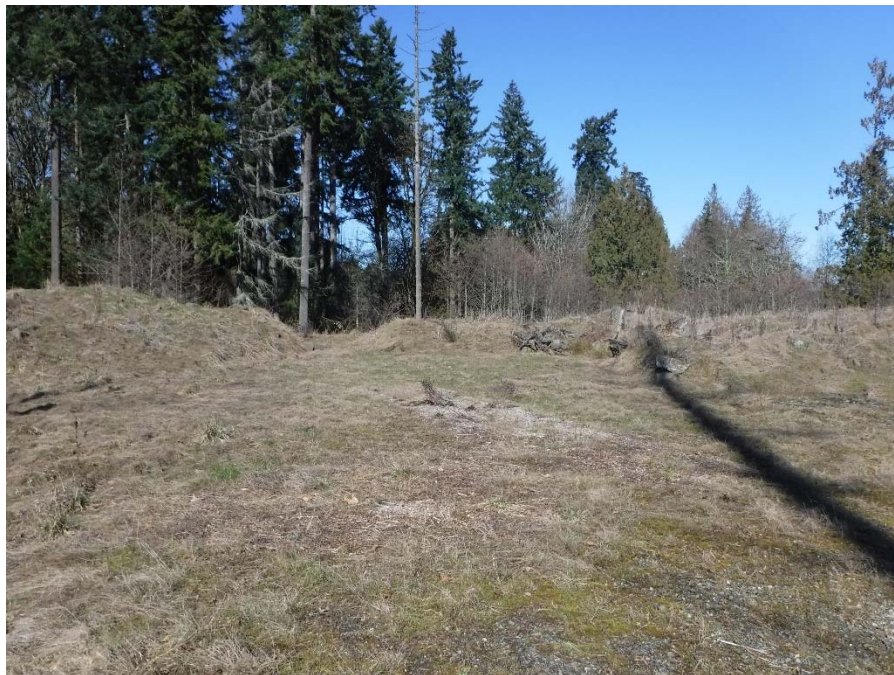
File Name: DSCF3960
Date Taken: 03/04/2019

Photo 4 - Description: Site 302, PCB Site, Open, central portion of site with stockpiles of old soil and boulders (1 of 3)

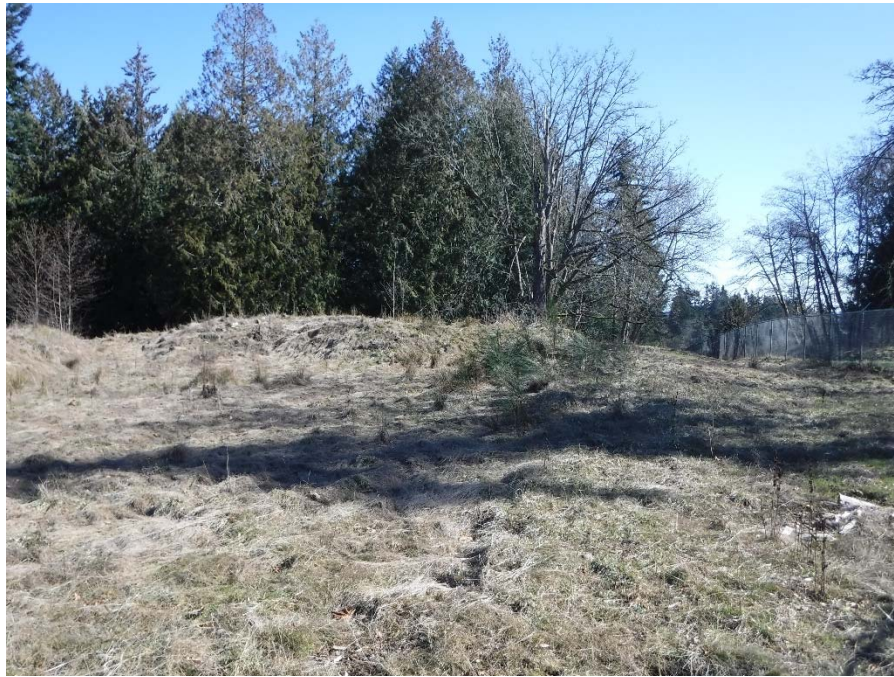
File Name: DSCF3961
Date Taken: 03/04/2019

Photo 5 - Description: Site 302, PCB Site, Open, central portion of site with stockpiles of old soil and boulders (2 of 3)

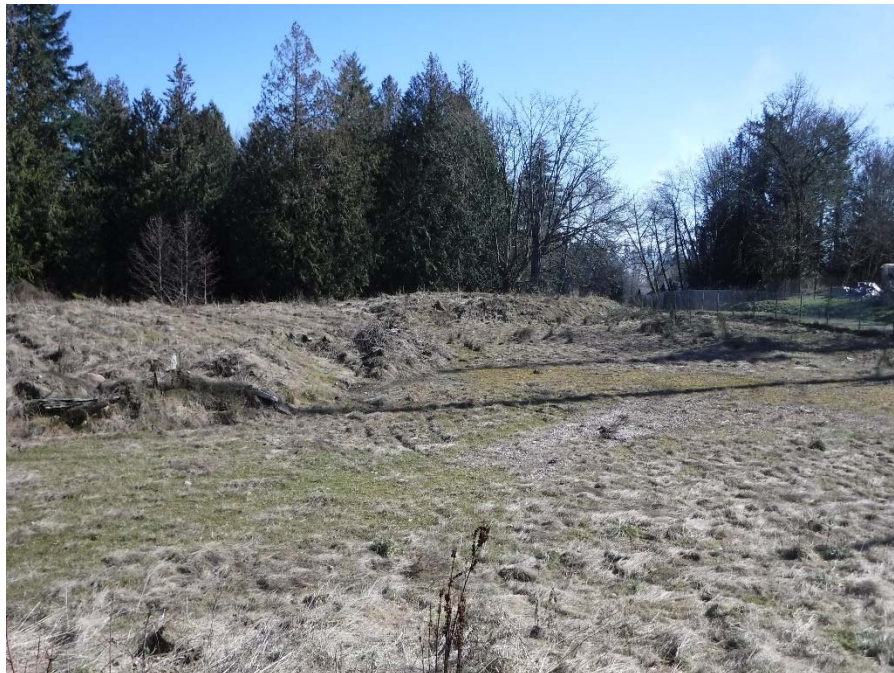
File Name: DSCF3966
Date Taken: 03/04/2019

Photo 6 - Description: Site 302, PCB Site, Open, central portion of site with stockpiles of old soil and boulders (3 of 3)

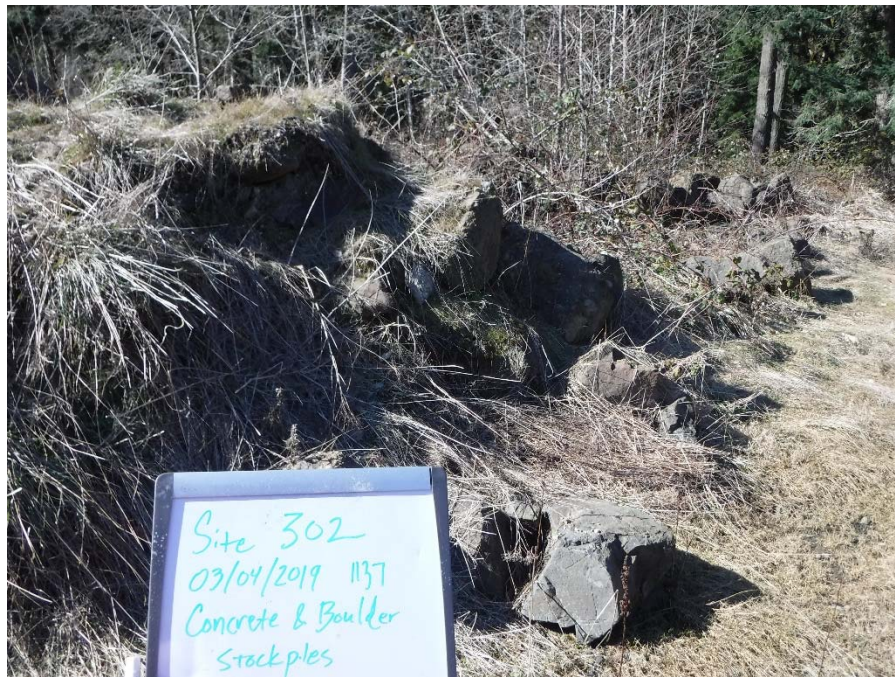
File Name: DSCF3967
Date Taken: 03/04/2019

Photo 7 - Description: Site 302, PCB Site, Concrete and boulder stockpile

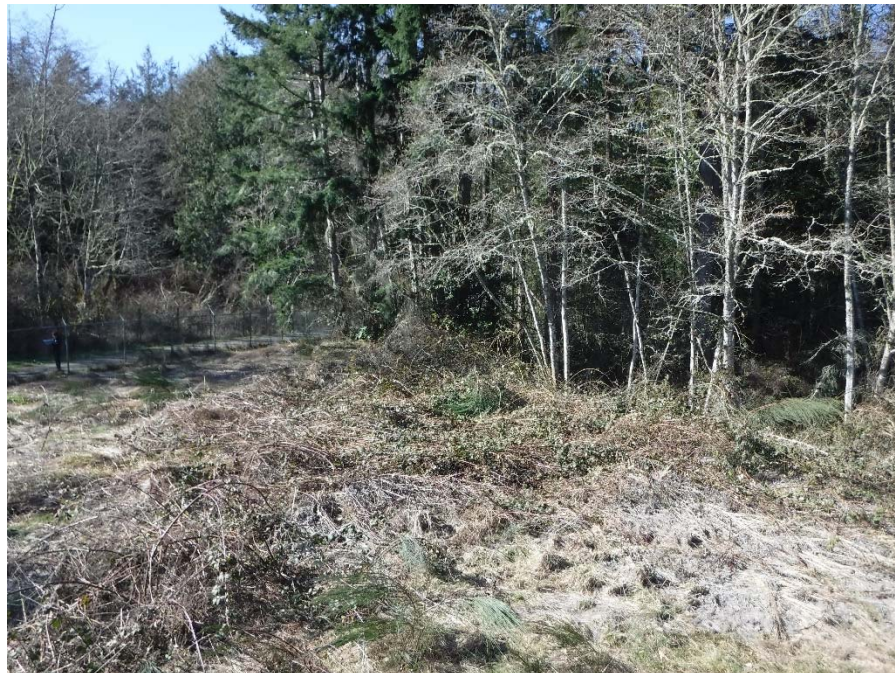
File Name: DSCF3962
Date Taken: 03/04/2019

Photo 8 - Description: Site 302, PCB Site, Open, central portion of site bordered by heavily wooded area (1 of 2)

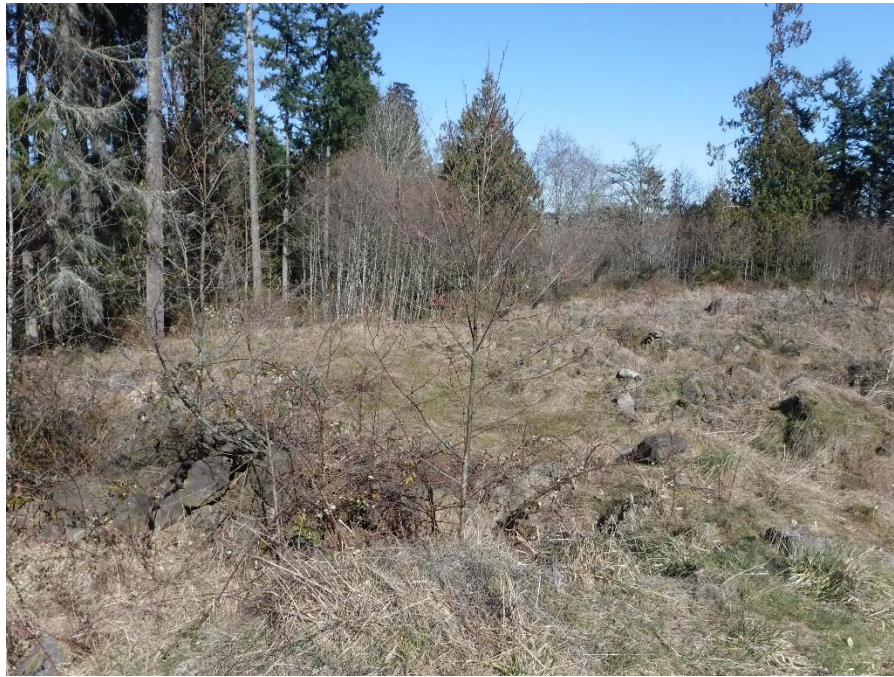
File Name: DSCF3964
Date Taken: 03/04/2019

Photo 9 - Description: Site 302, PCB Site, Open, central portion of site bordered by heavily wooded area (2 of 2)

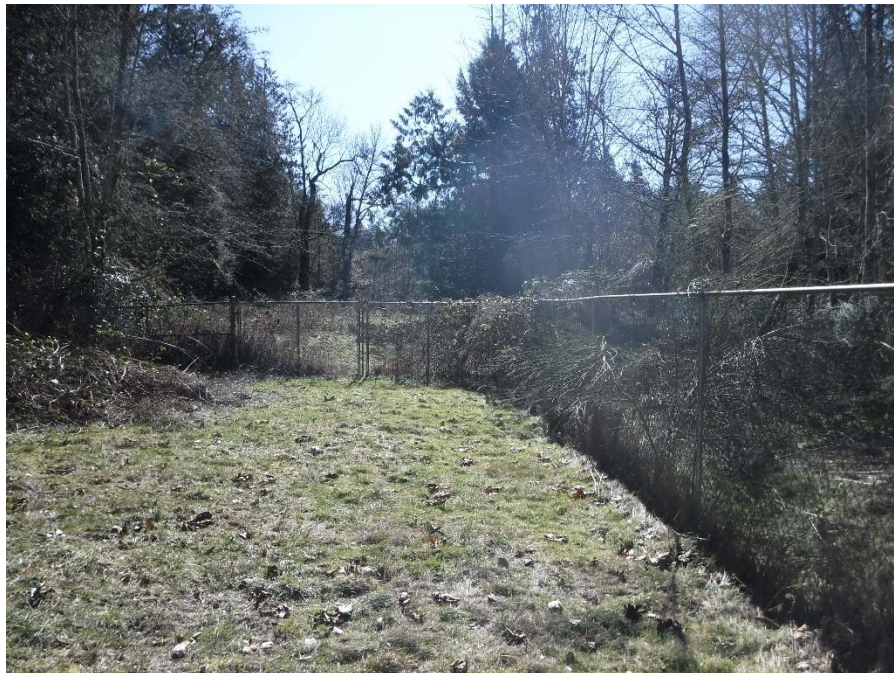
Photo 10 - Description: Site 302, PCB Site, Gated entrance on north side of site. No lock or LUC signage.

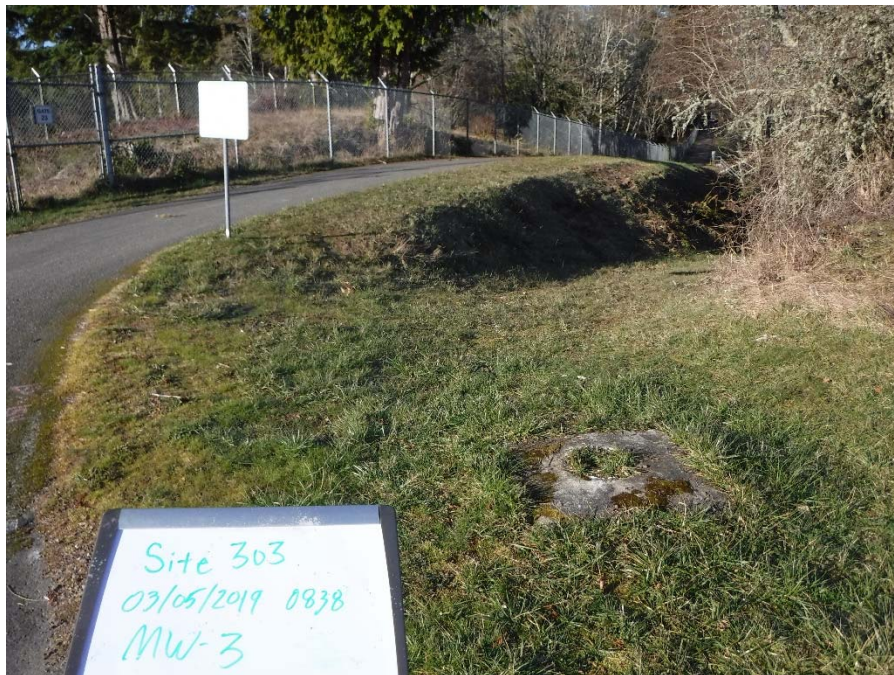
Photo 4 - Description: Site 303, D-Tunnel Tanks, Monument of abandoned monitoring well MW-3, South of Tank 24

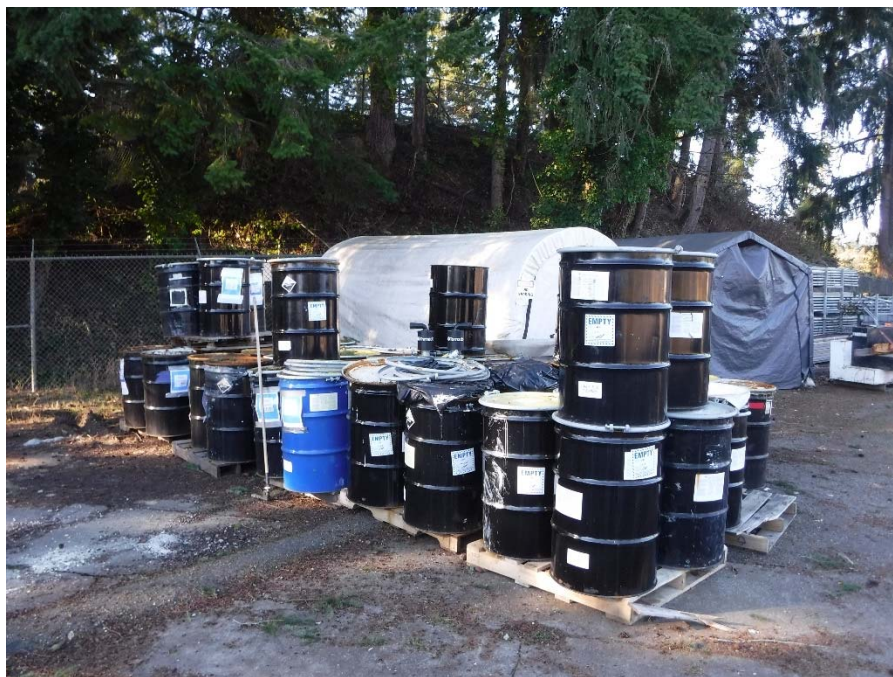
Photo 9 - Description: Site 303, D-Tunnel Tanks, Empty drum storage in laydown area southwest of Tank 24

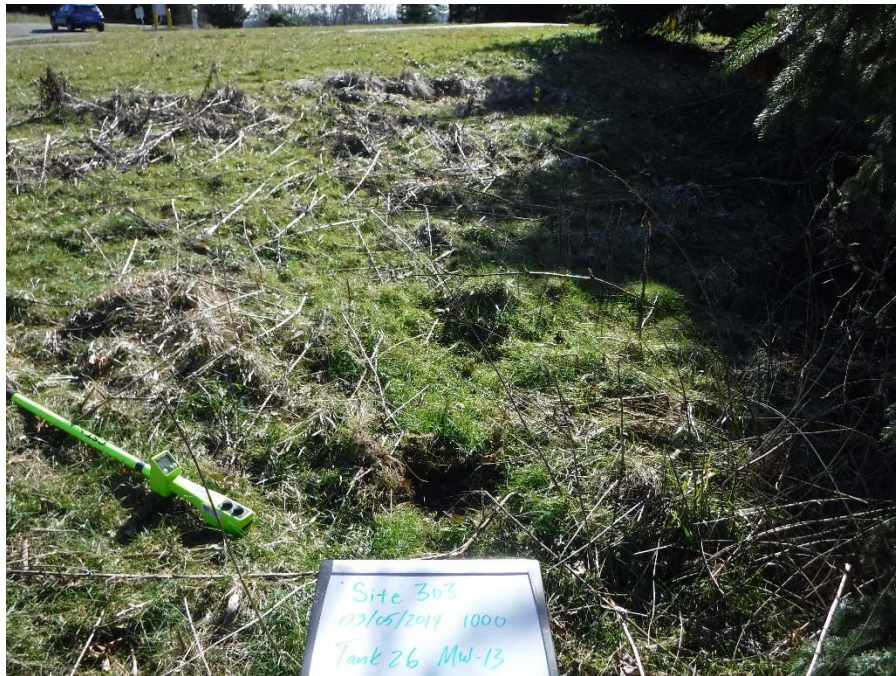
Found all 13 MWs; however MW-13 was found under trees + branches debris.

Photo 22 - Description: Site 303, D-Tunnel Tanks, Tank 26 MW-13 identified in thick overgrowth

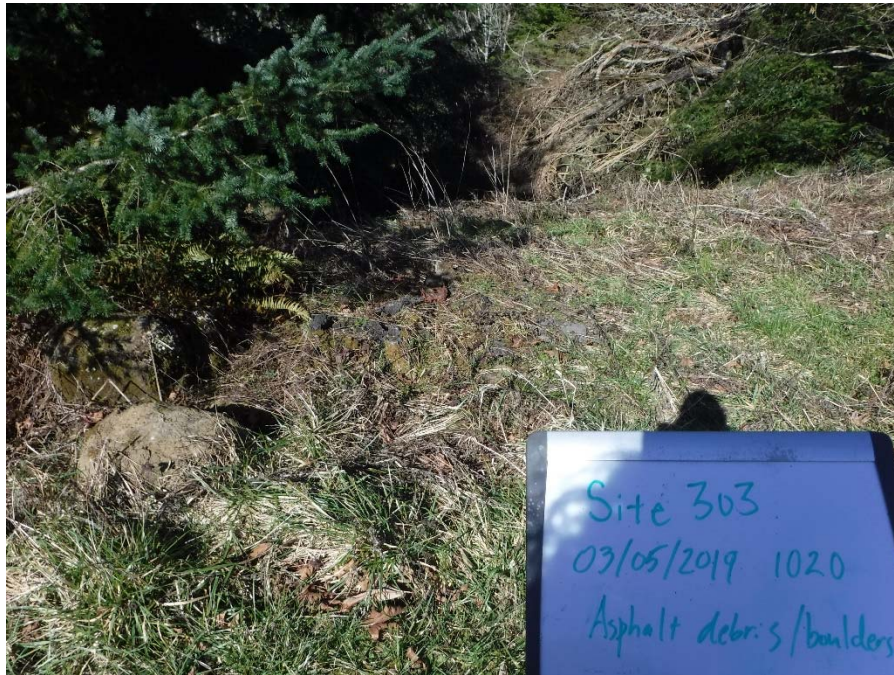
Photo 27 - Description: Site 303, D-Tunnel Tanks, Asphalt debris near Tank 28

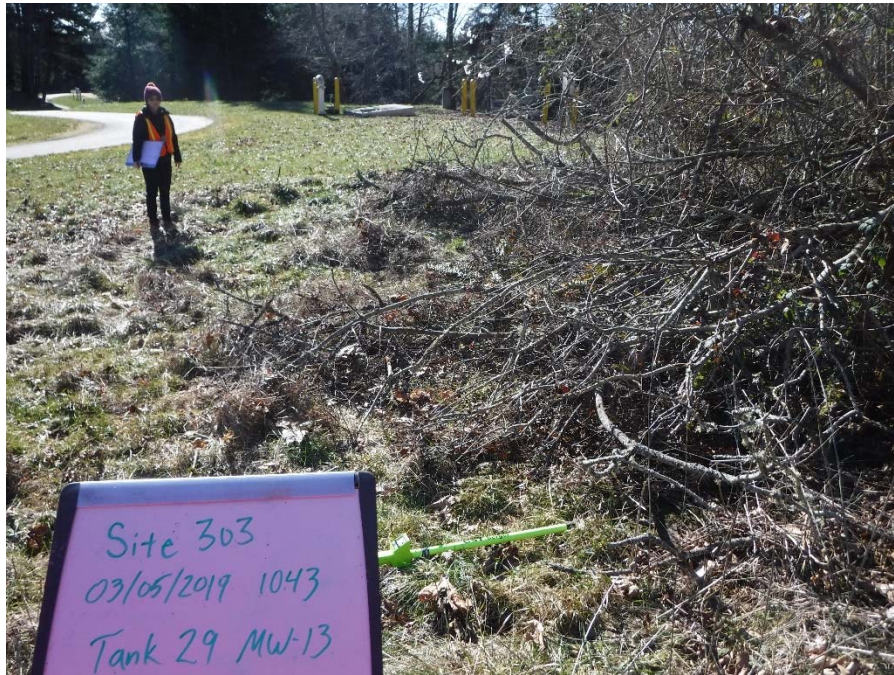
Photo 29 - Description: Site 303, D-Tunnel Tanks, Tank 29 MW-13 identified in thick overgrowth; metal detector pointing to location

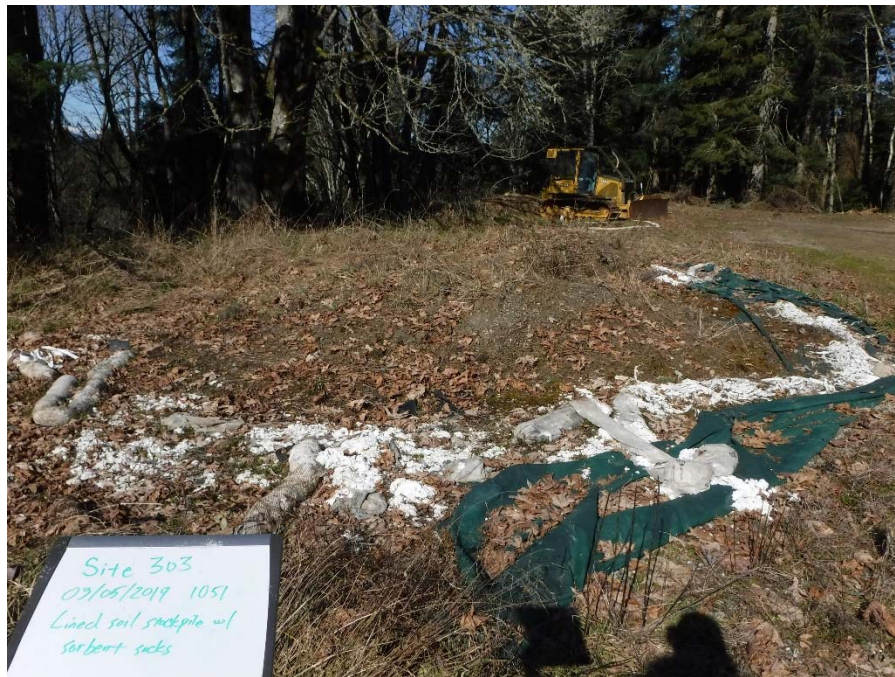
Photo 31 - Description: Site 303, D-Tunnel Tanks, Old soil stockpile with tarp and absorbent booms in laydown area north of Tank 29 (1 of 2)

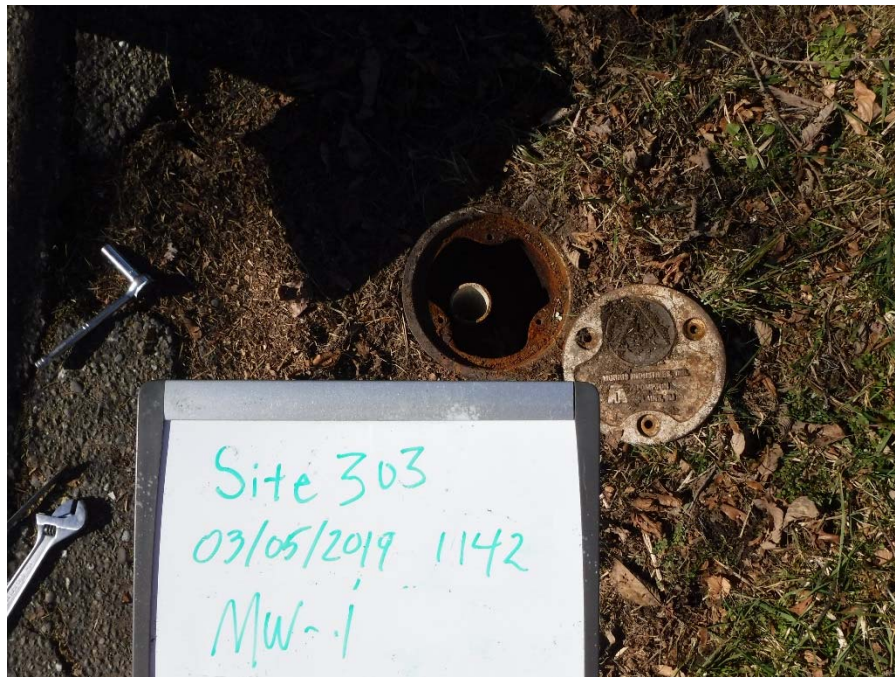
2" PVC casing in good condition; however, too tall for J-plug + lock. J-plug cap in well monument, but NOT on casing.

Well monument + lid rusty, but still functional, competent.

Overall, MW-1 in good condition.

Photo 37 - Description: Site 303, D-Tunnel Tanks, Monitoring well MW-1, south of Tank 24 (in overall good condition)

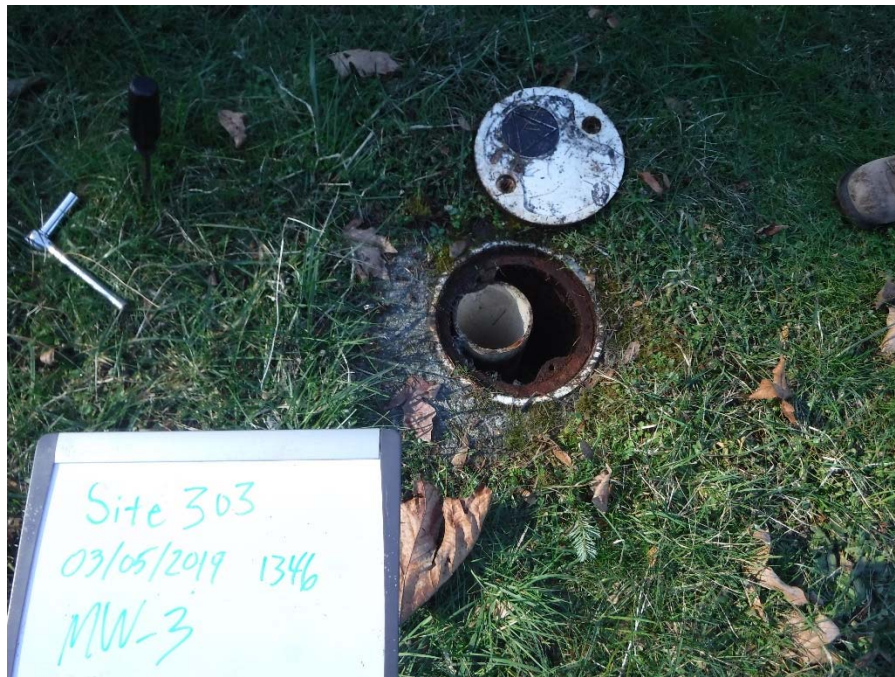
Photo 41 - Description: Site 303, D-Tunnel Tanks, Monitoring well MW-3, north of Tank 30 (in overall good condition)

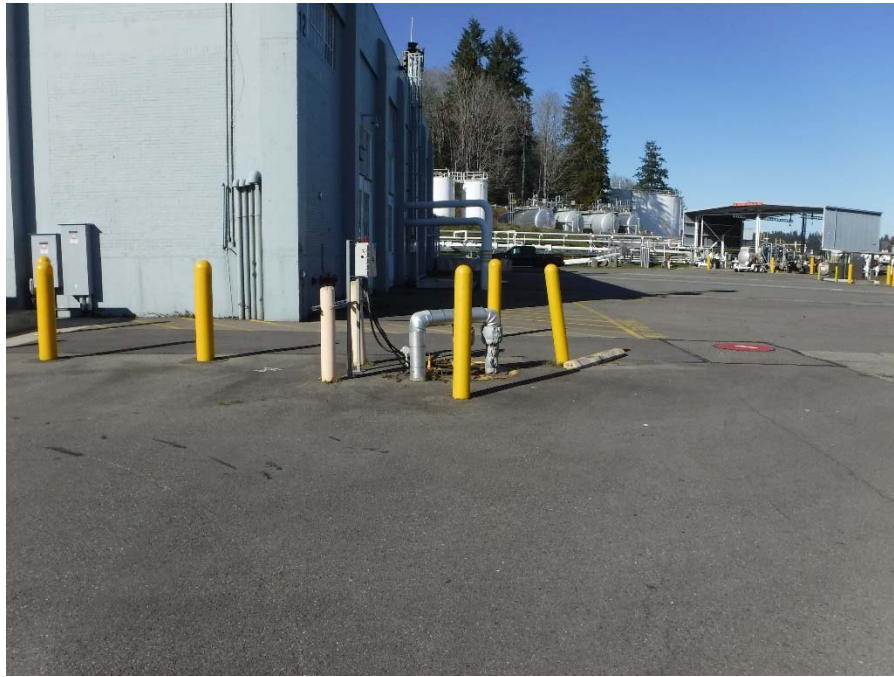
Photo 2 - Description: Site 304, Industrial Area, Area south of Building 12

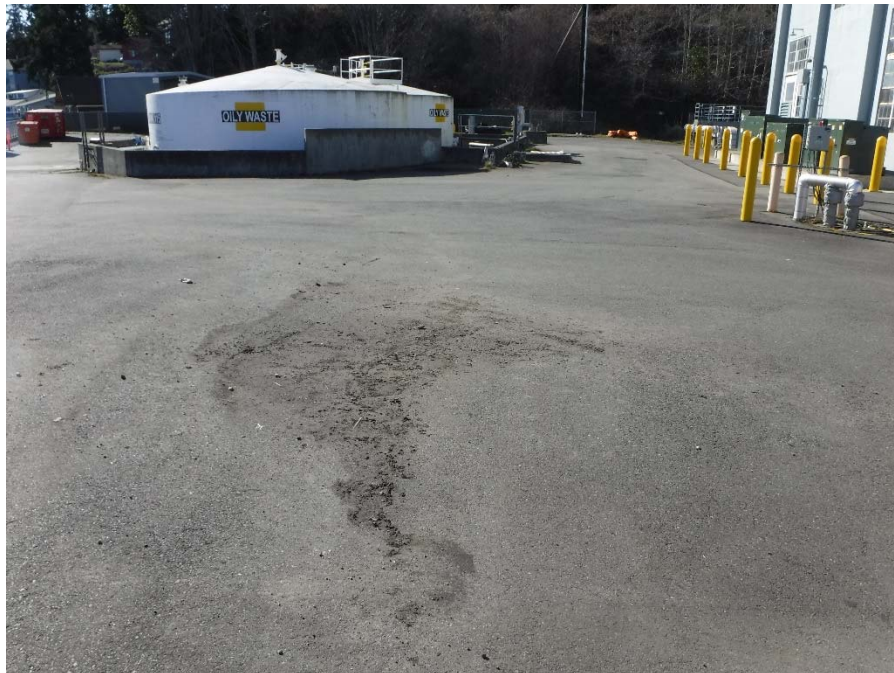
Photo 3 - Description: Site 304, Industrial Area, Area southeast of Building 12

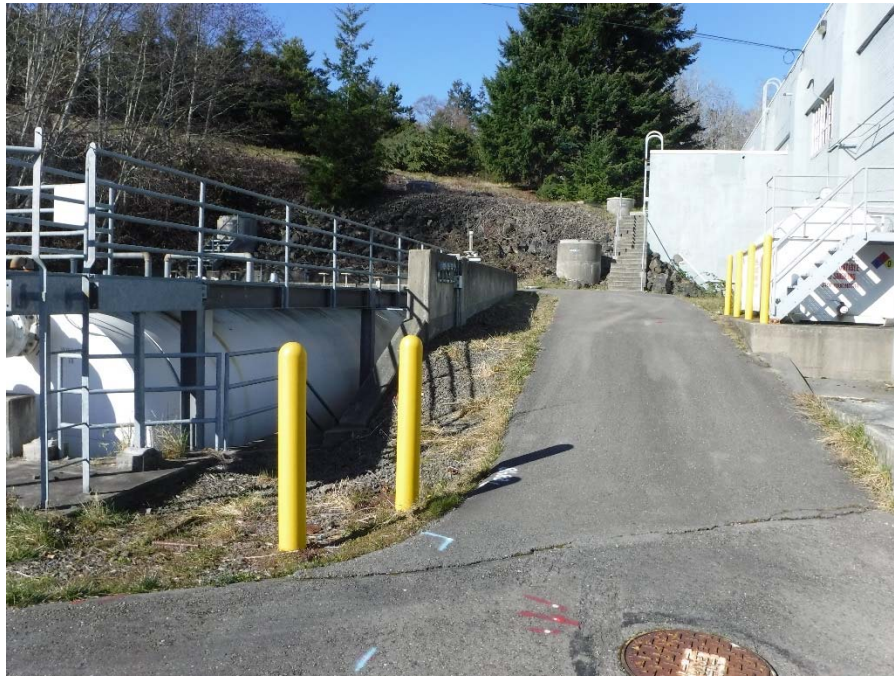
Photo 4 - Description: Site 304, Industrial Area, South side of Building 12

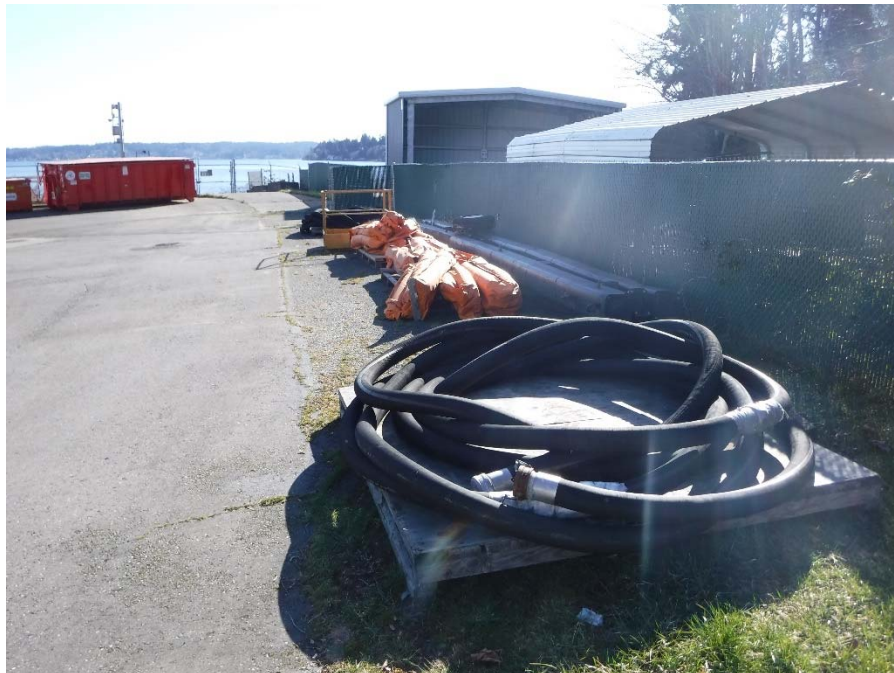
Photo 5 - Description: Site 304, Industrial Area, West side of Building 12

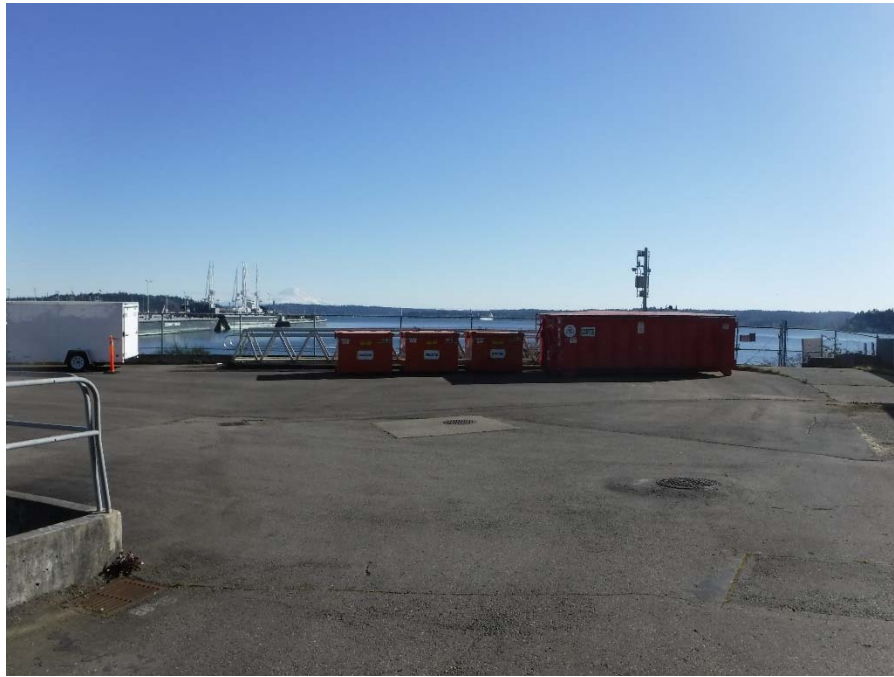
Photo 6 - Description: Site 304, Industrial Area, Laydown yard south of Building 12 for booms and hosing

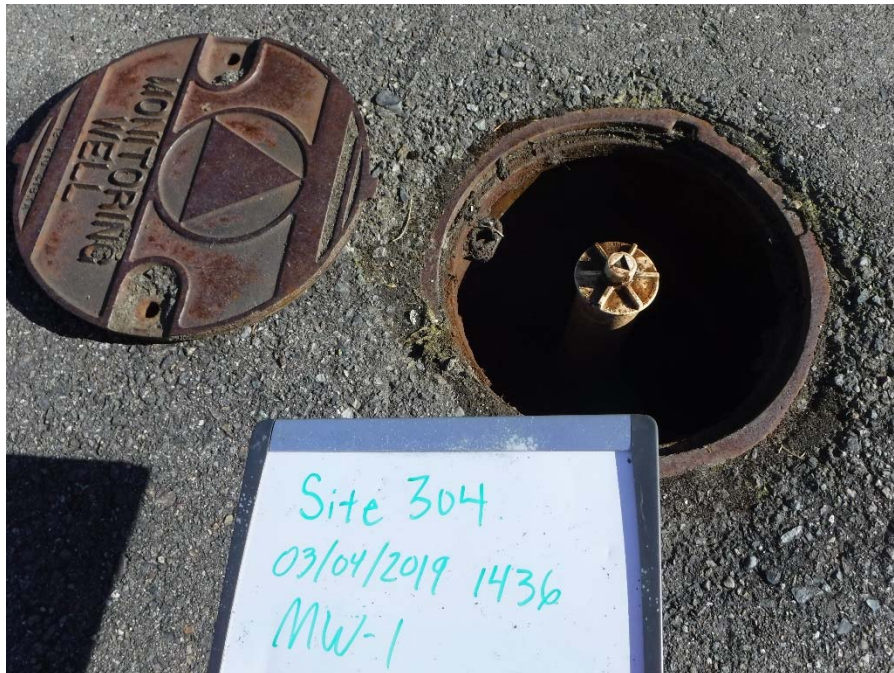
Photo 7 - Description: Site 304, Industrial Area, Southern boundary of site

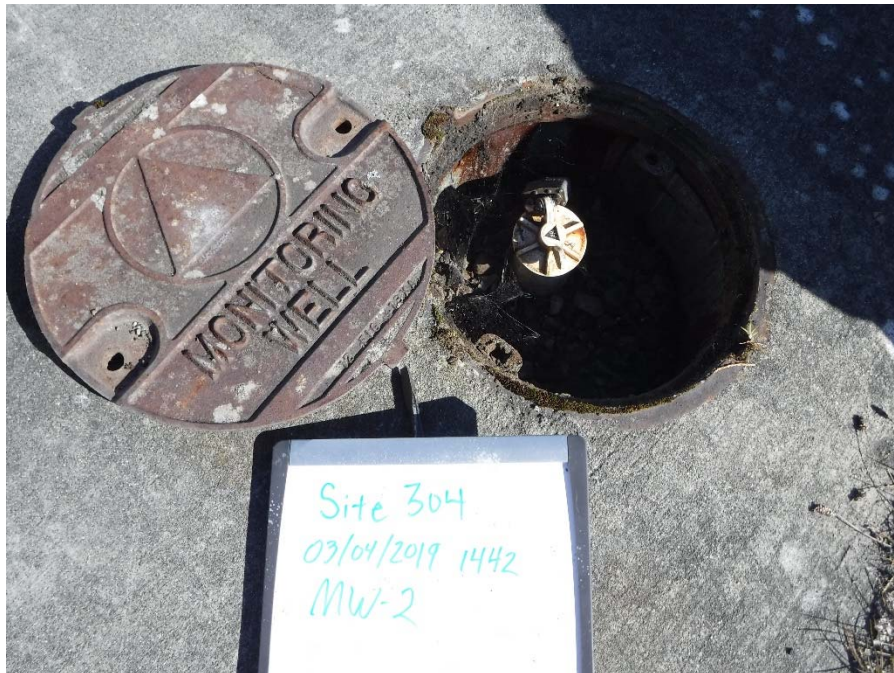
Photo 9 - Description: Site 304, Industrial Area, Fueling area between Buildings 12 and 1

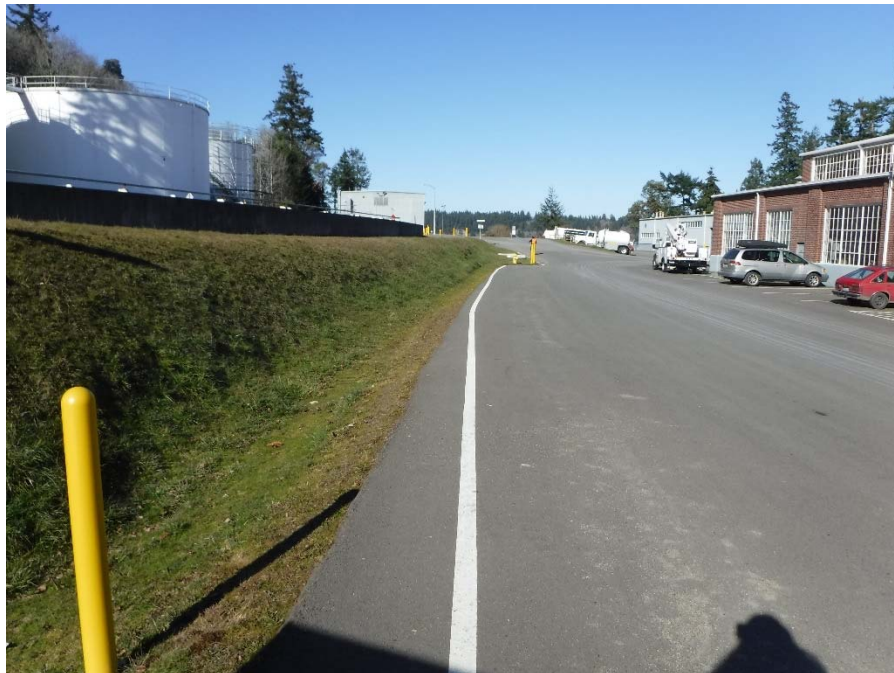
Photo 11 - Description: Site 304, Industrial Area, Spent fuel sorbent pad waste storage at the fueling area

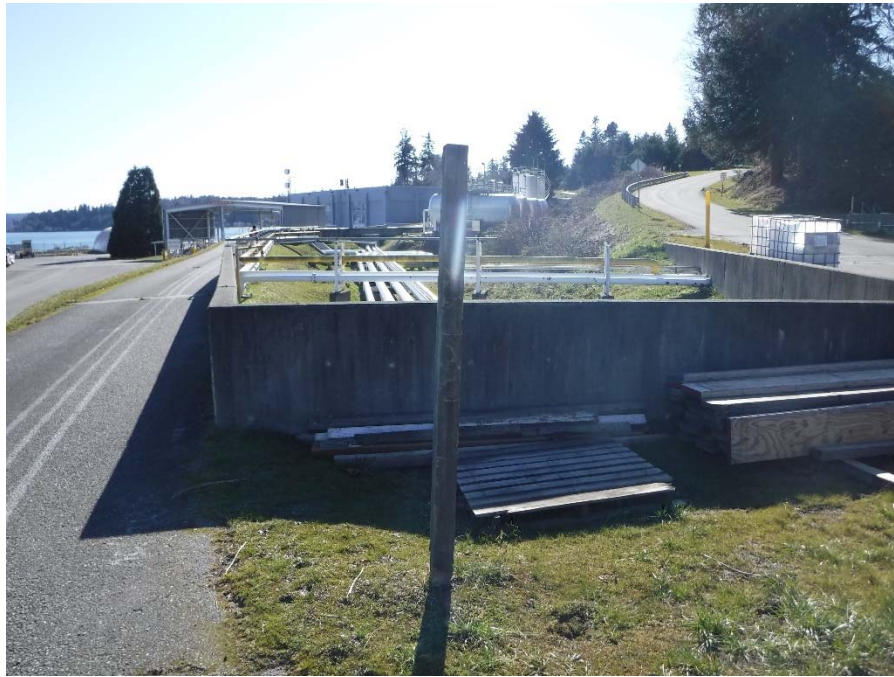
Photo 12 - Description: Site 304, Industrial Area, Main road to offices west of Building 1

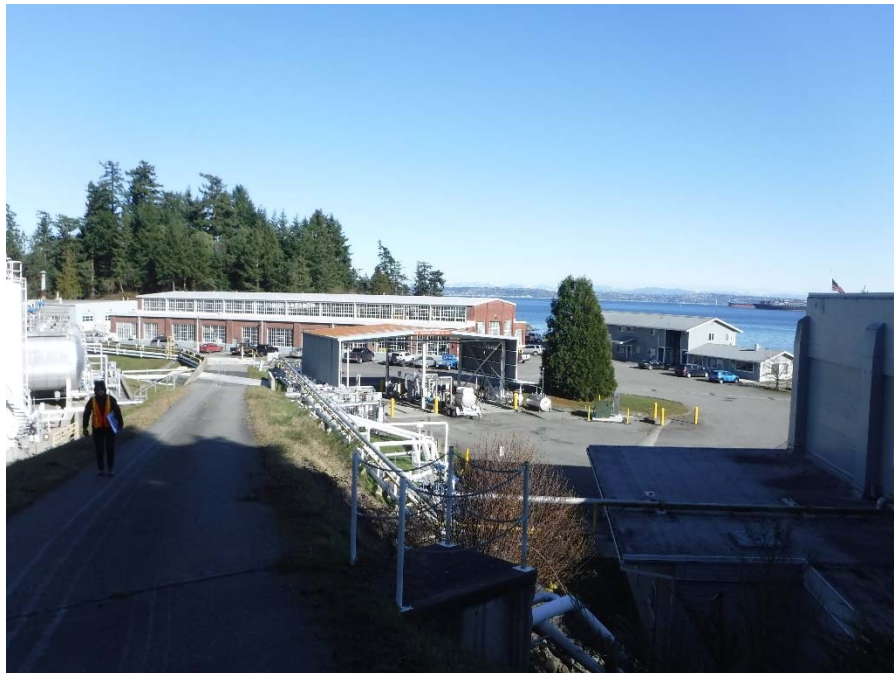
Photo 13 - Description: Site 304, Industrial Area, Piping and fork in main road to offices and to roads toward fuel storage tanks

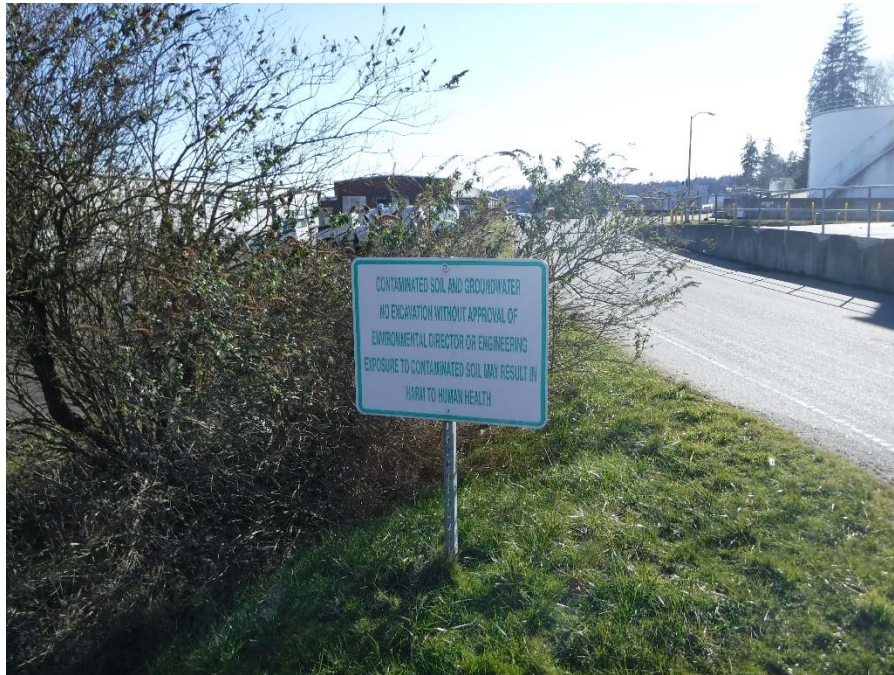
Photo 14 - Description: Site 304, Industrial Area, View towards buildings from roads toward fuel storage tanks

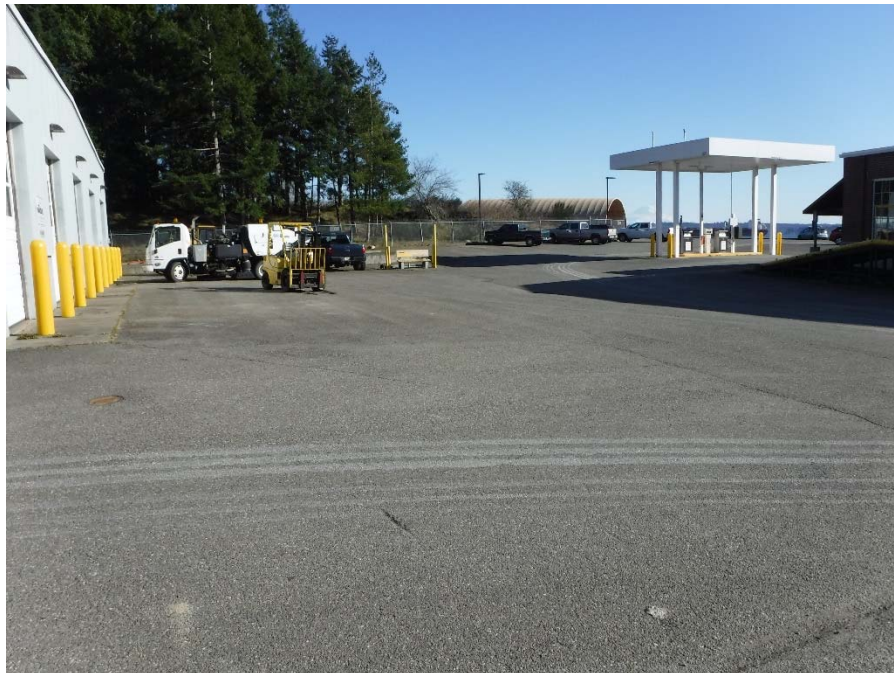
Photo 15 - Description: Site 304, Industrial Area, LUC signage for site, located north of actual site boundary along main road to offices

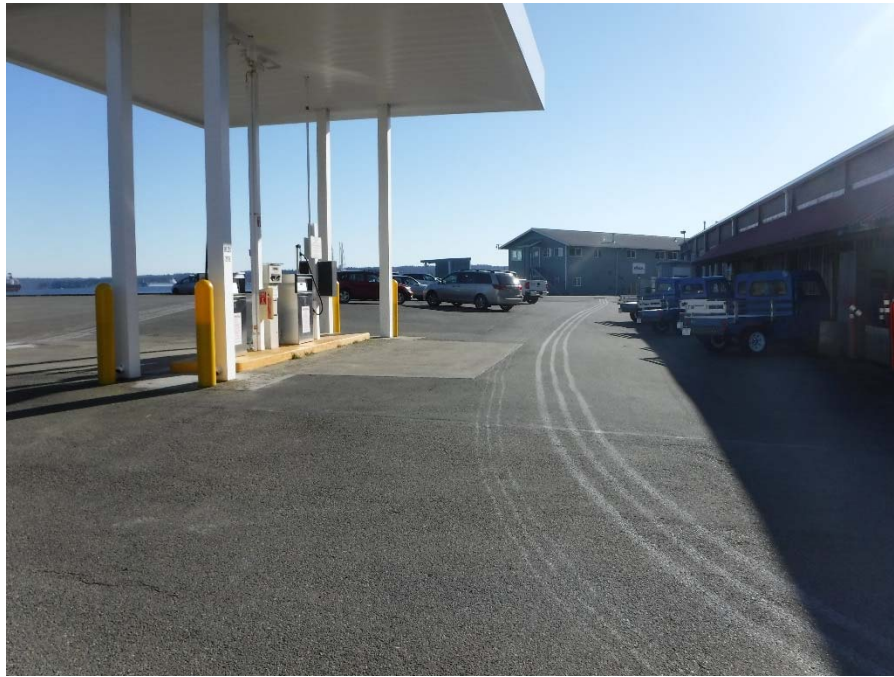
Photo 16 - Description: Site 304, Industrial Area, Area north of Building 1

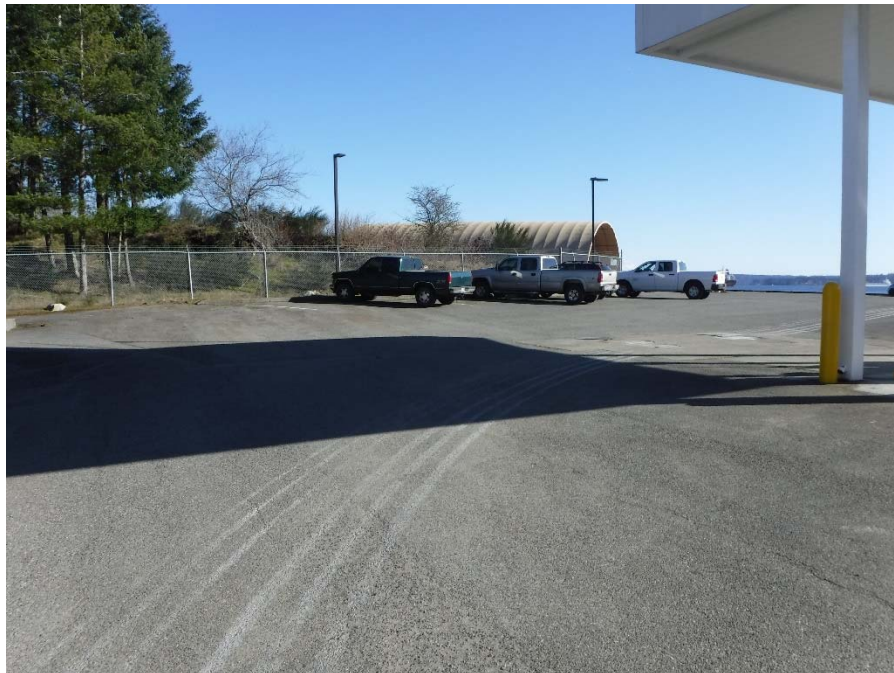
Photo 17 - Description: Site 304, Industrial Area, East side of Building 1
