2019 Land Use Control Inspection Technical Memorandum

Fleet Logistics Center Puget Sound Manchester Fuel Depot

Manchester, Washington

Department of the Navy

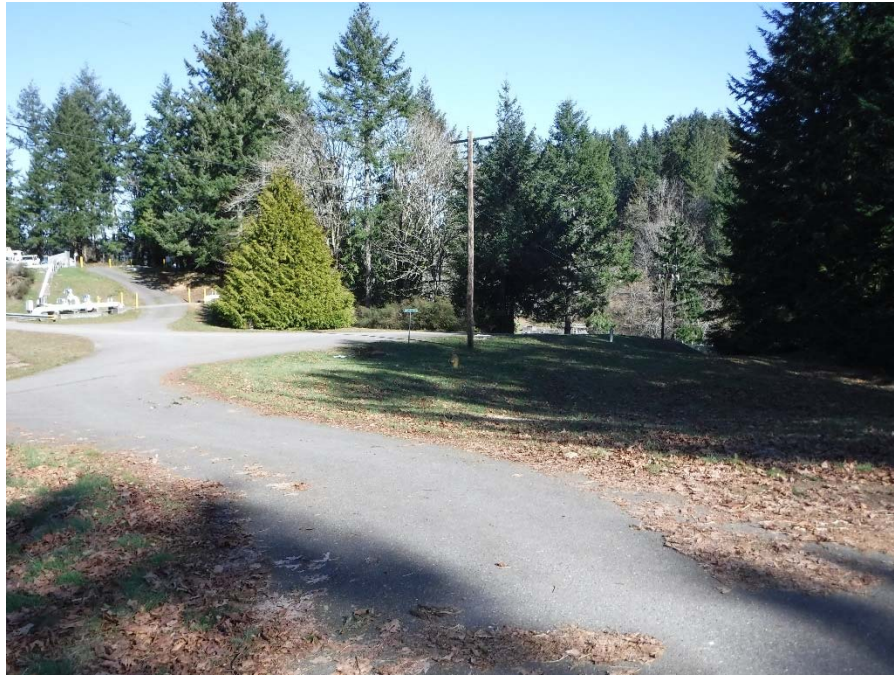
Photo 18 - Description: Site 304, Industrial Area, Southeastern boundary of site

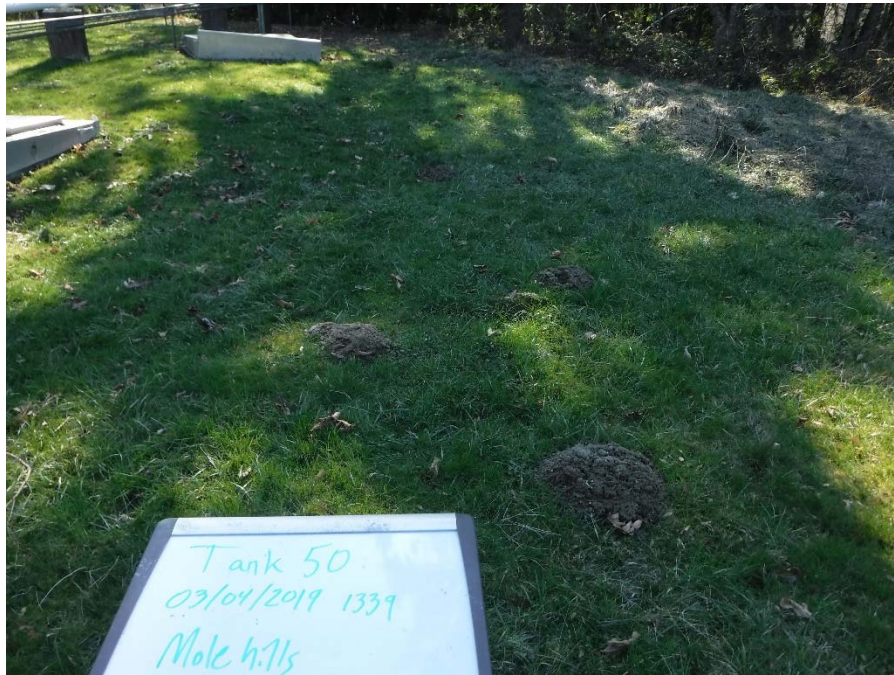
Photo 2 - Description: Tank 50, Tank 50 Release Site, View from top of site down to lower area to south

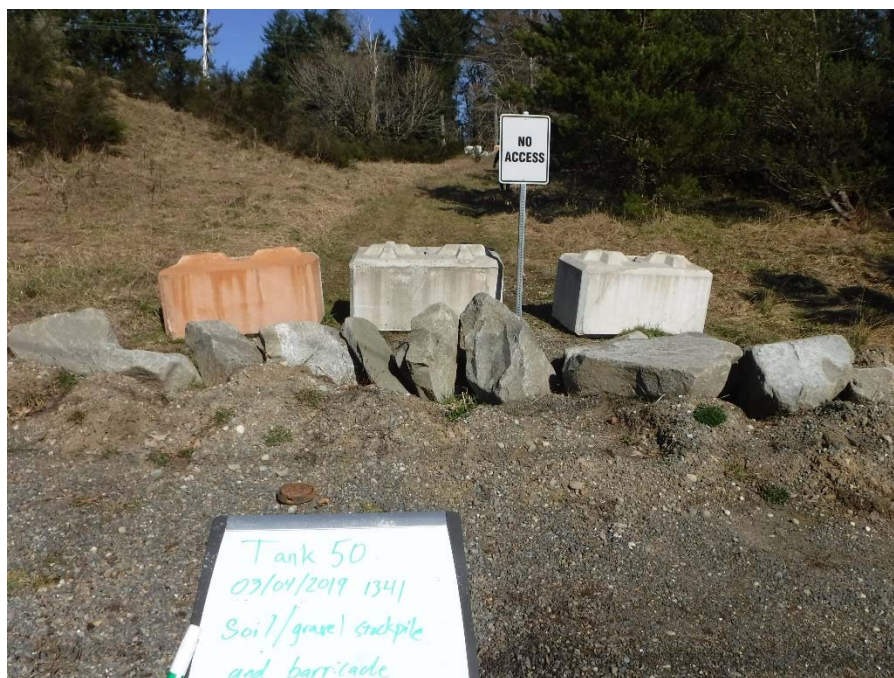
Photo 5 - Description: Tank 50, Tank 50 Release Site, Access road barricade from top of site to lower area, along northwest boundary of site

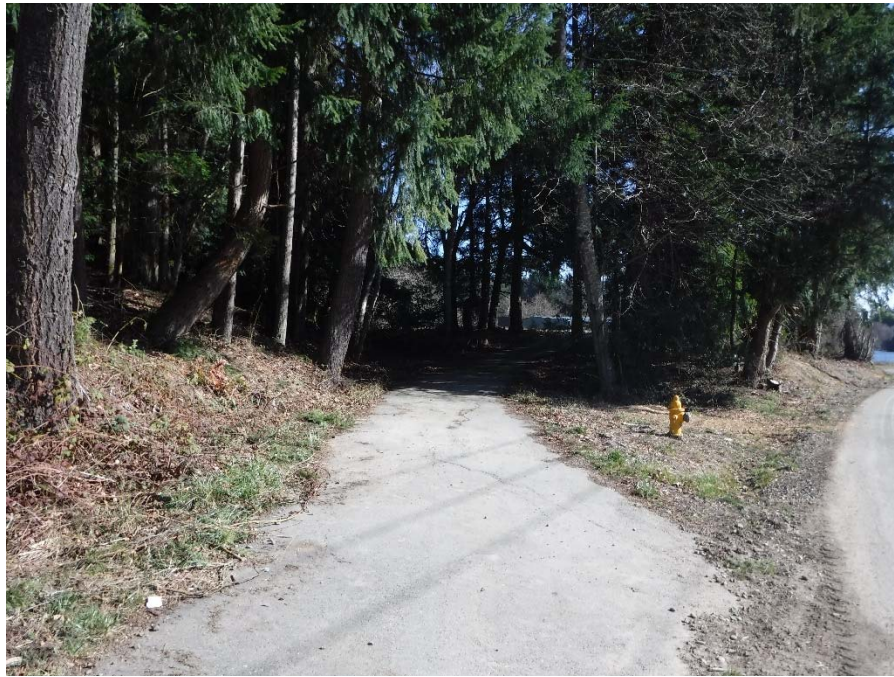
Photo 6 - Description: Tank 50, Tank 50 Release Site, Access road barricade at lower area, along northwest boundary of site

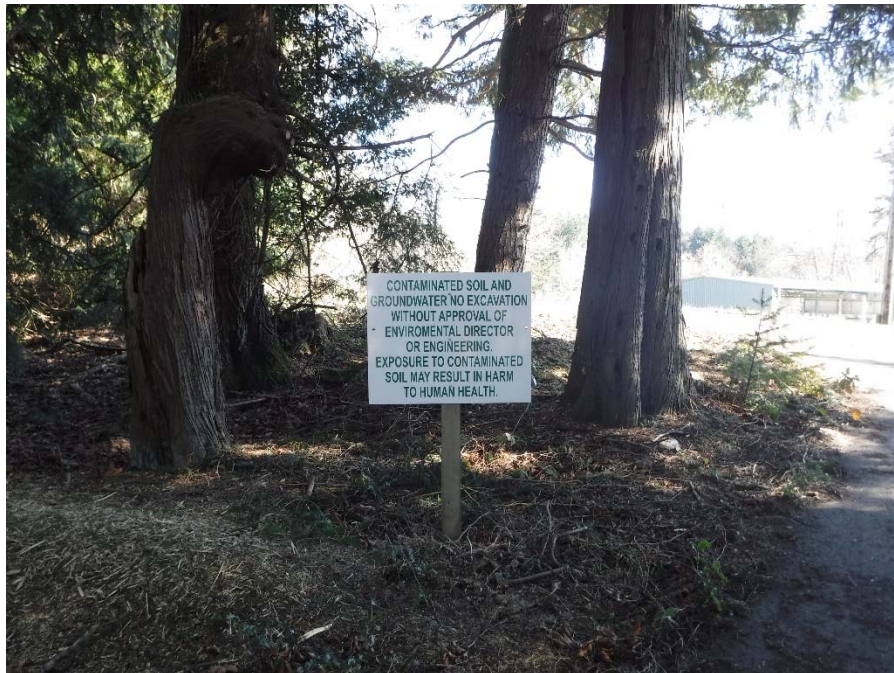
Photo 7 - Description: Tank 50, Tank 50 Release Site, Access road towards monitoring well MW-2

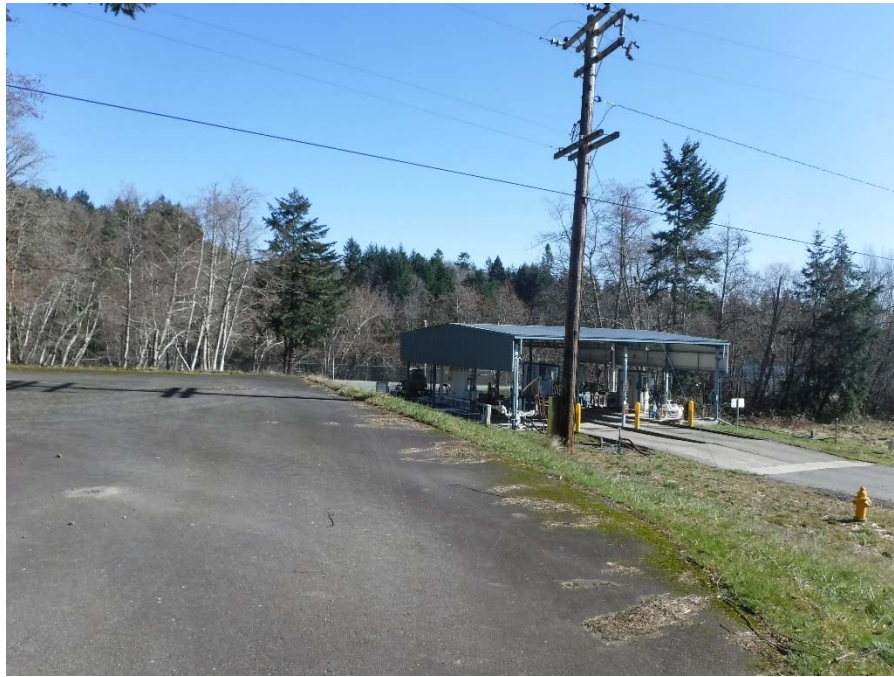
Photo 8 - Description: Tank 50, Tank 50 Release Site, LUC signage in lower area, adjacent to MW-2
