Gas Works Sediment Area

Joint Source Control Evaluation

Appendix A Shoreline Facilities Evaluation

ECOLOGY REVIEW DRAFT

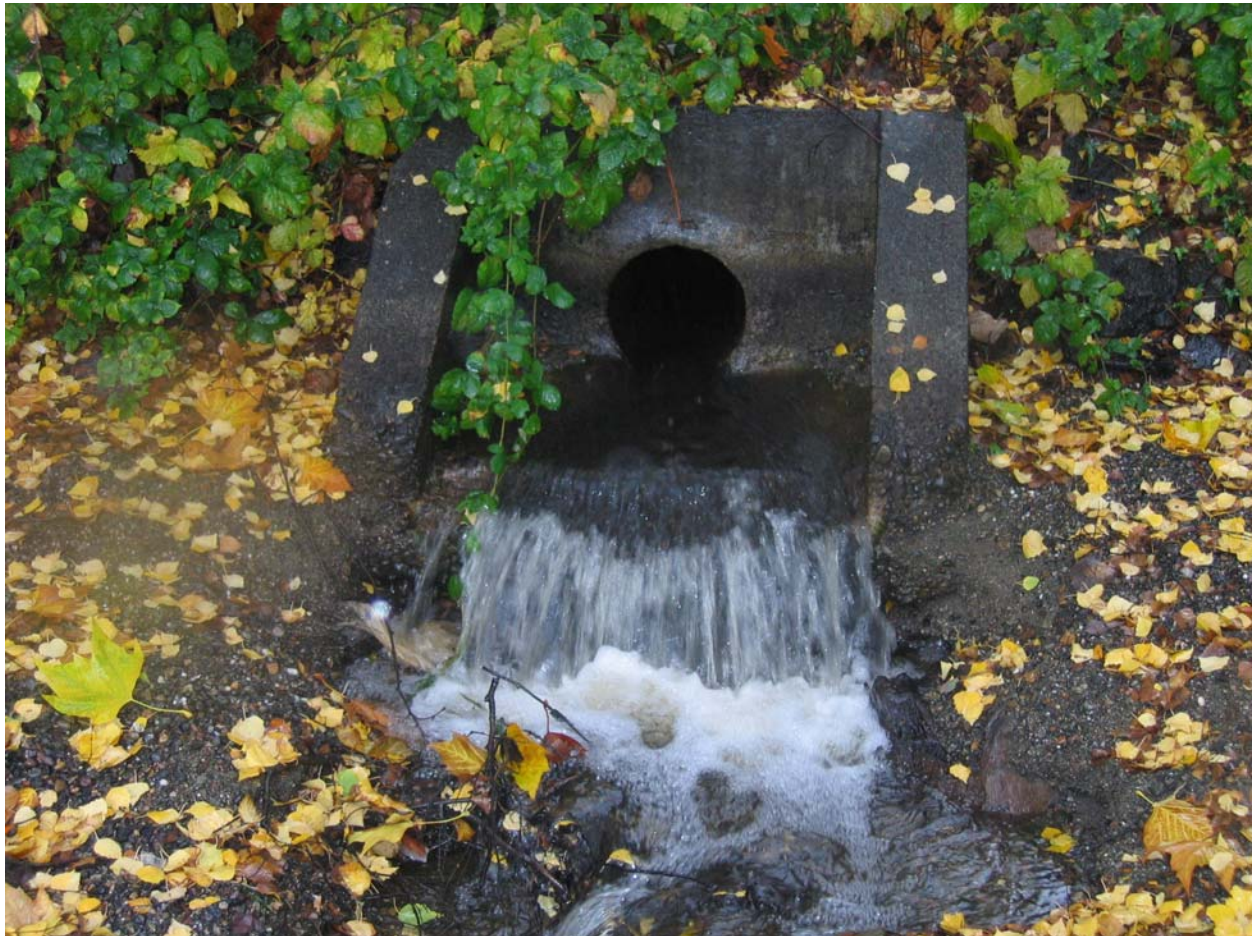
Photo 1: Outfall A during a storm, November 2006.

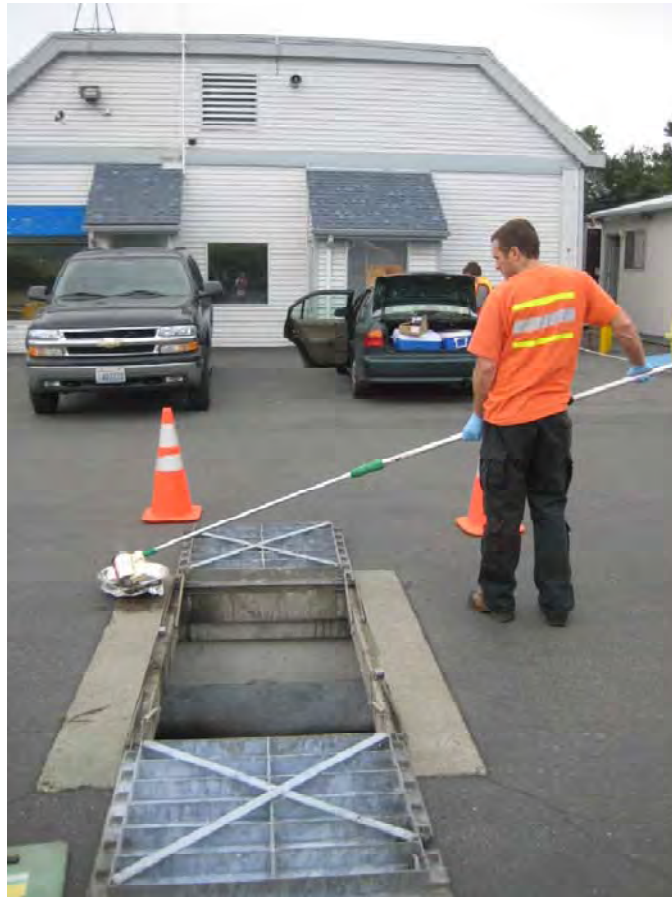
Photo 1. SPU staff sampling HP-OWS-Outlet in Harbor Patrol.

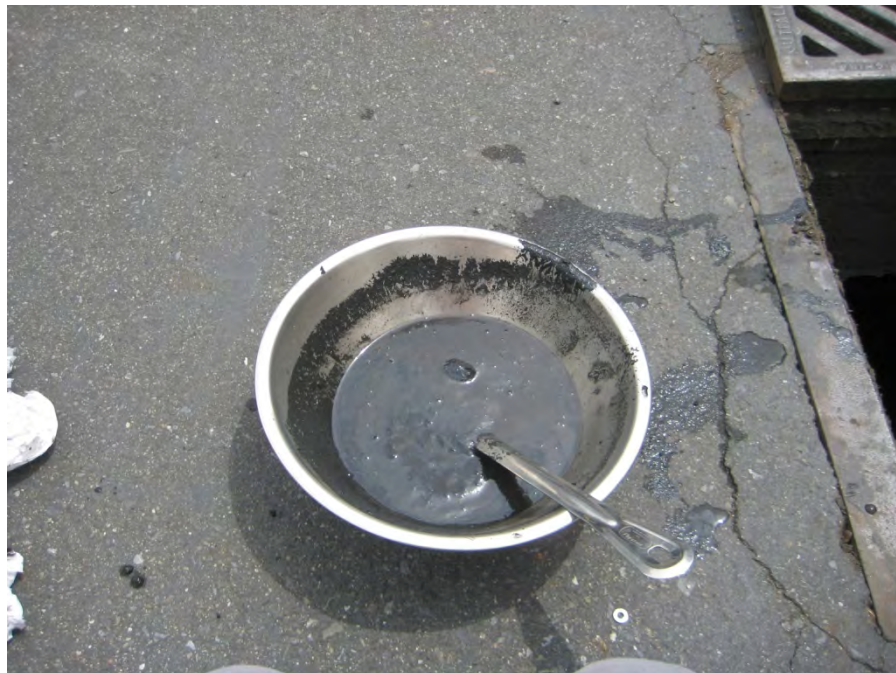
Photo 2. Solids sample, HP-OWS-Outlet in Harbor Patrol.

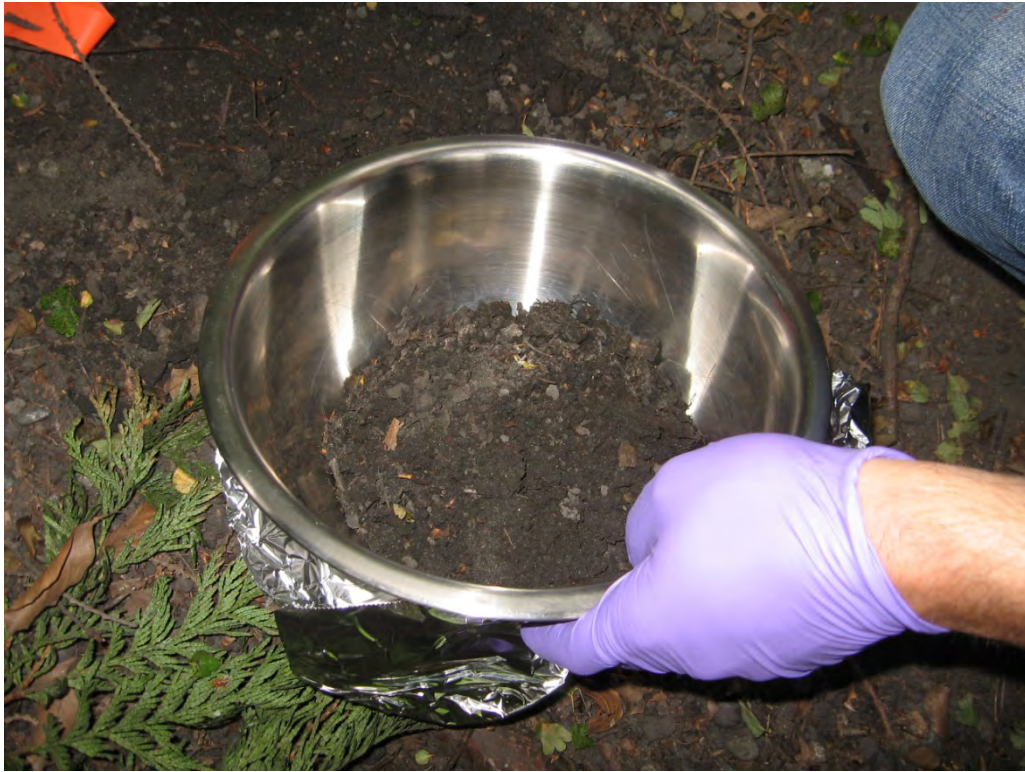
Photo 7. Floyd|Snider staff sampling Surface Soil Sample WW-19-03.

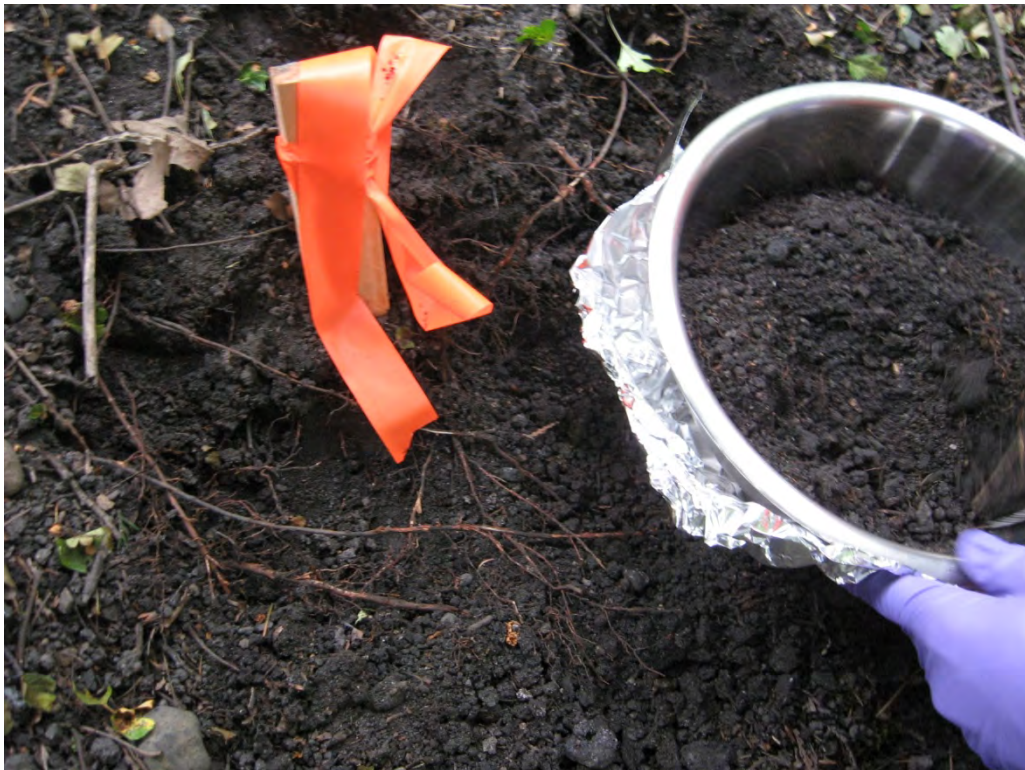
Photo 8. Floyd|Snider staff sampling Surface Soil Sample WW-19-05.

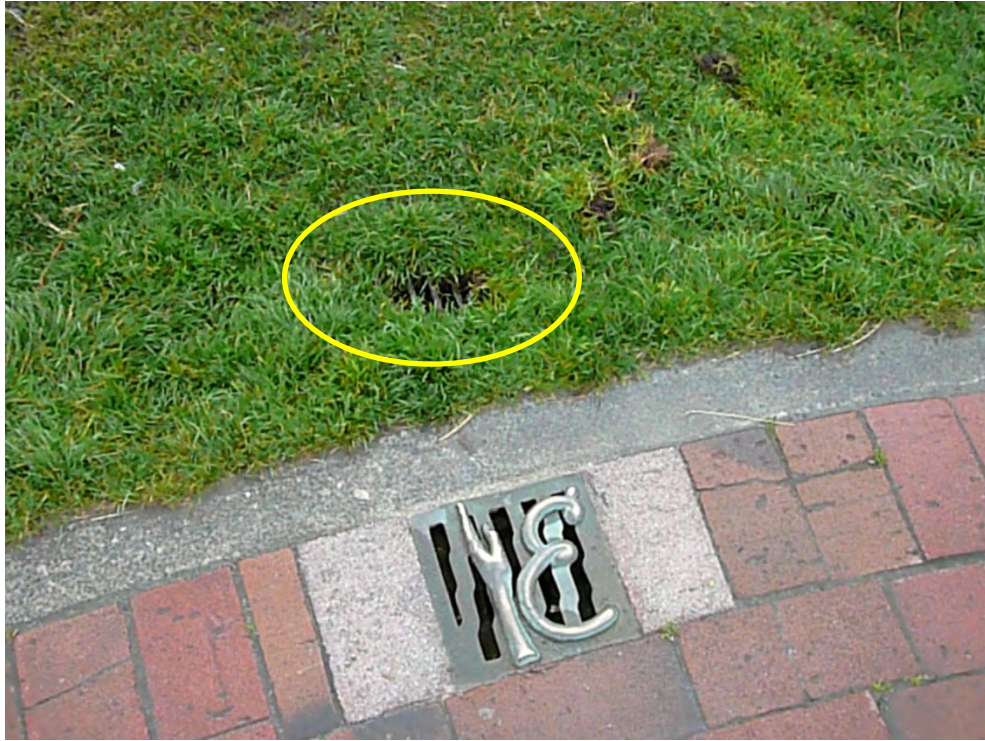
Photograph 3. Eastern Inlet on Kite Hill. August 22, 2011.

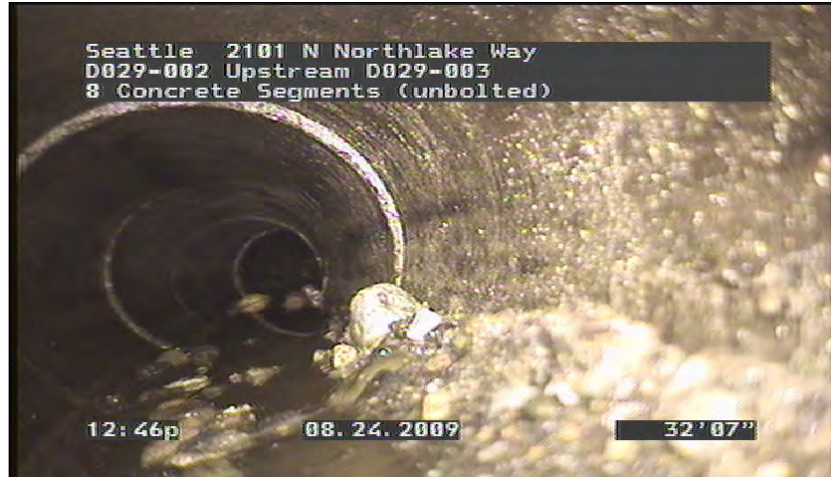
Photo: D029-003_D029-002_082409_124403_A.JPG, VCR #: GWP
8.24.2009

32.57FT, Deposits Settled Gravel, 15 %of cross sectional area,
from 04 to 08 o'clock, within 8 inches of joint: YES

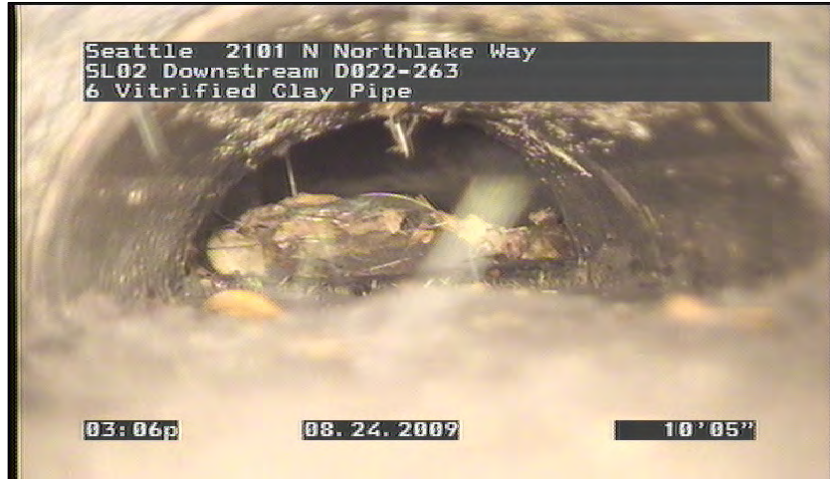
Photo: SL02_D022-263_082409_150340_A.JPG, VCR #: GWP
8.24.2009
10.4FT, Survey Abandoned, REMARK: Debris

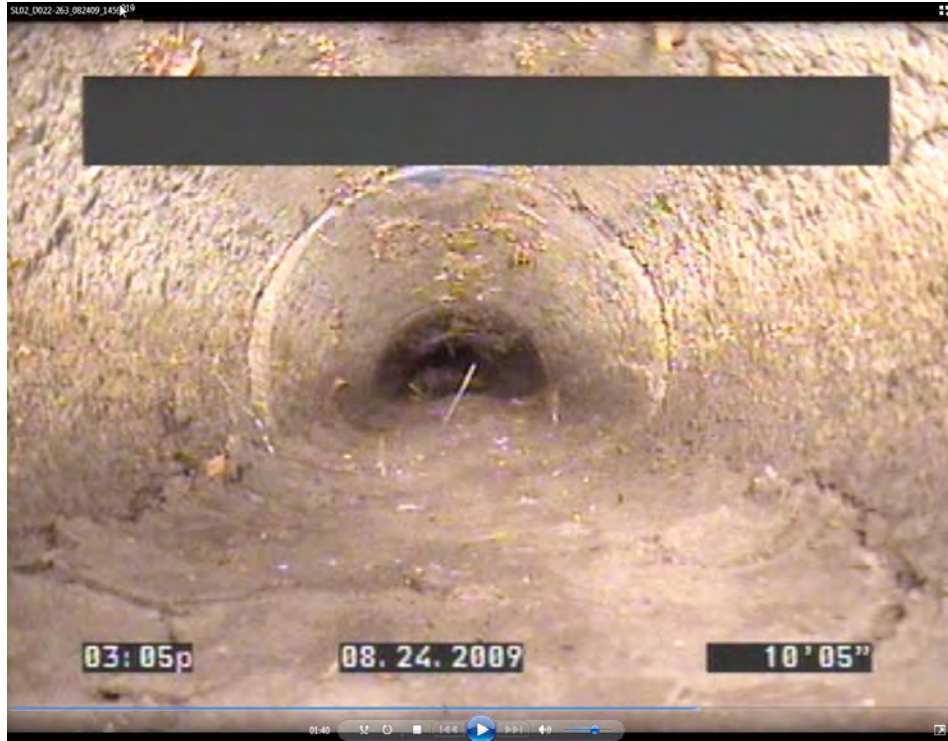
Photograph 11. SL 2 to SL 1.

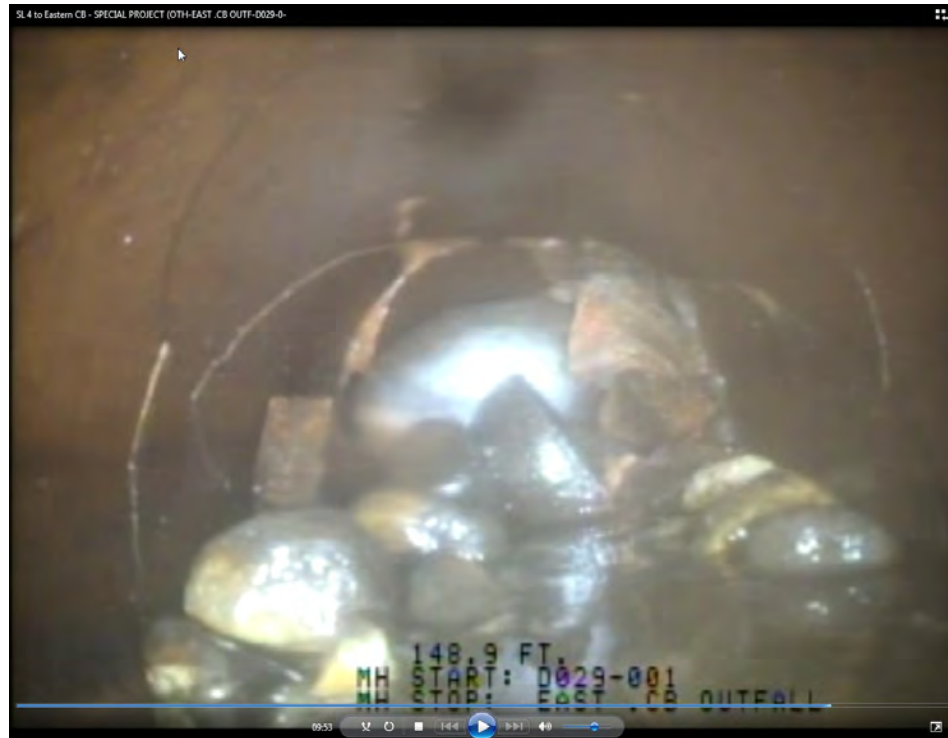
Photograph 12. SL 1 to Eastern CB.
