**Re: Geotechnical Construction Completion Letter**

Texaco Strickland Site  
Project No. 180357

**PRECONSTRUCTION CONDITION SURVEY PHOTO LOG** | September 19, 2022

**POSTCONSTRUCTION CONDITION SURVEY PHOTO LOG** | January 10, 2023 and January 25, 2023

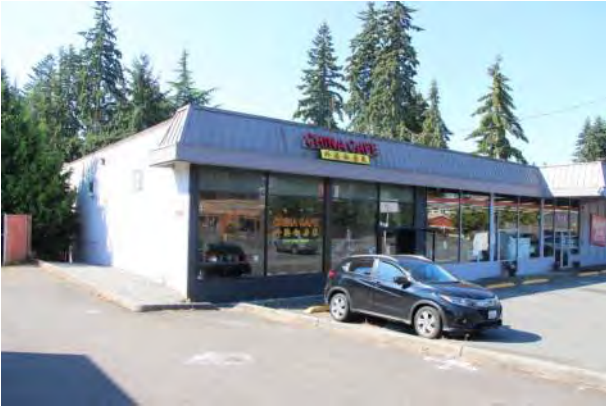
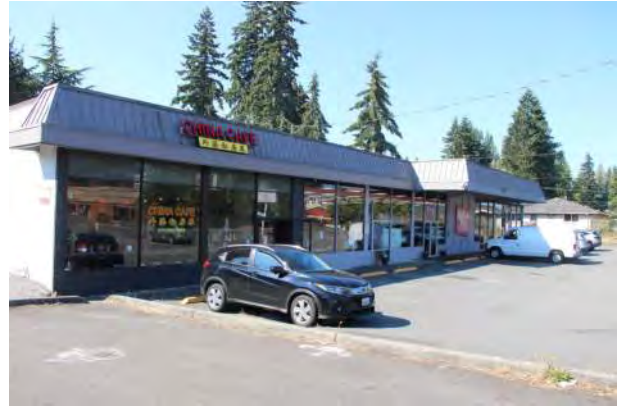
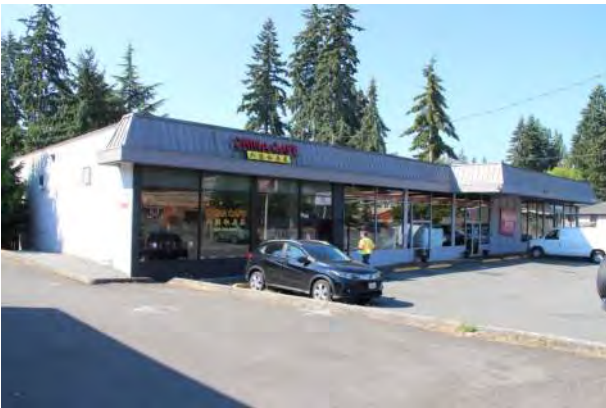
Photo No.	Location	Description/Conditions Observed
001-003	North Elevation, Exterior	Overall view of front (north side) of building
004-006	East Elevation, Exterior	Overall view of east side of building
006-013	East Elevation, Exterior	Wall finishes and roof coverings
014-020	East Elevation, Exterior	Detailed views of stairstep cracking in mortar of CMU wall
021-025	East Elevation, Exterior	Wall finishes and roof flashing
026-038	North Elevation, Exterior	Wall finishes, roof overhang, doors, and windows at China Café
039-041	North Elevation, Exterior	Parking lot slope
042-048	North Elevation, Exterior	Wall finishes, roof coverings, doors, and windows at Nielson Bros and Sound Sports
049-060	North Elevation, Exterior	Detailed view of wood panel separation on walls and roof overhang
061-063	North Elevation, Exterior	Walkway outside Nielson Bros
064-065	North Elevation, Exterior	Exterior views of Sound Sports

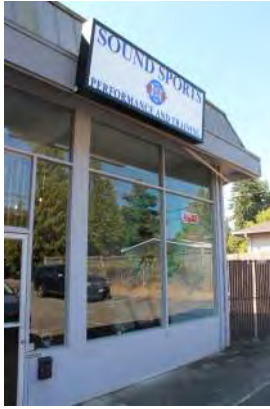
Pre\_064 - [IMG\_3521]

064-072	North Elevation, Exterior	Cracks in concrete sidewalk in front of Sound Sports

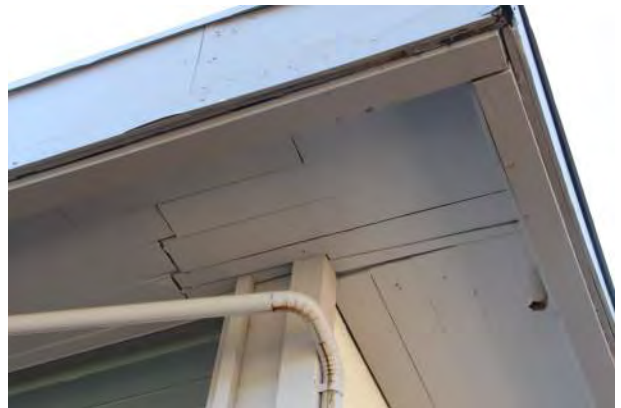
Pre\_077 - [IMG\_3534]

<b>Photo No.</b>	<b>Location</b>	<b>Description/Conditions Observed</b>
072-076	North Elevation, Exterior	Roof overhang at Sound Sports
077-078	North Elevation, Exterior	Detailed views of wood panel separation at underside of roof overhang
079-081	West Elevation, Exterior	Overall view of west side of building
079-088	West Elevation, Exterior	Wall finishes
089-093	West Elevation, Exterior	Concrete curb at base of wall, possibly the top of the foundation elements
094-096	South Elevation, Exterior	Wall finishes and concrete loading dock at southwest corner of structure
097-099	South Elevation, Exterior	Overall view of concrete loading dock
100-102	South Elevation, Exterior	Wall finishes
103-104	South Elevation, Exterior	Detailed views of cracks in concrete loading dock
105	South Elevation, Exterior	Wall finishes
106	South Elevation, Exterior	Detailed view of cracks in concrete loading dock
107-109	South Elevation, Exterior	Wall finishes

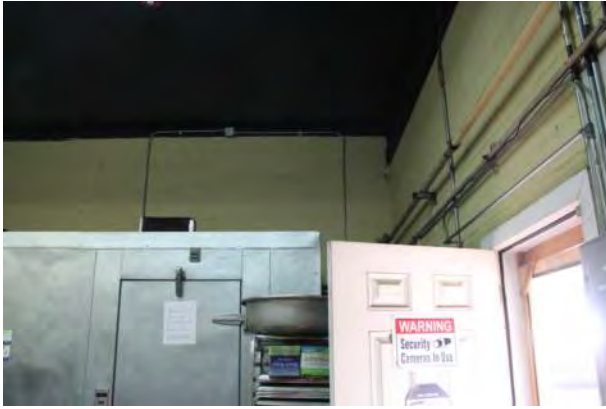
Pre\_176 - [IMG\_3633]

176	China Café, Interior	Detailed view of spalls on CMU
177-182	China Café, Interior	Wall finishes, kitchen equipment, interior of CMU walls
183-184	China Café, Interior	Detailed view of spalls on CMU
185-190	China Café, Interior	Wall finishes, kitchen equipment, interior of CMU walls
191-192	China Café, Interior	Front counter and seating area

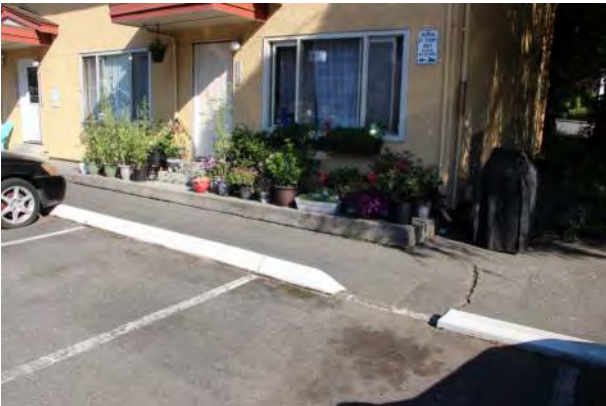
Pre\_005 - [IMG\_3274]

Photo No.	Location	Description/Conditions Observed
001-004	South Elevation, Exterior	Overall view of front of building, wall finishes, and roof coverings
005-007	South Elevation, Exterior	Detailed views of crack in asphalt parking lot
008-010	South Elevation, Exterior	Detailed views of separation between parking lot and concrete walkway
011-014	South Elevation, Exterior	Wall finishes and roof overhang
015-017	East Elevation, Exterior	Wall finishes
018-019	South Elevation, Exterior	Detailed views of crack in stucco at southeast corner of structure
020	South Elevation, Exterior	Detailed view of roof overhang at southeast corner of structure
021-022	South Elevation, Exterior	Detailed views of crack in concrete walkway in front of Unit 131
023-026	South Elevation, Exterior	Overall views of south wall and surface finishes
027-030	South Elevation, Exterior	Detailed views of crack in concrete walkway in front of Unit 131

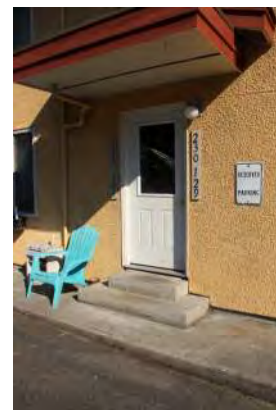
Pre\_031 - [IMG\_3300]

031	South Elevation, Exterior	Detailed view of crack in asphalt in front of Unit 131

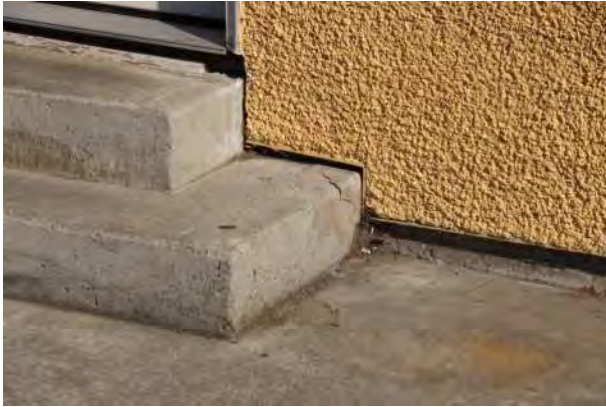
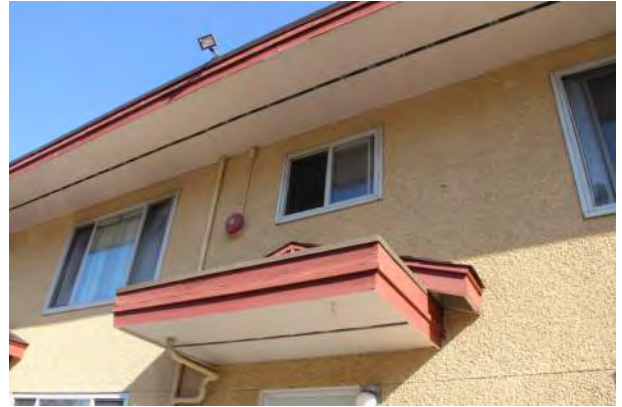
Pre\_032 - [IMG\_3301]

Photo No.	Location	Description/Conditions Observed
032-033	South Elevation, Exterior	Entryway to Units 127, 129, 228, and 230 with crack in concrete steps and separation between steps and wall
034	South Elevation, Exterior	Wall finishes
035-037	South Elevation, Exterior	Detailed views of cracks in concrete walkway and asphalt in front of entryway to Units 127, 129, 228, and 230
038-044	South Elevation, Exterior	Wall finishes and roof overhang
045-049	West Elevation, Exterior	Wall finishes and roof overhang
050-052	South Elevation, Exterior	Detailed views of crack in stucco beneath window
053-068	Unit 125, Interior	Interior views of Unit 125 with crack in drywall (Photo 058) and door racked in frame (Photos 067 and 068)
069-080	Unit 127, Interior	Interior views of Unit 127 with prior repairs in gypsum board ceiling of kitchen (Photos 078 and 079)
081-108	Unit 129, Interior	Interior views of Unit 129 with cracks in drywall above door frames (Photos 091, 092, 096, and 097) and near shower (Photo 101), cracked tile next to tub (Photos 105 and 106), and patched gypsum board above door frame (Photos 103 and 104)

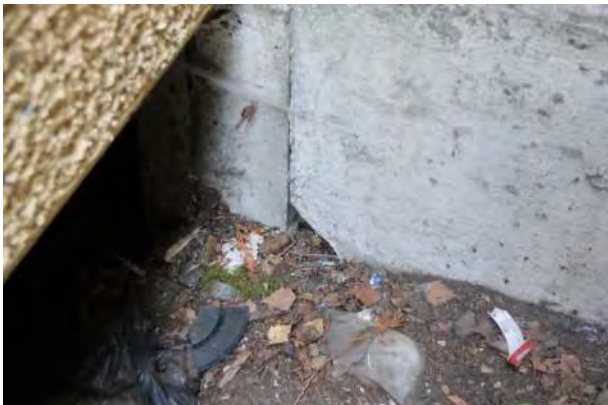
Pre\_183 - [IMG\_3452]

183-188	Crawlspace Entry	Concrete spalling and separation around crawlspace entry

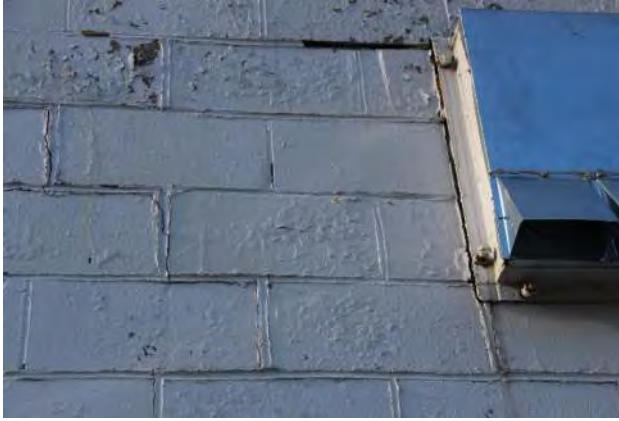
Post\_016

Photo No.	Location	Description/Conditions Observed
001-003	North Elevation, Exterior	Views of front of building
004-006	East Elevation, Exterior	Overall view of east side of building
006-013	East Elevation, Exterior	Exterior wall finishes and mansard cladding
014-020	East Elevation, Exterior	Stairstep cracking in mortar joints of CMU wall
021	East Elevation, Exterior	Wall finishes and roof coping
022	East Elevation, Exterior	Segmental retaining wall at southeast corner of structure
023-025	East Elevation, Exterior	Wall finishes and roof coping
026-038	North Elevation, Exterior	Wall finishes, mansards, soffits, and storefront at China Café
039-041	North Elevation, Exterior	Pavement at parking lot
042-048	North Elevation, Exterior	Wall finishes, mansards, soffits, and storefront at Nielson Bros and Sound Sports
049-060	North Elevation, Exterior	Detailed view of wood panel separation on walls and soffits

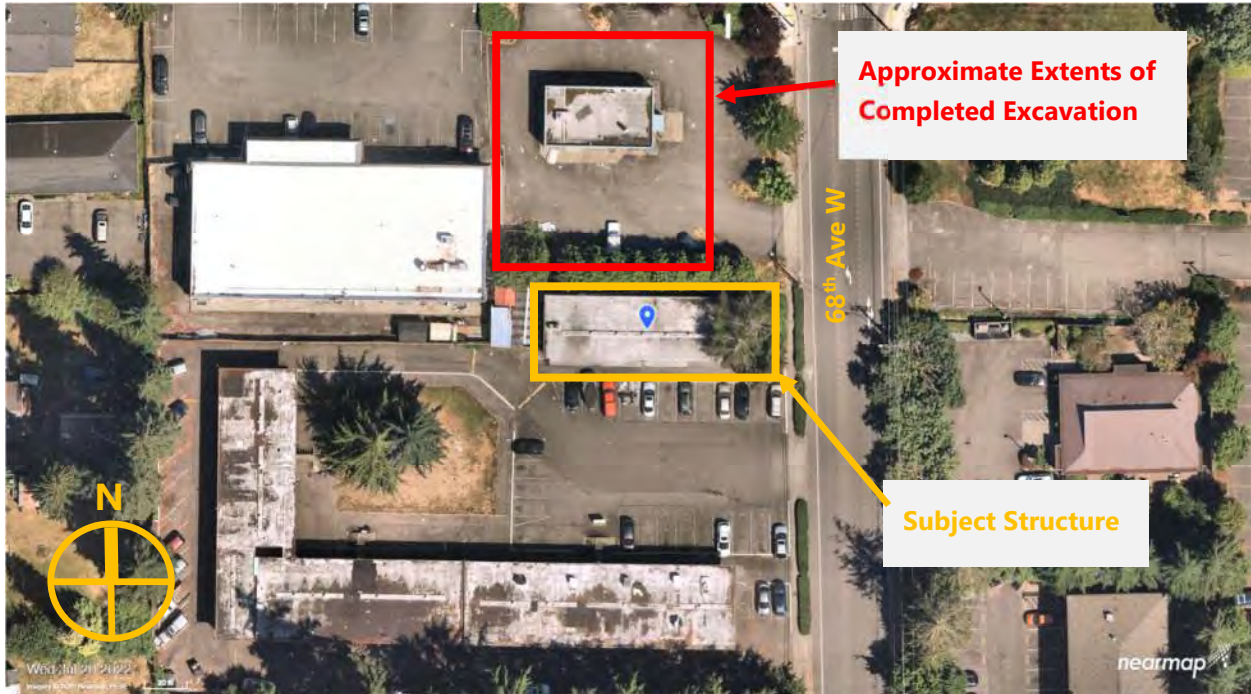
Figure 1. Aerial view of subject property. Image © 2022 Nearmap.

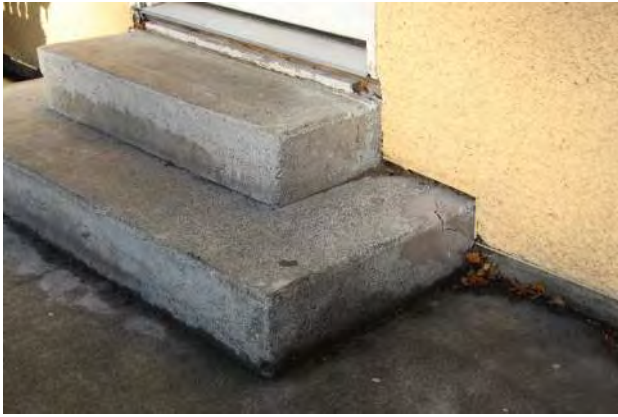
Post\_032

032-033	South Elevation, Exterior	Entryway to Units 127, 129, 228, and 230 with crack in concrete steps and separation between steps and wall

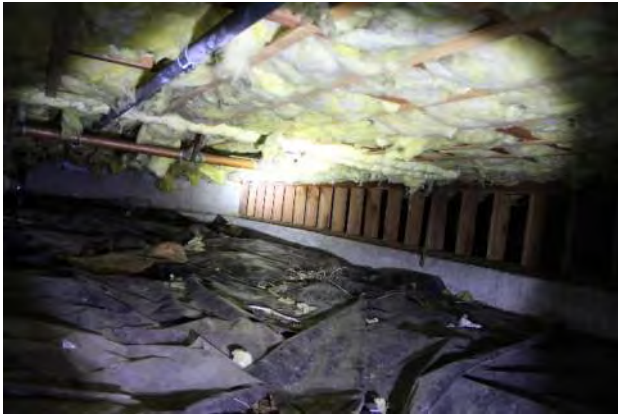
Post\_168

Photo "Pre\_170" was not replicated during January 10, 2023 site visit. Photo was of same portion of crawl space as "Pre\_171" and "Post\_171" taken from a different angle.

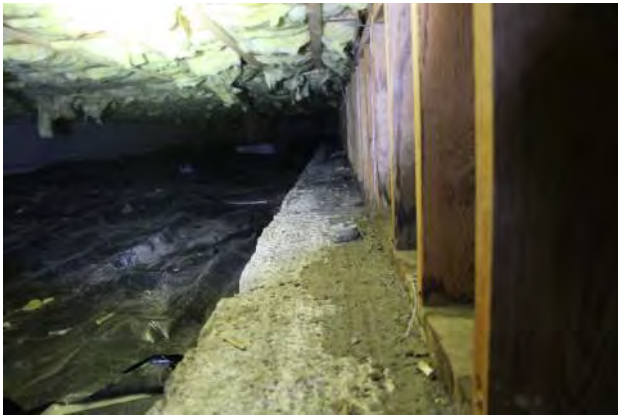
Post\_178

Photo "Pre\_180" was not replicated during January 10, 2023 site visit. Photo was of same portion of crawl space as "Pre\_179" and "Post\_179" taken from a different angle.

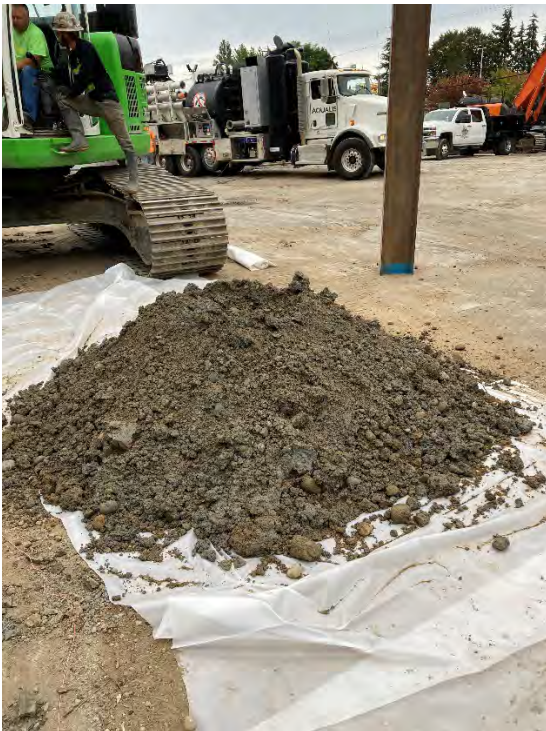
Photo 2: Soldier pile installation cuttings being placed on plastic.

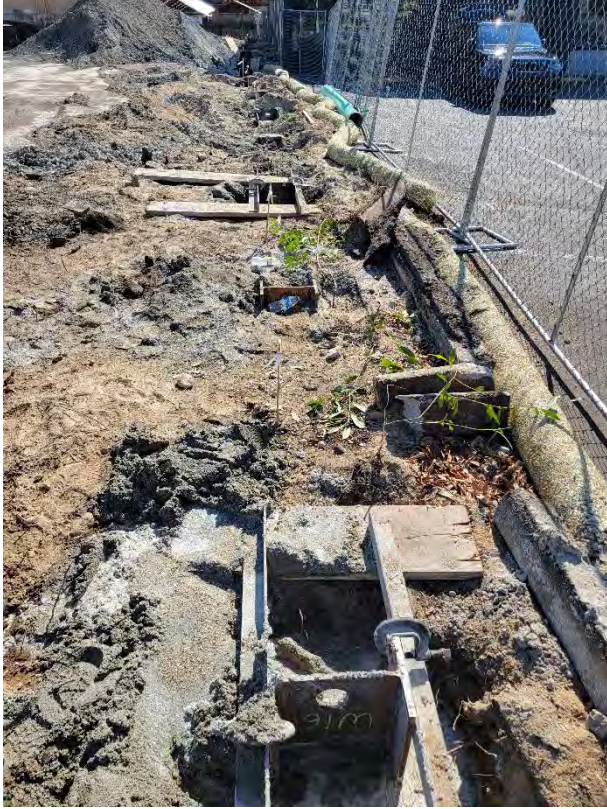
Photo 1 (left): Soldier piles installed on West Soldier Pile wall looking south.

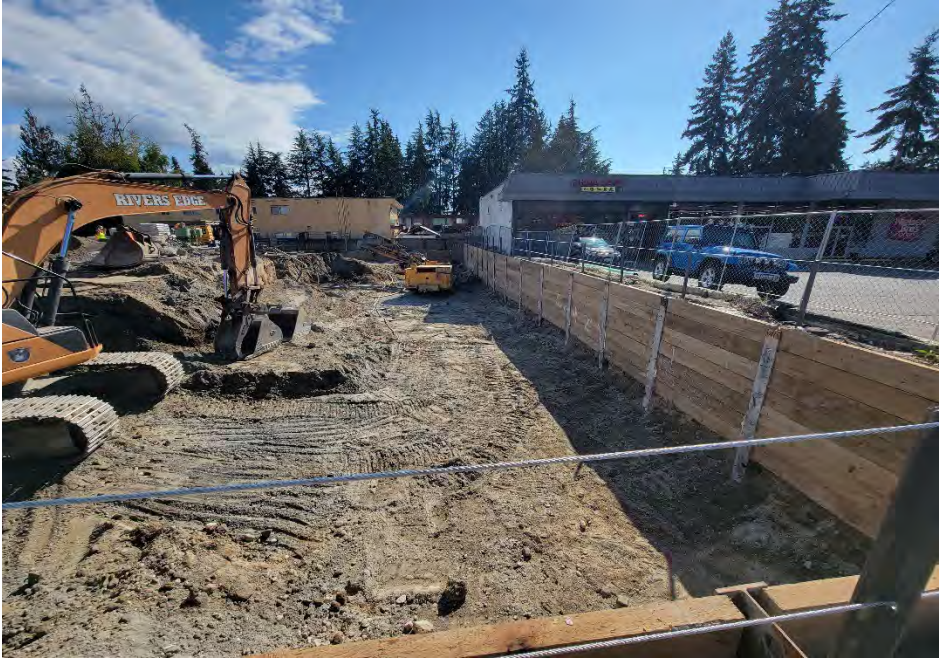
Photo 1: West Sidewalk facing South

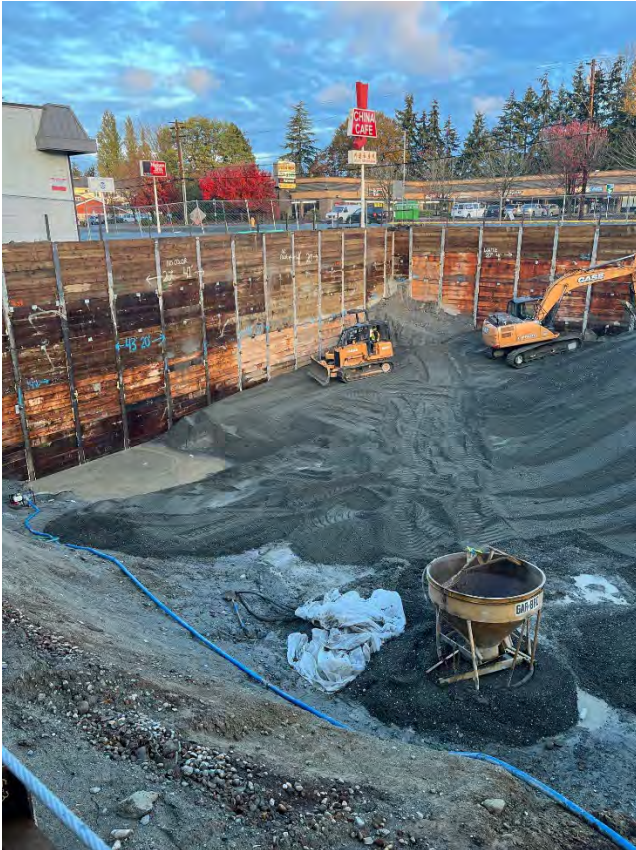
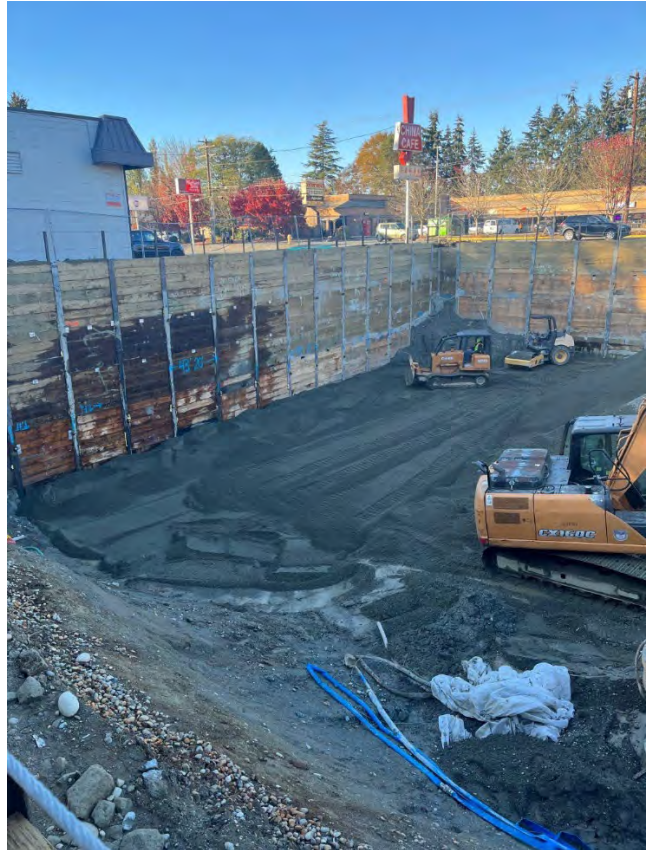
No discussions happened onsite today of significance. Garrett of Rivers Edge had planned to get the water pumped out of the area that had been collecting along the west wall overnight and into today's workday. That was executed, and the collection of water was removed, and fill material was put in its place and compacted.

Photos 1 (Left) and 2 (Right): Photo 1 is of the excavation backfill area at the start of the day, looking northwest. Photo 2 is of the same view at the end of the day today.

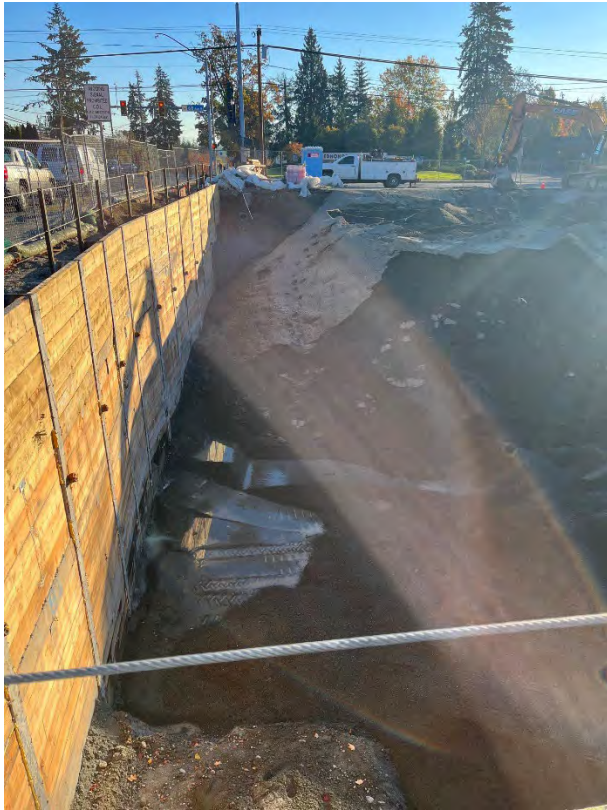
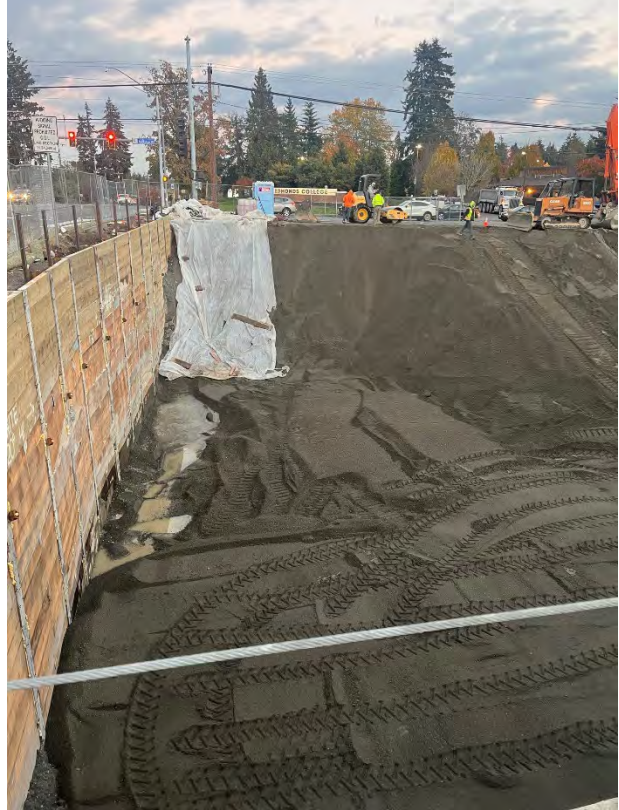
Photos 1 (left) and 2 (right): Photo 1 is of the backfill progression, looking north at the start of the day today and photo 2 is of the same area at the end of the day.

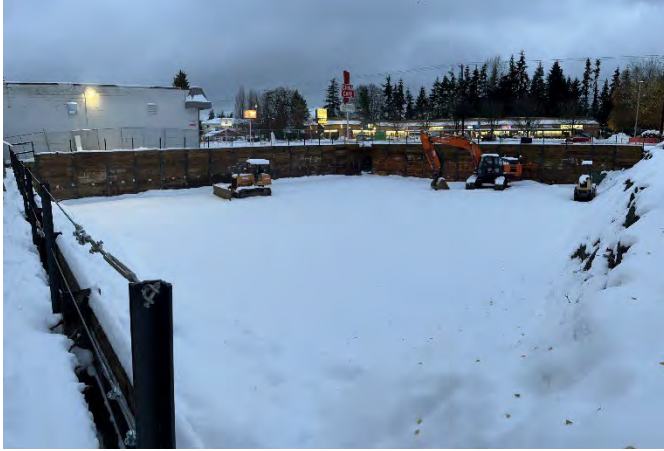
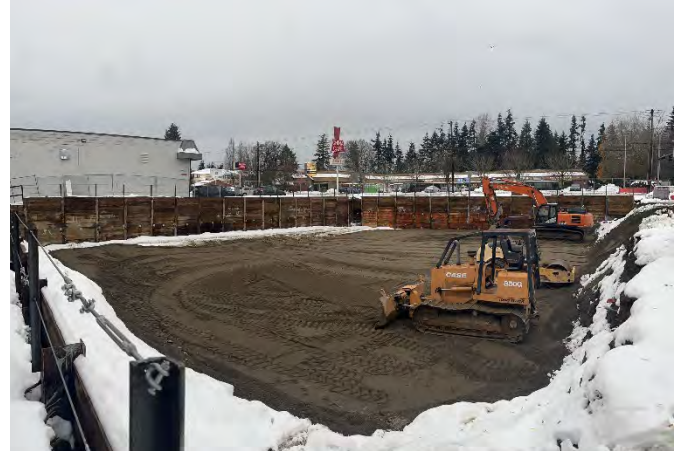
Photos 1 (left) and 2 (right): Photo 1 is of the backfill progression, looking northwest at the start of the day today and photo 2 is of the same area at the end of the day.

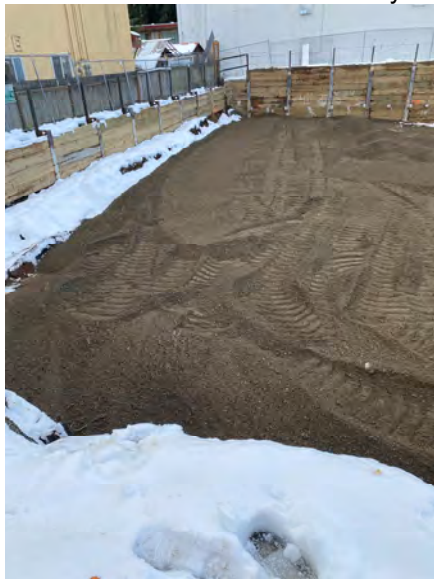
Graded Lift

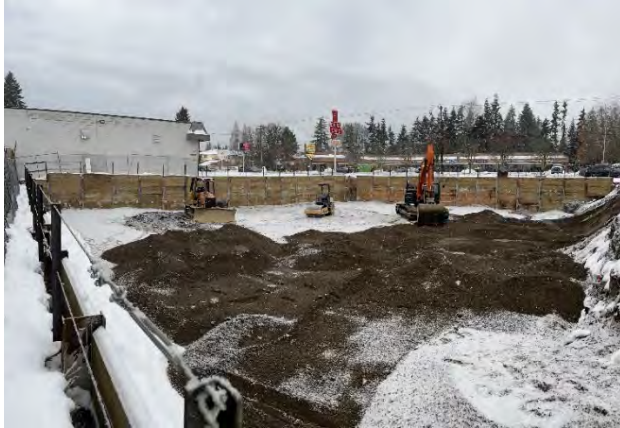
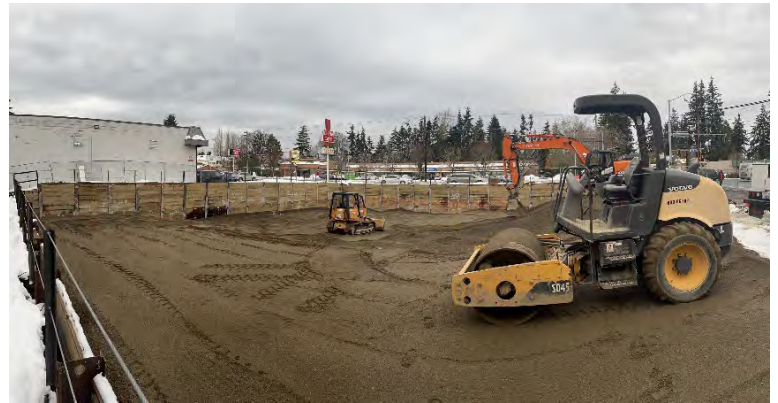
Photos 1 (left) and 2 (right): Photo 1 is of the backfill progression, looking northwest at the start of the day today and photo 2 is looking Northwest at the end of the day.

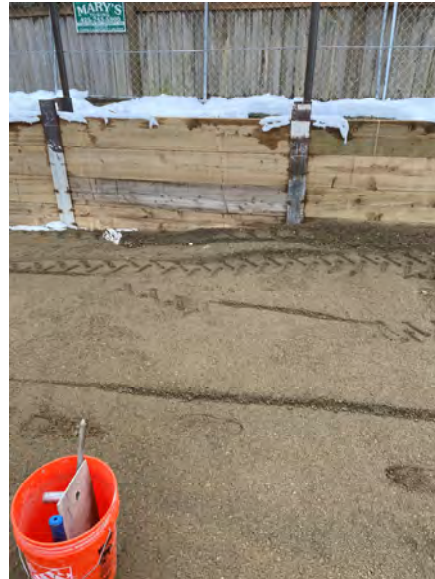
Tested South Area Of Site

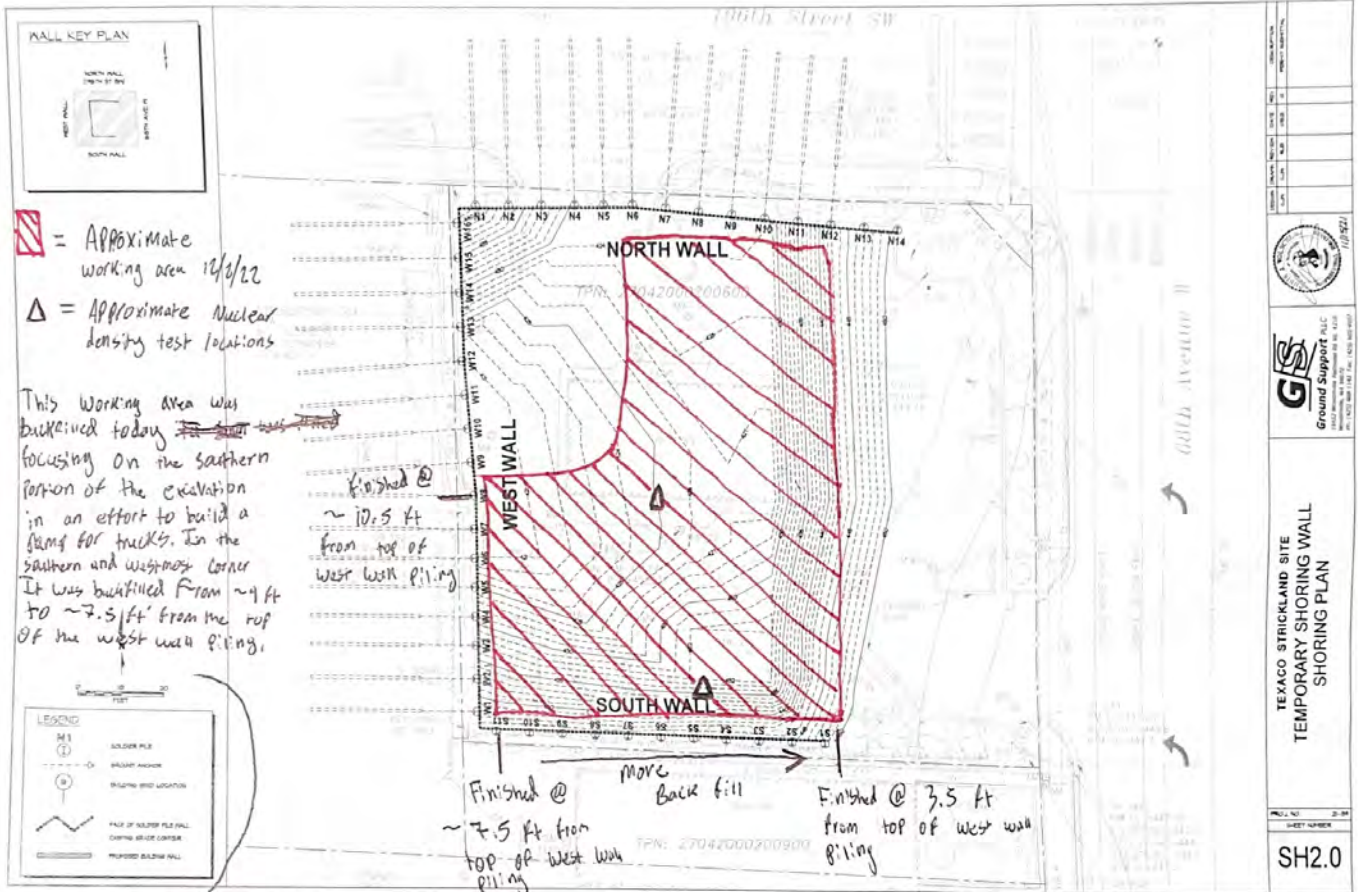
This working area was backfilled today ~~with backfill~~ focusing on the southern portion of the excavation in an effort to build a ramp for trucks. In the southern and west-most corner it was backfilled from ~4 ft to ~7.5 ft from the top of the west wall piling.

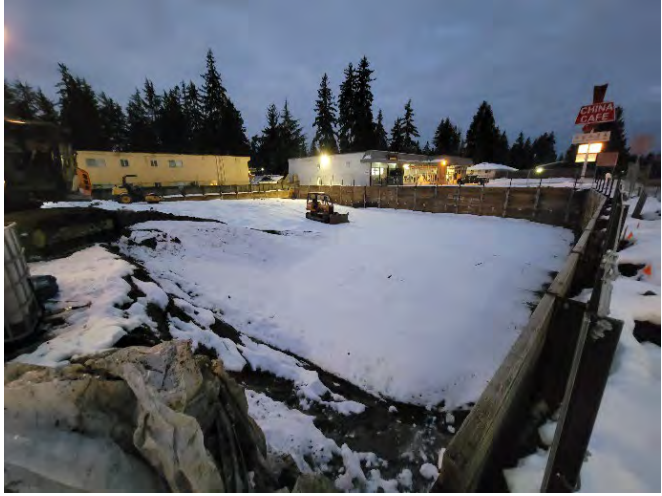
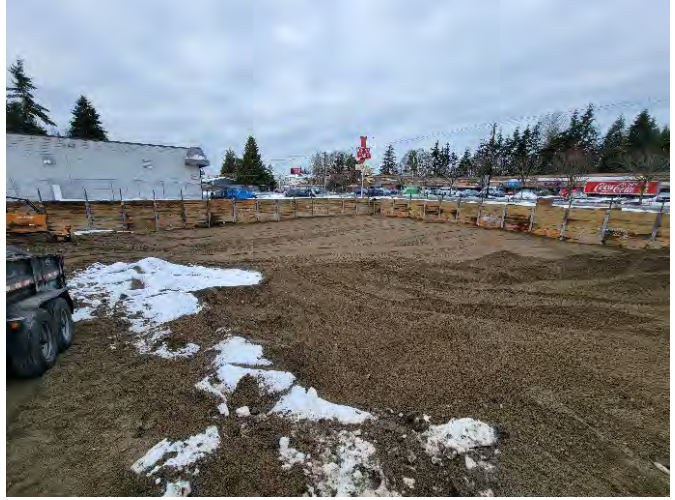
Photo 1. (left) Site conditions and elevation at start of day looking southwest. Photo 2. (right) Site at end of day looking northwest.

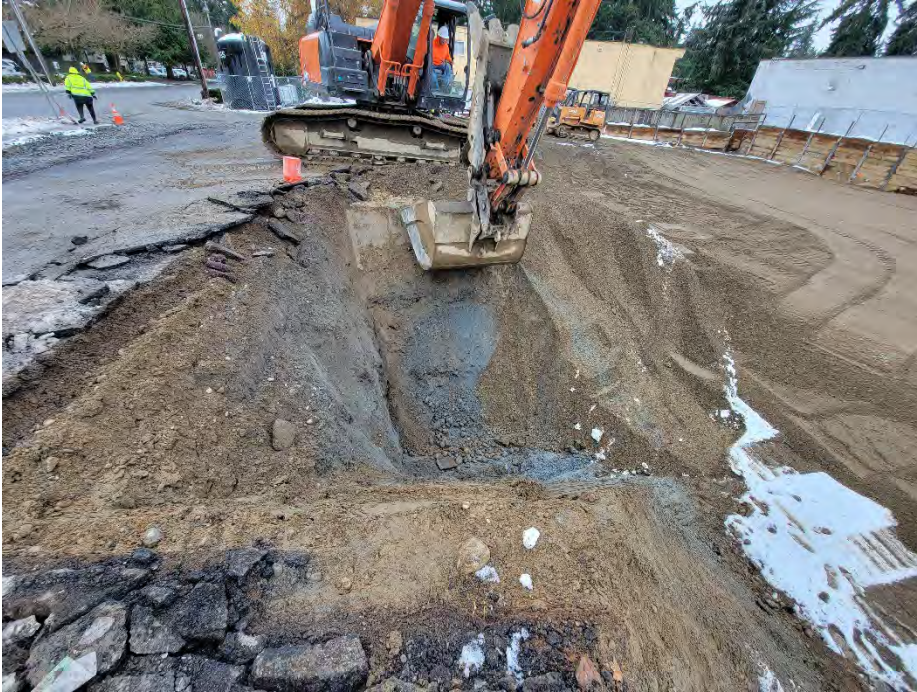
*Photo 1. Eastern slope overexcavation in progress, looking south. Contaminated soil is gray.*

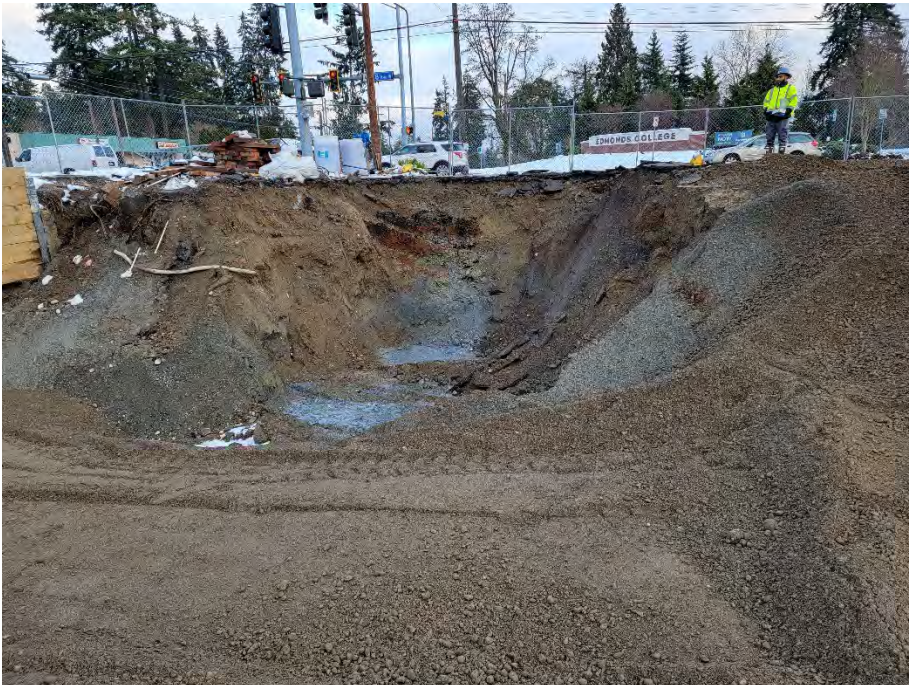
*Photo 2. Eastern slope overexcavation in progress, looking east. Contaminated soil is gray.*

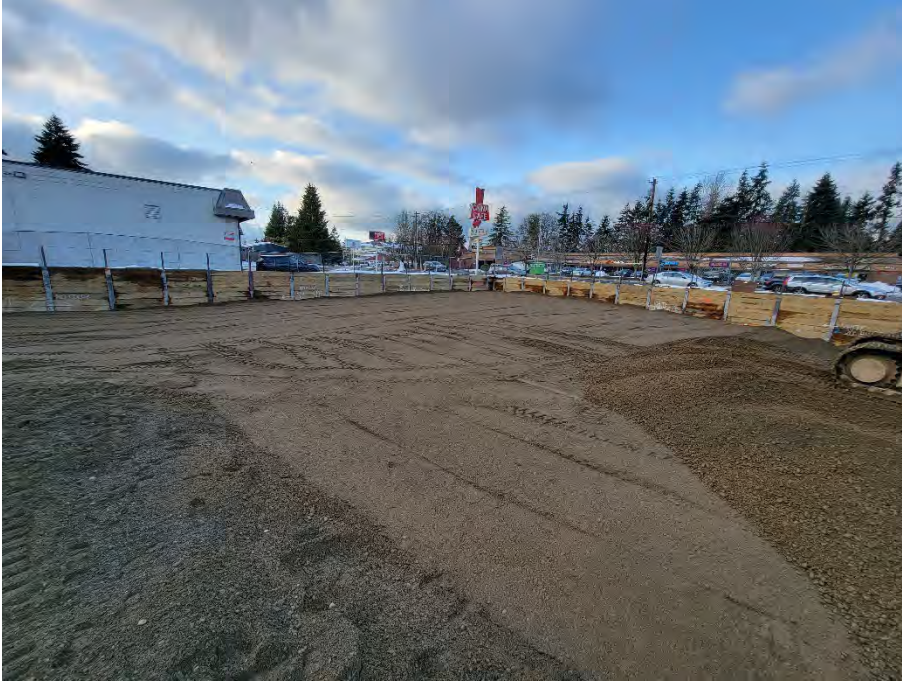
*Photo 3. Excavation backfill progress at end of day, looking northwest.*

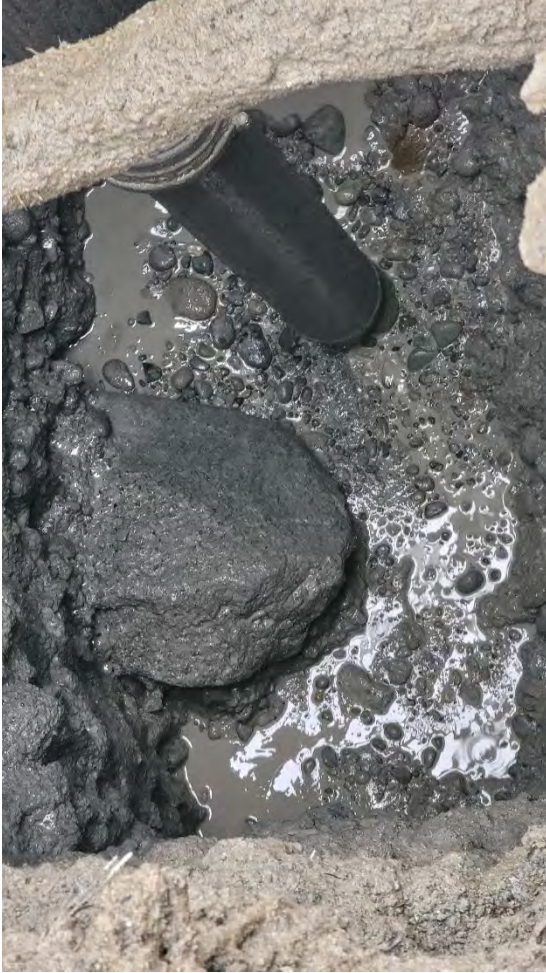
Figure 1. Glacial erratic at the bottom of the slot cut.
