January 2024

2023 Land Use Control Inspections Technical Memorandum

**Sites 302, 303, and 304 and Tank 50
Naval Base Kitsap Manchester, Kitsap County,
Washington**

**United States Department of the Navy
Naval Facilities Engineering Systems Command**
1101 Tautog Circle
Silverdale, WA 98315-1101

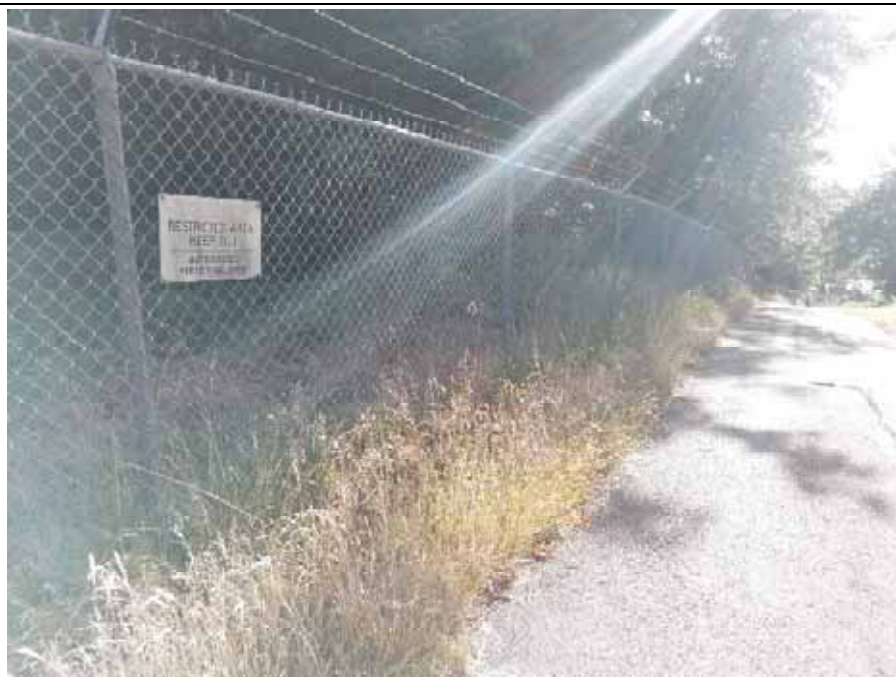
Photograph 1

Land use control (LUC) signage along southeastern road boundary, facing east.

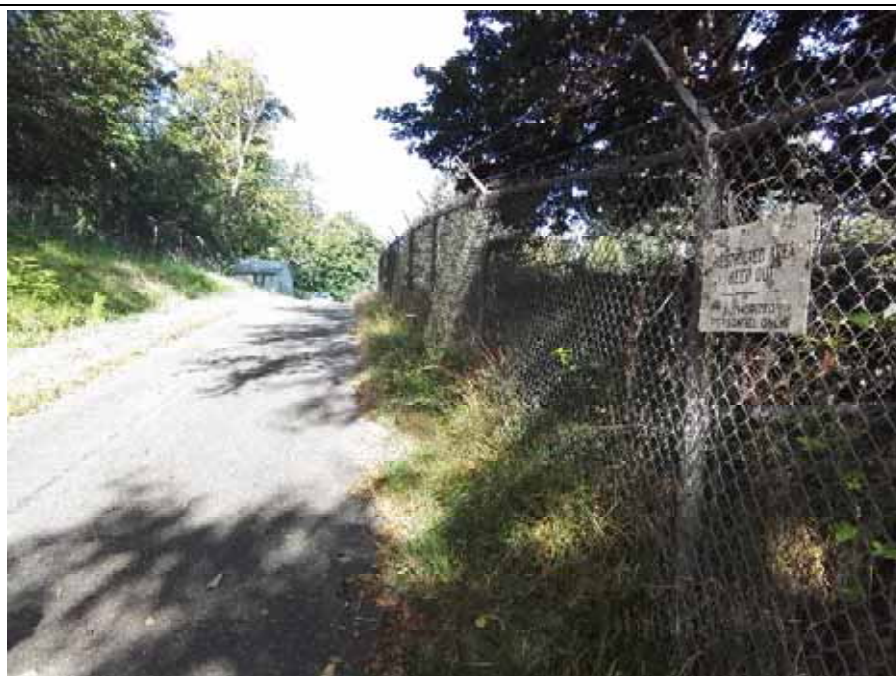
Photograph 2

LUC signage at southeast corner, facing west.

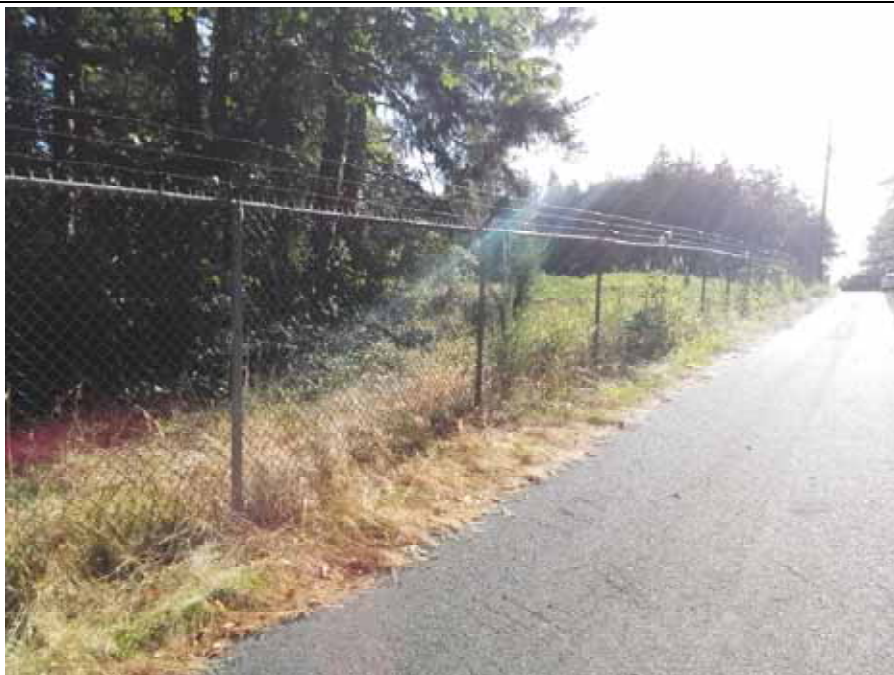
Photograph 3

Fencing along southwestern boundary of site, facing northeast.

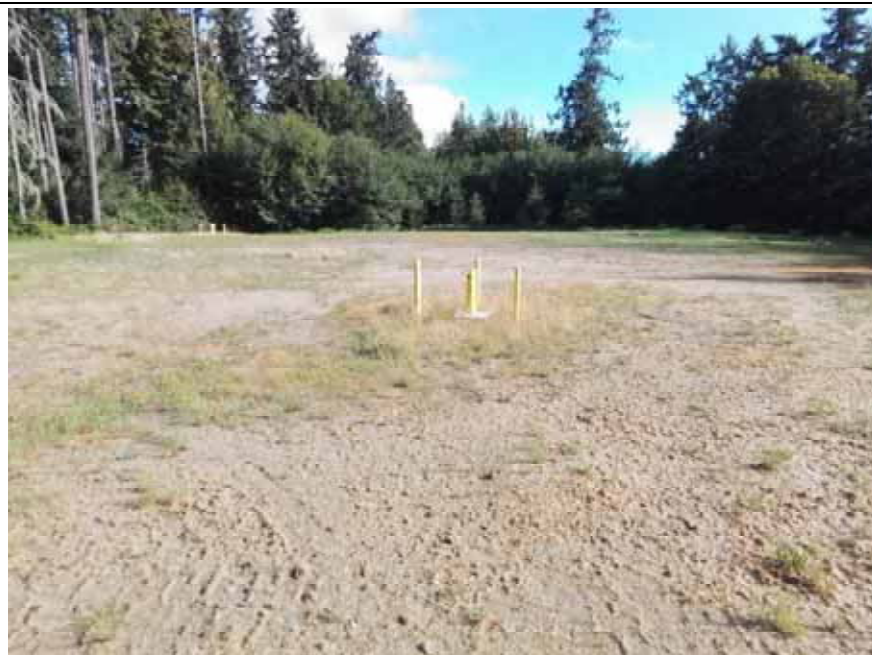
Photograph 4

South central area of site and new PFAS groundwater monitoring well MFD-S302-MW03, facing north.

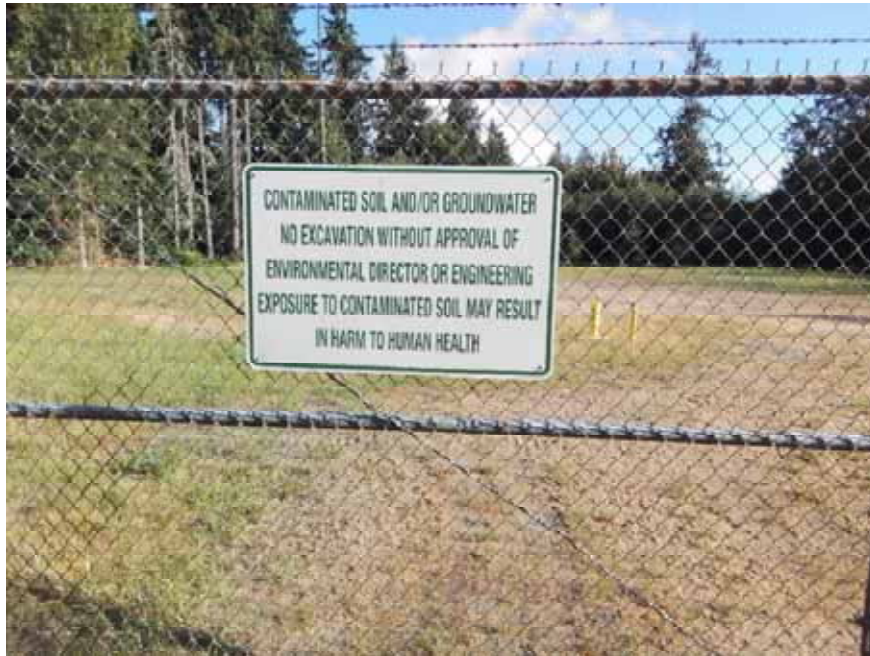
Photograph 5

LUC signage located on south side of site, facing north.

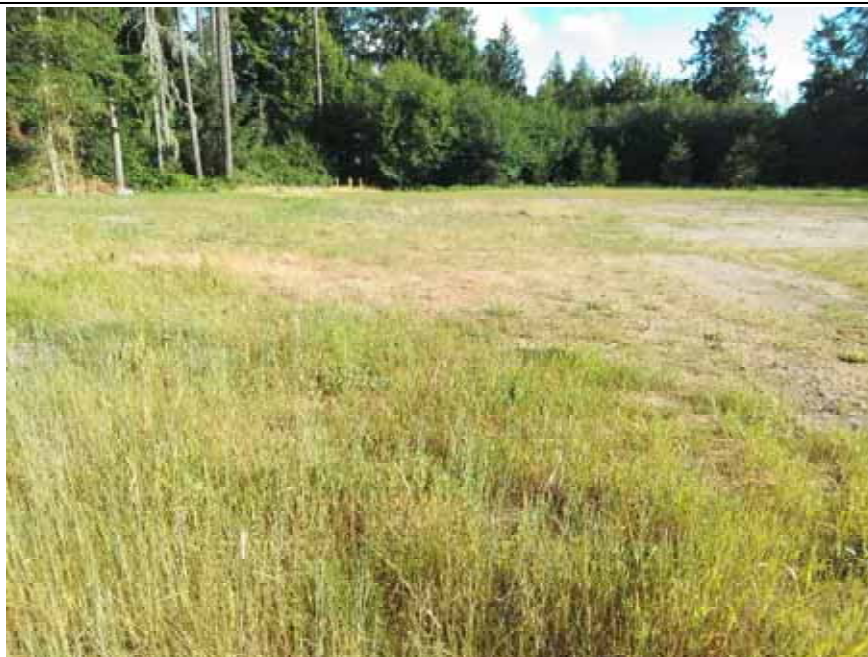
Photograph 8
South central area of site, facing northwest. PFAS groundwater monitoring well MFD-S302-MW02 in the background.

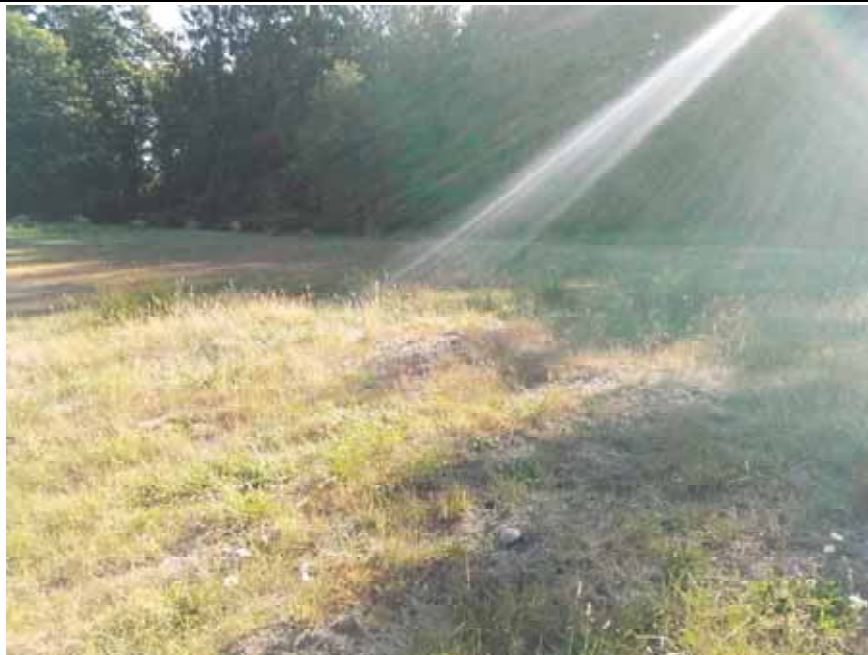
Photograph 10

Stockpiles with covered with vegetation, central area of site, facing northeast.

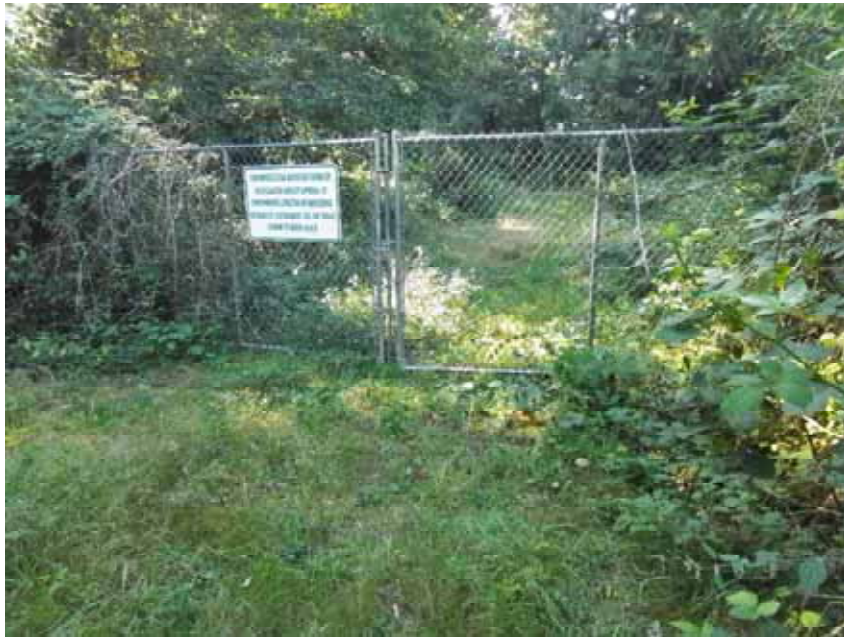
Photograph 13

Locked access gate and LUC signage located on north side of site, facing south. Chain has been added to secure the gate.

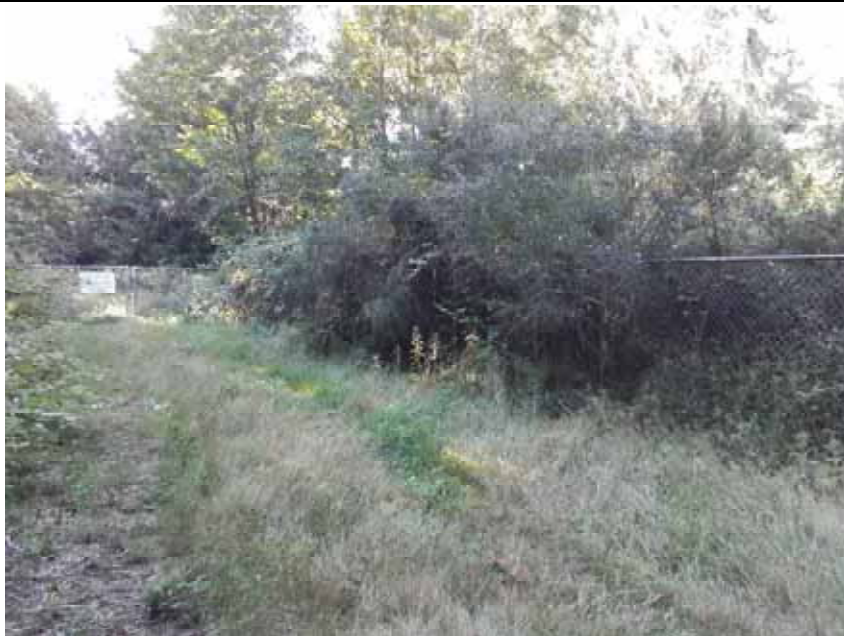
Photograph 14

Northern corner fence line, facing southwest.

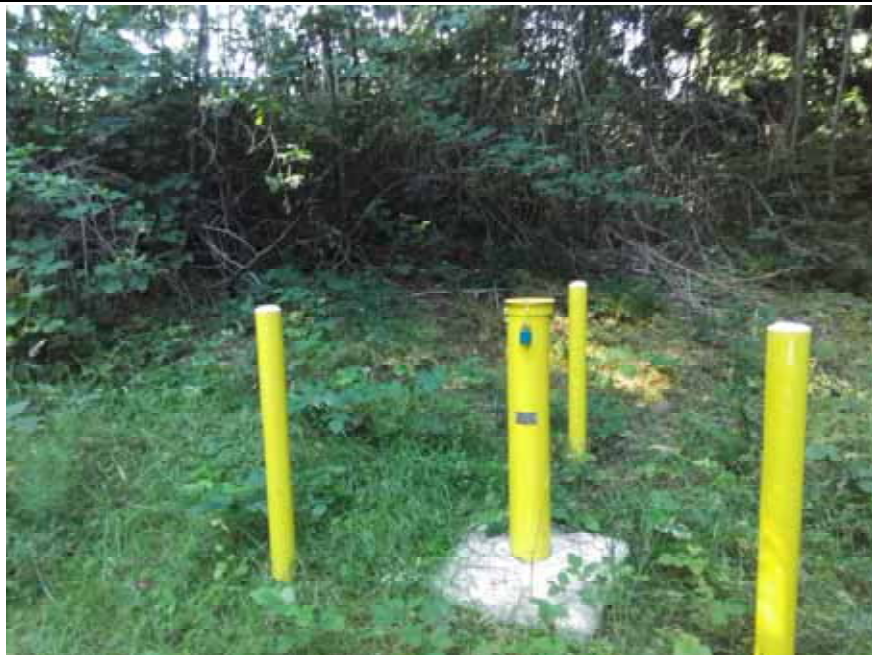
Photograph 18
New PFAS groundwater monitoring well MFD-S302-MW01 located within the northeast area of site, facing south.

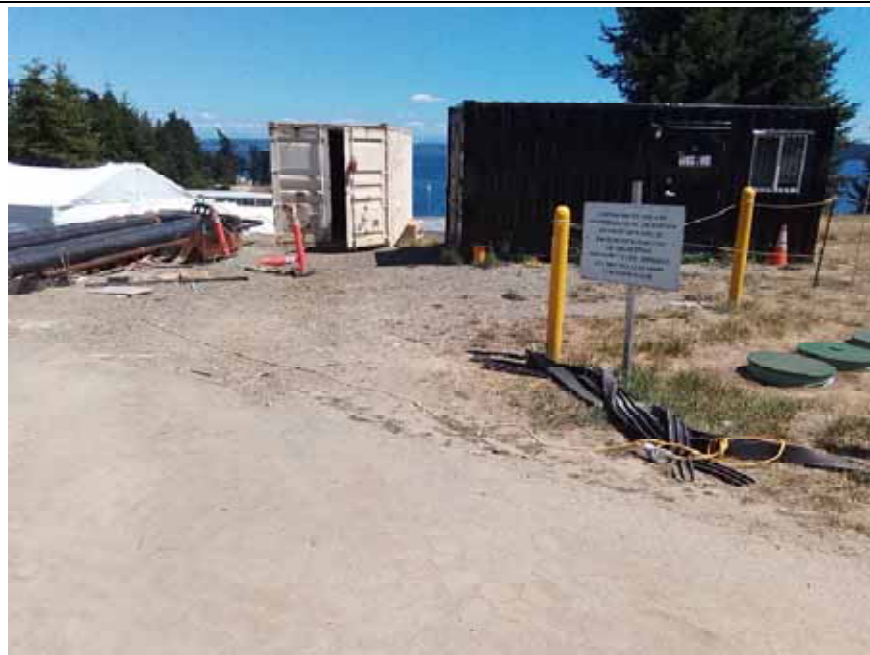
Photograph 2
Land Use Control (LUC) signage and storage containers, facing southeast.

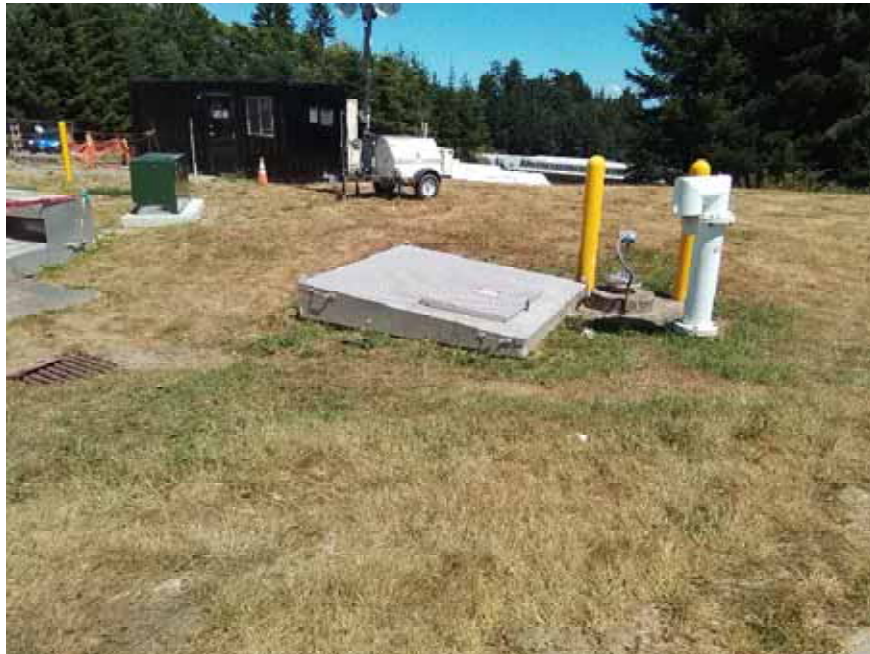
Photograph 3

Locations of former vapor monitoring wells and newly installed vault, facing east.

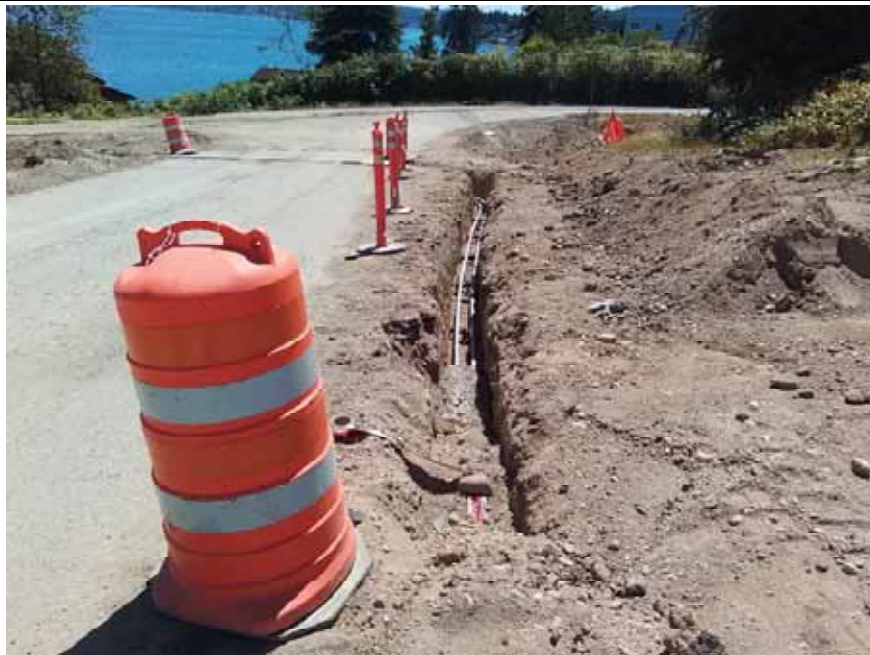
Photograph 4

Utility trench associated with active construction activities.

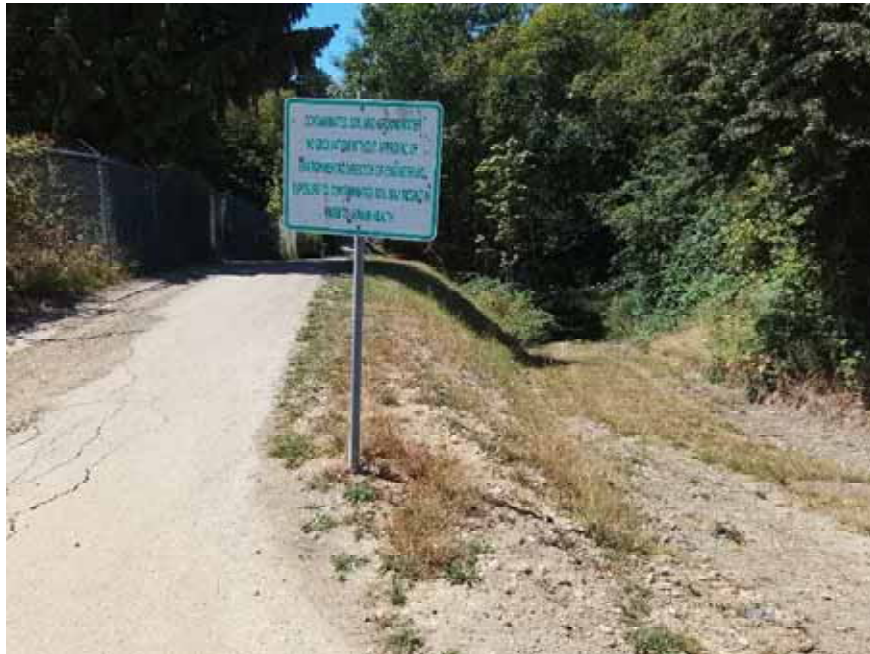
Photograph 5
LUC signage along southeast perimeter, facing west.

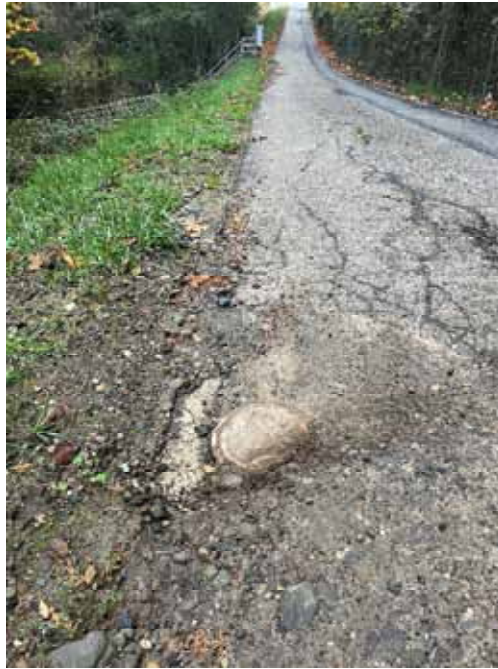
Photograph 7

Unable to locate groundwater monitoring well MW-1, facing east.

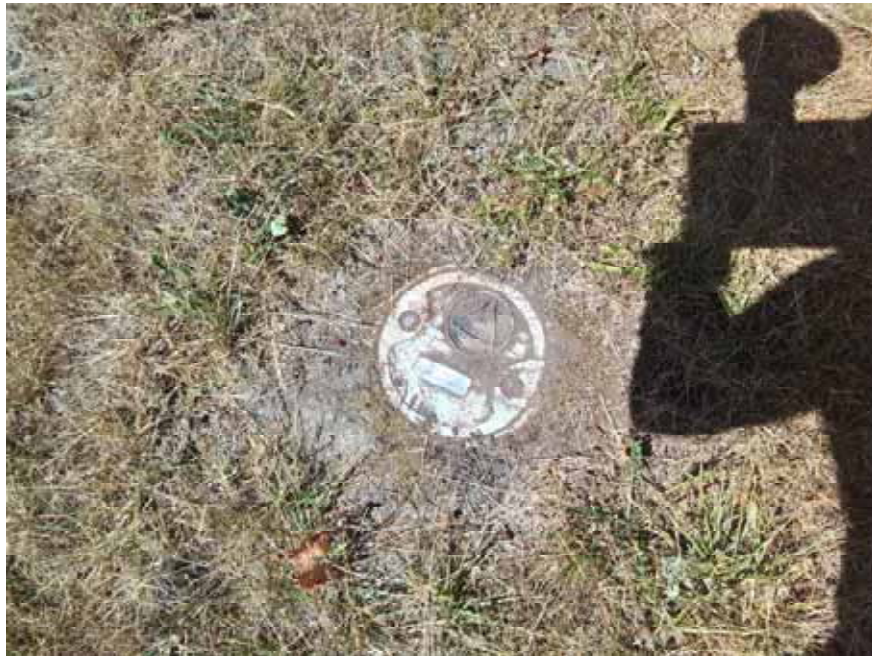
Photograph 23

Groundwater monitoring well MW-3, northwest of site boundary, facing north.

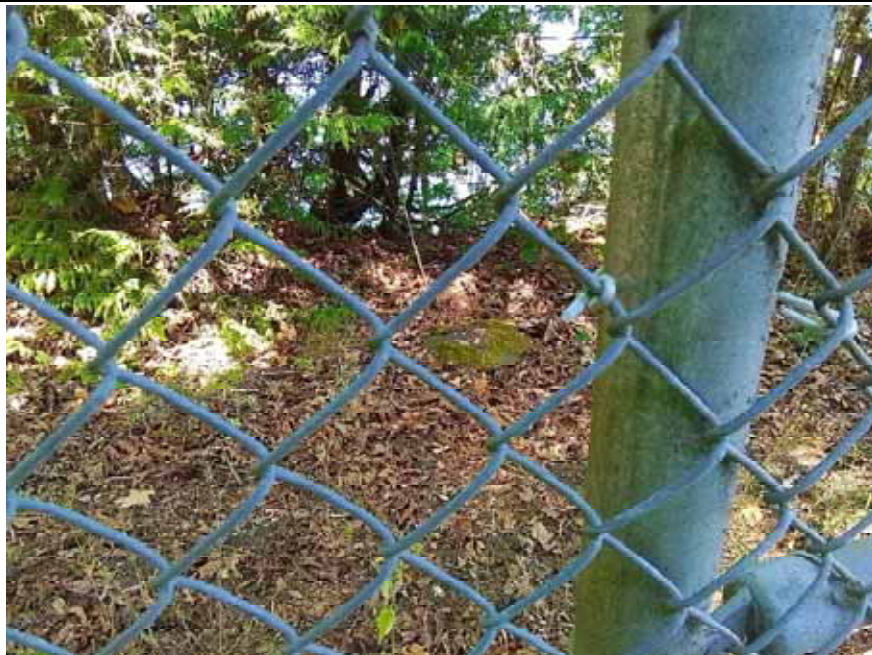
Photograph 24

Groundwater monitoring well MW-1, northwest of site boundary, facing north.

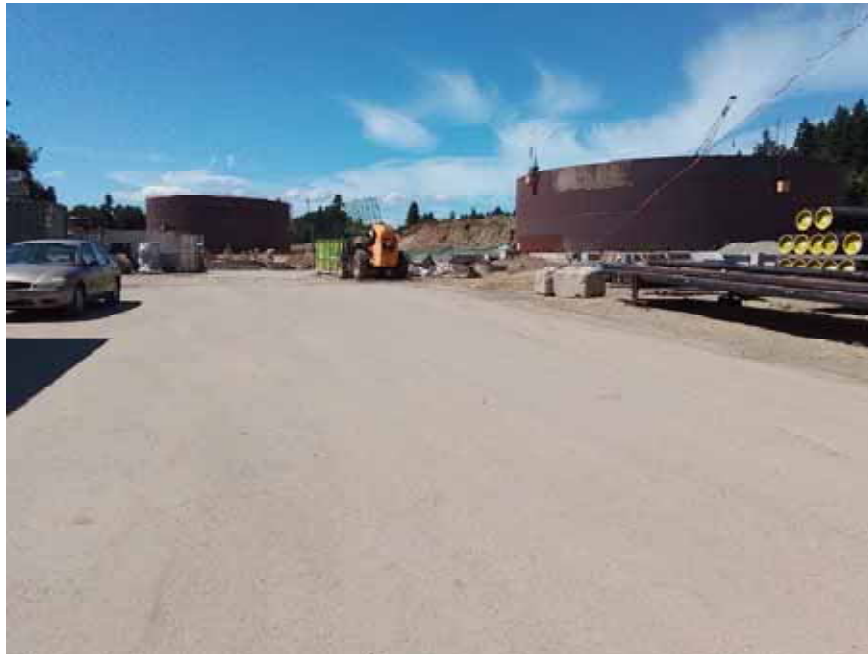
Photograph 25
Construction and earthwork activities, facing northwest.

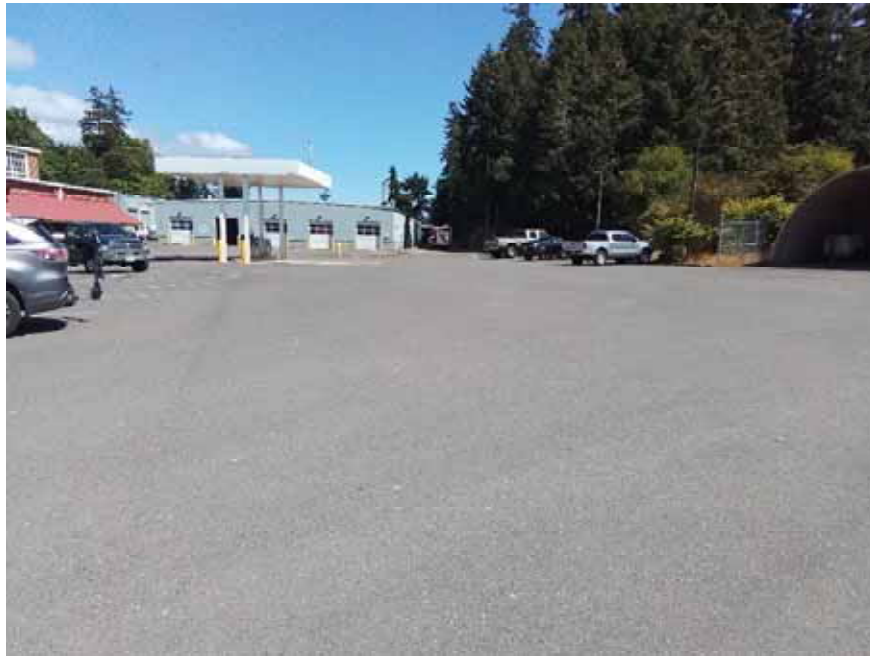
Photograph 1

Parking lot along northeast boundary, facing north.

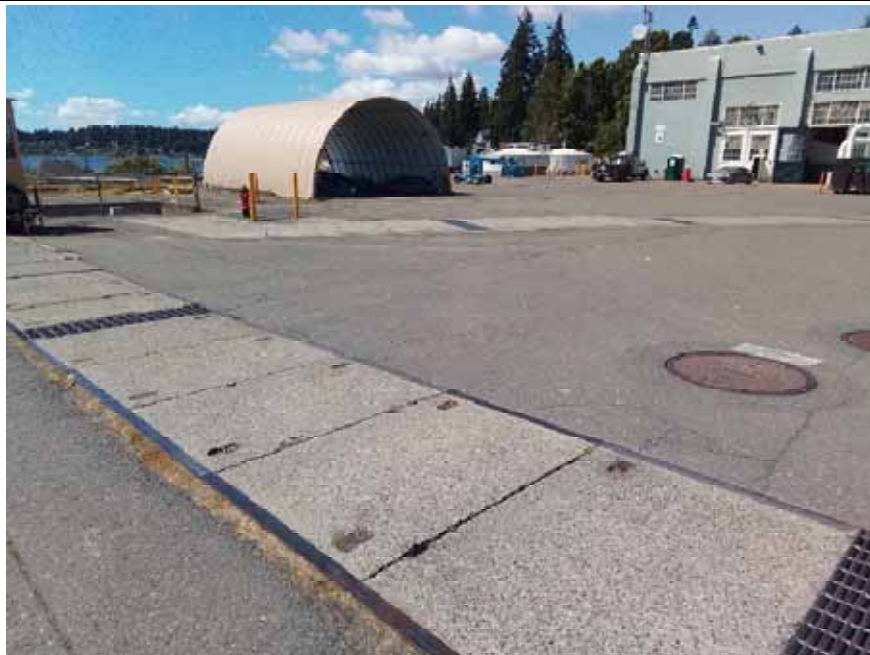
Photograph 2

Parking lot along southcentral area of site, facing southwest.

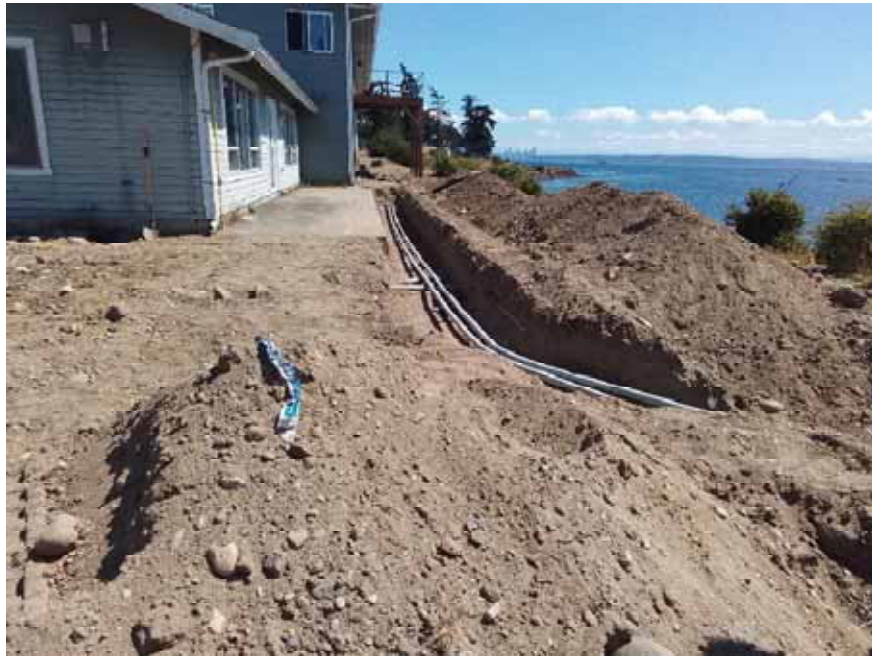
Photograph 3

South central boundary adjacent to Administration Building showing utility trench related to construction activities, facing northeast.

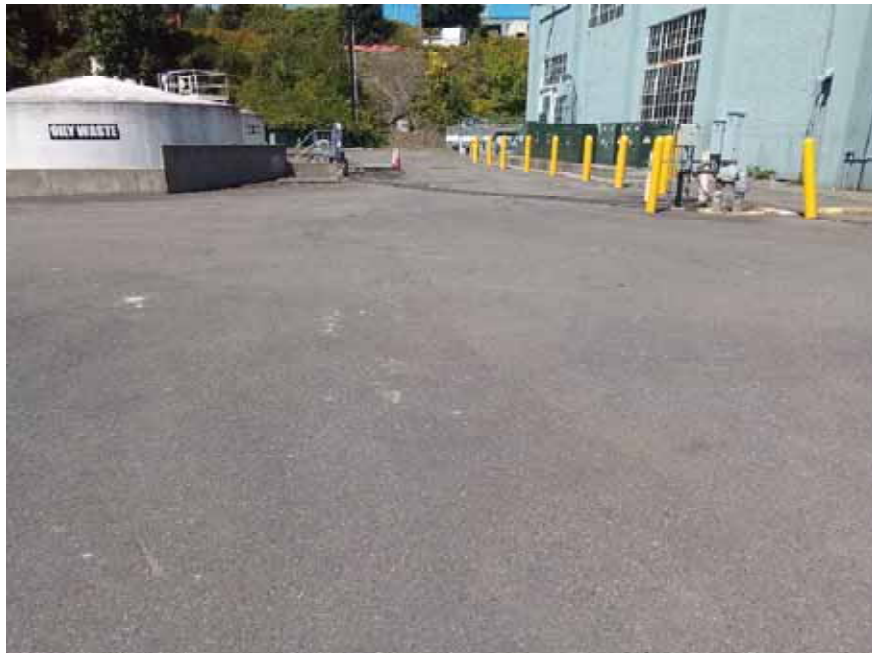
Photograph 6

Southwest boundary of site, facing west.

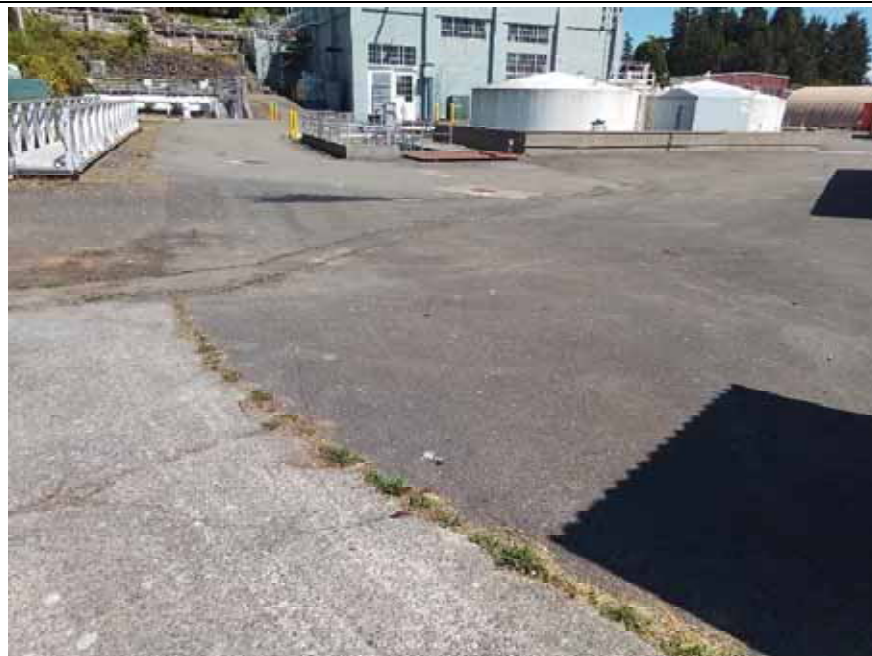
Photograph 7
Southwest boundary of site, facing northeast.

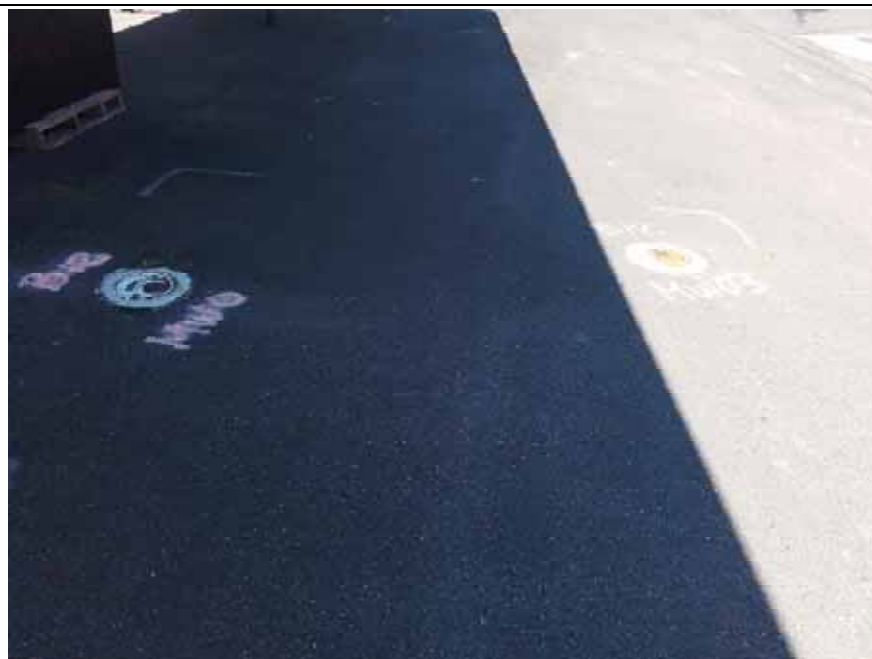
Photograph 8
Groundwater monitoring well MW-3 and one new PFAS monitoring well MFD-B12-MW03,
facing west.

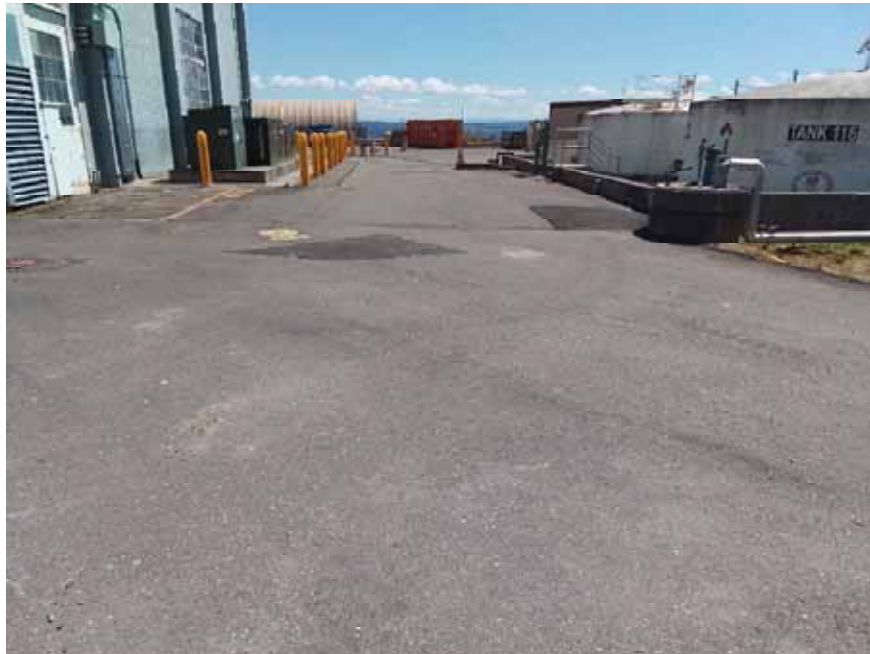
Photograph 9

Repaved asphalt located near southwest boundary, facing east.

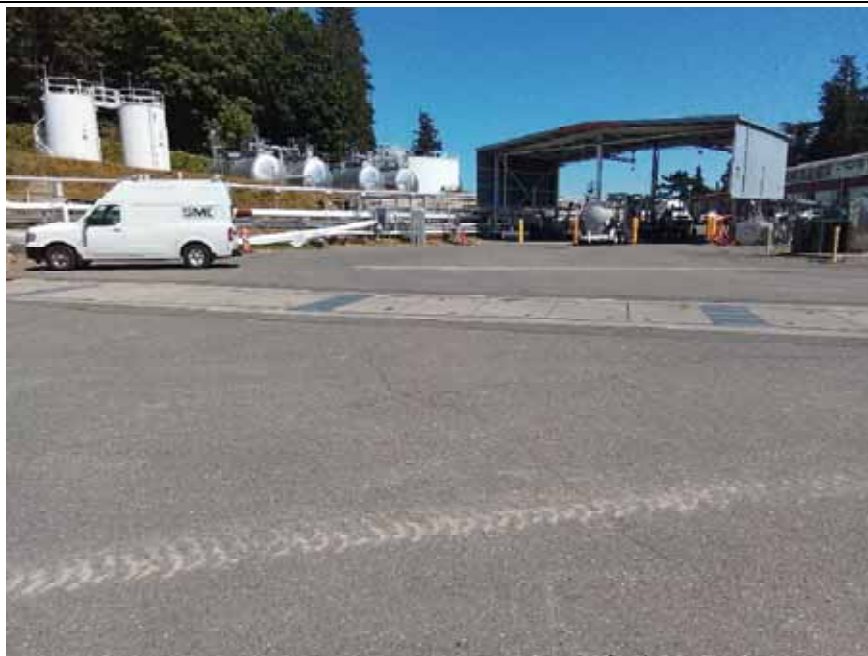
Photograph 11
West central area of site, facing northeast.

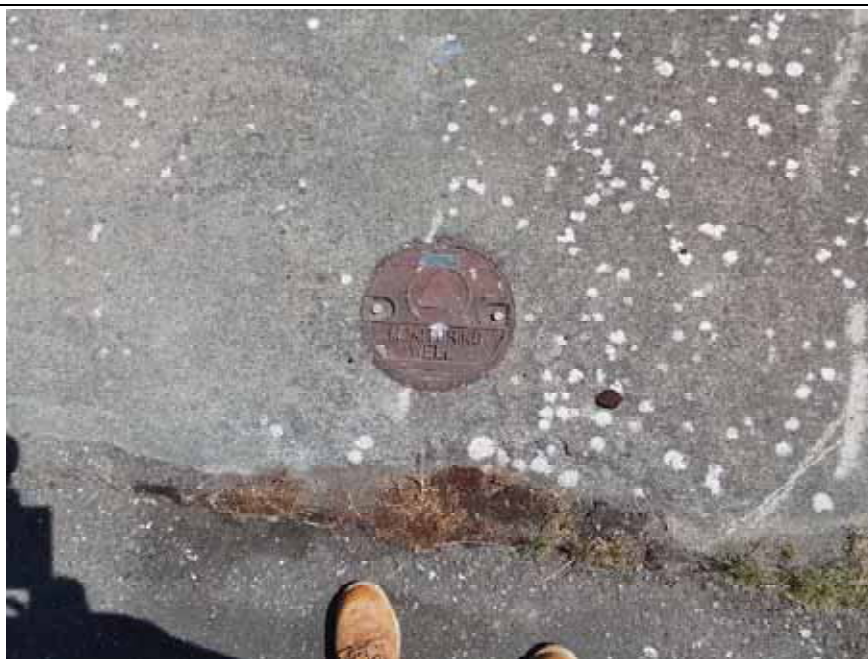
Photograph 12
Groundwater monitoring well MW-2, facing northeast.

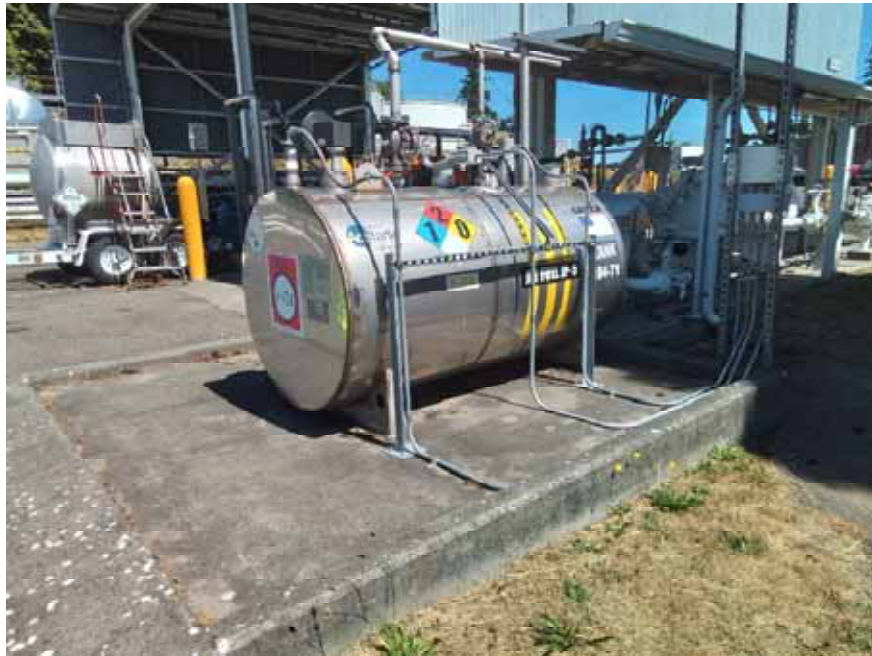
Photograph 13

Fuel related waste storage containers (under canopy), facing northwest.

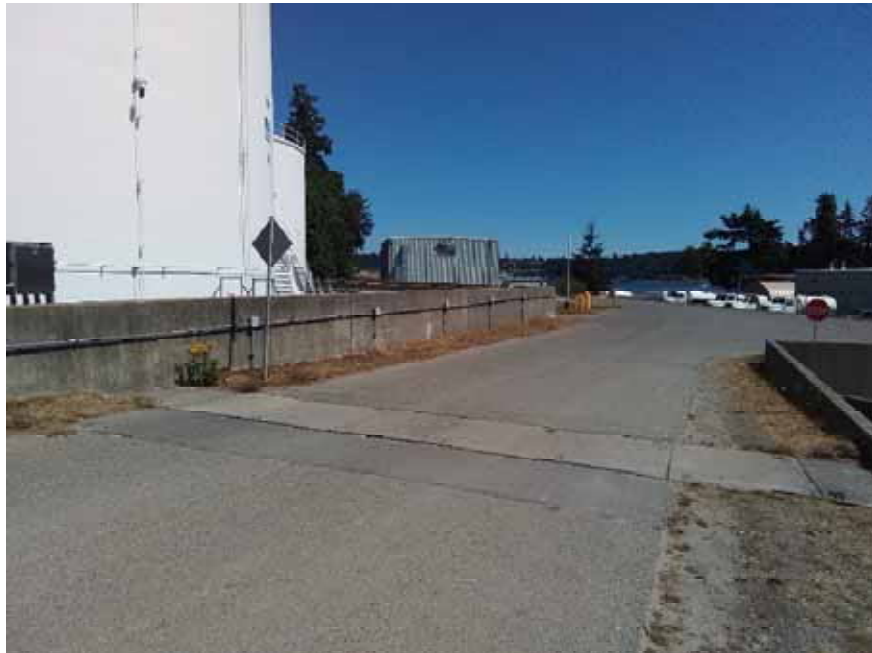
Photograph 14

Northeast boundary, facing northeast.

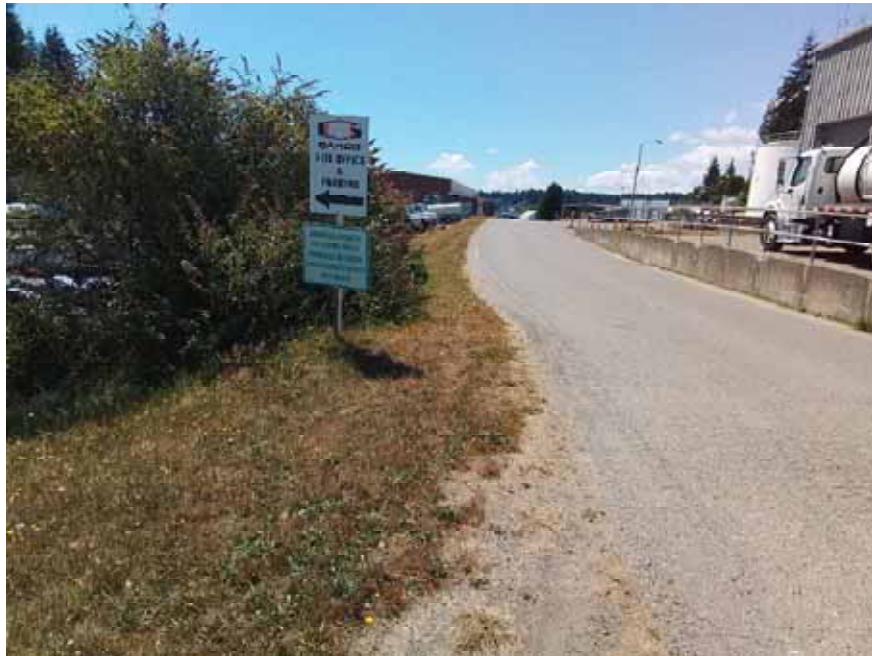
Photograph 15

The LUC signage for Site 304 is located at the northeastern corner of Building 178, outside and north of the Site 304 LUC boundary (see Figure 5). During finalization of the 2020 LUC Technical Memorandum (Battelle, 2020b), the Ecology Project Manager confirmed that it is not necessary to move/relocate the LUC signage for Site 304.

Land use control (LUC) signage located outside of north boundary of site, facing southwest.

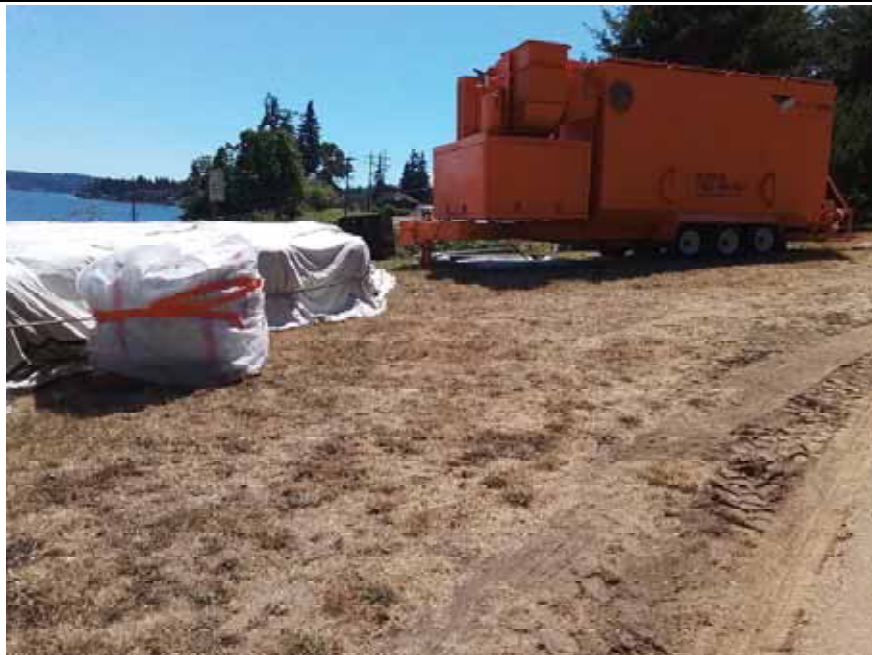
Photograph 16

Construction laydown area and location of former Tank 14, west of site boundary, facing southeast.

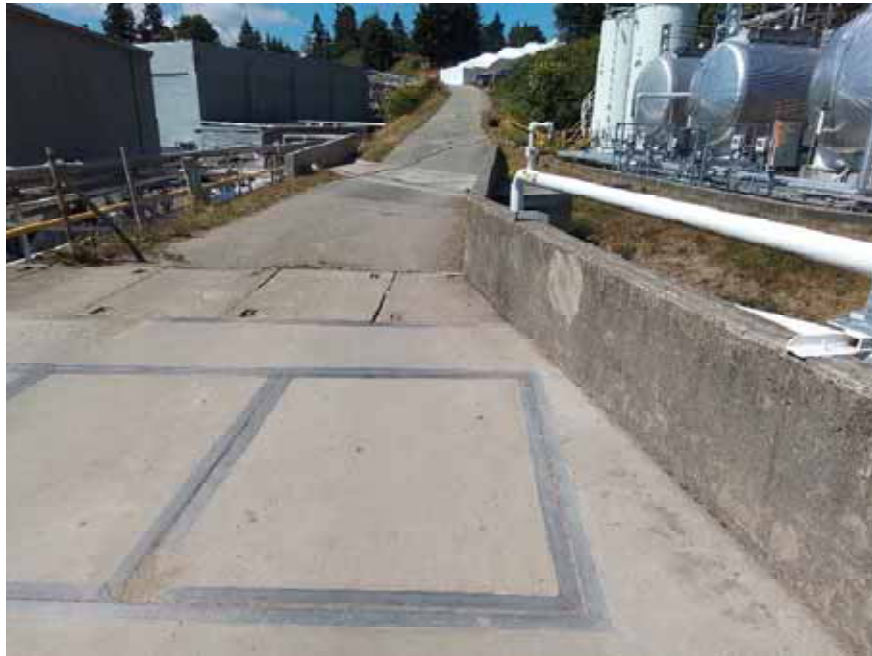
Photograph 17

Recently replaced concrete pad and vaults, along northwest boundary, facing southwest.

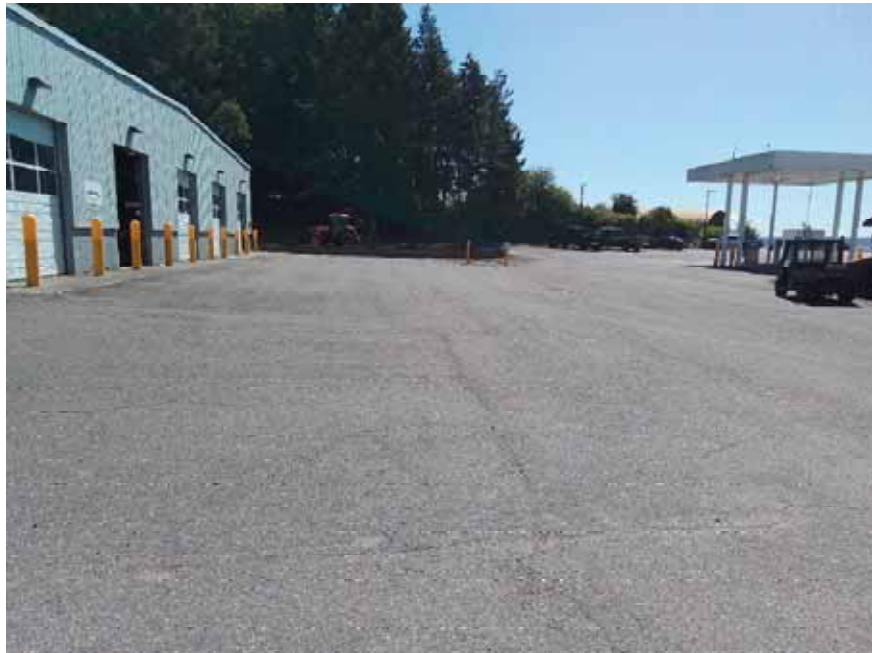
Photograph 18

Northeastern site boundary, facing southeast.

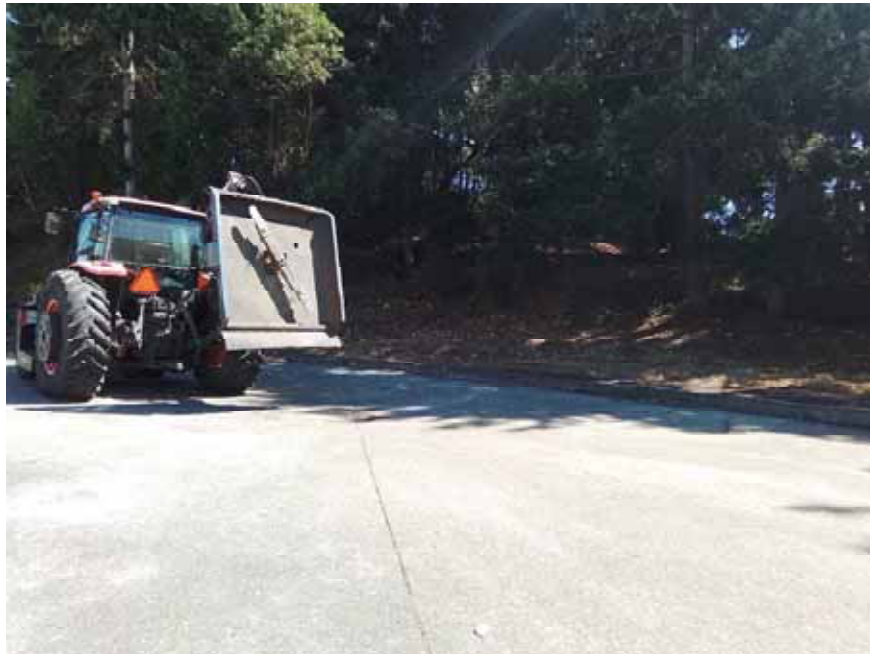
Photograph 19

Construction laydown are along eastern boundary of site, facing northeast. Fence has been removed.

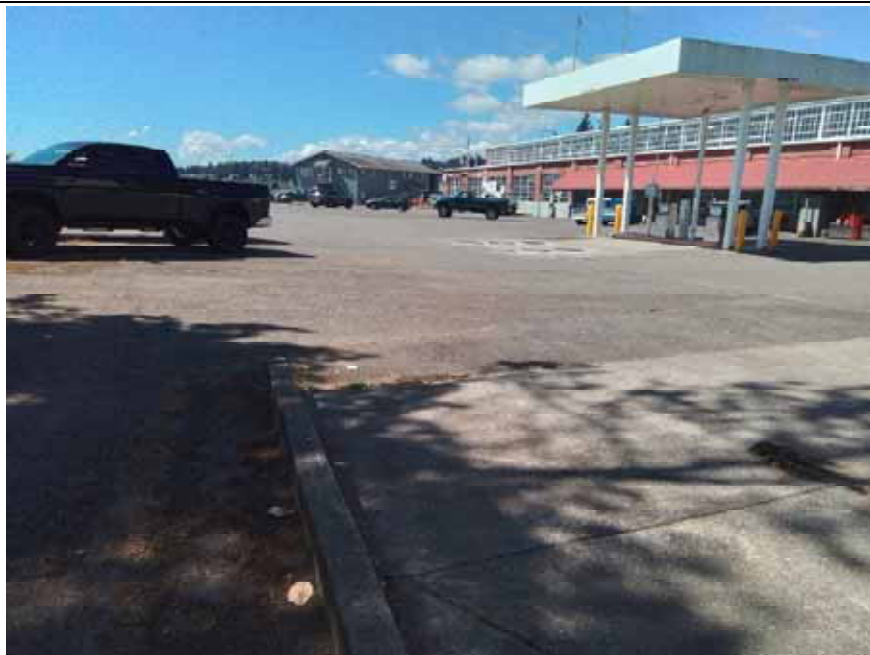
Photograph 20

Eastern site boundary, facing southwest.

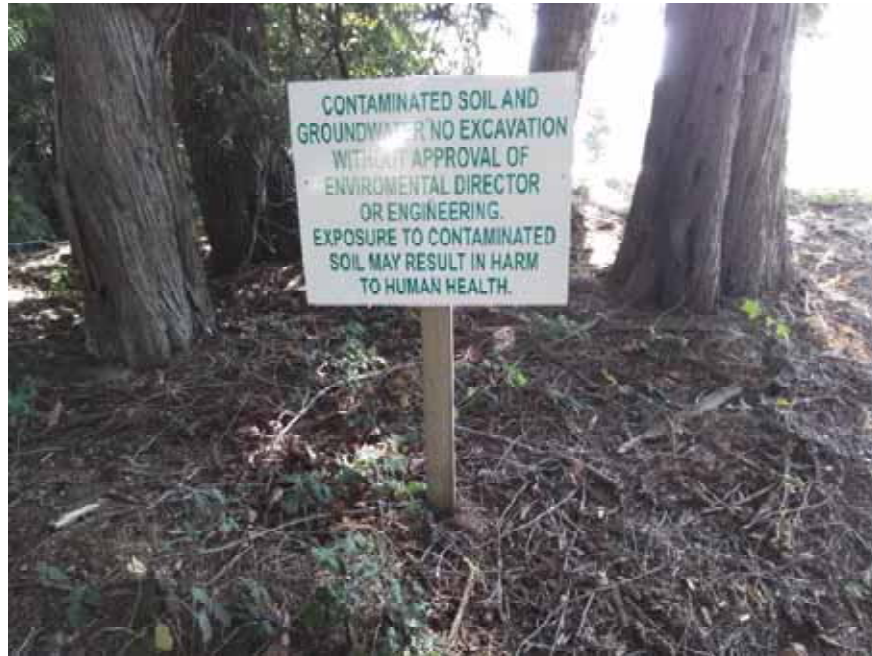
Photograph 1

Land use control (LUC) signage along southwest road boundary, facing southeast.

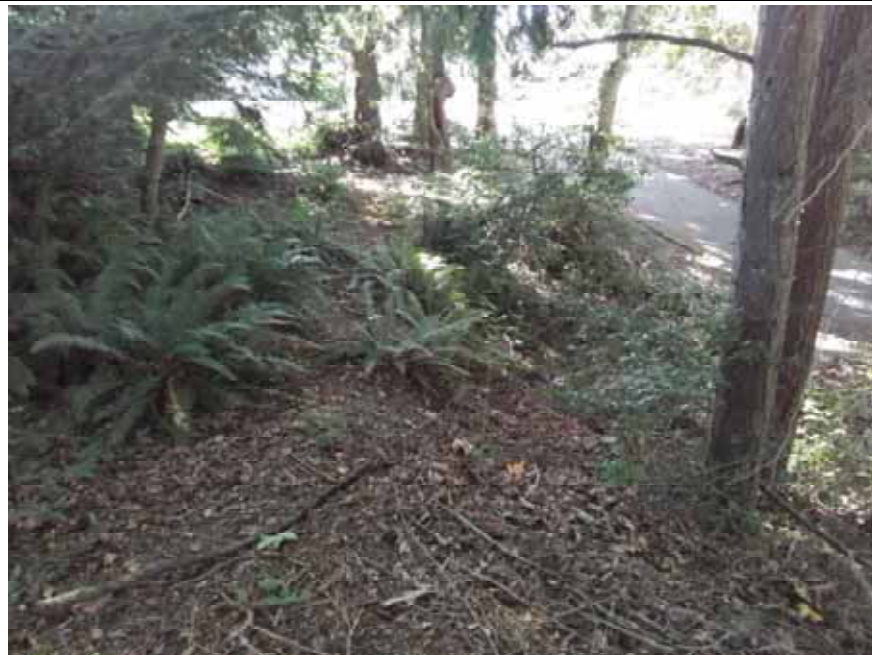
Photograph 2

LUC signage at the former location of monitoring well MW-2, located along the southwest area of the site, facing south.

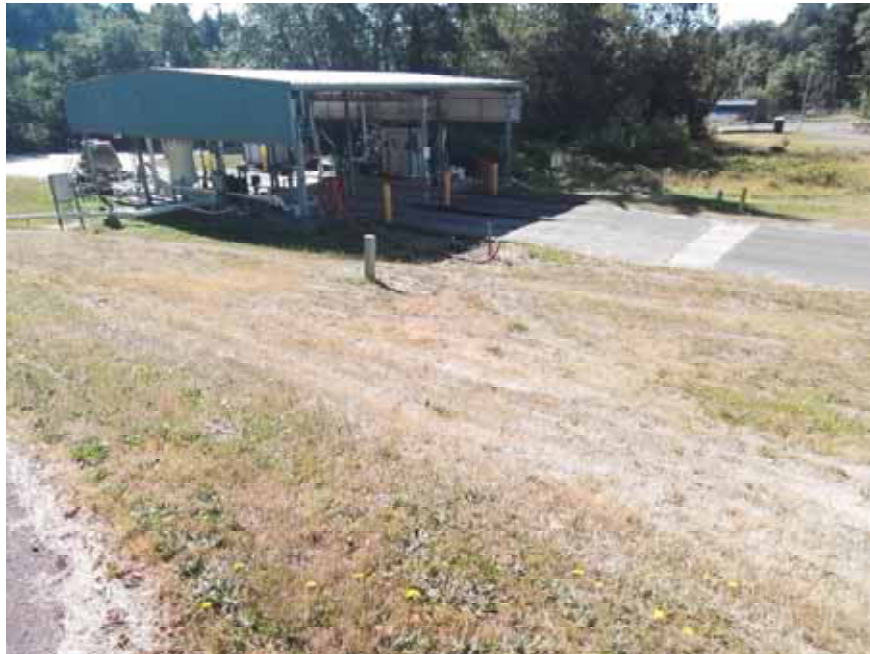
Photograph 3

Restored soil along the southwest boundary of site, facing southeast.

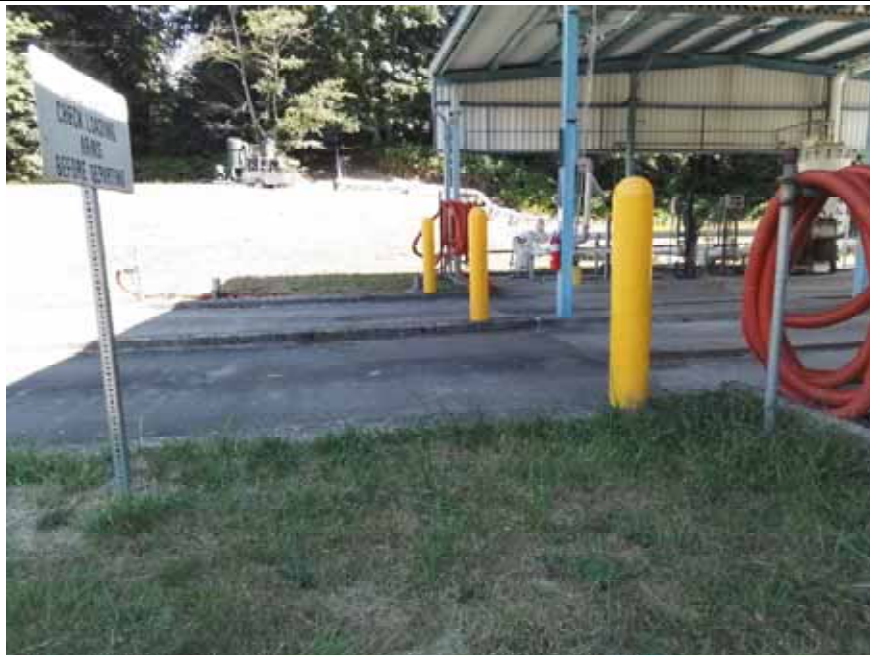
Photograph 4

Tanker truck facility and containerized fuel related waste, facing northeast.
