January 2024

2023 Land Use Control Inspections Technical Memorandum

**Sites 302, 303, and 304 and Tank 50
Naval Base Kitsap Manchester, Kitsap County,
Washington**

**United States Department of the Navy
Naval Facilities Engineering Systems Command**
1101 Tautog Circle
Silverdale, WA 98315-1101

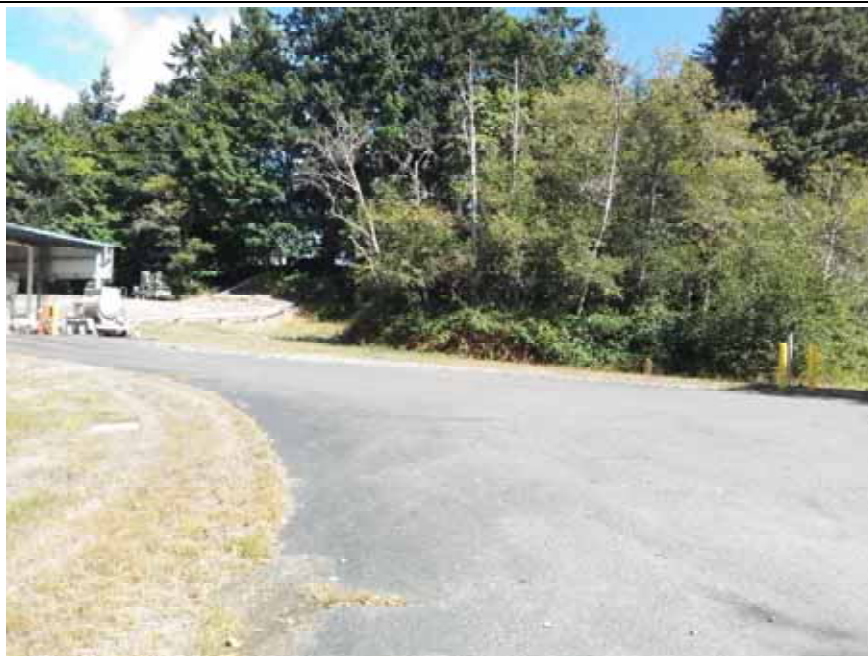
Photograph 5
Southeast boundary of site, facing northeast.

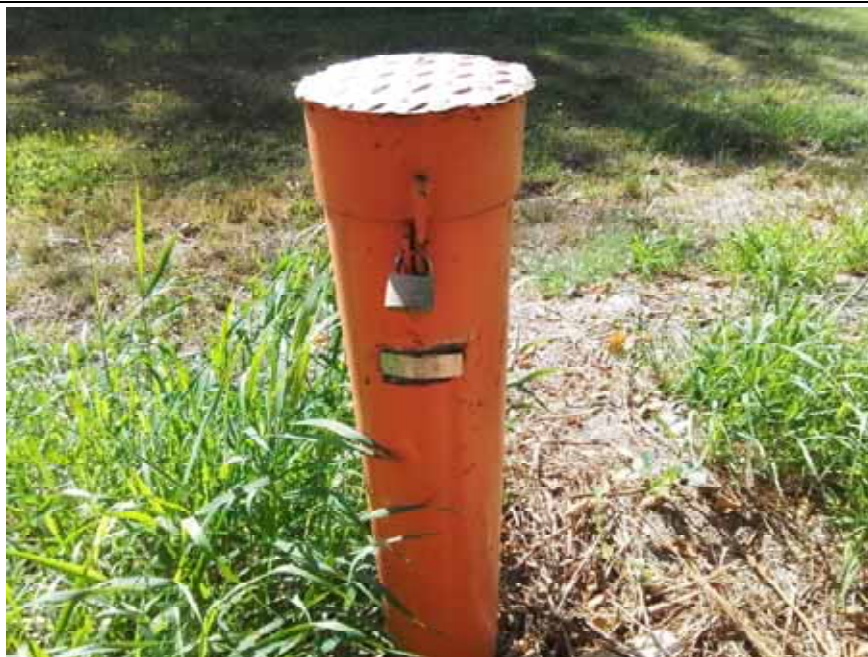
Photograph 6
Monitoring well MW-1, located along the southeast boundary, facing southeast.

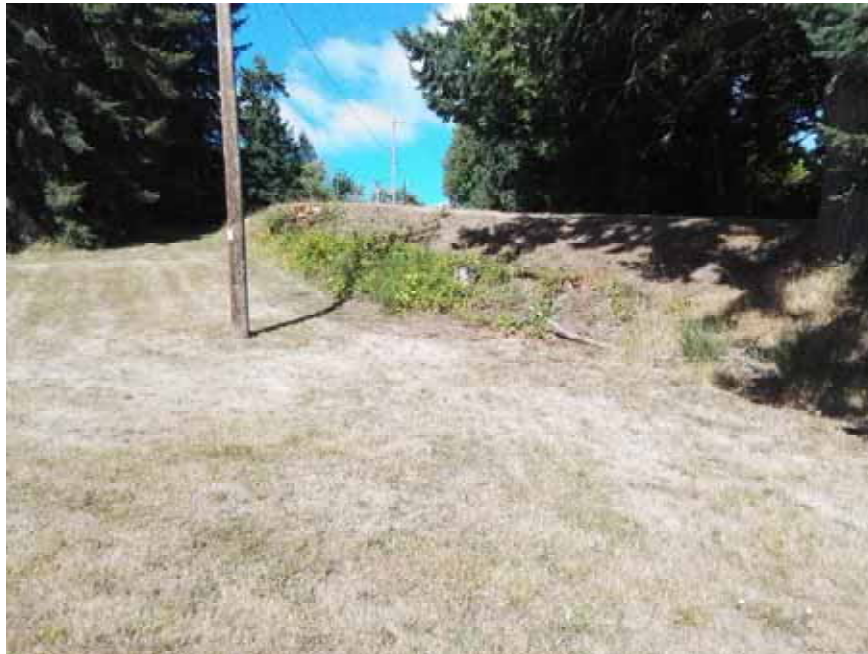
Photograph 7

Slope area recently cleared of trees, located along the northeast boundary, facing west.

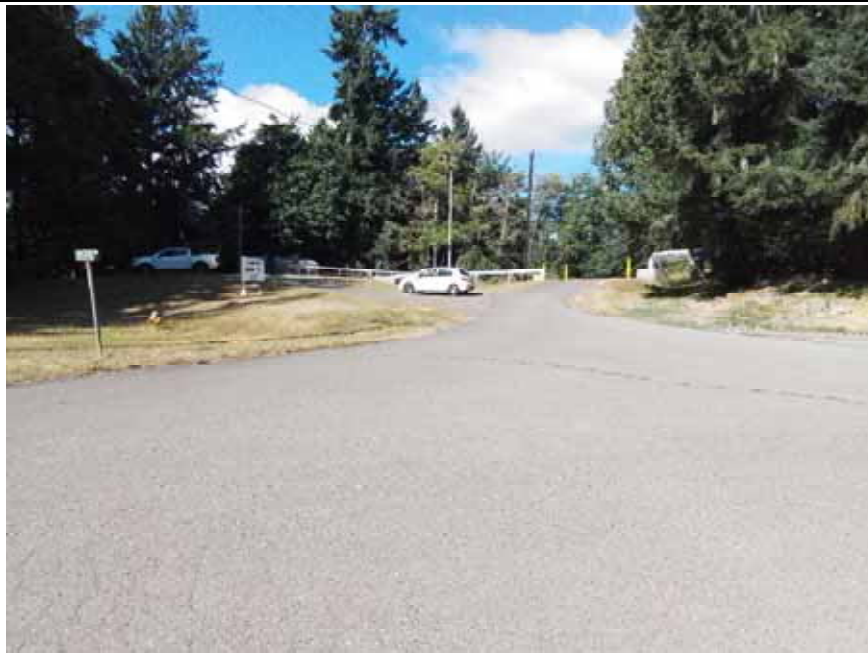
Photograph 8

Tank 50 site overview, facing southwest.

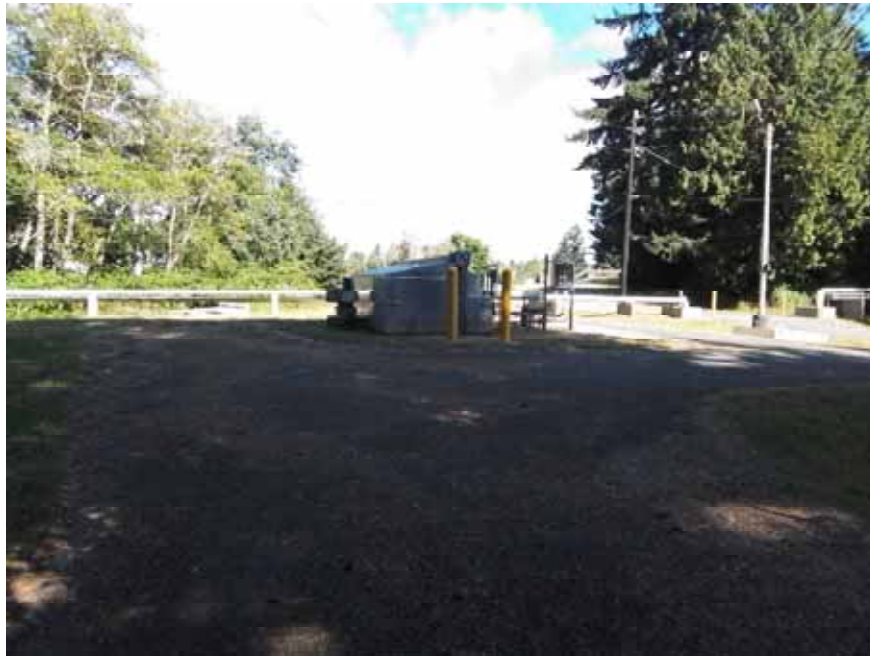
Photograph 9
Tank 50 site overview, facing northwest.

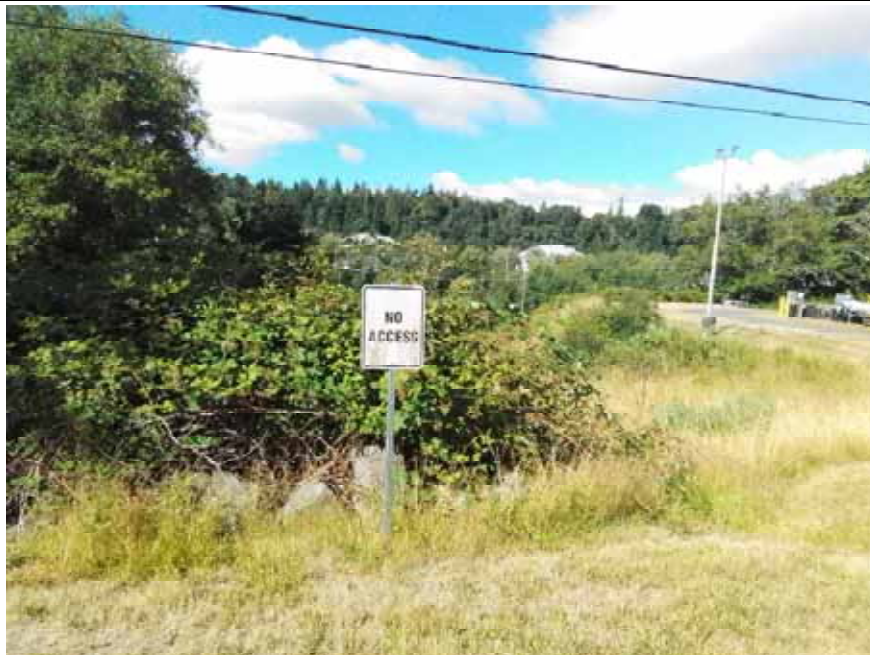
Photograph 10
Former road along northwest boundary of site, facing southwest.

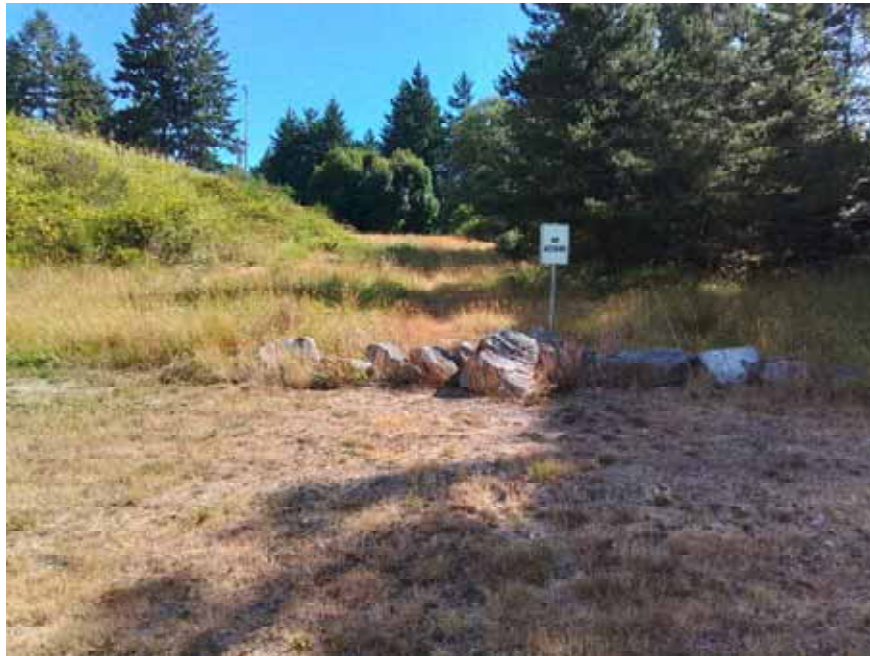
Photograph 11

Former road along northwest boundary of site, facing northeast.

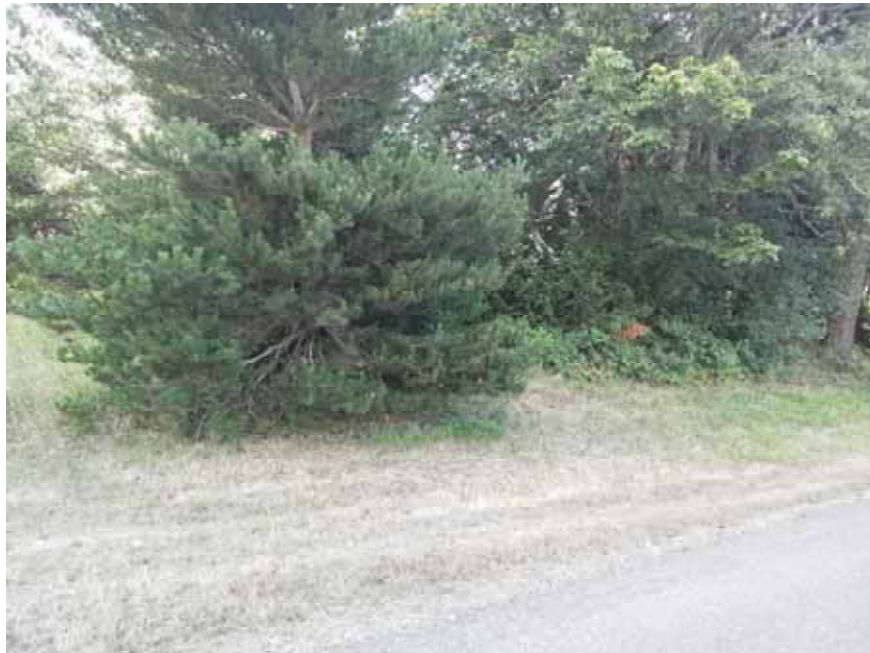
Photograph 12

Northwest boundary of site, facing southeast.

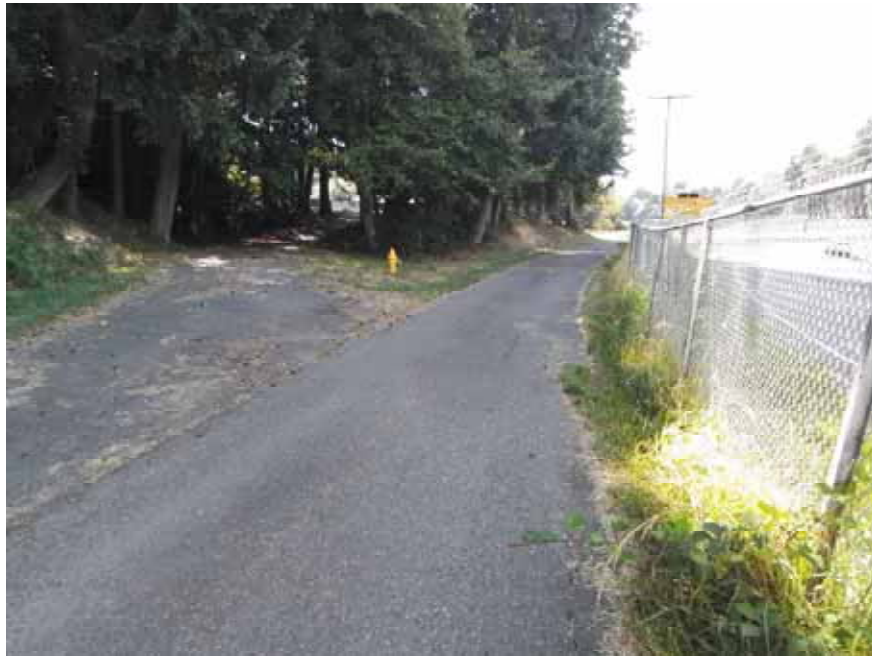
Photograph 13

Northwest boundary of site, facing southeast.
