2023 ANNUAL PROGRESS REPORT

SWMU-1 OILY WATER SEWER

HF SINCLAIR PUGET SOUND REFINING LLC

MARCH 21, 2024

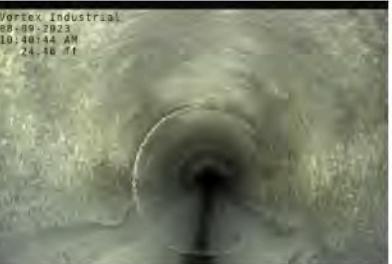
Description	Spatial Type	Distance (ft)	Type	Percent	Clock	SR	O&M	C	PR	Remarks	Photos
Manhole	Point	0	Constructional	0		0	0	0	0	D-1.1

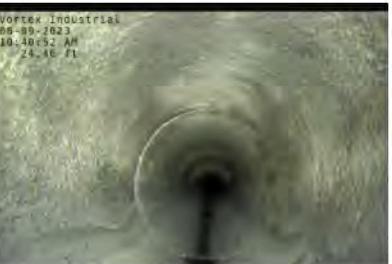
Miscellaneous Water Level	Point	0	Miscellaneous	0		0	0	0	0	Water Level at Start of Survey

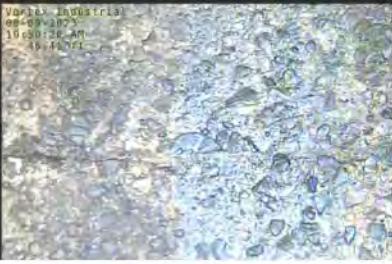
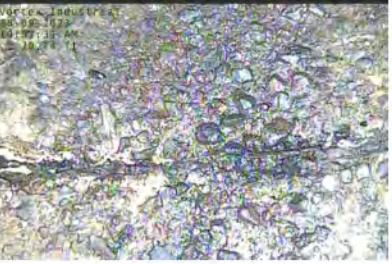
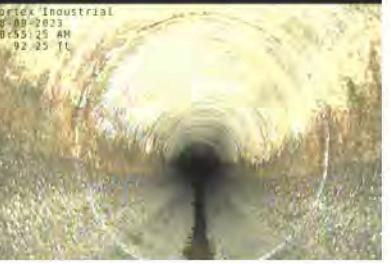
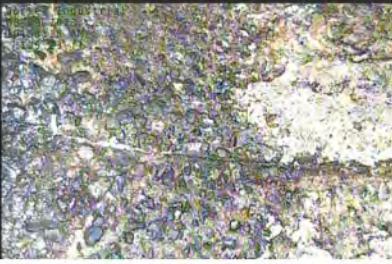
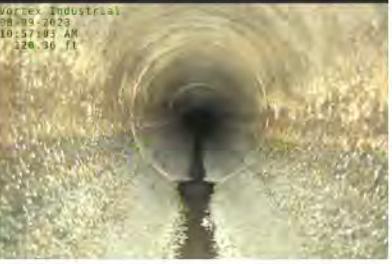
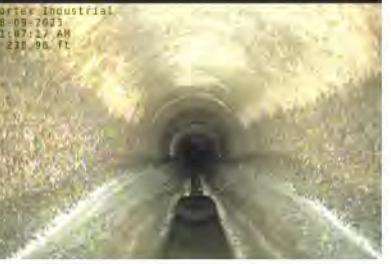
Surface Damage Aggregate Visible	Continuous	0 - 253.4	Structural	0	12-12	2	0	0	1	Surface Damage Aggregate Visible

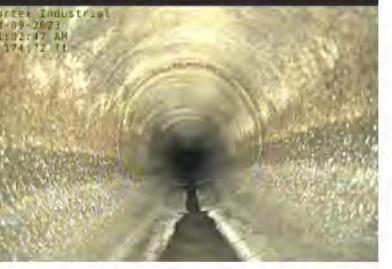
Description	Spatial Type	Distance (ft)	Type	Percent	Clock	SR	O&M	C	PR	Remarks	Photos
Crack Multiple	Point	176	Structural	0	5-6	3	0	0	1	Crack Multiple

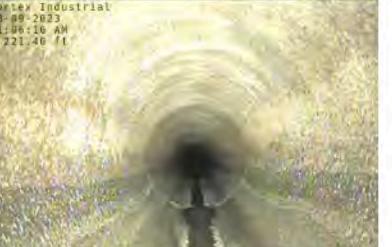
Crack Longitudinal	Point	221.5	Structural	0	8	2	0	0	1	Crack Longitudinal

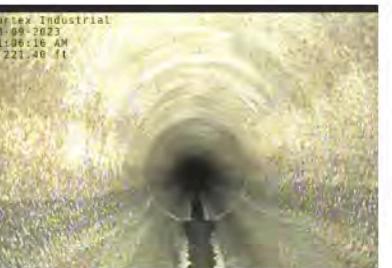
Crack Longitudinal	Point	221.5	Structural	0	4	2	0	0	1	Crack Longitudinal

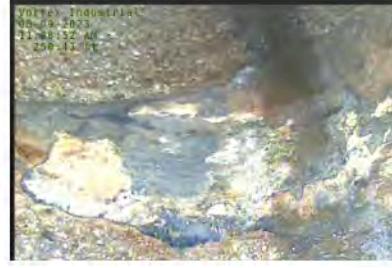
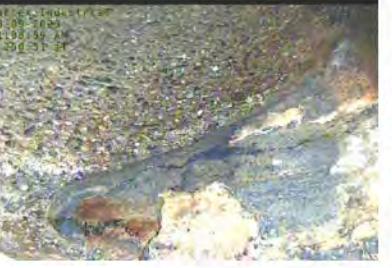
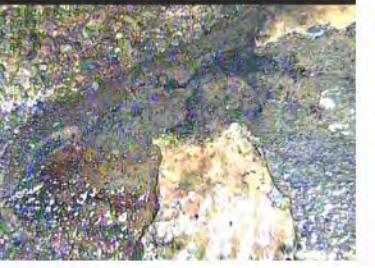
Crack Multiple	Point	250.8	Structural	0	6-7	3	0	0	1	Crack Multiple

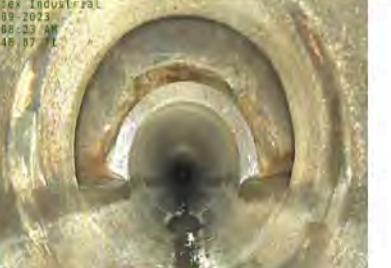
Crack Longitudinal	Point	250.8	Structural	0	2	2	0	0	1	Crack Longitudinal

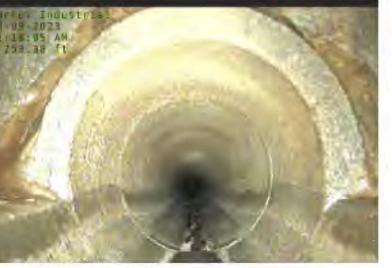
Manhole	Point	253.4	Constructional	0		0	0	0	0	D-2.1

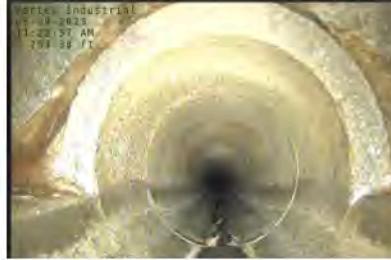
Description	Spatial Type	Distance (ft)	Type	Percent	Clock	SR	O&M	C	PR	Remarks	Photos
Manhole	Point	0	Constructional	0		0	0	0	0	D-2.1

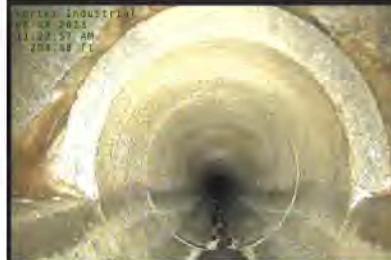
Miscellaneous Water Level	Point	0	Miscellaneous	0		0	0	0	0	Water Level at Start of Survey

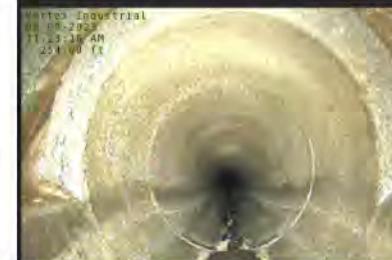
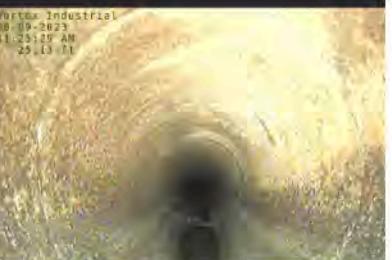
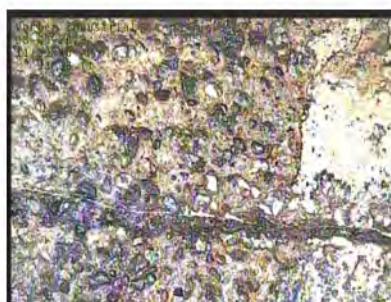
Surface Damage Aggregate Visible	Continuous	0 - 255.4	Structural	0	12-12	2	0	0	1	Surface Damage Aggregate Visible

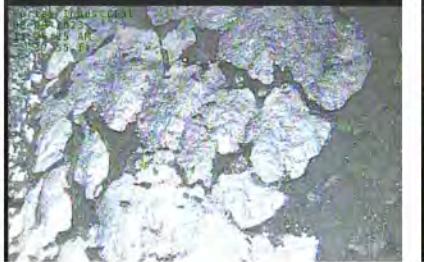
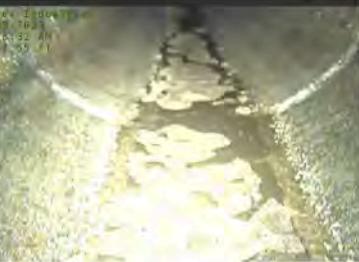
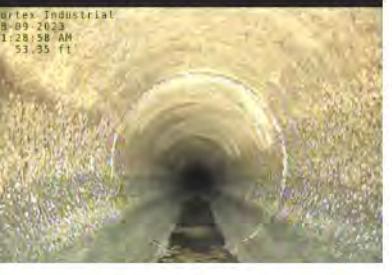
Description	Spatial Type	Distance (ft)	Type	Percent	Clock	SR	O&M	C	PR	Remarks	Photos
Deposits Settled Fine	Continuous	37.5 - 93.2	O&M	10	6	0	2	0	0	Deposits Settled Fine

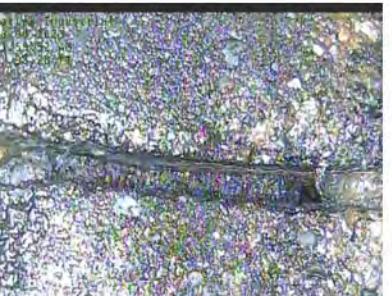
Crack Circumferential	Point	93.3	Structural	0	4-5	1	0	0	1	Crack Circumferential

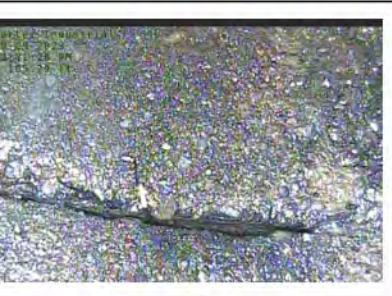
Crack Longitudinal	Point	105.29	Structural	0	5	2	0	0	1	Crack Longitudinal

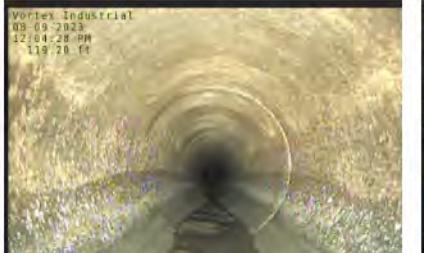
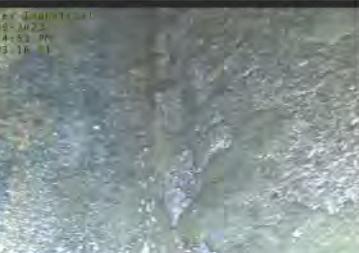
Deposits Settled Fine	Continuous	119.2 - 127	O&M	10	6	0	2	0	0	Deposits Settled Fine

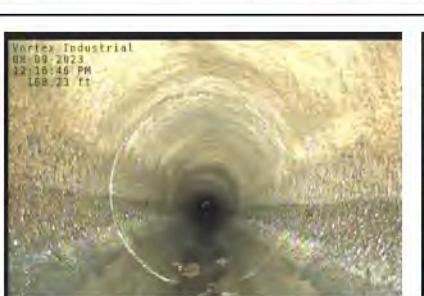
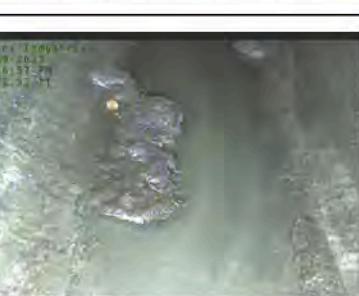
Deposits Settled Fine	Point	168.6	O&M	10	6	0	2	0	0	Deposits Settled Fine

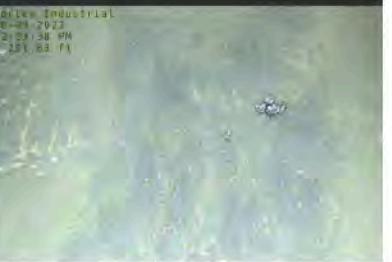
Description	Spatial Type	Distance (ft)	Type	Percent	Clock	SR	O&M	C	PR	Remarks	Photos
Crack Multiple	Point	201.8	Structural	0	6-7	3	0	0	1	Crack Multiple

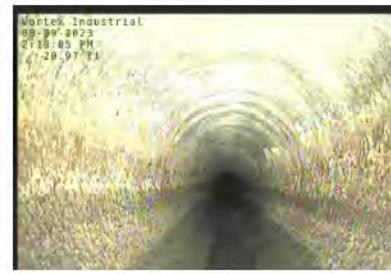
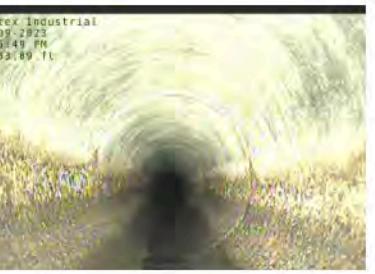
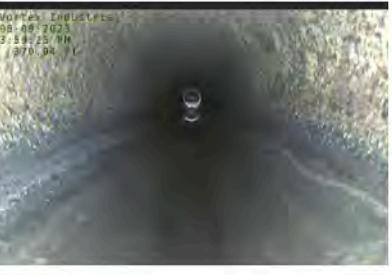
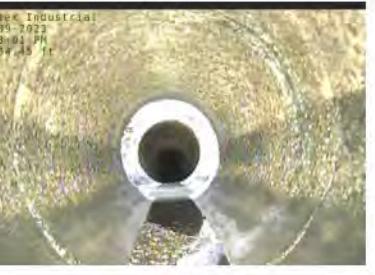
Surface Aggregate Visible	Continuous	0 - 412.3	Structural	0	12-12	2	0	0	1	1	Surface Aggregate Visible

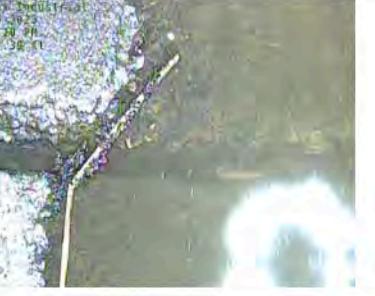
Description	Spatial Type	Distance (ft)	Type	Percent	Clock	SR	O&M	C	PR	Remarks	Photos
Miscellaneous General Observation	Point	87.4	Miscellaneous	0	6	0	0	0	0	Object in pipe

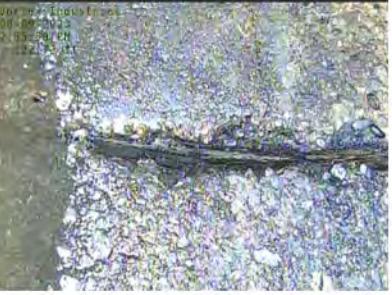
Crack Longitudinal	Point	122.7	Structural	0	5	2	0	0	1	Crack Longitudinal

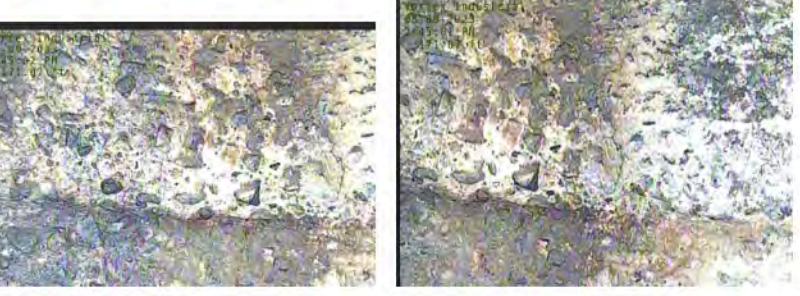
Crack Longitudinal	Point	171.1	Structural	0	3	2	0	0	1	Crack Longitudinal

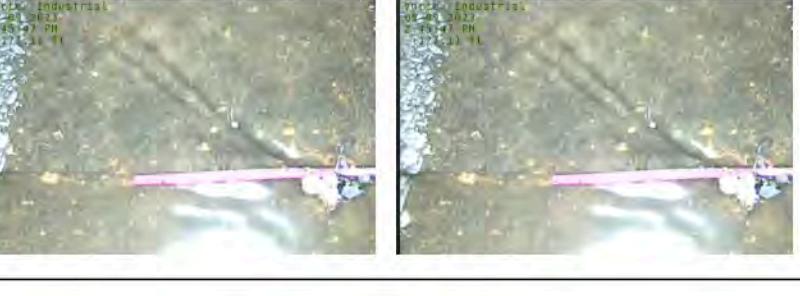
Miscellaneous General Observation	Point	177.1	Miscellaneous	0	6	0	0	0	0	Object in Pipe

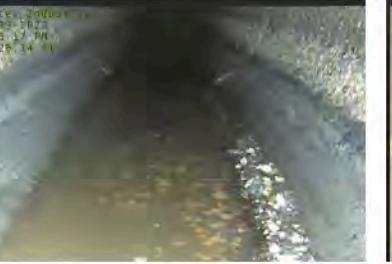
Description	Spatial Type	Distance (ft)	Type	Percent	Clock	SR	O&M	C	PR	Remarks	Photos
Deposits Settled Gravel	Continuous	228.1 - 236	O&M	10	6	0	2	0	0	Deposits Settled Gravel

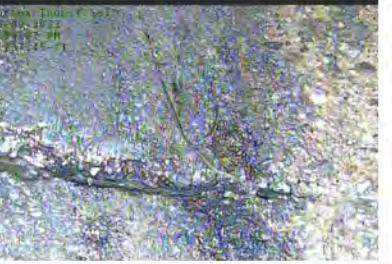
Crack Longitudinal	Point	237.5	Structural	0	5	2	0	0	1	Crack Longitudinal

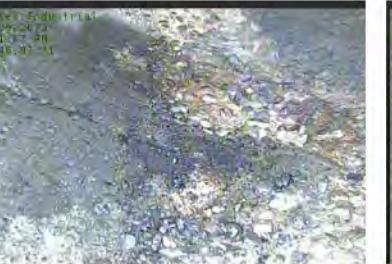
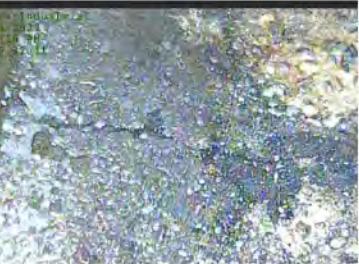
Crack Circumferential	Point	246.1	Structural	0	4-5	1	0	0	2	Crack Circumferential

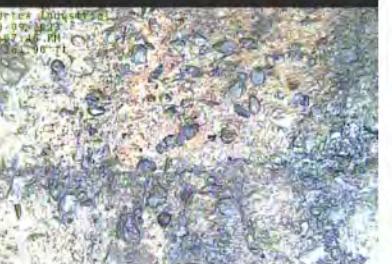
Crack Longitudinal	Point	261.9	Structural	0	8	2	0	0	1	Crack Longitudinal

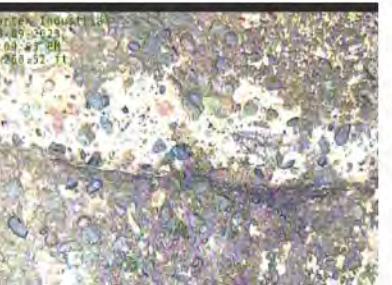
Crack Longitudinal	Point	268.5	Structural	0	2	2	0	0	1	Crack Longitudinal

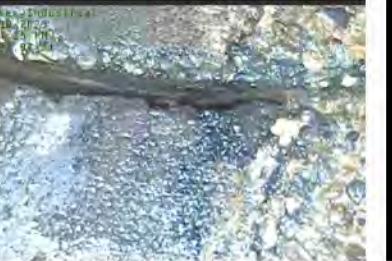
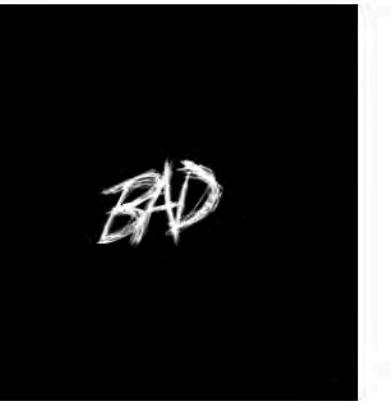
Description	Spatial Type	Distance (ft)	Type	Percent	Clock	SR	O&M	C	PR	Remarks	Photos
Crack Longitudinal	Point	292	Structural	0	5	2	0	0	1	Crack Longitudinal

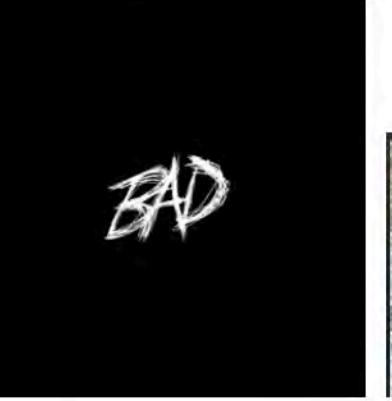
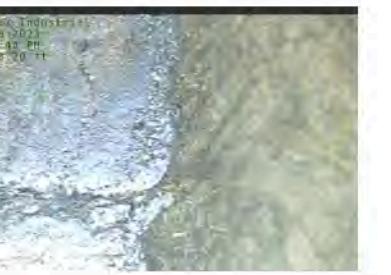
Crack Longitudinal	Point	327.9	Structural	0	7	2	0	0	1	Crack Longitudinal

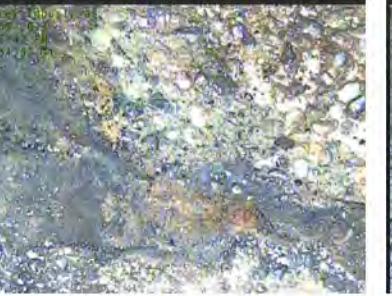
Crack Circumferential	Point	334.6	Structural	0	3-5	1	0	0	2	Crack Circumferential

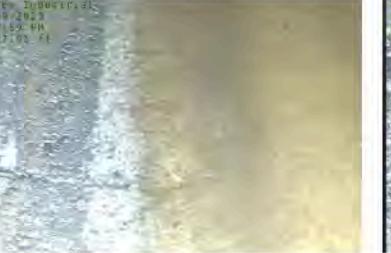
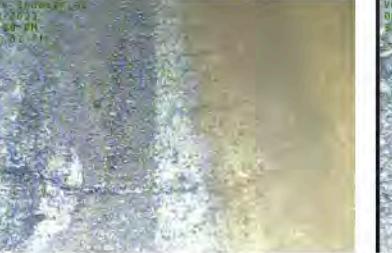
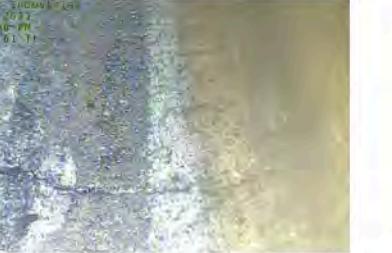
Description	Spatial Type	Distance (ft)	Type	Percent	Clock	SR	O&M	C	PR	Remarks	Photos
Crack Circumferential	Point	337.6	Structural	0	6-7	1	0	0	1	Crack Circumferential

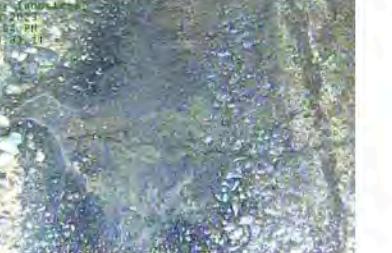
Crack Circumferential	Point	343.8	Structural	0	6-7	1	0	0	1	Crack Circumferential

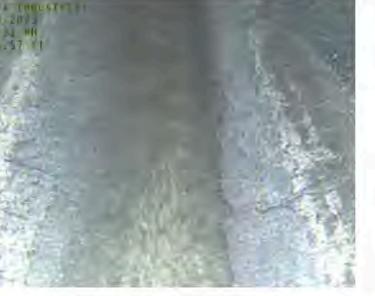
Description	Spatial Type	Distance (ft)	Type	Percent	Clock	SR	O&M	C	PR	Remarks	Photos
Crack Circumferential	Point	347.3	Structural	0	7-8	1	0	0	1	Crack Circumferential

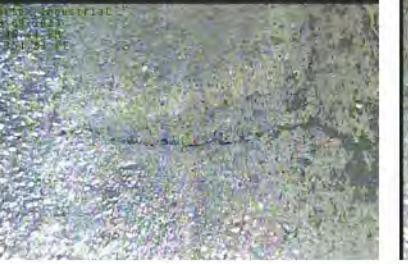
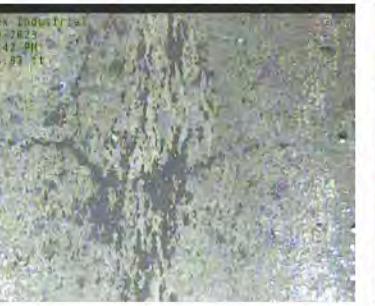
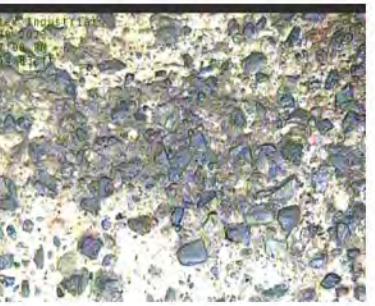
Crack Multiple	Point	354.8	Structural	0	5-10	2	0	0	1	Crack Multiple

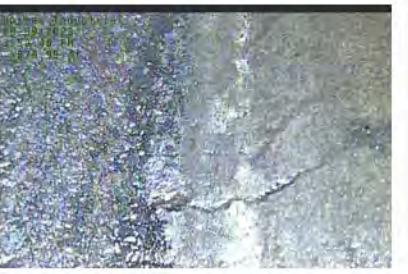
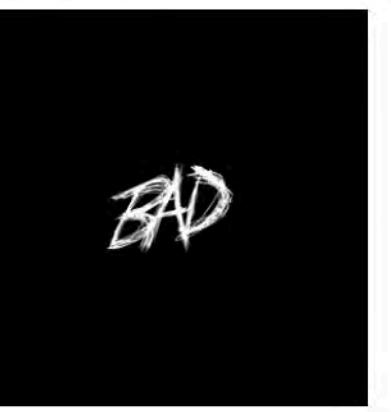
Crack Circumferential	Point	371	Structural	0	7-8	1	0	0	1	Crack Circumferential

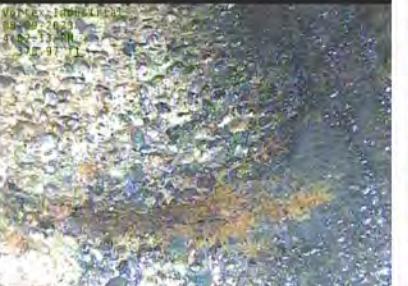
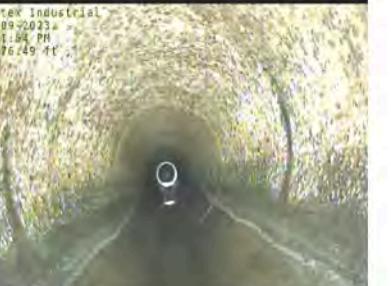
Crack Circumferential	Point	379.1	Structural	0	8-10	1	0	0	2	Crack Circumferential

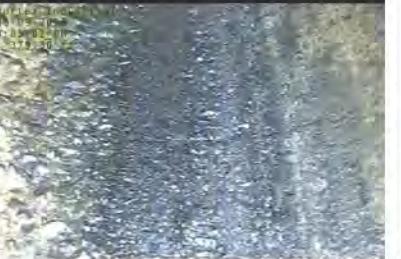
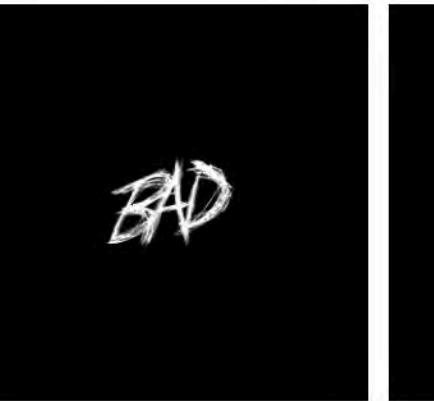
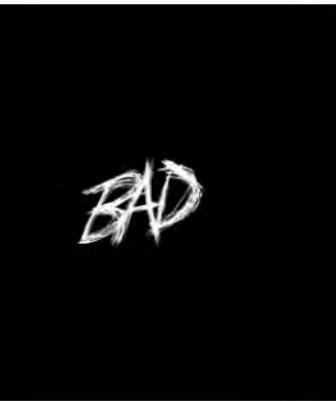
Description	Spatial Type	Distance (ft)	Type	Percent	Clock	SR	O&M	C	PR	Remarks	Photos
Crack Circumferential	Point	379.3	Structural	0	4-7	1	0	0	2	Crack Circumferential

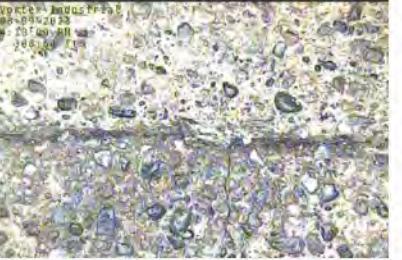
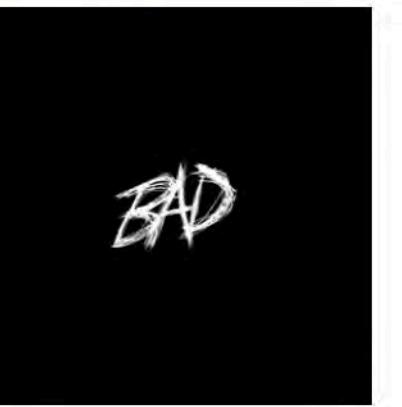
Crack Longitudinal	Point	388.6	Structural	0	1	2	0	0	1	Crack Longitudinal

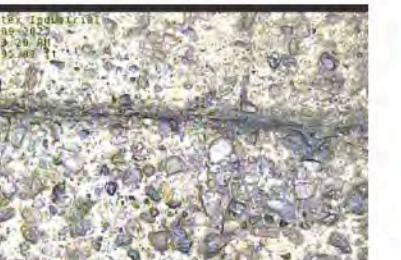
Crack Longitudinal	Point	395.1	Structural	0	11	2	0	0	1	Crack Longitudinal

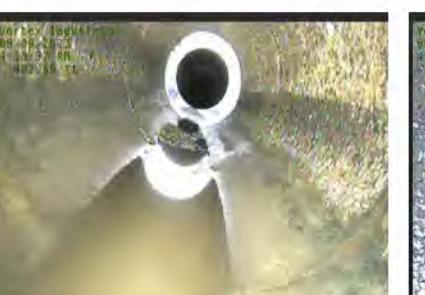
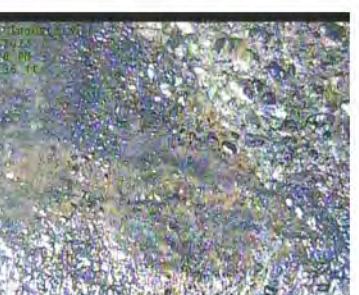
Crack Circumferential	Point	404.4	Structural	0	3-5	1	0	0	2	Crack Circumferential

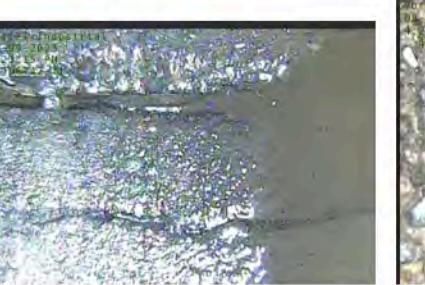
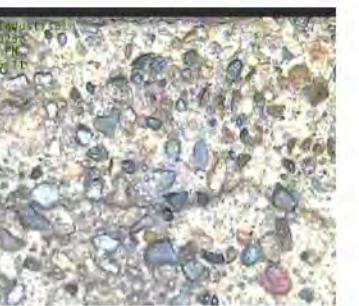
Crack Circumferential	Point	406.4	Structural	0	6-11	1	0	0	2	Crack Circumferential

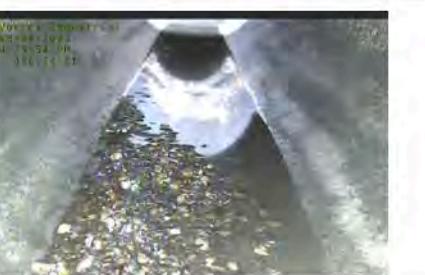
Deposits Settled Gravel	Point	406.7	O&M	10	6	0	2	0	0	Deposits Settled Gravel

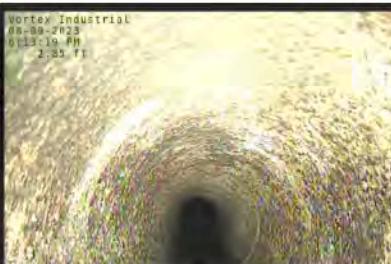
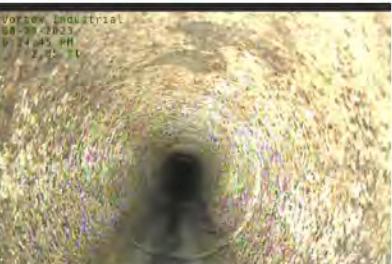
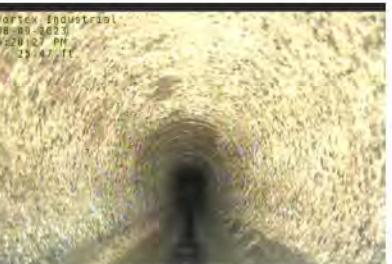
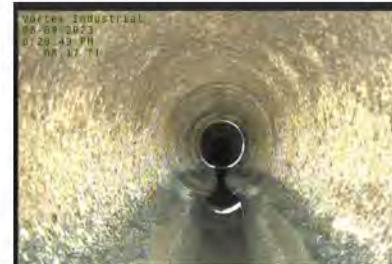
Surface Damage Aggregate Visible	Continuous	0 - 82.9	Structural	0	12-12	1	0	0	1	Surface Damage Aggregate Visible

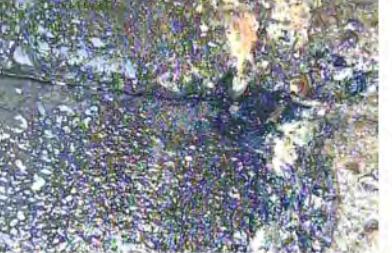
Description	Spatial Type	Distance (ft)	Type	Percent	Clock	SR	O&M	C	PR	Remarks	Photos
Crack Longitudinal	Point	7.8	Structural	0	5	2	0	0	1	Crack Longitudinal

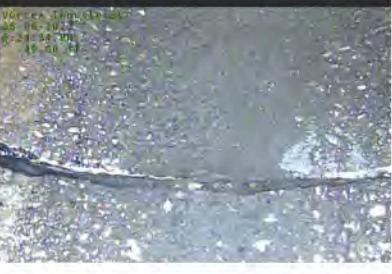
Crack Longitudinal	Point	49.6	Structural	0	6	2	0	0	1	Crack Longitudinal

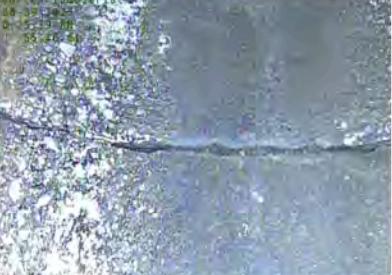
Crack Longitudinal	Point	55.4	Structural	0	6	2	0	0	1	Crack Longitudinal

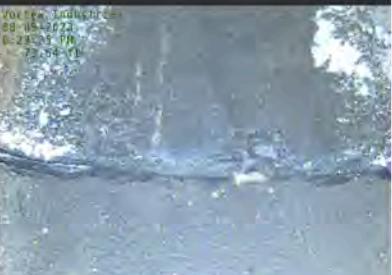
Crack Multiple	Point	73.7	Structural	0	6-7	3	0	0	1	Crack Multiple

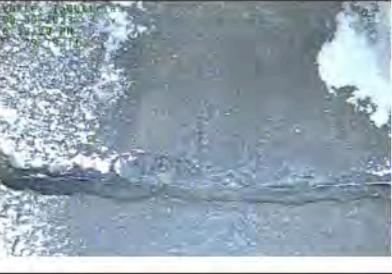
Crack Multiple	Point	79.8	Structural	0	6-7	3	0	0	1	Crack Multiple

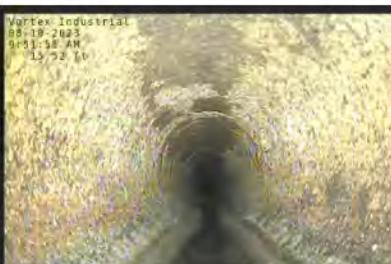
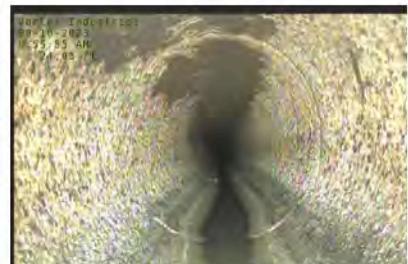
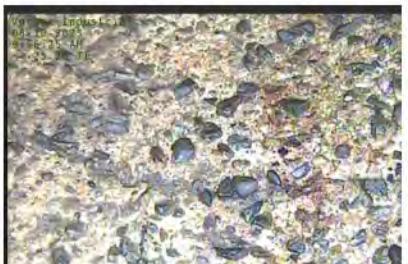
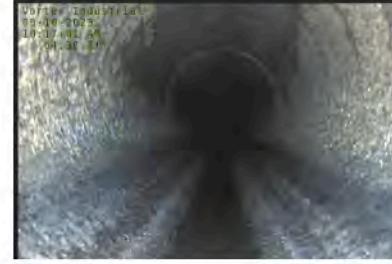
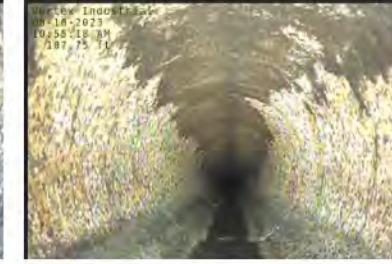
Surface Damage Aggregate Visible	Continuous	0 - 227.7	Structural	0	12-12	2	0	0	0	2	Surface Damage Aggregate Visible

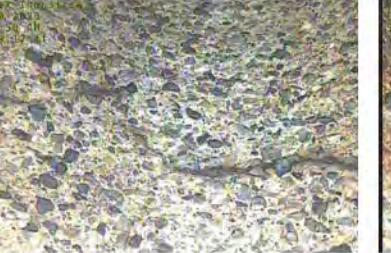
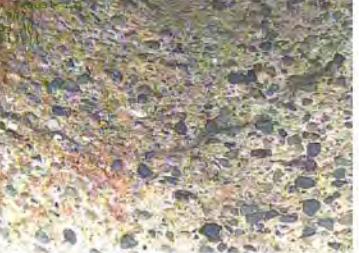
Description	Spatial Type	Distance (ft)	Type	Percent	Clock	SR	O&M	C	PR	Remarks	Photos
Crack Multiple	Point	9.2	Structural	0	10-3	3	0	0	1	Crack Multiple

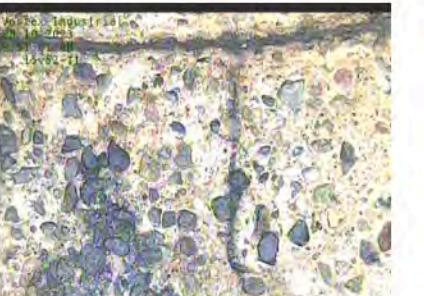
Crack Longitudinal	Point	15.5	Structural	0	10	2	0	0	1	Crack Longitudinal

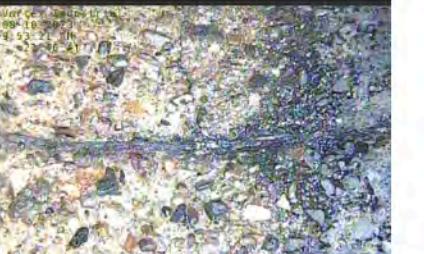
Crack Longitudinal	Point	21.5	Structural	0	7	2	0	0	1	Crack Longitudinal

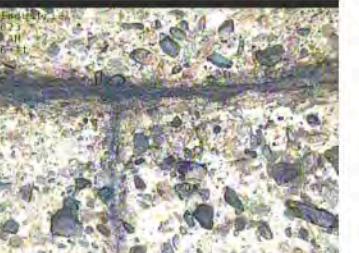
Crack Longitudinal	Point	21.5	Structural	0	10	2	0	0	1	Crack Longitudinal

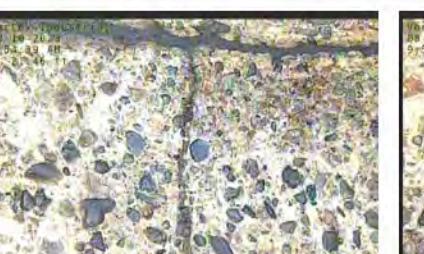
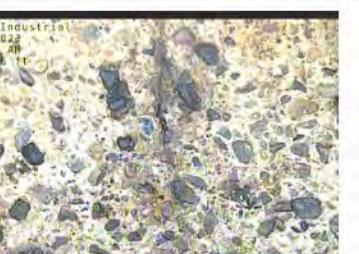
Crack Longitudinal	Point	21.5	Structural	0	3	2	0	0	1	Crack Longitudinal

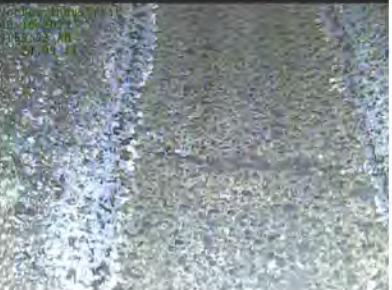
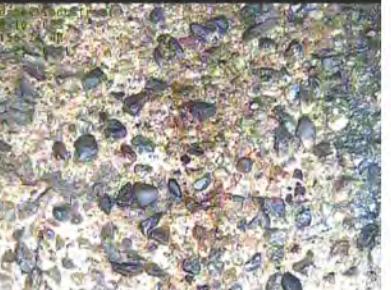
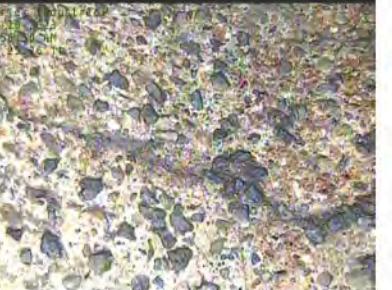
Crack Circumferential	Point	25.3	Structural	0	12-12	1	0	0	1	Crack Circumferential

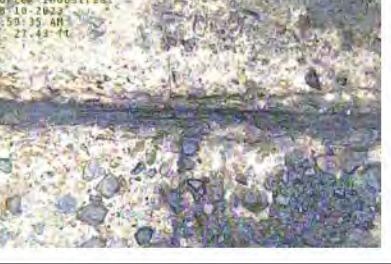
Crack Longitudinal	Point	27.4	Structural	0	12	2	0	0	2	Crack Longitudinal

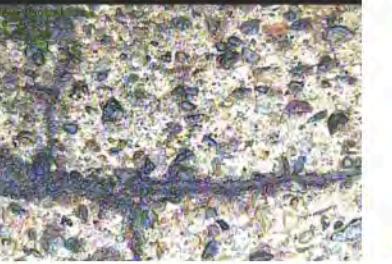
Crack Longitudinal	Point	45.3	Structural	0	8	2	0	0	2	Crack Longitudinal

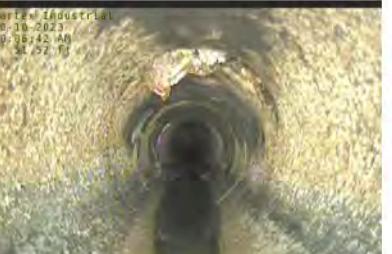
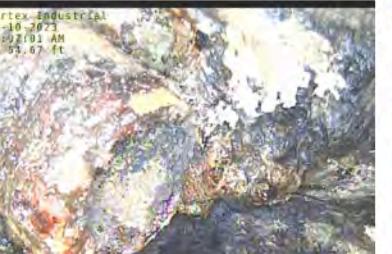
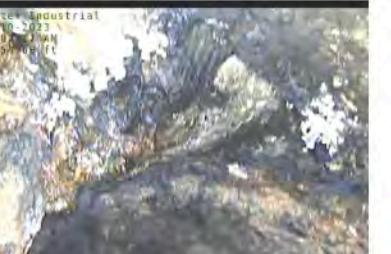
Description	Spatial Type	Distance (ft)	Type	Percent	Clock	SR	O&M	C	PR	Remarks	Photos
Tap Break-In Intruding	Point	54.7	Constructional	0	11	0	4	0	1	Tap Break-In Intruding

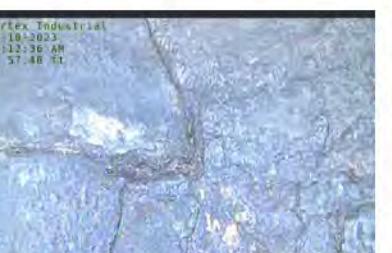
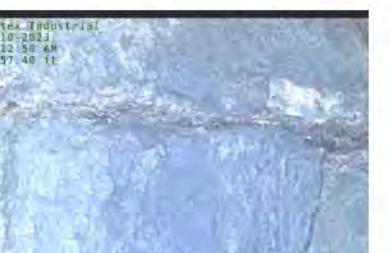
Fracture Multiple	Point	57.4	Structural	0	10-3	4	0	0	2	Fracture Multiple

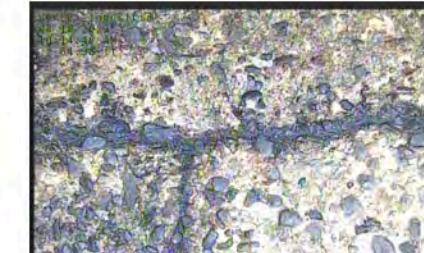
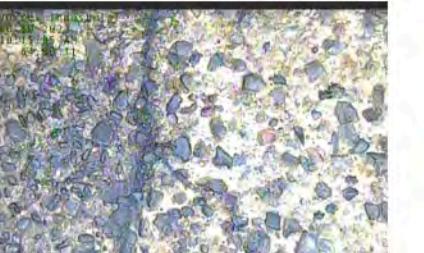
Crack Longitudinal	Point	64.4	Structural	0	9	2	0	0	2	Crack Longitudinal

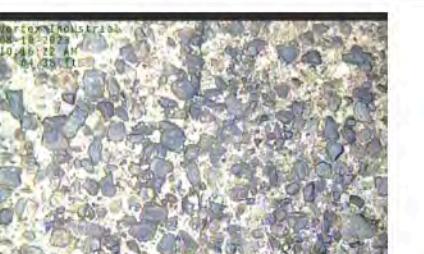
Crack Longitudinal	Point	64.4	Structural	0	3	2	0	0	1	Crack Longitudinal

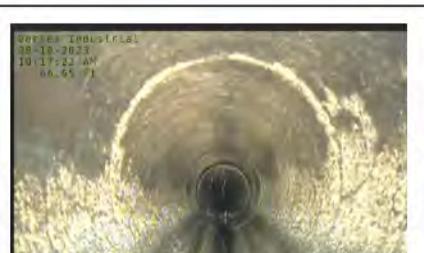
Miscellaneous Water Level	Point	66.7	Miscellaneous	0		0	0	0	0	Miscellaneous Water Level

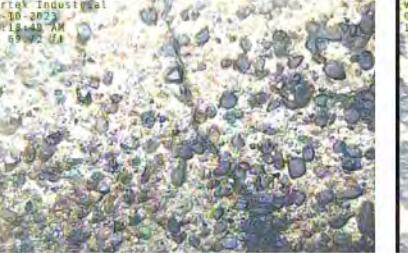
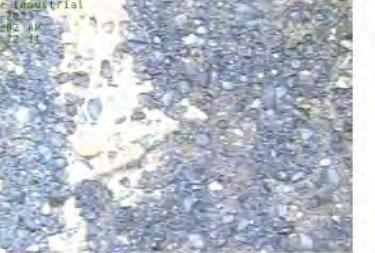
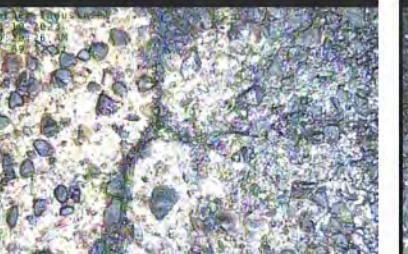
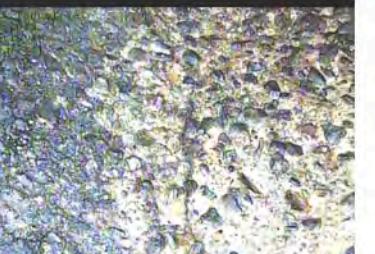
Description	Spatial Type	Distance (ft)	Type	Percent	Clock	SR	O&M	C	PR	Remarks	Photos
Crack Multiple	Point	69.7	Structural	0	3-6	3	0	0	1	Crack Multiple

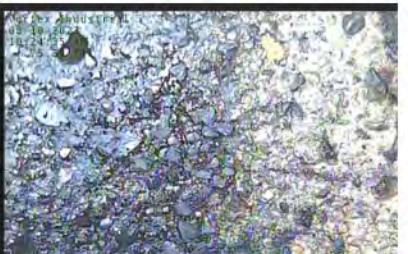
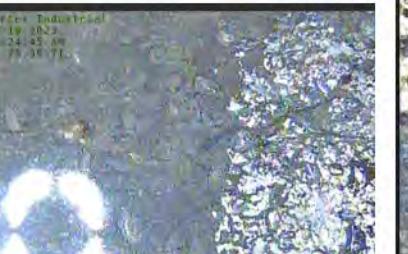
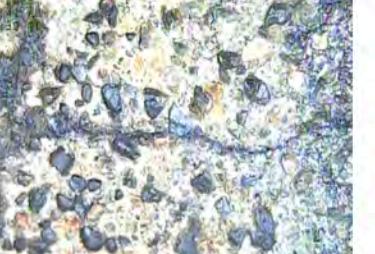
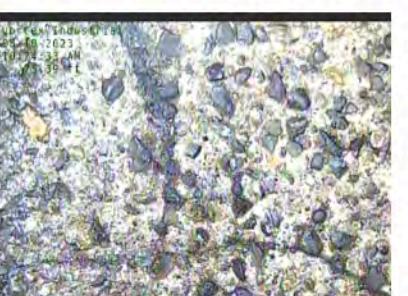
Crack Multiple	Point	75.4	Structural	0	12-12	3	0	0	1	Crack Multiple

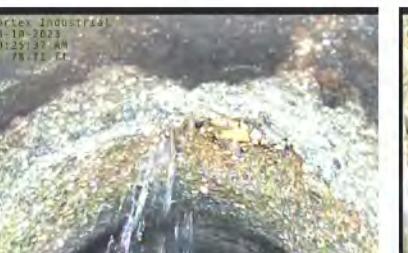
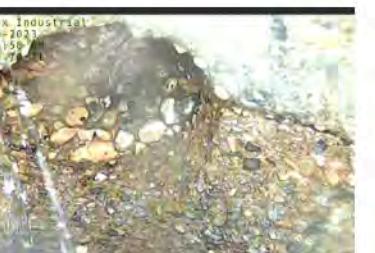
Tap Factory Activity	Point	79	Constructional	0	12	0	0	0	0	Tap Factory Activity

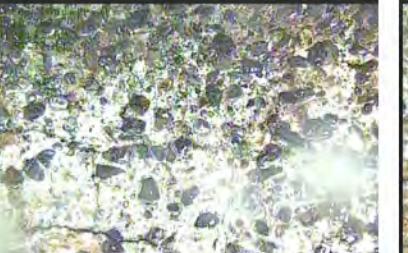
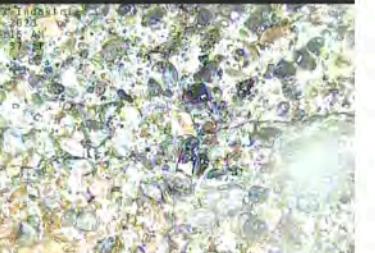
Crack Multiple	Point	80.4	Structural	0	12-2	3	0	0	1	Crack Multiple

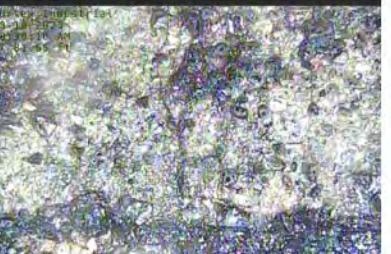
Description	Spatial Type	Distance (ft)	Type	Percent	Clock	SR	O&M	C	PR	Remarks	Photos
Crack Longitudinal	Point	81.7	Structural	0	10	2	0	0	1	Crack Longitudinal

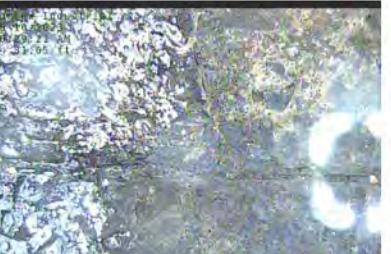
Crack Longitudinal	Point	81.7	Structural	0	6	2	0	0	1	Crack Longitudinal

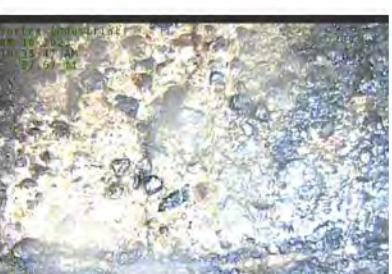
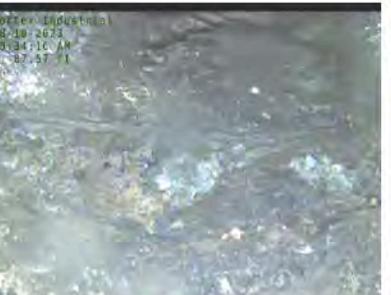
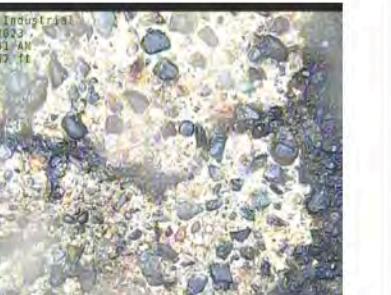
Crack Multiple	Point	87.7	Structural	0	3-9	3	0	0	1	Crack Multiple

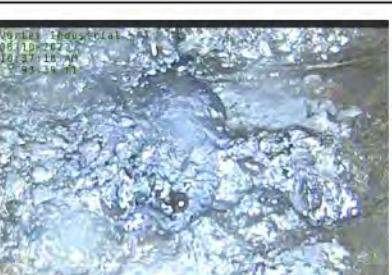
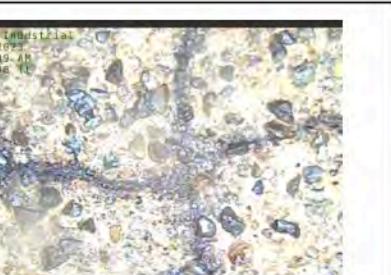
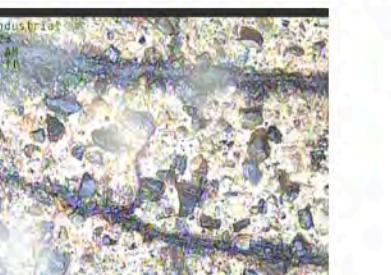
Crack Multiple	Point	93.4	Structural	0	12-12	3	0	0	2	Crack Multiple

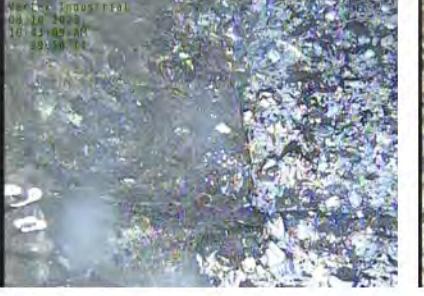
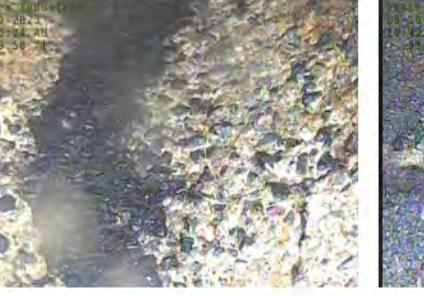
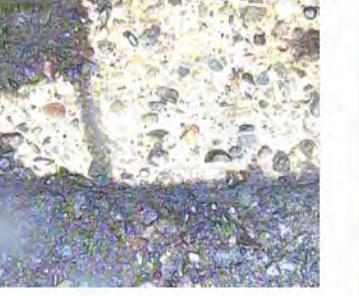
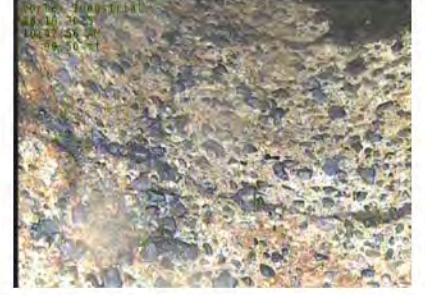
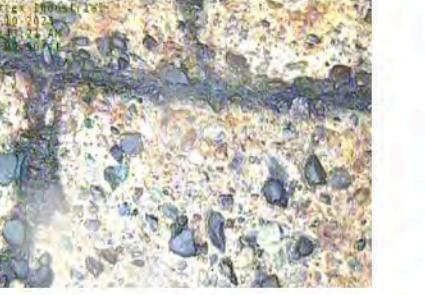
Description	Spatial Type	Distance (ft)	Type	Percent	Clock	SR	O&M	C	PR	Remarks	Photos
Crack Multiple	Point	99.5	Structural	0	12-12	3	0	0	2	Crack Multiple

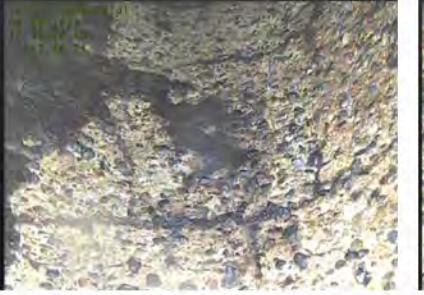
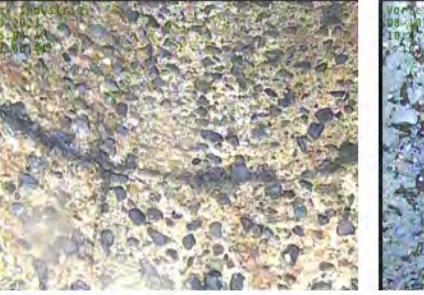
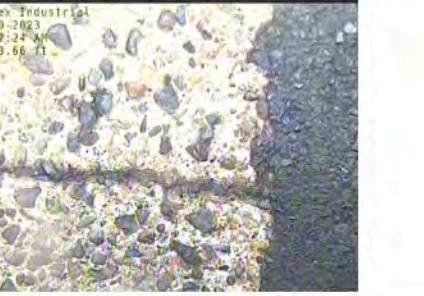
Crack Multiple	Point	103.7	Structural	0	12-12	3	0	0	2	Crack Multiple

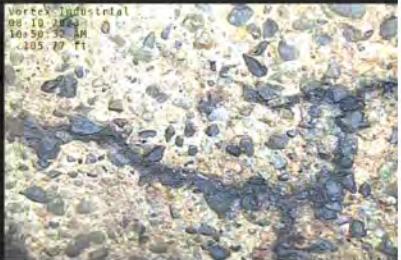
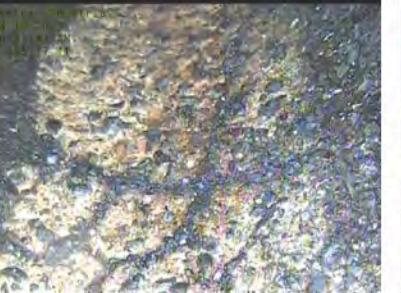
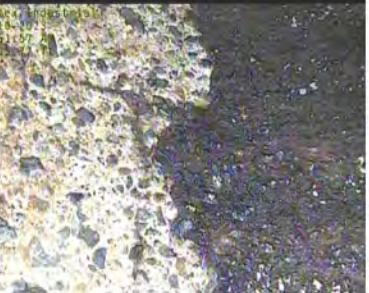
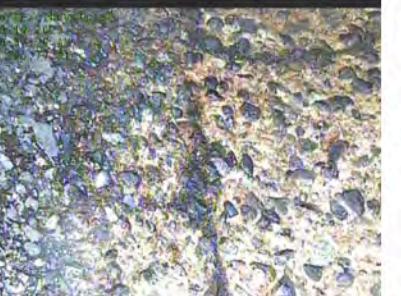
Fracture Circumferential	Point	105.8	Structural	0	5-7	2	0	0	3	Fracture Circumferential

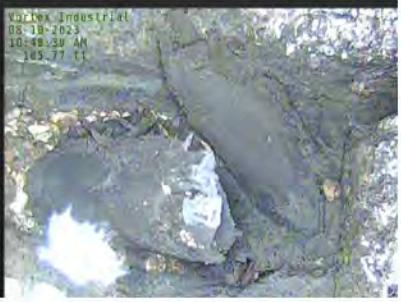
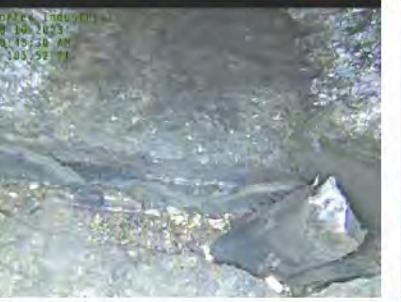
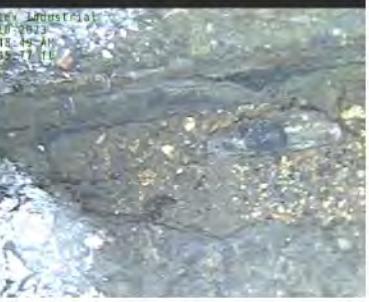
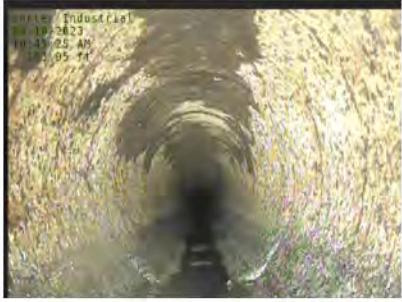
Crack Multiple	Point	107.7	Structural	0	12-12	1	0	0	1	Crack Multiple

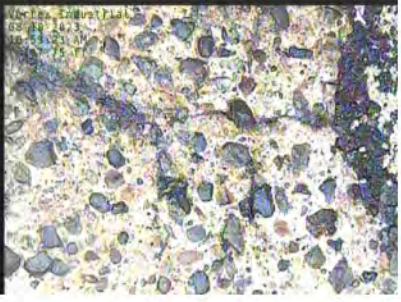
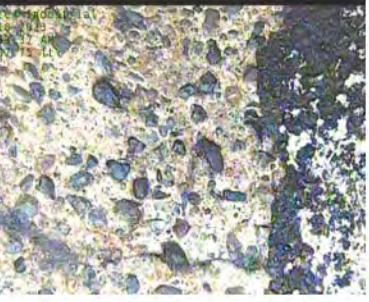
Description	Spatial Type	Distance (ft)	Type	Percent	Clock	SR	O&M	C	PR	Remarks		Photos
Crack Circumferential	Point	110.1	Structural	0	6-9	1	0	0	1	Crack Circumferential

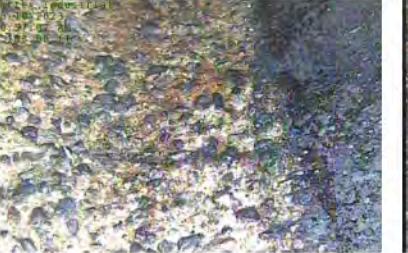
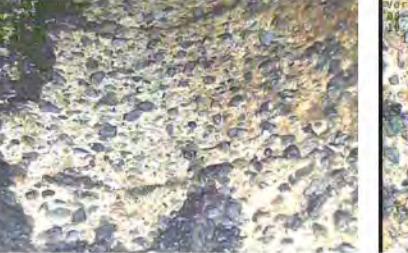
Crack Multiple	Point	111.8	Structural	0	8-4	2	0	0	1	Crack Multiple

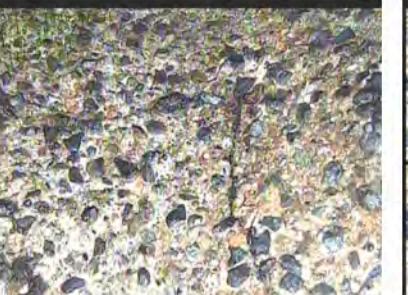
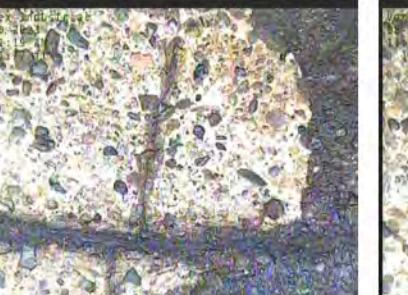
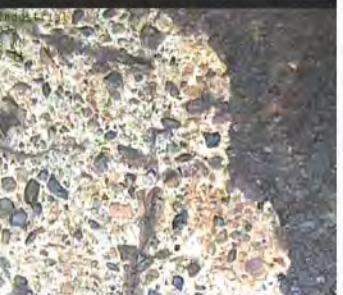
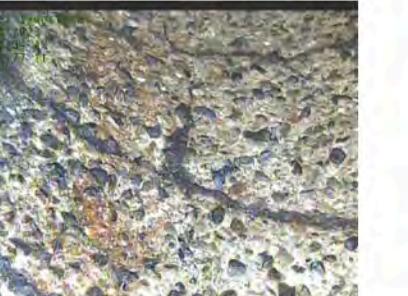
Crack Circumferential	Point	115.9	Structural	0	6-9	1	0	0	1	Crack Circumferential

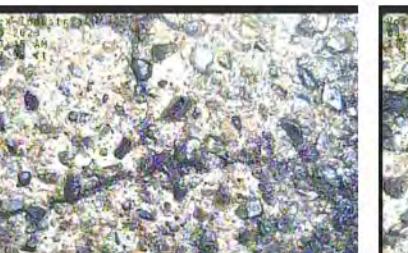
Crack Circumferential	Point	117.9	Structural	0	5-6	1	0	0	1	Crack Circumferential

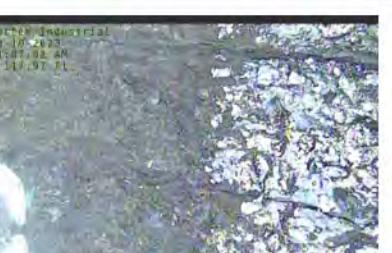
Description	Spatial Type	Distance (ft)	Type	Percent	Clock	SR	O&M	C	PR	Remarks		Photos
Crack Circumferential	Point	124.1	Structural	0	5-6	1	0	0	1	Crack Circumferential

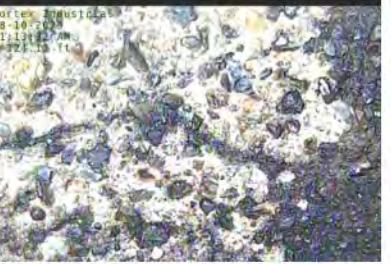
Crack Longitudinal	Point	129.8	Structural	0	9	2	0	0	2	Crack Longitudinal

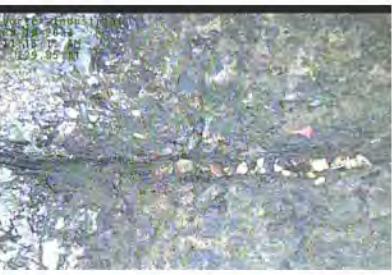
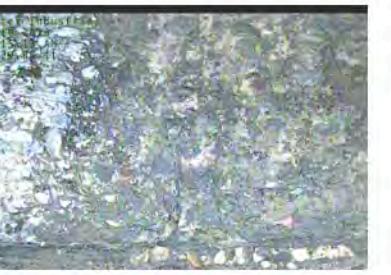
Crack Longitudinal	Point	135.8	Structural	0	11	2	0	0	1	Crack Longitudinal

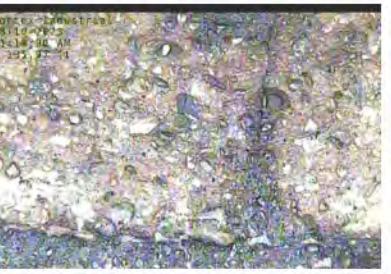
Crack Circumferential	Point	141.9	Structural	0	12-12	1	0	0	2	Crack Circumferential

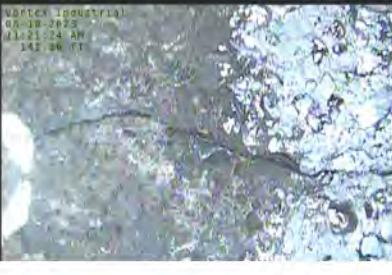
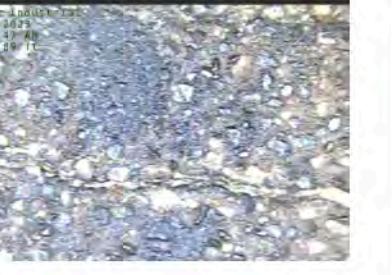
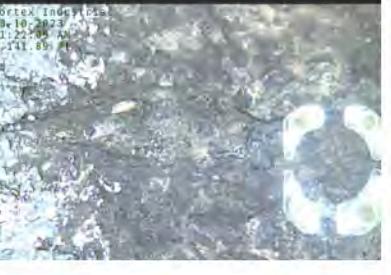
Description	Spatial Type	Distance (ft)	Type	Percent	Clock	SR	O&M	C	PR	Remarks		Photos
Crack Longitudinal	Point	148.2	Structural	0	2	2	0	0	1	Crack Longitudinal

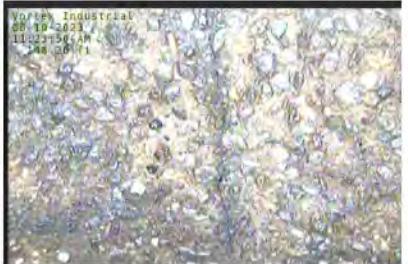
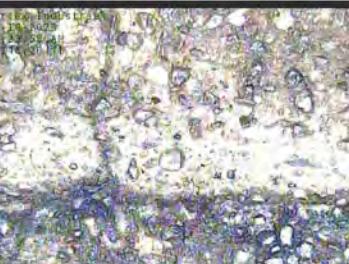
Crack Longitudinal	Point	154.1	Structural	0	9	2	0	0	1	Crack Longitudinal

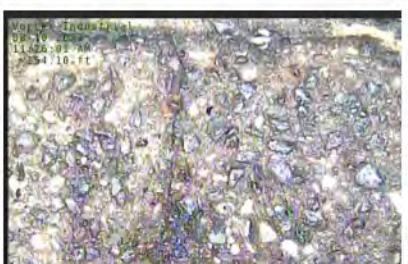
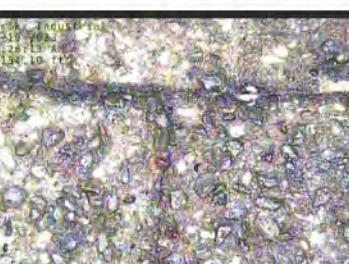
Crack Longitudinal	Point	154.1	Structural	0	4	2	0	0	1	Crack Longitudinal

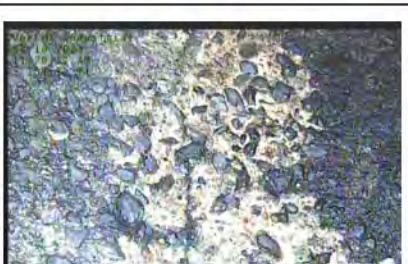
Crack Longitudinal	Point	154.1	Structural	0	6	2	0	0	1	Crack Longitudinal

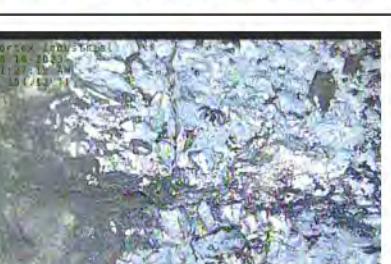
Crack Longitudinal	Point	160.2	Structural	0	1	2	0	0	1	Crack Longitudinal

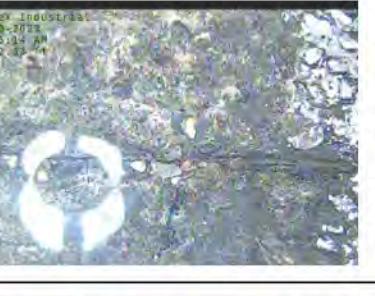
Crack Longitudinal	Point	172.3	Structural	0	6	2	0	0	1	Crack Longitudinal

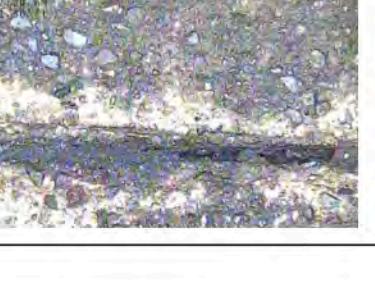
Crack Longitudinal	Point	172.3	Structural	0	12	2	0	0	1	Crack Longitudinal

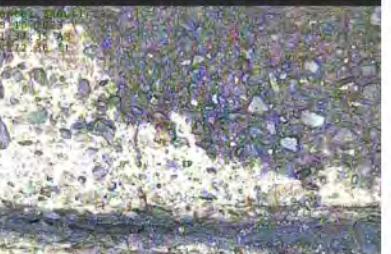
Description	Spatial Type	Distance (ft)	Type	Percent	Clock	SR	O&M	C	PR	Remarks	Photos
Crack Longitudinal	Point	172.3	Structural	0	1	2	0	0	1	Crack Longitudinal

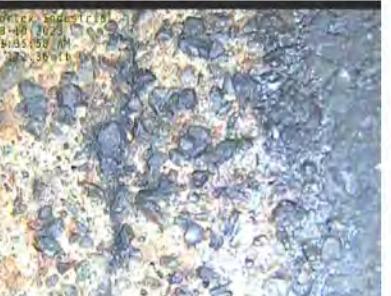
Crack Longitudinal	Point	172.3	Structural	0	8	2	0	0	1	Crack Longitudinal

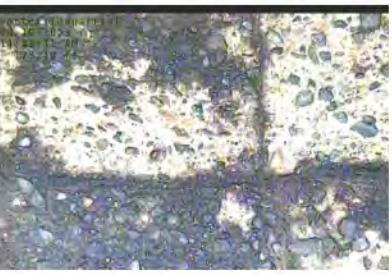
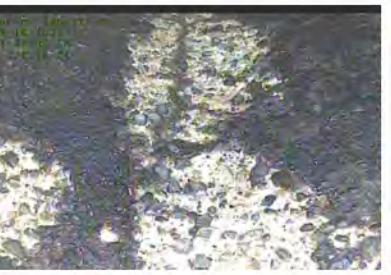
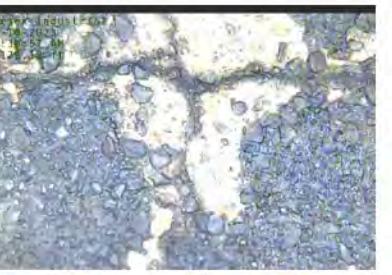
Crack Multiple	Point	178.2	Structural	0	6-11	3	0	0	1	Crack Multiple

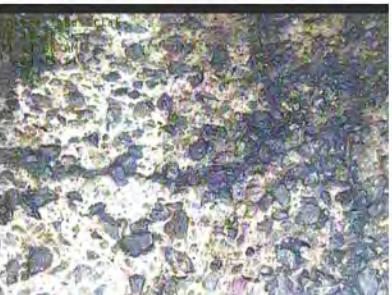
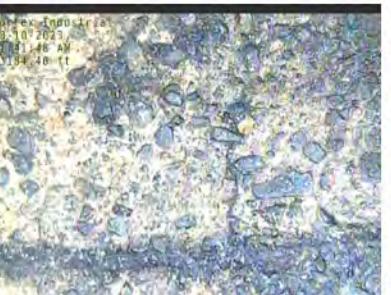
Crack Multiple	Point	184.5	Structural	0	8-9	2	0	0	1	Crack Multiple

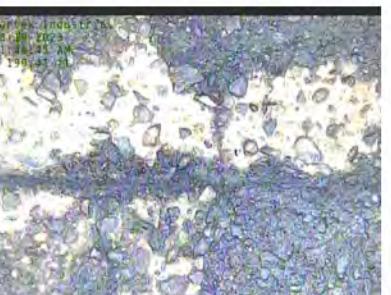
Crack Longitudinal	Point	190.4	Structural	0	9	2	0	0	1	Crack Longitudinal

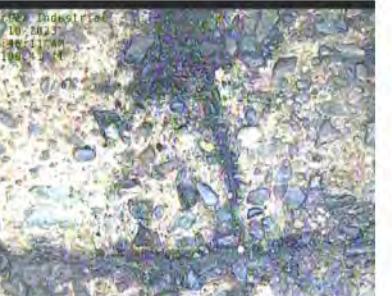
Description	Spatial Type	Distance (ft)	Type	Percent	Clock	SR	O&M	C	PR	Remarks		Photos
Crack Longitudinal	Point	190.4	Structural	0	8	2	0	0	1	Crack Longitudinal

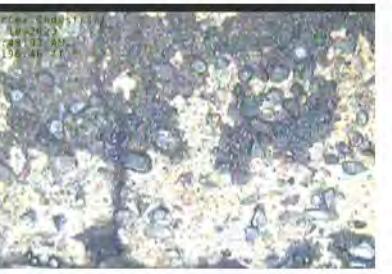
Crack Longitudinal	Point	196.4	Structural	0	1	2	0	0	1	Crack Longitudinal

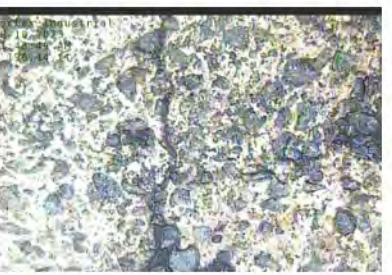
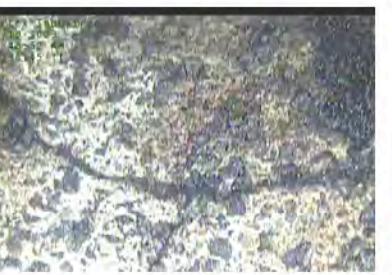
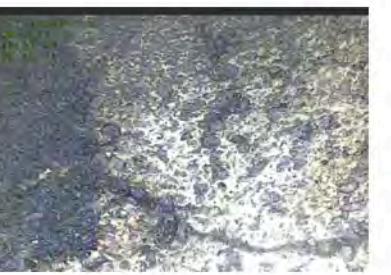
Crack Multiple	Point	196.4	Structural	0	8-10	3	0	0	1	Crack Multiple

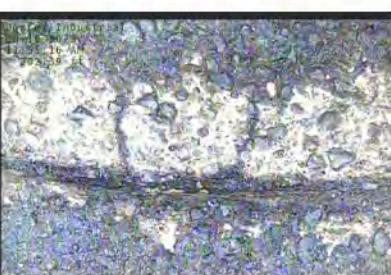
Crack Multiple	Point	202.4	Structural	0	1-2	3	0	0	1	Crack Multiple

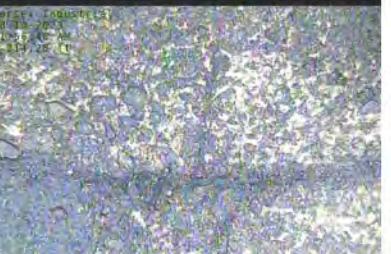
Description	Spatial Type	Distance (ft)	Type	Percent	Clock	SR	O&M	C	PR	Remarks		Photos
Crack Longitudinal	Point	214.3	Structural	0	11	2	0	0	1	Crack Longitudinal
