2023 ANNUAL PROGRESS REPORT

SWMU-1 OILY WATER SEWER

HF SINCLAIR PUGET SOUND REFINING LLC

MARCH 21, 2024

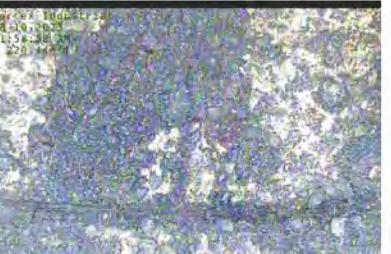
Crack Longitudinal	Point	220.4	Structural	0	12	2	0	0	1	Crack Longitudinal

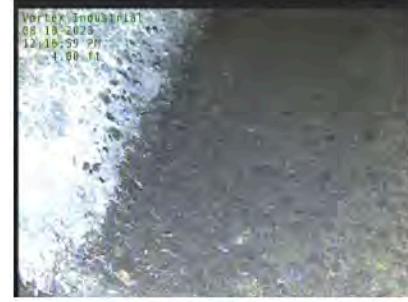
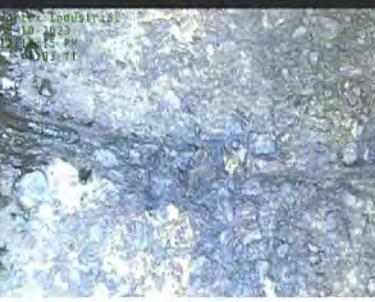
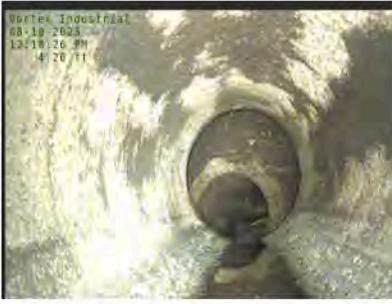
Surface Damage Roughness Increased	Continuous	0 - 10.5	Structural	0	12-12	1	0	0	1	Surface Damage Roughness Increased

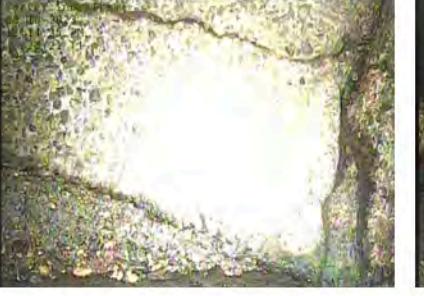
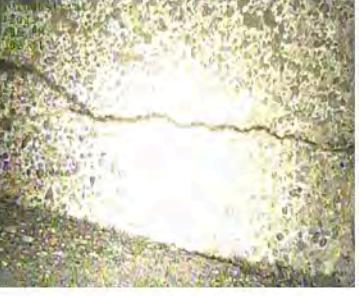
Description	Spatial Type	Distance (ft)	Type	Percent	Clock	SR	O&M	C	PR	Remarks		Photos
Fracture Multiple	Point	0.5	Structural	0	8-9	4	0	0	2	Fracture Multiple

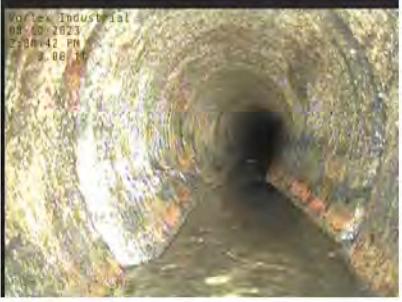
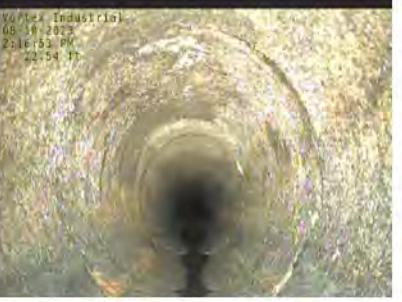
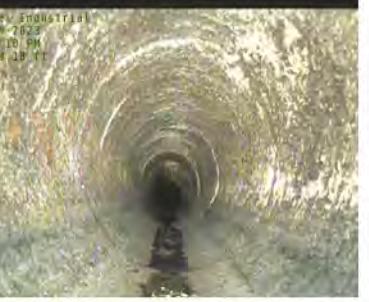
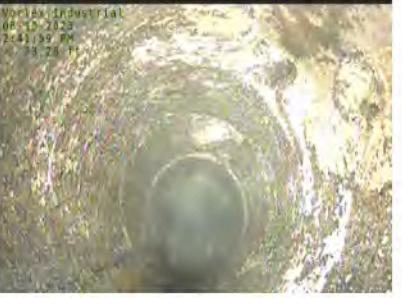
Surface Damage Aggregate Visible	Continuous	0 - 82	Structural	0	12-12	2	0	0	0	2	Surface Damage Aggregate Visible

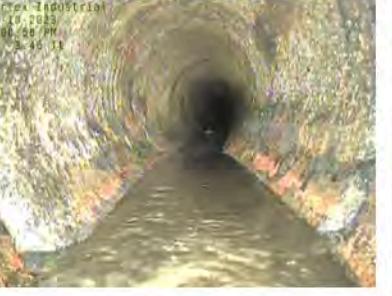
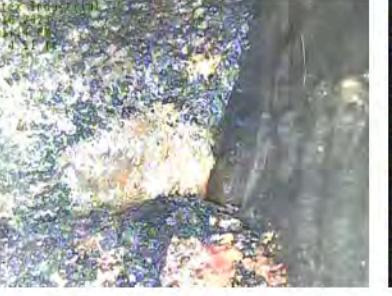
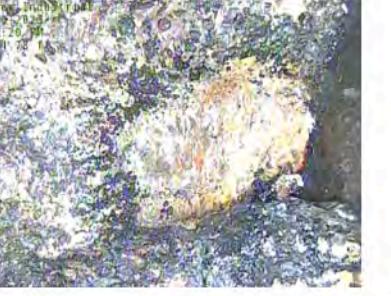
Description	Spatial Type	Distance (ft)	Type	Percent	Clock	SR	O&M	C	PR	Remarks	Photos
Fracture Circumferential	Point	4.8	Constructional	0	7-8	2	0	0	2	Fracture Circumferential

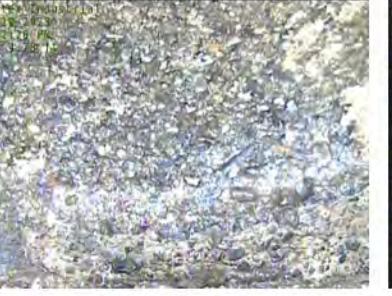
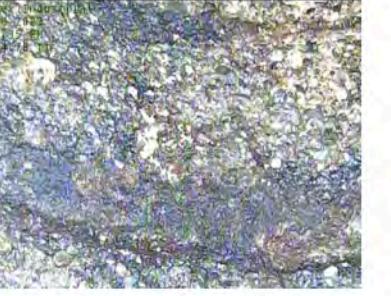
Crack Circumferential	Point	4.8	Structural	0	9-7	1	0	0	1	Crack Circumferential

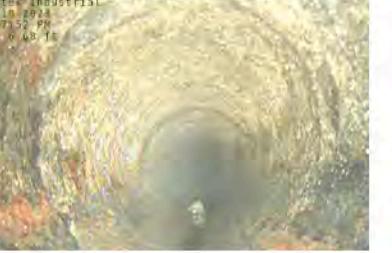
Miscellaneous Water Level	Point	7	Miscellaneous	0		0	0	0	0	Miscellaneous Water Level

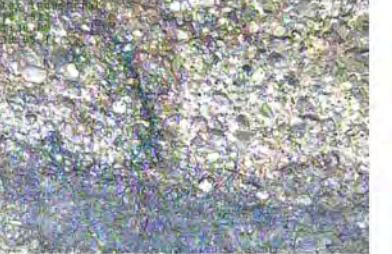
Crack Longitudinal	Point	13	Structural	0	4	2	0	0	1	Crack Longitudinal

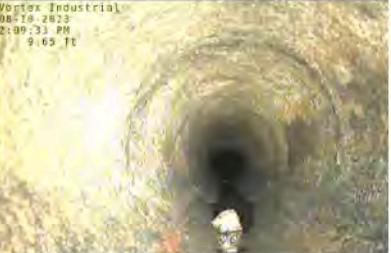
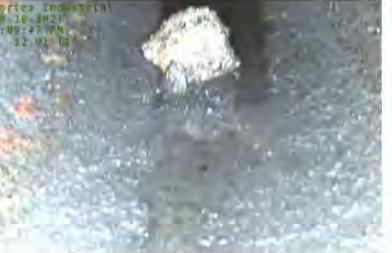
Obstruction Rocks	Point	14	O&M	10	6	0	2	0	0	Obstruction Rocks

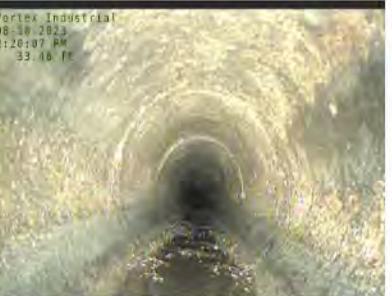
Description	Spatial Type	Distance (ft)	Type	Percent	Clock	SR	O&M	C	PR	Remarks	Photos
Miscellaneous Water Level	Point	33.4	Miscellaneous	10		0	0	0	0	Miscellaneous Water Level

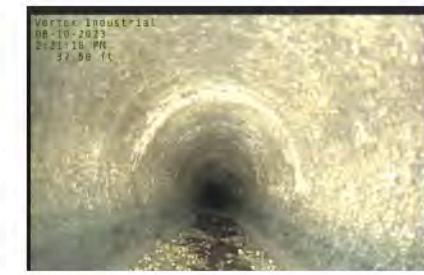
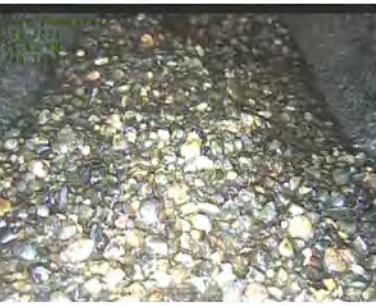
Deposits Settled Gravel	Continuous	37.5 - 52.8	O&M	10	6	0	2	0	0	Deposits Settled Gravel

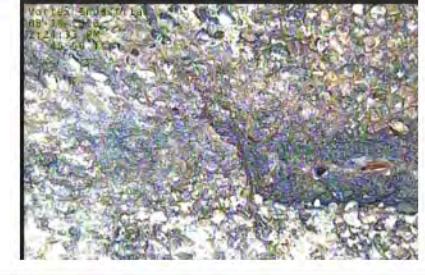
Crack Longitudinal	Point	45.5	Structural	0	1	2	0	0	1	Crack Longitudinal

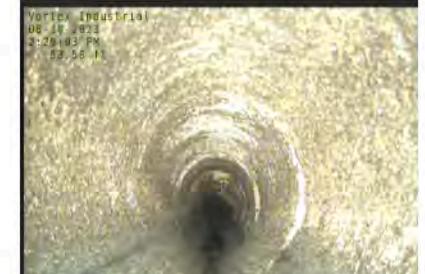
Miscellaneous Water Level	Point	53.6	Miscellaneous	0		0	0	0	0	Miscellaneous Water Level

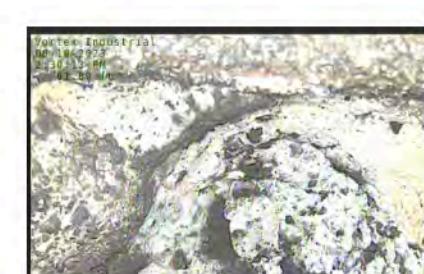
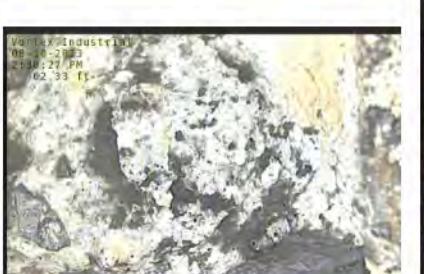
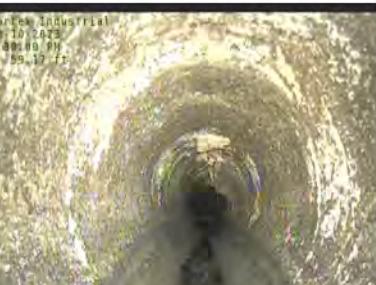
Point Repair Patch	Point	61.9	Structural	0	12	0	0	0	3	Point Repair Patch

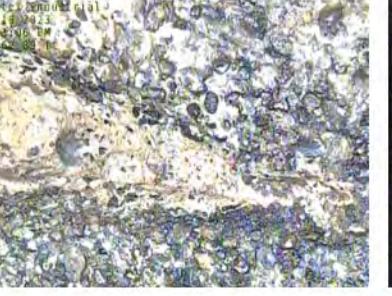
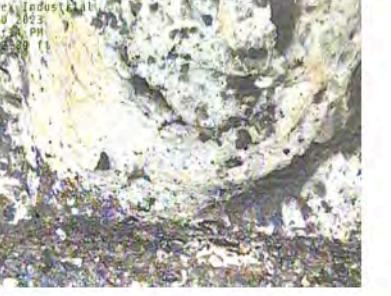
Description	Spatial Type	Distance (ft)	Type	Percent	Clock	SR	O&M	C	PR	Remarks	Photos
Crack Circumferential	Point	62.3	Structural	0	1-11	1	0	0	2	Crack Circumferential

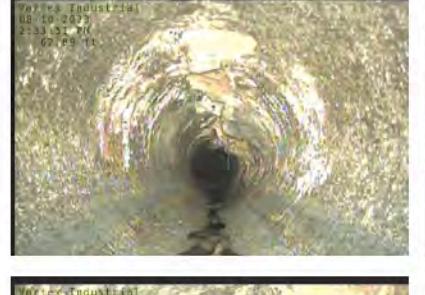
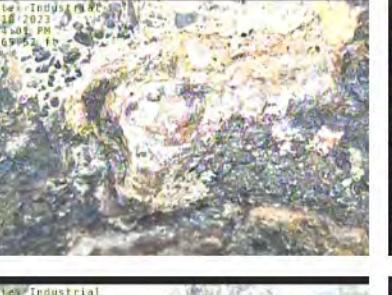
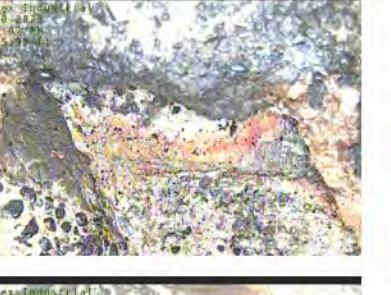
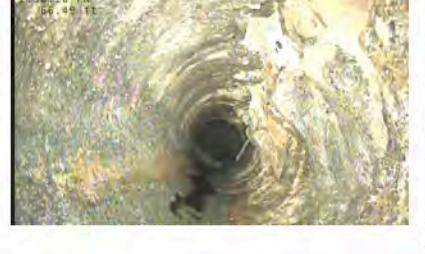
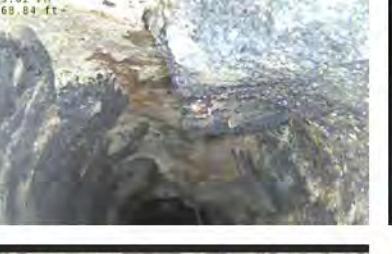
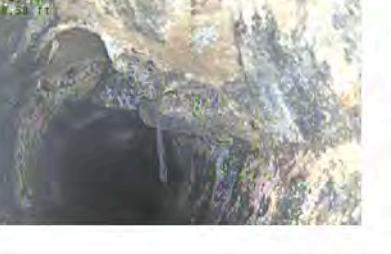
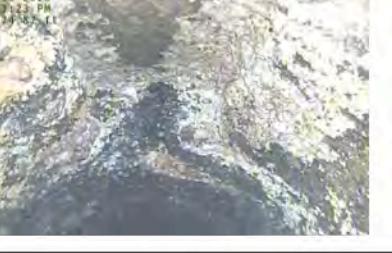
Point Repair Patch	Continuous	66.1 - 75.1	Structural	20	12-3	0	0	0	3	Point Repair Patch

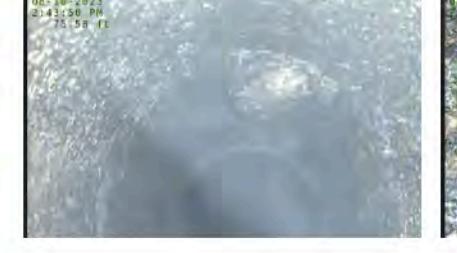
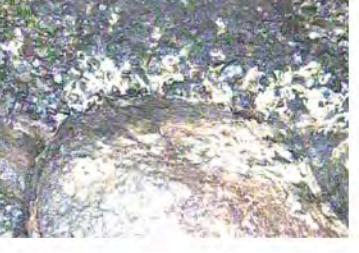
Deposits Attached Encrustation	Point	78.5	O&M	10	12	0	2	0	0	Deposits Attached Encrustation

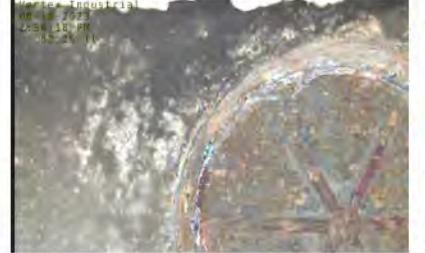
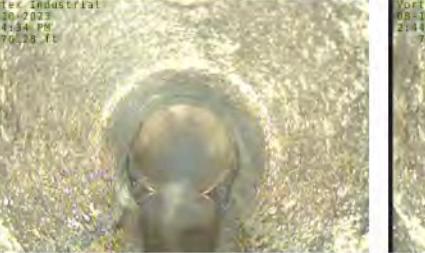
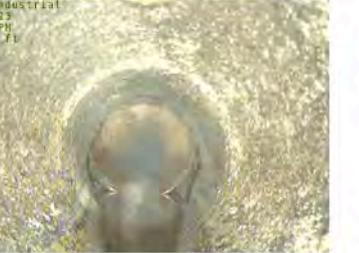
Description	Spatial Type	Distance (ft)	Type	Percent	Clock	SR	O&M	C	PR	Remarks	Photos
Manhole	Point	82	Constructional	0	0	0	0	0	0	D-19

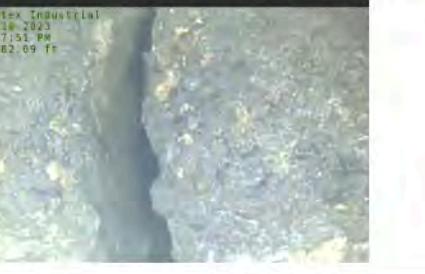
Fracture Longitudinal	Point	82	Structural	0	6	3	0	0	3	Fracture Longitudinal

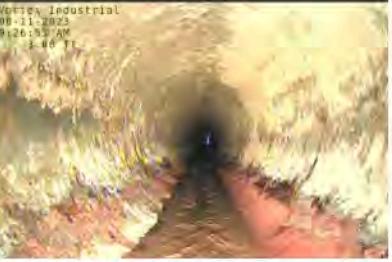
Description		Spatial Type	Distance (ft)	Type	Percent	Clock	SR	O&M	C	PR	Remarks	Photos
Manhole	Point	0	Constructional	0		0	0	0	0	0	D-19

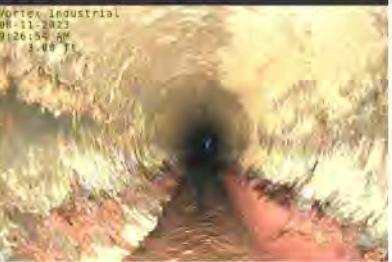
Miscellaneous Water Level	Point	0	Miscellaneous	10		0	0	0	0	0	Water Level at Start of Survey

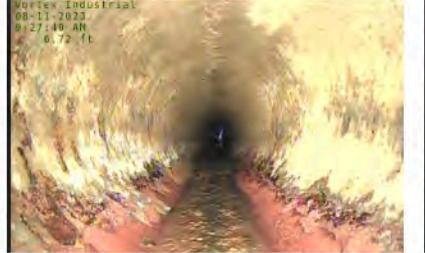
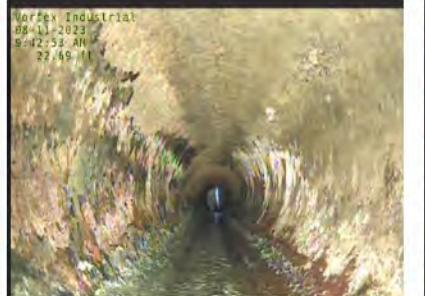
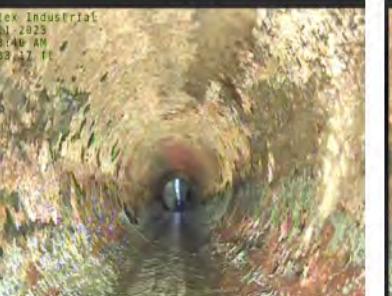
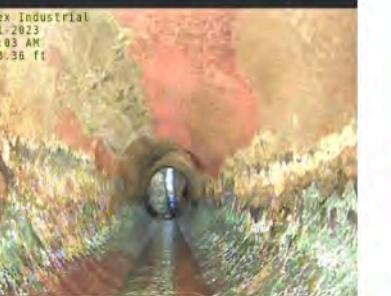
Description	Spatial Type	Distance (ft)	Type	Percent	Clock	SR	O&M	C	PR	Remarks	Photos
Surface Damage Surface Spalling	Continuous	0 - 64.3	Structural	0	12-12	2	0	0	1	Surface Damage Surface Spalling

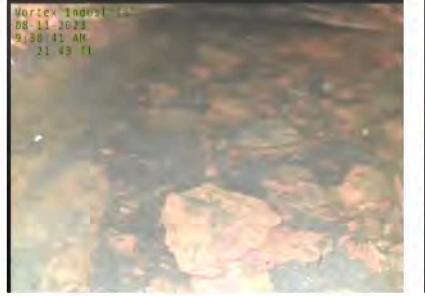
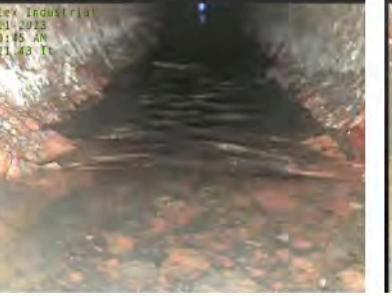
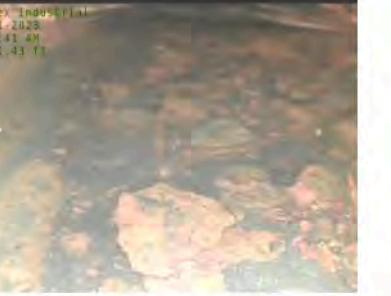
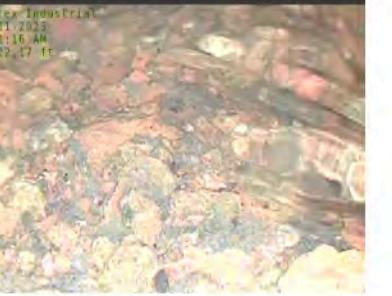
Deposits Settled Gravel	Continuous	18.2 - 22.2	O&M	10		0	2	0	0	Deposits Settled Gravel

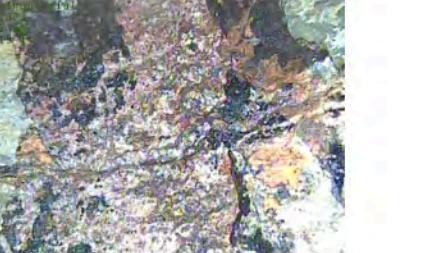
Crack Longitudinal	Point	20.2	Structural	0	8	2	0	0	1	Crack Longitudinal

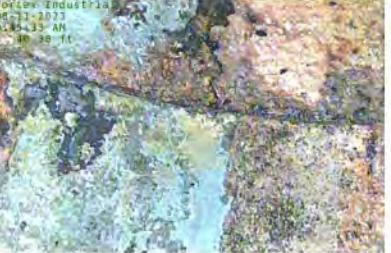
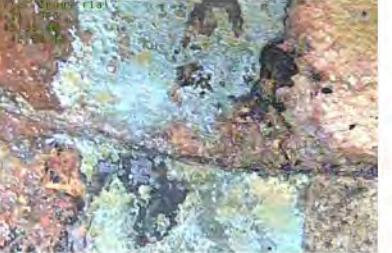
Description	Spatial Type	Distance (ft)	Type	Percent	Clock	SR	O&M	C	PR	Remarks		Photos
Crack Longitudinal	Point	40.4	Structural	0	4	2	0	0	1	Crack Longitudinal

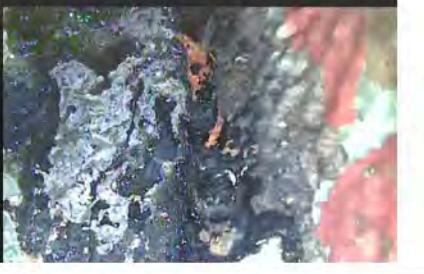
Crack Longitudinal	Point	59.1	Structural	0	7	2	0	0	1	Crack Longitudinal

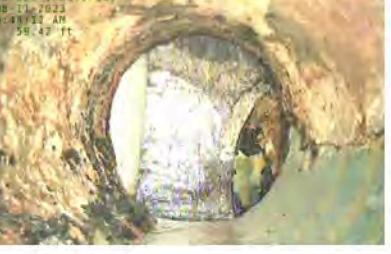
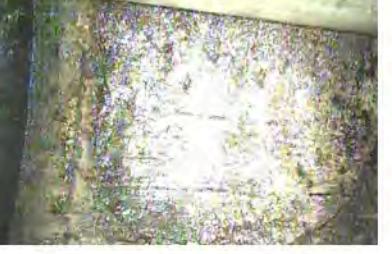
Manhole	Point	64.3	Constructional	0		0	0	0	0	D-20C

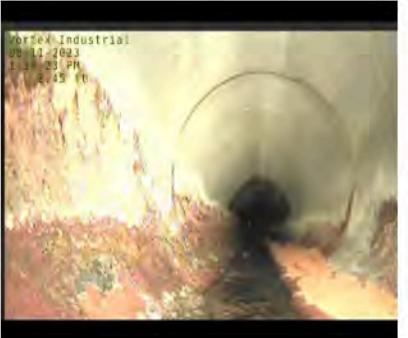
Description	Spatial Type	Distance (ft)	Type	Percent	Clock	SR	O&M	C	PR	Remarks	Photos
Manhole	Point	0	Constructional	0		0	0	0	0	D-22

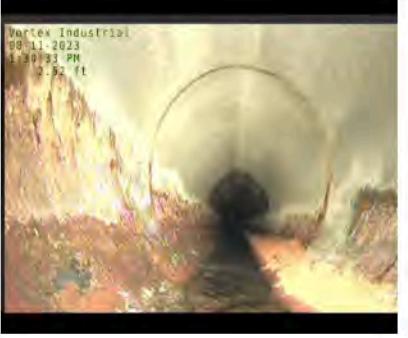
Miscellaneous Water Level	Point	0	Miscellaneous	10		0	0	0	0	Water Level at Start of Survey

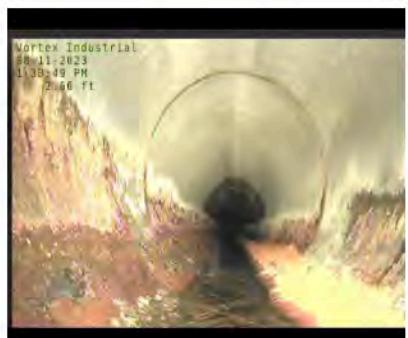
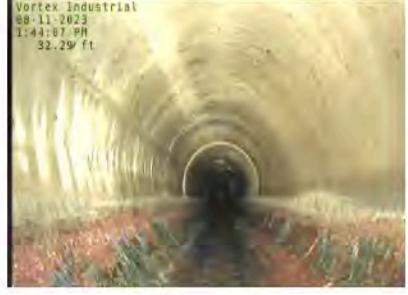
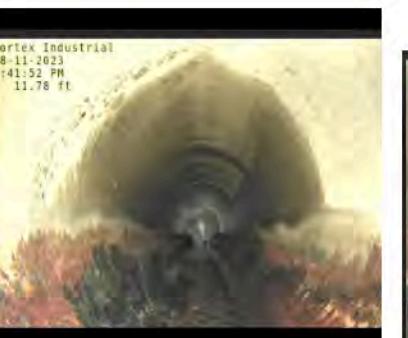
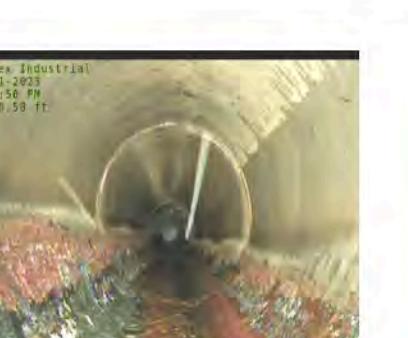
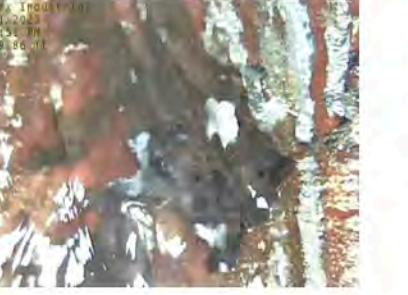
Surface Damage Corrosion	Continuous	0 - 332	Structural	0	3-9	3	0	0	2	Surface Damage Corrosion

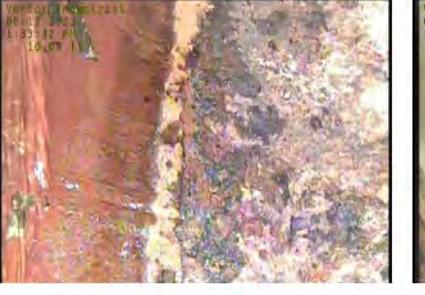
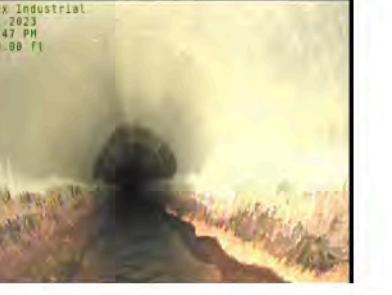
Crack Longitudinal	Point	10	Structural	0	5	2	0	0	1	Crack Longitudinal

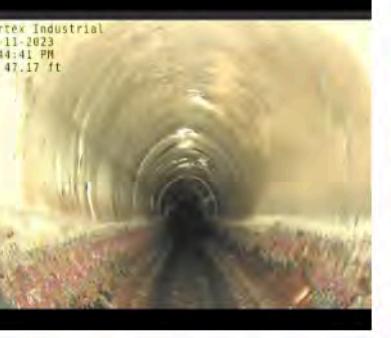
Surface Damage Roughness Increase	Point	47.7	Structural	0	9	1	0	0	2	Surface Damage Roughness Increase

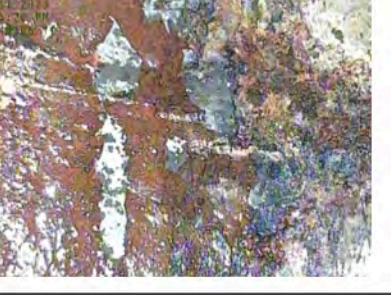
Crack Longitudinal	Point	49.8	Structural	0	4	2	0	0	1	Crack Longitudinal

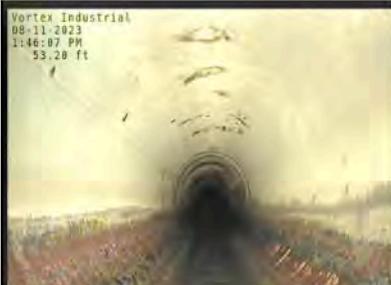
Description	Spatial Type	Distance (ft)	Type	Percent	Clock	SR	O&M	C	PR	Remarks	Photos
Surface Damage Roughness Increased	Continuous	55 - 61.3	Structural	0	11-1	1	0	0	1	Surface Damage Roughness Increased

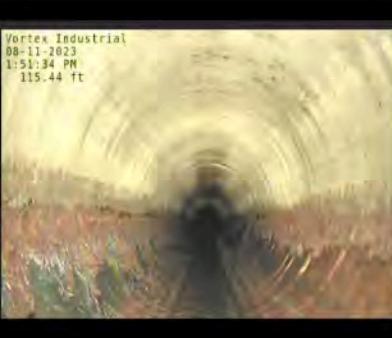
Crack Longitudinal	Continuous	110.8 - 127.2	Structural	0	3	2	0	0	1	Crack Longitudinal

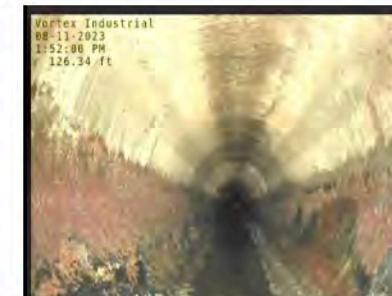
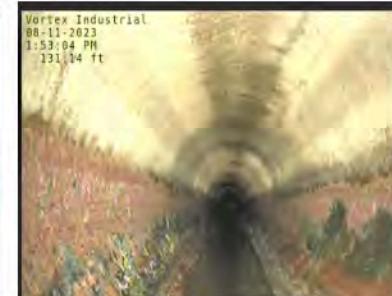
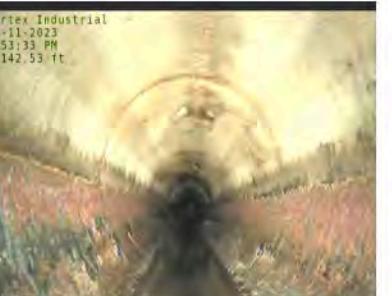
Crack Longitudinal	Continuous	129.2 - 147	Structural	0	1	2	0	0	2	Crack Longitudinal

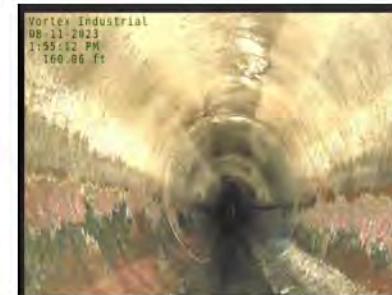
Surface Damage Roughness Increased	Point	162	Structural	0	12	1	0	0	1	Surface Damage Roughness Increased

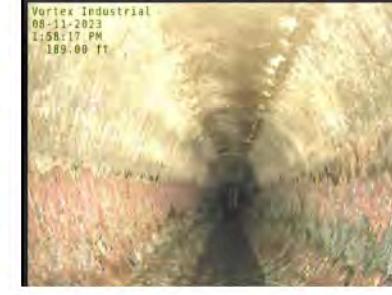
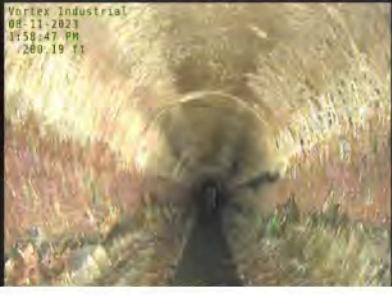
Surface Damage Roughness Increased	Continuous	189.2 - 208.9	Structural	0	9-3	1	0	0	1	Surface Damage Roughness Increased

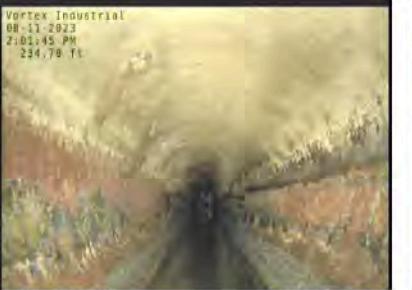
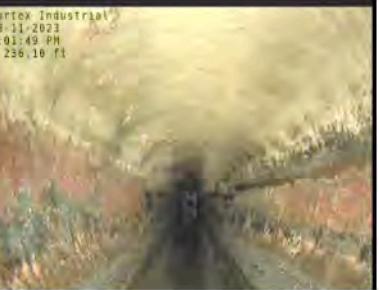
Description	Spatial Type	Distance (ft)	Type	Percent	Clock	SR	O&M	C	PR	Remarks	Photos
Surface Damage Roughness Increased	Continuous	237 - 247	Structural	0	11	1	0	0	1	Surface Damage Roughness Increased

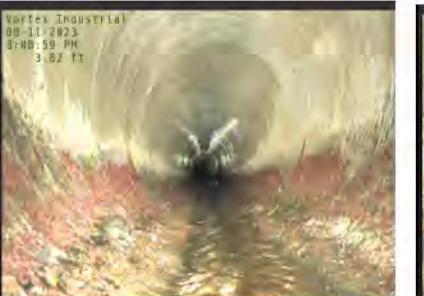
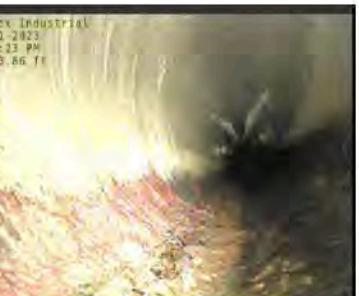
Description		Spatial Type	Distance (ft)	Type	Percent	Clock	SR	O&M	C	PR	Remarks	Photos		
Surface Damage Corrosion	Continuous	0 - 8	Structural	0	4-8	3	0	0	0	3	Surface Damage Corrosion

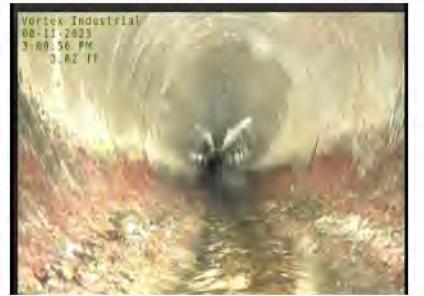
Miscellaneous Water Level	Point	0	Miscellaneous	10		0	0	0	0		Water Level at Start of Survey

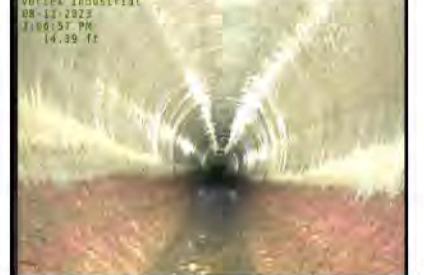
Surface Damage Corrosion	Continuous	8 - 17	Structural	0	4-8	3	0	0	0	2	Surface Damage Corrosion

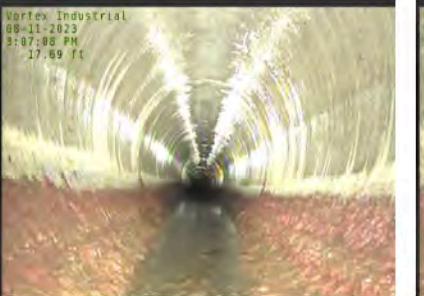
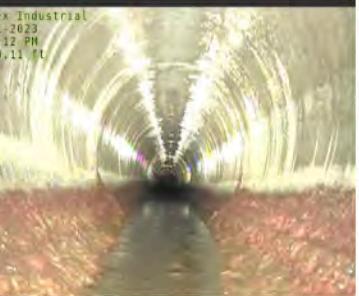
Description	Spatial Type	Distance (ft)	Type	Percent	Clock	SR	O&M	C	PR	Remarks	Photos
Surface Damage Corrosion	Point	17	Structural	0	4-8	3	0	0	3	Surface Damage Corrosion

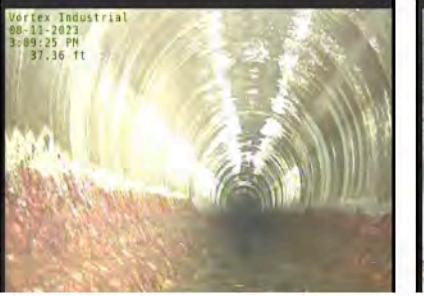
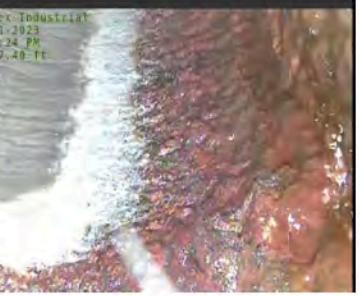
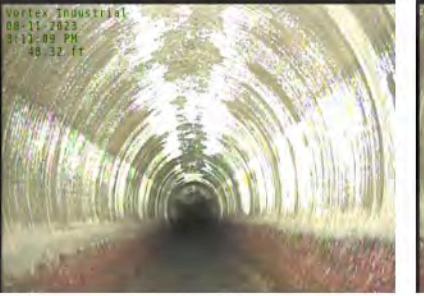
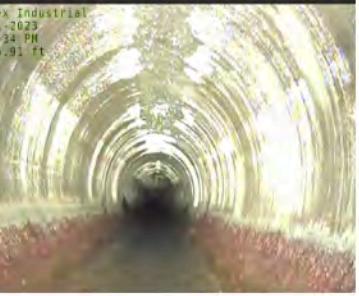
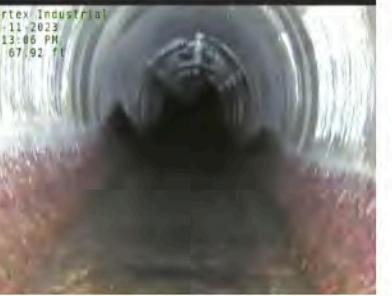
Surface Damage Corrosion	Continuous	19 - 75	Structural	0	4-8	3	0	0	2	Surface Damage Corrosion

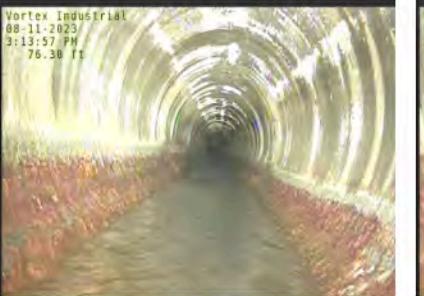
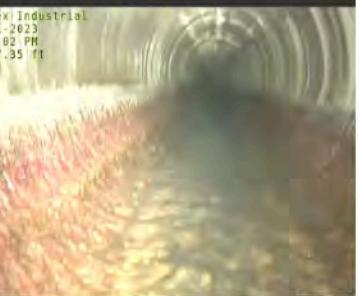
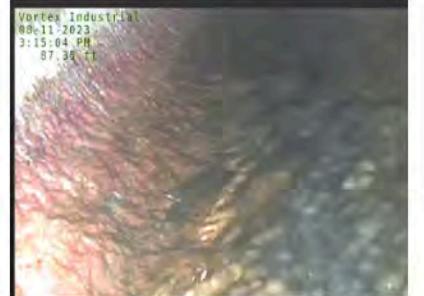
Description	Spatial Type	Distance (ft)	Type	Percent	Clock	SR	O&M	C	PR	Remarks	Photos
Surface Damage Corrosion	Continuous	75 - 88	Structural	0	4-8	3	0	0	3	Surface Damage Corrosion

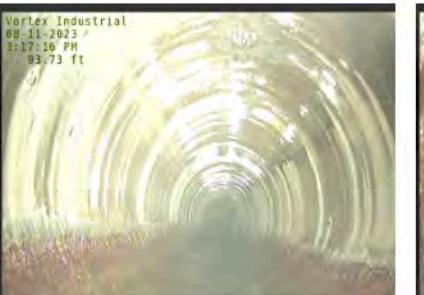
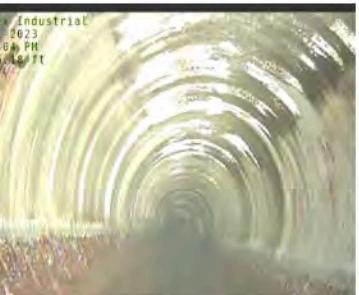
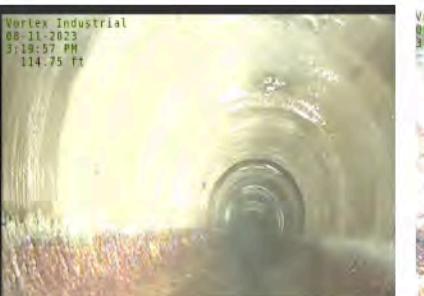
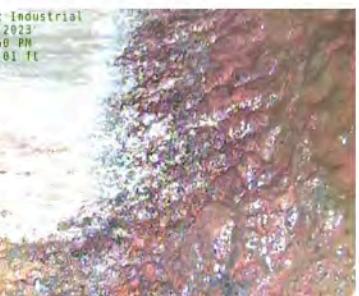
Surface Damage Corrosion	Continuous	88 - 120	Structural	0	4-8	3	0	0	2	Surface Damage Corrosion

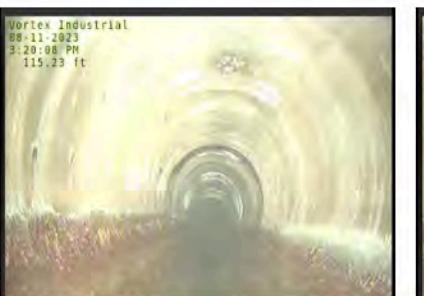
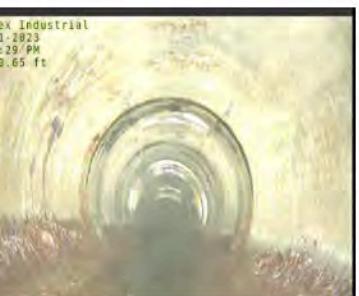
Surface Damage Roughness Increased	Continuous	117 - 125.4	Structural	0	9-1	1	0	0	1	Surface Damage Roughness Increased

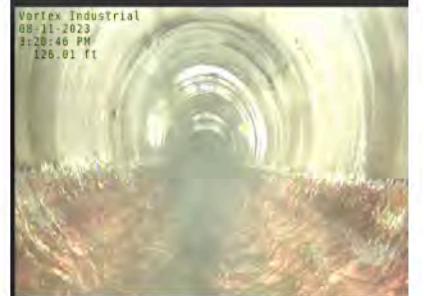
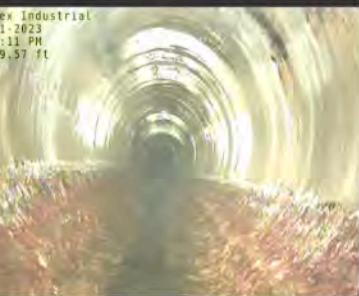
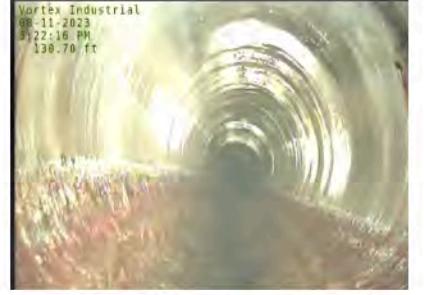
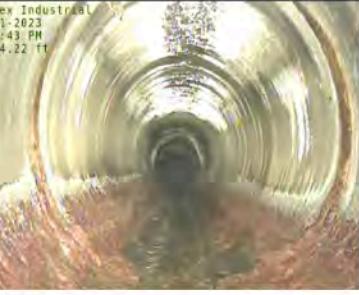
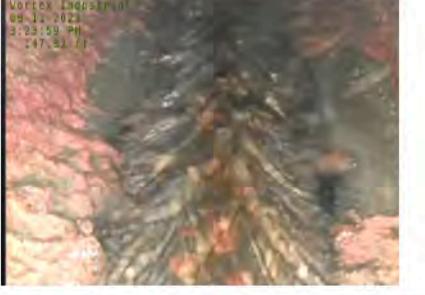
Description	Spatial Type	Distance (ft)	Type	Percent	Clock	SR	O&M	C	PR	Remarks	Photos
Surface Damage Corrosion	Continuous	120 - 150	Structural	0	4-8	3	0	0	3	Surface Damage Corrosion

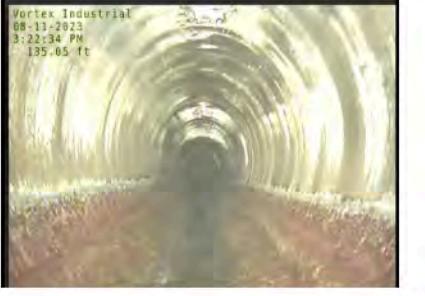
Surface Damage Roughness Increased	Point	135	Structural	0	11-1	1	0	0	1	Surface Damage Roughness Increased

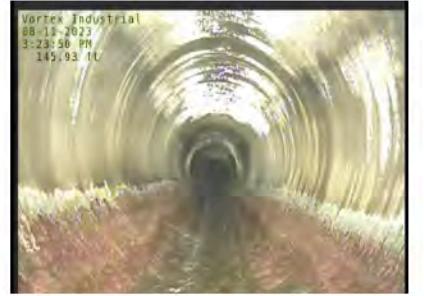
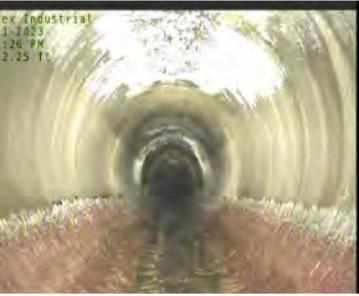
Surface Damage Roughness Increased	Continuous	146 - 158	Structural	0	10-2	1	0	0	1	Surface Damage Roughness Increased

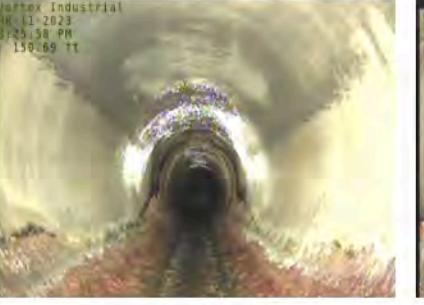
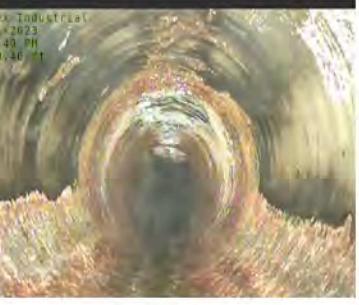
Description	Spatial Type	Distance (ft)	Type	Percent	Clock	SR	O&M	C	PR	Remarks	Photos
Surface Damage Corrosion	Continuous	150 - 176.1	Structural	0	4-8	3	0	0	2	Surface Damage Corrosion

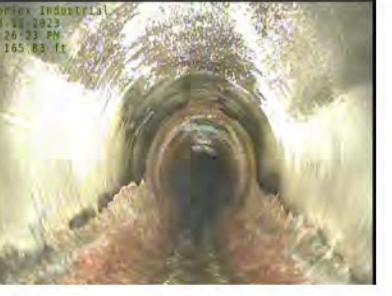
Surface Damage Roughness Increased	Continuous	165 - 171.4	Structural	0	10-2	1	0	0	1	Surface Damage Roughness Increased

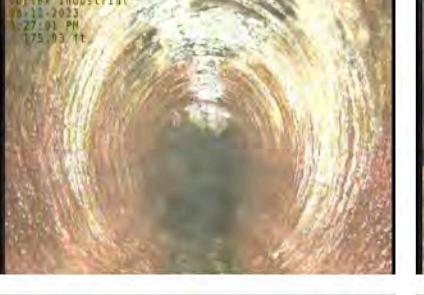
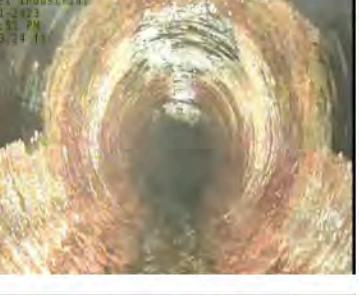
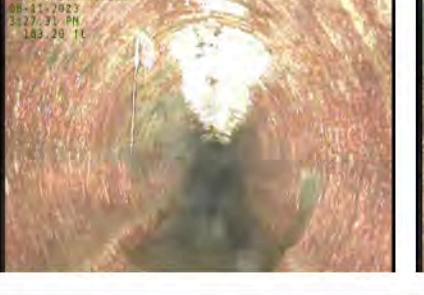
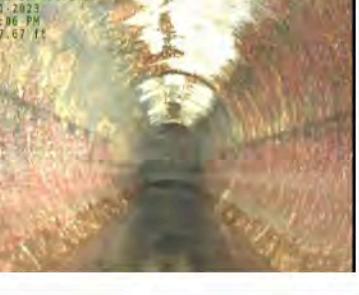
Surface Damage Corrosion	Continuous	176.2 - 217.3	Structural	0	12-12	3	0	0	2	Surface Damage Corrosion

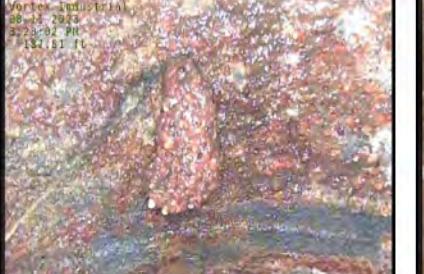
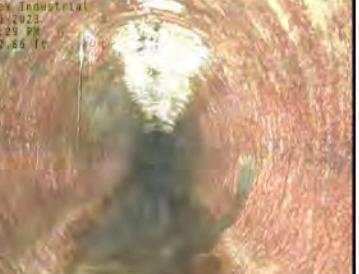
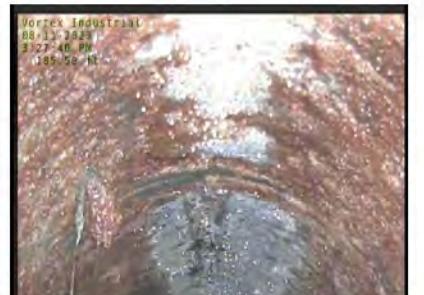
Description	Spatial Type	Distance (ft)	Type	Percent	Clock	SR	O&M	C	PR	Remarks	Photos
Surface Damage Spalling	Point	187.6	Structural	5	11	2	0	0	1	Surface Damage Spalling

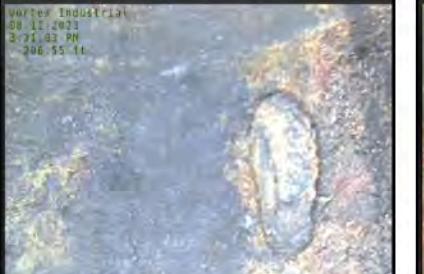
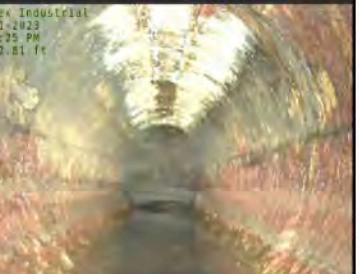
Miscellaneous General Observation	Point	206.5	Miscellaneous	5	10	0	0	0	0	Ring Inserted in Pipe

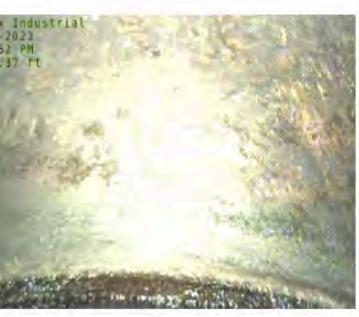
Manhole	Point	217.3	Constructional	0		0	0	0	0	D-24

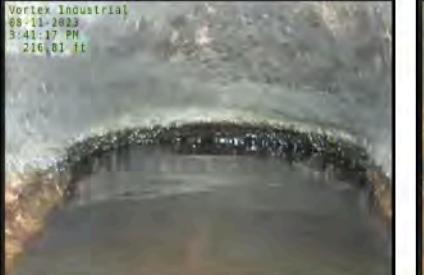
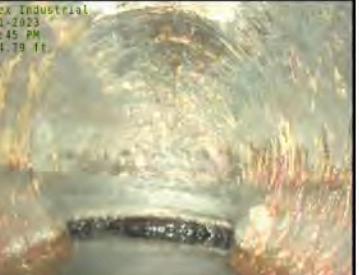
Line Down	Point	217.3	Constructional	100		0	4	4	0	Line Down

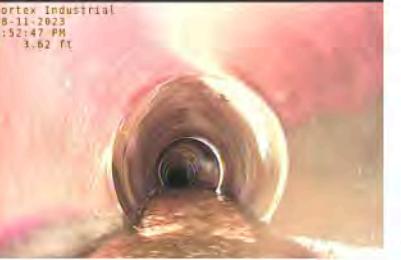
Description		Spatial Type	Distance (ft)	Type	Percent	Clock	SR	O&M	C	PR	Remarks	Photos		
Manhole	Point	0	Constructional	0	0	0	0	0	0	0	B-1

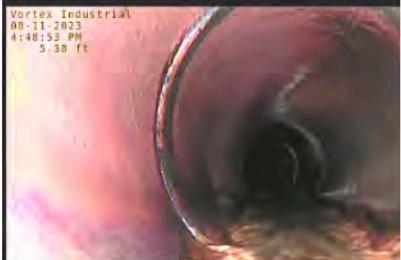
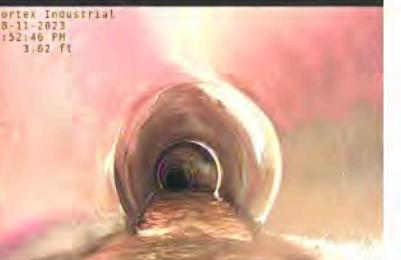
Miscellaneous Water Level	Point	0	Miscellaneous	20	0	0	0	0	0	0	Water Level at Start of Survey

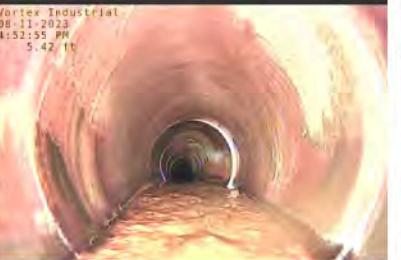
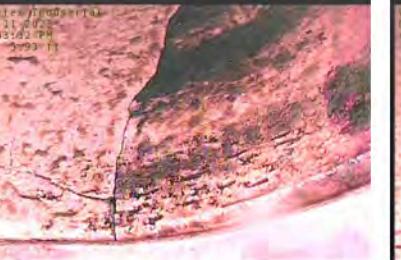
Fracture Multiple	Point	5.9	Structural	0	6-11	4	0	0	3	3	Fracture Multiple

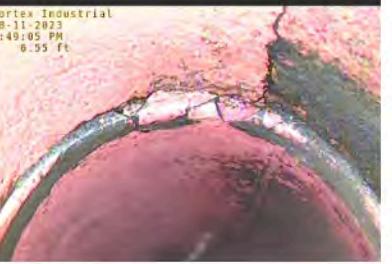
Description	Spatial Type	Distance (ft)	Type	Percent	Clock	SR	O&M	C	PR	Remarks	Photos
Crack Multiple	Point	7	Structural	0	12-1	3	0	0	2	Crack Multiple

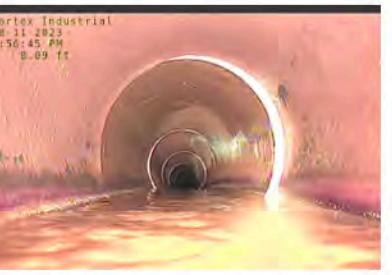
Joint Offset Medium	Point	9.8	Structural	0		3	0	0	2	Joint Offset Medium

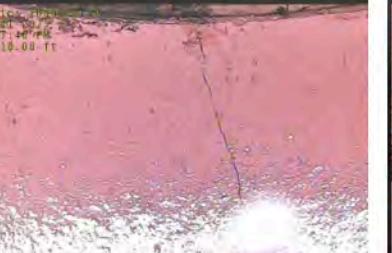
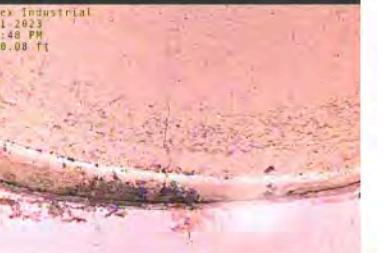
Crack Longitudinal	Point	10	Structural	0	3	2	0	0	1	Crack Longitudinal

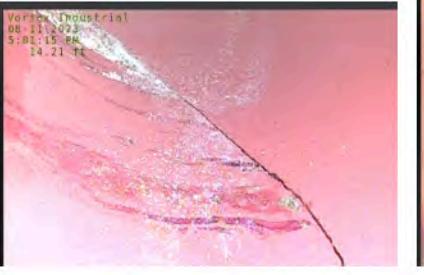
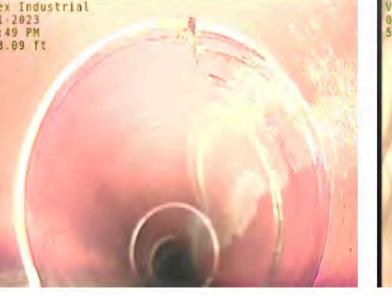
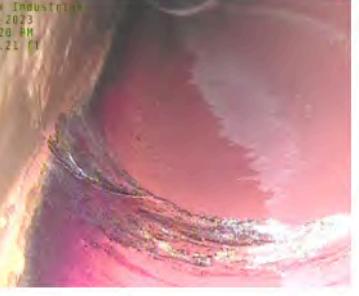
Description	Spatial Type	Distance (ft)	Type	Percent	Clock	SR	O&M	C	PR	Remarks	Photos
Fracture Multiple	Point	14.2	Structural	0	12-12	2	0	0	3	Fracture Multiple

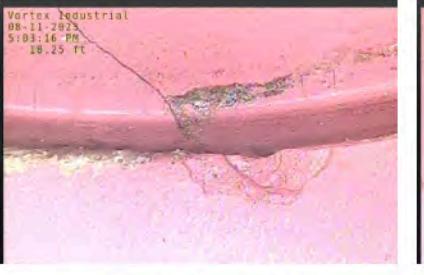
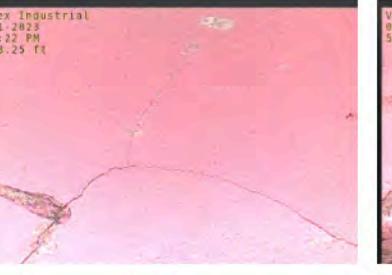
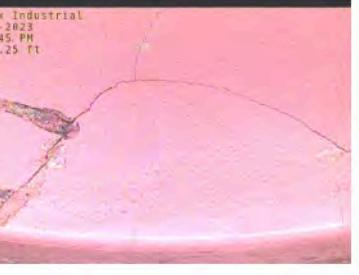
Crack Multiple	Point	18.2	Structural	0	1-3	3	0	0	2	Crack Multiple

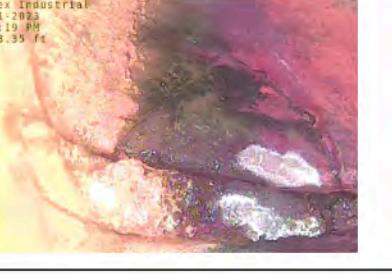
Crack Multiple	Point	18.2	Structural	0	5-6	3	0	0	2	Crack Multiple

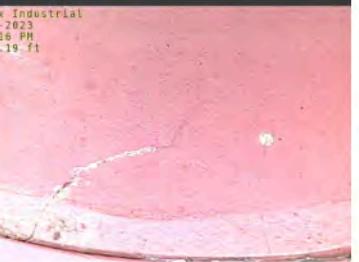
Description	Spatial Type	Distance (ft)	Type	Percent	Clock	SR	O&M	C	PR	Remarks	Photos
Crack Multiple	Point	22.2	Structural	0	12-12	3	0	0	2	Crack Multiple

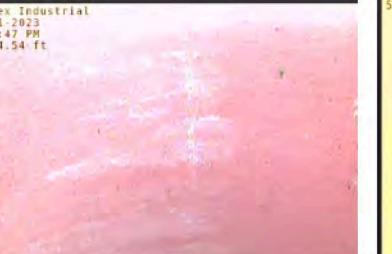
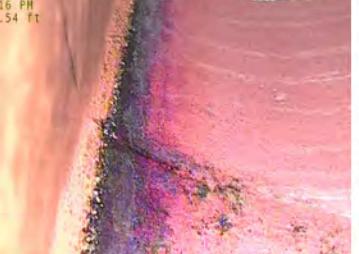
Crack Spiral	Point	24.5	Structural	0	2-6	2	0	0	1	Crack Spiral

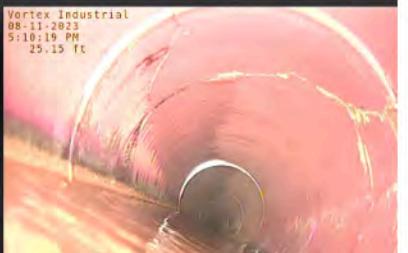
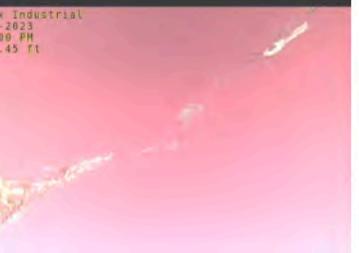
Crack Multiple	Point	26.5	Structural	0	12-12	3	0	0	2	Crack Multiple

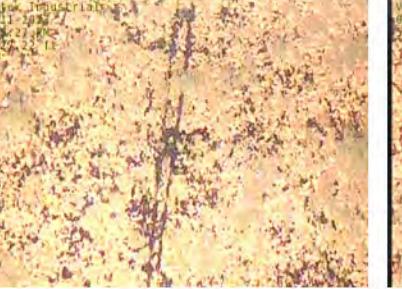
Description	Spatial Type	Distance (ft)	Type	Percent	Clock	SR	O&M	C	PR	Remarks	Photos
Crack Longitudinal	Point	27.2	Structural	0	6	2	0	0	1	Crack Longitudinal

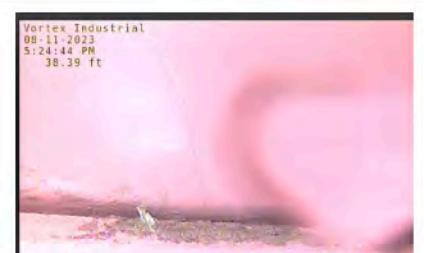
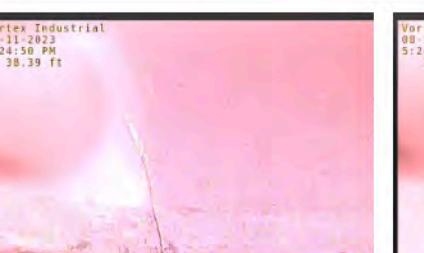
Crack Spiral	Point	38.4	Structural	0	2-5	2	0	0	2	Crack Spiral

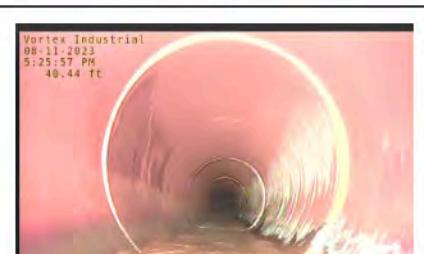
Crack Spiral	Point	42.2	Structural	0	6-11	2	0	0	2	Crack Spiral

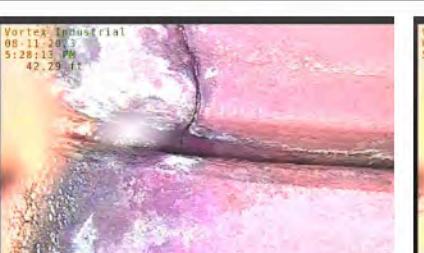
Crack Longitudinal	Point	42.2	Structural	0	5	2	0	0	2	Crack Longitudinal

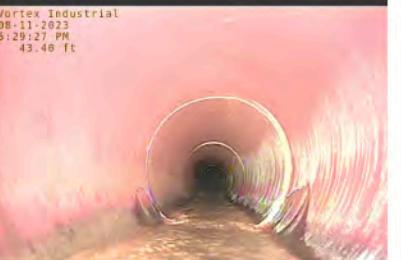
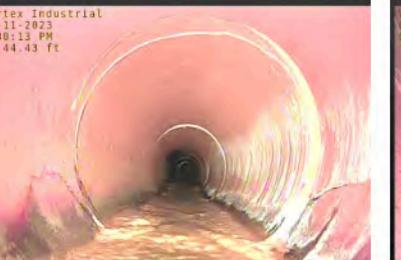
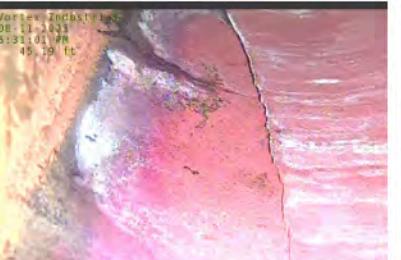
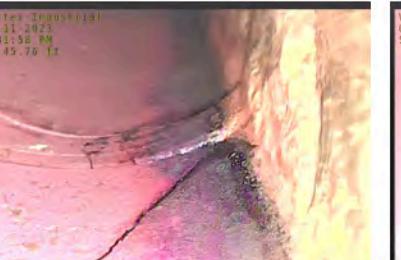
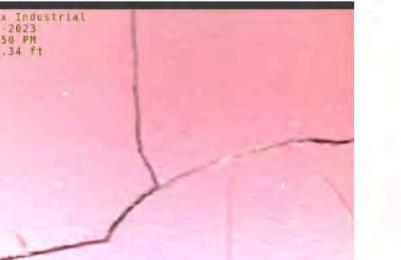
Description	Spatial Type	Distance (ft)	Type	Percent	Clock	SR	O&M	C	PR	Remarks	Photos
Crack Multiple	Point	46.3	Structural	0	12-12	3	0	0	2	Crack Multiple

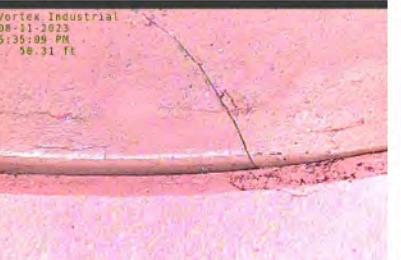
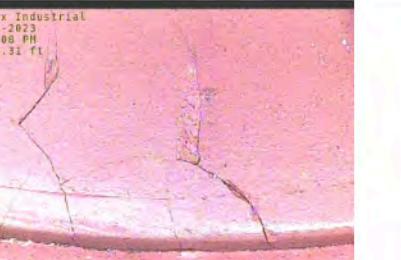
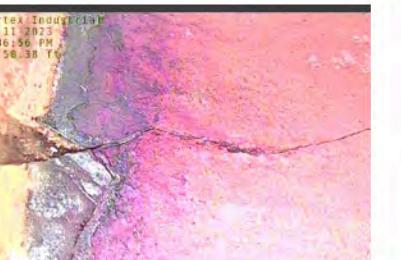
Crack Multiple	Point	50.4	Structural	0	12-12	3	0	0	2	Crack Multiple

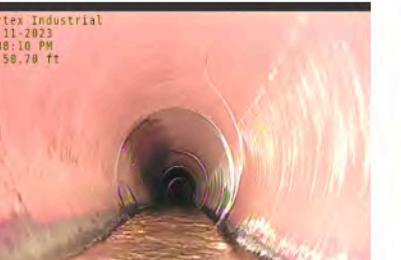
Crack Spiral	Point	54	Structural	0	12-5	2	0	0	2	Crack Spiral

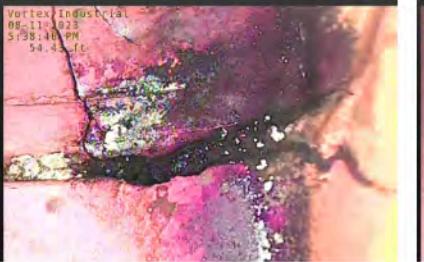
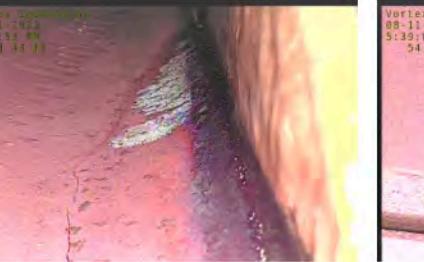
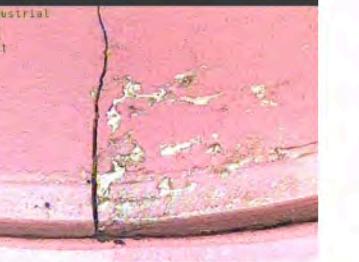
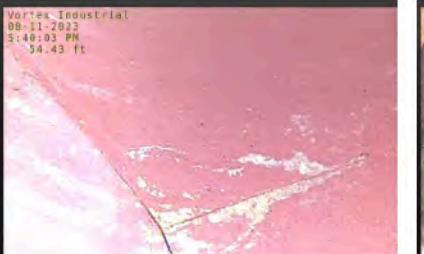
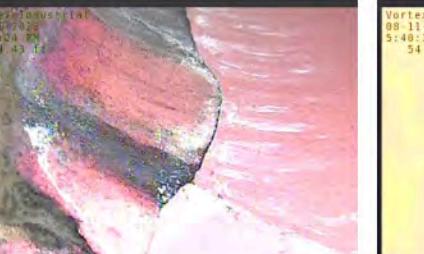
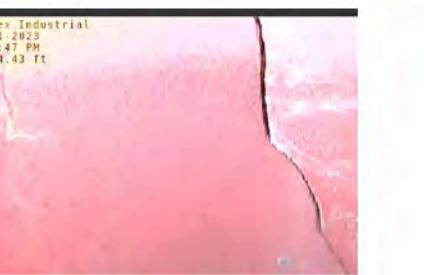
Description	Spatial Type	Distance (ft)	Type	Percent	Clock	SR	O&M	C	PR	Remarks	Photos
Fracture Multiple	Point	54.4	Structural	0	12-12	3	0	0	3	Fracture Multiple

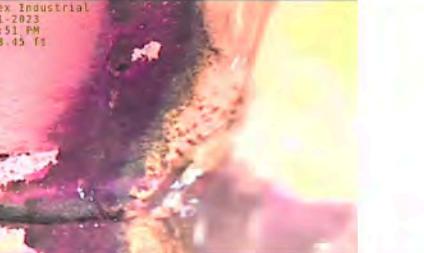
Crack Longitudinal	Point	58.5	Structural	0	7	2	0	0	1	Crack Longitudinal

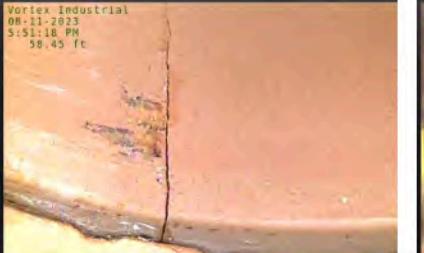
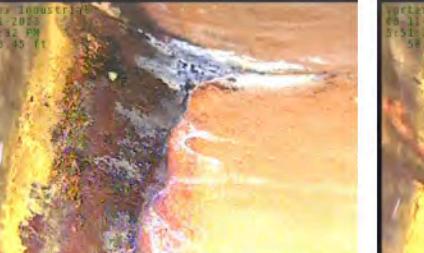
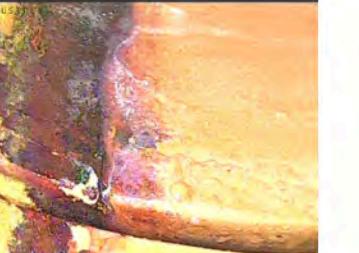
Crack Spiral	Point	58.5	Structural	0	2-6	2	0	0	2	Crack Spiral

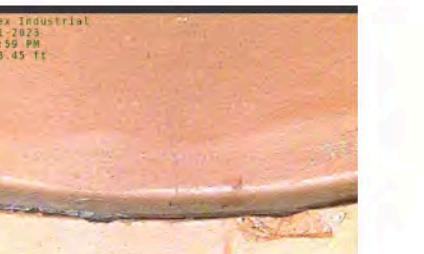
Crack Longitudinal	Point	58.5	Structural	0	10	2	0	0	1	Crack Longitudinal

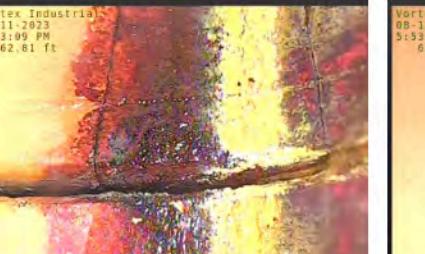
Description	Spatial Type	Distance (ft)	Type	Percent	Clock	SR	O&M	C	PR	Remarks	Photos
Crack Longitudinal	Point	62.8	Structural	0	7	2	0	0	2	Crack Longitudinal

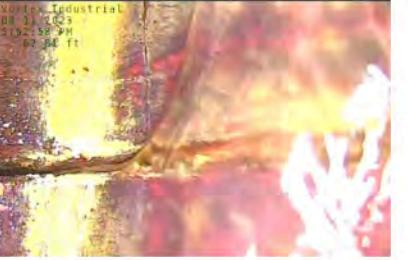
Crack Longitudinal	Point	62.8	Structural	0	6	2	0	0	2	Crack Longitudinal

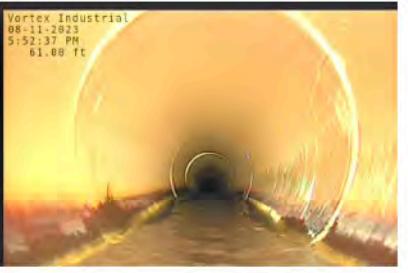
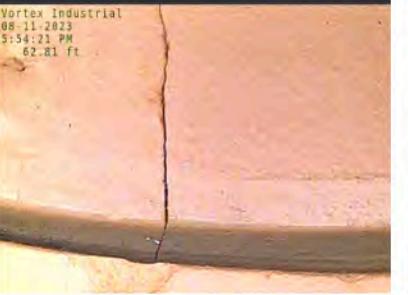
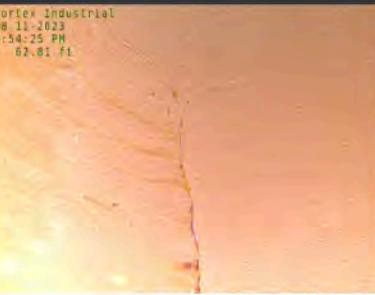
Crack Spiral	Point	62.8	Structural	0	1-6	2	0	0	2	Crack Spiral

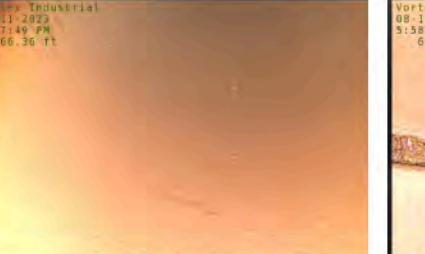
Crack Spiral	Point	66.4	Structural	0	11-5	2	0	0	2	Crack Spiral

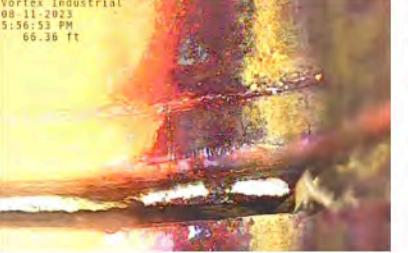
Crack Spiral	Point	66.4	Structural	0	6-8	2	0	0	2	Crack Spiral

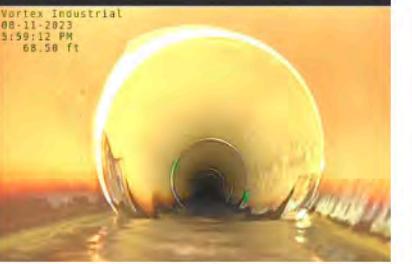
Description	Spatial Type	Distance (ft)	Type	Percent	Clock	SR	O&M	C	PR	Remarks	Photos
Joint Offset Medium	Point	70.3	Structural	0		3	0	0	1	Joint Offset Medium

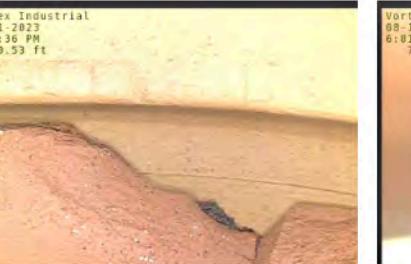
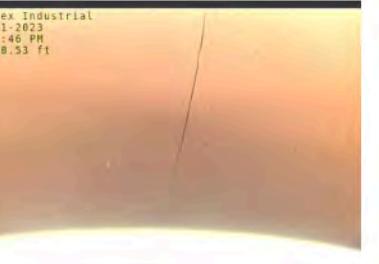
Fracture Circumferential	Point	70.5	Structural	0	10-11	4	0	0	2	Fracture Circumferential

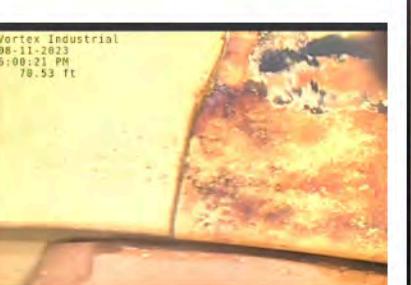
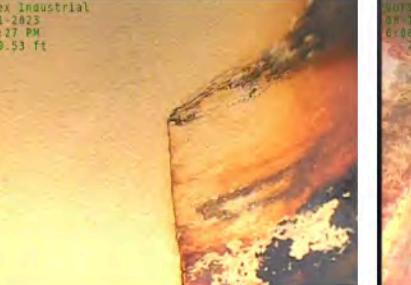
Fracture Spiral	Point	70.5	Structural	0	7-9	3	0	0	2	Fracture Spiral
