2023 ANNUAL PROGRESS REPORT

SWMU-1 OILY WATER SEWER

HF SINCLAIR PUGET SOUND REFINING LLC

MARCH 21, 2024

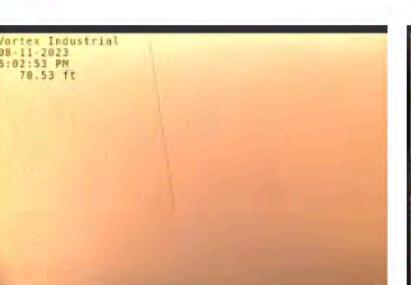
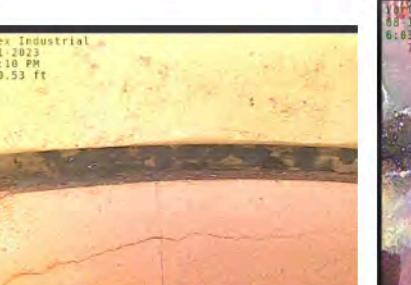
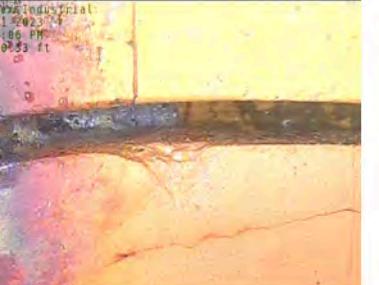
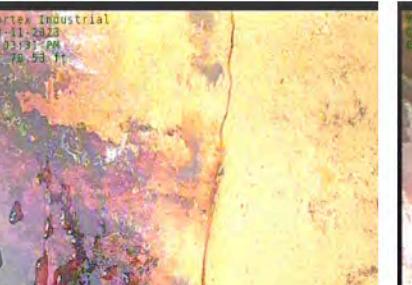
Crack Multiple	Point	70.5	Structural	0	3-5	3	0	0	2	Crack Multiple

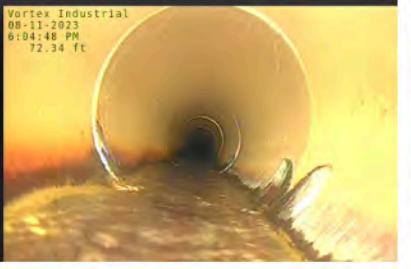
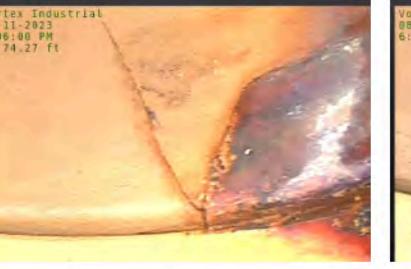
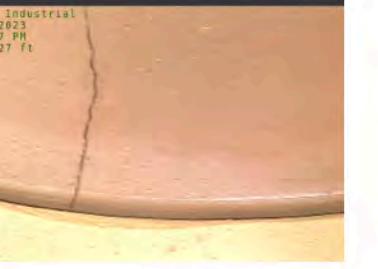
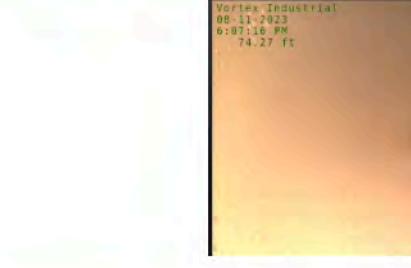
Description	Spatial Type	Distance (ft)	Type	Percent	Clock	SR	O&M	C	PR	Remarks	Photos
Crack Spiral	Point	74.3	Structural	0	12-12	2	0	0	2	Crack Spiral

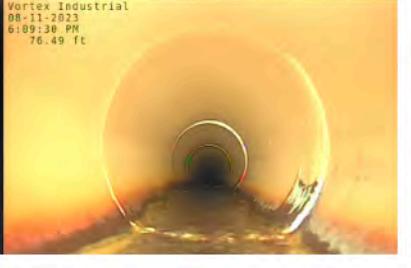
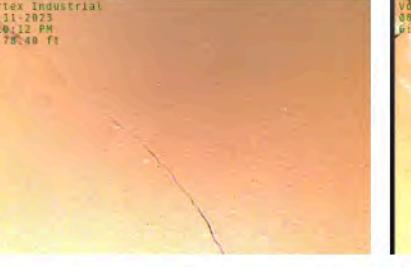
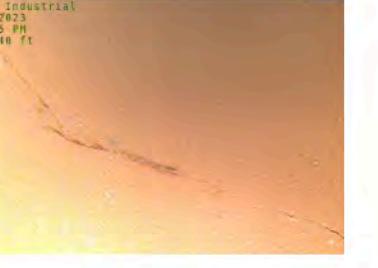
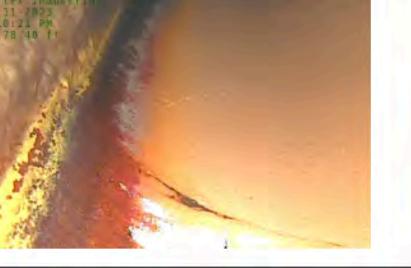
Crack Spiral	Point	78	Structural	0	12-8	2	0	0	2	Crack Spiral

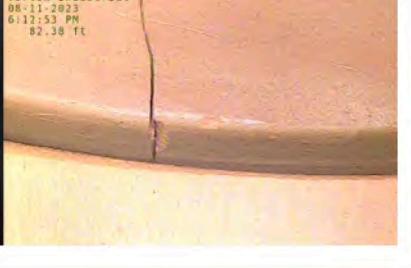
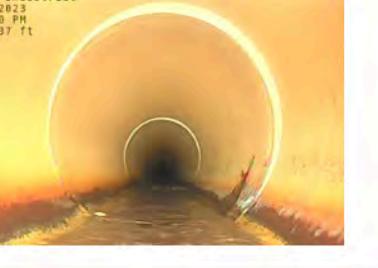
Crack Spiral	Point	82.4	Structural	0	2-5	2	0	0	2	Crack Spiral

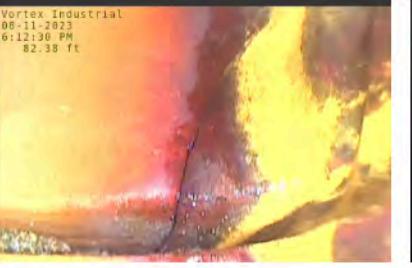
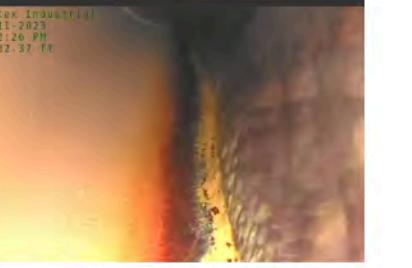
Crack Longitudinal	Point	82.4	Structural	0	7	2	0	0	2	Crack Longitudinal

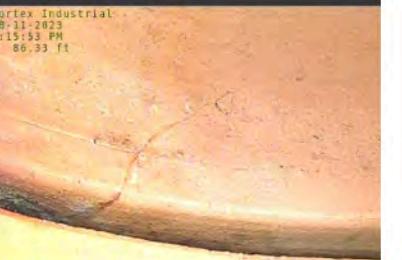
Description	Spatial Type	Distance (ft)	Type	Percent	Clock	SR	O&M	C	PR	Remarks	Photos
Crack Longitudinal	Point	86.3	Structural	0	5	2	0	0	1	Crack Longitudinal

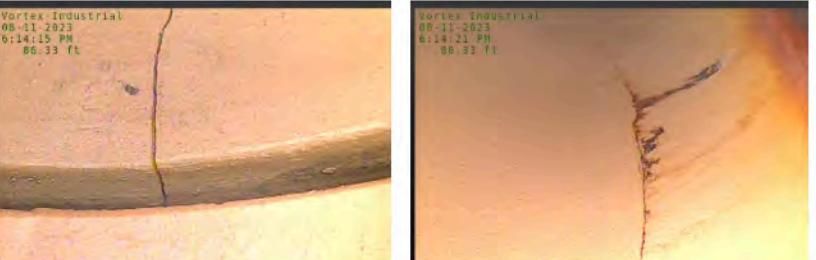
Crack Longitudinal	Point	86.3	Structural	0	9	2	0	0	2	Crack Longitudinal

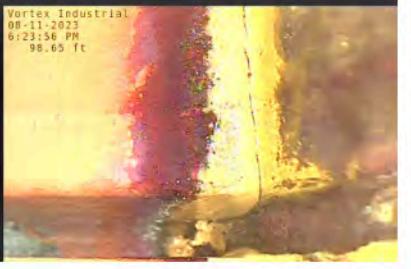
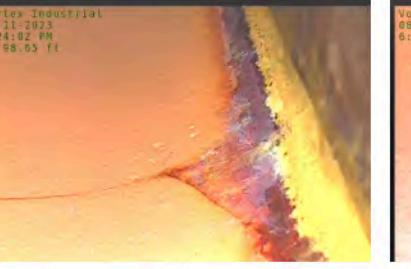
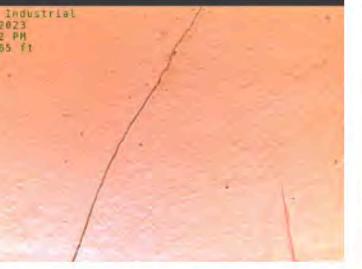
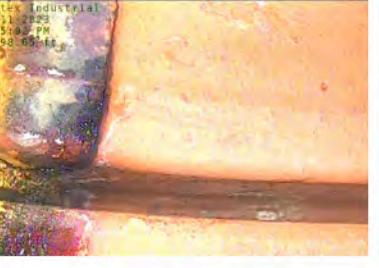
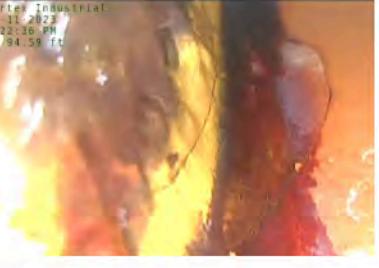
Description	Spatial Type	Distance (ft)	Type	Percent	Clock	SR	O&M	C	PR	Remarks	Photos
Crack Spiral	Point	98.7	Structural	0	5-1	2	0	0	2	Crack Spiral

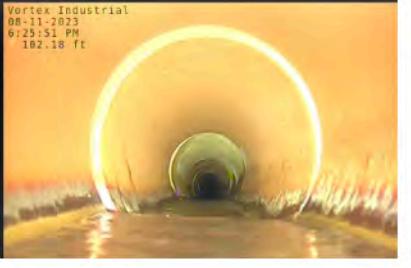
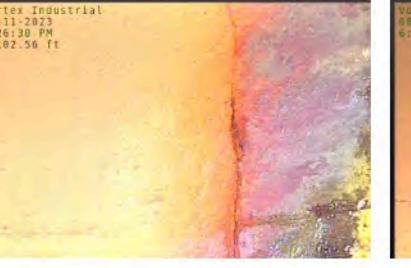
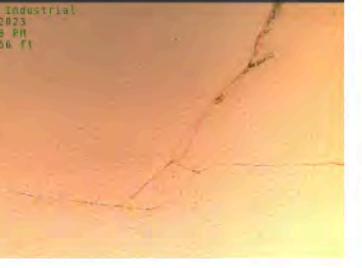
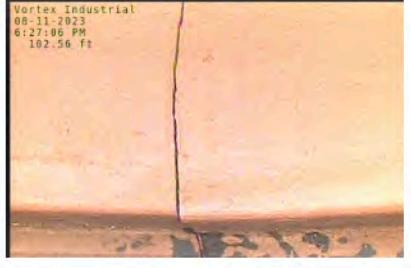
Crack Spiral	Point	102.5	Structural	0	6-1	2	0	0	2	Crack Spiral

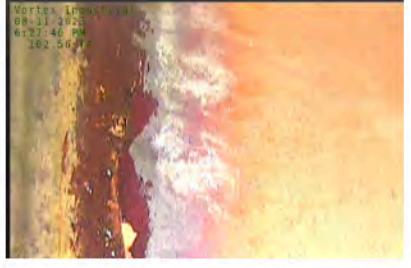
Crack Longitudinal	Point	102.7	Structural	0	5	2	0	0	2	Crack Longitudinal

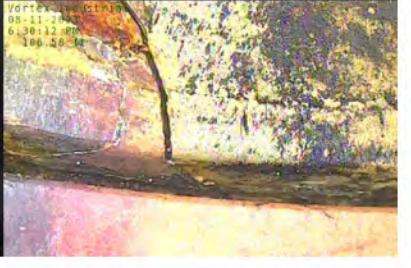
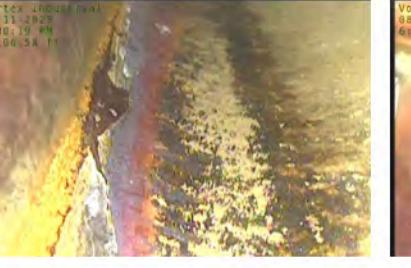
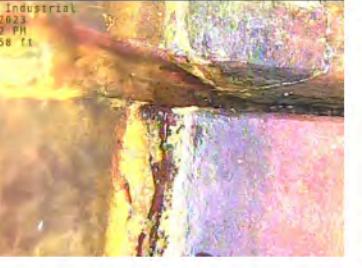
Fracture Longitudinal	Point	106.7	Structural	0	5	2	0	0	2	Fracture Longitudinal

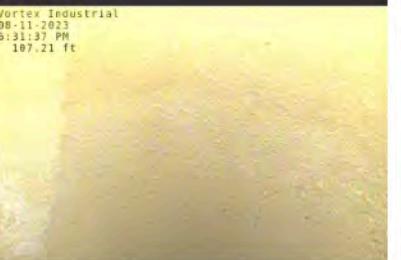
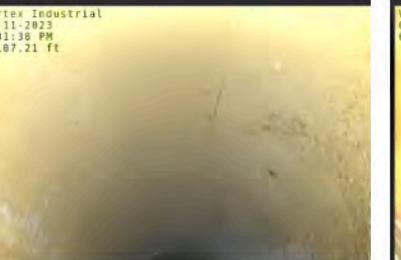
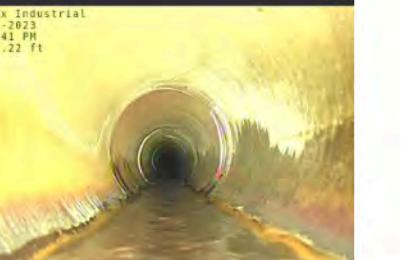
Description	Spatial Type	Distance (ft)	Type	Percent	Clock	SR	O&M	C	PR	Remarks	Photos
Crack Longitudinal	Continuous	107.2 - 110.9	Structural	0	12	2	0	0	2	Crack Longitudinal

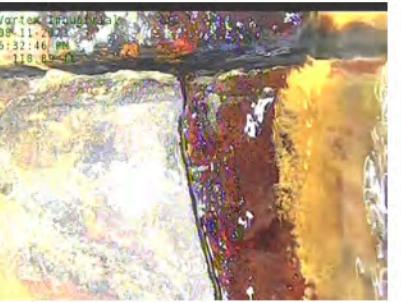
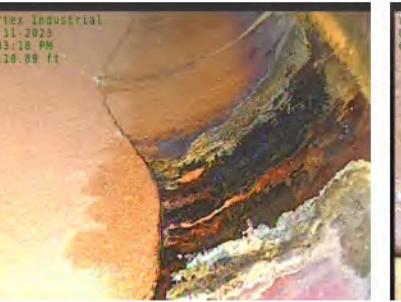
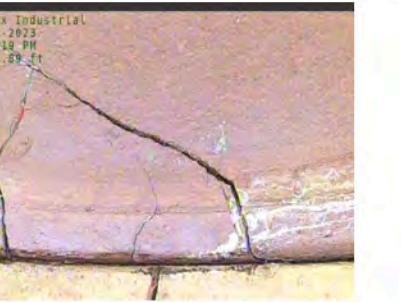
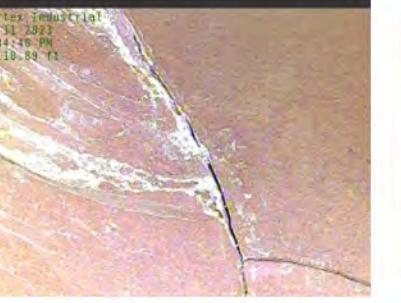
Fracture Multiple	Point	111	Structural	0	12-9	3	0	0	3	Fracture Multiple

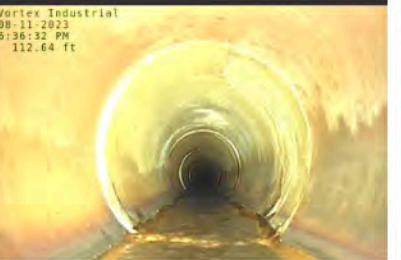
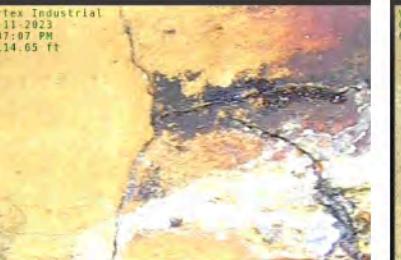
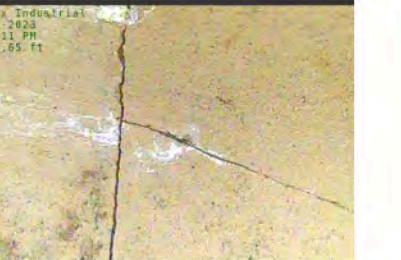
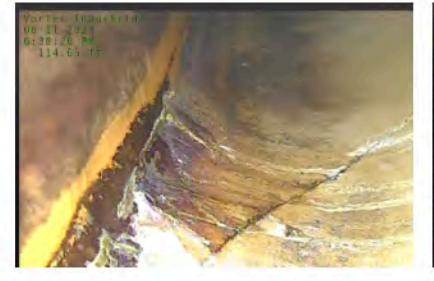
Crack Multiple	Point	114.7	Structural	0	12-12	2	0	0	2	Crack Multiple

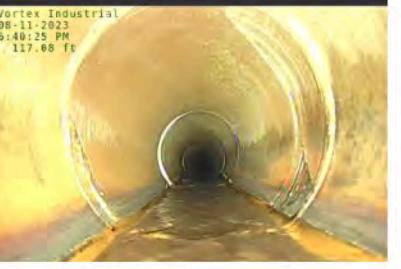
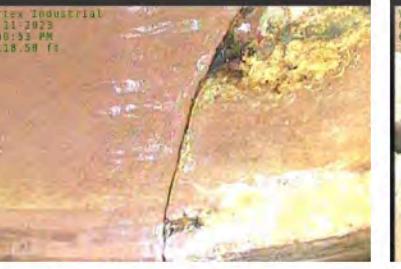
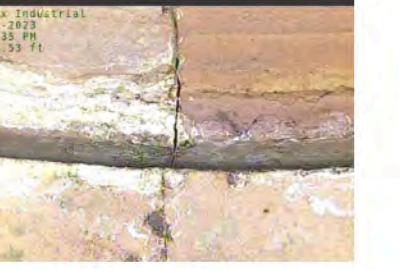
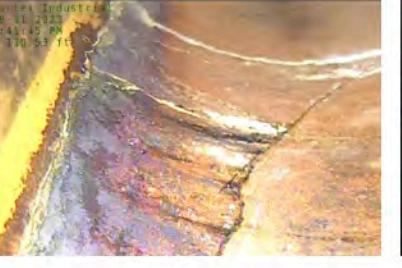
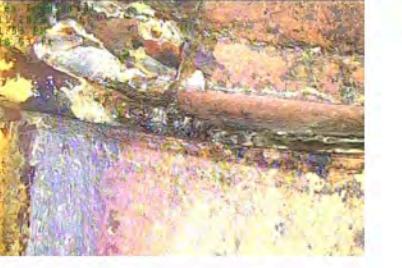
Description	Spatial Type	Distance (ft)	Type	Percent	Clock	SR	O&M	C	PR	Remarks	Photos
Crack Multiple	Point	118.5	Structural	0	12-9	3	0	0	2	Crack Multiple

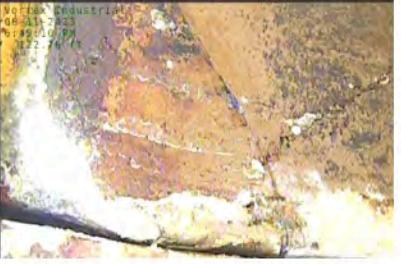
Crack Multiple	Point	122.8	Structural	0	5-6	3	0	0	2	Crack Multiple

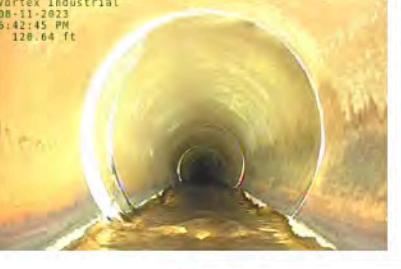
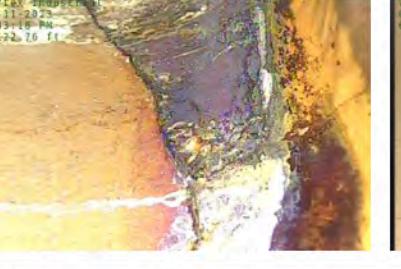
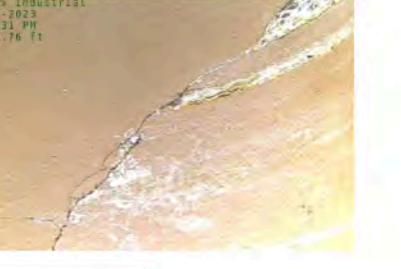
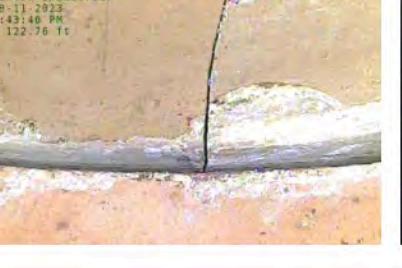
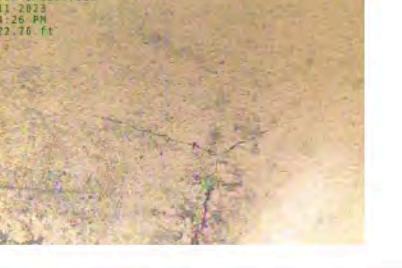
Crack Spiral	Point	122.8	Structural	0	7-11	2	0	0	2	Crack Spiral

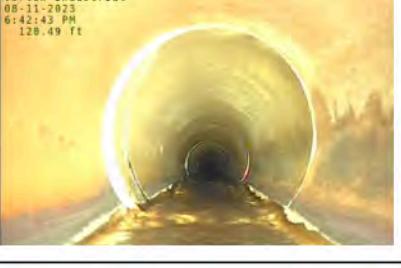
Joint Offset Medium	Point	122.8	Structural	0		3	0	0	1	Joint Offset Medium

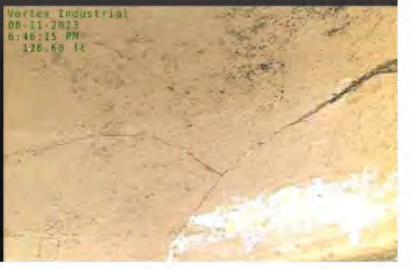
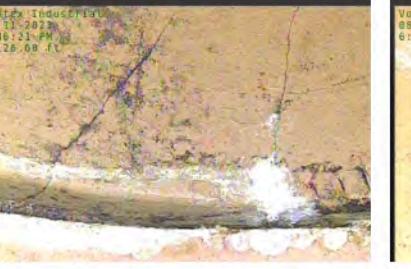
Description	Spatial Type	Distance (ft)	Type	Percent	Clock	SR	O&M	C	PR	Remarks	Photos
Crack Multiple	Point	126.6	Structural	0	12-12	3	0	0	2	Crack Multiple

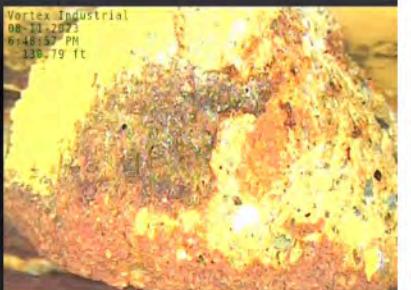
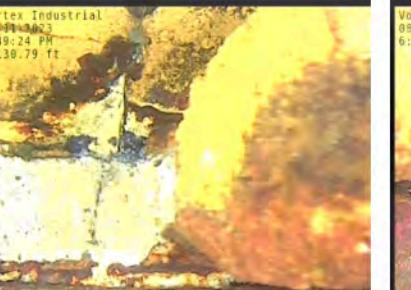
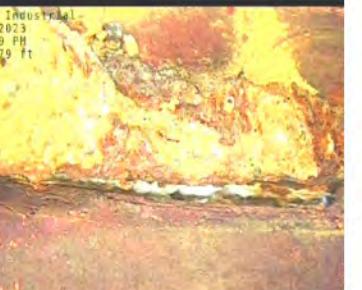
Obstruction Rocks	Point	130.8	O&M	10	6	0	2	0	0	Obstruction Rocks

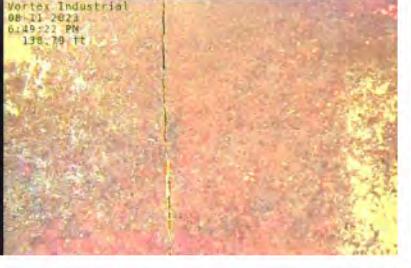
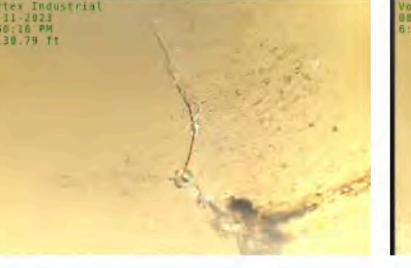
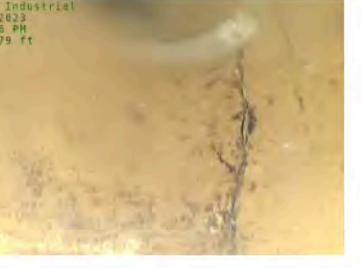
Crack Multiple	Point	130.8	Structural	0	12-12	3	0	0	1	Crack Multiple

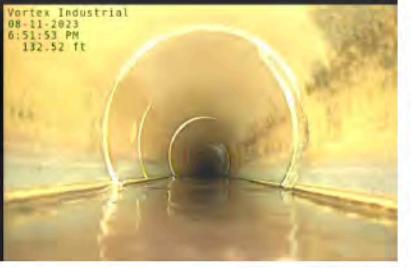
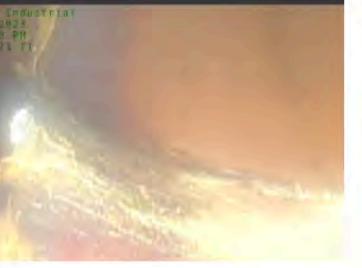
Crack Spiral	Point	134	Structural	0	1-6	2	0	0	2	Crack Spiral

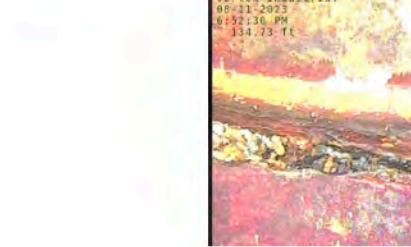
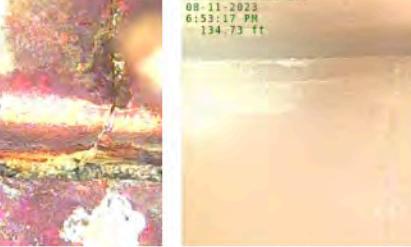
Crack Hinge 2	Point	134.7	Structural	0	6,9	2	0	0	2	Crack Hinge 2

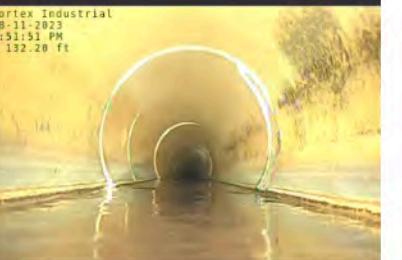
Description	Spatial Type	Distance (ft)	Type	Percent	Clock	SR	O&M	C	PR	Remarks	Photos
Crack Spiral	Point	135.5	Structural	0	7-10	2	0	0	2	Crack Spiral

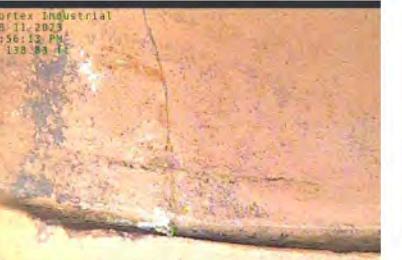
Crack Longitudinal	Point	138.8	Structural	0	4	2	0	0	1	Crack Longitudinal

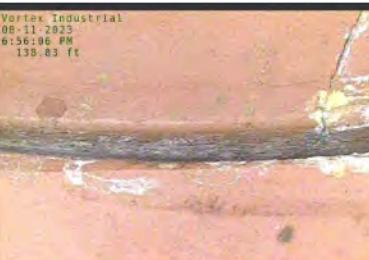
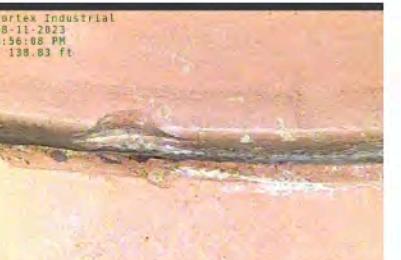
Crack Circumferential	Point	138.8	Structural	0	12-2	1	0	0	2	Crack Circumferential

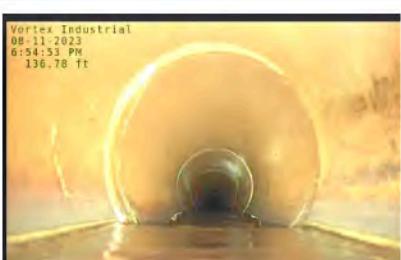
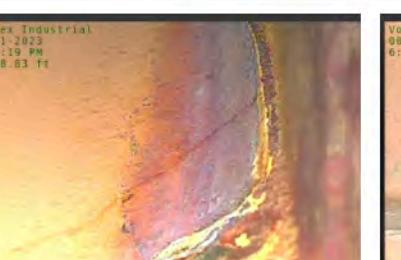
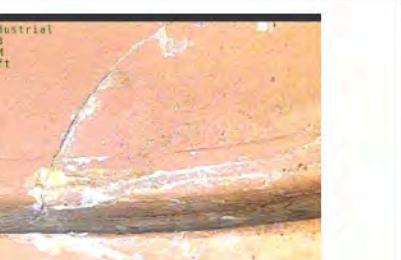
Crack Spiral	Point	138.8	Structural	0	7-12	2	0	0	2	Crack Spiral

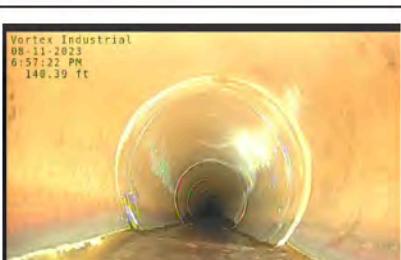
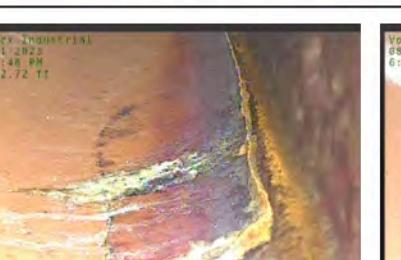
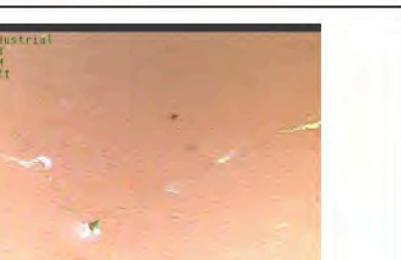
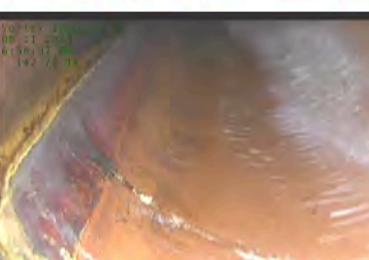
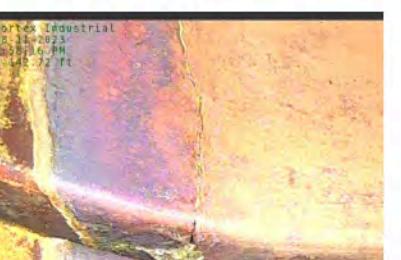
Crack Multiple	Point	142.7	Structural	0	12-12	3	0	0	2	Crack Multiple

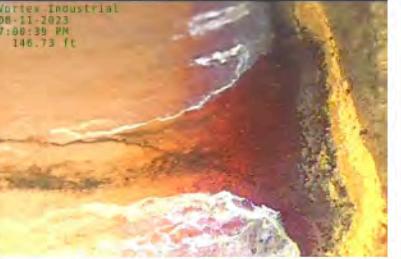
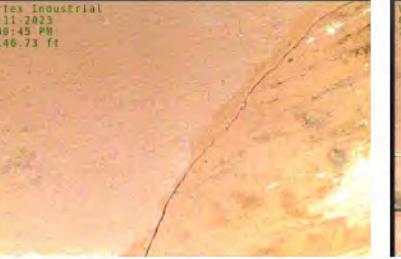
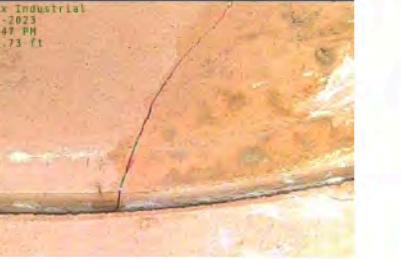
Description	Spatial Type	Distance (ft)	Type	Percent	Clock	SR	O&M	C	PR	Remarks	Photos
Crack Spiral	Point	146.7	Structural	0	7-9	2	0	0	2	Crack Spiral

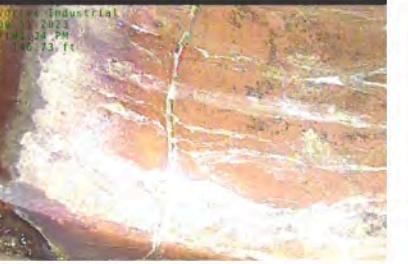
Crack Longitudinal	Point	146.7	Structural	0	5	2	0	0	2	Crack Longitudinal

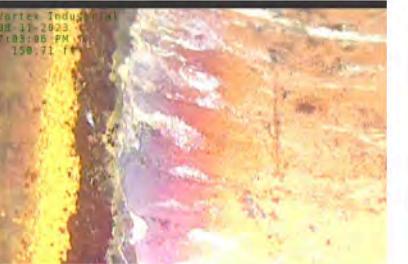
Crack Longitudinal	Point	151	Structural	0	4	2	0	0	1	Crack Longitudinal

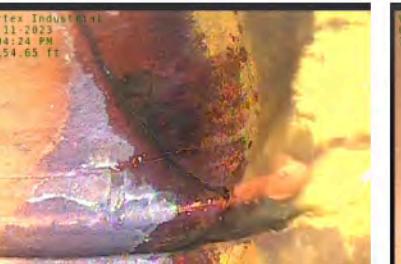
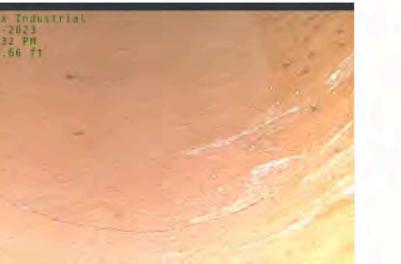
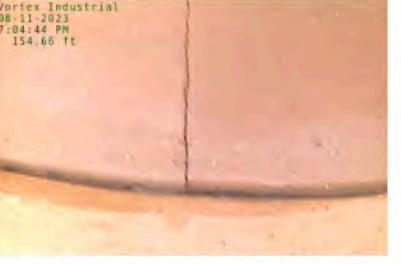
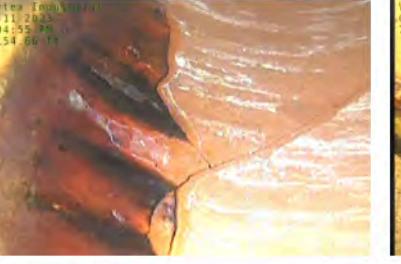
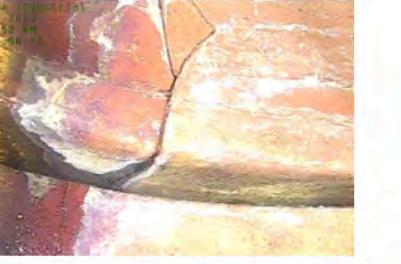
Crack Multiple	Point	154.7	Structural	0	12-12	3	0	0	2	Crack Multiple

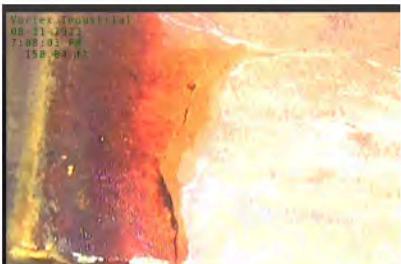
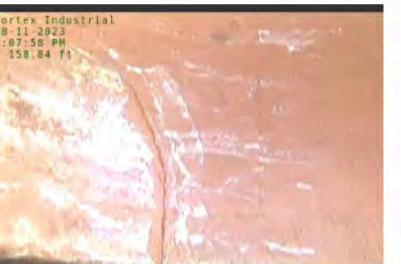
Crack Spiral	Point	158.8	Structural	0	4-5	2	0	0	2	Crack Spiral

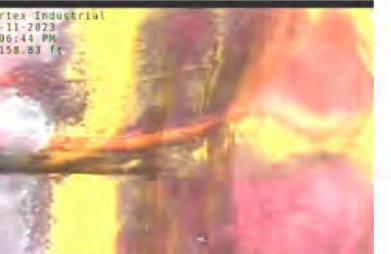
Description	Spatial Type	Distance (ft)	Type	Percent	Clock	SR	O&M	C	PR	Remarks	Photos
Crack Longitudinal	Point	158.8	Structural	0	7	2	0	0	1	Crack Longitudinal

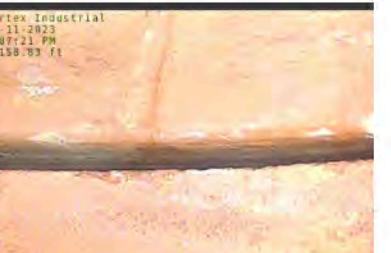
Crack Longitudinal	Point	158.8	Structural	0	8	2	0	0	1	Crack Longitudinal

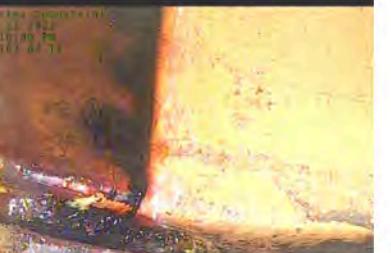
Crack Longitudinal	Point	162.7	Structural	0	5	2	0	0	2	Crack Longitudinal

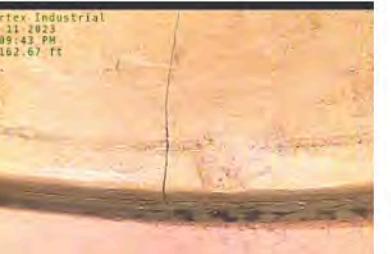
Crack Longitudinal	Point	162.7	Structural	0	2	2	0	0	1	Crack Longitudinal

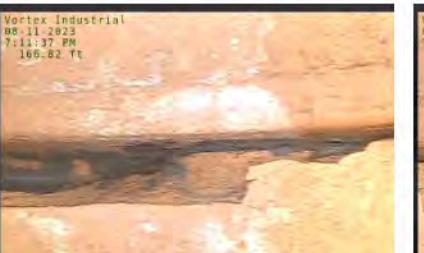
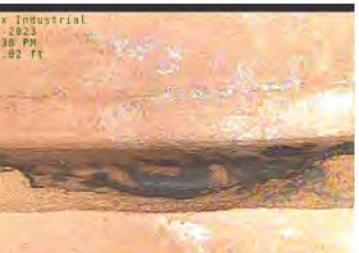
Fracture Circumferential	Point	166.8	Structural	0	10-11	2	0	0	2	Fracture Circumferential

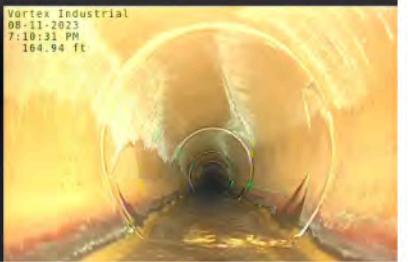
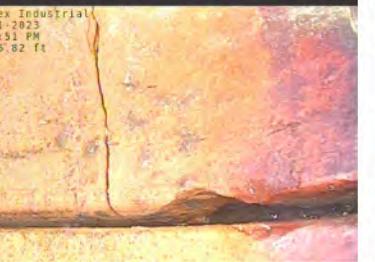
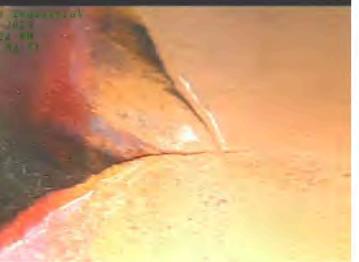
Description	Spatial Type	Distance (ft)	Type	Percent	Clock	SR	O&M	C	PR	Remarks	Photos
Crack Multiple	Point	166.8	Structural	0	12-12	3	0	0	2	Crack Multiple

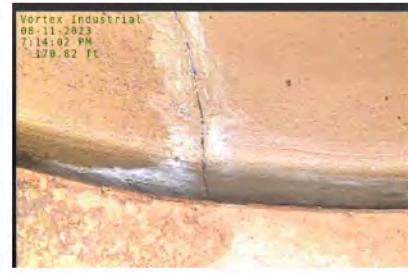
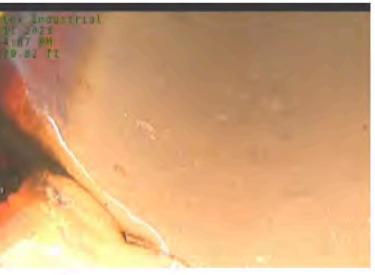
Crack Spiral	Point	170.8	Structural	0	3-5	2	0	0	2	Crack Spiral

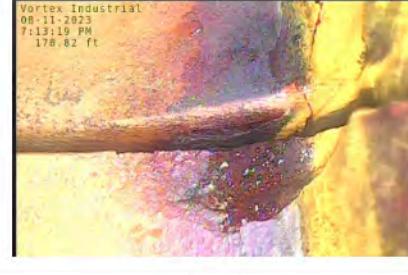
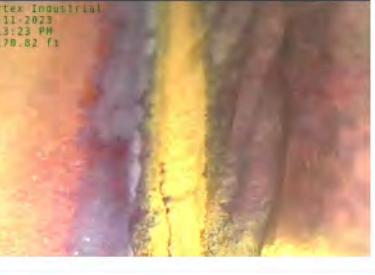
Crack Longitudinal	Point	170.8	Structural	0	7	2	0	0	2	Crack Longitudinal

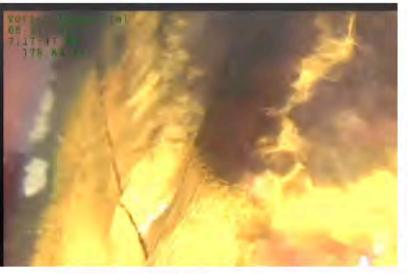
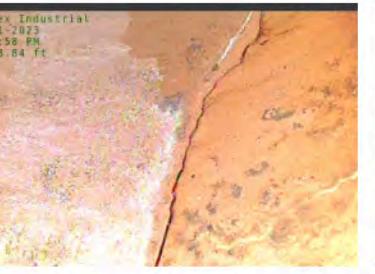
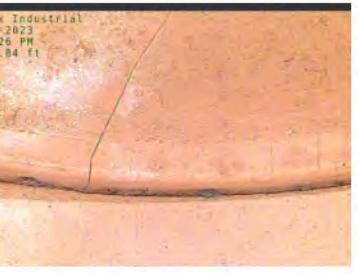
Crack Multiple	Point	174.8	Structural	0	12-12	3	0	0	2	Crack Multiple

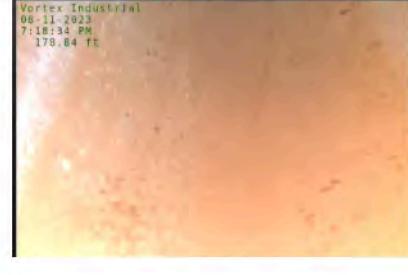
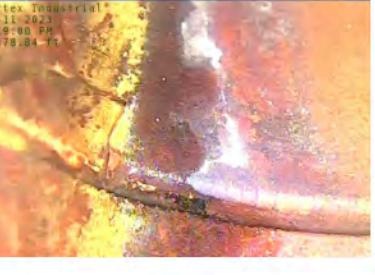
Description	Spatial Type	Distance (ft)	Type	Percent	Clock	SR	O&M	C	PR	Remarks	Photos
Deposits Settled Hard/Compacted	Point	174.8	O&M	10	5-6	0	2	0	0	Deposits Settled Hard/Compacted

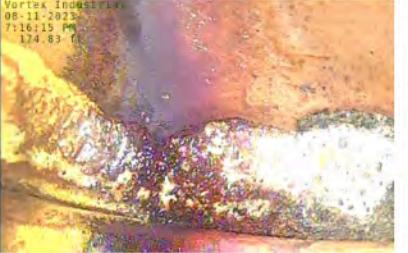
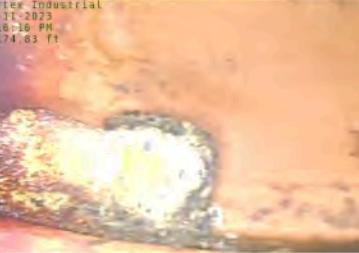
Crack Longitudinal	Point	174.8	Structural	0	8	2	0	0	2	Crack Longitudinal

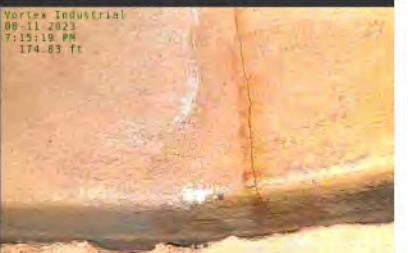
Fracture Circumferential	Point	178.8	Structural	0	3-4	2	0	0	2	Fracture Circumferential

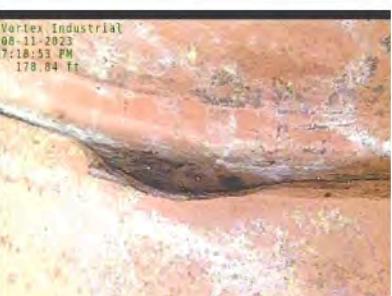
Crack Longitudinal	Point	178.8	Structural	0	12	2	0	0	1	Crack Longitudinal

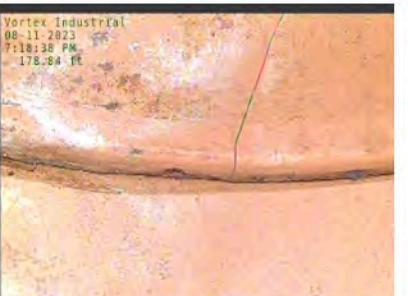
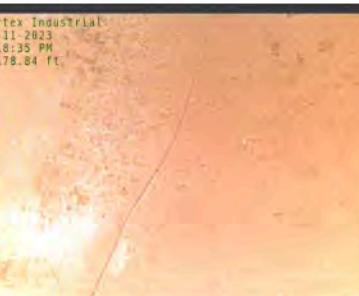
Crack Multiple	Point	178.8	Structural	0	6-9	3	0	0	2	Crack Multiple

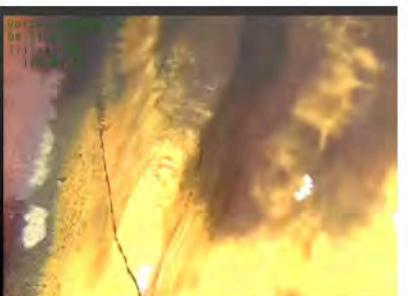
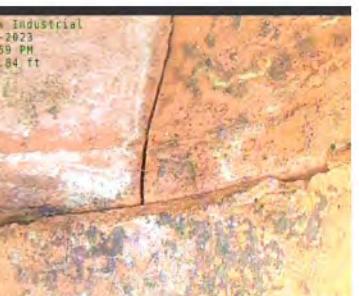
Description	Spatial Type	Distance (ft)	Type	Percent	Clock	SR	O&M	C	PR	Remarks	Photos
Crack Multiple	Point	182.9	Structural	0	12-9	3	0	0	2	Crack Multiple

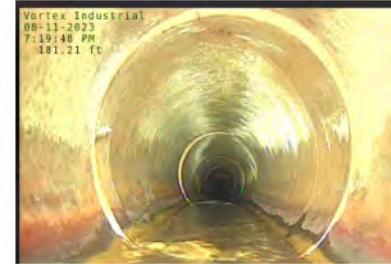
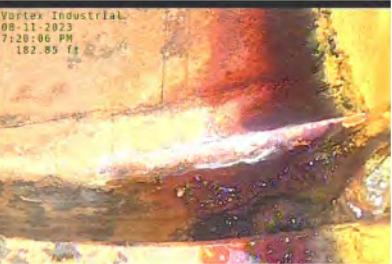
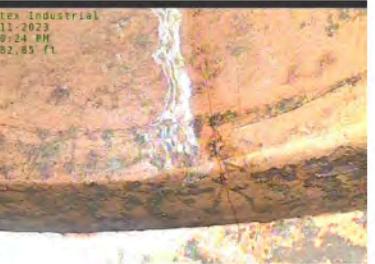
Crack Spiral	Point	190.8	Structural	0	3-5	2	0	0	2	Crack Spiral

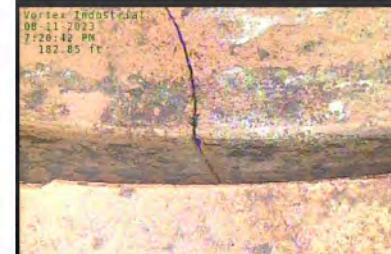
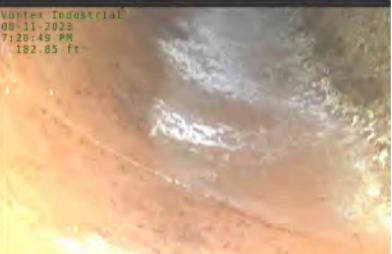
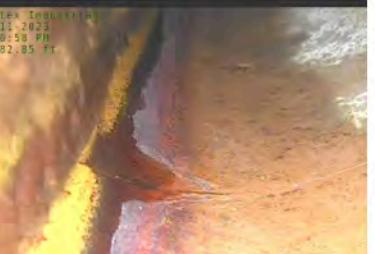
Crack Spiral	Point	190.8	Structural	0	6-10	2	0	0	2	Crack Spiral

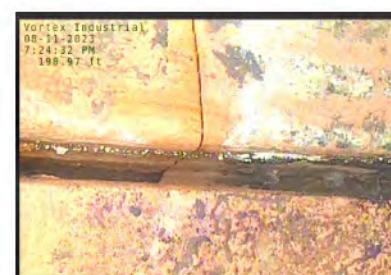
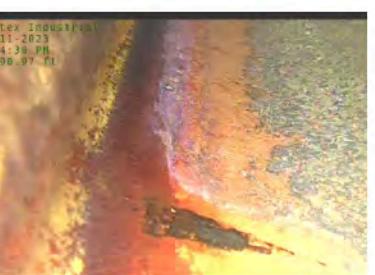
Crack Spiral	Point	195	Structural	0	1-5	2	0	0	2	Crack Spiral

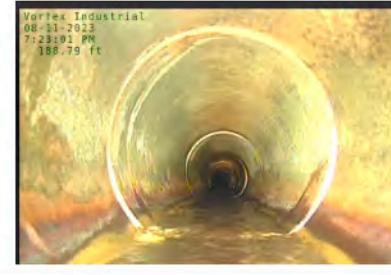
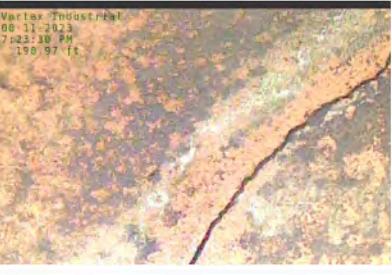
Description	Spatial Type	Distance (ft)	Type	Percent	Clock	SR	O&M	C	PR	Remarks	Photos
Crack Spiral	Point	198.8	Structural	0	6-7	2	0	0	2	Crack Spiral

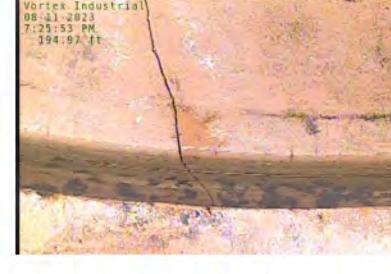
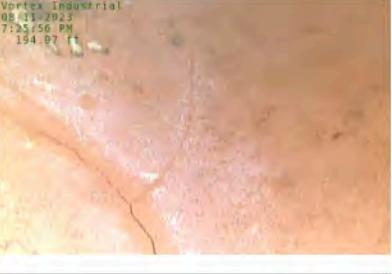
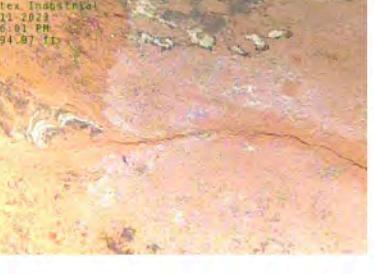
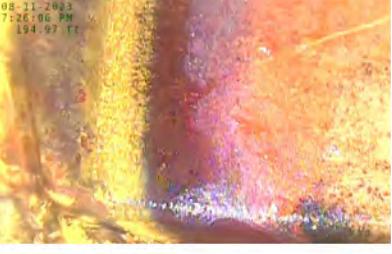
Crack Longitudinal	Point	198.8	Structural	0	3	2	0	0	1	Crack Longitudinal

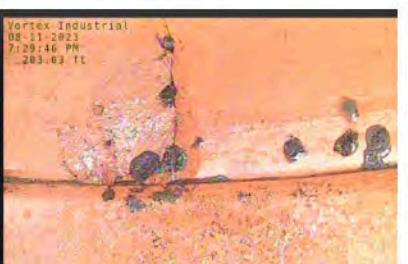
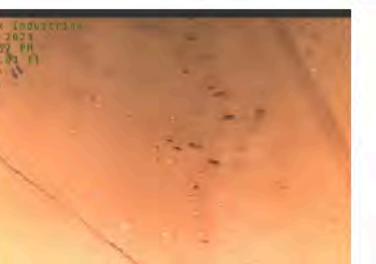
Crack Multiple	Point	203	Structural	0	10-5	3	0	0	2	Crack Multiple

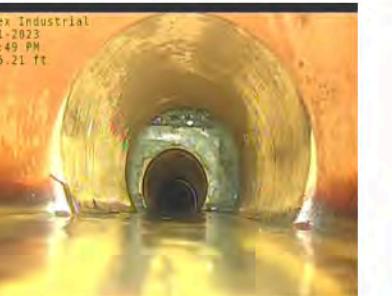
Joint Offset Medium	Point	206.8	Structural	0		3	0	0	2	Joint Offset Medium

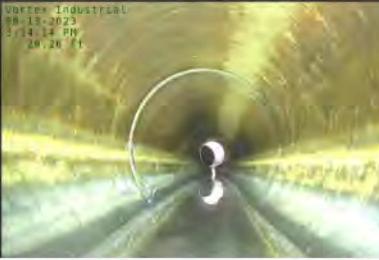
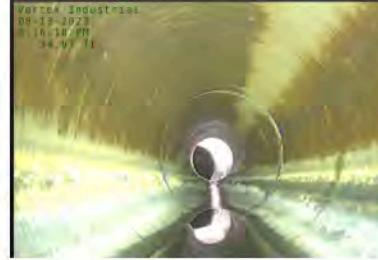
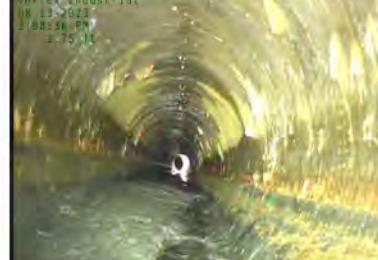
Surface Damage Roughness Increased	Continuous	0 - 55.7	Structural	0	12-12	1	0	0	0	1	Surface Damage Roughness Increased

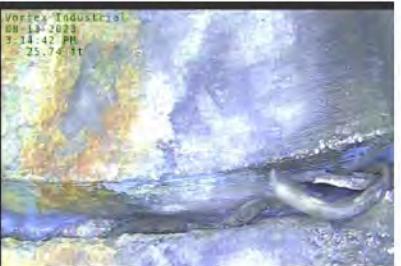
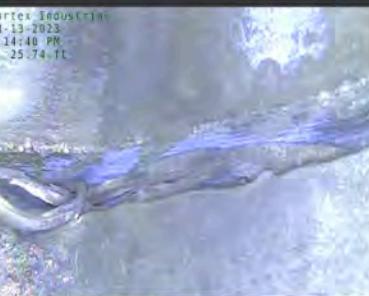
Description	Spatial Type	Distance (ft)	Type	Percent	Clock	SR	O&M	C	PR	Remarks	Photos
Intruding Sealing Material Grout	Point	25.7	O&M	10	7-8	0	2	0	0	Intruding Sealing Material Grout

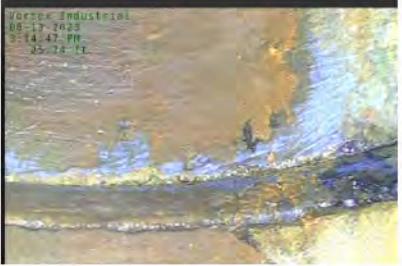
Crack Longitudinal	Point	25.7	Structural	0	9	2	0	0	1	Crack Longitudinal

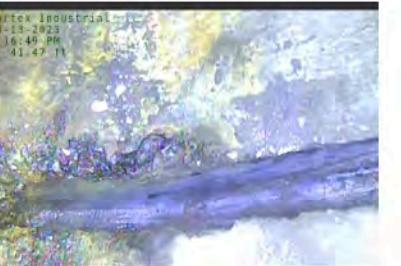
Surface Aggregate Visible	Point	41.5	Structural	0	8-9	2	0	0	2	Surface Aggregate Visible

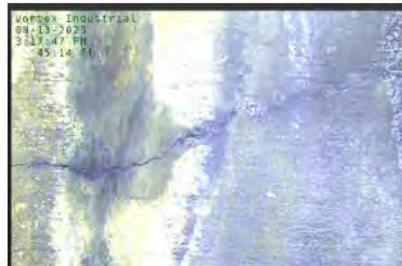
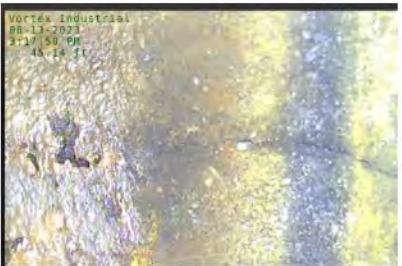
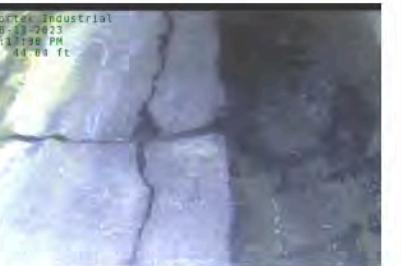
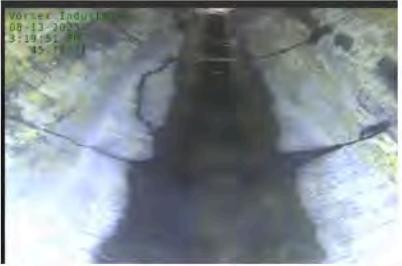
Crack Multiple	Continuous	44 - 47.1	Structural	0	5-10	3	0	0	2	Crack Multiple

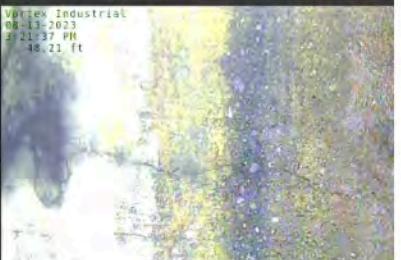
Description	Spatial Type	Distance (ft)	Type	Percent	Clock	SR	O&M	C	PR	Remarks	Photos
Crack Circumferential	Point	48.2	Structural	0	3-7	1	0	0	2	Crack Circumferential

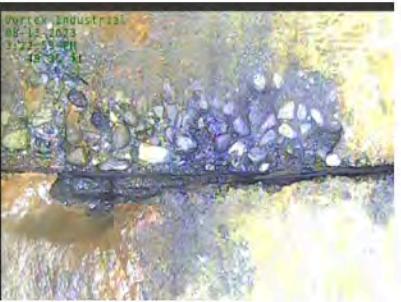
Surface Damage Aggregate Missing	Point	49.3	Structural	0	7-9	4	0	0	2	Surface Damage Aggregate Missing

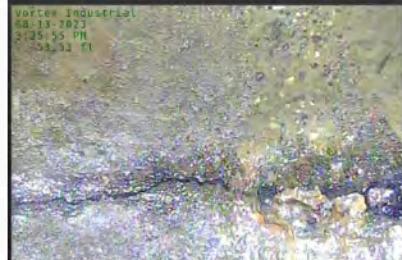
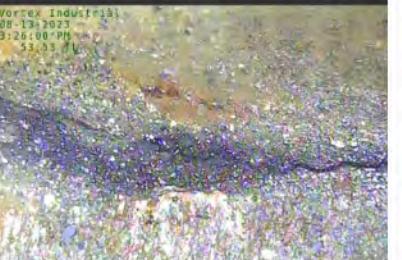
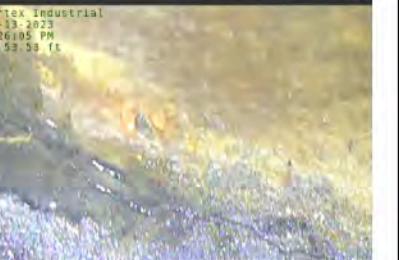
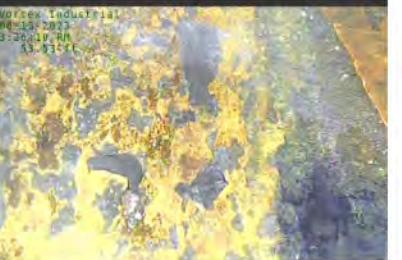
Crack Circumferential	Point	53.5	Structural	0	12-12	1	0	0	2	Crack Circumferential

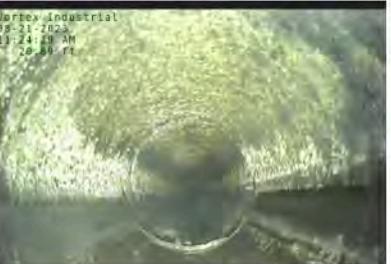
Description		Spatial Type	Distance (ft)	Type	Percent	Clock	SR	O&M	C	PR	Remarks	Photos					
Manhole	Point	0	Constructional	0		0	0	0	0	0	5-B

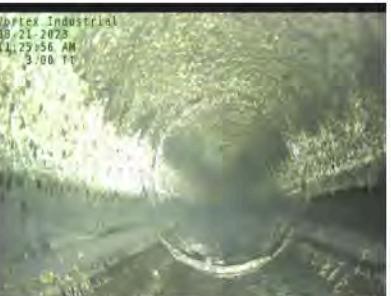
Miscellaneous Water Level	Point	0	Miscellaneous	0		0	0	0	0	0	Water Level at Start of Survey

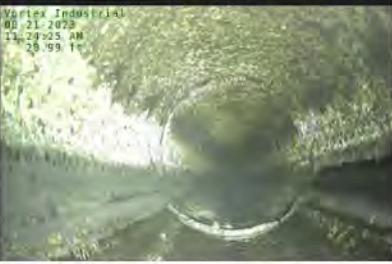
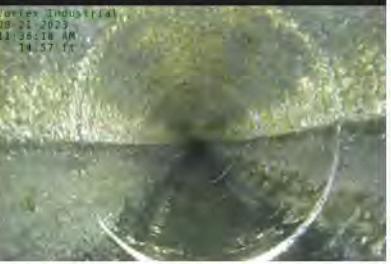
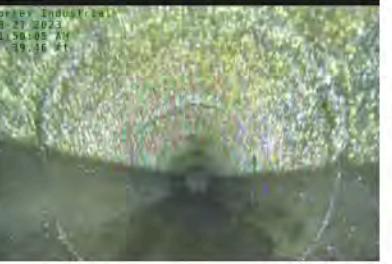
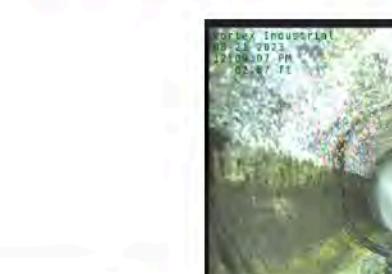
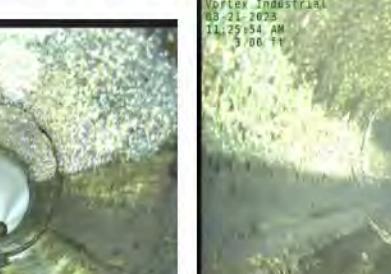
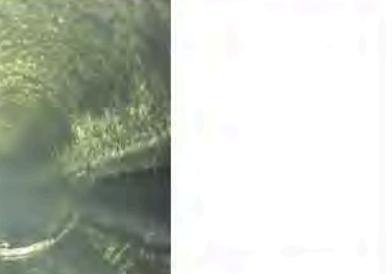
Surface Damage Aggregate Visible	Continuous	0 - 82	Structural	0	12-12	2	0	0	0	2	Surface Damage Aggregate Visible

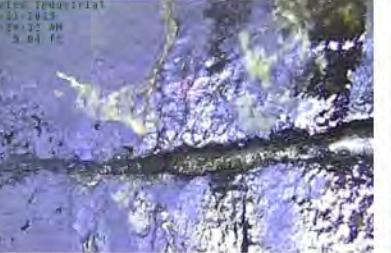
Description	Spatial Type	Distance (ft)	Type	Percent	Clock	SR	O&M	C	PR	Remarks	Photos
Crack Longitudinal	Point	5	Structural	0	8	2	0	0	2	Crack Longitudinal

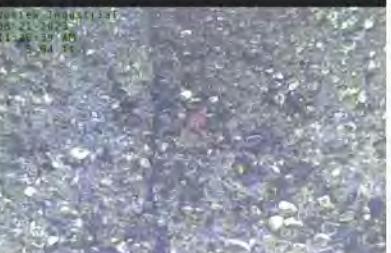
Crack Longitudinal	Point	5	Structural	0	12	2	0	0	1	Crack Longitudinal

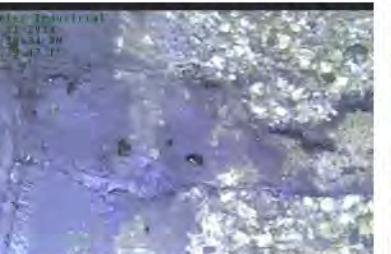
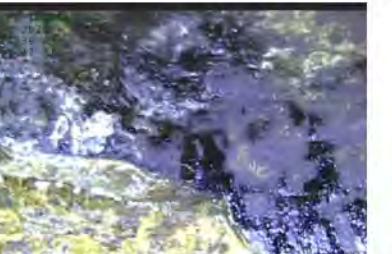
Crack Multiple	Point	9.5	Structural	0	5-6	3	0	0	2	Crack Multiple

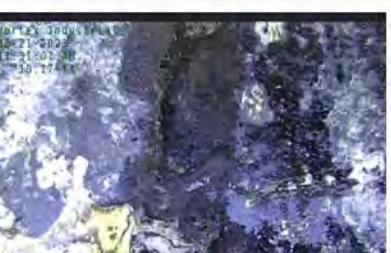
Crack Longitudinal	Point	10.2	Structural	0	6	2	0	0	2	Crack Longitudinal

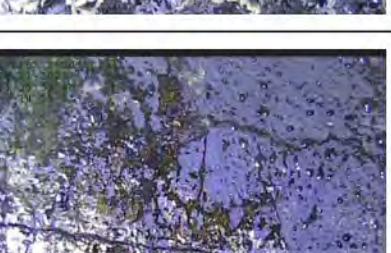
Crack Longitudinal	Point	14.5	Structural	0	4	2	0	0	1	Crack Longitudinal

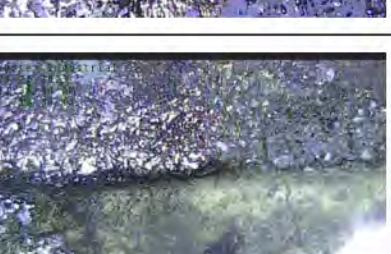
Crack Longitudinal	Point	18.3	Structural	0	6	2	0	0	1	Crack Longitudinal

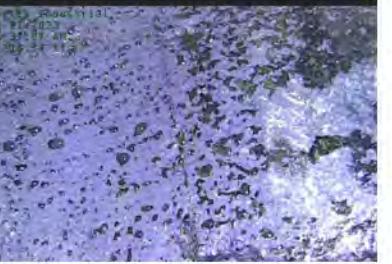
Description	Spatial Type	Distance (ft)	Type	Percent	Clock	SR	O&M	C	PR	Remarks	Photos
Crack Longitudinal	Point	18.3	Structural	0	8	2	0	0	1	Crack Longitudinal

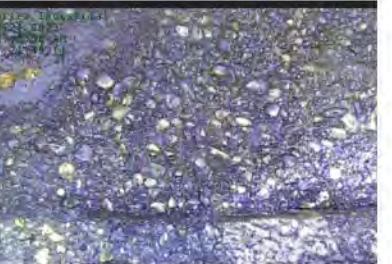
Crack Longitudinal	Point	21.5	Structural	0	11	2	0	0	1	Crack Longitudinal

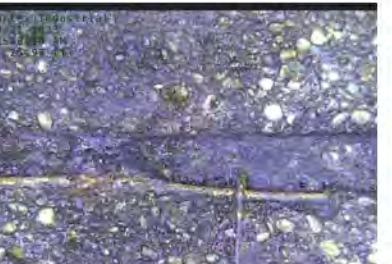
Surface Damage Reinforcement Visible	Point	25.9	Structural	0	12	4	0	0	2	Surface Damage Reinforcement Visible

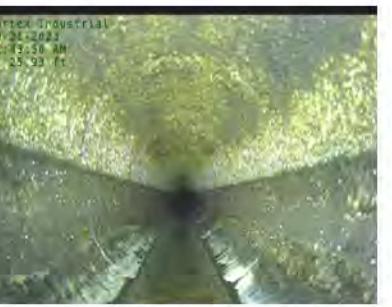
Miscellaneous Water Level	Point	26	Miscellaneous	10		0	0	0	0	Miscellaneous Water Level

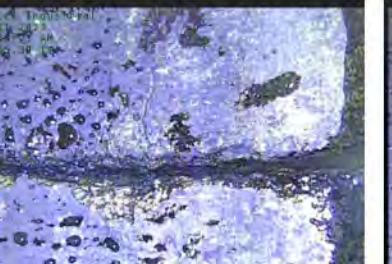
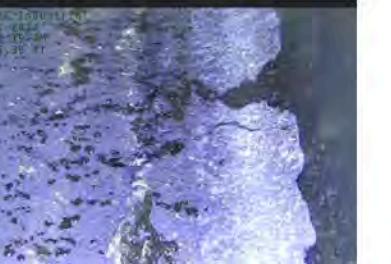
Crack Spiral	Point	35.3	Structural	0	6-7	2	0	0	2	Crack Spiral

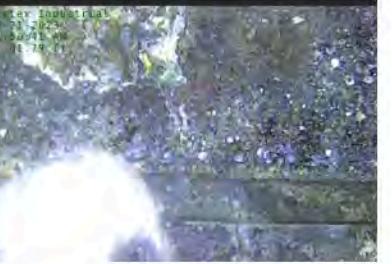
Description	Spatial Type	Distance (ft)	Type	Percent	Clock	SR	O&M	C	PR	Remarks	Photos
Crack Longitudinal	Point	41.8	Structural	0	6	2	0	0	1	Crack Longitudinal

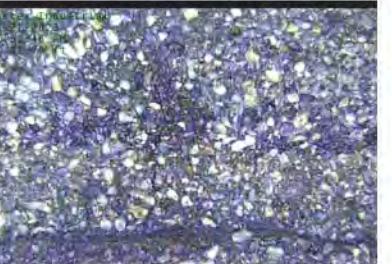
Crack Multiple	Point	41.8	Structural	0	12-1	3	0	0	1	Crack Multiple

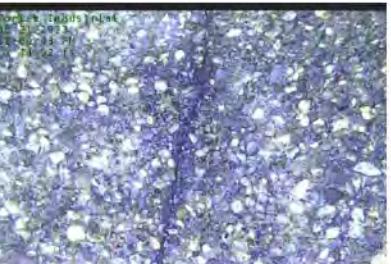
Crack Longitudinal	Point	45.2	Structural	0	4	2	0	0	2	Crack Longitudinal

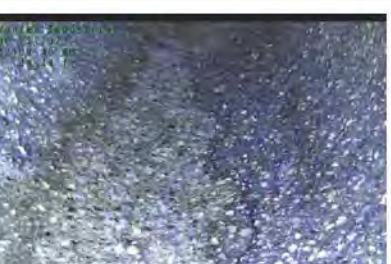
Crack Longitudinal	Point	48.4	Structural	0	2	2	0	0	1	Crack Longitudinal

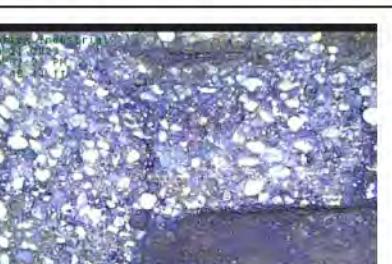
Crack Longitudinal	Point	48.4	Structural	0	1	2	0	0	1	Crack Longitudinal

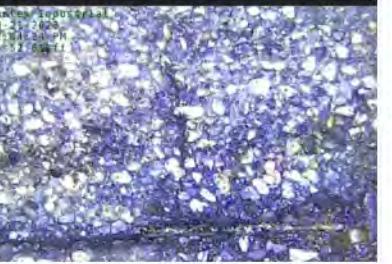
Description	Spatial Type	Distance (ft)	Type	Percent	Clock	SR	O&M	C	PR	Remarks	Photos
Crack Longitudinal	Point	52.6	Structural	0	11	2	0	0	1	Crack Longitudinal

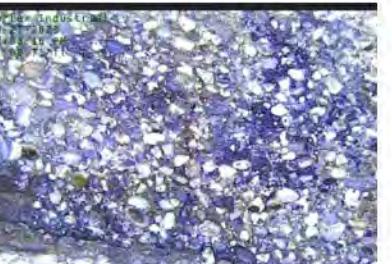
Crack Longitudinal	Point	60.7	Structural	0	1	2	0	0	1	Crack Longitudinal

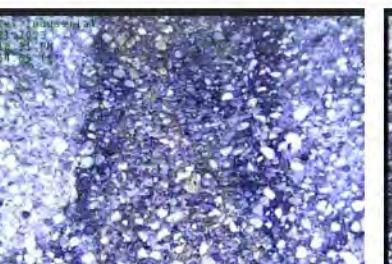
Crack Longitudinal	Point	64.9	Structural	0	10	2	0	0	1	Crack Longitudinal

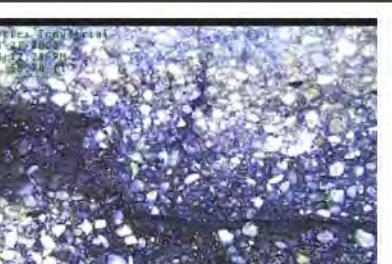
Crack Longitudinal	Point	68.7	Structural	0	12	2	0	0	1	Crack Longitudinal

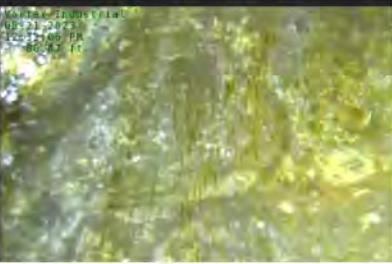
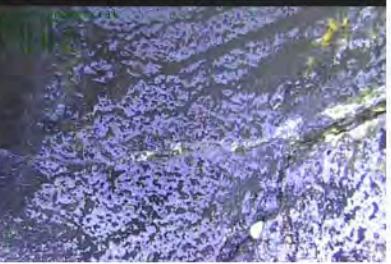
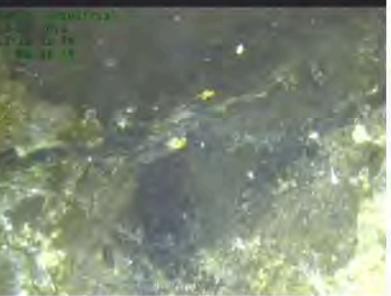
Fracture Spiral	Point	80.9	Structural	0	5-8	2	0	0	3	Fracture Spiral

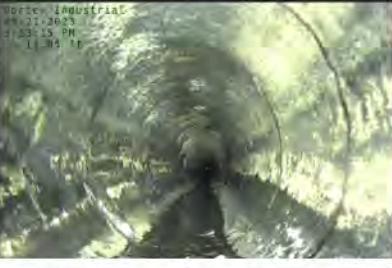
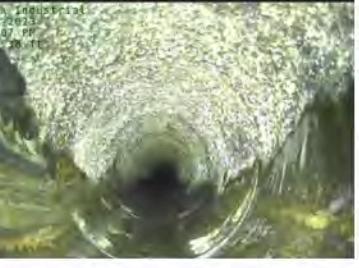
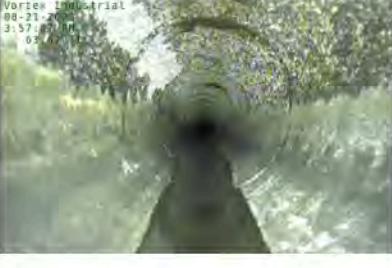
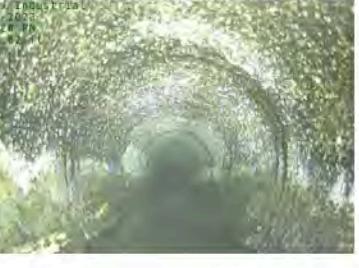
Description	Spatial Type	Distance (ft)	Type	Percent	Clock	SR	O&M	C	PR	Remarks	Photos
Surface Damage Aggregate Visible	Continuous	0 - 265.3	Structural	0	12-12	2	0	0	2	Surface Damage Aggregate Visible

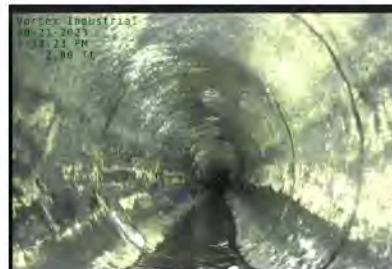
Description	Spatial Type	Distance (ft)	Type	Percent	Clock	SR	O&M	C	PR	Remarks	Photos
Crack Longitudinal	Point	2	Structural	0	7	2	0	0	2	Crack Longitudinal

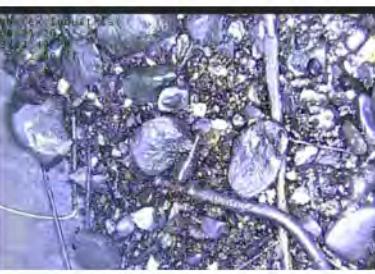
Crack Longitudinal	Point	2	Structural	0	6	2	0	0	2	Crack Longitudinal

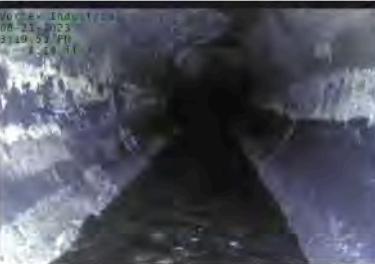
Crack Circumferential	Point	39.5	Structural	0	6-8	1	0	0	2	Crack Circumferential

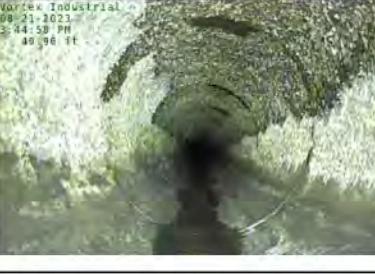
Crack Circumferential	Point	41.9	Structural	0	5-6	1	0	0	1	Crack Circumferential

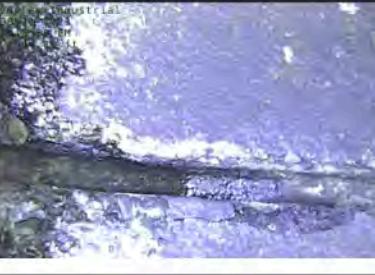
Crack Longitudinal	Point	44.9	Structural	0	4	2	0	0	1	Crack Longitudinal

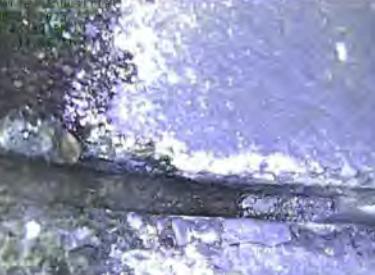
Crack Longitudinal	Point	52.7	Structural	0	11	2	0	0	2	Crack Longitudinal
