2023 ANNUAL PROGRESS REPORT

SWMU-1 OILY WATER SEWER

HF SINCLAIR PUGET SOUND REFINING LLC

MARCH 21, 2024

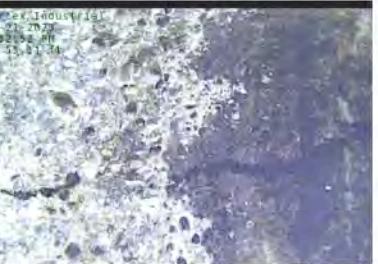
Crack Circumferential	Point	56.8	Structural	0	4-5	1	0	0	2	Crack Circumferential

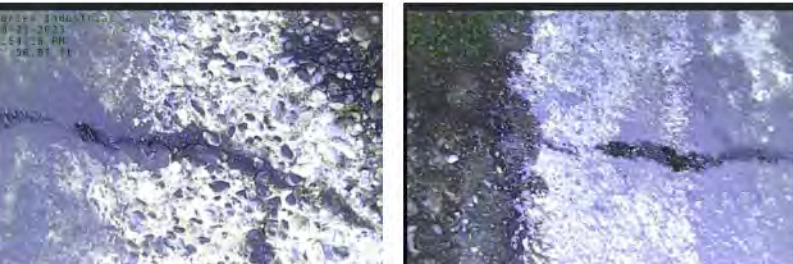
Crack Longitudinal	Point	65	Structural	0	3	2	0	0	1	Crack Longitudinal

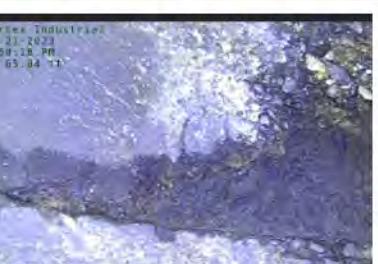
Crack Longitudinal	Point	65	Structural	0	5	2	0	0	1	Crack Longitudinal

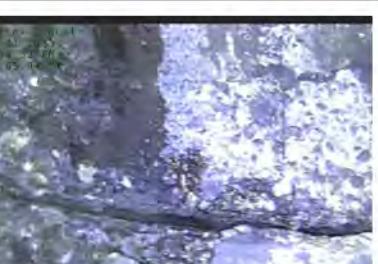
Crack Longitudinal	Point	69.2	Structural	0	8	2	0	0	1	Crack Longitudinal

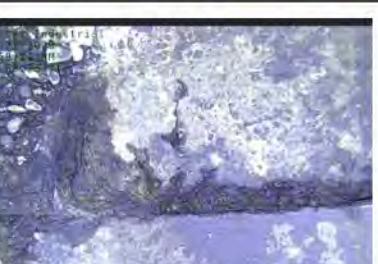
Description	Spatial Type	Distance (ft)	Type	Percent	Clock	SR	O&M	C	PR	Remarks	Photos
Surface Damage Reinforcement Visible	Point	73.1	Structural	0	10	4	0	0	2	Surface Damage Reinforcement Visible

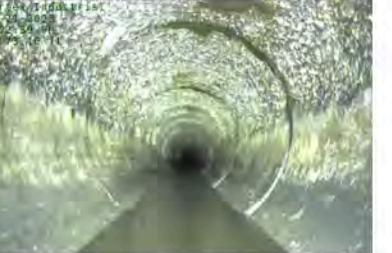
Crack Circumferential	Point	77.3	Structural	0	5-6	1	0	0	2	Crack Circumferential

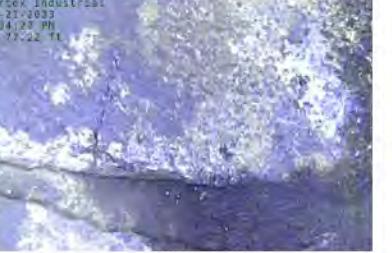
Crack Longitudinal	Point	81.3	Structural	0	8	2	0	0	1	Crack Longitudinal

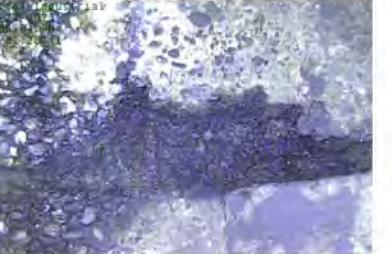
Description	Spatial Type	Distance (ft)	Type	Percent	Clock	SR	O&M	C	PR	Remarks	Photos
Surface Damage Reinforcement Visible	Point	85.5	Structural	0	4	4	0	0	2	Surface Damage Reinforcement Visible

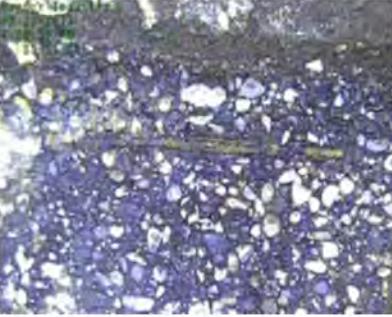
Crack Multiple	Point	89.5	Structural	0	3-4	3	0	0	2	Crack Multiple

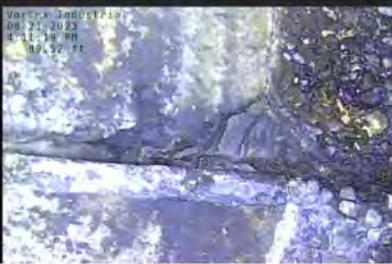
Crack Circumferential	Point	97.4	Structural	0	6-7	1	0	0	2	Crack Circumferential

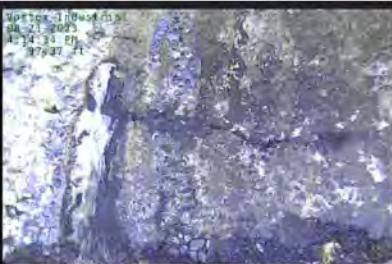
Crack Circumferential	Point	97.4	Structural	0	4-5	1	0	0	2	Crack Circumferential

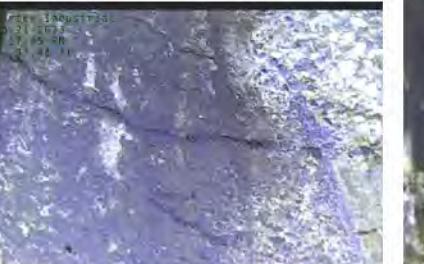
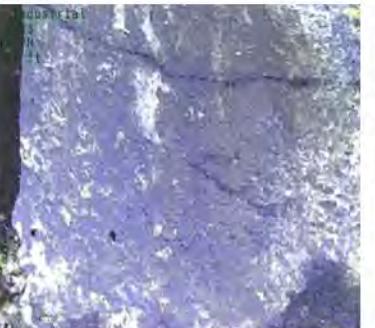
Crack Longitudinal	Point	101.7	Structural	0	8	2	0	0	2	Crack Longitudinal

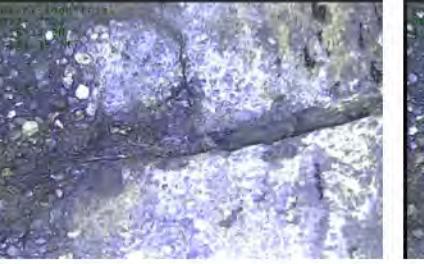
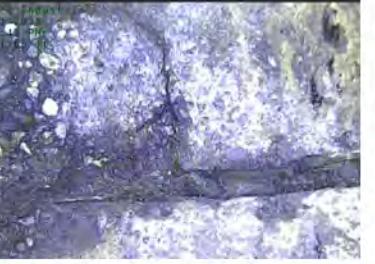
Description	Spatial Type	Distance (ft)	Type	Percent	Clock	SR	O&M	C	PR	Remarks	Photos
Crack Multiple	Point	101.7	Structural	0	4-6	3	0	0	2	Crack Multiple

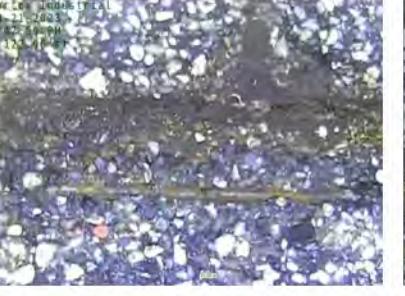
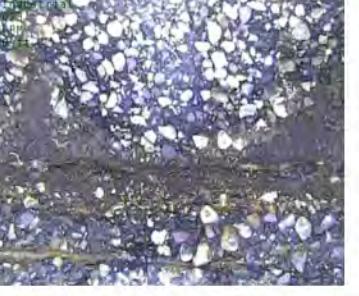
Surface Damage Reinforcement Visible	Point	122.1	Structural	0	5-7	4	0	0	2	Surface Damage Reinforcement Visible

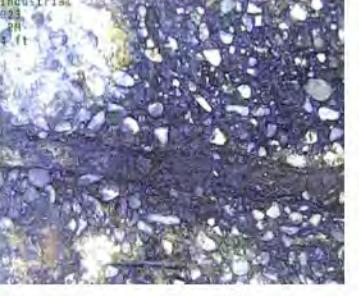
Surface Damage Reinforcement Visible	Point	126	Structural	0	7-10	4	0	0	2	Surface Damage Reinforcement Visible

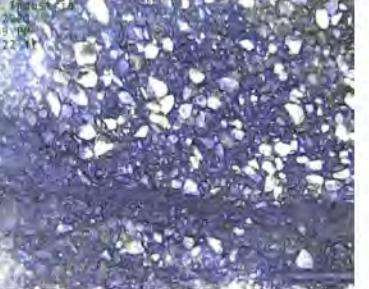
Surface Damage Reinforcement Visible	Point	134.2	Structural	0	1-4	4	0	0	2	Surface Damage Reinforcement Visible

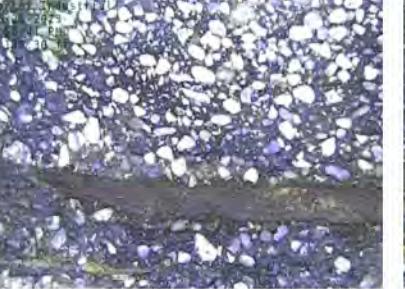
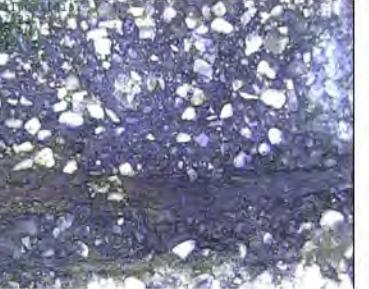
Surface Damage Reinforcement Visible	Point	138.3	Structural	0	2-4	4	0	0	2	Surface Damage Reinforcement Visible

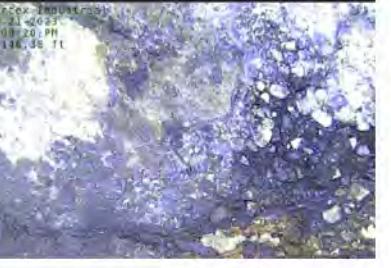
Crack Longitudinal	Point	146.4	Structural	0	2	2	0	0	2	Crack Longitudinal

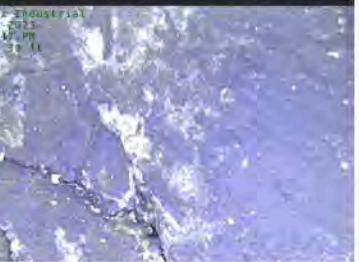
Description	Spatial Type	Distance (ft)	Type	Percent	Clock	SR	O&M	C	PR	Remarks	Photos
Crack Multiple	Point	146.4	Structural	0	8-9	3	0	0	2	Crack Multiple

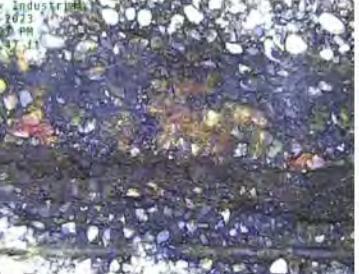
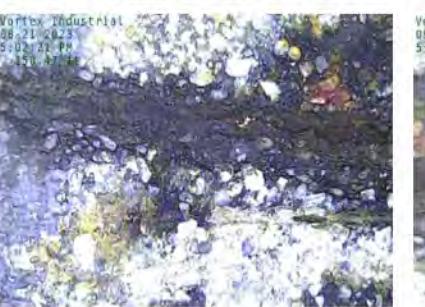
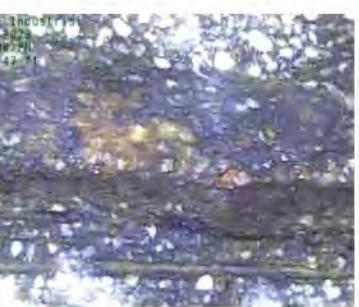
Surface Damage Reinforcement Visible	Point	150.5	Structural	0	50-10	4	0	0	2	Surface Damage Reinforcement Visible

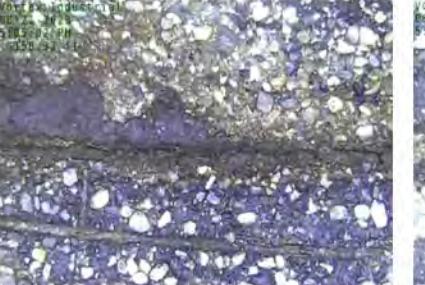
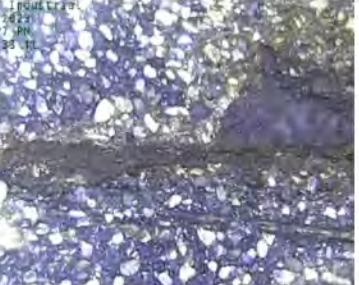
Surface Damage Reinforcement Visible	Point	158.5	Structural	0	5-10	4	0	0	2	Surface Damage Reinforcement Visible

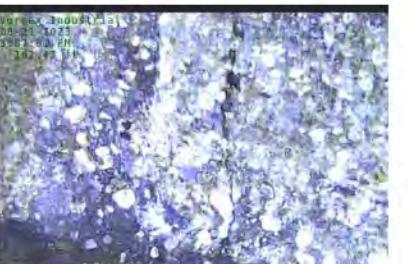
Crack Longitudinal	Point	162.4	Structural	0	3	2	0	0	1	Crack Longitudinal

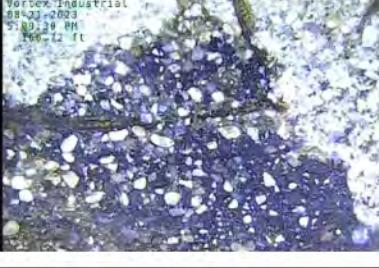
Crack Spiral	Point	166.7	Structural	0	9-10	2	0	0	2	Crack Spiral

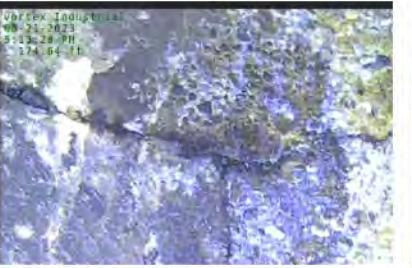
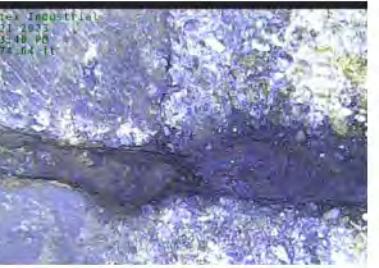
Crack Multiple	Point	174.6	Structural	0	3-5	3	0	0	2	Crack Multiple

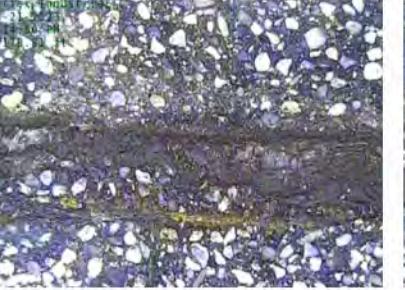
Description	Spatial Type	Distance (ft)	Type	Percent	Clock	SR	O&M	C	PR	Remarks	Photos
Surface Damage Reinforcement Visible	Point	178.8	Structural	0	7-10	4	0	0	2	Surface Damage Reinforcement Visible

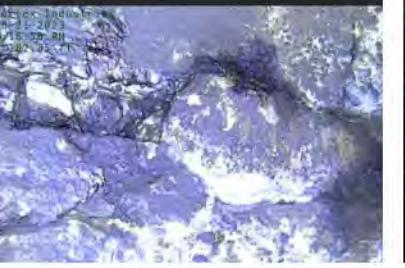
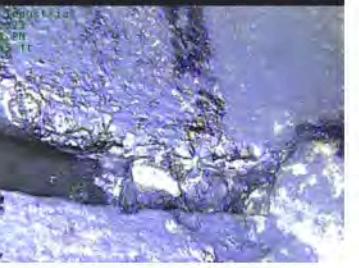
Crack Multiple	Point	182.9	Structural	0	4-5	3	0	0	2	Crack Multiple

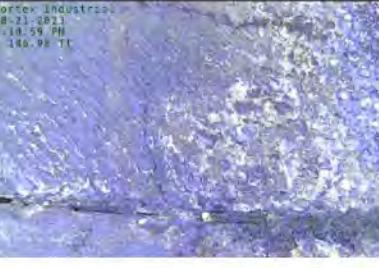
Crack Longitudinal	Point	187	Structural	0	4	2	0	0	1	Crack Longitudinal

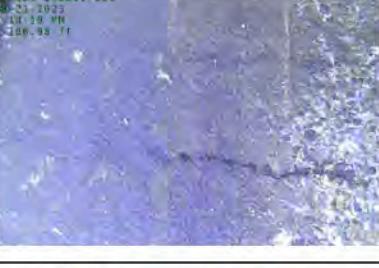
Crack Circumferential	Point	187	Structural	0	3-4	1	0	0	1	Crack Circumferential

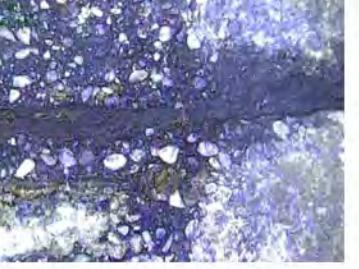
Surface Damage Reinforcement Visible	Point	191	Structural	0	7-10	4	0	0	2	Surface Damage Reinforcement Visible

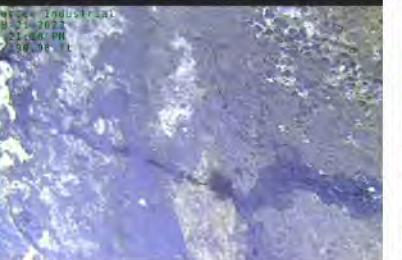
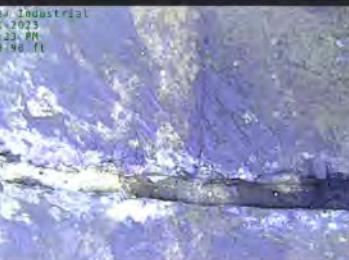
Description	Spatial Type	Distance (ft)	Type	Percent	Clock	SR	O&M	C	PR	Remarks	Photos
Crack Multiple	Point	191	Structural	0	3-5	3	0	0	2	Crack Multiple

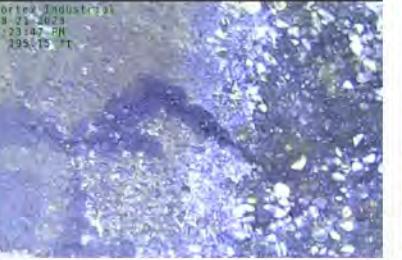
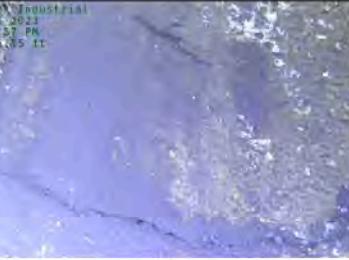
Crack Multiple	Point	195.2	Structural	0	3-5	3	0	0	2	Crack Multiple

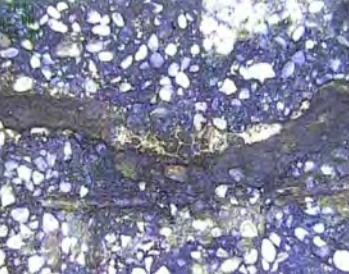
Surface Damage Reinforcement Visible	Point	195.2	Structural	0	5-9	4	0	0	2	Surface Damage Reinforcement Visible

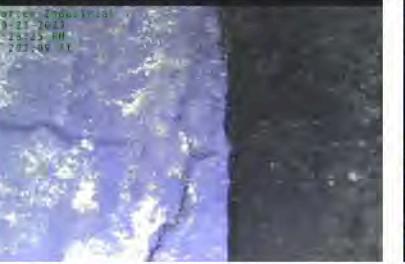
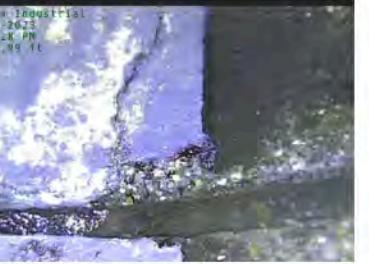
Description	Spatial Type	Distance (ft)	Type	Percent	Clock	SR	O&M	C	PR	Remarks	Photos
Crack Longitudinal	Point	203	Structural	0	7	2	0	0	2	Crack Longitudinal

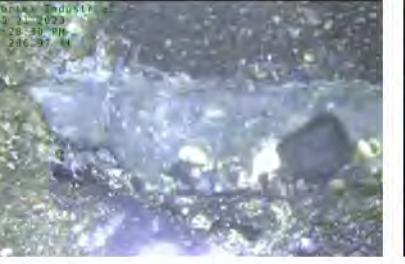
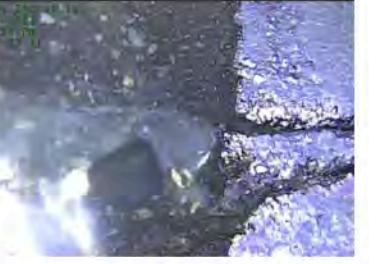
Fracture Circumferential	Point	207	Structural	0	5-6	2	0	0	2	Fracture Circumferential

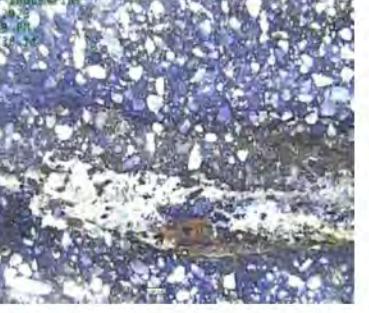
Surface Damage Reinforcement Visible	Point	215.3	Structural	0	5-10	4	0	0	2	Surface Damage Reinforcement Visible

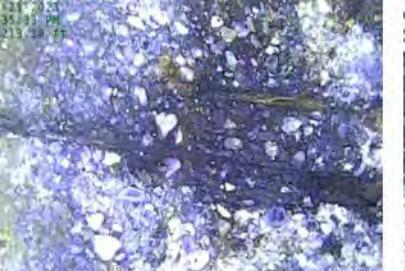
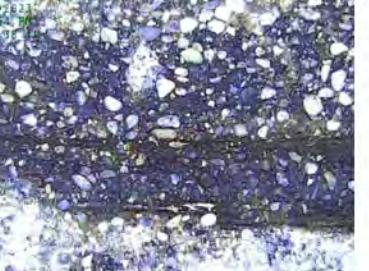
Surface Damage Reinforcement Visible	Point	219.4	Structural	0	1-4	4	0	0	2	Surface Damage Reinforcement Visible

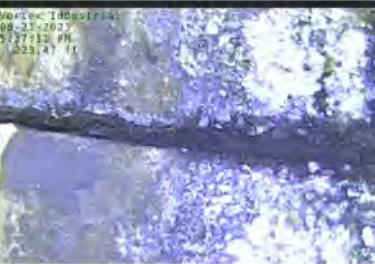
Description	Spatial Type	Distance (ft)	Type	Percent	Clock	SR	O&M	C	PR	Remarks	Photos
Crack Longitudinal	Point	223.5	Structural	0	3	2	0	0	1	Crack Longitudinal

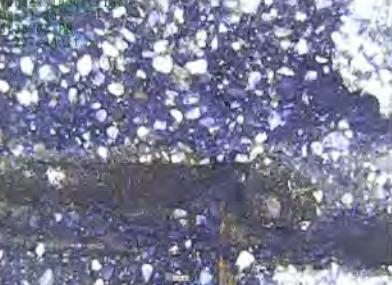
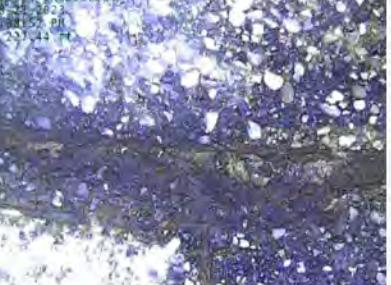
Surface Damage Reinforcement Visible	Point	227.4	Structural	0	6-10	4	0	0	2	Surface Damage Reinforcement Visible

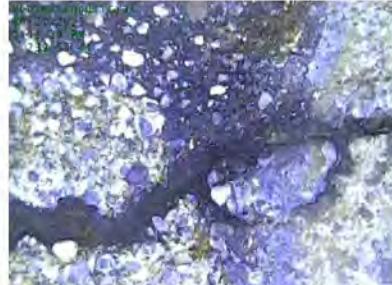
Crack Circumferential	Point	239.5	Structural	0	7-8	1	0	0	2	Crack Circumferential

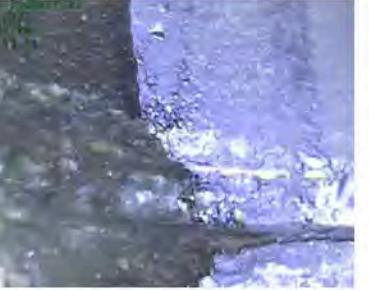
Description	Spatial Type	Distance (ft)	Type	Percent	Clock	SR	O&M	C	PR	Remarks	Photos
Surface Damage Reinforcement Visible	Point	243.5	Structural	0	12-12	4	0	0	2	Surface Damage Reinforcement Visible

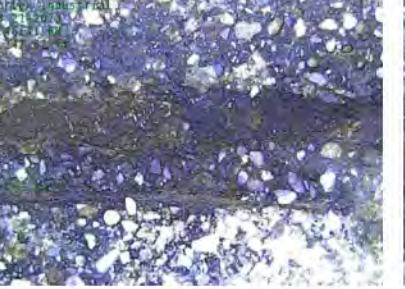
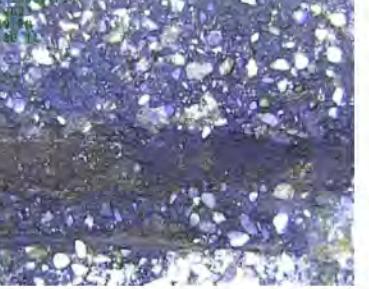
Surface Damage Reinforcement Visible	Point	247.8	Structural	0	2-4	4	0	0	2	Surface Damage Reinforcement Visible

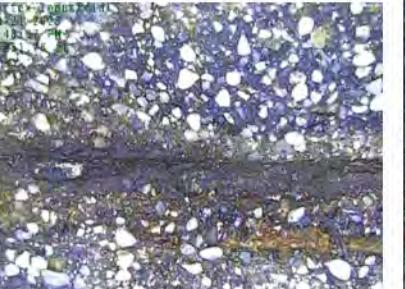
Surface Damage Reinforcement Visible	Point	251.8	Structural	0	6-8	4	0	0	2	Surface Damage Reinforcement Visible

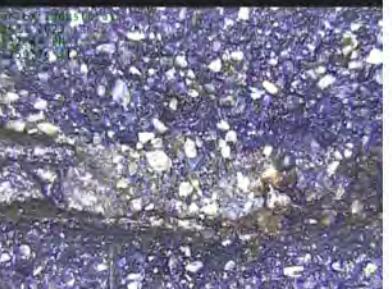
Surface Damage Reinforcement Visible	Point	259.8	Structural	0	6-10	4	0	0	2	Surface Damage Reinforcement Visible

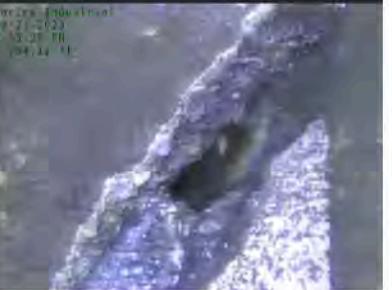
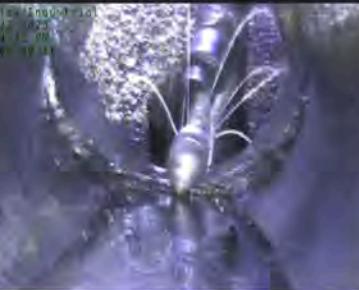
Joint Offset Large	Point	264.1	Structural	0		3	0	0	3	Joint Offset Large

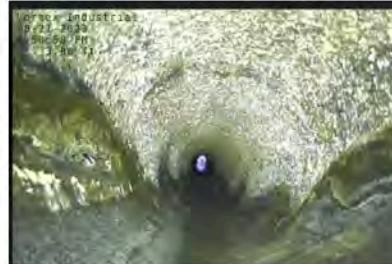
Description	Spatial Type	Distance (ft)	Type	Percent	Clock	SR	O&M	C	PR	Remarks	Photos
Manhole	Point	0	Constructional	0		0	0	2	0	5-D

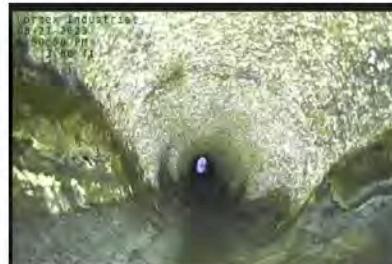
Miscellaneous Water Level	Point	0	Miscellaneous	0		0	0	0	0	Water Level at Start of Survey

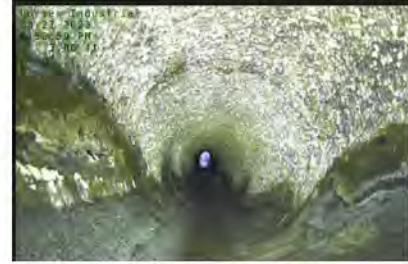
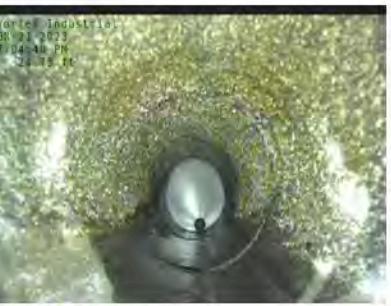
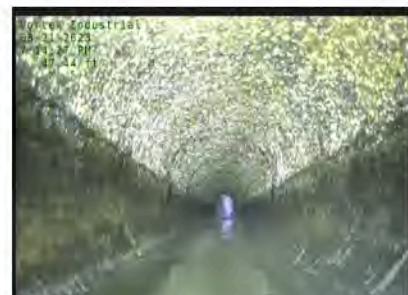
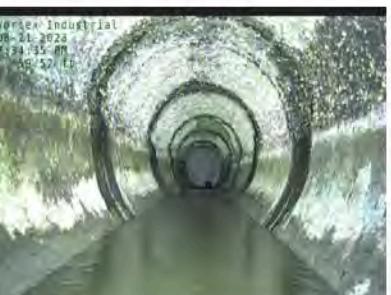
Surface Damage Aggregate Visible	Continuous	0 - 89.5	Structural	0	9-4	2	0	0	2	Surface Damage Aggregate Visible

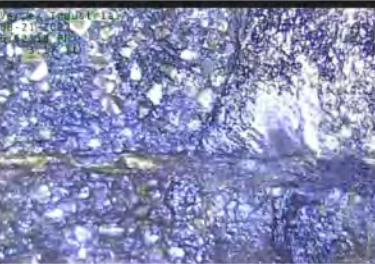
Description	Spatial Type	Distance (ft)	Type	Percent	Clock	SR	O&M	C	PR	Remarks	Photos
Crack Longitudinal	Point	3.2	Structural	0	10	2	0	0	1	Crack Longitudinal

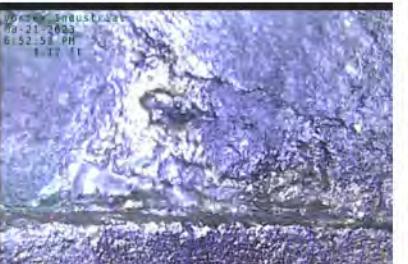
Crack Spiral	Point	3.2	Structural	0	3-4	2	0	0	1	Crack Spiral

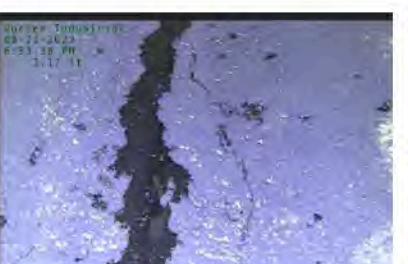
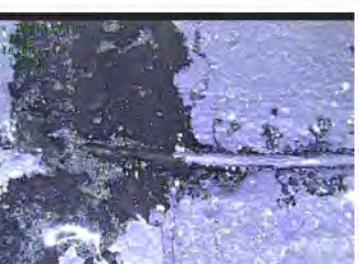
Crack Longitudinal	Point	3.2	Structural	0	6	2	0	0	1	Crack Longitudinal

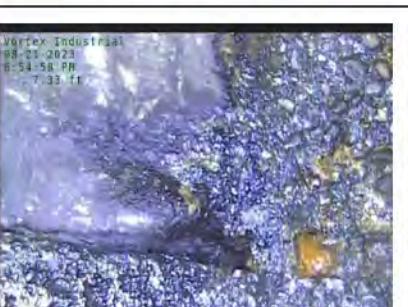
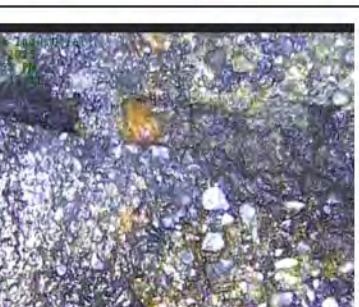
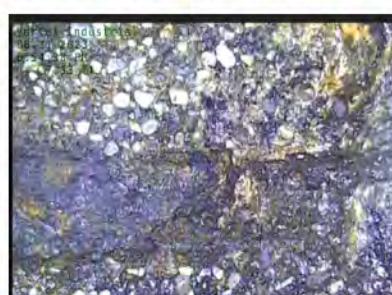
Surface Damage Reinforcement Visible	Point	7.3	Structural	0	2-4	4	0	0	2	Surface Damage Reinforcement Visible

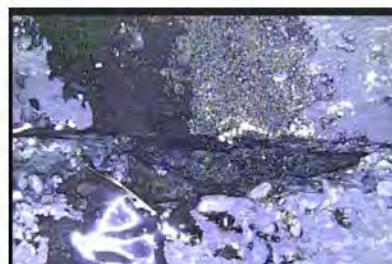
Fracture Circumferential	Point	7.3	Structural	0	5-6	2	0	0	2	Fracture Circumferential

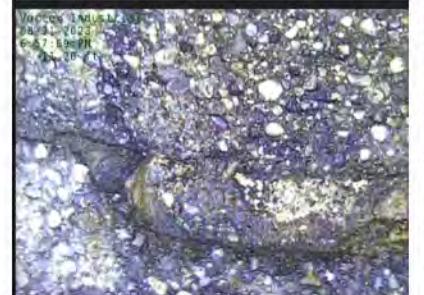
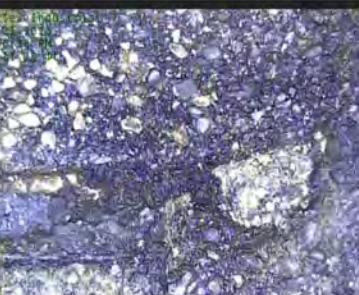
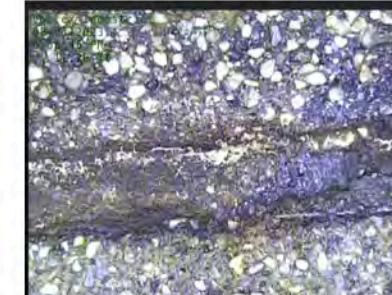
Surface Damage Reinforcement Visible	Point	11.2	Structural	0	2-4	4	0	0	2	Surface Damage Reinforcement Visible

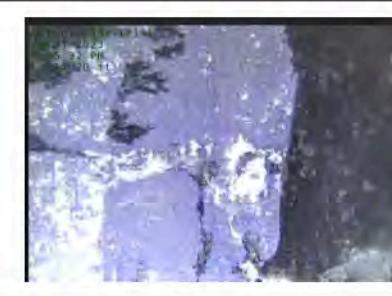
Crack Longitudinal	Point	11.2	Structural	0	7	2	0	0	2	Crack Longitudinal

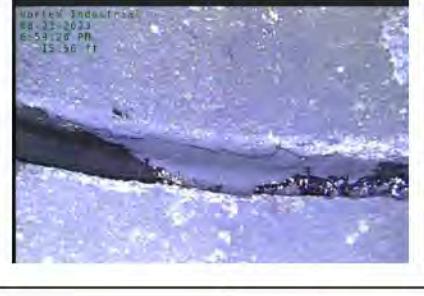
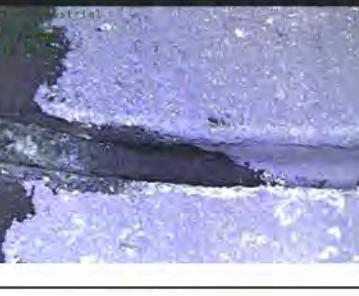
Crack Circumferential	Point	15.6	Structural	0	4-5	1	0	0	1	Crack Circumferential

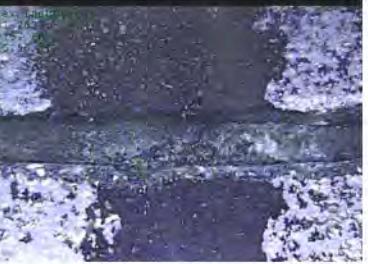
Description	Spatial Type	Distance (ft)	Type	Percent	Clock	SR	O&M	C	PR	Remarks	Photos
Crack Longitudinal	Point	15.6	Structural	0	6	2	0	0	2	Crack Longitudinal

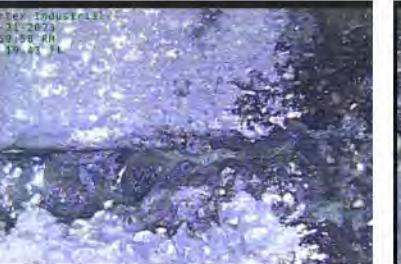
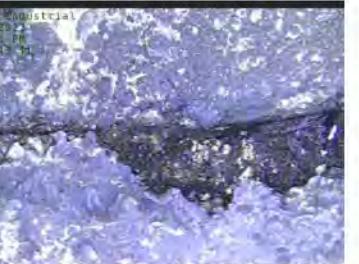
Fracture Circumferential	Point	19.4	Structural	0	6-7	2	0	0	2	Fracture Circumferential

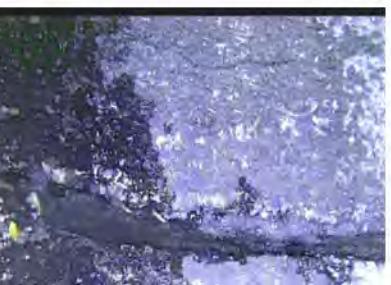
Crack Longitudinal	Point	26.2	Structural	0	4	2	0	0	1	Crack Longitudinal

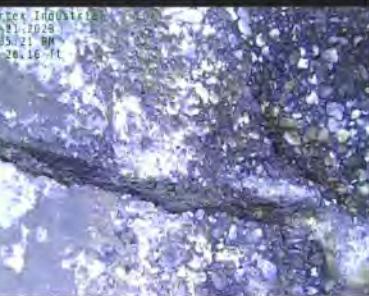
Description	Spatial Type	Distance (ft)	Type	Percent	Clock	SR	O&M	C	PR	Remarks	Photos
Fracture Circumferential	Point	26.2	Structural	0	2-3	2	0	0	2	Fracture Circumferential

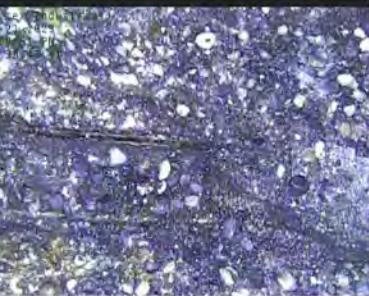
Surface Damage Reinforcement Visible	Point	38.4	Structural	0	8	4	0	0	2	Surface Damage Reinforcement Visible

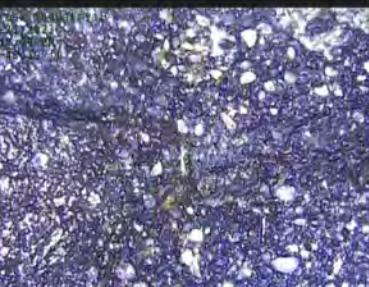
Surface Damage Reinforcement Visible	Point	48.2	Structural	0	4	4	0	0	2	Surface Damage Reinforcement Visible

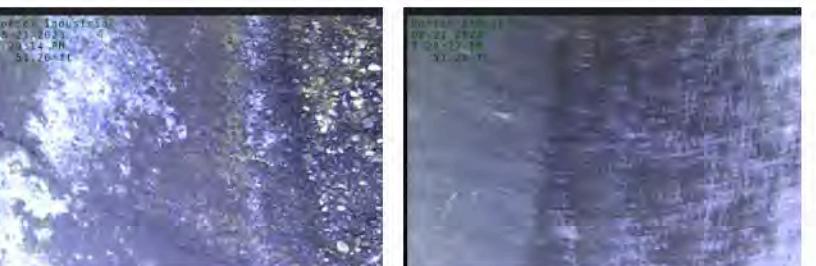
Crack Circumferential	Point	51.3	Structural	0	3-5	1	0	0	1	Crack Circumferential

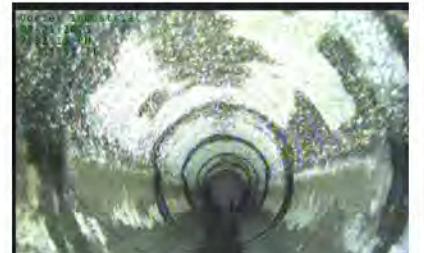
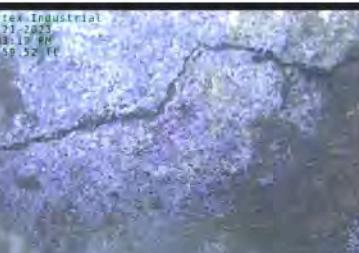
Crack Spiral	Point	59.5	Structural	0	6-9	2	0	0	2	Crack Spiral

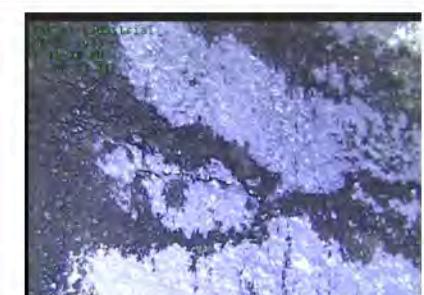
Crack Longitudinal	Point	62.3	Structural	0	4	2	0	0	1	Crack Longitudinal

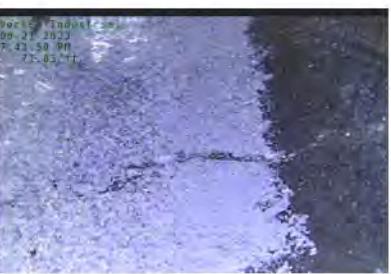
Crack Circumferential	Point	71.8	Structural	0	6-7	1	0	0	2	Crack Circumferential

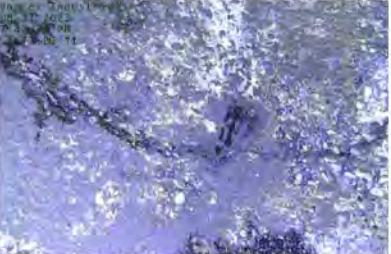
Crack Circumferential	Point	71.8	Structural	0	4-5	1	0	0	2	Crack Circumferential

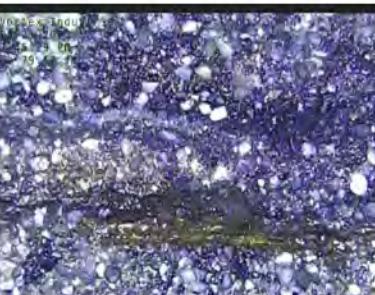
Surface Damage Reinforcement Visible	Point	79.5	Structural	0	2-4	4	0	0	2	Surface Damage Reinforcement Visible

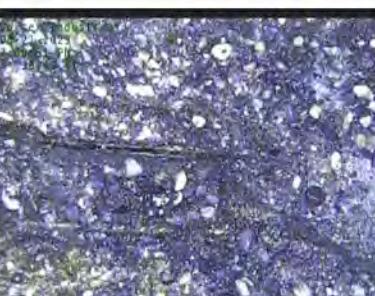
Surface Damage Reinforcement Visible	Point	87.9	Structural	0	10	4	0	0	2	Surface Damage Reinforcement Visible

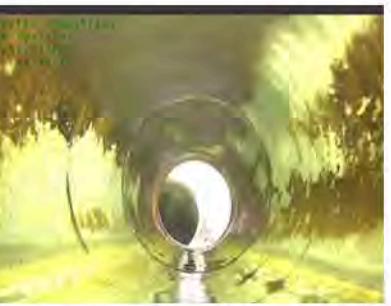
Surface Damage Roughness Increased	Continuous	0 - 55.2	Structural	0	12-12	1	0	0	1	Surface Damage Roughness Increased

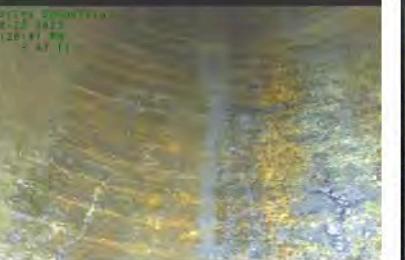
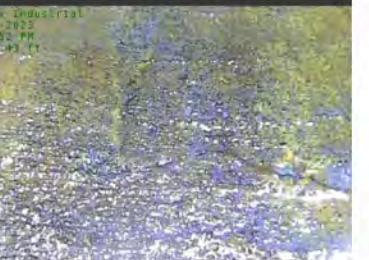
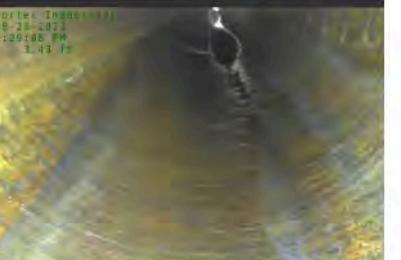
Description	Spatial Type	Distance (ft)	Type	Percent	Clock	SR	O&M	C	PR	Remarks	Photos
Crack Spiral	Point	3.4	Structural	0	5-7	2	0	0	2	Crack Spiral

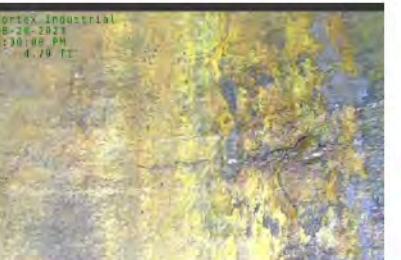
Crack Circumferential	Point	4.8	Structural	0	6-7	1	0	0	2	Crack Circumferential

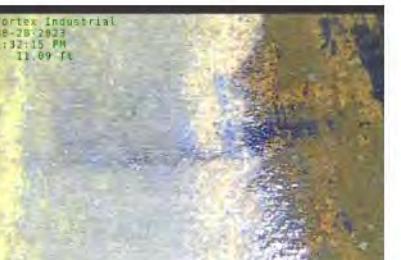
Crack Circumferential	Point	11.1	Structural	0	6-7	1	0	0	2	Crack Circumferential

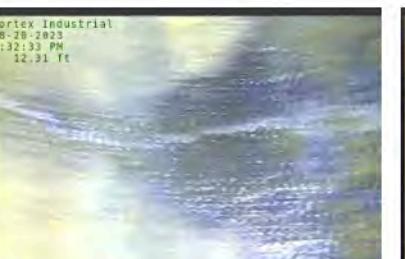
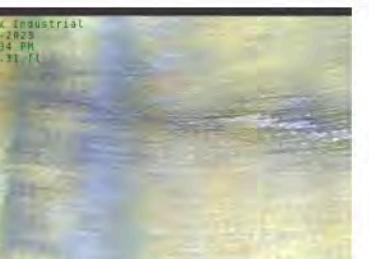
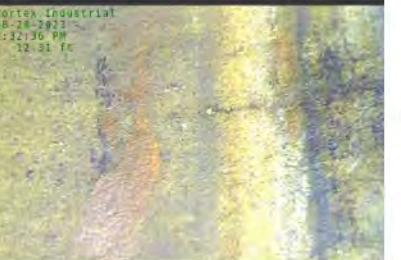
Crack Circumferential	Point	12.3	Structural	0	6-9	1	0	0	2	Crack Circumferential

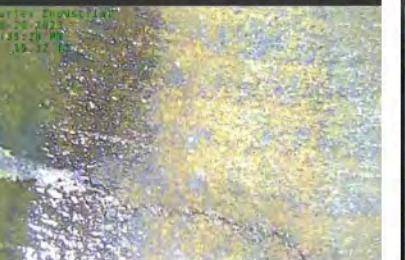
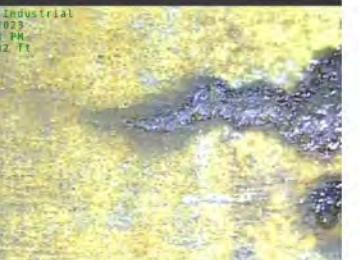
Description	Spatial Type	Distance (ft)	Type	Percent	Clock	SR	O&M	C	PR	Remarks	Photos
Crack Circumferential	Point	15.3	Structural	0	5-7	1	0	0	2	Crack Circumferential

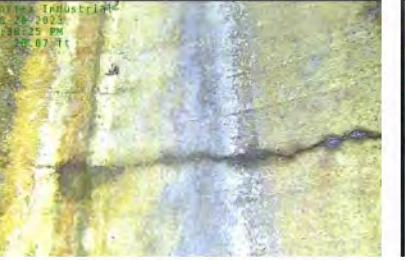
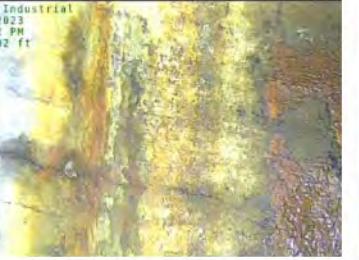
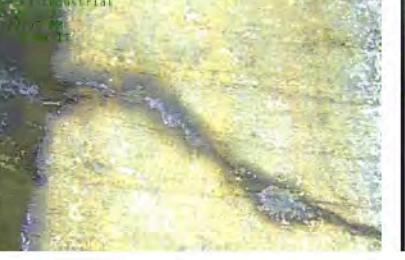
Crack Circumferential	Point	20.1	Structural	0	3-9	1	0	0	2	Crack Circumferential

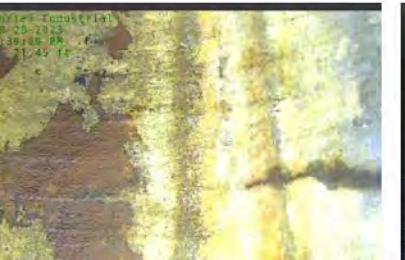
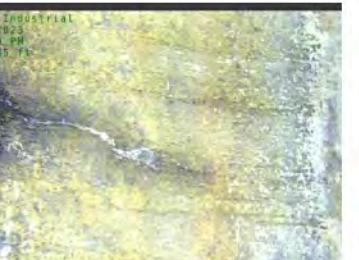
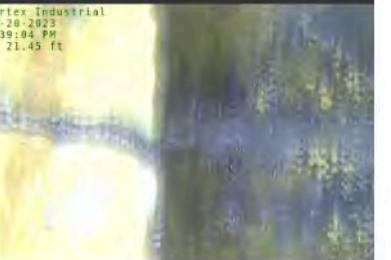
Crack Circumferential	Point	21.5	Structural	0	5-9	1	0	0	2	Crack Circumferential

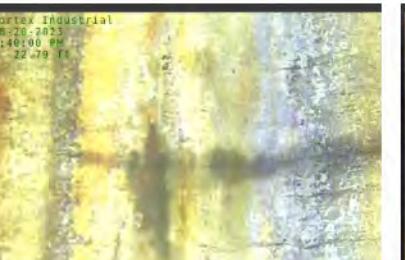
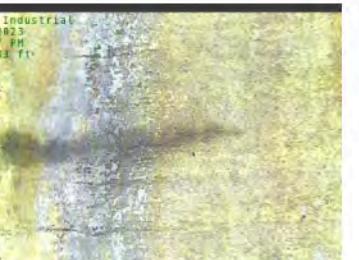
Crack Circumferential	Point	22.8	Structural	0	8-9	1	0	0	2	Crack Circumferential

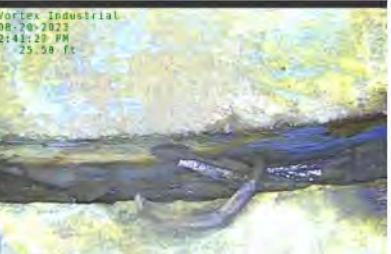
Description	Spatial Type	Distance (ft)	Type	Percent	Clock	SR	O&M	C	PR	Remarks	Photos
Intruding Sealing Material Grout	Point	25.6	O&M	10	7	0	2	0	0	Intruding Sealing Material Grout

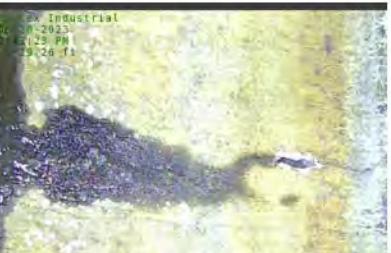
Crack Circumferential	Point	29.3	Structural	0	5-6	1	0	0	2	Crack Circumferential

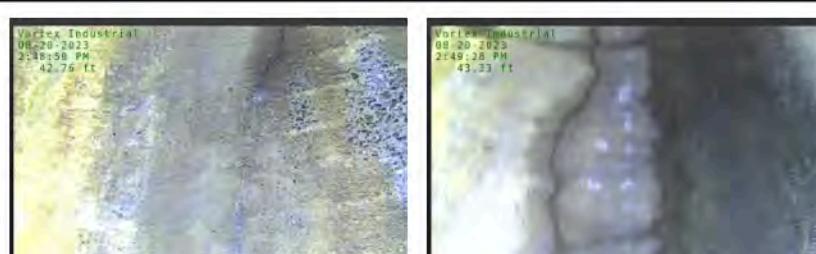
Crack Multiple	Continuous	43 - 47.3	Structural	0	5-7	3	0	0	2	Crack Multiple

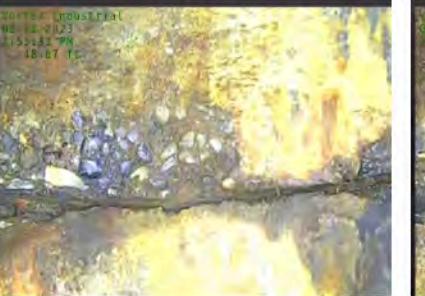
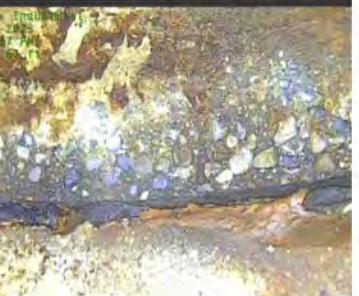
Description	Spatial Type	Distance (ft)	Type	Percent	Clock	SR	O&M	C	PR	Remarks	Photos
Surface Damage Aggregate Missing	Point	48.7	Structural	0	12-12	4	0	0	2	Surface Damage Aggregate Missing

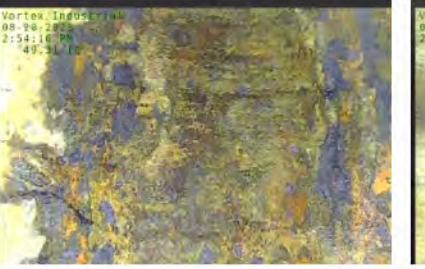
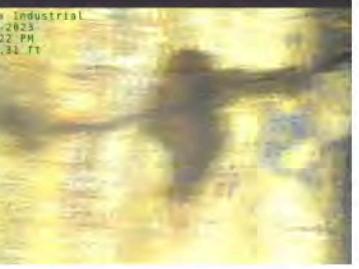
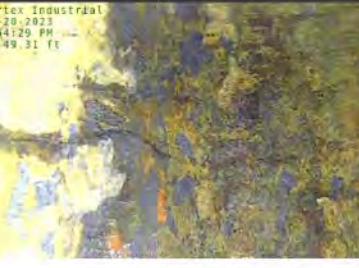
Crack Circumferential	Point	49.3	Structural	0	6-8	1	0	0	2	Crack Circumferential

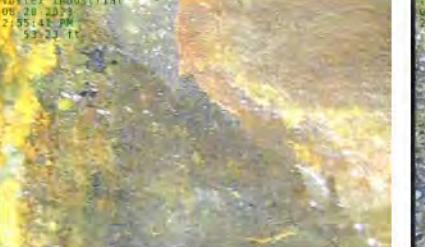
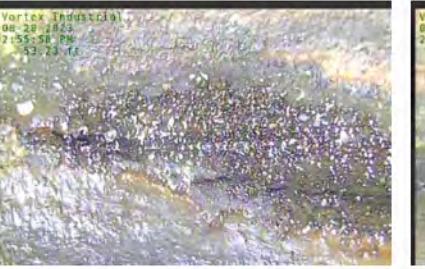
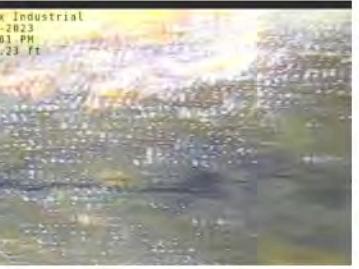
Crack Circumferential	Point	53.2	Structural	0	8-5	1	0	0	2	Crack Circumferential

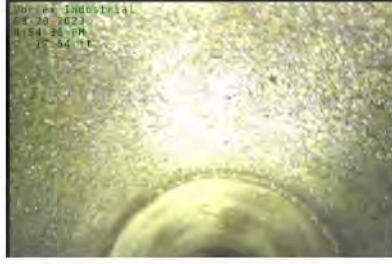
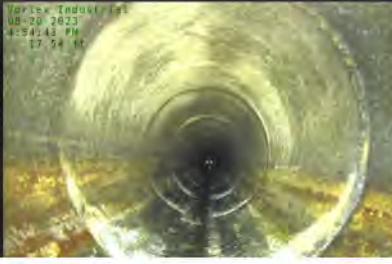
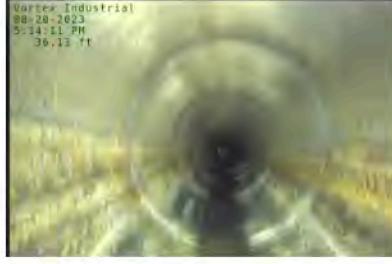
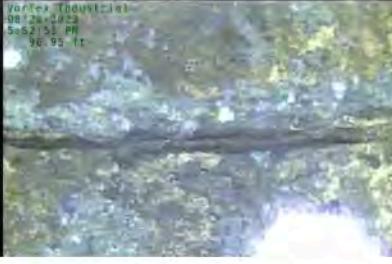
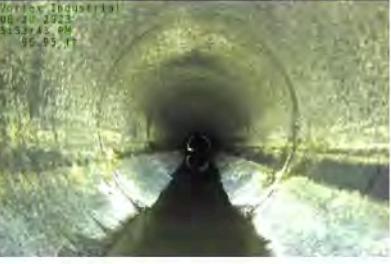
Surface Aggregate Visible	Continuous	0 - 133.2	Structural	0	12-12	2	0	0	1	Surface Aggregate Visible

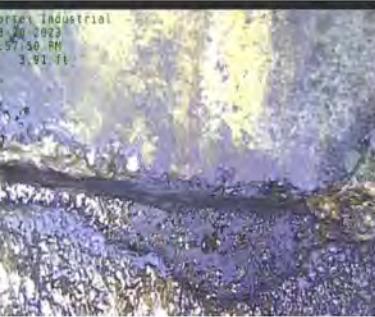
Description	Spatial Type	Distance (ft)	Type	Percent	Clock	SR	O&M	C	PR	Remarks	Photos
Fracture Circumferential	Point	3.9	Structural	0	9	2	0	0	2	Fracture Circumferential

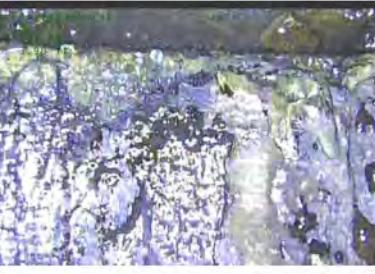
Crack Longitudinal	Point	3.9	Structural	0	6	2	0	0	2	Crack Longitudinal

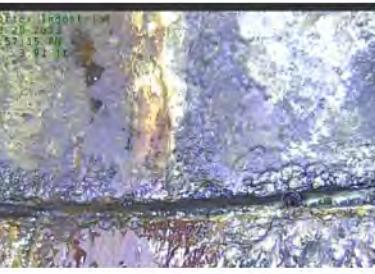
Crack Longitudinal	Point	3.9	Structural	0	7	2	0	0	2	Crack Longitudinal

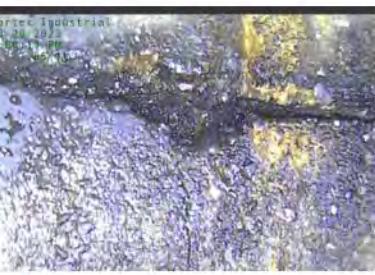
Crack Longitudinal	Point	7.9	Structural	0	3	2	0	0	1	Crack Longitudinal

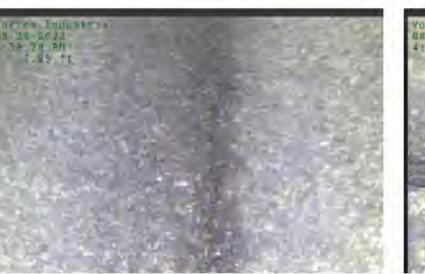
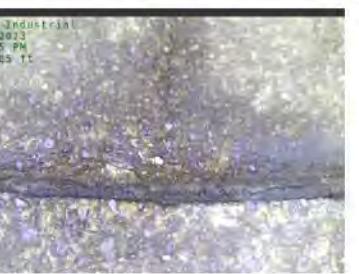
Crack Longitudinal	Point	7.9	Structural	0	11	2	0	0	1	Crack Longitudinal

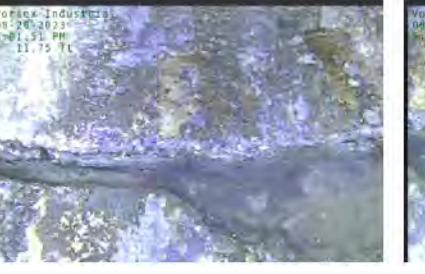
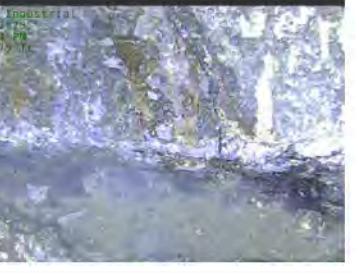
Fracture Circumferential	Point	11.8	Structural	0	5-6	2	0	0	2	Fracture Circumferential

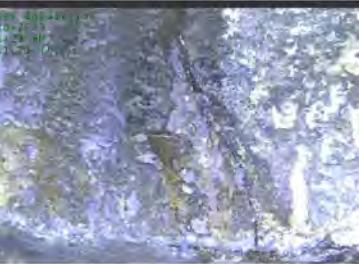
Description	Spatial Type	Distance (ft)	Type	Percent	Clock	SR	O&M	C	PR	Remarks	Photos
Crack Longitudinal	Point	11.8	Structural	0	6	2	0	0	2	Crack Longitudinal

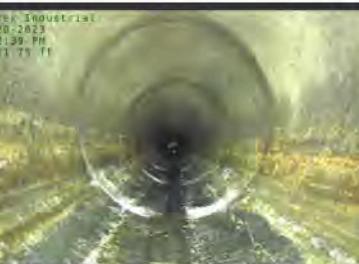
Crack Longitudinal	Point	15.5	Structural	0	5	2	0	0	2	Crack Longitudinal

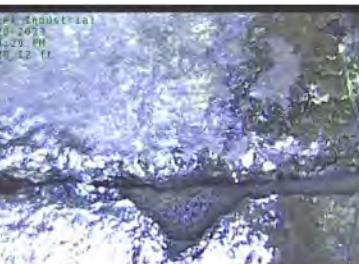
Fracture Circumferential	Point	21.1	Structural	0	6-7	2	0	0	2	Fracture Circumferential

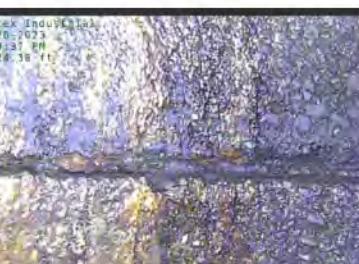
Crack Longitudinal	Point	24.4	Structural	0	3	2	0	0	2	Crack Longitudinal

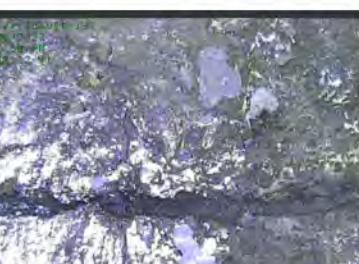
Crack Longitudinal	Point	28.1	Structural	0	6	2	0	0	2	Crack Longitudinal

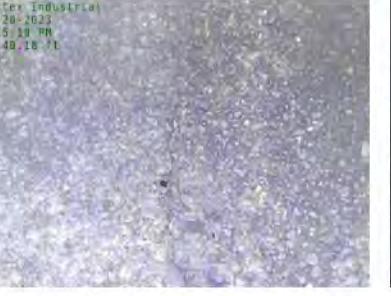
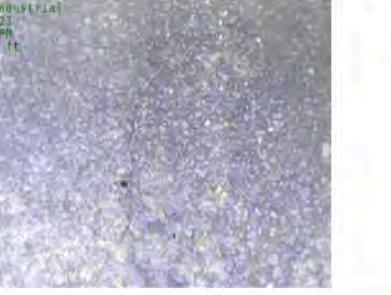
Description	Spatial Type	Distance (ft)	Type	Percent	Clock	SR	O&M	C	PR	Remarks	Photos
Crack Longitudinal	Point	40.2	Structural	0	8	2	0	0	1	Crack Longitudinal

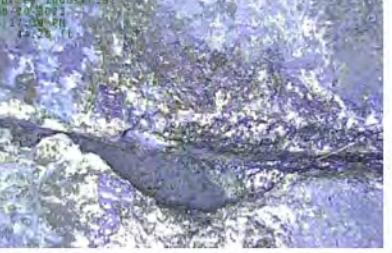
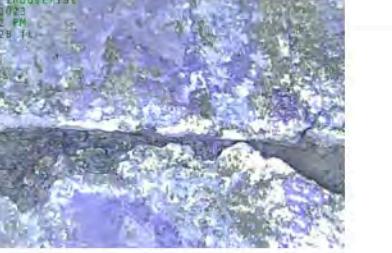
Fracture Circumferential	Point	44.3	Structural	0	5-6	2	0	0	2	Fracture Circumferential

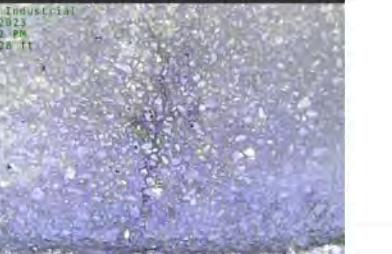
Crack Longitudinal	Point	44.3	Structural	0	11	2	0	0	2	Crack Longitudinal

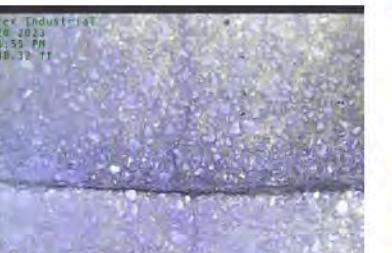
Crack Longitudinal	Point	48.3	Structural	0	12	2	0	0	1	Crack Longitudinal

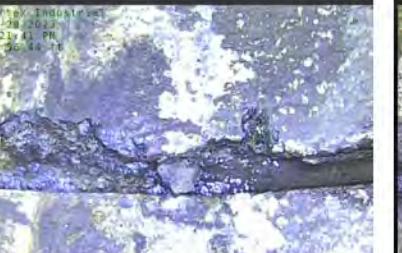
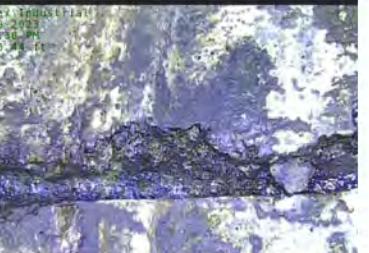
Fracture Circumferential	Point	56.4	Structural	0	7-8	2	0	0	2	Fracture Circumferential

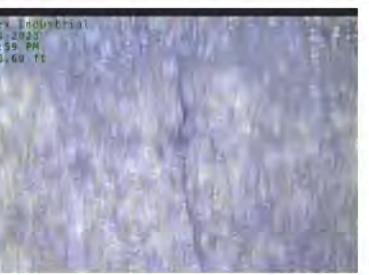
Crack Longitudinal	Point	60.6	Structural	0	1	2	0	0	1	Crack Longitudinal

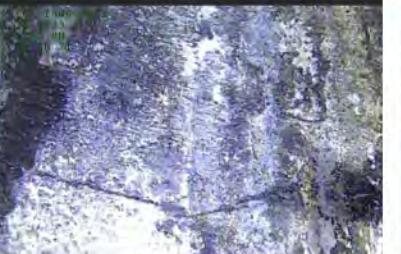
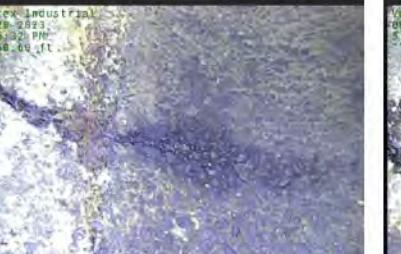
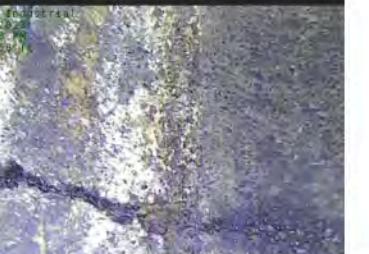
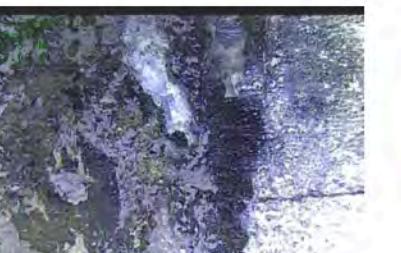
Crack Circumferential	Point	60.6	Structural	0	2-5	1	0	0	2	Crack Circumferential

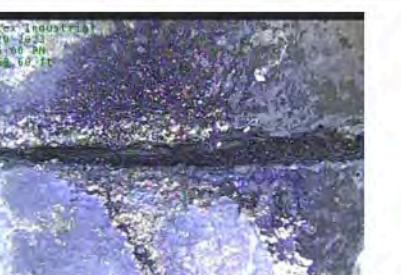
Crack Longitudinal	Point	60.6	Structural	0	6	2	0	0	2	Crack Longitudinal

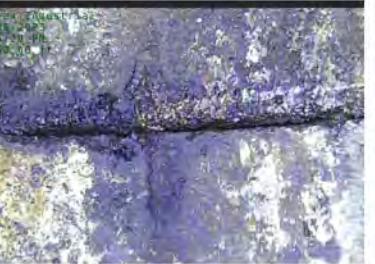
Description	Spatial Type	Distance (ft)	Type	Percent	Clock	SR	O&M	C	PR	Remarks	Photos
Crack Longitudinal	Point	60.6	Structural	0	8	2	0	0	2	Crack Longitudinal

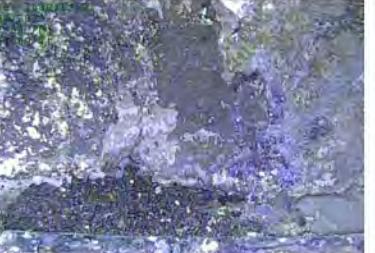
Crack Longitudinal	Point	64.7	Structural	0	6	2	0	0	1	Crack Longitudinal

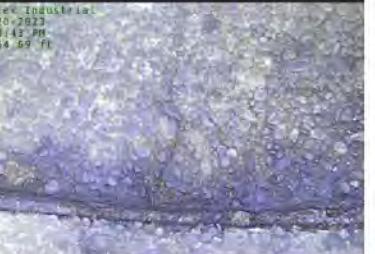
Crack Longitudinal	Point	64.7	Structural	0	1	2	0	0	1	Crack Longitudinal

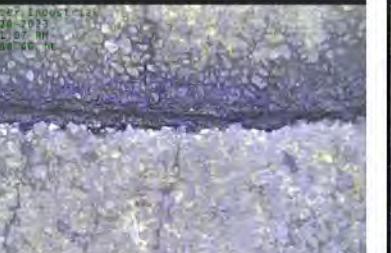
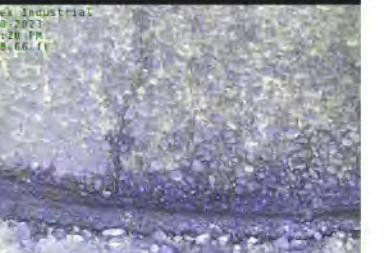
Crack Multiple	Point	68.7	Structural	0	12-1	3	0	0	1	Crack Multiple

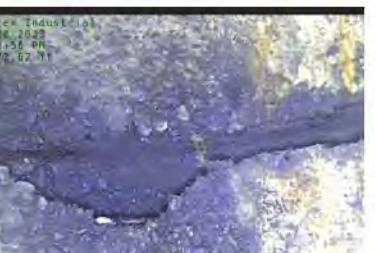
Fracture Circumferential	Point	72.6	Structural	0	8-9	2	0	0	2	Fracture Circumferential

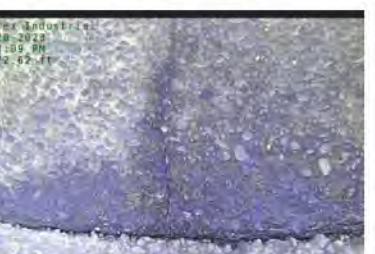
Crack Longitudinal	Point	72.6	Structural	0	12	2	0	0	2	Crack Longitudinal

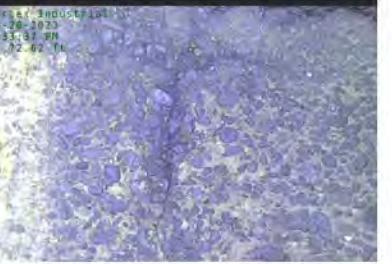
Description	Spatial Type	Distance (ft)	Type	Percent	Clock	SR	O&M	C	PR	Remarks	Photos
Crack Longitudinal	Point	72.6	Structural	0	2	2	0	0	2	Crack Longitudinal

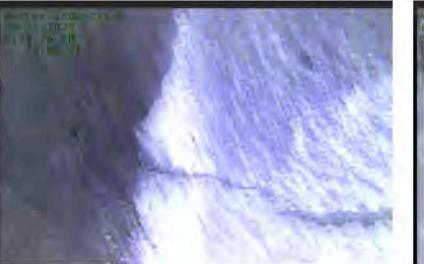
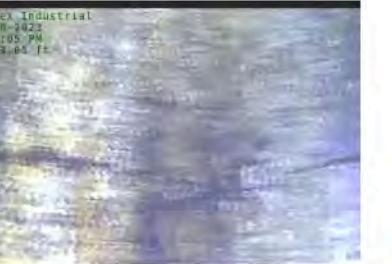
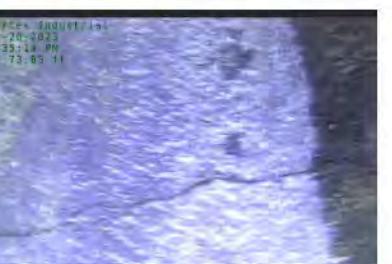
Crack Circumferential	Point	73	Structural	0	3-9	1	0	0	2	Crack Circumferential

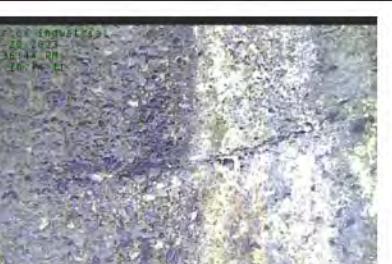
Crack Circumferential	Point	76.7	Structural	0	6-9	1	0	0	2	Crack Circumferential

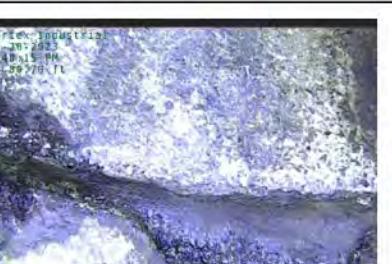
Fracture Circumferential	Point	80.7	Structural	0	4-5	2	0	0	2	Fracture Circumferential

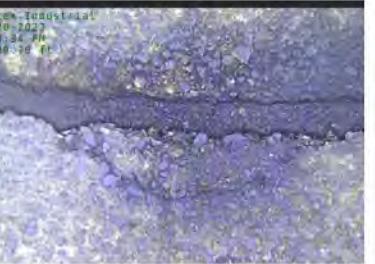
Description	Spatial Type	Distance (ft)	Type	Percent	Clock	SR	O&M	C	PR	Remarks	Photos
Crack Circumferential	Point	80.7	Structural	0	1-2	1	0	0	2	Crack Circumferential

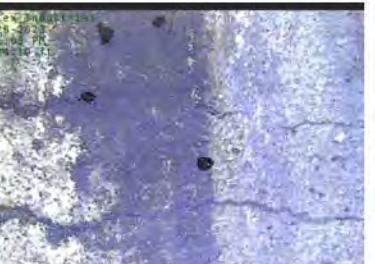
Crack Circumferential	Point	84.2	Structural	0	7-9	1	0	0	1	Crack Circumferential

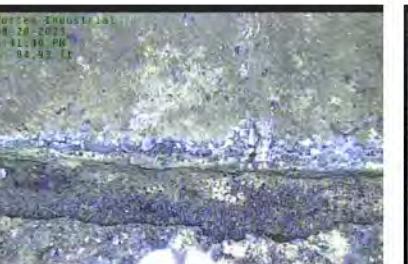
Crack Longitudinal	Point	84.9	Structural	0	6	2	0	0	1	Crack Longitudinal

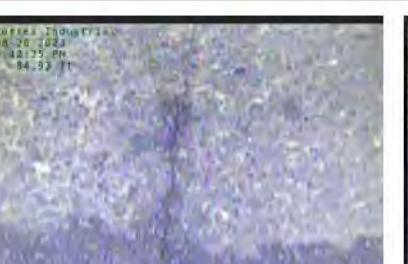
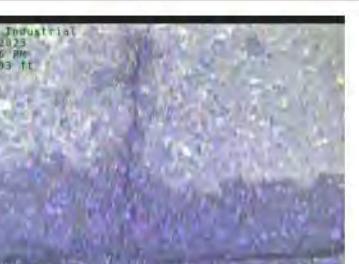
Crack Longitudinal	Point	84.9	Structural	0	12	2	0	0	1	Crack Longitudinal

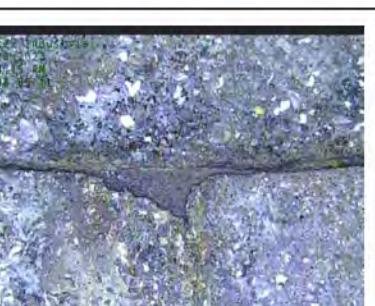
Surface Damage Aggregate Missing	Point	88.5	Structural	0	7	4	0	0	1	Surface Damage Aggregate Missing

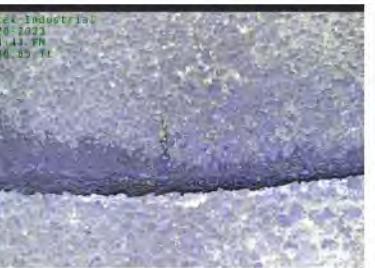
Description	Spatial Type	Distance (ft)	Type	Percent	Clock	SR	O&M	C	PR	Remarks	Photos
Crack Longitudinal	Point	88.5	Structural	0	11	2	0	0	1	Crack Longitudinal

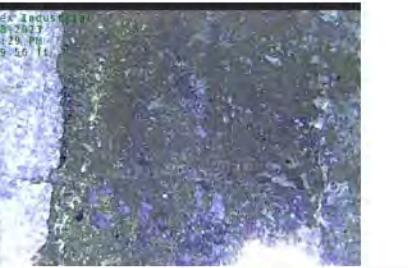
Crack Circumferential	Point	89.6	Structural	0	6-10	1	0	0	2	Crack Circumferential

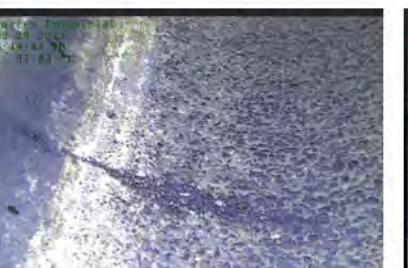
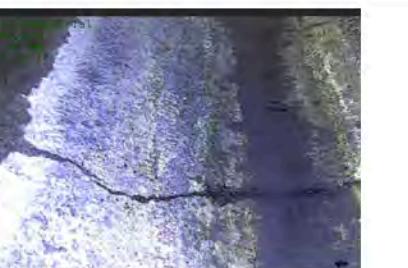
Fracture Circumferential	Point	92.8	Structural	0	3-5	1	0	0	2	Fracture Circumferential
