2023 ANNUAL PROGRESS REPORT

SWMU-1 OILY WATER SEWER

HF SINCLAIR PUGET SOUND REFINING LLC

MARCH 21, 2024

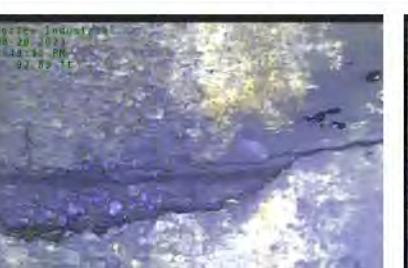
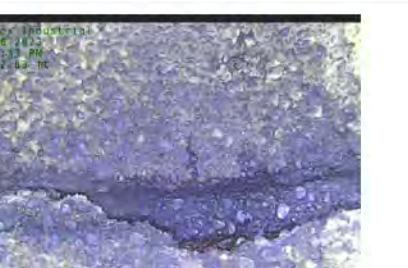
Fracture Circumferential	Point	92.8	Structural	0	9-10	2	0	0	2	Fracture Circumferential

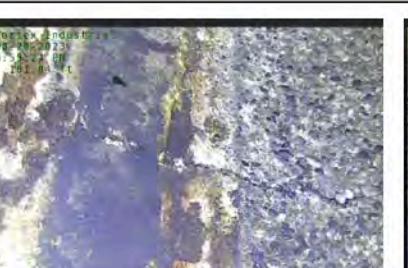
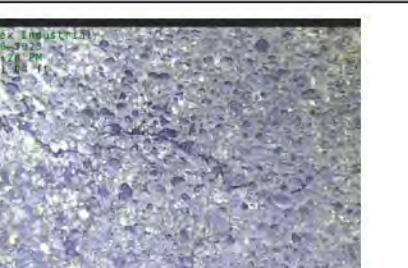
Crack Circumferential	Point	101.1	Structural	0	3-5	1	0	0	2	Crack Circumferential

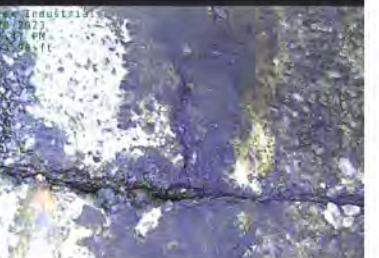
Description	Spatial Type	Distance (ft)	Type	Percent	Clock	SR	O&M	C	PR	Remarks	Photos
Crack Longitudinal	Point	105	Structural	0	4	2	0	0	2	Crack Longitudinal

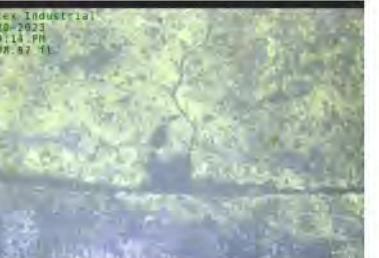
Crack Longitudinal	Point	109	Structural	0	6	2	0	0	2	Crack Longitudinal

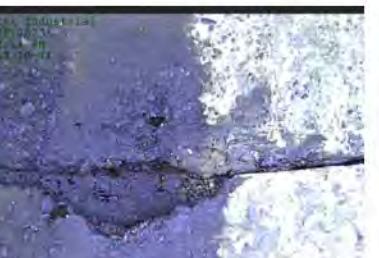
Fracture Circumferential	Point	113.1	Structural	0	8-9	2	0	0	2	Fracture Circumferential

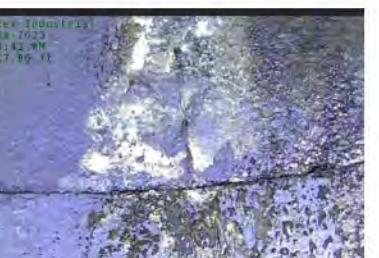
Crack Longitudinal	Point	117	Structural	0	8	2	0	0	2	Crack Longitudinal

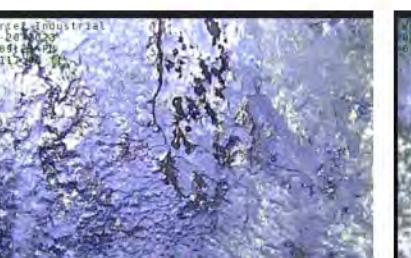
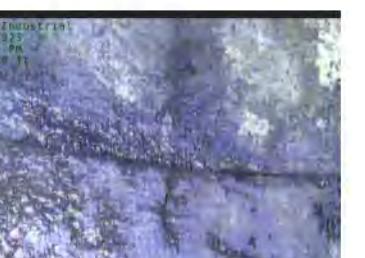
Crack Longitudinal	Point	117	Structural	0	5	2	0	0	1	Crack Longitudinal

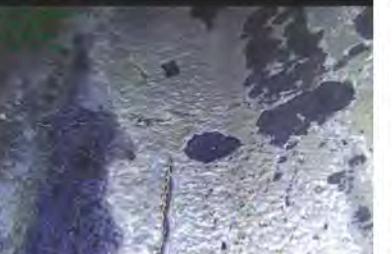
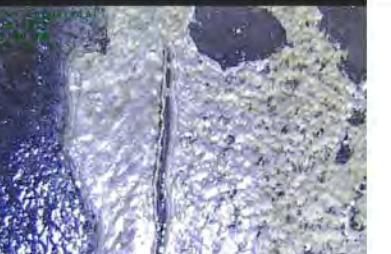
Description	Spatial Type	Distance (ft)	Type	Percent	Clock	SR	O&M	C	PR	Remarks	Photos
Crack Longitudinal	Point	120.4	Structural	0	7	2	0	0	2	Crack Longitudinal

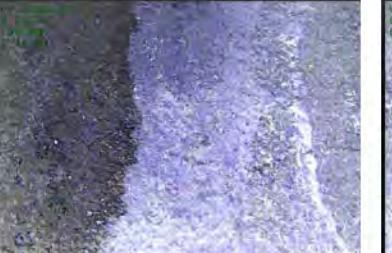
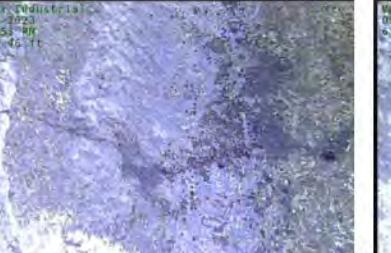
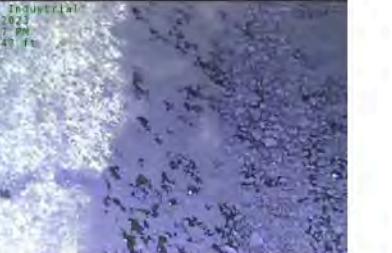
Crack Circumferential	Point	121.5	Structural	0	4-5	1	0	0	1	Crack Circumferential

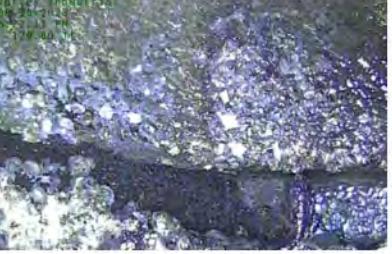
Fracture Circumferential	Point	129	Structural	0	5-6	2	0	0	2	Fracture Circumferential

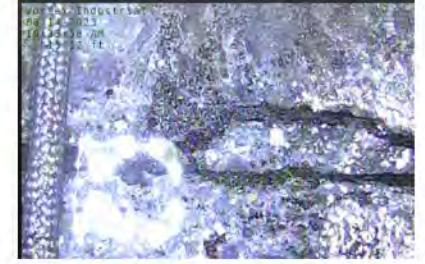
Crack Circumferential	Point	15.1	Structural	0	6-7	1	0	0	0	2	Crack Circumferential

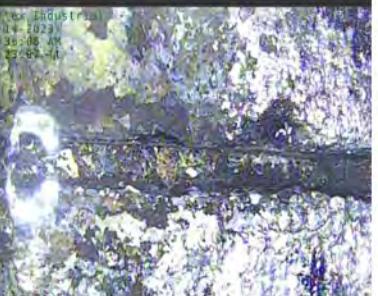
Description	Spatial Type	Distance (ft)	Type	Percent	Clock	SR	O&M	C	PR	Remarks	Photos
Crack Longitudinal	Point	23.1	Structural	0	4	2	0	0	1	Crack Longitudinal

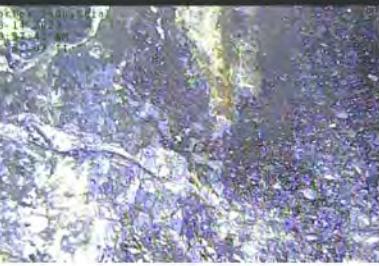
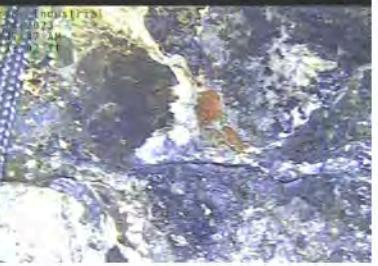
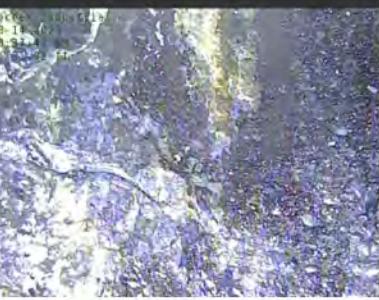
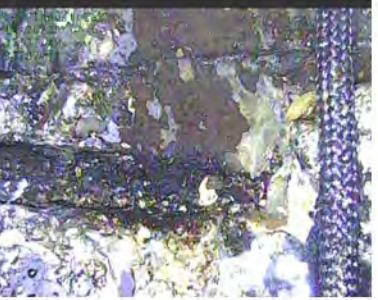
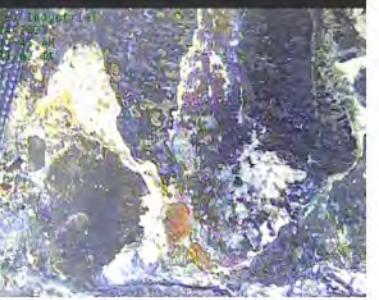
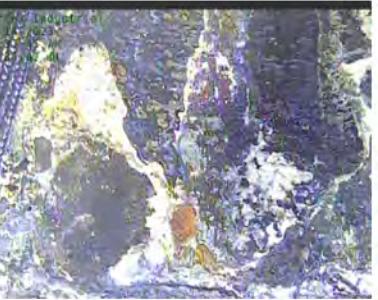
Crack Circumferential	Point	31	Structural	0	6-8	1	0	0	2	Crack Circumferential

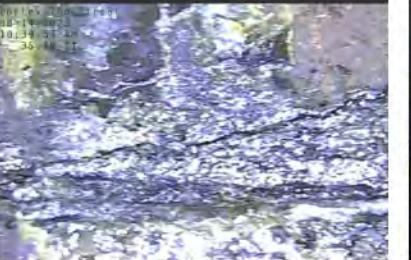
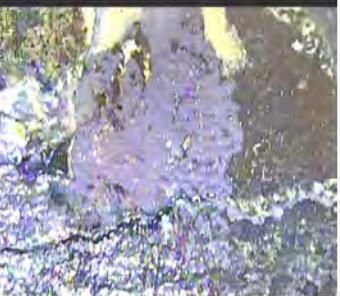
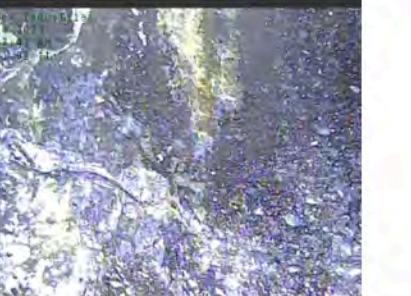
Description	Spatial Type	Distance (ft)	Type	Percent	Clock	SR	O&M	C	PR	Remarks	Photos
Crack Multiple	Point	35.5	Structural	0	4-6	3	0	0	2	Crack Multiple

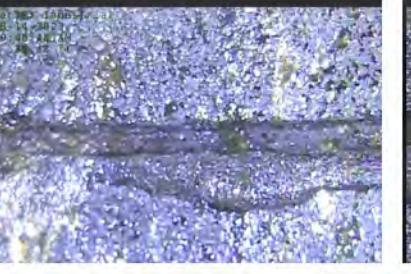
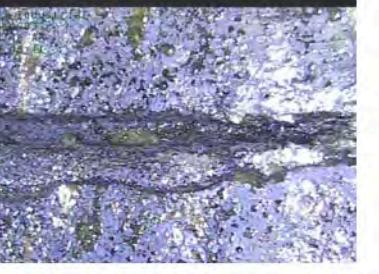
Fracture Circumferential	Point	35.5	Structural	0	7-8	2	0	0	2	Fracture Circumferential

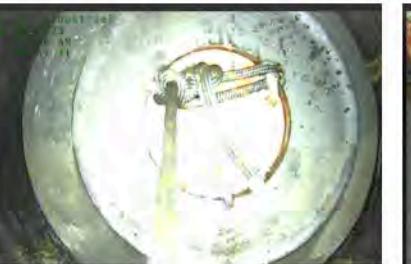
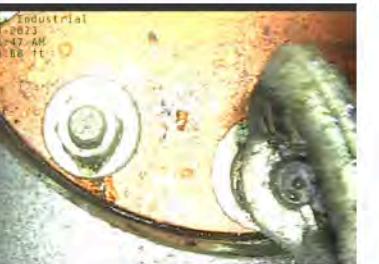
Miscellaneous Survey Abandoned	Point	38.7	Miscellaneous	0		0	0	0	0	Plugged

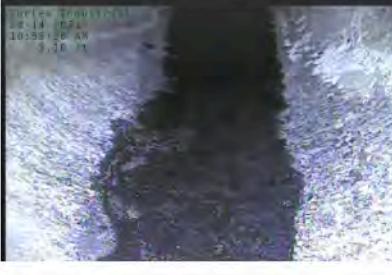
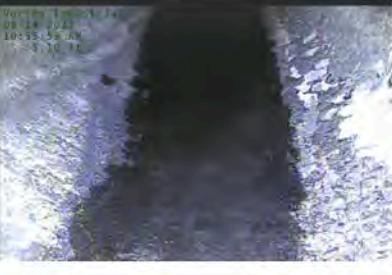
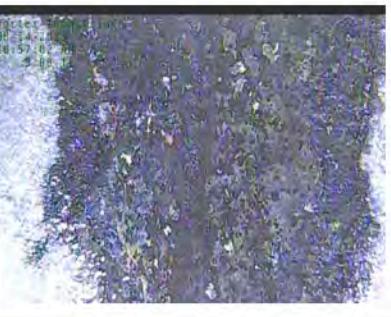
Crack Longitudinal		Point	5.1	Structural	0	6	2	0	0	1	Crack Longitudinal

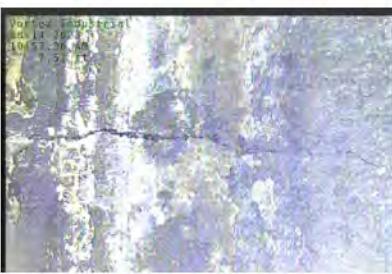
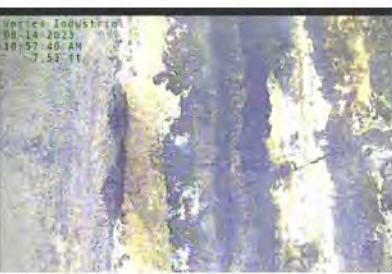
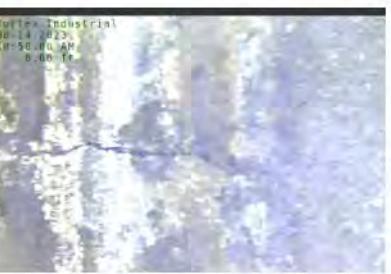
Crack Circumferential		Point	7.5	Structural	0	7-9	1	0	0	2	Crack Circumferential

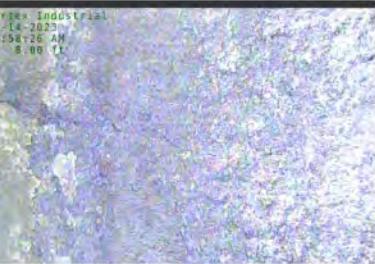
Description	Spatial Type	Distance (ft)	Type	Percent	Clock	SR	O&M	C	PR	Remarks	Photos
Crack Circumferential	Point	8	Structural	0	8-9	1	0	0	1	Crack Circumferential

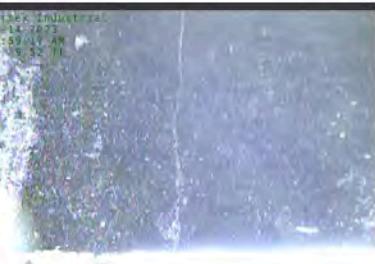
Crack Longitudinal	Point	9.5	Structural	0	9	2	0	0	1	Crack Longitudinal

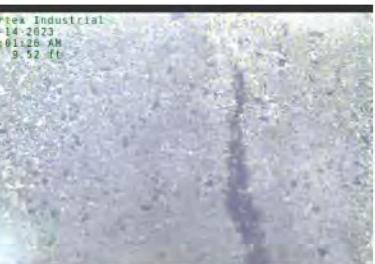
Crack Longitudinal	Point	9.5	Structural	0	6	2	0	0	1	Crack Longitudinal

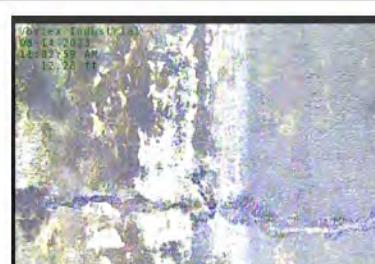
Crack Circumferential	Point	12.2	Structural	0	6-9	1	0	0	2	Crack Circumferential

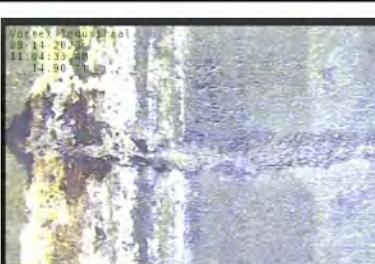
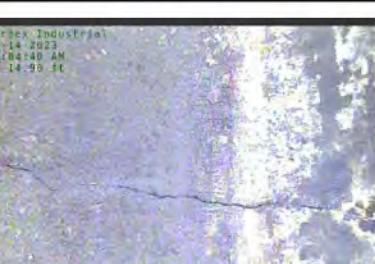
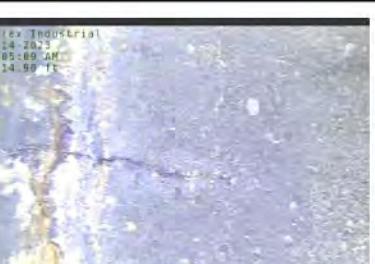
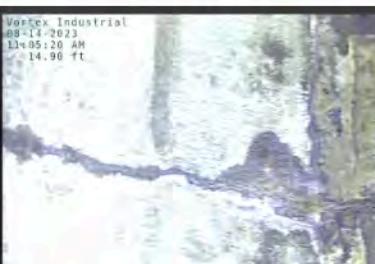
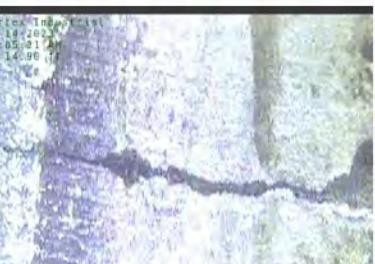
Crack Circumferential	Point	14.9	Structural	0	7-5	1	0	0	1	Crack Circumferential

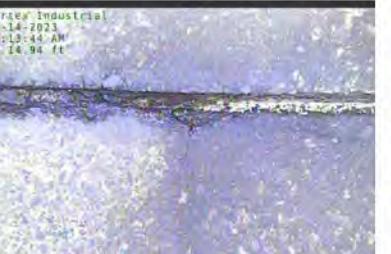
Description	Spatial Type	Distance (ft)	Type	Percent	Clock	SR	O&M	C	PR	Remarks	Photos
Crack Longitudinal	Point	14.9	Structural	0	11	2	0	0	2	Crack Longitudinal

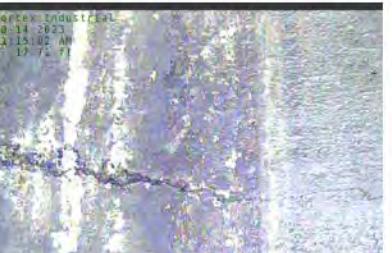
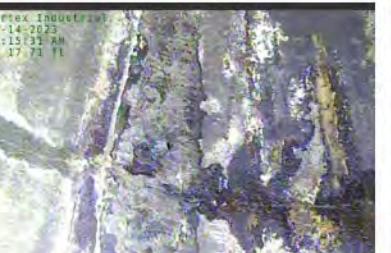
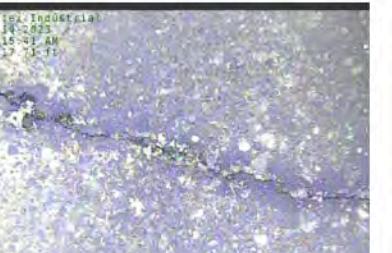
Crack Circumferential	Point	17.7	Structural	0	6-5	1	0	0	2	Crack Circumferential

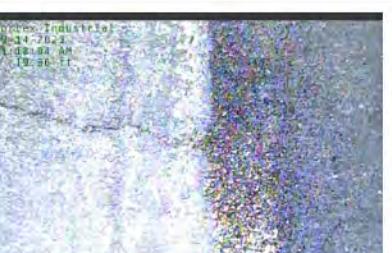
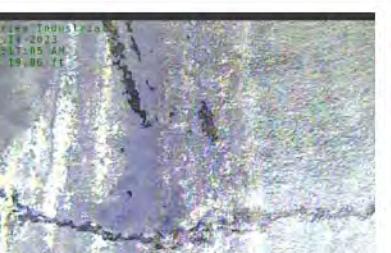
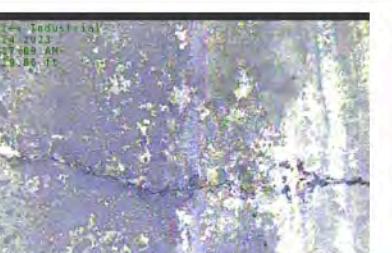
Crack Circumferential	Point	19.9	Structural	0	7-11	1	0	0	2	Crack Circumferential

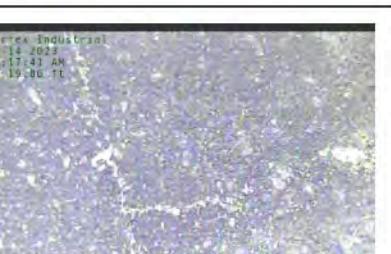
Crack Longitudinal	Point	19.9	Structural	0	11	2	0	0	1	Crack Longitudinal

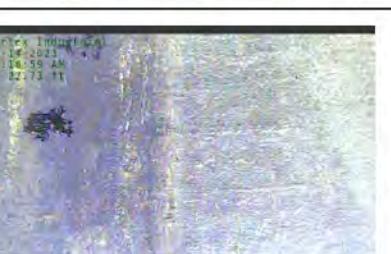
Crack Longitudinal	Point	22.7	Structural	0	8	2	0	0	1	Crack Longitudinal

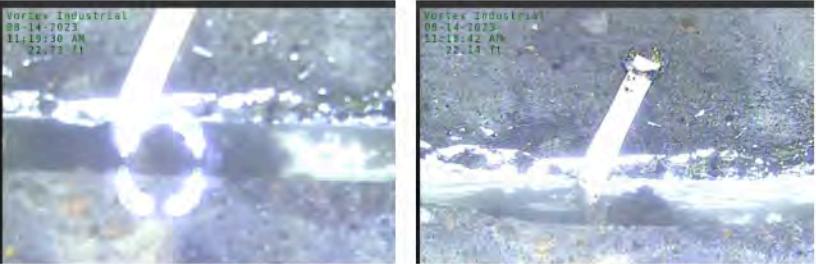
Description	Spatial Type	Distance (ft)	Type	Percent	Clock	SR	O&M	C	PR	Remarks	Photos
Miscellaneous General Photograph	Point	22.7	Miscellaneous	0	6	0	0	0	0	Object in Joint

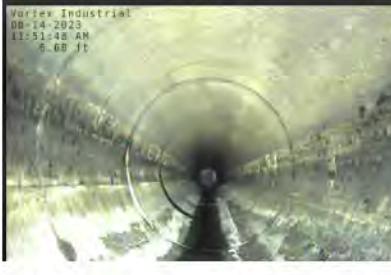
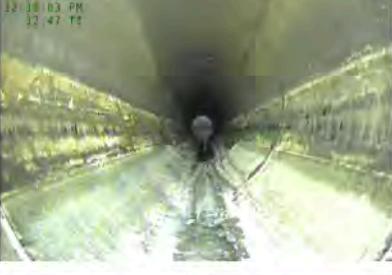
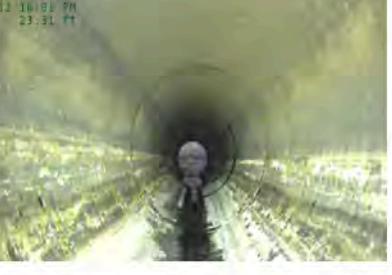
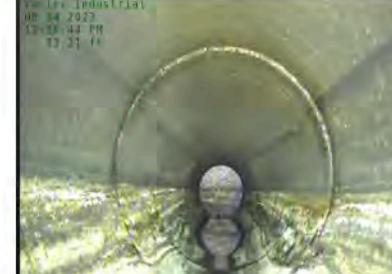
Surface Damage Aggregate Visible	Continuous	0 - 52.6	Structural	0	10-2	2	0	0	0	1	Surface Damage Aggregate Visible

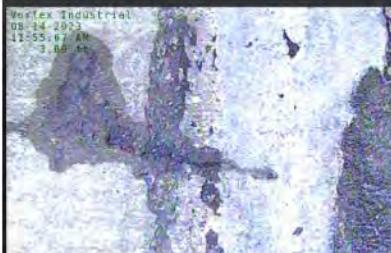
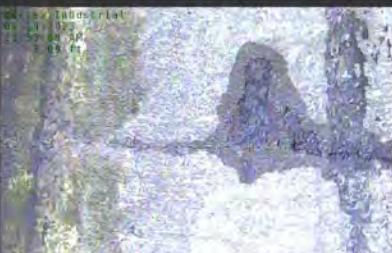
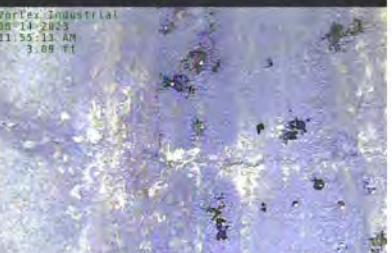
Crack Circumferential	Point	3.1	Structural	0	7-9	1	0	0	1	Crack Circumferential

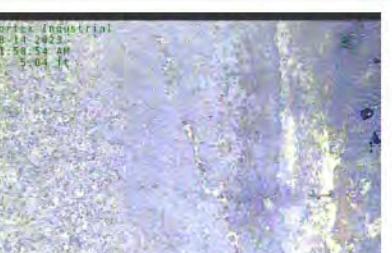
Crack Spiral	Point	5	Structural	0	6-8	2	0	0	1	Crack Spiral

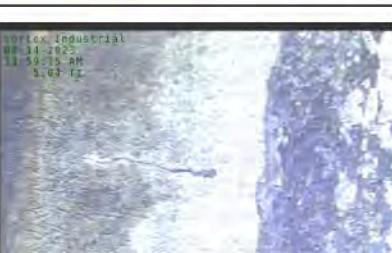
Crack Circumferential	Point	5	Structural	0	7-8	1	0	0	1	Crack Circumferential

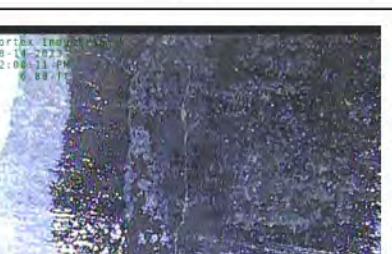
Crack Longitudinal	Point	6.8	Structural	0	6	2	0	0	1	Crack Longitudinal

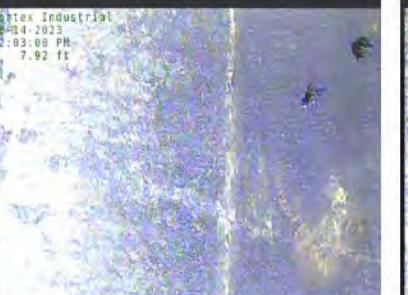
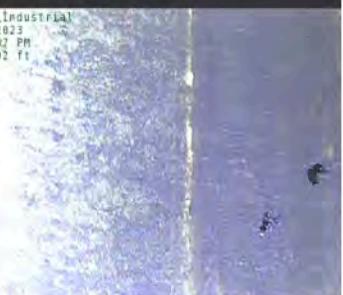
Crack Longitudinal	Point	7.9	Structural	0	4	2	0	0	1	Crack Longitudinal

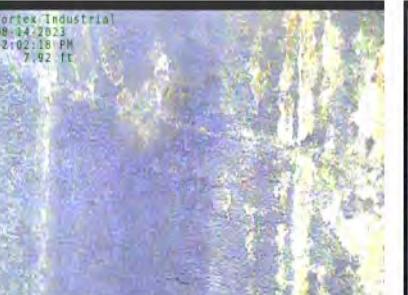
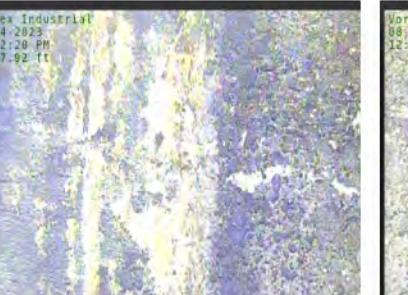
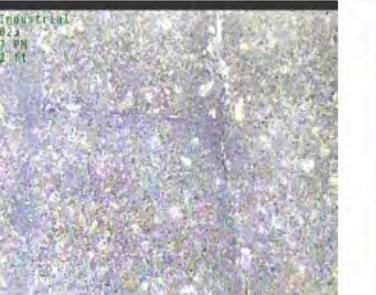
Crack Multiple	Point	7.9	Structural	0	1-5	3	0	0	2	Crack Multiple

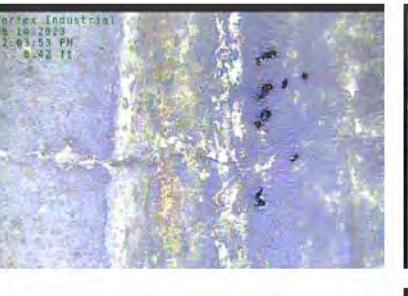
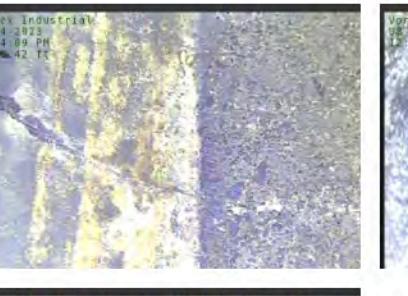
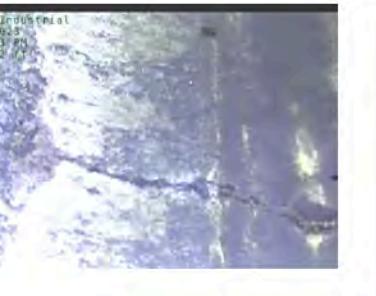
Crack Circumferential	Point	8.4	Structural	0	10-5	1	0	0	2	Crack Circumferential

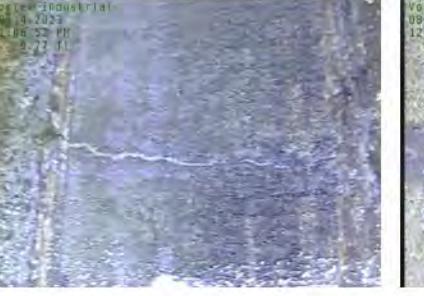
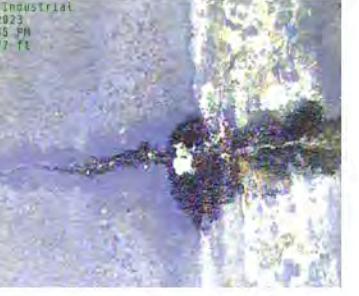
Description	Spatial Type	Distance (ft)	Type	Percent	Clock	SR	O&M	C	PR	Remarks		Photos
Crack Circumferential	Point	9.8	Structural	0	5-8	1	0	0	2	Crack Circumferential

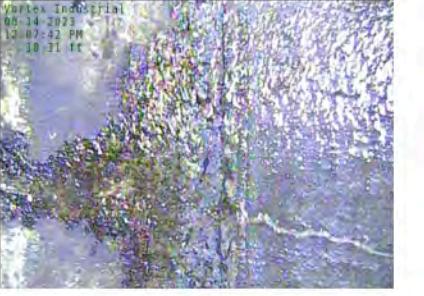
Crack Circumferential	Point	10.3	Structural	0	6-8	1	0	0	1	Crack Circumferential

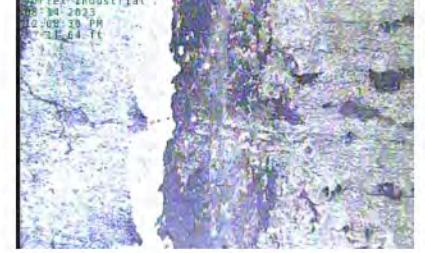
Crack Circumferential	Point	11.6	Structural	0	2-5	1	0	0	1	Crack Circumferential

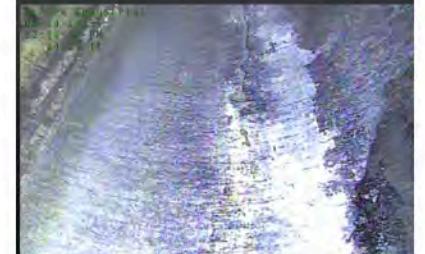
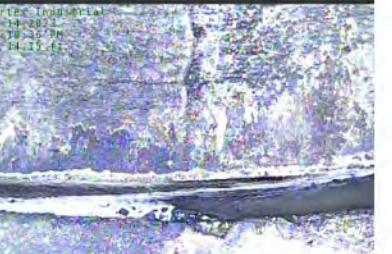
Crack Longitudinal	Point	14.2	Structural	0	7	2	0	0	2	Crack Longitudinal

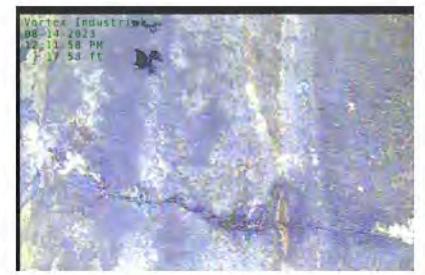
Crack Circumferential	Point	17.6	Structural	0	7-4	1	0	0	2	Crack Circumferential

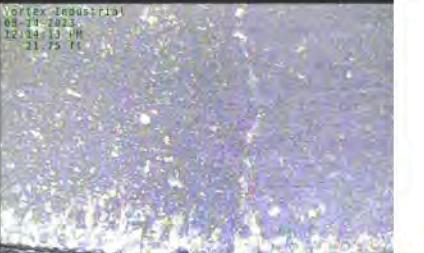
Crack Longitudinal	Point	21.7	Structural	0	2	2	0	0	1	Crack Longitudinal

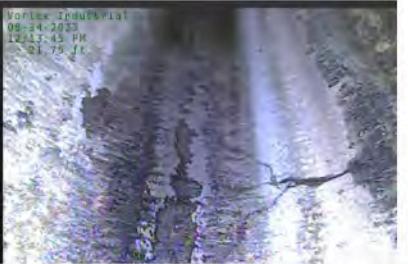
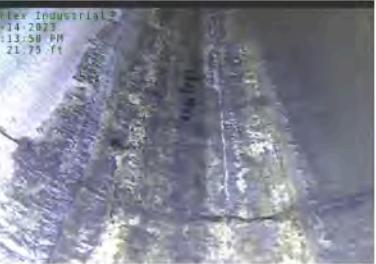
Description	Spatial Type	Distance (ft)	Type	Percent	Clock	SR	O&M	C	PR	Remarks	Photos
Crack Multiple	Point	22	Structural	0	7-6	3	0	0	2	Crack Multiple

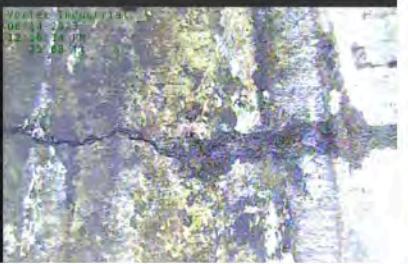
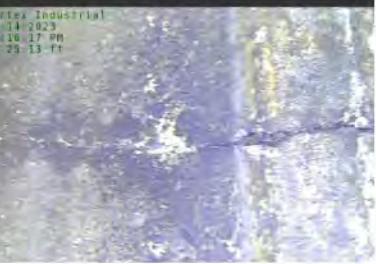
Crack Circumferential	Point	25.1	Structural	0	6-10	1	0	0	2	Crack Circumferential

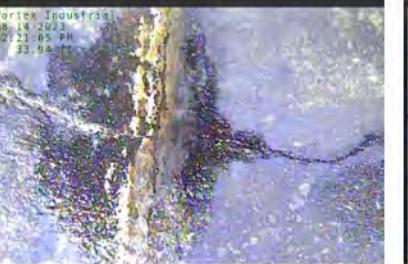
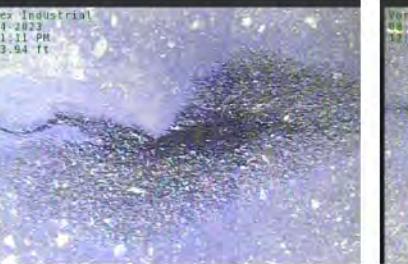
Crack Circumferential	Point	33.9	Structural	0	12-5	1	0	0	2	Crack Circumferential

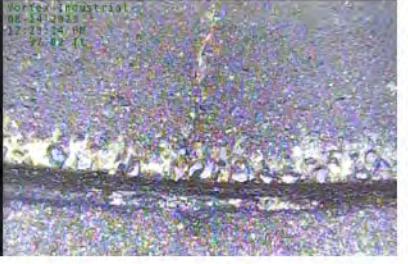
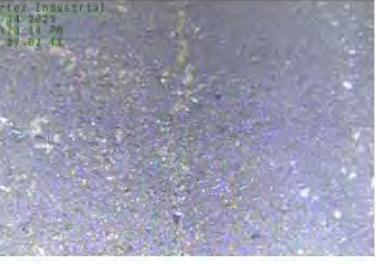
Crack Longitudinal	Point	37	Structural	0	1	2	0	0	1	Crack Longitudinal

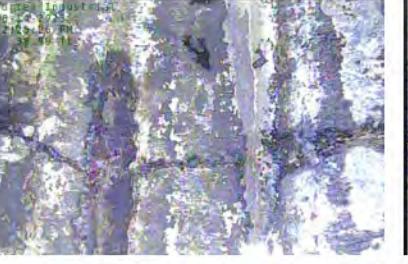
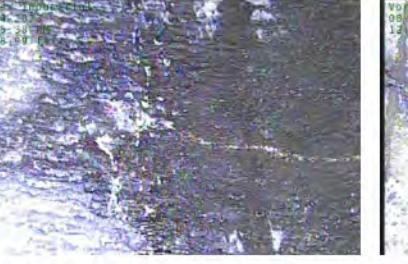
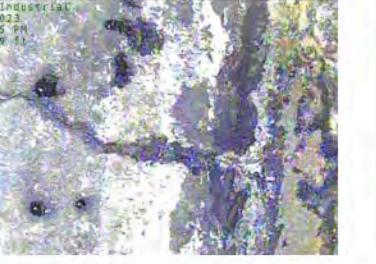
Crack Circumferential	Point	39	Structural	0	3-9	1	0	0	2	Crack Circumferential

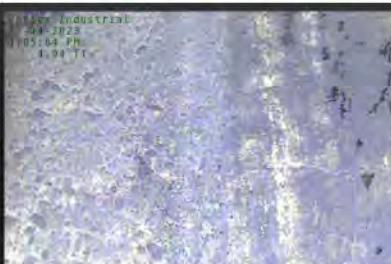
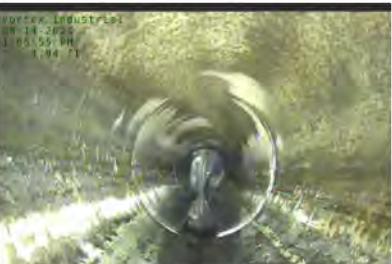
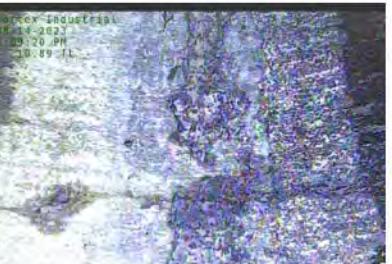
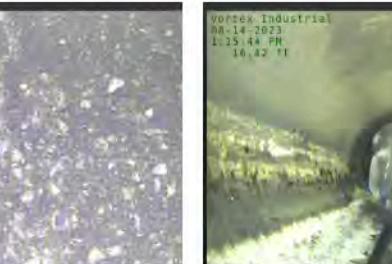
Surface Damage Aggregate Visible		Continuous	0 - 26.1	Structural	0	12-12	1	0	0	1	Surface Damage Aggregate Visible

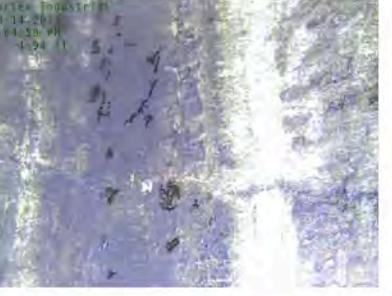
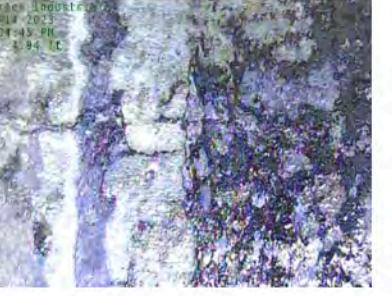
Description	Spatial Type	Distance (ft)	Type	Percent	Clock	SR	O&M	C	PR	Remarks	Photos
Crack Circumferential	Point	4.9	Structural	0	5-6	1	0	0	2	Crack Circumferential

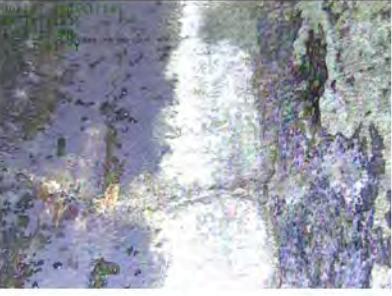
Crack Circumferential	Point	7.4	Structural	0	6-7	1	0	0	2	Crack Circumferential

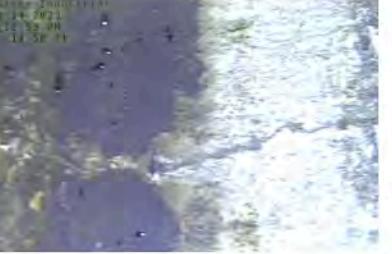
Crack Circumferential	Point	14.6	Structural	0	6-9	1	0	0	2	Crack Circumferential

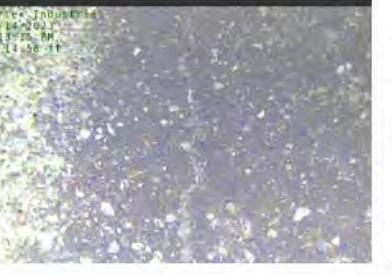
Crack Longitudinal	Point	14.6	Structural	0	11	2	0	0	1	Crack Longitudinal

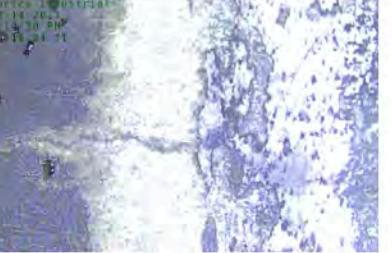
Crack Multiple	Point	16	Structural	0	6-8	3	0	0	2	Crack Multiple

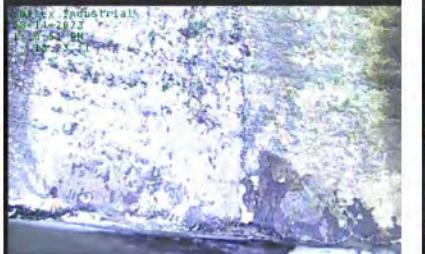
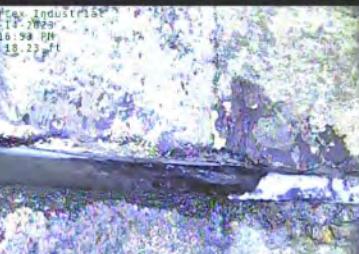
Description	Spatial Type	Distance (ft)	Type	Percent	Clock	SR	O&M	C	PR	Remarks	Photos
Crack Longitudinal	Point	18.2	Structural	0	5	2	0	0	1	Crack Longitudinal

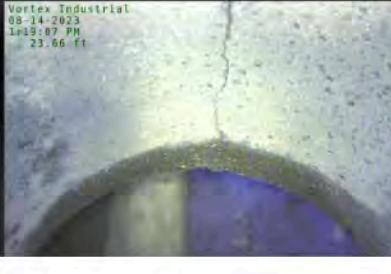
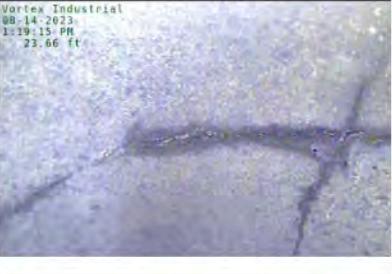
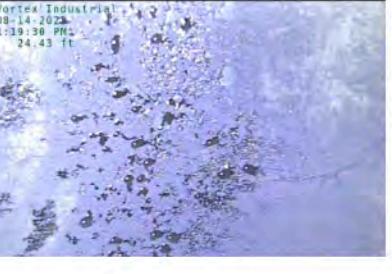
Crack Multiple	Point	23.7	Structural	0	10-6	3	0	0	2	Crack Multiple

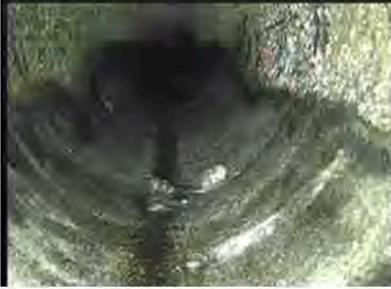
Description	Spatial Type	Distance (ft)	Type	Percent	Clock	SR	O&M	C	PR	Remarks	Photos	
Miscellaneous Water Level	Point	0	Miscellaneous	0		0	0	0	0	Water Level at Start of Survey

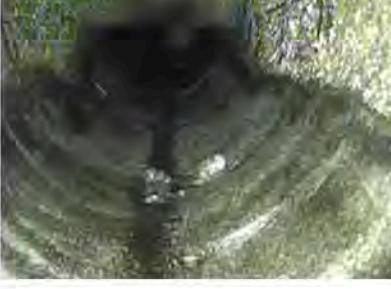
Surface Damage Aggregate Visible	Point	0	Structural	0	6	2	0	0	1	Surface Damage Aggregate Visible

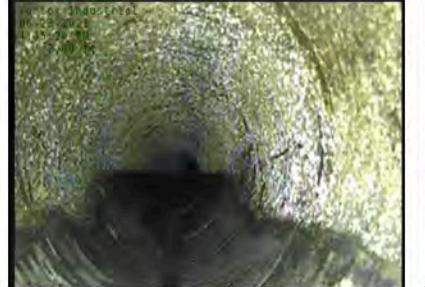
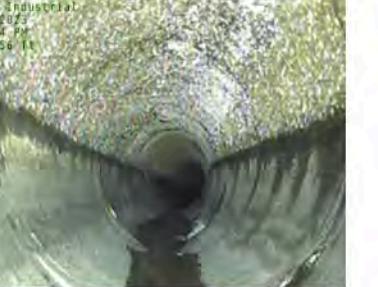
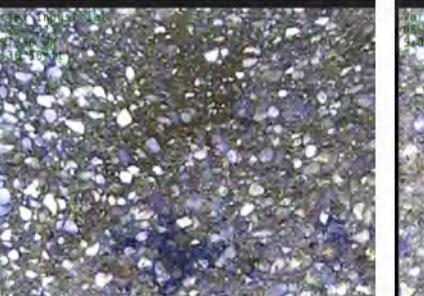
Description	Spatial Type	Distance (ft)	Type	Percent	Clock	SR	O&M	C	PR	Remarks		Photos
Surface Damage Aggregate Projecting	Continuous	0 - 55.8	Structural	0	9-3	3	0	0	2	Surface Damage Aggregate Projecting

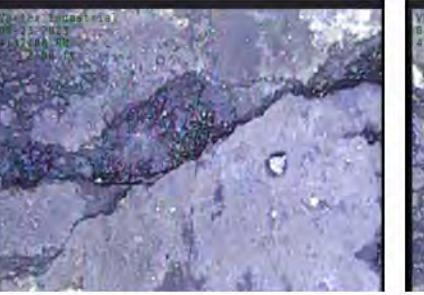
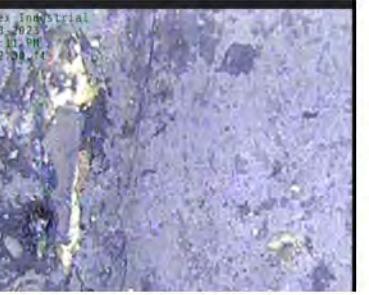
Crack Multiple	Point	2	Structural	0	8-9	3	0	0	2	Crack Multiple

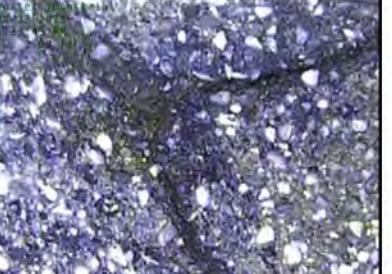
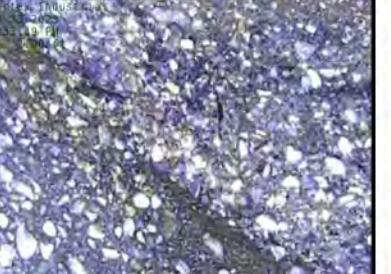
Description	Spatial Type	Distance (ft)	Type	Percent	Clock	SR	O&M	C	PR	Remarks	Photos
Fracture Multiple	Point	2	Structural	0	1-3	4	0	0	2	Fracture Multiple

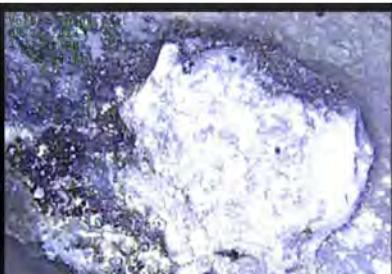
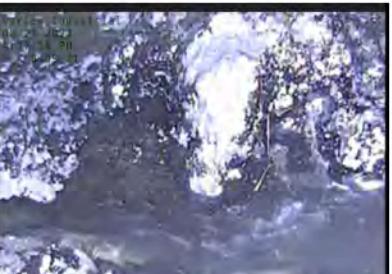
Deposits Attached Encrustation	Point	8.1	O&M	10	5-6	0	2	0	0	Deposits Attached Encrustation

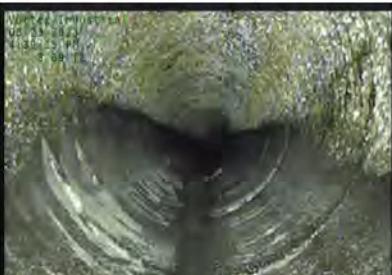
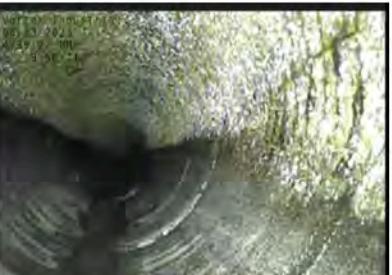
Surface Damage Reinforcement Visible	Point	9	Structural	0	2-3	4	0	0	3	Surface Damage Reinforcement Visible

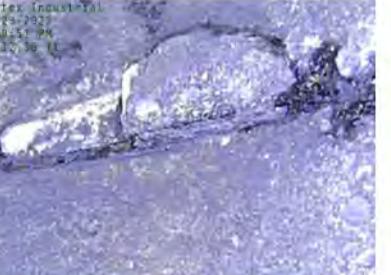
Fracture Multiple	Point	12.4	Structural	0	7-8	0	0	0	2	Fracture Multiple

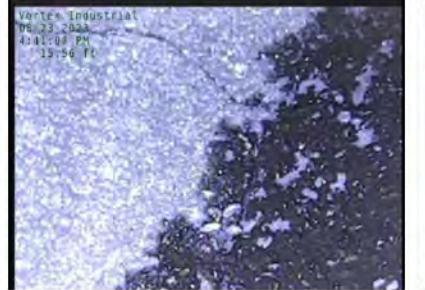
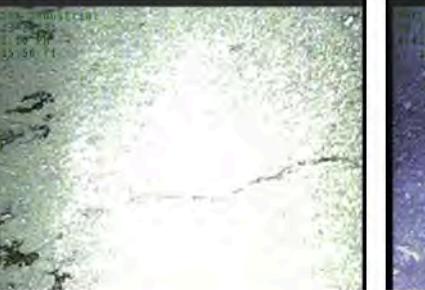
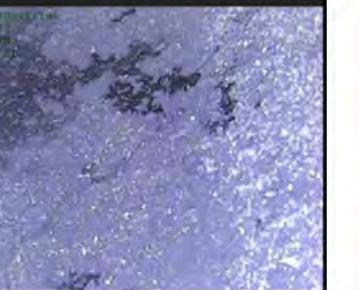
Description	Spatial Type	Distance (ft)	Type	Percent	Clock	SR	O&M	C	PR	Remarks	Photos
Crack Multiple	Point	15.5	Structural	0	6-7	3	0	0	2	Crack Multiple

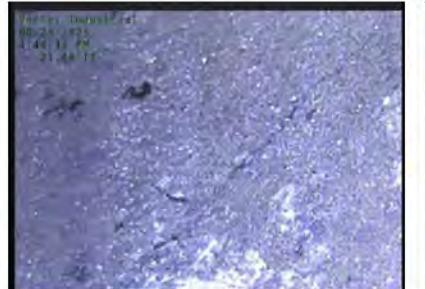
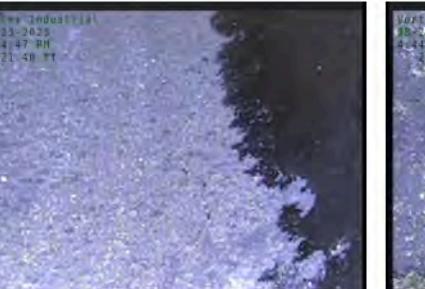
Crack Spiral	Point	21.4	Structural	0	7-8	2	0	0	1	Crack Spiral

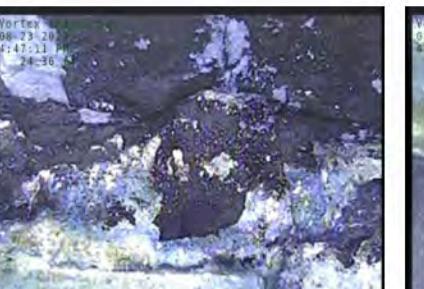
Crack Multiple	Point	24.3	Structural	0	6-7	2	0	0	2	Crack Multiple

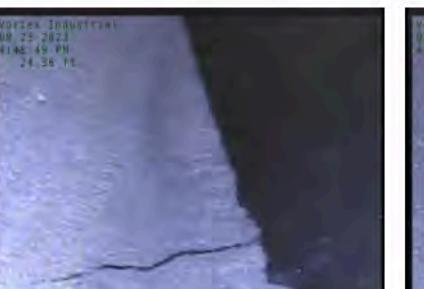
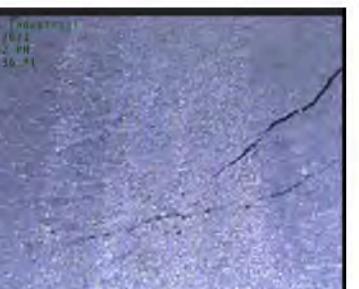
Crack Circumferential	Point	25.5	Structural	0	7-8	1	0	0	1	Crack Circumferential

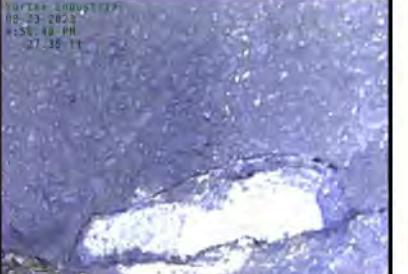
Description	Spatial Type	Distance (ft)	Type	Percent	Clock	SR	O&M	C	PR	Remarks		Photos
Crack Spiral	Point	27.3	Structural	0	8-9	2	0	0	2	Crack Spiral

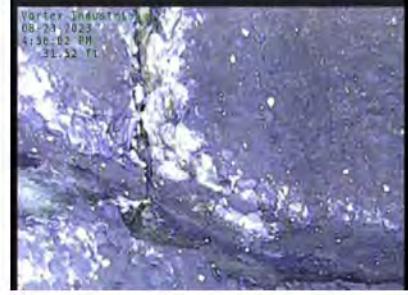
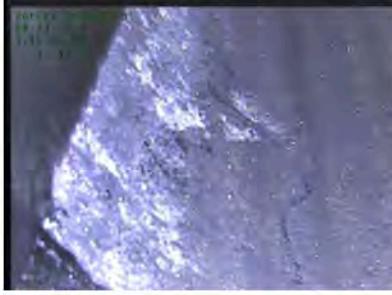
Fracture Circumferential	Point	31.5	Structural	0	5-6	2	0	0	2	Fracture Circumferential

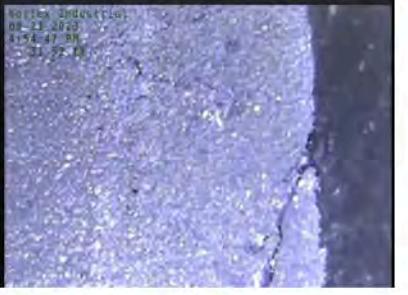
Crack Longitudinal	Point	31.5	Structural	0	7	2	0	0	2	Crack Longitudinal

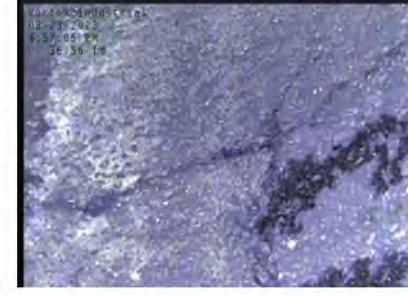
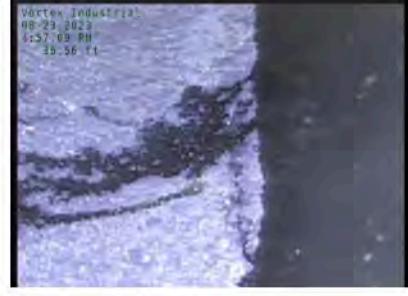
Crack Multiple	Point	36.5	Structural	0	3-9	3	0	0	2	Crack Multiple

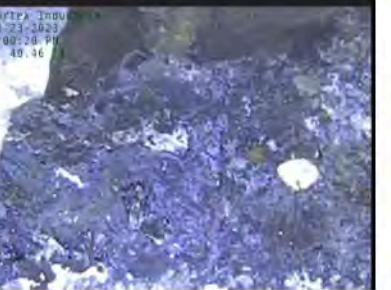
Description	Spatial Type	Distance (ft)	Type	Percent	Clock	SR	O&M	C	PR	Remarks		Photos
Crack Longitudinal	Point	40.4	Structural	0	6	2	0	0	1	Crack Longitudinal

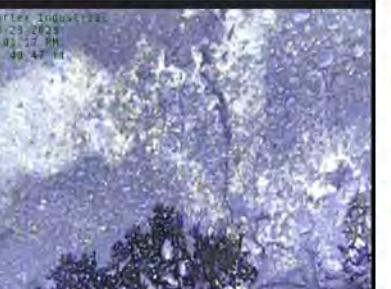
Crack Longitudinal	Point	40.4	Structural	0	8	2	0	0	1	Crack Longitudinal

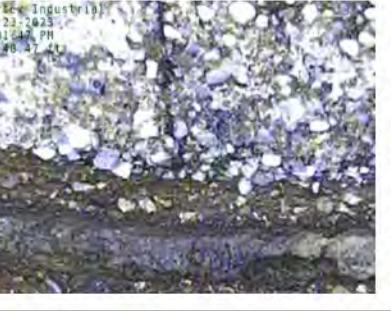
Crack Longitudinal	Point	40.5	Structural	0	1	2	0	0	2	Crack Longitudinal

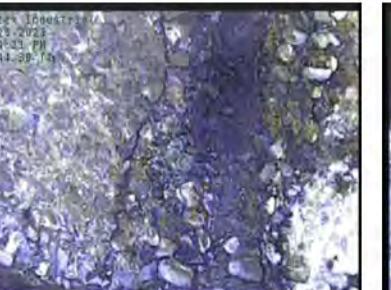
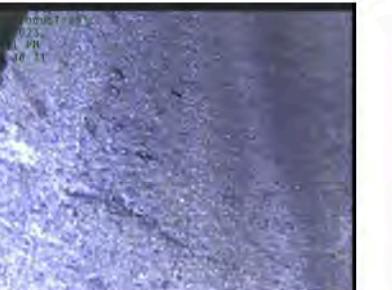
Crack Spiral	Point	44.3	Structural	0	3-5	2	0	0	2	Crack Spiral

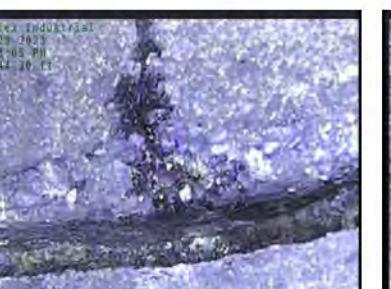
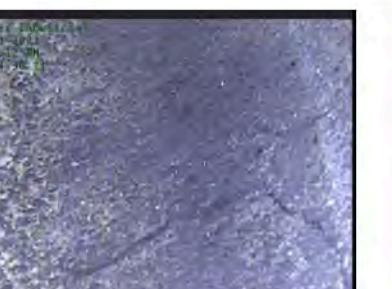
Crack Spiral	Point	44.3	Structural	0	8-9	2	0	0	2	Crack Spiral

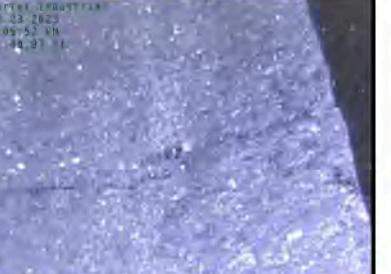
Description	Spatial Type	Distance (ft)	Type	Percent	Clock	SR	O&M	C	PR	Remarks		Photos
Crack Circumferential	Point	48.9	Structural	0	7-8	1	0	0	1	Crack Circumferential

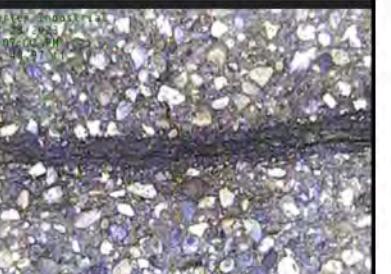
Crack Longitudinal	Point	48.9	Structural	0	12	2	0	0	2	Crack Longitudinal

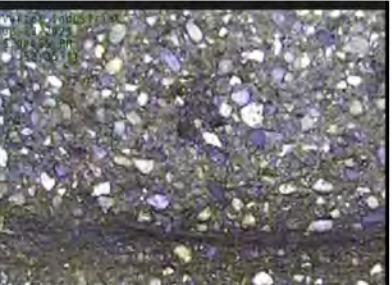
Crack Multiple	Point	52.3	Structural	0	11-12	3	0	0	1	Crack Multiple

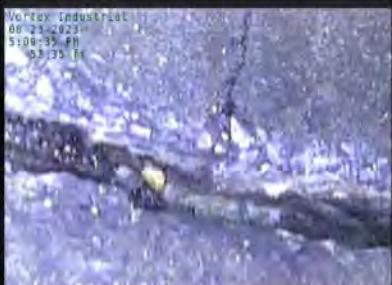
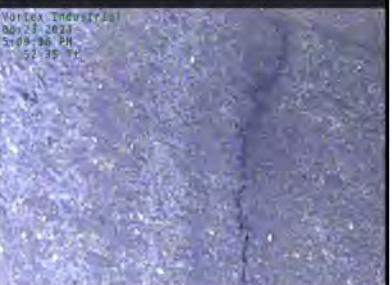
Crack Longitudinal	Point	52.3	Structural	0	5	2	0	0	2	Crack Longitudinal

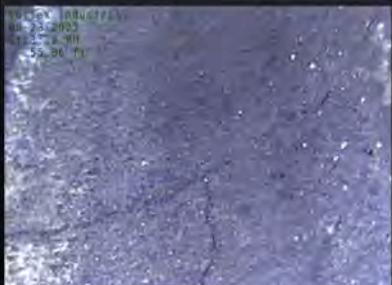
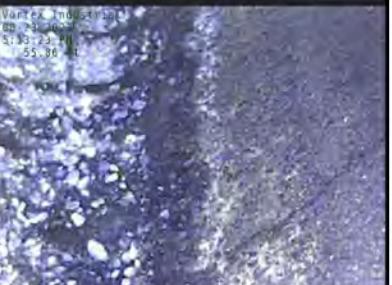
Crack Multiple	Point	55.8	Structural	0	7-8	3	0	0	2	Crack Multiple

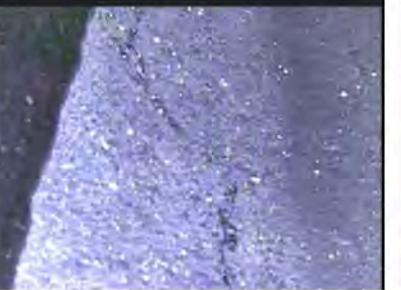
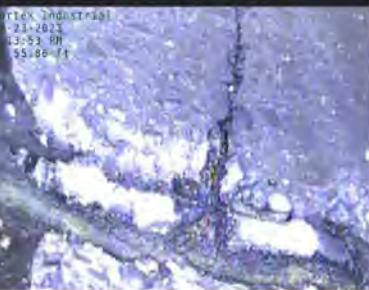
Description	Spatial Type	Distance (ft)	Type	Percent	Clock	SR	O&M	C	PR	Remarks		Photos
Crack Longitudinal	Point	55.8	Structural	0	5	2	0	0	2	Crack Longitudinal

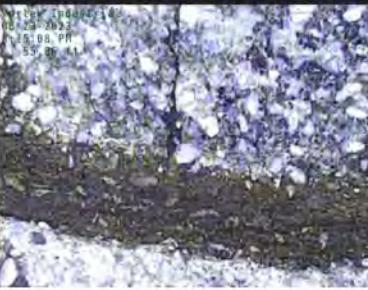
Crack Longitudinal	Point	55.8	Structural	0	2	2	0	0	2	Crack Longitudinal

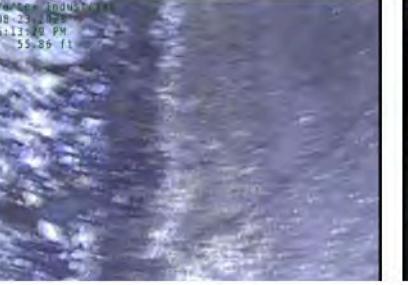
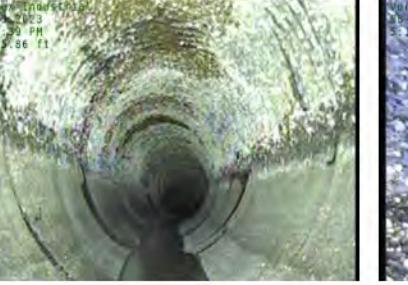
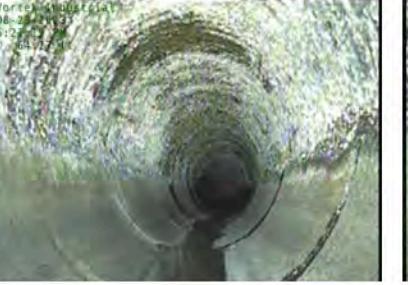
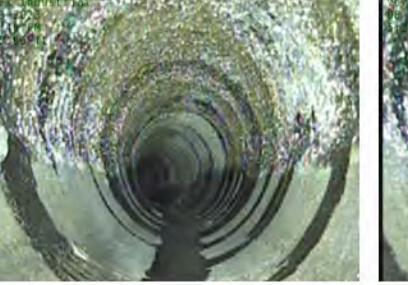
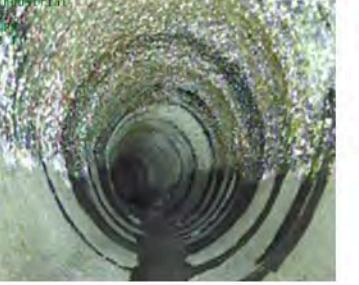
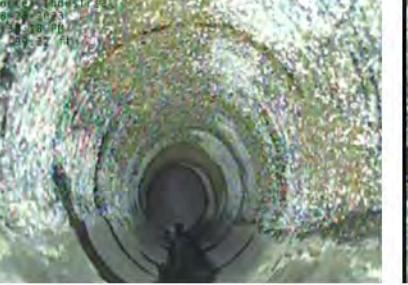
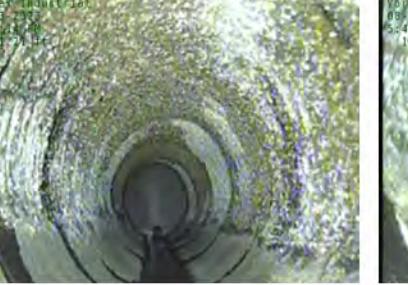
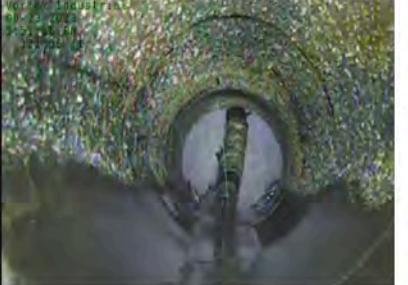
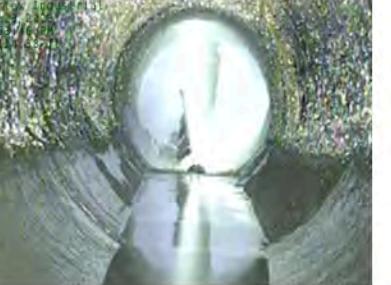
Description	Spatial Type	Distance (ft)	Type	Percent	Clock	SR	O&M	C	PR	Remarks	Photos
Surface Damage Reinforcement Visible	Continuous	55.8 - 134.5	Structural	0	9-3	4	0	0	3	Surface Damage Reinforcement Visible

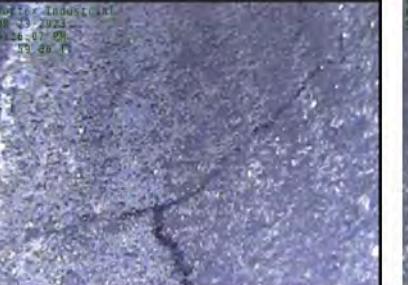
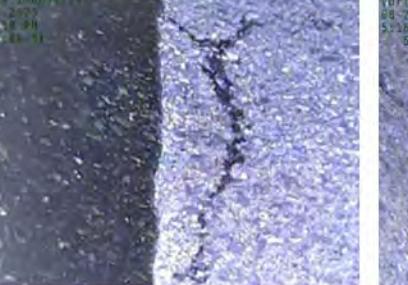
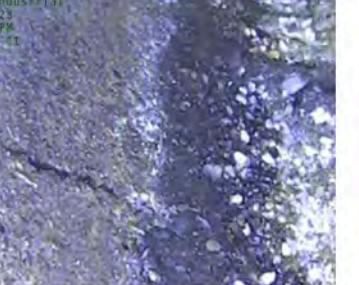
Crack Multiple	Point	59.8	Structural	0	12-12	3	0	0	2	Crack Multiple

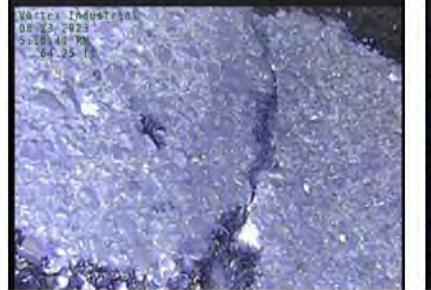
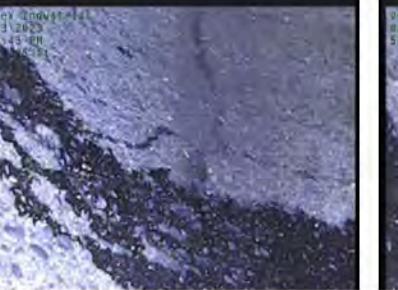
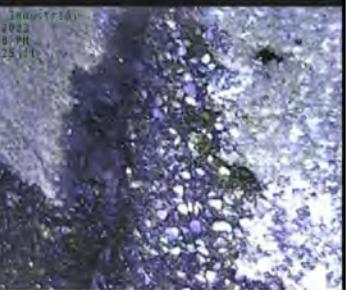
Description	Spatial Type	Distance (ft)	Type	Percent	Clock	SR	O&M	C	PR	Remarks	Photos
Crack Multiple	Point	64.2	Structural	0	3-5	3	0	0	2	Crack Multiple

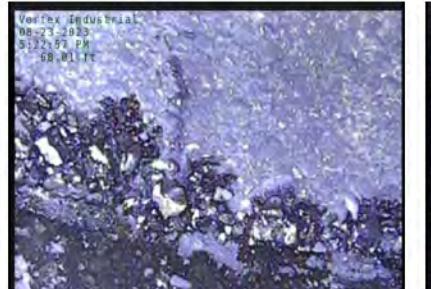
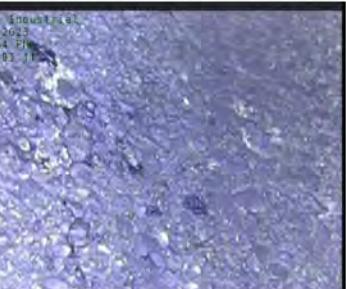
Crack Longitudinal	Point	68	Structural	0	4	2	0	0	1	Crack Longitudinal

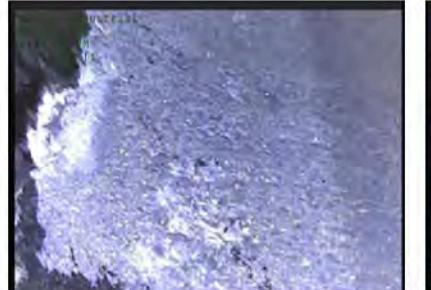
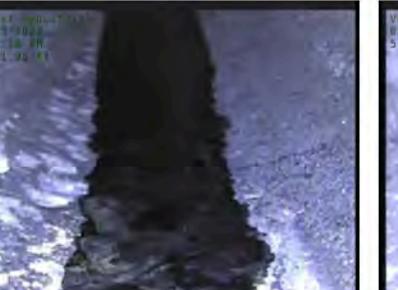
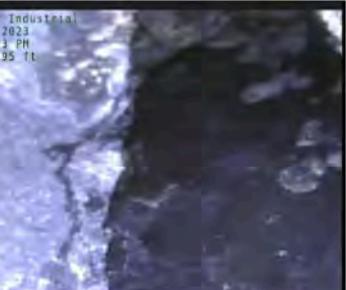
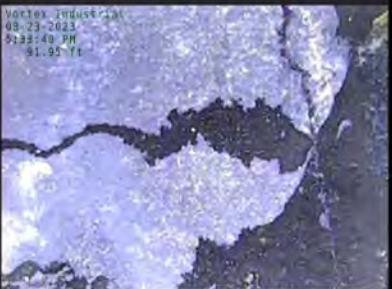
Crack Multiple	Point	91.9	Structural	0	5-8	3	0	0	2	Crack Multiple

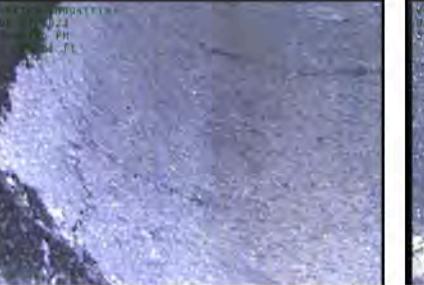
Description	Spatial Type	Distance (ft)	Type	Percent	Clock	SR	O&M	C	PR	Remarks	Photos
Crack Multiple	Point	96.8	Structural	0	4-6	3	0	0	1	Crack Multiple

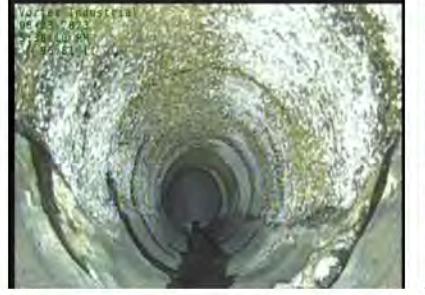
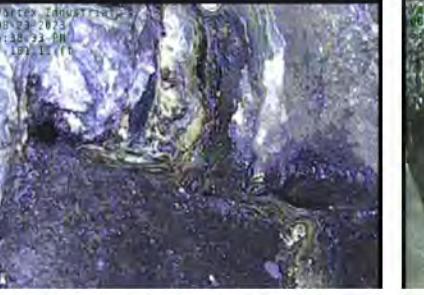
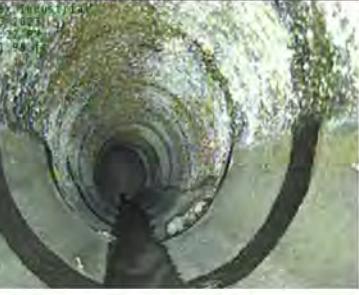
Deposits Attached Encrustation	Point	99	O&M	10	4-5	0	2	0	0	Deposits Attached Encrustation

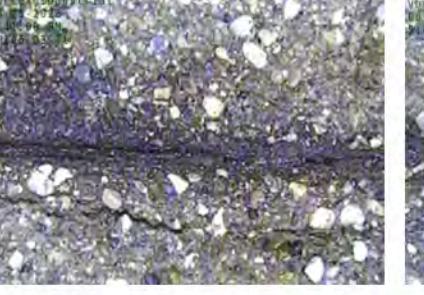
Crack Circumferential	Point	105	Structural	0	10-12	1	0	0	1	Crack Circumferential

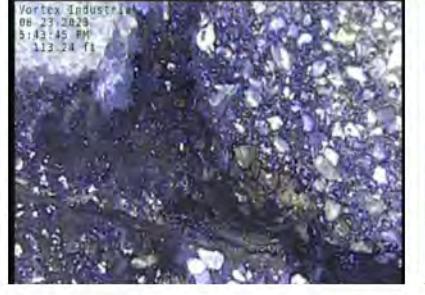
Crack Longitudinal	Point	113.2	Structural	0	3	2	0	0	1	Crack Longitudinal

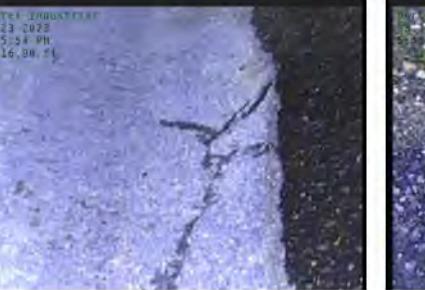
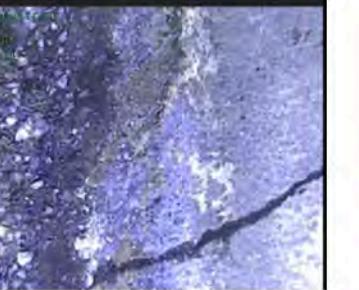
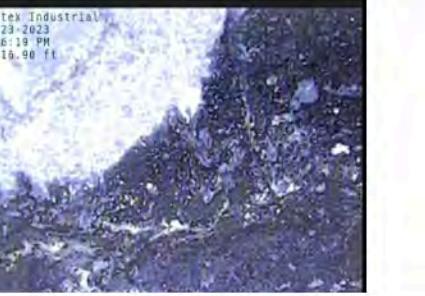
Description	Spatial Type	Distance (ft)	Type	Percent	Clock	SR	O&M	C	PR	Remarks	Photos
Crack Multiple	Point	116.9	Structural	0	7-8	3	0	0	2	Crack Multiple

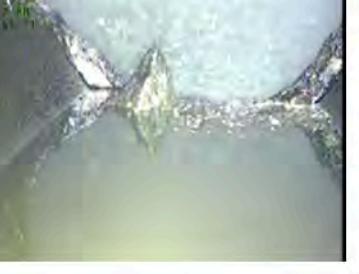
Obstruction Rocks	Point	132.6	O&M	10	7	0	0	0	0	Obstruction Rocks

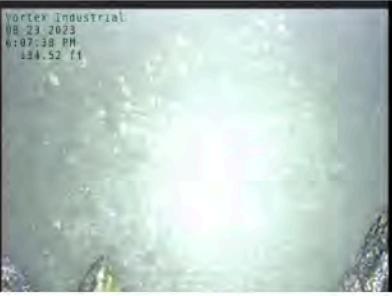
Description	Spatial Type	Distance (ft)	Type	Percent	Clock	SR	O&M	C	PR	Remarks		Photos
Miscellaneous Survey Abandoned	Point	134.5	Miscellaneous	0		0	0	0	0	Inspection ended due to tap at bottom of pipe
