2023 ANNUAL PROGRESS REPORT

SWMU-1 OILY WATER SEWER

HF SINCLAIR PUGET SOUND REFINING LLC

MARCH 21, 2024

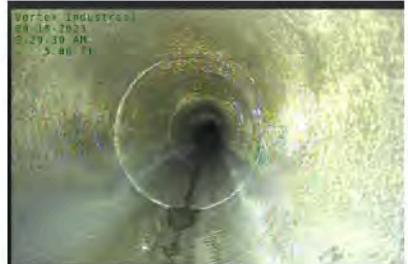
Surface Damage Aggregate Visible	Continuous	0 - 253.1	Structural	0	12-12	2	0	0	1	Surface Damage Aggregate Visible

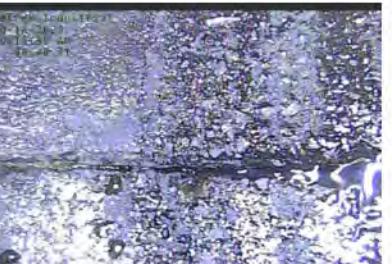
Crack Longitudinal	Point	46.5	Structural	0	6	2	0	0	1	Crack Longitudinal

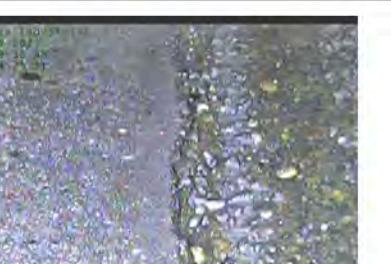
Crack Longitudinal	Point	64.7	Constructional	0	7	2	0	0	1	Crack Longitudinal

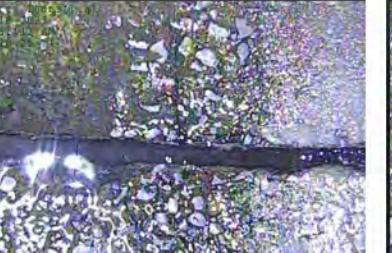
Description	Spatial Type	Distance (ft)	Type	Percent	Clock	SR	O&M	C	PR	Remarks	Photos
Crack Longitudinal	Point	70.3	Structural	0	6	2	0	0	1	Crack Longitudinal

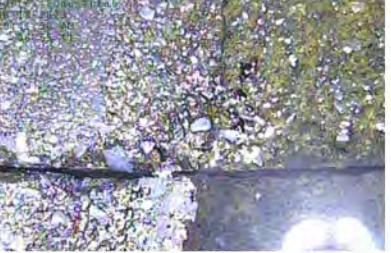
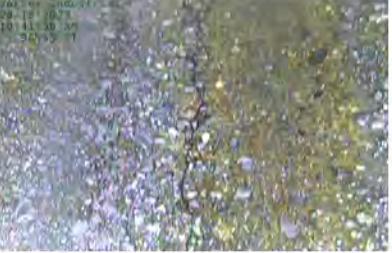
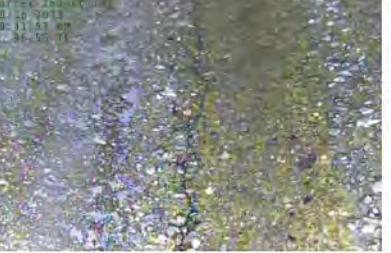
Crack Longitudinal	Point	96.6	Structural	0	6	2	0	0	1	Crack Longitudinal

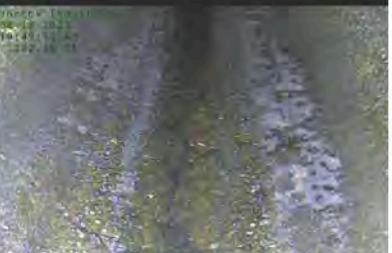
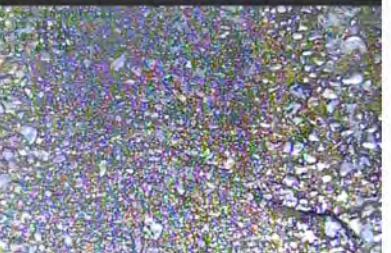
Crack Multiple	Point	102.4	Structural	0	6-7	3	0	0	1	Crack Multiple

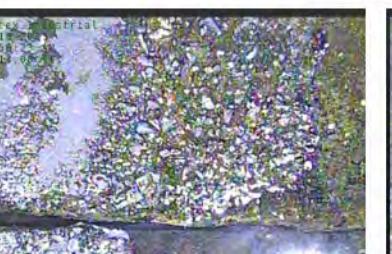
Crack Multiple	Point	113.1	Structural	0	6-7	3	0	0	1	Crack Multiple

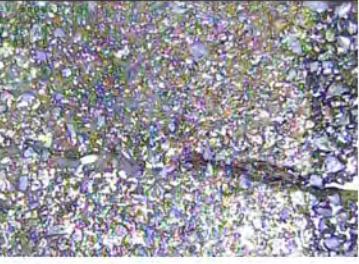
Description	Spatial Type	Distance (ft)	Type	Percent	Clock	SR	O&M	C	PR	Remarks	Photos	
Crack Circumferential	Point	121.8	Structural	0	5-7	1	0	0	1	Crack Circumferential

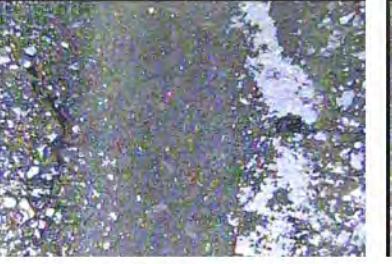
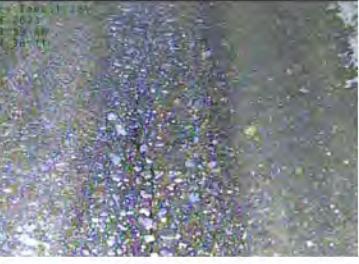
Crack Longitudinal	Point	134.4	Structural	0	6	2	0	0	1	Crack Longitudinal

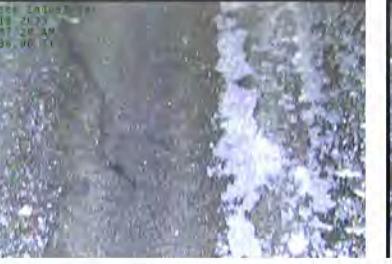
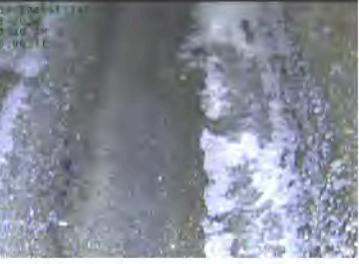
Crack Longitudinal	Point	136.1	Structural	0	6	2	0	0	1	Crack Longitudinal

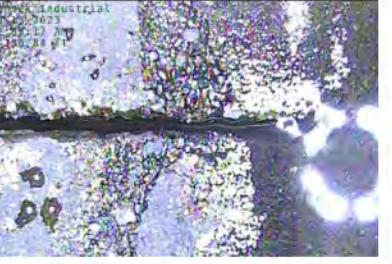
Crack Longitudinal	Point	136.8	Structural	0	6	2	0	0	1	Crack Longitudinal

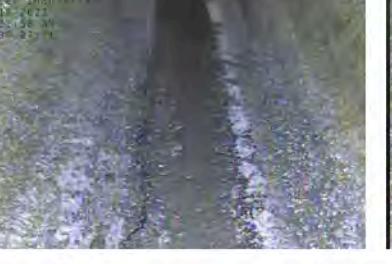
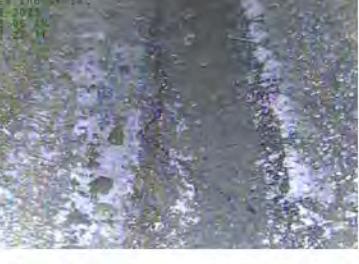
Crack Longitudinal	Point	137.3	Structural	0	6	2	0	0	1	Crack Longitudinal

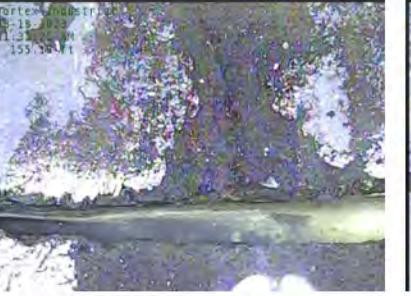
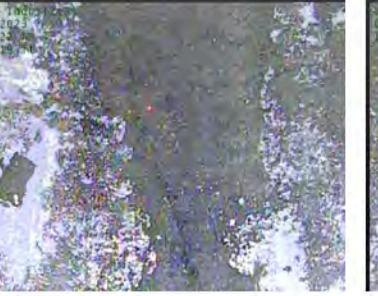
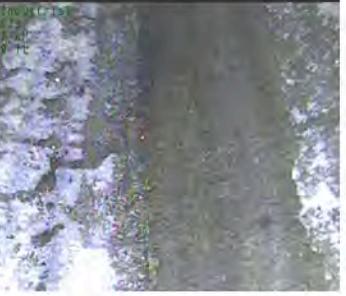
Crack Longitudinal	Point	155.2	Structural	0	6	2	0	0	1	Crack Longitudinal

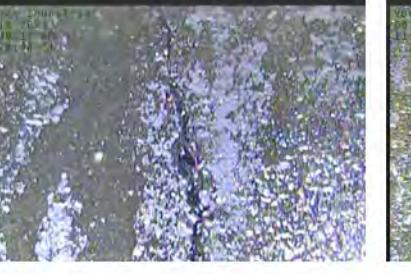
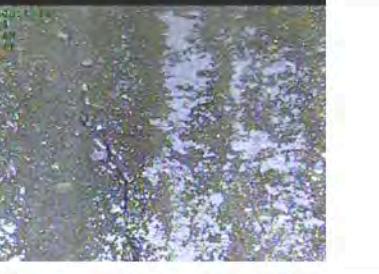
Crack Longitudinal	Point	179	Structural	0	6	2	0	0	1	Crack Longitudinal

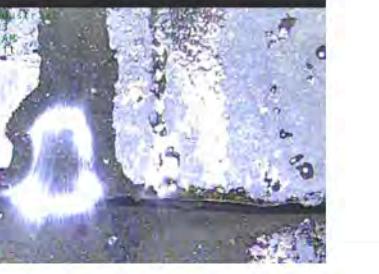
Crack Longitudinal	Point	185	Structural	0	6	2	0	0	1	Crack Longitudinal

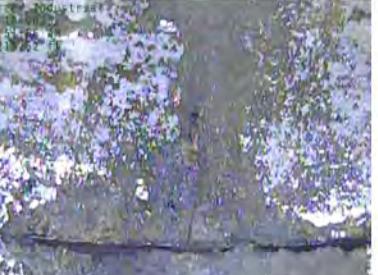
Crack Longitudinal	Point	216	Structural	0	6	2	0	0	1	Crack Longitudinal

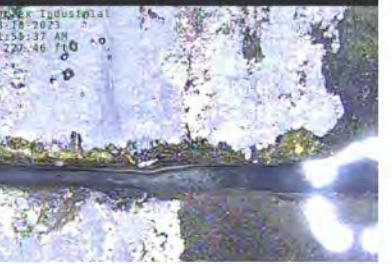
Description	Spatial Type	Distance (ft)	Type	Percent	Clock	SR	O&M	C	PR	Remarks	Photos
Crack Longitudinal	Point	227.5	Structural	0	6	2	0	0	1	Crack Longitudinal

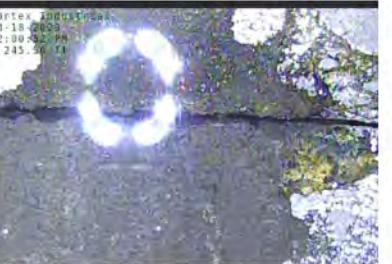
Crack Longitudinal	Point	245.6	Structural	0	6	2	0	0	1	Crack Longitudinal

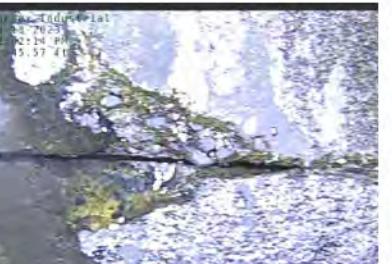
Fracture Circumferential	Point	245.6	Structural	0	5-6	2	0	0	2	Fracture Circumferential

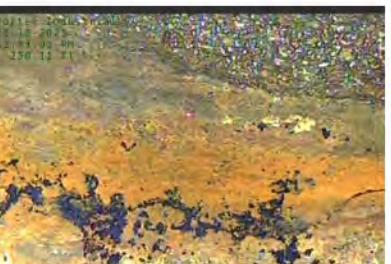
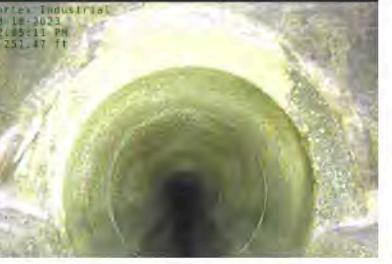
Crack Circumferential	Point	250.1	Structural	0	10-4	1	0	0	1	Crack Circumferential

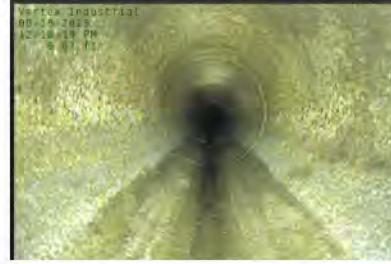
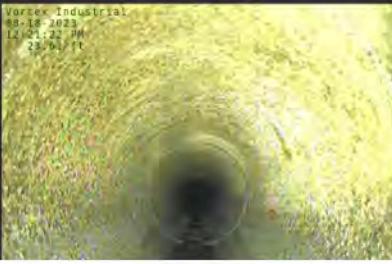
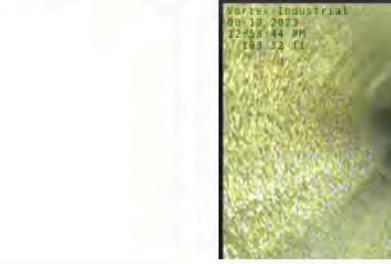
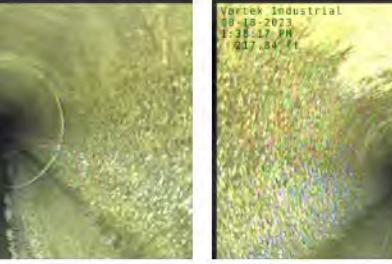
Surface Damage Aggregate Visible	Continuous	0 - 253.3	Structural	0	12-12	2	0	0	1	1	Surface Damage Aggregate Visible

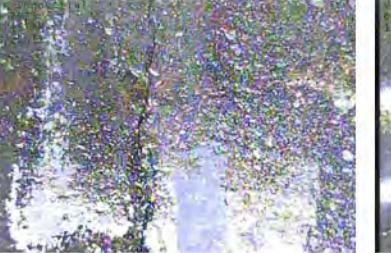
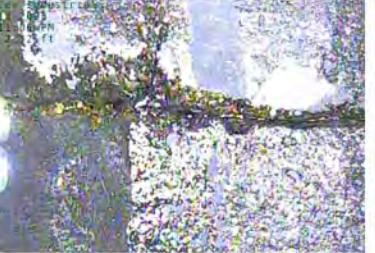
Description	Spatial Type	Distance (ft)	Type	Percent	Clock	SR	O&M	C	PR	Remarks	Photos
Crack Longitudinal	Point	2.5	Structural	0	6	2	0	0	1	Crack Longitudinal

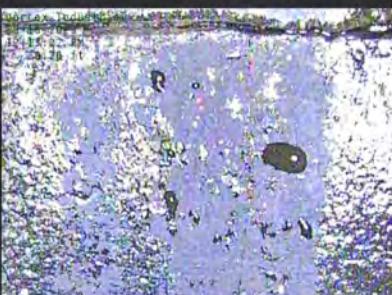
Crack Longitudinal	Point	8.2	Structural	0	6	2	0	0	1	Crack Longitudinal

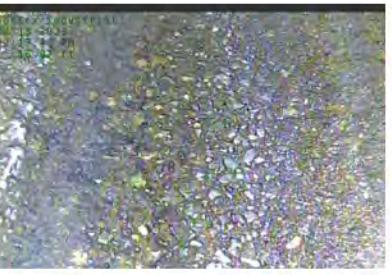
Crack Longitudinal	Point	16.1	Structural	0	6	2	0	0	1	Crack Longitudinal

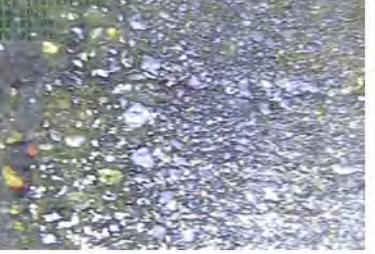
Crack Circumferential	Point	16.9	Structural	0	5-7	1	0	0	1	Crack Circumferential

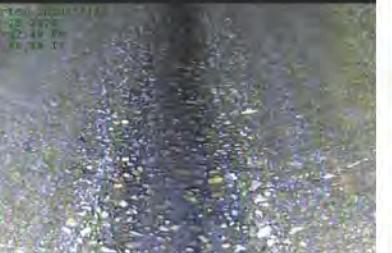
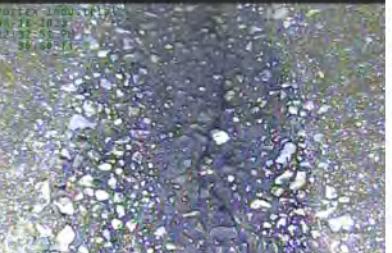
Crack Longitudinal	Continuous	36.8 - 42.9	Structural	0	6	2	0	0	1	Crack Longitudinal

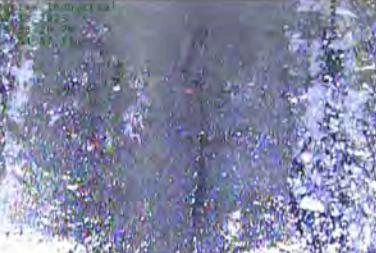
Crack Longitudinal	Point	54.9	Structural	0	6	2	0	0	1	Crack Longitudinal

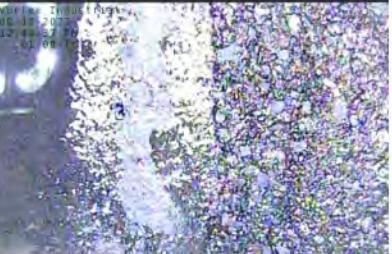
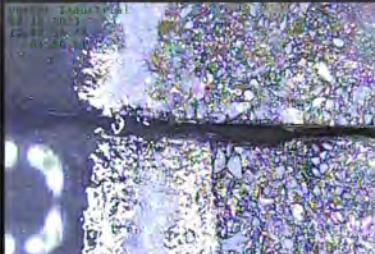
Crack Longitudinal	Point	61	Structural	0	6	2	0	0	1	Crack Longitudinal

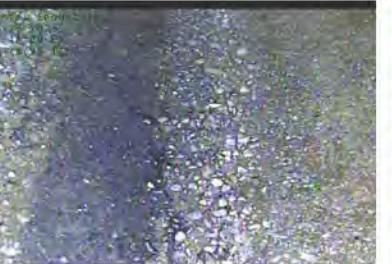
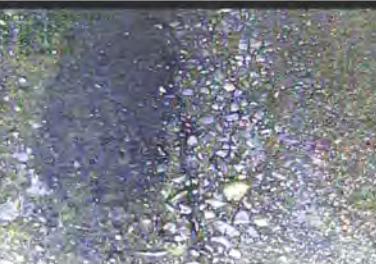
Crack Longitudinal	Point	79	Structural	0	6	2	0	0	1	Crack Longitudinal

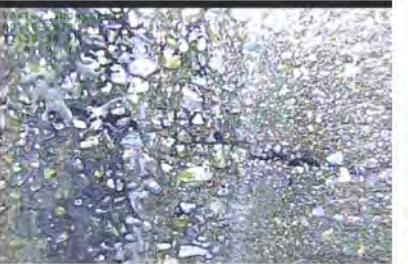
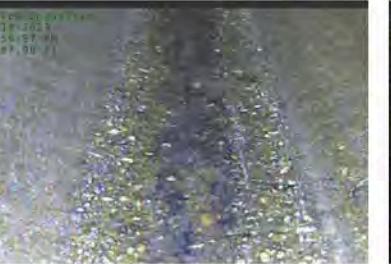
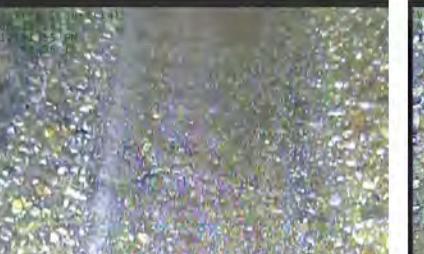
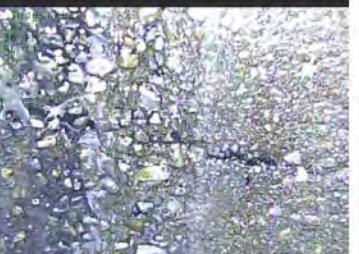
Description	Spatial Type	Distance (ft)	Type	Percent	Clock	SR	O&M	C	PR	Remarks	Photos
Crack Multiple	Point	87.9	Structural	0	6-8	3	0	0	2	Crack Multiple

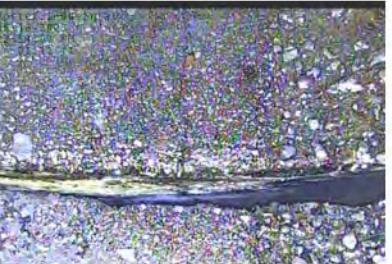
Crack Longitudinal	Point	91.1	Structural	0	6	2	0	0	1	Crack Longitudinal

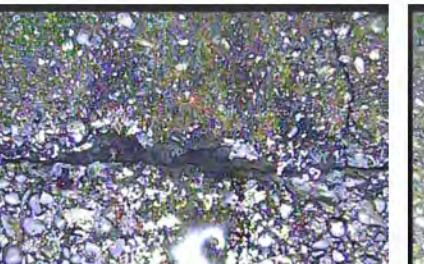
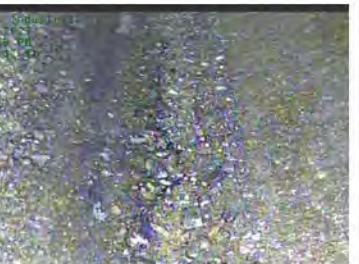
Crack Longitudinal	Point	127.4	Structural	0	6	2	0	0	1	Crack Longitudinal

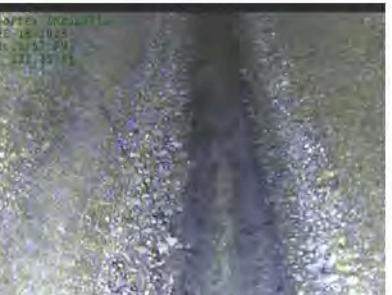
Crack Longitudinal	Point	134	Structural	0	6	2	0	0	1	Crack Longitudinal

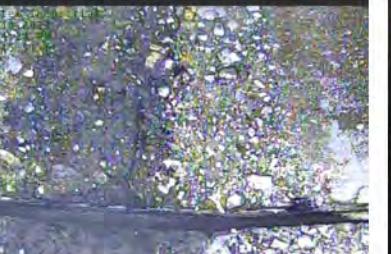
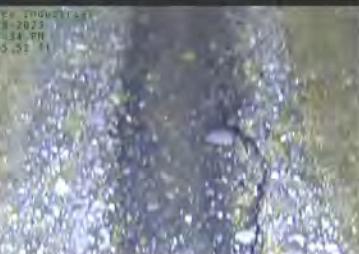
Description	Spatial Type	Distance (ft)	Type	Percent	Clock	SR	O&M	C	PR	Remarks	Photos
Crack Longitudinal	Point	145.5	Structural	0	6	2	0	0	1	Crack Longitudinal

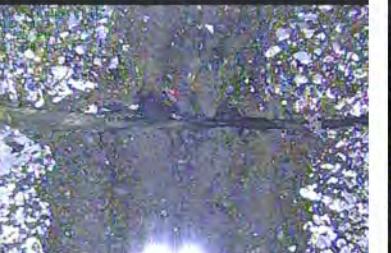
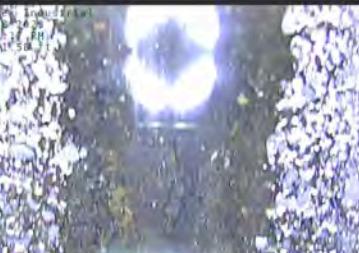
Crack Longitudinal	Point	151.6	Structural	0	6	2	0	0	1	Crack Longitudinal

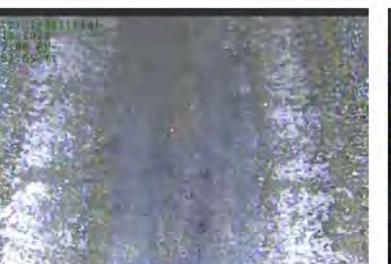
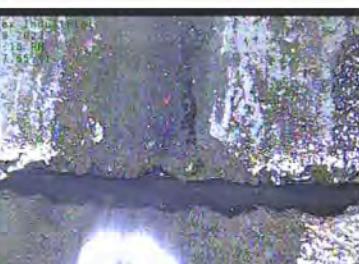
Crack Longitudinal	Point	157.7	Structural	0	6	2	0	0	1	Crack Longitudinal

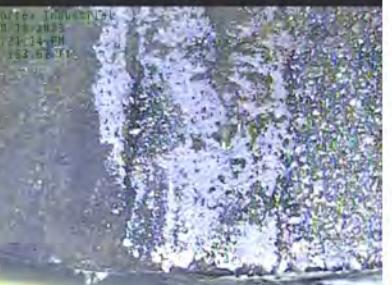
Crack Longitudinal	Point	163.7	Structural	0	6	2	0	0	2	Crack Longitudinal

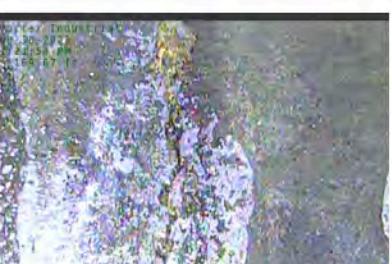
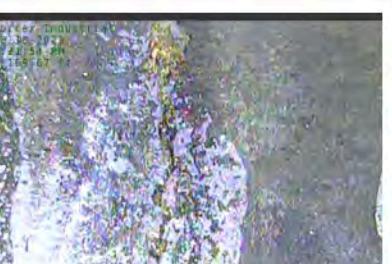
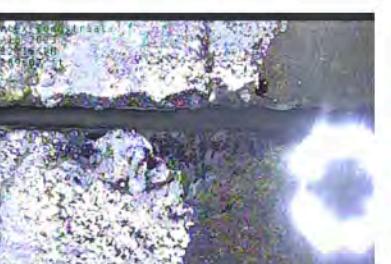
Crack Longitudinal	Point	169.7	Structural	0	7	2	0	0	1	Crack Longitudinal

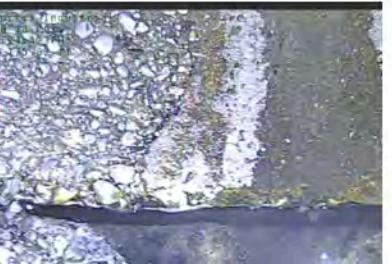
Crack Longitudinal	Point	175.6	Structural	0	6	2	0	0	1	Crack Longitudinal

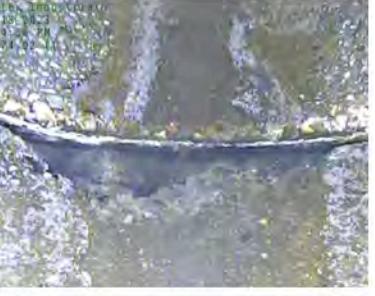
Description	Spatial Type	Distance (ft)	Type	Percent	Clock	SR	O&M	C	PR	Remarks		Photos
Fracture Circumferential	Point	175.6	Structural	0	6-7	2	0	0	2	Fracture Circumferential

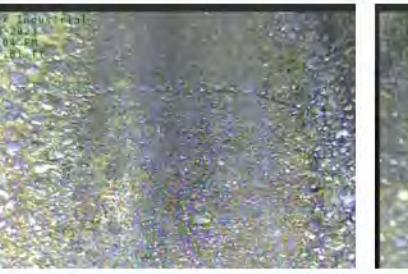
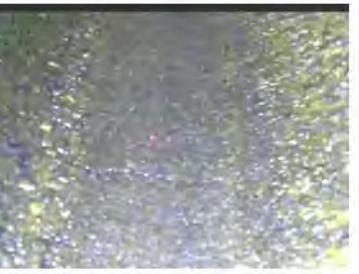
Crack Circumferential	Point	188	Structural	0	5-7	1	0	0	1	Crack Circumferential

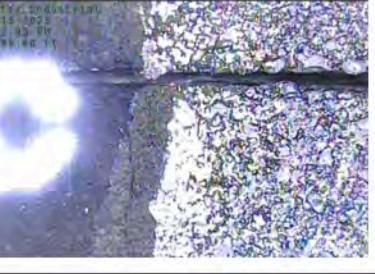
Crack Longitudinal	Point	199.9	Structural	0	6	2	0	0	1	Crack Longitudinal

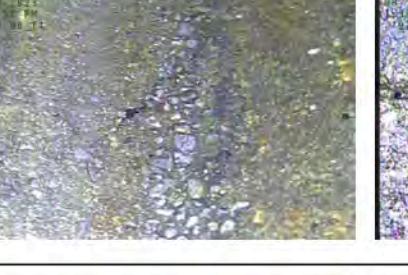
Crack Multiple	Point	224	Structural	0	6-7	3	0	0	1	Crack Multiple

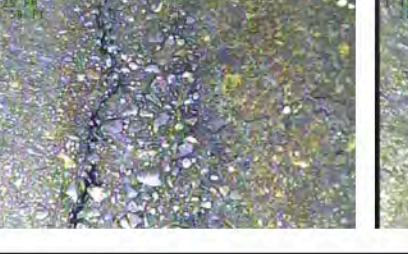
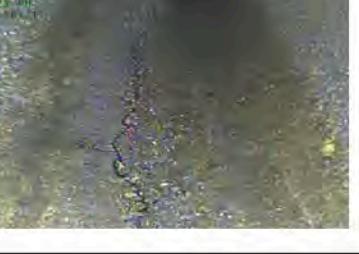
Crack Longitudinal	Point	225.5	Structural	0	6	2	0	0	2	Crack Longitudinal

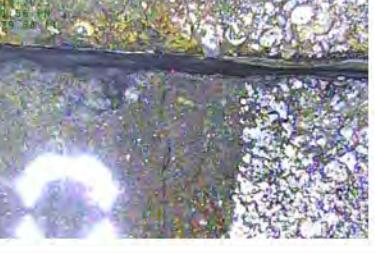
Crack Longitudinal	Point	229.9	Structural	0	6	2	0	0	1	Crack Longitudinal

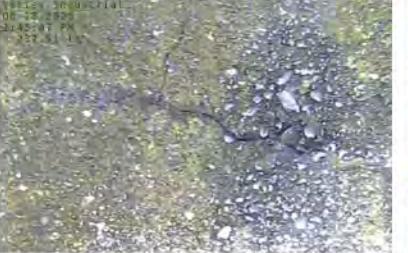
Description	Spatial Type	Distance (ft)	Type	Percent	Clock	SR	O&M	C	PR	Remarks	Photos
Crack Multiple	Point	237.5	Structural	0	5-6	3	0	0	1	Crack Multiple

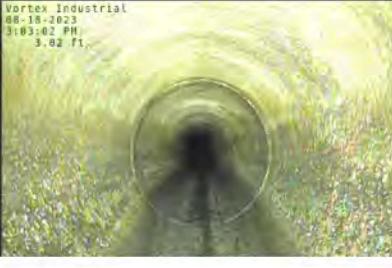
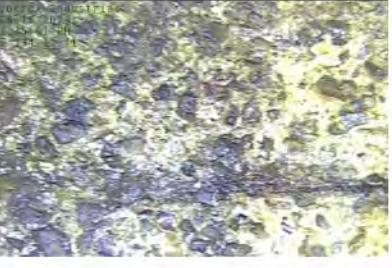
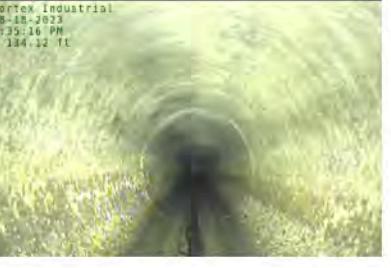
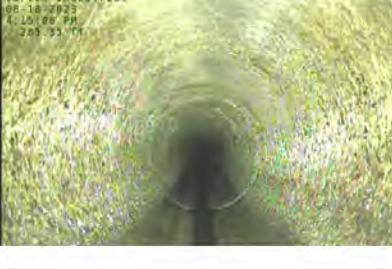
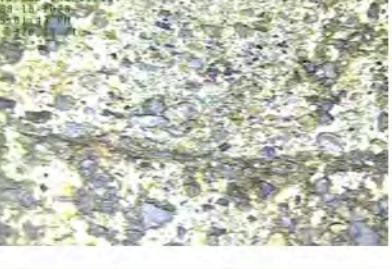
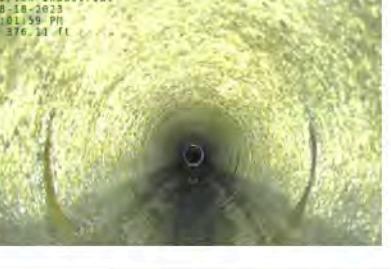
Surface Damage Aggregate Visible		Continuous	0 - 412	Structural	0	12-12	2	0	0	1	Surface Damage Aggregate Visible

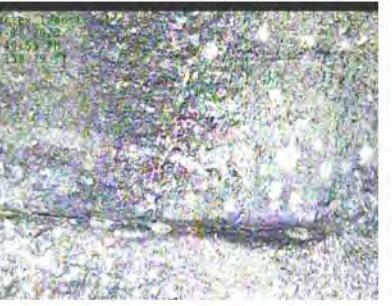
Crack Longitudinal	Point	158.3	Structural	0	3	2	0	0	1	Crack Longitudinal

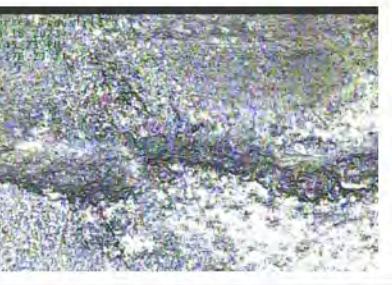
Crack Longitudinal	Point	176.3	Structural	0	12	2	0	0	1	Crack Longitudinal

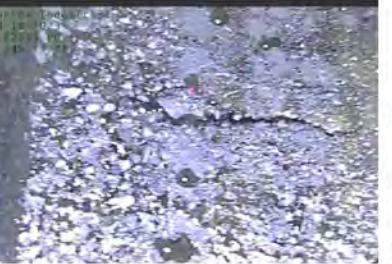
Crack Circumferential	Point	245.7	Structural	0	5-6	1	0	0	1	Crack Circumferential

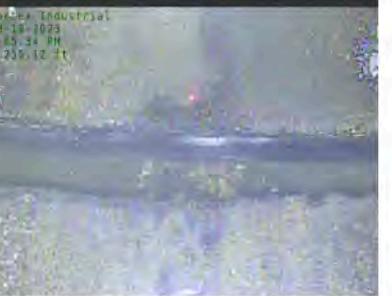
Crack Longitudinal	Point	255.1	Structural	0	6	2	0	0	1	Crack Longitudinal

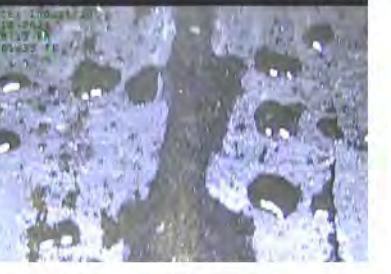
Crack Longitudinal	Point	261.3	Structural	0	6	2	0	0	1	Crack Longitudinal

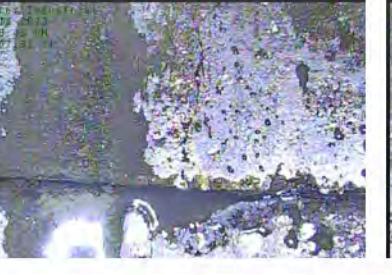
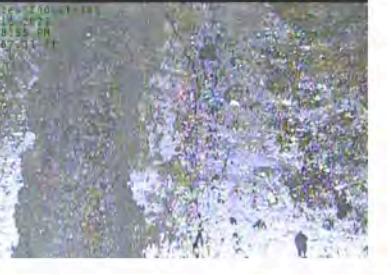
Crack Longitudinal	Point	267.3	Structural	0	6	2	0	0	1	Crack Longitudinal

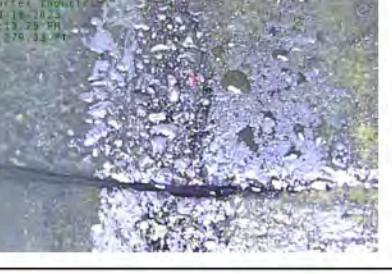
Crack Longitudinal	Point	279.3	Structural	0	6	2	0	0	1	Crack Longitudinal

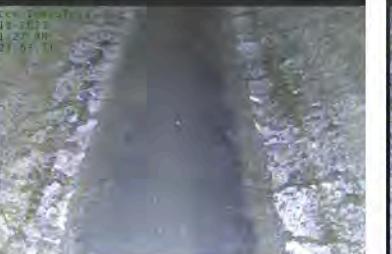
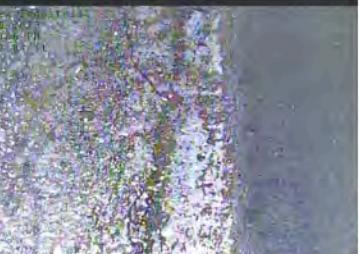
Description	Spatial Type	Distance (ft)	Type	Percent	Clock	SR	O&M	C	PR	Remarks	Photos
Crack Longitudinal	Point	323.8	Structural	0	7	2	0	0	1	Crack Longitudinal

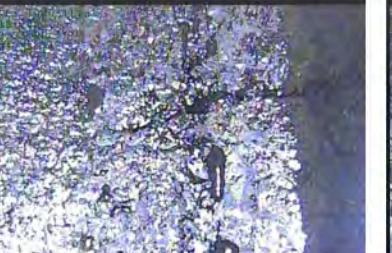
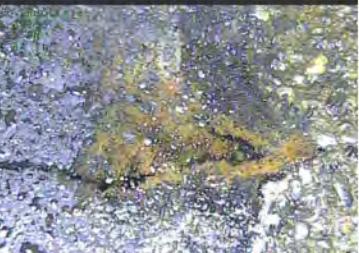
Crack Circumferential	Point	323.8	Structural	0	4-7	1	0	0	1	Crack Circumferential

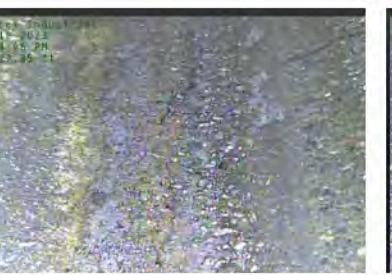
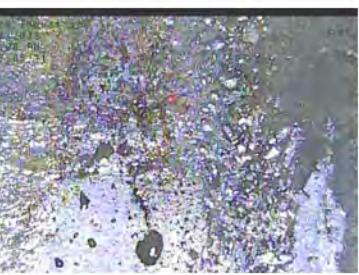
Crack Longitudinal	Point	327.8	Structural	0	7	2	0	0	1	Crack Longitudinal

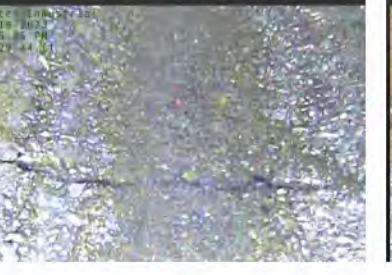
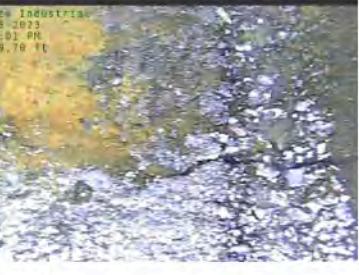
Crack Circumferential	Point	329.7	Structural	0	5-7	1	0	0	1	Crack Circumferential

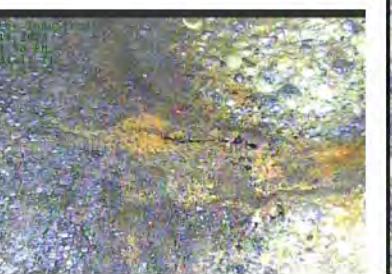
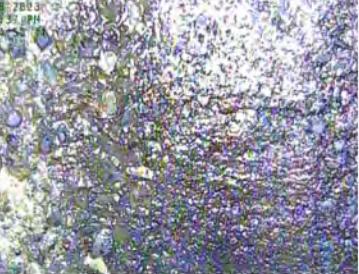
Crack Circumferential	Point	334.1	Structural	0	5-7	1	0	0	1	Crack Circumferential

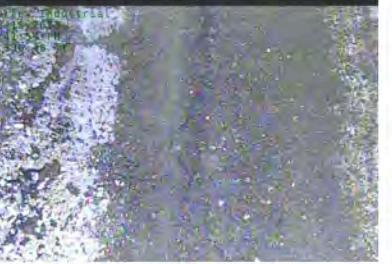
Description	Spatial Type	Distance (ft)	Type	Percent	Clock	SR	O&M	C	PR	Remarks	Photos
Crack Longitudinal	Point	336.5	Structural	0	6	2	0	0	1	Crack Longitudinal

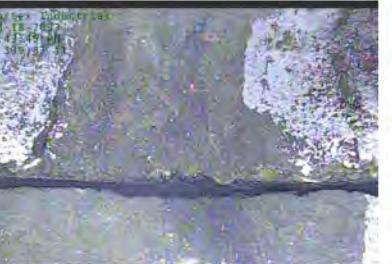
Crack Longitudinal	Point	339.8	Structural	0	6	2	0	0	1	Crack Longitudinal

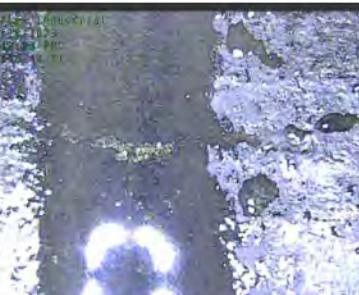
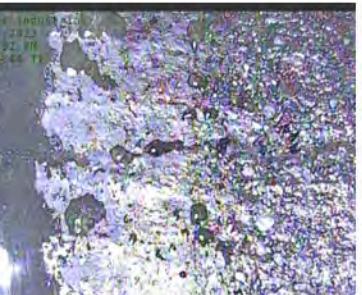
Crack Circumferential	Point	340.4	Structural	0	5-7	1	0	0	1	Crack Circumferential

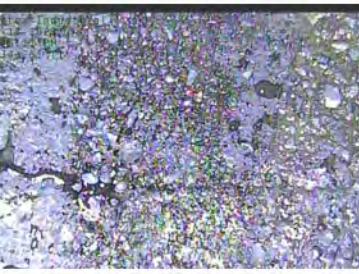
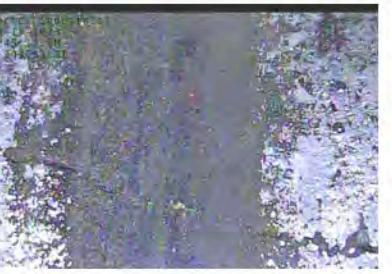
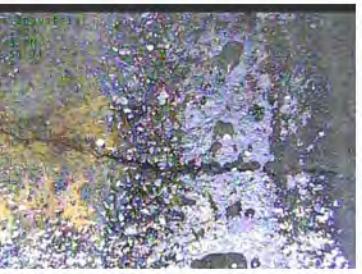
Crack Circumferential	Point	343.5	Structural	0	5-7	1	0	0	2	Crack Circumferential

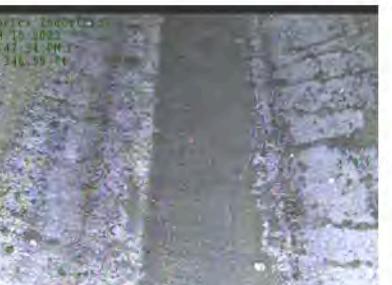
Crack Longitudinal	Point	346.6	Structural	0	6	2	0	0	1	Crack Longitudinal

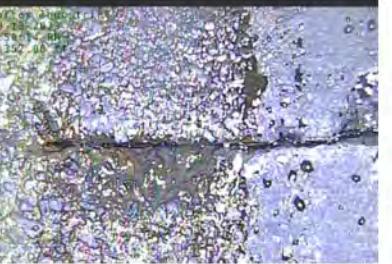
Crack Longitudinal	Point	352.1	Structural	0	7	2	0	0	1	Crack Longitudinal

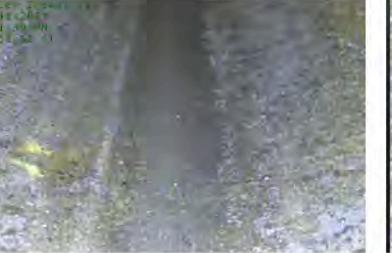
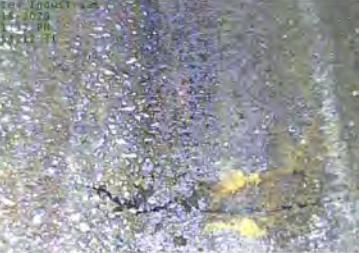
Description	Spatial Type	Distance (ft)	Type	Percent	Clock	SR	O&M	C	PR	Remarks	Photos
Crack Multiple	Point	353.4	Structural	0	6-7	3	0	0	1	Crack Multiple

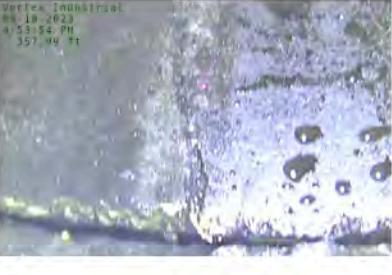
Crack Longitudinal	Point	358	Structural	0	6	2	0	0	2	Crack Longitudinal

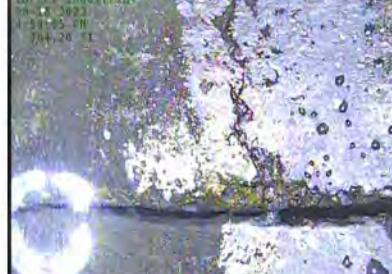
Crack Longitudinal	Point	364.2	Structural	0	6	2	0	0	2	Crack Longitudinal

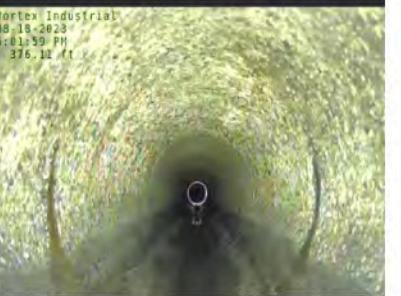
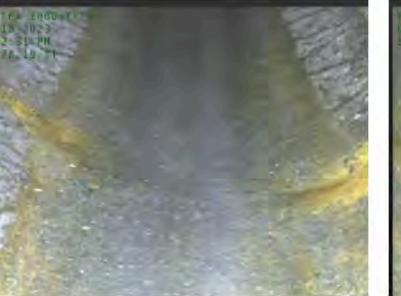
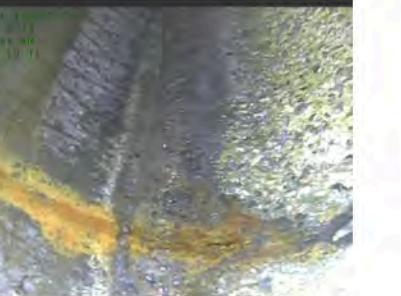
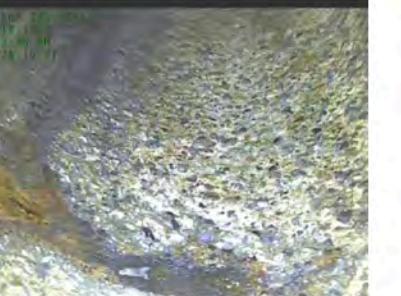
Description	Spatial Type	Distance (ft)	Type	Percent	Clock	SR	O&M	C	PR	Remarks	Photos
Crack Circumferential	Point	378.2	Structural	0	2-10	1	0	0	1	Crack Circumferential

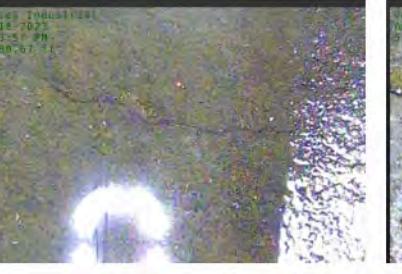
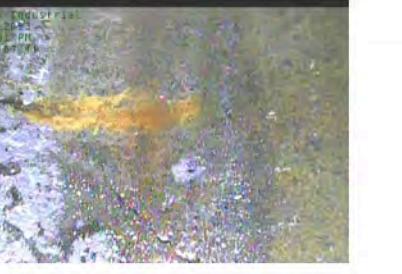
Crack Circumferential	Point	380.7	Structural	0	5-7	1	0	0	1	Crack Circumferential

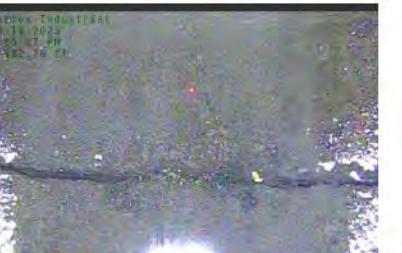
Crack Longitudinal	Point	382.3	Structural	0	6	2	0	0	1	Crack Longitudinal

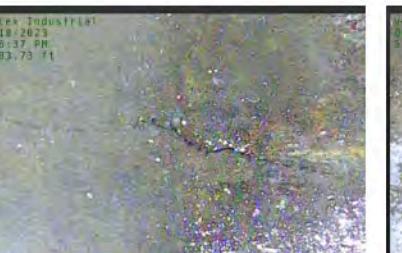
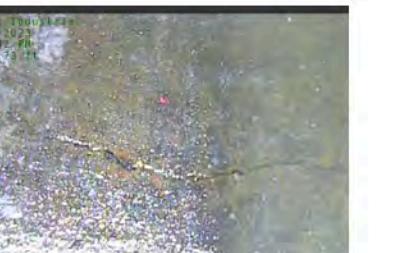
Crack Circumferential	Point	383.7	Structural	0	5-7	1	0	0	2	Crack Circumferential

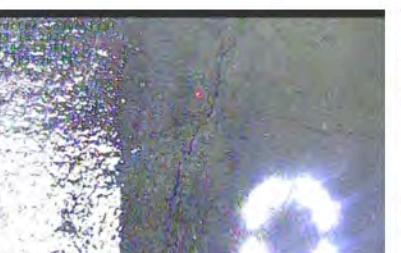
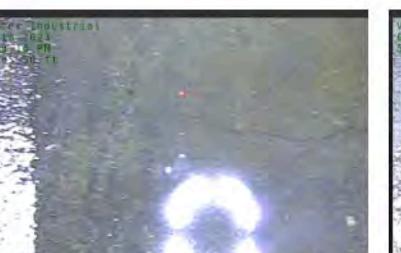
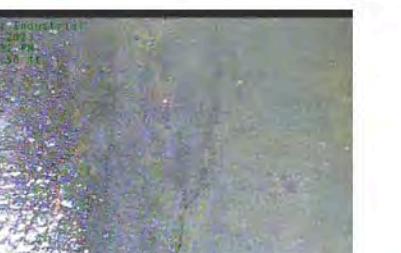
Crack Multiple	Point	385.5	Structural	0	5-6	3	0	0	2	Crack Multiple

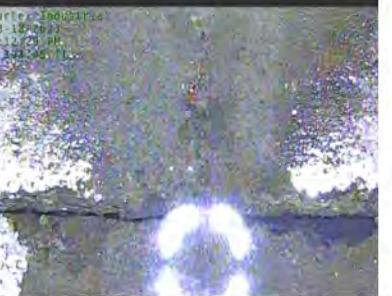
Description	Spatial Type	Distance (ft)	Type	Percent	Clock	SR	O&M	C	PR	Remarks	Photos
Crack Longitudinal	Point	394.5	Structural	0	6	2	0	0	1	Crack Longitudinal

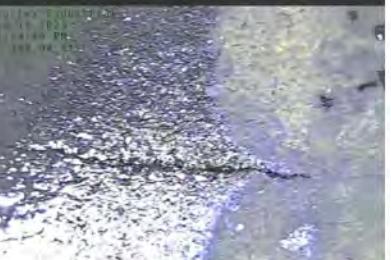
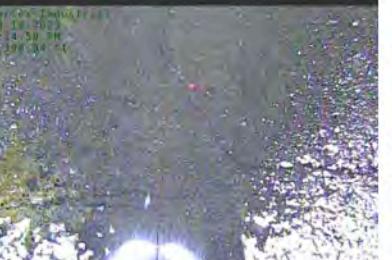
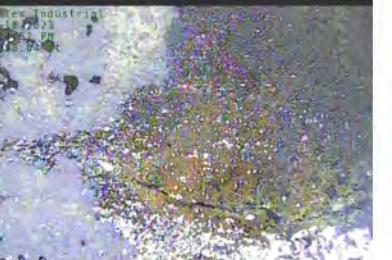
Crack Multiple	Point	398	Structural	0	5-7	3	0	0	2	Crack Multiple

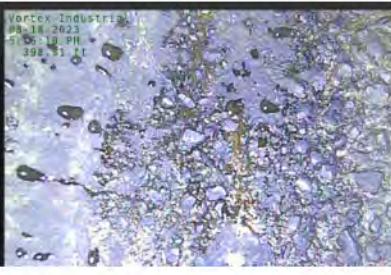
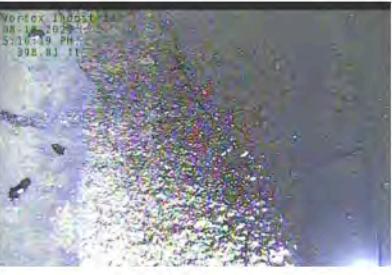
Crack Multiple	Point	398.8	Structural	0	4-6	3	0	0	1	Crack Multiple

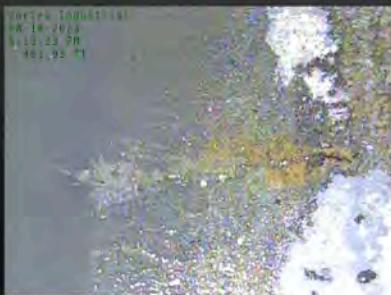
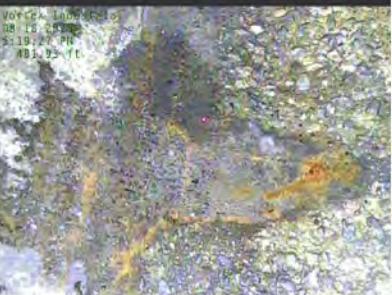
Crack Circumferential	Point	401.9	Structural	0	4-6	1	0	0	1	Crack Circumferential

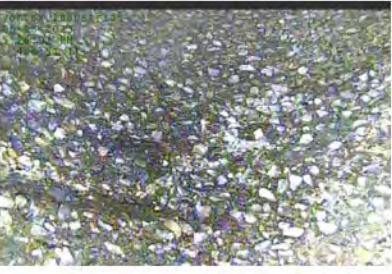
Crack Longitudinal	Point	406.5	Structural	0	2	2	0	0	1	Crack Longitudinal

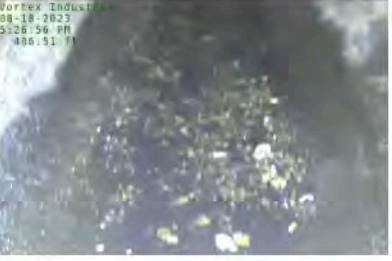
Deposits Settled Gravel	Point	407	O&M	10	6	0	2	0	0	Deposits Settled Gravel

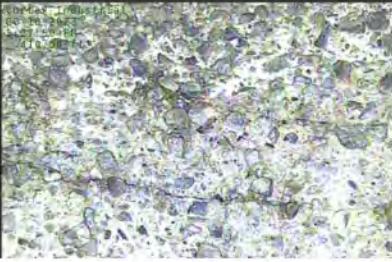
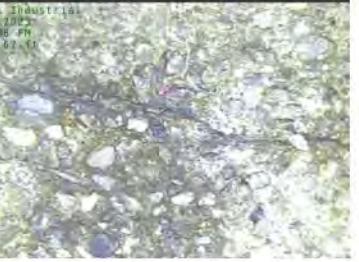
Crack Multiple	Point	410.6	Structural	0	10-2	3	0	0	1	Crack Multiple

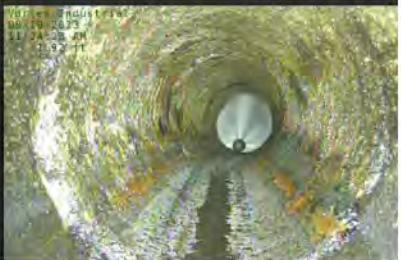
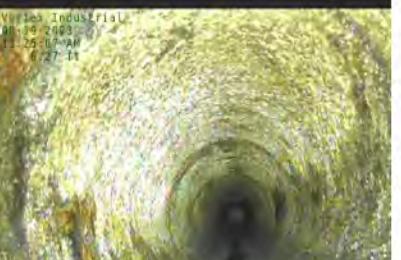
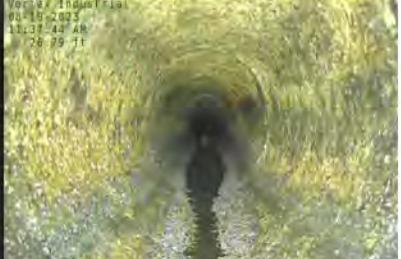
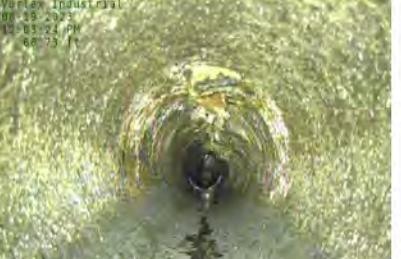
Surface Damage Aggregate Visible	Continuous	0 - 82.3	Structural	0	12-12	2	0	0	2	Surface Damage Aggregate Visible

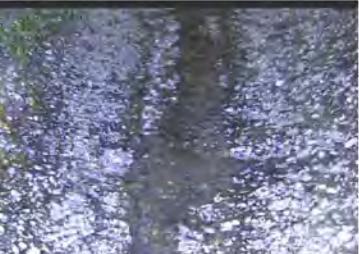
Description	Spatial Type	Distance (ft)	Type	Percent	Clock	SR	O&M	C	PR	Remarks	Photos
Fracture Longitudinal	Point	11.9	Structural	0	6	3	0	0	2	Fracture Longitudinal

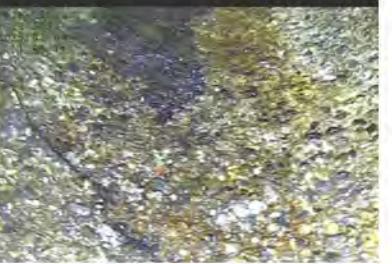
Crack Spiral	Point	11.9	Structural	0	3-5	2	0	0	1	Crack Spiral

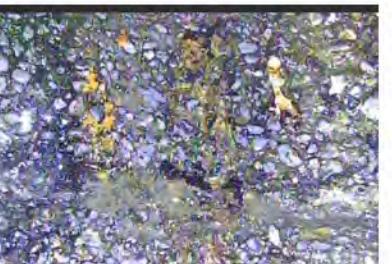
Crack Longitudinal	Point	44.5	Structural	0	5	2	0	0	1	Crack Longitudinal

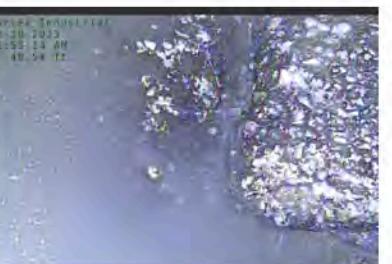
Fracture Longitudinal	Point	48.5	Structural	0	6	3	0	0	2	Fracture Longitudinal

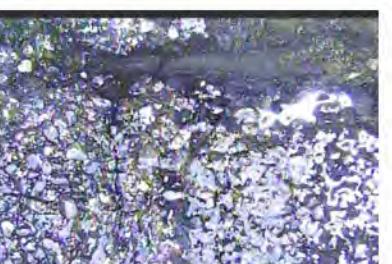
Crack Longitudinal	Point	52.7	Structural	0	6	2	0	0	1	Crack Longitudinal

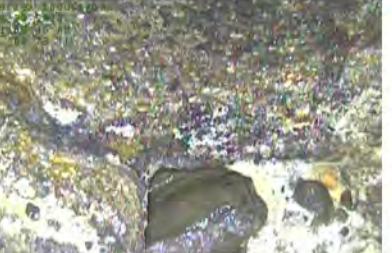
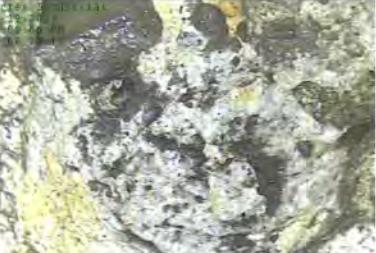
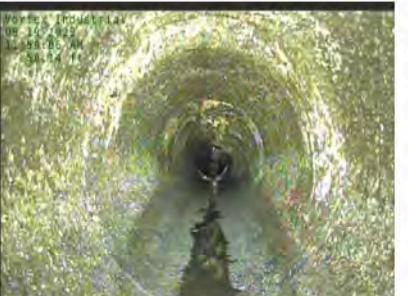
Point Repair Patch	Point	60.7	Structural	0	12	0	0	0	3	Point Repair Patch

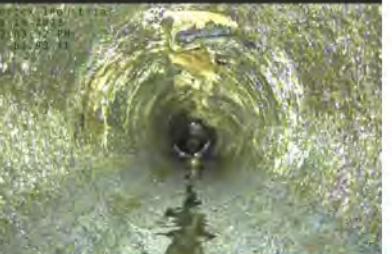
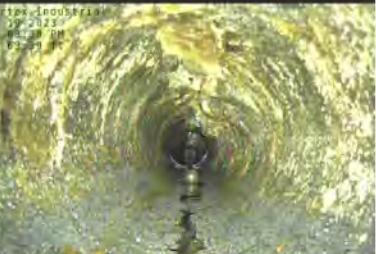
Point Repair Patch Defective	Continuous	64 - 73.4	Structural	10	12-1	4	0	0	3	Point Repair Patch Defective

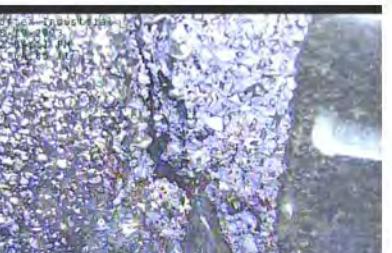
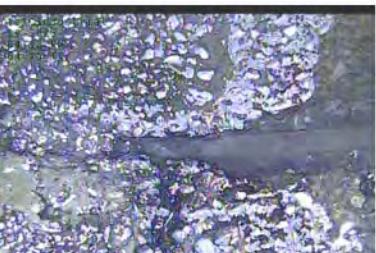
Crack Longitudinal	Point	64.9	Structural	0	6	2	0	0	2	Crack Longitudinal

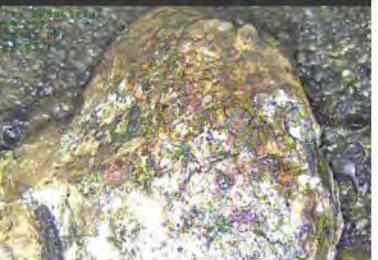
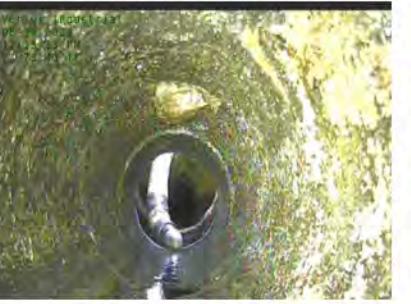
Description	Spatial Type	Distance (ft)	Type	Percent	Clock	SR	O&M	C	PR	Remarks	Photos
Deposits Attached Encrustation	Point	76.9	O&M	10	12-1	0	2	0	0	Deposits Attached Encrustation

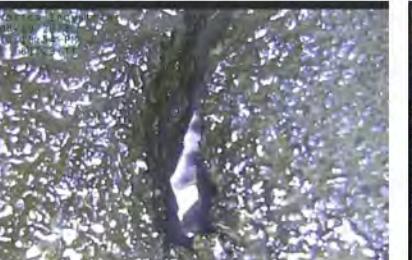
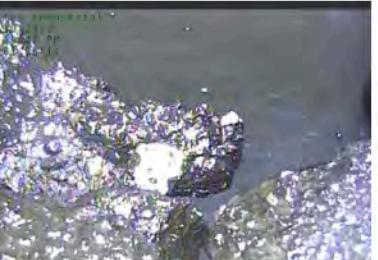
Fracture Longitudinal	Point	81.2	Structural	0	6	3	0	0	3	Fracture Longitudinal

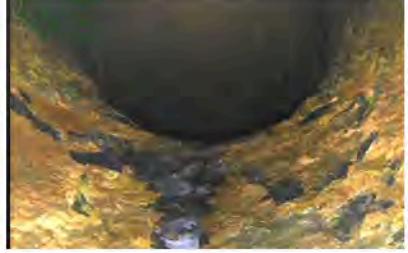
Surface Damage Corrosion	Continuous	0 - 14.9	Structural	0	12-12	3	0	0	2	2	Surface Damage Corrosion

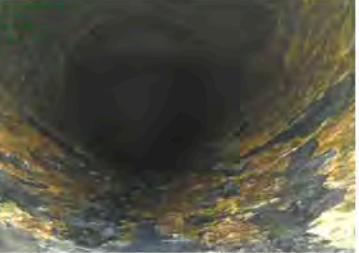
Description	Spatial Type	Distance (ft)	Type	Percent	Clock	SR	O&M	C	PR	Remarks		Photos
Line Down	Point	5.7	Constructional	100		0	4	4	0	Line Down

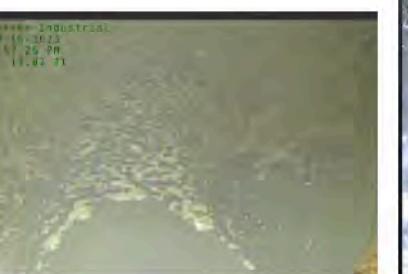
Miscellaneous Survey Abandoned	Point	14.9	Miscellaneous	0		0	0	0	0	Impassable High Water Level

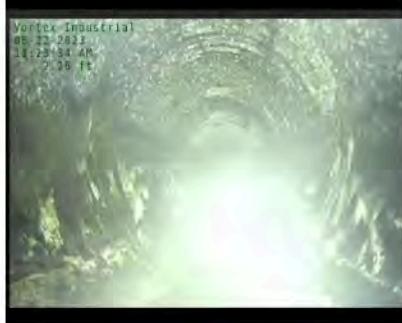
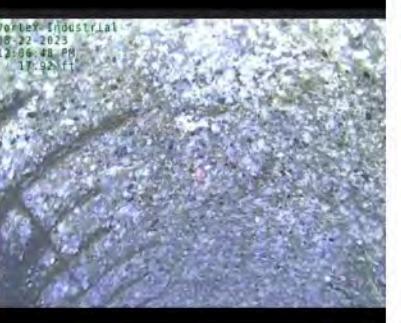
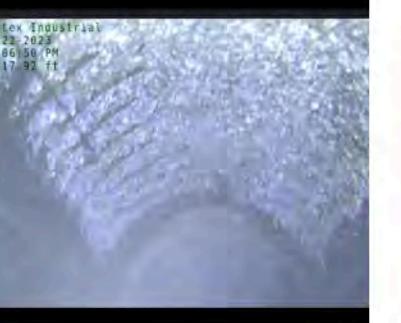
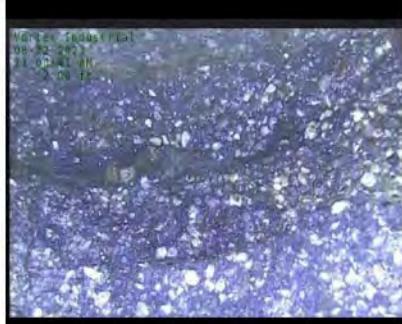
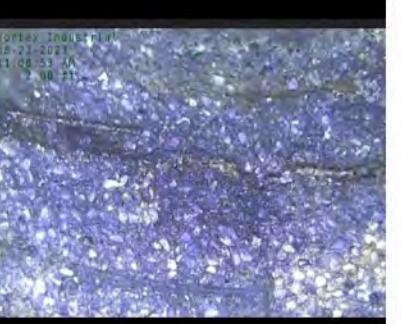
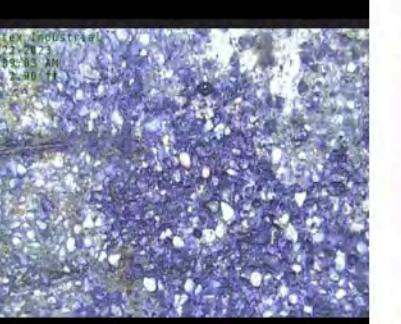
Description	Spatial Type	Distance (ft)	Type	Percent	Clock	SR	O&M	C	PR	Remarks	Photos
Surface Damage Reinforcement Visible	Continuous	2 - 61.3	Structural	0	10-2	4	0	0	3	Surface Damage Reinforcement Visible

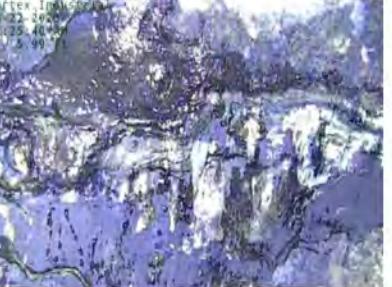
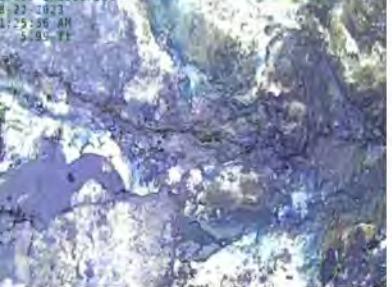
Description	Spatial Type	Distance (ft)	Type	Percent	Clock	SR	O&M	C	PR	Remarks	Photos
Crack Multiple	Point	5.9	Structural	0	3-6	0	0	0	2	Crack Multiple

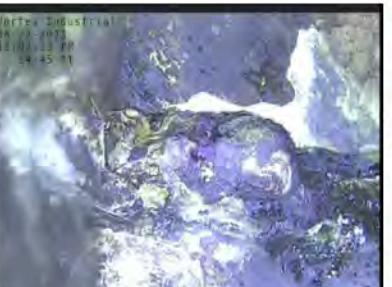
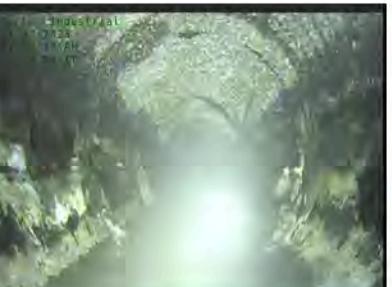
Deposits Attached Encrustation	Point	14.5	O&M	10	4-5	0	2	0	0	Deposits Attached Encrustation

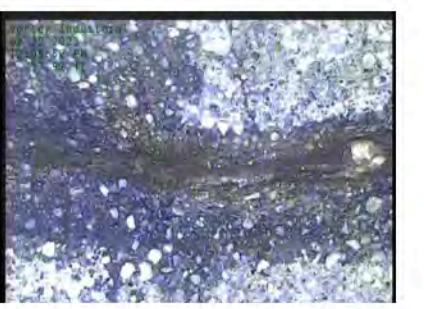
Crack Longitudinal	Point	17.9	Structural	0	12	2	0	0	1	Crack Longitudinal

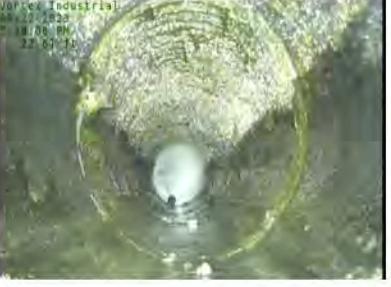
Deposits Attached Encrustation	Point	26.5	O&M	10	10	0	2	0	0	Deposits Attached Encrustation

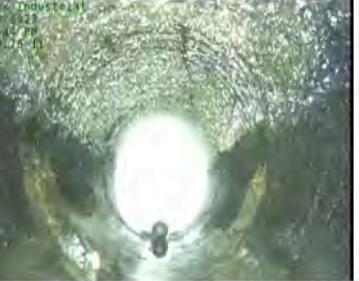
Description	Spatial Type	Distance (ft)	Type	Percent	Clock	SR	O&M	C	PR	Remarks	Photos
Deposits Attached Encrustation	Point	34.4	O&M	10	7	0	2	0	0	Deposits Attached Encrustation

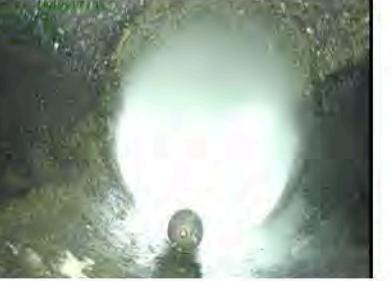
Crack Longitudinal	Point	35.5	Structural	0	8	2	0	0	2	Crack Longitudinal

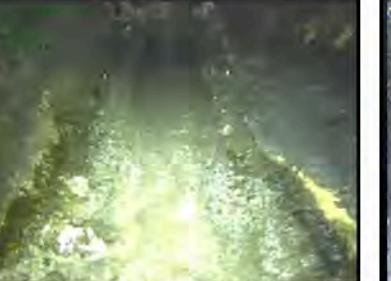
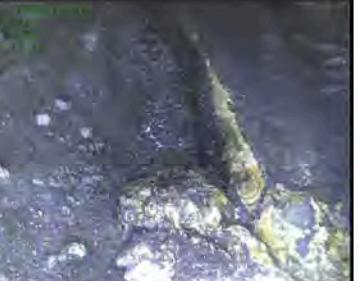
Crack Longitudinal	Point	38.3	Structural	0	5	2	0	0	2	Crack Longitudinal

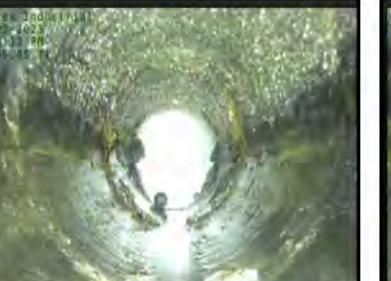
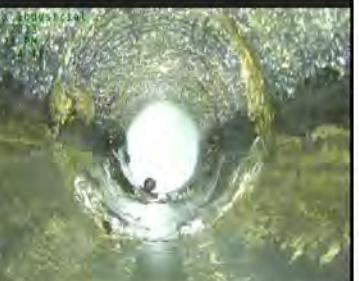
Crack Longitudinal Hinge, 2	Point	38.3	Structural	0	9-3	2	0	0	2	Crack Longitudinal Hinge, 2

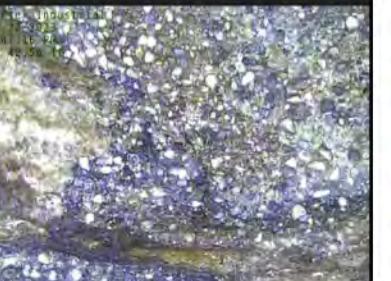
Crack Longitudinal	Point	42.5	Structural	0	11	2	0	0	1	Crack Longitudinal

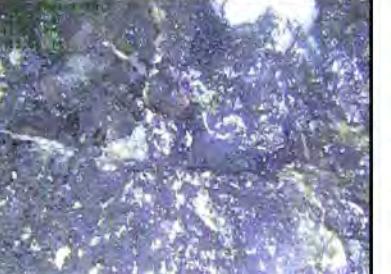
Description	Spatial Type	Distance (ft)	Type	Percent	Clock	SR	O&M	C	PR	Remarks	Photos
Crack Longitudinal	Point	42.5	Structural	0	5	2	0	0	1	Crack Longitudinal

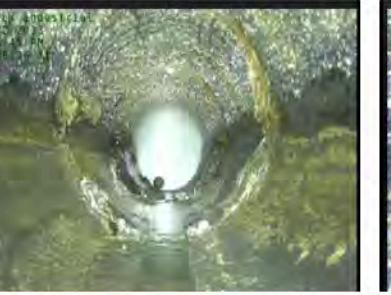
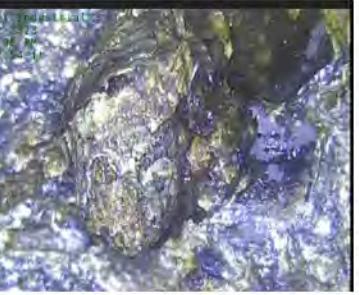
Deposits Attached Encrustation	Point	42.5	O&M	10	12-12	0	2	0	0	Deposits Attached Encrustation

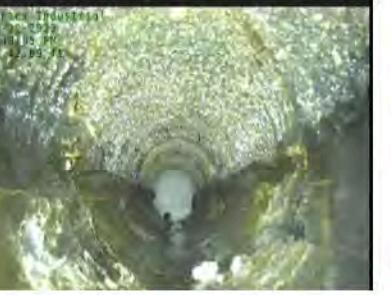
Deposits Attached Encrustation	Point	46.5	O&M	10	3-9	0	2	0	0	Deposits Attached Encrustation

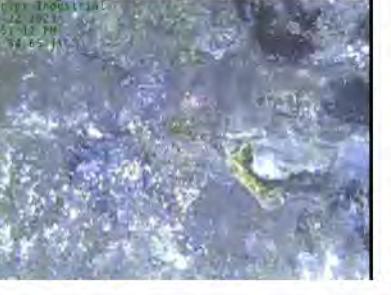
Crack Spiral	Point	54.6	Structural	0	5-6	2	0	0	1	Crack Spiral

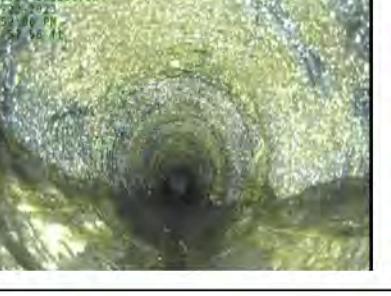
Fracture Longitudinal	Point	58.9	Structural	0	4	3	0	0	3	Fracture Longitudinal
