2023 ANNUAL PROGRESS REPORT

SWMU-1 OILY WATER SEWER

HF SINCLAIR PUGET SOUND REFINING LLC

MARCH 21, 2024

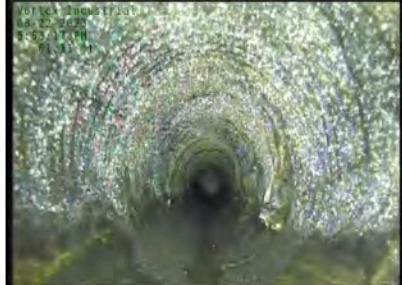
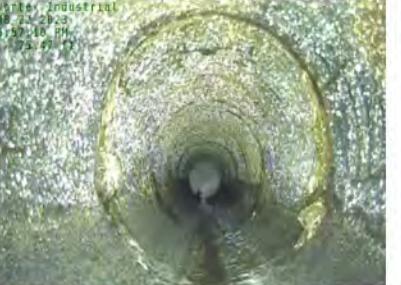
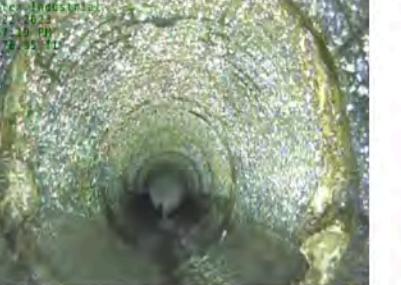
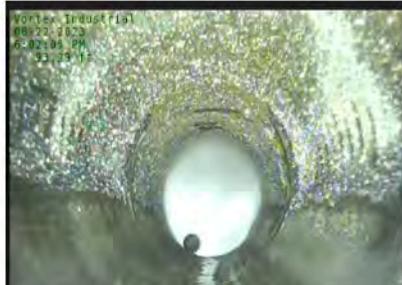
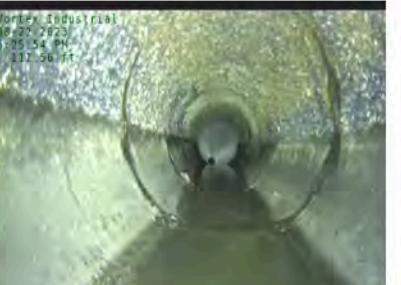
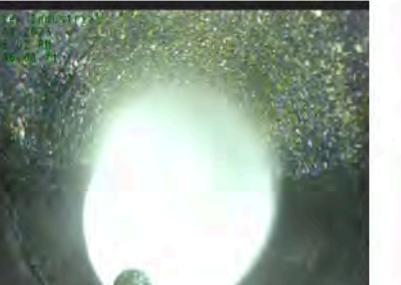
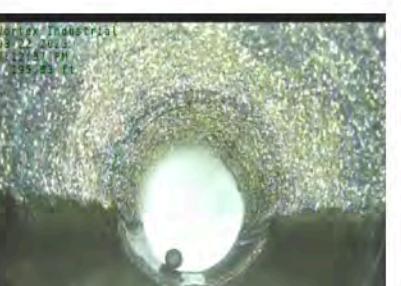
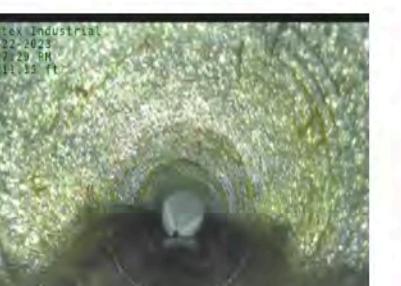
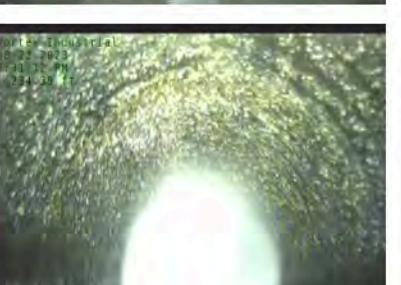
Description	Spatial Type	Distance (ft)	Type	Percent	Clock	SR	O&M	C	PR	Remarks	Photos
Surface Damage Reinforcement Visible	Continuous	61.4 - 234	Structural	0	8-4	4	0	0	3	Surface Damage Reinforcement Visible

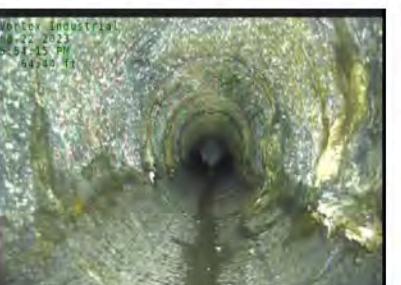
Deposits Attached Encrustation	Point	67.3	O&M	10	2-4	0	2	0	0	Deposits Attached Encrustation

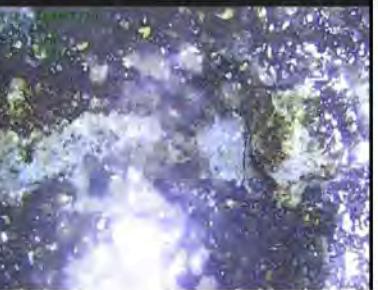
Description	Spatial Type	Distance (ft)	Type	Percent	Clock	SR	O&M	C	PR	Remarks	Photos
Crack Longitudinal	Point	67.3	Structural	0	6	2	0	0	1	Crack Longitudinal

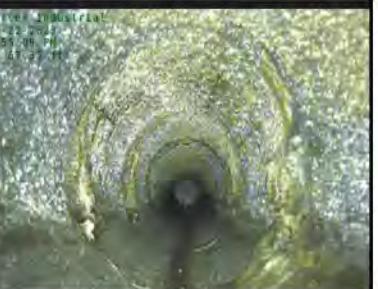
Deposits Attached Encrustation	Point	71.7	O&M	10	3-5	0	2	0	0	Deposits Attached Encrustation

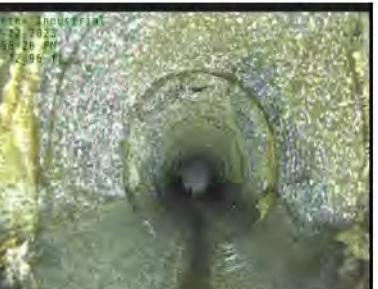
Deposits Attached Encrustation	Point	75.4	O&M	10	8-9	0	2	0	0	Deposits Attached Encrustation

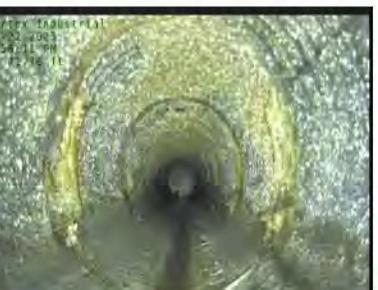
Deposits Attached Encrustation	Point	75.4	O&M	10	3-4	0	2	0	0	Deposits Attached Encrustation

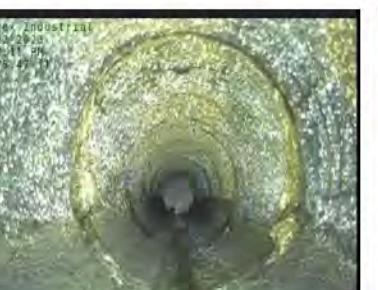
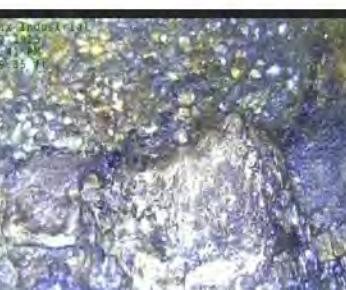
Deposits Attached Encrustation	Point	79.3	O&M	10	8	0	2	0	0	Deposits Attached Encrustation

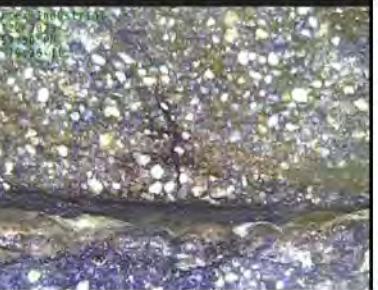
Description	Spatial Type	Distance (ft)	Type	Percent	Clock	SR	O&M	C	PR	Remarks	Photos
Crack Longitudinal	Point	79.3	Structural	0	12	2	0	0	1	Crack Longitudinal

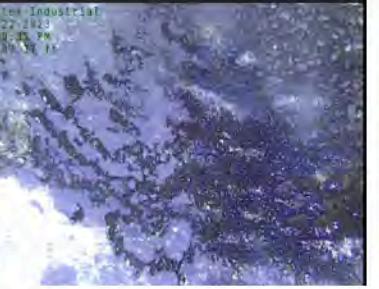
Crack Multiple	Point	87.3	Structural	0	4-5	3	0	0	1	Crack Multiple

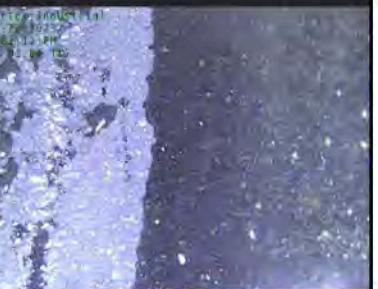
Crack Multiple	Point	91.8	Structural	0	6-7	3	0	0	1	Crack Multiple

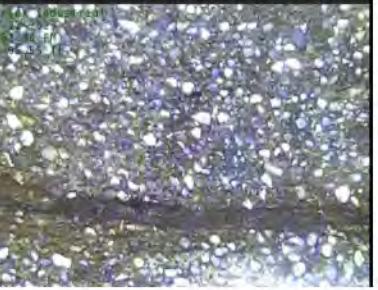
Crack Multiple	Point	95.5	Structural	0	10-11	3	0	0	1	Crack Multiple

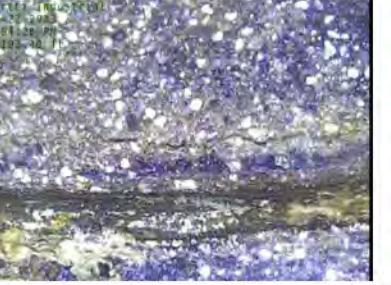
Description	Spatial Type	Distance (ft)	Type	Percent	Clock	SR	O&M	C	PR	Remarks	Photos
Crack Circumferential	Point	103.4	Structural	0	12-1	1	0	0	1	Crack Circumferential

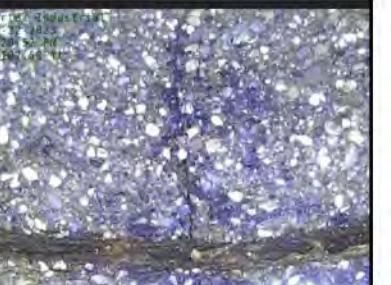
Crack Longitudinal	Point	107.5	Structural	0	12	2	0	0	1	Crack Longitudinal

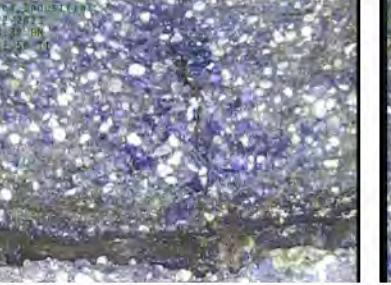
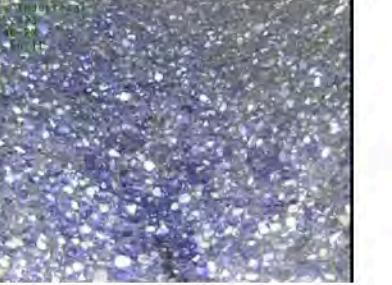
Crack Longitudinal	Point	111.5	Structural	0	12	2	0	0	1	Crack Longitudinal

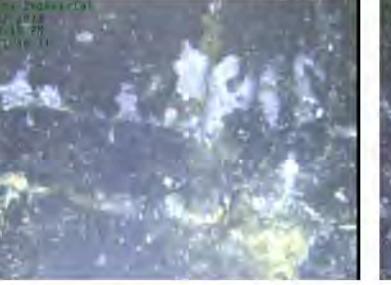
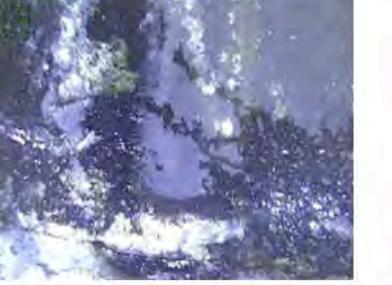
Crack Multiple	Point	111.5	Structural	0	5-7	3	0	0	2	Crack Multiple

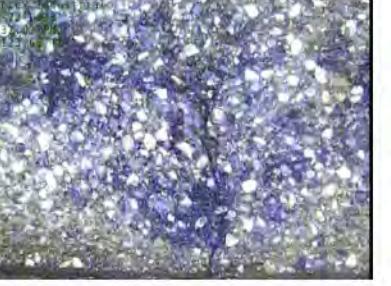
Crack Longitudinal	Point	123.6	Structural	0	12	2	0	0	1	Crack Longitudinal

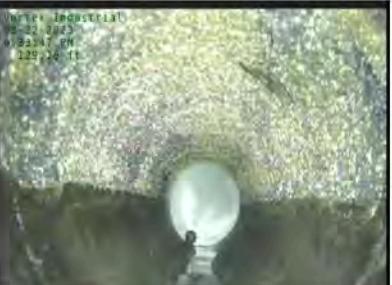
Description	Spatial Type	Distance (ft)	Type	Percent	Clock	SR	O&M	C	PR	Remarks		Photos
Crack Longitudinal	Point	132.5	Structural	0	1	2	0	0	1	Crack Longitudinal

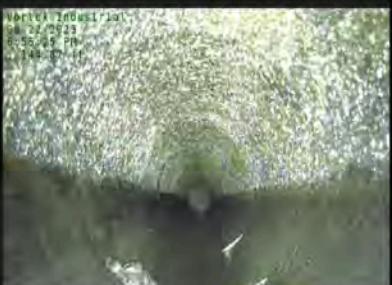
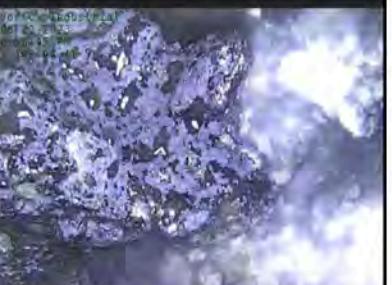
Deposits Attached Encrustation	Point	148.9	O&M	10	7-8	0	2	0	0	Deposits Attached Encrustation

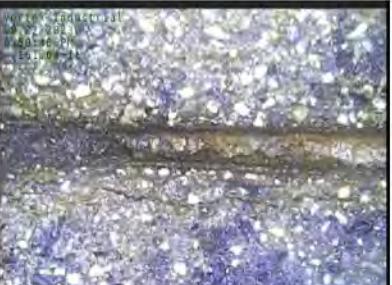
Description	Spatial Type	Distance (ft)	Type	Percent	Clock	SR	O&M	C	PR	Remarks	Photos
Crack Circumferential	Point	161	Structural	0	11-12	1	0	0	1	Crack Circumferential

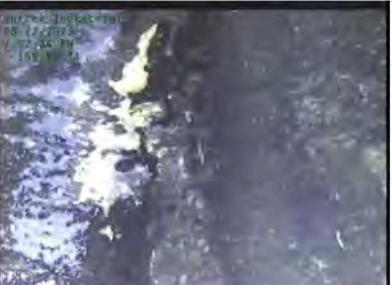
Crack Longitudinal	Point	168.9	Structural	0	6	2	0	0	1	Crack Longitudinal

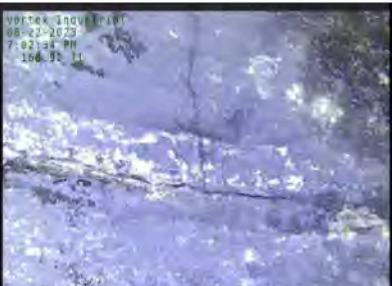
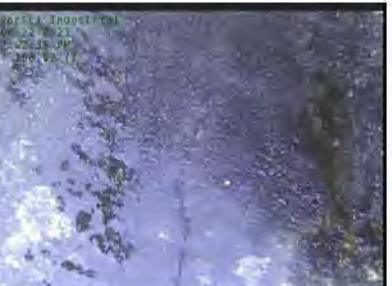
Crack Multiple	Point	168.9	Structural	0	4-5	2	0	0	1	Crack Multiple

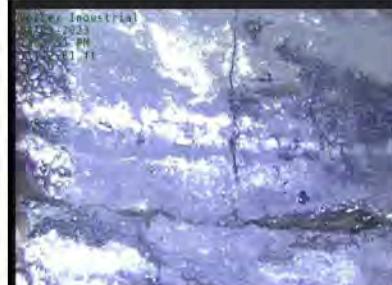
Crack Multiple	Point	172.8	Structural	0	4-5	2	0	0	2	Crack Multiple

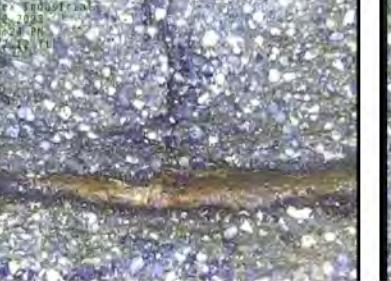
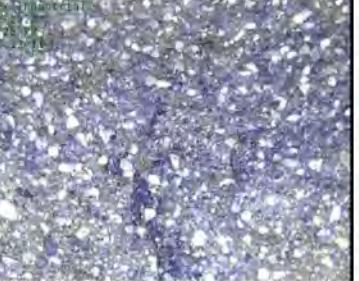
Description	Spatial Type	Distance (ft)	Type	Percent	Clock	SR	O&M	C	PR	Remarks	Photos
Crack Longitudinal	Point	177.1	Structural	0	12	2	0	0	1	Crack Longitudinal

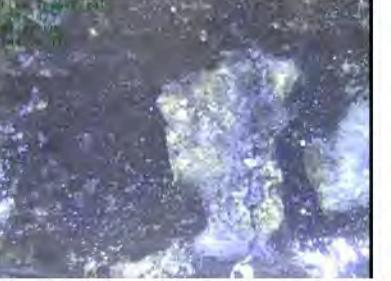
Crack Longitudinal	Point	184.7	Structural	0	6	2	0	0	1	Crack Longitudinal

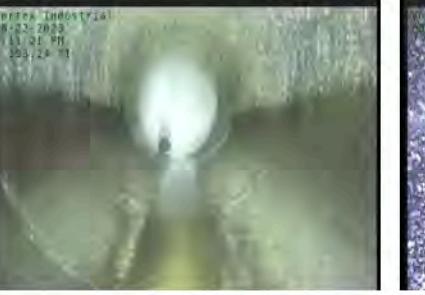
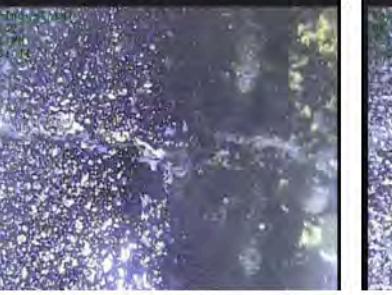
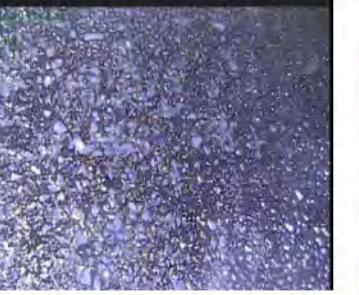
Crack Circumferential	Point	195.5	Structural	0	3-9	1	0	0	1	Crack Circumferential

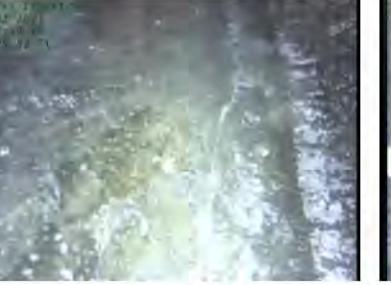
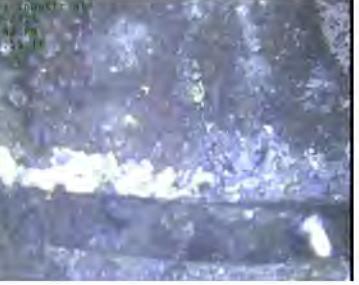
Description	Spatial Type	Distance (ft)	Type	Percent	Clock	SR	O&M	C	PR	Remarks	Photos
Crack Longitudinal	Point	225.5	Structural	0	6	2	0	0	1	Crack Longitudinal

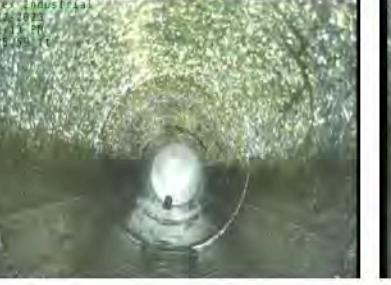
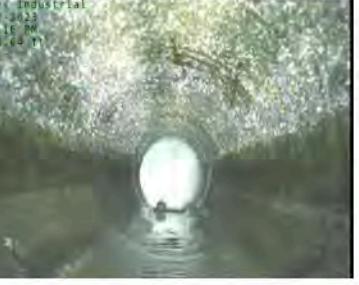
Surface Damage Reinforcement Visible	Continuous	234.1 - 268	Structural	0	10-2	4	0	0	2	Surface Damage Reinforcement Visible

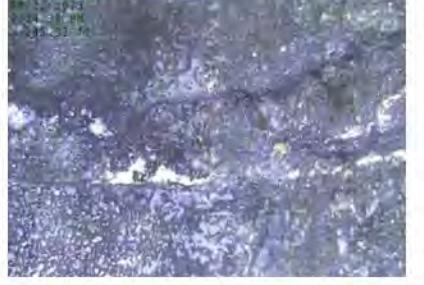
Crack Circumferential	Point	245.3	Structural	0	5-6	1	0	0	1	Crack Circumferential

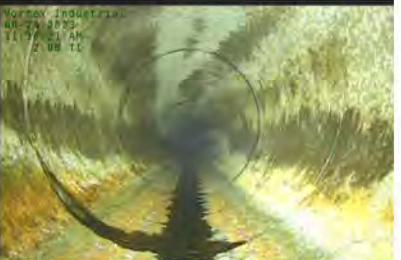
Miscellaneous Water Level	Point	0	Miscellaneous	0		0	0	0	0	Water Level at Start of Survey

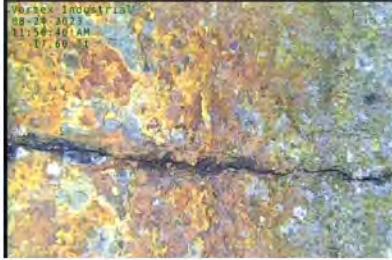
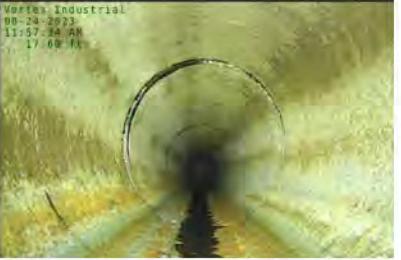
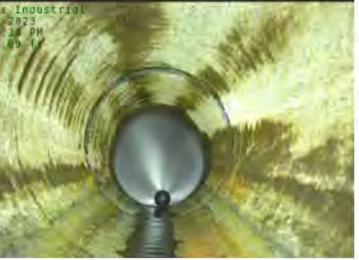
Surface Damage Roughness Increased	Continuous	0 - 207.7	Structural	0	12-12	1	0	0	1	Surface Damage Roughness Increased

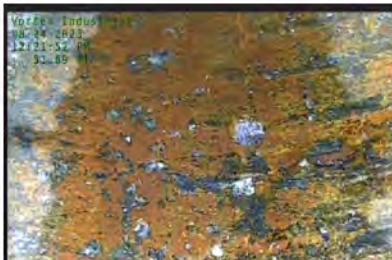
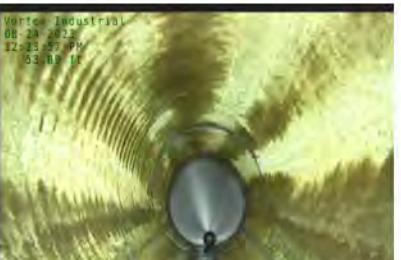
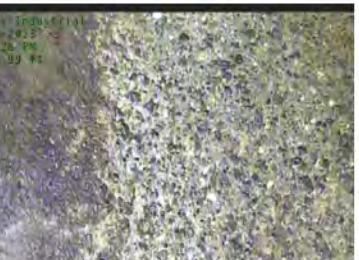
Description	Spatial Type	Distance (ft)	Type	Percent	Clock	SR	O&M	C	PR	Remarks	Photos
Crack Circumferential	Point	2.3	Structural	0	5-7	1	0	0	2	Crack Circumferential

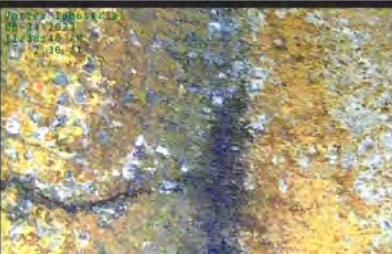
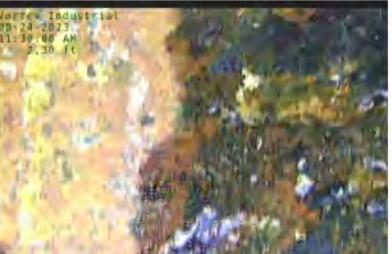
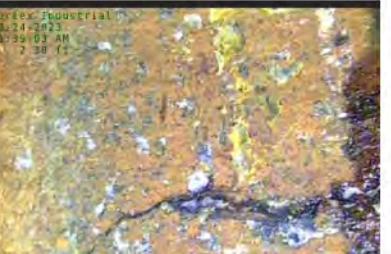
Crack Circumferential	Point	3.1	Structural	0	5-7	1	0	0	2	Crack Circumferential

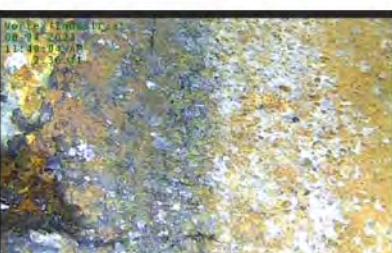
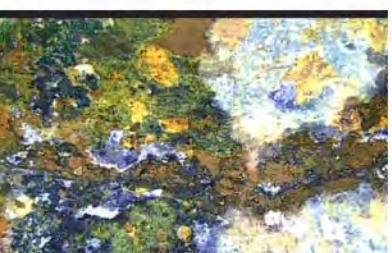
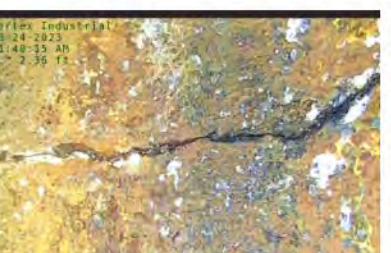
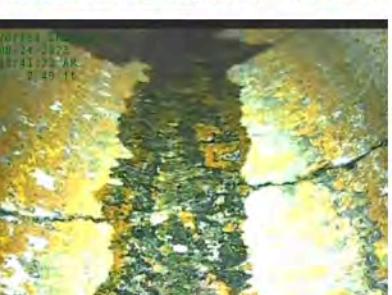
Crack Circumferential	Point	4.3	Structural	0	5-6	1	0	0	1	Crack Circumferential

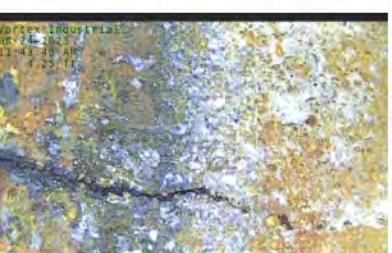
Crack Circumferential	Point	5.3	Structural	0	4-7	1	0	0	2	Crack Circumferential

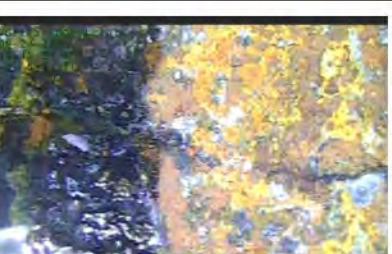
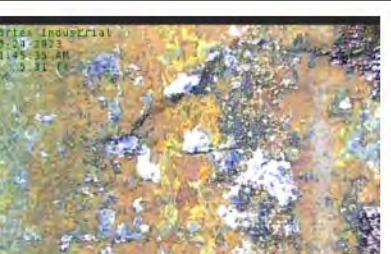
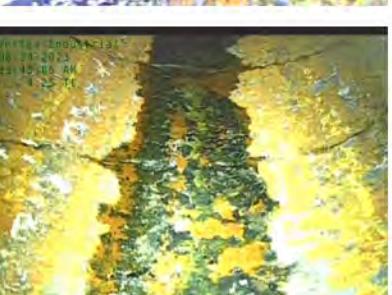
Description	Spatial Type	Distance (ft)	Type	Percent	Clock	SR	O&M	C	PR	Remarks	Photos
Crack Circumferential	Point	6	Structural	0	4-8	1	0	0	1	Crack Circumferential

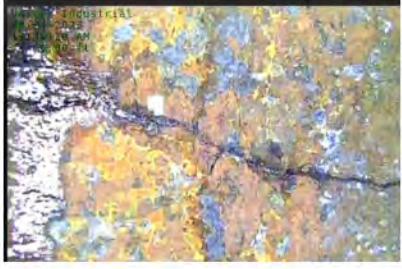
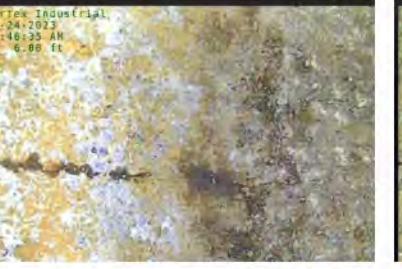
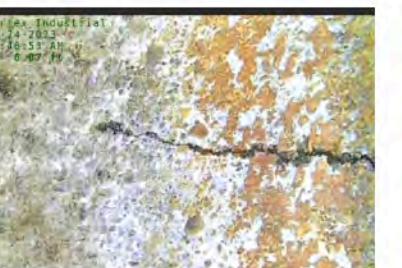
Crack Circumferential	Point	6.9	Structural	0	5-7	1	0	0	1	Crack Circumferential

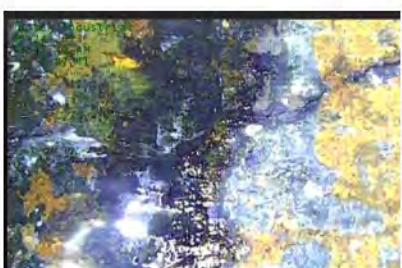
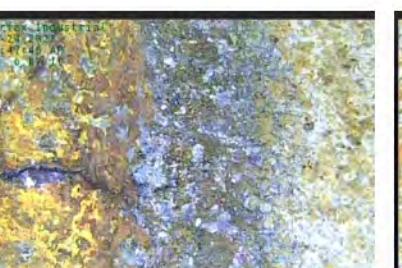
Crack Circumferential	Point	7.5	Structural	0	5-8	1	0	0	1	Crack Circumferential

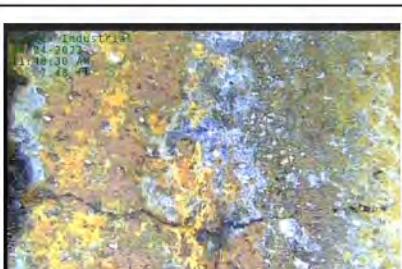
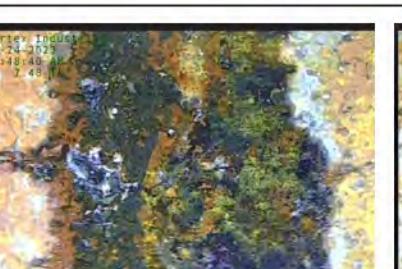
Description	Spatial Type	Distance (ft)	Type	Percent	Clock	SR	O&M	C	PR	Remarks	Photos
Crack Circumferential	Point	9.1	Structural	0	3-8	1	0	0	1	Crack Circumferential

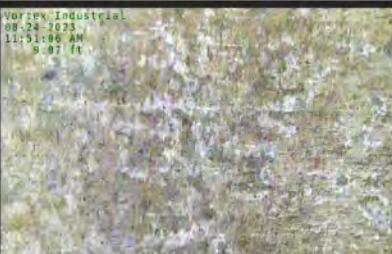
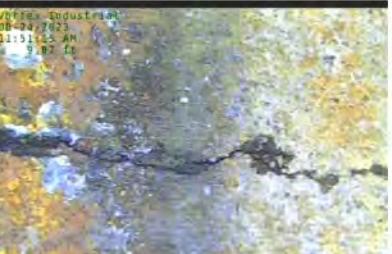
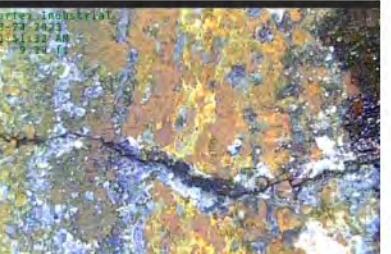
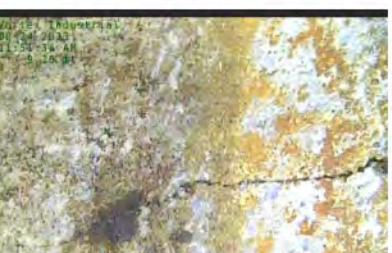
Crack Circumferential	Point	11.3	Structural	0	5-8	1	0	0	1	Crack Circumferential

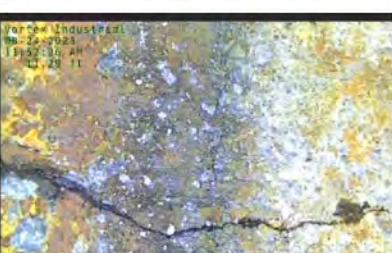
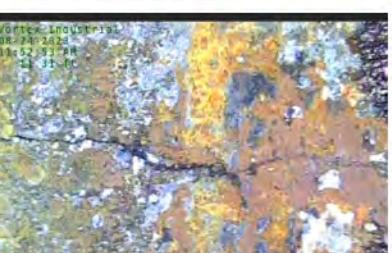
Crack Circumferential	Point	12.8	Structural	0	4-7	1	0	0	1	Crack Circumferential

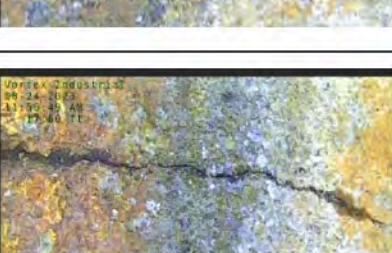
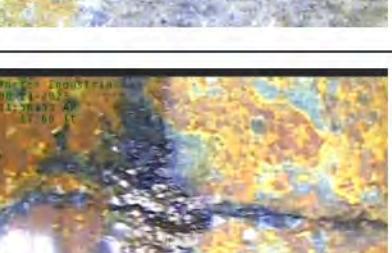
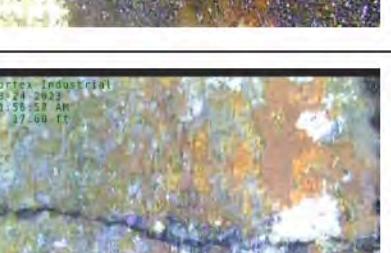
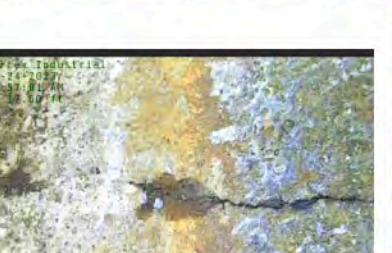
Crack Circumferential	Point	17.6	Structural	0	4-8	1	0	0	2	Crack Circumferential

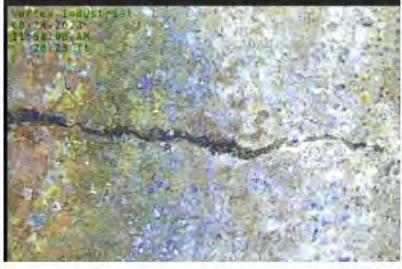
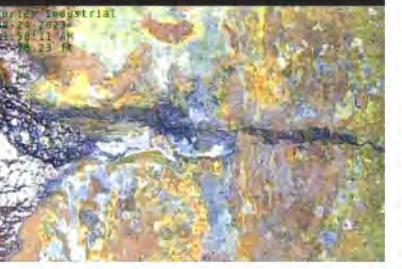
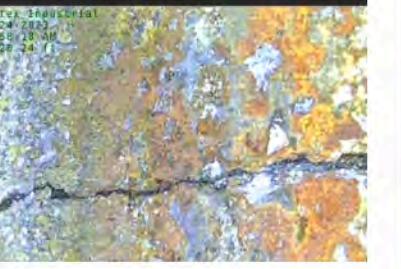
Description	Spatial Type	Distance (ft)	Type	Percent	Clock	SR	O&M	C	PR	Remarks		Photos
Crack Circumferential	Point	20.2	Structural	0	4-7	1	0	0	1	Crack Circumferential

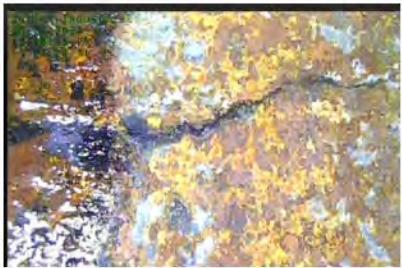
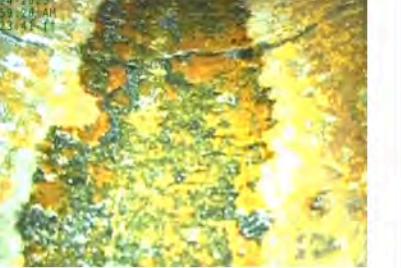
Crack Circumferential	Point	24.2	Structural	0	5-7	1	0	0	2	Crack Circumferential

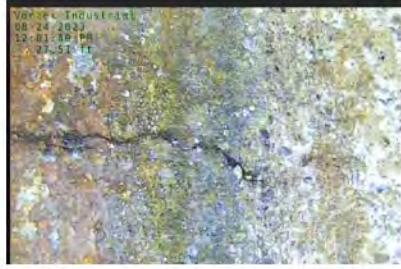
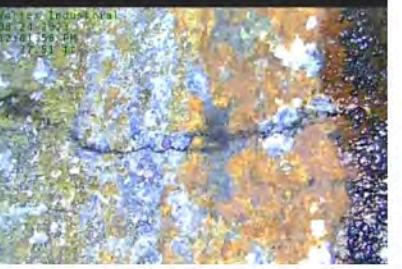
Crack Circumferential	Point	27.5	Structural	0	5-7	1	0	0	1	Crack Circumferential

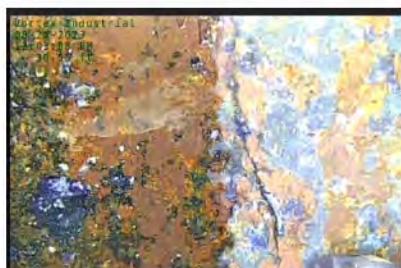
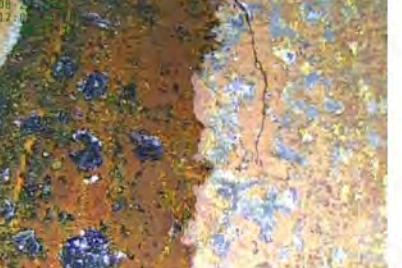
Crack Longitudinal	Point	30.6	Structural	0	6	2	0	0	1	Crack Longitudinal

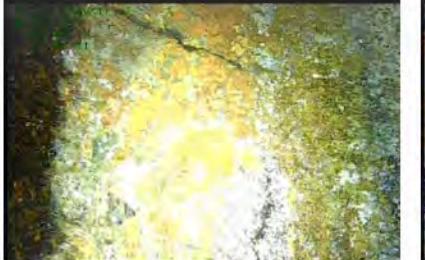
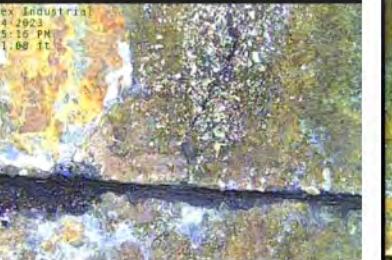
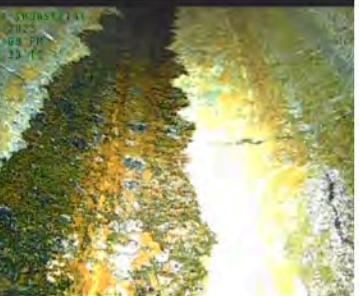
Description	Spatial Type	Distance (ft)	Type	Percent	Clock	SR	O&M	C	PR	Remarks	Photos
Crack Multiple	Point	31.1	Structural	0	5-7	3	0	0	1	Crack Multiple

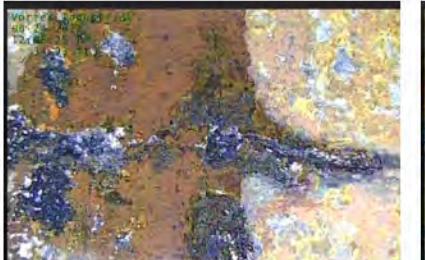
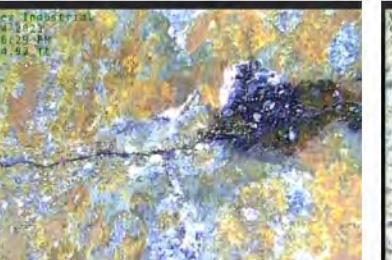
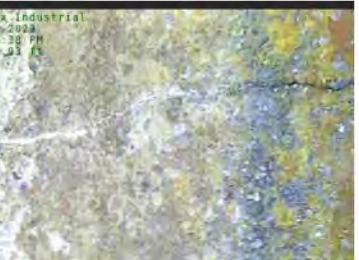
Crack Circumferential	Point	34.9	Structural	0	4-8	1	0	0	1	Crack Circumferential

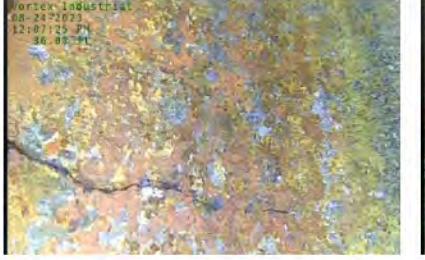
Crack Multiple	Point	36.1	Structural	0	5-8	3	0	0	1	Crack Multiple

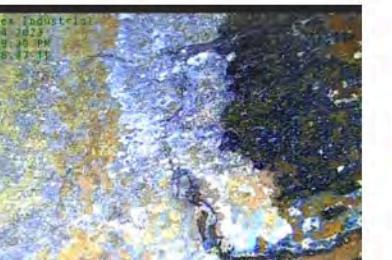
Crack Multiple	Point	38.5	Structural	0	6-7	3	0	0	1	Crack Multiple

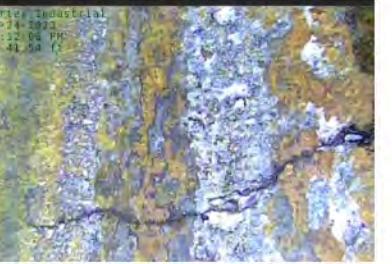
Description	Spatial Type	Distance (ft)	Type	Percent	Clock	SR	O&M	C	PR	Remarks		Photos
Crack Circumferential	Point	41.5	Structural	0	6-7	1	0	0	1	Crack Circumferential

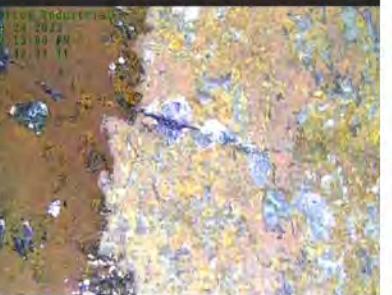
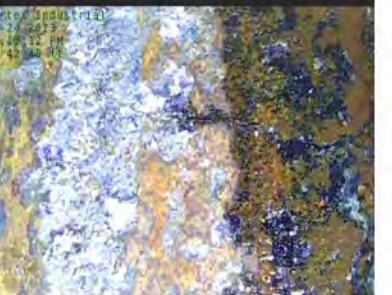
Crack Circumferential	Point	42.4	Structural	0	5-6	1	0	0	1	Crack Circumferential

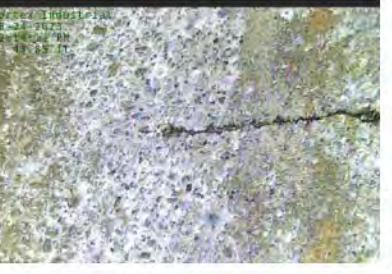
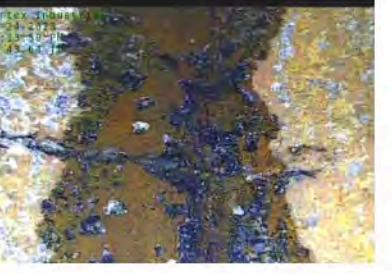
Crack Circumferential	Point	43.9	Structural	0	6-8	1	0	0	2	Crack Circumferential

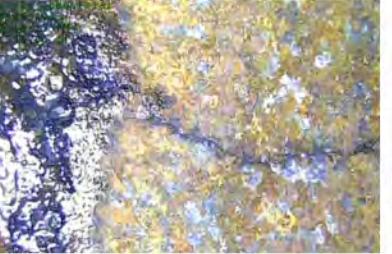
Crack Circumferential	Point	45.1	Structural	0	5-7	1	0	0	1	Crack Circumferential

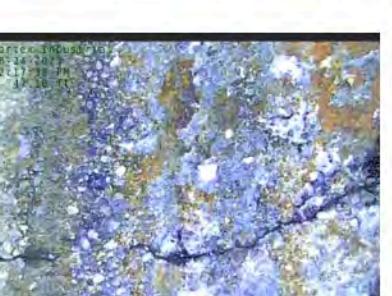
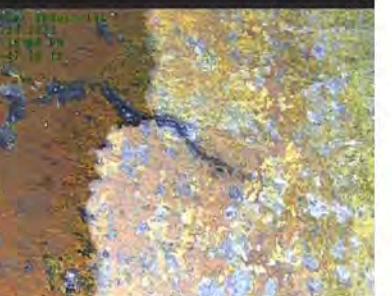
Crack Circumferential	Point	47.1	Structural	0	6-7	1	0	0	1	Crack Circumferential

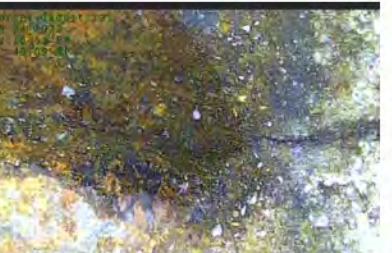
Crack Circumferential	Point	49.6	Structural	0	5-7	1	0	0	1	Crack Circumferential

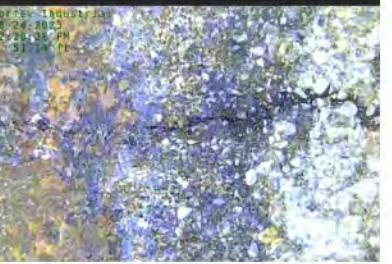
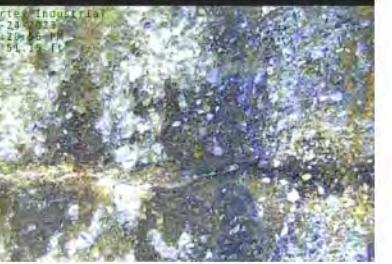
Description	Spatial Type	Distance (ft)	Type	Percent	Clock	SR	O&M	C	PR	Remarks	Photos
Crack Circumferential	Point	51.1	Structural	0	5-7	1	0	0	1	Crack Circumferential

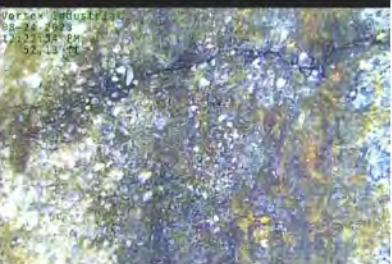
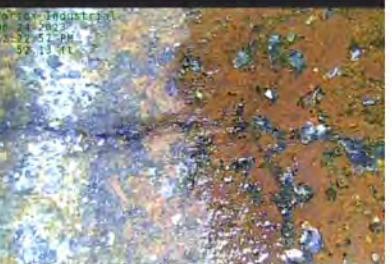
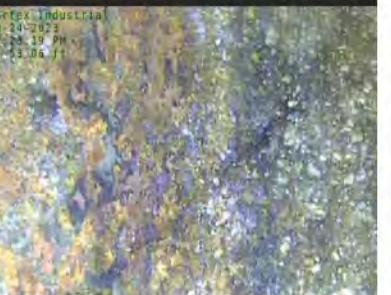
Crack Multiple	Point	52.1	Structural	0	6-7	1	0	0	1	Crack Circumferential

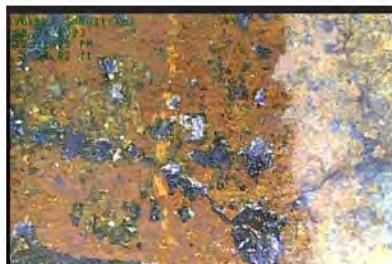
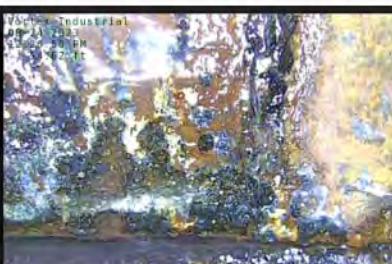
Crack Multiple	Point	54.6	Structural	0	5-7	3	0	0	1	Crack Multiple

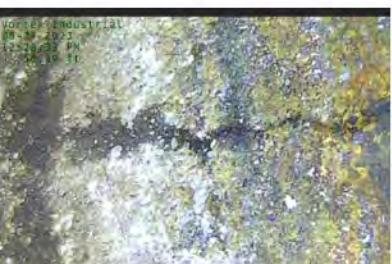
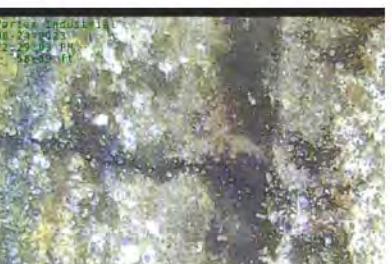
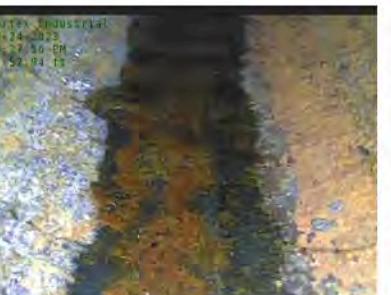
Crack Multiple	Point	58.4	Structural	0	4-9	1	0	0	1	Crack Circumferential

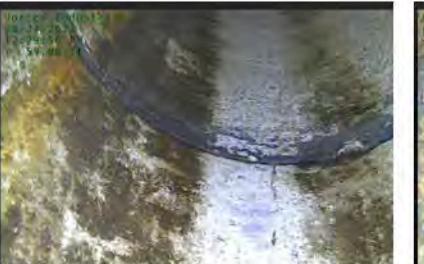
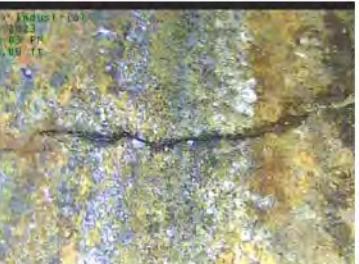
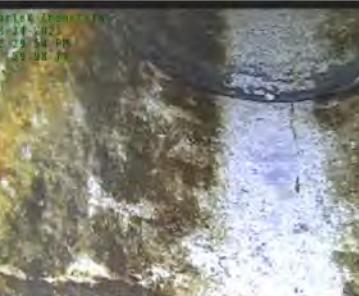
Description	Spatial Type	Distance (ft)	Type	Percent	Clock	SR	O&M	C	PR	Remarks	Photos
Crack Spiral	Point	60	Structural	0	4-6	2	0	0	1	Crack Spiral

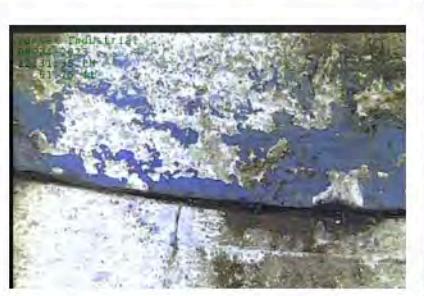
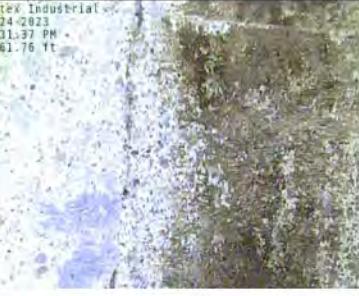
Crack Longitudinal	Point	61.8	Structural	0	2	2	0	0	1	Crack Longitudinal

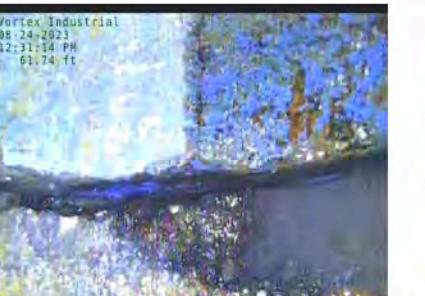
Crack Longitudinal	Point	61.8	Structural	0	7	2	0	0	1	Crack Longitudinal

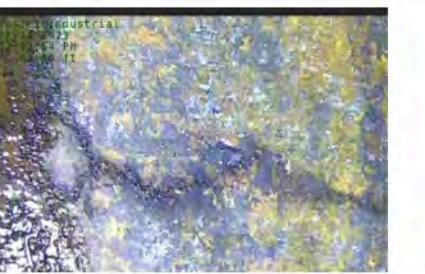
Crack Multiple	Point	62.5	Structural	0	5-6	3	0	0	1	Crack Multiple

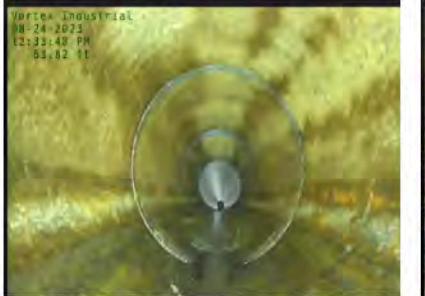
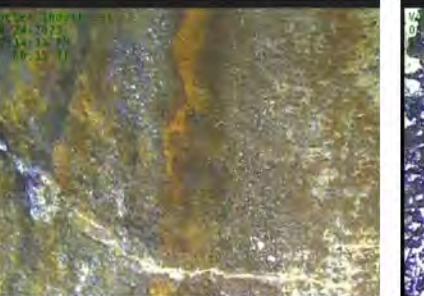
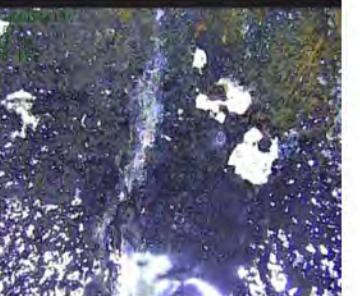
Description	Spatial Type	Distance (ft)	Type	Percent	Clock	SR	O&M	C	PR	Remarks	Photos
Crack Multiple	Point	66.4	Structural	0	3-7	0	0	0	2	Crack Multiple

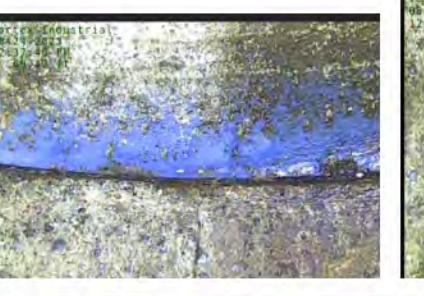
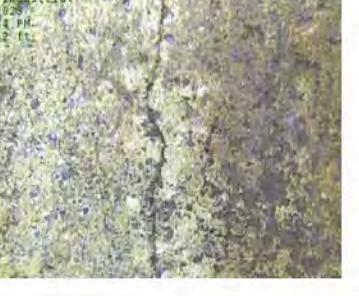
Crack Longitudinal	Point	69.4	Structural	0	2	2	0	0	1	Crack Longitudinal

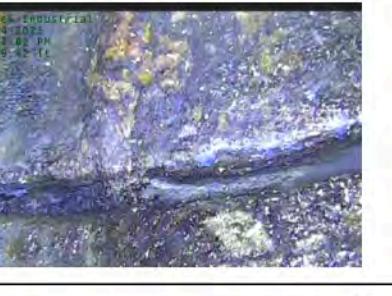
Crack Longitudinal	Point	69.4	Structural	0	7	2	0	0	1	Crack Longitudinal

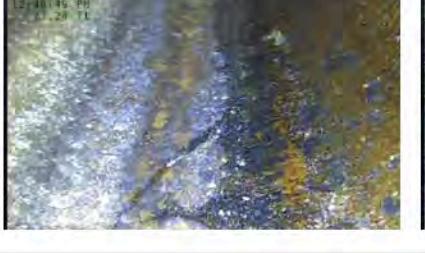
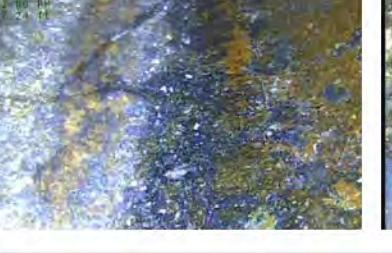
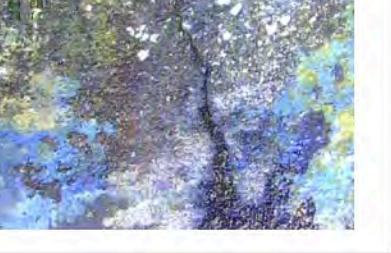
Crack Multiple	Point	77.2	Structural	0	6-7	3	0	0	1	Crack Multiple

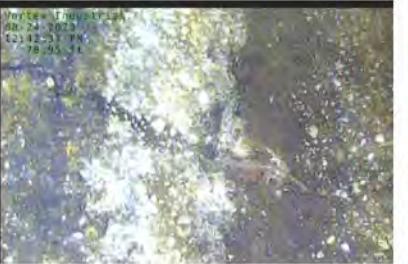
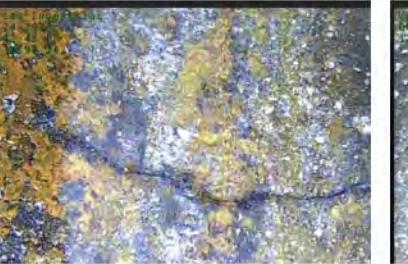
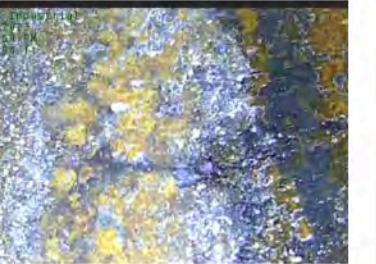
Description	Spatial Type	Distance (ft)	Type	Percent	Clock	SR	O&M	C	PR	Remarks	Photos
Crack Circumferential	Point	79	Structural	0	5-7	1	0	0	1	Crack Circumferential

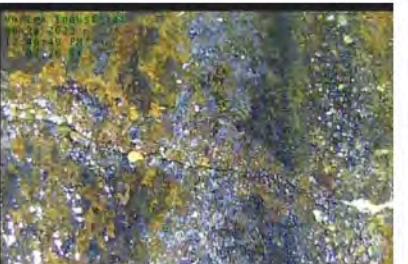
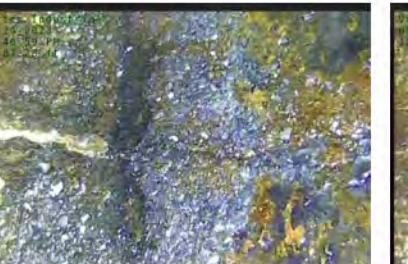
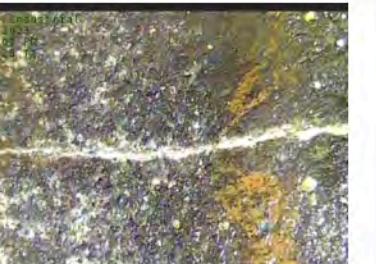
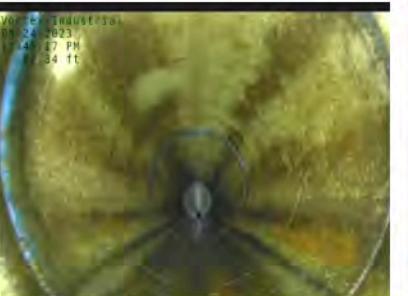
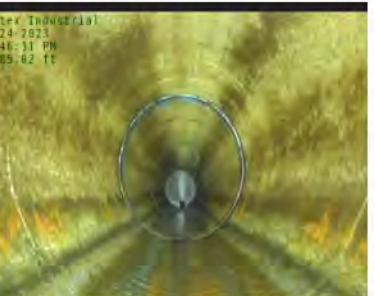
Crack Circumferential	Point	87.3	Structural	0	3-9	1	0	0	1	Crack Circumferential

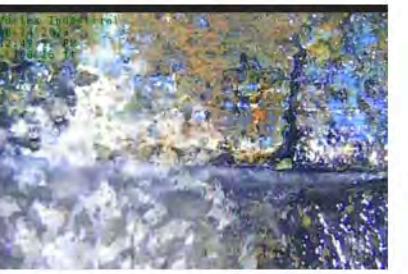
Crack Longitudinal	Point	100.1	Structural	0	6	2	0	0	1	Crack Longitudinal

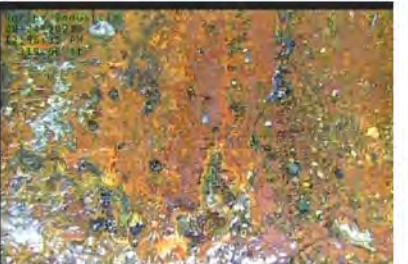
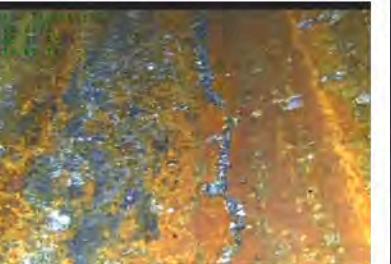
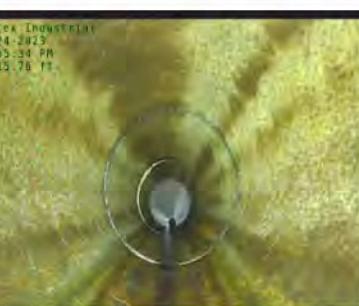
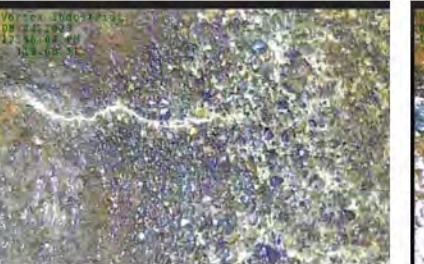
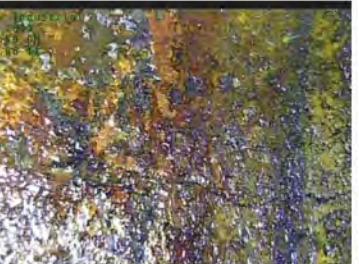
Description	Spatial Type	Distance (ft)	Type	Percent	Clock	SR	O&M	C	PR	Remarks	Photos
Crack Multiple	Point	119.7	Structural	0	4-6	2	0	0	1	Crack Multiple

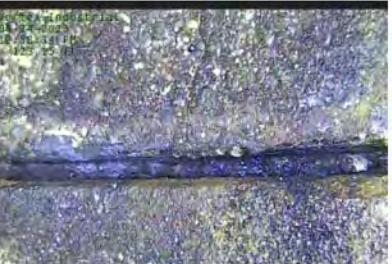
Crack Longitudinal	Point	123.2	Structural	0	10	2	0	0	1	Crack Longitudinal

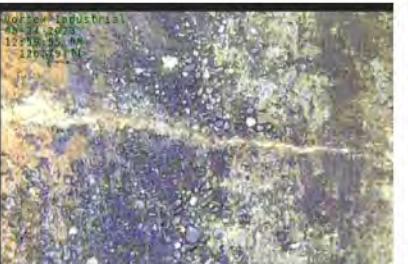
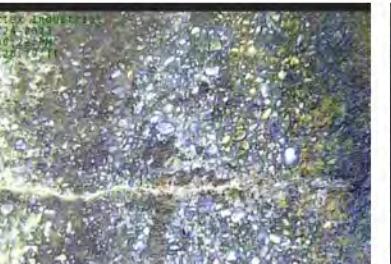
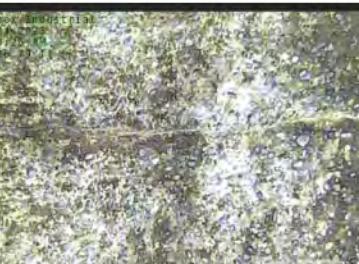
Crack Circumferential	Point	126.8	Structural	0	4-8	1	0	0	1	Crack Circumferential

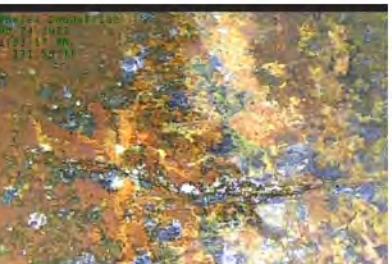
Crack Circumferential	Point	131.6	Structural	0	5-6	1	0	0	1	Crack Circumferential

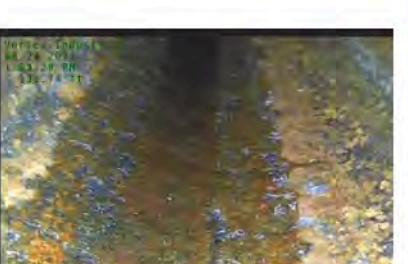
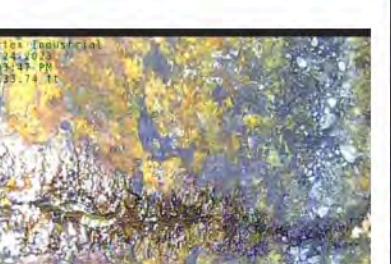
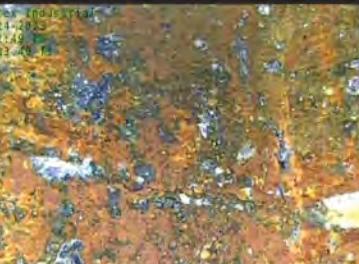
Crack Multiple	Point	133.7	Structural	0	6-7	3	0	0	1	Crack Multiple

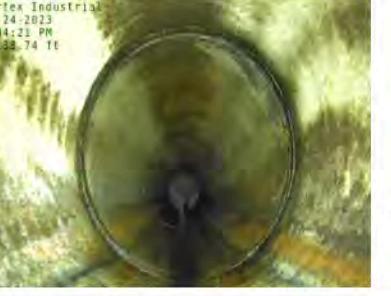
Description	Spatial Type	Distance (ft)	Type	Percent	Clock	SR	O&M	C	PR	Remarks	Photos
Crack Longitudinal	Point	134.4	Structural	0	2	2	0	0	1	Crack Longitudinal

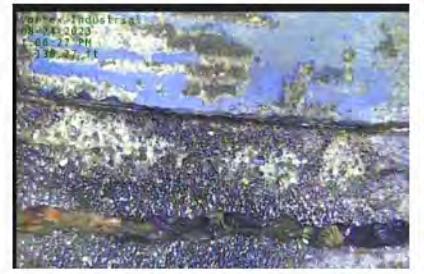
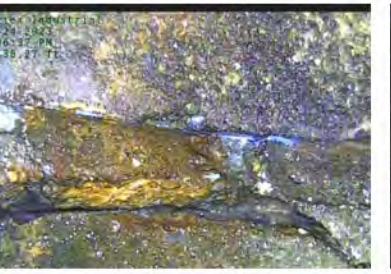
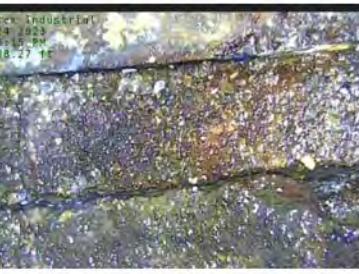
Crack Circumferential	Point	138.3	Structural	0	12-12	1	0	0	2	Crack Circumferential

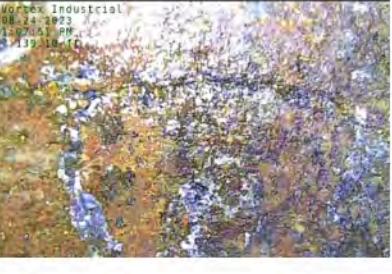
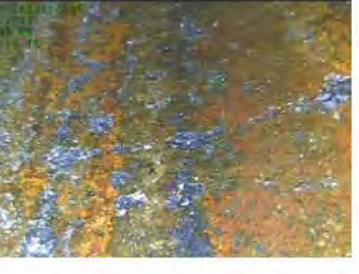
Crack Multiple	Point	139.1	Structural	0	5-7	3	0	0	1	Crack Multiple

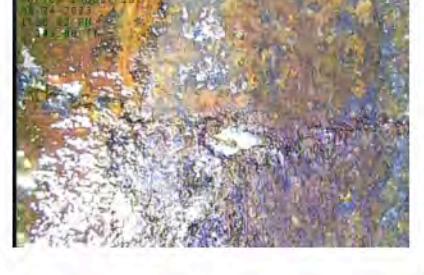
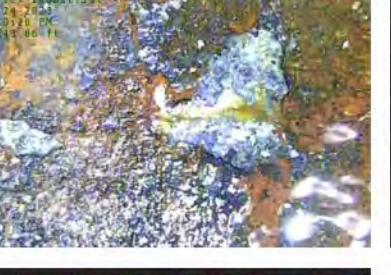
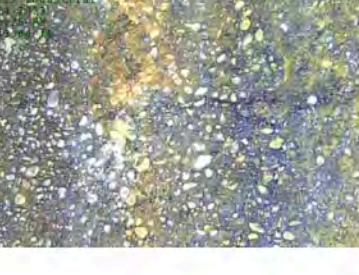
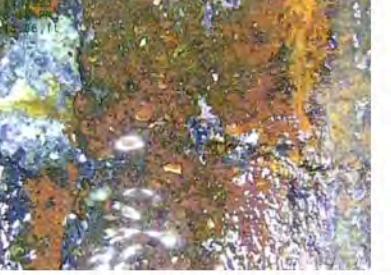
Crack Multiple	Point	143	Structural	0	4-7	3	0	0	1	Crack Multiple

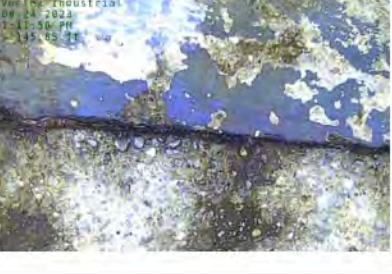
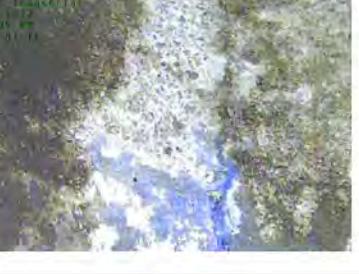
Crack Longitudinal	Point	145.9	Structural	0	3	2	0	0	1	Crack Longitudinal

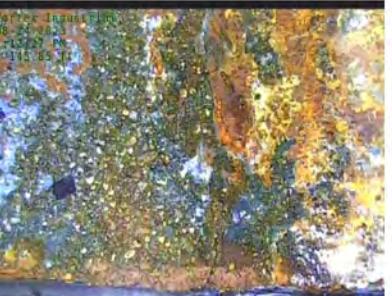
Description	Spatial Type	Distance (ft)	Type	Percent	Clock	SR	O&M	C	PR	Remarks	Photos
Crack Longitudinal	Point	145.9	Structural	0	6	2	0	0	1	Crack Longitudinal

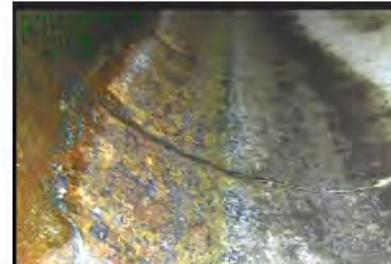
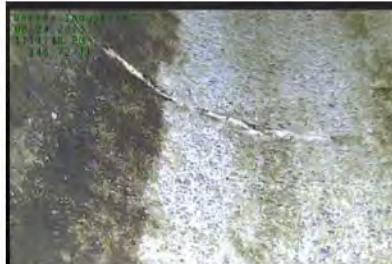
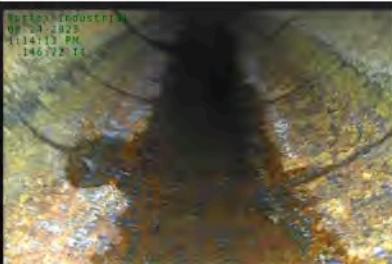
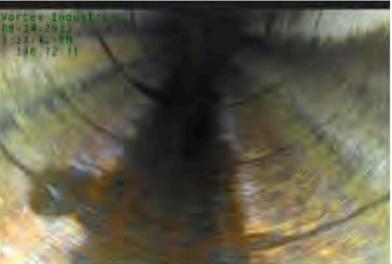
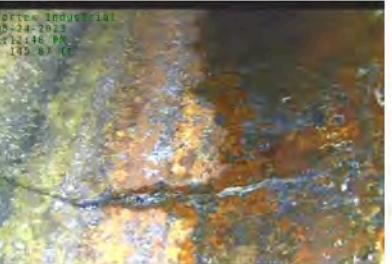
Crack Multiple	Continuous	146.7 - 150	Structural	0	4-8	3	0	0	2	Crack Multiple

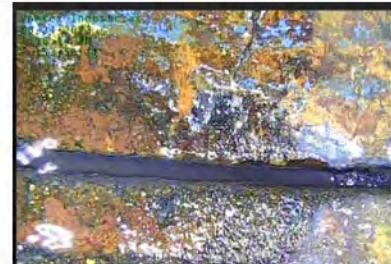
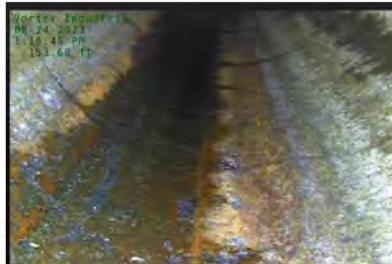
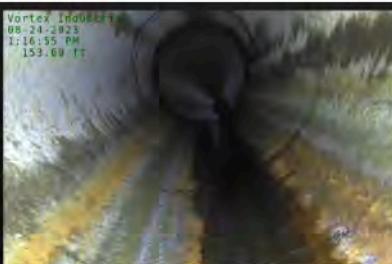
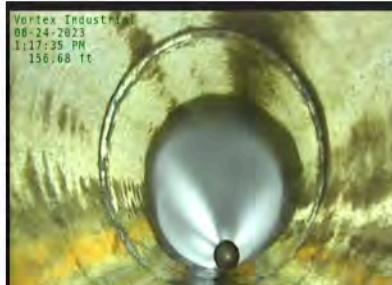
Crack Multiple	Continuous	153.6 - 158.8	Structural	0	4-9	3	0	0	1	Crack Multiple

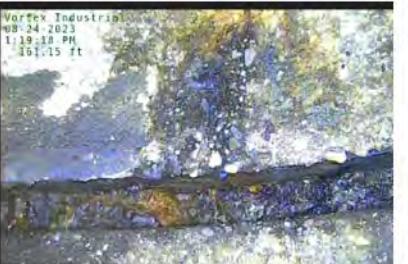
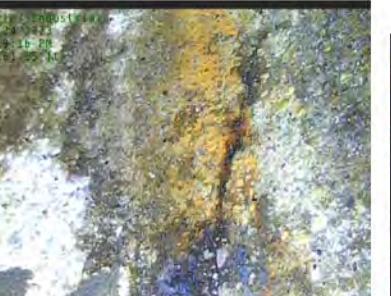
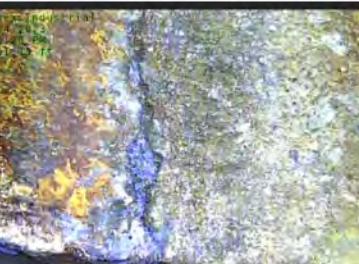
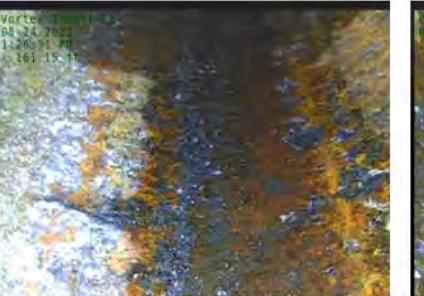
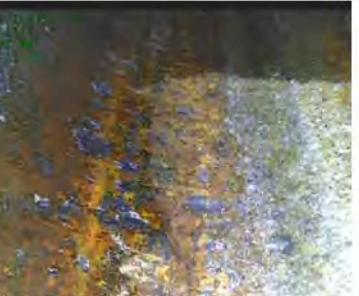
Description	Spatial Type	Distance (ft)	Type	Percent	Clock	SR	O&M	C	PR	Remarks	Photos
Crack Spiral	Point	161.2	Structural	0	5-7	2	0	0	2	Crack Spiral

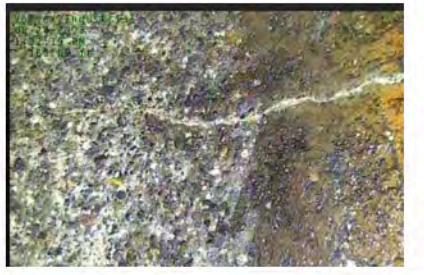
Crack Circumferential	Point	165.9	Structural	0	6-8	1	0	0	1	Crack Circumferential

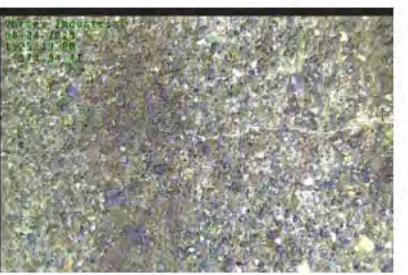
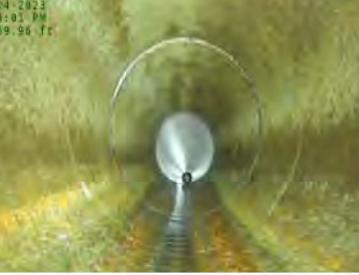
Crack Circumferential	Point	174	Structural	0	3-9	1	0	0	1	Crack Circumferential

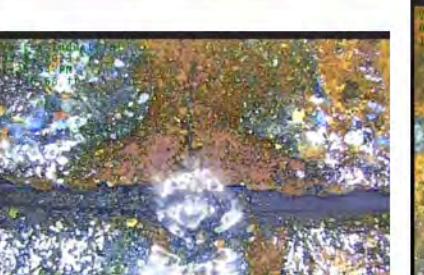
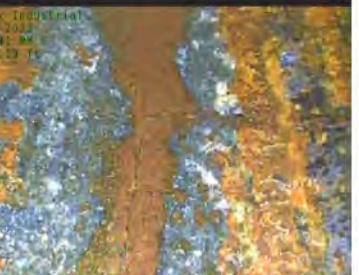
Crack Longitudinal	Point	176.7	Structural	0	6	2	0	0	1	Crack Longitudinal

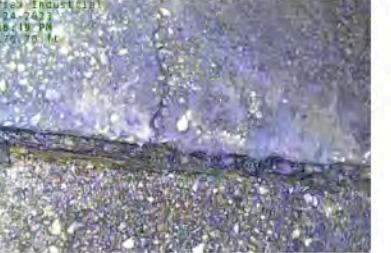
Description	Spatial Type	Distance (ft)	Type	Percent	Clock	SR	O&M	C	PR	Remarks	Photos
Crack Longitudinal	Point	176.7	Structural	0	4	2	0	0	1	Crack Longitudinal

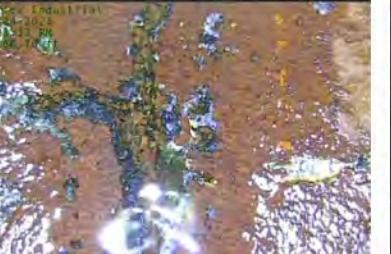
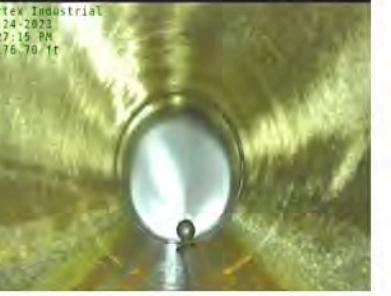
Crack Multiple	Point	180.8	Structural	0	5-8	3	0	0	1	Crack Multiple
