2023 ANNUAL PROGRESS REPORT

SWMU-1 OILY WATER SEWER

HF SINCLAIR PUGET SOUND REFINING LLC

MARCH 21, 2024

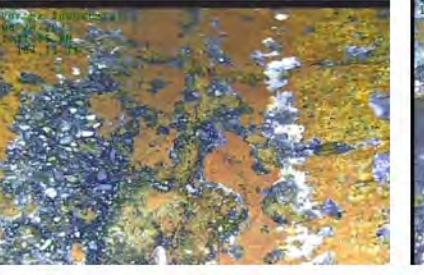
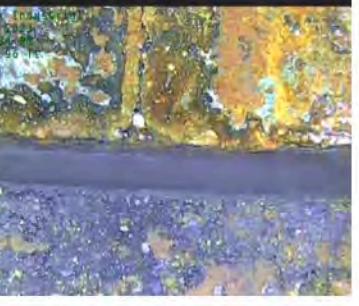
Crack Longitudinal	Point	184	Structural	0	6	2	0	0	1	Crack Longitudinal

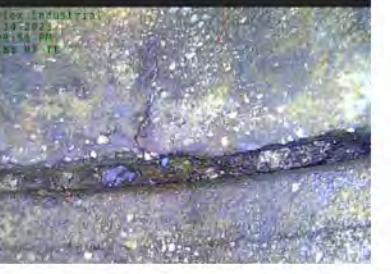
Crack Longitudinal	Point	184	Structural	0	7	2	0	0	1	Crack Longitudinal

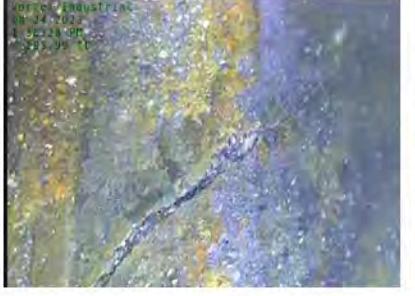
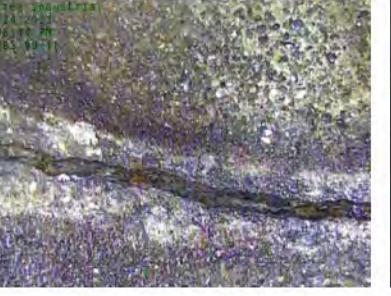
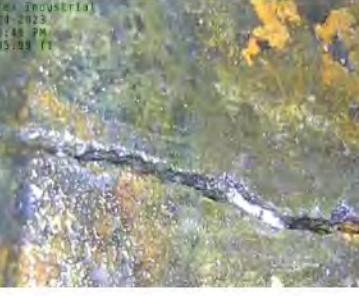
Description	Spatial Type	Distance (ft)	Type	Percent	Clock	SR	O&M	C	PR	Remarks	Photos
Fracture Circumferential	Point	206	Structural	0	7-5	2	0	0	2	Fracture Circumferential

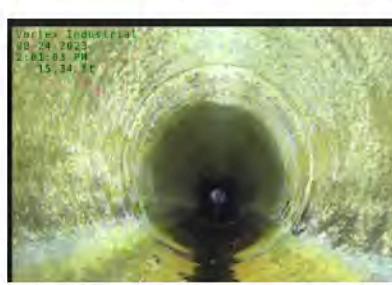
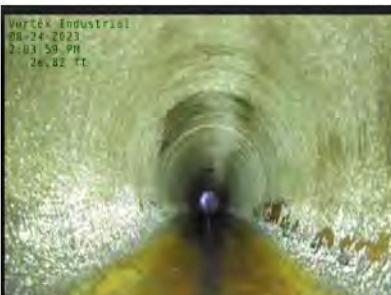
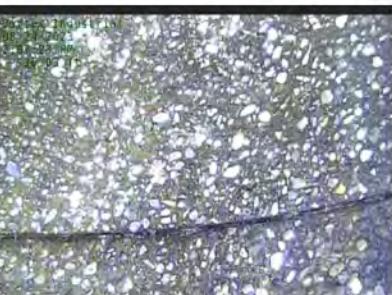
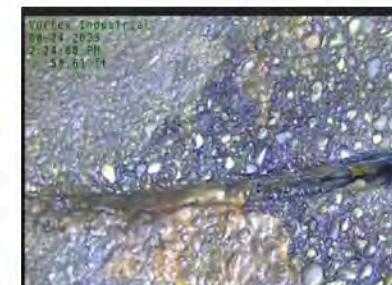
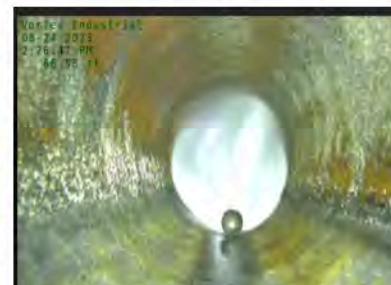
Surface Aggregate Visible	Continuous	0 - 82	Structural	0	12-12	2	0	0	1	Surface Aggregate Visible

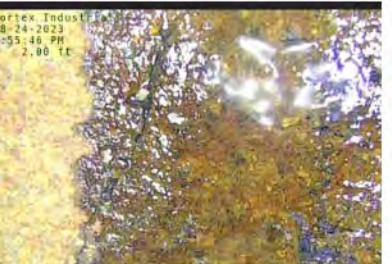
Description	Spatial Type	Distance (ft)	Type	Percent	Clock	SR	O&M	C	PR	Remarks	Photos
Crack Longitudinal	Point	2	Structural	0	6	2	0	0	1	Crack Longitudinal

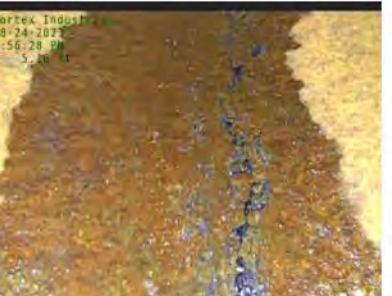
Crack Longitudinal	Point	5.4	Structural	0	6	2	0	0	1	Crack Longitudinal

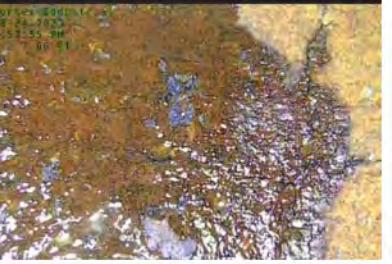
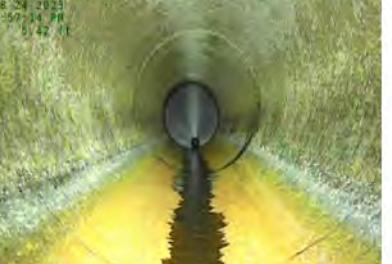
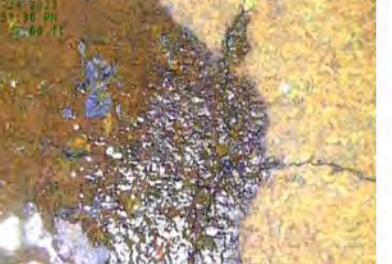
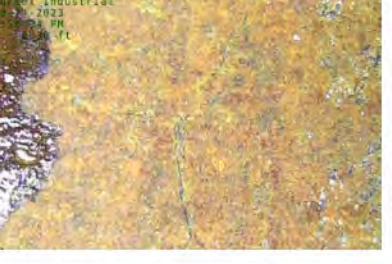
Crack Multiple	Point	7.7	Structural	0	4-8	3	0	0	1	Crack Multiple

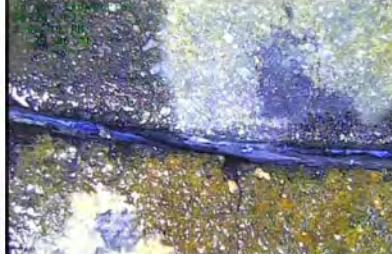
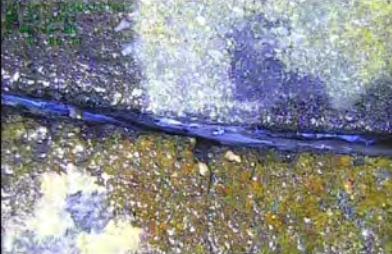
Crack Longitudinal	Point	12.7	Structural	0	5	2	0	0	1	Crack Longitudinal

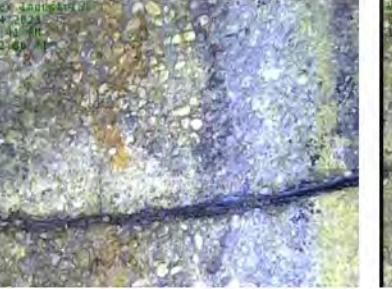
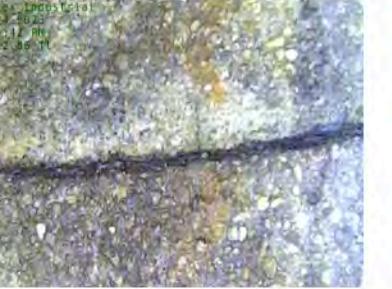
Description	Spatial Type	Distance (ft)	Type	Percent	Clock	SR	O&M	C	PR	Remarks	Photos
Crack Multiple	Point	12.8	Constructional	0	9-10	3	0	0	1	Crack Multiple

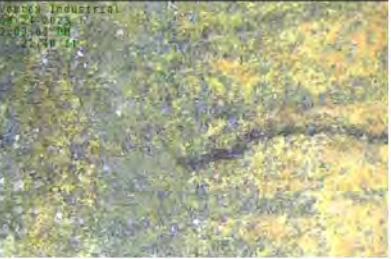
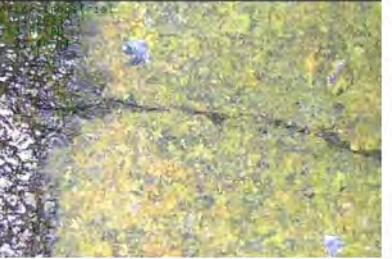
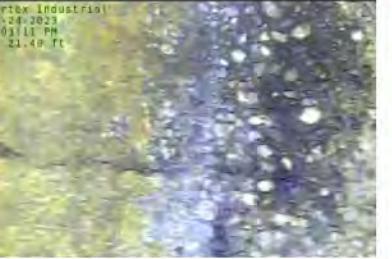
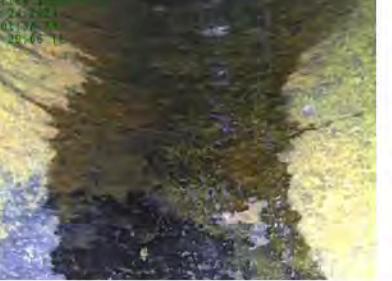
Crack Multiple	Point	21.4	Structural	0	4-7	3	0	0	1	Crack Multiple

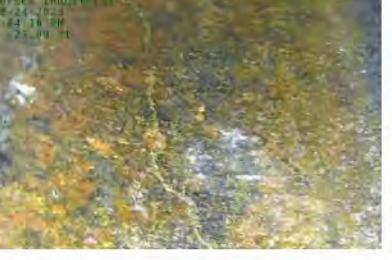
Crack Longitudinal	Point	27.1	Structural	0	6	2	0	0	1	Crack Longitudinal

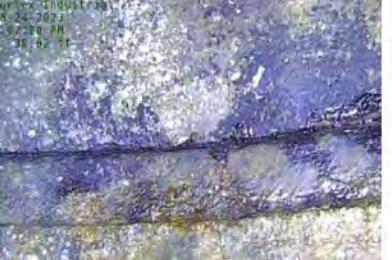
Crack Longitudinal	Point	36	Structural	0	7	2	0	0	1	Crack Longitudinal

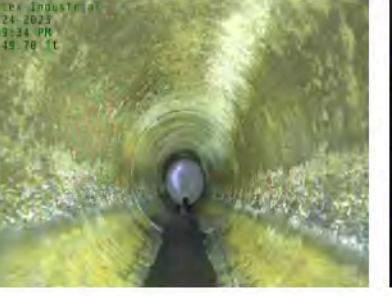
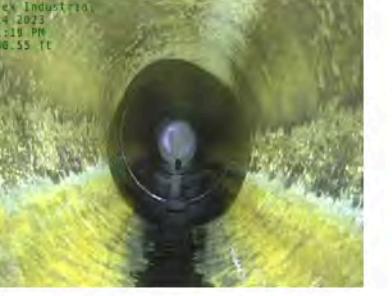
Description	Spatial Type	Distance (ft)	Type	Percent	Clock	SR	O&M	C	PR	Remarks	Photos
Crack Longitudinal	Point	51.5	Structural	0	5	2	0	0	1	Crack Longitudinal

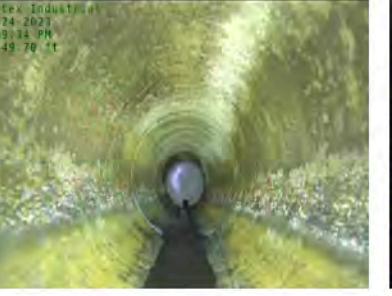
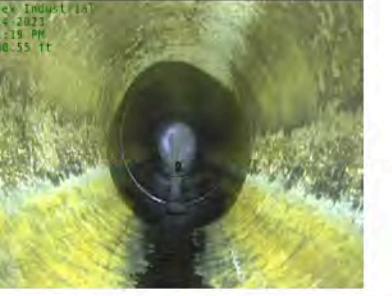
Crack Longitudinal	Point	51.5	Structural	0	7	2	0	0	1	Crack Longitudinal

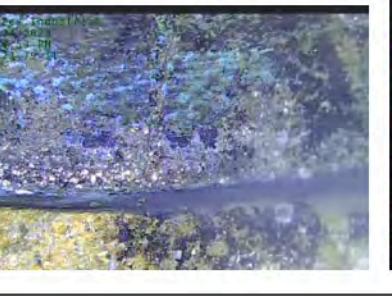
Crack Longitudinal	Point	73.8	Structural	0	6	2	0	0	1	Crack Longitudinal

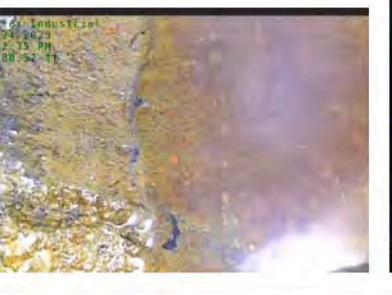
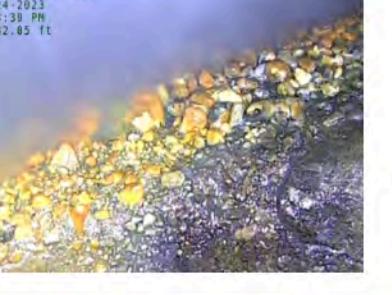
Crack Longitudinal	Point	80.5	Structural	0	6	2	0	0	1	Crack Longitudinal

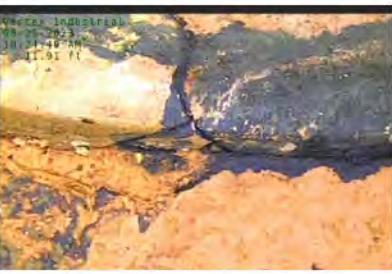
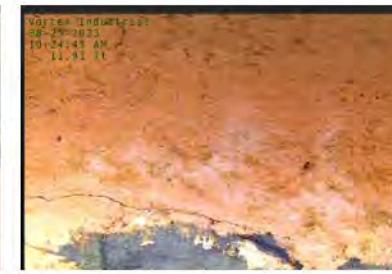
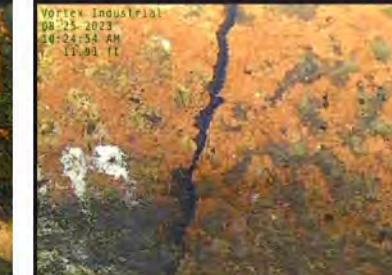
Crack Multiple	Point	2	Structural	0	11-1	3	0	0	2	Crack Multiple

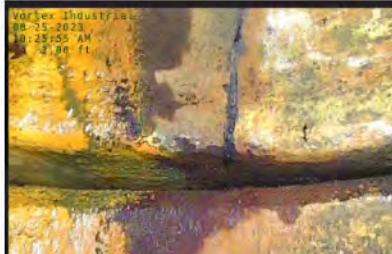
Description	Spatial Type	Distance (ft)	Type	Percent	Clock	SR	O&M	C	PR	Remarks	Photos
Crack Longitudinal	Point	2	Structural	0	5	2	0	0	1	Crack Longitudinal

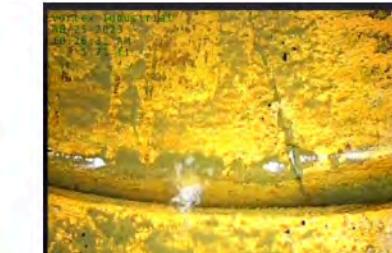
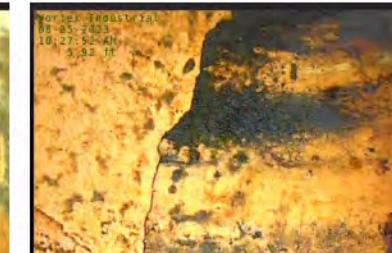
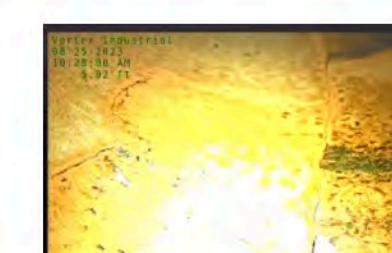
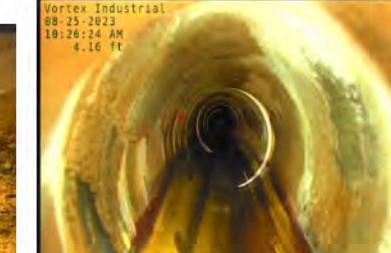
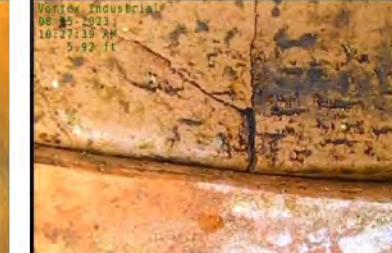
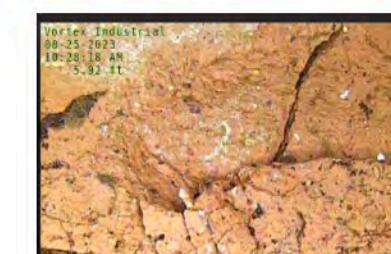
Fracture Multiple	Point	5.7	Structural	0	6-10	3	0	0	3	Fracture Multiple

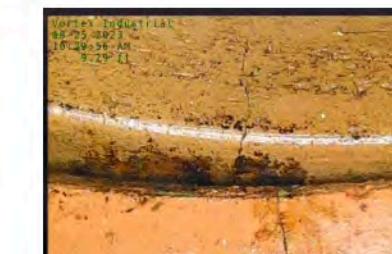
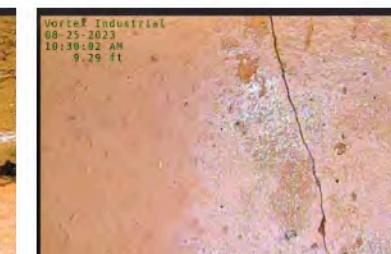
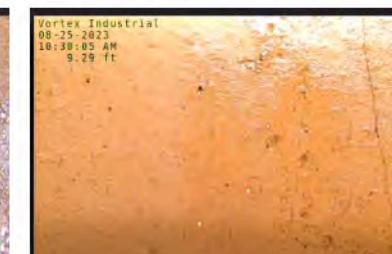
Crack Longitudinal	Point	9.3	Structural	0	12	2	0	0	1	Crack Longitudinal

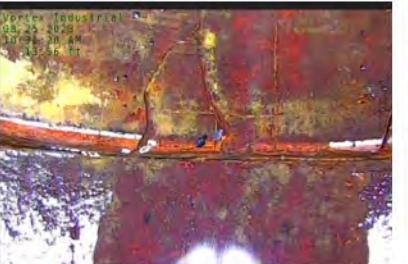
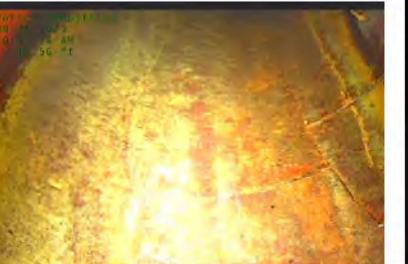
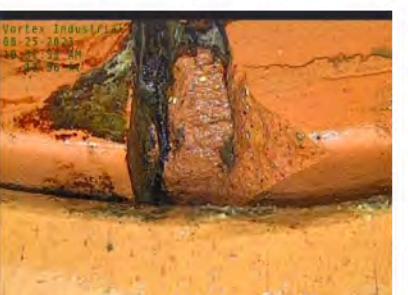
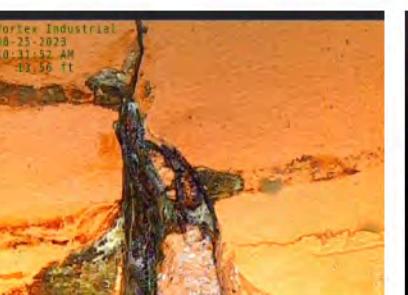
Description	Spatial Type	Distance (ft)	Type	Percent	Clock	SR	O&M	C	PR	Remarks	Photos
Fracture Multiple	Point	13.6	Structural	0	12-12	3	0	0	3	Fracture Multiple

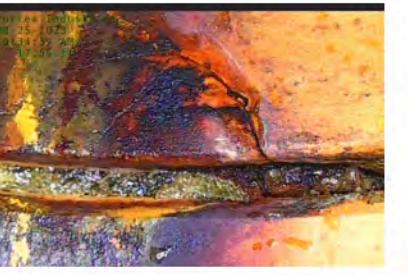
Crack Multiple	Point	17.6	Structural	0	5-6	3	0	0	1	Crack Multiple

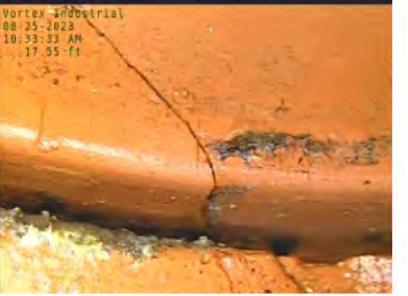
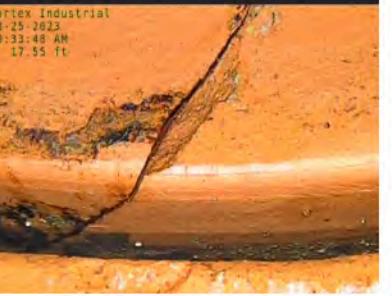
Crack Multiple	Point	17.6	Structural	0	10-1	3	0	0	2	Crack Multiple

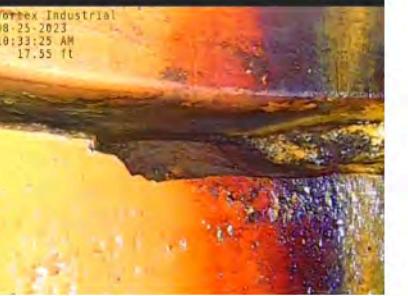
Fracture Spiral	Point	17.6	Structural	0	6-7	3	0	0	2	Fracture Spiral

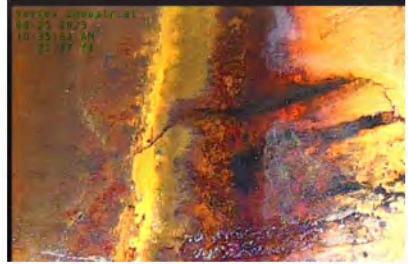
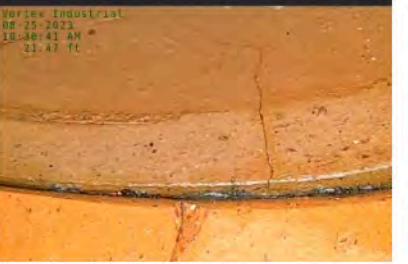
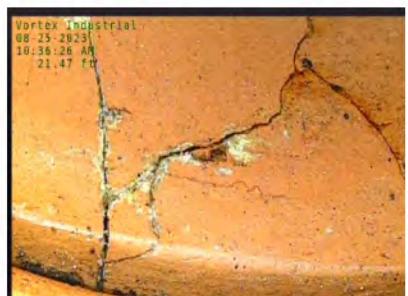
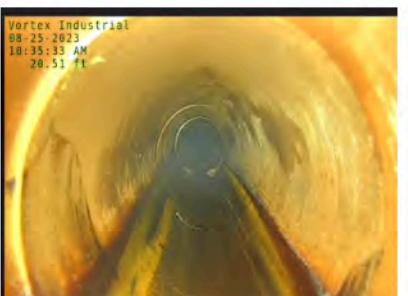
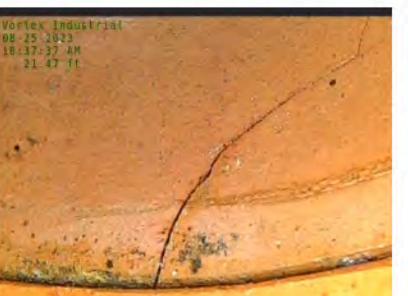
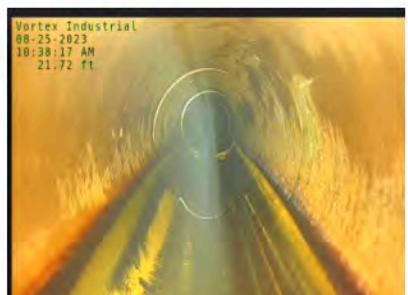
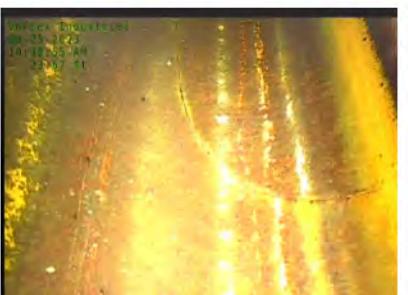
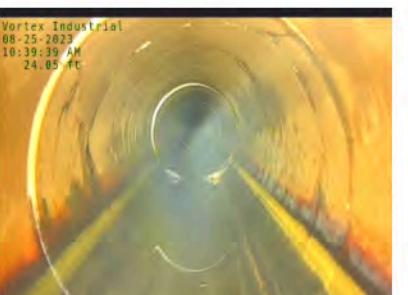
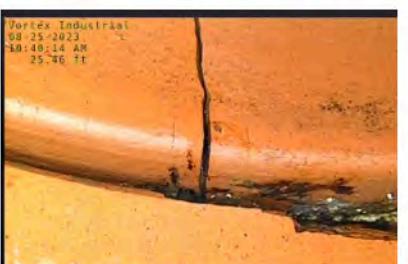
Description	Spatial Type	Distance (ft)	Type	Percent	Clock	SR	O&M	C	PR	Remarks	Photos
Crack Multiple	Continuous	21.5 - 26	Structural	0	12-12	3	0	0	2	Crack Multiple

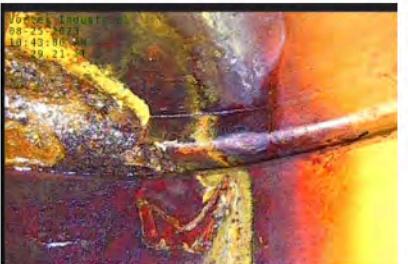
Crack Longitudinal	Point	29.2	Structural	0	6	2	0	0	1	Crack Longitudinal

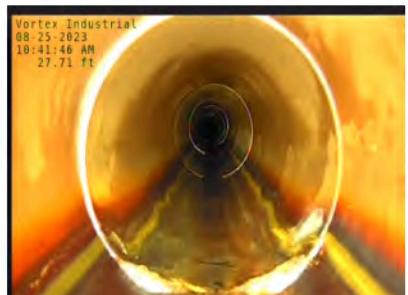
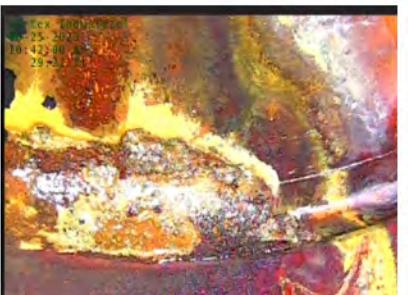
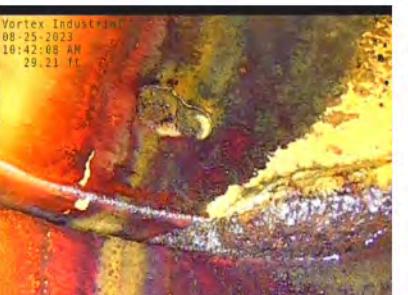
Deposits Attached Encrustation	Point	29.2	O&M	10	5-7	0	2	0	0	Deposits Attached Encrustation

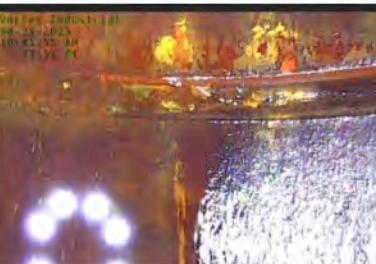
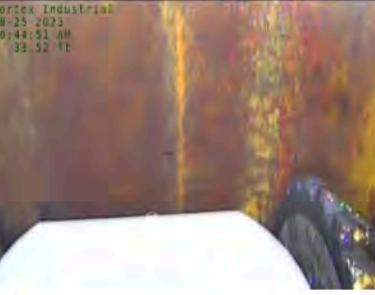
Crack Longitudinal	Point	33.5	Structural	0	6	2	0	0	1	Crack Longitudinal

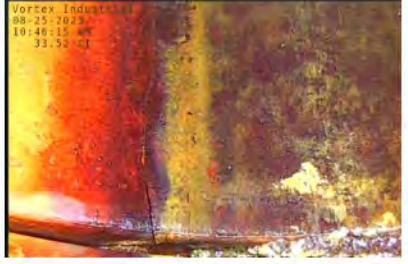
Crack Longitudinal	Point	33.5	Structural	0	7	2	0	0	1	Crack Longitudinal

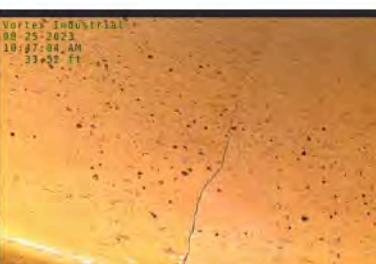
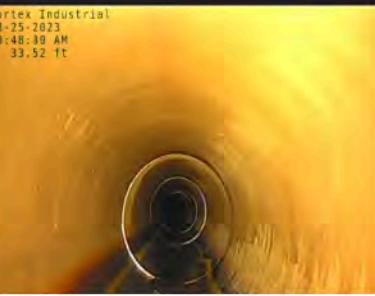
Crack Longitudinal	Continuous	33.5 - 36.8	Structural	0	10	2	0	0	1	Crack Longitudinal

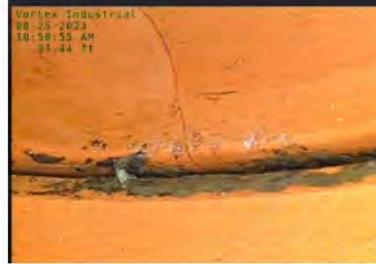
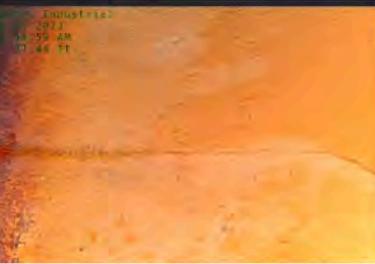
Crack Spiral	Point	37.4	Structural	0	3-5	2	0	0	1	Crack Spiral

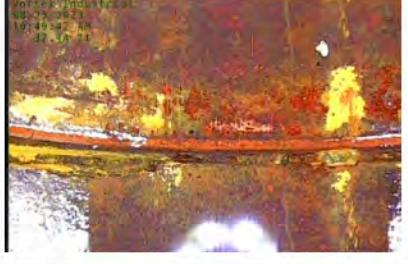
Crack Longitudinal	Point	37.4	Structural	0	6	2	0	0	1	Crack Longitudinal

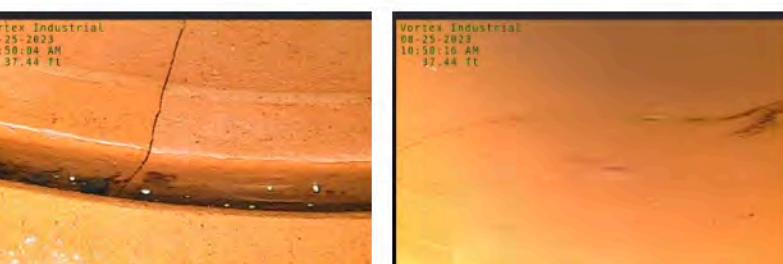
Crack Spiral	Point	37.4	Structural	0	8-10	2	0	0	1	Crack Spiral

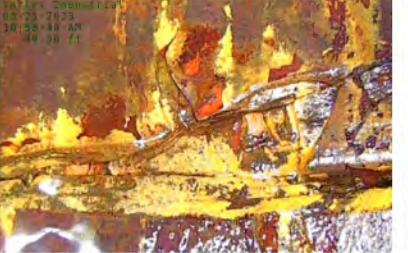
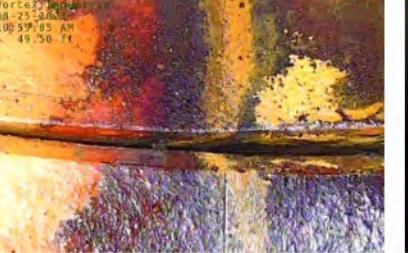
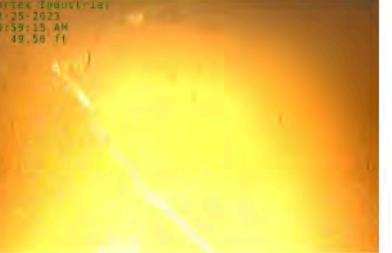
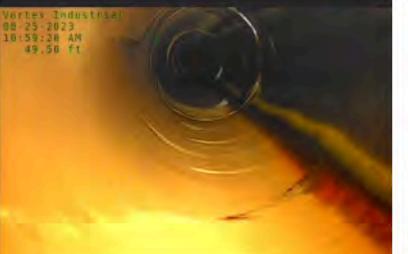
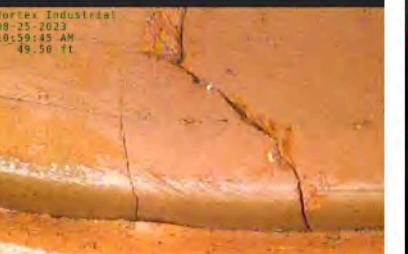
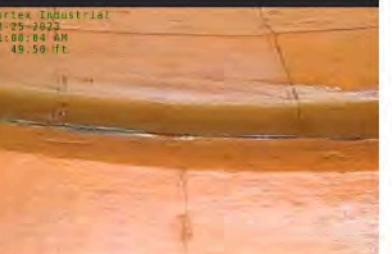
Description	Spatial Type	Distance (ft)	Type	Percent	Clock	SR	O&M	C	PR	Remarks	Photos
Crack Multiple	Point	49.5	Structural	0	12-12	3	0	0	2	Crack Multiple

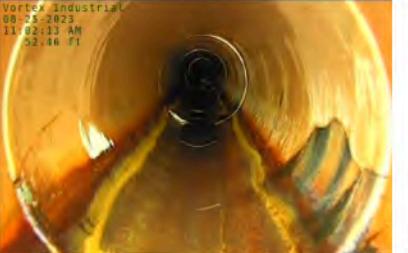
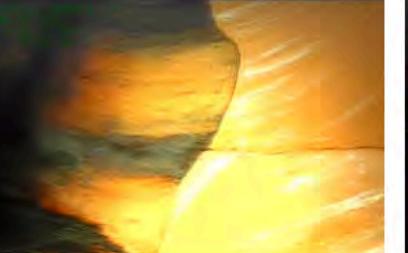
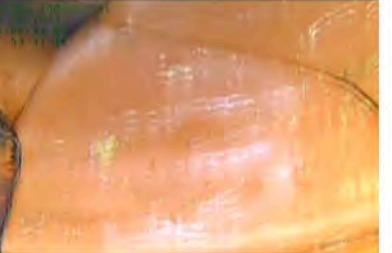
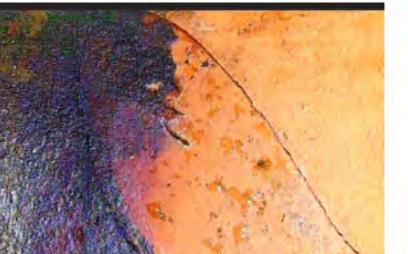
Fracture Multiple	Point	53.4	Structural	0	12-12	3	0	0	3	Fracture Multiple

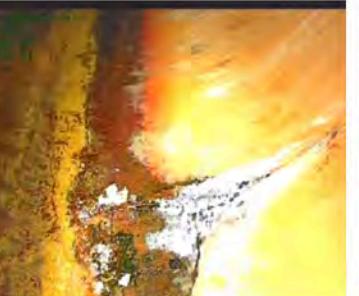
Description	Spatial Type	Distance (ft)	Type	Percent	Clock	SR	O&M	C	PR	Remarks	Photos
Crack Multiple	Point	57.4	Structural	0	3-7	3	0	0	1	Crack Multiple

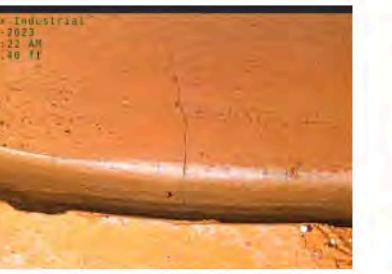
Crack Longitudinal	Point	57.4	Structural	0	12	2	0	0	1	Crack Longitudinal

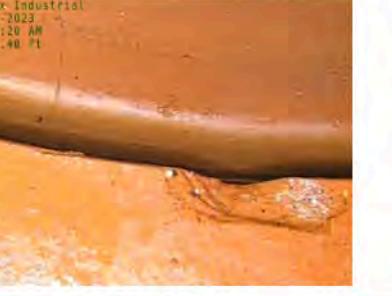
Fracture Spiral	Point	57.4	Structural	0	10-11	3	0	0	2	Fracture Spiral

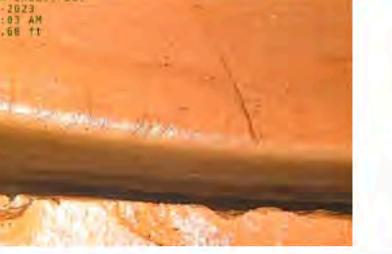
Crack Longitudinal	Point	61.7	Structural	0	10	2	0	0	1	Crack Longitudinal

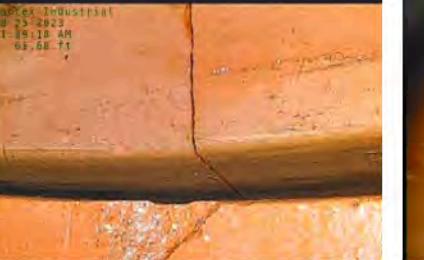
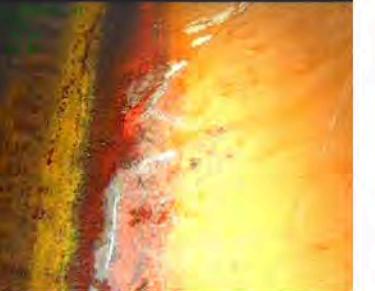
Description	Spatial Type	Distance (ft)	Type	Percent	Clock	SR	O&M	C	PR	Remarks	Photos
Crack Multiple	Point	61.7	Structural	0	3-5	3	0	0	2	Crack Longitudinal

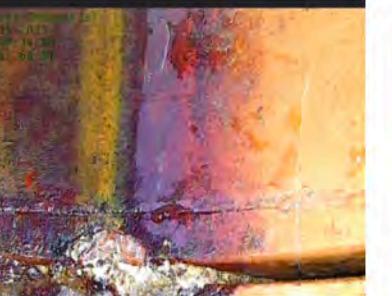
Crack Longitudinal	Point	61.7	Structural	0	6	2	0	0	1	Crack Longitudinal

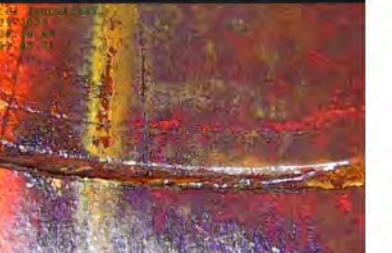
Crack Longitudinal	Point	61.7	Structural	0	7	2	0	0	1	Crack Longitudinal

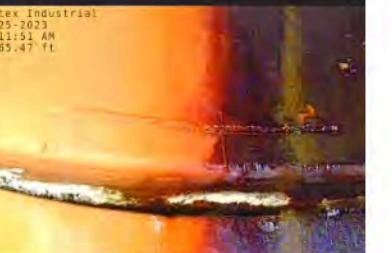
Crack Longitudinal	Point	65.5	Structural	0	7	2	0	0	1	Crack Longitudinal

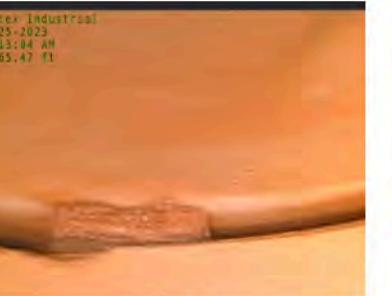
Fracture Spiral	Point	65.5	Structural	0	2-3	3	0	0	2	Fracture Spiral

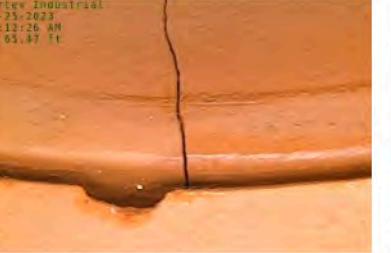
Description	Spatial Type	Distance (ft)	Type	Percent	Clock	SR	O&M	C	PR	Remarks		Photos
Crack Spiral	Point	65.5	Structural	0	2-5	2	0	0	1	Crack Spiral

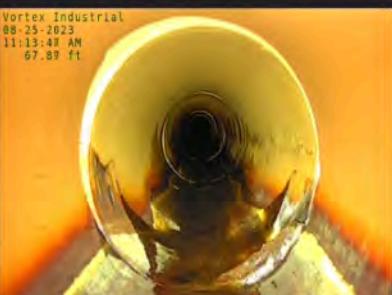
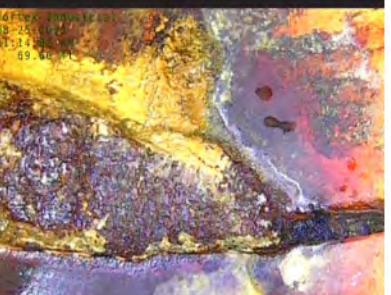
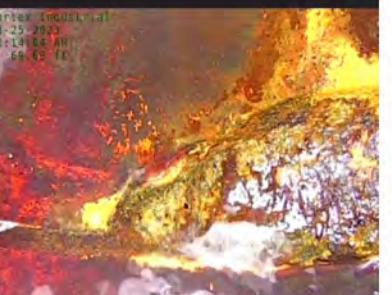
Fracture Multiple	Point	69.6	Structural	0	5-6	4	0	0	2	Fracture Multiple

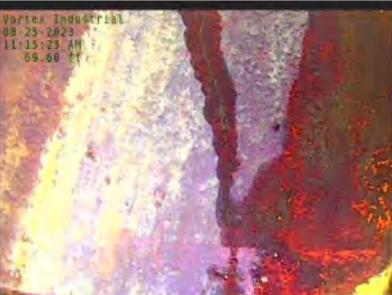
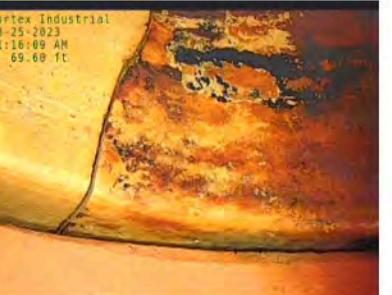
Fracture Spiral	Point	69.6	Structural	0	7-9	3	0	0	2	Fracture Spiral

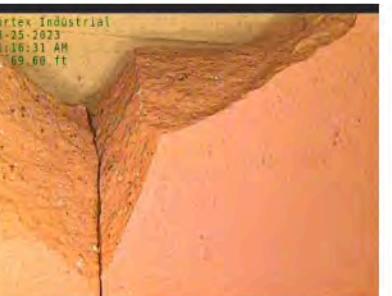
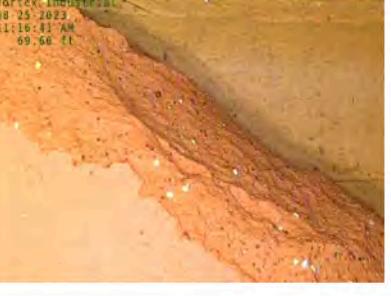
Fracture Circumferential	Point	69.6	Structural	0	10-11	2	0	0	2	Fracture Circumferential

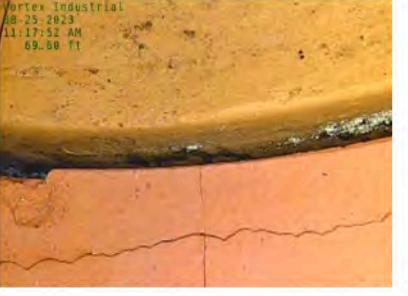
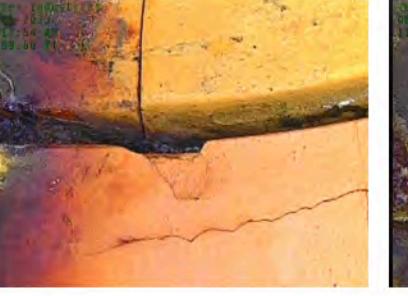
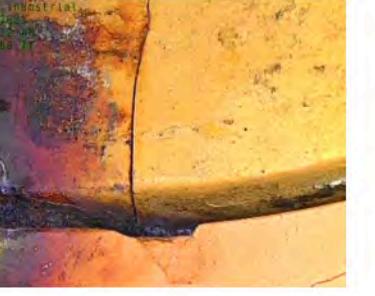
Description	Spatial Type	Distance (ft)	Type	Percent	Clock	SR	O&M	C	PR	Remarks	Photos
Crack Multiple	Point	69.6	Structural	0	3-4	3	0	0	2	Crack Multiple

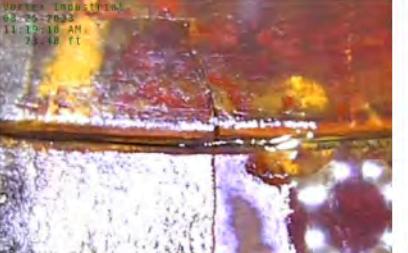
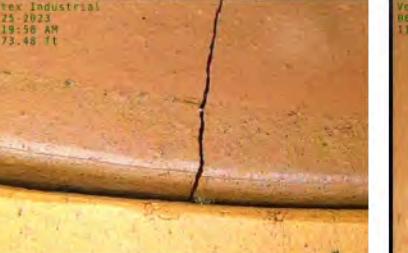
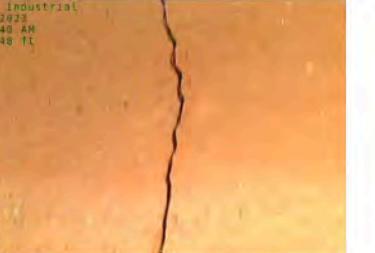
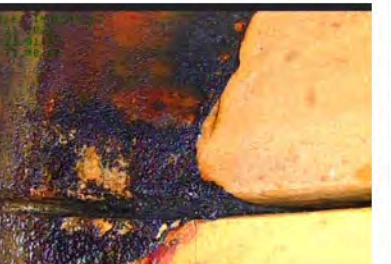
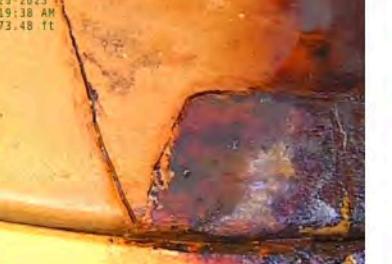
Crack Multiple	Point	73.5	Structural	0	12-12	3	0	0	2	Crack Multiple

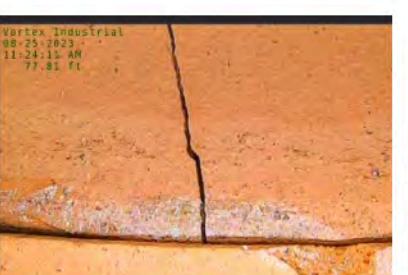
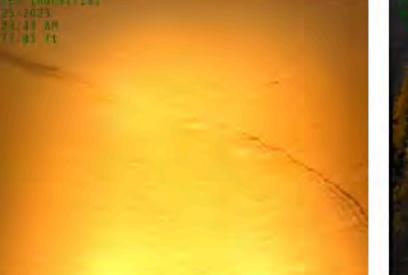
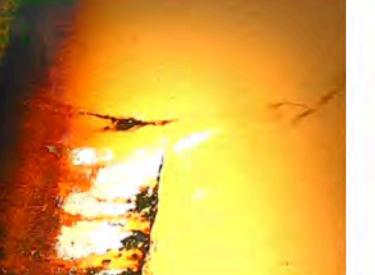
Crack Multiple	Point	77.8	Structural	0	12-5	2	0	0	2	Crack Multiple

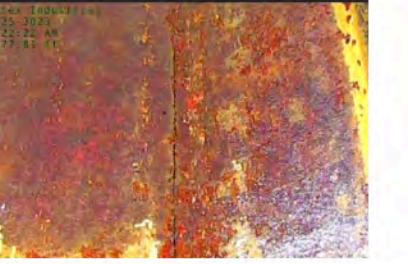
Crack Longitudinal	Point	77.8	Structural	0	6	2	0	0	1	Crack Longitudinal

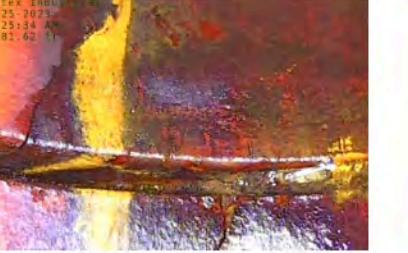
Crack Multiple	Point	81.6	Structural	0	6-7	3	0	0	1	Crack Multiple

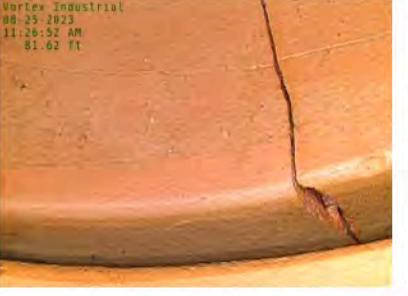
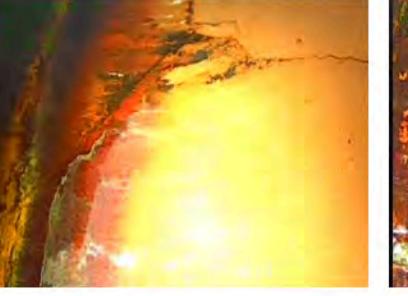
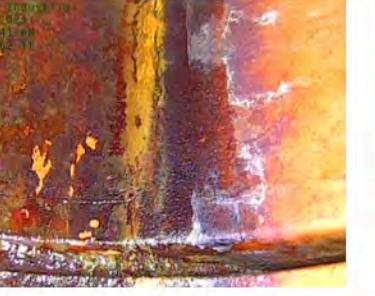
Description	Spatial Type	Distance (ft)	Type	Percent	Clock	SR	O&M	C	PR	Remarks	Photos
Fracture Multiple	Point	81.6	Structural	0	2-5	3	0	0	2	Fracture Multiple

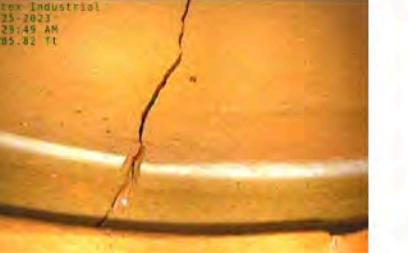
Crack Longitudinal	Point	85.8	Structural	0	1	2	0	0	2	Crack Longitudinal

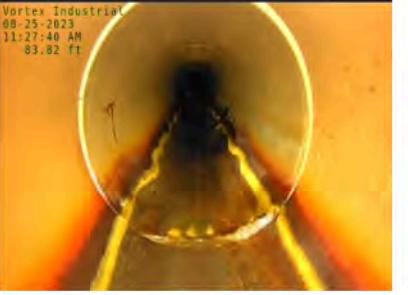
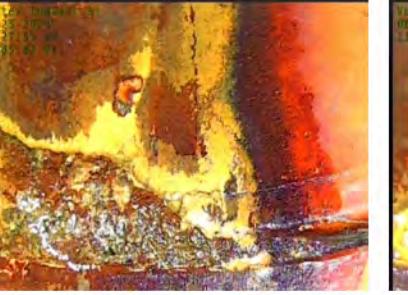
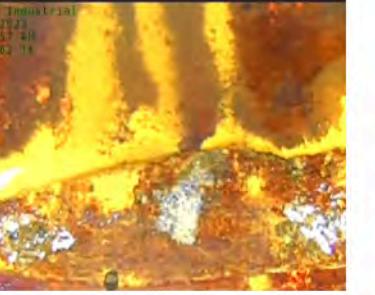
Deposits Attached Encrustation	Point	85.8	O&M	10	5-7	0	2	0	0	Deposits Attached Encrustation

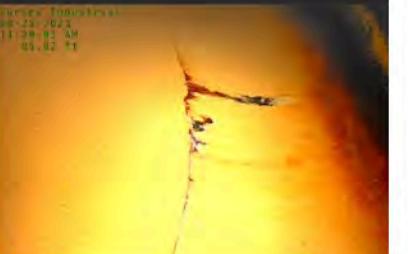
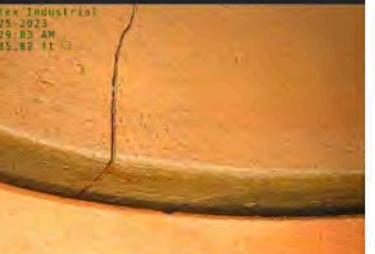
Crack Longitudinal	Point	85.8	Structural	0	9	2	0	0	2	Crack Longitudinal

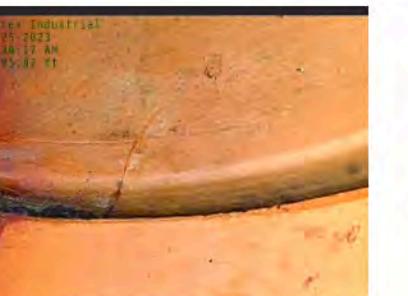
Crack Longitudinal	Point	85.8	Structural	0	4	2	0	0	1	Crack Longitudinal

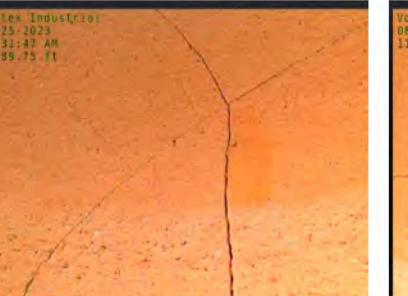
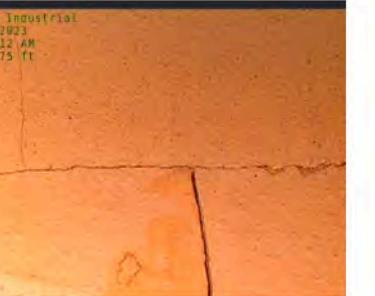
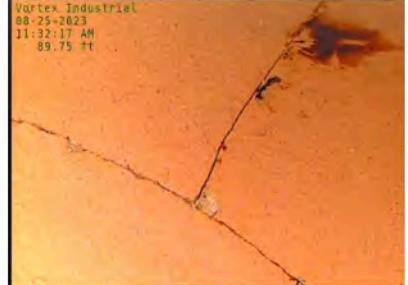
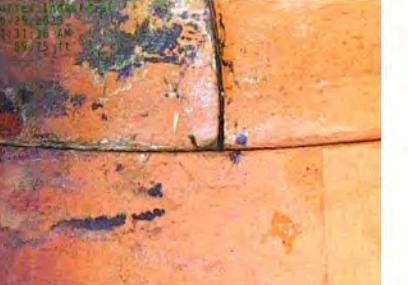
Description	Spatial Type	Distance (ft)	Type	Percent	Clock	SR	O&M	C	PR	Remarks	Photos
Crack Multiple	Point	89.6	Structural	0	12-12	3	0	0	2	Crack Multiple

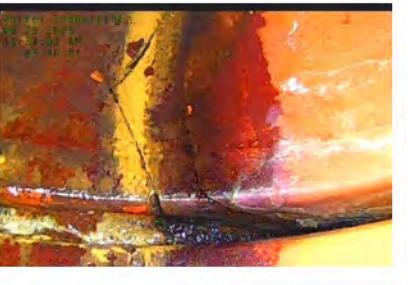
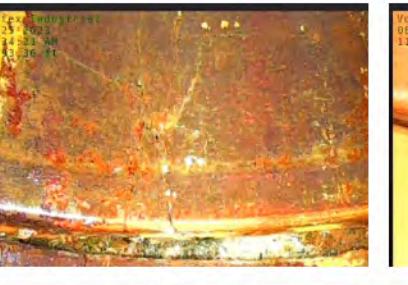
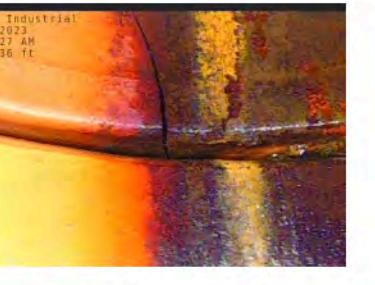
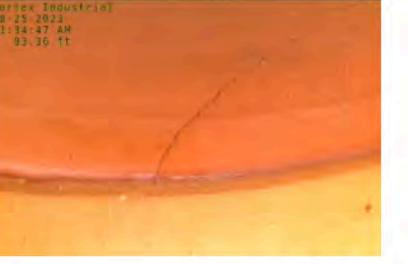
Crack Multiple	Point	93.4	Structural	0	12-12	3	0	0	2	Crack Multiple

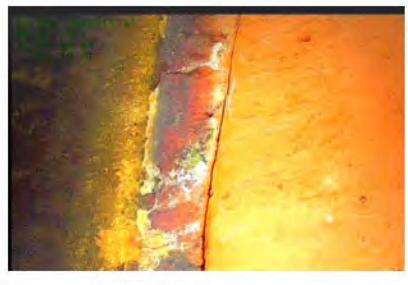
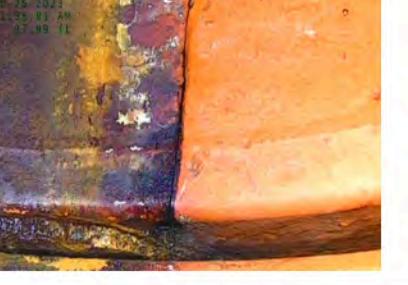
Crack Longitudinal	Point	98	Structural	0	5	2	0	0	1	Crack Longitudinal

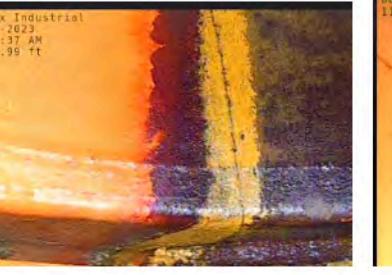
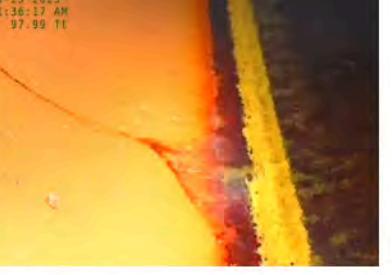
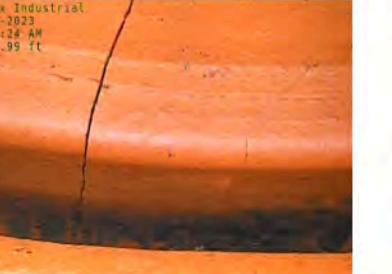
Description	Spatial Type	Distance (ft)	Type	Percent	Clock	SR	O&M	C	PR	Remarks	Photos
Crack Spiral	Point	98	Structural	0	7-11	3	0	0	1	Crack Spiral

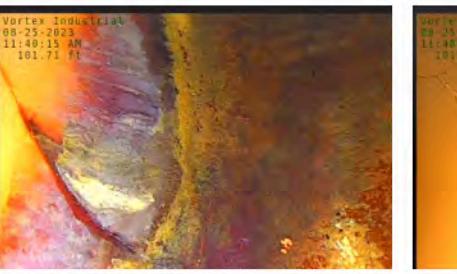
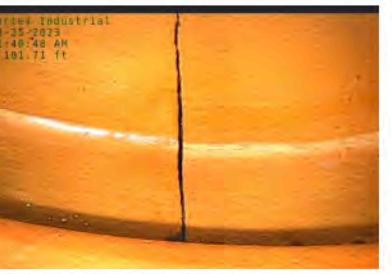
Crack Multiple	Point	101.7	Structural	0	6-12	3	0	0	2	Crack Multiple

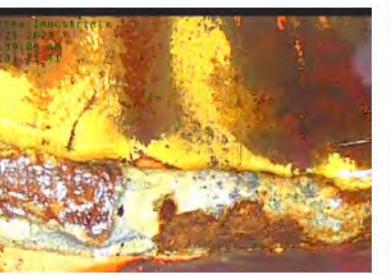
Deposits Settled Hard/Compacted	Point	101.7	O&M	10	6-7	0	2	0	0	Deposits Settled Hard/Compacted

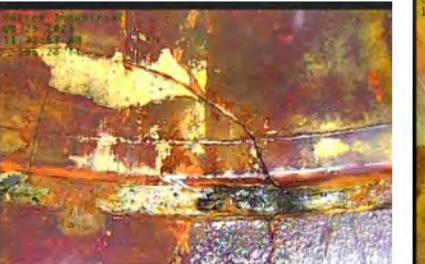
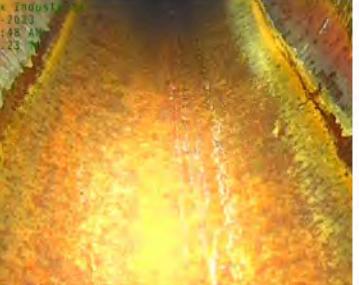
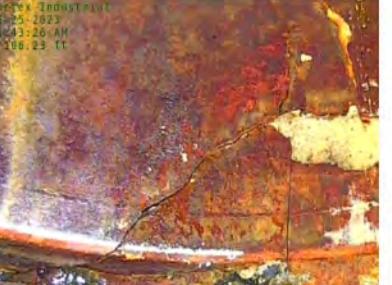
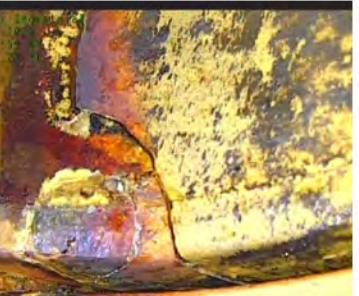
Description	Spatial Type	Distance (ft)	Type	Percent	Clock	SR	O&M	C	PR	Remarks	Photos
Crack Multiple	Point	106.2	Structural	0	5-7	3	0	0	2	Crack Multiple

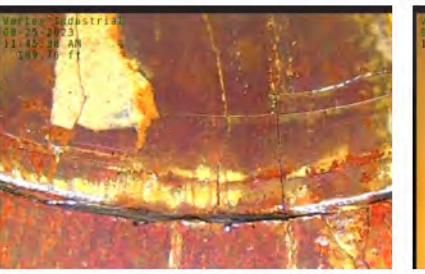
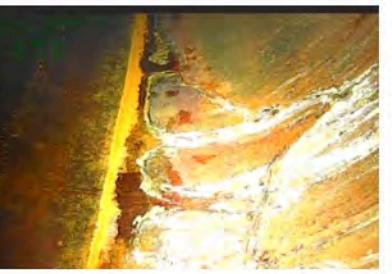
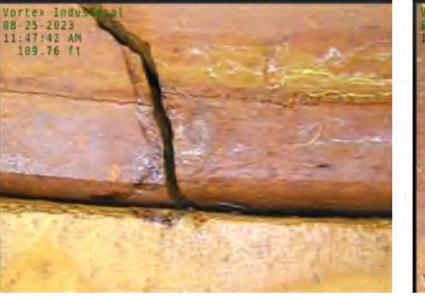
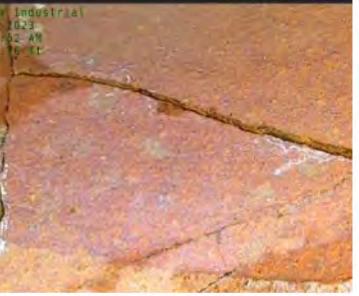
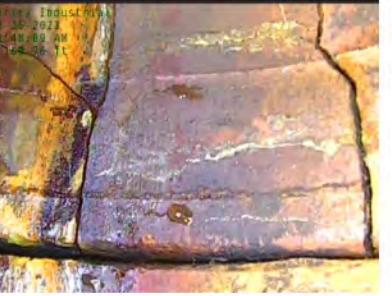
Fracture Multiple	Point	109.8	Structural	0	12-12	3	0	0	3	Fracture Multiple

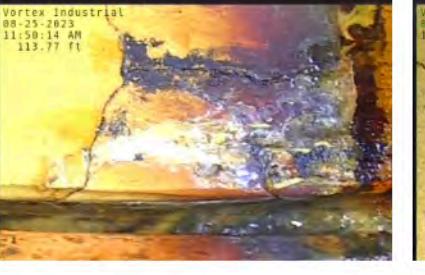
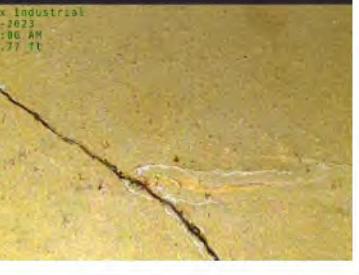
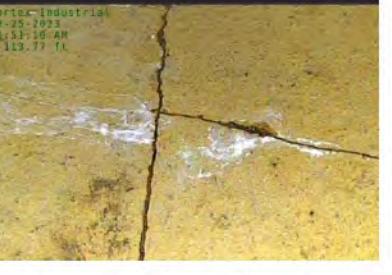
Crack Multiple	Point	113.8	Structural	0	12-12	3	0	0	2	Crack Multiple

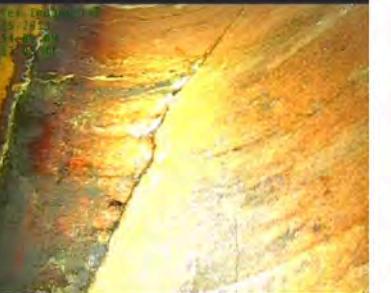
Description	Spatial Type	Distance (ft)	Type	Percent	Clock	SR	O&M	C	PR	Remarks	Photos
Crack Multiple	Point	118	Structural	0	12-6	3	0	0	2	Crack Multiple

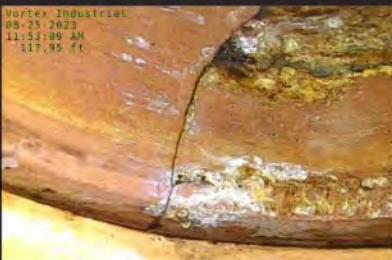
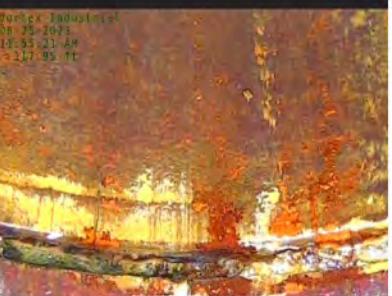
Crack Spiral	Point	118	Structural	0	6-8	2	0	0	1	Crack Spiral

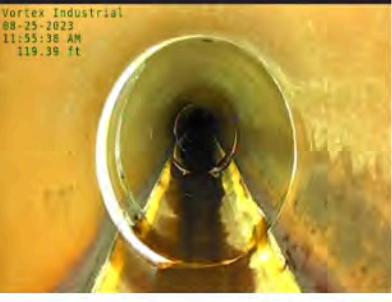
Joint Offset Medium	Point	121.8	Structural	0		3	0	0	1	Joint Offset Medium

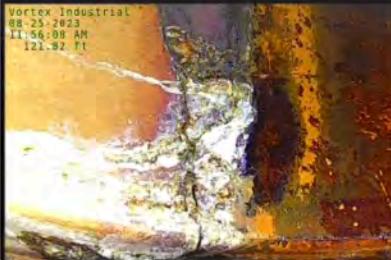
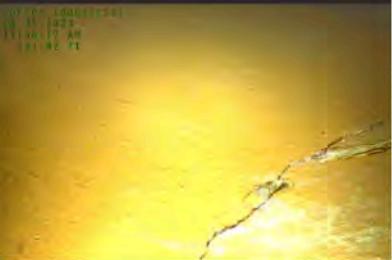
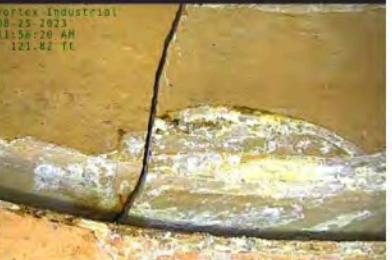
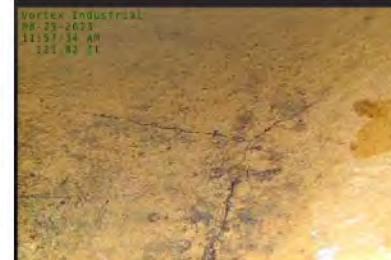
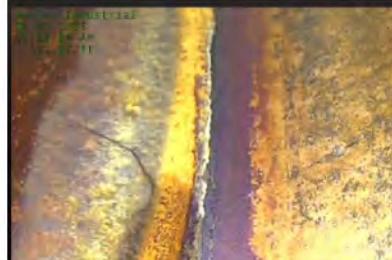
Crack Multiple	Point	121.8	Structural	0	12-12	3	0	0	2	Crack Multiple

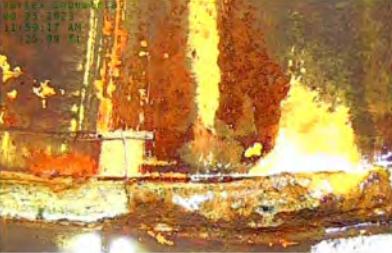
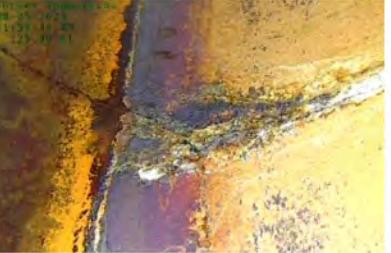
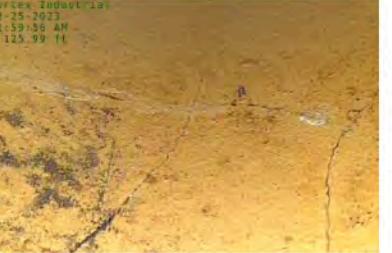
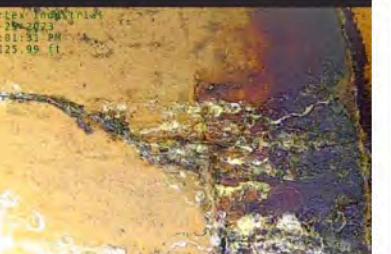
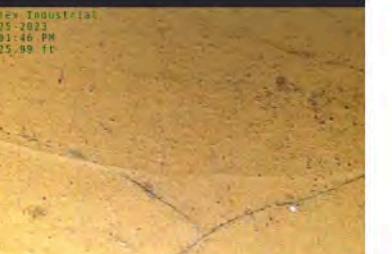
Description	Spatial Type	Distance (ft)	Type	Percent	Clock	SR	O&M	C	PR	Remarks	Photos
Crack Multiple	Point	126	Structural	0	12-12	3	0	0	1	Crack Multiple

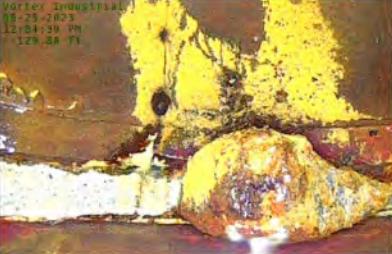
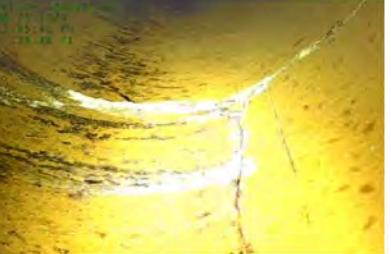
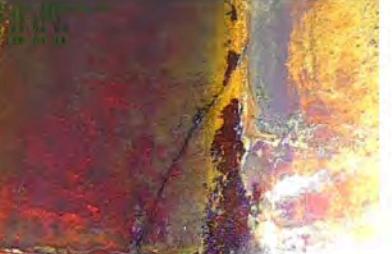
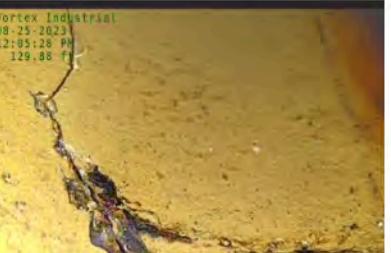
Crack Multiple	Point	130.4	Structural	0	12-12	3	0	0	2	Crack Multiple

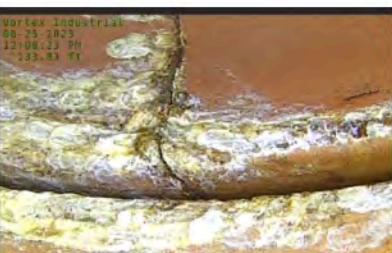
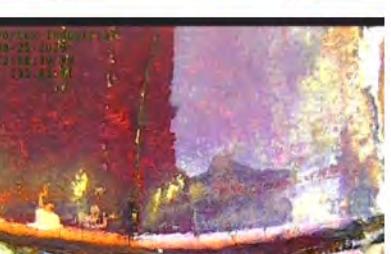
Crack Multiple	Point	133.8	Structural	0	2-6	2	0	0	2	Crack Multiple

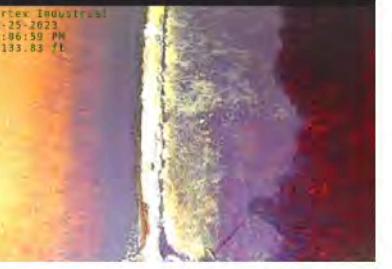
Description	Spatial Type	Distance (ft)	Type	Percent	Clock	SR	O&M	C	PR	Remarks		Photos
Crack Longitudinal	Point	133.8	Structural	0	7	2	0	0	1	Crack Longitudinal

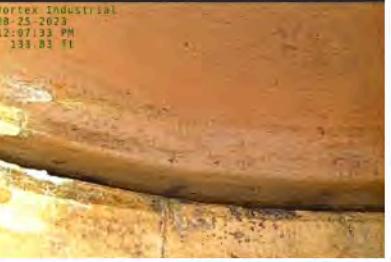
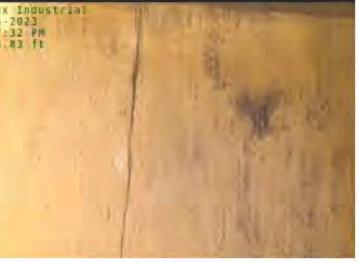
Crack Longitudinal	Point	133.8	Structural	0	9	2	0	0	1	Crack Longitudinal

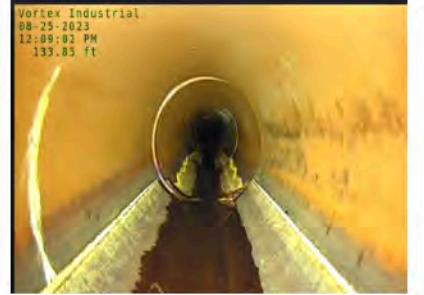
Crack Circumferential	Point	134.4	Structural	0	7-10	1	0	0	1	Crack Circumferential

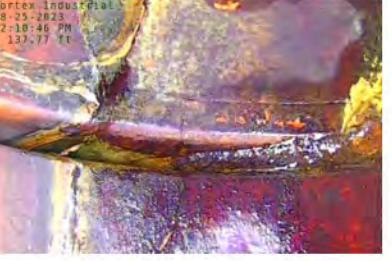
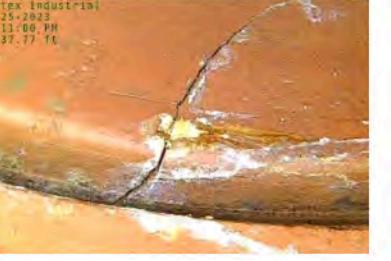
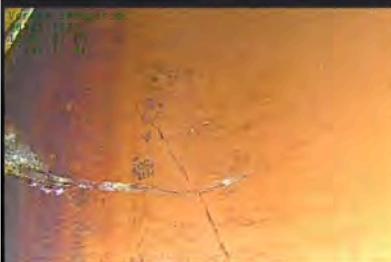
Crack Multiple	Point	137.8	Structural	0	4-9	3	0	0	1	Crack Multiple

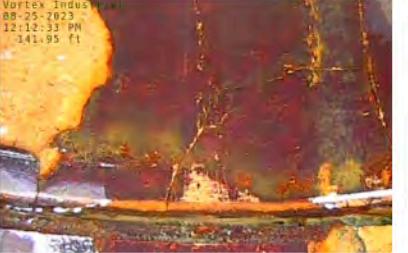
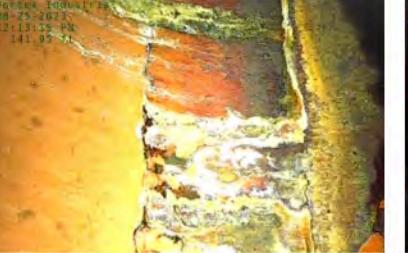
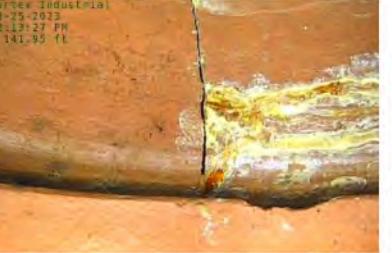
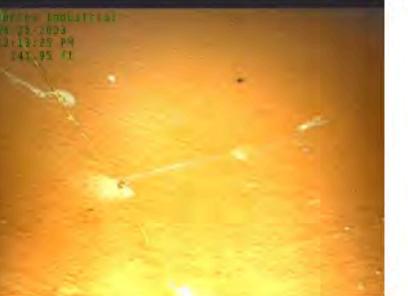
Description	Spatial Type	Distance (ft)	Type	Percent	Clock	SR	O&M	C	PR	Remarks	Photos
Crack Multiple	Point	142	Structural	0	12-12	3	0	0	1	Crack Multiple

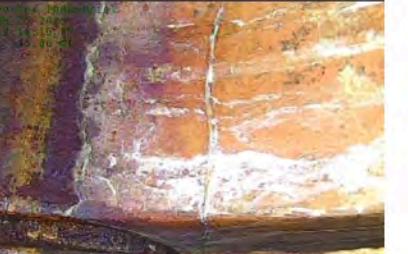
Crack Longitudinal	Point	145.9	Structural	0	5	2	0	0	1	Crack Longitudinal

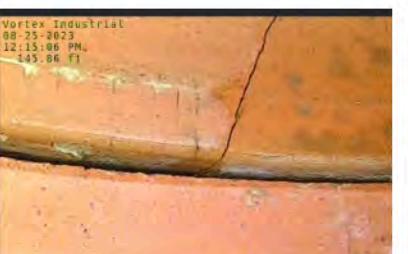
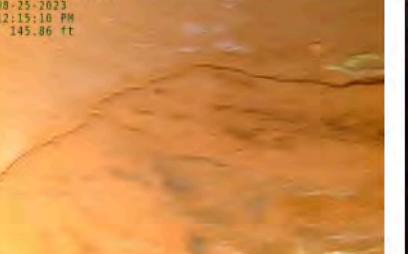
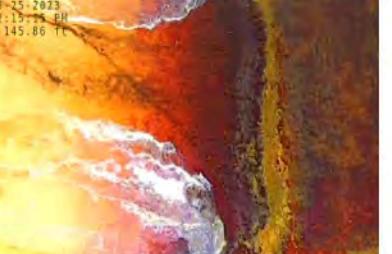
Crack Spiral	Point	145.9	Structural	0	6-9	2	0	0	1	Crack Spiral
