2023 ANNUAL PROGRESS REPORT

SWMU-1 OILY WATER SEWER

HF SINCLAIR PUGET SOUND REFINING LLC

MARCH 21, 2024

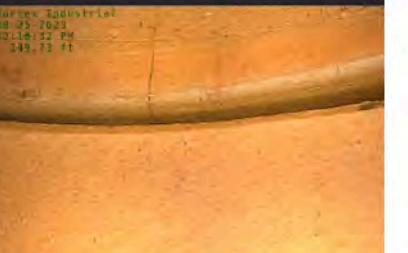
Crack Longitudinal	Point	149.7	Structural	0	3	2	0	0	1	Crack Longitudinal

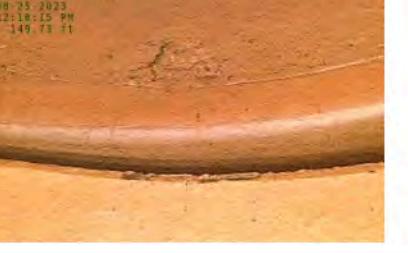
Crack Longitudinal	Point	149.7	Structural	0	2	2	0	0	1	Crack Longitudinal

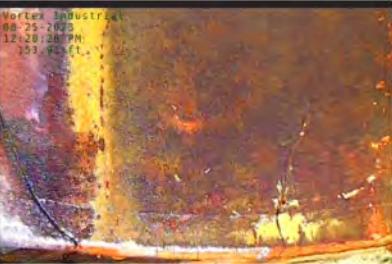
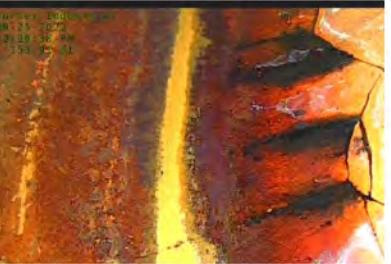
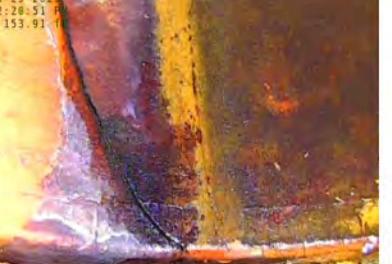
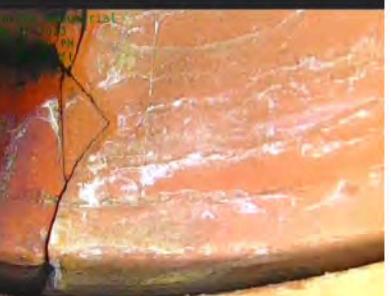
Description	Spatial Type	Distance (ft)	Type	Percent	Clock	SR	O&M	C	PR	Remarks	Photos
Crack Multiple	Point	153.9	Structural	0	12-12	3	0	0	2	Crack Multiple

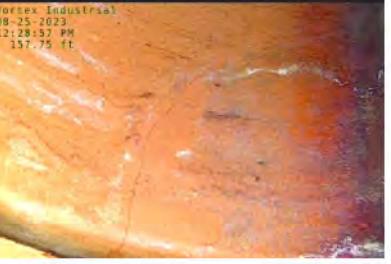
Crack Longitudinal	Point	157.7	Structural	0	8	2	0	0	1	Crack Longitudinal

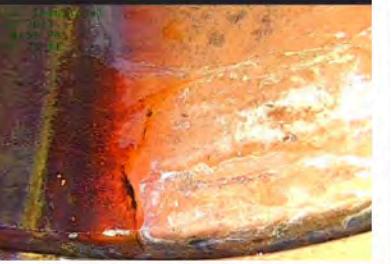
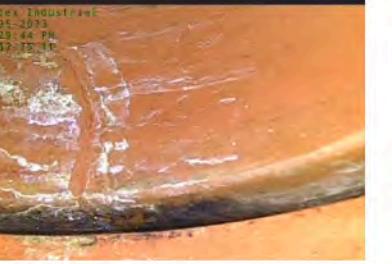
Crack Spiral	Point	157.7	Structural	0	4-5	2	0	0	1	Crack Spiral

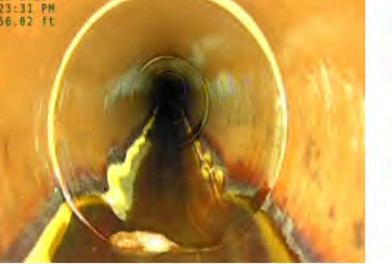
Deposits Settled Hard/Compacted	Point	157.7	O&M	10	6	0	2	0	0	Deposits Settled Hard/Compacted

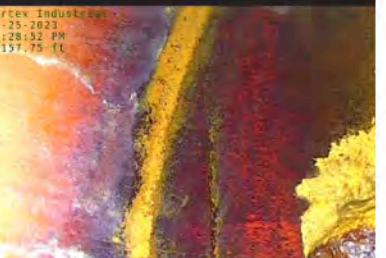
Description	Spatial Type	Distance (ft)	Type	Percent	Clock	SR	O&M	C	PR	Remarks	Photos
Crack Longitudinal	Point	157.7	Structural	0	7	2	0	0	1	Crack Longitudinal

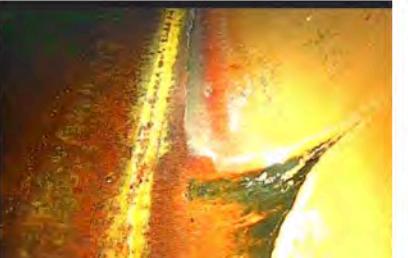
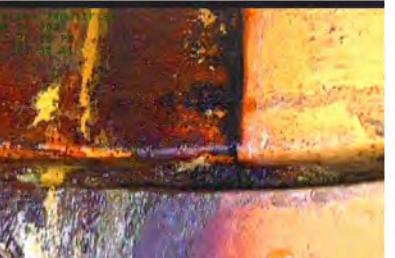
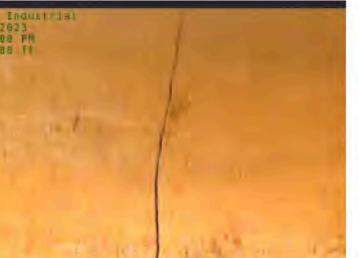
Crack Multiple	Point	161.9	Structural	0	12-5	3	0	0	1	Crack Multiple

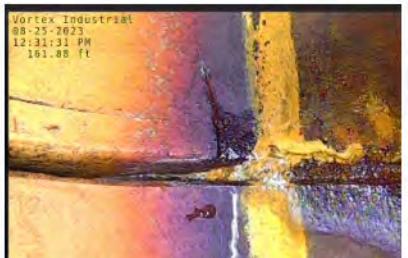
Crack Longitudinal	Point	161.9	Structural	0	7	2	0	0	1	Crack Longitudinal

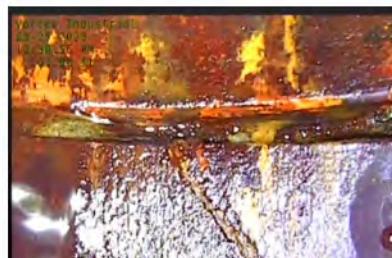
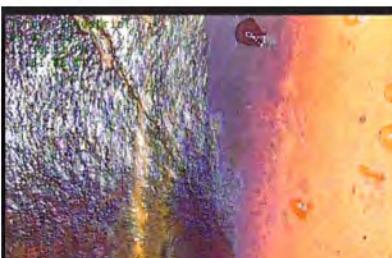
Crack Longitudinal	Point	161.9	Structural	0	6	2	0	0	1	Crack Longitudinal

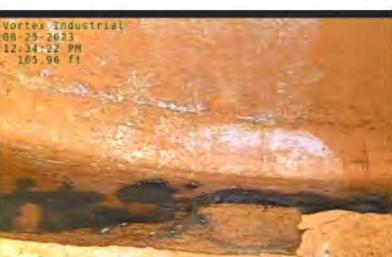
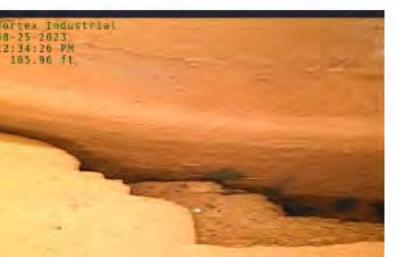
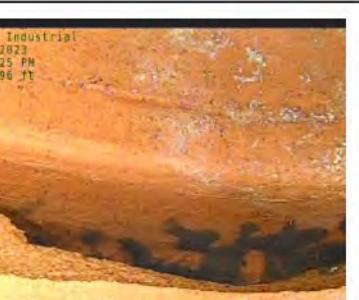
Fracture Circumferential	Point	166	Structural	0	10-11	2	0	0	2	Fracture Circumferential

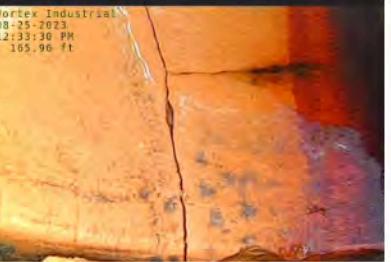
Description	Spatial Type	Distance (ft)	Type	Percent	Clock	SR	O&M	C	PR	Remarks	Photos
Crack Multiple	Point	166	Structural	0	7-9	3	0	0	1	Crack Multiple

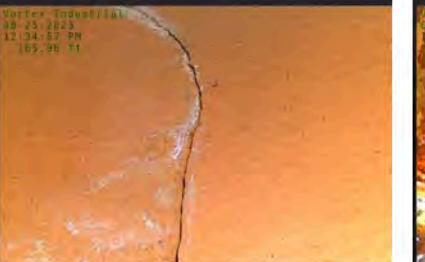
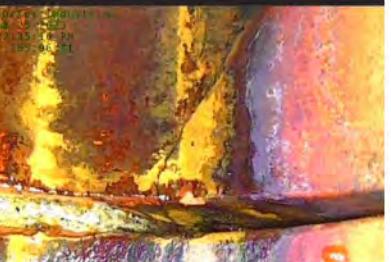
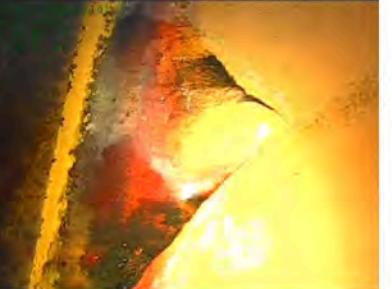
Crack Multiple	Point	166	Structural	0	3-5	2	0	0	1	Crack Multiple

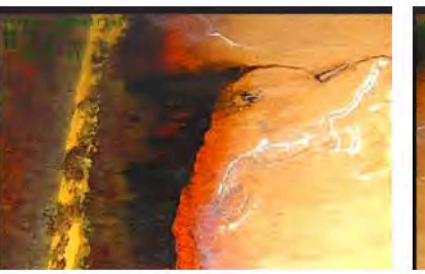
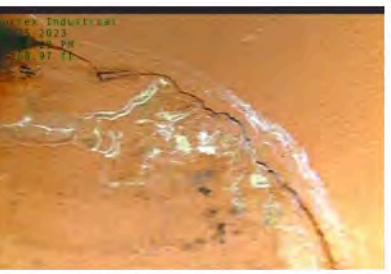
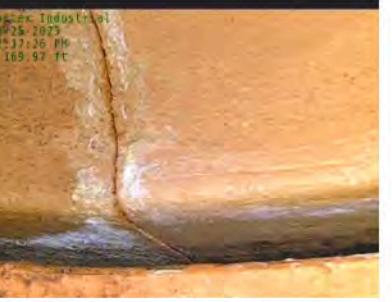
Crack Multiple	Point	170	Structural	0	2-5	3	0	0	1	Crack Multiple

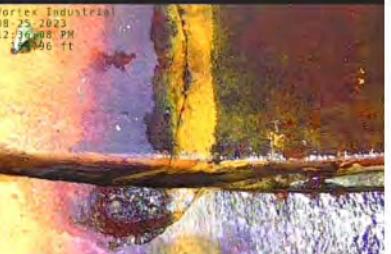
Crack Longitudinal	Point	170	Structural	0	7	2	0	0	1	Crack Longitudinal

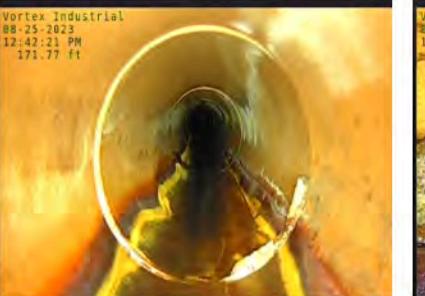
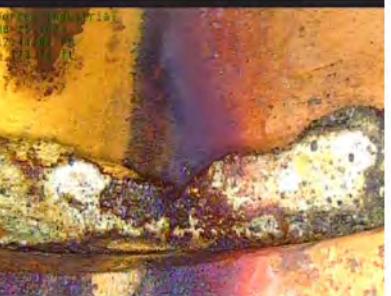
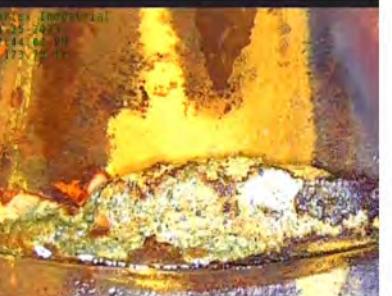
Deposits Attached Encrustation	Point	173.8	O&M	10	4-6	0	2	0	0	Deposits Attached Encrustation

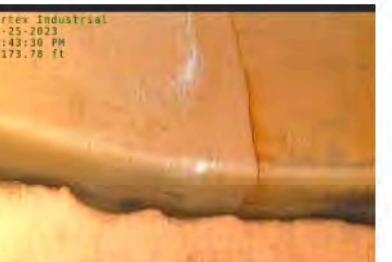
Description	Spatial Type	Distance (ft)	Type	Percent	Clock	SR	O&M	C	PR	Remarks	Photos
Crack Longitudinal	Point	173.8	Structural	0	8	2	0	0	1	Crack Longitudinal

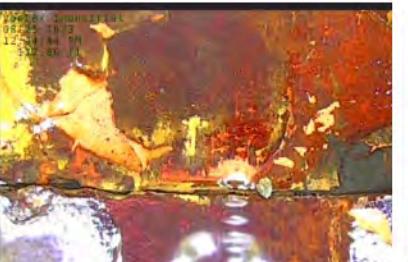
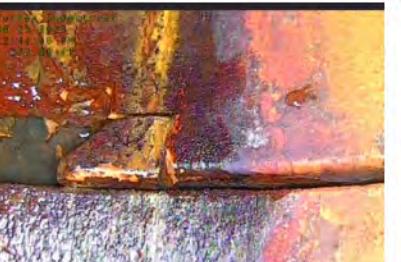
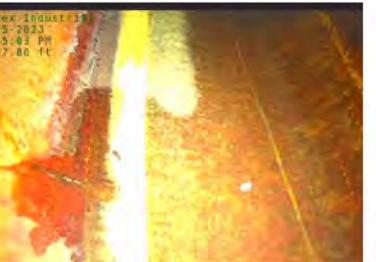
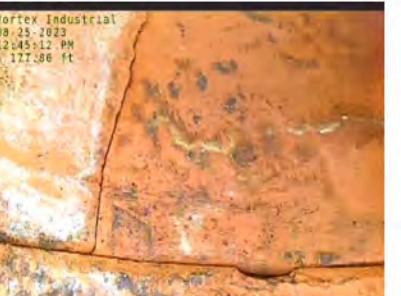
Crack Multiple	Point	177.9	Structural	0	6-9	3	0	0	1	Crack Multiple

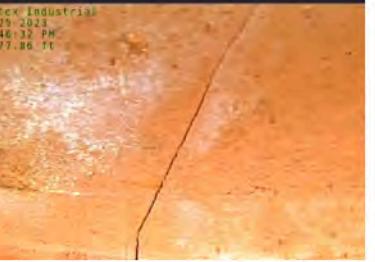
Crack Longitudinal	Point	177.9	Structural	0	12	2	0	0	1	Crack Longitudinal

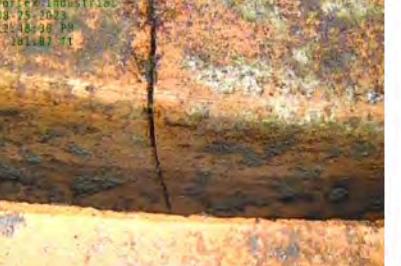
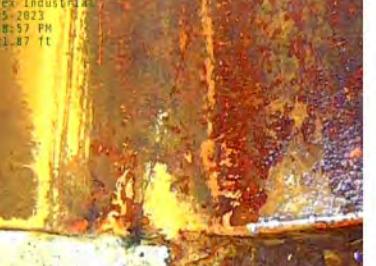
Crack Spiral	Point	181.9	Structural	0	1-6	2	0	0	1	Crack Spiral

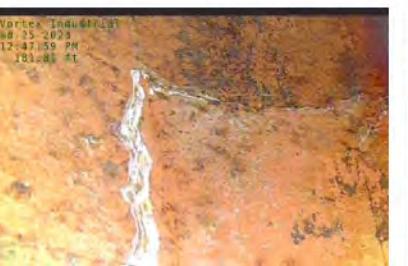
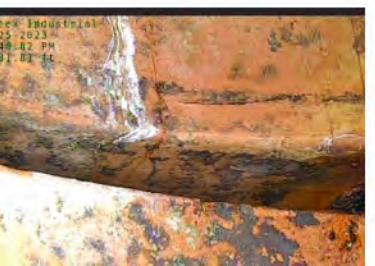
Crack Multiple	Point	181.9	Structural	0	7-8	3	0	0	1	Crack Multiple

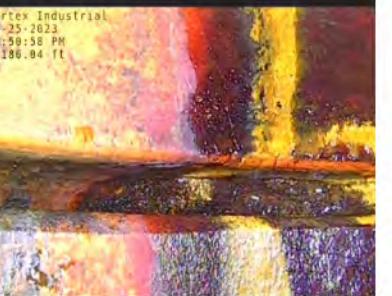
Description	Spatial Type	Distance (ft)	Type	Percent	Clock	SR	O&M	C	PR	Remarks	Photos
Crack Longitudinal	Point	186	Structural	0	7	2	0	0	1	Crack Longitudinal

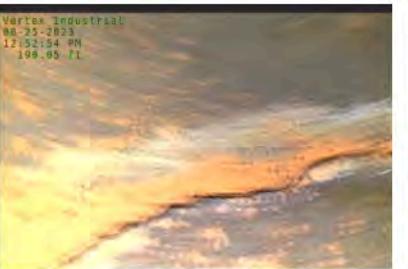
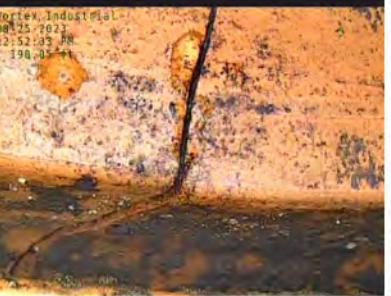
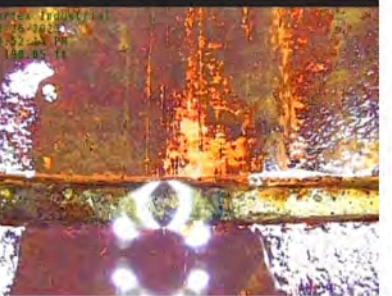
Crack Spiral	Point	190.1	Structural	0	6-10	2	0	0	2	Crack Spiral

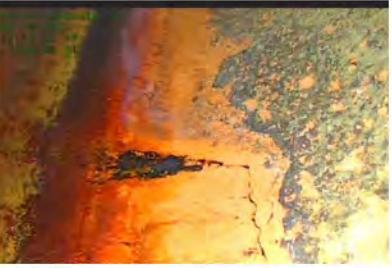
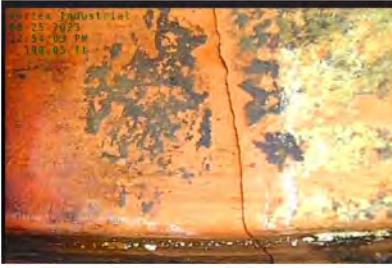
Crack Spiral	Point	190.1	Structural	0	4-5	2	0	0	1	Crack Spiral

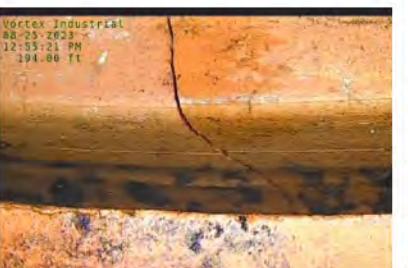
Crack Spiral	Point	194	Structural	0	2-5	2	0	0	1	Crack Spiral

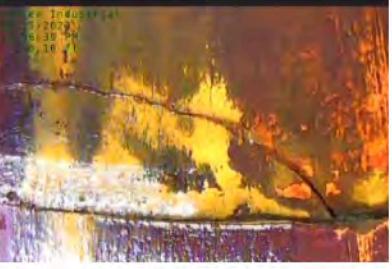
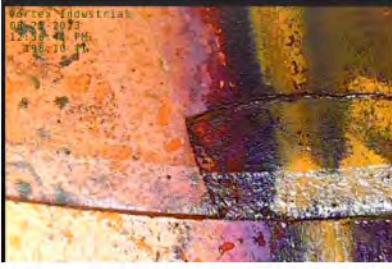
Crack Spiral	Point	198.1	Structural	0	6-7	1	0	0	1	Crack Spiral

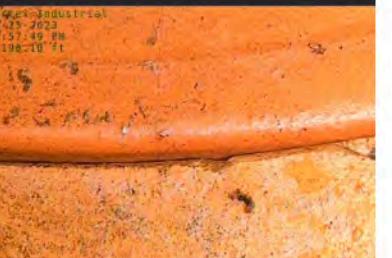
Description	Spatial Type	Distance (ft)	Type	Percent	Clock	SR	O&M	C	PR	Remarks	Photos
Crack Longitudinal	Point	198.1	Structural	0	4	2	0	0	1	Crack Longitudinal

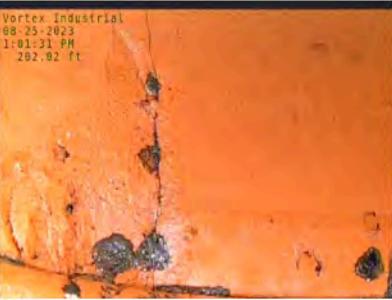
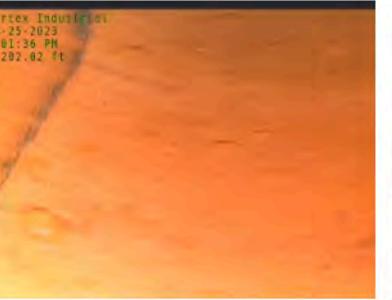
Crack Multiple	Point	202	Structural	0	11-4	3	0	0	2	Crack Multiple

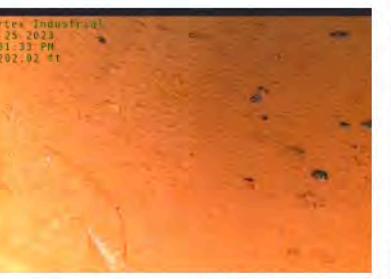
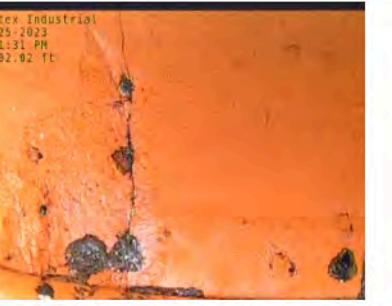
Crack Longitudinal	Point	202	Structural	0	11	2	0	0	1	Crack Longitudinal

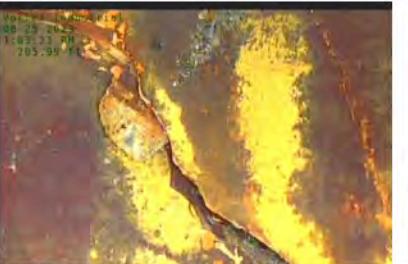
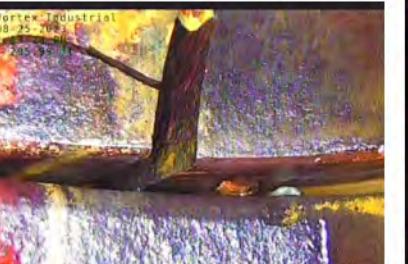
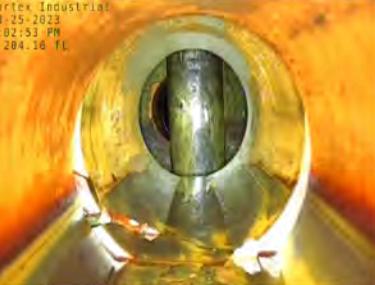
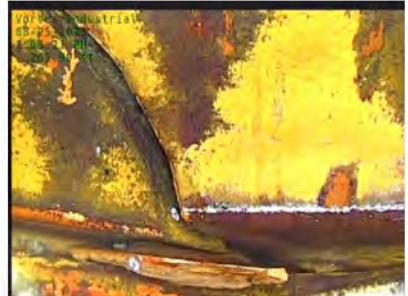
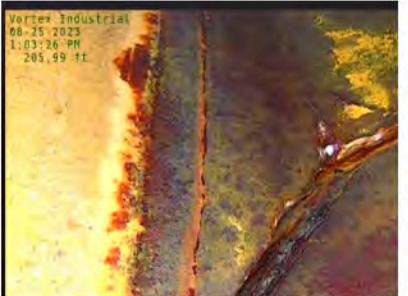
Description	Spatial Type	Distance (ft)	Type	Percent	Clock	SR	O&M	C	PR	Remarks	Photos
Broken	Point	206	Structural	0	5-8	4	0	0	4	Broken

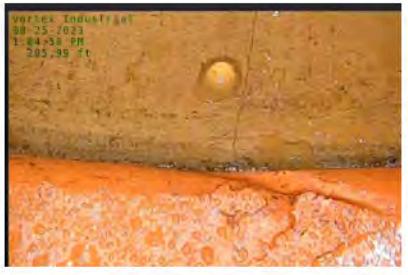
Crack Longitudinal	Point	206	Structural	0	1	2	0	0	1	Crack Longitudinal

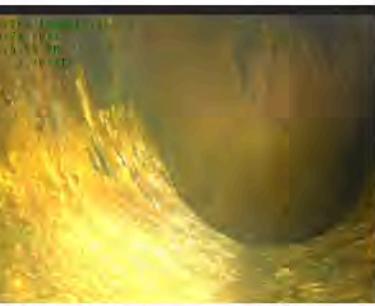
Surface Damage Corrosion		Continuous	0 - 21.5	Structural	0	12-12	3	0	0	2	Surface Damage Corrosion

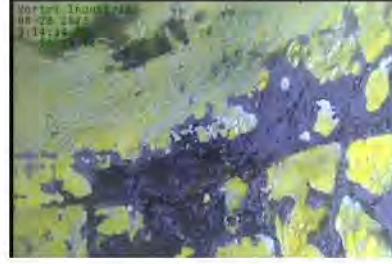
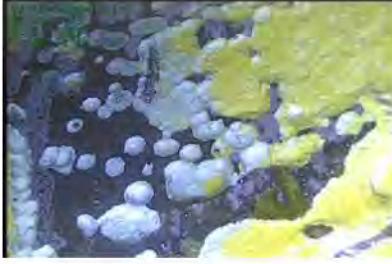
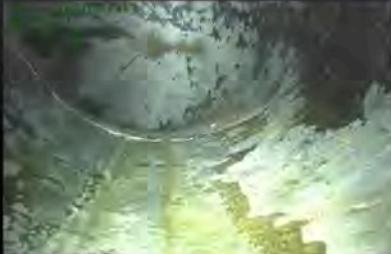
Surface Damage Surface Spalling	Continuous	0 - 16.2	Structural	0	12-12	2	0	0	0	1	Surface Damage Surface Spalling

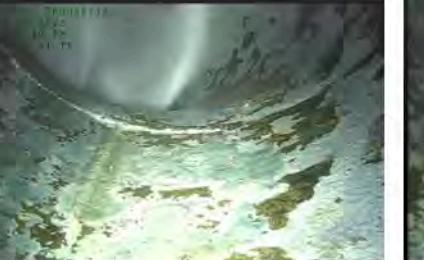
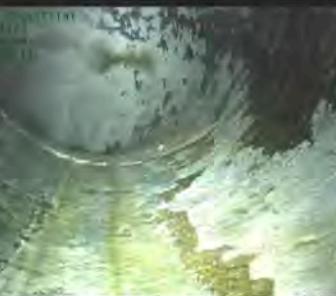
Description	Spatial Type	Distance (ft)	Type	Percent	Clock	SR	O&M	C	PR	Remarks	Photos
Line Left Down	Point	6.2	Constructional	50		0	4	4	0	Line Left Down

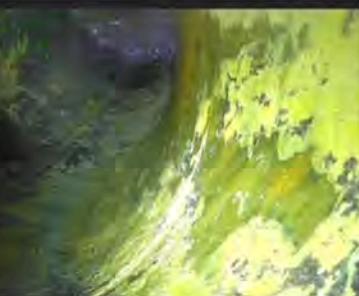
Line Right	Point	10.2	Constructional	15		0	4	2	0	Line Right

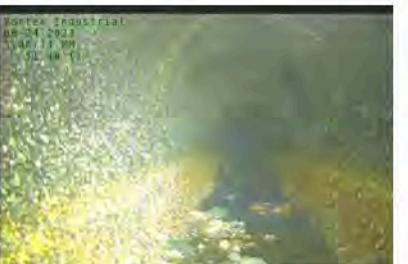
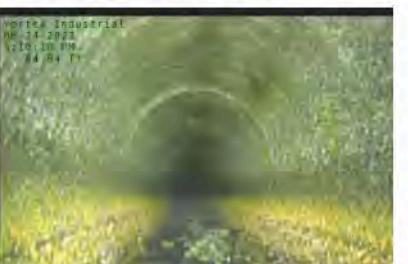
Surface Damage Roughness Increased		Continuous	52.6 - 106	Structural	10	12-12	1	0	0	2	Surface Damage Roughness Increased

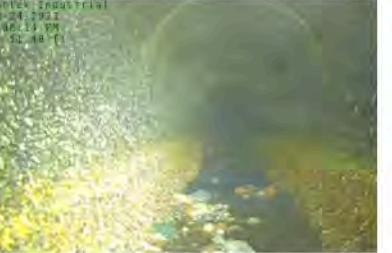
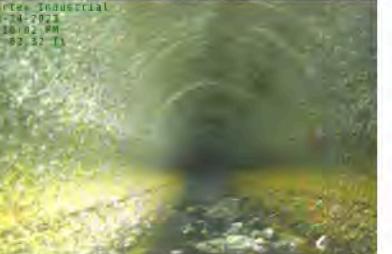
Description	Spatial Type	Distance (ft)	Type	Percent	Clock	SR	O&M	C	PR	Remarks	Photos
Deposits Settled Gravel	Continuous	52.6 - 106	O&M	10	6	0	2	0	0	Deposits Settled Gravel

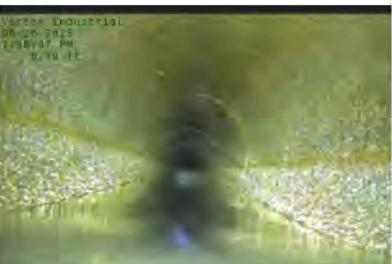
Surface Damage Roughness Increased	Continuous	0 - 103.4	O&M	0	12-12	2	0	0	2	Surface Damage Roughness Increased

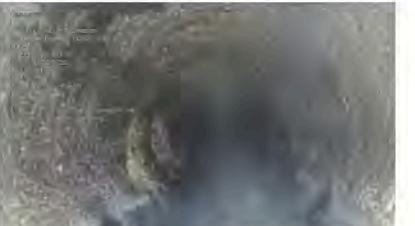
Surface Damage Aggregate Missing	Point	5.6	Structural	0	8-9	4	0	0	2	Surface Damage Aggregate Missing

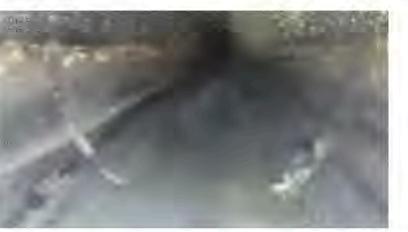
Q3-R8 (S-F to D-I2)
Intruding Sealing Material Grout	Point	26.4	Constructional	10	4-5	0	2	2	0	Intruding Sealing Material Grout

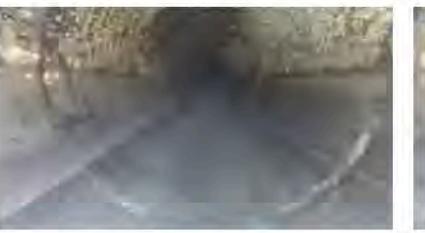
Q3-R8 (S-F to D-I2)
Crack Multiple	Point	34.8	Structural	0	9-11	3	0	0	1	Crack Multiple

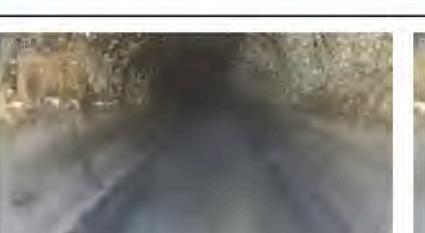
Crack Circumferential	Point	40.8	Structural	0	8-10	1	0	0	1	Crack Circumferential

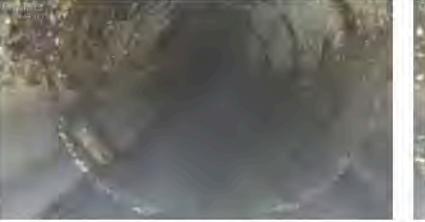
Crack Circumferential	Point	63.8	Structural	0	7-8	1	0	0	1	Crack Circumferential

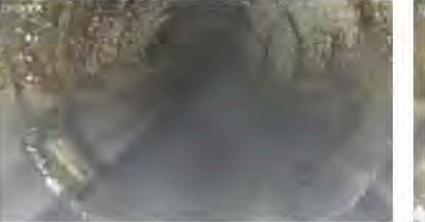
Surface Damage Aggregate Missing	Point	63.8	Structural	0	10	4	0	0	2	Surface Damage Aggregate Missing

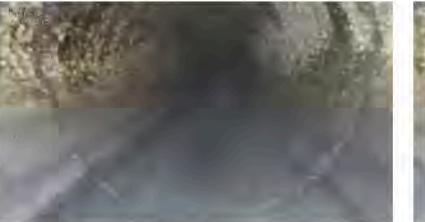
Surface Damage Aggregate Missing	Point	66.5	Structural	0	10	4	0	0	2	Surface Damage Aggregate Missing

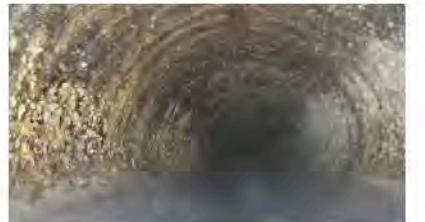
Surface Damage Reinforcement Visible	Point	69.3	Structural	0	9-3	4	0	0	3	Surface Damage Reinforcement Visible

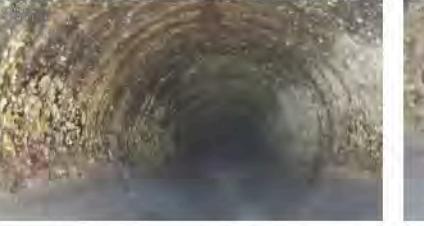
Description	Spatial Type	Distance (ft)	Type	Percent	Clock	SR	O&M	C	PR	Remarks	Photos
Joint Separated Medium	Point	72.2	Structural	0		3	0	0	1	Joint Separated Medium

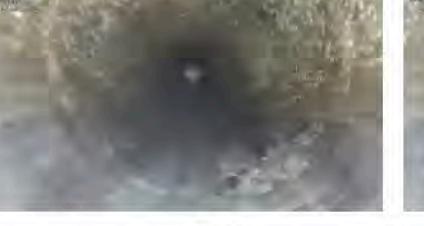
Deposits Settled Fine	Point	100.1	O&M	10	4-6	0	2	0	0	Deposits Settled Fine

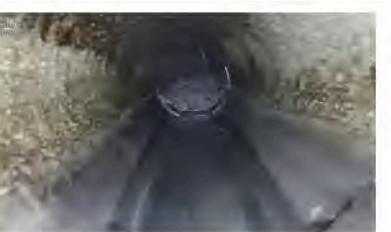
Miscellaneous Water Level	Point	127.5	Miscellaneous	10		0	0	0	0	Miscellaneous Water Level

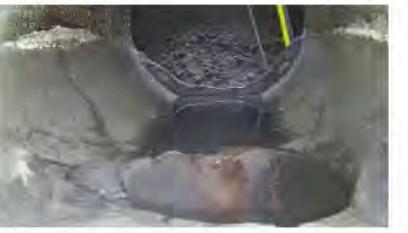
Crack Longitudinal	Point	134.1	Structural	0	7	2	0	0	1	Crack Longitudinal

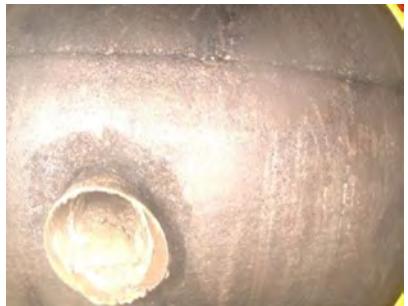
Surface Damage Aggregate Missing	Point	4	Structural	0	3	4	0	0	1	Surface Damage Aggregate Missing

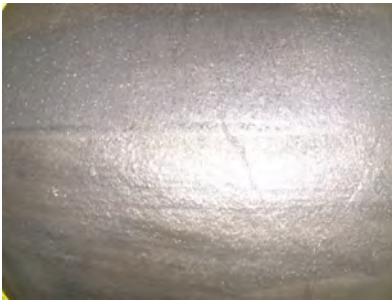
Crack Longitudinal	Point	8.4	Structural	0	5	2	0	0	1	Crack Longitudinal

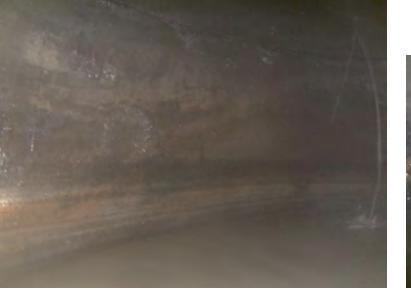
Description	Spatial Type	Distance (ft)	Type	Percent	Clock	SR	O&M	C	ER	Remarks	Photos
Surface Damage Aggregate Missing	Point	11.7	Structural	0	5	4	0	0	1	Surface Damage Aggregate Missing

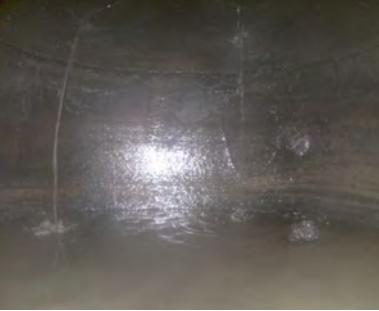
Surface Damage Aggregate Visible	Point	12	Structural	0	8	2	0	0	1	Surface Damage Aggregate Visible

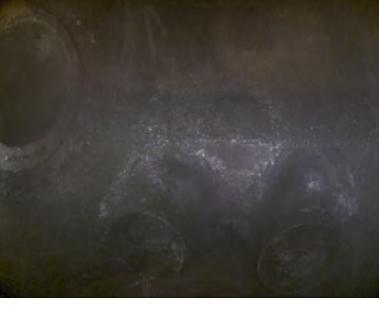
Surface Damage Roughness Increased	Point	12	Structural	0	7-9	1	0	0	1	Surface Damage Roughness Increased

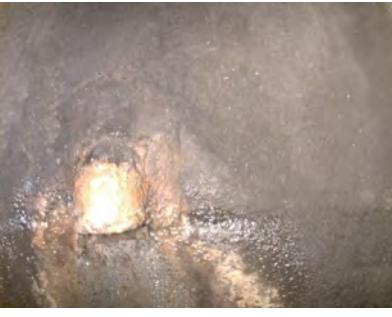
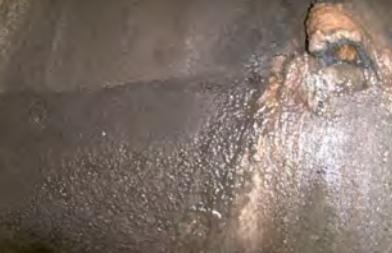
Surface Damage Aggregate Visible		Point	3	Structural	0	3	2	0	0	1	Surface Damage Aggregate Visible

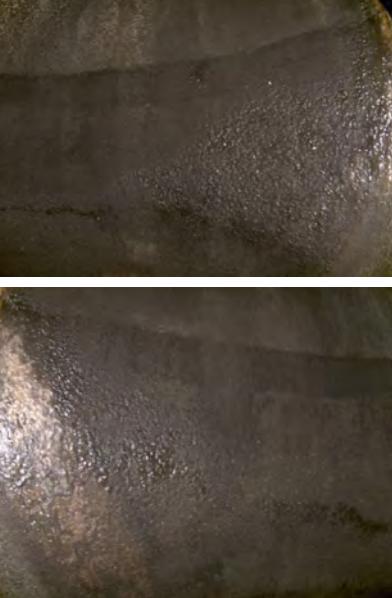
Description	Spatial Type	Distance (ft)	Type	Percent	Clock	SR	O&M	C	ER	Remarks	Photos
Surface Damage Roughness Increased	Point	4	Structural	0	12-5	1	0	0	1	Surface Damage Roughness Increased

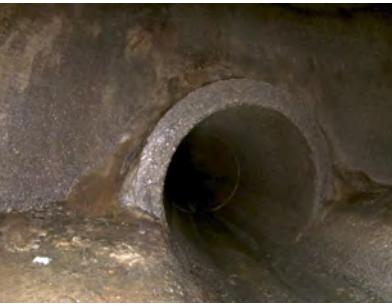
Surface Damage Roughness Increased	Point	6.2	Structural	0	6	1	0	0	1	Surface Damage Roughness Increased

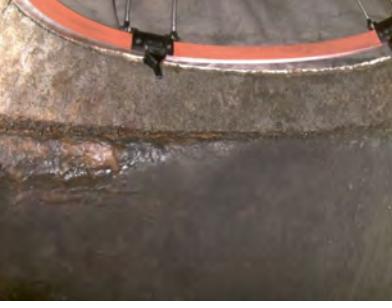
Surface Damage Aggregate Missing	Point	12	Structural	0	2	4	0	0	2	Surface Damage Aggregate Missing

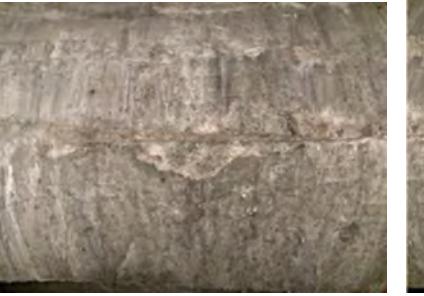
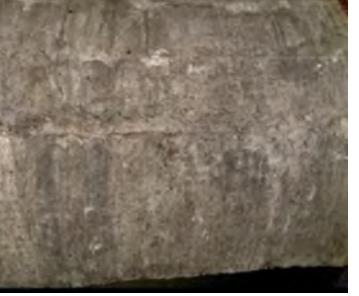
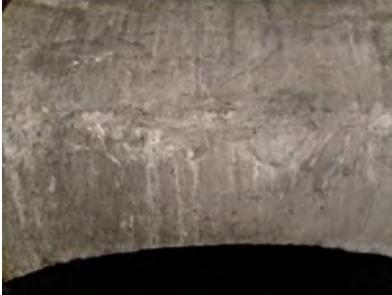
Description	Spatial Type	Distance (ft)	Type	Percent	Clock	SR	O&M	C	ER	Remarks	Photos
Fracture Circumferential	Point	1.8	Structural	0	12-12	3	0	0	1	Fracture Circumferential

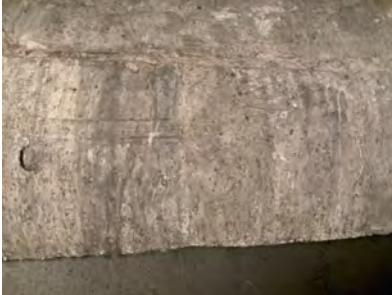
Fracture Circumferential	Point	3	Structural	0	2-3	3	0	0	2	Fracture Circumferential

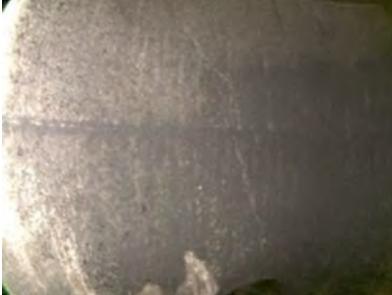
Crack Longitudinal	Point	3.5	Structural	0	05	2	0	0	2	Crack Longitudinal

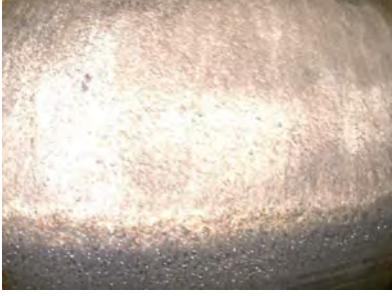
Surface Damage Roughness Increased	Point	6.7	Structural	0	12-12	1	0	0	1	Surface Damage Roughness Increased

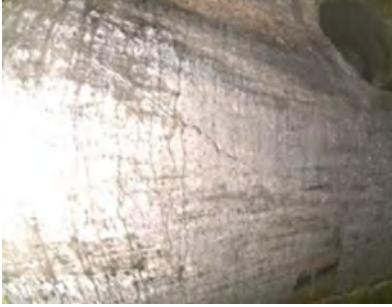
Description	Spatial Type	Distance (ft)	Type	Percent	Clock	SR	O&M	C	ER	Remarks	Photos
Crack Circumferential	Point	8	Structural	0	4-5	2	0	0	2	Crack Circumferential

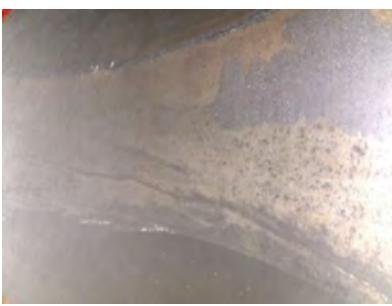
Crack Circumferential	Point	11	Structural	0	11-03	2	0	0	2	Crack Circumferential

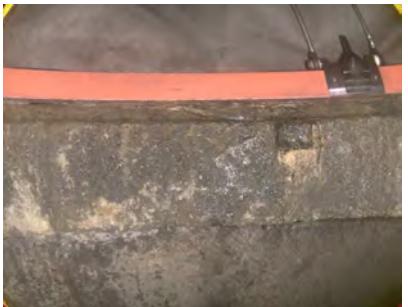
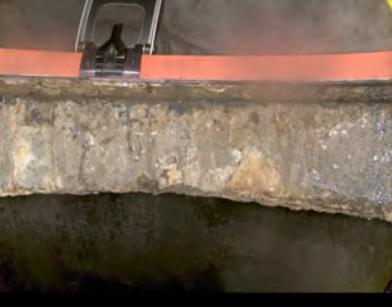
Surface Damage Roughness Increased	Continuous	0 - 1.1	Structural	0	12-12	1	0	0	1	Surface Damage Roughness Increased

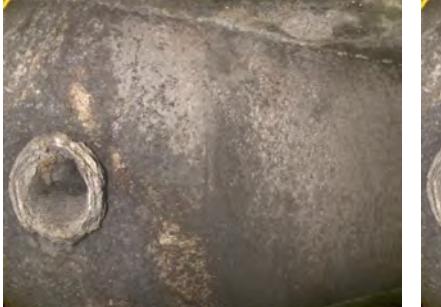
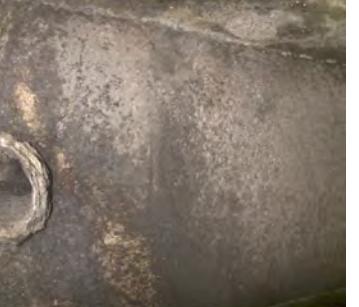
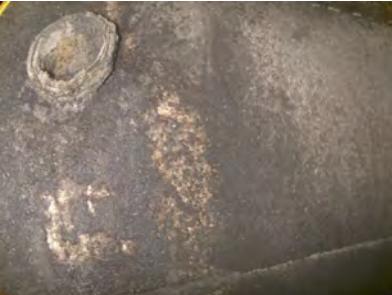
Description	Spatial Type	Distance (ft)	Type	Percent	Clock	SR	O&M	C	ER	Remarks		Photos
Surface Damage Roughness Increased	Point	2	Structural	0	9-10	1	0	0	1	Surface Damage Roughness Increased

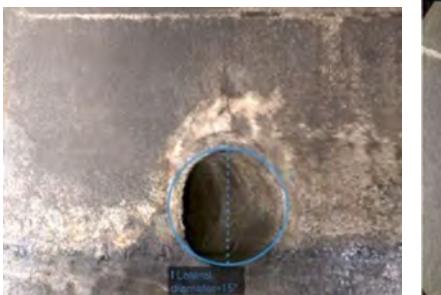
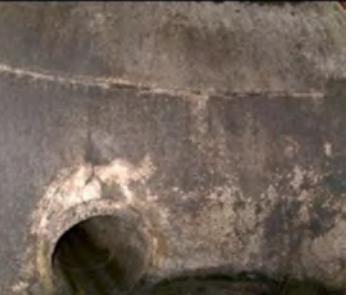
Crack Longitudinal	Point	3	Structural	0	6	2	0	0	2	Crack Longitudinal

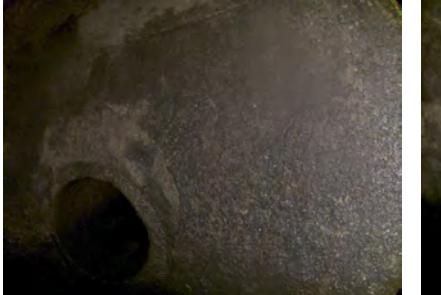
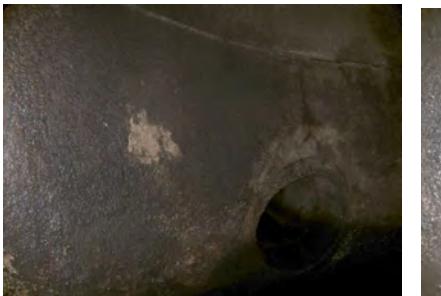
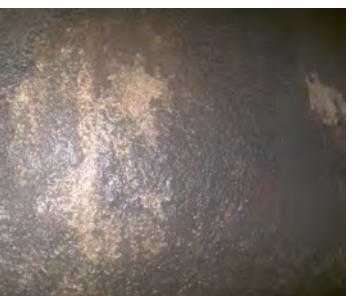
Surface Damage Roughness Increased	Continuous	3.5 - 5.2	Structural	0	12-12	1	0	0	1	Surface Damage Roughness Increased

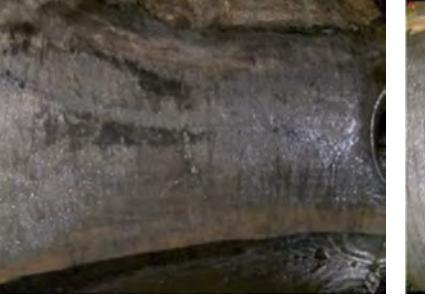
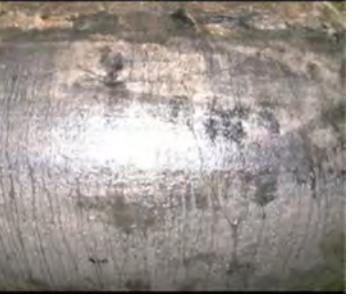
Description	Spatial Type	Distance (ft)	Type	Percent	Clock	SR	O&M	C	ER	Remarks	Photos
Crack Multiple	Point	5.5	Structural	0	2-3	3	0	0	1	Crack Multiple

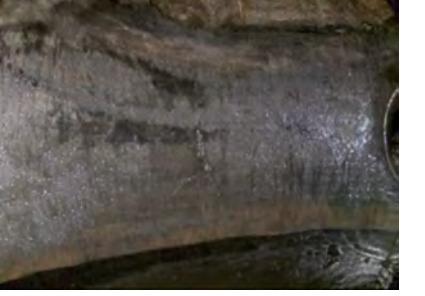
Crack Longitudinal	Point	5.5	Structural	0	11	2	0	0	1	Crack Longitudinal

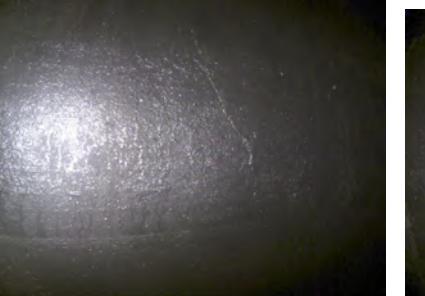
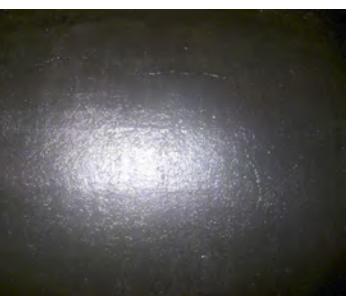
Crack Longitudinal	Point	6	Structural	0	9	2	0	0	1	Crack Longitudinal

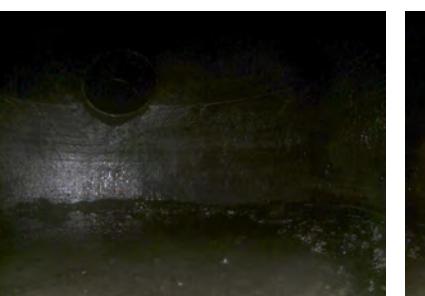
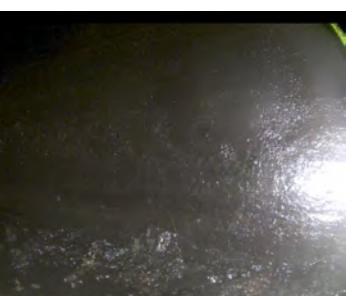
Deposits Settled Other	Point	8	O&M	0	12-12	0	0	0	0	Deposits Settled Other

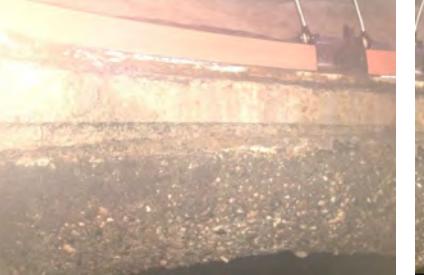
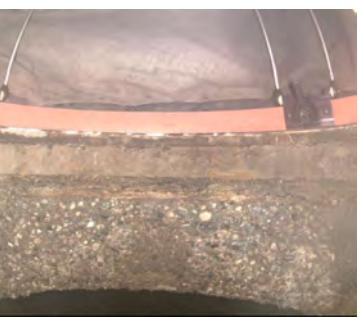
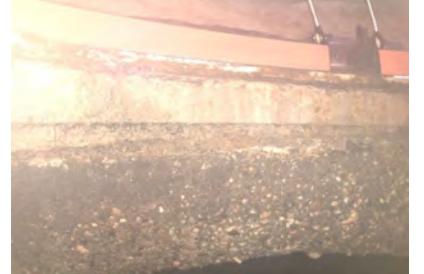
Description	Spatial Type	Distance (ft)	Type	Percent	Clock	SR	O&M	C	ER	Remarks	Photos
Surface Damage Aggregate Visible	Point	1	Structural	0	12-12	2	0	0	1	Surface Damage Aggregate Visible

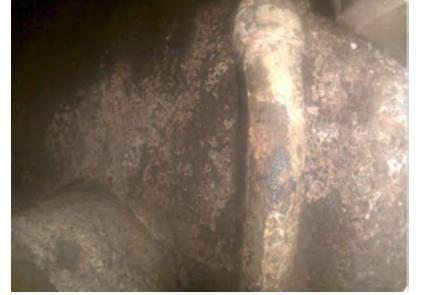
Surface Damage Aggregate Visible	Continuous	2 - 4.4	Structural	0	9-2	2	0	0	1	Surface Damage Aggregate Visible

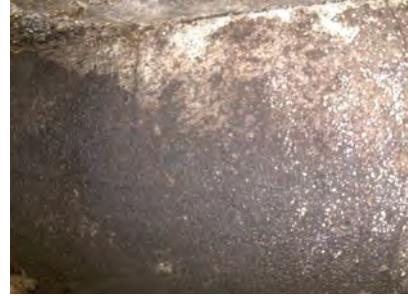
Crack Longitudinal		Point	1	Structural	0	1	2	0	0	1	Crack Longitudinal

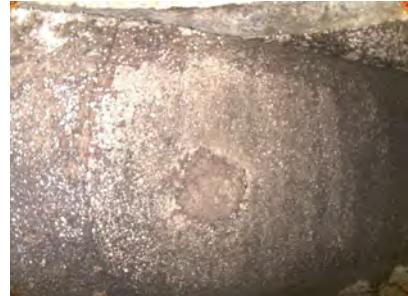
Crack Longitudinal		Point	1	Structural	0	3	2	0	0	1	Crack Longitudinal

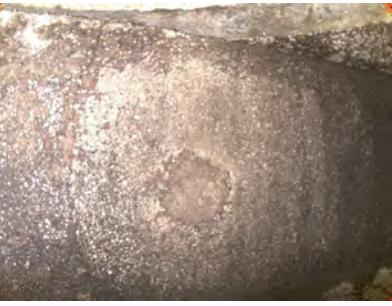
Description	Spatial Type	Distance (ft)	Type	Percent	Clock	SR	O&M	C	ER	Remarks	Photos
Surface Damage Aggregate Missing	Point	1.3	Structural	0	2	4	0	0	1	Surface Damage Aggregate Missing

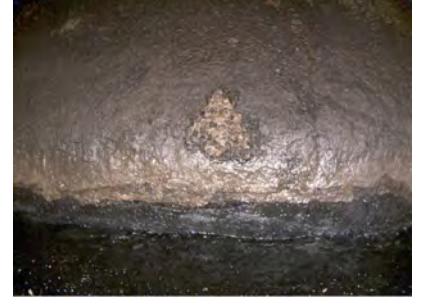
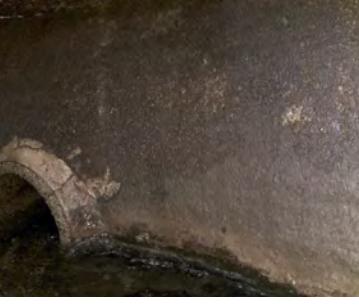
Surface Damage Aggregate Visible	Point	1.7	O&M	0	12	2	0	0	1	Surface Damage Aggregate Visible

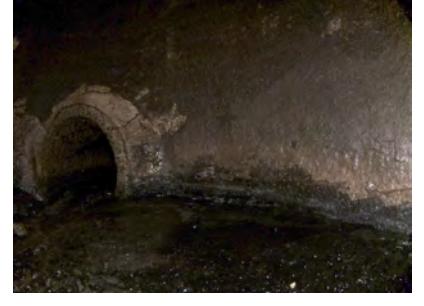
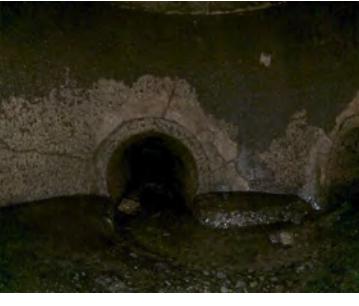
Crack Multiple	Continuous	2 - 3	Structural	0	4-7	3	0	0	2	Crack Multiple

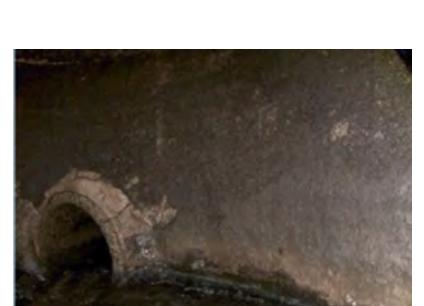
Crack Multiple	Point	2.5	Structural	0	9-10	3	0	0	2	Crack Multiple

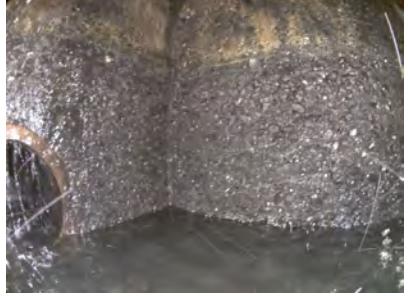
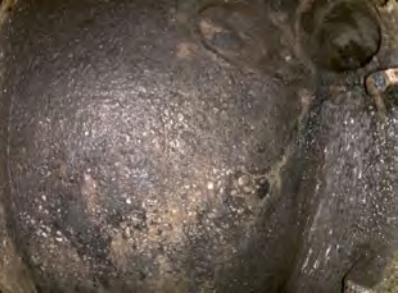
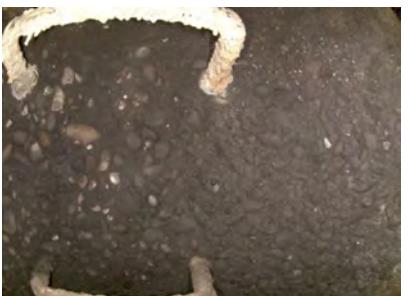
Description	Spatial Type	Distance (ft)	Type	Percent	Clock	SR	O&M	C	ER	Remarks	Photos
Surface Damage Aggregate Visible	Continuous	0 - 9.5	Structural	0	12-12	2	0	0	1	Surface Damage Aggregate Visible

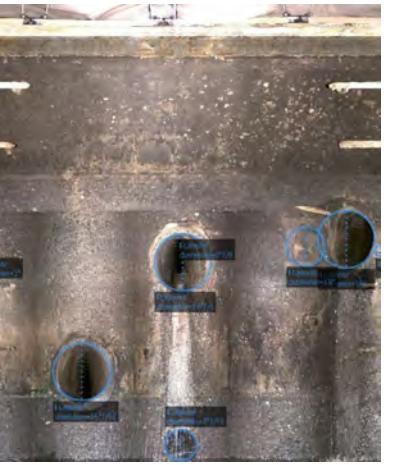
Miscellaneous General Photograph	Point	0	Miscellaneous	0	0	0	0	0	0	Side View of Structure

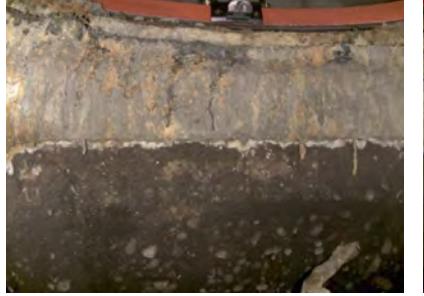
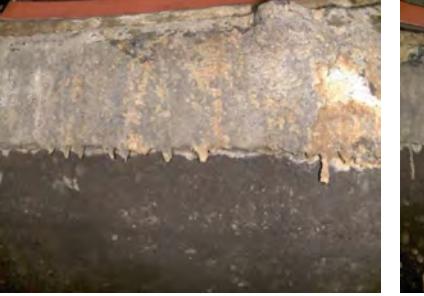
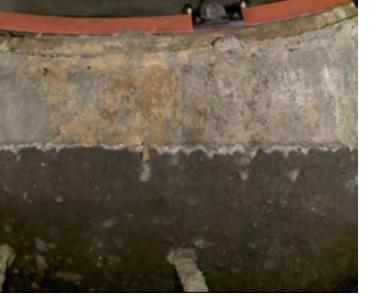
Description	Spatial Type	Distance (ft)	Type	Percent	Clock	SR	O&M	C	ER	Remarks	Photos
Surface Damage Roughness Increased	Continuous	1 - 2	Structural	0	12-12	1	0	0	1	Surface Damage Roughness Increased

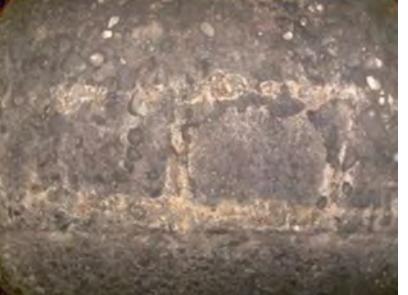
Crack Multiple	Point	2.5	Structural	0	6-9	3	0	0	1	Crack Multiple

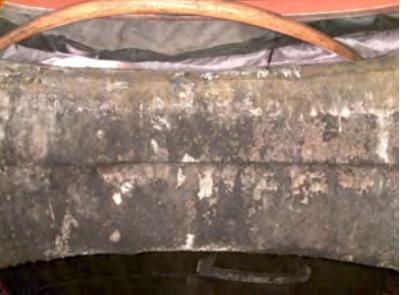
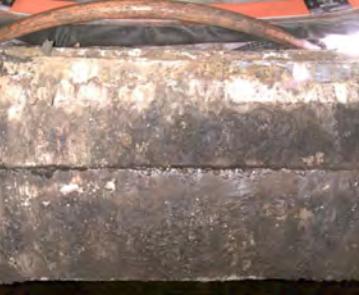
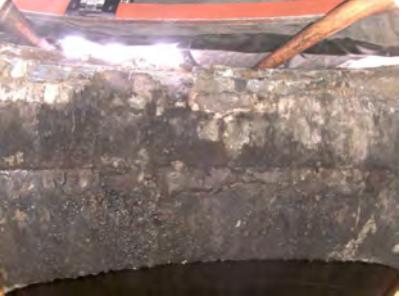
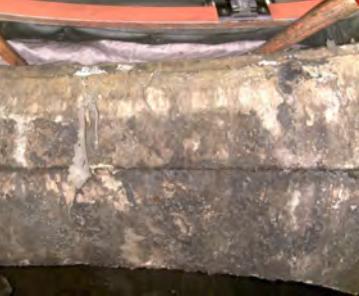
Surface Damage Roughness Increased	Point	1	Structural	0	12-12	1	0	0	1	Surface Damage Roughness Increased

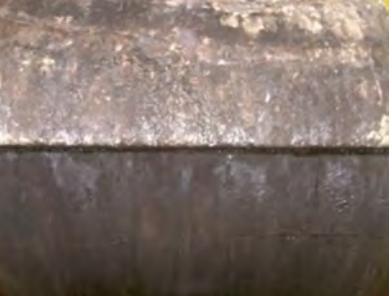
Description	Spatial Type	Distance (ft)	Type	Percent	Clock	SR	O&M	C	ER	Remarks		Photos
Crack Longitudinal	Point	1.5	Structural	0	9	2	0	0	1	Crack Longitudinal

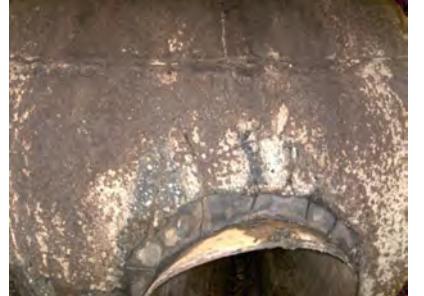
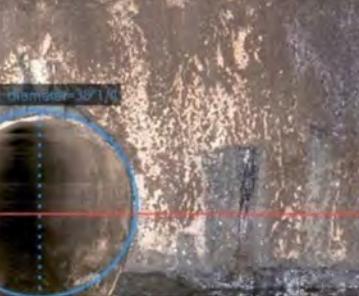
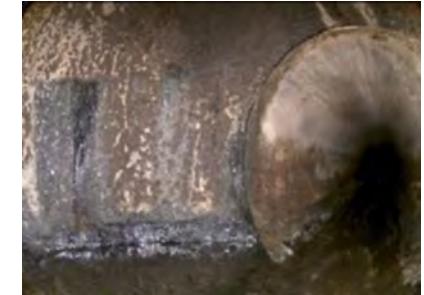
Crack Multiple	Point	2	Structural	0	5-7	3	0	0	2	Crack Multiple

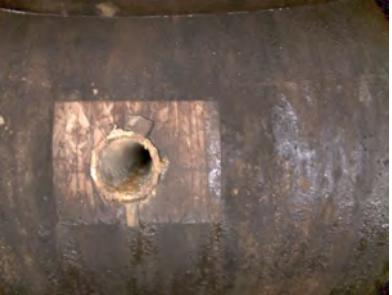
Surface Damage Roughness Increased	Point	4	Structural	0	8	1	0	0	1	Surface Damage Roughness Increased

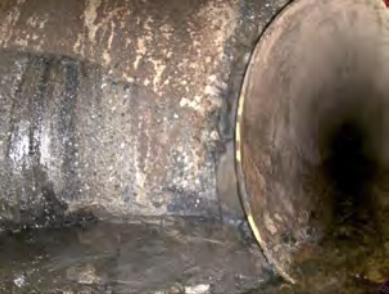
Deposits Settled Fine	Point	10	O&M	10	10	0	0	0	0	Deposits Settled Fine

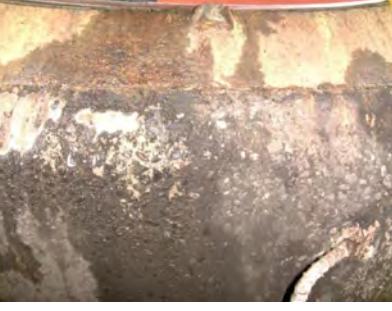
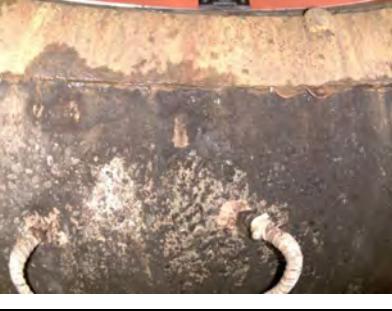
Description	Spatial Type	Distance (ft)	Type	Percent	Clock	SR	O&M	C	ER	Remarks	Photos
Surface Damage Aggregate Visible	Point	0.5	Structural	0	9-10	2	0	0	1	Surface Damage Aggregate Visible

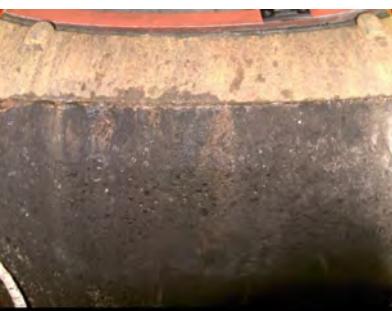
Surface Damage Roughness Increased	Point	1	Structural	0	5-9	1	0	0	1	Surface Damage Roughness Increased

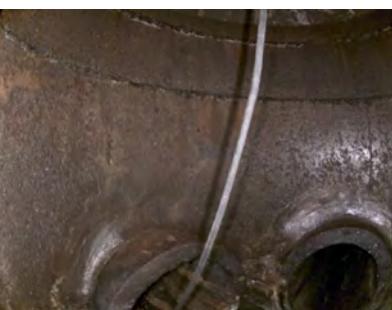
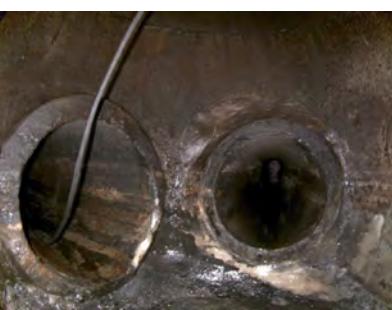
Crack Longitudinal	Point	3.8	Constructional	0	6	2	0	0	1	Crack Longitudinal

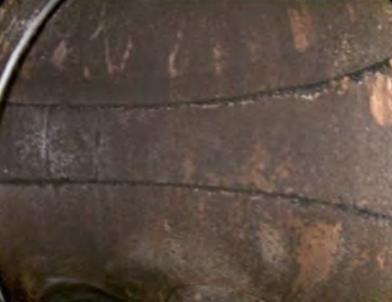
Description	Spatial Type	Distance (ft)	Type	Percent	Clock	SR	O&M	C	ER	Remarks	Photos
Crack Longitudinal	Point	3.8	Structural	0	7	2	0	0	1	Crack Longitudinal

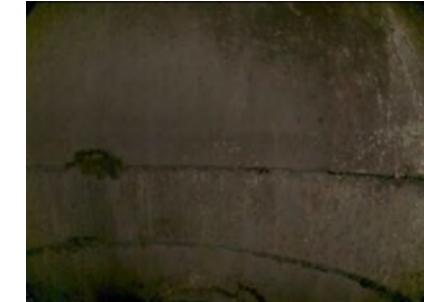
Surface Damage Aggregate Missing		Point	4	Structural	0	8	4	0	0	2	Surface Damage Aggregate Missing

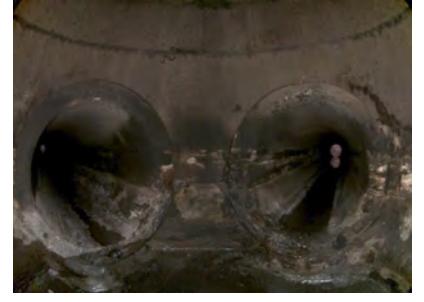
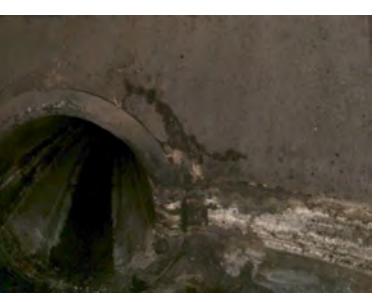
Crack Longitudinal		Point	6	Structural	0	9	2	0	0	1	Crack Longitudinal

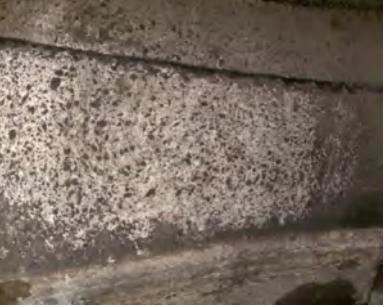
Description	Spatial Type	Distance (ft)	Type	Percent	Clock	SR	O&M	C	ER	Remarks	Photos
Surface Damage Aggregate Visible	Point	6	Structural	0	1-4	2	0	0	1	Surface Damage Aggregate Visible

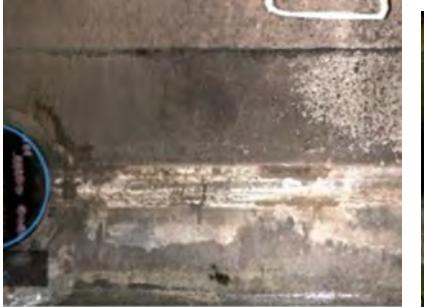
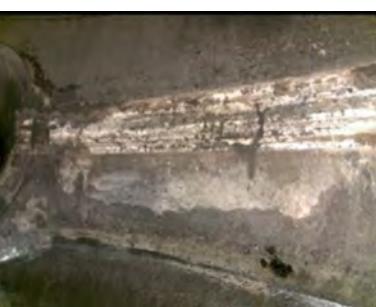
Crack Longitudinal	Point	7	Structural	0	12	2	0	0	1	Crack Longitudinal

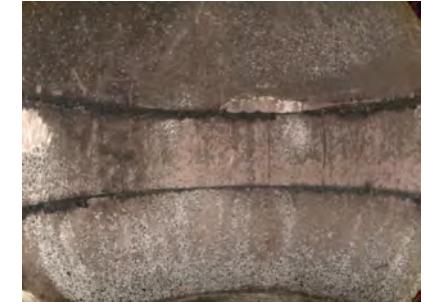
Surface Damage Aggregate Visible		Continuous	1.5 - 4	Structural	0	2-6	2	0	0	1	Surface Damage Aggregate Visible

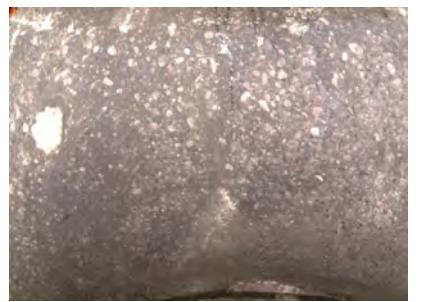
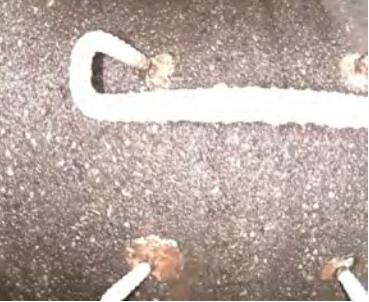
Surface Damage Aggregate Visible		Point	4	Structural	0	11	2	0	0	1	Surface Damage Aggregate Visible

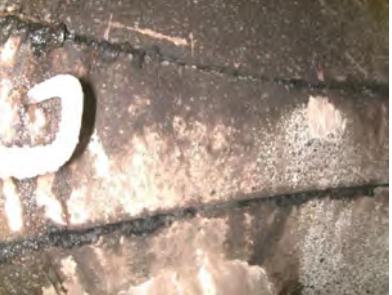
Description	Spatial Type	Distance (ft)	Type	Percent	Clock	SR	O&M	C	ER	Remarks	Photos
Surface Damage Aggregate Visible	Point	5	Structural	0	6	2	0	0	1	Surface Damage Aggregate Visible

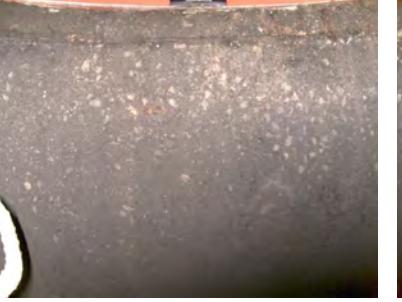
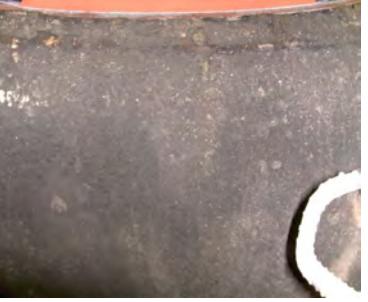
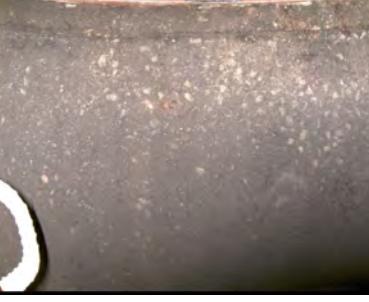
Description	Spatial Type	Distance (ft)	Type	Percent	Clock	SR	O&M	C	ER	Remarks	Photos
Surface Damage Roughness Increased	Point	0.2	Structural	0	12-12	1	0	0	1	Surface Damage Roughness Increased

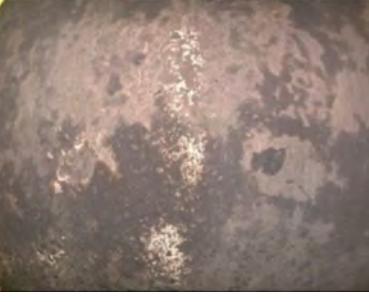
Surface Damage Aggregate Visible	Point	5.5	Structural	0	9	2	0	0	1	Surface Damage Aggregate Visible

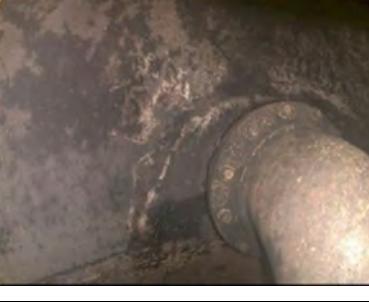
Crack Multiple	Point	6	Structural	0	11-12	3	0	0	1	Crack Multiple

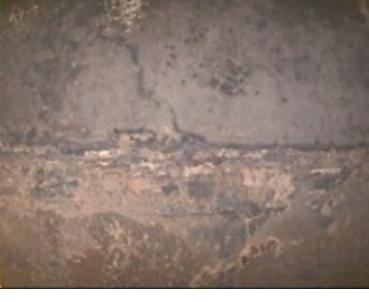
Crack Multiple	Point	7	Structural	0	9-10	3	0	0	1	Crack Multiple

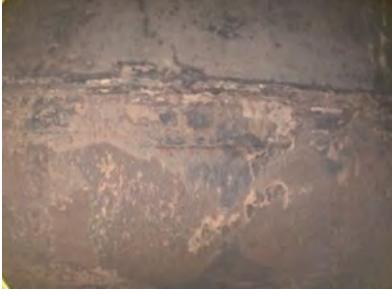
Description	Spatial Type	Distance (ft)	Type	Percent	Clock	SR	O&M	C	ER	Remarks	Photos
Crack Circumferential	Point	7.3	Structural	0	9-10	2	0	0	1	Crack Circumferential
