2023 ANNUAL PROGRESS REPORT

SWMU-1 OILY WATER SEWER

HF SINCLAIR PUGET SOUND REFINING LLC

MARCH 21, 2024

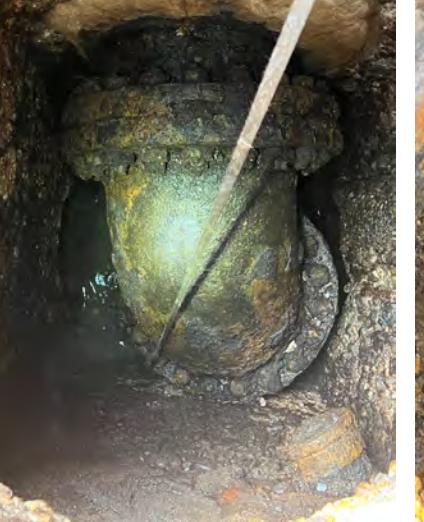
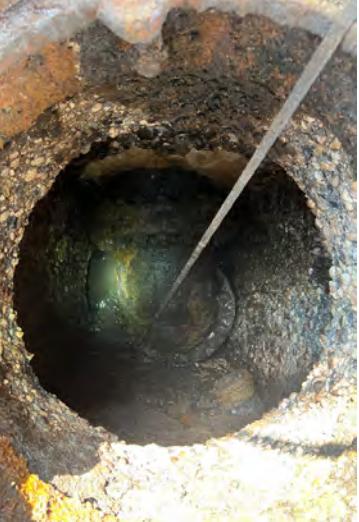
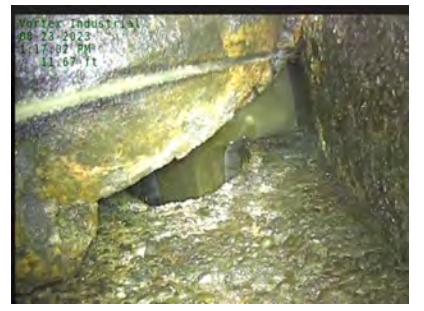
Description	Spatial Type	Distance (ft)	Type	Percent	Clock	SR	O&M	C	ER	Remarks	Photos
Surface Damage Aggregate Visible	Continuous	0 - 9.8	Structural	0	12-12	2	0	0	2	Surface Damage Aggregate Visible

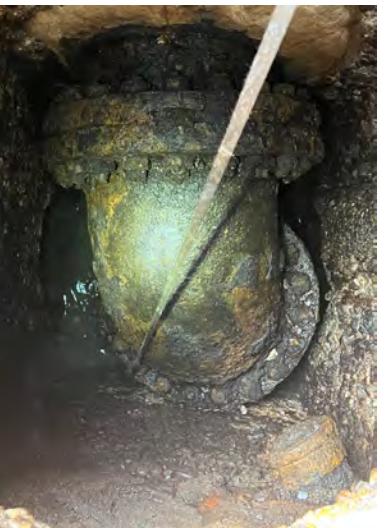
Crack Longitudinal	Point	4.5	Structural	0	12	2	0	0	1	Crack Multiple

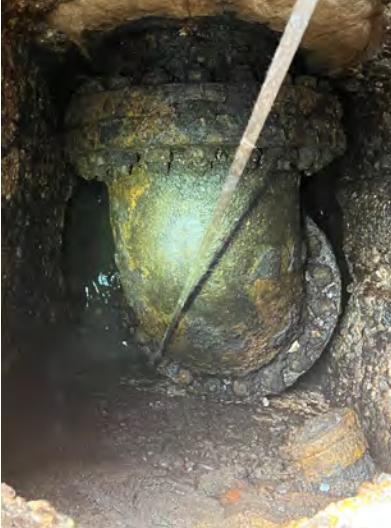
Description	Spatial Type	Distance (ft)	Type	Percent	Clock	SR	O&M	C	ER	Remarks		Photos
Crack Longitudinal	Point	4.5	Structural	0	1	2	0	0	1	Crack Longitudinal

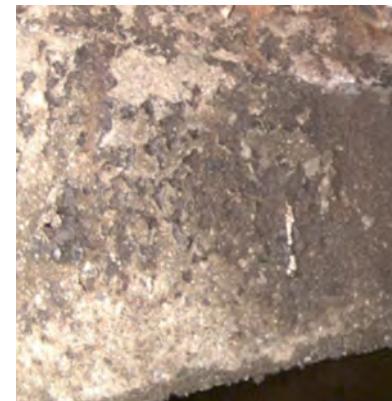
Description	Spatial Type	Distance (ft)	Type	Percent	Clock	SR	O&M	C	ER	Remarks		Photos
Surface Damage Roughness Increased	Point	0.3	Structural	0	12-12	1	0	0	1	Surface Damage Roughness Increased

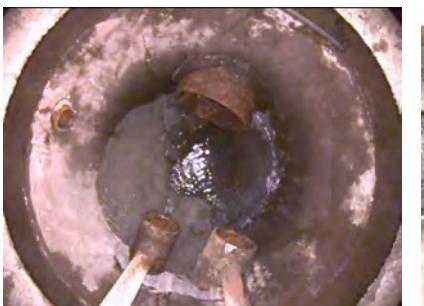
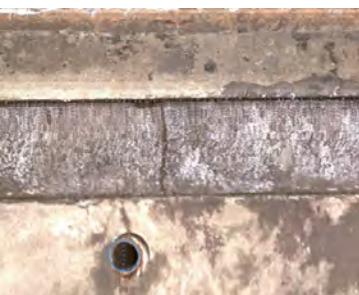
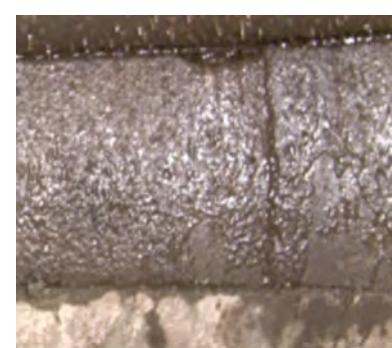
Crack Longitudinal	Point	1.3	Structural	0	4	2	0	0	1	Crack Longitudinal

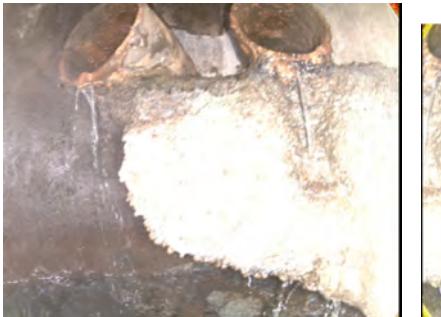
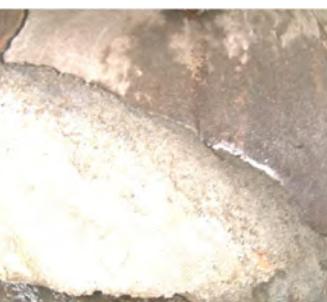
Description	Spatial Type	Distance (ft)	Type	Percent	Clock	SR	O&M	C	ER	Remarks		Photos
Miscellaneous General Observation	Continuous	4 - 6	Structural	0	12-5	0	0	0	0	Concrete Shelf

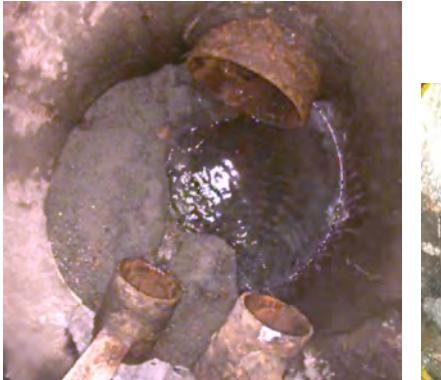
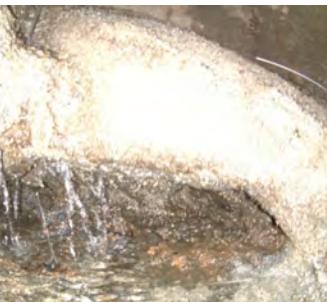
Crack Longitudinal	Point	4.7	Structural	0	3	2	0	0	1	Crack Longitudinal

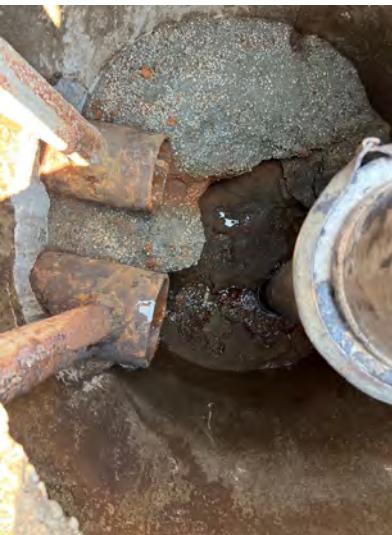
Surface Damage Aggregate Missing	Point	7.6	Structural	0	12-12	4	0	0	2	Surface Damage Aggregate Missing

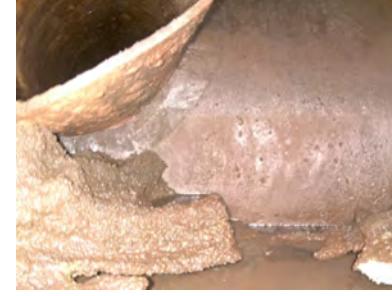
Description	Spatial Type	Distance (ft)	Type	Percent	Clock	SR	O&M	C	ER	Remarks	Photos
Deposits Settled Compacted	Point	7.6	O&M	10	12-12	0	0	0	0	Deposits Settled Compacted

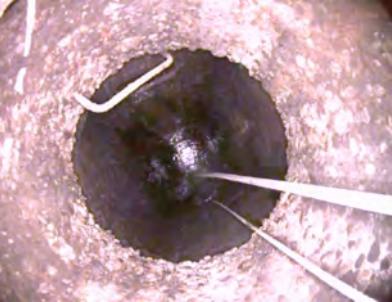
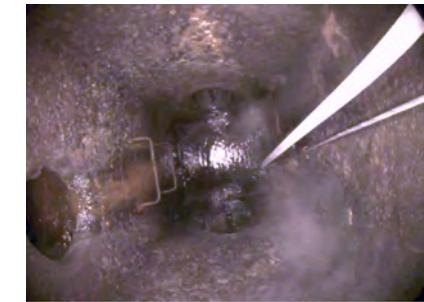
Description	Spatial Type	Distance (ft)	Type	Percent	Clock	SR	O&M	C	ER	Remarks	Photos
Surface Damage Aggregate Visible	Continuous	1 - 2.6	Structural	0	12-12	2	0	0	1	Surface Damage Aggregate Visible

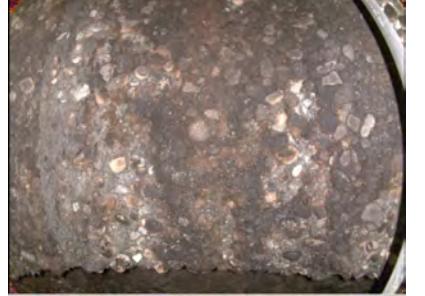
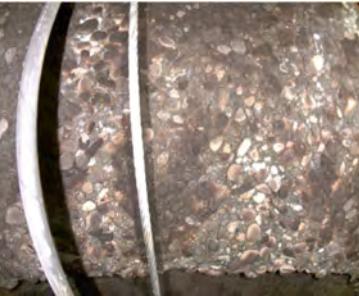
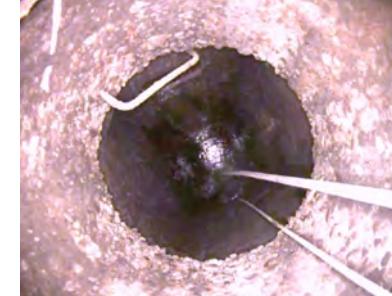
Surface Damage Aggregate Visible	Continuous	4.5 - 7	Structural	0	12-12	2	0	0	1	Surface Damage Aggregate Visible

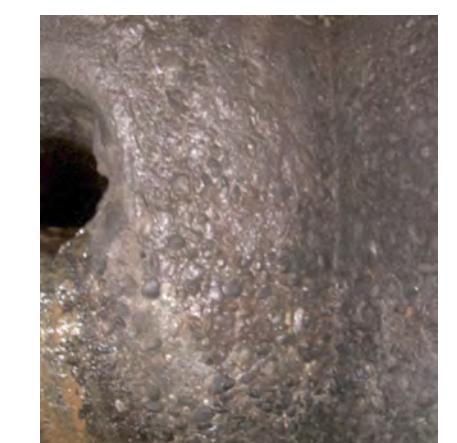
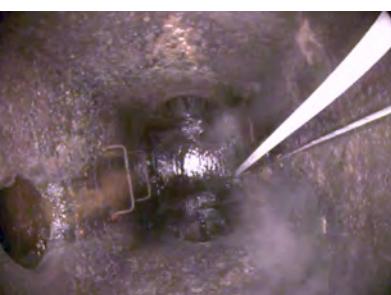
Surface Damage Aggregate Missing	Continuous	4.9 - 6.5	Structural	0	6	4	0	0	2	Surface Damage Aggregate Missing

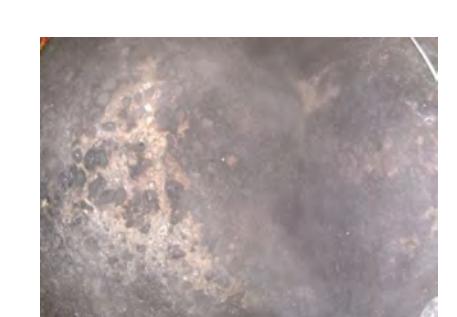
Description	Spatial Type	Distance (ft)	Type	Percent	Clock	SR	O&M	C	ER	Remarks	Photos
Surface Damage Aggregate Missing	Point	5.7	Structural	0	9	4	0	0	2	Surface Damage Aggregate Missing

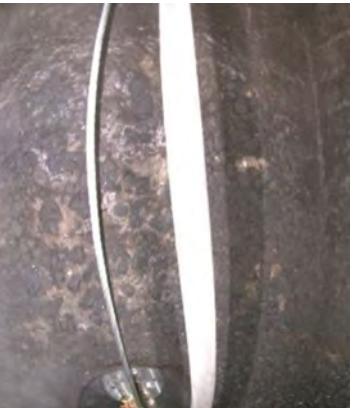
Surface Damage Aggregate Missing	Point	6.3	Structural	0	11	4	0	0	2	Surface Damage Aggregate Missing

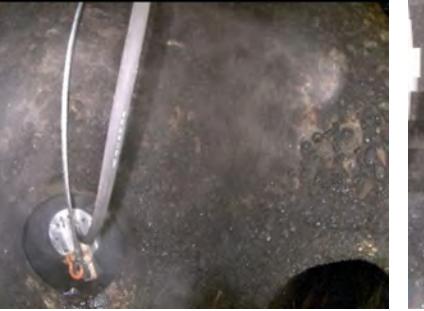
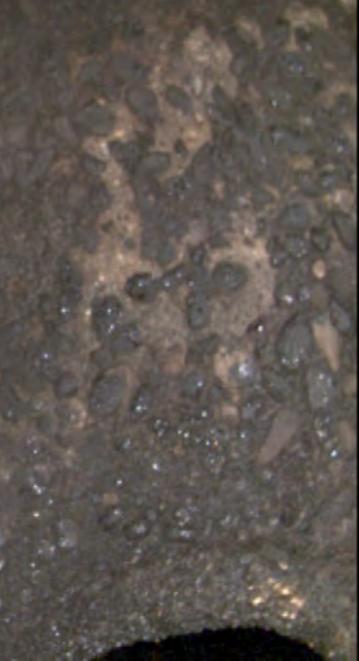
Surface Damage Roughness Increased	Continuous	8 - 10.8	Structural	0	12-12	1	0	0	2	Surface Damage Roughness Increased

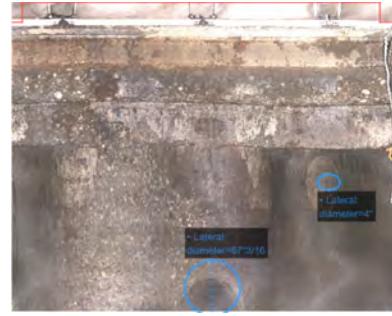
Surface Damage Aggregate Visible	Point	1	Structural	0	12-12	2	0	0	1	Surface Damage Aggregate Visible

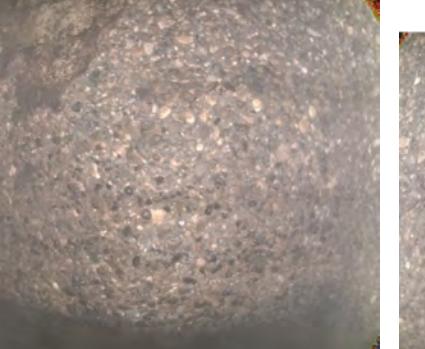
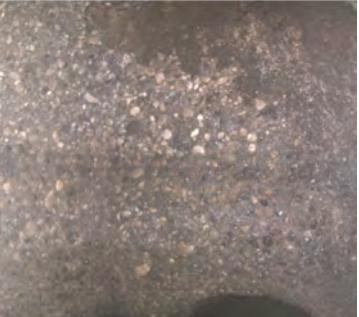
Description	Spatial Type	Distance (ft)	Type	Percent	Clock	SR	O&M	C	ER	Remarks	Photos
Surface Damage Aggregate Visible	Continuous	2.5 - 6	Structural	0	12-6	2	0	0	2	Surface Damage Aggregate Visible

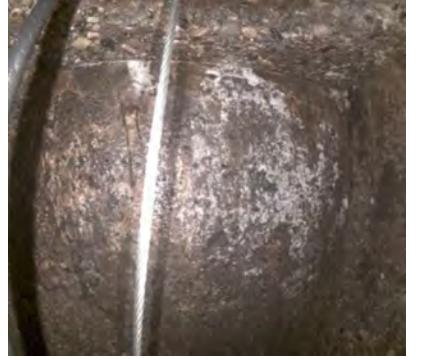
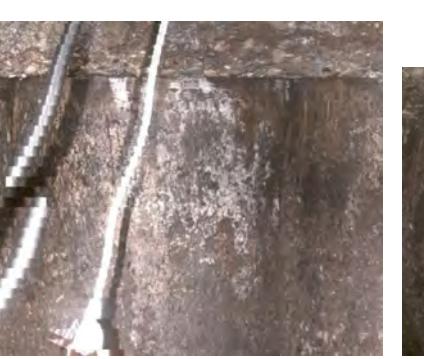
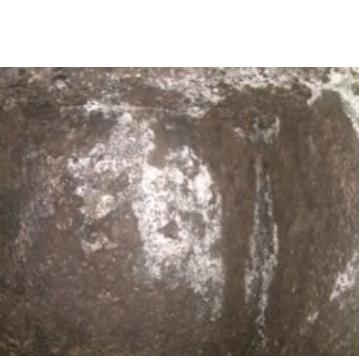
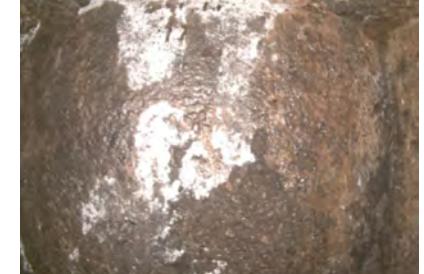
Surface Damage Aggregate Visible	Continuous	3.8 - 6.5	Structural	0	12-12	2	0	0	1	Surface Damage Aggregate Visible

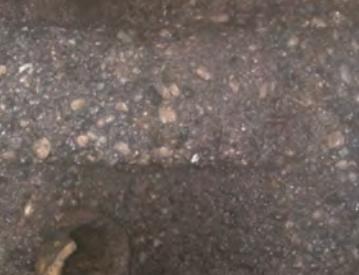
Surface Damage Aggregate Missing	Point	4.8	Structural	0	1	4	0	0	2	Surface Damage Aggregate Missing

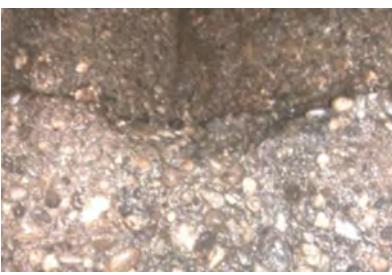
Surface Damage Reinforcement Visible	Point	5	Structural	0	6	5	0	0	2	Surface Damage Reinforcement Visible

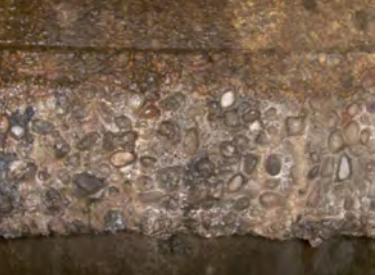
Description	Spatial Type	Distance (ft)	Type	Percent	Clock	SR	O&M	C	ER	Remarks		Photos
Surface Damage Aggregate Visible	Point	0.7	Structural	0	12-12	2	0	0	1	Surface Damage Aggregate Visible

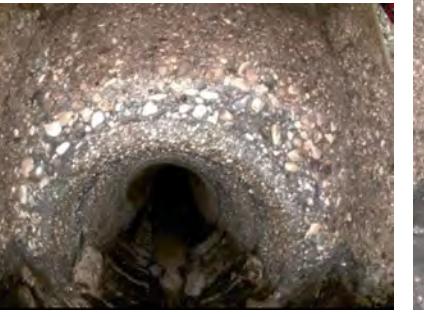
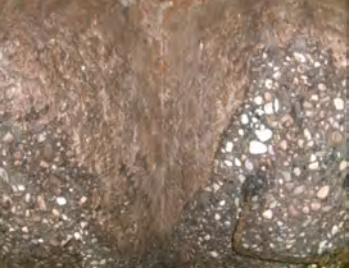
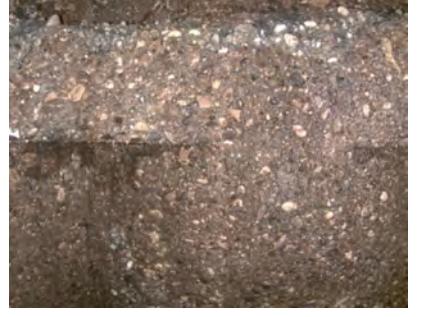
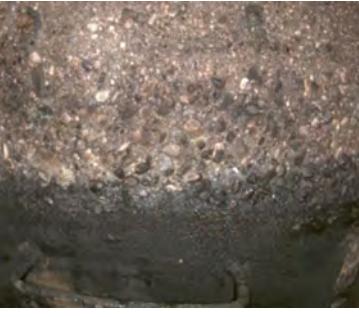
Surface Damage Aggregate Visible	Continuous	2.3 - 8.5	Structural	0	12	2	0	0	2	Surface Damage Aggregate Visible

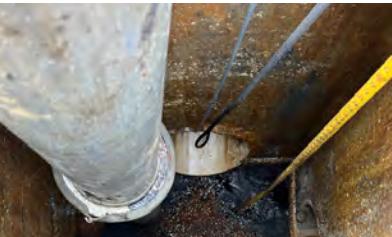
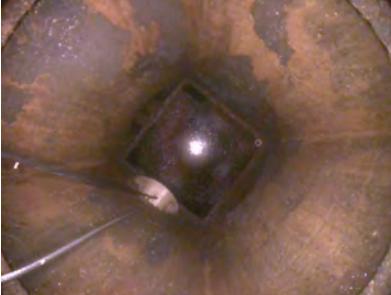
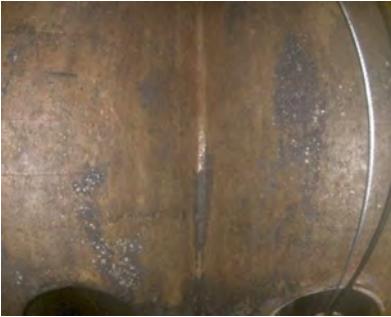
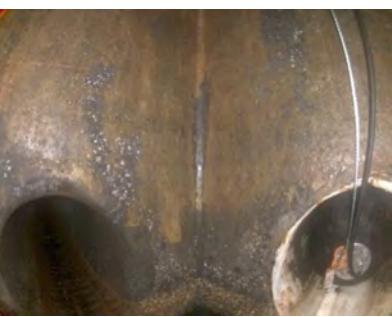
Description	Spatial Type	Distance (ft)	Type	Percent	Clock	SR	O&M	C	ER	Remarks		Photos
Surface Damage Roughness Increased	Continuous	1 - 7.5	Structural	0	12-12	1	0	0	1	Surface Damage Roughness Increased

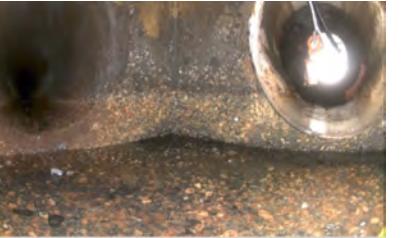
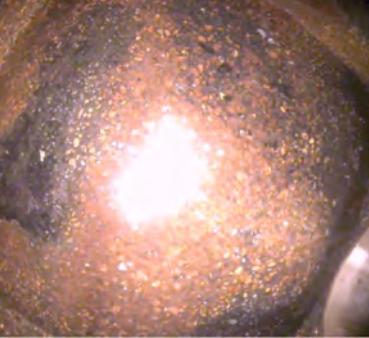
Description	Spatial Type	Distance (ft)	Type	Percent	Clock	SR	O&M	C	ER	Remarks		Photos
Surface Damage Aggregate Visible	Point	7.6	Structural	0	12-12	2	0	0	2	Surface Damage Aggregate Visible

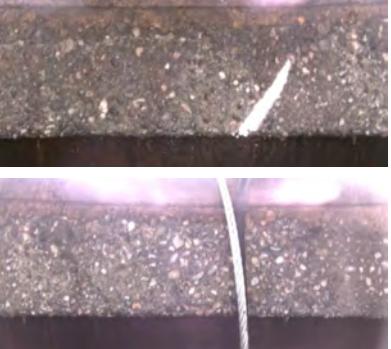
Description	Spatial Type	Distance (ft)	Type	Percent	Clock	SR	O&M	C	ER	Remarks	Photos
Surface Damage Aggregate Visible	Point	0.5	Structural	0	12-12	2	0	0	1	Surface Damage Aggregate Visible

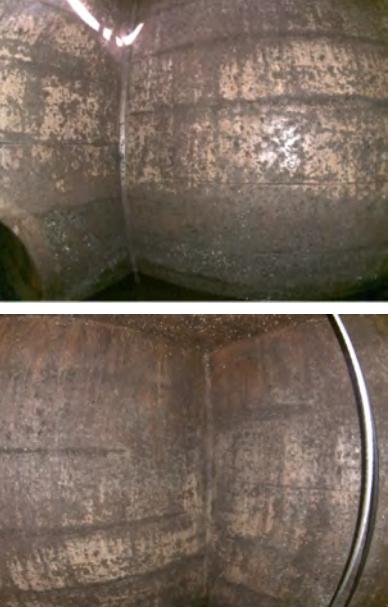
Surface Damage Roughness Increased	Continuous	0.6 - 6.2	Structural	0	12-12	1	0	0	1	Surface Damage Roughness Increased

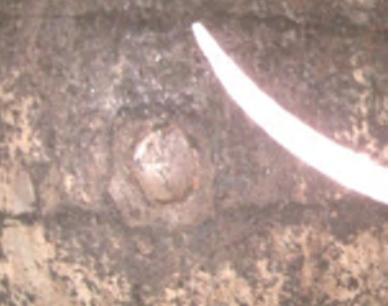
Surface Damage Aggregate Missing	Point	2.6	Structural	0	6	4	0	0	1	Surface Damage Aggregate Missing

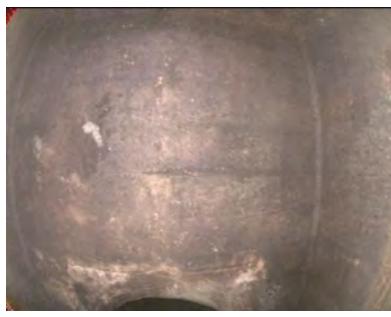
Surface Damage Aggregate Missing	Point	2.8	Structural	0	6-7	4	0	0	1	Surface Damage Aggregate Missing

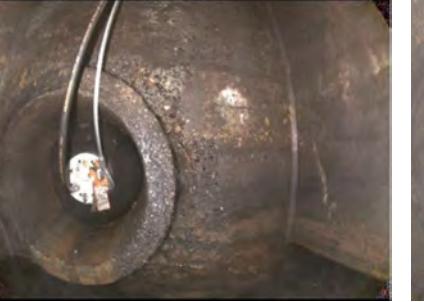
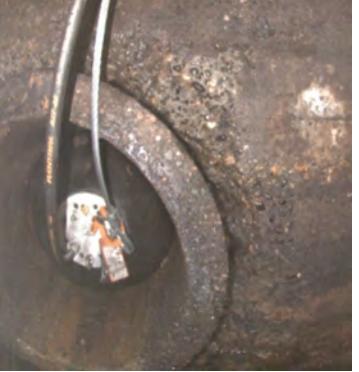
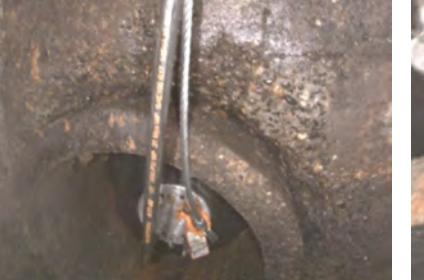
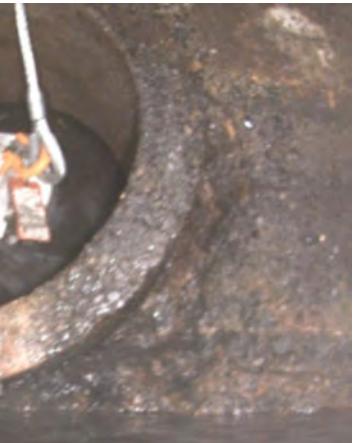
Surface Damage Aggregate Missing	Point	4.8	Structural	0	12	4	0	0	2	Surface Damage Aggregate Missing

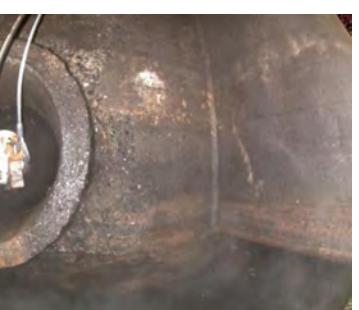
Crack Longitudinal	Point	5.2	Structural	0	2	2	0	0	1	Crack Longitudinal

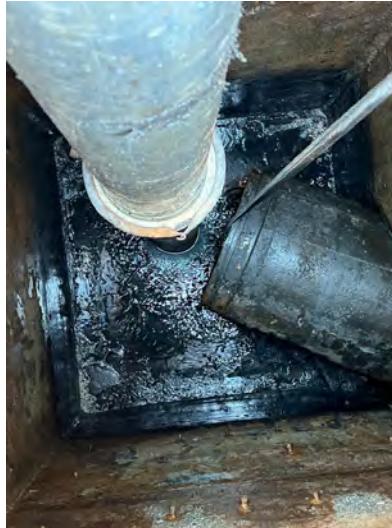
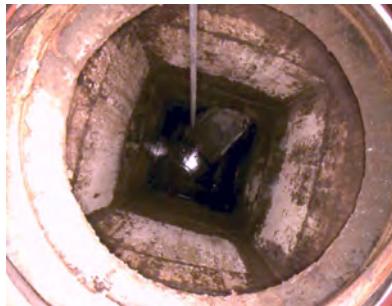
Description		Spatial Type	Distance (ft)	Type	Percent	Clock	SR	O&M	C	ER	Remarks	Photos
Miscellaneous General Photograph		Point	0	Miscellaneous	0	0	0	0	0	0	View Down Structure

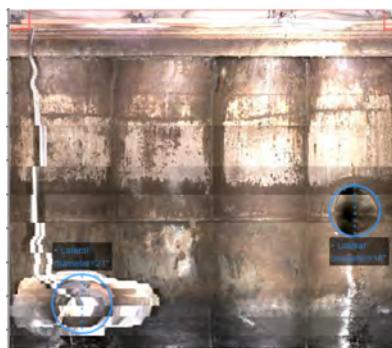
Miscellaneous General Photograph		Point	0	Miscellaneous	0	0	0	0	0	0	Side View of Structure

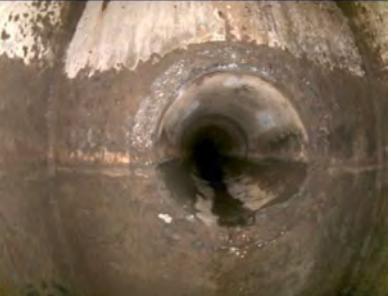
Description	Spatial Type	Distance (ft)	Type	Percent	Clock	SR	O&M	C	ER	Remarks	Photos
Surface Damage Roughness Increased	Point	5.5	Structural	0	6	1	0	0	1	Surface Damage Roughness Increased

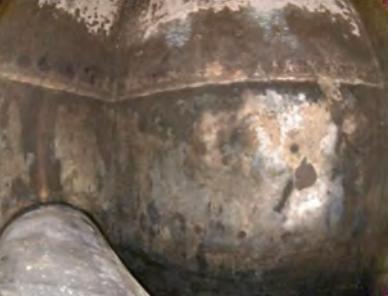
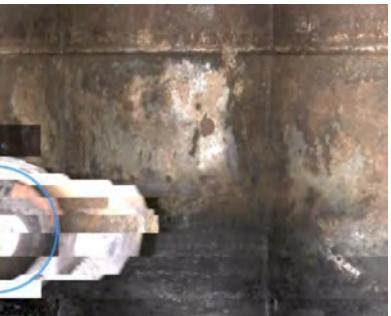
Surface Damage Surface Spalling	Point	6.5	Structural	0	12	2	0	0	1	Surface Damage Surface Spalling

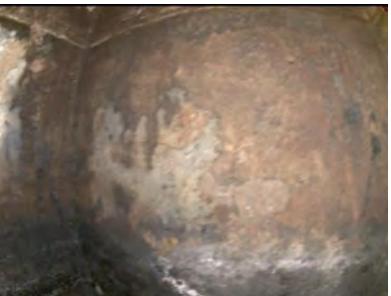
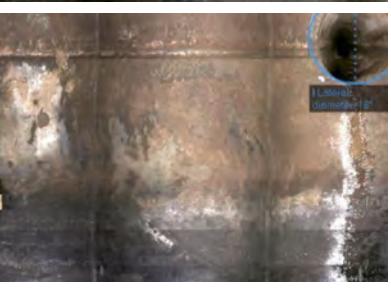
Surface Damage Surface Spalling	Point	7.2	Structural	0	3	2	0	0	1	Surface Damage Surface Spalling

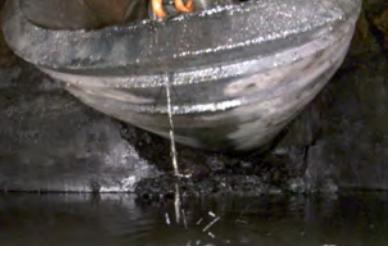
Surface Damage Aggregate Missing	Point	9	Structural	0	11	4	0	0	2	Surface Damage Aggregate Missing

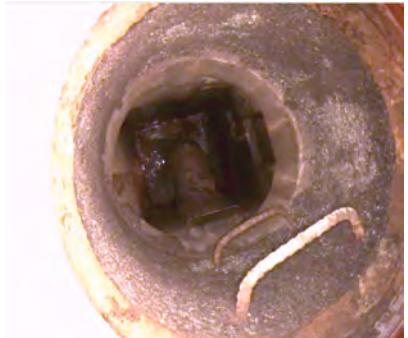
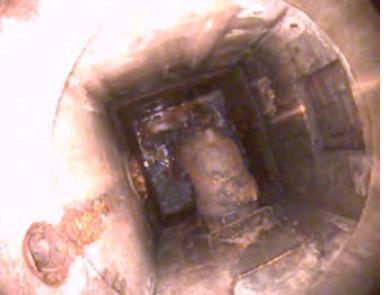
Description	Spatial Type	Distance (ft)	Type	Percent	Clock	SR	O&M	C	ER	Remarks	Photos
Miscellaneous General Photograph	Point	0	Miscellaneous	0	0	0	0	0	0	View Down Structure

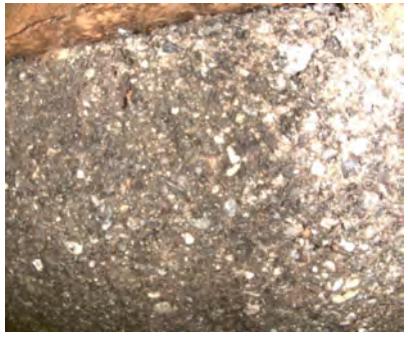
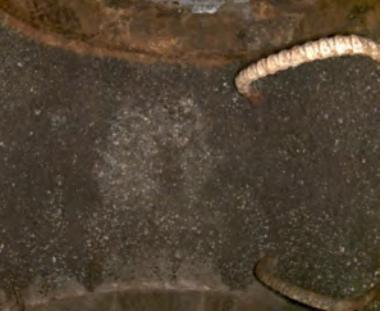
Surface Damage Roughness Increased	Continuous	0.6 - 2.5	Structural	0	12-12	1	0	0	1	Surface Damage Roughness Increased

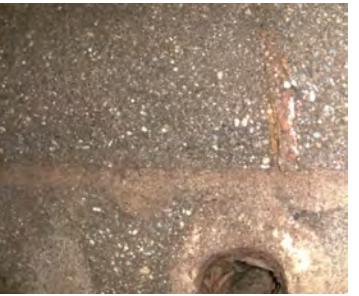
Description	Spatial Type	Distance (ft)	Type	Percent	Clock	SR	O&M	C	ER	Remarks		Photos
Surface Damage Reinforcement Visible	Point	2.6	Structural	0	12-12	5	0	0	2	Surface Damage Reinforcement Visible

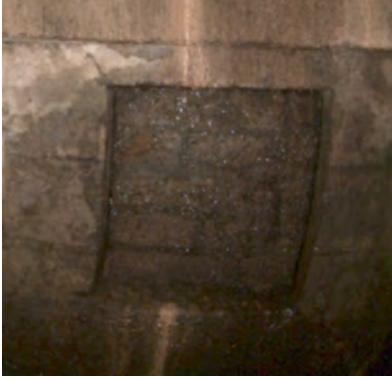
Miscellaneous General Photograph	Point	3.6	Miscellaneous	0	12	0	0	0	0	Cut Out Wall

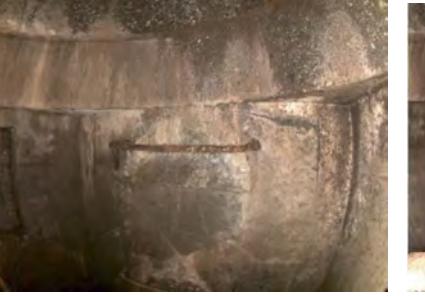
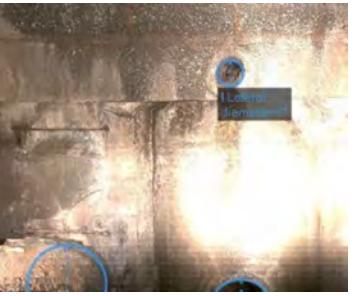
Crack Multiple	Point	3.8	Structural	0	3-4	3	0	0	2	Crack Multiple

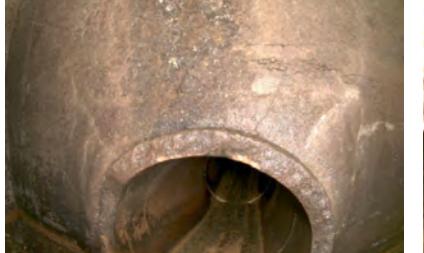
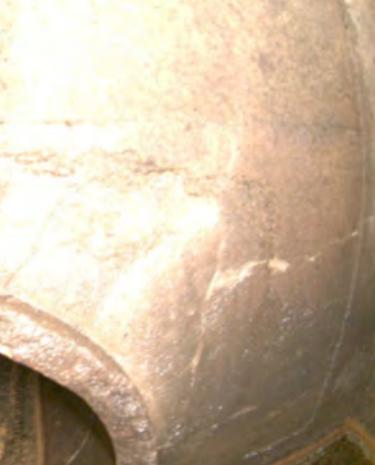
Description	Spatial Type	Distance (ft)	Type	Percent	Clock	SR	O&M	C	ER	Remarks		Photos
Crack Multiple	Point	5	Structural	0	5-10	3	0	0	2	Crack Multiple

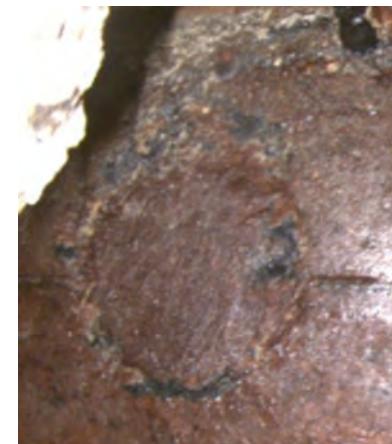
Surface Damage Aggregate Missing	Point	7.5	Structural	0	3	4	0	0	1	Surface Damage Aggregate Missing

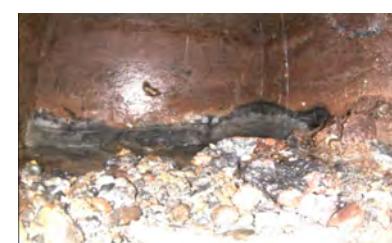
Deposits Settled Gravel	Point	8.7	O&M	0	12-12	0	0	0	0	Deposits Settled Gravel

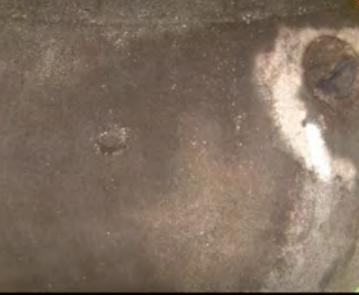
Surface Damage Aggregate Missing	Point	4.8	Structural	0	12	4	0	0	1	Surface Damage Aggregate Missing

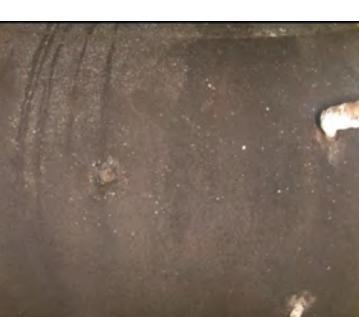
Surface Damage Aggregate Missing	Point	4.9	Structural	0	6	4	0	0	1	Surface Damage Aggregate Missing

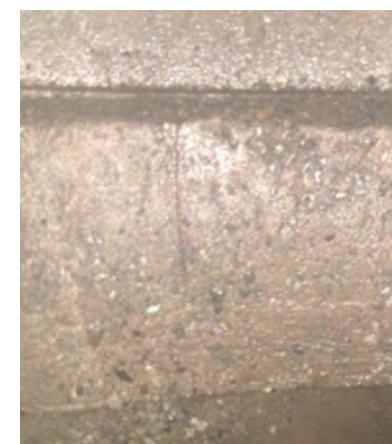
Crack Longitudinal	Point	10.5	Structural	0	6	2	0	0	1	Crack Longitudinal

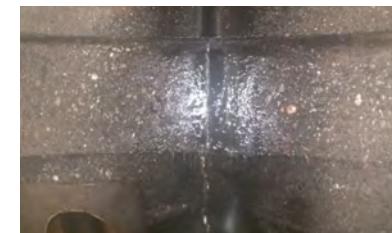
Surface Damage Aggregate Visible	Point	10.5	Structural	0	12-3	2	0	0	1	Surface Damage Aggregate Visible

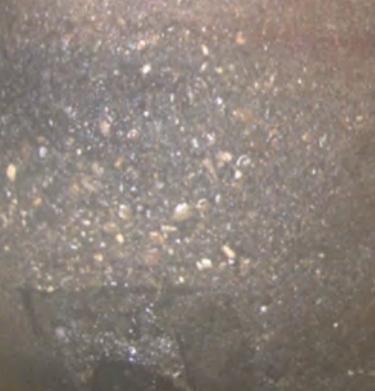
Description	Spatial Type	Distance (ft)	Type	Percent	Clock	SR	O&M	C	ER	Remarks	Photos
Surface Damage Aggregate Visible	Point	13	Structural	0	3	2	0	0	1	Surface Damage Aggregate Visible

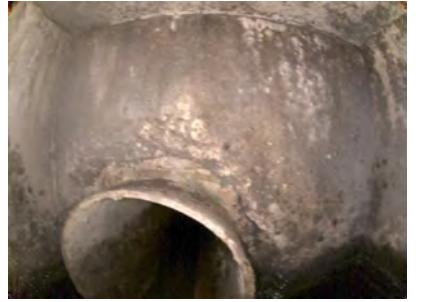
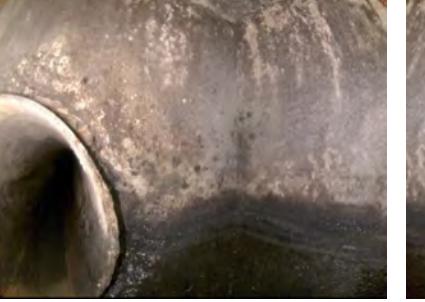
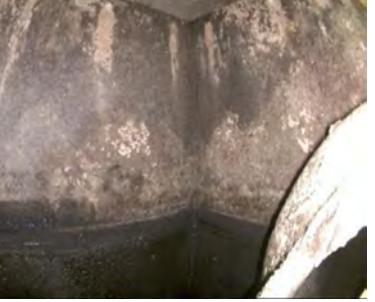
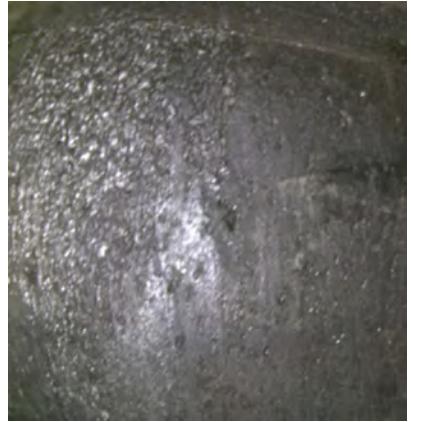
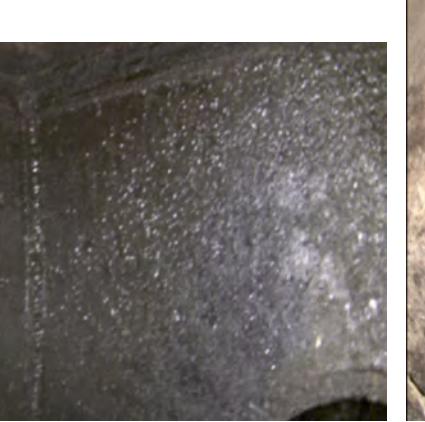
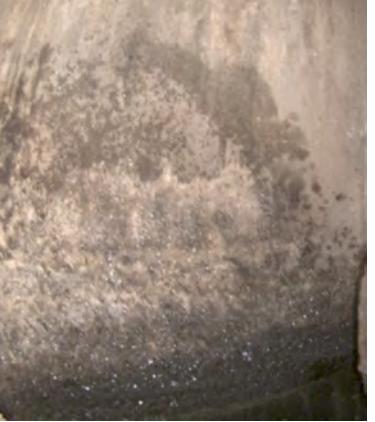
Description		Spatial Type	Distance (ft)	Type	Percent	Clock	SR	O&M	C	ER	Remarks	Photos
Surface Damage Roughness Increased	Continuous	0 - 8.2	Structural	0	12-12	1	0	0	1		Surface Damage Roughness Increased

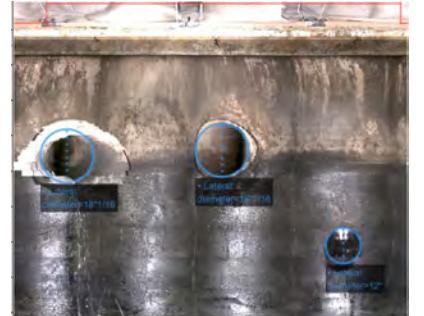
Surface Damage Aggregate Missing	Continuous	2.5 - 4.1	Structural	0	6	4	0	0	2	Surface Damage Aggregate Missing

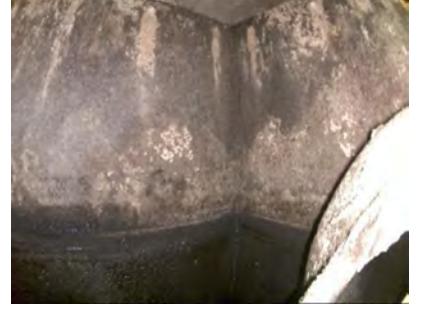
Description	Spatial Type	Distance (ft)	Type	Percent	Clock	SR	O&M	C	ER	Remarks	Photos
Miscellaneous General Photograph	Point	5	Miscellaneous	0	12	0	0	0	0	Broken Pipe

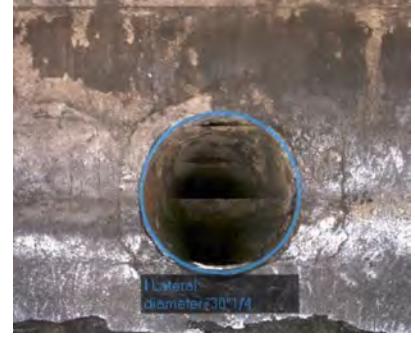
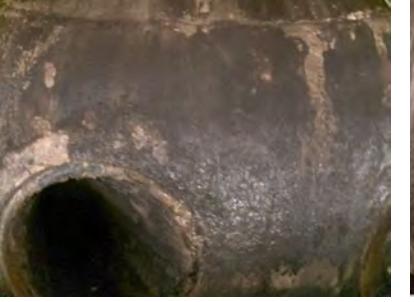
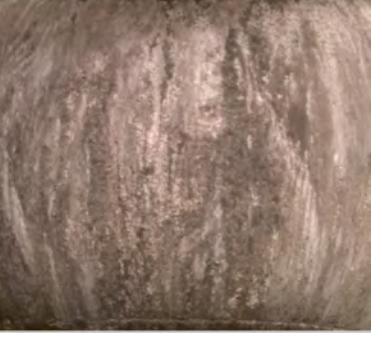
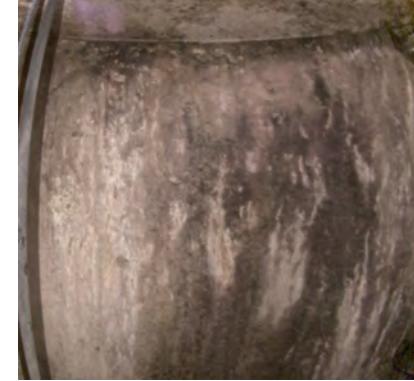
Description		Spatial Type	Distance (ft)	Type	Percent	Clock	SR	O&M	C	ER	Remarks	Photos			
Surface Damage Roughness Increased	Continuous	0 - 10		Structural	0	12-12	1	0	0	1	Surface Damage Roughness Increased

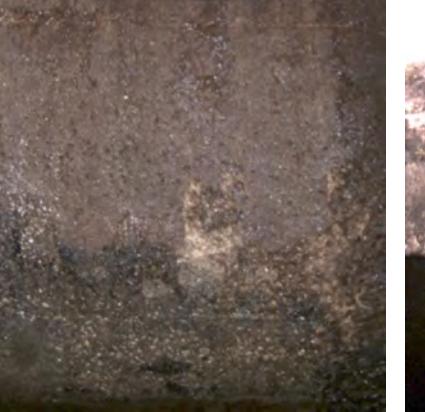
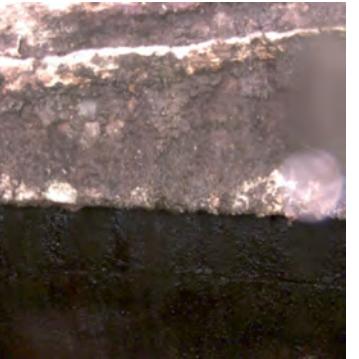
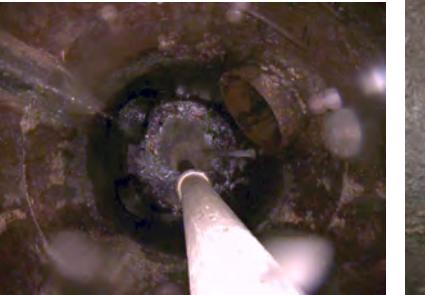
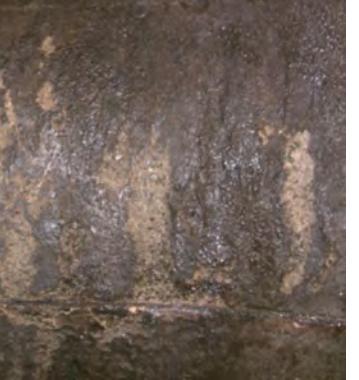
Description	Spatial Type	Distance (ft)	Type	Percent	Clock	SR	O&M	C	ER	Remarks		Photos
Surface Damage Roughness Increased	Continuous	0 - 16.3	Structural	0	12-12	1	0	0	1	Surface Damage Roughness Increased

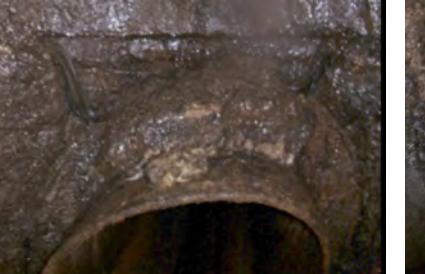
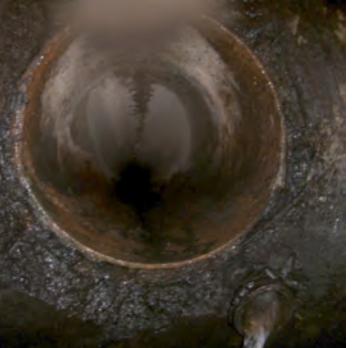
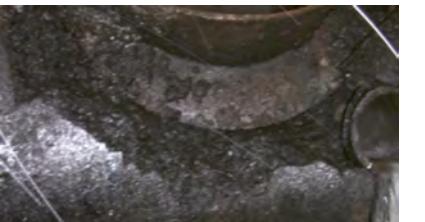
Surface Damage Aggregate Missing	Continuous	8.6 - 13	Structural	0	6	4	0	0	2	Surface Damage Aggregate Missing

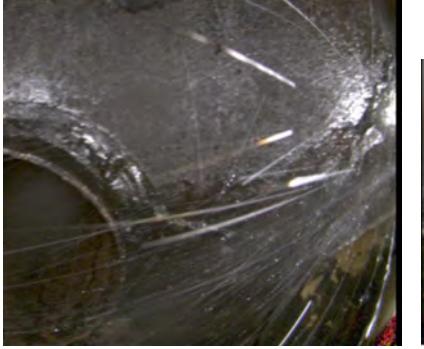
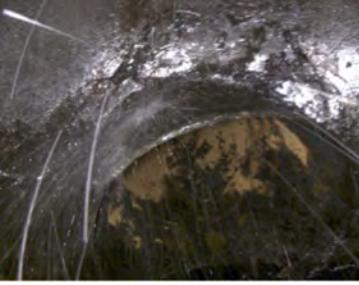
Description	Spatial Type	Distance (ft)	Type	Percent	Clock	SR	O&M	C	ER	Remarks		Photos
Crack Circumferential	Point	13	Structural	0	12-2	2	0	0	2	Crack Circumferential

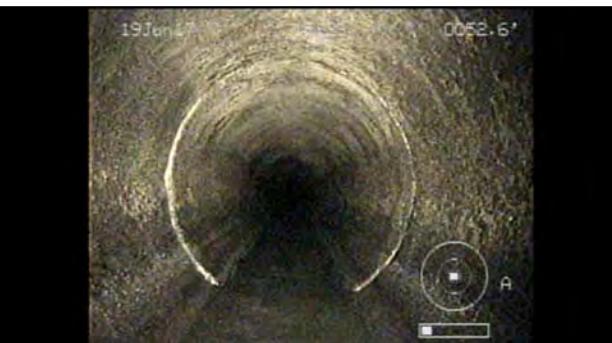
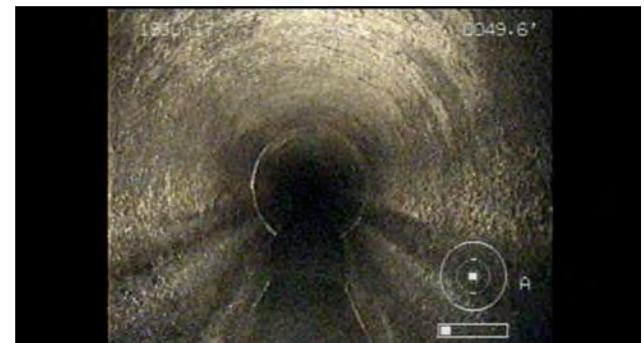
Obs: SRI - Surface Damage Roughness Increased		Obs: SRI - Surface Damage Roughness Increased
Comments:		Comments:
EER: 1		EER: 1

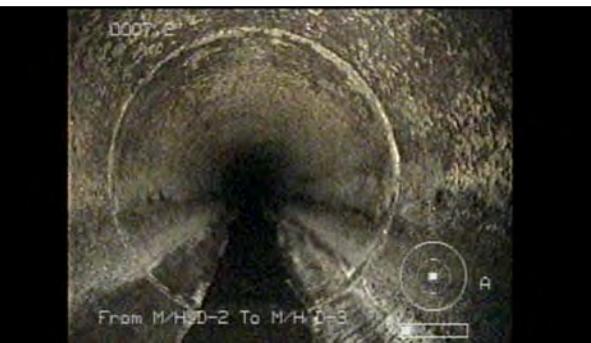
Obs: SRI - Surface Damage Roughness Increased		
Comments:		
EER: 1

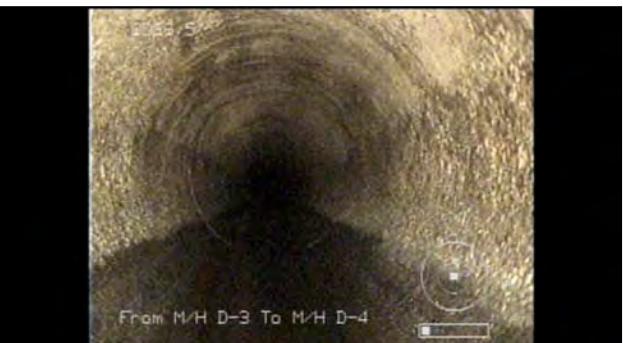
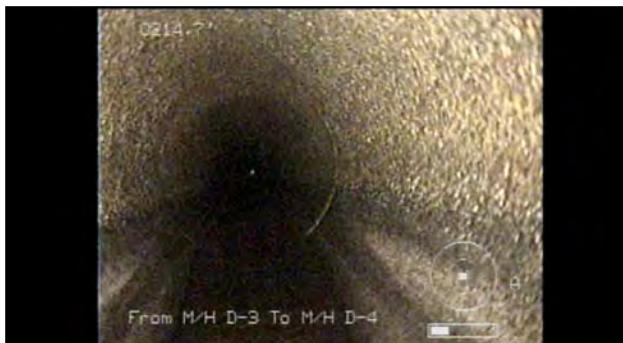
Distance: 21 ft		Date: 11/09/2022
Obs: SRI - Surface Damage Roughness Increased		Distance: 201 ft
Comments:		Obs: SRI - Surface Damage Roughness Increased
EER: 1		Comments:
		EER: 1
	247.0_SAV_From-04_To-05.jpg	
Date: 10/17/2022

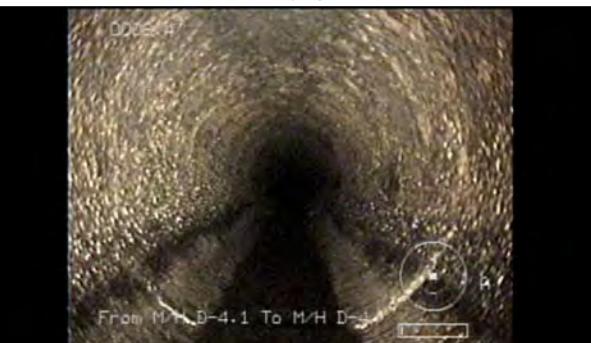
Obs: SRI - Surface Damage Roughness Increased		
Comments:		
EER: 1

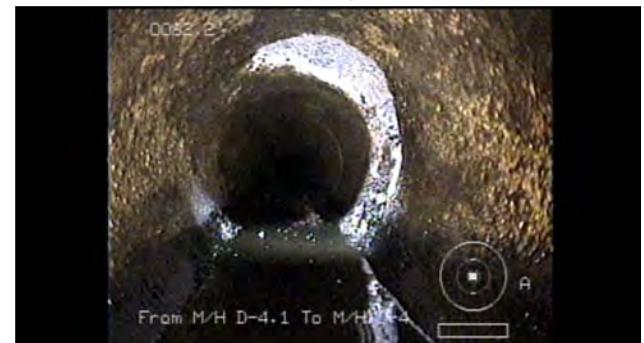
Sewer Trunk Segment (MH to MH)	NASSCO Code	EER	Location (Length (ft.)/Clock position)	Comments
MH D-4 to MH D-20 & MH D-6.1 to MH D-20	Hole Soil Visible	4	85.5' / 12 to 5 o'clock & 233.8' / 7 to 12 o'clock	Hole created to access Manhole D-20. Infiltration Runner Connection (IRC) from hole. The same code is in both sewer segements because both inspections end at MH D-20.
MH D-6.1 to MH D-20	Broken Void Visible	3	172.6' / 11 o'clock	Noticeably displaced pieces moved from their original position above the flow line.
MH D-6 to MH D-19	Broken Void Visible	3	69.0' / 12 o'clock	Noticeably displaced pieced moved from their original position above the flow line.
MH D-6 to MH D-19	Hole Soil Visible	3	74.0' / 12 o'clock	4 inch hole above flow line.

56.2	F01	SRI - Surface Damage Roughness Increased				07	05		EER: 1
85.5		HSV - Hole Soil Visible				12	05		EER: 4. Hole is access manhole.
85.5		IRC - Infil Runner Connection				05			EER: 2. Runner is coming from manhole.

Per the IRP, the defects which were identified as EER 3 or EER 4 (as shown on Table 2) are considered potential releases. Site investigation activities should be initiated in these areas to determine if a release has occurred. In addition, pursuant to the IRP, these areas should be prioritized for sewer repairs as needed.

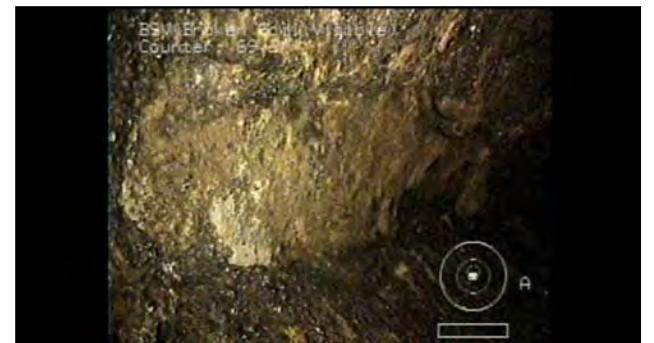
69.0		BSV - Broken Soil Visible	6.0			12			EER: 3
74.0		HSV - Hole Soil Visible	4.0			12			EER: 3
80.0		DAE - Deposits Attached Encrustation		015	X	12			EER: 1. Calcium Built in Joint

Obs: MWL - Miscellaneous Water Level		
Comments:	From M/H D-6 To M/H D-19	
EER: 3		
Date: 10/17/2022	74.0_HSV_From-12_To-.jpg	80.0_DAE_From-12_To-.jpg
Distance: 74 ft

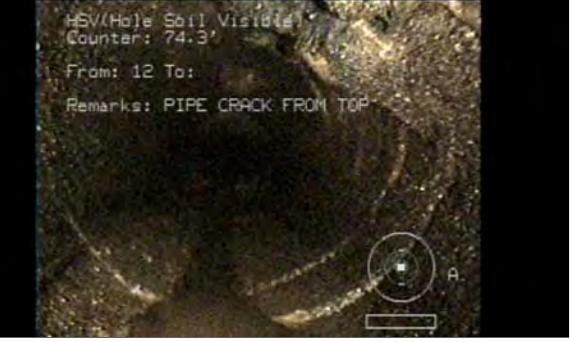
Obs: HSV - Hole Soil Visible		
Comments:		
EER: 3

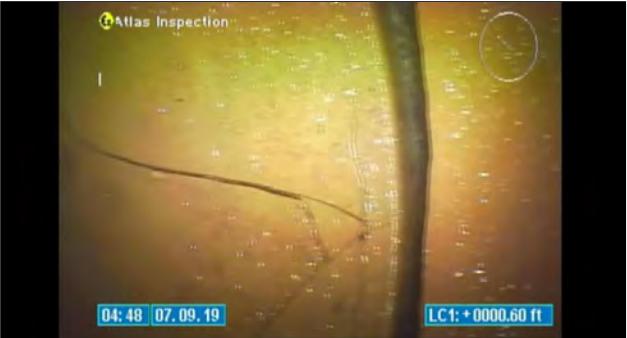
Obs: CM - Crack Multiple		
Comments:		
EER: 1	04:48 07.09.19 LC1: +0000.60 ft	04:48 07.09.19 LC1: +0000.90 ft
	0.6_FC_From-06_To-06.jpg	4.2_CS_From-08_To-10.jpg
Date: 10/18/2022

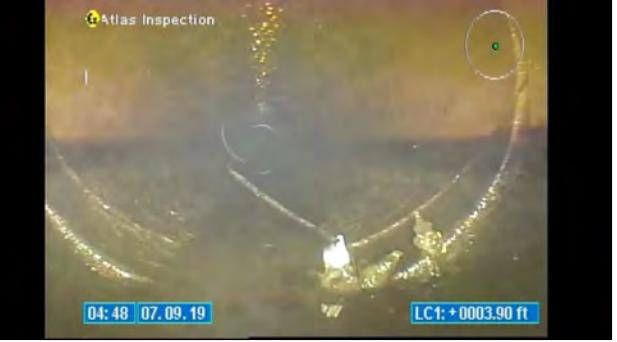
Date:	10/18/2022		
Distance:	4.2 ft		Distance:	8.5 ft		
Obs:	OBJ - Obstruction Wedged In The Joint		Obs:	CM - Crack Multiple		
Comments:			Comments:			
EER:	1. Zip ties and possibly a dead vermin. Unclear.	04:48 07.09.19 LC1: +0003.90 ft	EER: 1	04:49 07.09.19 LC1: +0008.50 ft		
		16.7_CL_From-02_To-.jpg		20.6_CL_From-12_To-.jpg		
Date:	10/18/2022

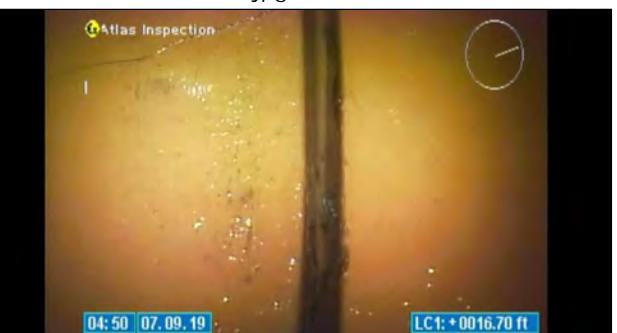
Date:	10/18/2022		
Distance:	16.7 ft		Distance:	20.6 ft		
Obs:	CL - Crack Longitudinal		Obs:	CL - Crack Longitudinal		
Comments:			Comments:			
EER:	1	04:50 07.09.19 LC1: +0016.70 ft	EER: 1	04:50 07.09.19 LC1: +0020.60 ft

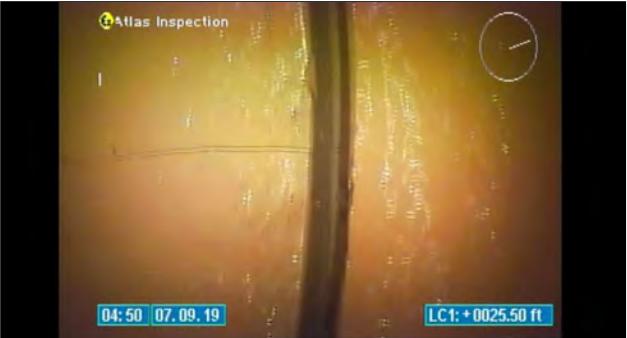
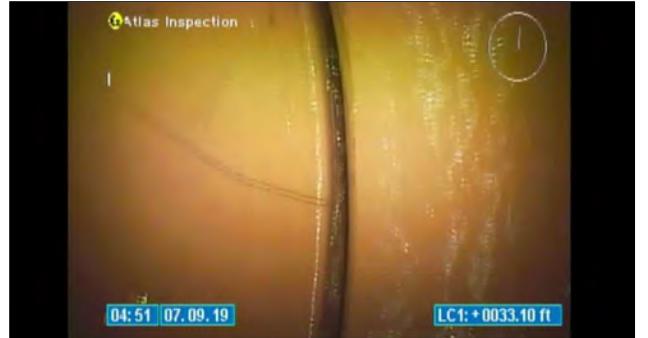
Obs: CL - Crack Longitudinal		
Comments:		
EER: 1	04:50 07.09.19 LC1:+0025.50 ft	04:51 07.09.19 LC1:+0033.10 ft
Date: 10/18/2022	37.4_CL_From-12_To-.jpg	41.0_CL_From-03_To--A.jpg
Distance: 37.4 ft

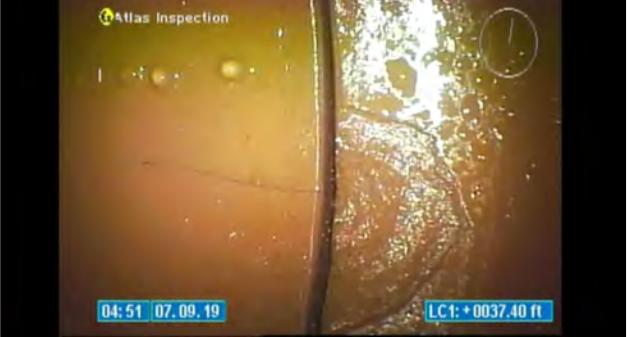
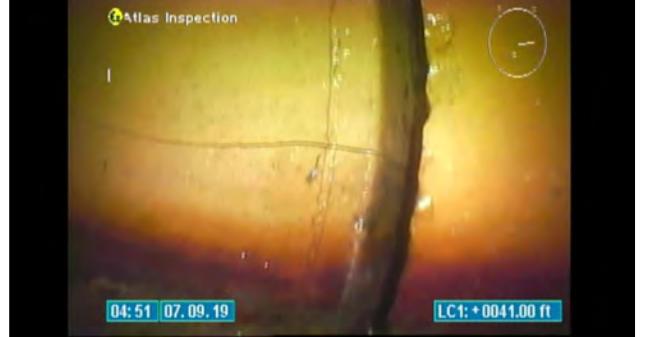
Obs: CL - Crack Longitudinal		
Comments:		
EER: 1	04:51 07.09.19 LC1:+0037.40 ft	04:51 07.09.19 LC1:+0041.00 ft

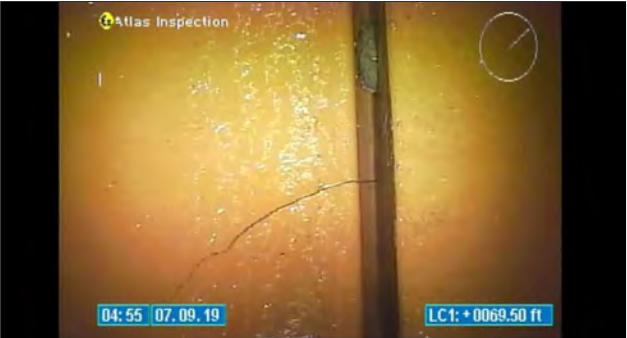
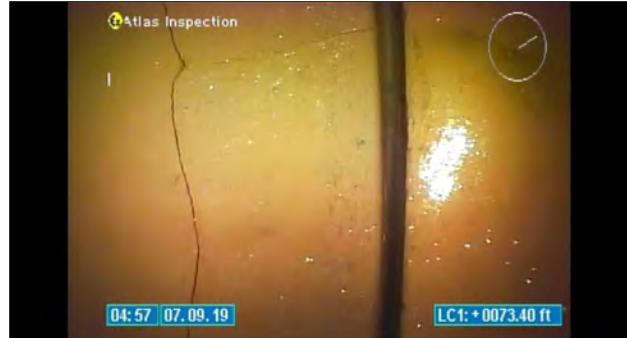
Obs: CS - Crack Spiral		
Comments:		
EER: 1	04:55 07.09.19 LC1: +0069.50 ft	04:57 07.09.19 LC1: +0073.40 ft
Date: 10/18/2022	77.7_CL_From-01_To-.jpg	82.3_CS_From-02_To-04.jpg
Distance: 77.7 ft

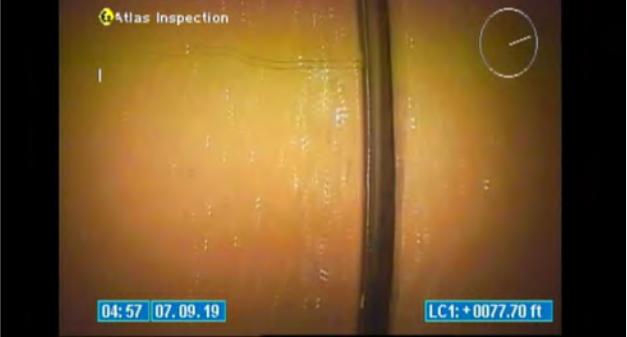
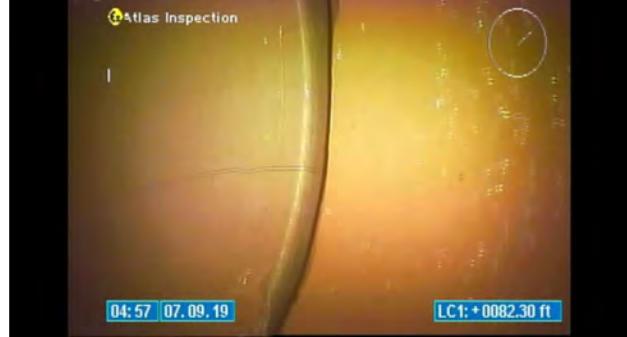
Obs: CL - Crack Longitudinal		
Comments:		
EER: 1	04:57 07.09.19 LC1: +0077.70 ft	04:57 07.09.19 LC1: +0082.30 ft

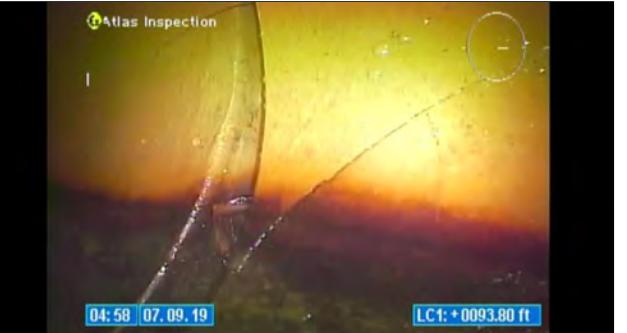
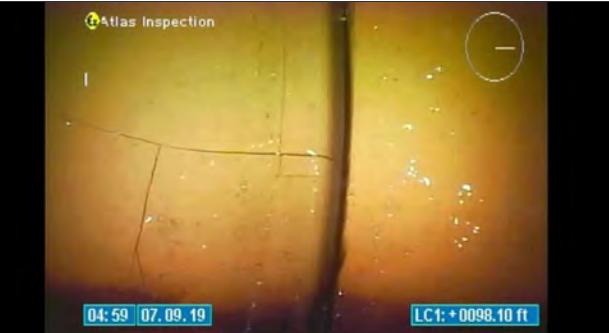
Obs: CS - Crack Spiral						
Comments:						
EER: 1

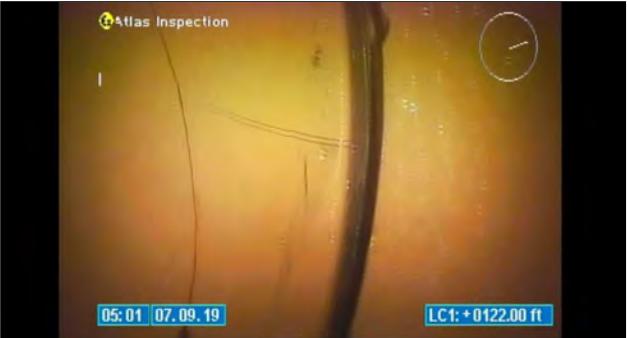
Obs: CM - Crack Multiple		Obs: IWB - Infiltration Weeper Barrel
Comments:		Comments:
EER: 1		EER: 1. Related to CM at 122.00'.
Date: 10/18/2022	125.9_CM_From-12_To-05.jpg	130.2_CS_From-01_To-04.jpg
Distance: 125.9 ft

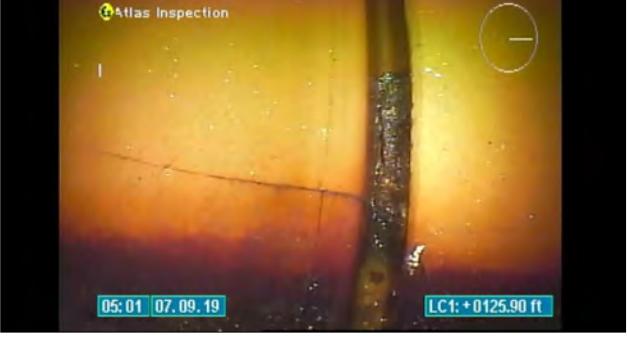
Obs: CM - Crack Multiple		Obs: CS - Crack Spiral
Comments:		Comments:
EER: 1		EER: 1

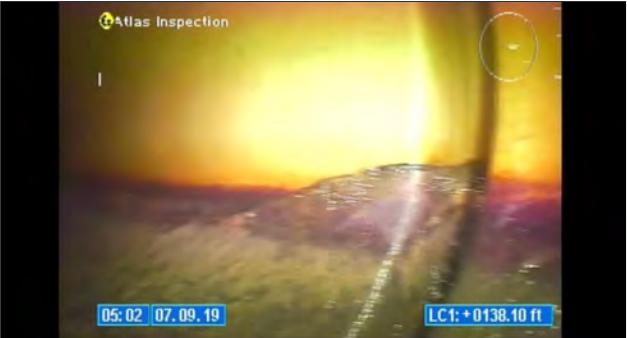
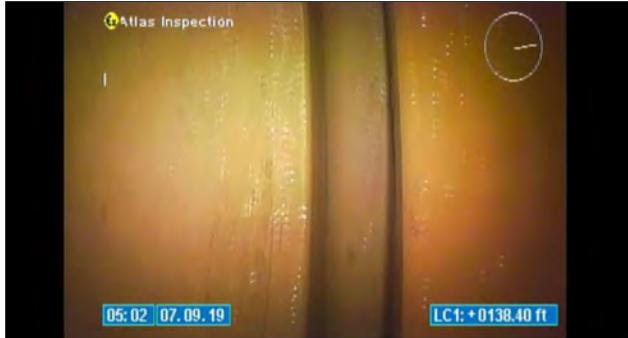
Obs: DAE - Deposits Attached Encrustation		
Comments:		
EER: 1	05:02 07.09.19 LC1: +0138.10 ft	05:02 07.09.19 LC1: +0138.40 ft
Date: 11/08/2022	142.3_CM_From-02_To-03.jpg	142.3_ISB_From-02_To-03.jpg
Distance: 142.3 ft

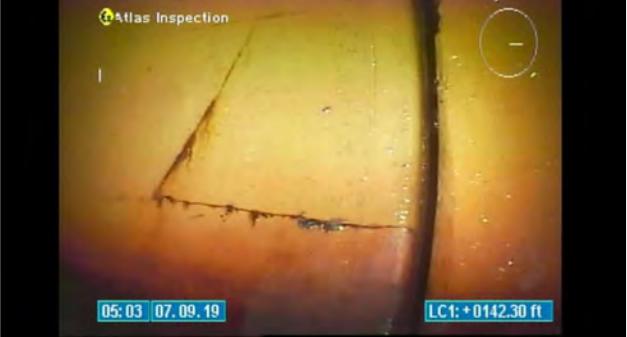
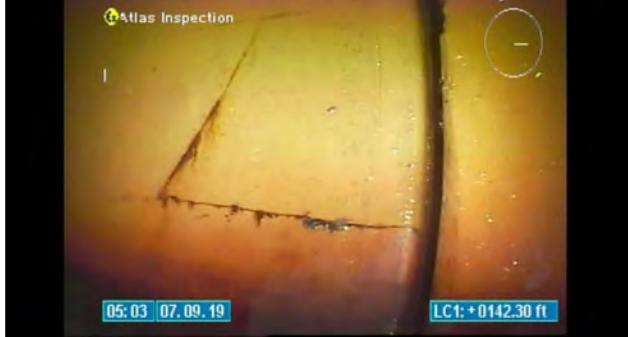
Obs: CM - Crack Multiple		
Comments:		
EER: 1	05:03 07.09.19 LC1: +0142.30 ft	05:03 07.09.19 LC1: +0142.30 ft
