2023 ANNUAL PROGRESS REPORT

SWMU-1 OILY WATER SEWER

HF SINCLAIR PUGET SOUND REFINING LLC

MARCH 21, 2024

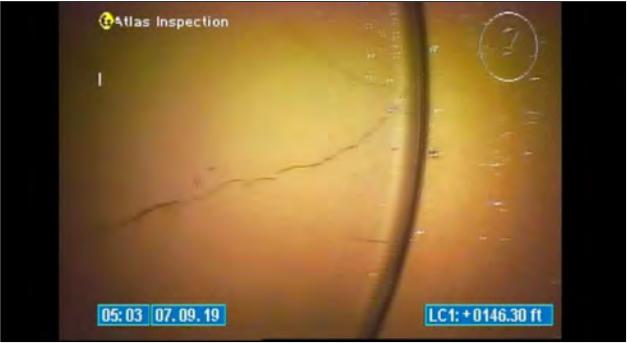
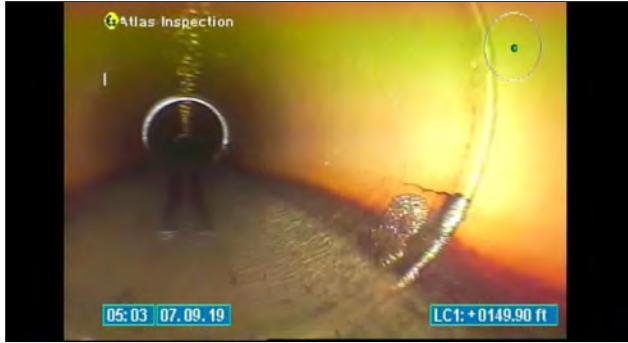
Obs: CM - Crack Multiple		
Comments:		
EER: 1	05:03 07.09.19 LC1:+0146.30 ft	05:03 07.09.19 LC1:+0149.90 ft
Date: 11/08/2022	150.5_FM_From-02_To-04.jpg	150.5_IWB_From-04_To-.jpg
Distance: 150.5 ft

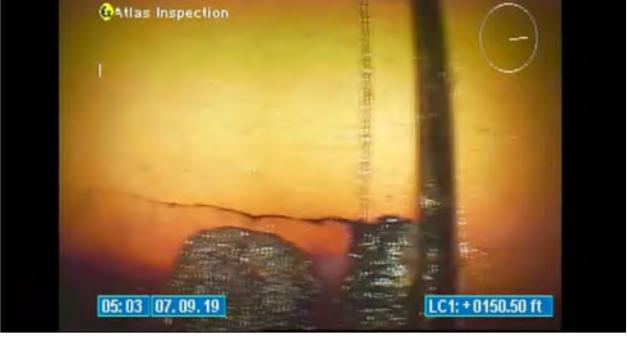
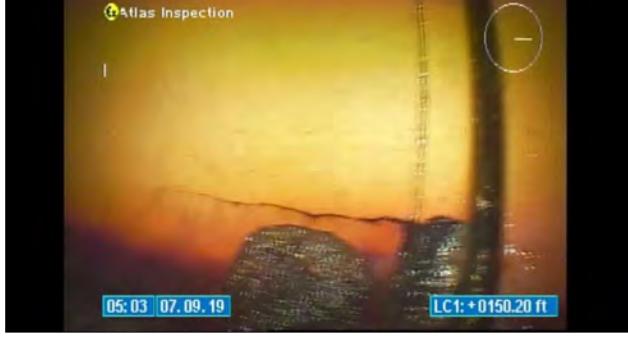
Obs: FM - Fracture Multiple		
Comments:		
EER: 2	05:03 07.09.19 LC1:+0150.50 ft	05:03 07.09.19 LC1:+0150.20 ft

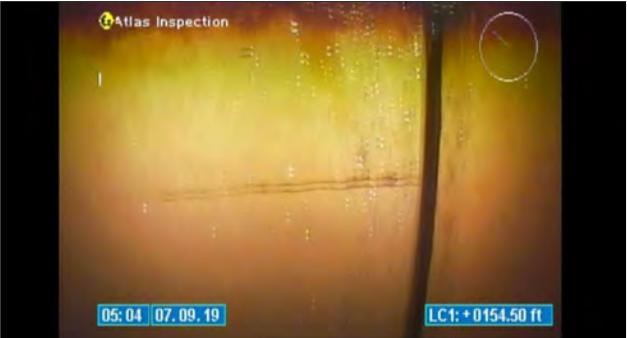
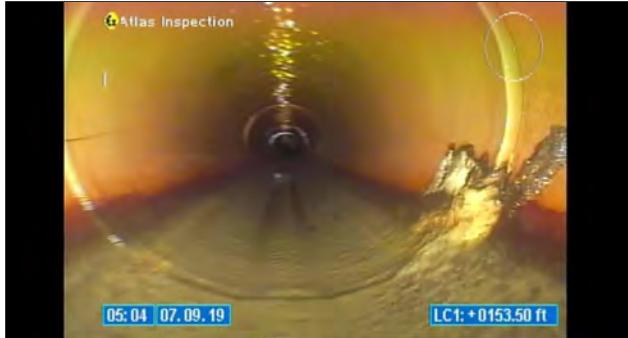
Obs: CL - Crack Longitudinal		
Comments:		
EER: 1	05:04 07.09.19 LC1: +0154.50 ft	05:04 07.09.19 LC1: +0153.50 ft
	158.4_CS_From-02_To-05.jpg	158.4_CS_From-07_To-09.jpg
Date: 10/18/2022

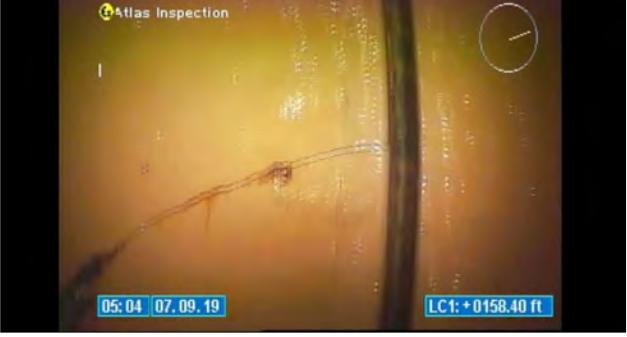
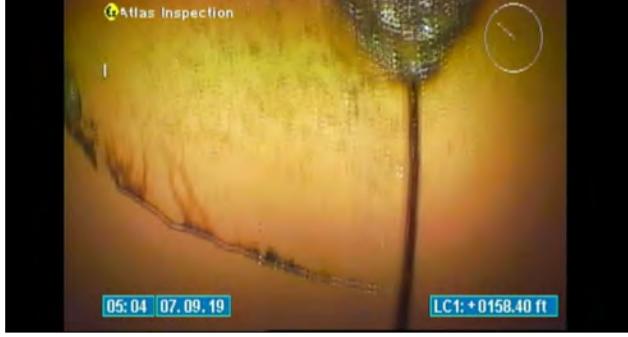
158.4	IWB - Infiltration Weeper Barrel			X 07 09	EER: 1. Related to the CS 158.4'.		
162.7	CL - Crack Longitudinal			X 03	EER: 1		
162.7	ISB - Infil Stain Barrel			03	EER: 1. Related to the CL at 162.7'.

Distance: 158.4 ft		
Obs: CS - Crack Spiral		
Comments:		
EER: 1	05:04 07.09.19 LC1: +0158.40 ft	05:04 07.09.19 LC1: +0158.40 ft

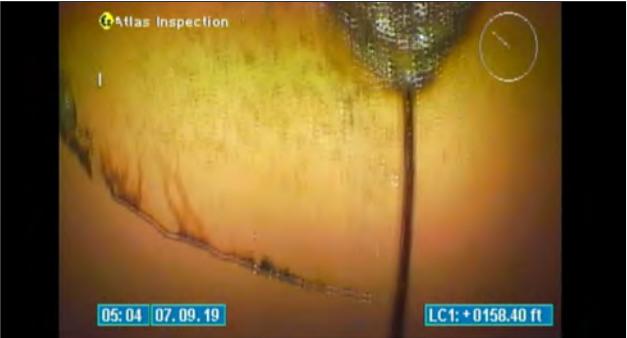
Obs: IWB - Infiltration Weeper Barrel		
Comments:		
EER: 1. Related to the CS 158.4',	05:04 07.09.19 LC1: +0158.40 ft	05:05 07.09.19 LC1: +0162.70 ft
Date: 11/08/2022	167.3_CS_From-03_To-05.jpg	174.5_CS_From-02_To-05.jpg
Distance: 167.3 ft

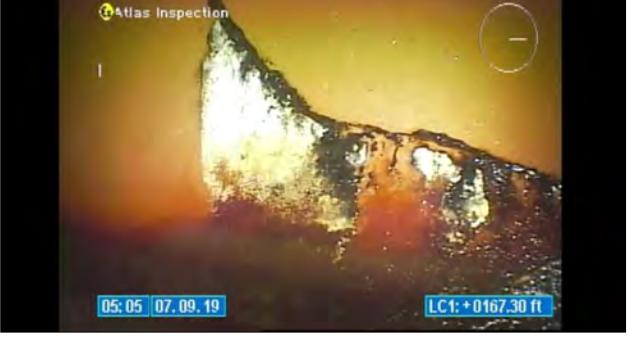
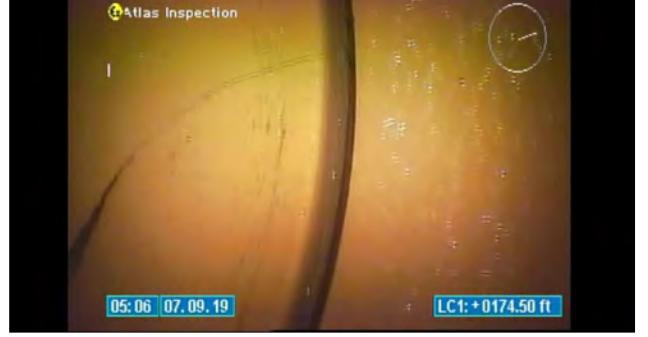
Obs: CS - Crack Spiral		
Comments:		
EER: 1	05:05 07.09.19 LC1: +0167.30 ft	05:06 07.09.19 LC1: +0174.50 ft

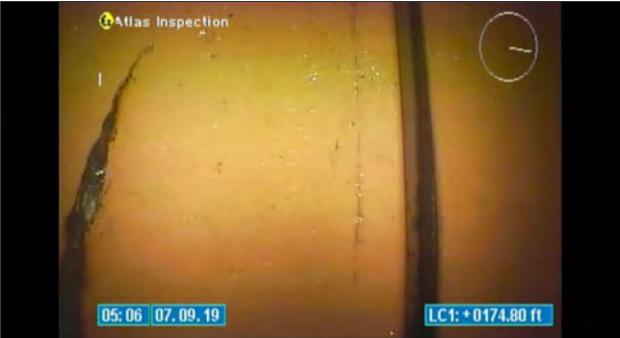
Obs: IWB - Infiltration Weeper Barrel		
Comments:		
EER: 1. Related to CS at 174.5'.	05:06 07.09.19 LC1: +0174.80 ft	05:06 07.09.19 LC1: +0178.40 ft
Date: 10/18/2022	178.8_IS_From-03_To-.jpg	180.0_CC_From-08_To-09.jpg
Distance: 178.8 ft

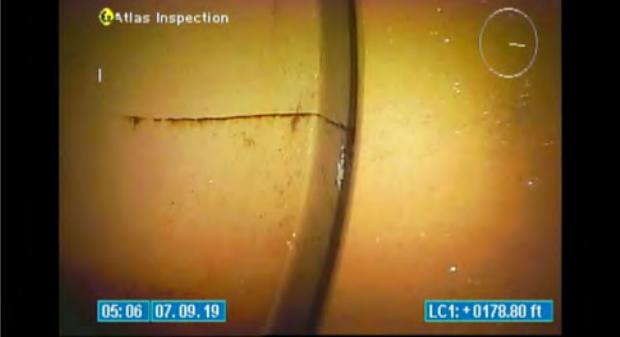
Obs: ISB - Infil Stain Barrel		
Comments:		
EER: 1. Related to the CL at 178.8'.	05:06 07.09.19 LC1: +0178.80 ft	05:06 07.09.19 LC1: +0178.80 ft

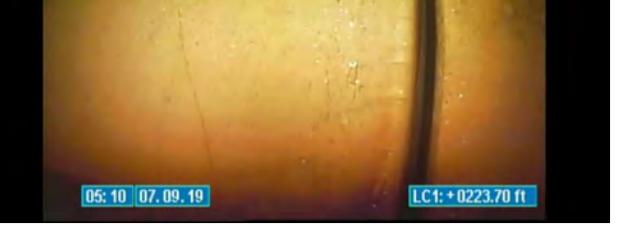
Distance:	223.7 ft			
Obs:	CS - Crack Spiral			
Comments:				
EER:	1	05:10 07.09.19	LC1: +0223.70 ft	05:11 07.09.19
				LC1: +0231.60 ft
		231.6_CL_From-04_To-.jpg		231.6_IS_From-04_To-.jpg
Date:	10/19/2022

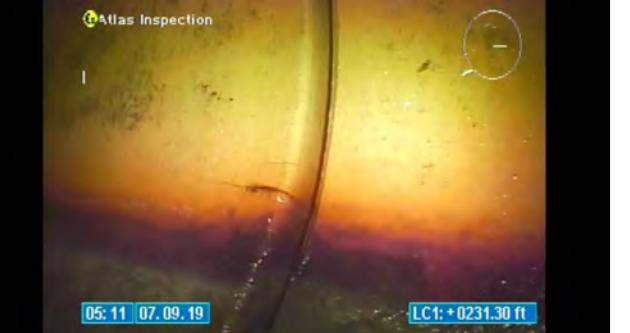
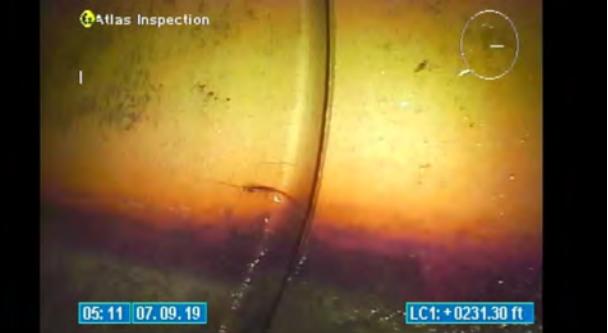
Distance:	231.6 ft			
Obs:	CL - Crack Longitudinal			
Comments:				
EER:	1	05:11 07.09.19	LC1: +0231.30 ft	05:11 07.09.19
				LC1: +0231.30 ft

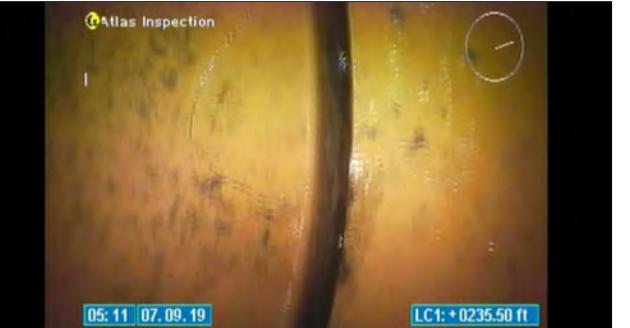
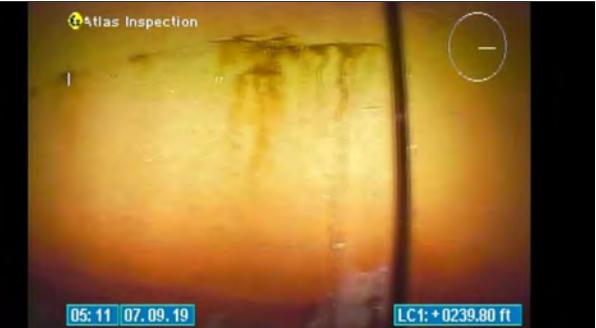
Work Order		Date 1:15 20190709	Sheet 8			
Street B Street		Weather				
City Anacortes						
Location						
Up Node B-3		Down Node 3-N		Direction Downstream		
	235.9_CS_From-03_To-04.jpg		239.8_CL_From-02_To-.jpg			
Date:	10/19/2022		Date:	10/19/2022		
Distance:	235.9 ft		Distance:	239.8 ft		
Obs:			Obs:			
CS - Crack Spiral			CL - Crack Longitudinal			
Comments:			Comments:			
EER: 1			EER: 1

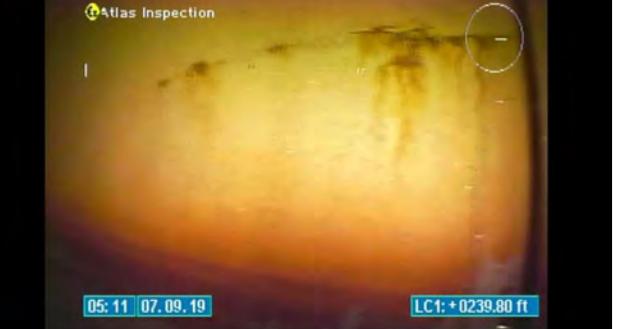
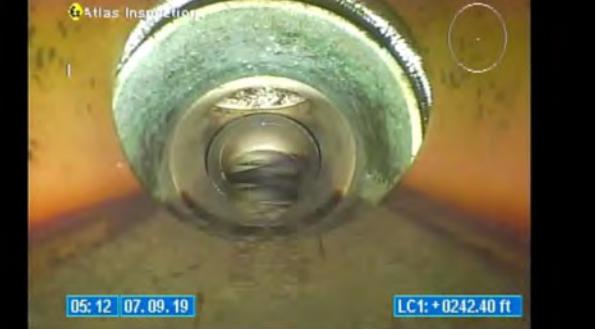
239.8	CL - Crack Longitudinal				X	02		EER: 1		
239.8	IW - Infil Weeper				X	02		EER: 1. Related to the CL at 239.8'.		
243.7	JOM - Joint Offset Medium							EER: 2. At Acess Manhole

05:11 07.09.19	LC1: +0235.50 ft	05:11 07.09.19	LC1: +0239.80 ft		
	239.8_IW_From-02_To-.jpg		243.7_JOM_From-_To-.jpg			
Date:	10/19/2022		Date:	10/19/2022		
Distance:	239.8 ft		Distance:	243.7 ft		
Obs:			Obs:			
IW - Infil Weeper			JOM - Joint Offset Medium			
Comments:			Comments:			
EER: 1. Related to the CL at 239.8'			EER: 2. At Access Manhole

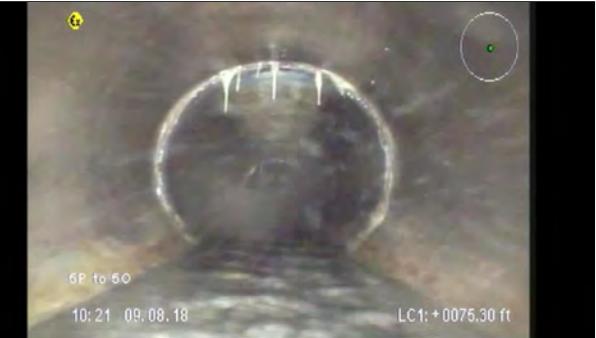
<table><tr> <th colspan="3">Miscellaneous</th> <th colspan="3">Structural</th> <th colspan="2">O&M</th> <th>Constructional</th> </tr><tr> <td>76.3</td> <td>S02</td> <td>IWJ - Infiltration Weeper Joint</td> <td></td> <td></td> <td></td> <td>X</td> <td>11</td> <td>01 EER: 1. Related to the DAE.</td> </tr></table>

Obs: RFJ - Roots Fine Joint			Obs: DAE - Deposits Attached Encrustation		
Comments:			Comments:		
EER: 1	10:21 09.08.18	LC1: +0060.40 ft	EER: 1. Related to the IWJ.	10:21 09.08.18	LC1: +0075.30 ft
	114.4_DAE_From-11_To-01.jpg

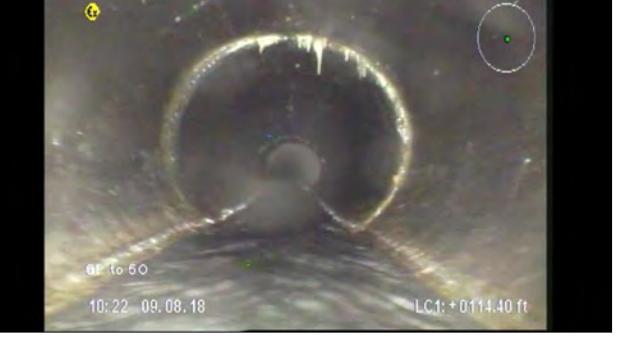
<table><tr> <th colspan="3">Miscellaneous</th> <th colspan="3">Structural</th> <th colspan="2">O&M</th> <th>Constructional</th> </tr><tr> <td>114.4</td> <td></td> <td>IWJ - Infiltration Weeper Joint</td> <td></td> <td></td> <td></td> <td>X</td> <td>11</td> <td>01 EER: 1. Related to the DAE.</td> </tr></table>

121.2_RFJ_From-10_To-03.jpg	
Date: 11/07/2022			Date: 11/07/2022		
Distance: 114.4 ft			Distance: 121.2 ft		
Obs: DAE - Deposits Attached Encrustation			Obs: RFJ - Roots Fine Joint		
Comments:			Comments:		
EER: 1. Related to the IWJ	10:22 09.08.18	LC1: +0114.40 ft	EER: 1.	10:24 09.08.18	LC1: +0121.20 ft

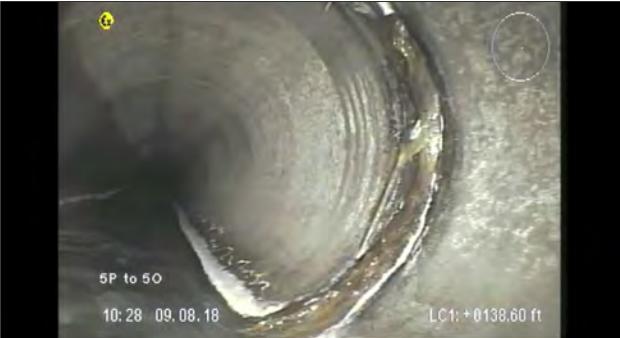
<table><tr> <th colspan="3">Miscellaneous</th> <th colspan="3">Structural</th> <th colspan="2">O&M</th> <th>Constructional</th> </tr><tr> <td>138.6</td> <td></td> <td>IWJ - Infiltration Weeper Joint</td> <td></td> <td></td> <td></td> <td>X</td> <td>12</td> <td>03 EER: 1. Related to the DAE.</td> </tr></table>

Obs: DAE - Deposits Attached Encrustation		
Comments:		
EER: 1. Related to the IWJ.

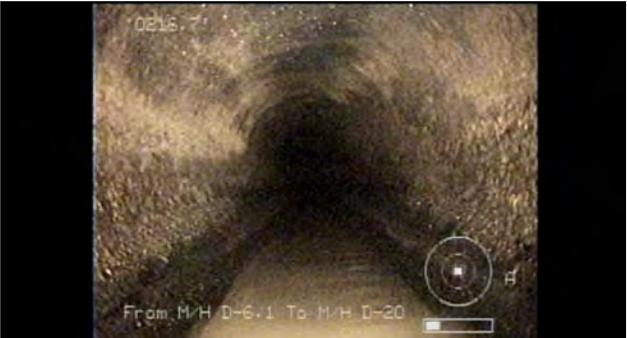
Work Order	Date	Sheet
Street D Street		
City Anacortes		
Location		
Up Node D-20	Down Node D-6.1	Direction Upstream
0.0_SAV_From-08_To-04.jpg	149.4_TBA_From-12_To-.jpg	
Date: 11/09/2022	Date: 11/07/2022	
Distance: 0 ft	Distance: 149.4 ft	
Obs: SAV - Surface Aggregate Visible	Obs: TBA - Tap Break-in Activity	
Comments:	Comments:	
EER: 1.	EER: 1

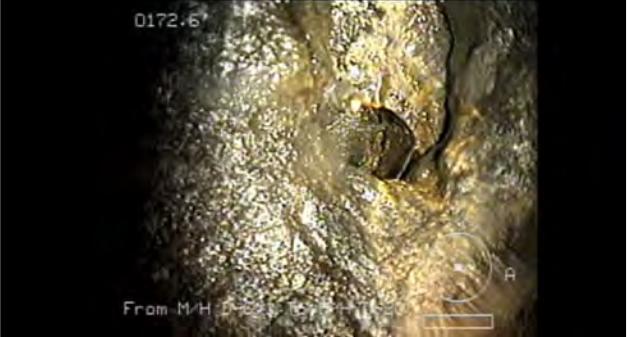
172.6		BVV - Broken Void Visible				11			EER: 3.
172.6		TBI - Tap Break-in Intruding	4.0	2.0		12			EER: 1
233.8		HSV - Hole Soil Visible				07	12		EER: 4. Hole is access manhole.

149.4_BVV_From-09_To-.jpg	172.6_TBI_From-12_To-.jpg	
Date: 11/07/2022	Date: 11/07/2022	
Distance: 172.6 ft	Distance: 172.6 ft	
Obs: BVV - Broken Void Visible	Obs: TBI - Tap Break-in Intruding	
Comments:	Comments:	
EER: 3.	EER: 1

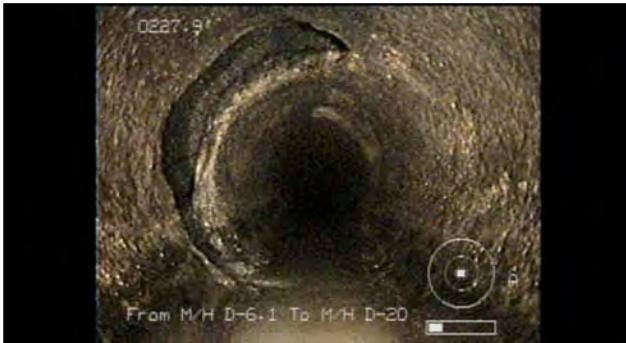
EER: 2. Runner is
coming from manhole.

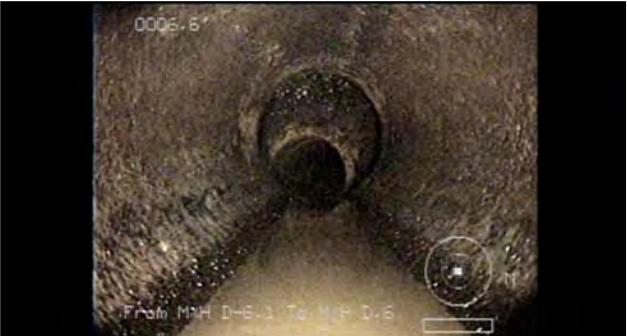
Work Order	Date 3:33 20170629	Sheet 22
Street D Street		
City Anacortes	Weather	
Location		
Up Node D-6.1	Down Node D-6	Direction Downstream
	0.0_SAV_From-07_To-04.jpg	
Date: 11/09/2022		
Distance: 0 ft

Obs:		
SAV - Surface Aggregate Visible		
Comments:

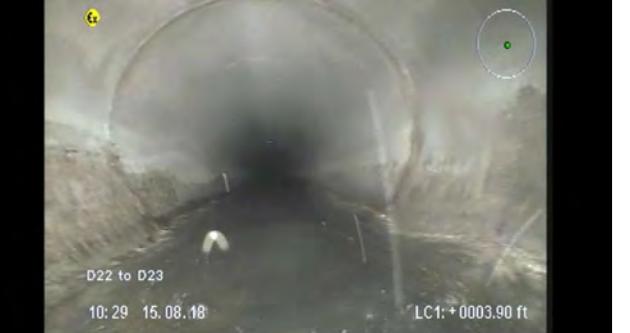
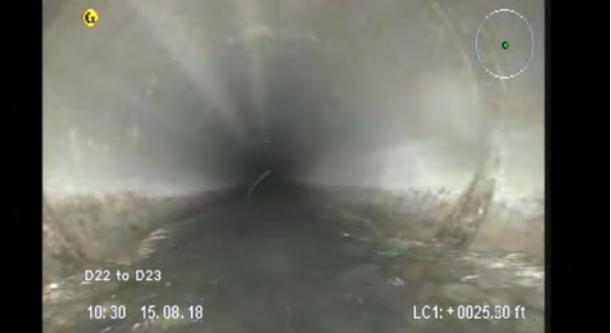
Work Order		Date 0:25 20180808	Sheet 23			
Street D Street						
City Anacortes		Weather				
Location						
Up Node	D-22	Down Node	D-23	Direction Downstream		
		2.0_SRI_From-08_To-09.jpg		2.0_SRI_From-03_To-04.jpg		
Date:	11/09/2022		Date:	11/09/2022		
Distance:	2 ft		Distance:	2 ft		
Obs:			Obs:			
SRI - Surface Damage			SRI - Surface Damage			
Roughness Increased			Roughness Increased			
Comments:			Comments:			
EER: 1

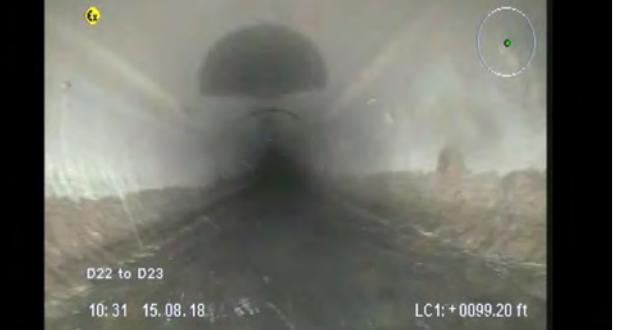
99.9_IWB_From-11_To-01.jpg		105.1_ISB_From-01_To-.jpg		
Date:	11/07/2022		Date:	11/07/2022		
Distance:	99.9 ft		Distance:	105.1 ft		
Obs:			Obs:			
IWB - Infiltration			ISB - Infil Stain Barrel			
Weeper Barrel						
Comments:			Comments:			
EER: 1

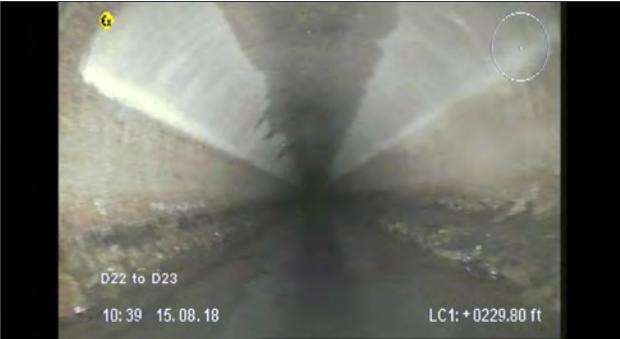
Work Order	Date 0:25 20180808	Sheet 23
Street D Street	Weather	
City Anacortes		
Location		
Up Node D-22	Down Node D-23	Direction Downstream
219.3_IWB_From-11_To-01.jpg		329.1_DAE_From-07_To-08.jpg
Date: 11/07/2022	Date: 11/09/2022	
Distance: 229.8 ft	Distance: 329.1 ft	
Obs: IWB - Infiltration Weeper Barrel	Obs: DAE - Deposits Attached Encrustation	
Comments:	Comments:	
EER: 1	EER: 1
