YAKIMA MILL SITE
 CITY OF YAKIMA, YAKIMA COUNTY, WASHINGTON

Photograph Locations at the Boise
Cascade Mill Site (aka Yakima Mill
Site) and East of Interstate 82

Fulcrum Environmental Consulting, Inc.
406 N 2nd St, Yakima, WA 98901
509.574.0839 | www.efulcrum.net
YMS East of I-82 . 11.13.2023 . RKM

Attachment B
Site Photographs

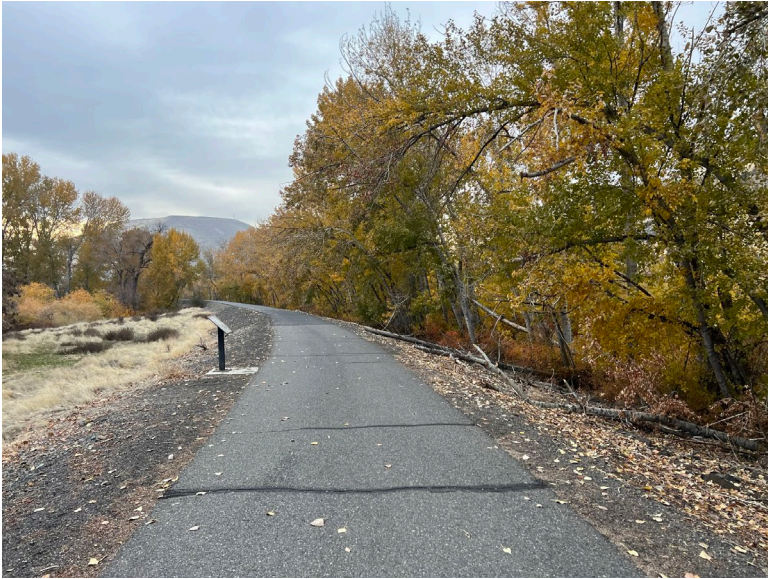
B1.1 Parcel F – The approximate west extent of the parcel.

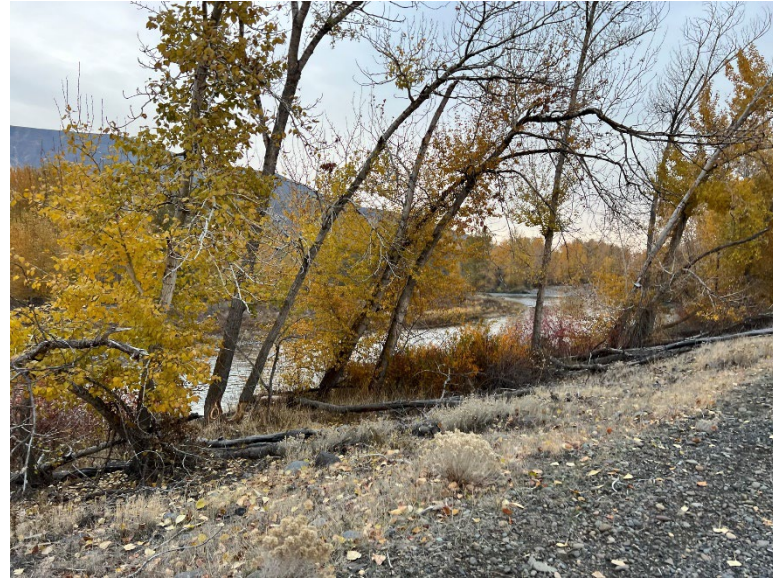
B2.2 Parcel A – The Yakima River along Parcel A.

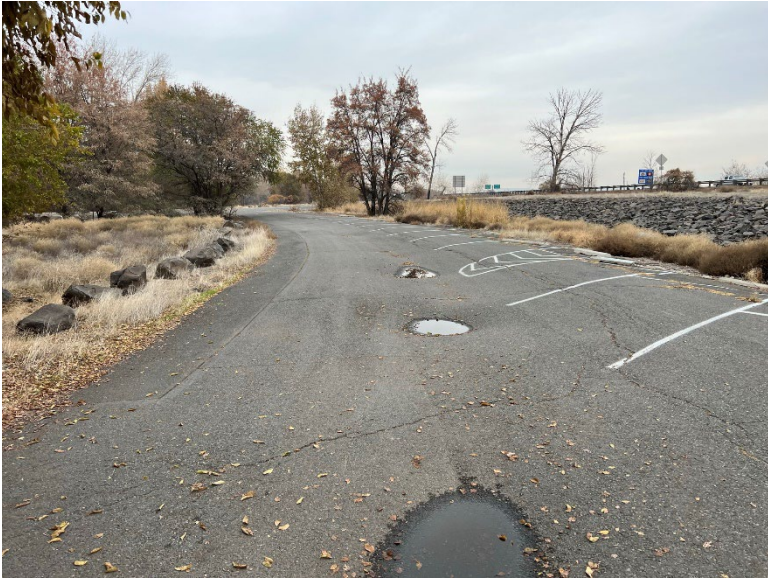
B4.1 Parcel B – The Yakima Greenway Park and Ride parking lot.

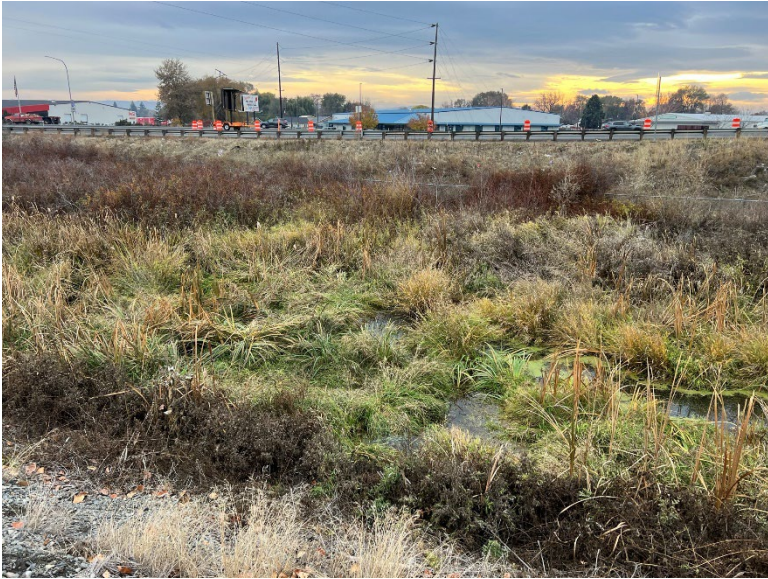
B5.1 Parcel B – Vegetated area between the Yakima Greenway and I-82.

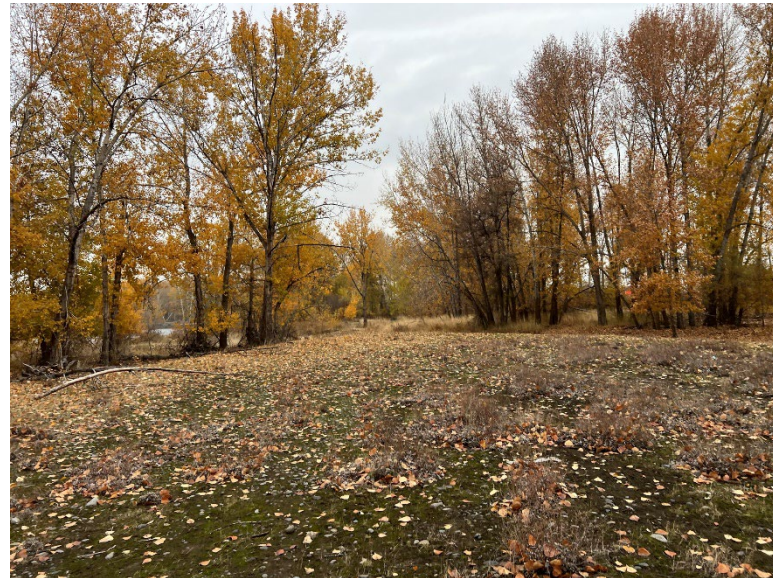
B5.4 Parcel B – Open areas appear to be frequently underwater.

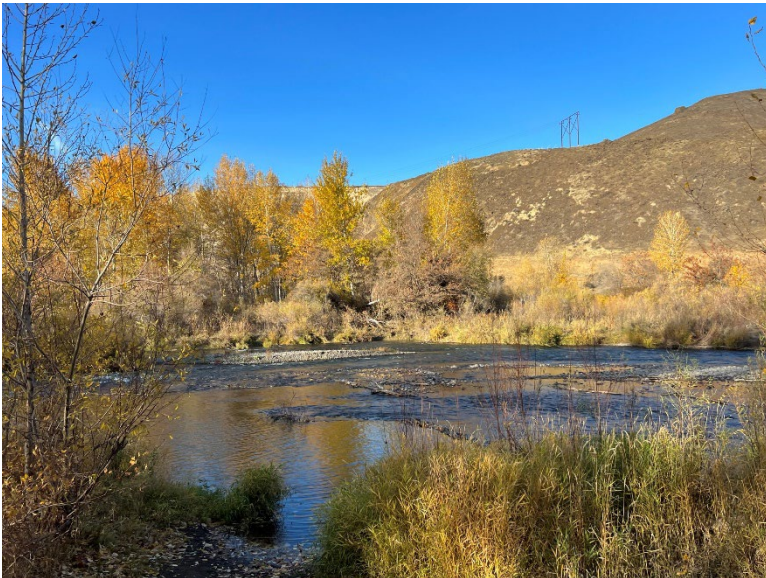
B7.3 Parcel C2 – Islands are present in the Yakima River.

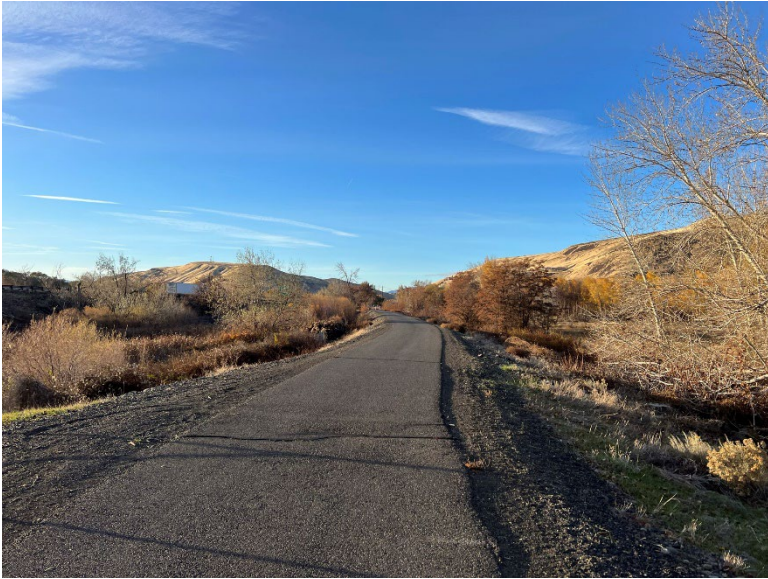
B9.1 Parcel C1 – The Yakima Greenway on the parcel.

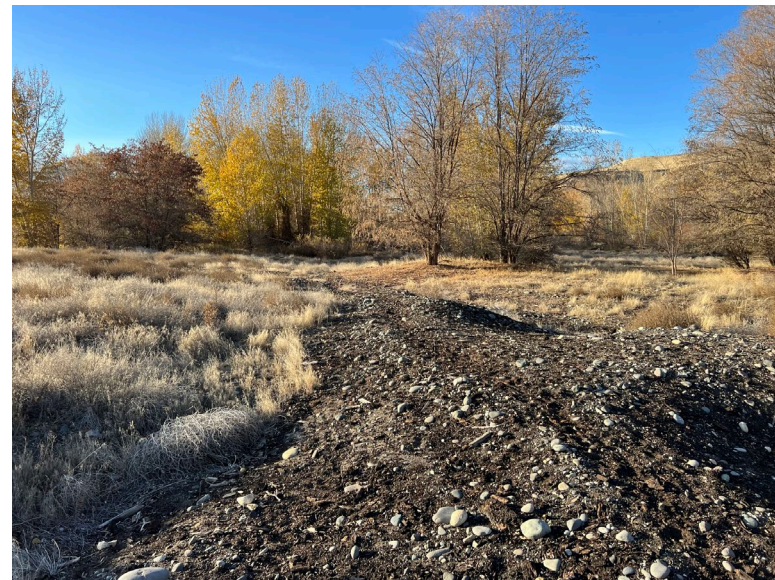
B12.4 Parcel D – A typical area of log yard material.

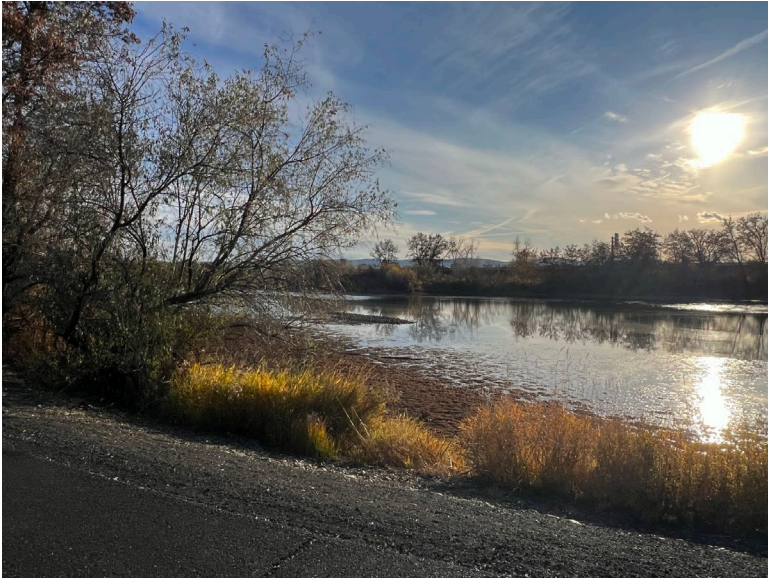
B13.1 Parcel D – Cascade Mill Pond as viewed from the northeast.

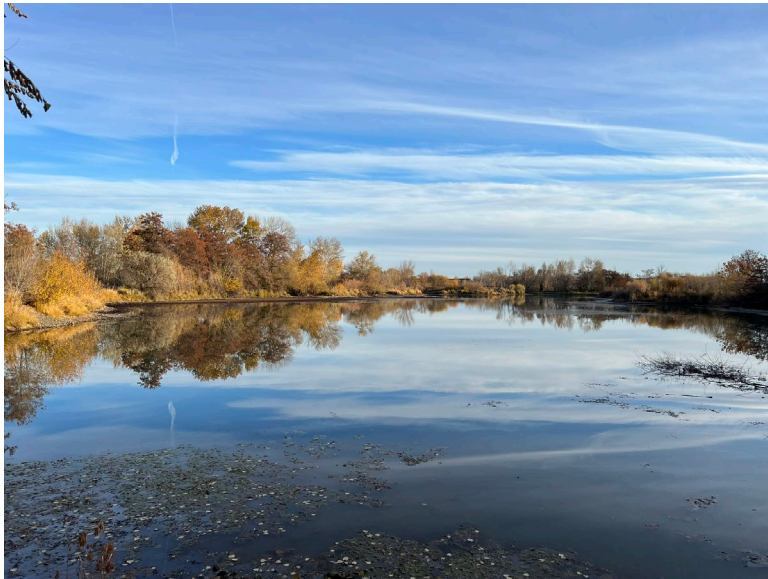
B16.1 Parcel D – The Cascade Mill Pond viewed to the south.

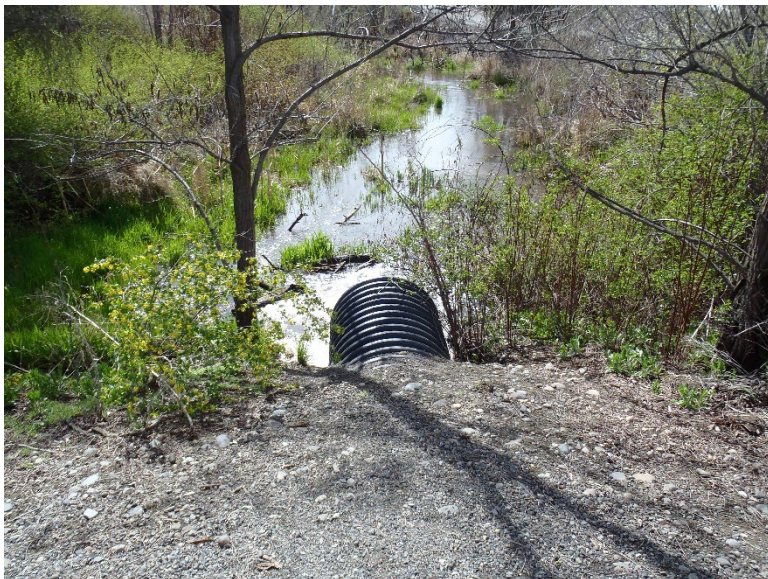
B16.3 Parcel D – Water overflow from Cascade Mill Pond (April 2017).

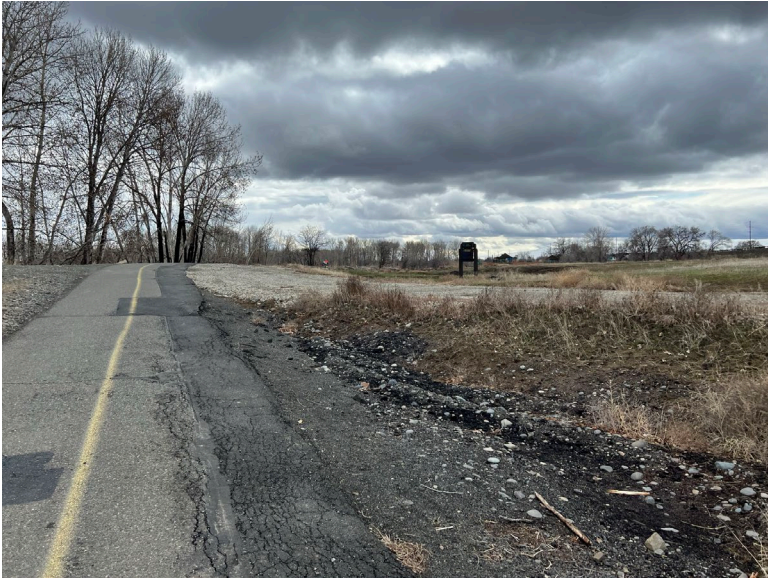
B17.1 Parcel D – The Yakima Greenway south of the railroad trestle.
