APRIL 2024

2023 Land Use Controls Inspection Report

Naval Air Station Whidbey Island, Oak Harbor, Washington

**Department of the Navy
Naval Facilities Engineering Systems Command Northwest**

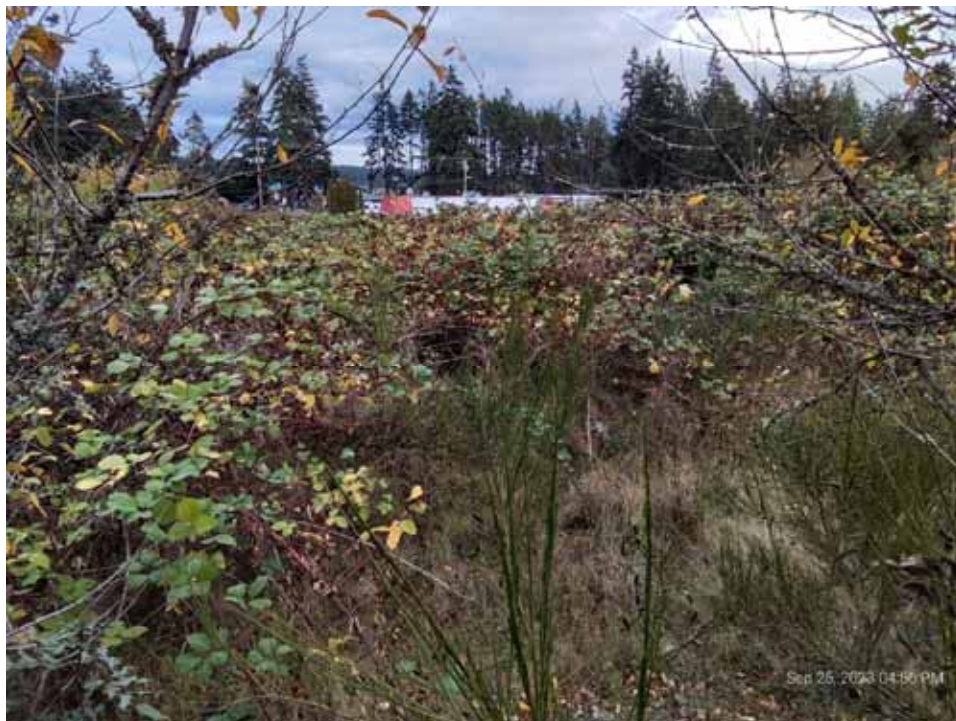
Site: OU 1 Area 5

A10: Overgrown fencing and commercial area east of site

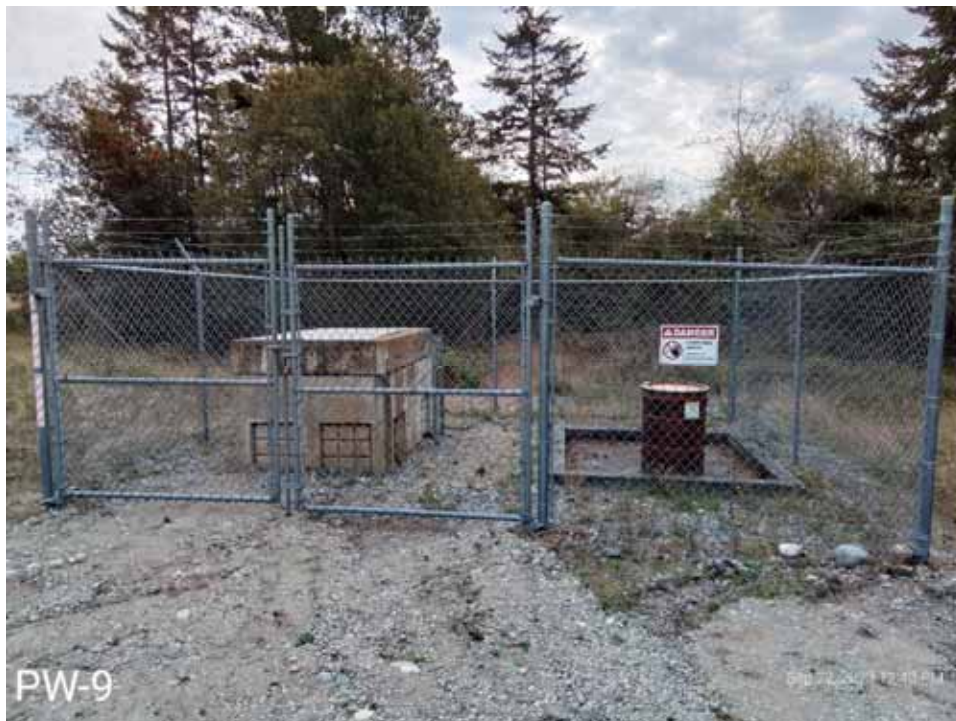
B76: PW-9 exterior,
and drum in secondary
containment

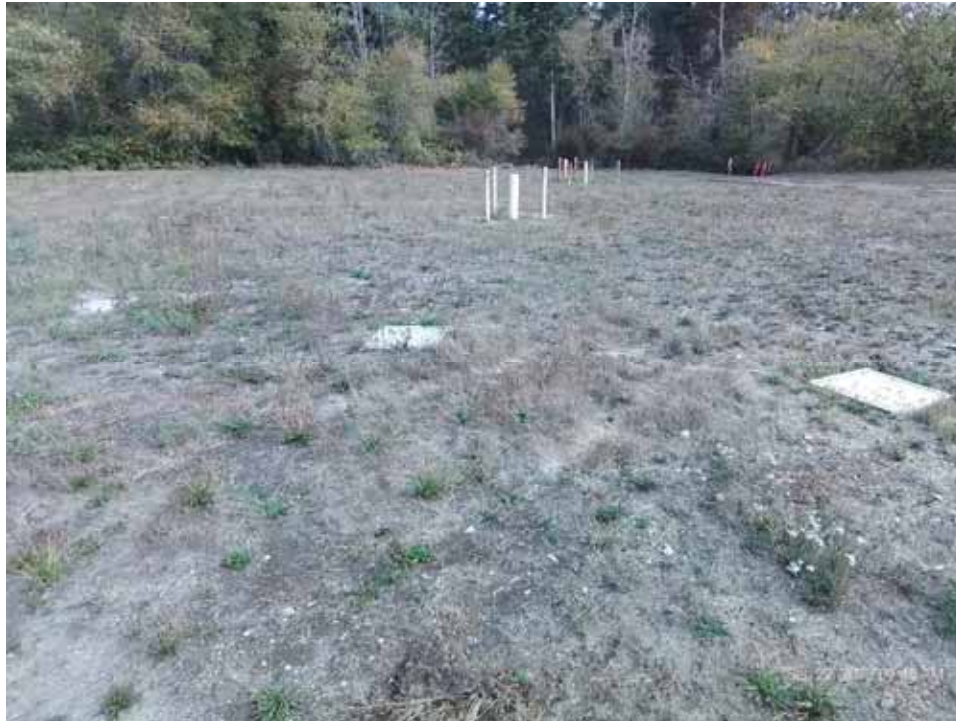
B81: Newly installed
flush mount wells

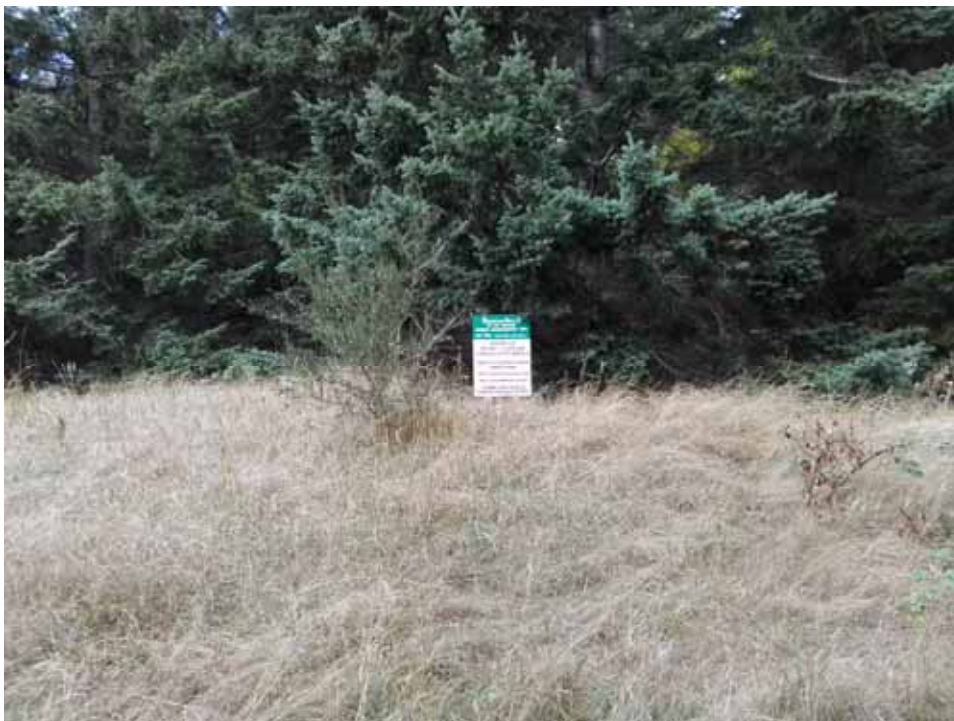
C3: Signage at
northwest corner

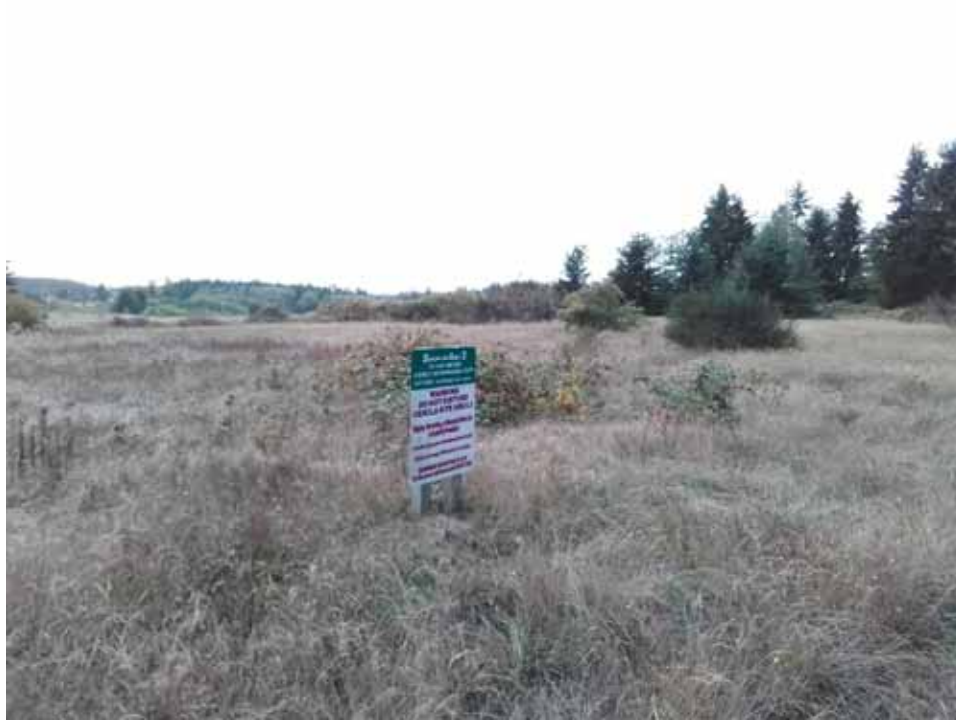
C4: Signage on
northwest portion of site

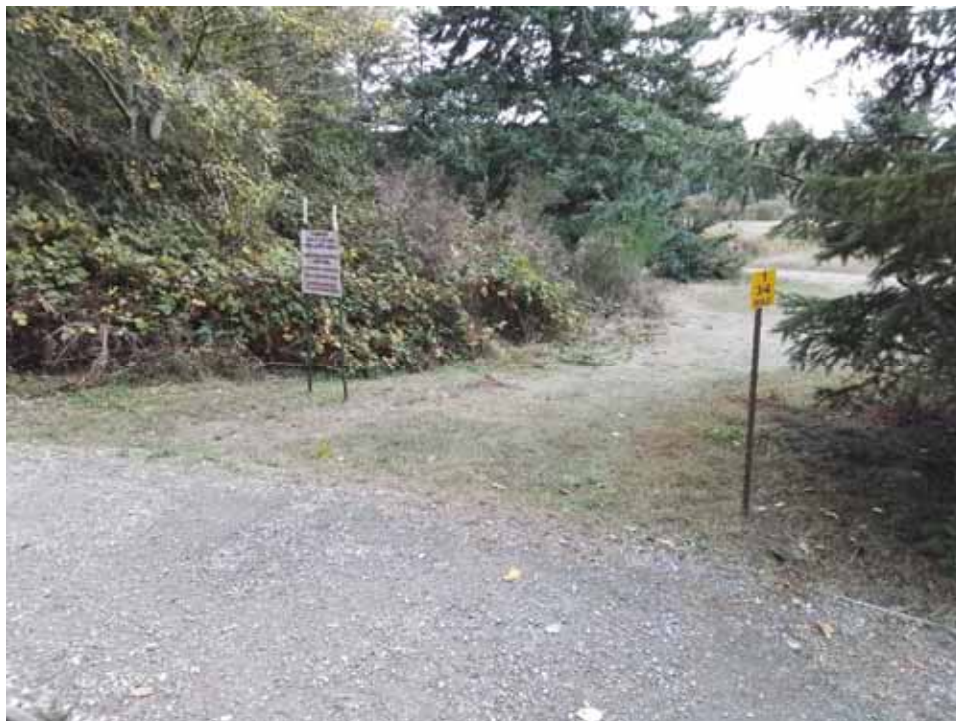
C5: Central site
overview and signage,
facing south

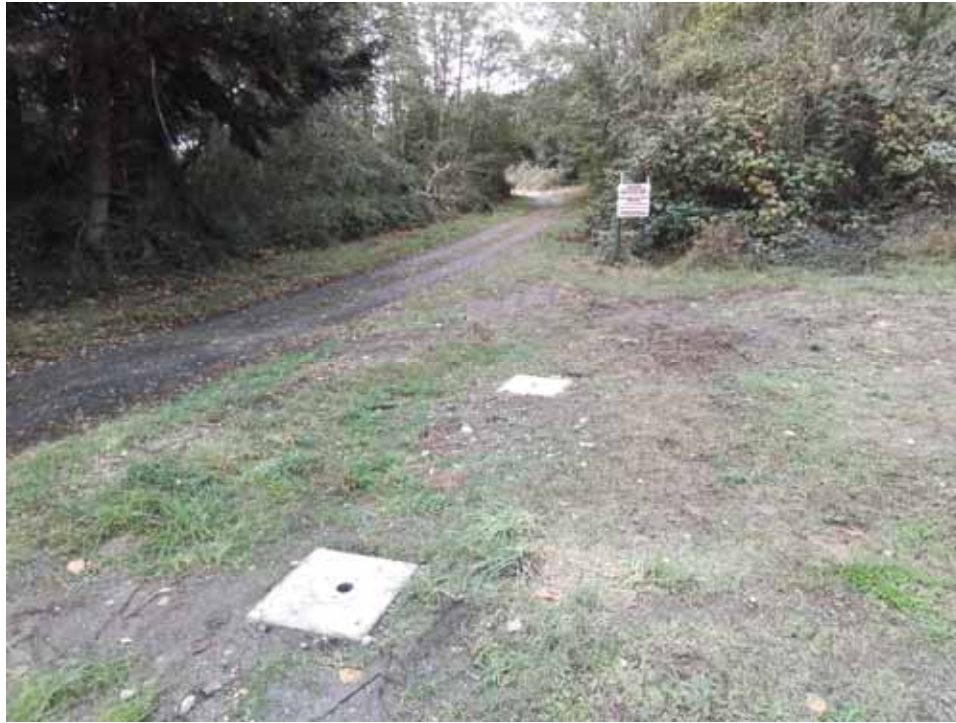
C6: Site access and
signage, facing
southeast

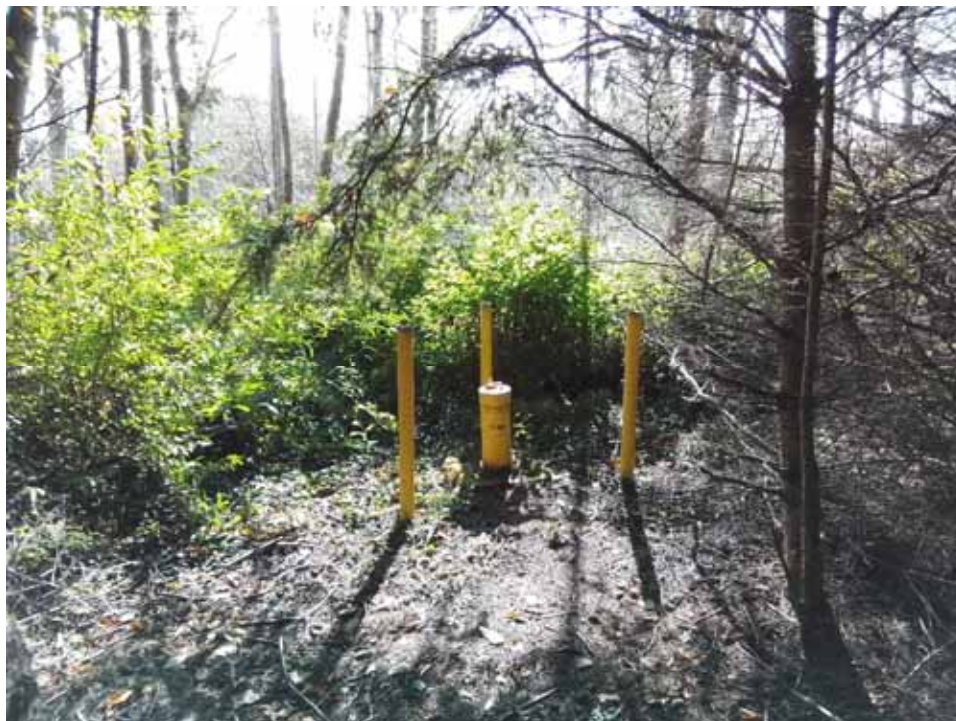
C7: Wells 622D and 622I, Signage on northern portion of site

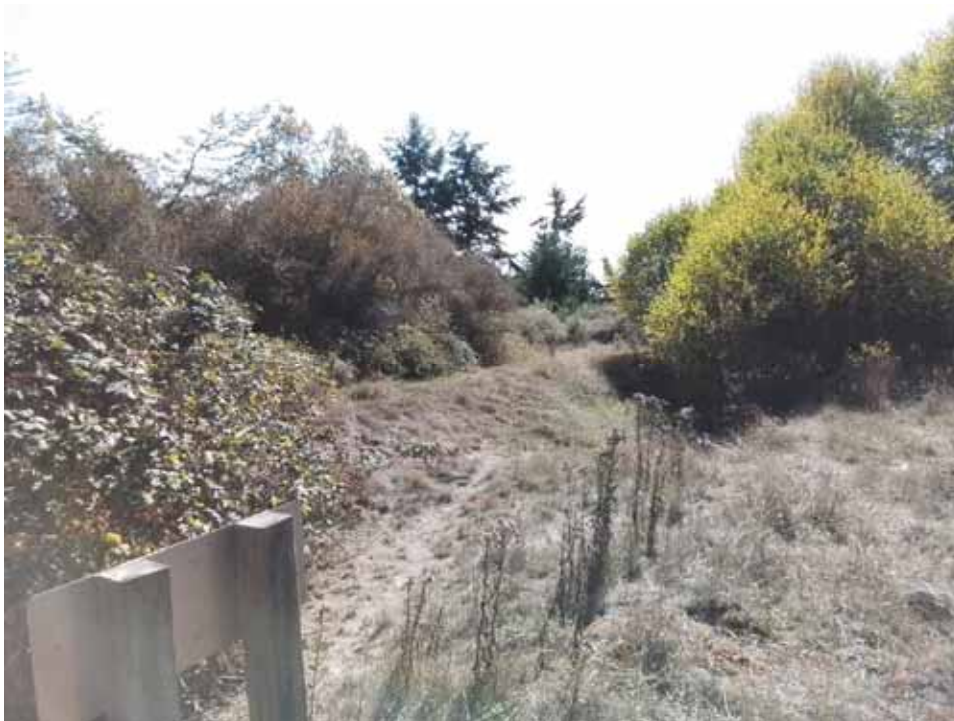
D1: Site overview from southeast site area, facing north

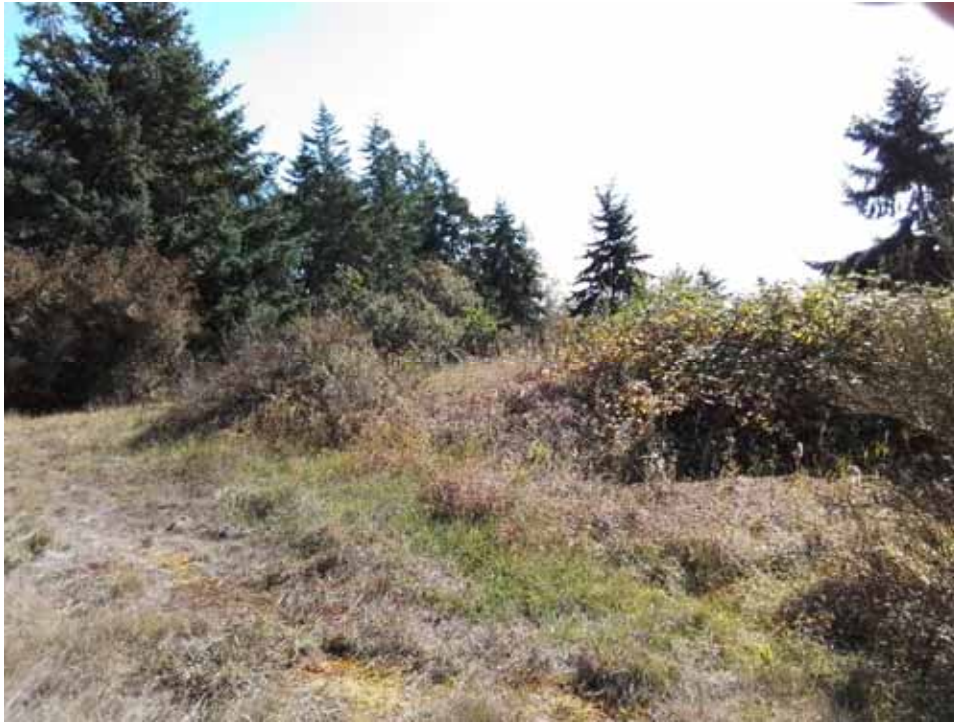
D2: Site overview from west, facing southeast

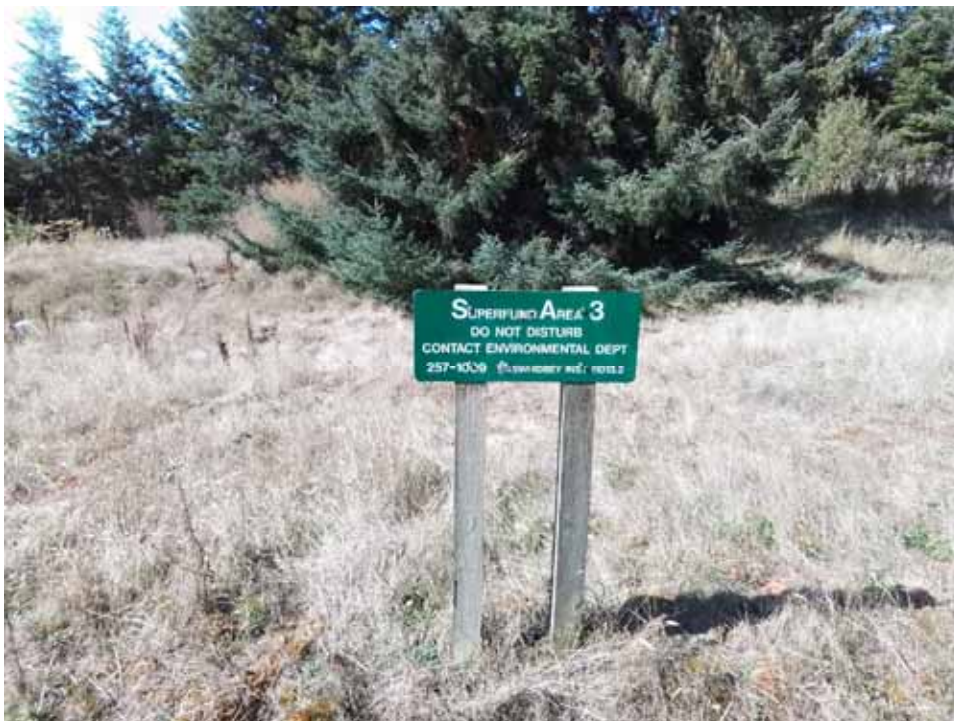
D3: Site overview from northwest corner facing southeast

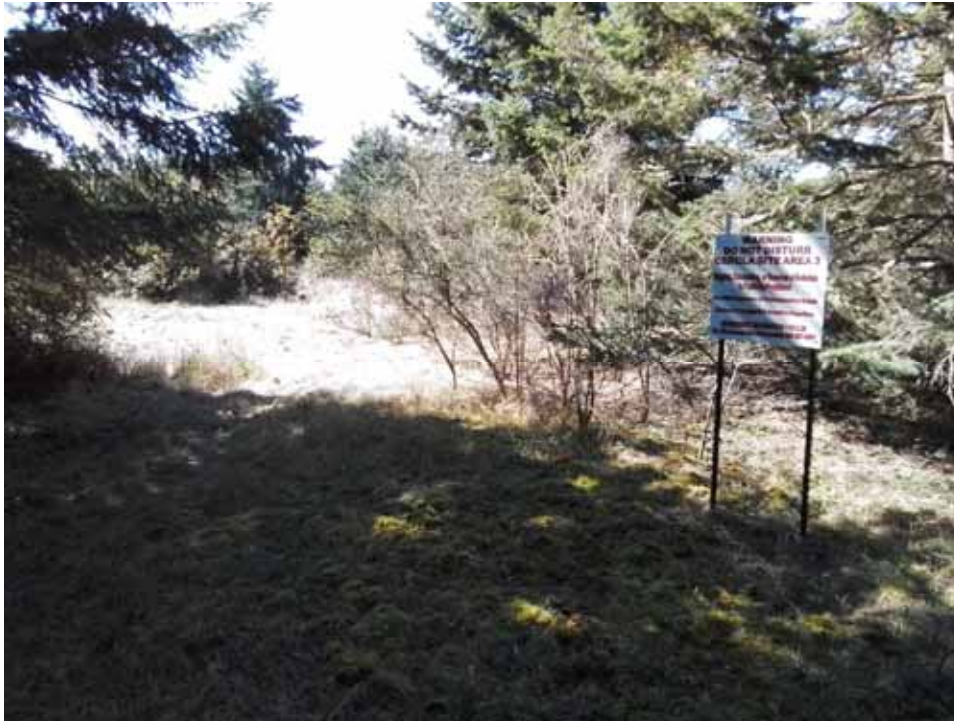
D4: Signage in central site area

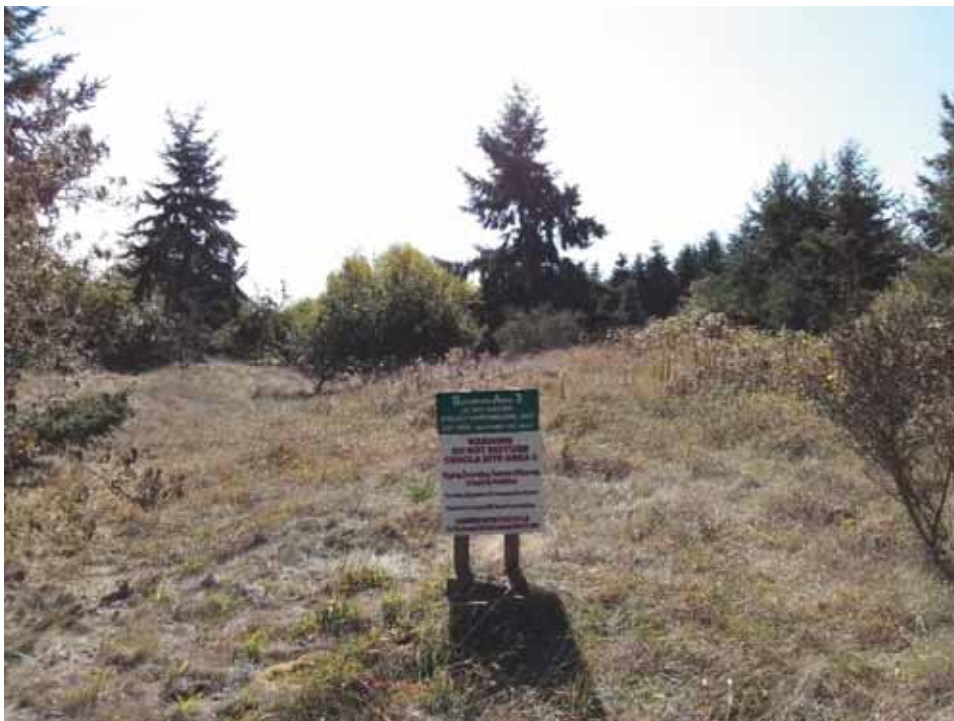
D5: Signage northeast of site boundary

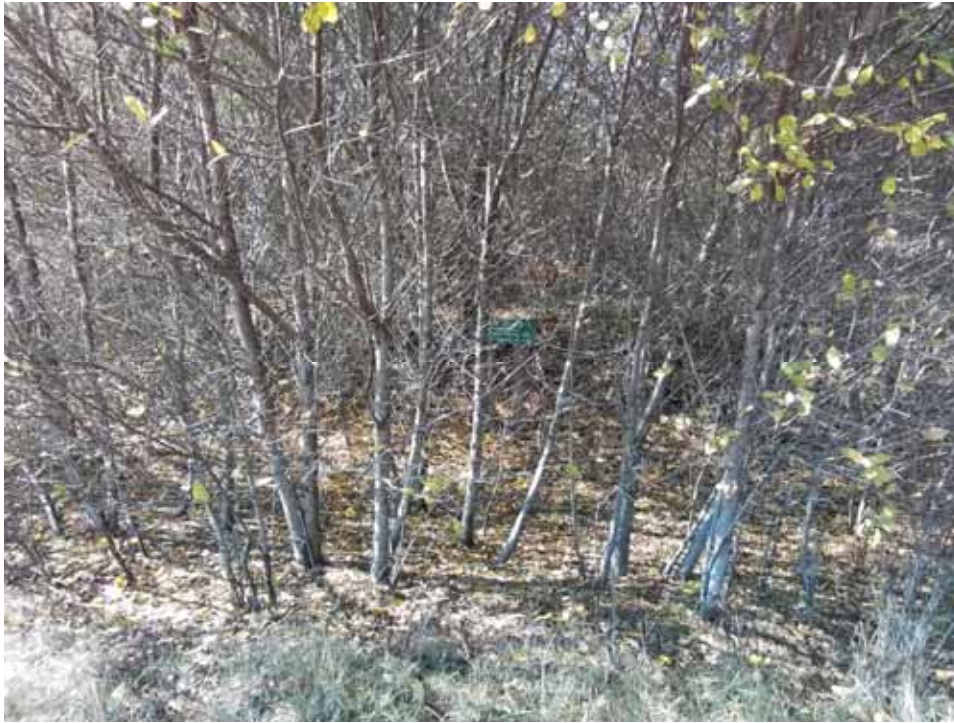
D6: Site overview and signage in northern site area

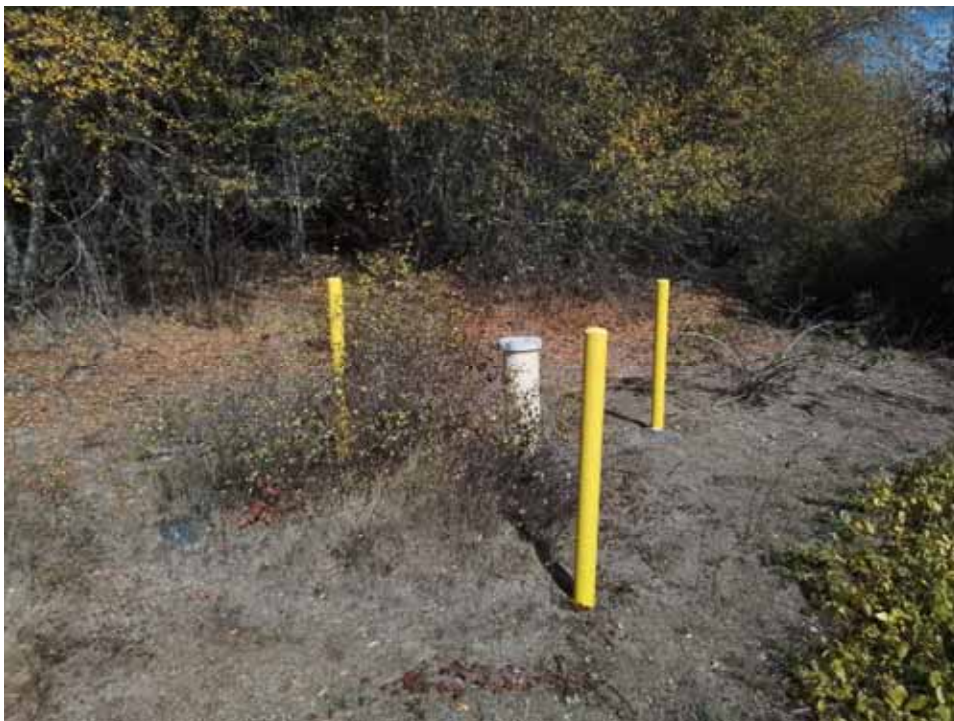
D7: Signage in central site area, facing southwest

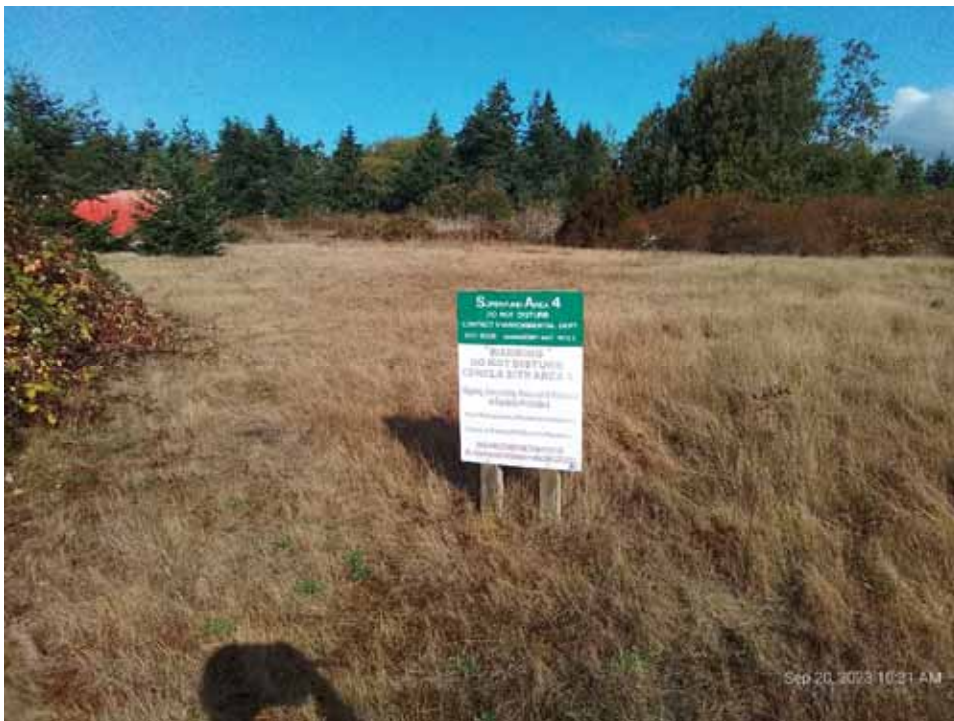
E1: Site overview and
signage facing east

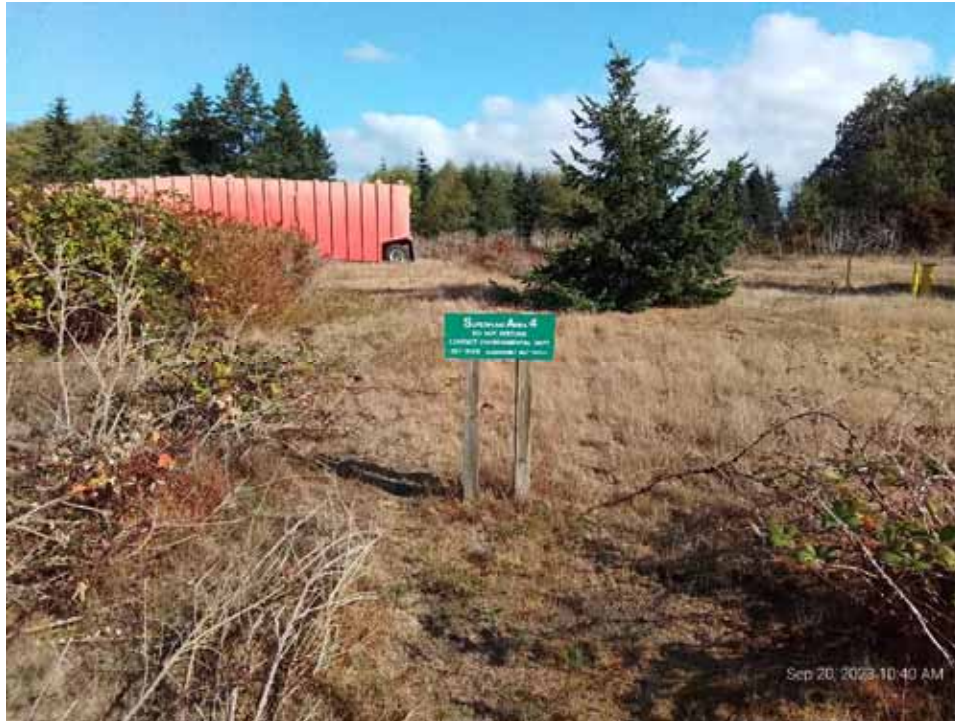
E2: Site overview and
signage, facing
northwest

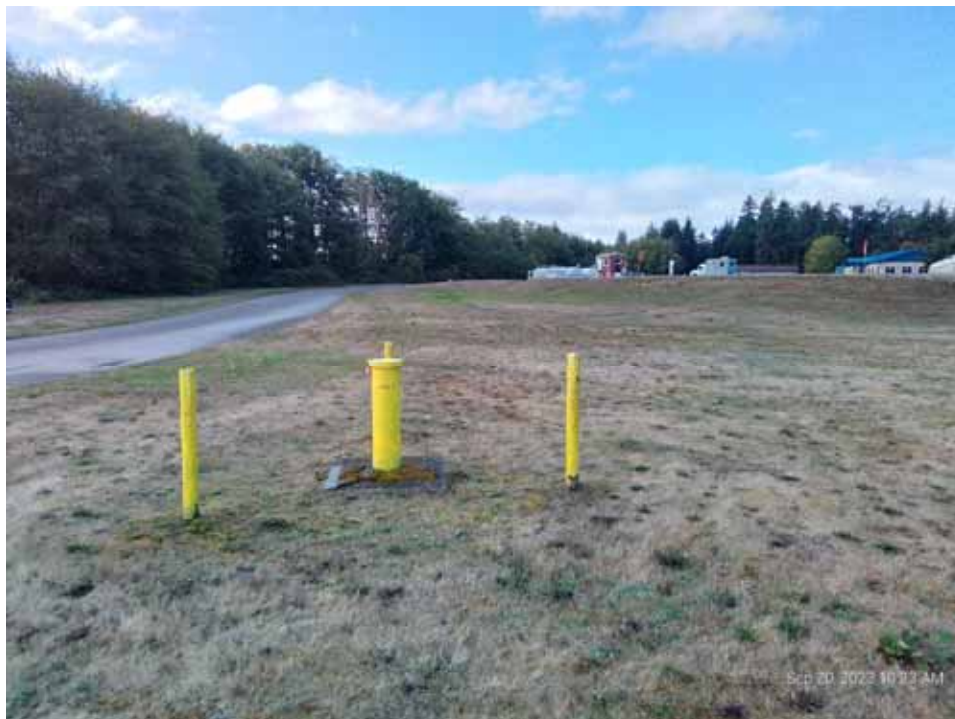
E3: Site overview and signage along southern site boundary

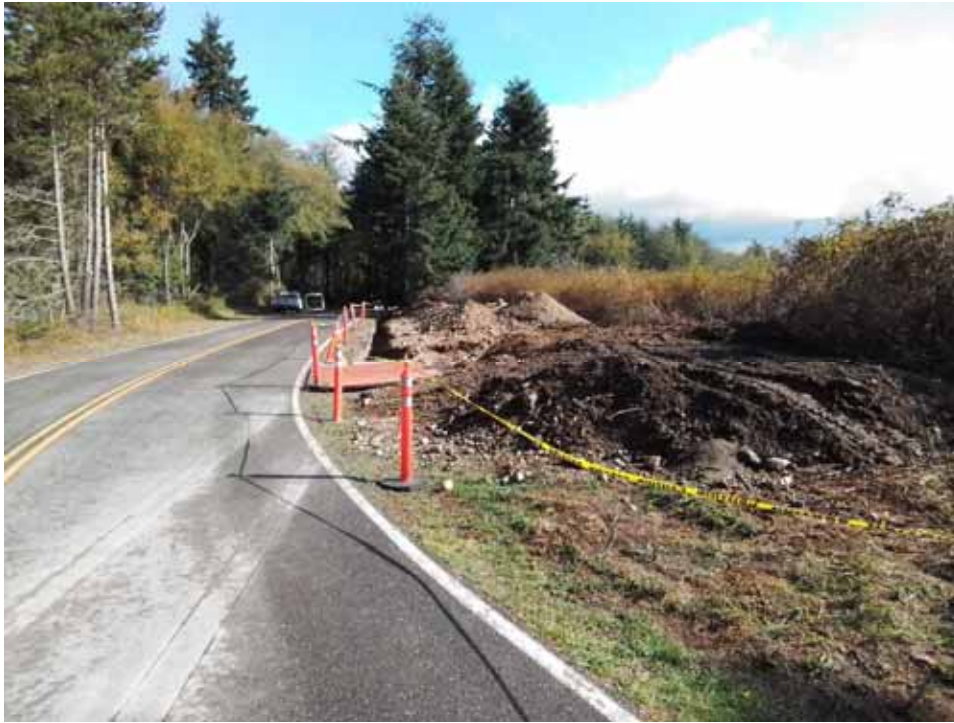
E6: Construction
laydown area within site
boundary

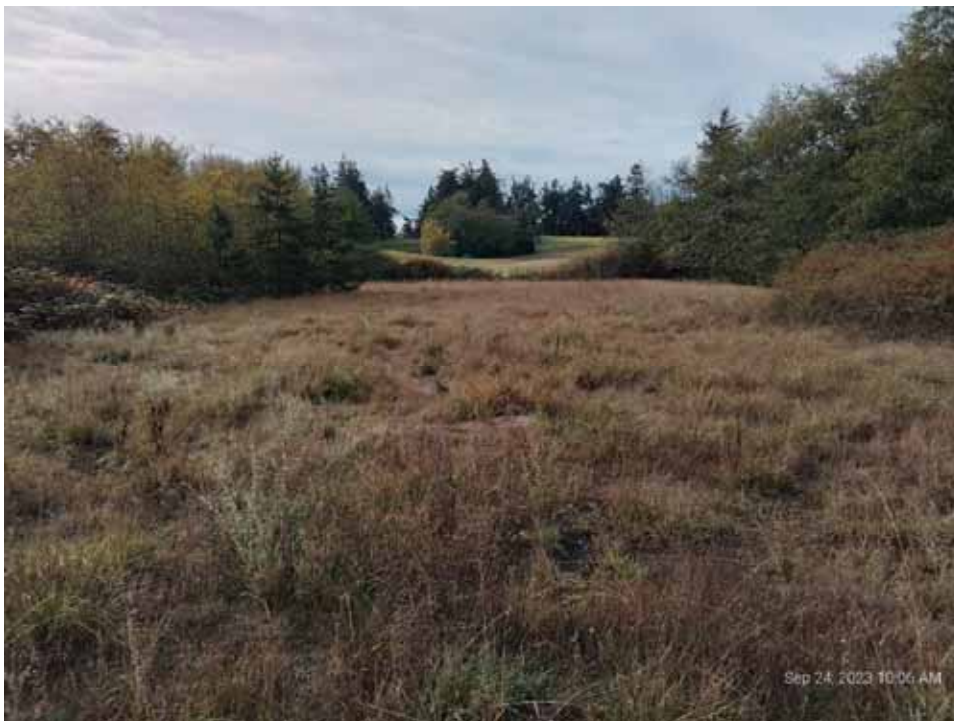
F1: Site overview facing north

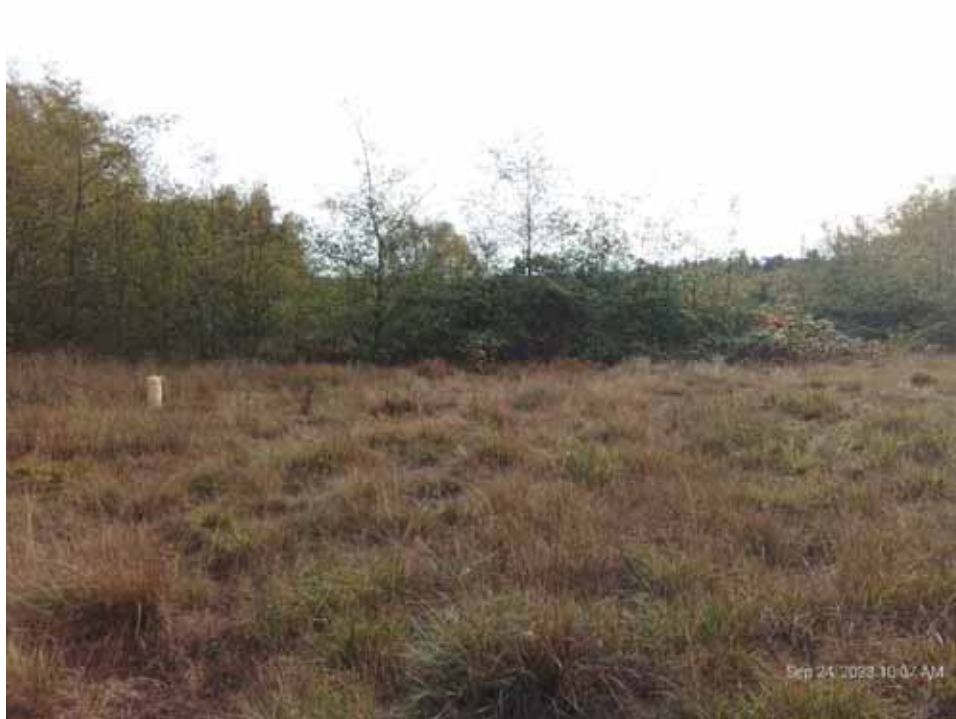
F2: Site overview facing south

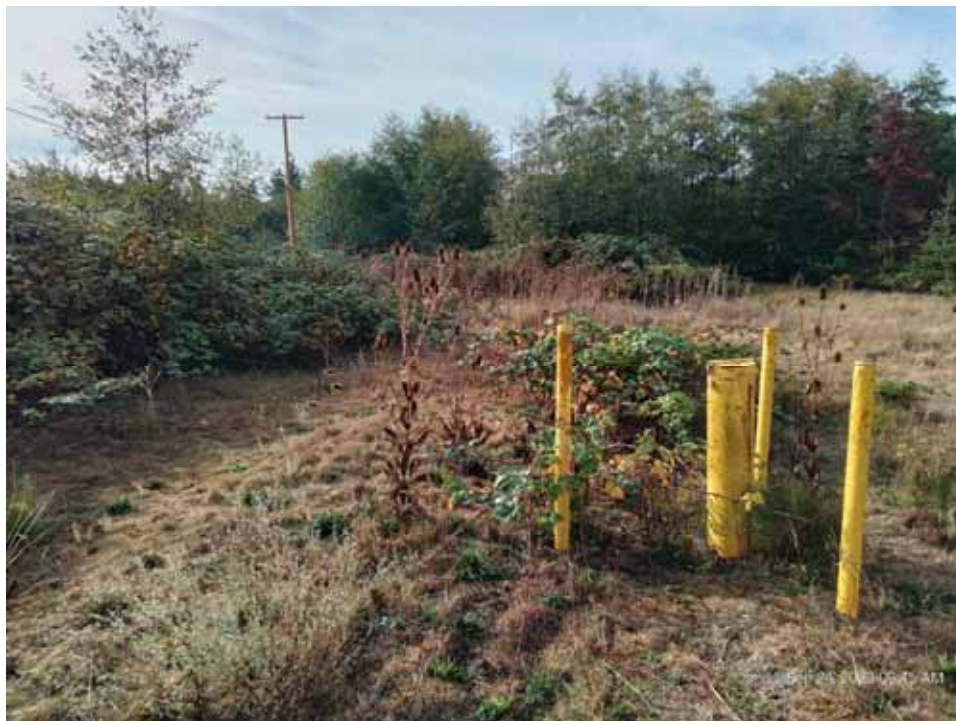
F3: Site overview facing east

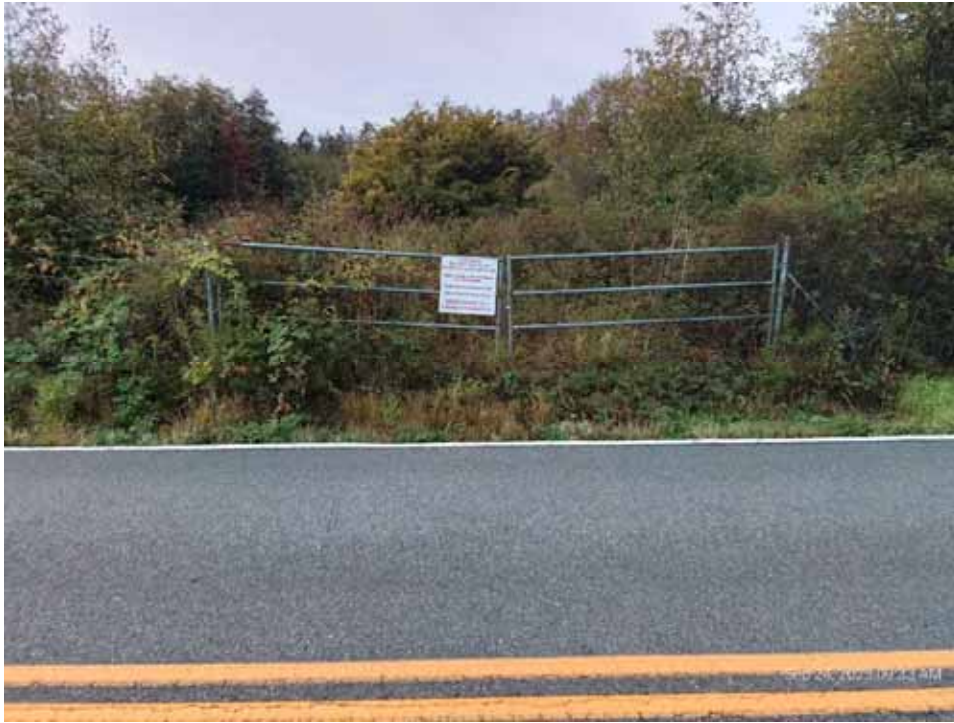
F4: Site overview facing south

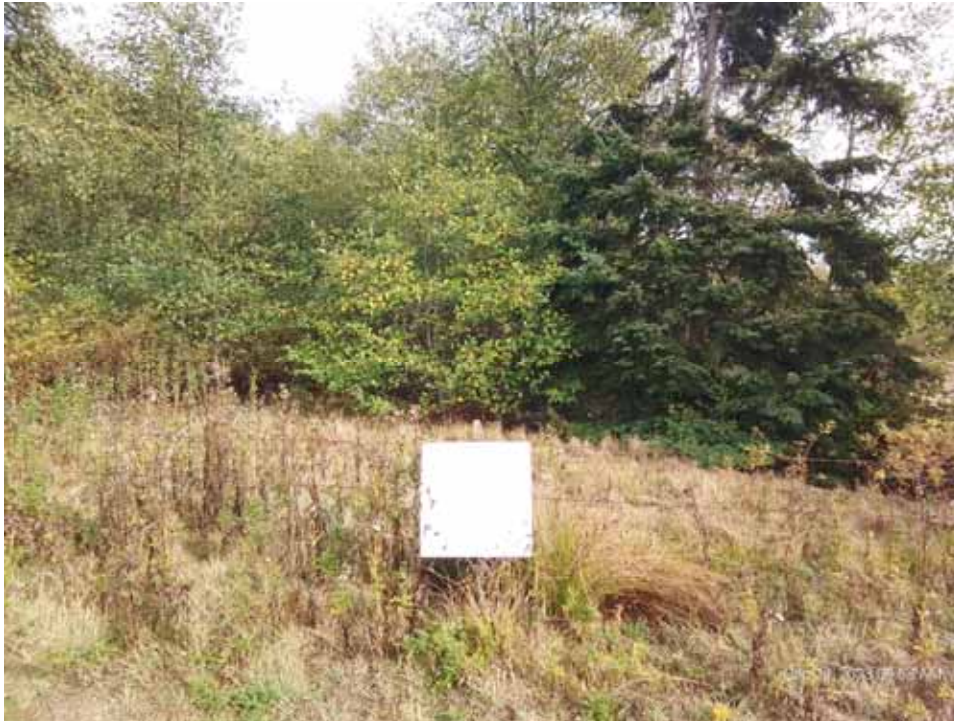
F6: Obscured signage

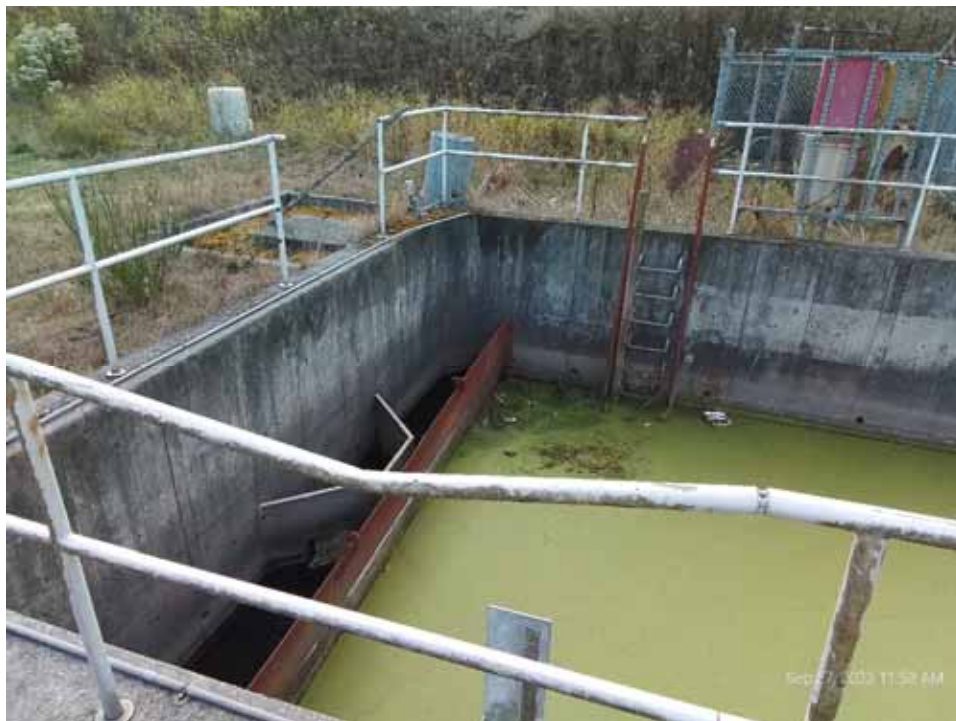
G5: 16b runway ditch
dammed weir facing
west

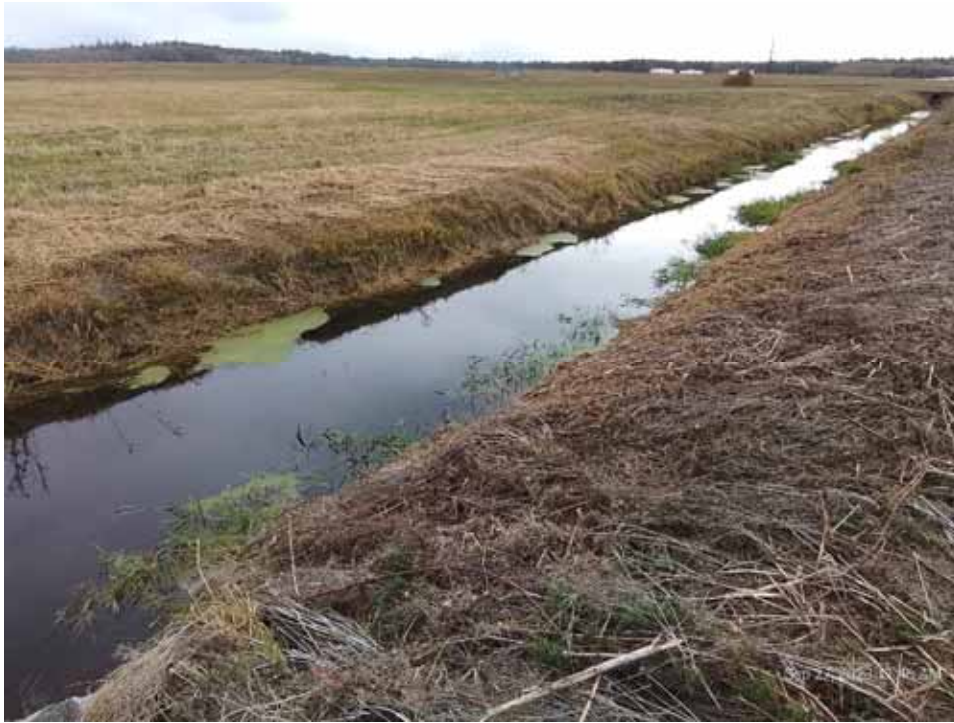
G6: 16b runway ditch
weir dam facing
southeast

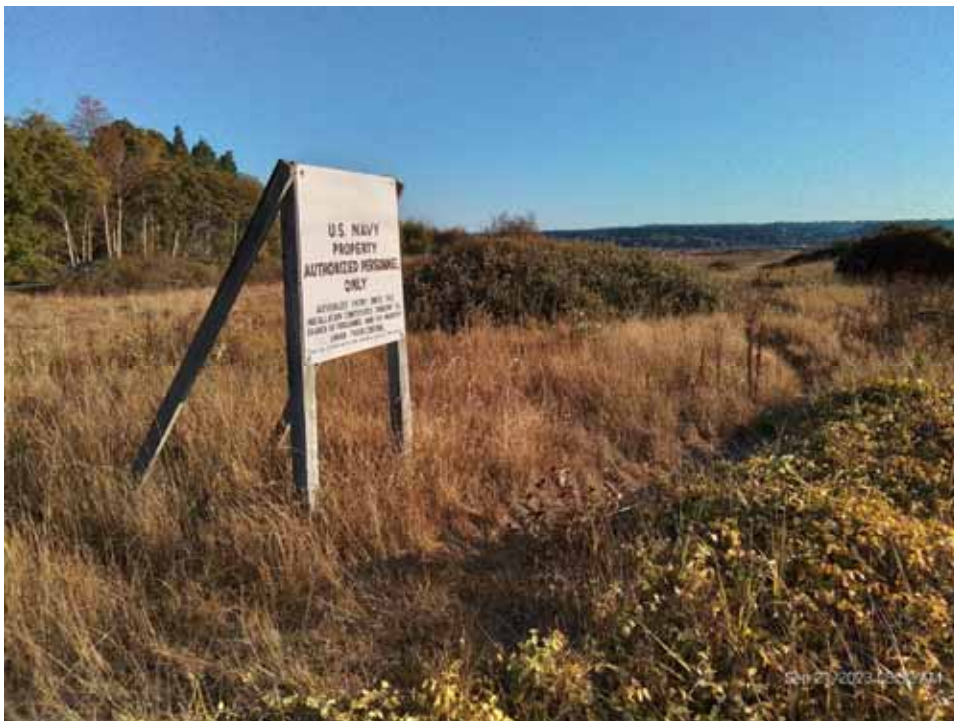
H11: Faded signage
facing northeast

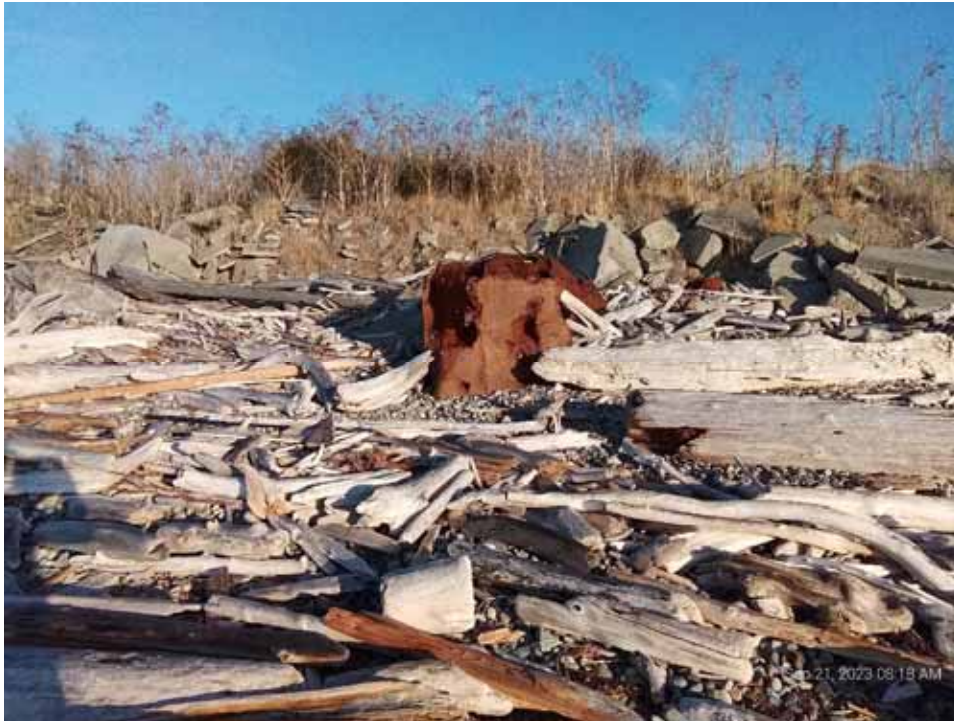
H18: North side vehicle
ruts, facing east

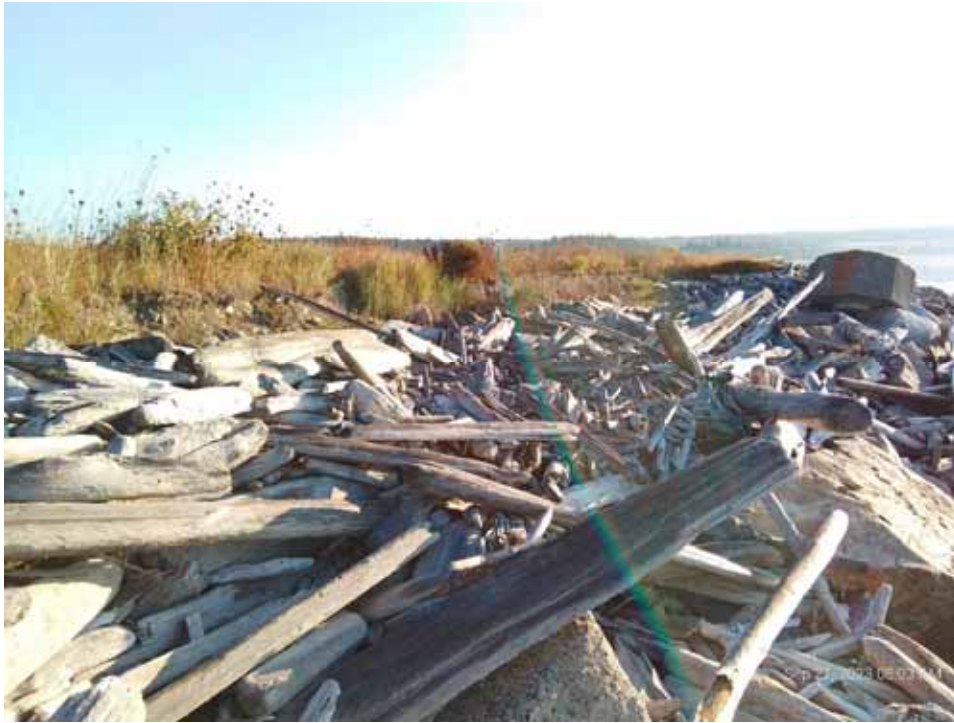
H20: Concrete debris
along southern site
boundary

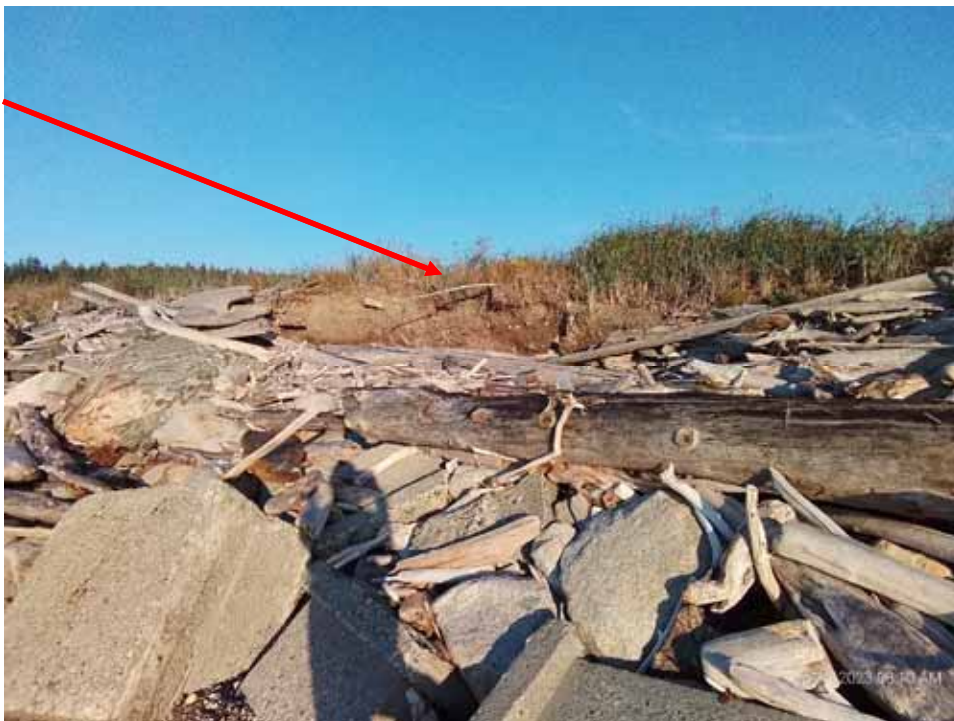
H21: Central shoreline
concrete rip rap and
debris

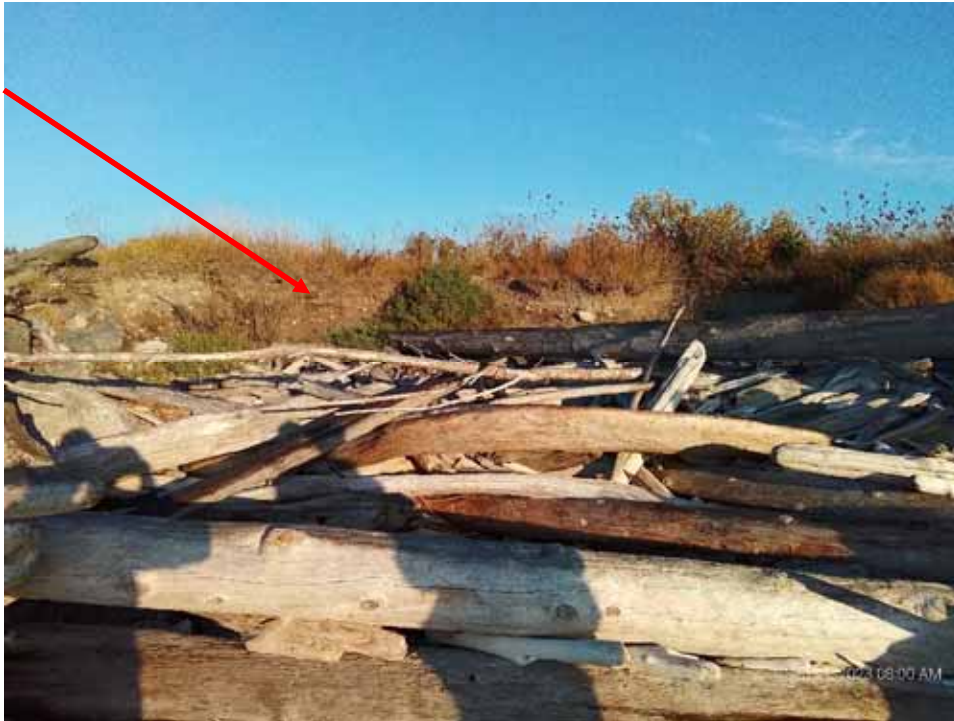
H22: Central shoreline
erosion facing
northwest

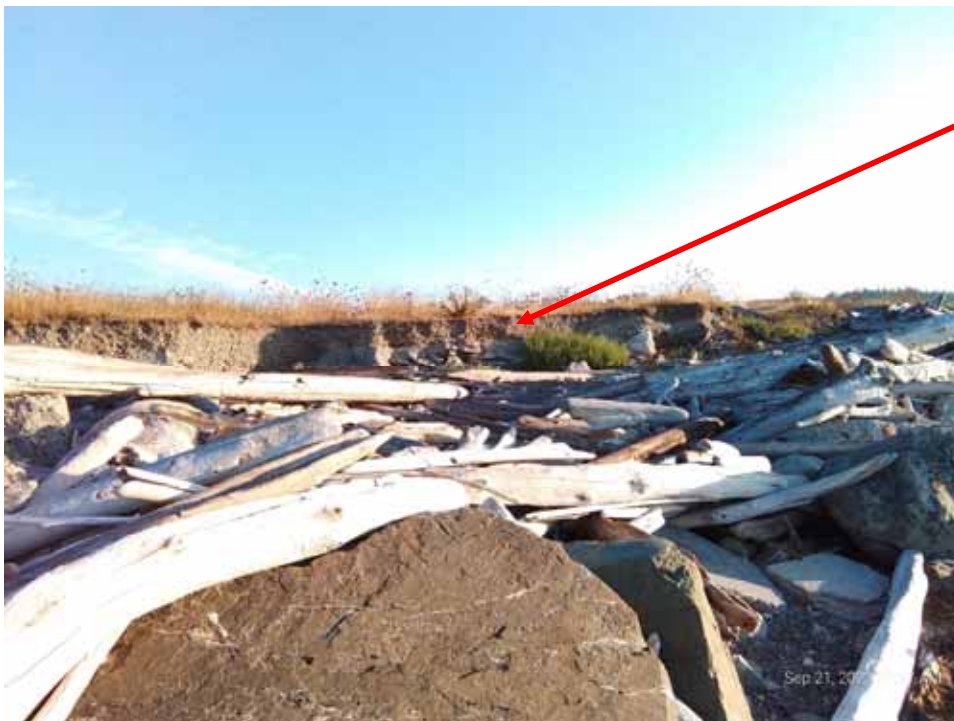
H23: Shoreline erosion and debris, facing north

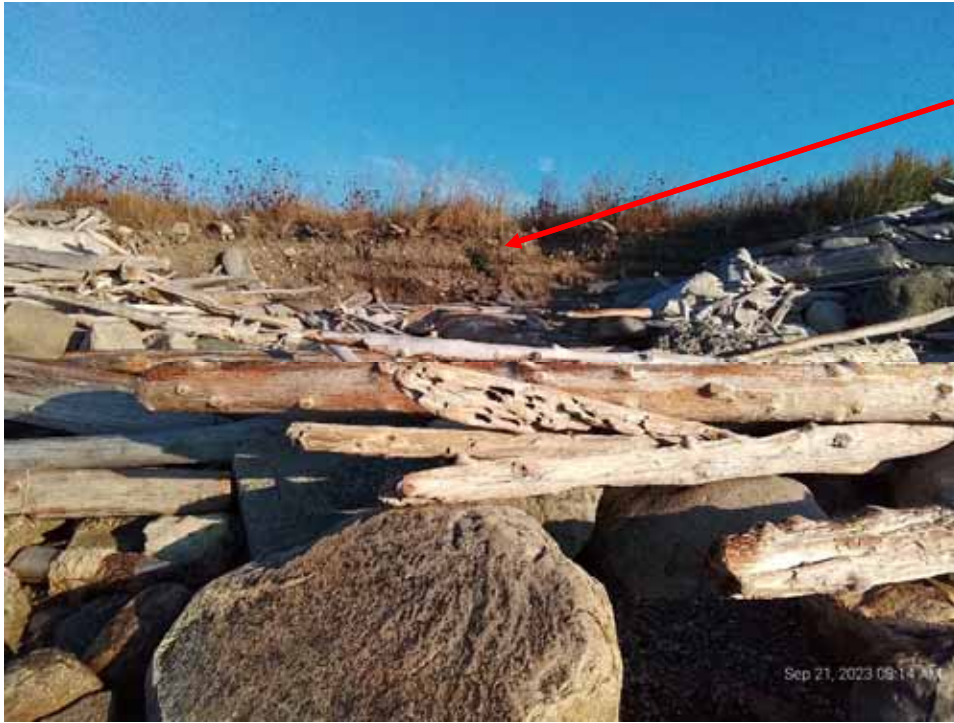
H24: Central shoreline erosion
