APRIL 2024

2023 Land Use Controls Inspection Report

Naval Air Station Whidbey Island, Oak Harbor, Washington

**Department of the Navy
Naval Facilities Engineering Systems Command Northwest**

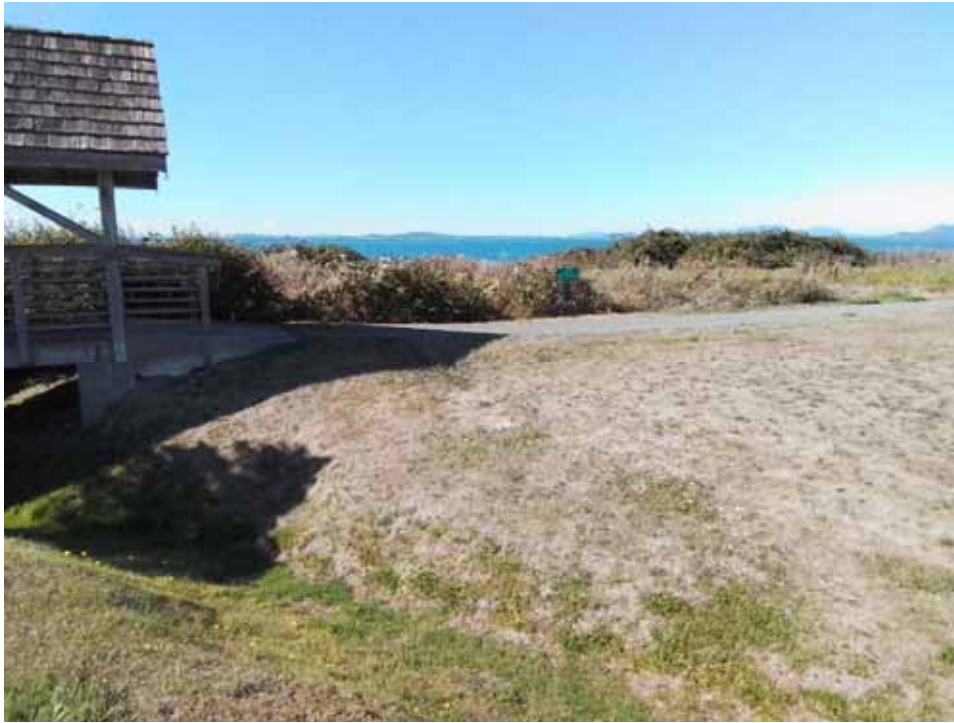
H25: Central shoreline erosion

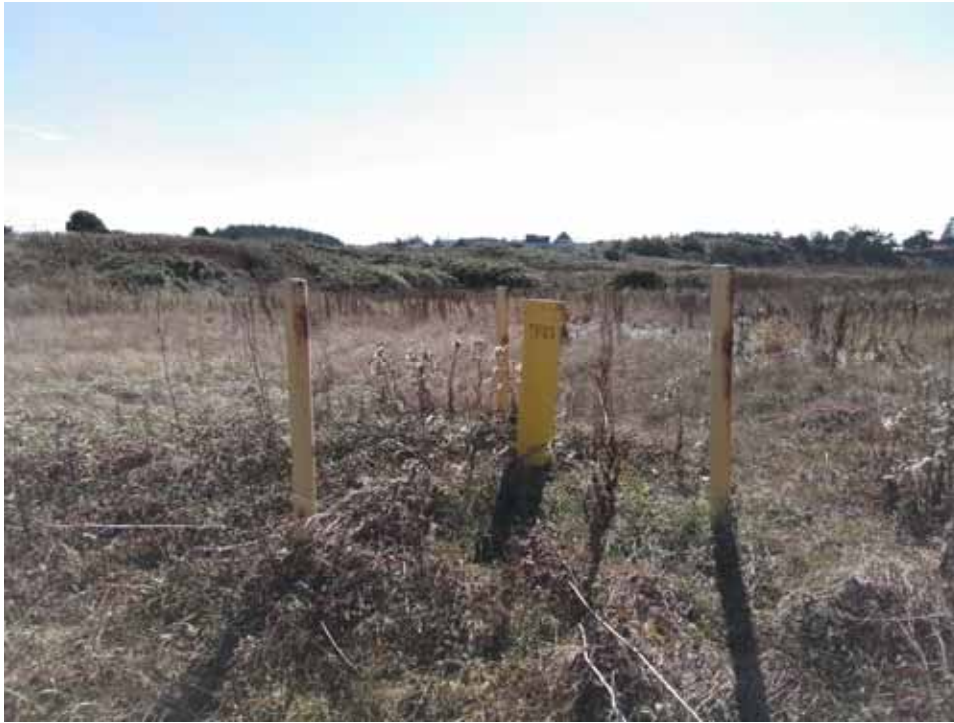
I10: Faded CERCLA
signage facing west

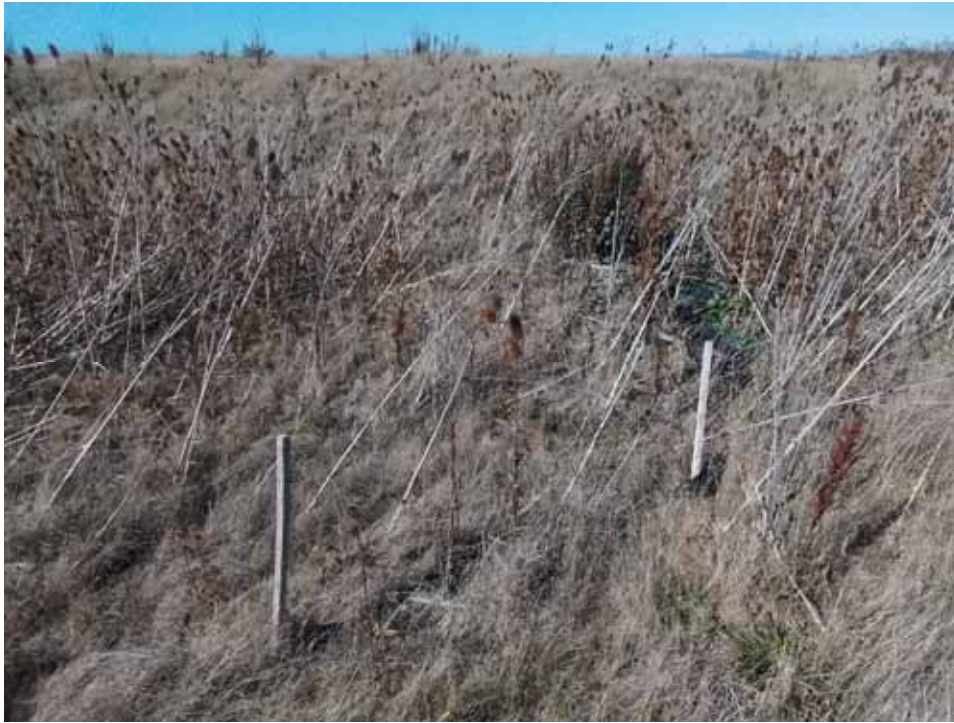
I14: Stormwater BMP
silt fence facing south

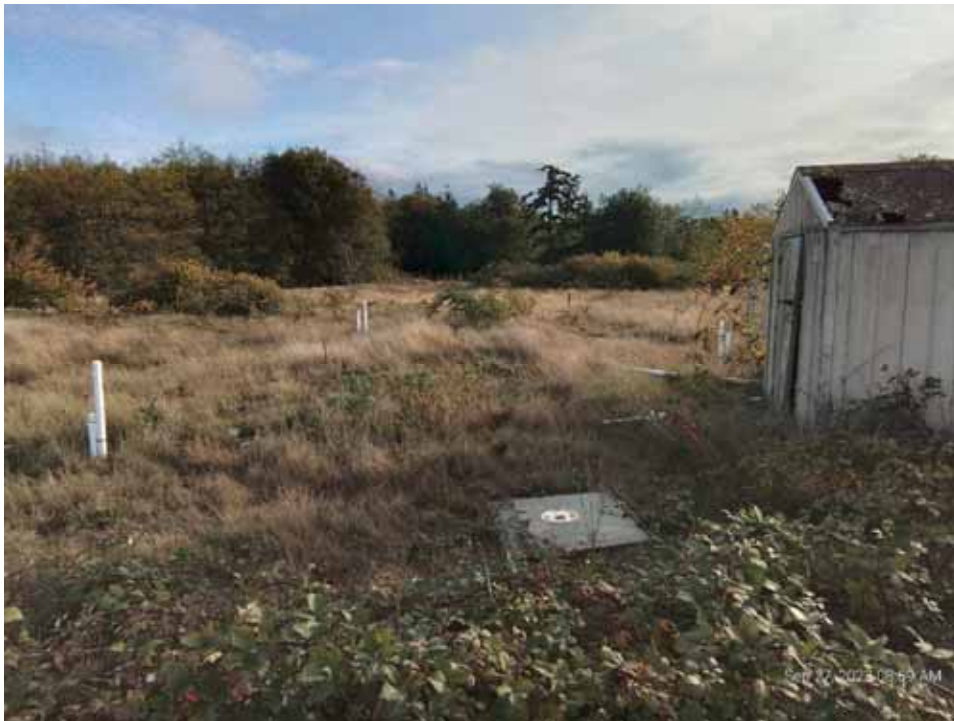
J11: Non-operational
AS/SVE System facing
south

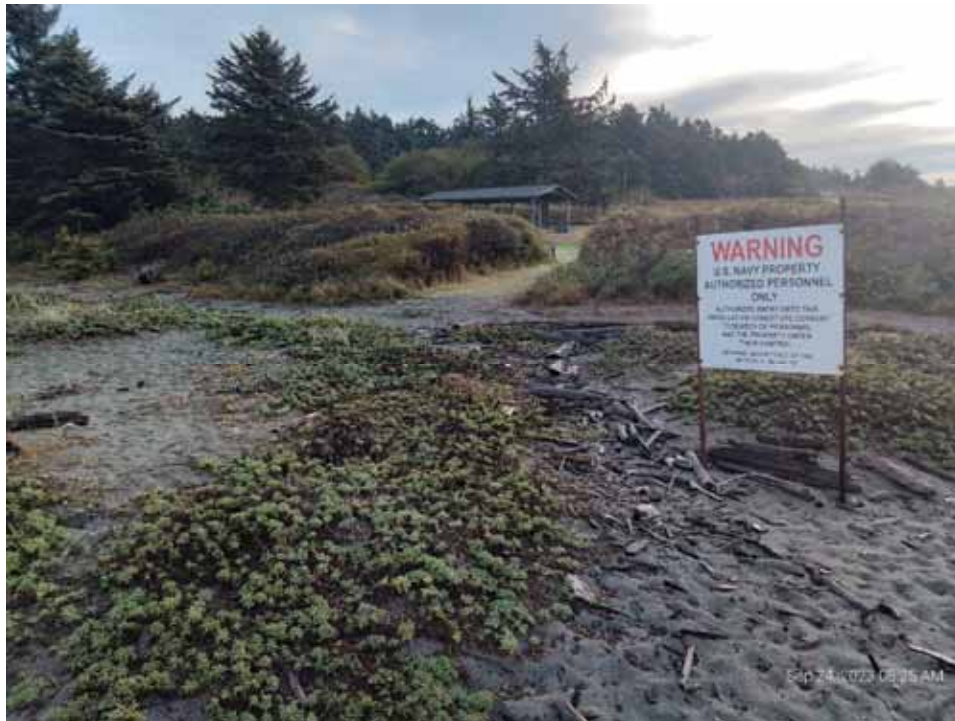
M14: Signage at beach
access north of
northwest corner facing
west

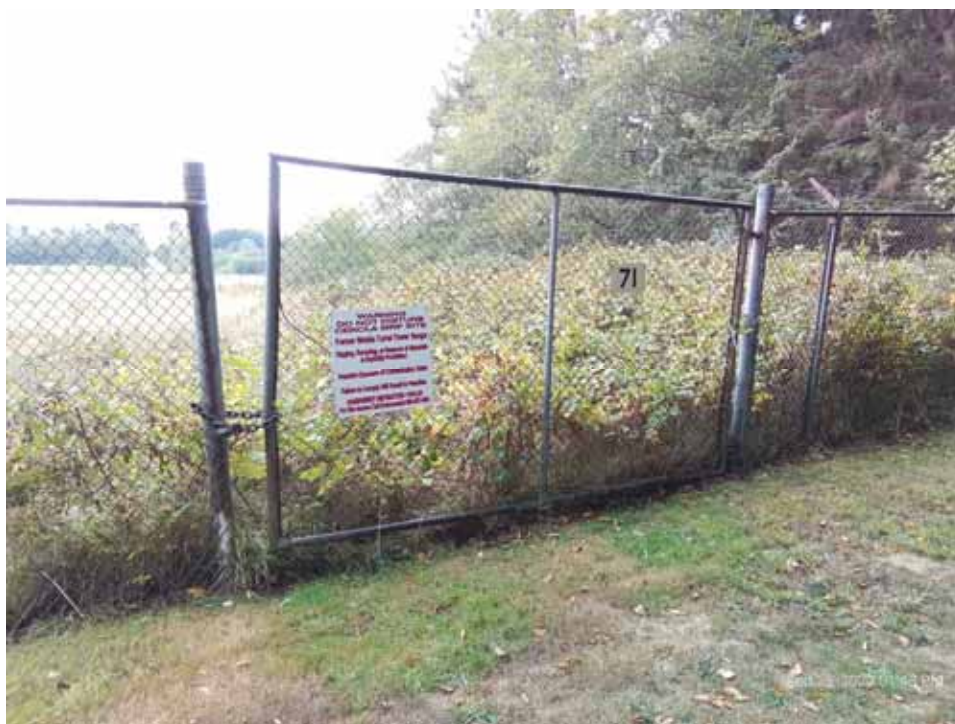
N11: Entrance gate
along southern
boundary facing north

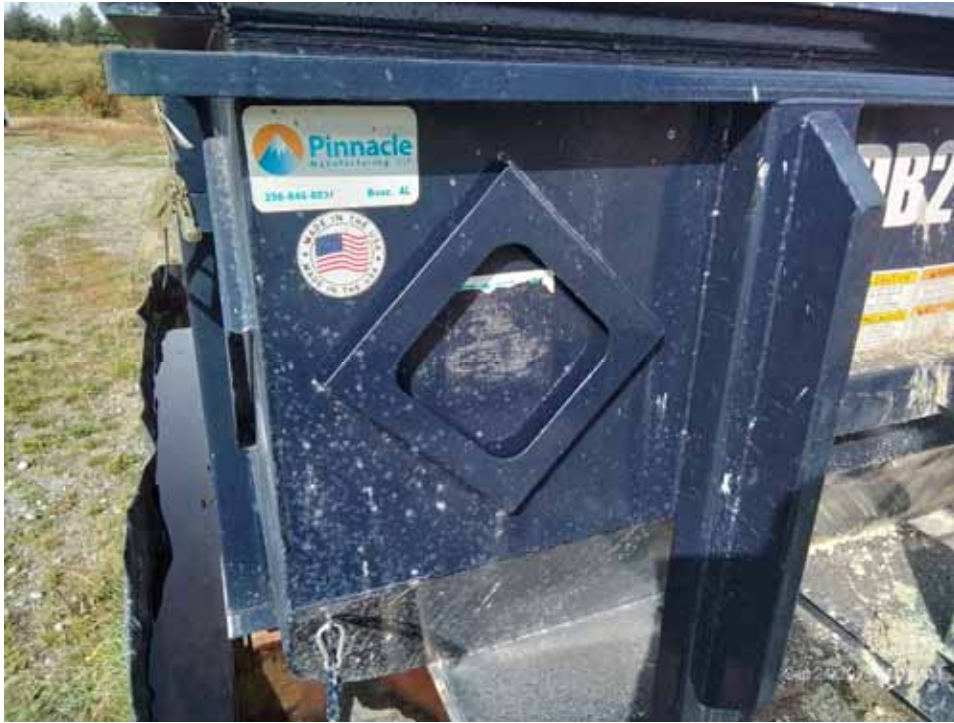
N14: IDW storage area
east of site, facing
northeast

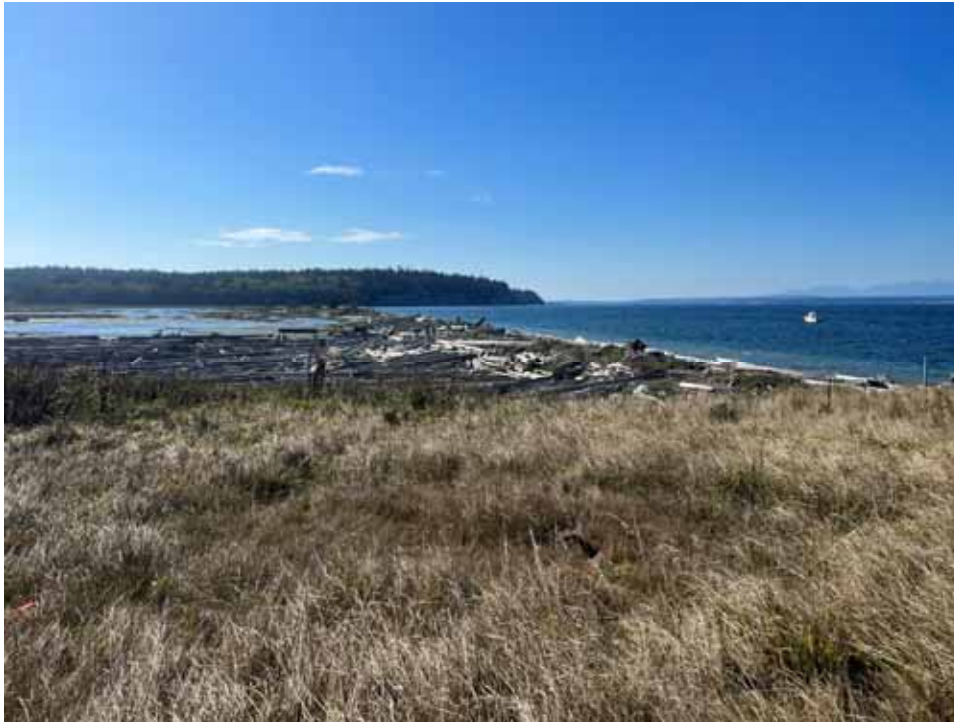
N17: End of fence near
shoreline in
northwestern site area

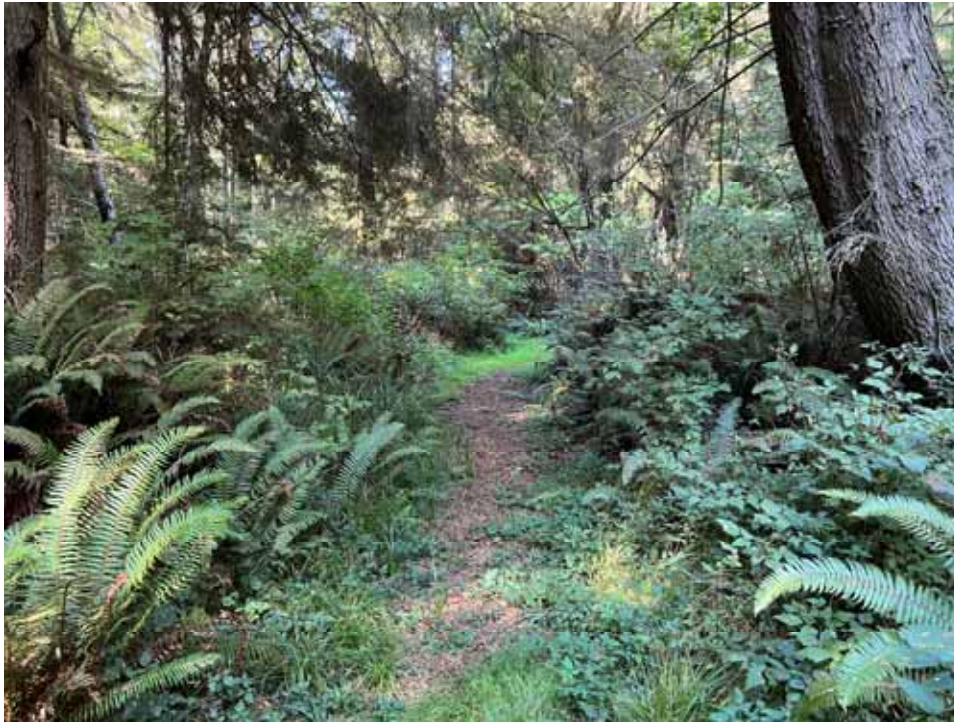
O12: Trail to southwest
corner of site;
downed/cut up trees at
southwest corner of site
facing east

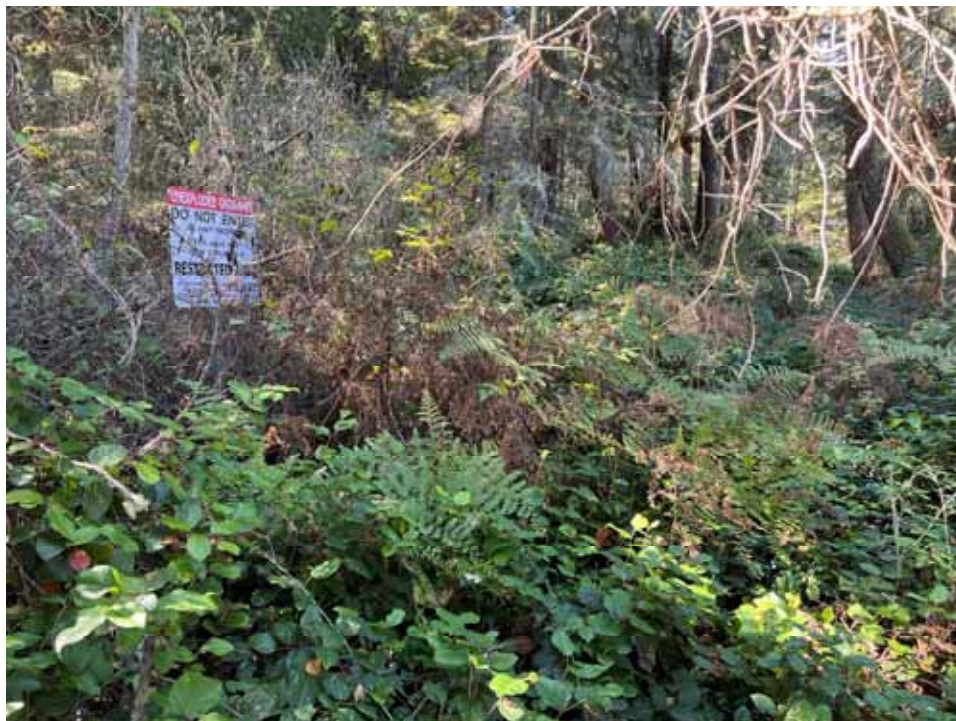
O23: Trailhead at
northwest corner with
signage

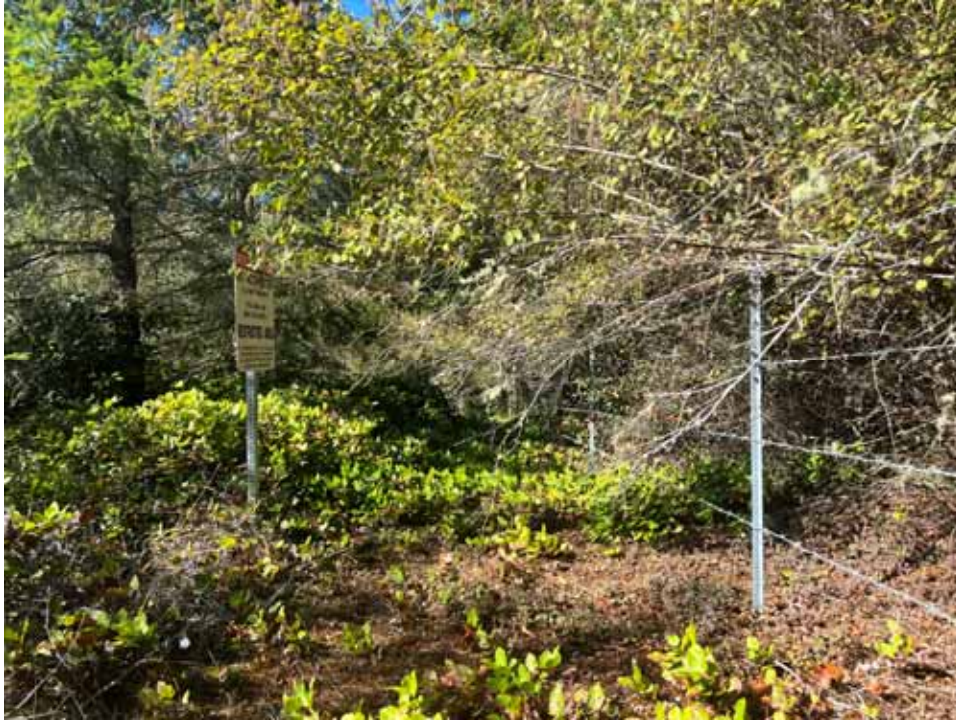
O24: Signage along
northern site boundary

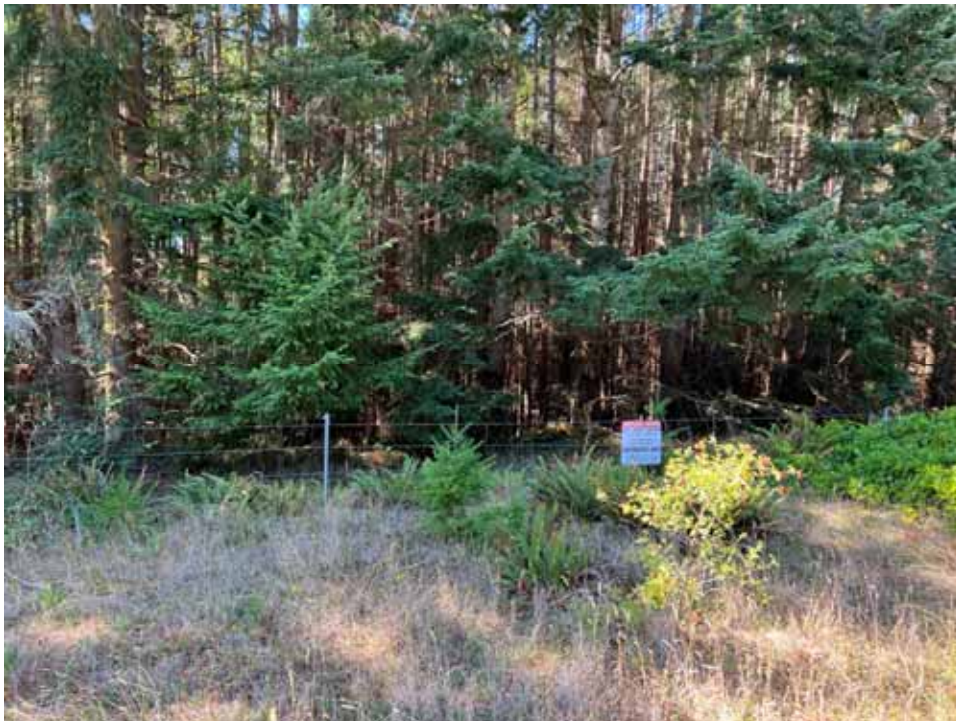
O25: Northern site
boundary and signage,
facing west

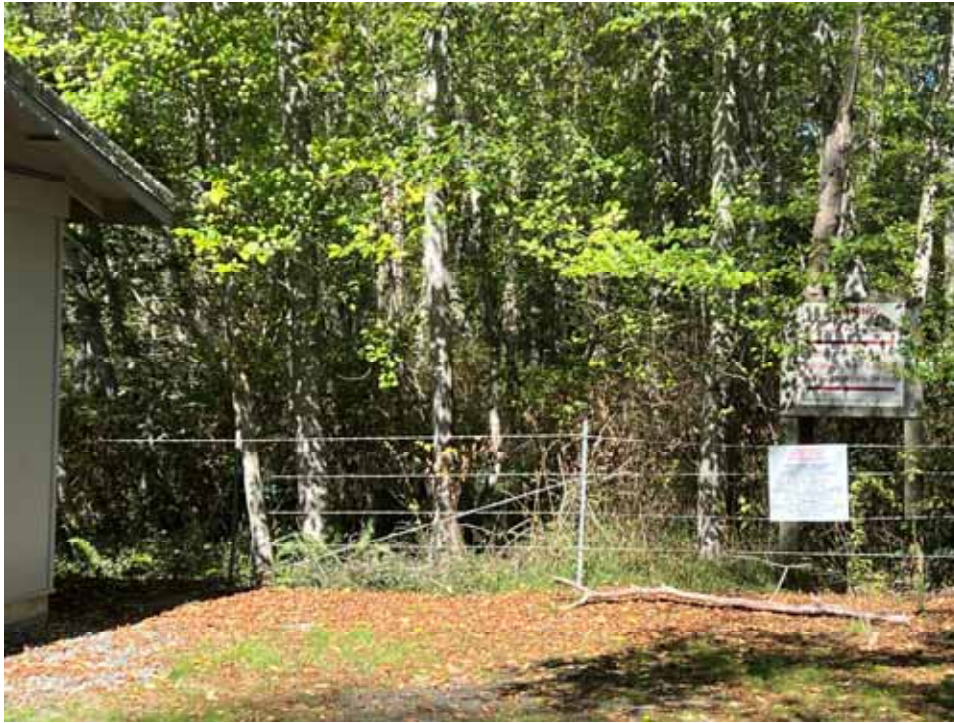
O26: Signage along
eastern boundary
facing west

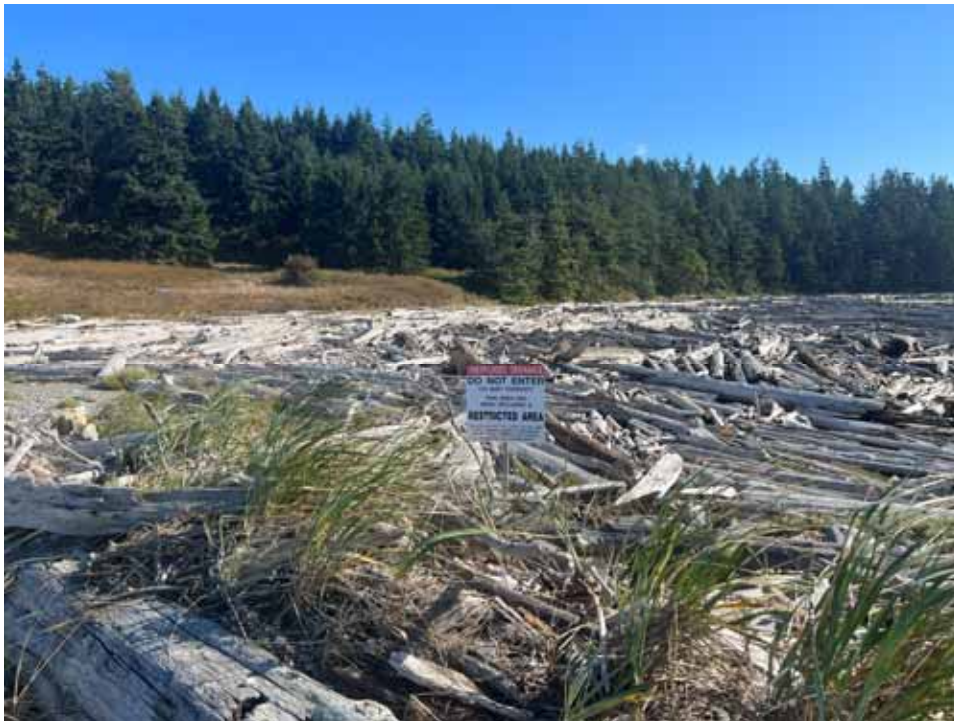
O27: Warning signage
along southern site
boundary, near utility
building

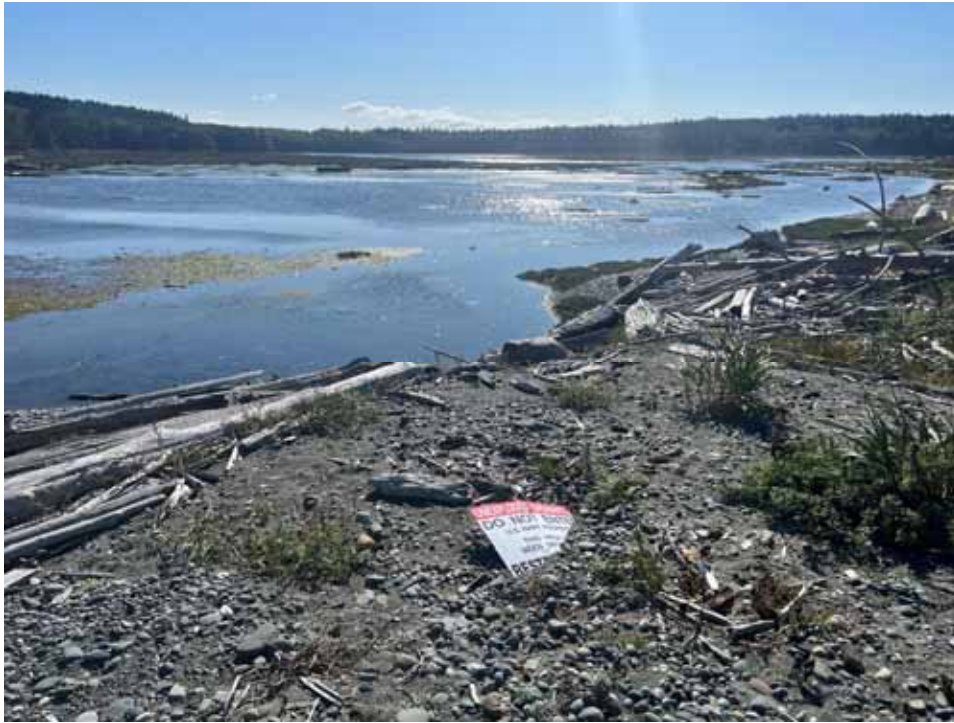
O28: Northwest
shoreline signage,
facing northeast

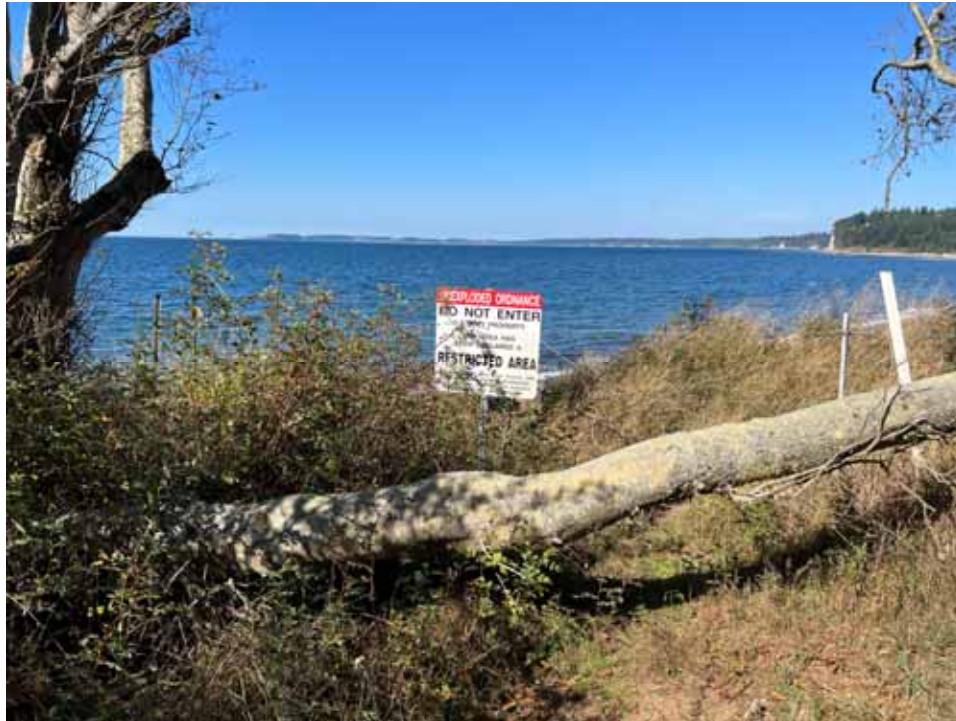
O30: Southwest
warning signage facing
northwest

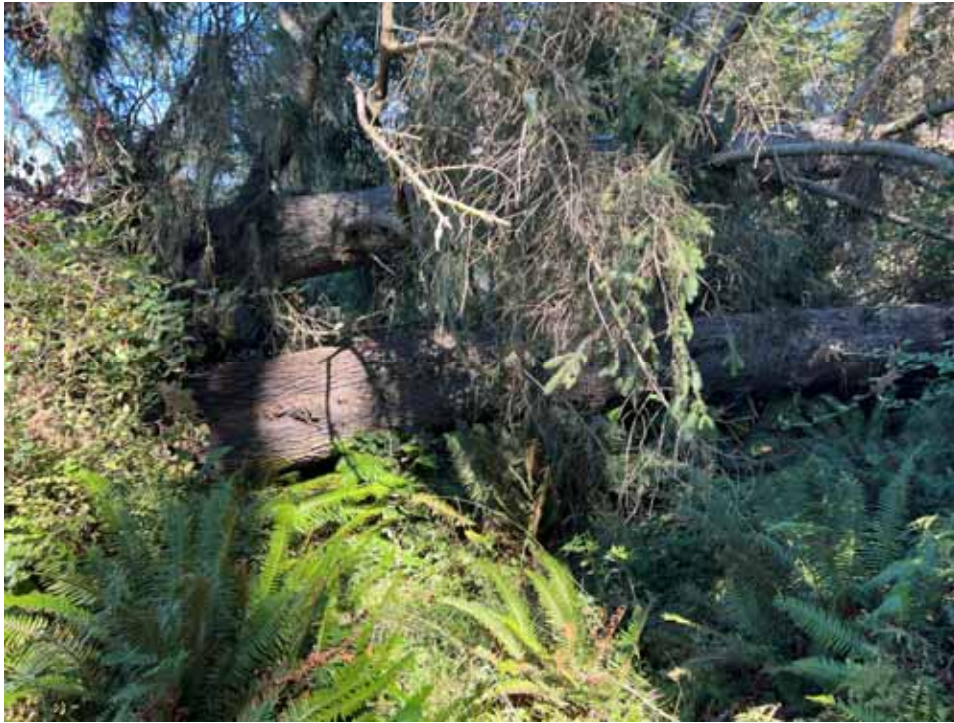
O32: Signage and
minor erosion in
southwest portion of
site

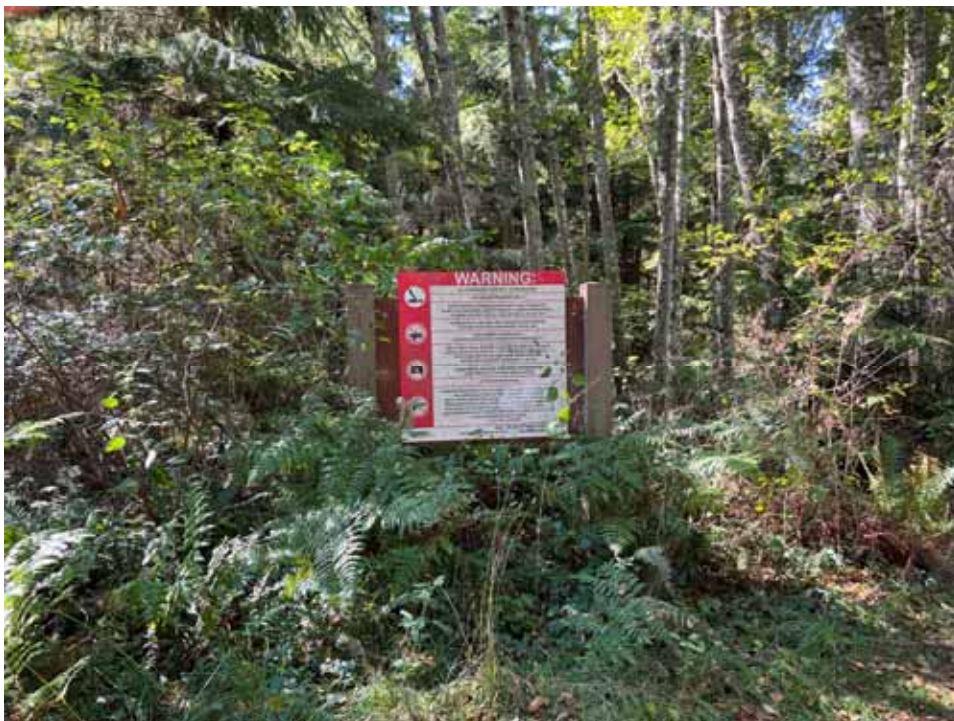
O41: One of three signs
along shoreline south of
lake Hancock inlet
facing northeast

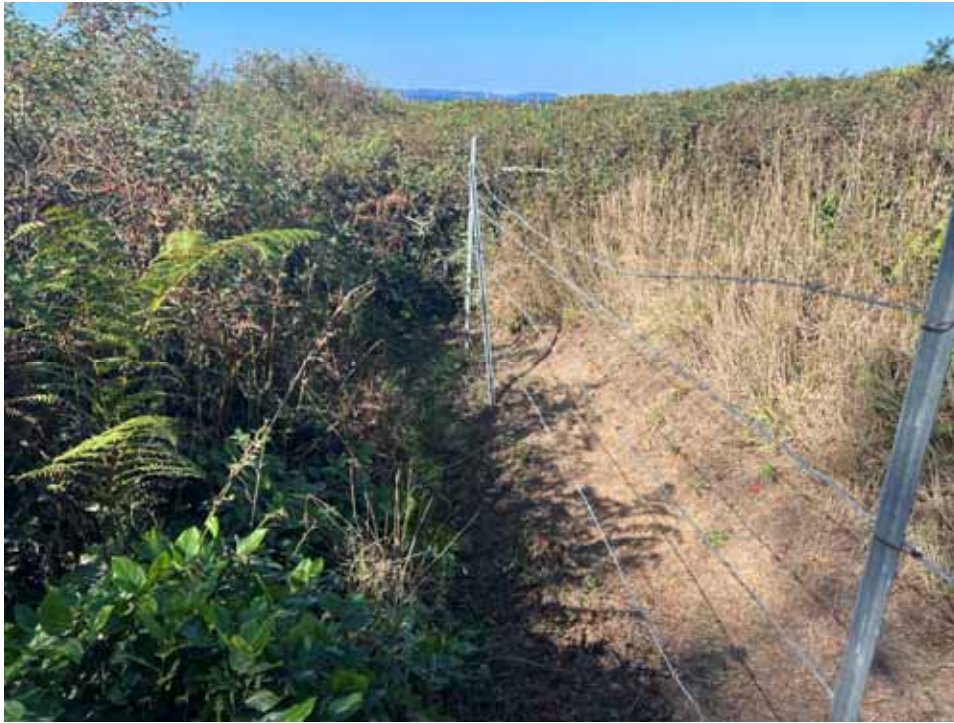
O50: Compromised
fencing along northern
boundary facing
northeast

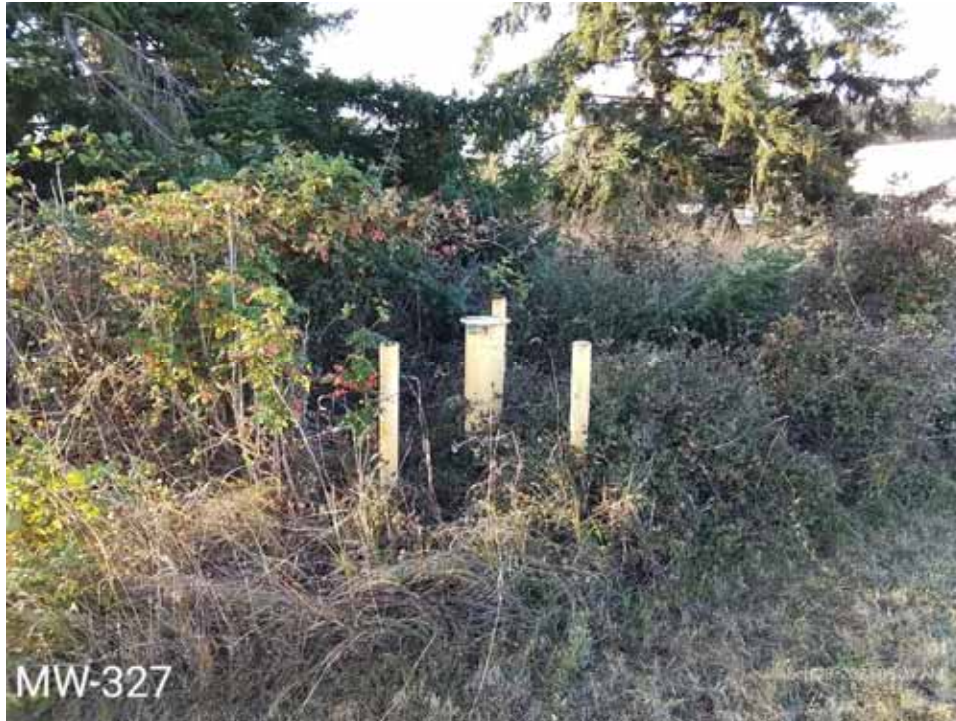
P12: Shellfish hazard signage facing southeast

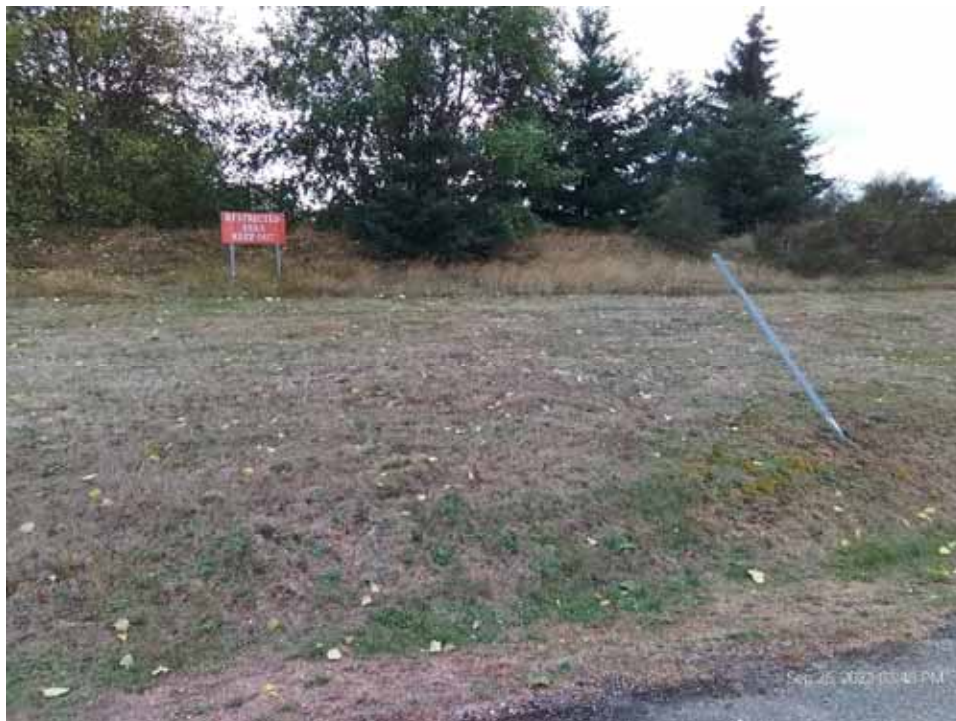
R21: Warning signage in northeast corner facing south

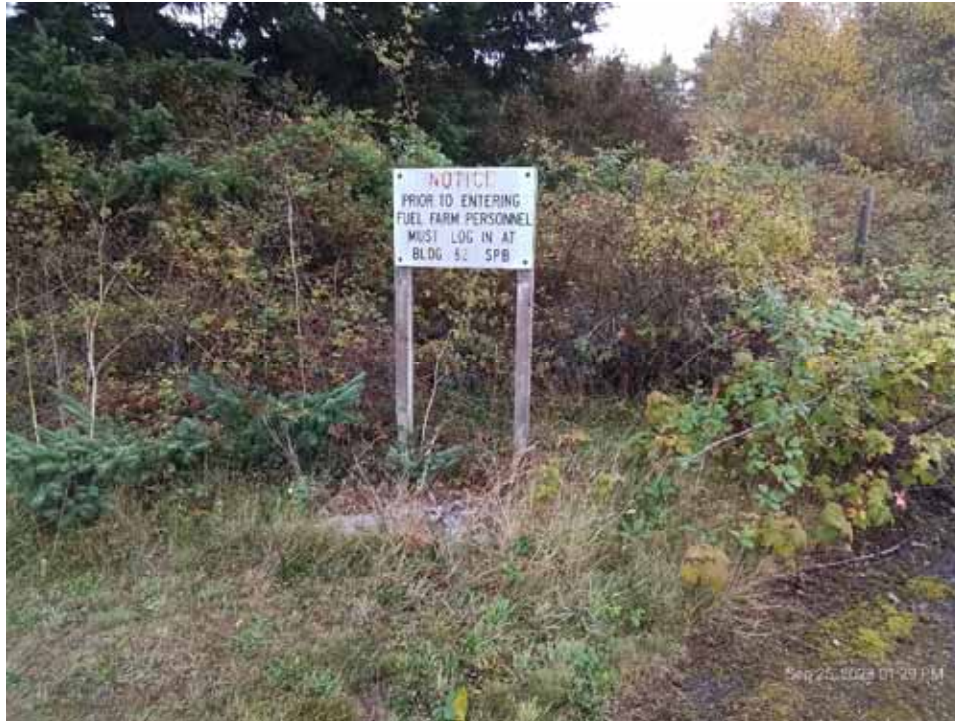
Site: Site 11, Former Fuel Farm 4

S4: Southern warning signage

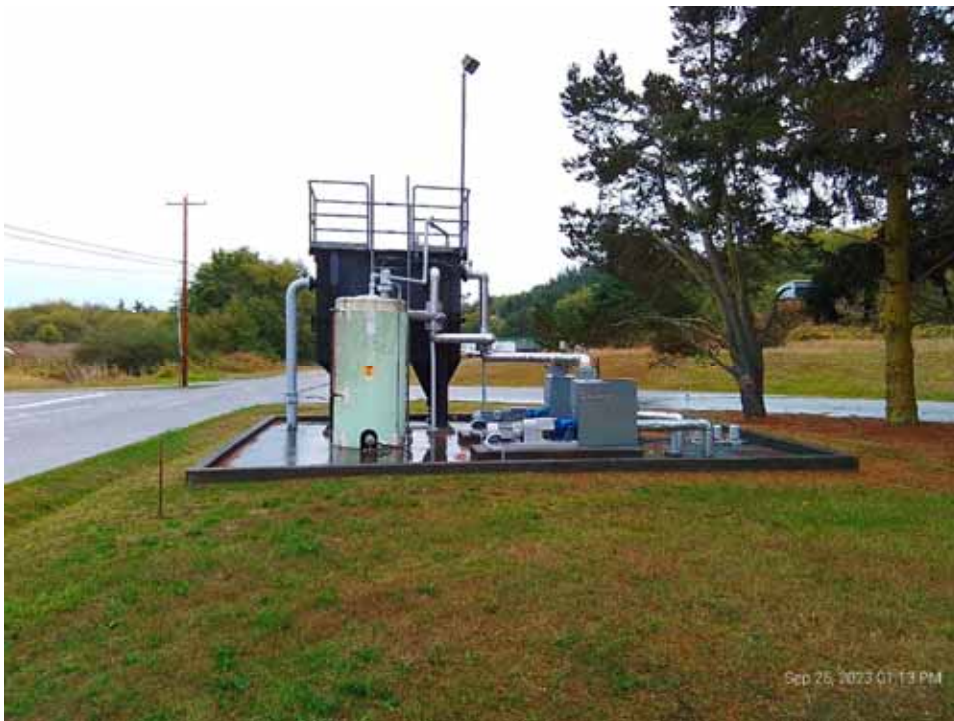
Site: Site 11, Former Fuel Farm 4

S17: Oil water separator along northern site boundary facing west

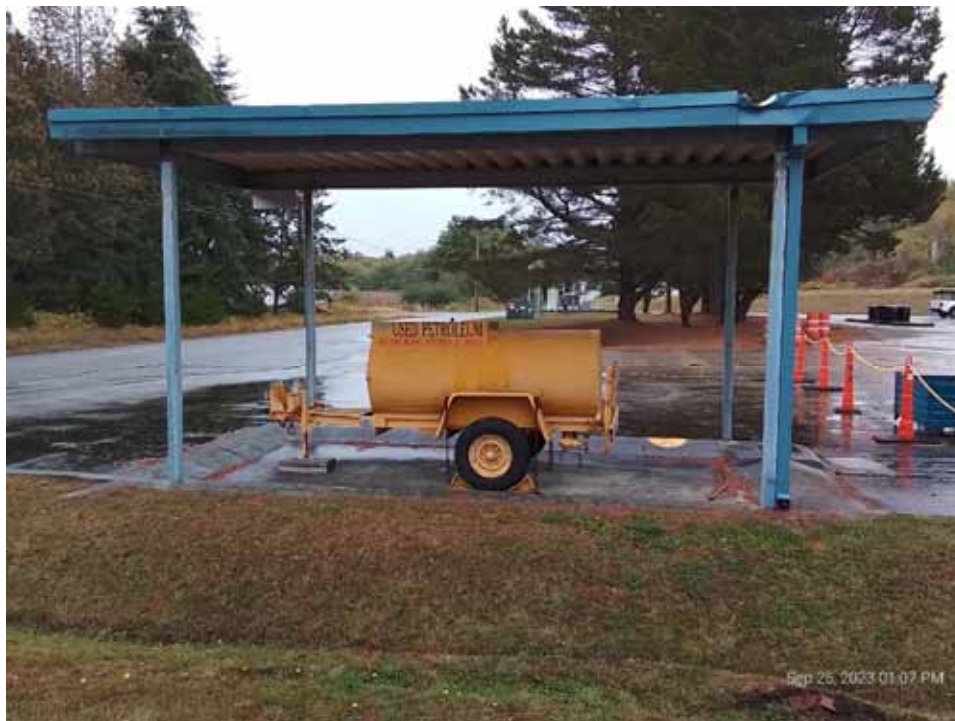
Site: Site 11, Former Fuel Farm 4

S19: Waste petroleum trailer in covered area with containment berm and adjacent work area with barriers

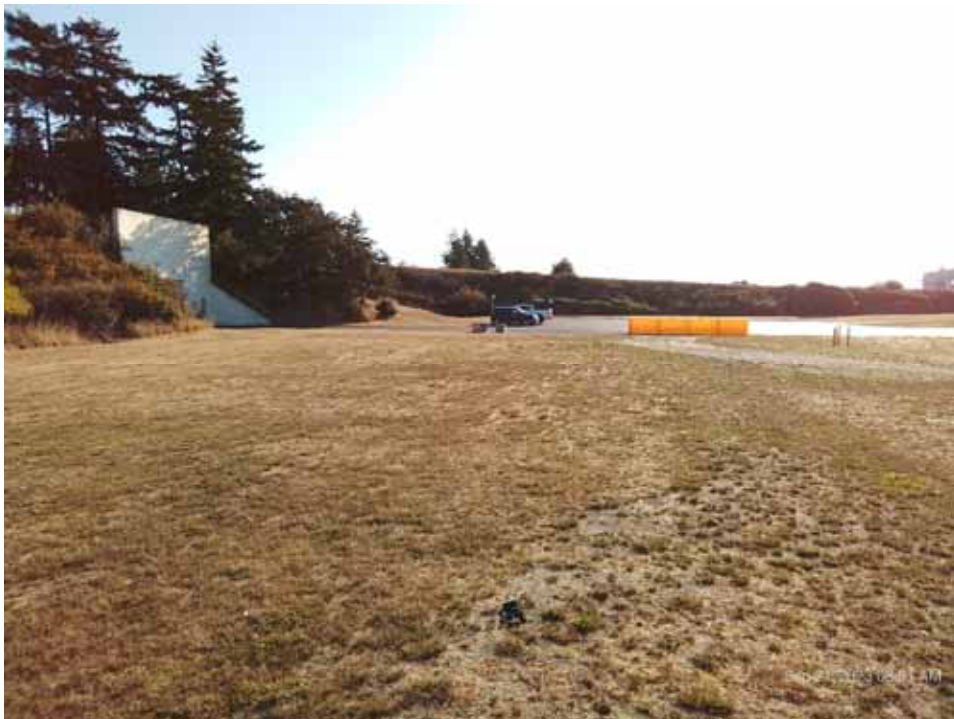
Site: Site 45, TCE Tank

T1: North site overview
from northeast corner

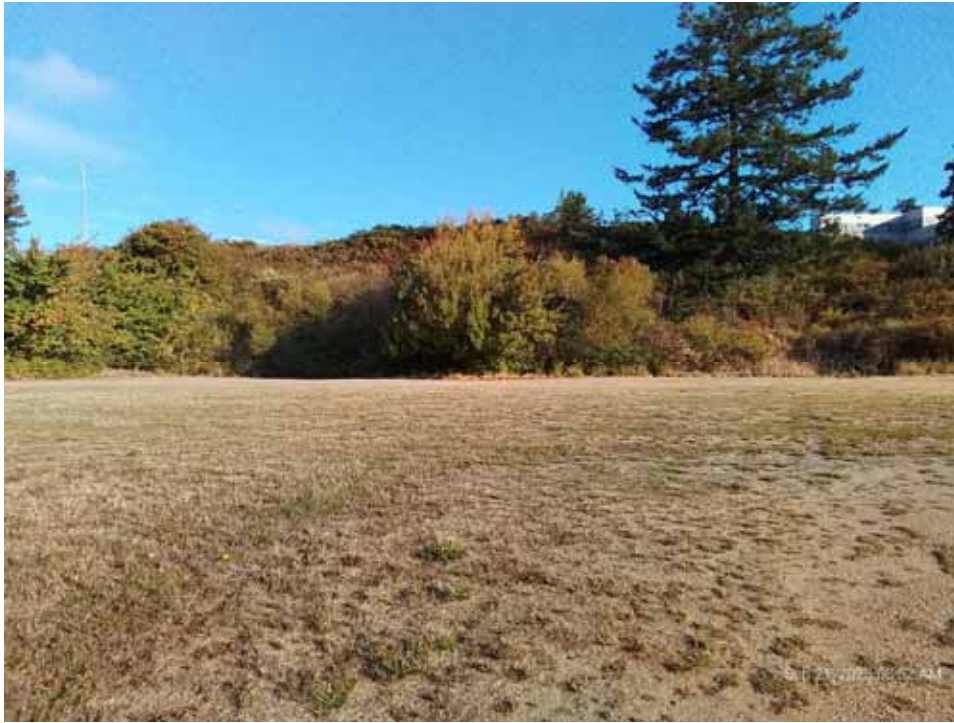
Site: Site 45, TCE Tank

T2: Site overview from
central area, facing east

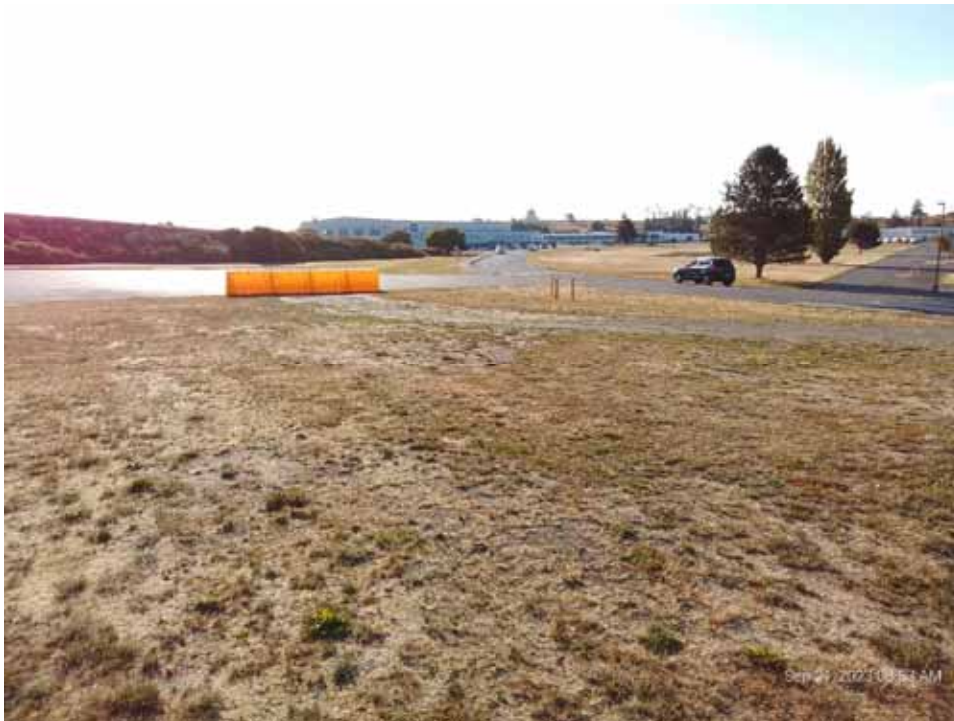
Site: Site 45, TCE Tank

T3: Site overview from southern boundary facing northwest
