**2024 LAND USE CONTROL INSPECTIONS TECHNICAL MEMORANDUM  
SITES 302 303 AND 304 AND TANK 50 NAVAL BASE KITSAP MANCHESTER  
KITSAP COUNTY WASHINGTON  
04/28/2025  
LIBERTY JOINT VENTURE (JV)**

# **2024 Land Use Control Inspections Technical Memorandum**

**Sites 302, 303, and 304 and Tank 50**

**Naval Base Kitsap Manchester, Kitsap County,  
Washington**

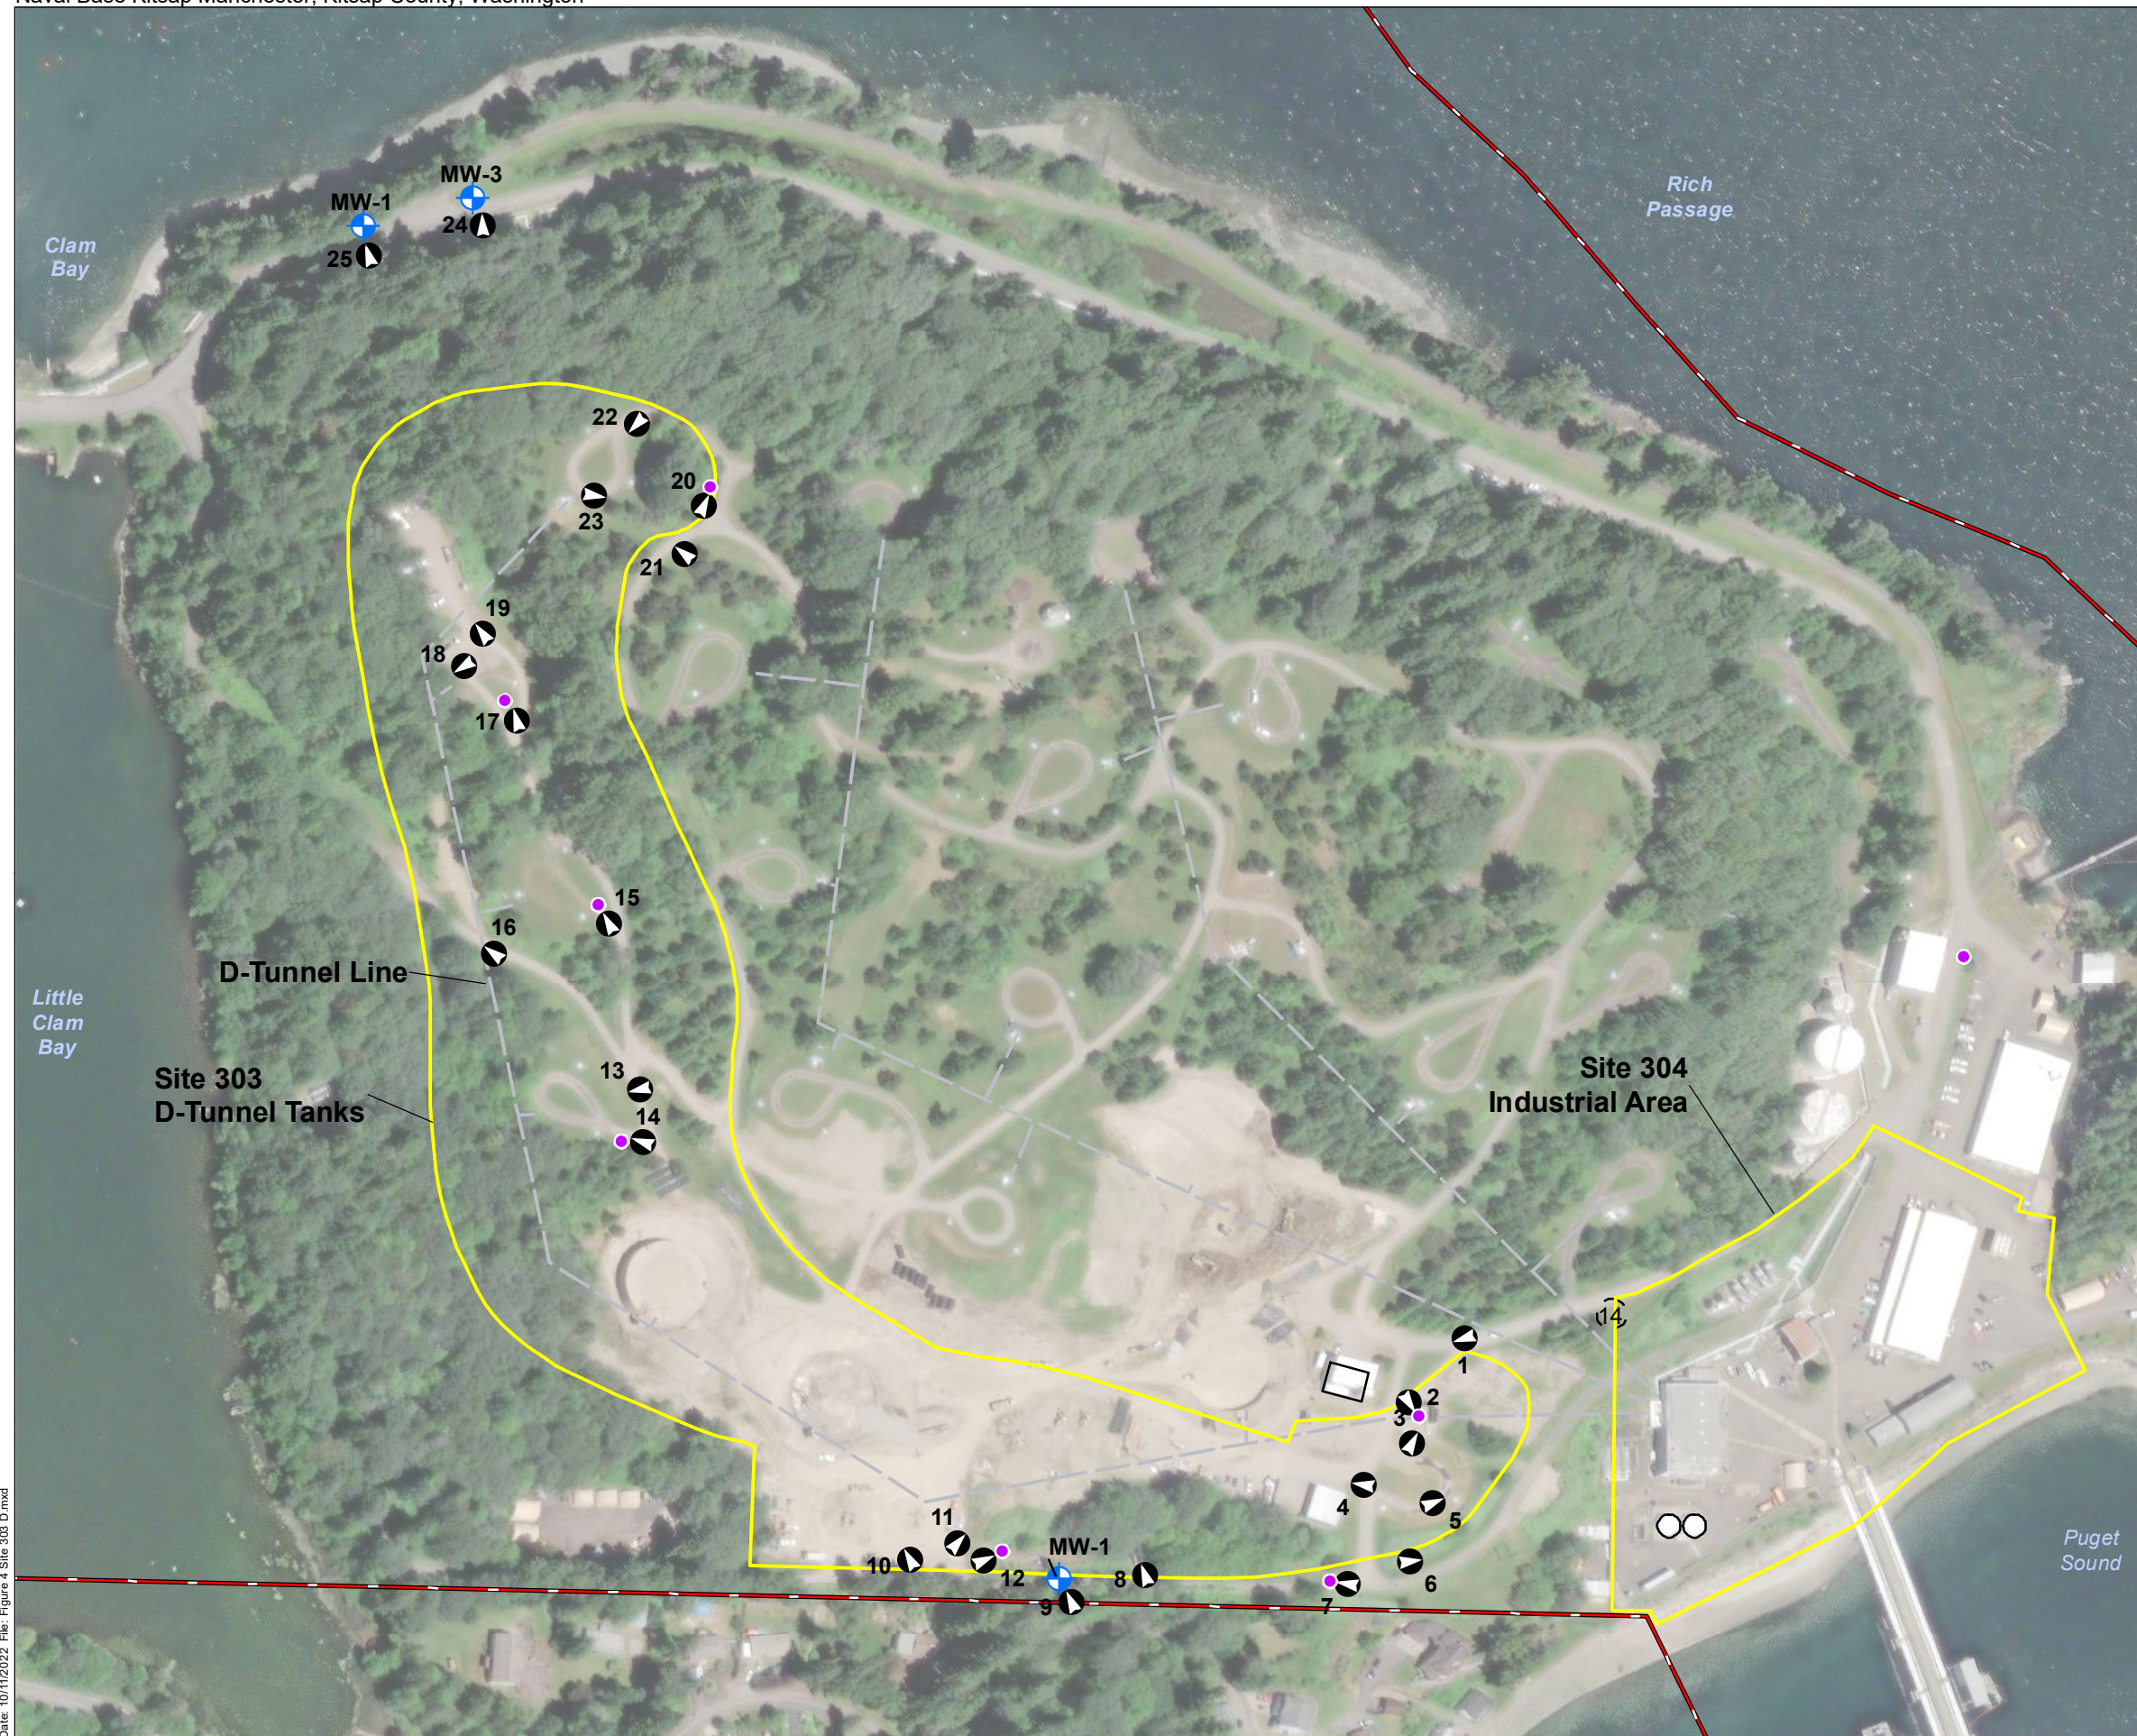
FIGURE  
4

Site 303 is currently under heavy construction with the removal of USTs and the replacement of aboveground storage tanks (ASTs). Site 303 consisted of eight 20,000- to 50,000-barrel (840,000- to 2,100,000-gallon) concrete USTs used to store marine diesel fuel; however, three of the tanks (Tanks 24, 25, and 26) have been decommissioned (see Figures 2 and 4). Two ASTs were under construction during the site inspection (see Appendix D, Site 304 Photographs 10 and 11). The Navy Special Fuel stored and dispensed at NBK Manchester is designated as F-76. The USTs/ASTs are located adjacent to the D-tunnel line, which extends from Tank 30 to Building 12 in the Industrial Area (Site 304), as shown on Figure 4. Site-specific LUCs are as follows:

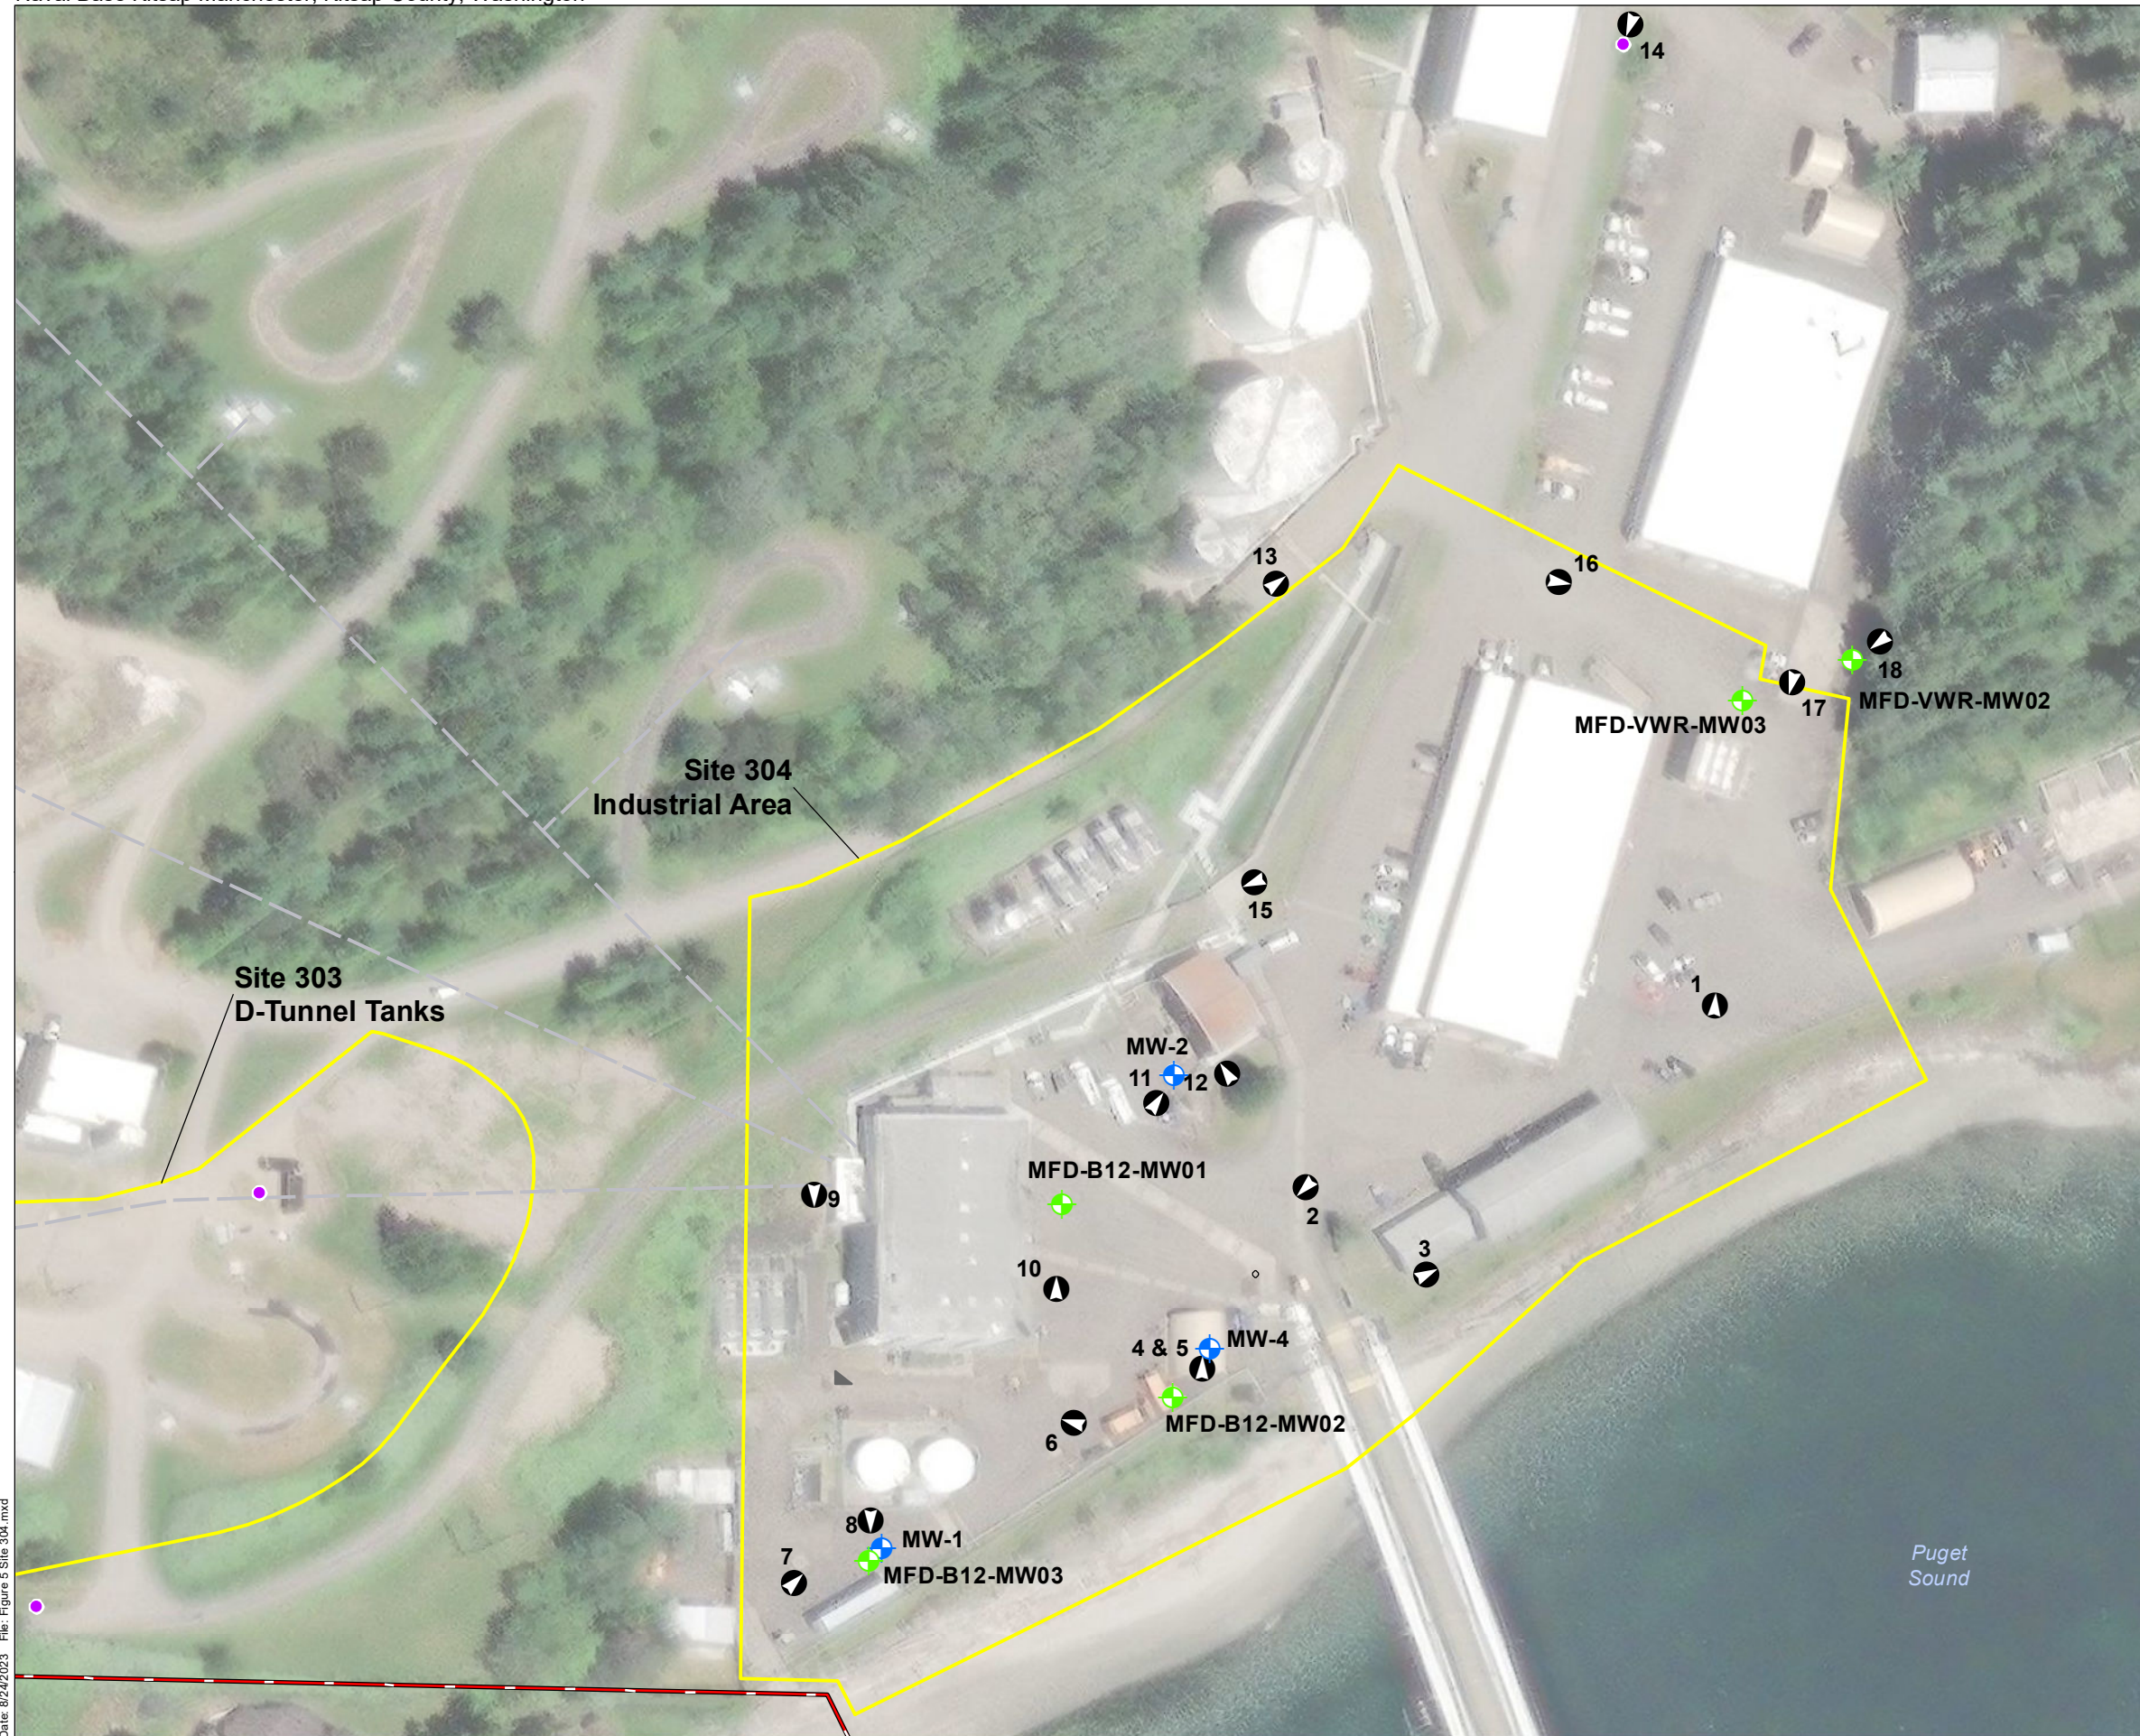
FIGURE  
**5**

The 2024 LUC inspections confirmed LUC requirements 1 through 7 above are being met at Site 304. Remaining areas of concern are identified on facility maps and specified in facility permit instructions in response to a previous recommendation for the Contractor ESG (Navy, 2016a). The five groundwater monitoring wells related to the PFAS investigation within the Site 304 boundary (MFD-B12-MW01, MFD-B12-MW02, MFD-B12-MW03, MFD-VWR-MW02 and MFD-VWR-MW03) were observed in good condition (Figure 5).

The LUC signage for Site 304 is located at the northeastern corner of Building 178, outside and north of the Site 304 LUC boundary (see Figure 5). The area in the northeast portion of the site is no longer used as a construction laydown area; it was in-use for parking at the time of the 2024 inspections (see Appendix D, Site 304 Photograph 18). The area of active soil excavation observed during the 2023 LUC inspection related to a utility line installation on the south side of the main office building (Building 217) has since been backfilled and re-vegetated (see Appendix D, Site 304 Photograph 3).

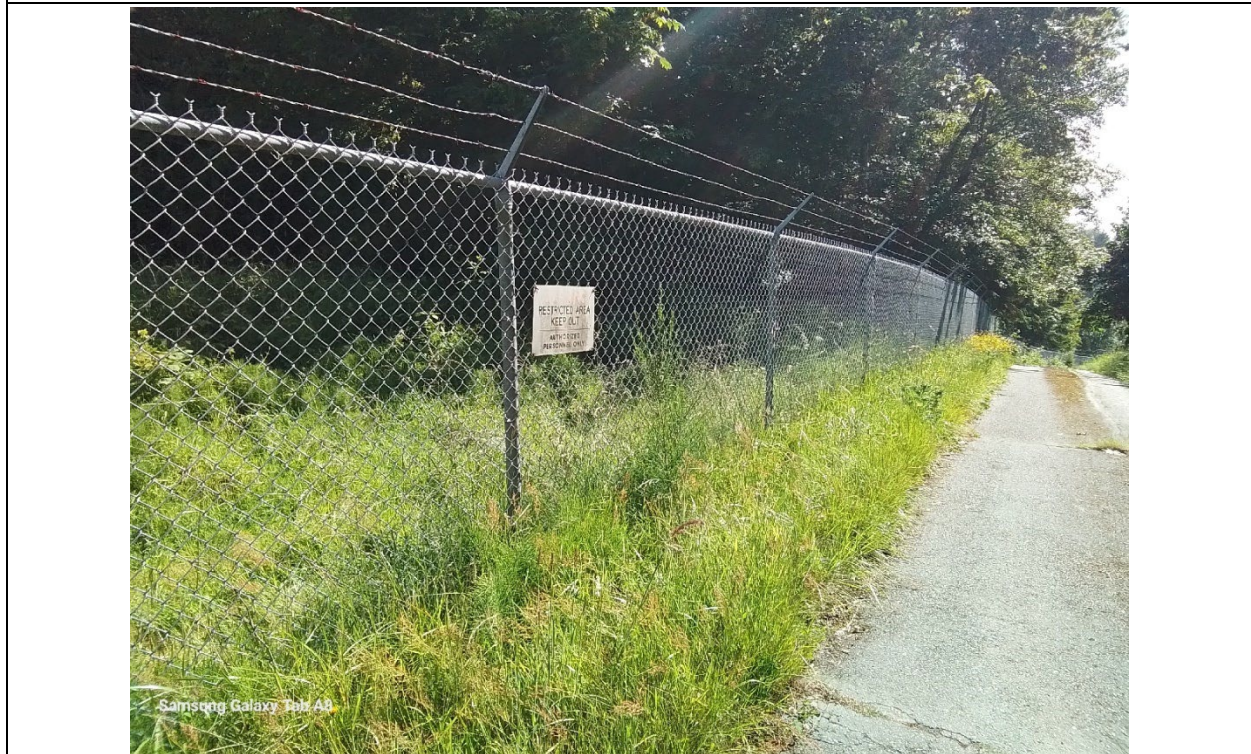
**Photograph 2**  
Land use control (LUC) signage along southeastern road boundary, facing east.

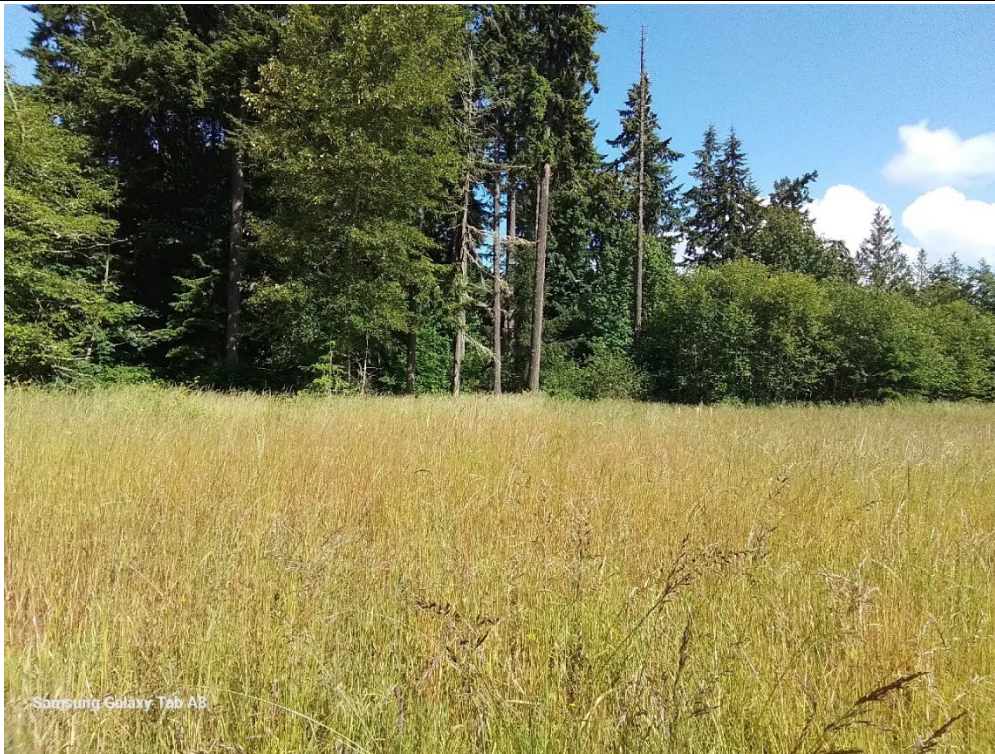
**Photograph 9**

South central area of site, facing northwest. PFAS groundwater monitoring well MFD-S302-MW02 in the background.

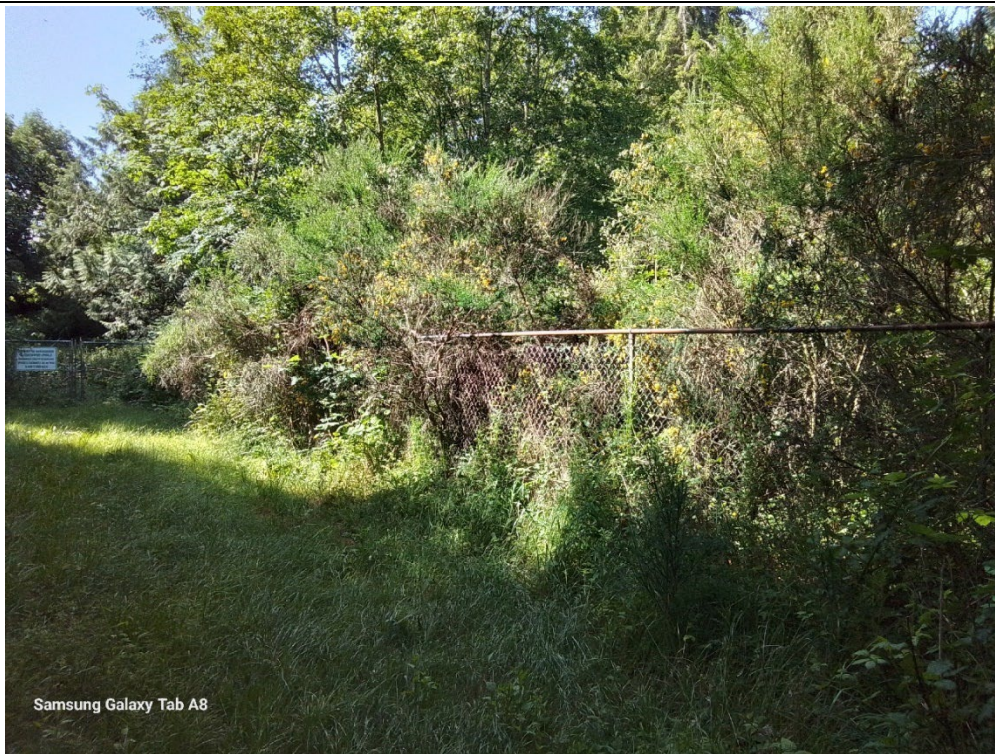
**Photograph 17**  
Northern corner fence line, facing southwest.

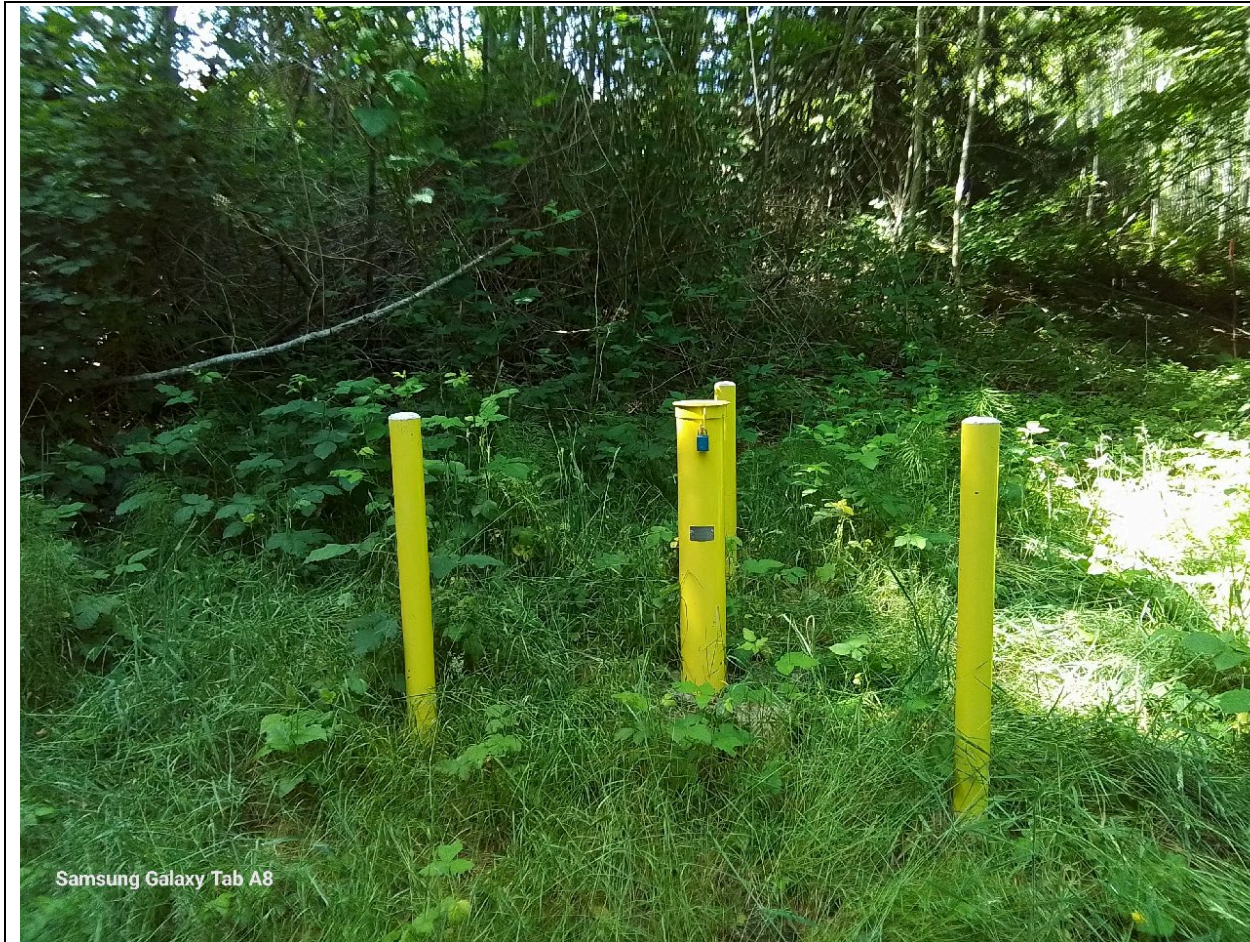
**Photograph 19**

PFAS groundwater monitoring well MFD-S302-MW01 located within the northeast area of site, facing south.

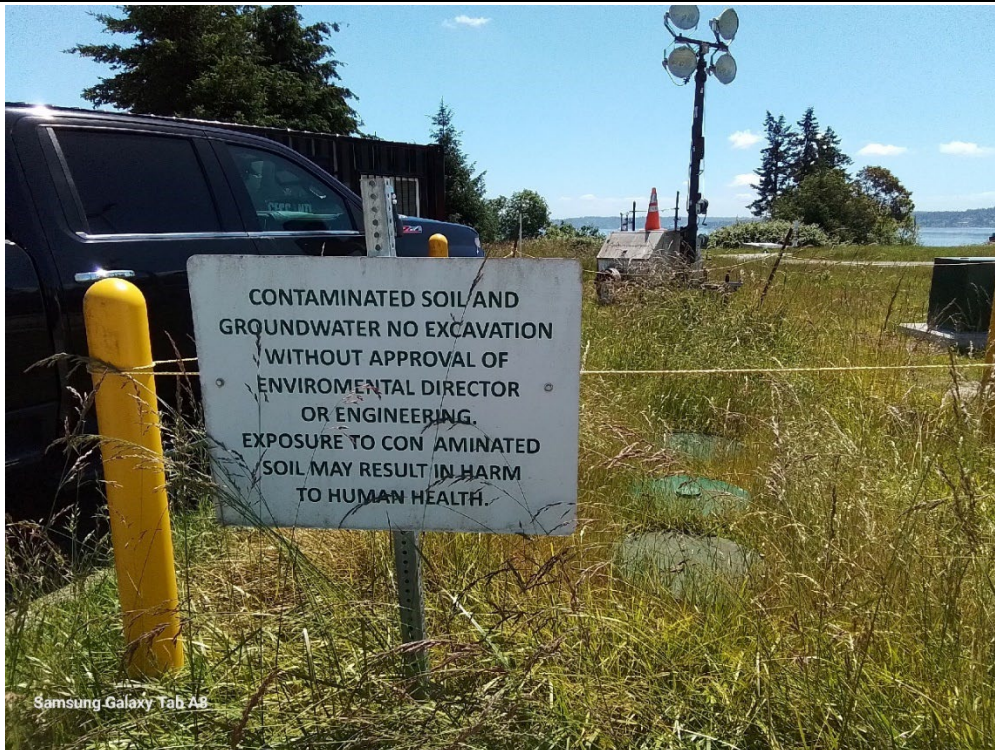
**Photograph 2**  
LUC signage at Tank 22 and storage containers, facing southeast.

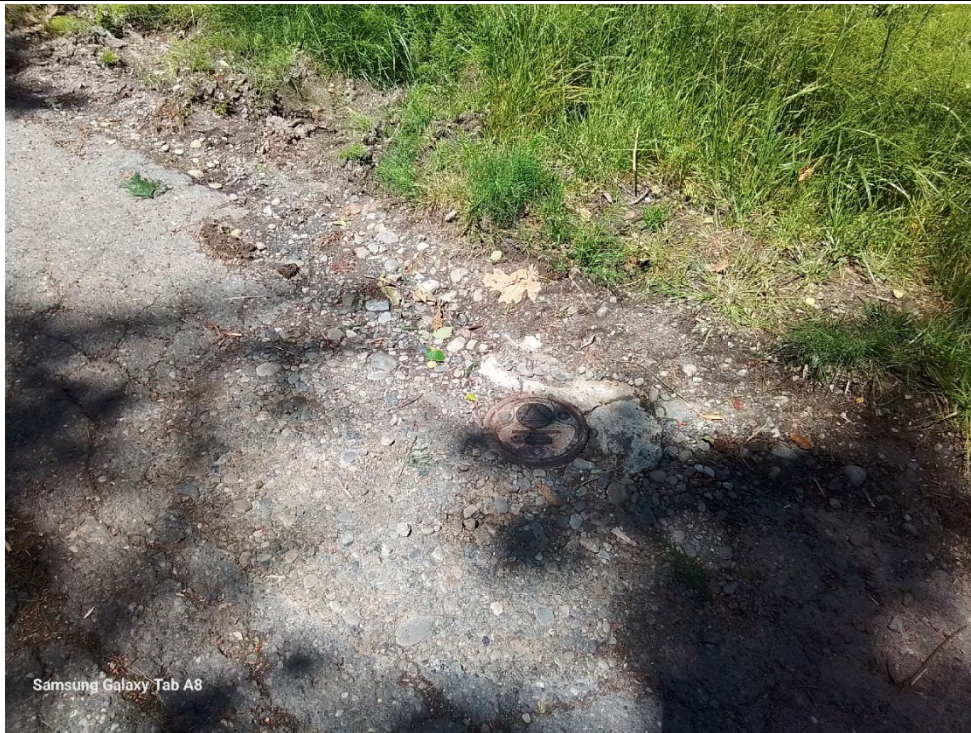
Monitoring wells MW-1 and MW-3 north of Tank 30 and MW-1 south of Tank 24 were located as part of the 2024 LUC inspection (see Appendix D, Site 303 Photographs 9, 24, and 25). Monitoring well MW-1 north of Tank 30 was visually located behind a fence with a locked gate; therefore, it was inaccessible and not opened and inspected. The monitoring well was recorded to be in moderate condition because the well monument was observed to be rusted with moss growing over it and not clearly labeled. Monitoring wells MW-3 north of Tank 30 and MW-1 south of Tank 24 were opened and inspected. Monitoring well MW-3 north of Tank 30 was recorded to be in good condition. Monitoring well MW-1 south of Tank 24 was recorded to be in moderate condition because the monument apron was cracked and not clearly labeled, but the outer and

**Photograph 9**  
Groundwater monitoring well MW-1, facing northwest.

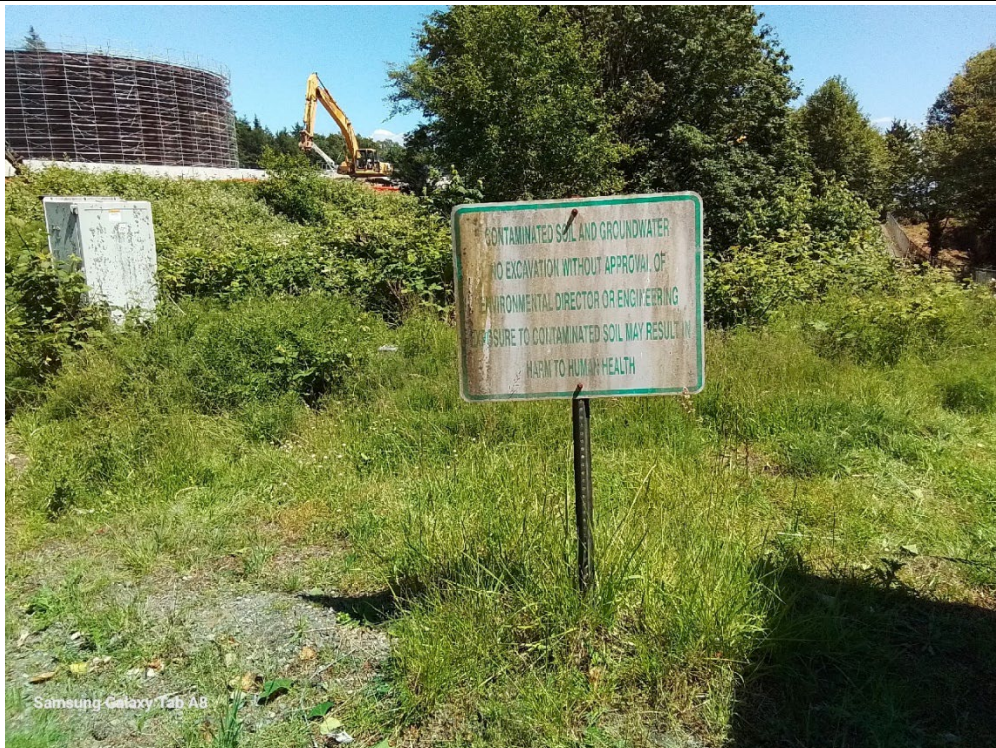
**Photograph 12**  
LUC signage, facing east.

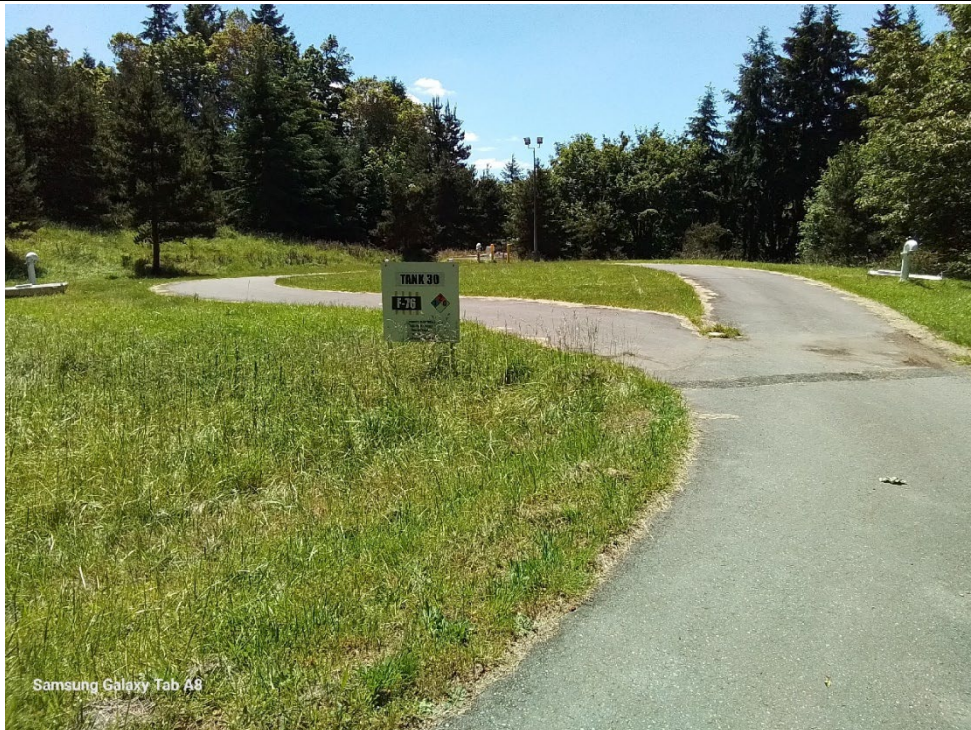
**Photograph 22**

Tank 30 site overview facing northeast.

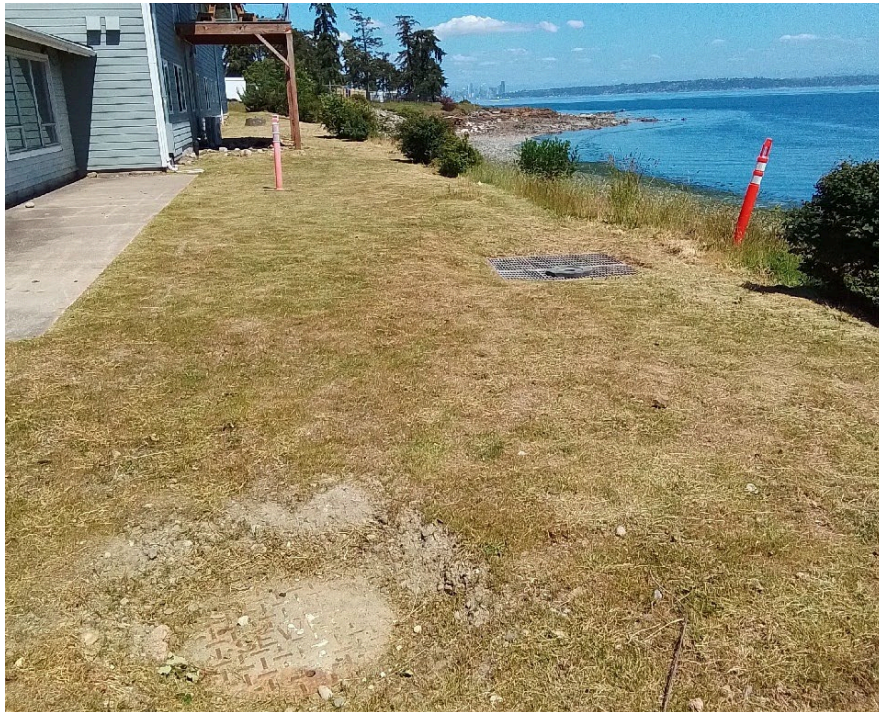
**Photograph 3**

South central boundary adjacent to Administration Building showing where a utility trench had previously been excavated, facing northeast.

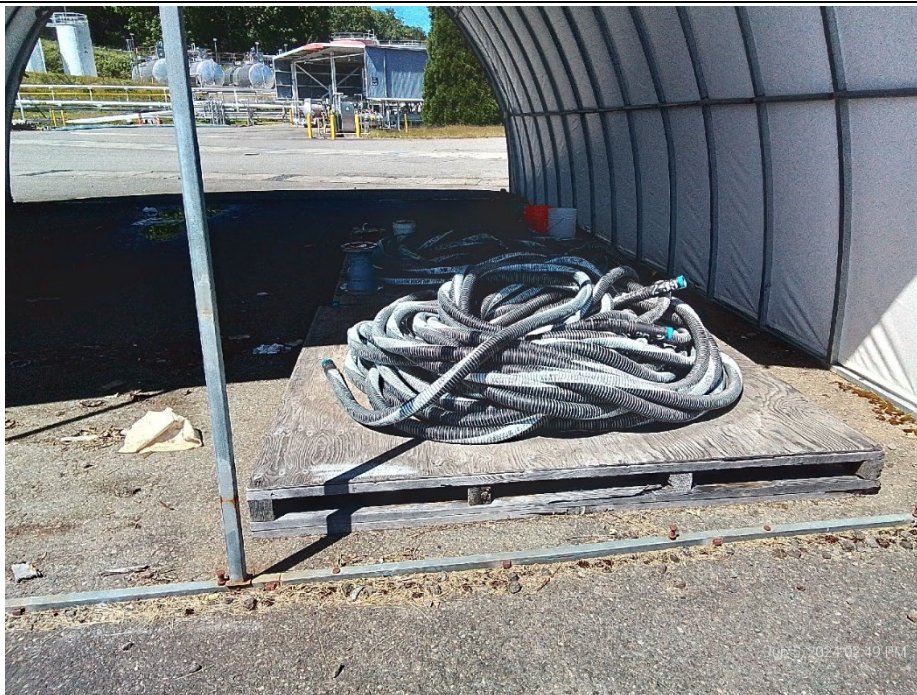
**Photograph 4**

As detailed in Section 2.1, monitoring wells MW-1, MW-2, and MW-4 at Site 304 were located as part of the 2024 LUC inspection (see Appendix B, and Appendix D, Site 304 Photographs 5, 8, and 11). Monitoring well MW-1 was opened and inspected; it was recorded to be in moderate condition because it requires maintenance to monument lid seal and was not clearly labeled. Monitoring well MW-2 was opened and inspected and recorded to be in good condition but not clearly labeled. Monitoring well MW-4 was not opened and inspected because it remains covered by a pallet and materials. Table 2-2 summarizes the inspection findings/observations at each monitoring well.

Groundwater monitoring well MW-4 (covered by pallets), located along southcentral boundary of site facing north.

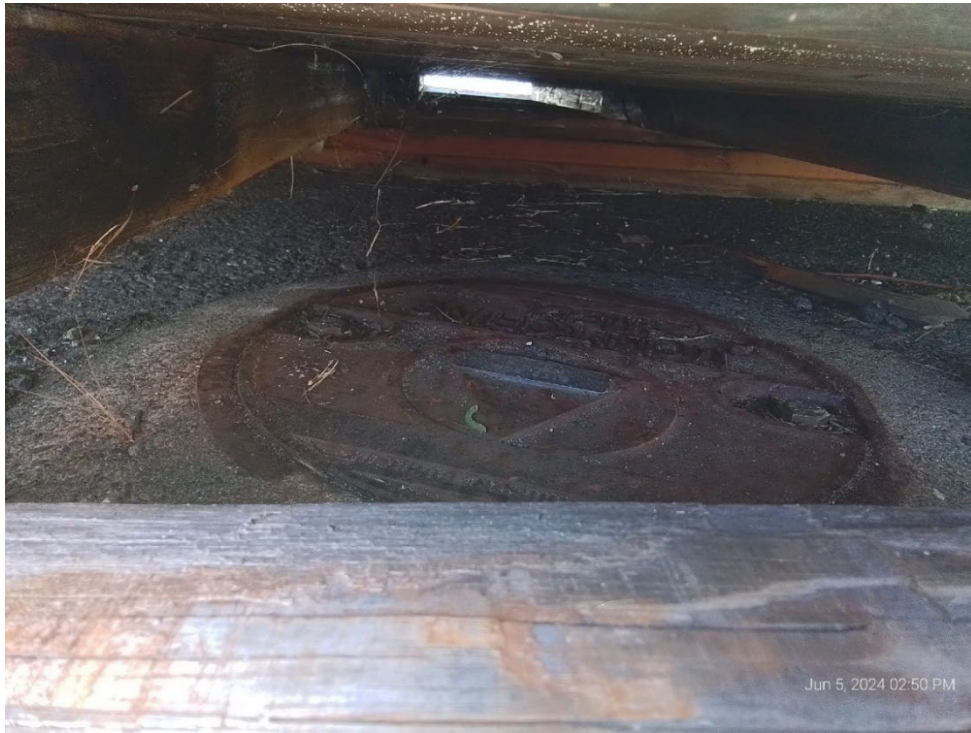
**Photograph 5**

Close up of groundwater monitoring well MW-4 (covered by pallets), located along southcentral boundary of site facing north.

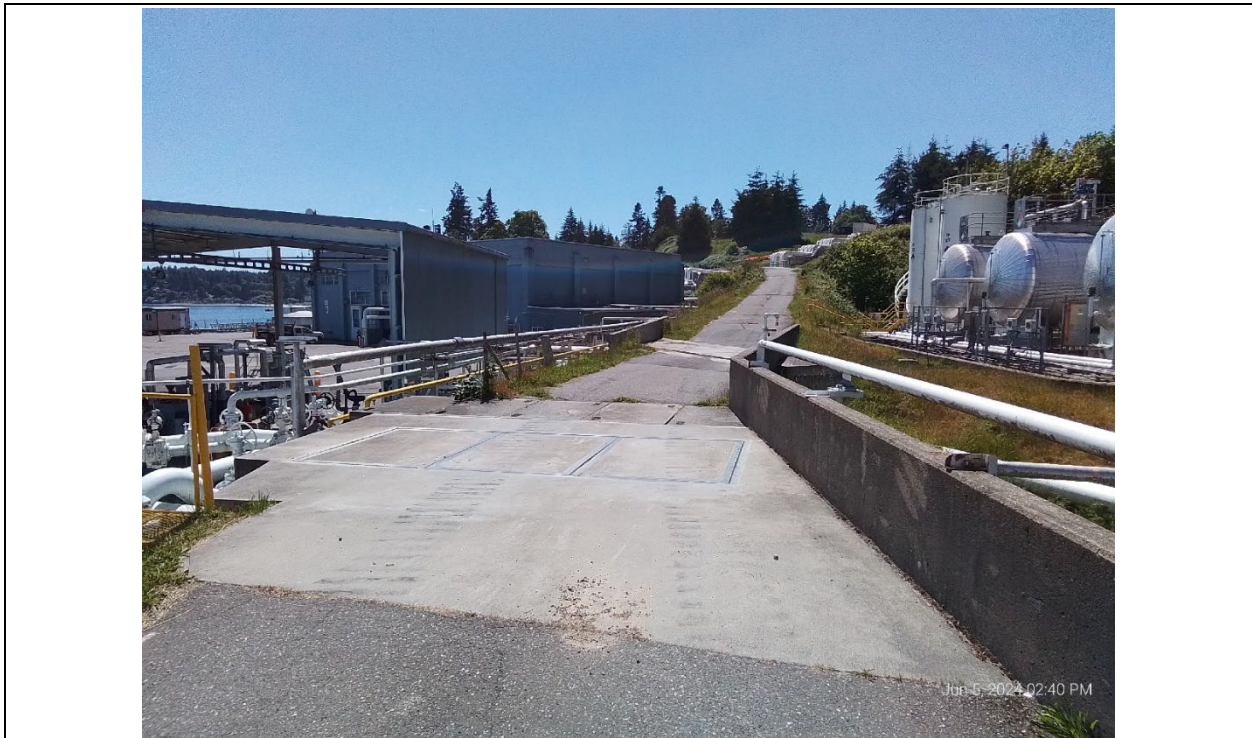
**Photograph 15**

Recently replaced concrete pad and vaults, along northwest boundary, facing southwest.

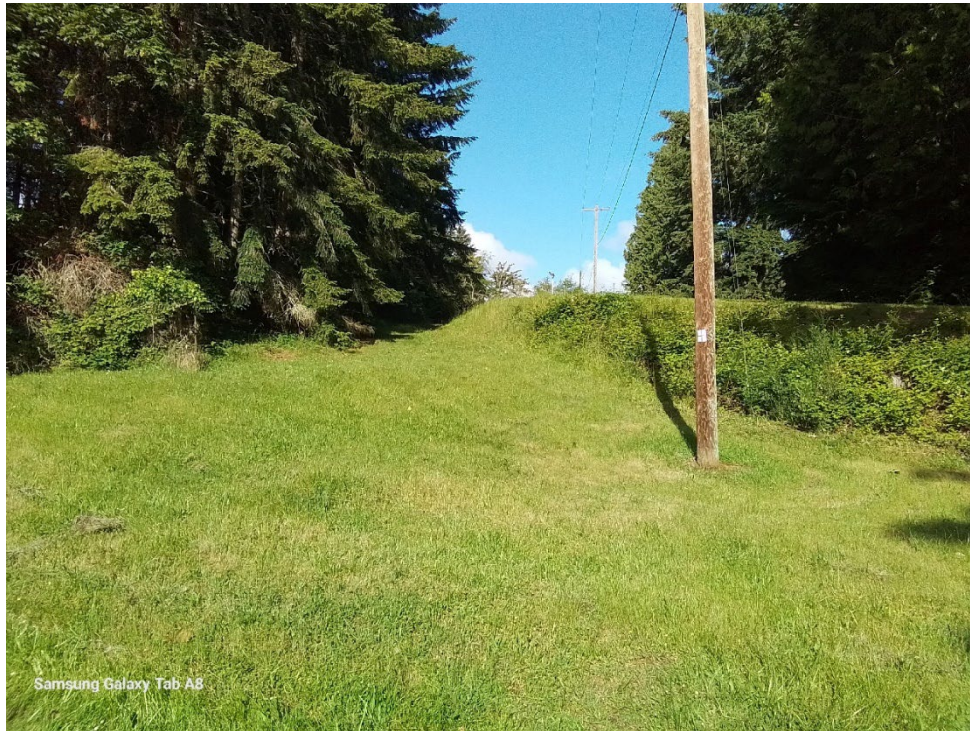
**Photograph 6**

Slope area cleared of trees, located along the northeast boundary, facing west.
