FINAL
APRIL 2022

2021 Land Use Controls Inspection Report

Naval Air Station Whidbey Island, Oak Harbor, Washington

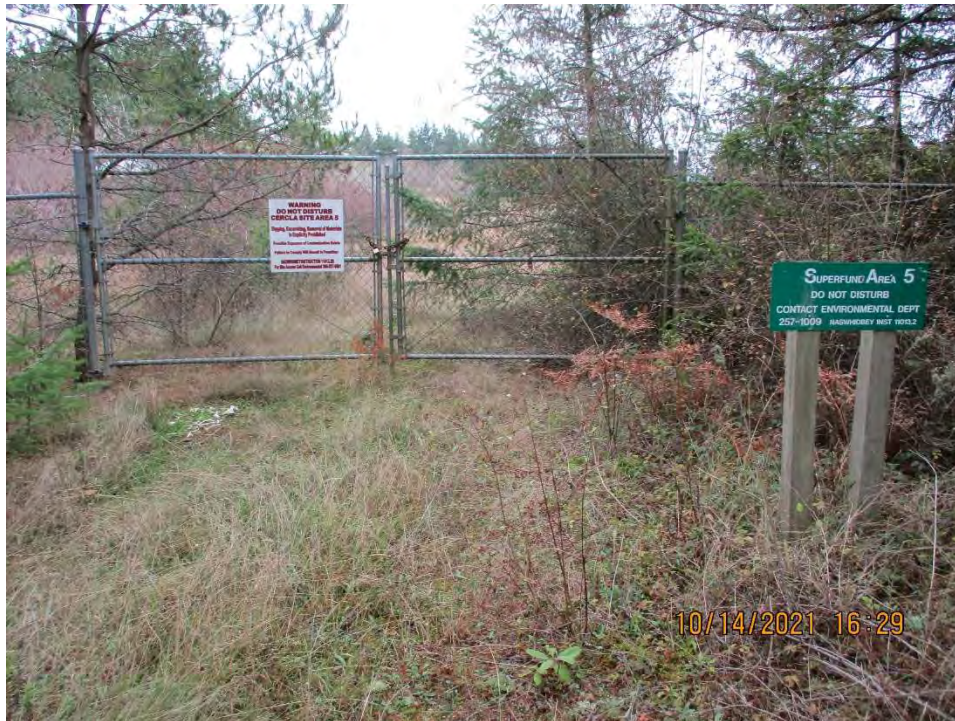
Site: OU 1 Area 5

A1: Gate and signage at road access on west side

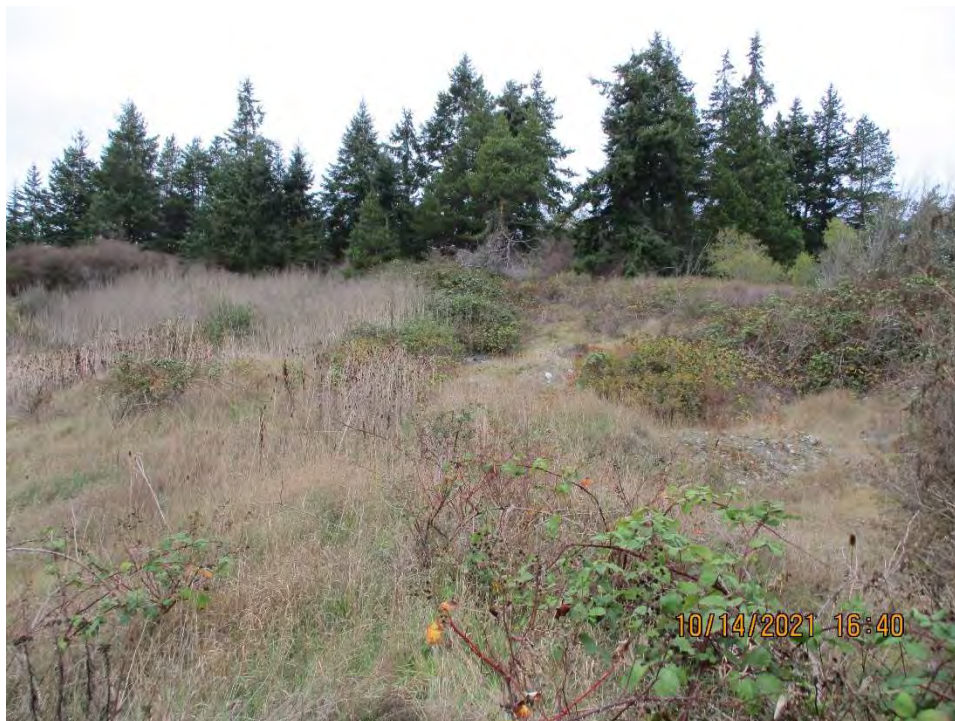
Site: OU 1 Area 5

A6: Southeast corner - stockpiles remain undisturbed

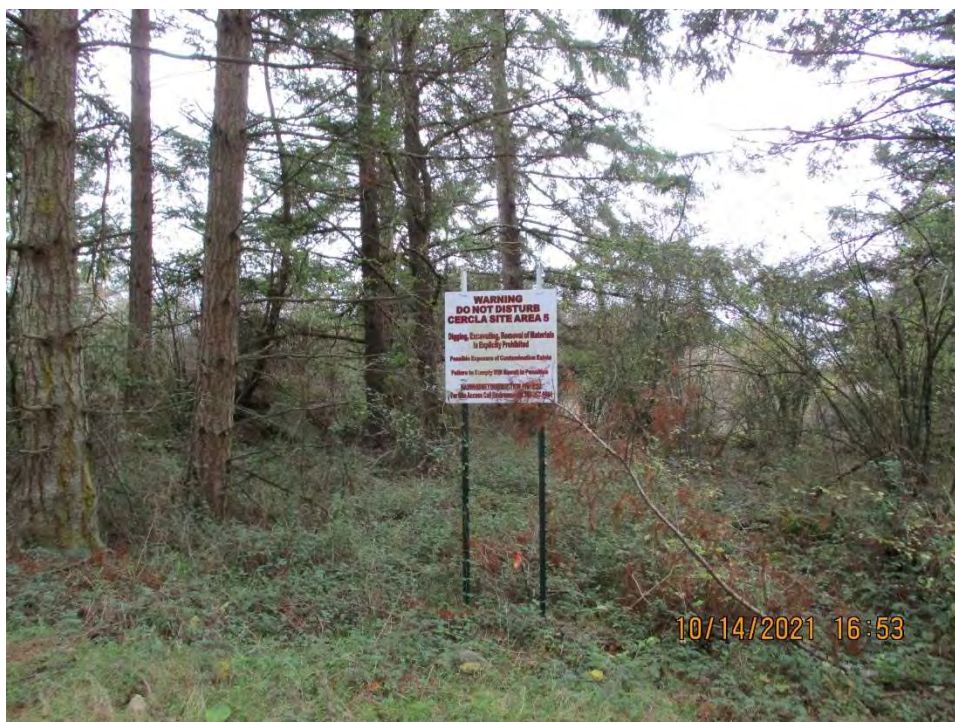
Site: OU 1 Area 5

A8: Signage on road north of site

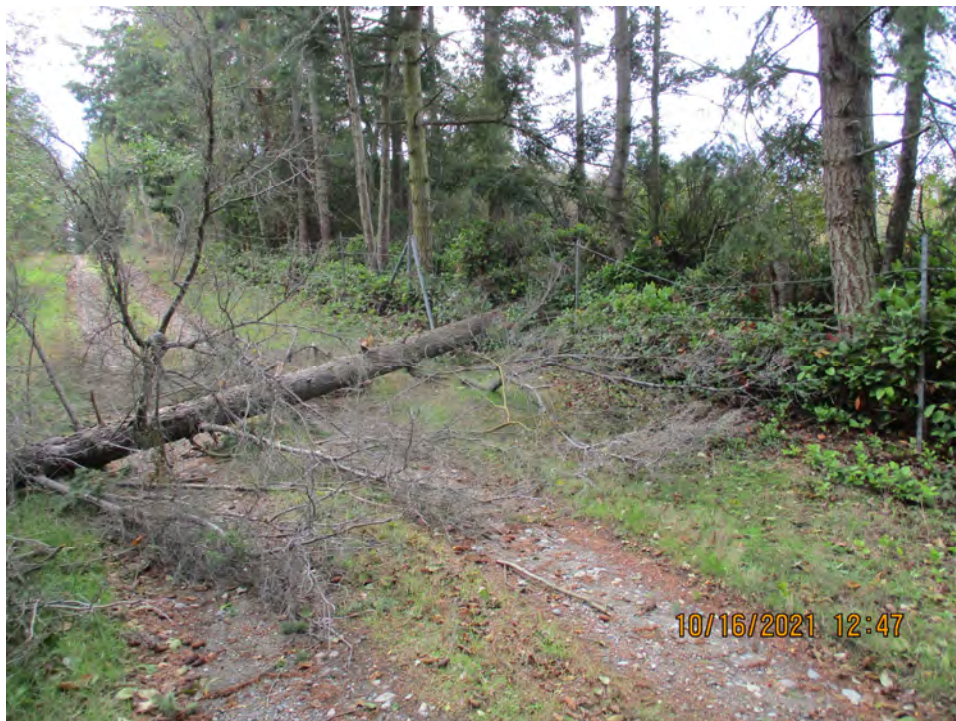
B4: Downed tree
resulting in
compromised fence
along western boundary
- in vicinity of 6-S-30

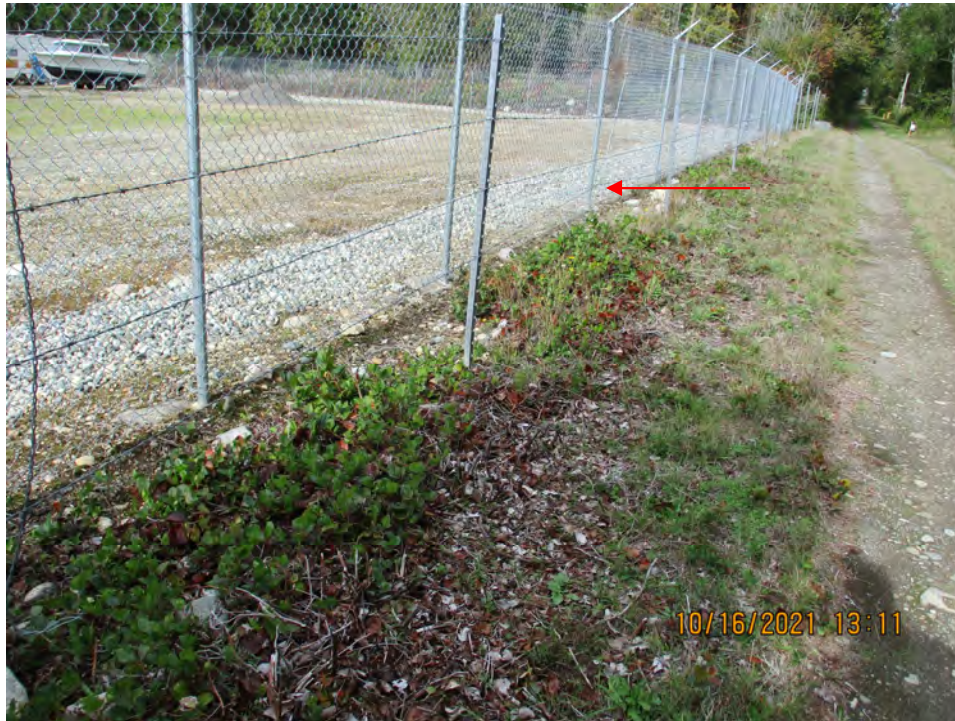
B11: Compromised
fencing along western
boundary adjacent to
storage facility

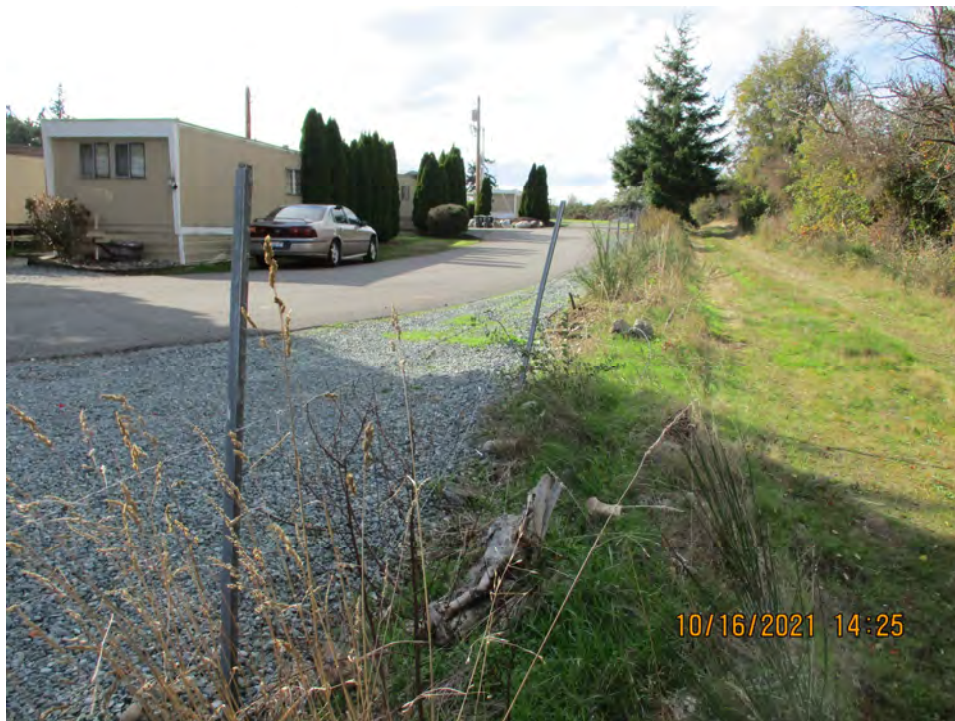
B36: Compromised fenceline on southeast corner facing southern boundary

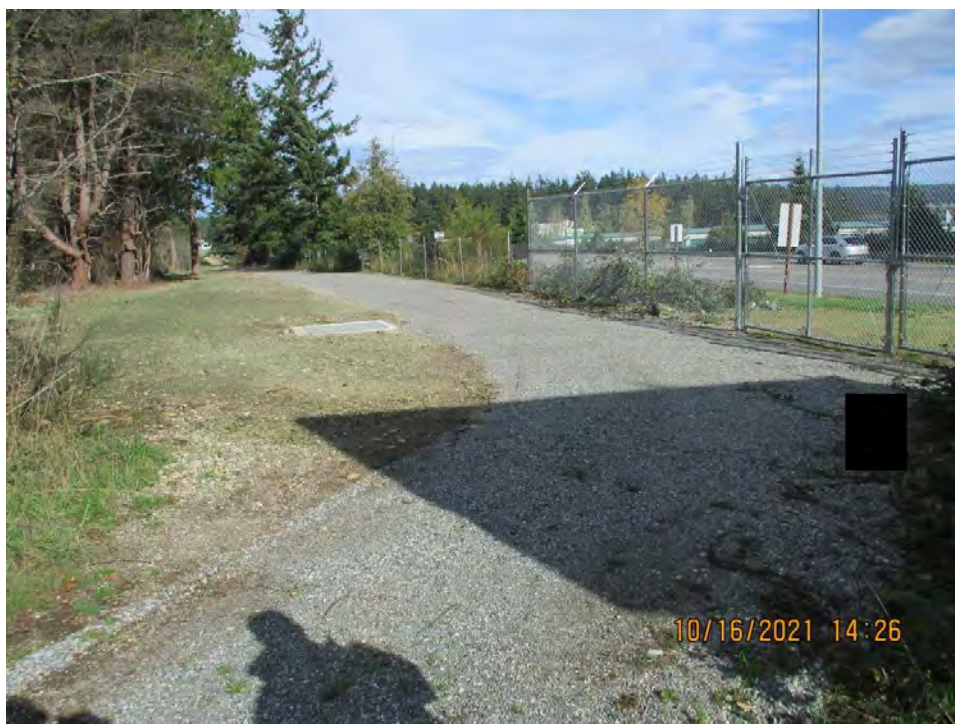
B38: Eastern boundary
from southeast corner
with new gate

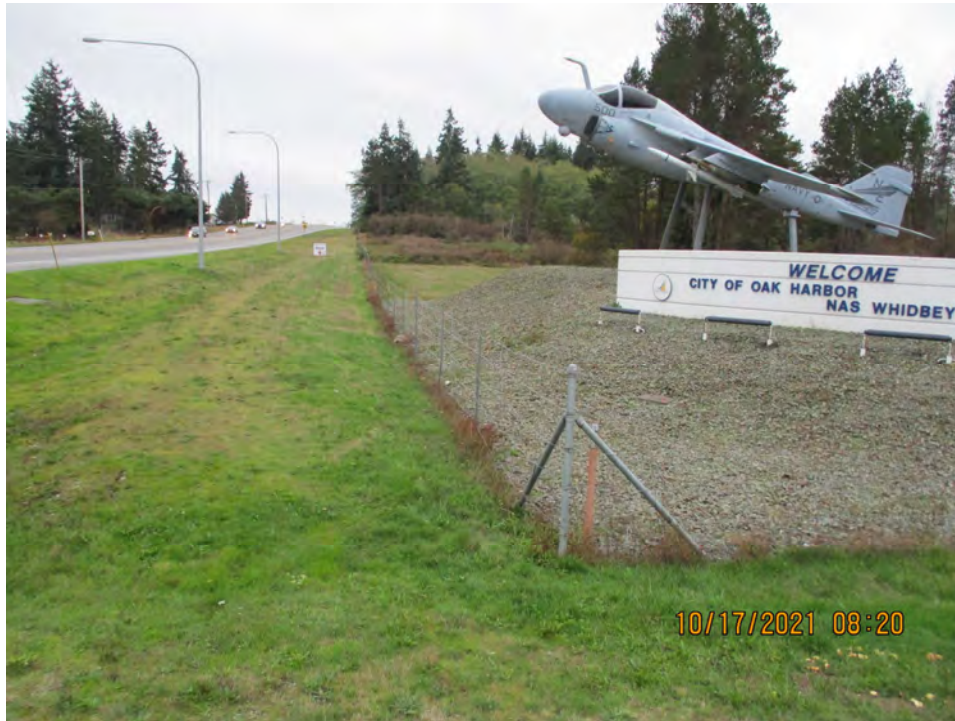
B88: Compromised fence in northeast corner

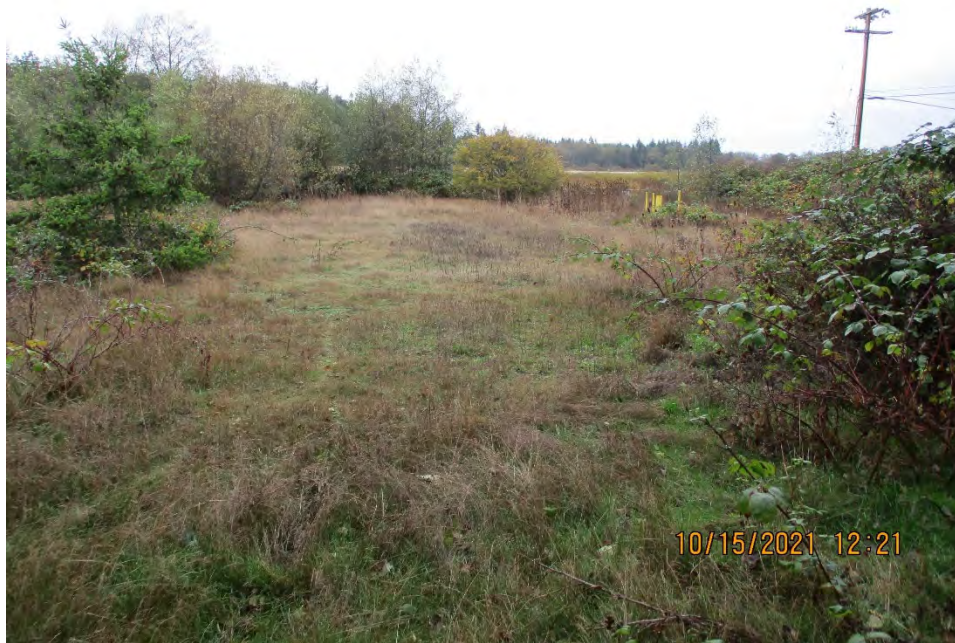
F7: Site overview from southeast corner looking north

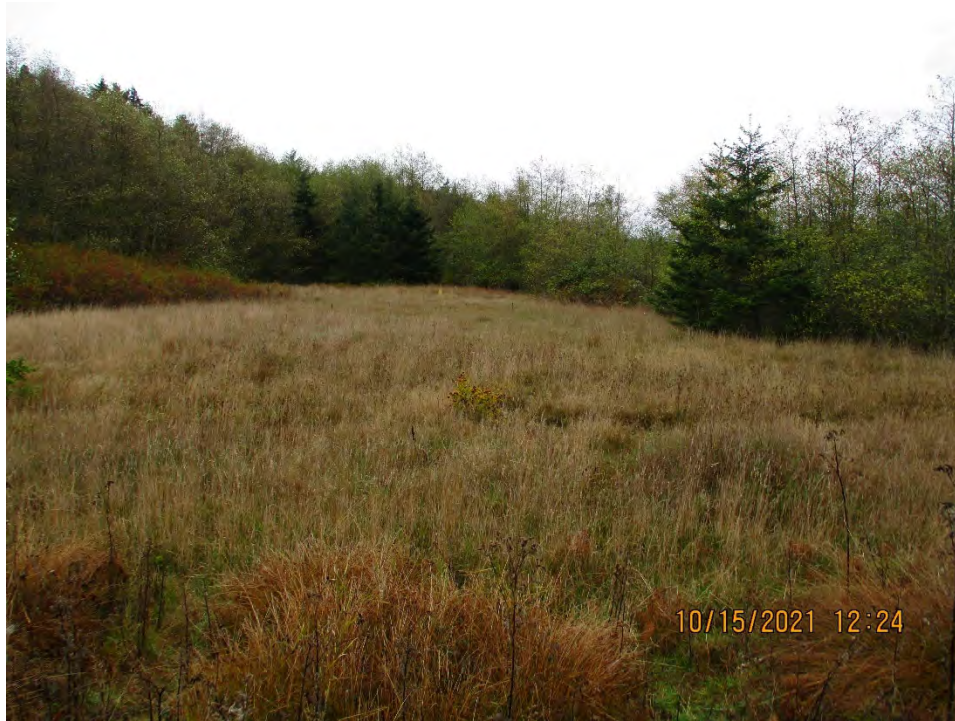
F9: Site overview from southwest corner facing north

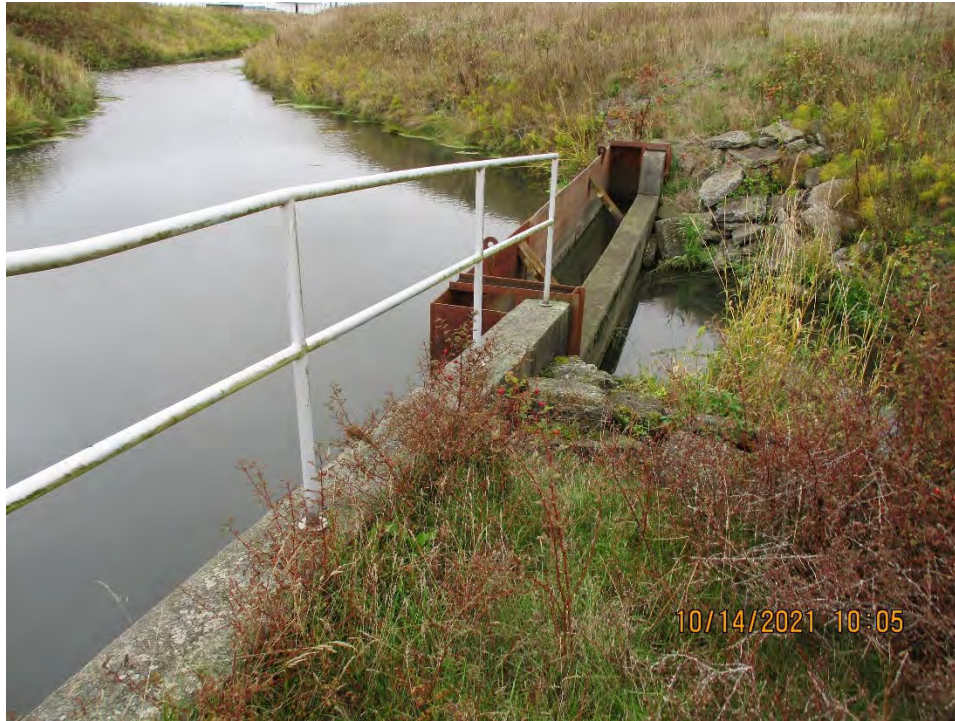
G5: 16b dammed weir

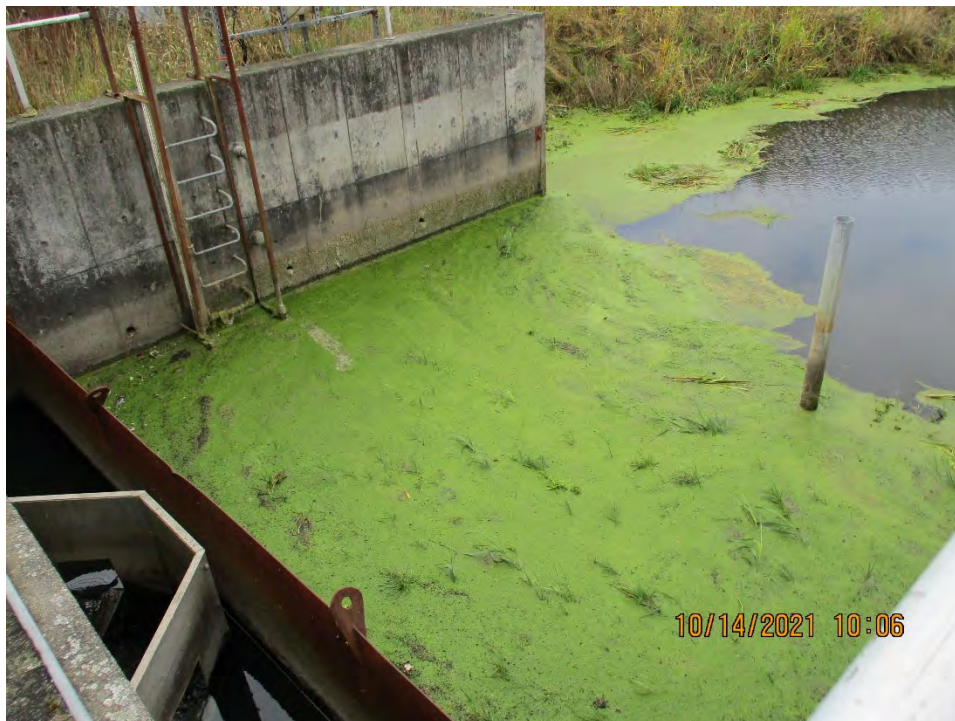
G6: 16b weir/filter

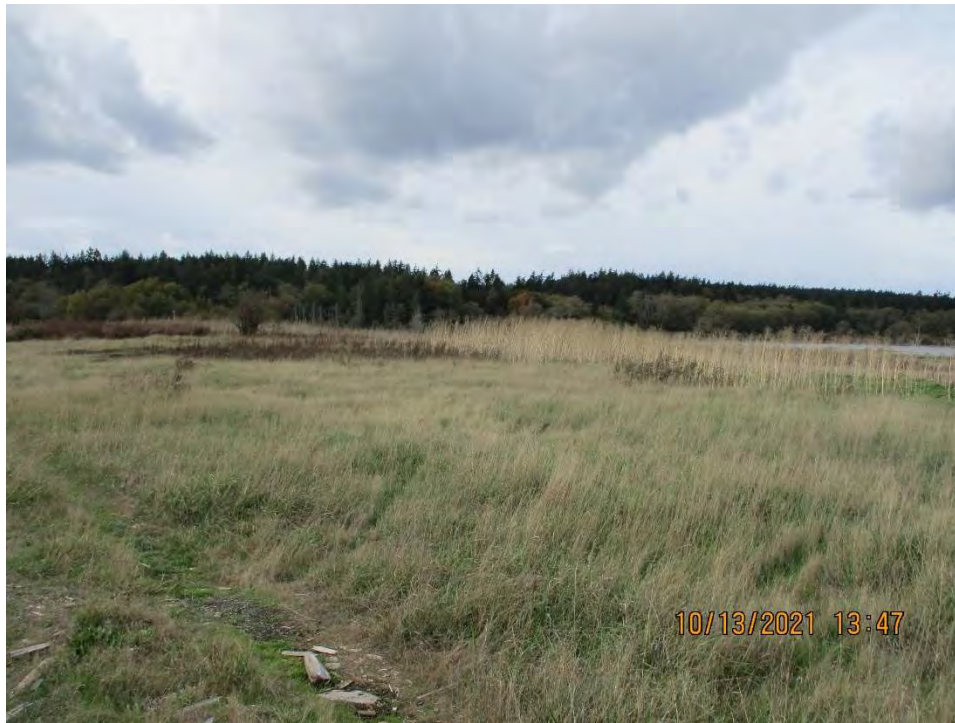
H6: Potential Erosion
along South Side

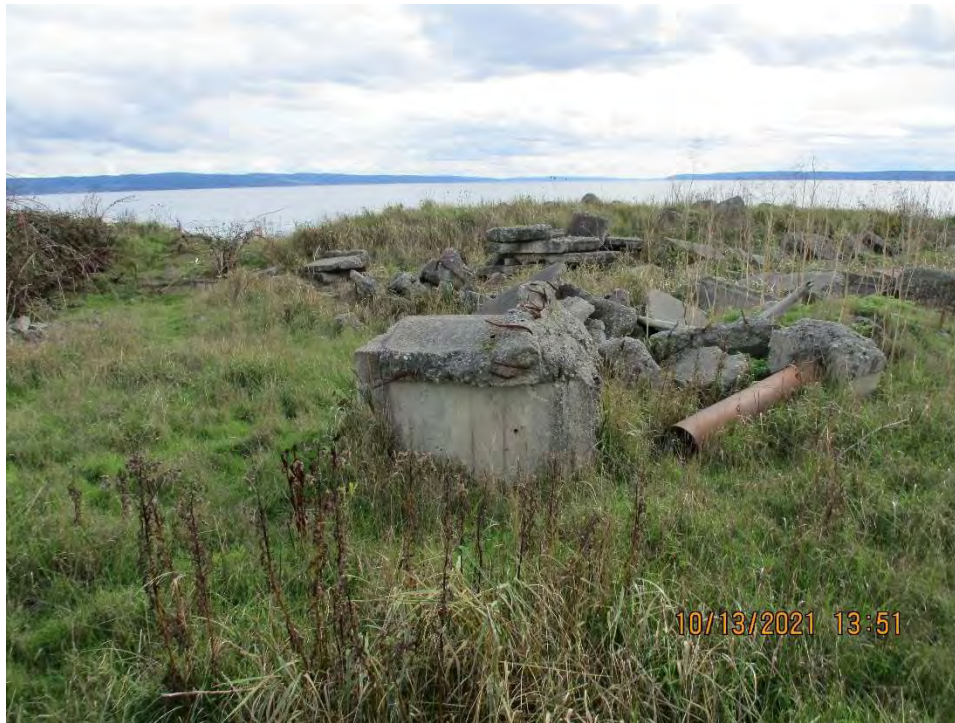
H8: Wood and concrete
debris along shoreline,
south side of site

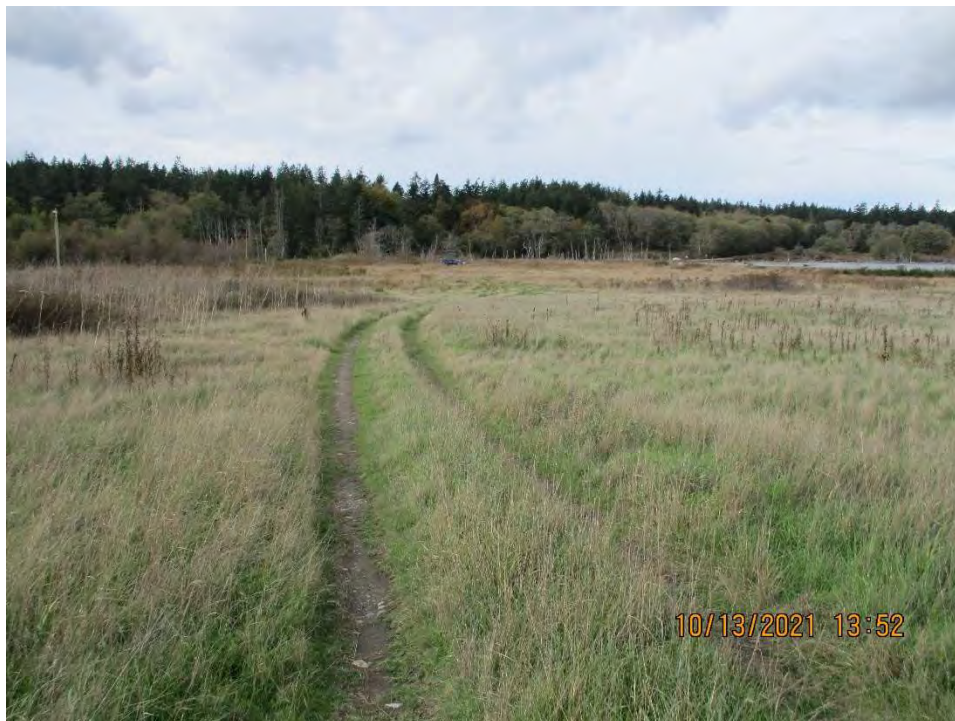
H9: Concrete debris
along south shoreline

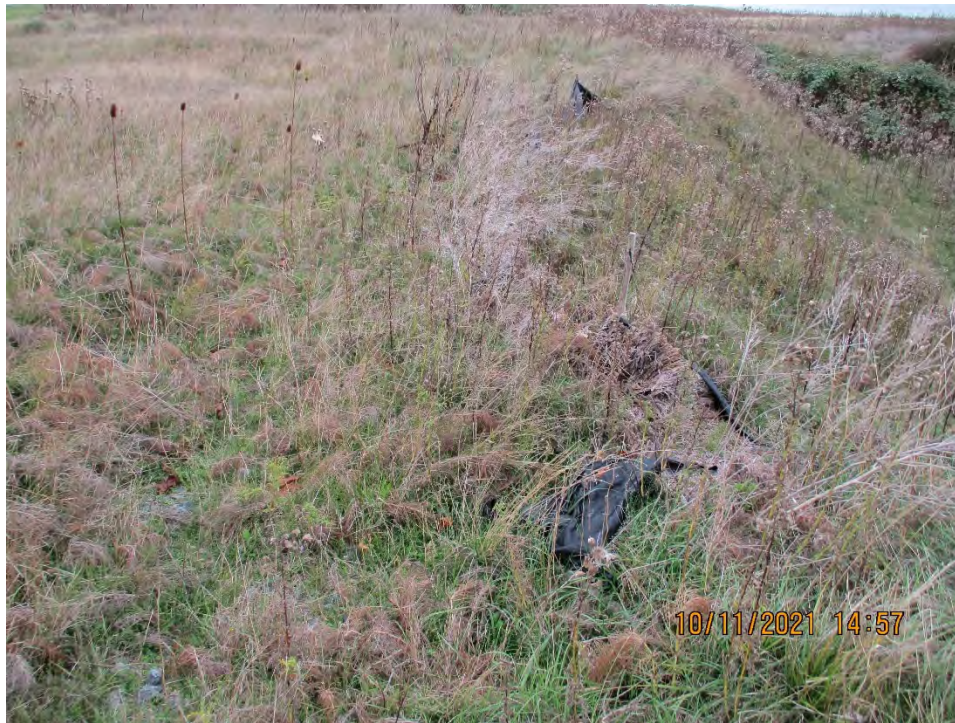
I2: Old CERCLA signage

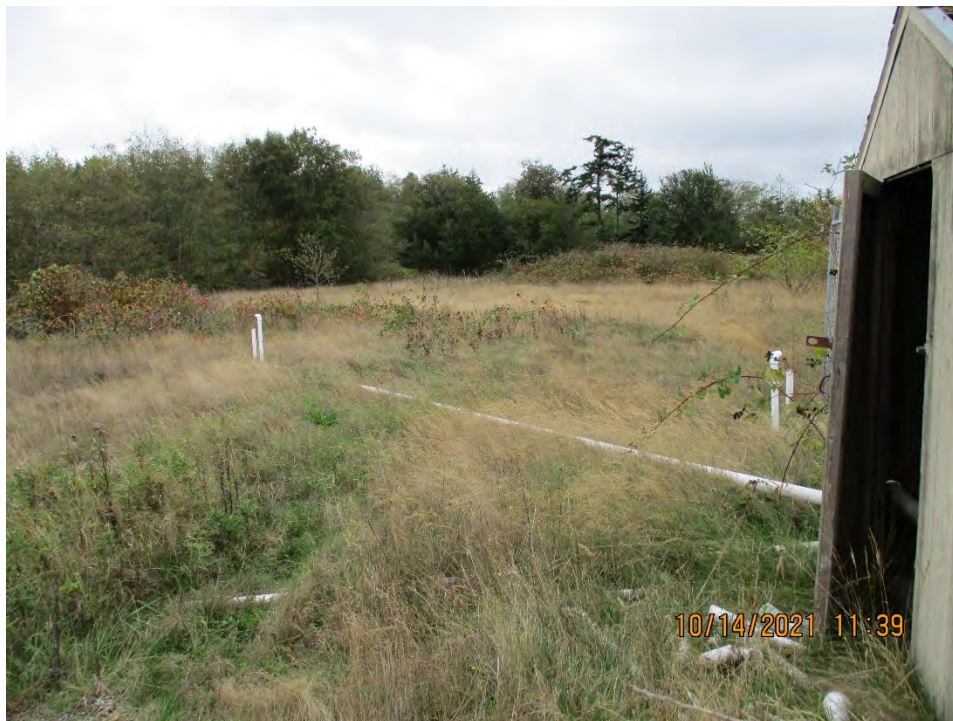
J7: Non-operational
AS/SVE System

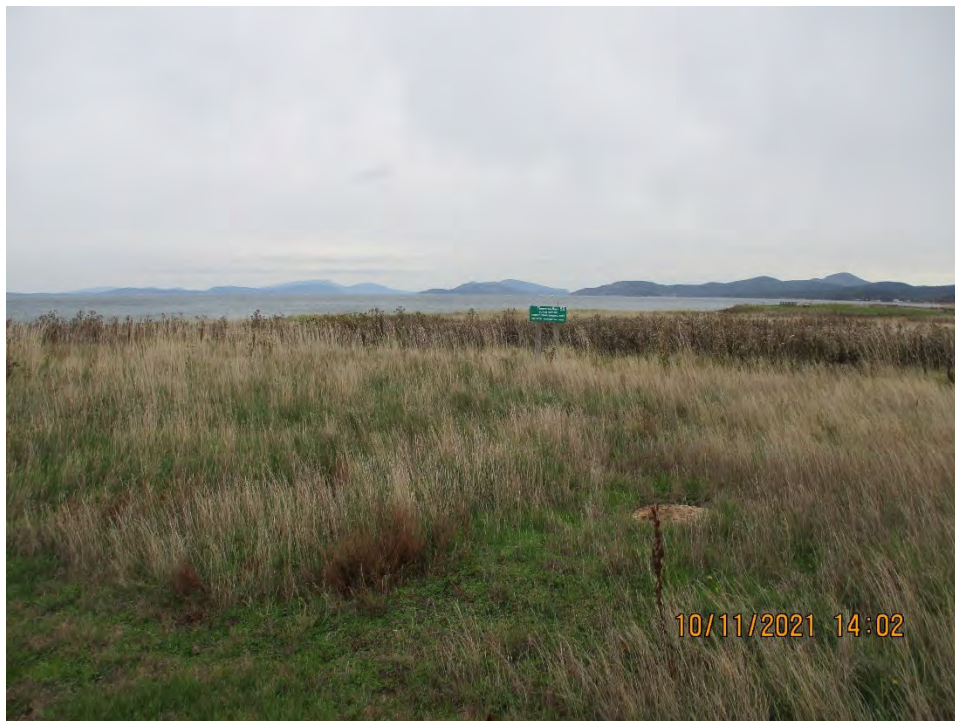
K1: Building demolition
post construction

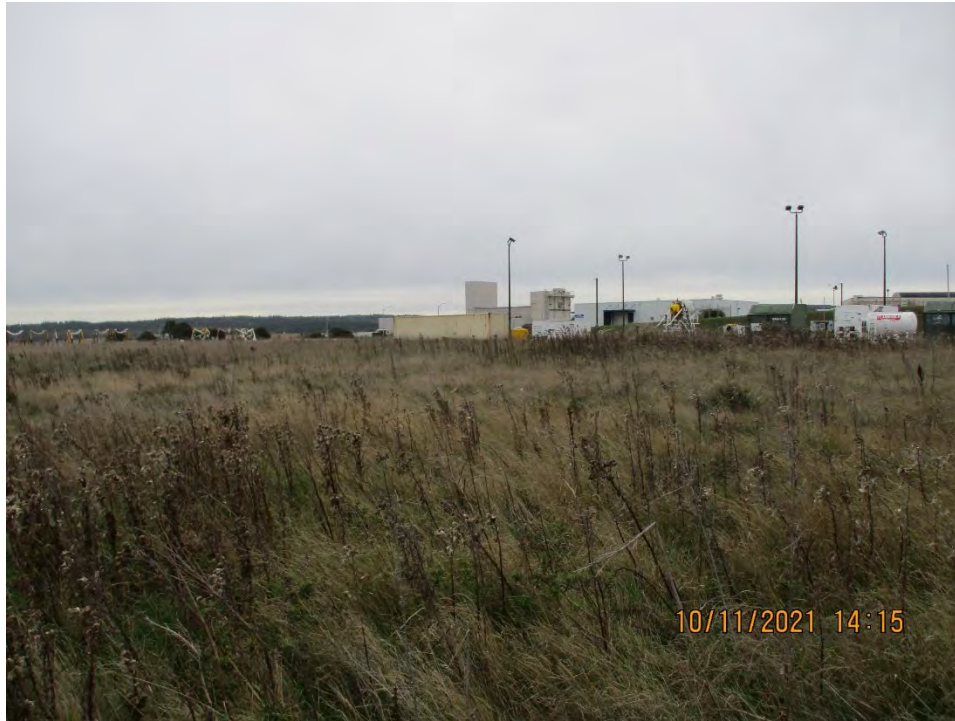
Site: OU 5 Area 52
K4: Regraded area
near staircase
Date: 10/12/2021

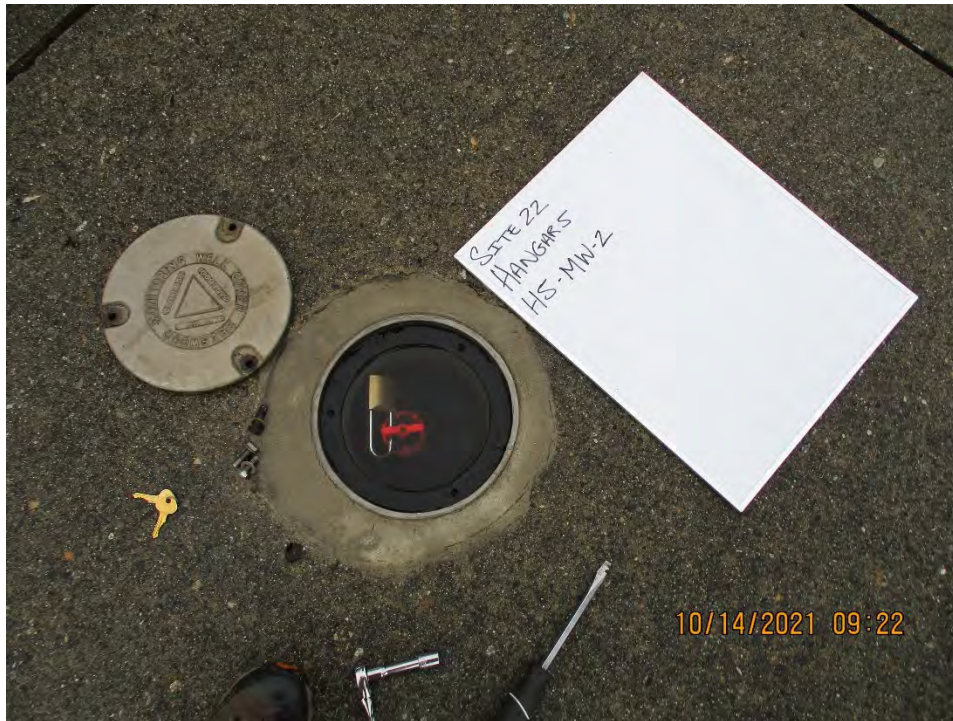
K13: Repaired flush
mount cover of
observed monitoring
well

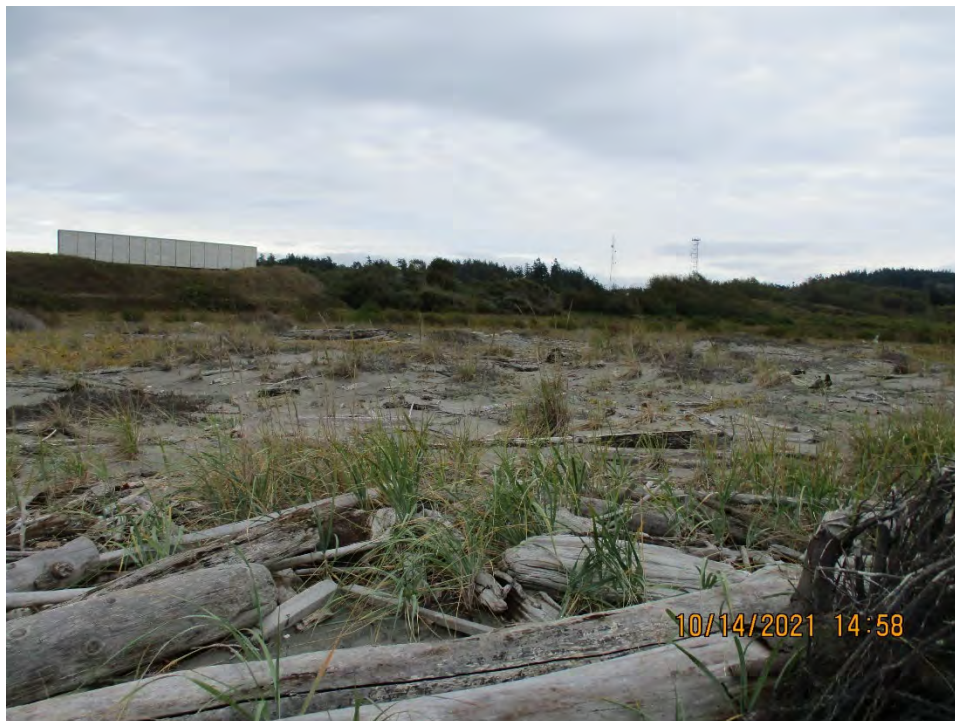
M14: Site overview
facing east from
northwest corner

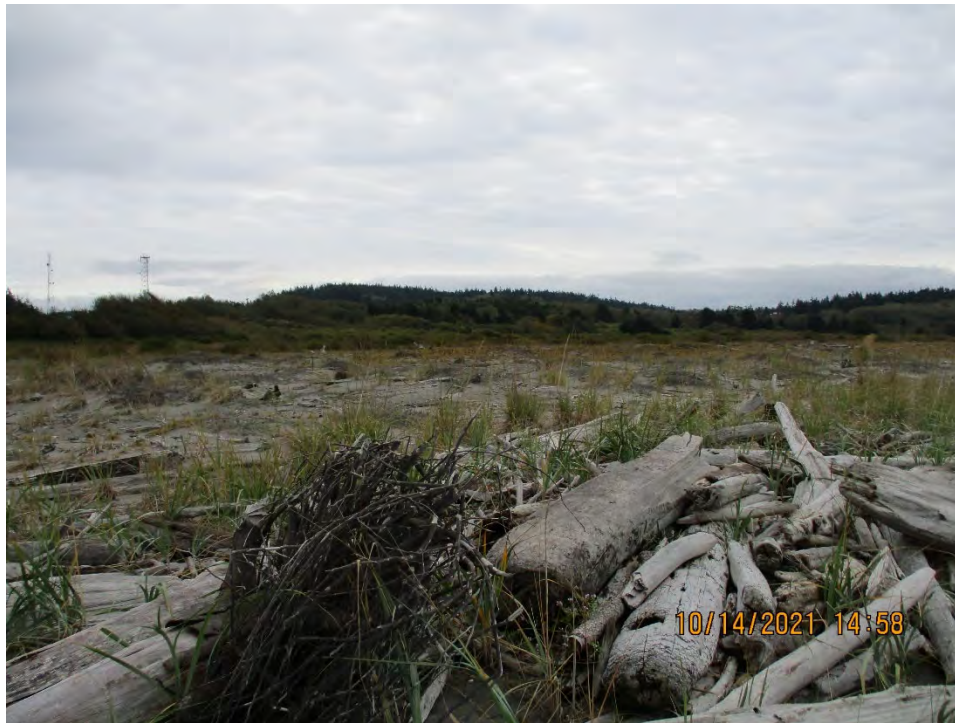
M15: Site overview
facing southeast from
northwest corner

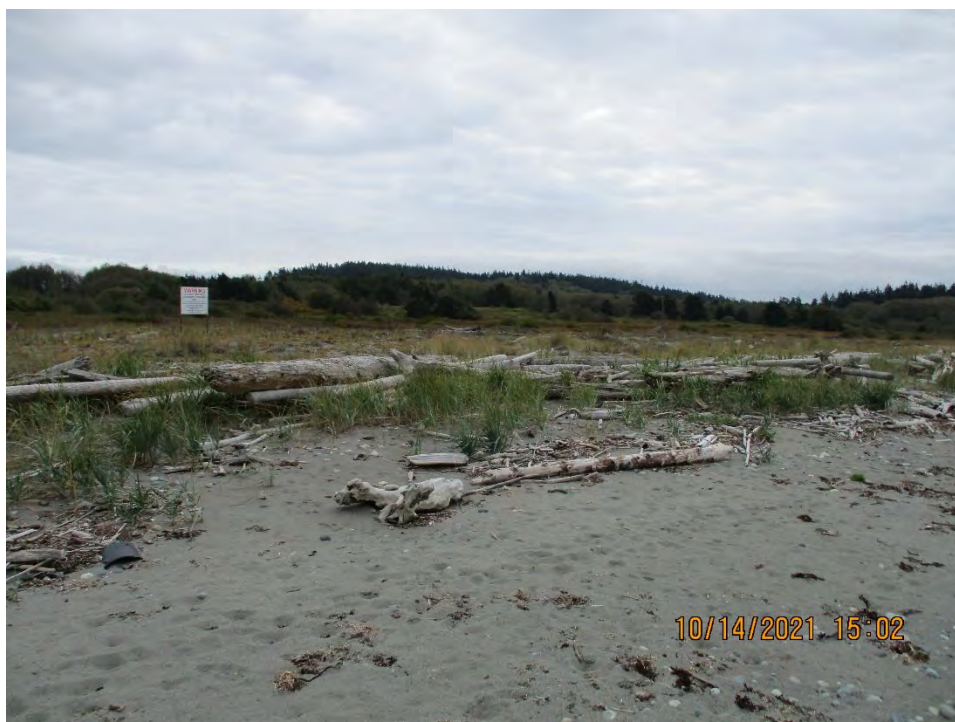
M16: Site overview
facing east from middle
of western boundary

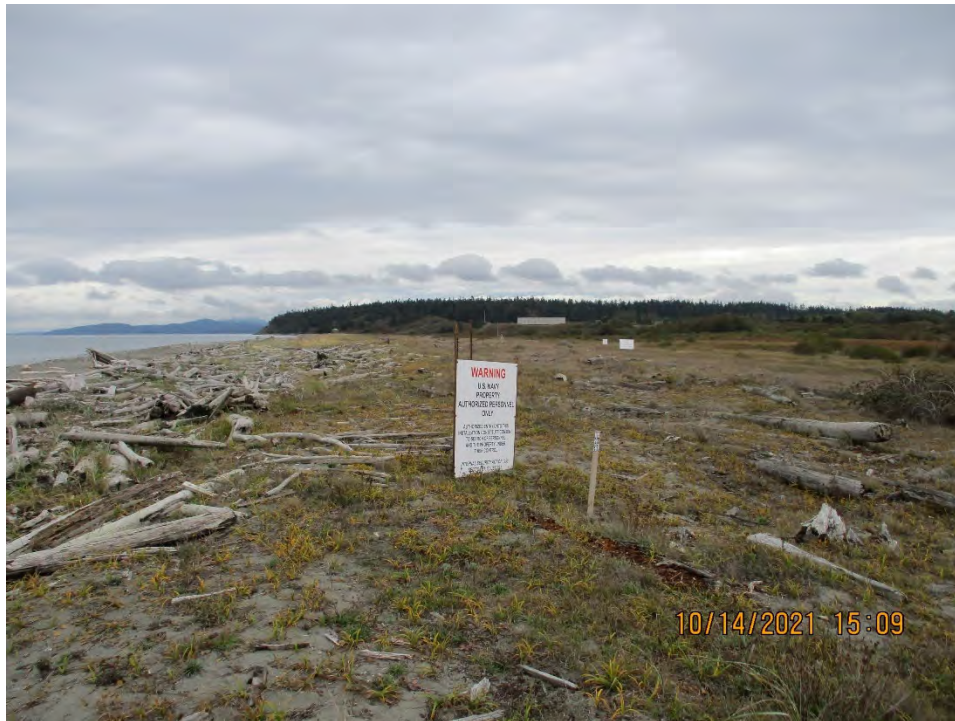
M17: Site overview
from southwest corner
facing northeast

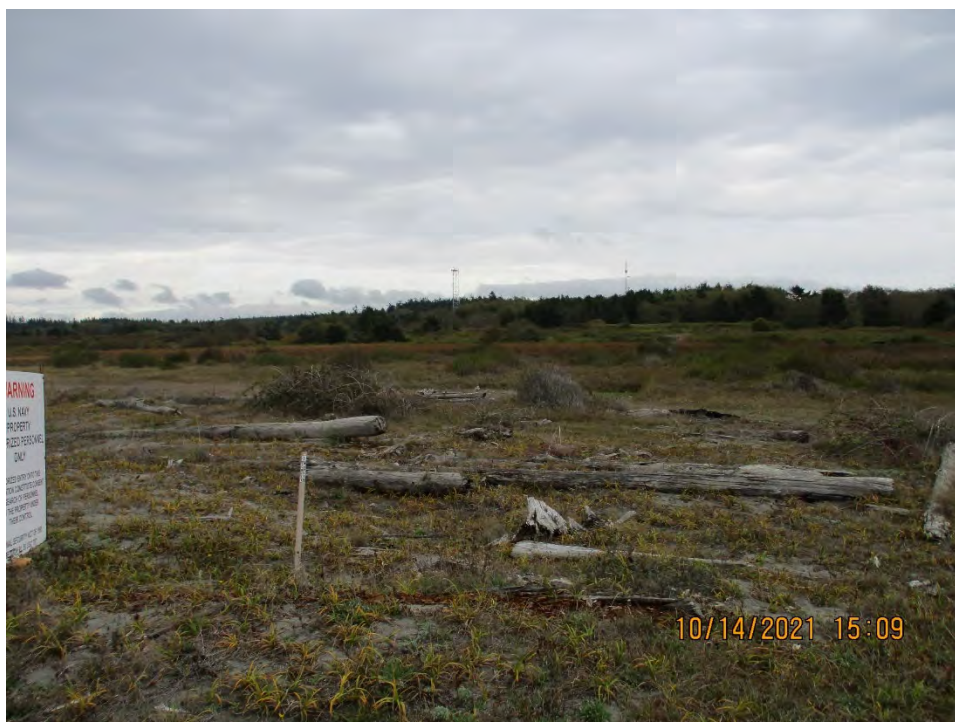
M18: Site overview
from southwest corner
facing east

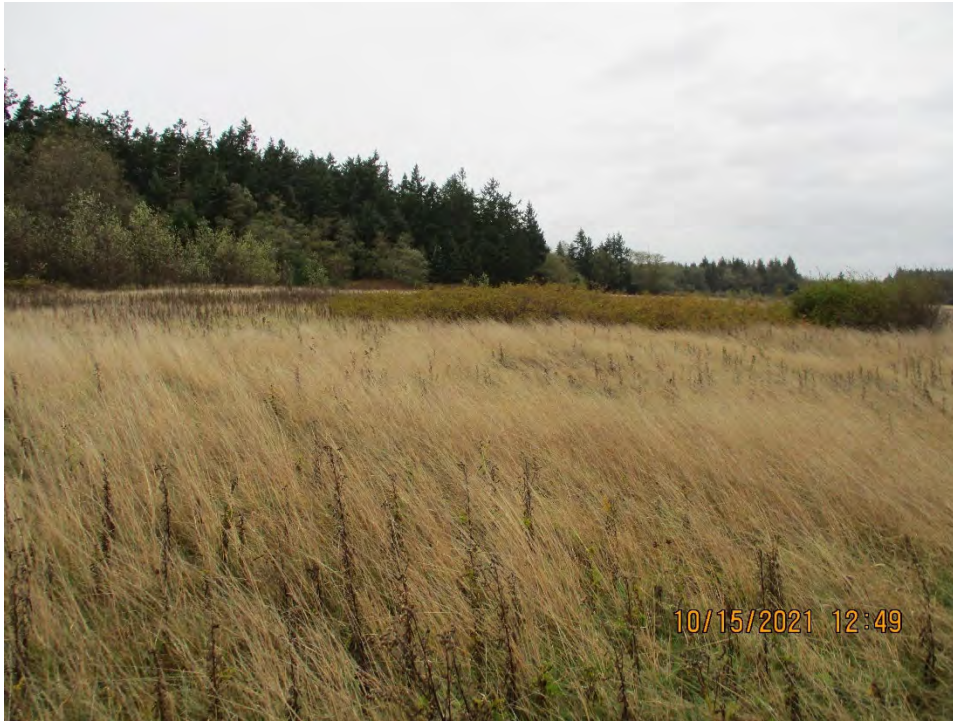
N1: Southern boundary,
middle, facing north

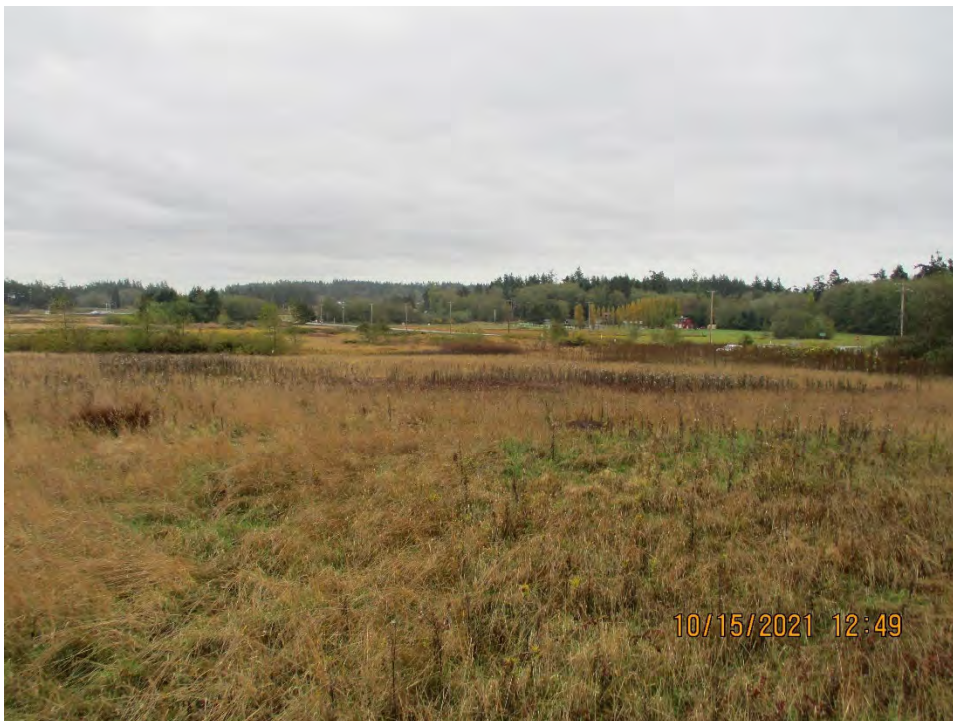
N2: Southern boundary,
middle, facing east

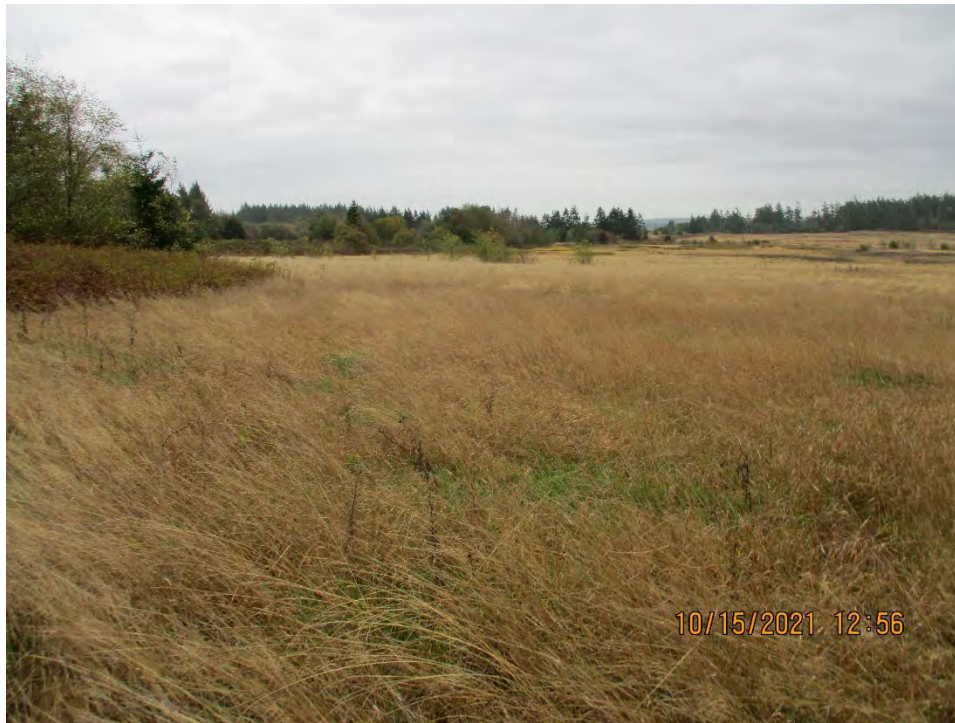
N3: Site overview from
central area facing
northeast

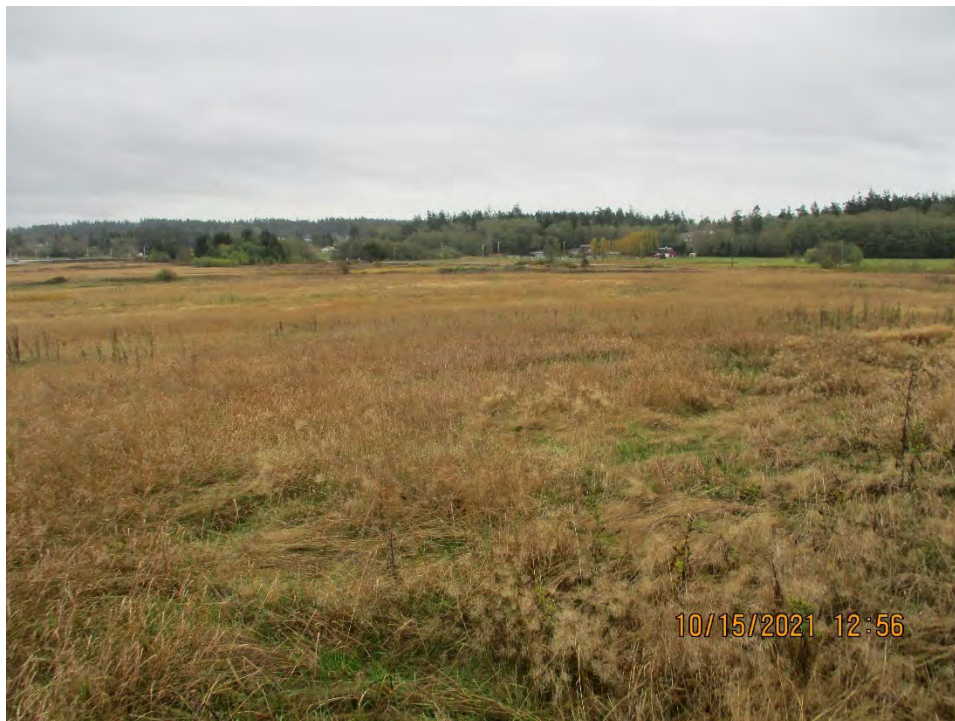
N4: Site overview from
central area facing
southeast

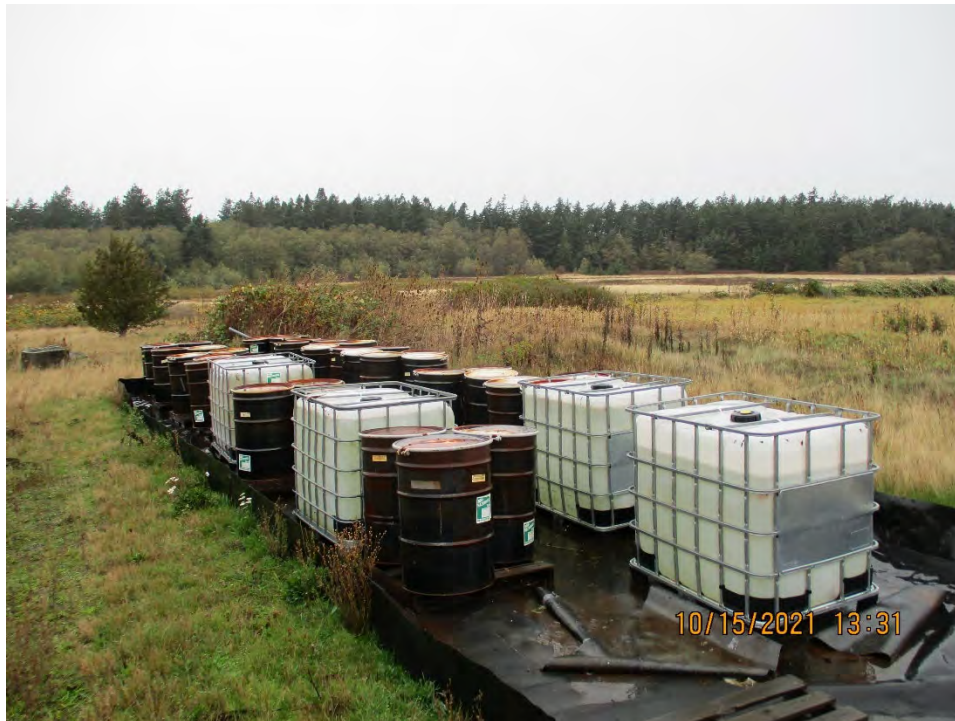
N9: Stored drums and
totes in secondary
containment

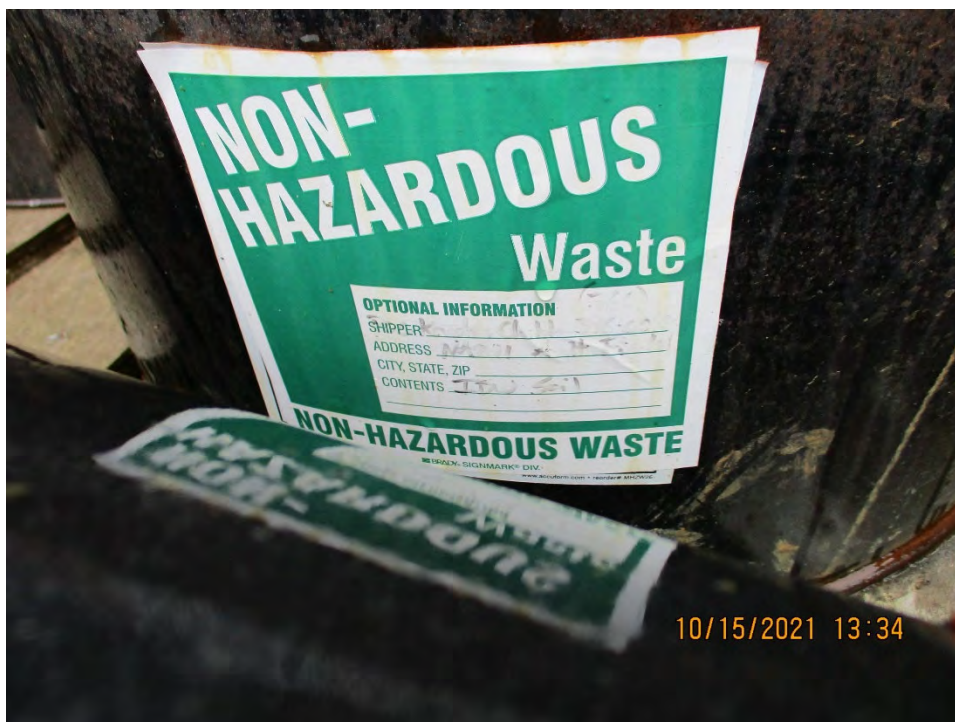
N10: NonHaz label on
stored drum

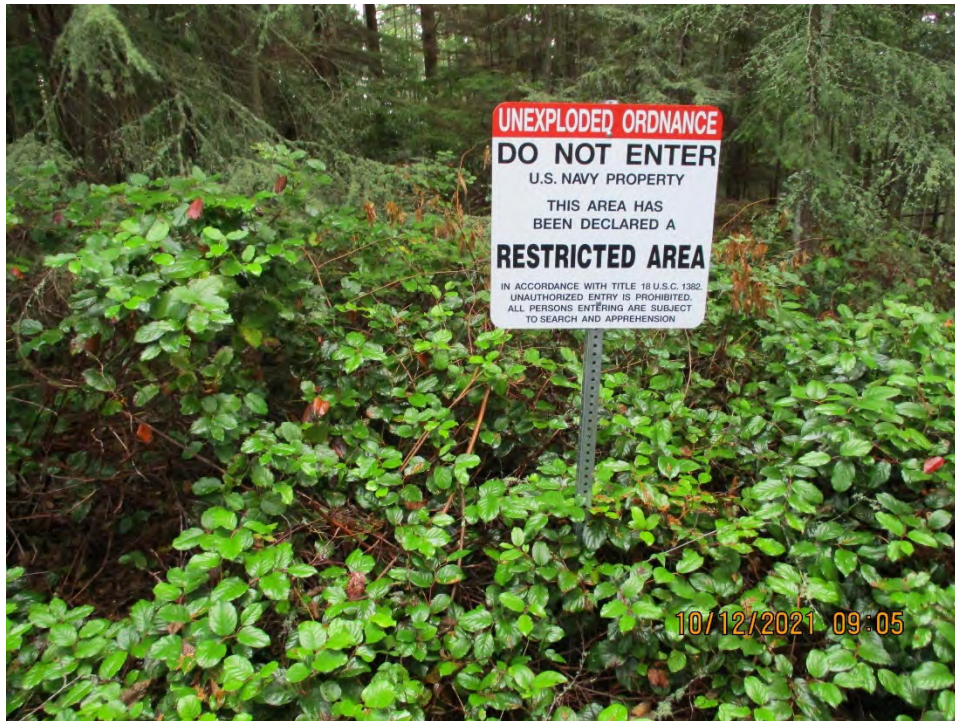
O7: New signage

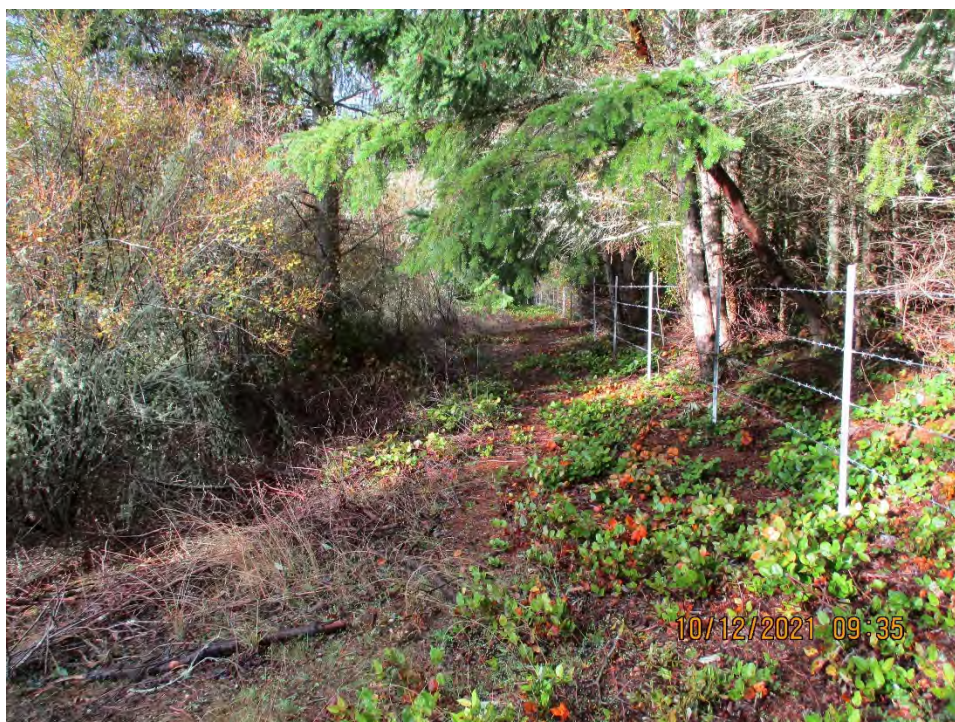
O12: Northern site
boundary
